**Project Number 2481**

**Management  
Asbestos Survey Report**

**675 Army Air Corps, Somerset, TA1 5LJ**

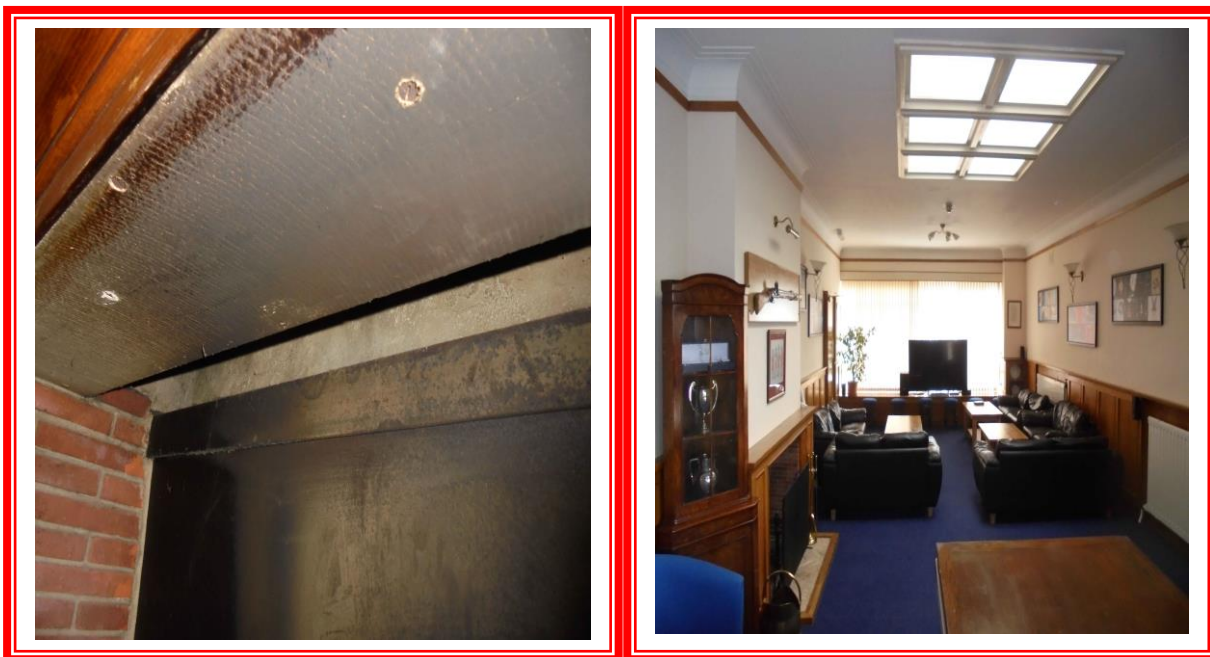
**Location: Officers Lounge – First Floor**

<b>Material Description:</b>	Panel to top of fireplace	
<b>Identification:</b>	Sampled – Asbestos Detected	
<b>Approx. quantity:</b>	1M2	
<b>Accessibility</b>	Low	<i>Assessment Score</i>
<b>Product type:</b>	Cement	1
<b>Extent of Damage:</b>	Minor	1
<b>Surface Treatment:</b>	Unsealed	1
<b>Asbestos type:</b>	Chrysotile	1
<b>Material Assessment Score:</b>		4
<b>Priority Assessment Score:</b>		Negligible
<b>Action:</b>	Manage/Encapsulate	
<b>Comments:</b>	N/A

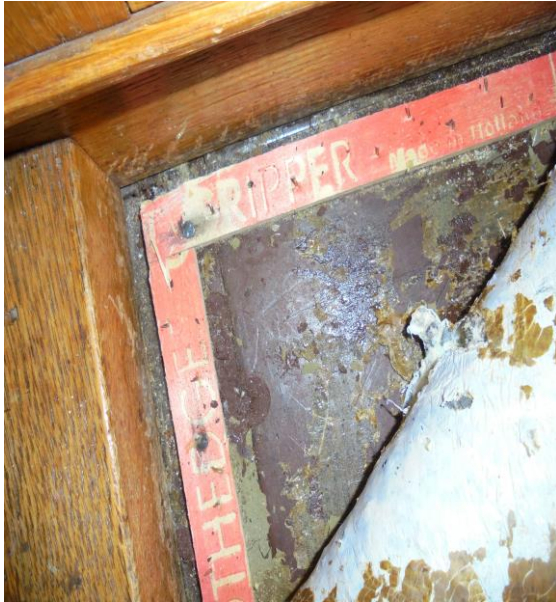
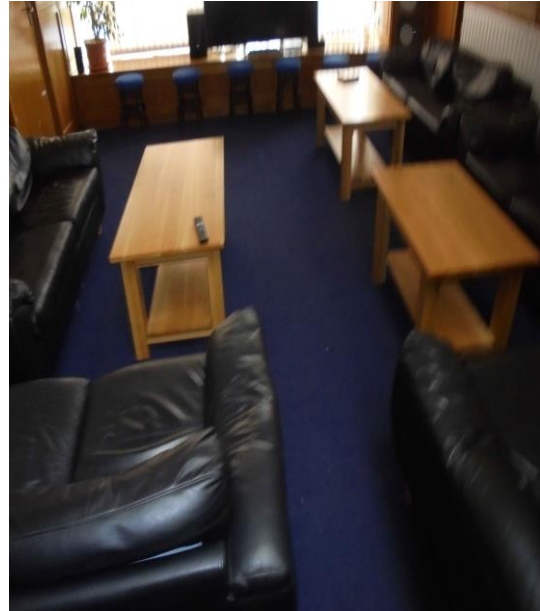
**Location: Officers Lounge – First Floor**

<b>Material Description:</b>	Floor tiles under carpet	
<b>Identification:</b>	Sampled – Asbestos Detected	
<b>Approx. quantity:</b>	50M2	
<b>Accessibility</b>	Low	<i>Assessment Score</i>
<b>Product type:</b>	Cement	1
<b>Extent of Damage:</b>	Minor	1
<b>Surface Treatment:</b>	Non-Friable	0
<b>Asbestos type:</b>	Chrysotile	1
<b>Material Assessment Score:</b>		3
<b>Priority Assessment Score:</b>		Negligible
<b>Action:</b>	Manage	
<b>Comments:</b>	N/A

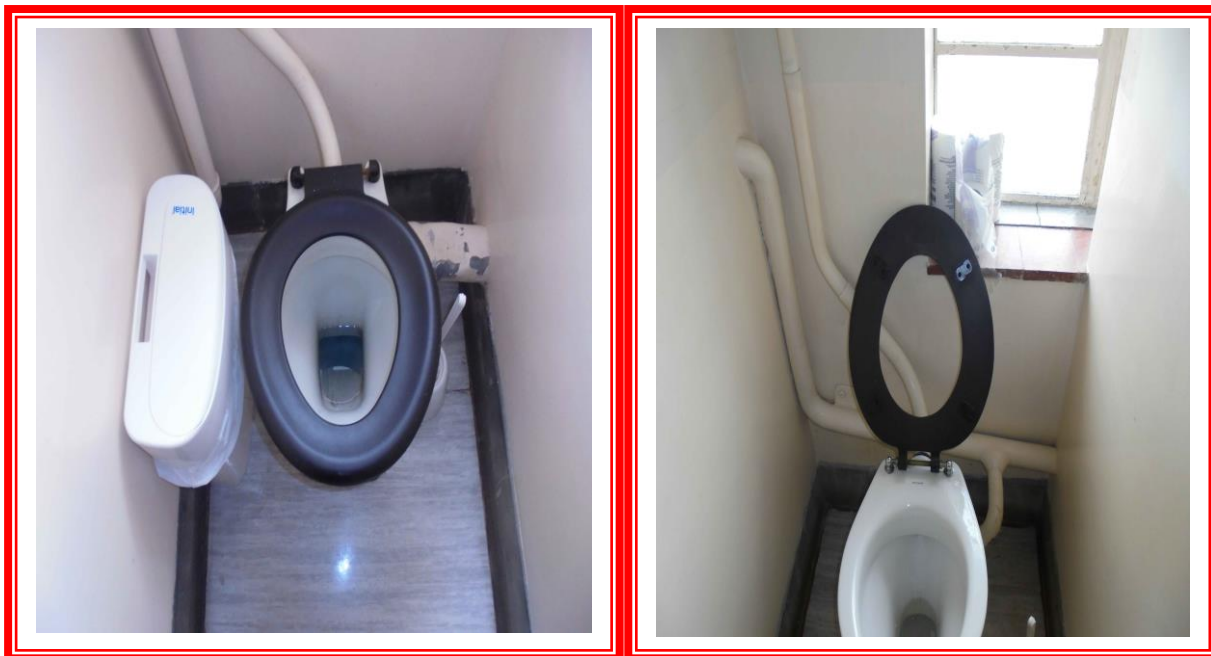
**Item No: 4****Sample No: N/A****Location: WC's x 2**

<b>Material Description:</b>	Reinforced plastic toilet seats	
<b>Identification:</b>	Presumed to Contain Asbestos	
<b>Approx. quantity:</b>	X 2	
<b>Accessibility</b>	High	<i>Assessment Score</i>
<b>Product type:</b>	Composite	1
<b>Extent of Damage:</b>	Good	0
<b>Surface Treatment:</b>	Non-Friable	0
<b>Asbestos type:</b>	Chrysotile	1
<b>Material Assessment Score:</b>		2
<b>Priority Assessment Score:</b>		Negligible
<b>Action:</b>	Manage	
<b>Comments:</b>	No access to samples as it would damage the integrity of the seat

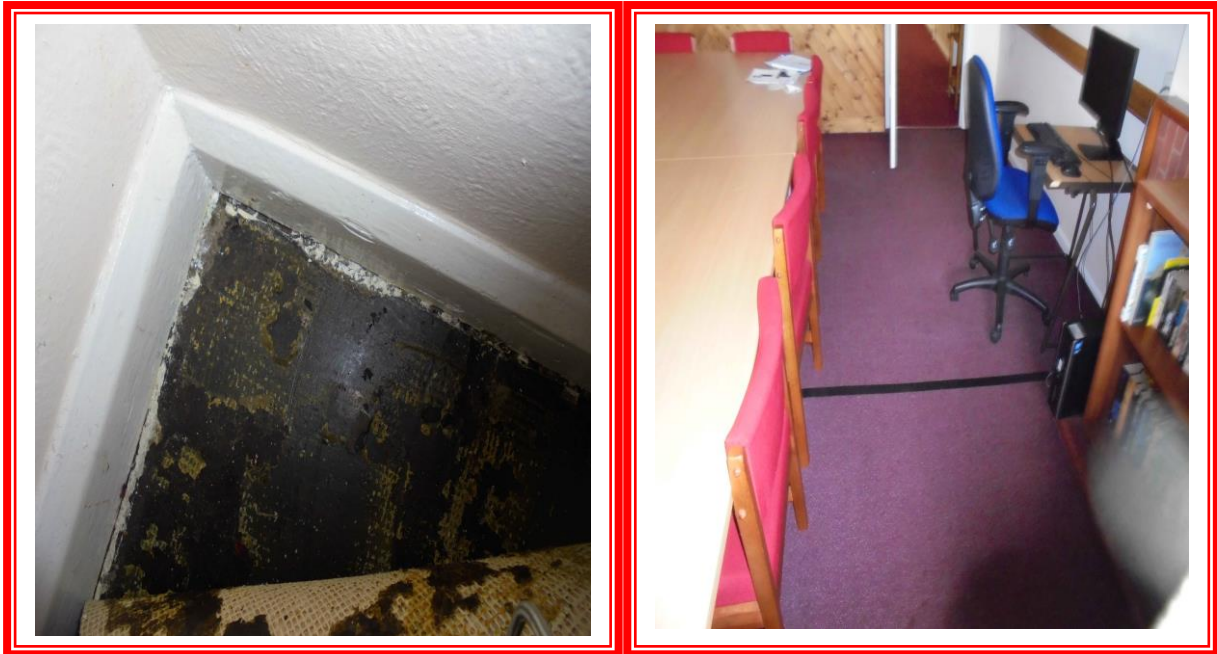
<b>Material Description:</b>	Floor tiles under carpet	
<b>Identification:</b>	Sampled – Asbestos Detected	
<b>Approx. quantity:</b>	35M2	
<b>Accessibility</b>	Low	<i>Assessment Score</i>
<b>Product type:</b>	Composite	1
<b>Extent of Damage:</b>	Minor	1
<b>Surface Treatment:</b>	Non-Friable	0
<b>Asbestos type:</b>	Chrysotile	1
<b>Material Assessment Score:</b>		3
<b>Priority Assessment Score:</b>		Negligible
<b>Action:</b>	Manage	
<b>Comments:</b>	N/A

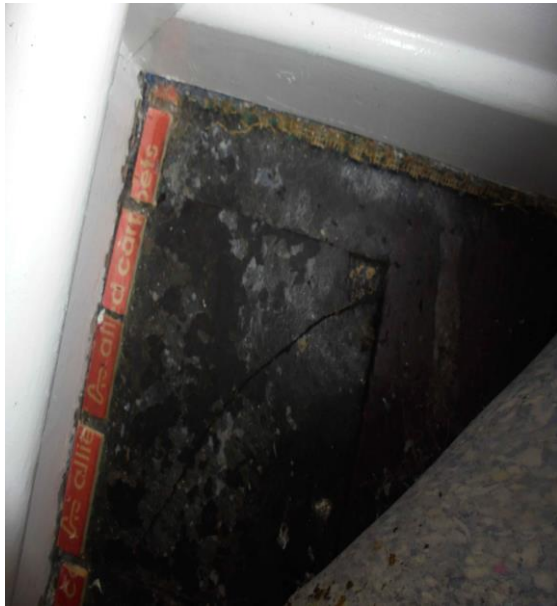
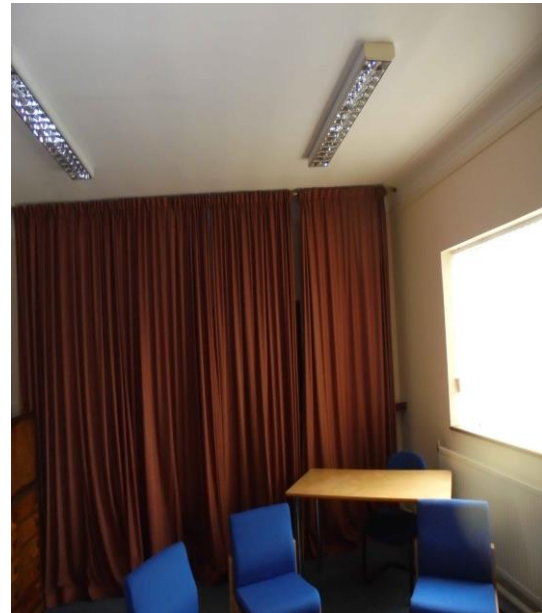
<b>Material Description:</b>	Floor tiles and adhesive under carpet	
<b>Identification:</b>	Sampled – Asbestos Detected	
<b>Approx. quantity:</b>	36M2	
<b>Accessibility</b>	Low	<i>Assessment Score</i>
<b>Product type:</b>	Composite	1
<b>Extent of Damage:</b>	Minor	1
<b>Surface Treatment:</b>	Non-Friable	0
<b>Asbestos type:</b>	Chrysotile	1
<b>Material Assessment Score:</b>		3
<b>Priority Assessment Score:</b>		Negligible
<b>Action:</b>	Manage	
<b>Comments:</b>	N/A

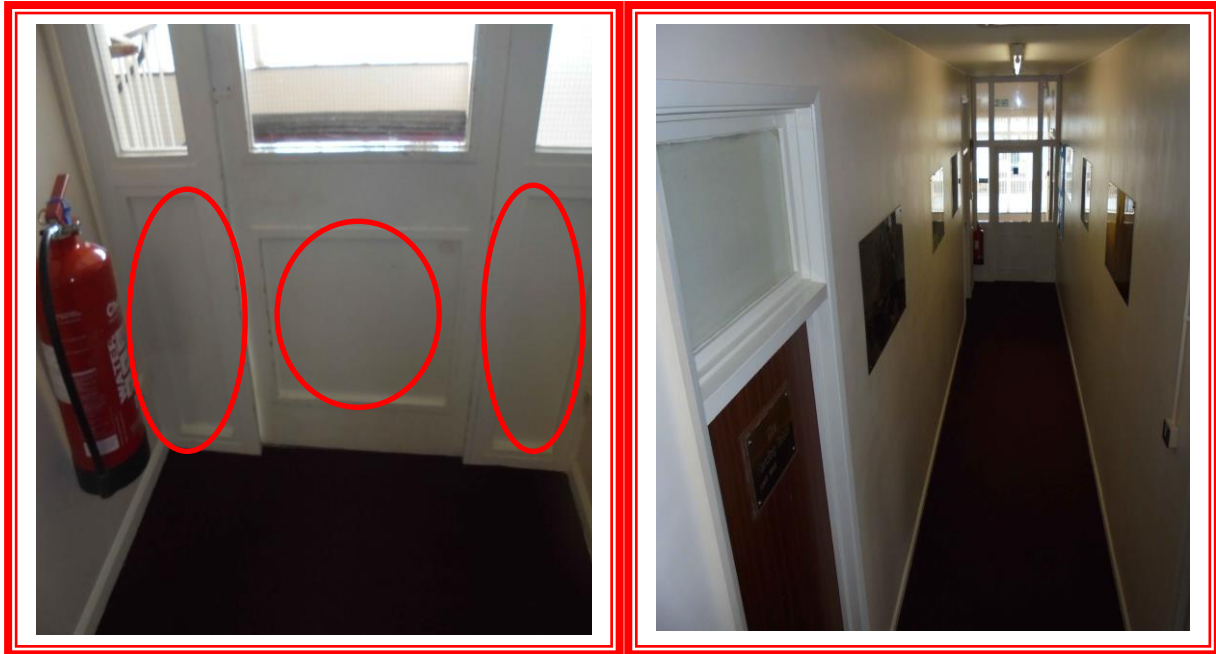
<b>Material Description:</b>	Insulation board infill panels	
<b>Identification:</b>	Sampled – Asbestos Detected	
<b>Approx. quantity:</b>	X 3 Panels (2M2)	
<b>Accessibility</b>	Medium	<i>Assessment Score</i>
<b>Product type:</b>	Asbestos Insulation Board	2
<b>Extent of Damage:</b>	Good	0
<b>Surface Treatment:</b>	Sealed	1
<b>Asbestos type:</b>	Amosite	2
<b>Material Assessment Score:</b>		5
<b>Priority Assessment Score:</b>		Low
<b>Action:</b>	Manage	
<b>Comments:</b>	Located either side of door and panel within door

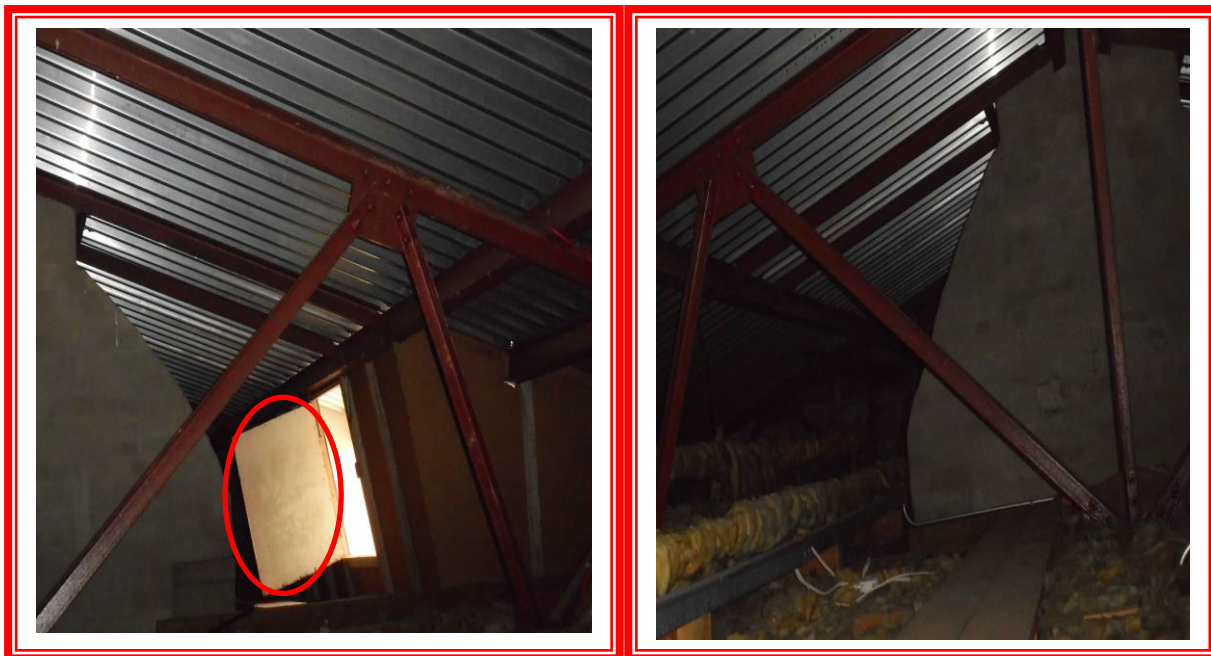
<b>Material Description:</b>	Insulation board panel to door	
<b>Identification:</b>	Presumed to Contain Asbestos	
<b>Approx. quantity:</b>	1M2	
<b>Accessibility</b>	Low	<i>Assessment Score</i>
<b>Product type:</b>	Asbestos Insulation Board	2
<b>Extent of Damage:</b>	Minor	1
<b>Surface Treatment:</b>	Unsealed	2
<b>Asbestos type:</b>	Amosite	2
<b>Material Assessment Score:</b>		7
<b>Priority Assessment Score:</b>		Medium
<b>Action:</b>	Further Investigation Required	
<b>Comments:</b>	No safe access to loft due to the height – The panel was visible from the loft hatch

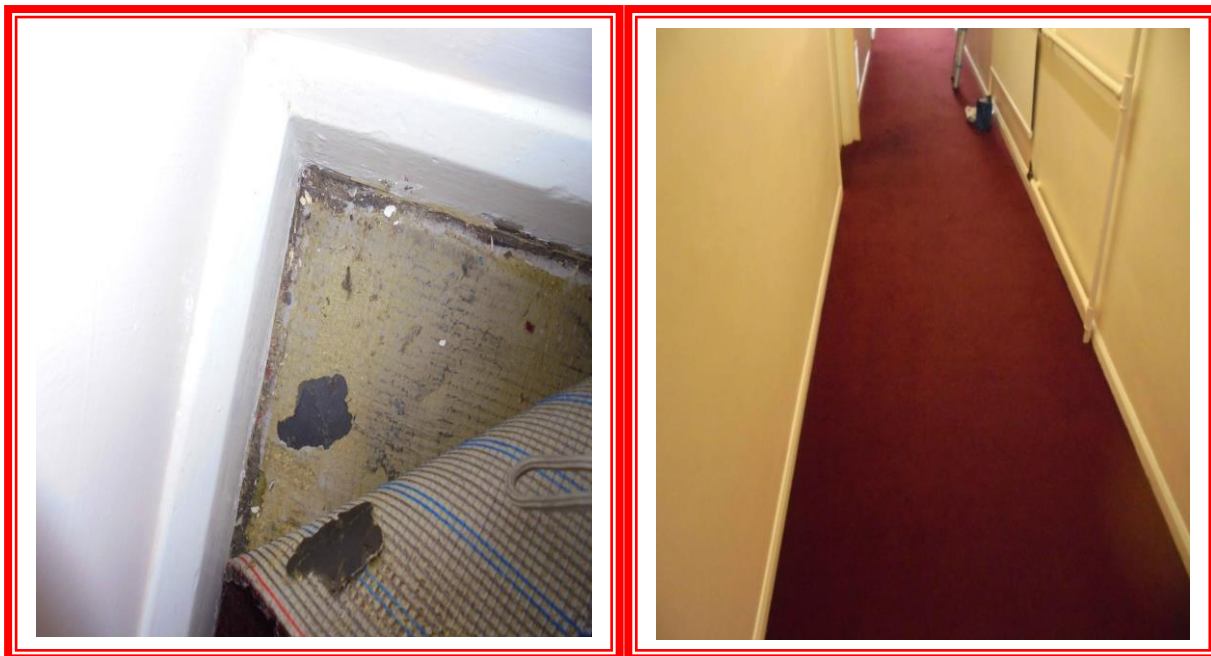
<b>Material Description:</b>	Floor tiles under carpet	
<b>Identification:</b>	As Per Sample DK/6 – Asbestos Detected	
<b>Approx. quantity:</b>	22M2	
<b>Accessibility</b>	Low	<i>Assessment Score</i>
<b>Product type:</b>	Composite	1
<b>Extent of Damage:</b>	Minor	1
<b>Surface Treatment:</b>	Non-Friable	0
<b>Asbestos type:</b>	Chrysotile	1
<b>Material Assessment Score:</b>		3
<b>Priority Assessment Score:</b>		Negligible
<b>Action:</b>	Manage	
<b>Comments:</b>	N/A

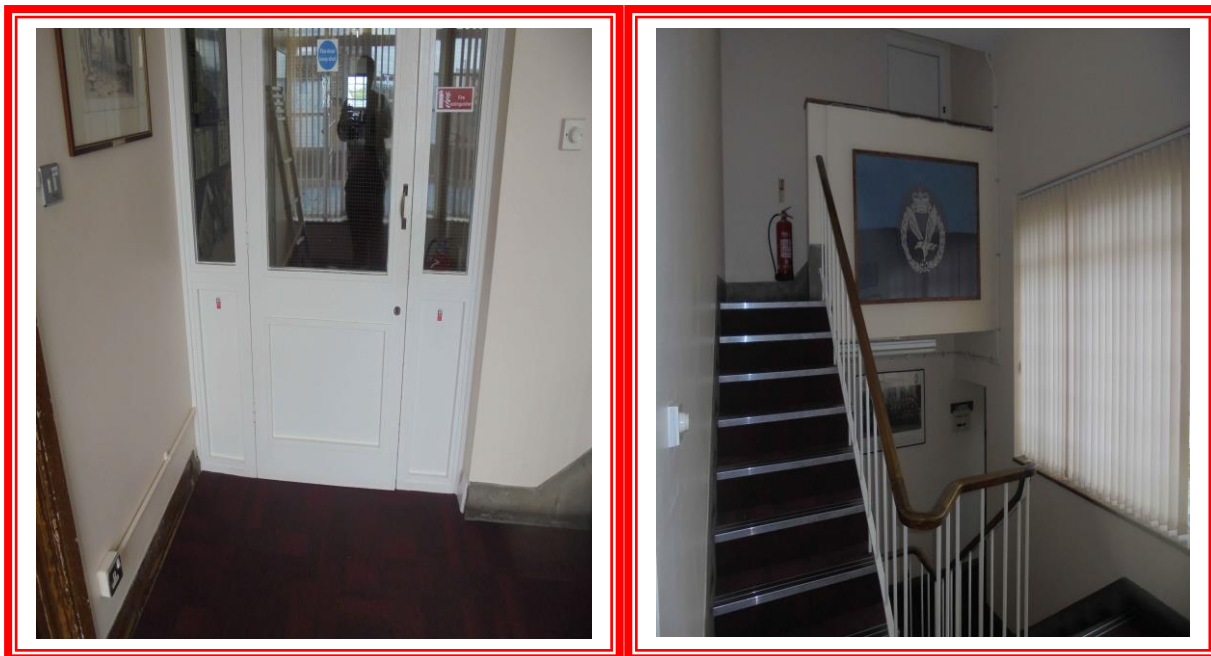
<b>Material Description:</b>	Insulation board infill panels to door and either side of door	
<b>Identification:</b>	As Per Sample DK/7 – Asbestos Detected	
<b>Approx. quantity:</b>	X 3 Panels (2M2)	
<b>Accessibility</b>	Medium	Assessment Score
<b>Product type:</b>	Asbestos Insulation Board	2
<b>Extent of Damage:</b>	Good	0
<b>Surface Treatment:</b>	Encapsulated	1
<b>Asbestos type:</b>	Amosite	2
<b>Material Assessment Score:</b>		5
<b>Priority Assessment Score:</b>		Low
<b>Action:</b>	Manage	
<b>Comments:</b>	Non-Asbestos lino under the carpet. Modern stair nosing

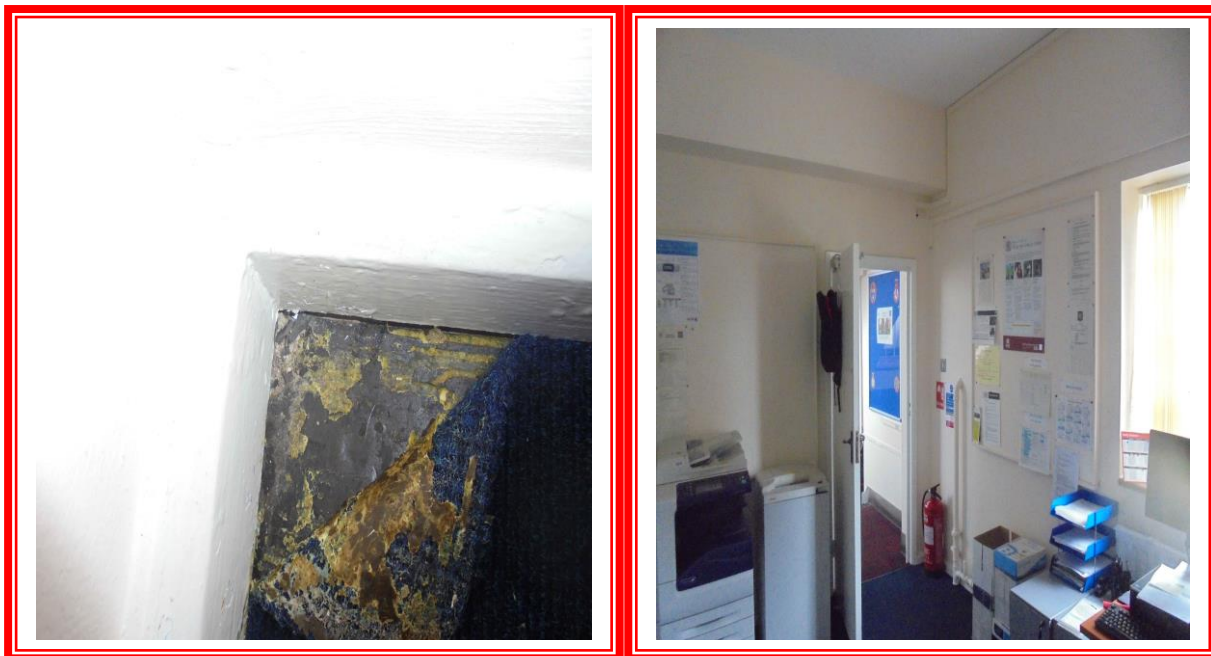
<b>Material Description:</b>	Floor tiles under carpet	
<b>Identification:</b>	As Per Sample DK/6 – Asbestos Detected	
<b>Approx. quantity:</b>	16M2	
<b>Accessibility</b>	Low	<i>Assessment Score</i>
<b>Product type:</b>	Composite	1
<b>Extent of Damage:</b>	Minor	1
<b>Surface Treatment:</b>	Non-Friable	0
<b>Asbestos type:</b>	Chrysotile	1
<b>Material Assessment Score:</b>		3
<b>Priority Assessment Score:</b>		Negligible
<b>Action:</b>	Manage	
<b>Comments:</b>	No access within timber boxings

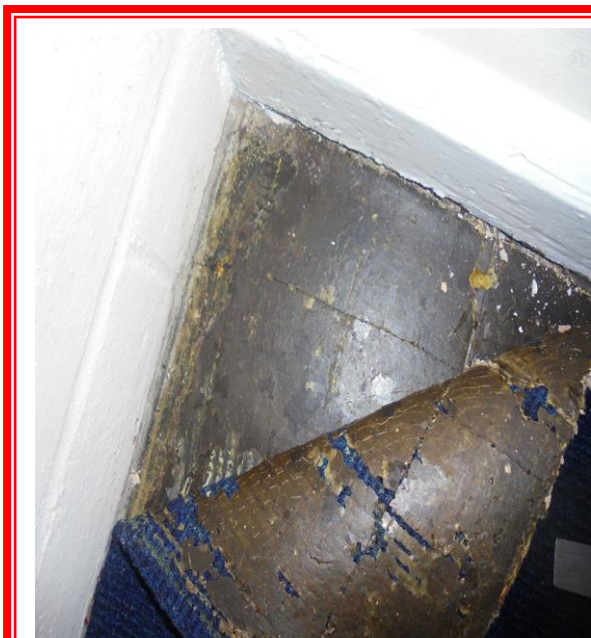
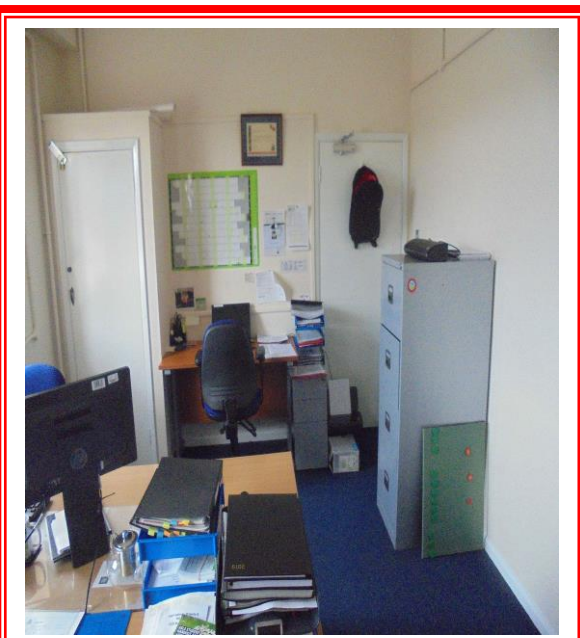
**Location: CEO Office – First Floor**

<b>Material Description:</b>	Floor tiles under carpet	
<b>Identification:</b>	As Per Sample DK/1 – Asbestos Detected	
<b>Approx. quantity:</b>	16M2	
<b>Accessibility</b>	Low	<i>Assessment Score</i>
<b>Product type:</b>	Composite	1
<b>Extent of Damage:</b>	Minor	1
<b>Surface Treatment:</b>	Non-Friable	0
<b>Asbestos type:</b>	Chrysotile	1
<b>Material Assessment Score:</b>		3
<b>Priority Assessment Score:</b>		Negligible
<b>Action:</b>	Manage	
<b>Comments:</b>	No access within timber boxing or locked cupboard

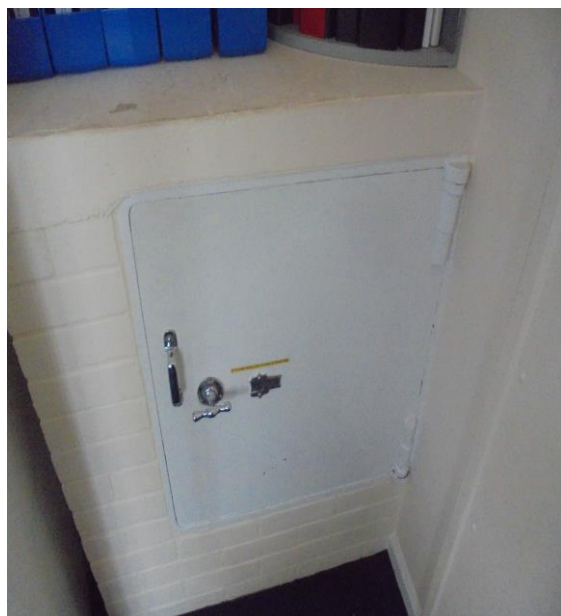
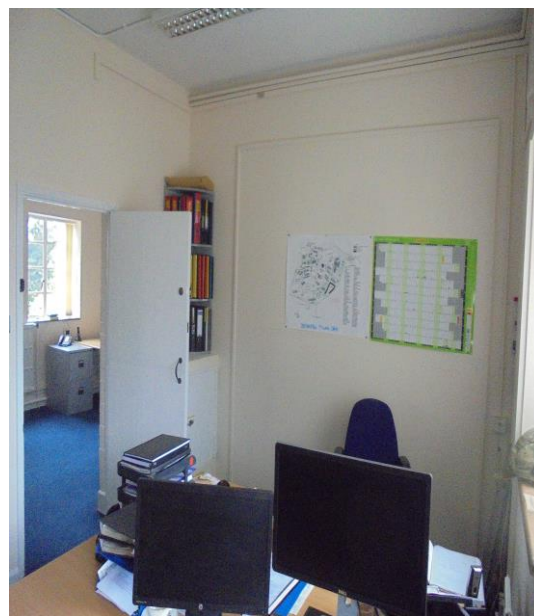
<b>Material Description:</b>	No access within safe	
<b>Identification:</b>	Presumed to Contain Asbestos	
<b>Approx. quantity:</b>	X 1 Safe	
<b>Accessibility</b>	Low	<i>Assessment Score</i>
<b>Product type:</b>	No Access	2
<b>Extent of Damage:</b>	No Access	2
<b>Surface Treatment:</b>	No Access	2
<b>Asbestos type:</b>	No Access	2
<b>Material Assessment Score:</b>		8
<b>Priority Assessment Score:</b>		Medium
<b>Action:</b>	Manage	
<b>Comments:</b>	N/A

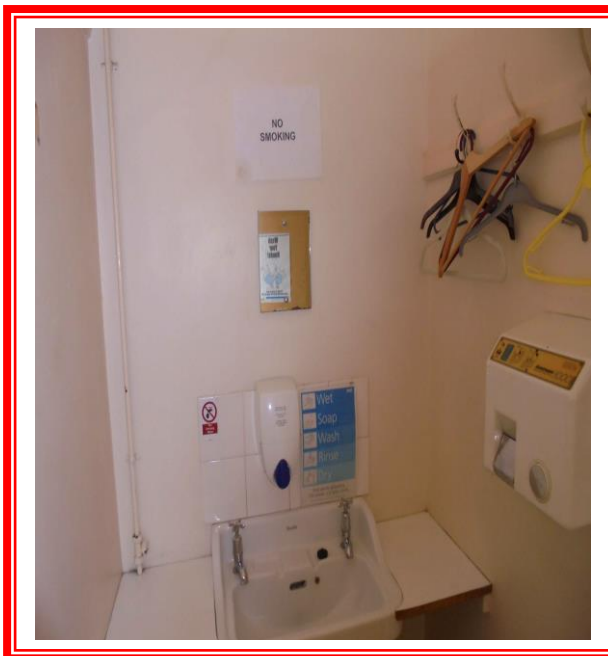
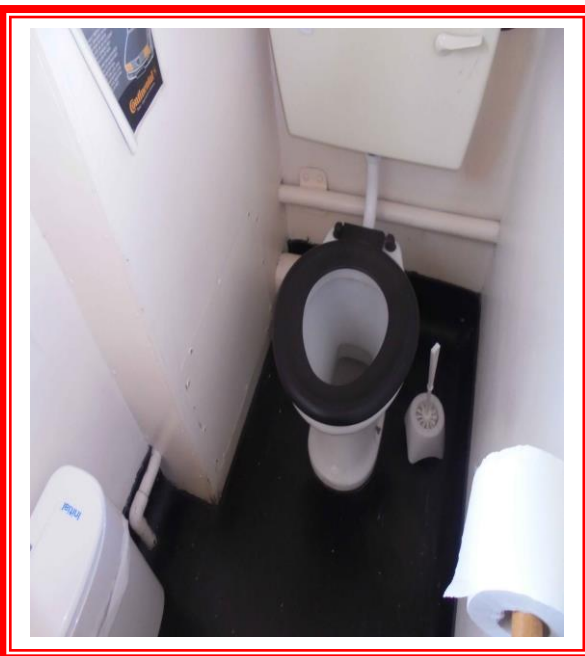
<b>Material Description:</b>	Reinforced plastic toilet seat	
<b>Identification:</b>	Presumed to Contain Asbestos	
<b>Approx. quantity:</b>	X 1	
<b>Accessibility</b>	High	Assessment Score
<b>Product type:</b>	Composite	1
<b>Extent of Damage:</b>	Good	0
<b>Surface Treatment:</b>	Non-Friable	0
<b>Asbestos type:</b>	Chrysotile	1
<b>Material Assessment Score:</b>		2
<b>Priority Assessment Score:</b>		Negligible
<b>Action:</b>	Manage	
<b>Comments:</b>	No access to sample as it would damage the integrity of the seat. No access within the timber boxing

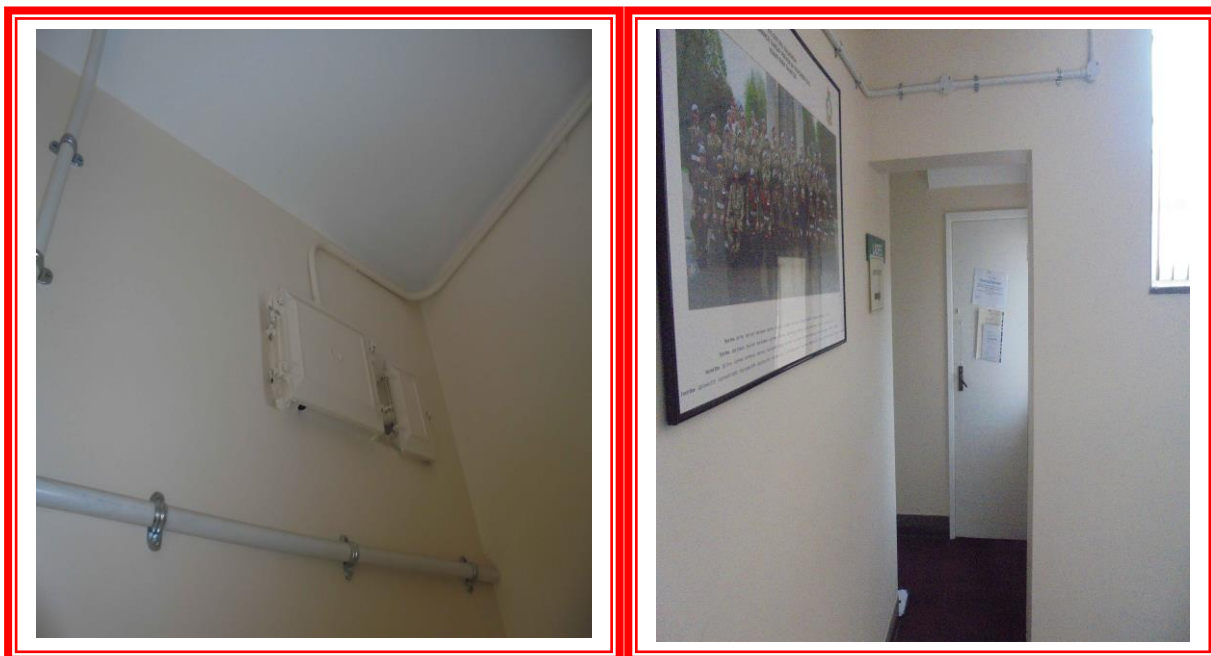
<b>Material Description:</b>	Components within electrical boxes	
<b>Identification:</b>	Presumed to Contain Asbestos	
<b>Approx. quantity:</b>	X 2 Boxes	
<b>Accessibility</b>	Low	<i>Assessment Score</i>
<b>Product type:</b>	No Access	2
<b>Extent of Damage:</b>	No Access	1
<b>Surface Treatment:</b>	No Access	1
<b>Asbestos type:</b>	No Access	1
<b>Material Assessment Score:</b>		5
<b>Priority Assessment Score:</b>		Low
<b>Action:</b>	Manage	
<b>Comments:</b>	No access to sample as live

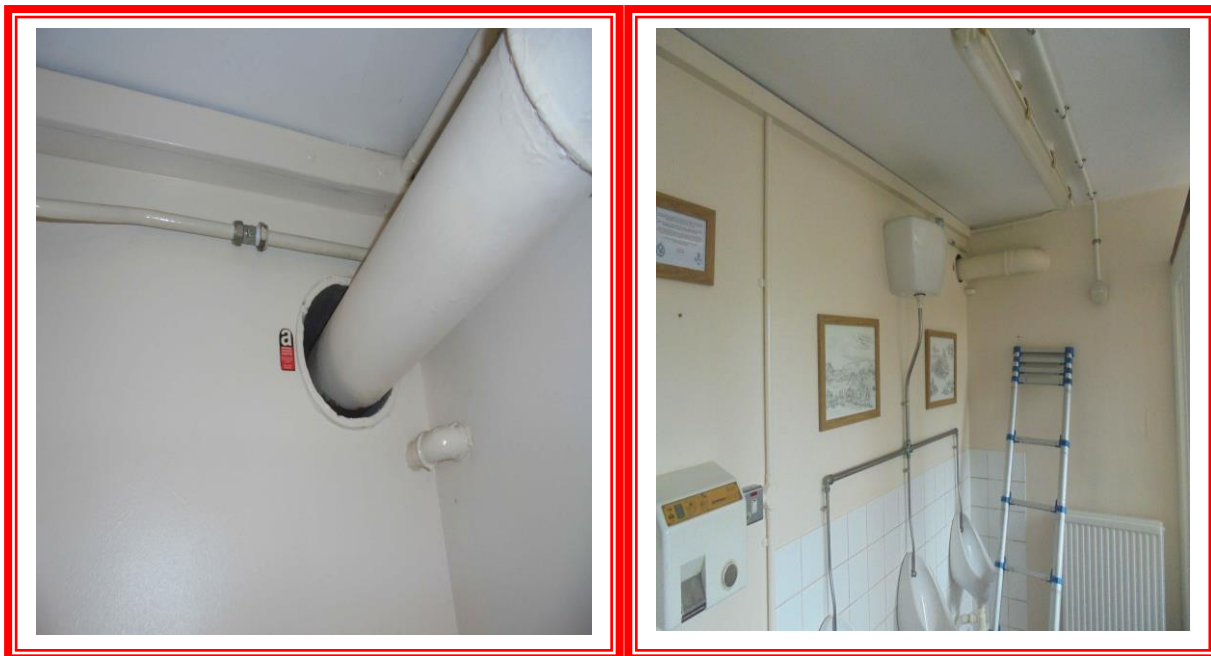
<b>Material Description:</b>	Cement pipework sleeve within wall	
<b>Identification:</b>	Sampled – Asbestos Detected	
<b>Approx. quantity:</b>	<1LM	
<b>Accessibility</b>	Low	<i>Assessment Score</i>
<b>Product type:</b>	Cement	1
<b>Extent of Damage:</b>	Minor	1
<b>Surface Treatment:</b>	Unsealed	1
<b>Asbestos type:</b>	Chrysotile	1
<b>Material Assessment Score:</b>		4
<b>Priority Assessment Score:</b>		Negligible
<b>Action:</b>	Manage	
<b>Comments:</b>	N/A

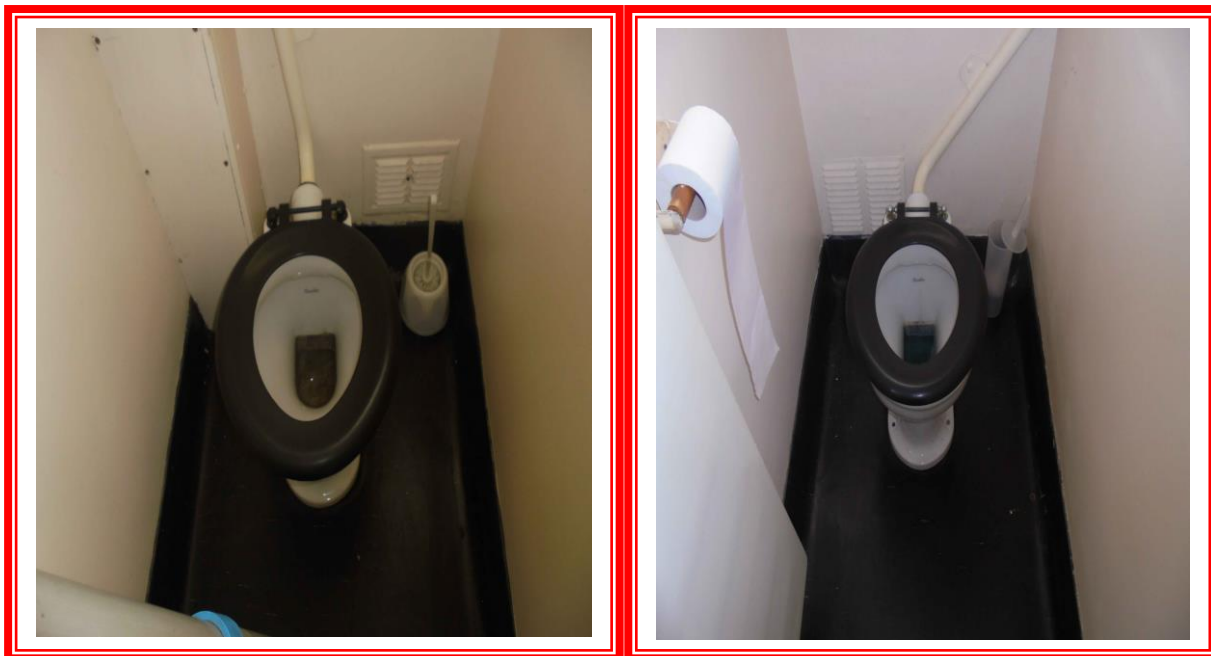
<b>Material Description:</b>	Reinforced plastic toilet seats	
<b>Identification:</b>	Presumed to Contain Asbestos	
<b>Approx. quantity:</b>	X 2	
<b>Accessibility</b>	High	<i>Assessment Score</i>
<b>Product type:</b>	Composite	1
<b>Extent of Damage:</b>	Good	0
<b>Surface Treatment:</b>	Non-Friable	0
<b>Asbestos type:</b>	Chrysotile	1
<b>Material Assessment Score:</b>		2
<b>Priority Assessment Score:</b>		Negligible
<b>Action:</b>	Manage	
<b>Comments:</b>	N/A

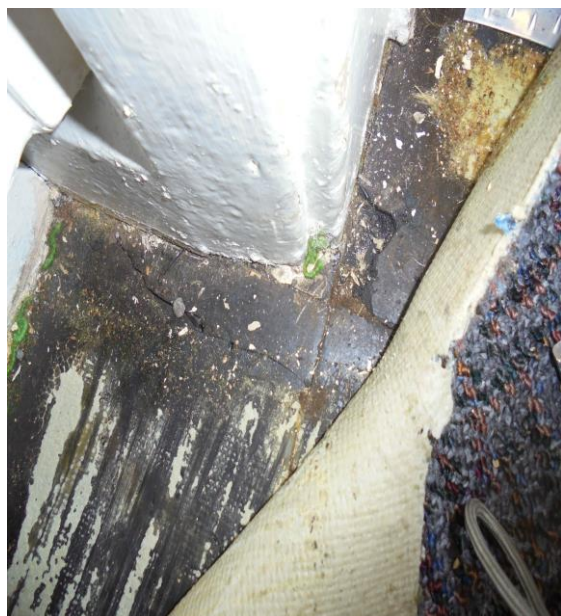
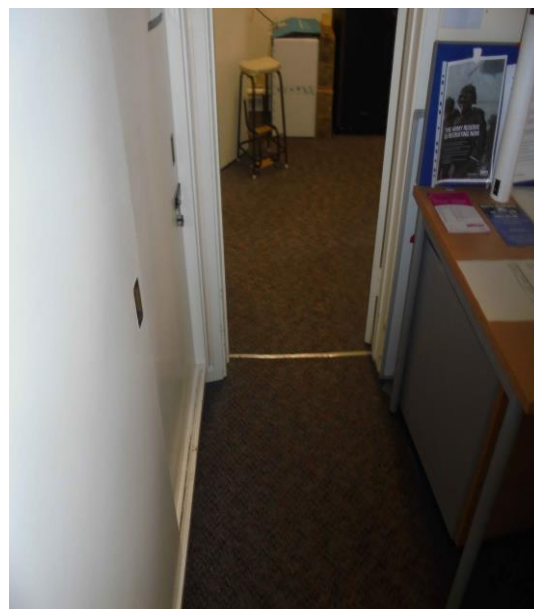
<b>Material Description:</b>	Floor tiles and adhesive under carpet	
<b>Identification:</b>	Sampled – Asbestos Detected	
<b>Approx. quantity:</b>	28M2	
<b>Accessibility</b>	Low	<i>Assessment Score</i>
<b>Product type:</b>	Composite	1
<b>Extent of Damage:</b>	Moderate	2
<b>Surface Treatment:</b>	Non-Friable	0
<b>Asbestos type:</b>	Chrysotile	1
<b>Material Assessment Score:</b>		4
<b>Priority Assessment Score:</b>		Negligible
<b>Action:</b>	Manage	
<b>Comments:</b>	No access within timber boxings or locked cupboard

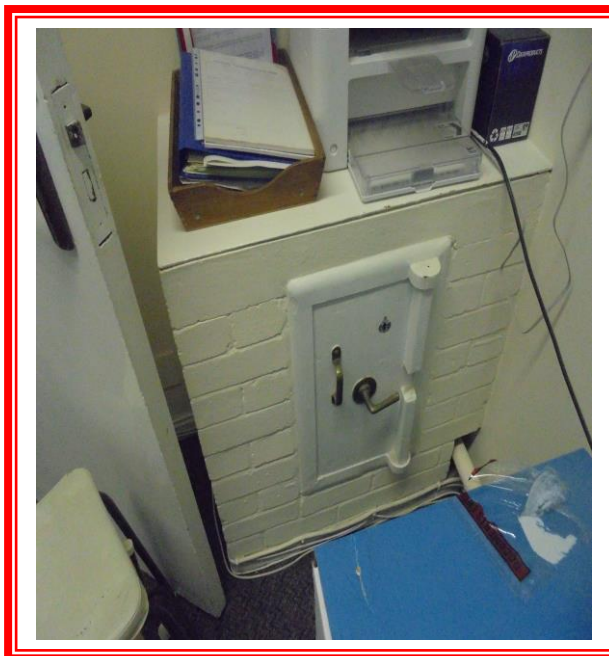
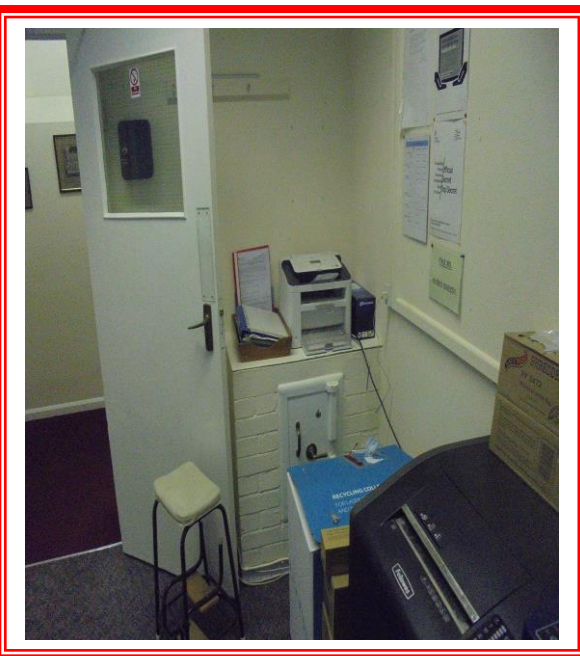
<b>Material Description:</b>	No access within Safe	
<b>Identification:</b>	Presumed to Contain Asbestos	
<b>Approx. quantity:</b>	X 1 Safe	
<b>Accessibility</b>	Low	<i>Assessment Score</i>
<b>Product type:</b>	No Access	2
<b>Extent of Damage:</b>	No Access	2
<b>Surface Treatment:</b>	No Access	2
<b>Asbestos type:</b>	No Access	2
<b>Material Assessment Score:</b>		8
<b>Priority Assessment Score:</b>		Medium
<b>Action:</b>	Manage	
<b>Comments:</b>	No access

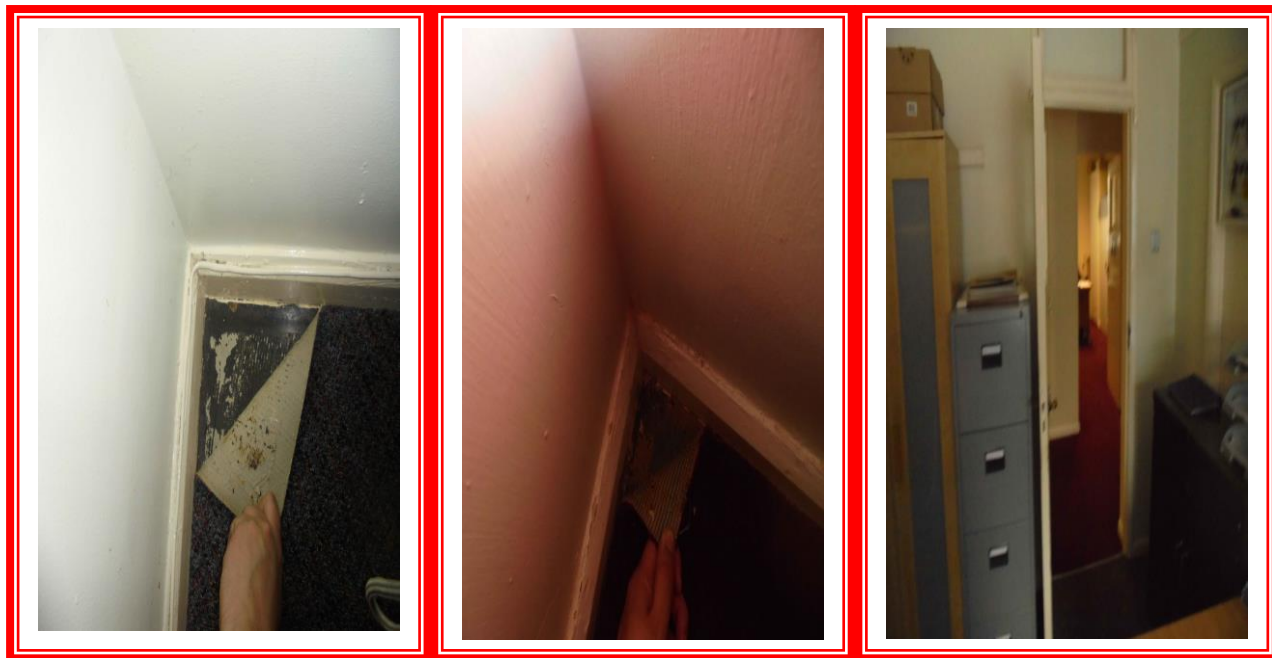
<b>Material Description:</b>	Floor tiles and adhesive under carpets	
<b>Identification:</b>	As Per Sample DK/10 – Asbestos Detected	
<b>Approx. quantity:</b>	22M2	
<b>Accessibility</b>	Low	<i>Assessment Score</i>
<b>Product type:</b>	Composite	1
<b>Extent of Damage:</b>	Good	0
<b>Surface Treatment:</b>	Non-Friable	0
<b>Asbestos type:</b>	Chrysotile	1
<b>Material Assessment Score:</b>		2
<b>Priority Assessment Score:</b>		Negligible
<b>Action:</b>	Manage	
<b>Comments:</b>	Located in both rooms

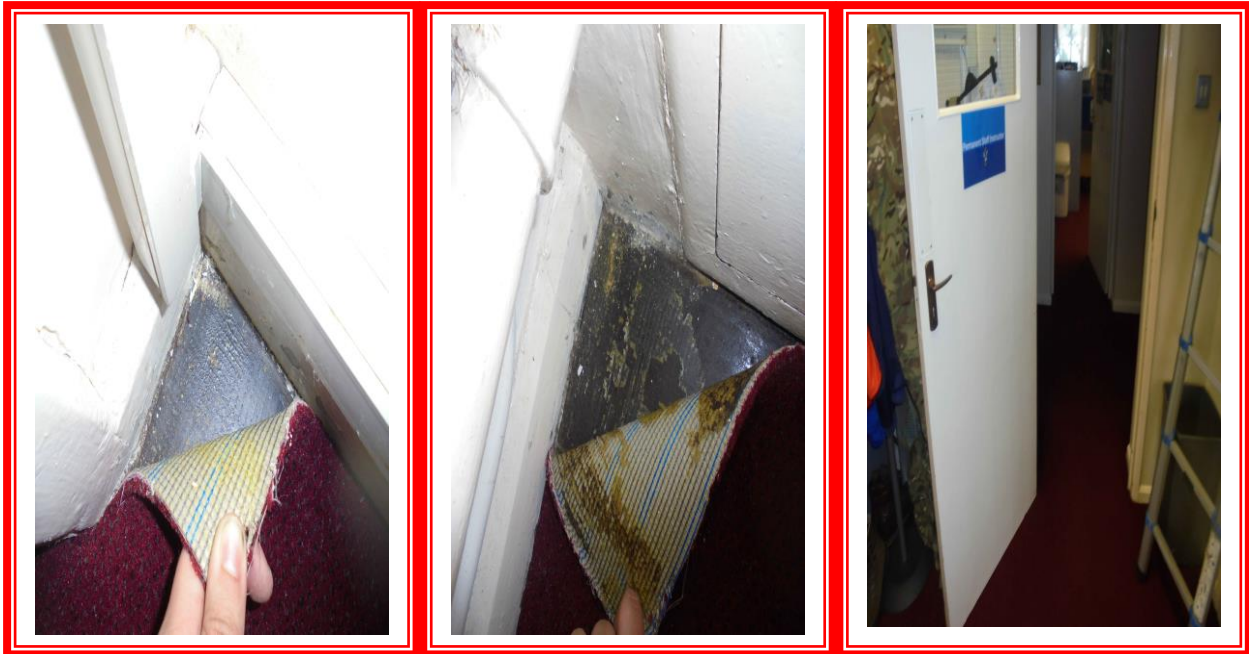
<b>Material Description:</b>	Floor tiles and adhesive under carpets	
<b>Identification:</b>	As Per Sample DK/10 – Asbestos Detected	
<b>Approx. quantity:</b>	30M2	
<b>Accessibility</b>	Low	<i>Assessment Score</i>
<b>Product type:</b>	Composite	1
<b>Extent of Damage:</b>	Minor	1
<b>Surface Treatment:</b>	Non-Friable	0
<b>Asbestos type:</b>	Chrysotile	1
<b>Material Assessment Score:</b>		3
<b>Priority Assessment Score:</b>		Negligible
<b>Action:</b>	Manage	
<b>Comments:</b>	N/A

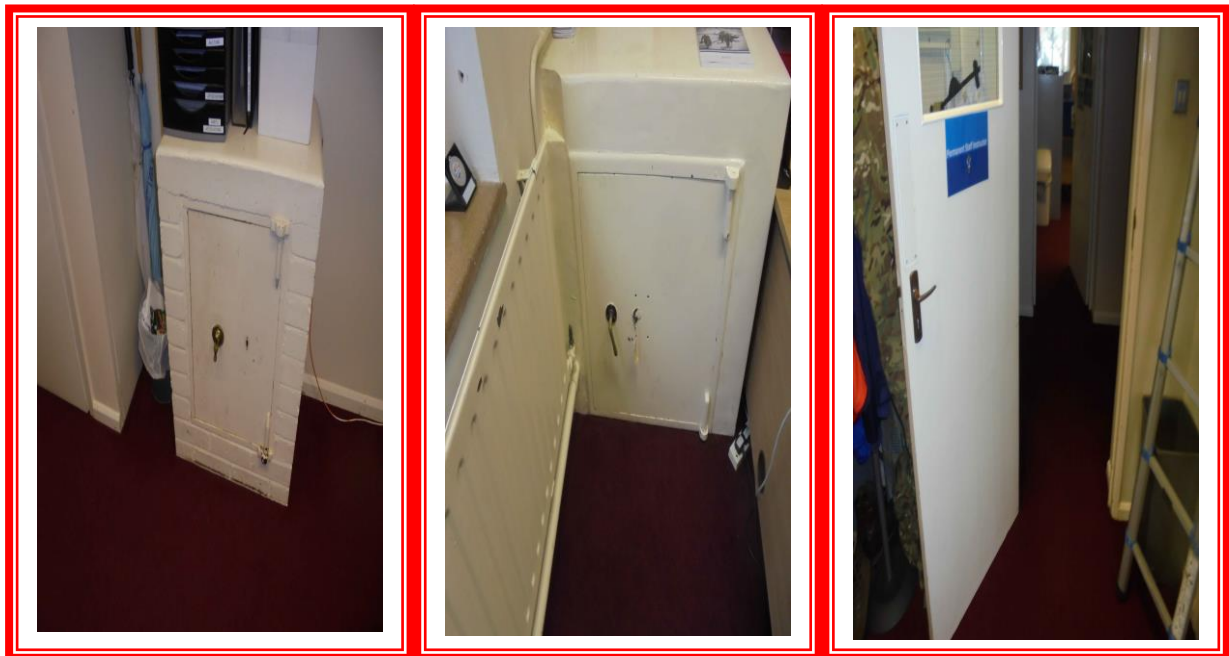
<b>Material Description:</b>	No access within Safes	
<b>Identification:</b>	Presumed to Contain Asbestos	
<b>Approx. quantity:</b>	X 2 Safes	
<b>Accessibility</b>	Low	<i>Assessment Score</i>
<b>Product type:</b>	No Access	2
<b>Extent of Damage:</b>	No Access	2
<b>Surface Treatment:</b>	No Access	2
<b>Asbestos type:</b>	No Access	2
<b>Material Assessment Score:</b>		8
<b>Priority Assessment Score:</b>		Medium
<b>Action:</b>	Manage	
<b>Comments:</b>	No access within safe casings

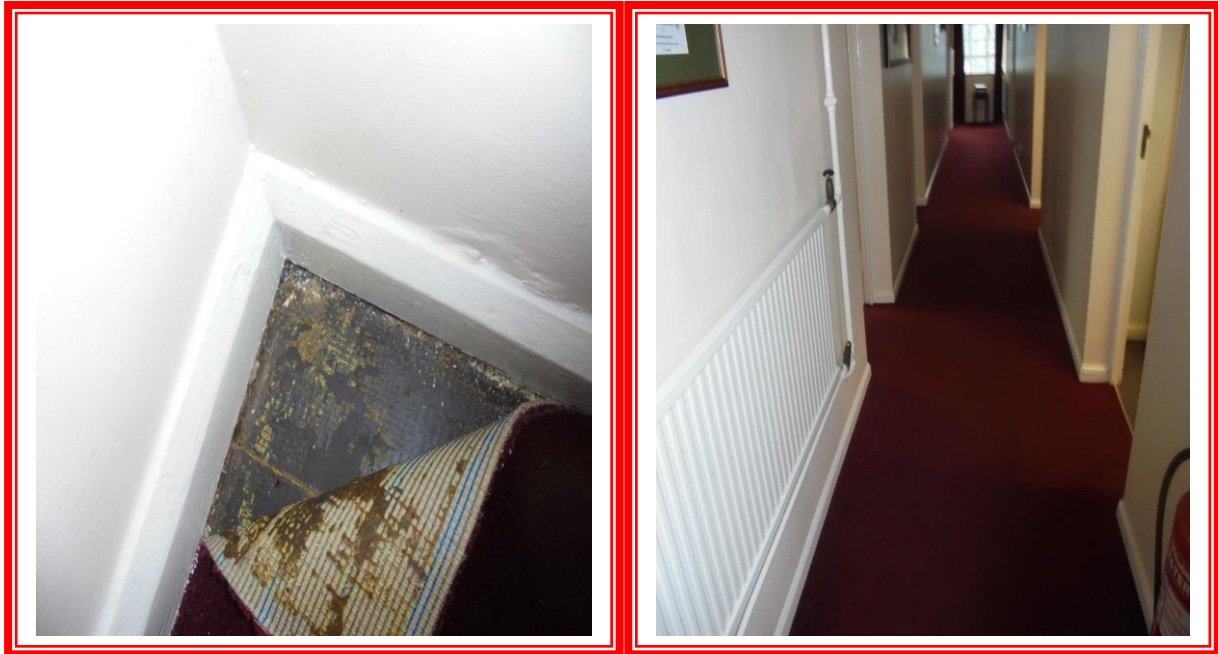
<b>Material Description:</b>	Floor tiles and adhesive under carpet	
<b>Identification:</b>	As Per Sample DK/10 – Asbestos Detected	
<b>Approx. quantity:</b>	30M2	
<b>Accessibility</b>	Low	<i>Assessment Score</i>
<b>Product type:</b>	Composite	1
<b>Extent of Damage:</b>	Good	0
<b>Surface Treatment:</b>	Non-Friable	0
<b>Asbestos type:</b>	Chrysotile	1
<b>Material Assessment Score:</b>		2
<b>Priority Assessment Score:</b>		Negligible
<b>Action:</b>	Manage	
<b>Comments:</b>	N/A

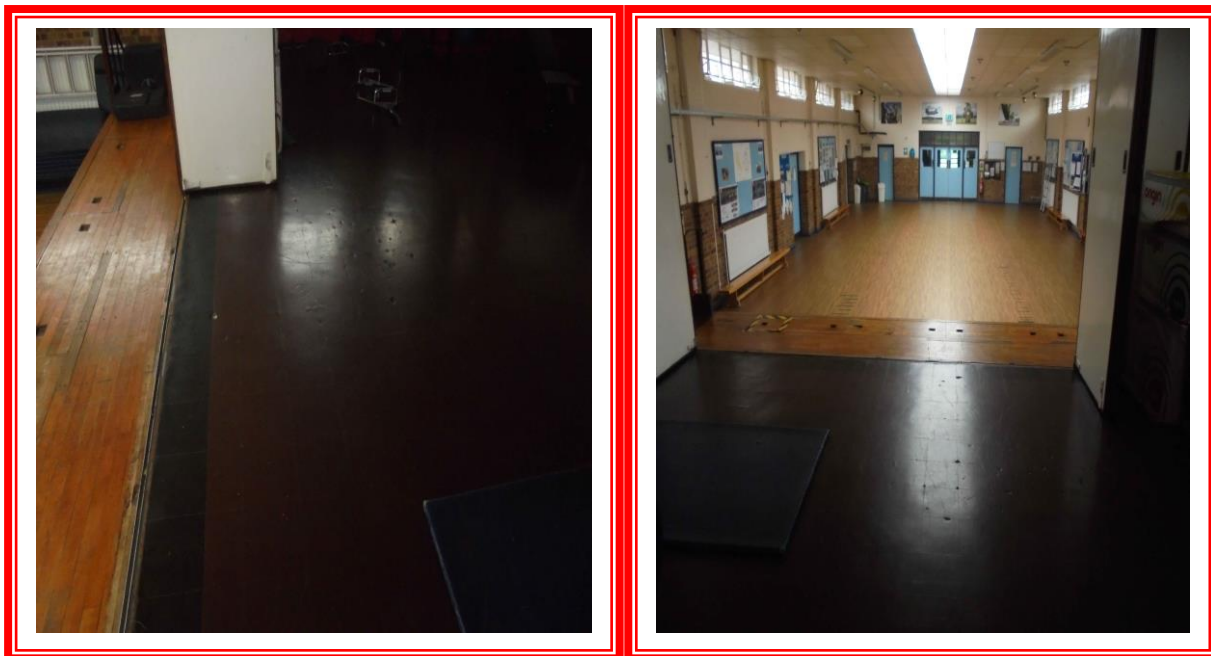
<b>Material Description:</b>	Red and black floor tiles and adhesive	
<b>Identification:</b>	Sampled – Asbestos Detected	
<b>Approx. quantity:</b>	50M2	
<b>Accessibility</b>	High	<i>Assessment Score</i>
<b>Product type:</b>	Composite	1
<b>Extent of Damage:</b>	Moderate	2
<b>Surface Treatment:</b>	Non-Friable	0
<b>Asbestos type:</b>	Chrysotile	1
<b>Material Assessment Score:</b>		4
<b>Priority Assessment Score:</b>		Negligible
<b>Action:</b>	Manage	
<b>Comments:</b>	No access under laminate flooring to main hall. Limited access above main hall suspended ceiling due to height

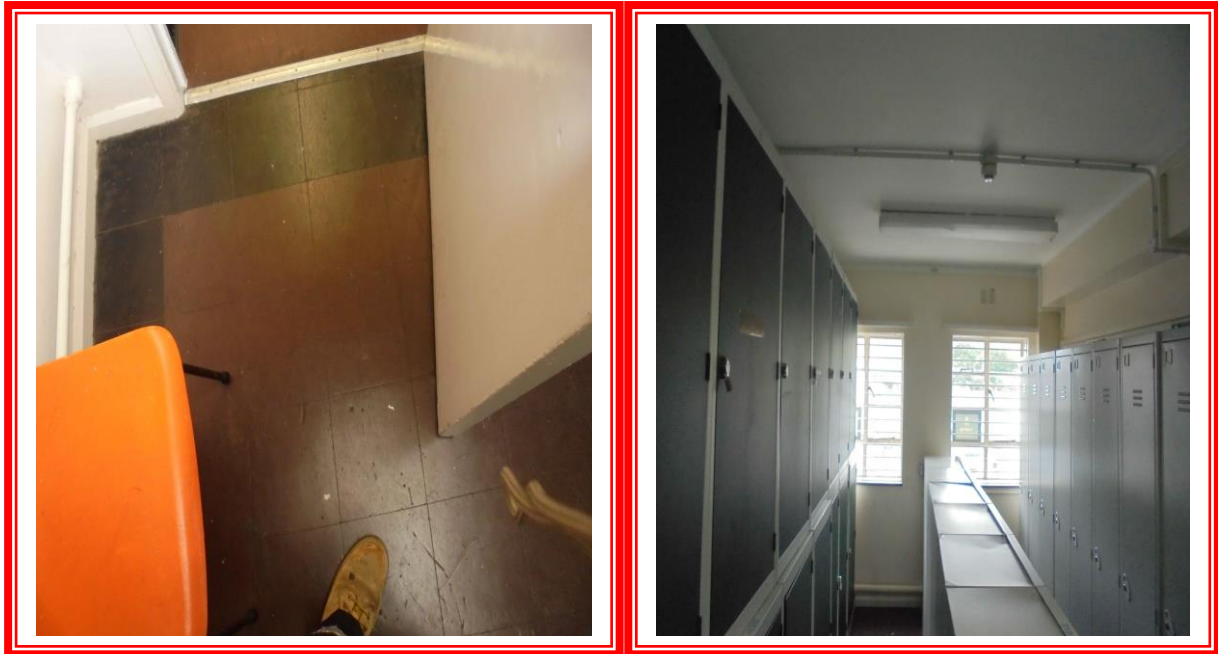
<b>Material Description:</b>	Red and Black floor tiles and adhesive	
<b>Identification:</b>	As Per Sample DK/11 – Asbestos Detected	
<b>Approx. quantity:</b>	18M2	
<b>Accessibility</b>	High	<i>Assessment Score</i>
<b>Product type:</b>	Composite	1
<b>Extent of Damage:</b>	Moderate	2
<b>Surface Treatment:</b>	Non-Friable	0
<b>Asbestos type:</b>	Chrysotile	1
<b>Material Assessment Score:</b>		4
<b>Priority Assessment Score:</b>		Negligible
<b>Action:</b>	Manage	
<b>Comments:</b>	Limited access within room due to lockers

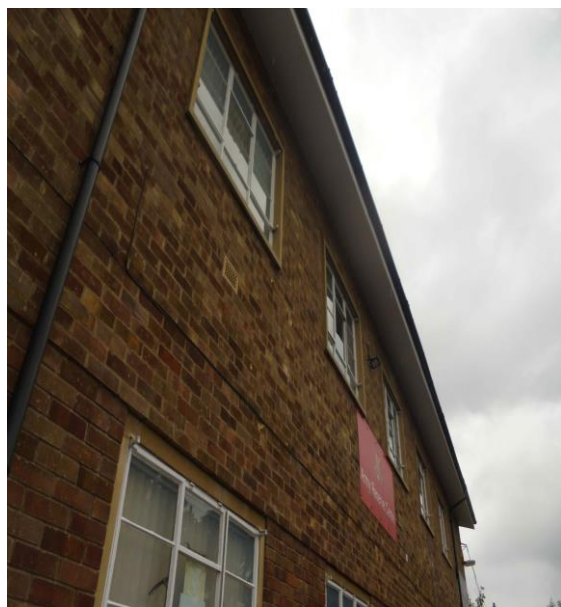
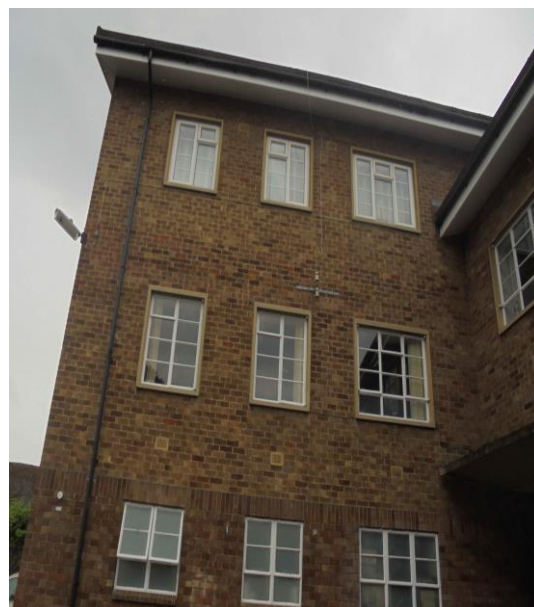
<b>Material Description:</b>	Insulation board soffits	
<b>Identification:</b>	As Per Previous Sample GU/TA/0020/17 – Asbestos Detected	
<b>Approx. quantity:</b>	110LM	
<b>Accessibility</b>	Low	Assessment Score
<b>Product type:</b>	Asbestos Insulation Board	2
<b>Extent of Damage:</b>	Minor	1
<b>Surface Treatment:</b>	Encapsulated	1
<b>Asbestos type:</b>	Amosite	2
<b>Material Assessment Score:</b>		6
<b>Priority Assessment Score:</b>		Medium
<b>Action:</b>	Manage	
<b>Comments:</b>	No access above UPVC soffits. Previous survey states that there are asbestos insulation board soffits behind UPVC soffits.
