**Project Number 2481**

**Management  
Asbestos Survey Report**

**675 Army Air Corps, Somerset, TA1 5LJ**

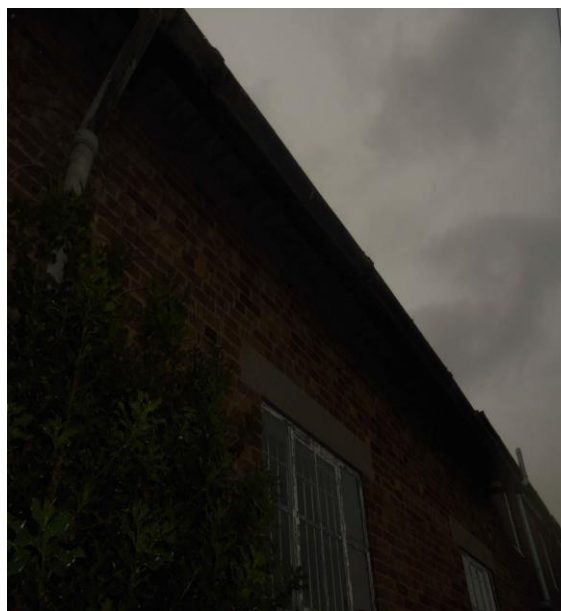
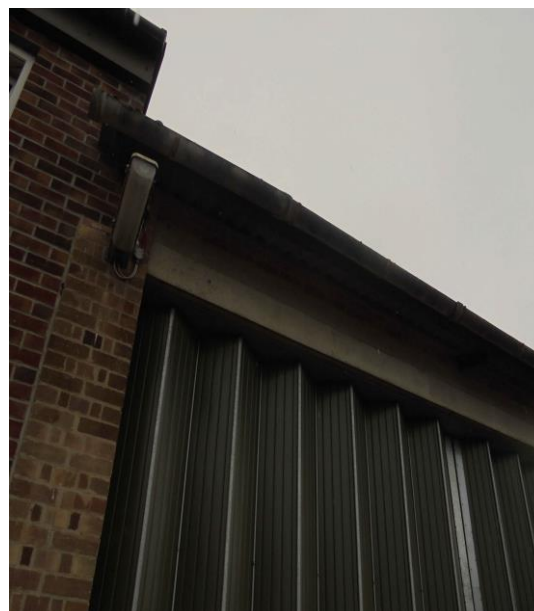
<b>Material Description:</b>	Cement guttering	
<b>Identification:</b>	As Per Sample DK/12 – Asbestos Detected	
<b>Approx. quantity:</b>	60LM	
<b>Accessibility</b>	Low	<i>Assessment Score</i>
<b>Product type:</b>	Cement	1
<b>Extent of Damage:</b>	Minor	1
<b>Surface Treatment:</b>	Unsealed	1
<b>Asbestos type:</b>	Chrysotile	1
<b>Material Assessment Score:</b>		4
<b>Priority Assessment Score:</b>		Negligible
<b>Action:</b>	Manage	
<b>Comments:</b>	N/A

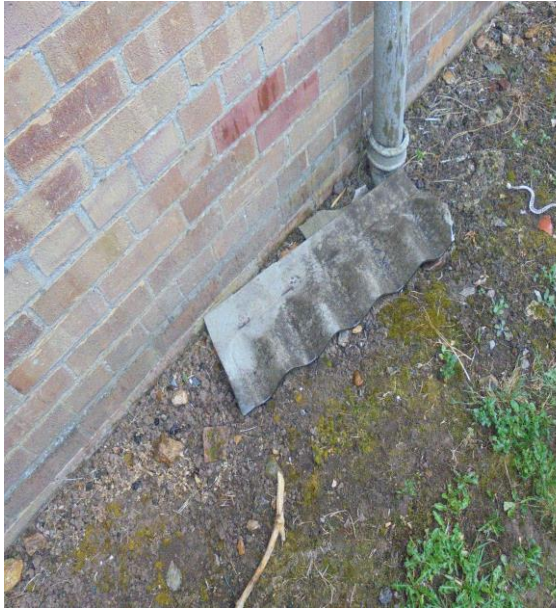
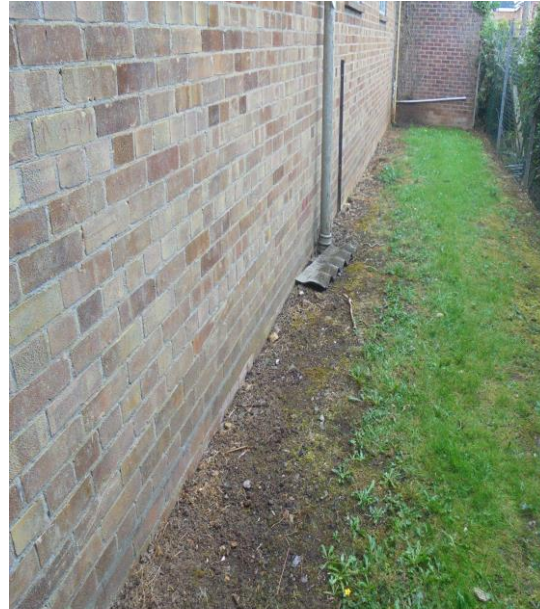
<b>Material Description:</b>	Profiled cement sheet debris	
<b>Identification:</b>	As Per Sample DK/19 – Asbestos Detected	
<b>Approx. quantity:</b>	1M2	
<b>Accessibility</b>	Medium	<i>Assessment Score</i>
<b>Product type:</b>	Cement	1
<b>Extent of Damage:</b>	Moderate	2
<b>Surface Treatment:</b>	Unsealed	1
<b>Asbestos type:</b>	Chrysotile	1
<b>Material Assessment Score:</b>		5
<b>Priority Assessment Score:</b>		Medium
<b>Action:</b>	Remove	
<b>Comments:</b>	N/A

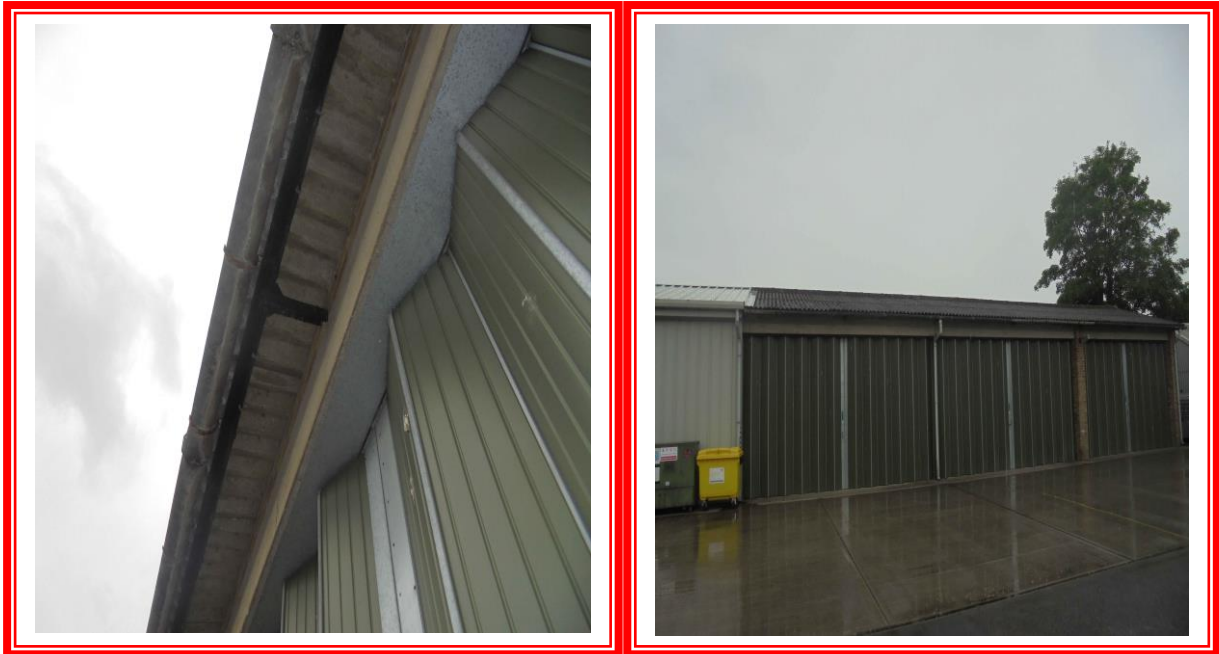
<b>Material Description:</b>	Profiled cement roof sheets	
<b>Identification:</b>	Sampled – Asbestos Detected	
<b>Approx. quantity:</b>	200M2	
<b>Accessibility</b>	Low	<i>Assessment Score</i>
<b>Product type:</b>	Cement	1
<b>Extent of Damage:</b>	Moderate	1
<b>Surface Treatment:</b>	Unsealed	1
<b>Asbestos type:</b>	Chrysotile	1
<b>Material Assessment Score:</b>		4
<b>Priority Assessment Score:</b>		Negligible
<b>Action:</b>	Manage	
<b>Comments:</b>	N/A

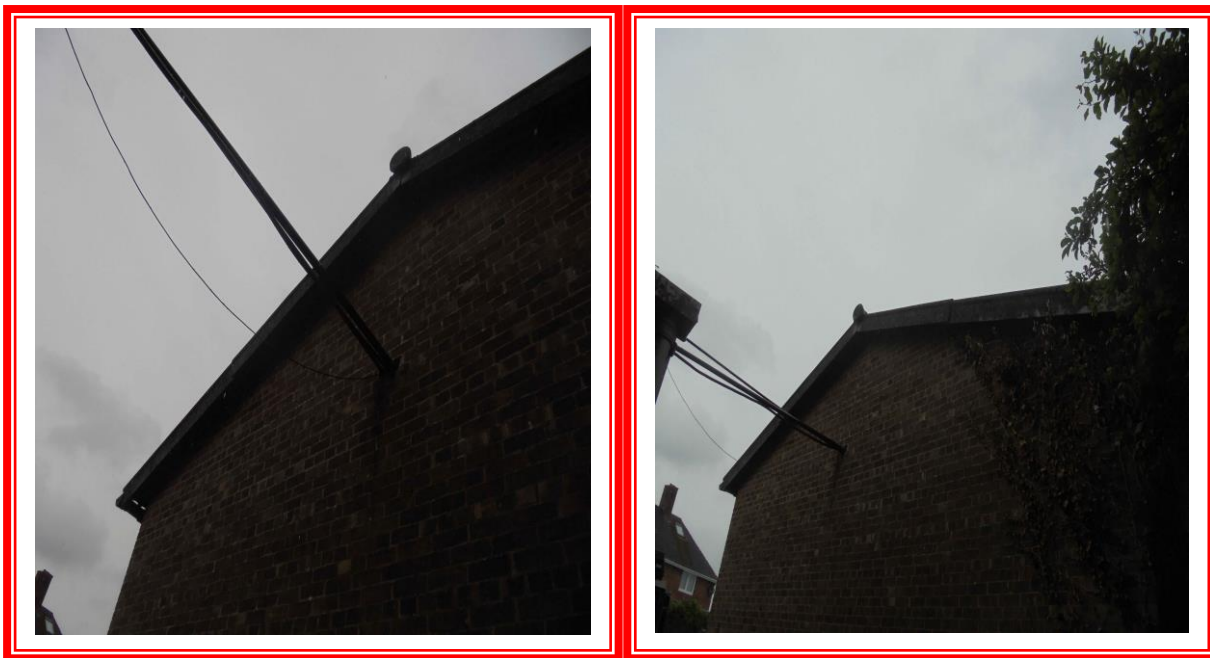
<b>Material Description:</b>	Cement roof edging	
<b>Identification:</b>	Presumed to Contain Asbestos	
<b>Approx. quantity:</b>	8LM	
<b>Accessibility</b>	Low	<i>Assessment Score</i>
<b>Product type:</b>	Cement	1
<b>Extent of Damage:</b>	Minor	1
<b>Surface Treatment:</b>	Unsealed	1
<b>Asbestos type:</b>	Chrysotile	1
<b>Material Assessment Score:</b>		4
<b>Priority Assessment Score:</b>		Negligible
<b>Action:</b>	Manage	
<b>Comments:</b>	No access to sample due to the height

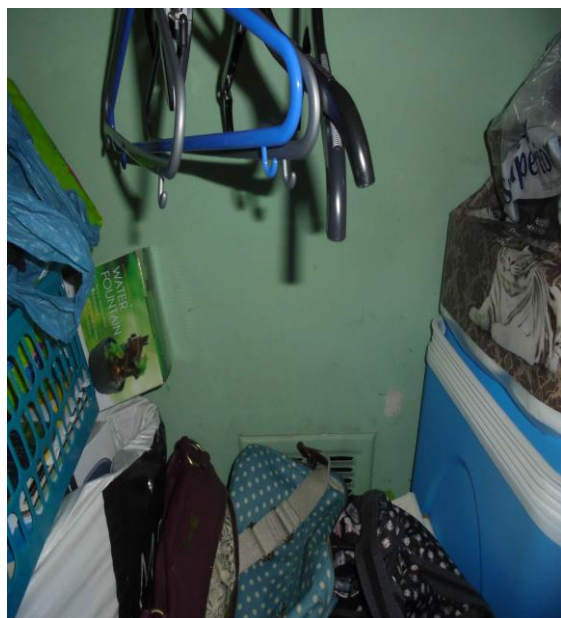
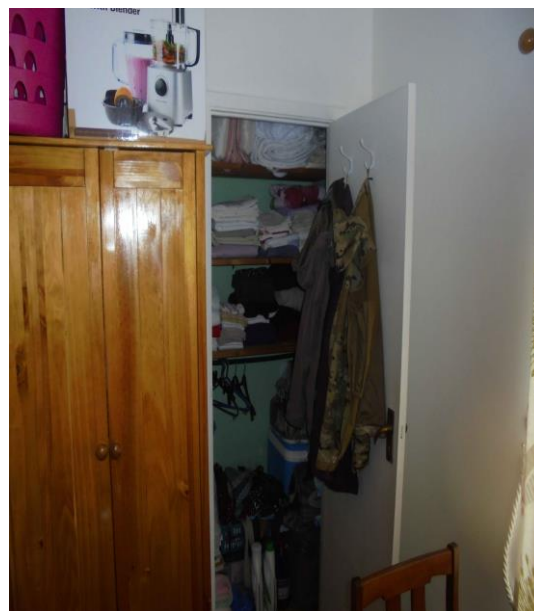
<b>Material Description:</b>	Cement wall panel	
<b>Identification:</b>	Sampled – Asbestos Detected	
<b>Approx. quantity:</b>	3M2	
<b>Accessibility</b>	Medium	Assessment Score
<b>Product type:</b>	Cement	1
<b>Extent of Damage:</b>	Good	0
<b>Surface Treatment:</b>	Unsealed	1
<b>Asbestos type:</b>	Chrysotile	1
<b>Material Assessment Score:</b>		3
<b>Priority Assessment Score:</b>		Negligible
<b>Action:</b>	Manage	
<b>Comments:</b>	Entire back wall of cupboard

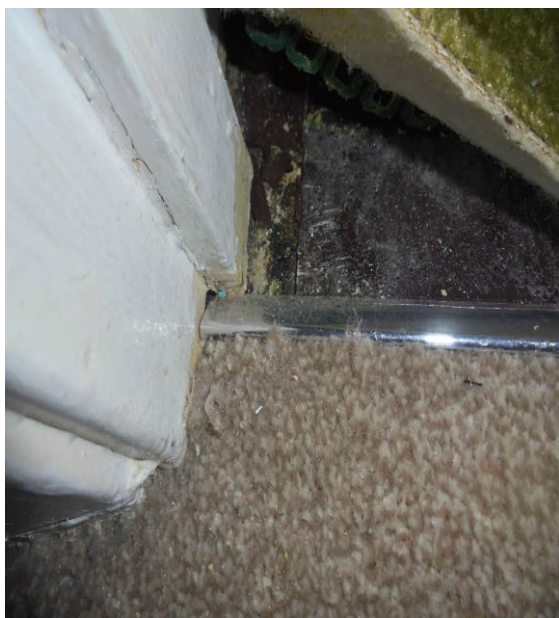
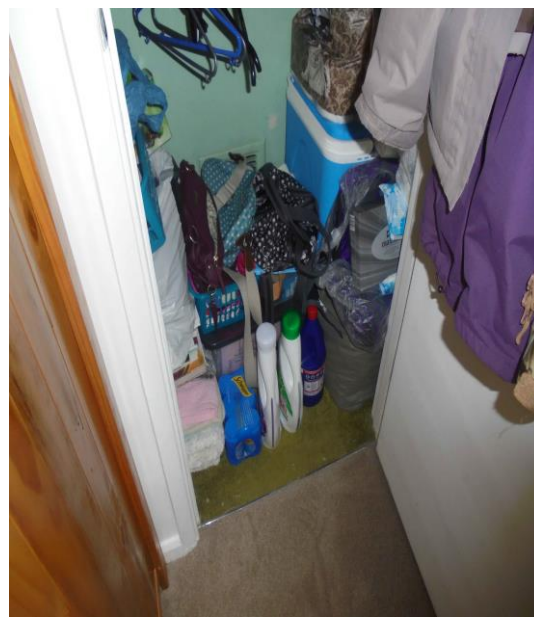
<b>Material Description:</b>	Floor tiles and adhesive under carpet	
<b>Identification:</b>	Sampled – Asbestos Detected	
<b>Approx. quantity:</b>	2M2	
<b>Accessibility</b>	Low	<i>Assessment Score</i>
<b>Product type:</b>	Composite	1
<b>Extent of Damage:</b>	Minor	1
<b>Surface Treatment:</b>	Non-Friable	0
<b>Asbestos type:</b>	Chrysotile	1
<b>Material Assessment Score:</b>		3
<b>Priority Assessment Score:</b>		Negligible
<b>Action:</b>	Manage	
<b>Comments:</b>	May also be under fixed carpet in bedroom 2 – Apply caution

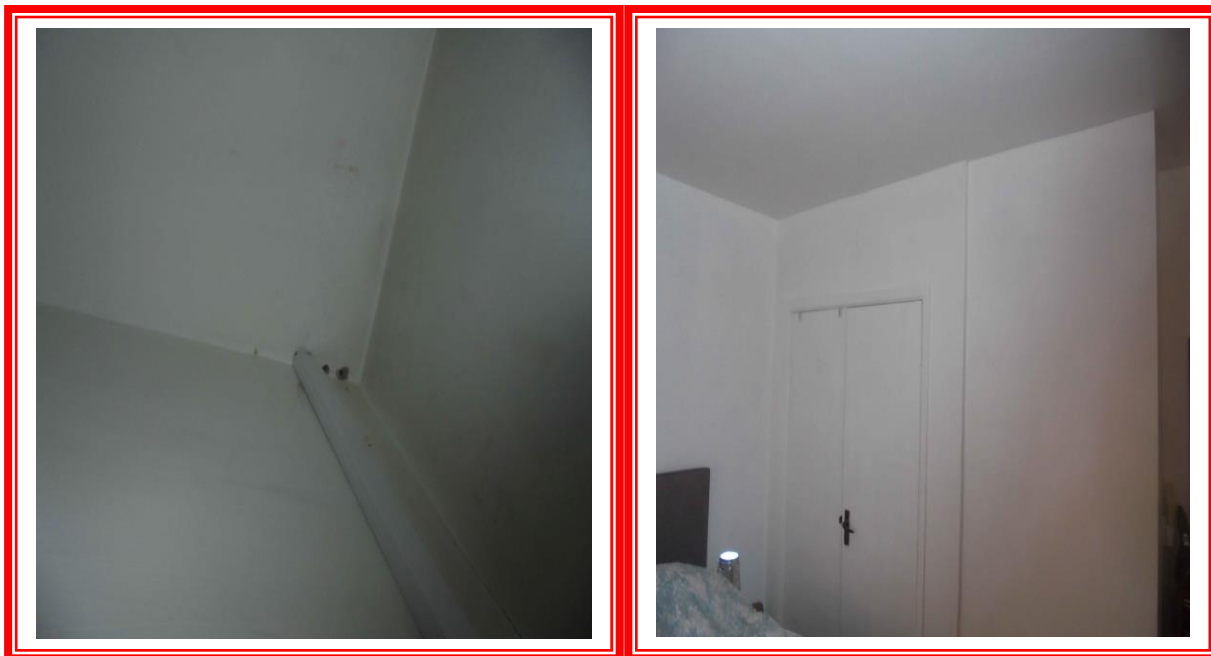
<b>Material Description:</b>	Insulation board ceiling to cupboard	
<b>Identification:</b>	As Per Previous Sample GU/TA/001/17 – Asbestos Detected	
<b>Approx. quantity:</b>	2M2	
<b>Accessibility</b>	Medium	Assessment Score
<b>Product type:</b>	Asbestos Insulation Board	2
<b>Extent of Damage:</b>	Moderate	2
<b>Surface Treatment:</b>	Encapsulated	1
<b>Asbestos type:</b>	Amosite	2
<b>Material Assessment Score:</b>		7
<b>Priority Assessment Score:</b>		Medium
<b>Action:</b>	Encapsulate	
<b>Comments:</b>	Holes in the ceiling should be encapsulated. No access under the fixed carpet.

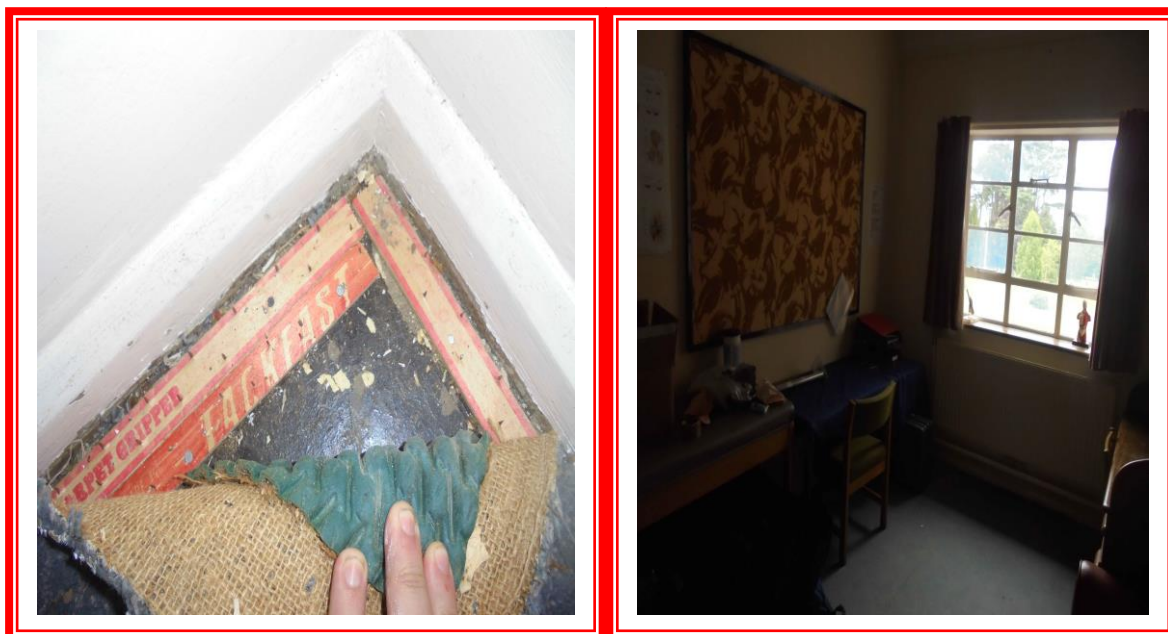
<b>Material Description:</b>	Floor tiles under carpet	
<b>Identification:</b>	As Per Sampled DK/6 – No Asbestos Detected	
<b>Approx. quantity:</b>	15M2	
<b>Accessibility</b>	Low	Assessment Score
<b>Product type:</b>	Composite	1
<b>Extent of Damage:</b>	Minor	1
<b>Surface Treatment:</b>	Non-Friable	0
<b>Asbestos type:</b>	Chrysotile	1
<b>Material Assessment Score:</b>		3
<b>Priority Assessment Score:</b>		Negligible
<b>Action:</b>	Manage	
<b>Comments:</b>	N/A

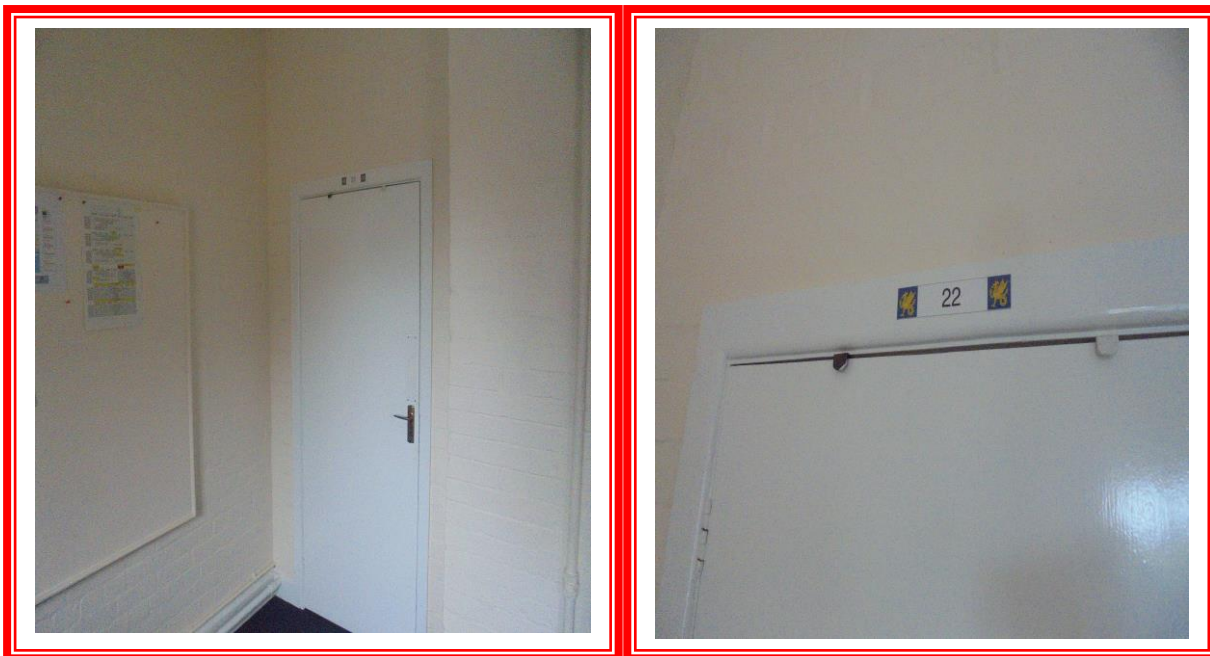
<b>Material Description:</b>	No access within Office 22	
<b>Identification:</b>	Presumed to Contain Asbestos	
<b>Approx. quantity:</b>	Unknown	
<b>Accessibility</b>	Low	<i>Assessment Score</i>
<b>Product type:</b>	No Access	3
<b>Extent of Damage:</b>	No Access	3
<b>Surface Treatment:</b>	No Access	3
<b>Asbestos type:</b>	No Access	3
<b>Material Assessment Score:</b>		12
<b>Priority Assessment Score:</b>		High
<b>Action:</b>	Further Investigation Required	
<b>Comments:</b>	Locked and no key available on day of survey

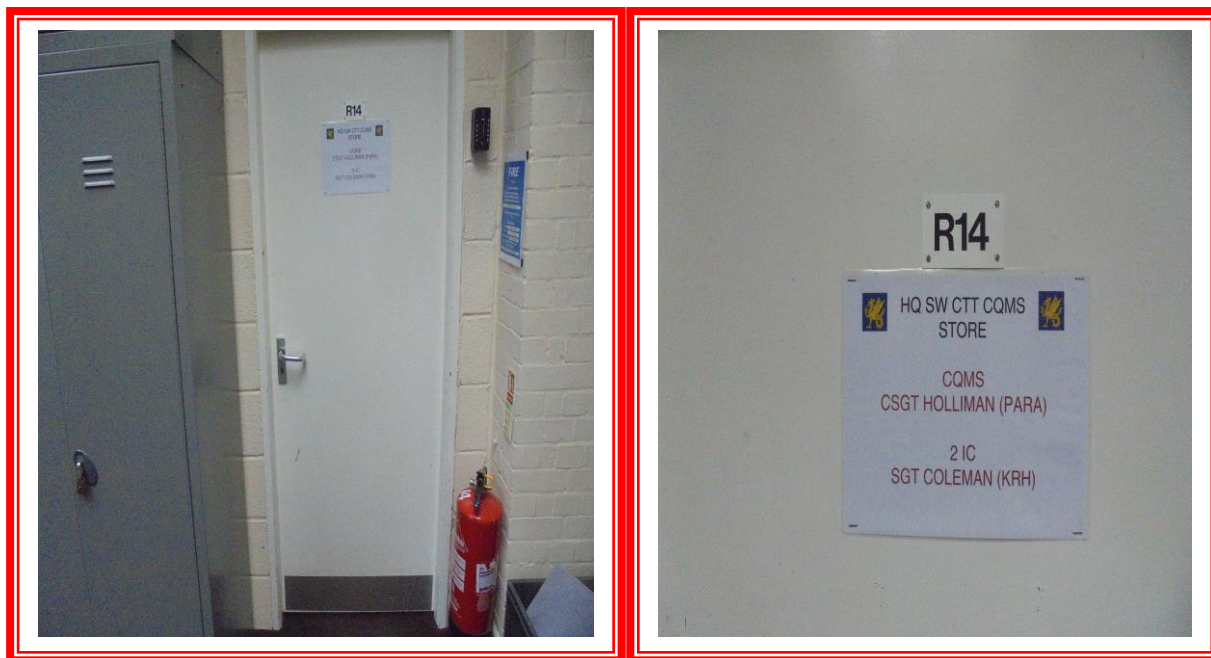
<b>Material Description:</b>	No access within Store R14	
<b>Identification:</b>	Presumed to Contain Asbestos	
<b>Approx. quantity:</b>	Unknown	
<b>Accessibility</b>	Low	<i>Assessment Score</i>
<b>Product type:</b>	No Access	3
<b>Extent of Damage:</b>	No Access	3
<b>Surface Treatment:</b>	No Access	3
<b>Asbestos type:</b>	No Access	3
<b>Material Assessment Score:</b>		12
<b>Priority Assessment Score:</b>		High
<b>Action:</b>	Further Investigation Required	
<b>Comments:</b>	Locked and no key available on day of survey

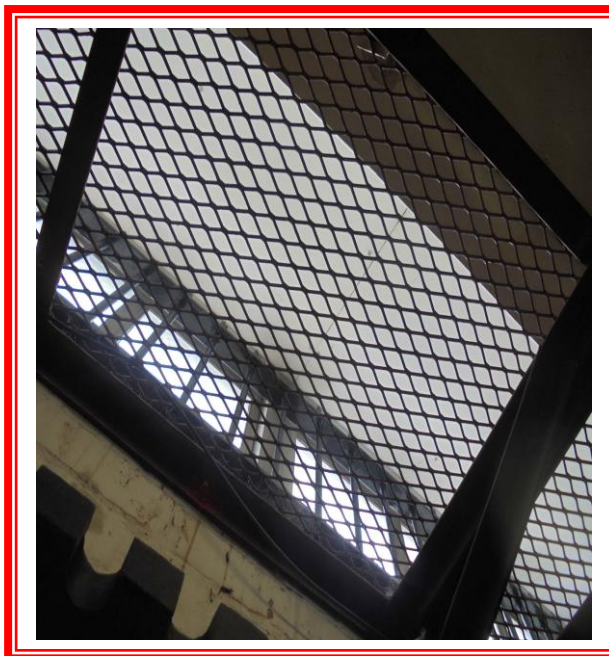
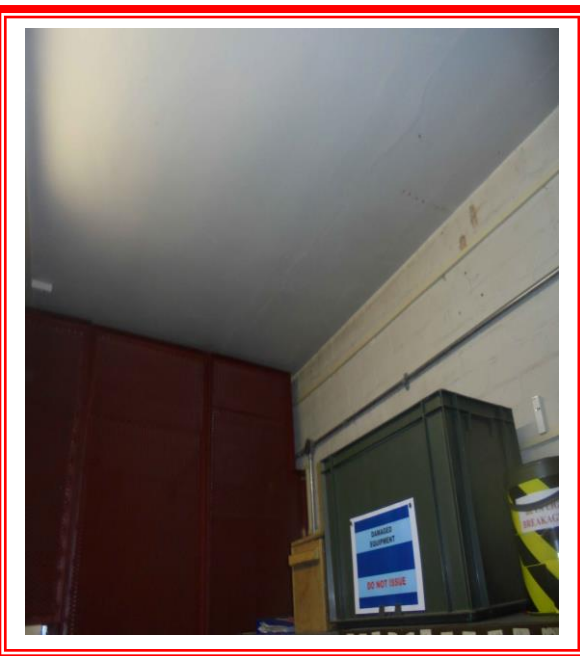
<b>Material Description:</b>	Panels above cage	
<b>Identification:</b>	Presumed to Contain Asbestos	
<b>Approx. quantity:</b>	6LM	
<b>Accessibility</b>	Low	<i>Assessment Score</i>
<b>Product type:</b>	Asbestos Insulation Board	2
<b>Extent of Damage:</b>	Minor	1
<b>Surface Treatment:</b>	Encapsulated	1
<b>Asbestos type:</b>	Amosite	2
<b>Material Assessment Score:</b>		6
<b>Priority Assessment Score:</b>		Medium
<b>Action:</b>	Further Investigation Required	
<b>Comments:</b>	No access to sample as located above cage

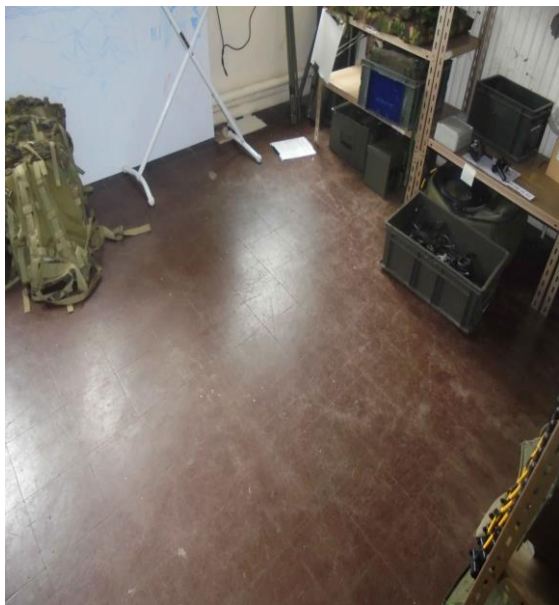
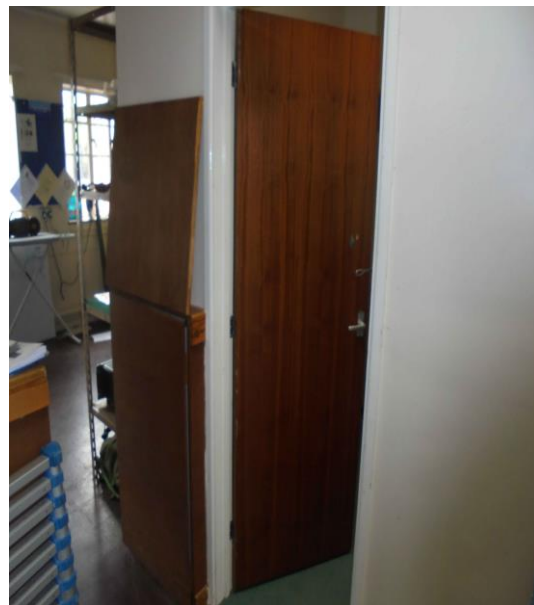
<b>Material Description:</b>	Floor tiles and adhesive	
<b>Identification:</b>	As Per Sample DK/11 – Asbestos Detected	
<b>Approx. quantity:</b>	20M2	
<b>Accessibility</b>	High	<i>Assessment Score</i>
<b>Product type:</b>	Composite	1
<b>Extent of Damage:</b>	Moderate	2
<b>Surface Treatment:</b>	Non-Friable	0
<b>Asbestos type:</b>	Chrysotile	1
<b>Material Assessment Score:</b>		4
<b>Priority Assessment Score:</b>		Negligible
<b>Action:</b>	Manage	
<b>Comments:</b>	N/A
