ARMOUR
ANALYTICAL SERVICES

Project Number 2481

**Management
Asbestos Survey Report**

1069 Wimborne, Dorset, BH21 2DB

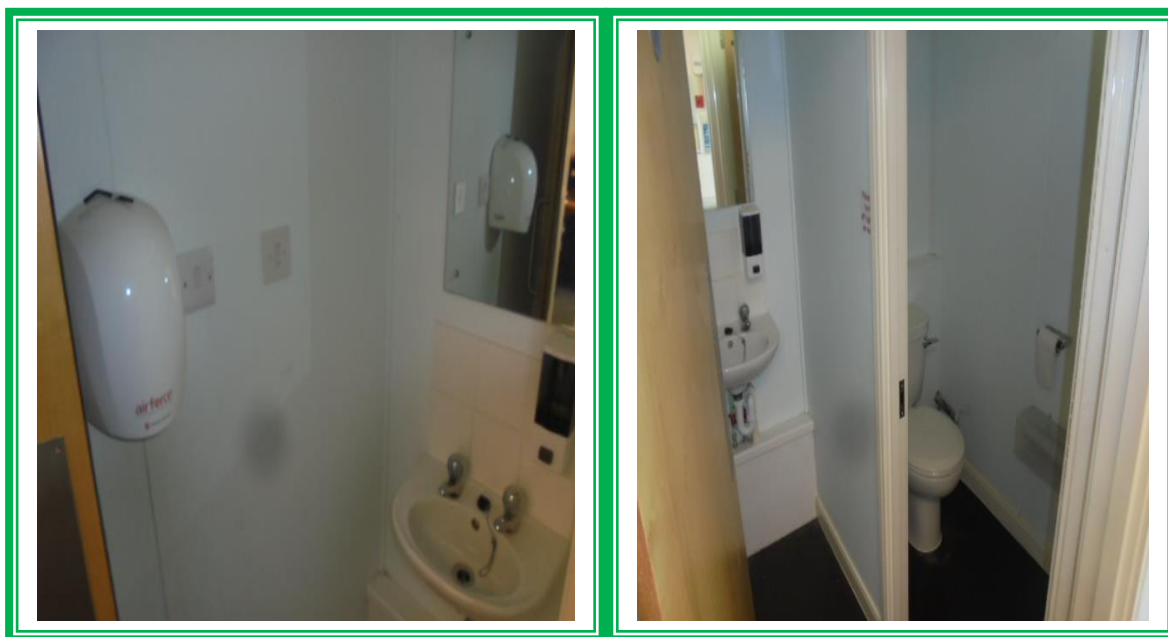
Item No: 1

Location: Ground Floor – Male WC

Material Description:	Visual Inspection – No Suspect Materials Found	
Identification:	N/A	
Approx. quantity:	N/A	
Accessibility	High	<i>Assessment Score</i>
Product type:	N/A	N/A
Extent of Damage:	N/A	N/A
Surface Treatment:	N/A	N/A
Asbestos type:	N/A	N/A
Material Assessment Score:		N/A
Priority Assessment Score:		N/A
Action:	N/A	
Comments:	N/A

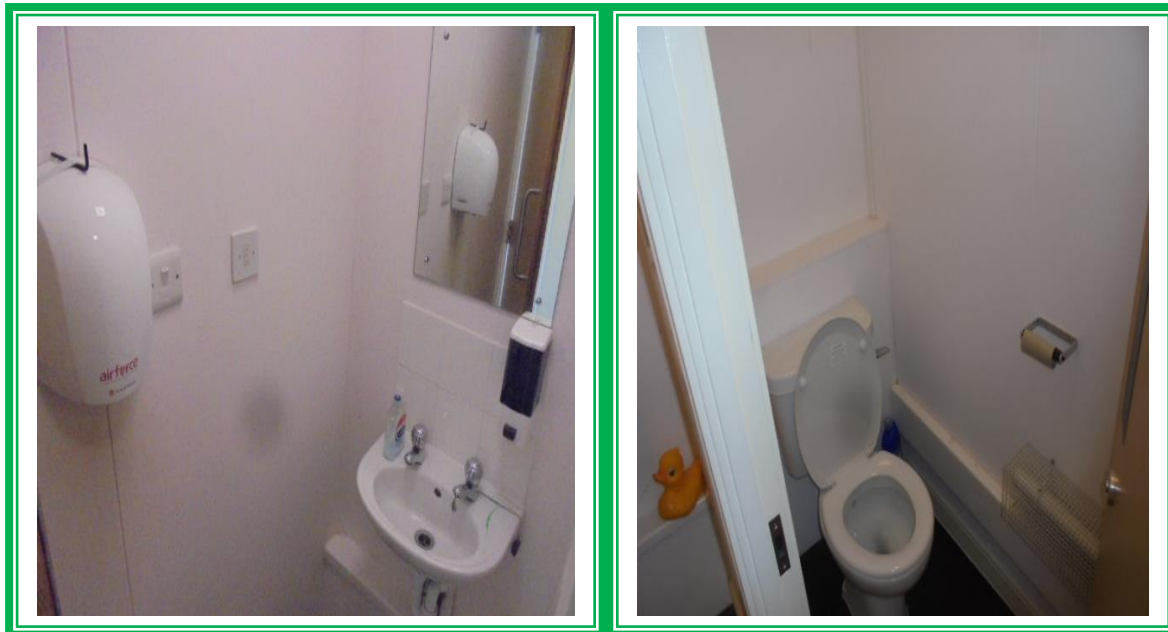
Item No: 2

Location: Ground Floor – Female WC

Material Description:	Visual Inspection – No Suspect Materials Found	
Identification:	N/A	
Approx. quantity:	N/A	
Accessibility	N/A	<i>Assessment Score</i>
Product type:	N/A	N/A
Extent of Damage:	N/A	N/A
Surface Treatment:	N/A	N/A
Asbestos type:	N/A	N/A
Material Assessment Score:		N/A
Priority Assessment Score:		N/A
Action:	N/A	
Comments:	N/A

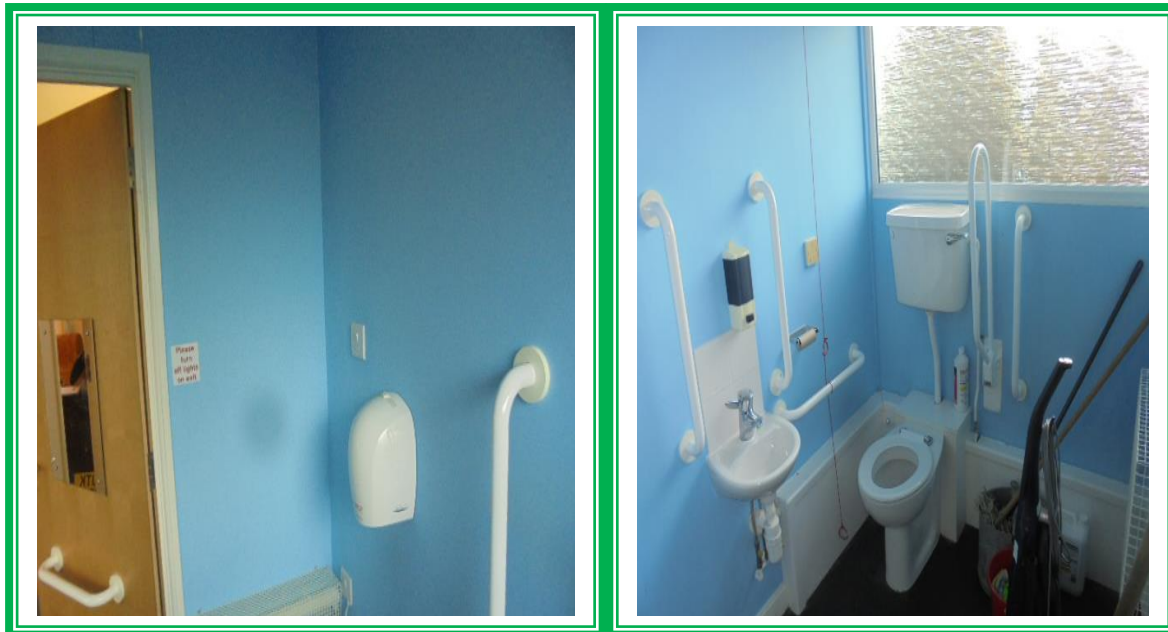
Item No: 3

Location: Ground Floor – Disabled WC

Material Description:	Visual Inspection – No Suspect Materials Found	
Identification:	N/A	
Approx. quantity:	N/A	
Accessibility	N/A	Assessment Score
Product type:	N/A	N/A
Extent of Damage:	N/A	N/A
Surface Treatment:	N/A	N/A
Asbestos type:	N/A	N/A
Material Assessment Score:		N/A
Priority Assessment Score:		N/A
Action:	N/A	
Comments:	N/A

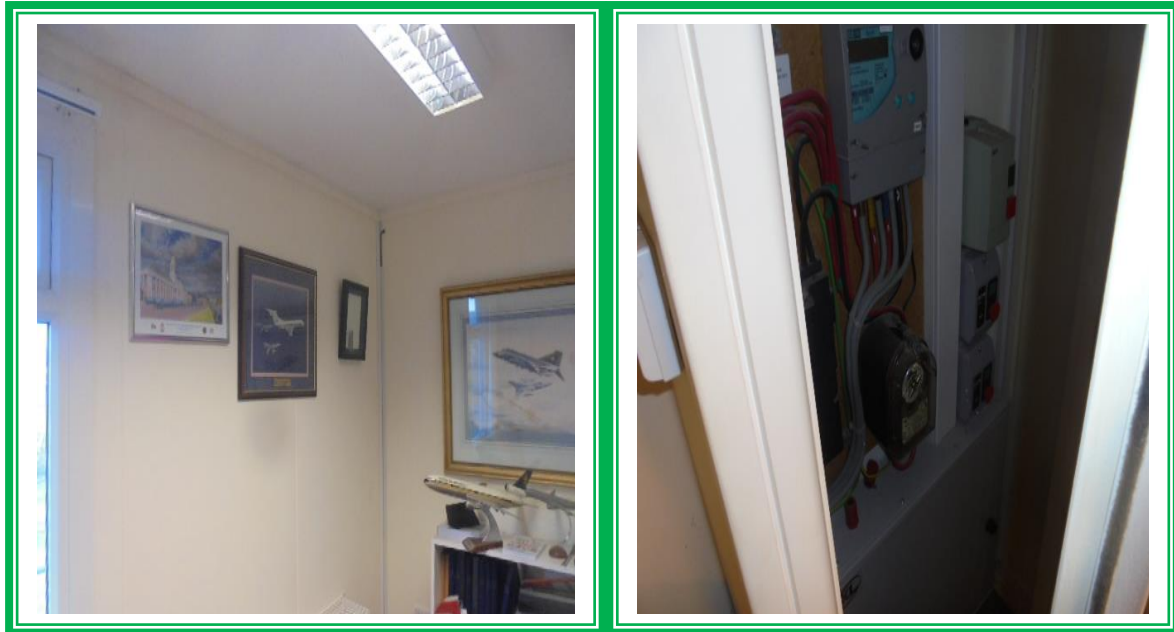
Item No: 4

Location: Ground Floor – Office and Cupboard

Material Description:	Visual Inspection – No Suspect Materials Found	
Identification:	N/A	
Approx. quantity:	N/A	
Accessibility	N/A	Assessment Score
Product type:	N/A	N/A
Extent of Damage:	N/A	N/A
Surface Treatment:	N/A	N/A
Asbestos type:	N/A	N/A
Material Assessment Score:		N/A
Priority Assessment Score:		N/A
Action:	N/A	
Comments:	Modern Electrics

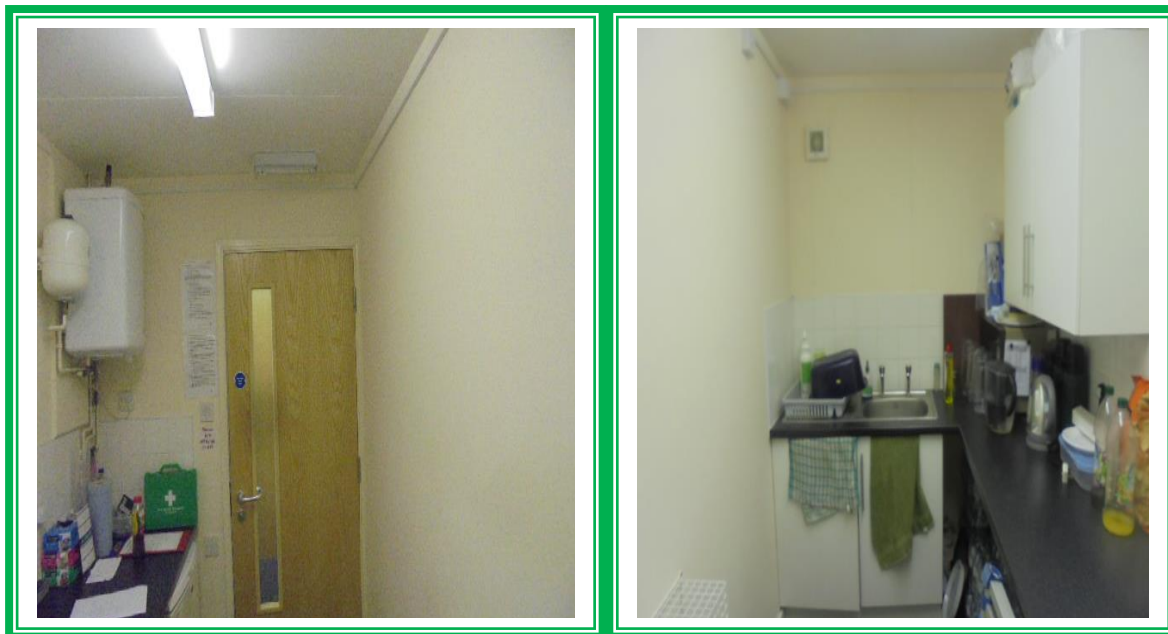
Item No: 5

Location: Ground Floor – Kitchen

Material Description:	Visual Inspection – No Suspect Materials Found	
Identification:	N/A	
Approx. quantity:	N/A	
Accessibility	N/A	<i>Assessment Score</i>
Product type:	N/A	N/A
Extent of Damage:	N/A	N/A
Surface Treatment:	N/A	N/A
Asbestos type:	N/A	N/A
Material Assessment Score:		N/A
Priority Assessment Score:		N/A
Action:	N/A	
Comments:	Modern Sink Pad

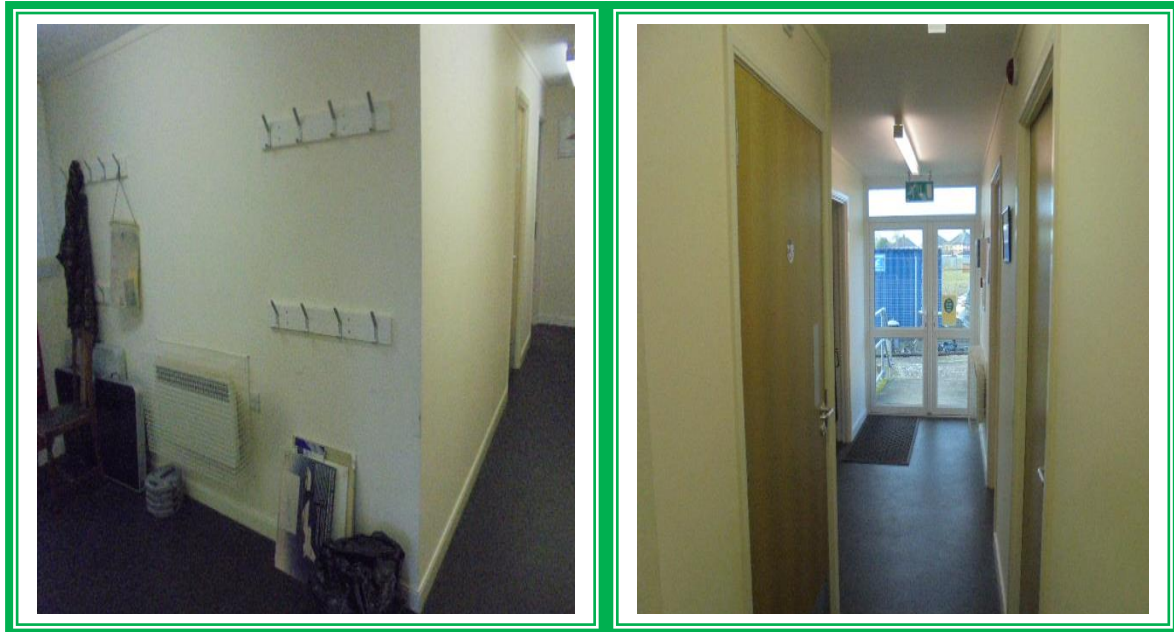
Item No: 6

Location: Ground Floor – Lobby's x 2 and Corridor

Material Description:	Visual Inspection – No Suspect Materials Found	
Identification:	N/A	
Approx. quantity:	N/A	
Accessibility	N/A	<i>Assessment Score</i>
Product type:	N/A	N/A
Extent of Damage:	N/A	N/A
Surface Treatment:	N/A	N/A
Asbestos type:	N/A	N/A
Material Assessment Score:		N/A
Priority Assessment Score:		N/A
Action:	N/A	
Comments:	N/A

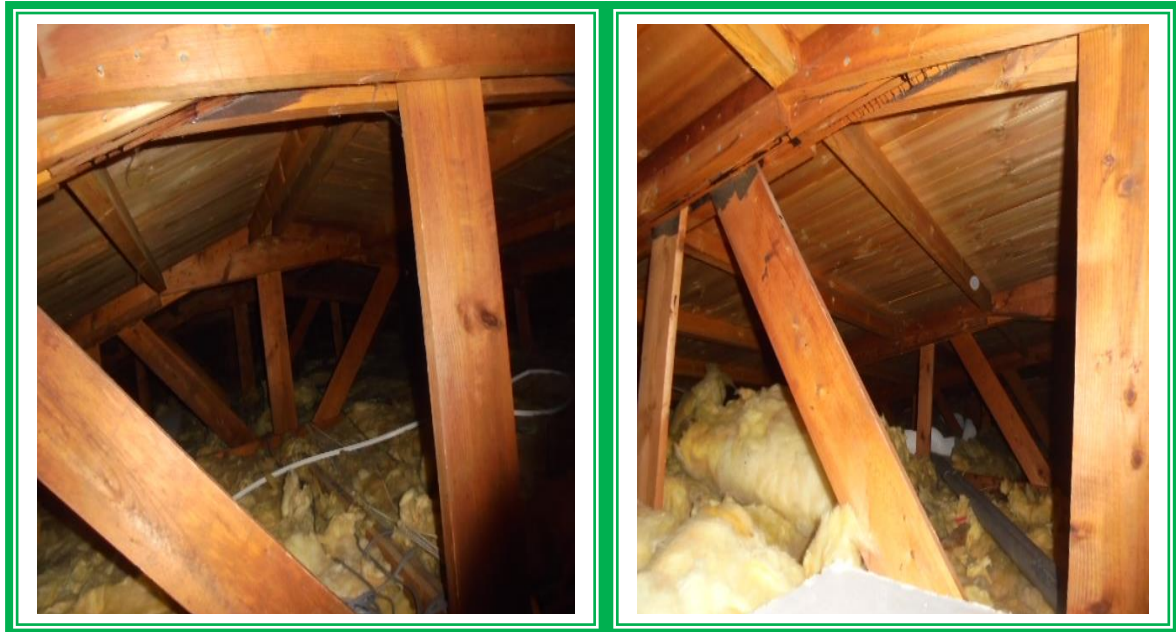
Item No: 7

Location: Loft Space

Material Description:	Visual Inspection – No Suspect Materials Found	
Identification:	N/A	
Approx. quantity:	N/A	
Accessibility	N/A	<i>Assessment Score</i>
Product type:	N/A	N/A
Extent of Damage:	N/A	N/A
Surface Treatment:	N/A	N/A
Asbestos type:	N/A	N/A
Material Assessment Score:		N/A
Priority Assessment Score:		N/A
Action:	N/A	
Comments:	N/A

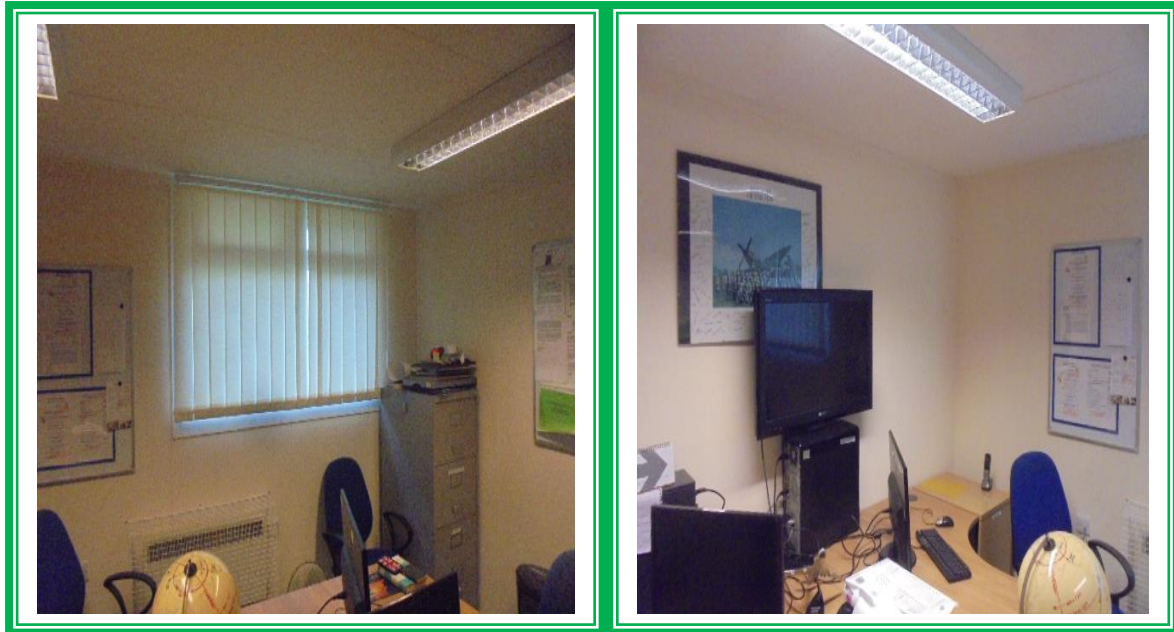
Item No: 8

Location: Ground Floor – Nissen Office

Material Description:	Visual Inspection – No Suspect Materials Found	
Identification:	N/A	
Approx. quantity:	N/A	
Accessibility	N/A	<i>Assessment Score</i>
Product type:	N/A	N/A
Extent of Damage:	N/A	N/A
Surface Treatment:	N/A	N/A
Asbestos type:	N/A	N/A
Material Assessment Score:		N/A
Priority Assessment Score:		N/A
Action:	N/A	
Comments:	N/A

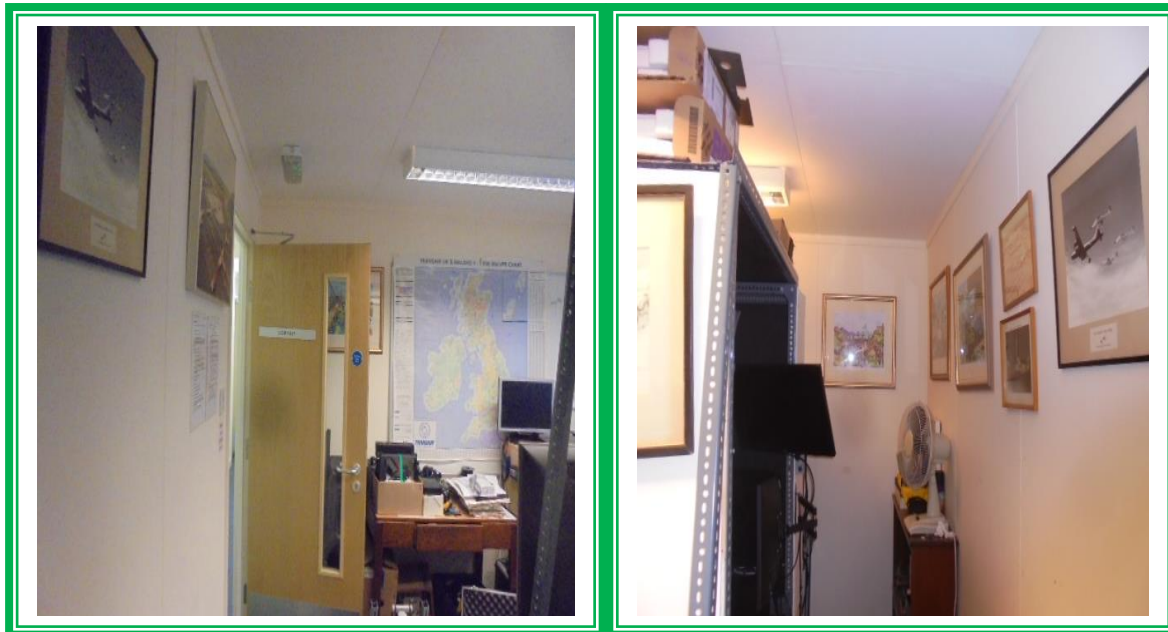
Item No: 9

Location: Ground Floor – Cobham Room

Material Description:	Visual Inspection – No Suspect Materials Found	
Identification:	N/A	
Approx. quantity:	N/A	
Accessibility	N/A	Assessment Score
Product type:	N/A	N/A
Extent of Damage:	N/A	N/A
Surface Treatment:	N/A	N/A
Asbestos type:	N/A	N/A
Material Assessment Score:		N/A
Priority Assessment Score:		N/A
Action:	N/A	
Comments:	N/A

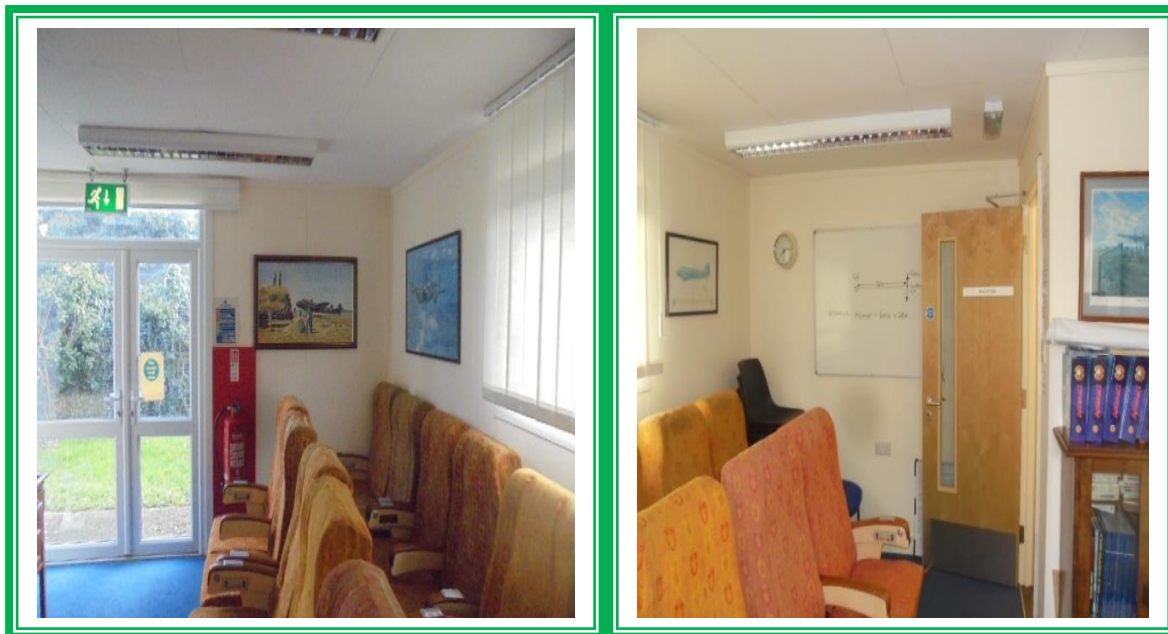
Item No: 10

Location: Ground Floor – Rushton Room

Material Description:	Visual Inspection – No Suspect Materials Found	
Identification:	N/A	
Approx. quantity:	N/A	
Accessibility	N/A	<i>Assessment Score</i>
Product type:	N/A	N/A
Extent of Damage:	N/A	N/A
Surface Treatment:	N/A	N/A
Asbestos type:	N/A	N/A
Material Assessment Score:		N/A
Priority Assessment Score:		N/A
Action:	N/A	
Comments:	N/A

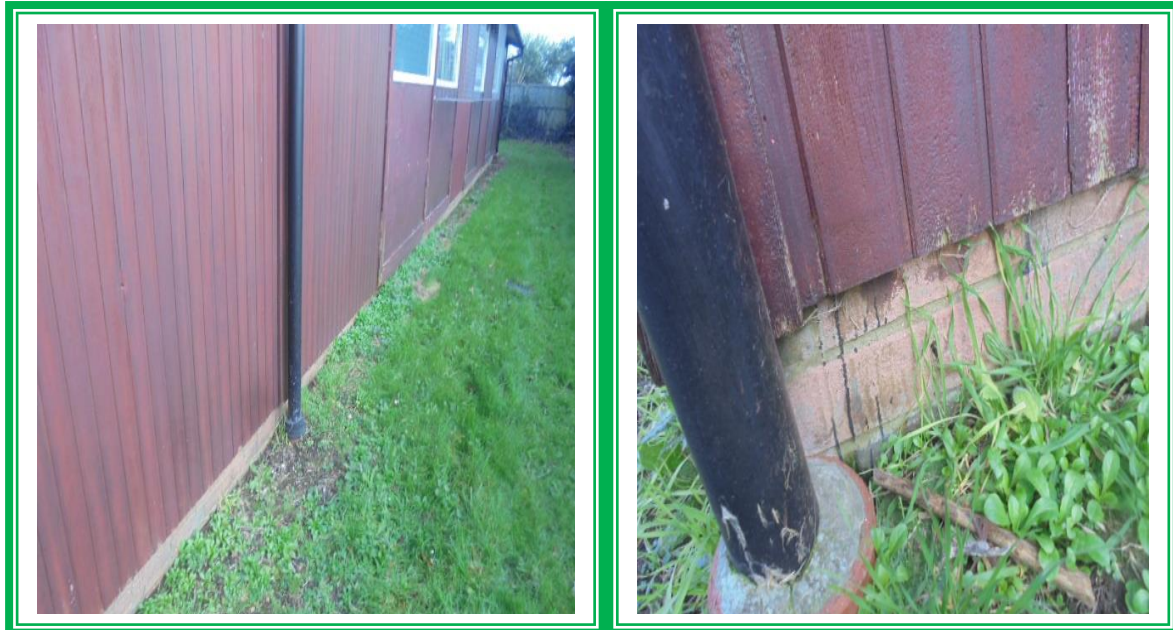
Item No: 11

Sample Number	Sample Type	Location	Analysis
DK/1	Damp Proof Course	External	N.A.D.I.S

Sample No: DK/1

Location: External

Material Description:	Damp Proof Course	
Identification:	Sampled – No Asbestos Detected	
Approx. quantity:	Entire Perimeter	
Accessibility	N/A	<i>Assessment Score</i>
Product type:	N/A	N/A
Extent of Damage:	N/A	N/A
Surface Treatment:	N/A	N/A
Asbestos type:	N/A	N/A
Material Assessment Score:		N/A
Priority Assessment Score:		N/A
Action:	N/A	
Comments:	N/A

Sample No.	Sample Ref.	Location	Asbestos Detected	Asbestos Type
DK/1	BS590516	External - Damp Proof Course	No

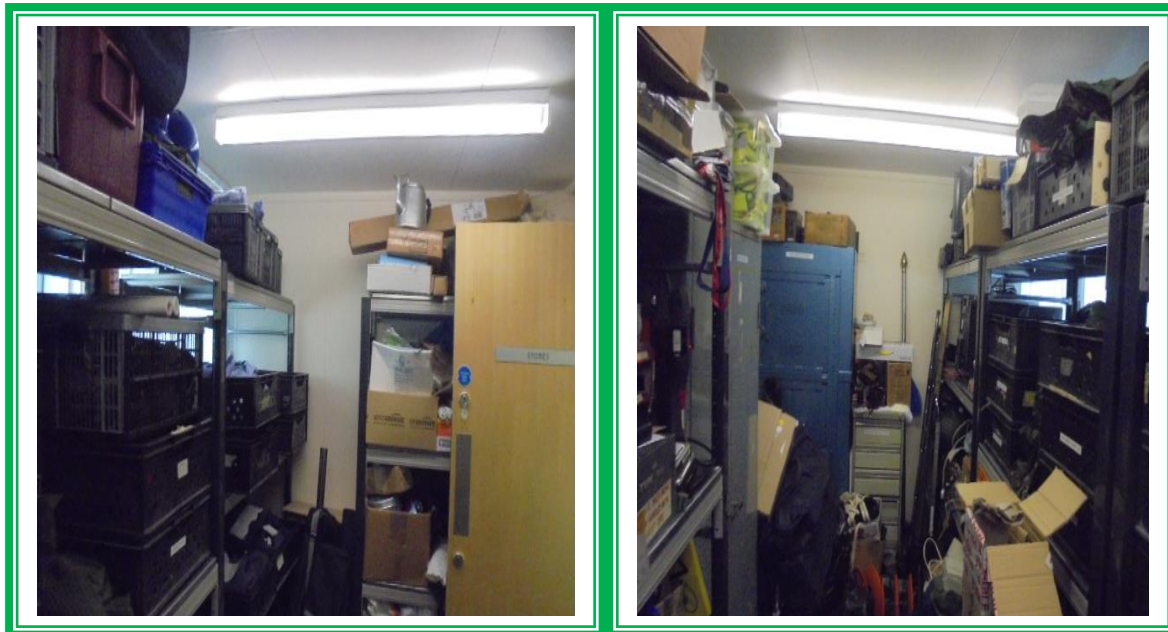
Item No: 12

Location: Ground Floor – Stores

Material Description:	Visual Inspection – No Suspect Materials Found	
Identification:	N/A	
Approx. quantity:	N/A	
Accessibility	N/A	<i>Assessment Score</i>
Product type:	N/A	N/A
Extent of Damage:	N/A	N/A
Surface Treatment:	N/A	N/A
Asbestos type:	N/A	N/A
Material Assessment Score:		N/A
Priority Assessment Score:		N/A
Action:	N/A	
Comments:	N/A

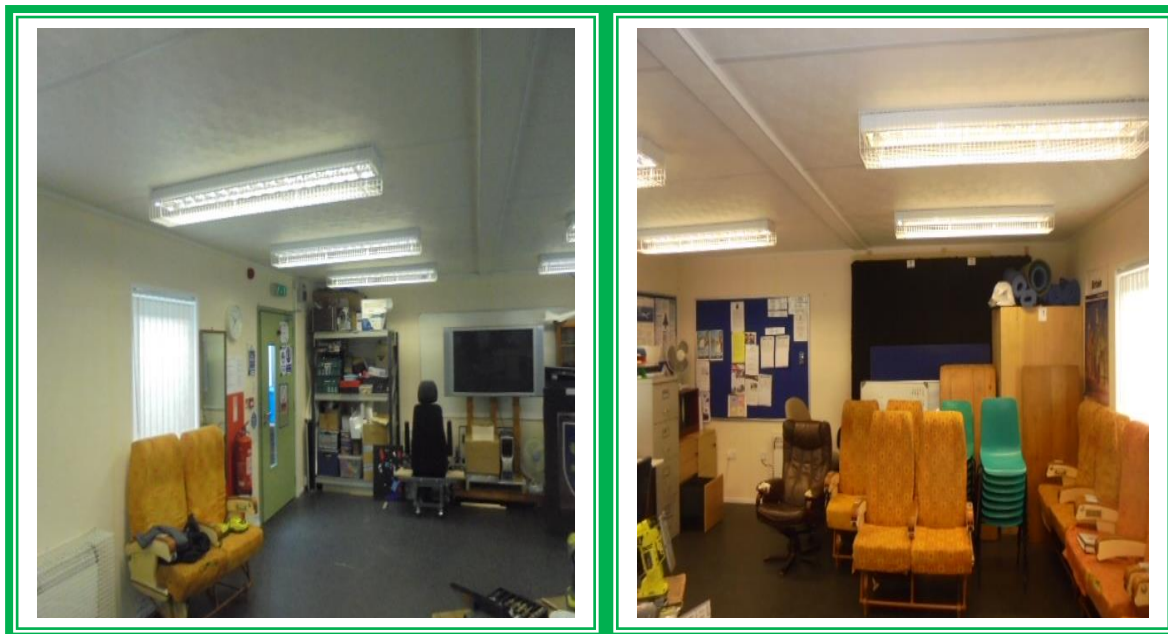
Item No: 13

Location: Ground Floor – Workshop

Material Description:	Visual Inspection – No Suspect Materials Found	
Identification:	N/A	
Approx. quantity:	N/A	
Accessibility	N/A	Assessment Score
Product type:	N/A	N/A
Extent of Damage:	N/A	N/A
Surface Treatment:	N/A	N/A
Asbestos type:	N/A	N/A
Material Assessment Score:		N/A
Priority Assessment Score:		N/A
Action:	N/A	
Comments:	Built in 2010
