Project Number A-00618 (3700)

**Re-Inspection
Asbestos Survey Report**

**Thornbury Platoon
Gloucester Road
Gloucestershire
BS35 1JH**

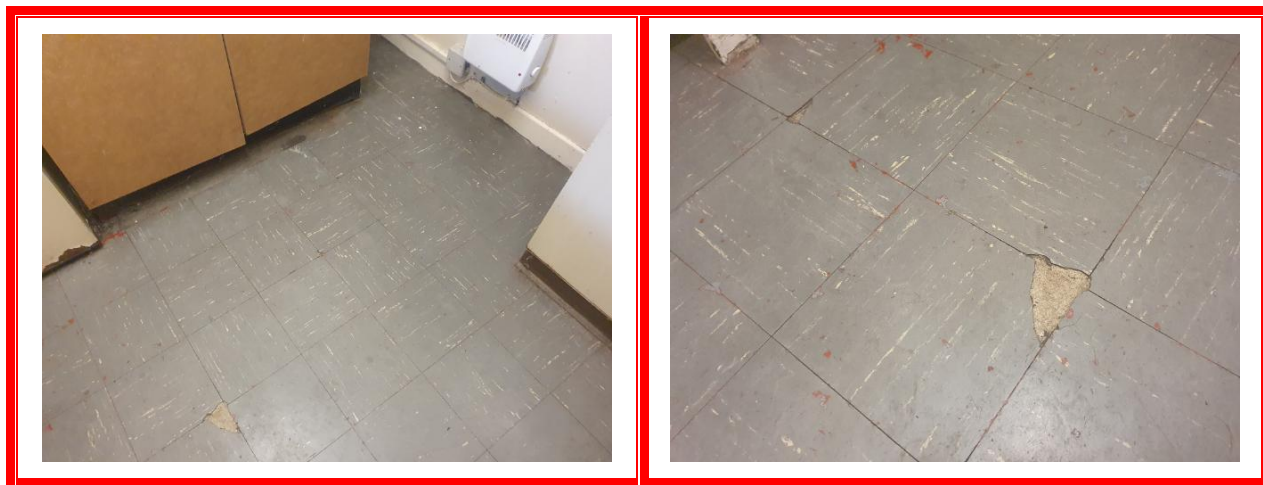
Item No:	1	Sample No:	N/A
Location:	Ground Floor - Kitchen 001

Material Description:	Floor Tiles and Adhesive - Vinyl Products	
Identification:	Previously Sampled - Asbestos Detected	
Approx. quantity:	6 m ²	
Accessibility	Easy	<i>Assessment Score</i>
Product type:	Vinyl	1
Extent of Damage:	Moderate damage	2
Surface Treatment:	Non-friable	0
Asbestos type:	Chrysotile	1
Material Assessment Score:		4
Priority Assessment Score:		Negligible
Action:	Manage	
Comments:	Previously sampled ref: Armour 7/10/19 - Sample DK/2

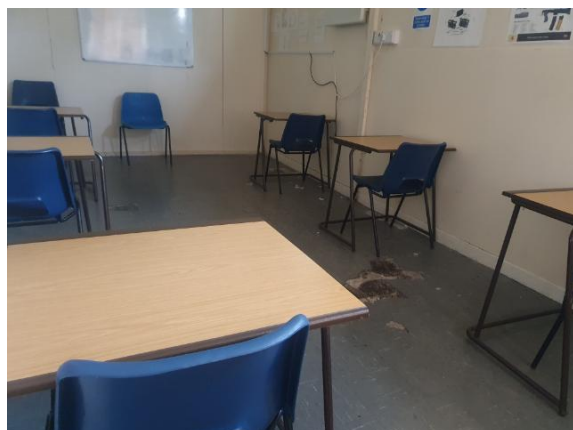
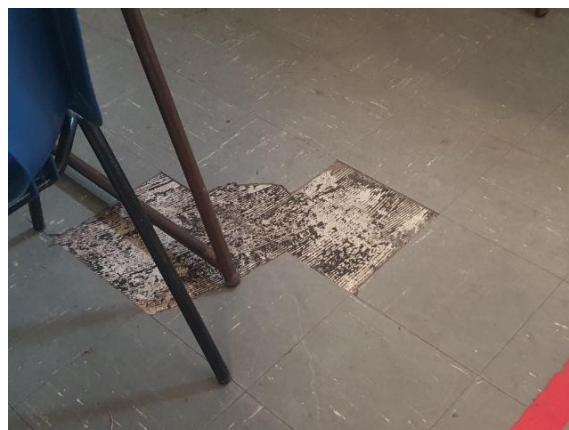
Location: Ground Floor - Classroom 002

Material Description:	Floor Tiles and Adhesive - Vinyl Products	
Identification:	Previously Sampled - Asbestos Detected	
Approx. quantity:	20 m ²	
Accessibility	Easy	<i>Assessment Score</i>
Product type:	Vinyl	1
Extent of Damage:	Major damage	3
Surface Treatment:	Non-friable	0
Asbestos type:	Chrysotile	1
Material Assessment Score:		5
Priority Assessment Score:		Low
Action:	Manage	
Comments:	Previously sampled ref: Armour 7/10/19 - Sample DK/2. Several broken tiles. Consider removal or covering

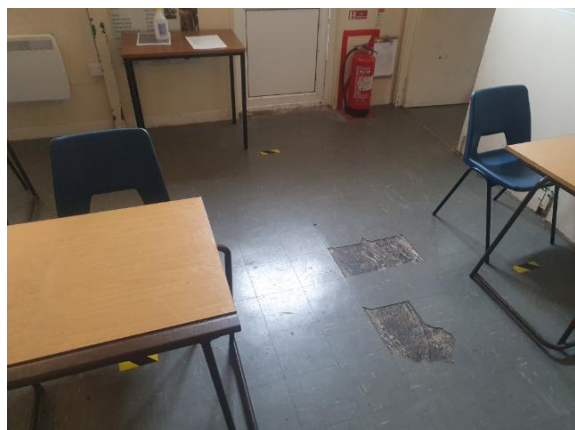
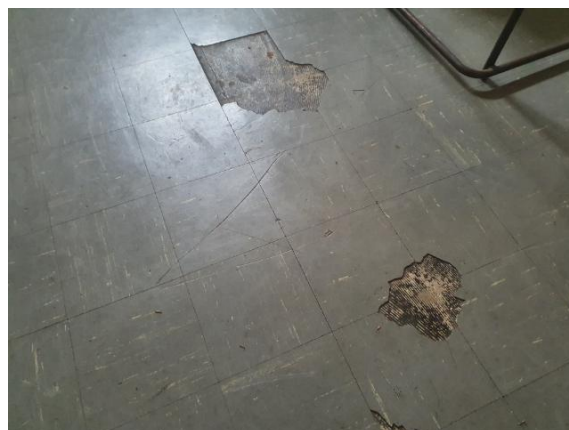
Location: Ground Floor - Classroom 003

Material Description:	Floor Tiles and Adhesive - Vinyl Products	
Identification:	Previously Sampled - Asbestos Detected	
Approx. quantity:	20 m ²	
Accessibility	Easy	<i>Assessment Score</i>
Product type:	Vinyl	1
Extent of Damage:	Major damage	3
Surface Treatment:	Non-friable	0
Asbestos type:	Chrysotile	1
Material Assessment Score:		5
Priority Assessment Score:		Low
Action:	Manage	
Comments:	Previously sampled ref: Armour 7/10/19 - Sample DK/2. Several broken tiles. Consider removal or covering

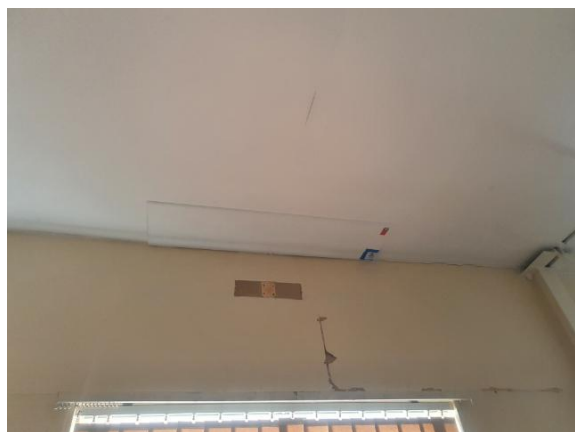
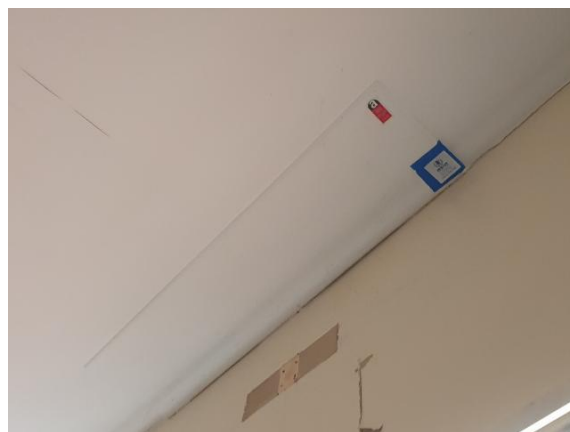
Location: Ground Floor - Classroom 004

Material Description:	Panels on Ceiling - Insulating Board	
Identification:	Previously Sampled - Asbestos Detected	
Approx. quantity:	1 m ²	
Accessibility	Difficult	<i>Assessment Score</i>
Product type:	Asbestos Insulating Board	2
Extent of Damage:	Slight / minor damage	1
Surface Treatment:	Encapsulated AIB	1
Asbestos type:	Amosite	2
Material Assessment Score:		6
Priority Assessment Score:		Low
Action:	Manage	
Comments:	Previously sampled ref: Armour 7/10/19 - Sample DK/3

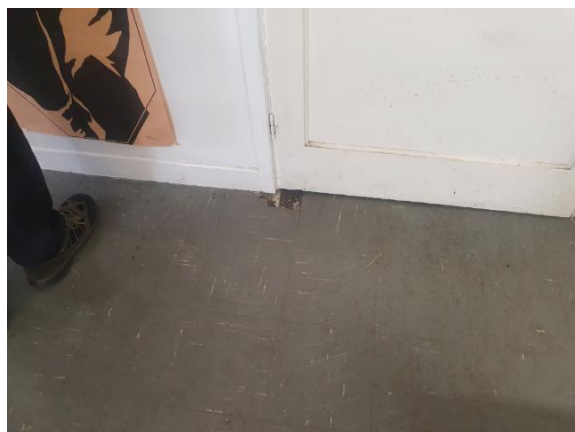
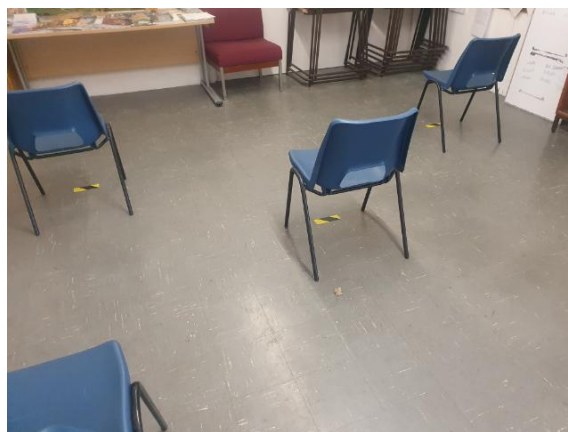
Location: Ground Floor - Drill Hall 005

Material Description:	Floor Tiles and Adhesive - Vinyl Products	
Identification:	Previously Sampled - Asbestos Detected	
Approx. quantity:	30 m ²	
Accessibility	Easy	<i>Assessment Score</i>
Product type:	Vinyl	1
Extent of Damage:	Moderate damage	2
Surface Treatment:	Non-friable	0
Asbestos type:	Chrysotile	1
Material Assessment Score:		4
Priority Assessment Score:		Negligible
Action:	Manage	
Comments:	Previously sampled ref: Armour 7/10/19 - Sample DK/2

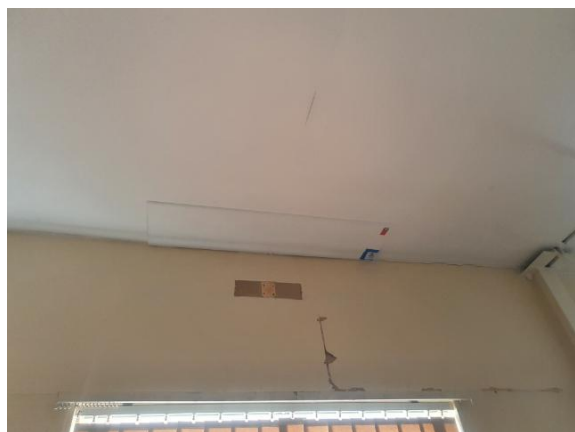
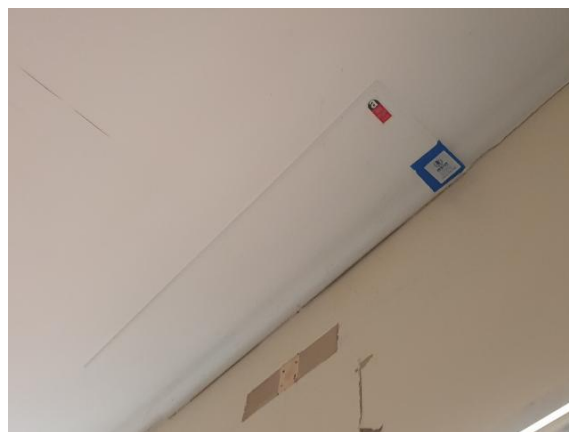
Location: Ground Floor - Drill Hall 006

Material Description:	Panels on Ceiling - Insulating Board	
Identification:	Previously Sampled - Asbestos Detected	
Approx. quantity:	1 m ²	
Accessibility	Difficult	<i>Assessment Score</i>
Product type:	Asbestos Insulating Board	2
Extent of Damage:	Slight / minor damage	1
Surface Treatment:	Encapsulated AIB	1
Asbestos type:	Amosite	2
Material Assessment Score:		6
Priority Assessment Score:		Low
Action:	Manage	
Comments:	Previously sampled ref: Armour 7/10/19 - Sample DK/3. 2no panels

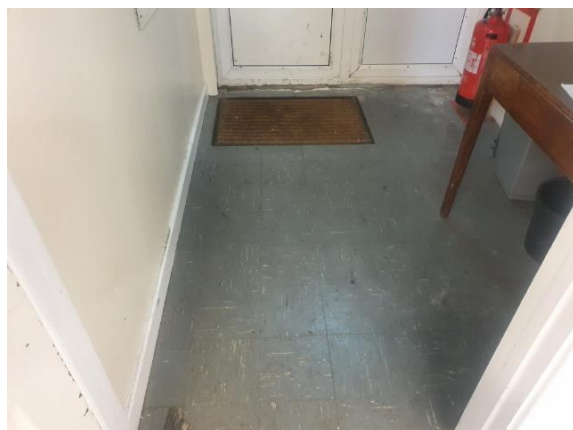
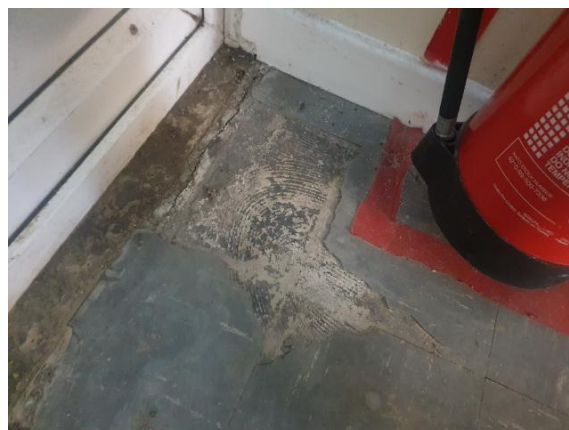
Location: Ground Floor - Lobby 007

Material Description:	Floor Tiles and Adhesive - Vinyl Products	
Identification:	Previously Sampled - Asbestos Detected	
Approx. quantity:	4 m ²	
Accessibility	Easy	<i>Assessment Score</i>
Product type:	Vinyl	1
Extent of Damage:	Moderate damage	2
Surface Treatment:	Non-friable	0
Asbestos type:	Chrysotile	1
Material Assessment Score:		4
Priority Assessment Score:		Negligible
Action:	Manage	
Comments:	Previously sampled ref: Armour 7/10/19 - Sample DK/2. Several areas of damage. Consider removal or covering

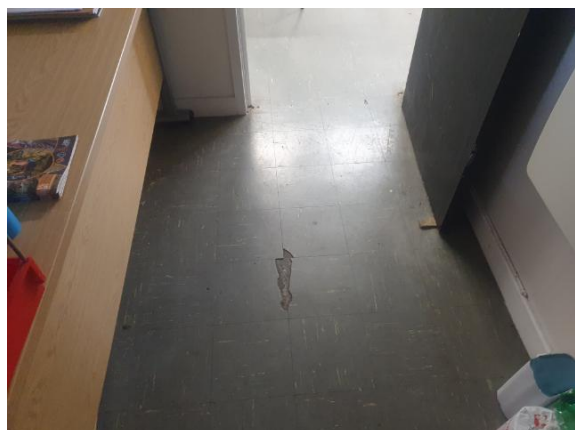
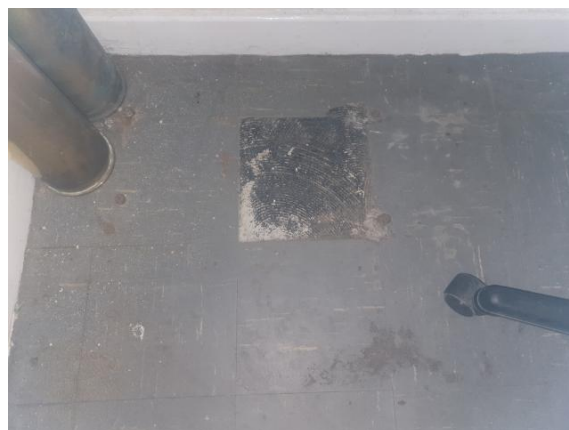
Location: Ground Floor - Office 008

Material Description:	Floor Tiles and Adhesive - Vinyl Products	
Identification:	Previously Sampled - Asbestos Detected	
Approx. quantity:	8 m ²	
Accessibility	Easy	<i>Assessment Score</i>
Product type:	Vinyl	1
Extent of Damage:	Moderate damage	2
Surface Treatment:	Non-friable	0
Asbestos type:	Chrysotile	1
Material Assessment Score:		4
Priority Assessment Score:		Negligible
Action:	Manage	
Comments:	Previously sampled ref: Armour 7/10/19 - Sample DK/2. Several areas of damage. Consider removal or covering

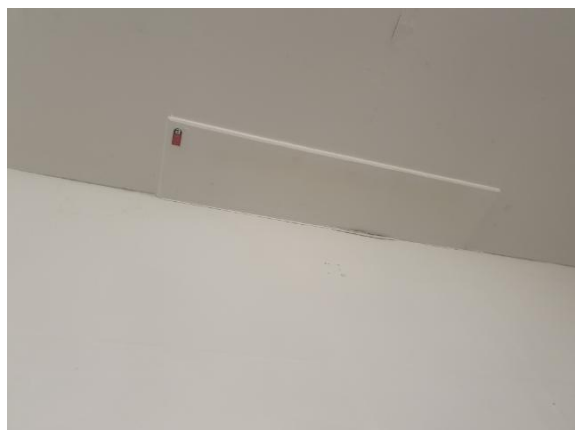
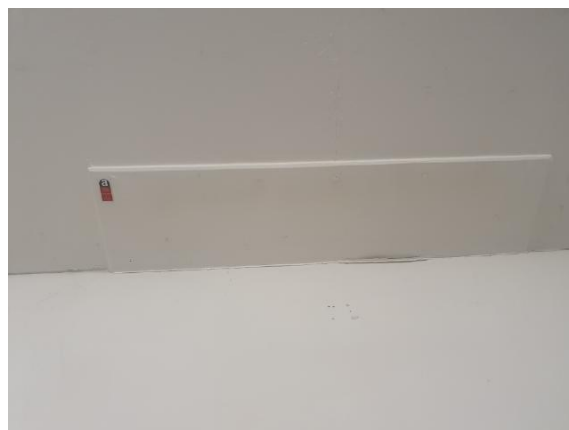
Location: Ground Floor - Office 009

Material Description:	Panel on Ceiling - Insulating Board	
Identification:	Previously Sampled - Asbestos Detected	
Approx. quantity:	<1 m ²	
Accessibility	Difficult	<i>Assessment Score</i>
Product type:	Asbestos Insulating Board	2
Extent of Damage:	Slight / minor damage	1
Surface Treatment:	Encapsulated AIB	1
Asbestos type:	Amosite	2
Material Assessment Score:		6
Priority Assessment Score:		Low
Action:	Manage	
Comments:	Previously sampled ref: Armour 7/10/19 - Sample DK/3
