ARMOUR
ANALYTICAL SERVICES

Project Number 2481

**Management
Asbestos Survey Report**

Yate Platoon, Gloucestershire, BS37 5NG

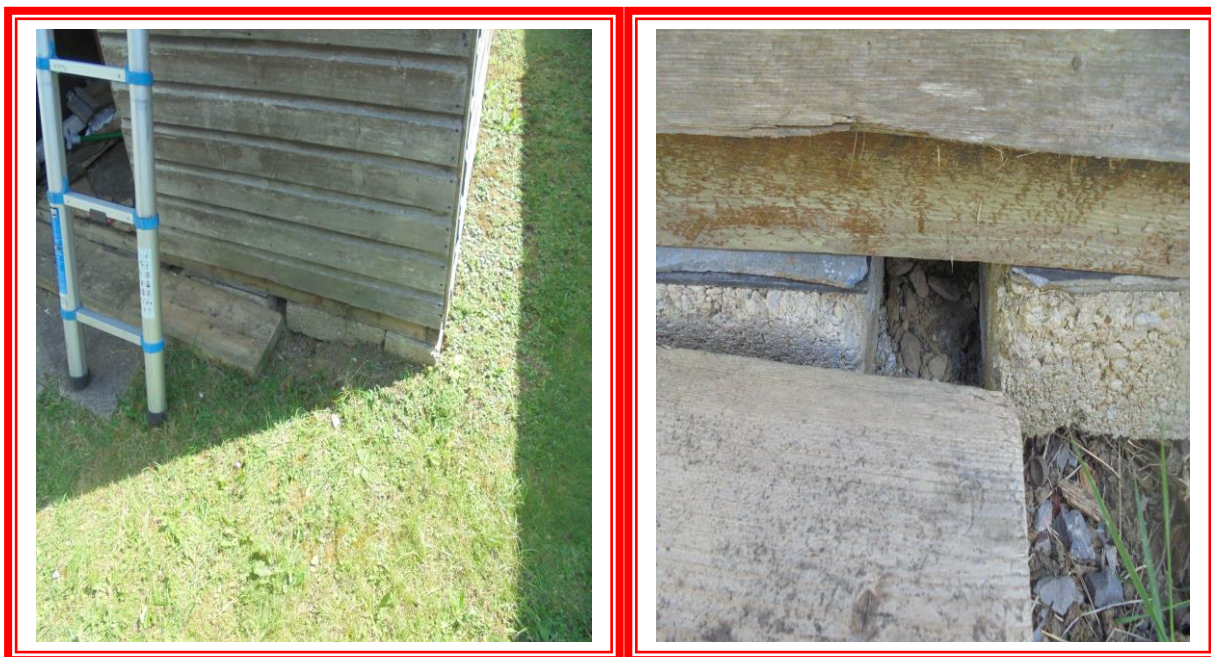
Item No: 12

Sample No: DK/6

Location: External to Shed

| Material Description: | Cement Tiles under Shed | |
| Identification: | Sampled – Asbestos Detected | |
| Approx. quantity: | Unknown – 1M2 Visible | |
| Extent of Damage: | Minor | 1 |
| Asbestos type: | Chrysotile | 1 |
| Material Assessment Score: | | 4 |
| Priority Assessment Score: | | Negligible |

| Action: | Manage | |

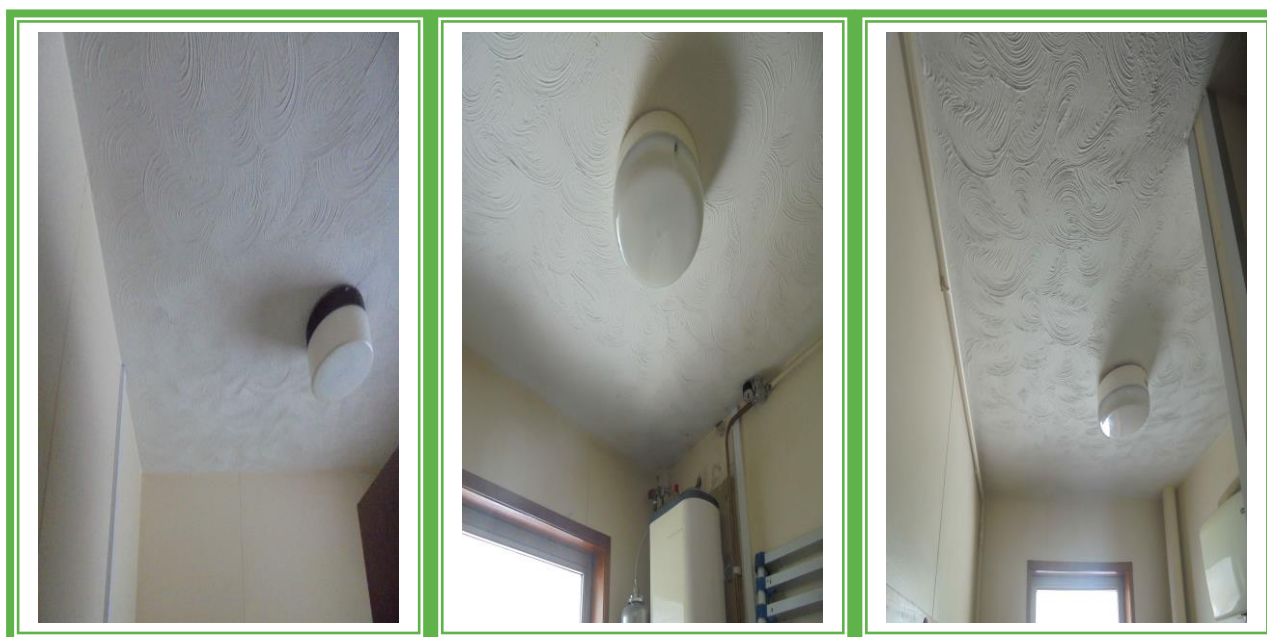
Item No: 1

Sample No: DK/1

Location: WC's x 3

| Material Description: | Textured Coating to Ceilings | |
| Identification: | Sampled – No Asbestos Detected | |

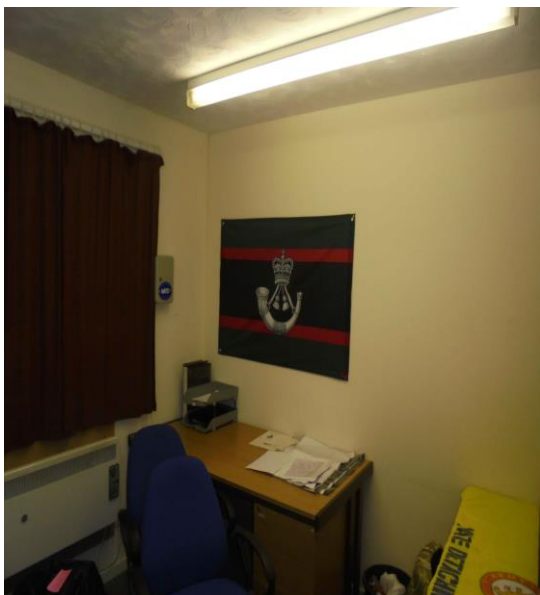
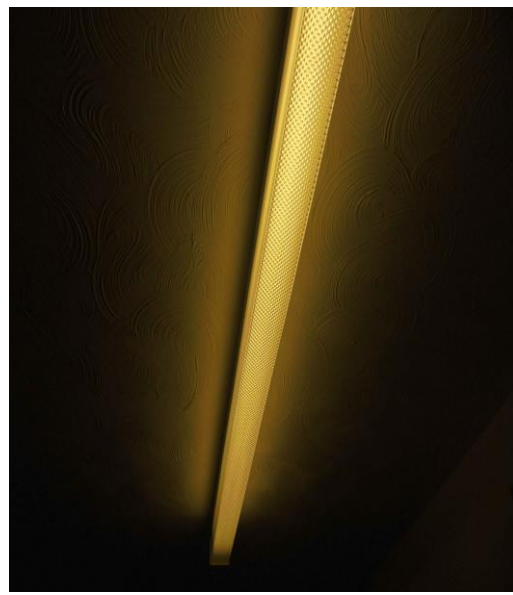
Item No: 2

Location: Office

| Material Description: | Textured Coating to Ceiling | |
| Identification: | Sampled – No Asbestos Detected | |

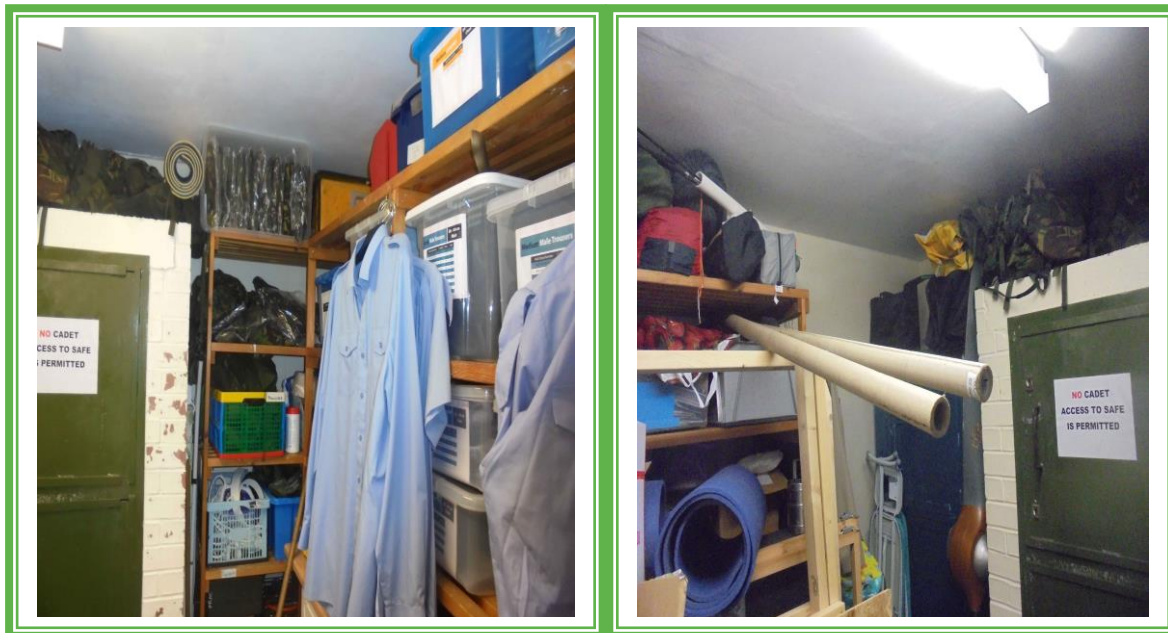
Item No: 3

Location: Store

| Material Description: | Visual Inspection – No Suspect Materials Found | |

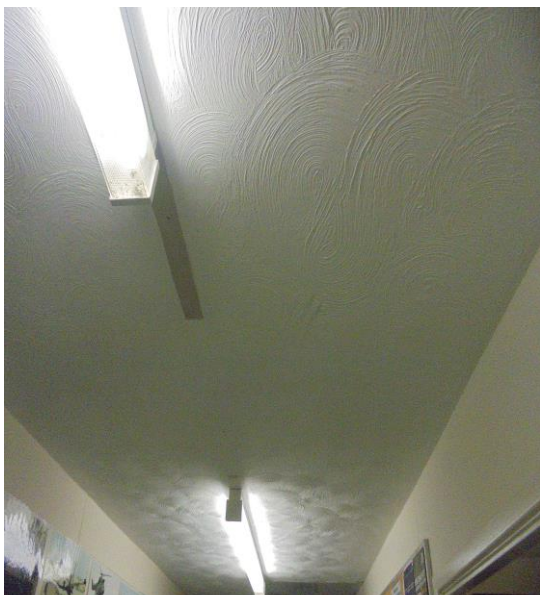
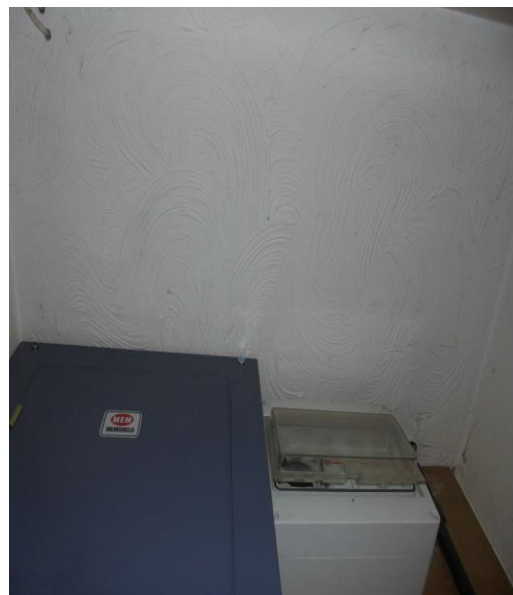
**Item No: 4****Sample No: N/A****Location: Corridors and Cupboard**

| Material Description: | Textured Coating to Ceilings | |
| Identification: | As Per Sample DK/1 – No Asbestos Detected | |

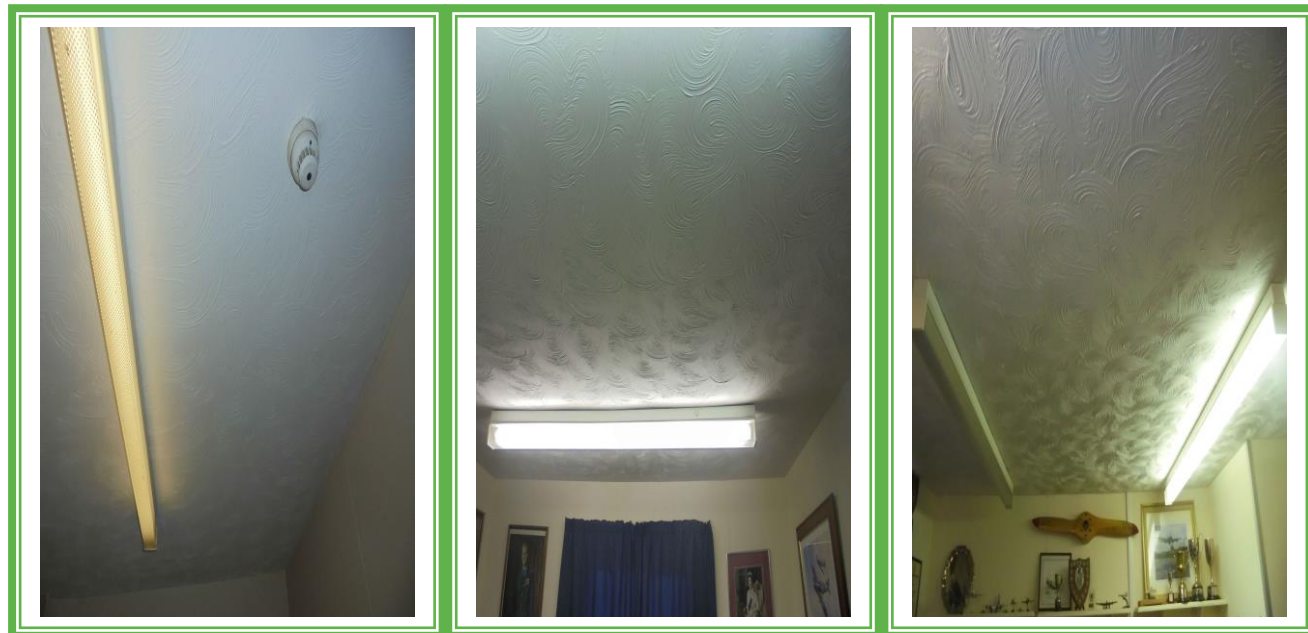
**Item No: 5****Sample No: DK/2****Location: Offices x 2 and Kitchen**

| Material Description: | Textured Coating to Ceiling | |
| Identification: | Sampled – No Asbestos Detected | |

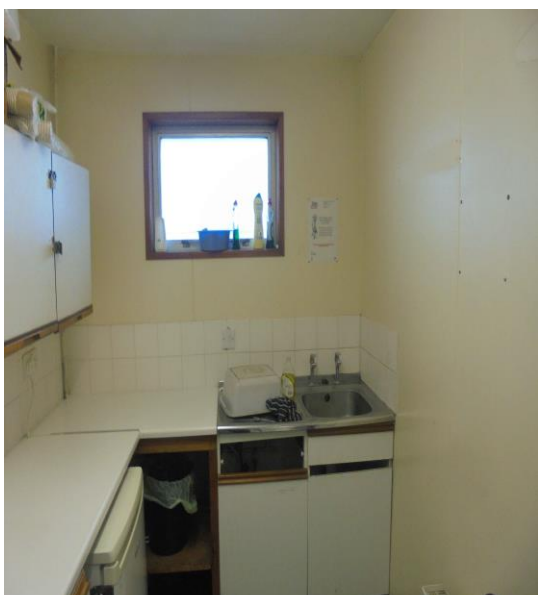
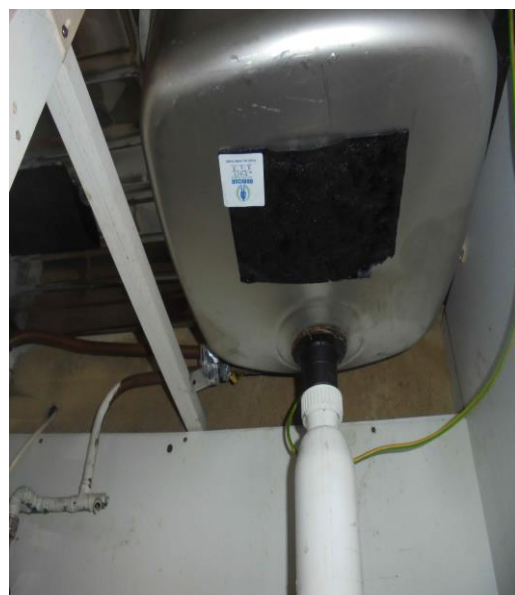
Item No: 6

Sample No: DK/3

Location: Kitchen

| Material Description: | Sink Pad | |
| Identification: | Sampled – No Asbestos Detected | |

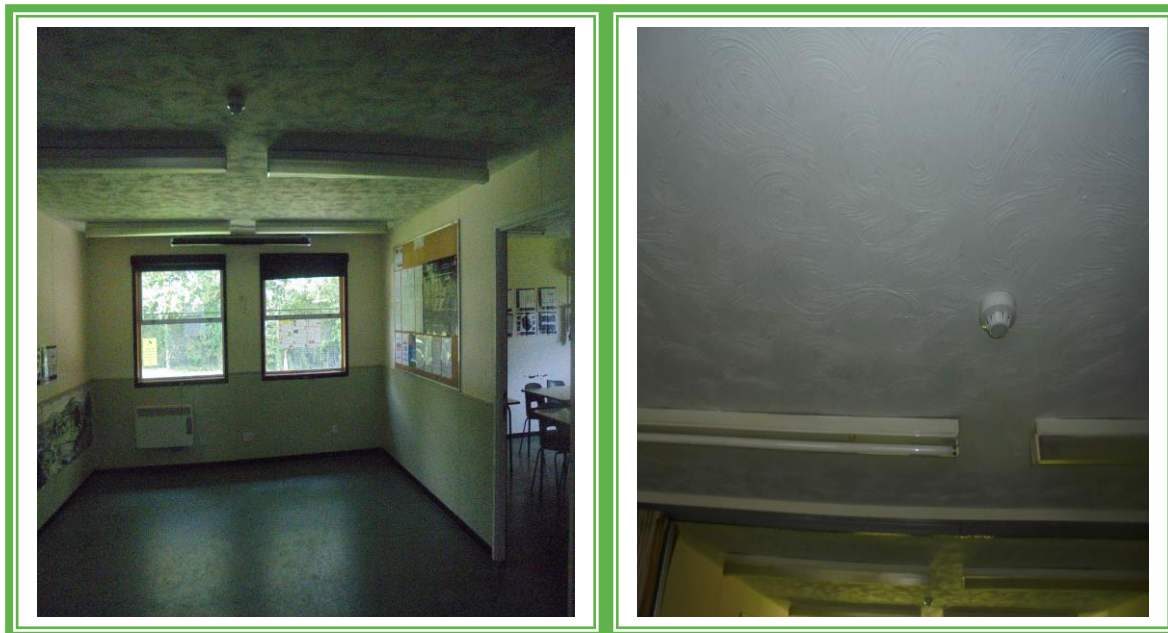
Item No: 7

Location: Drill Hall

| Material Description: | Textured Coating to Ceiling | |
| Identification: | As Per Sample DK/2 – No Asbestos Detected | |

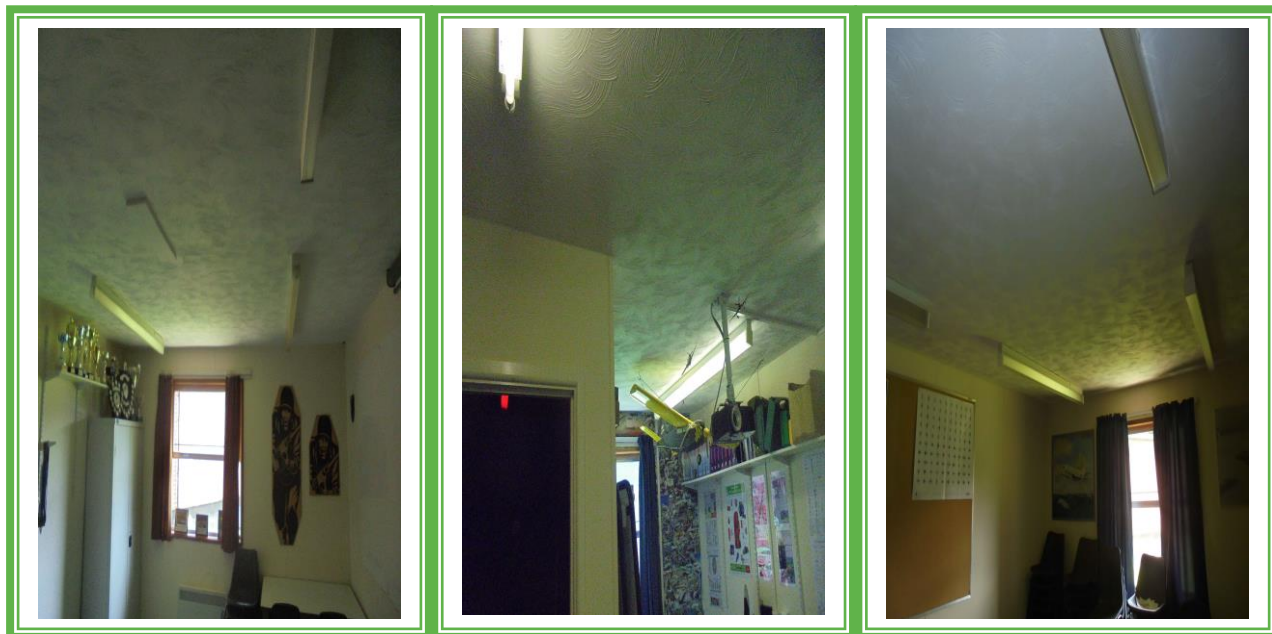
Item No: 8

Sample No: DK/4

Location: Classrooms x 2, Meeting Room and Simulator Room

| Material Description: | Textured Coating to Ceilings | |
| Identification: | Sampled – No Asbestos Detected | |

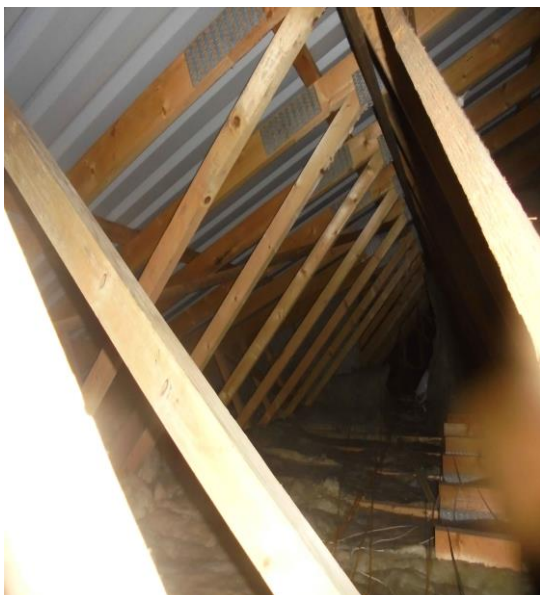
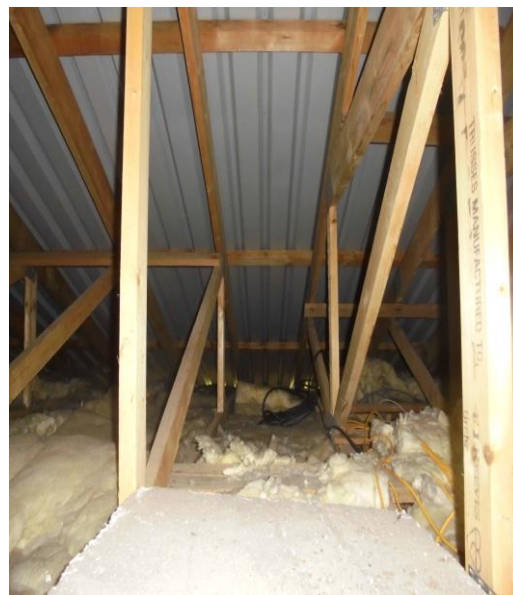
**Item No: 9****Sample No: N/A****Location: Loft space**

| Material Description: | Visual Inspection – No Suspect Materials Found | |

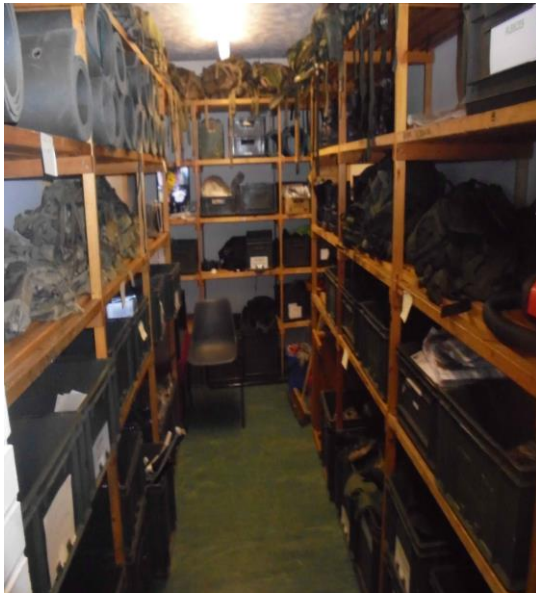
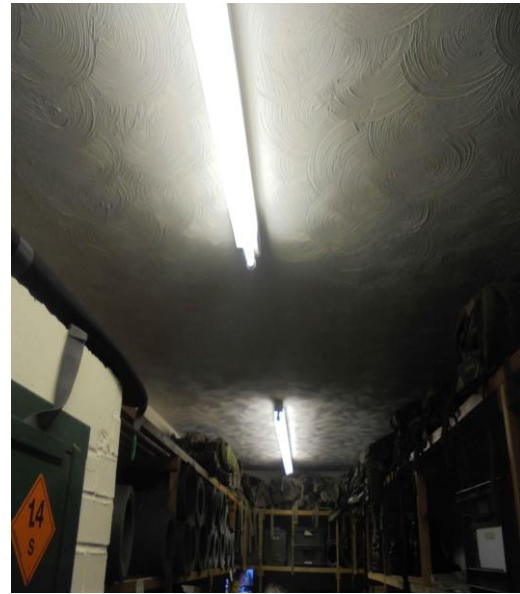
Item No: 10

Location: Armoury

| Material Description: | Textured Coating to Ceiling | |
| Identification: | As Per Sample DK/4 – No Asbestos Detected | |

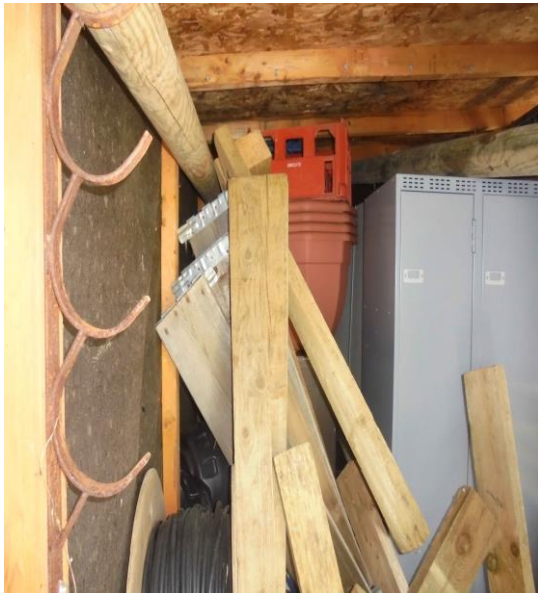
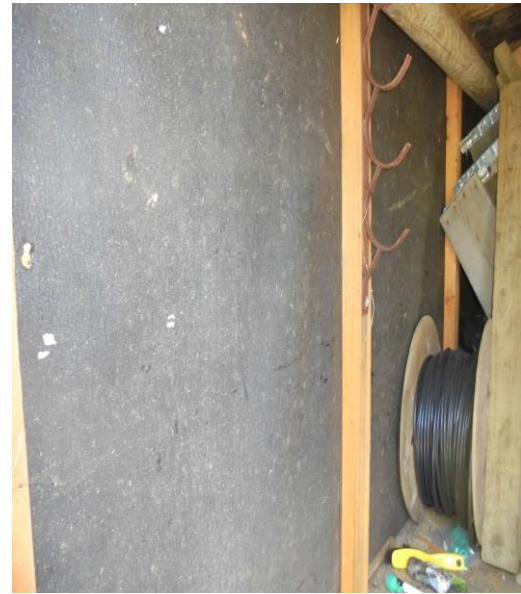
**Item No: 11****Sample No: DK/5****Location: Shed**

| Material Description: | Bitumen Felt to Walls | |
| Identification: | Sampled – No Asbestos Detected | |

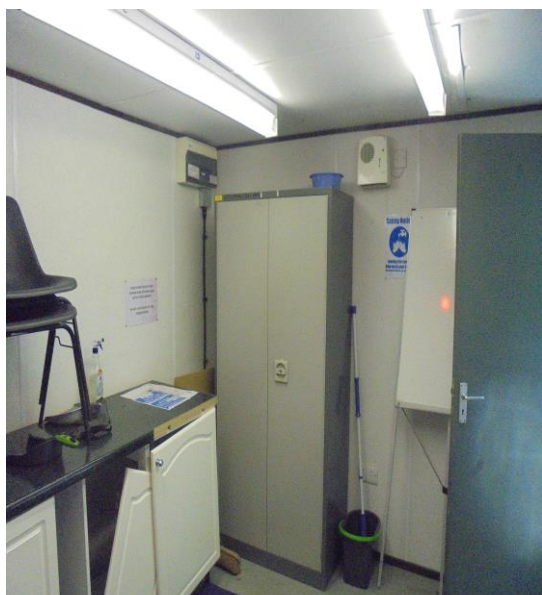
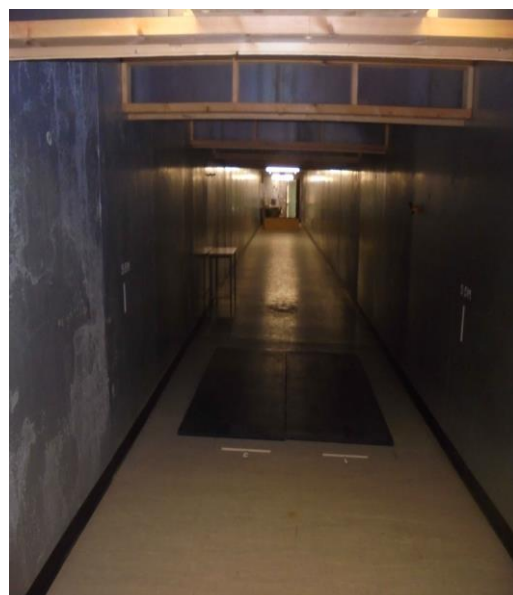
Item No: 13

Location: Range and Lobby

| Material Description: | Visual Inspection – No Suspect Materials Found | |
