Project Number 2481

**Management
Asbestos Survey Report**

**Wyvern Barracks, Barrack Road, Exeter, Devon,
EX2 6AE (Building 8)**

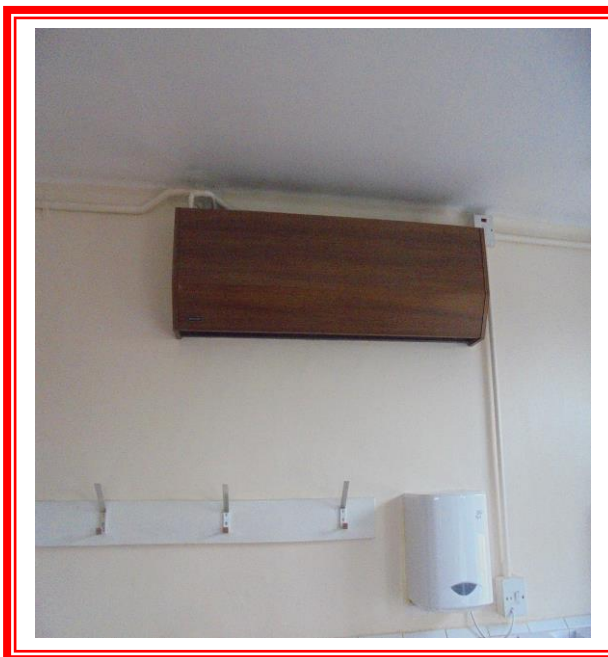
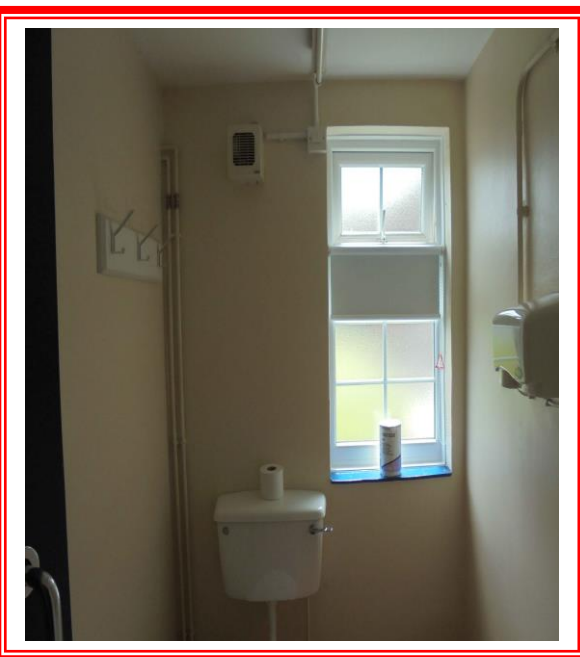
Item No: 13

Item 13 – Shower Room and WC's x 2 – Heater – Unable to sample as live

Location: Shower Room and WC's x 2

Material Description:	No access within Heater	
Identification:	Presumed to Contain Asbestos	
Approx. quantity:	X 1 Heater	
Accessibility	Low	<i>Assessment Score</i>
Product type:	No Access	2
Extent of Damage:	No Access	2
Surface Treatment:	No Access	2
Asbestos type:	No Access	2
Material Assessment Score:		8
Priority Assessment Score:		Medium
Action:	Manage	
Comments:	No access as live

The presence of asbestos in these areas cannot be ascertained at this time. If any works are to be carried out in these areas in the future, then these works should be approached cautiously.

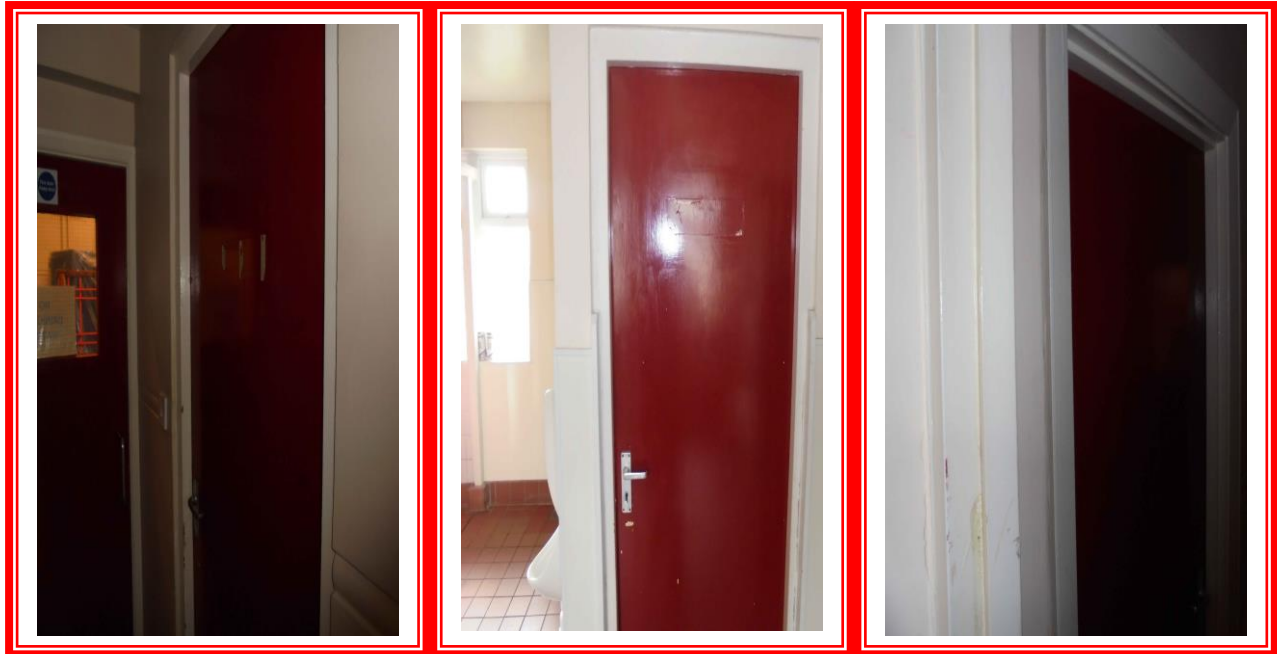
**Item No: 15****Sample No: N/A****Location: Cupboards x 3 – First Floor**

Item 15 – Cupboards x 3 First Floor – Unable to access as locked and no key was available

Material Description:	No access within locked cupboard	
Identification:	Presumed to Contain Asbestos	
Approx. quantity:	X 3 Rooms	
Accessibility	Low	<i>Assessment Score</i>
Product type:	No Access	3
Extent of Damage:	No Access	3
Surface Treatment:	No Access	2
Asbestos type:	No Access	3
Material Assessment Score:		11
Priority Assessment Score:		High
Action:	Further Investigation Required	
Comments:	No key was available during the survey. Neither Andy Palmer nor the main contact in building 8 had keys.

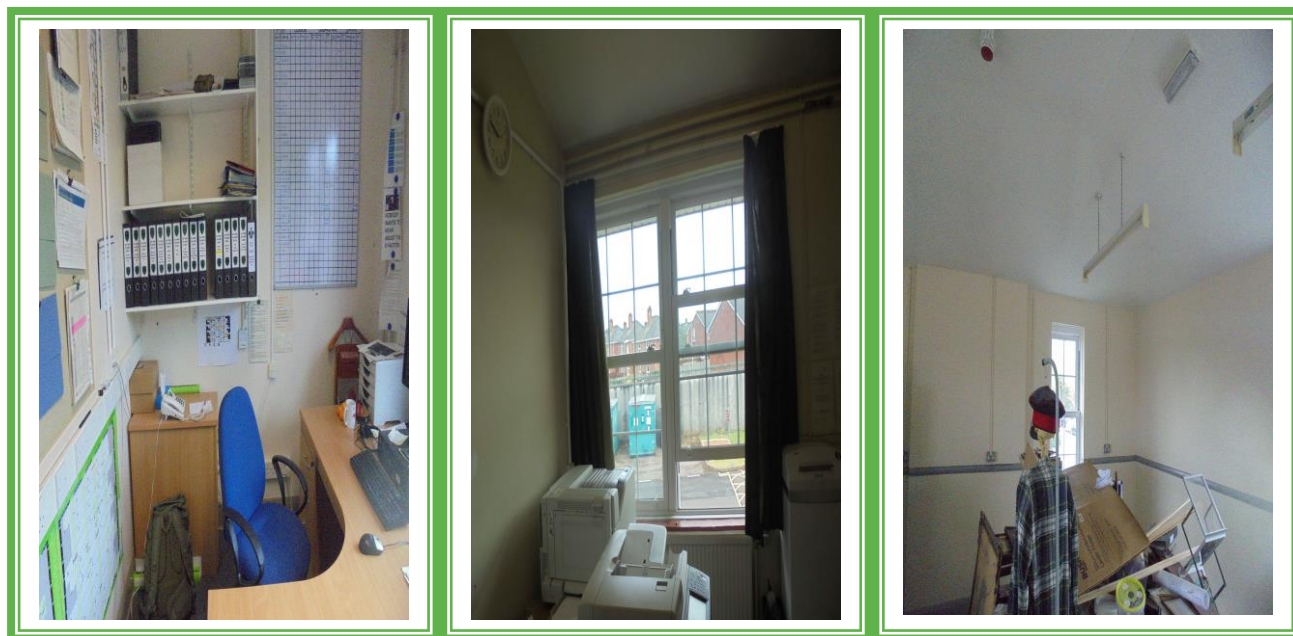
Item No: 1
Sample No: N/A
Location: Classroom and Offices x 2 – First Floor

Material Description:	Visual Inspection – No Suspect Materials Found	
Identification:	N/A	
Approx. quantity:	N/A	
Accessibility	N/A	<i>Assessment Score</i>
Product type:		N/A
Extent of Damage:		N/A
Surface Treatment:		N/A
Asbestos type:		N/A
Material Assessment Score:		N/A
Priority Assessment Score:		N/A
Action:	N/A	
Comments:	N/A

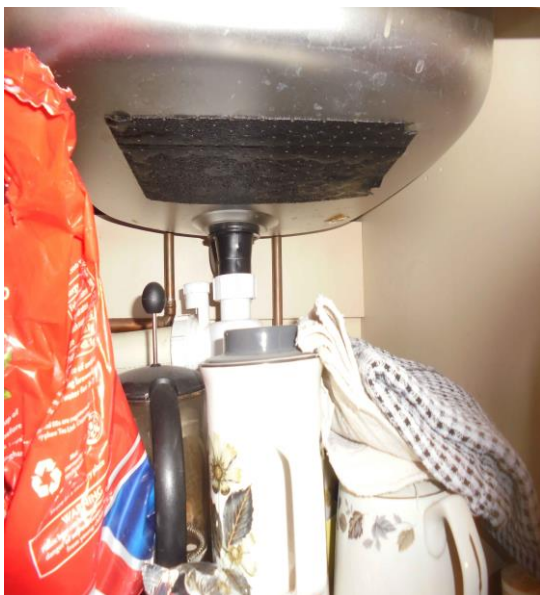
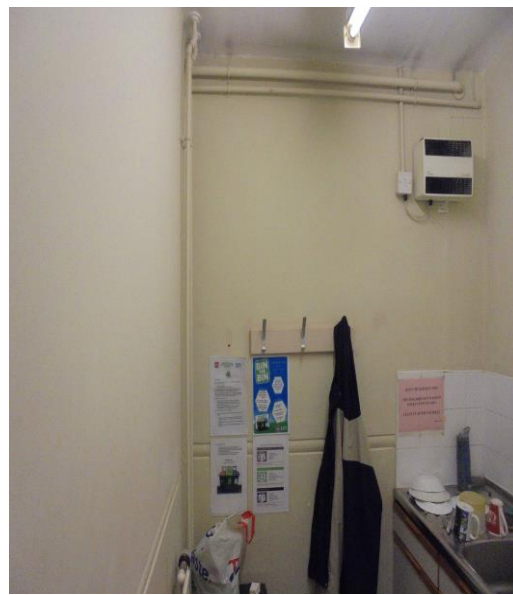
Item No: 2

Location: Kitchen – First Floor

Material Description:	Sink Pad	
Identification:	Sampled – No Asbestos Detected	
Approx. quantity:	X 1 Sink	
Accessibility	N/A	<i>Assessment Score</i>
Product type:		N/A
Extent of Damage:		N/A
Surface Treatment:		N/A
Asbestos type:		N/A
Material Assessment Score:		N/A
Priority Assessment Score:		N/A
Action:	N/A	
Comments:	N/A

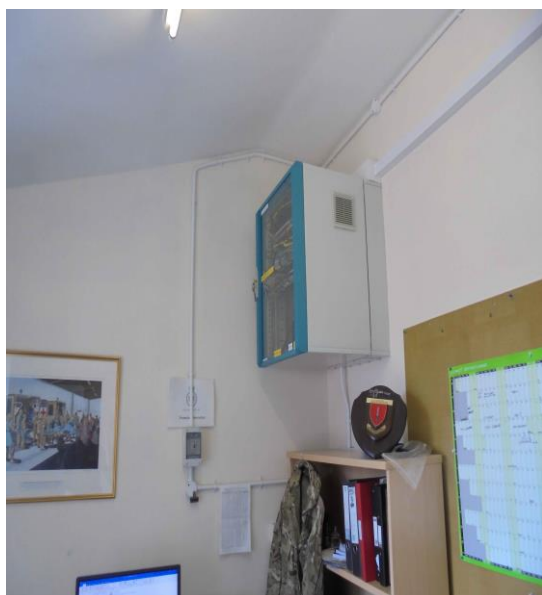
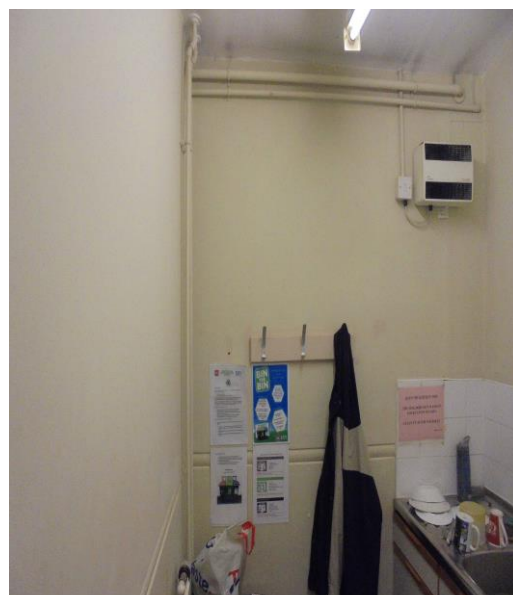
**Item No: 3****Sample No: N/A****Location: Officer x 2**

Material Description:	Visual Inspection – No Suspect Materials Found	
Identification:	N/A	
Approx. quantity:	N/A	
Accessibility	N/A	<i>Assessment Score</i>
Product type:		N/A
Extent of Damage:		N/A
Surface Treatment:		N/A
Asbestos type:		N/A
Material Assessment Score:		N/A
Priority Assessment Score:		N/A
Action:	N/A	
Comments:	N/A

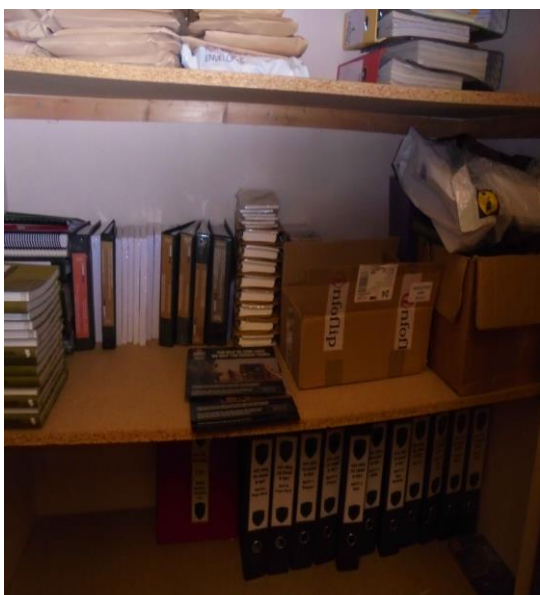
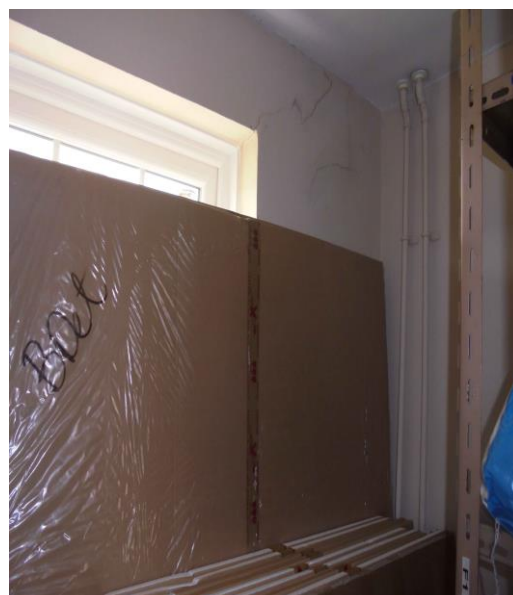
Item No: 4

Location: Cupboards x 2

Material Description:	Visual Inspection – No Suspect Materials Found	
Identification:	N/A	
Approx. quantity:	N/A	
Accessibility	N/A	<i>Assessment Score</i>
Product type:		N/A
Extent of Damage:		N/A
Surface Treatment:		N/A
Asbestos type:		N/A
Material Assessment Score:		N/A
Priority Assessment Score:		N/A
Action:	N/A	
Comments:	N/A

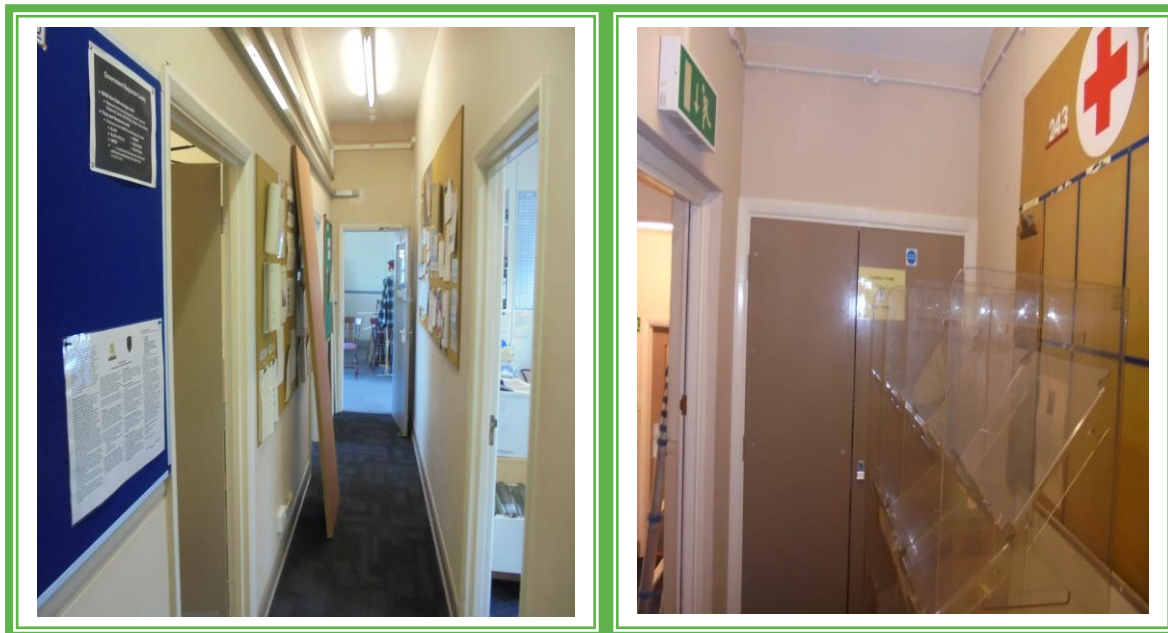
Item No: 5

Location: Corridor – First Floor

Material Description:	Visual Inspection – No Suspect Materials Found	
Identification:	N/A	
Approx. quantity:	N/A	
Accessibility	N/A	<i>Assessment Score</i>
Product type:		N/A
Extent of Damage:		N/A
Surface Treatment:		N/A
Asbestos type:		N/A
Material Assessment Score:		N/A
Priority Assessment Score:		N/A
Action:	N/A	
Comments:	N/A

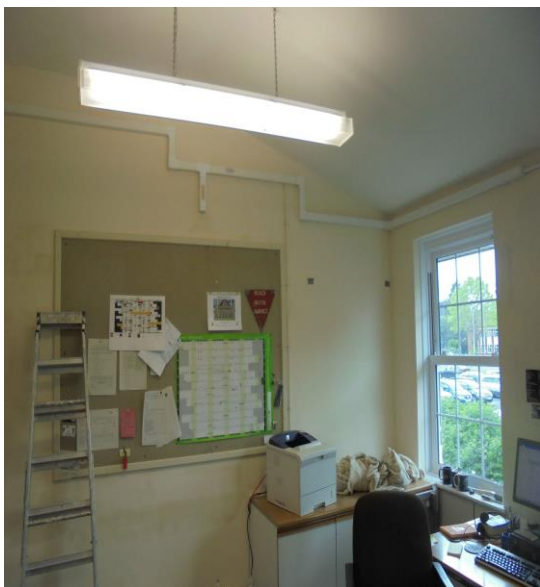
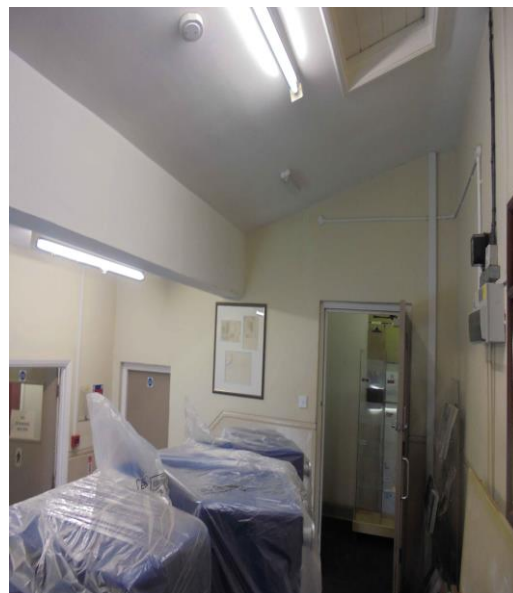
**Item No: 6****Sample No: N/A****Location: Office and Landing**

Material Description:	Visual Inspection – No Suspect Materials Found	
Identification:	N/A	
Approx. quantity:	N/A	
Accessibility	N/A	<i>Assessment Score</i>
Product type:		N/A
Extent of Damage:		N/A
Surface Treatment:		N/A
Asbestos type:		N/A
Material Assessment Score:		N/A
Priority Assessment Score:		N/A
Action:	N/A	
Comments:	No access into high level loft due to height

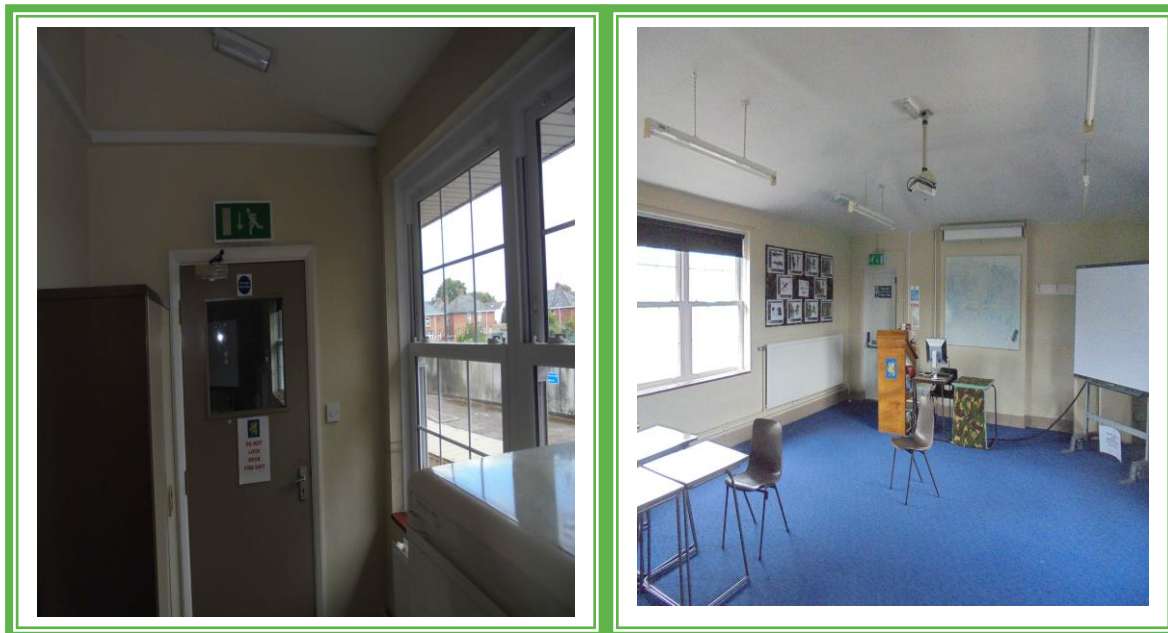
Item No: 7

Location: Classroom, Office and Corridor – First Floor

Material Description:	Visual Inspection – No Suspect Materials Found	
Identification:	N/A	
Approx. quantity:	N/A	
Accessibility	N/A	<i>Assessment Score</i>
Product type:		N/A
Extent of Damage:		N/A
Surface Treatment:		N/A
Asbestos type:		N/A
Material Assessment Score:		N/A
Priority Assessment Score:		N/A
Action:	N/A	
Comments:	N/A

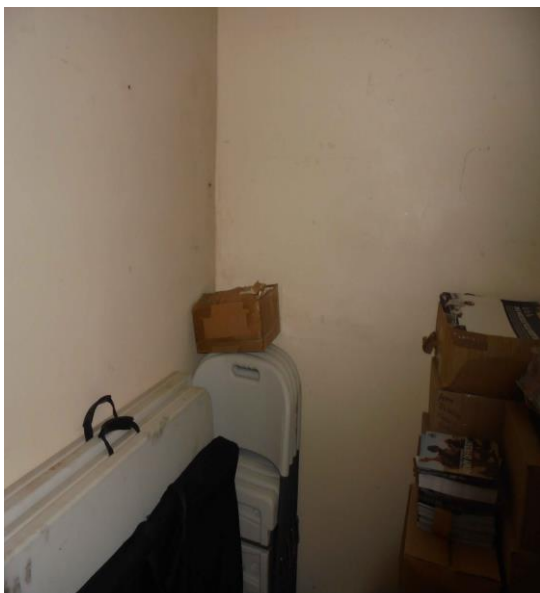
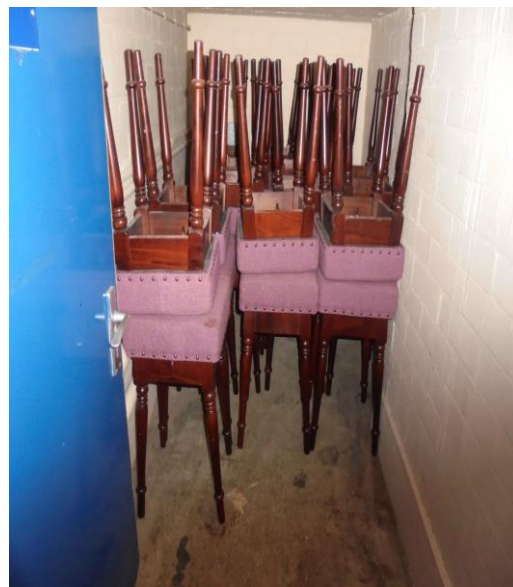
Item No: 8

Location: Cupboards and Store – Ground Floor

Material Description:	Visual Inspection – No Suspect Materials Found	
Identification:	N/A	
Approx. quantity:	N/A	
Accessibility	N/A	<i>Assessment Score</i>
Product type:		N/A
Extent of Damage:		N/A
Surface Treatment:		N/A
Asbestos type:		N/A
Material Assessment Score:		N/A
Priority Assessment Score:		N/A
Action:	N/A	
Comments:	N/A

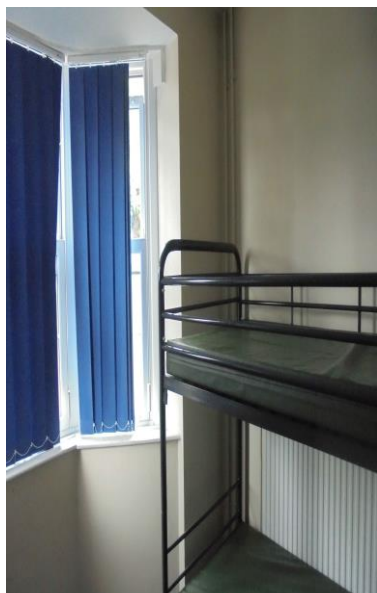
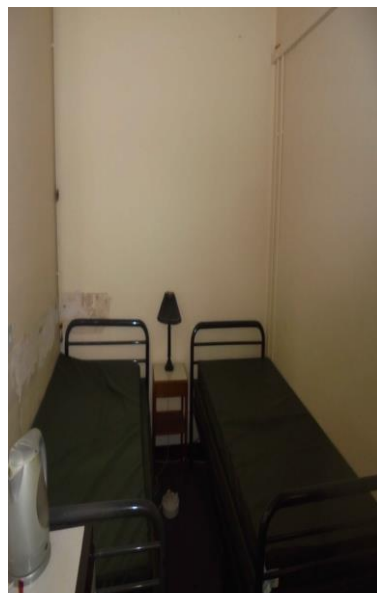
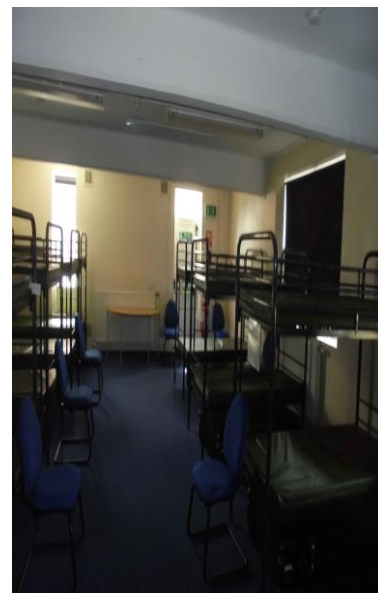
**Item No: 9****Sample No: N/A****Location: Rooms 6,7 and 8 – Ground Floor**

Material Description:	Visual Inspection – No Suspect Materials Found	
Identification:	N/A	
Approx. quantity:	N/A	
Accessibility	N/A	<i>Assessment Score</i>
Product type:		N/A
Extent of Damage:		N/A
Surface Treatment:		N/A
Asbestos type:		N/A
Material Assessment Score:		N/A
Priority Assessment Score:		N/A
Action:	N/A	
Comments:	N/A

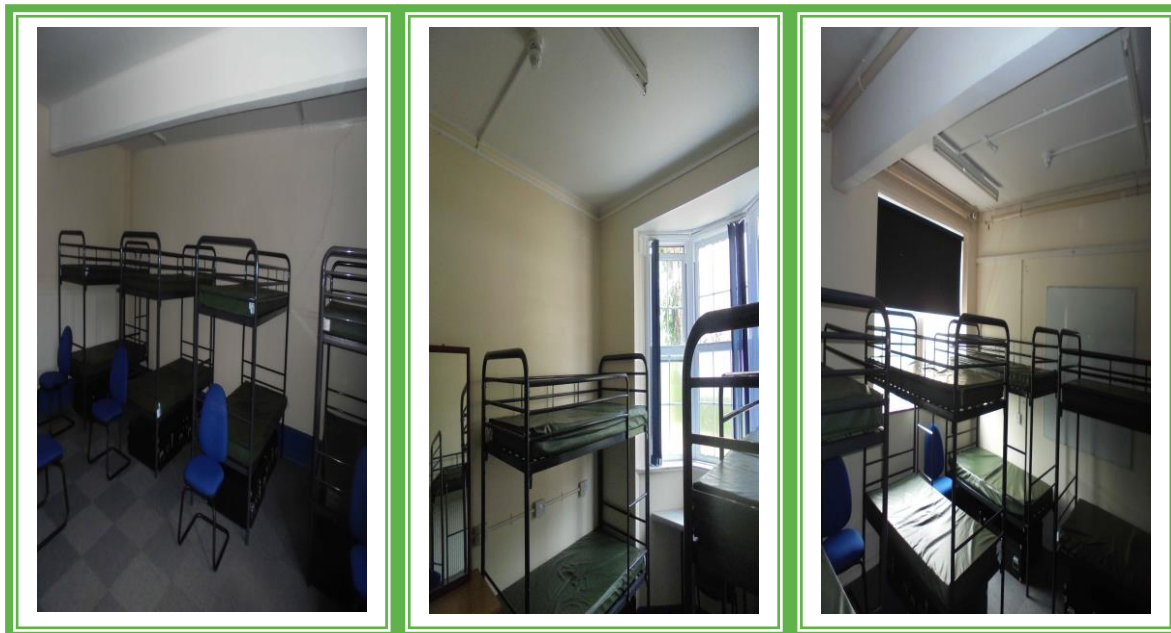
**Item No: 10****Sample No: N/A****Location: Rooms 1, 2 and 3 – Ground Floor**

Material Description:	Visual Inspection – No Suspect Materials Found	
Identification:	N/A	
Approx. quantity:	N/A	
Accessibility	N/A	<i>Assessment Score</i>
Product type:		N/A
Extent of Damage:		N/A
Surface Treatment:		N/A
Asbestos type:		N/A
Material Assessment Score:		N/A
Priority Assessment Score:		N/A
Action:	N/A	
Comments:	N/A

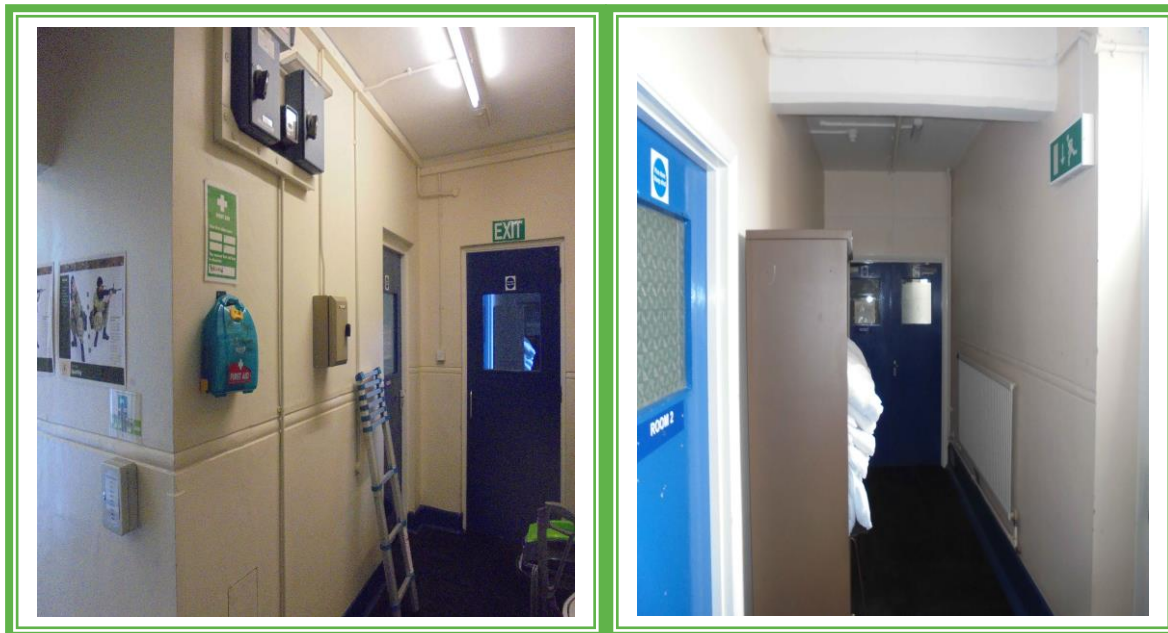
**Item No: 11****Sample No: N/A****Location: Corridors x 2 – Ground Floor**

Material Description:	Visual Inspection – No Suspect Materials Found	
Identification:	N/A	
Approx. quantity:	N/A	
Accessibility	N/A	<i>Assessment Score</i>
Product type:		N/A
Extent of Damage:		N/A
Surface Treatment:		N/A
Asbestos type:		N/A
Material Assessment Score:		N/A
Priority Assessment Score:		N/A
Action:	N/A	
Comments:	Non-asbestos electrical panel

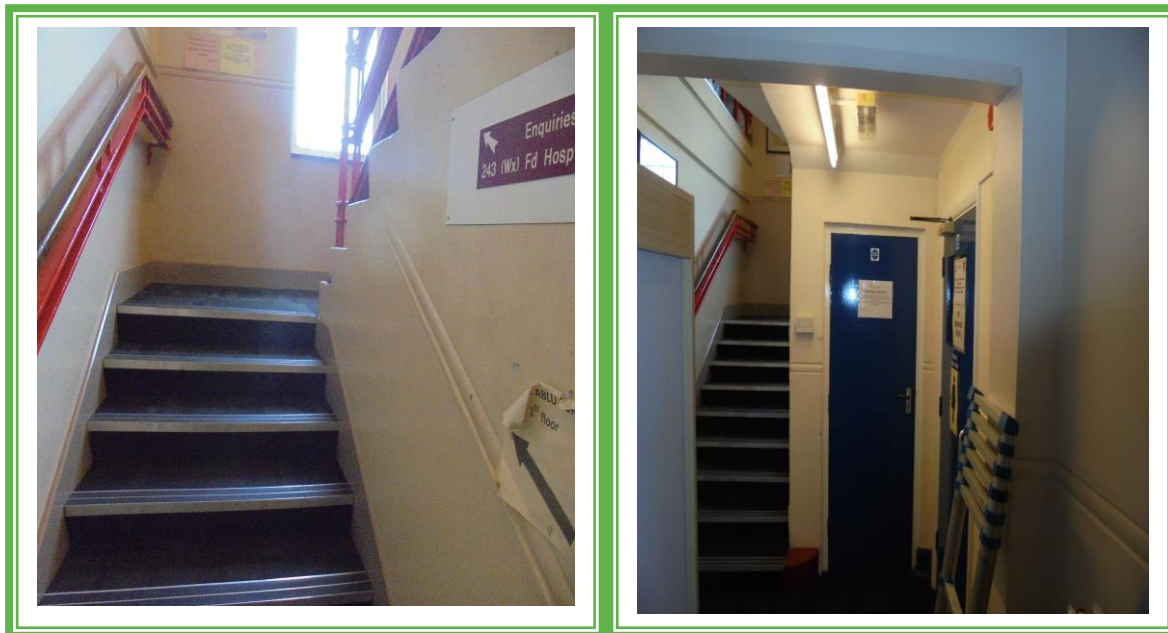
Item No: 12

Location: Lobby, Cupboard and stairwell

Material Description:	Visual Inspection – No Suspect Materials Found	
Identification:	N/A	
Approx. quantity:	N/A	
Accessibility	N/A	<i>Assessment Score</i>
Product type:		N/A
Extent of Damage:		N/A
Surface Treatment:		N/A
Asbestos type:		N/A
Material Assessment Score:		N/A
Priority Assessment Score:		N/A
Action:	N/A	
Comments:	N/A

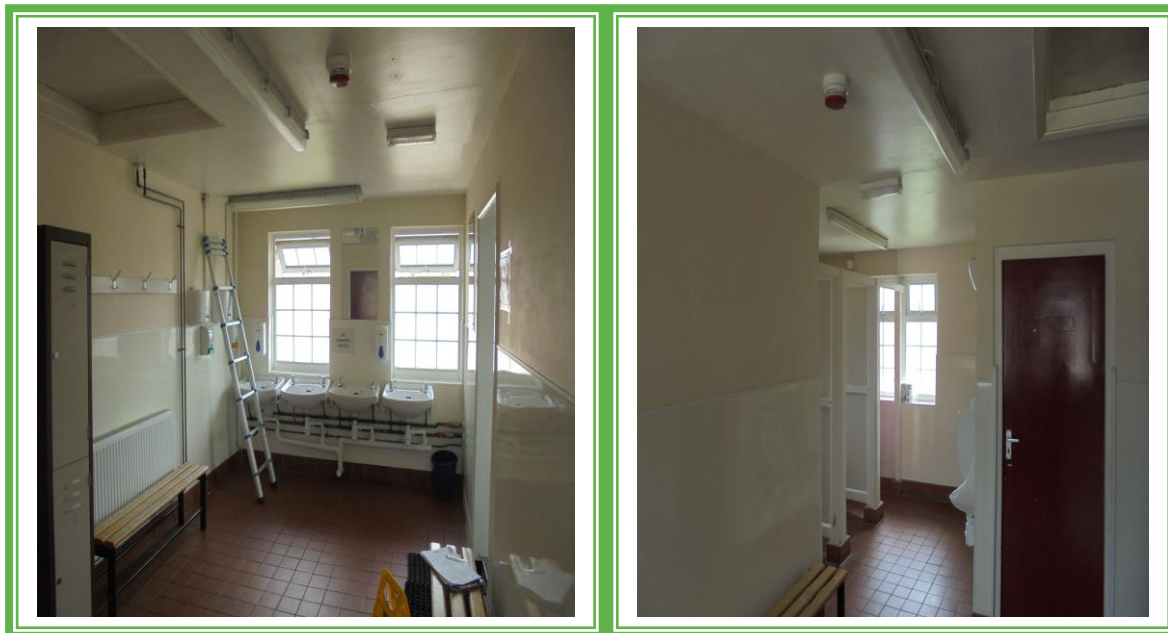
Item No: 14

Location: Shower Room – First Floor

Material Description:	Visual Inspection – No Suspect Materials Found	
Identification:	N/A	
Approx. quantity:	N/A	
Accessibility	N/A	<i>Assessment Score</i>
Product type:		N/A
Extent of Damage:		N/A
Surface Treatment:		N/A
Asbestos type:		N/A
Material Assessment Score:		N/A
Priority Assessment Score:		N/A
Action:	N/A	
Comments:	Metal panels between toilets

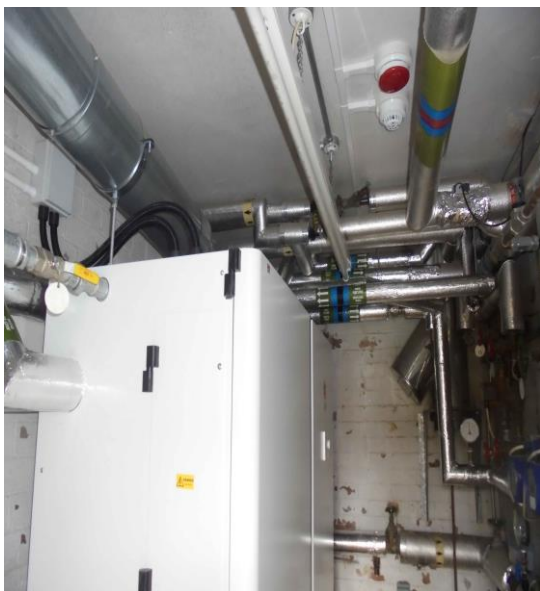
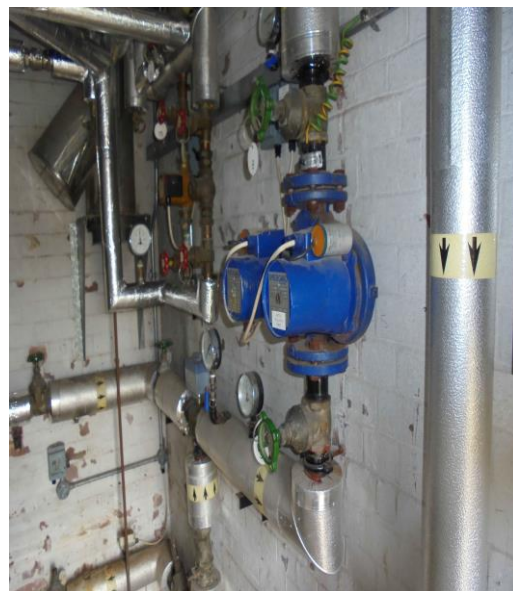
Item No: 16

Location: Boiler Room

Material Description:	Gaskets	
Identification:	Sampled – No Asbestos Detected	
Approx. quantity:	X 2	
Accessibility	N/A	<i>Assessment Score</i>
Product type:		N/A
Extent of Damage:		N/A
Surface Treatment:		N/A
Asbestos type:		N/A
Material Assessment Score:		N/A
Priority Assessment Score:		N/A
Action:	N/A	
Comments:	Modern boiler and pipework
