Project Number A-00543 (3700)

**Re-Inspection
Asbestos Survey Report**

**2385 Melksham
33 Lancaster Road
Wiltshire
SN12 6SS**

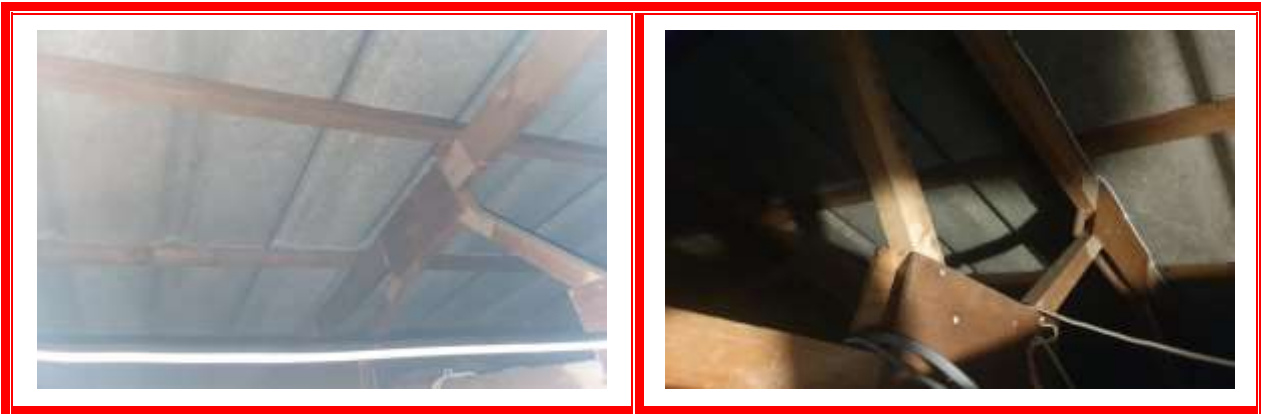
Item No:	2	Sample No:	N/A
Location:	Ground Floor - Building 1 - Loft Space 002

Material Description:	Profiled Roof - Cement Product	
Identification:	Previously Sampled - Asbestos Detected	
Approx. quantity:	120 m ²	
Accessibility	Difficult	<i>Assessment Score</i>
Product type:	Cement	1
Extent of Damage:	Slight / minor damage	1
Surface Treatment:	Unsealed Cement	1
Asbestos type:	Chrysotile	1
Material Assessment Score:		4
Priority Assessment Score:		Negligible
Action:	Manage	
Comments:	Previously sampled ref: Armour 30/9/19 Sample DK/3. Overclad with metal roof

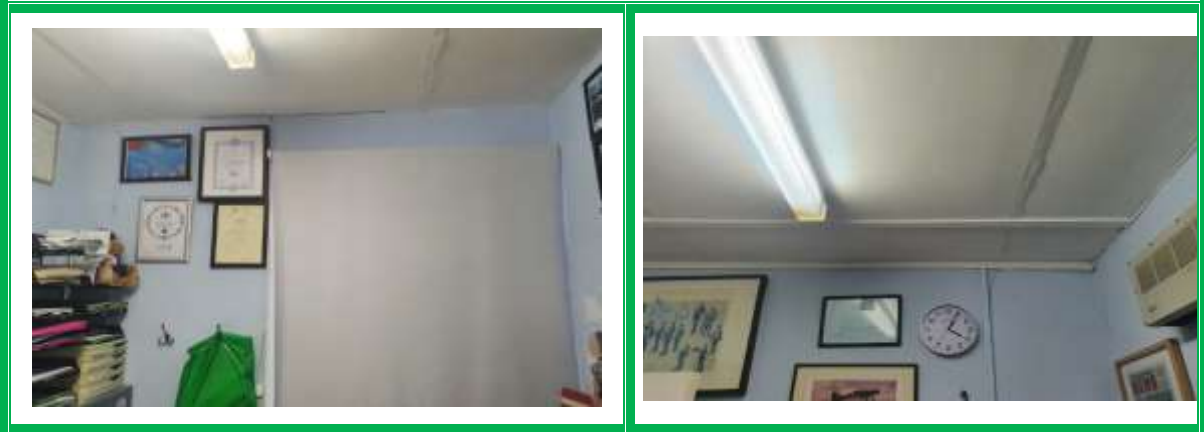
Item No:	1	Sample No:	N/A
Location:	Ground Floor - Building 1 - OC Office 001

Material Description:	No Suspect Materials Found	
Identification:	N/A	
Approx. quantity:	N/A	
Accessibility	N/A	<i>Assessment Score</i>
Product type:	N/A	N/A
Extent of Damage:	N/A	N/A
Surface Treatment:	N/A	N/A
Asbestos type:	N/A	N/A
Material Assessment Score:		N/A
Priority Assessment Score:		N/A
Action:	N/A	
Comments:	Previously a no access area. Now accessed and no asbestos found
