Project Number 2481

**Management
Asbestos Survey Report**

**Speedwell Platoon, Speedwell,
Bristol, BS5 7TJ**

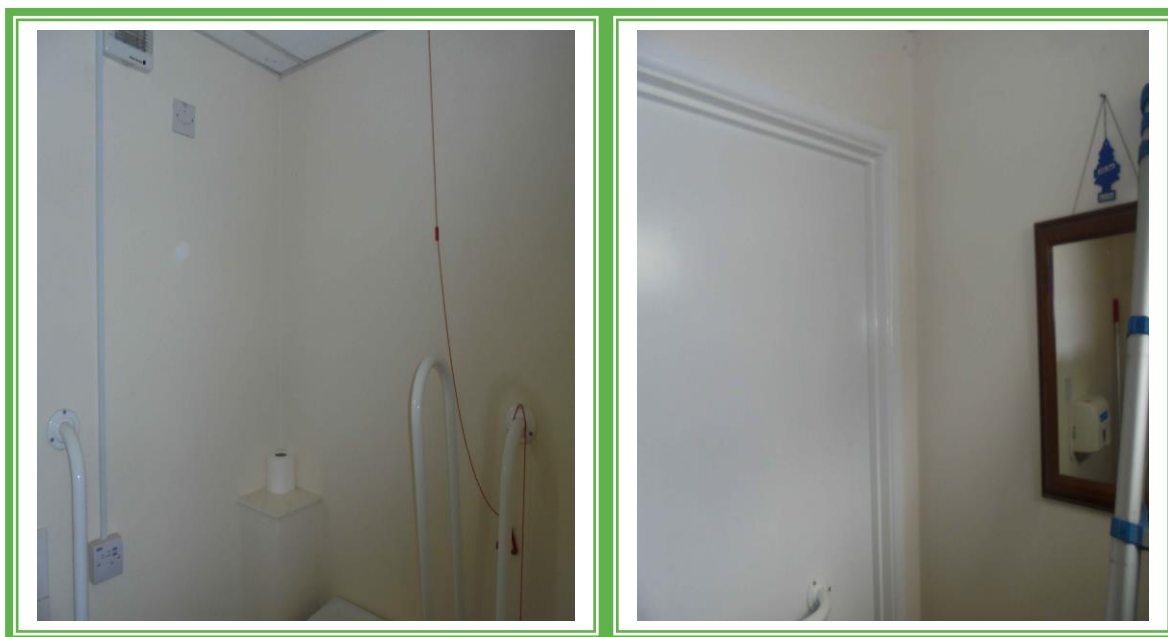
Location: Ground Floor - WC

Material Description:	Visual Inspection – No Suspect Materials Found	
Identification:	N/A	
Approx. quantity:	N/A	
Accessibility	N/A	<i>Assessment Score</i>
Product type:		N/A
Extent of Damage:		N/A
Surface Treatment:		N/A
Asbestos type:		N/A
Material Assessment Score:		N/A
Priority Assessment Score:		N/A
Action:	N/A	
Comments:	N/A

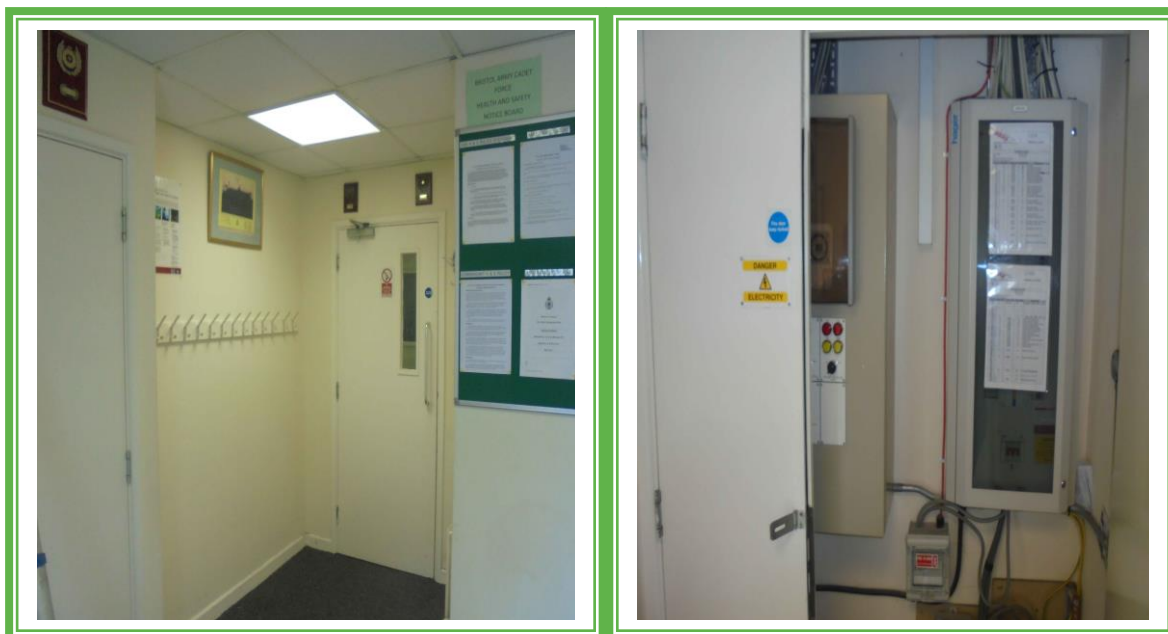
Location: Ground Floor – Lobby & Electric Cupboard

Material Description:	Visual Inspection – No Suspect Materials Found	
Identification:	N/A	
Approx. quantity:	N/A	
Accessibility	N/A	<i>Assessment Score</i>
Product type:		N/A
Extent of Damage:		N/A
Surface Treatment:		N/A
Asbestos type:		N/A
Material Assessment Score:		N/A
Priority Assessment Score:		N/A
Action:	N/A	
Comments:	Modern electrics

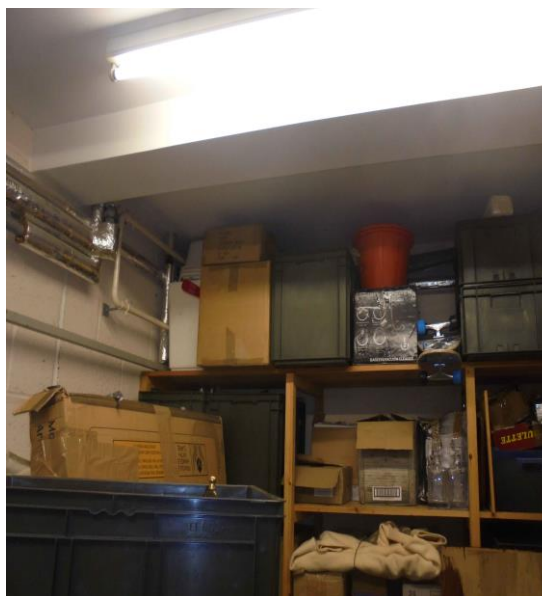
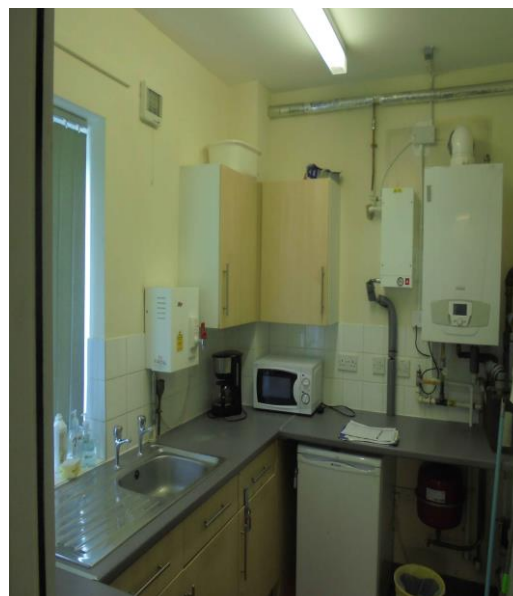
Location: Ground Floor – Plant Room & Kitchen

Material Description:	Visual Inspection – No Suspect Materials Found	
Identification:	N/A	
Approx. quantity:	N/A	
Accessibility	N/A	<i>Assessment Score</i>
Product type:		N/A
Extent of Damage:		N/A
Surface Treatment:		N/A
Asbestos type:		N/A
Material Assessment Score:		N/A
Priority Assessment Score:		N/A
Action:	N/A	
Comments:	Modern boiler and pipework

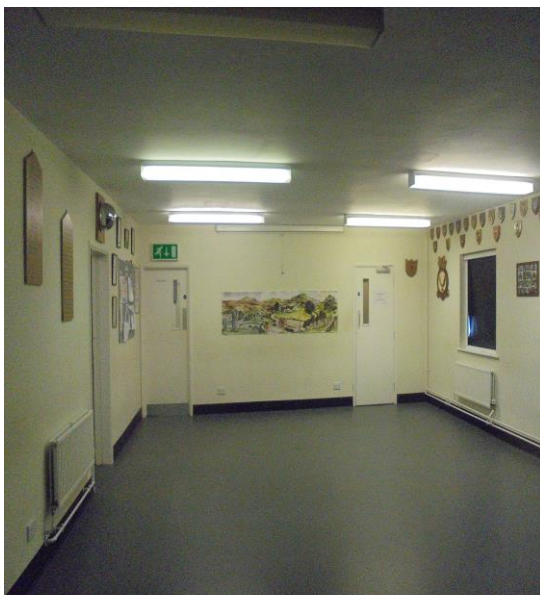
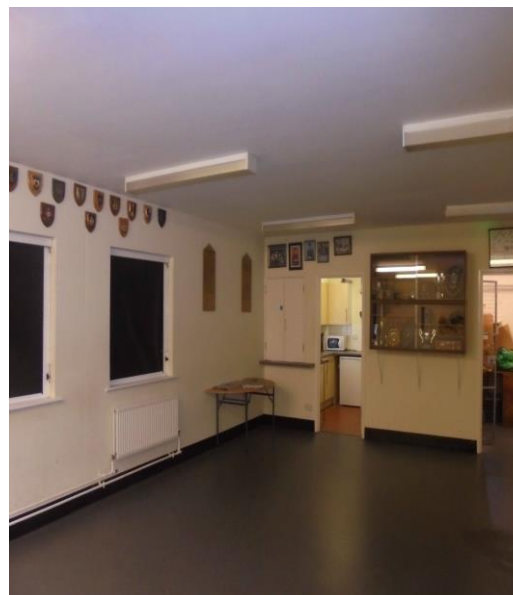
Location: Ground Floor – Main Hall

Material Description:	Visual Inspection – No Suspect Materials Found	
Identification:	N/A	
Approx. quantity:	N/A	
Accessibility	N/A	<i>Assessment Score</i>
Product type:		N/A
Extent of Damage:		N/A
Surface Treatment:		N/A
Asbestos type:		N/A
Material Assessment Score:		N/A
Priority Assessment Score:		N/A
Action:	N/A	
Comments:	N/A

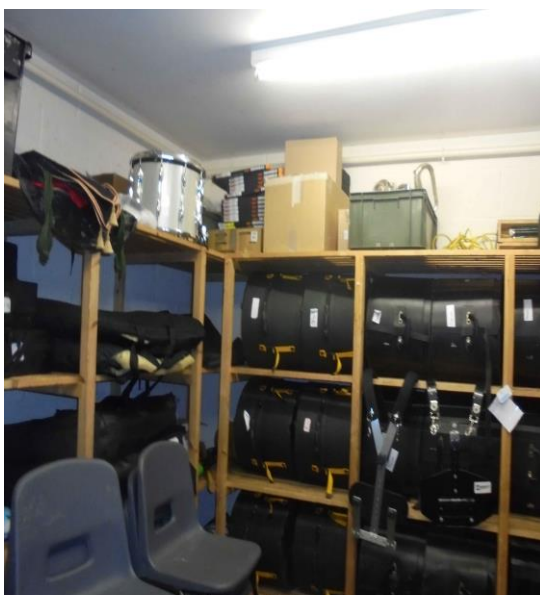
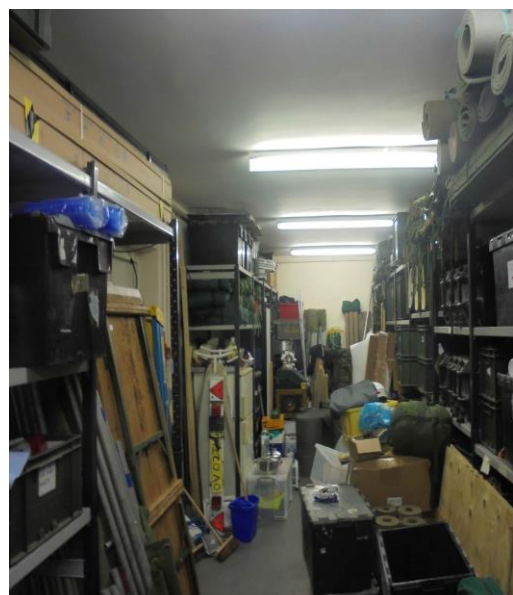
Location: Ground Floor – Stores x 2

Material Description:	Visual Inspection – No Suspect Materials Found	
Identification:	N/A	
Approx. quantity:	N/A	
Accessibility	N/A	<i>Assessment Score</i>
Product type:		N/A
Extent of Damage:		N/A
Surface Treatment:		N/A
Asbestos type:		N/A
Material Assessment Score:		N/A
Priority Assessment Score:		N/A
Action:	N/A	
Comments:	N/A

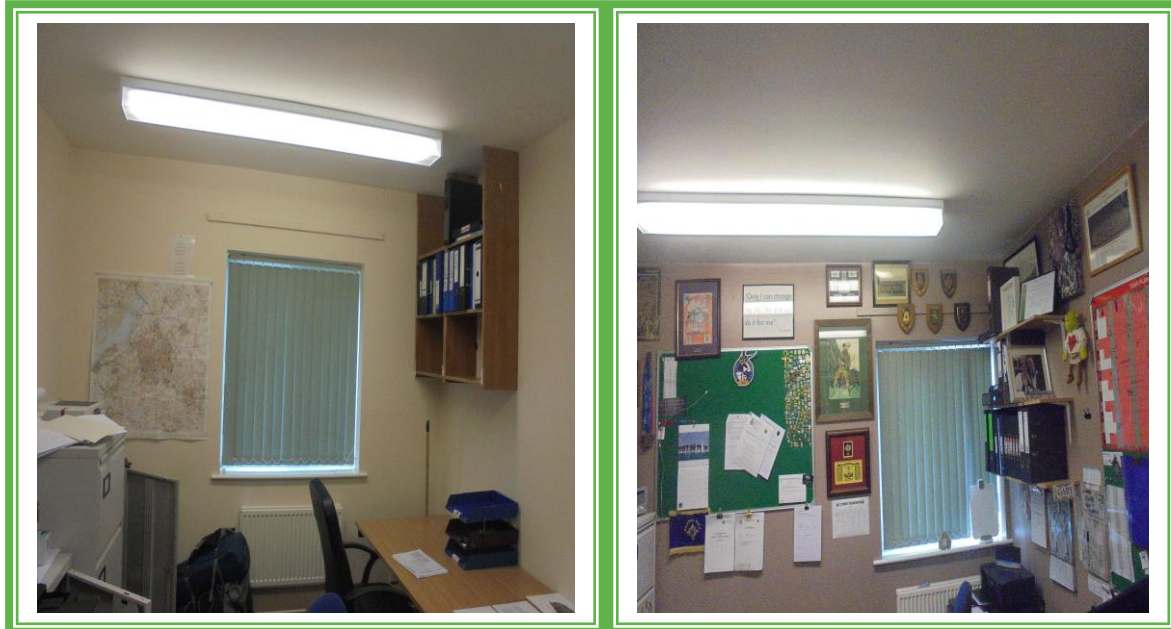
Location: Ground Floor – Offices x 3

Material Description:	Visual Inspection – No Suspect Materials Found	
Identification:	N/A	
Approx. quantity:	N/A	
Accessibility	N/A	<i>Assessment Score</i>
Product type:		N/A
Extent of Damage:		N/A
Surface Treatment:		N/A
Asbestos type:		N/A
Material Assessment Score:		N/A
Priority Assessment Score:		N/A
Action:	N/A	
Comments:	N/A

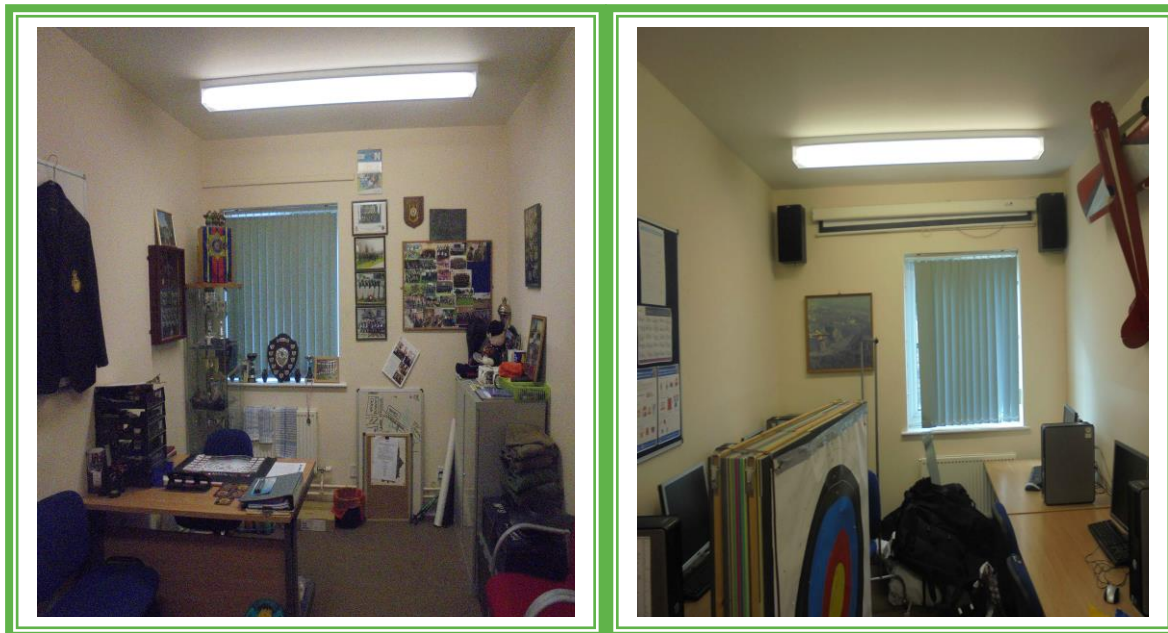
Location: Ground Floor – Offices x 2

Material Description:	Visual Inspection – No Suspect Materials Found	
Identification:	N/A	
Approx. quantity:	N/A	
Accessibility	N/A	<i>Assessment Score</i>
Product type:		N/A
Extent of Damage:		N/A
Surface Treatment:		N/A
Asbestos type:		N/A
Material Assessment Score:		N/A
Priority Assessment Score:		N/A
Action:	N/A	
Comments:	N/A

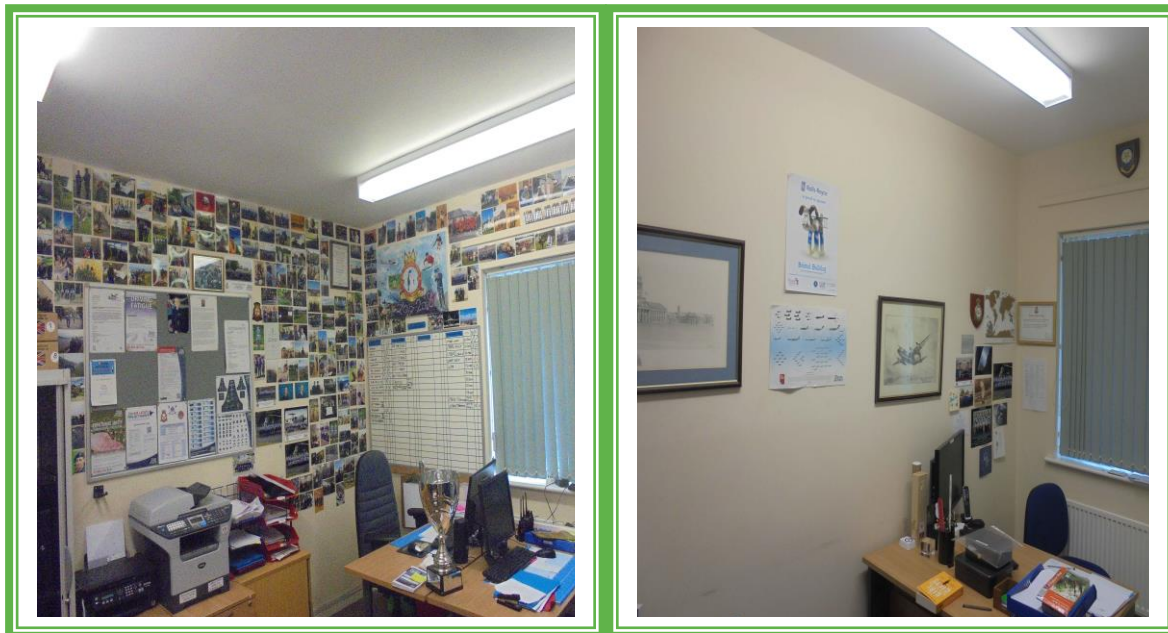
Location: Ground Floor – Offices x 2

Material Description:	Visual Inspection – No Suspect Materials Found	
Identification:	N/A	
Approx. quantity:	N/A	
Accessibility	N/A	<i>Assessment Score</i>
Product type:		N/A
Extent of Damage:		N/A
Surface Treatment:		N/A
Asbestos type:		N/A
Material Assessment Score:		N/A
Priority Assessment Score:		N/A
Action:	N/A	
Comments:	N/A

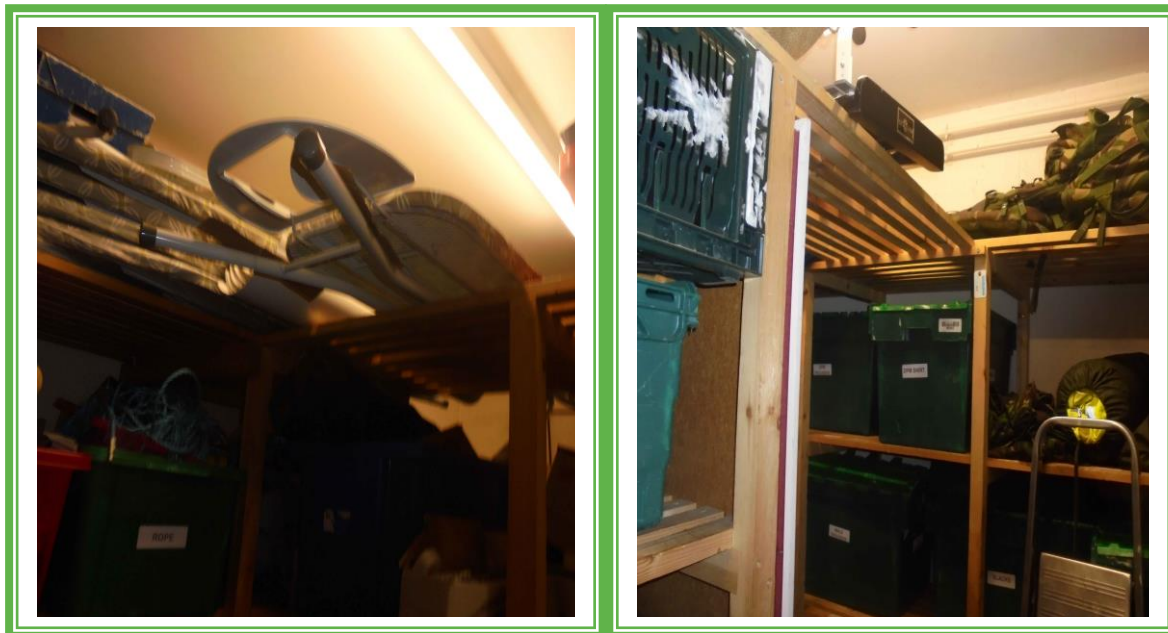
Location: Ground Floor – Store

Material Description:	Visual Inspection – No Suspect Materials Found	
Identification:	N/A	
Approx. quantity:	N/A	
Accessibility	N/A	<i>Assessment Score</i>
Product type:		N/A
Extent of Damage:		N/A
Surface Treatment:		N/A
Asbestos type:		N/A
Material Assessment Score:		N/A
Priority Assessment Score:		N/A
Action:	N/A	
Comments:	N/A

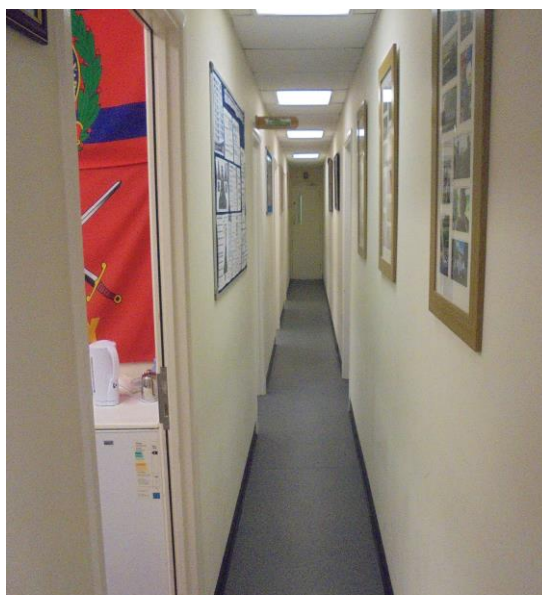
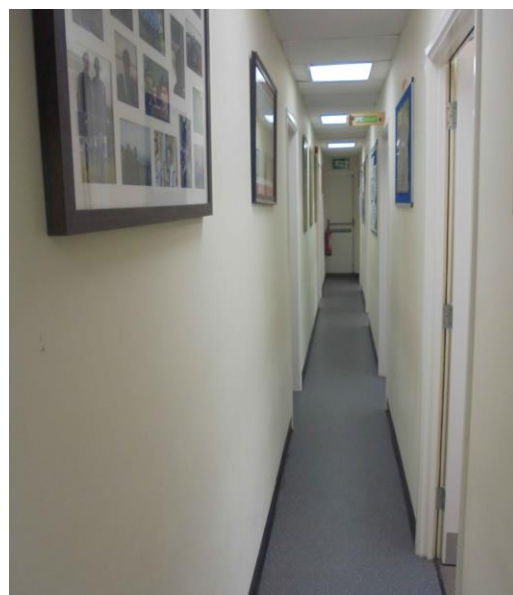
**Item No: 10****Sample No: N/A****Location: Ground Floor – Corridor**

Material Description:	Visual Inspection – No Suspect Materials Found	
Identification:	N/A	
Approx. quantity:	N/A	
Accessibility	N/A	<i>Assessment Score</i>
Product type:		N/A
Extent of Damage:		N/A
Surface Treatment:		N/A
Asbestos type:		N/A
Material Assessment Score:		N/A
Priority Assessment Score:		N/A
Action:	N/A	
Comments:	N/A

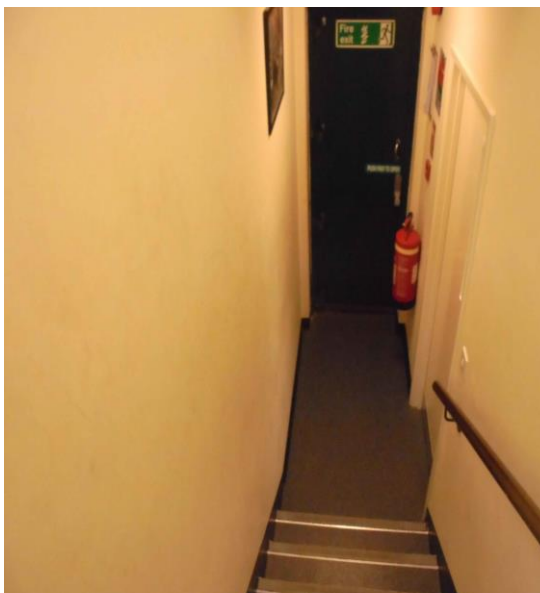
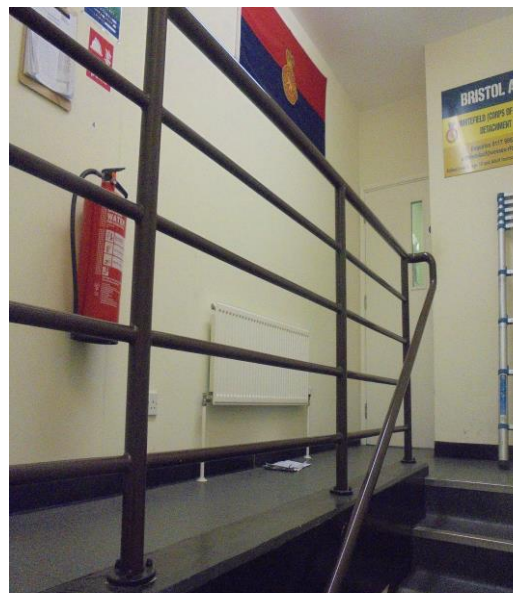
Location: First Floor – Lobby, Stairwell & Landing

Material Description:	Visual Inspection – No Suspect Materials Found	
Identification:	N/A	
Approx. quantity:	N/A	
Accessibility	N/A	<i>Assessment Score</i>
Product type:		N/A
Extent of Damage:		N/A
Surface Treatment:		N/A
Asbestos type:		N/A
Material Assessment Score:		N/A
Priority Assessment Score:		N/A
Action:	N/A	
Comments:	N/A

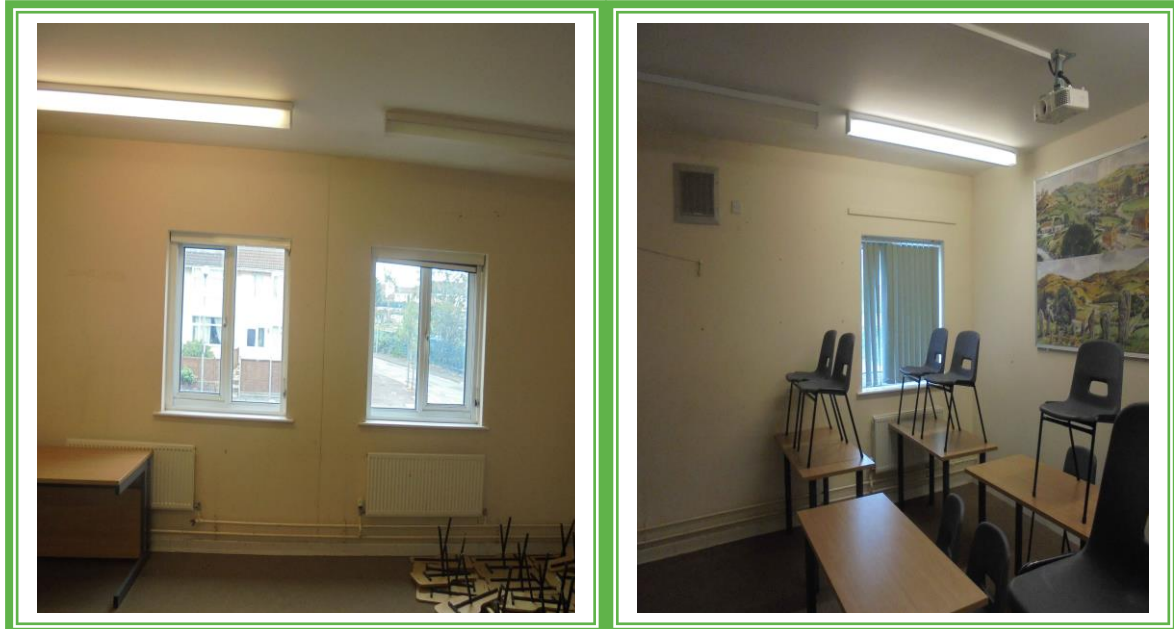
**Item No: 12****Sample No: N/A****Location: First Floor – Classrooms x 3**

Material Description:	Visual Inspection – No Suspect Materials Found	
Identification:	N/A	
Approx. quantity:	N/A	
Accessibility	N/A	<i>Assessment Score</i>
Product type:		N/A
Extent of Damage:		N/A
Surface Treatment:		N/A
Asbestos type:		N/A
Material Assessment Score:		N/A
Priority Assessment Score:		N/A
Action:	N/A	
Comments:	N/A

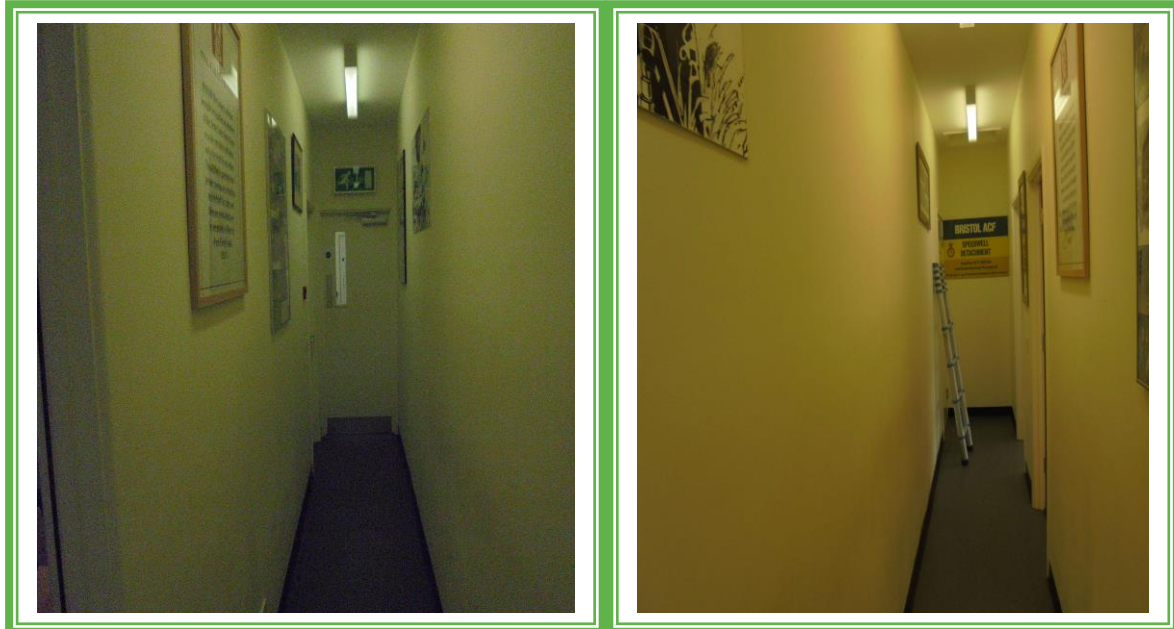
Location: First Floor – Circulation

Material Description:	Visual Inspection – No Suspect Materials Found	
Identification:	N/A	
Approx. quantity:	N/A	
Accessibility	N/A	<i>Assessment Score</i>
Product type:		N/A
Extent of Damage:		N/A
Surface Treatment:		N/A
Asbestos type:		N/A
Material Assessment Score:		N/A
Priority Assessment Score:		N/A
Action:	N/A	
Comments:	N/A

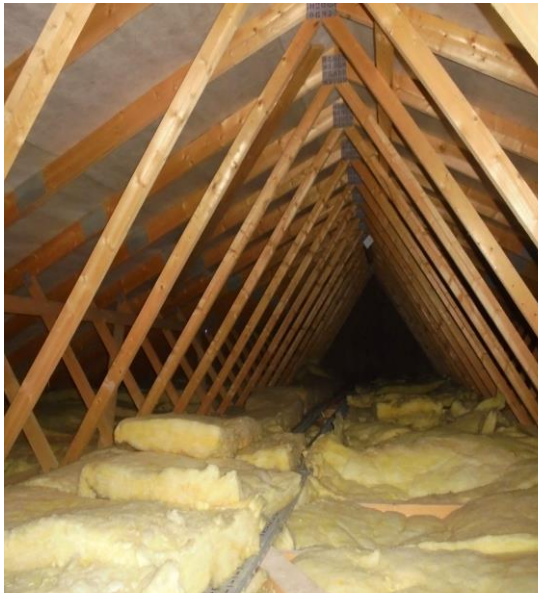
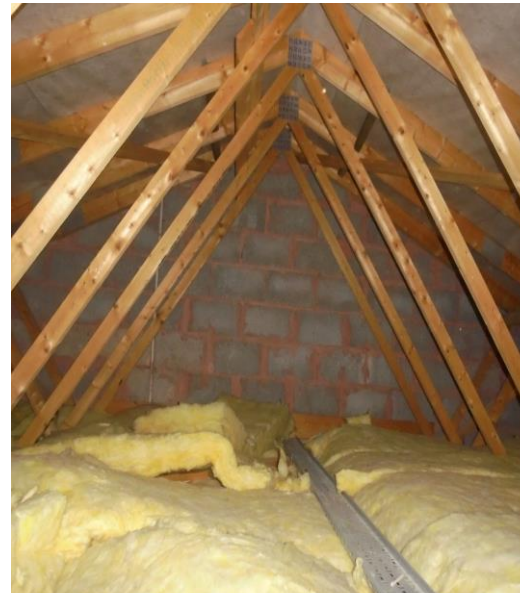
**Item No: 14****Sample No: N/A****Location: First Floor – Loft**

Material Description:	Visual Inspection – No Suspect Materials Found	
Identification:	N/A	
Approx. quantity:	N/A	
Accessibility	N/A	<i>Assessment Score</i>
Product type:		N/A
Extent of Damage:		N/A
Surface Treatment:		N/A
Asbestos type:		N/A
Material Assessment Score:		N/A
Priority Assessment Score:		N/A
Action:	N/A	
Comments:	N/A

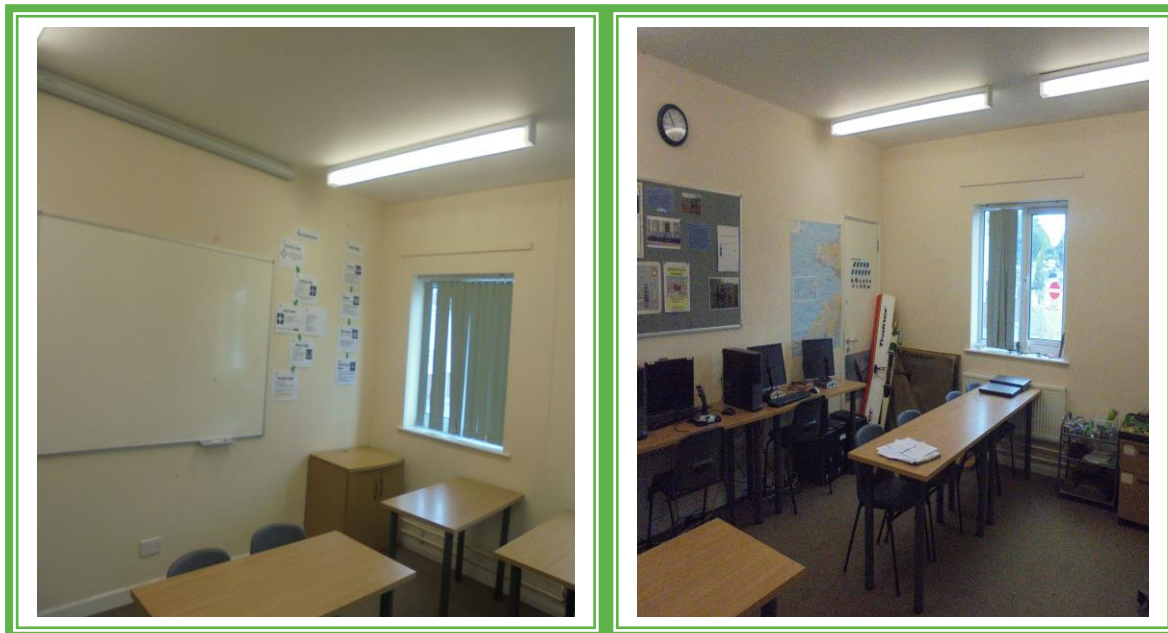
Location: First Floor – Classrooms x 2

Material Description:	Visual Inspection – No Suspect Materials Found	
Identification:	N/A	
Approx. quantity:	N/A	
Accessibility	N/A	<i>Assessment Score</i>
Product type:		N/A
Extent of Damage:		N/A
Surface Treatment:		N/A
Asbestos type:		N/A
Material Assessment Score:		N/A
Priority Assessment Score:		N/A
Action:	N/A	
Comments:	N/A

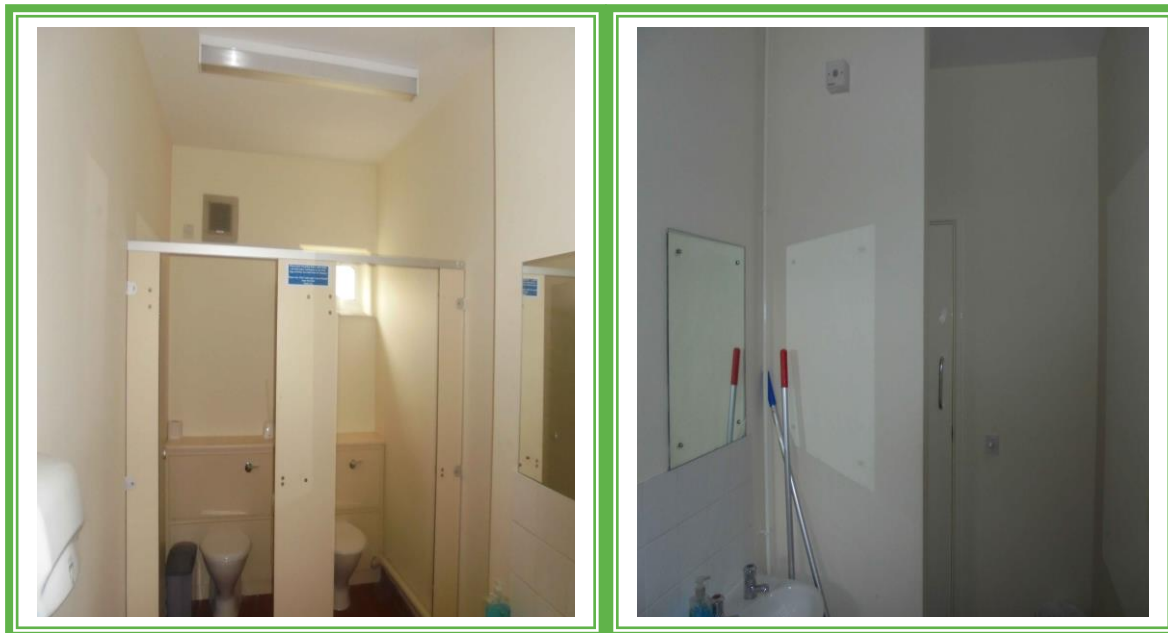
Location: First Floor – Ladies WC

Material Description:	Visual Inspection – No Suspect Materials Found	
Identification:	N/A	
Approx. quantity:	N/A	
Accessibility	N/A	<i>Assessment Score</i>
Product type:		N/A
Extent of Damage:		N/A
Surface Treatment:		N/A
Asbestos type:		N/A
Material Assessment Score:		N/A
Priority Assessment Score:		N/A
Action:	N/A	
Comments:	N/A

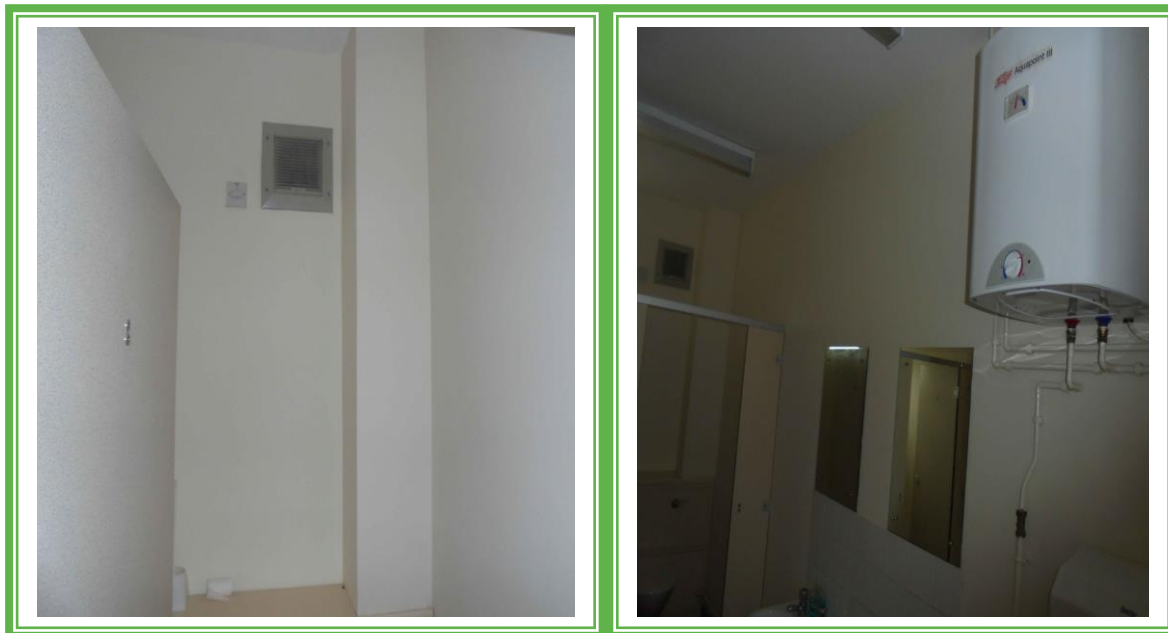
Location: First Floor – Men's WC

Sample Number	Sample Type	Location	Analysis
DK/1	Insulation Board Boxing	Men's WC, First Floor	N.A.D.I.S
DK/2	Insulation Board Ceiling	External Porch	N.A.D.I.S

Material Description:	Insulation Board Boxing	
Identification:	Sampled – No Asbestos Detected	
Approx. quantity:	3LM	
Accessibility	N/A	<i>Assessment Score</i>
Product type:		N/A
Extent of Damage:		N/A
Surface Treatment:		N/A
Asbestos type:		N/A
Material Assessment Score:		N/A
Priority Assessment Score:		N/A
Action:	N/A	
Comments:	N/A

Sample No.	Sample Ref.	Location	Asbestos Detected	Asbestos Type
DK/1	BS567632	Mens WC, First Floor - Insulation board boxing	No	
DK/2	BS567633	External Porch - Insulation board ceiling	No

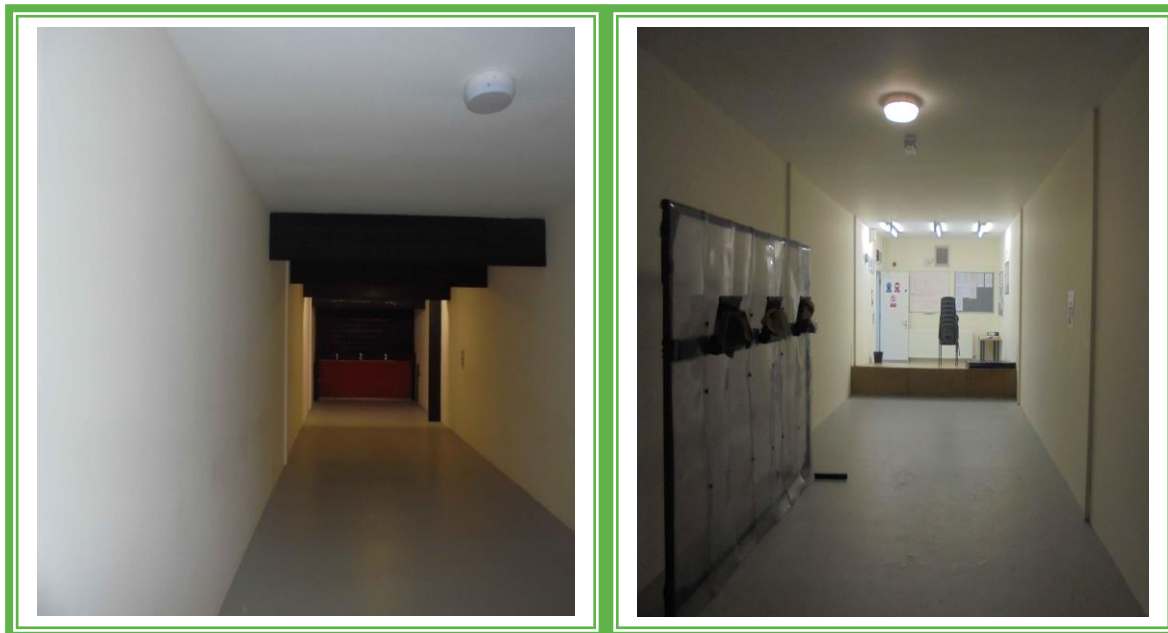
**Item No: 18****Sample No: N/A****Location: First Floor – Range**

Material Description:	Visual Inspection – No Suspect Materials Found	
Identification:	N/A	
Approx. quantity:	N/A	
Accessibility	N/A	<i>Assessment Score</i>
Product type:		N/A
Extent of Damage:		N/A
Surface Treatment:		N/A
Asbestos type:		N/A
Material Assessment Score:		N/A
Priority Assessment Score:		N/A
Action:	N/A	
Comments:	N/A

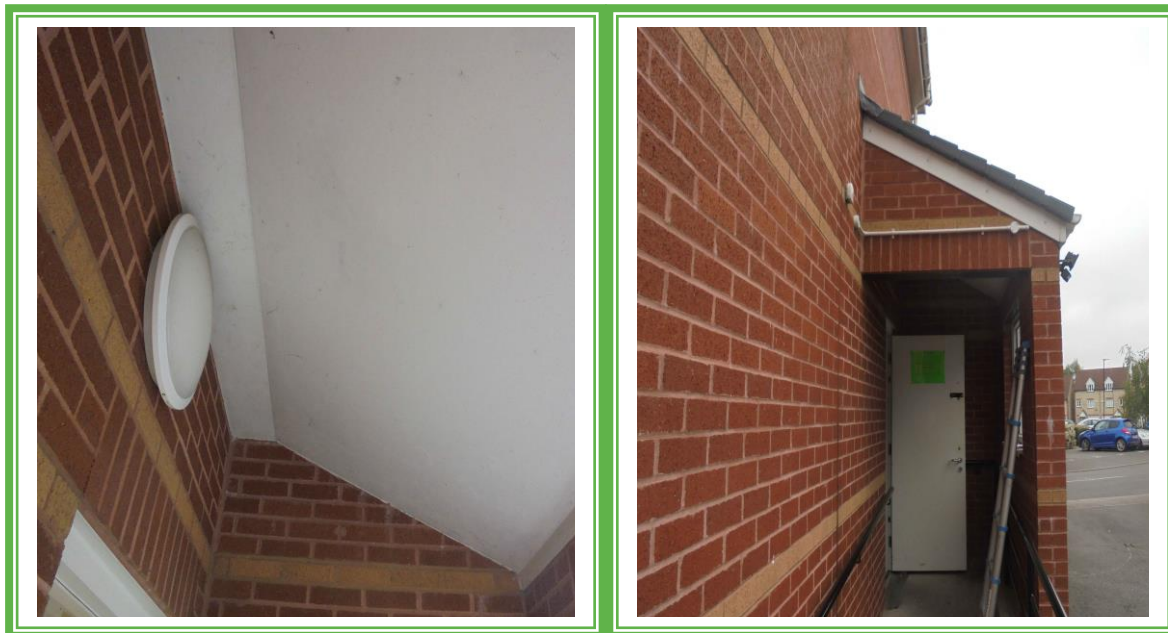
**Item No: 19****Sample No: DK/2****Location: External - Porch**

Material Description:	Insulation Board Ceiling Panels	
Identification:	Sampled – No Asbestos Detected	
Approx. quantity:	4M2	
Accessibility	N/A	<i>Assessment Score</i>
Product type:		N/A
Extent of Damage:		N/A
Surface Treatment:		N/A
Asbestos type:		N/A
Material Assessment Score:		N/A
Priority Assessment Score:		N/A
Action:	N/A	
Comments:	N/A
