ARMOUR
ANALYTICAL SERVICES

Project Number 2481

**Management
Asbestos Survey Report**

**Wyvern Barracks, Barrack Road, Exeter, Devon,
EX2 6AE (Building 2)**

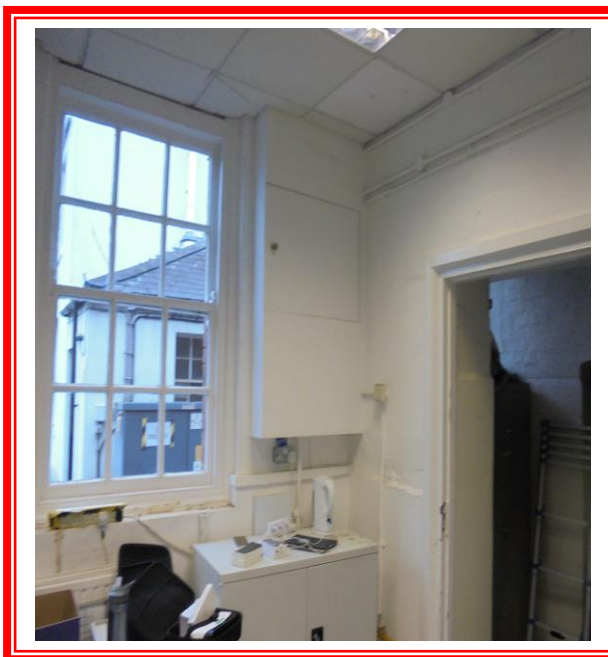
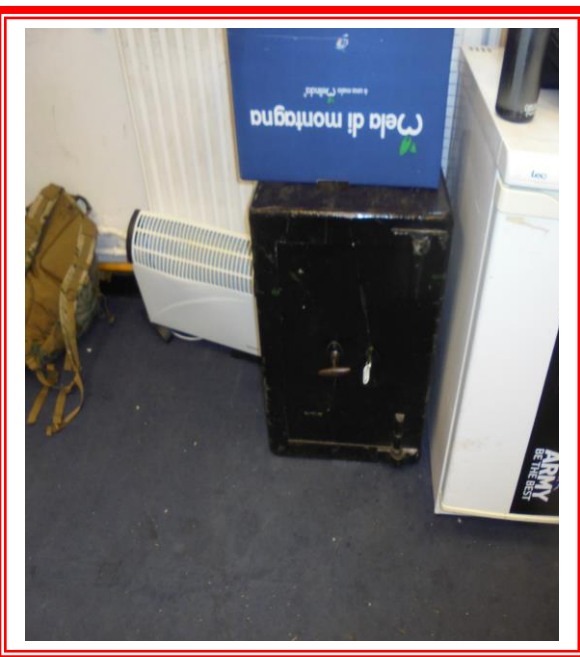
Item No: 5

Item 5 – Reception Room – No access within safe casings

Material Description:	No access within safe casings	
Identification:	Presumed to Contain Asbestos	
Approx. quantity:	X 1 Safe	
Accessibility	Low	<i>Assessment Score</i>
Product type:	No Access	2
Extent of Damage:	No Access	2
Surface Treatment:	No Access	2
Asbestos type:	No Access	2
Material Assessment Score:		8
Priority Assessment Score:		Medium
Action:	Manage	
Comments:	No access within safe casings without irreparable damage

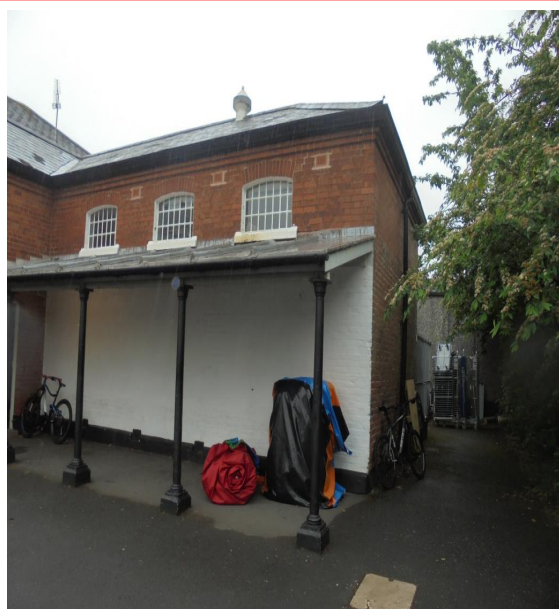
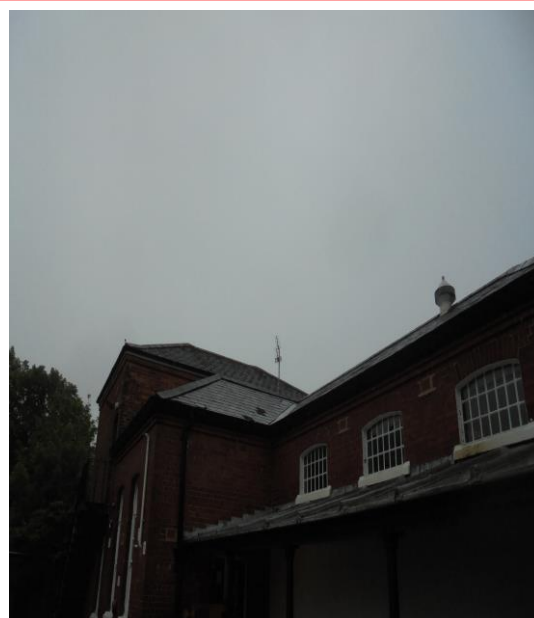
**Item No: 9****Sample No: N/A****Location: External**

Item 9 – External – Cement Roof Tiles – No access to sample due to height

Material Description:	Cement Roof Tiles	
Identification:	Presumed to Contain Asbestos	
Approx. quantity:	150M2	
Accessibility	Low	<i>Assessment Score</i>
Product type:	Cement	1
Extent of Damage:	Minor	1
Surface Treatment:	Unsealed	1
Asbestos type:	Chrysotile	1
Material Assessment Score:		4
Priority Assessment Score:		Negligible
Action:	Manage	
Comments:	No access to sample due to height

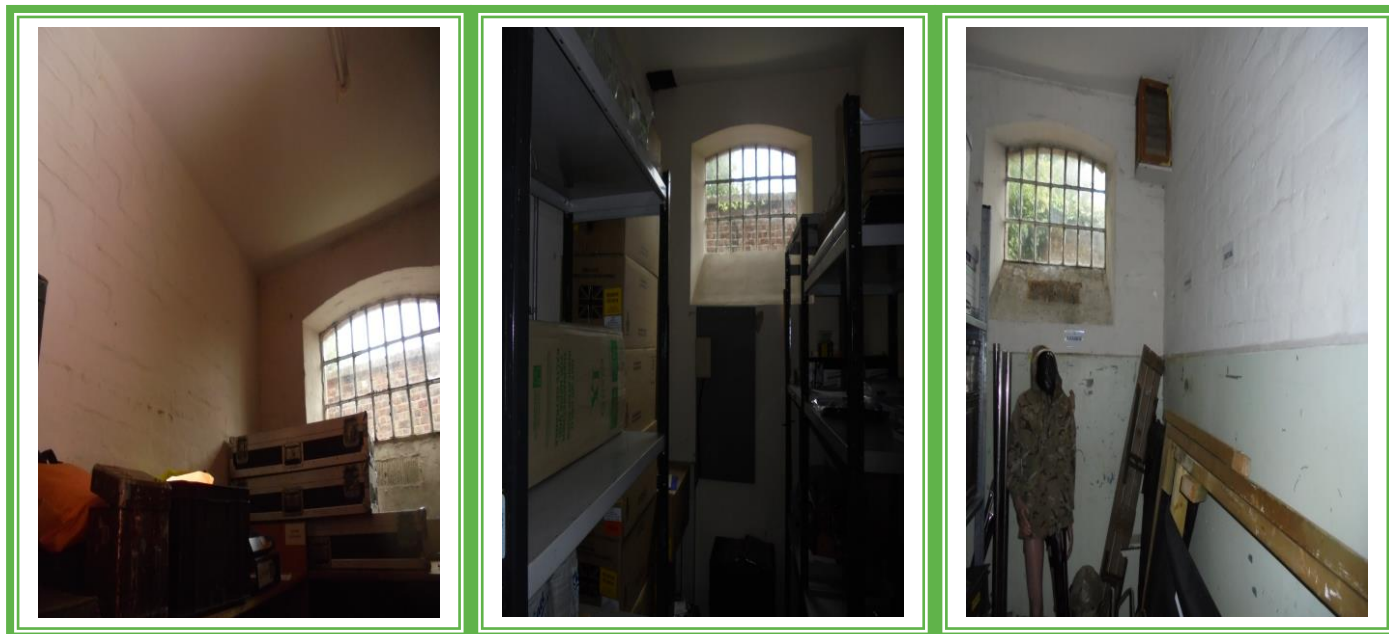
Item No: 1

Material Description:	Visual Inspection – No Suspect Materials Found	
Identification:	N/A	
Approx. quantity:	N/A	
Accessibility	N/A	<i>Assessment Score</i>
Product type:		N/A
Extent of Damage:		N/A
Surface Treatment:		N/A
Asbestos type:		N/A
Material Assessment Score:		N/A
Priority Assessment Score:		N/A
Action:	N/A	
Comments:	Metal panels on wall

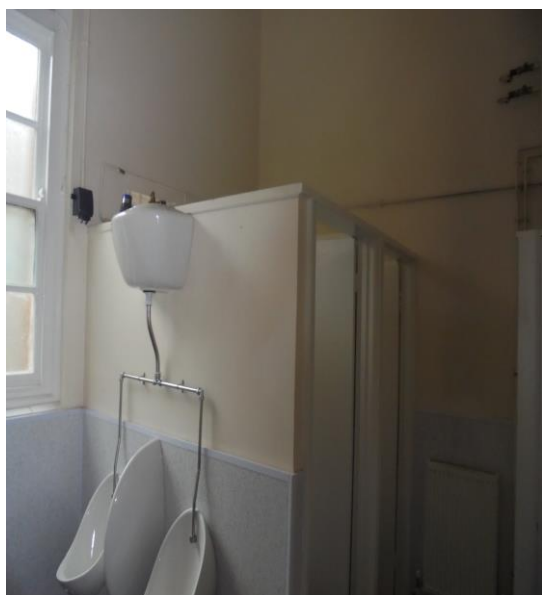
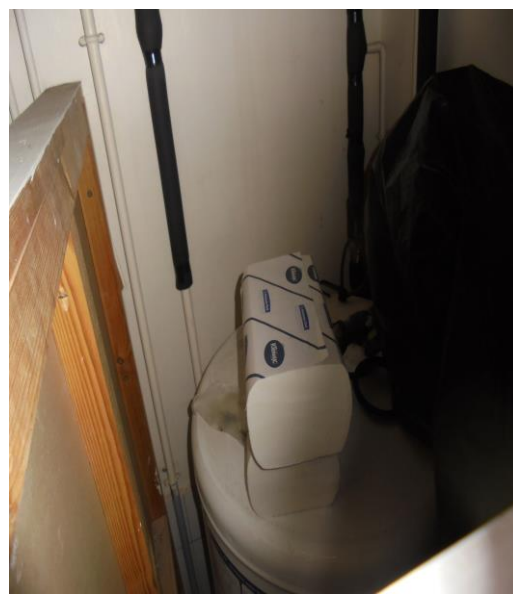
Item No: 2

Material Description:	Visual Inspection – No Suspect Materials Found	
Identification:	N/A	
Approx. quantity:	N/A	
Accessibility	N/A	<i>Assessment Score</i>
Product type:		N/A
Extent of Damage:		N/A
Surface Treatment:		N/A
Asbestos type:		N/A
Material Assessment Score:		N/A
Priority Assessment Score:		N/A
Action:	N/A	
Comments:	Modern Water Heater

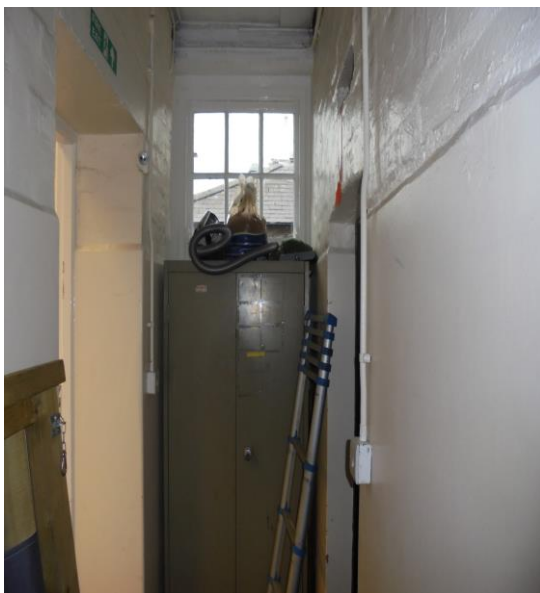
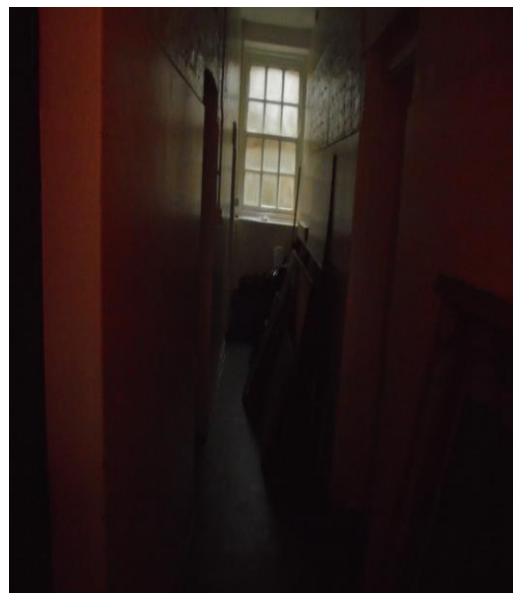
Item No: 3

Material Description:	Visual Inspection – No Suspect Materials Found	
Identification:	N/A	
Approx. quantity:	N/A	
Accessibility	N/A	<i>Assessment Score</i>
Product type:		N/A
Extent of Damage:		N/A
Surface Treatment:		N/A
Asbestos type:		N/A
Material Assessment Score:		N/A
Priority Assessment Score:		N/A
Action:	N/A	
Comments:	N/A

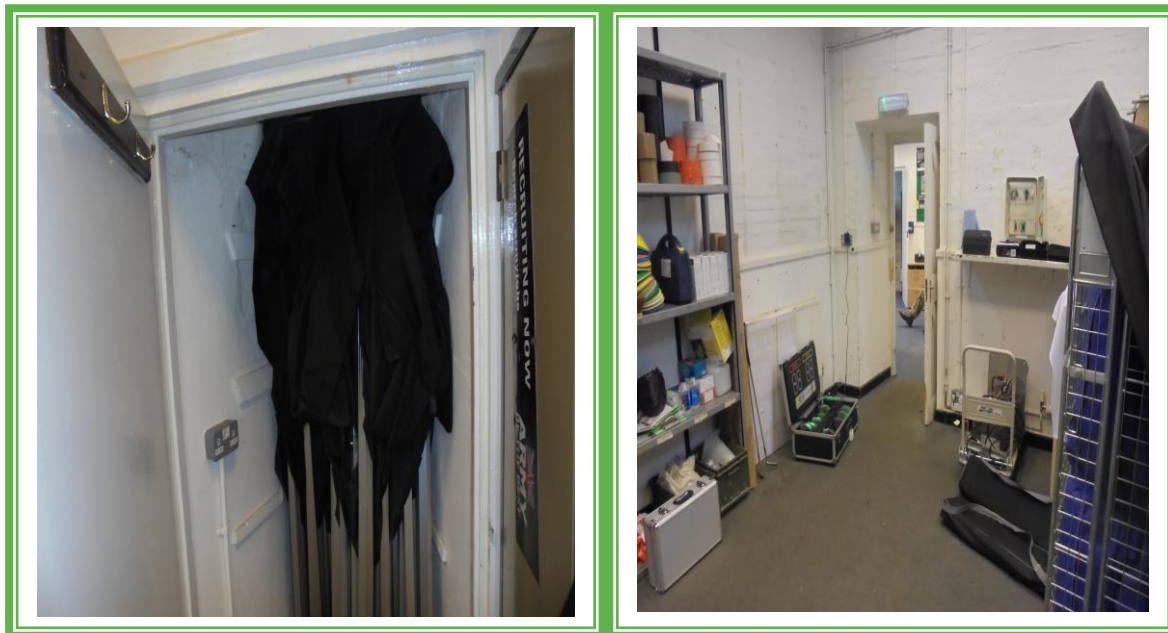
Item No: 4

Material Description:	Visual Inspection – No Suspect Materials Found	
Identification:	N/A	
Approx. quantity:	N/A	
Accessibility	N/A	<i>Assessment Score</i>
Product type:		N/A
Extent of Damage:		N/A
Surface Treatment:		N/A
Asbestos type:		N/A
Material Assessment Score:		N/A
Priority Assessment Score:		N/A
Action:	N/A	
Comments:	Limited access into cupboard due to stored items. limited access above suspended ceiling due to height.

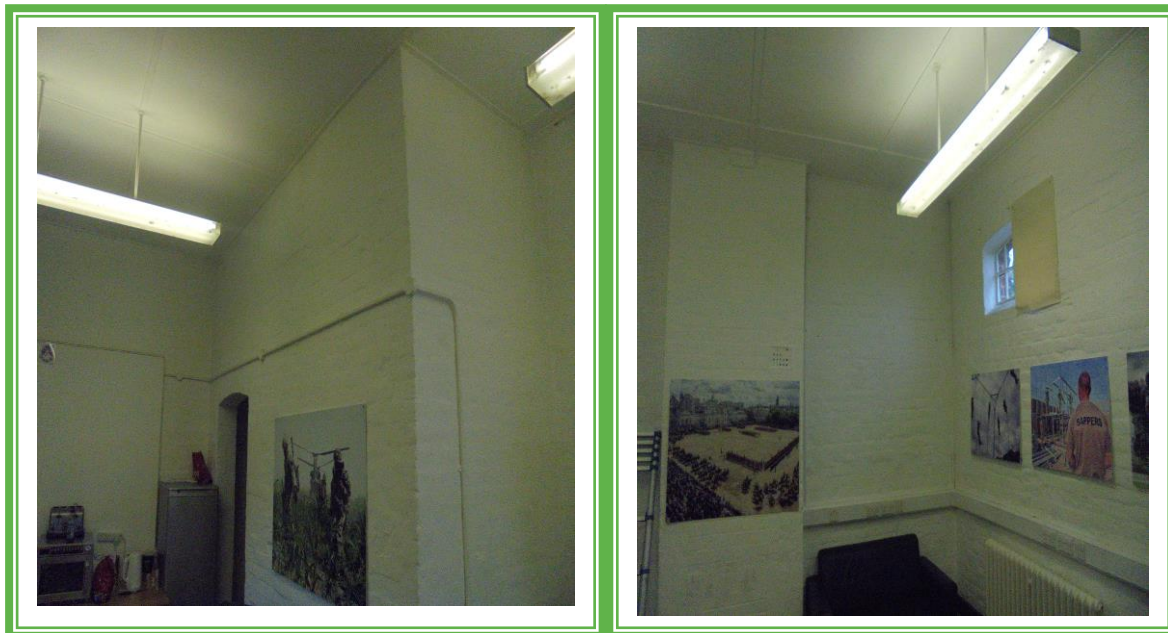
Item No: 6

Material Description:	Visual Inspection – No Suspect Materials Found	
Identification:	N/A	
Approx. quantity:	N/A	
Accessibility	N/A	<i>Assessment Score</i>
Product type:		N/A
Extent of Damage:		N/A
Surface Treatment:		N/A
Asbestos type:		N/A
Material Assessment Score:		N/A
Priority Assessment Score:		N/A
Action:	N/A	
Comments:	Non-asbestos fiberboard ceiling

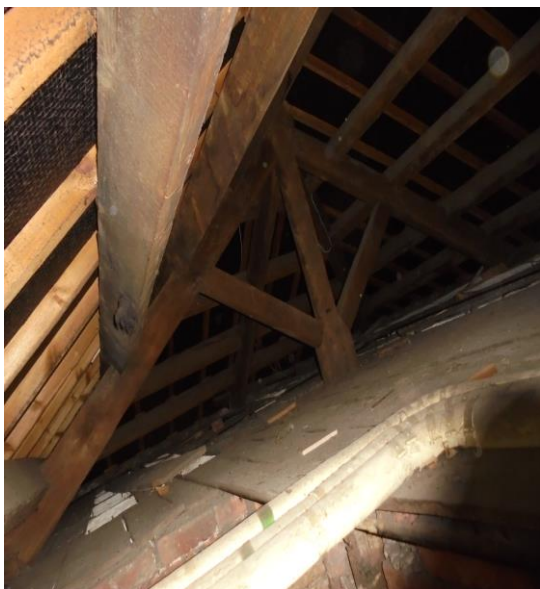
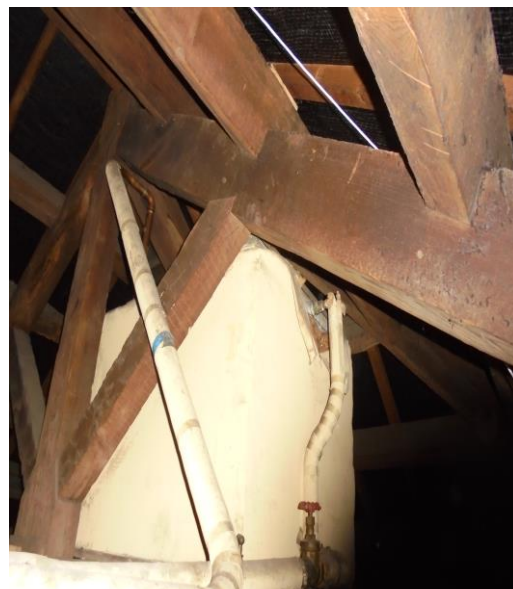
**Item No: 7****Sample No: N/A****Location: Loft Space**

Material Description:	Visual Inspection – No Suspect Materials Found	
Identification:	N/A	
Approx. quantity:	N/A	
Accessibility	N/A	<i>Assessment Score</i>
Product type:		N/A
Extent of Damage:		N/A
Surface Treatment:		N/A
Asbestos type:		N/A
Material Assessment Score:		N/A
Priority Assessment Score:		N/A
Action:	N/A	
Comments:	Modern pipework and metal tank

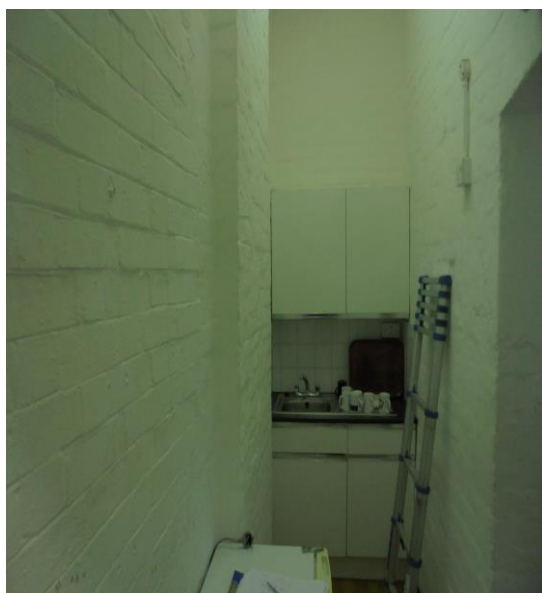
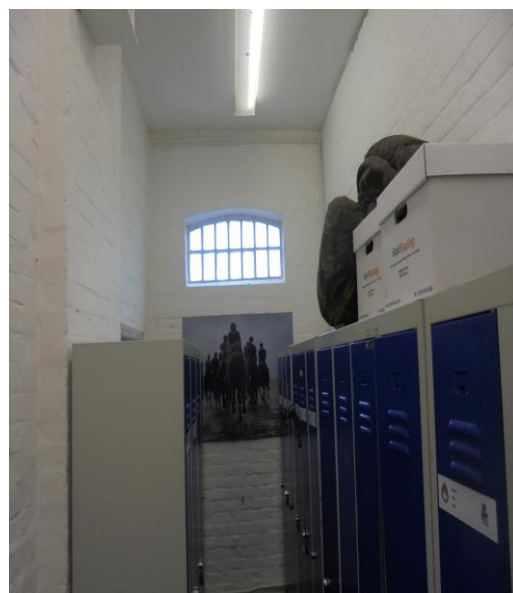
Item No: 8

Material Description:	Visual Inspection – No Suspect Materials Found	
Identification:	N/A	
Approx. quantity:	N/A	
Accessibility	N/A	<i>Assessment Score</i>
Product type:		N/A
Extent of Damage:		N/A
Surface Treatment:		N/A
Asbestos type:		N/A
Material Assessment Score:		N/A
Priority Assessment Score:		N/A
Action:	N/A	
Comments:	N/A
