**Project Number 2481**

**Management  
Asbestos Survey Report**

**Saltash Platoon, Elwess Lane, Cornwall,  
PL12 6AP**

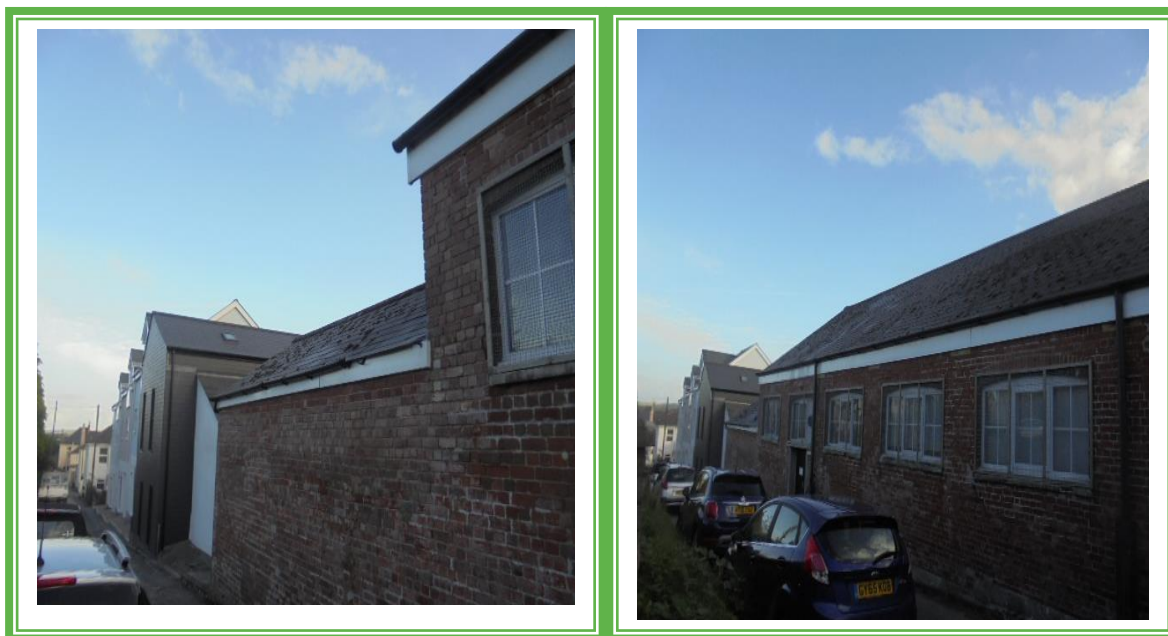
**Item No: 1**

| <b>Material Description:</b> | Cement Roof Tiles | |
| <b>Identification:</b> | As Per Sample DK/1 – No Asbestos Detected | |
| <b>Approx. quantity:</b> | To All Roofs | |

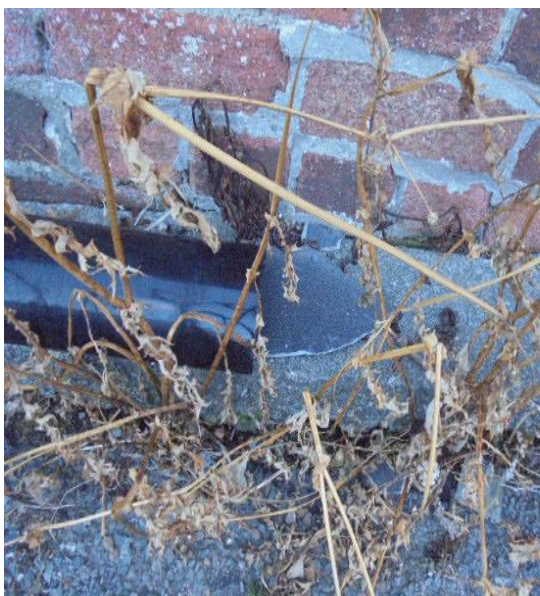
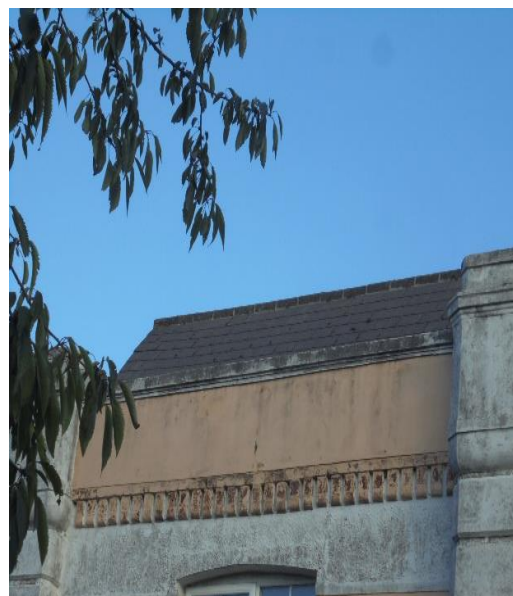
**Item No: 2**

| <b>Material Description:</b> | Cement Roof Tile Debris | |
| <b>Identification:</b> | Sampled – No Asbestos Detected | |
| <b>Approx. quantity:</b> | <1M2 | |
| <b>Comments:</b> | Located to Side of Road | |

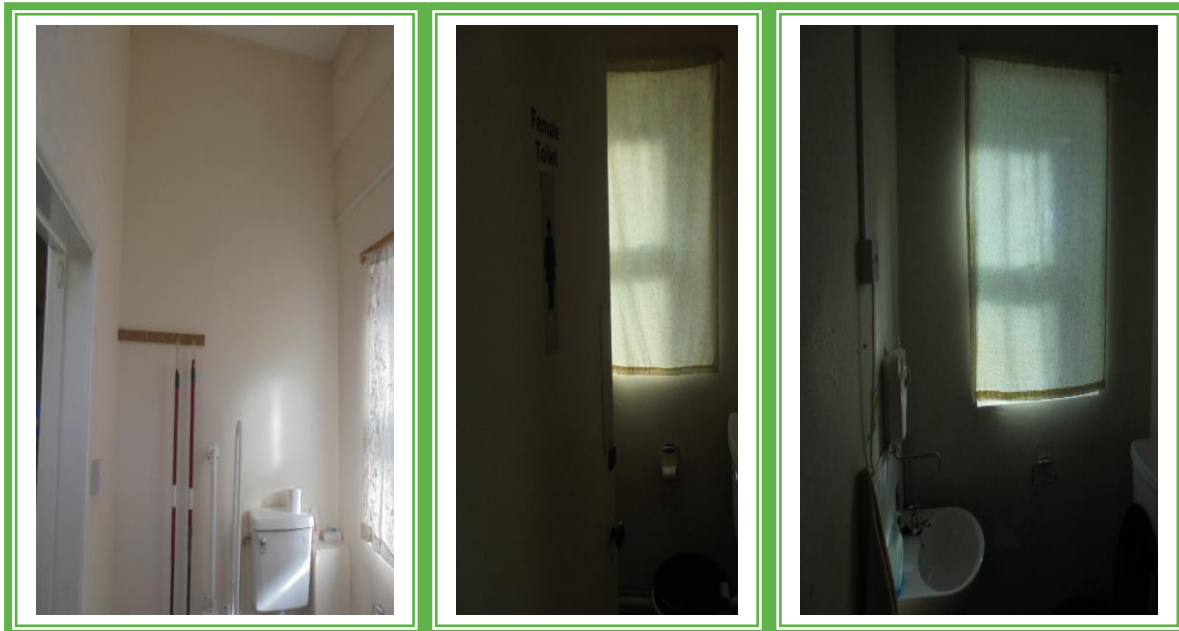
**Item No: 3**

| <b>Material Description:</b> | Visual Inspection – No Suspect Materials Found | |
| <b>Comments:</b> | Modern Electrics in Adult WC. No Access Within Timber Boxings | |

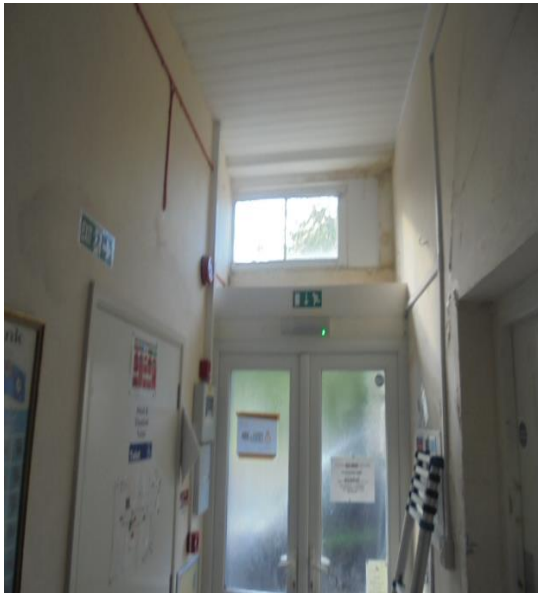
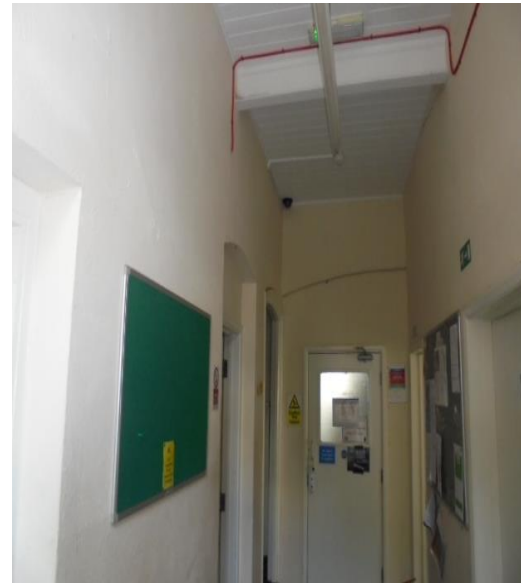
**Item No: 4**

| <b>Material Description:</b> | Visual Inspection – No Suspect Materials Found | |

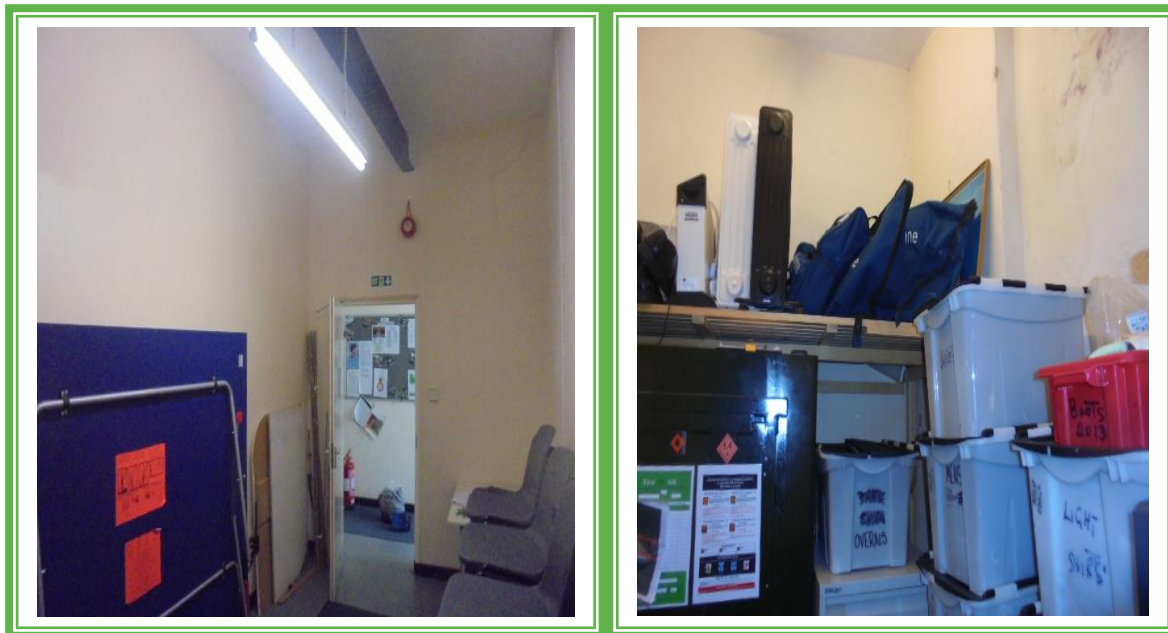
**Item No: 5**

| <b>Material Description:</b> | Visual Inspection – No Suspect Materials Found | |

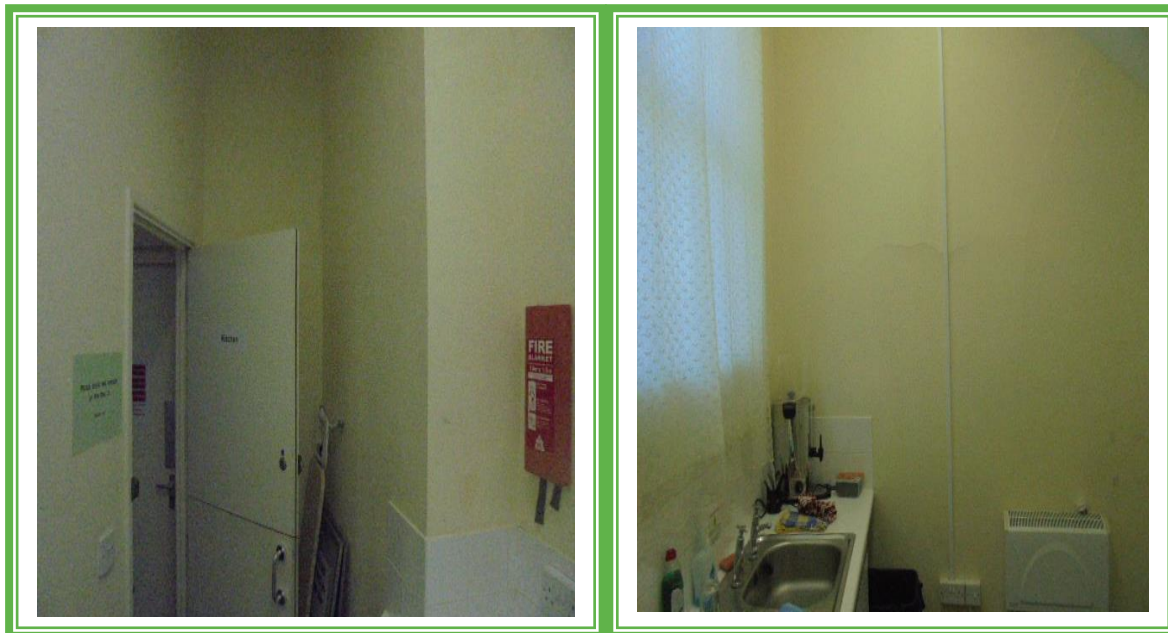
**Item No: 6****Sample No: N/A****Location: Ground Floor – Kitchen**

| <b>Material Description:</b> | Visual Inspection – No Suspect Materials Found | |
| <b>Comments:</b> | Modern Sink Pad | |

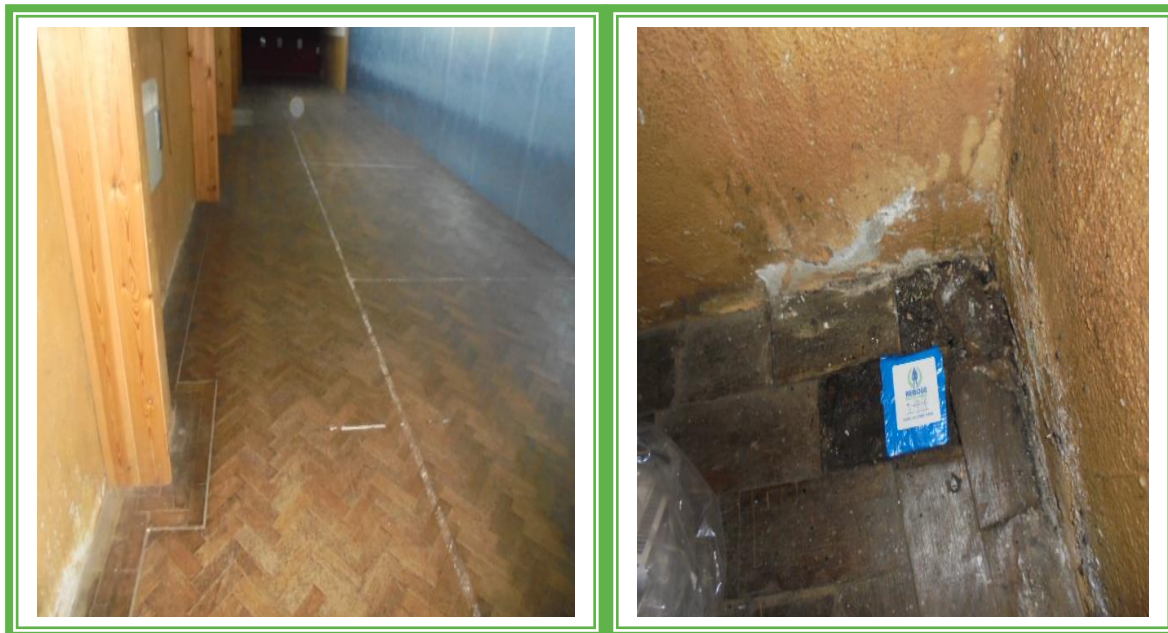
**Item No: 7**

| <b>Material Description:</b> | Bitumen Under Parquet Flooring | |
| <b>Identification:</b> | Sampled – No Asbestos Detected | |
| <b>Approx. quantity:</b> | 76M2 – Treat as Uniform to Parquet Flooring Throughout | |
| <b>Comments:</b> | Limited Access Above Suspended Ceiling Due to Height and Insulation Above Tiles. | |

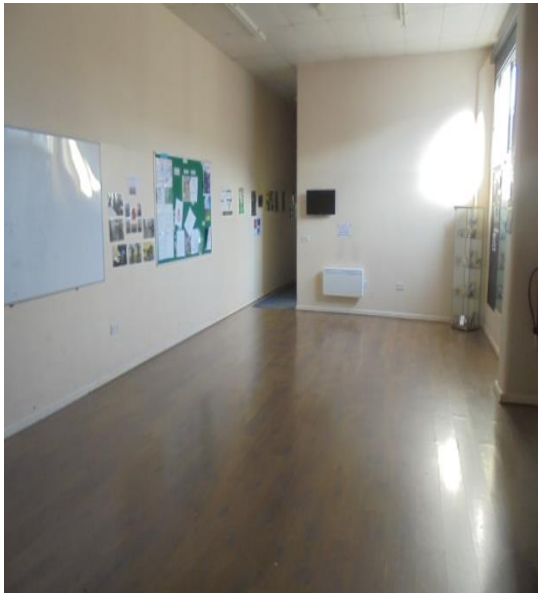
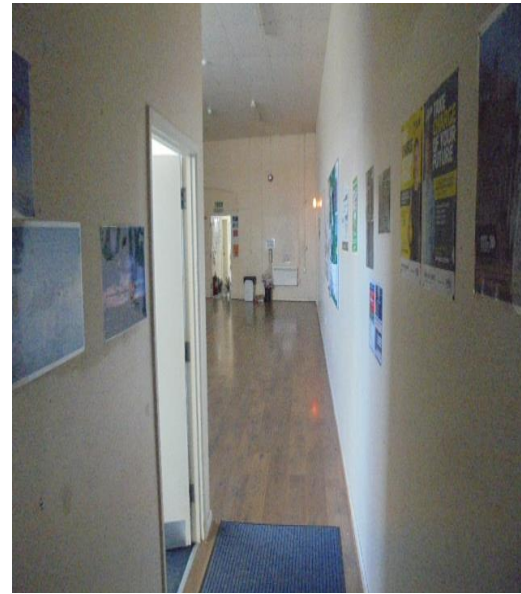
**Item No: 8**

| <b>Material Description:</b> | Visual Inspection – No Suspect Materials Found | |
| <b>Comments:</b> | Limited Access Above Suspended Ceiling Due to Height and Insulation Above Tiles. Modern Electric Heaters Throughout. | |

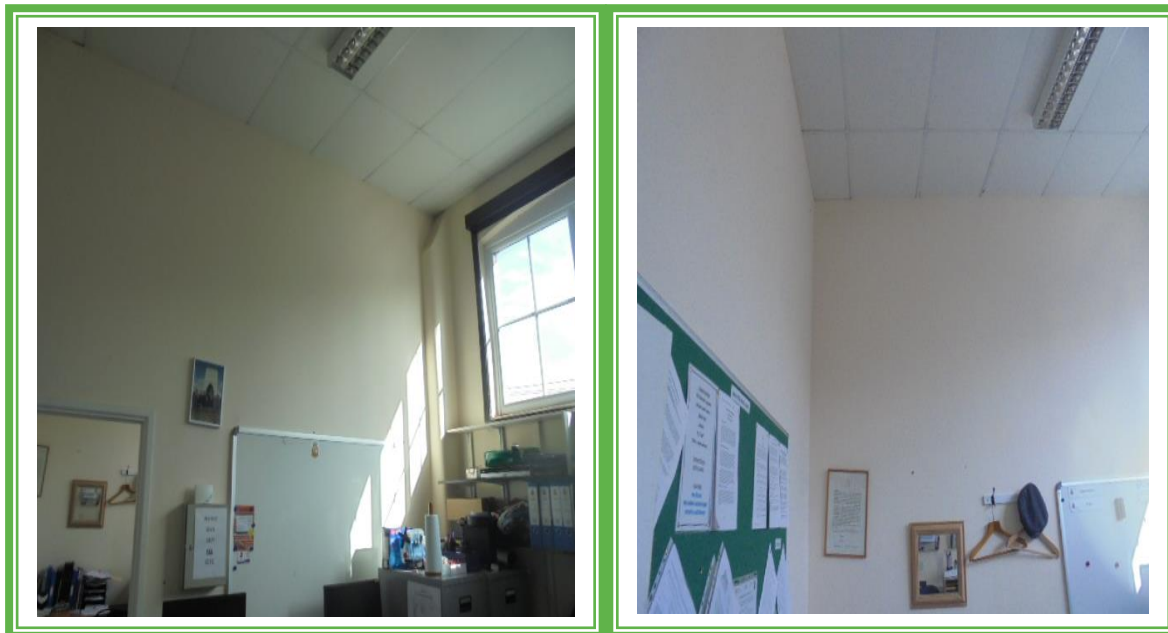
**Item No: 9**

| <b>Material Description:</b> | Visual Inspection – No Suspect Materials Found | |
| <b>Comments:</b> | Limited Access Above Suspended Ceiling Due to Height and Insulation Above Tiles. | |

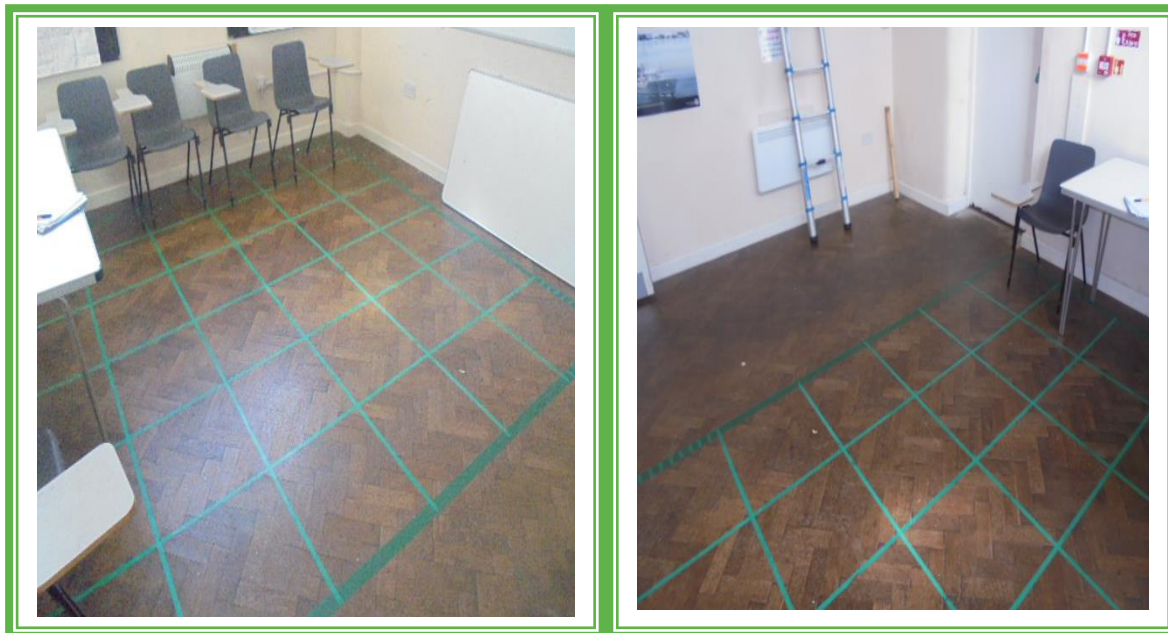
**Item No: 10**

| <b>Material Description:</b> | Bitumen Under Parquet Flooring | |
| <b>Identification:</b> | As Per Sample DK/2 – No Asbestos Detected | |
| <b>Approx. quantity:</b> | 20M2 | |
| <b>Comments:</b> | Limited Access Above Suspended Ceiling Due to Height and Insulation Above Tiles. | |

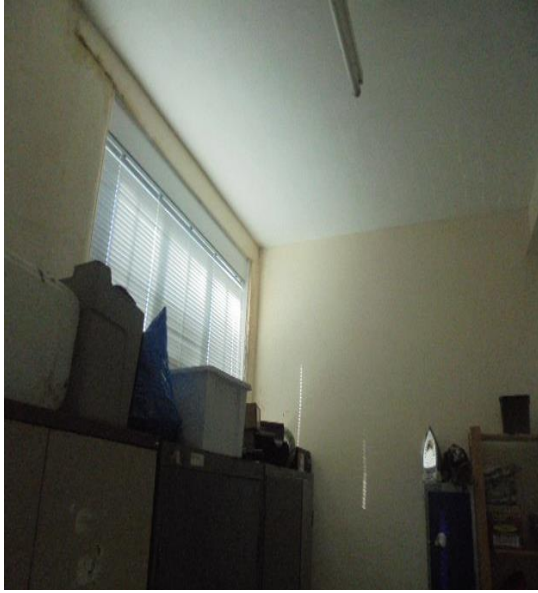
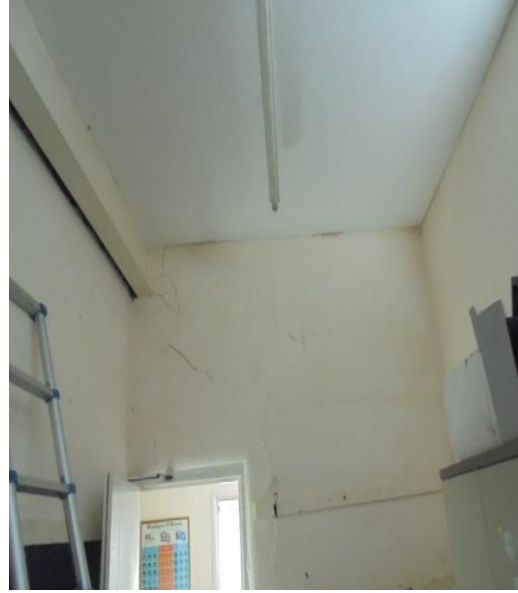
**Item No: 11****Sample No: N/A****Location: Ground Floor – Office**

| <b>Material Description:</b> | Visual Inspection – No Suspect Materials Found | |
| <b>Comments:</b> | Limited Access to Inspect Room Due to Filing Cabinets blocking access | |

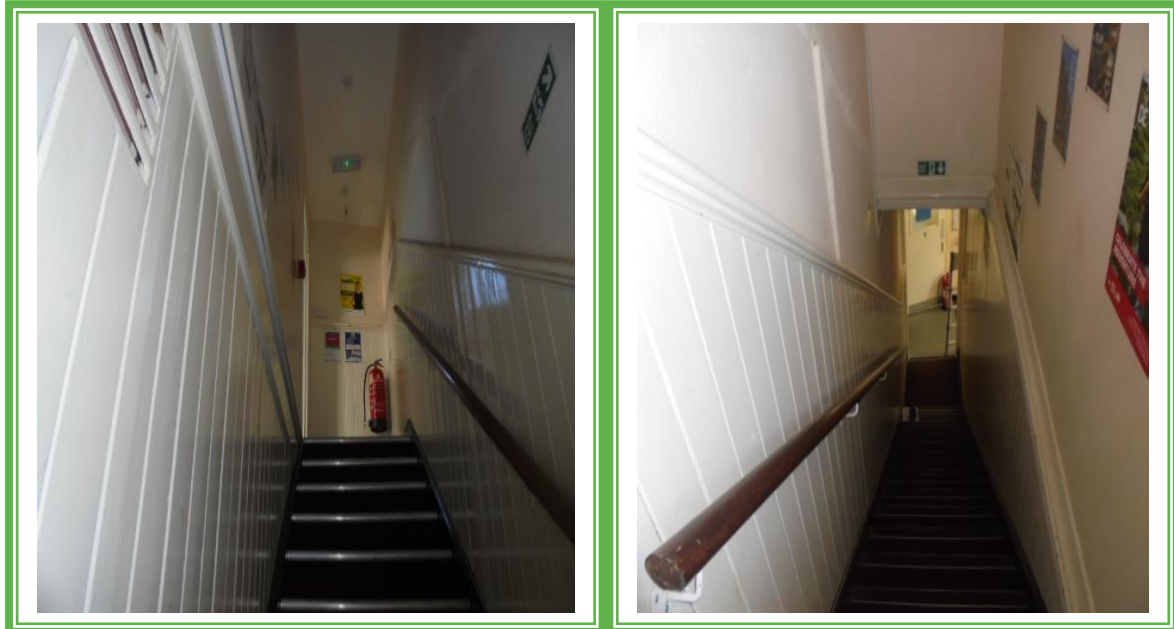
**Item No: 12****Sample No: N/A****Location: Ground Floor - Stairwell**

| <b>Material Description:</b> | Visual Inspection – No Suspect Materials Found | |
| <b>Comments:</b> | Timber Wall Paneling with Brick and Plasterboard Behind. Modern Stair Nosing | |

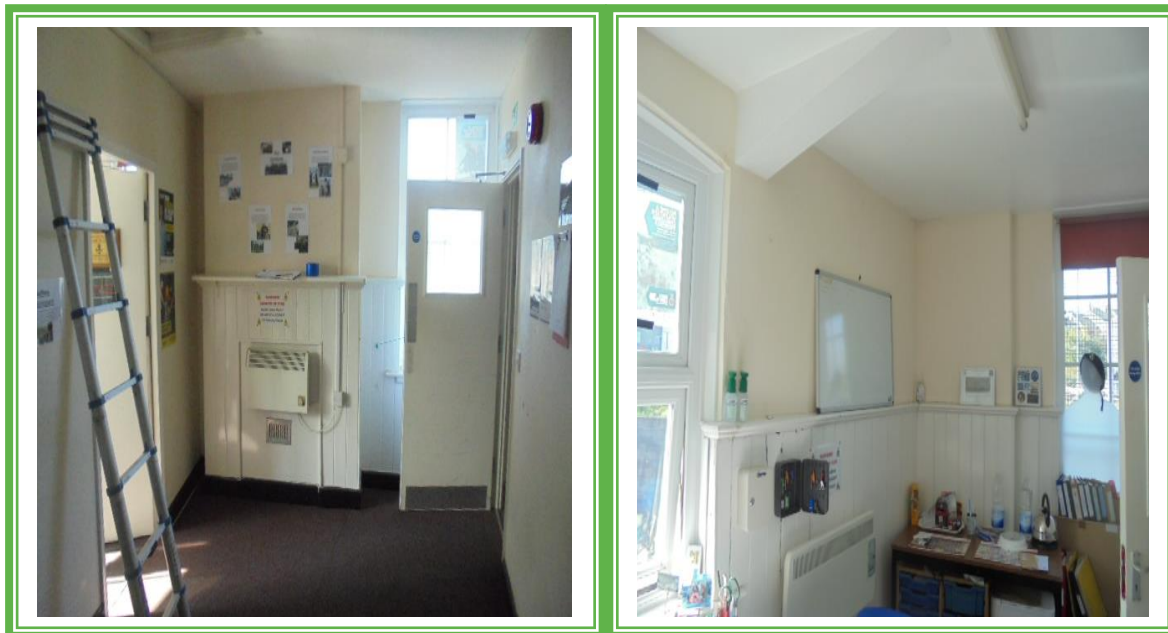
**Item No: 13**

| <b>Material Description:</b> | Visual Inspection – No Suspect Materials Found | |
| <b>Comments:</b> | No Access Behind Timber Fireplace Panel | |

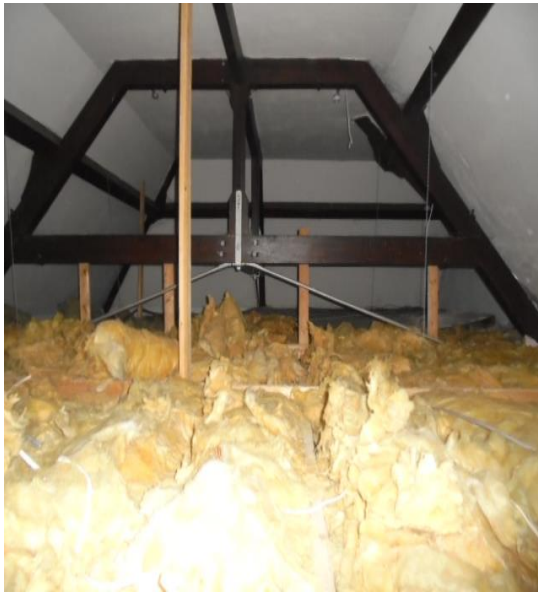
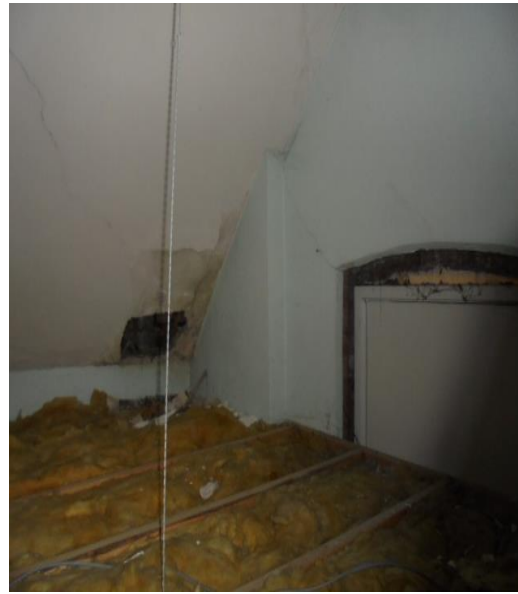
**Item No: 14****Sample No: N/A****Location: Loft Space**

| <b>Material Description:</b> | Visual Inspection – No Suspect Materials Found | |
| <b>Comments:</b> | Limited Access Within Loft as No Crawlboards were Available. | |

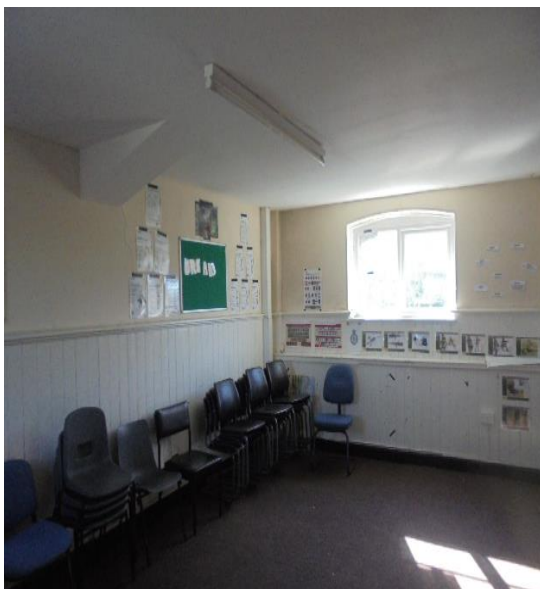
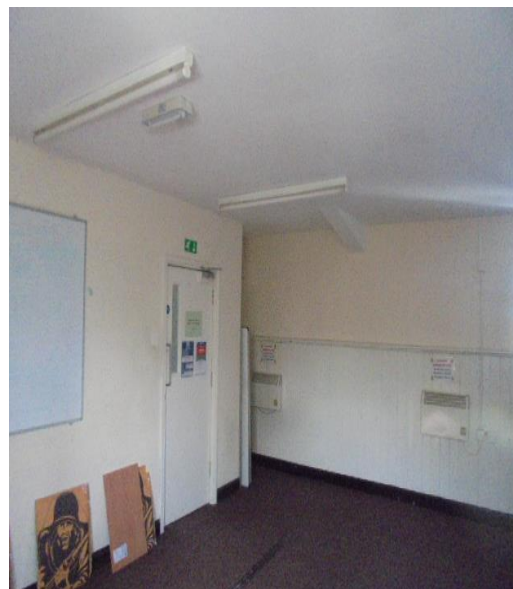
**Item No: 15****Sample No: N/A****Location: First Floor - Classroom**

| <b>Material Description:</b> | Visual Inspection – No Suspect Materials Found | |
