ARMOUR
ANALYTICAL SERVICES

Project Number 2481

**Management
Asbestos Survey Report**

Frome Platoon, Frome, BA11 1JJ

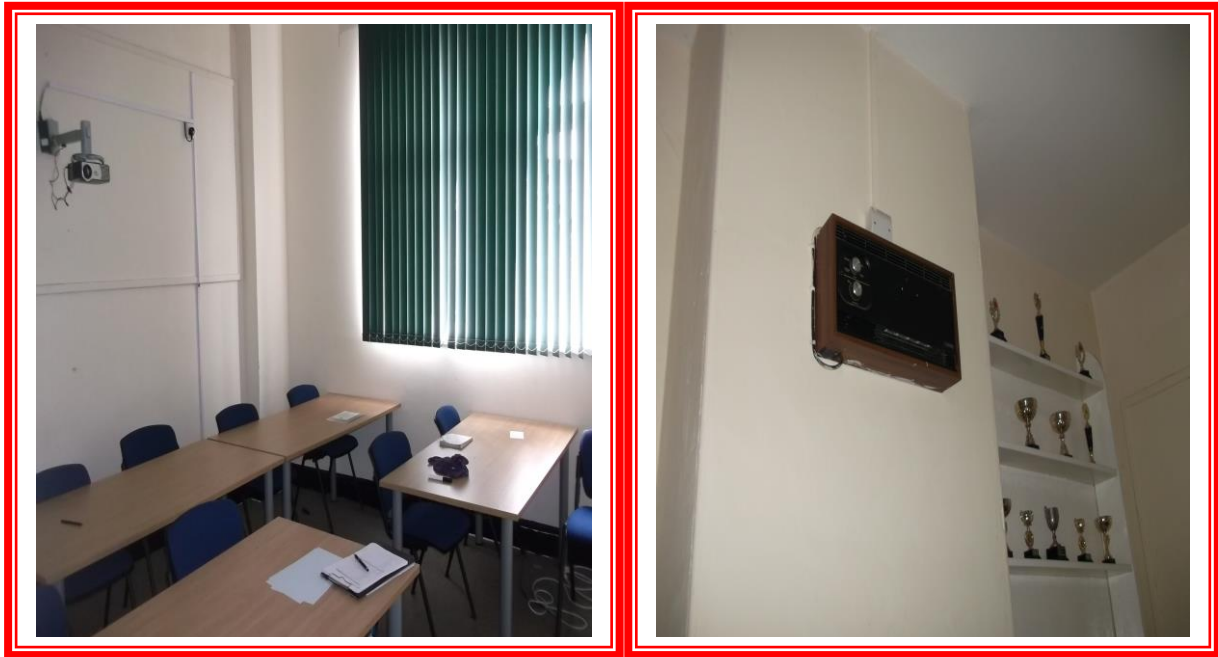
Item No: 2

Location: First Floor – Classroom 2

Material Description:	Asbestos Products to Heater on Wall	
Identification:	Strongly Presumed to Contain Asbestos	
Approx. quantity:	X1	
Accessibility	Low	<i>Assessment Score</i>
Product type:	Textiles	1
Extent of Damage:	No Access	3
Surface Treatment:	Unsealed	1
Asbestos type:	Chrysotile	1
Material Assessment Score:		6
Priority Assessment Score:		Low
Action:	Manage	
Comments:	Known to Contain Asbestos - unable to sample due to live electrics

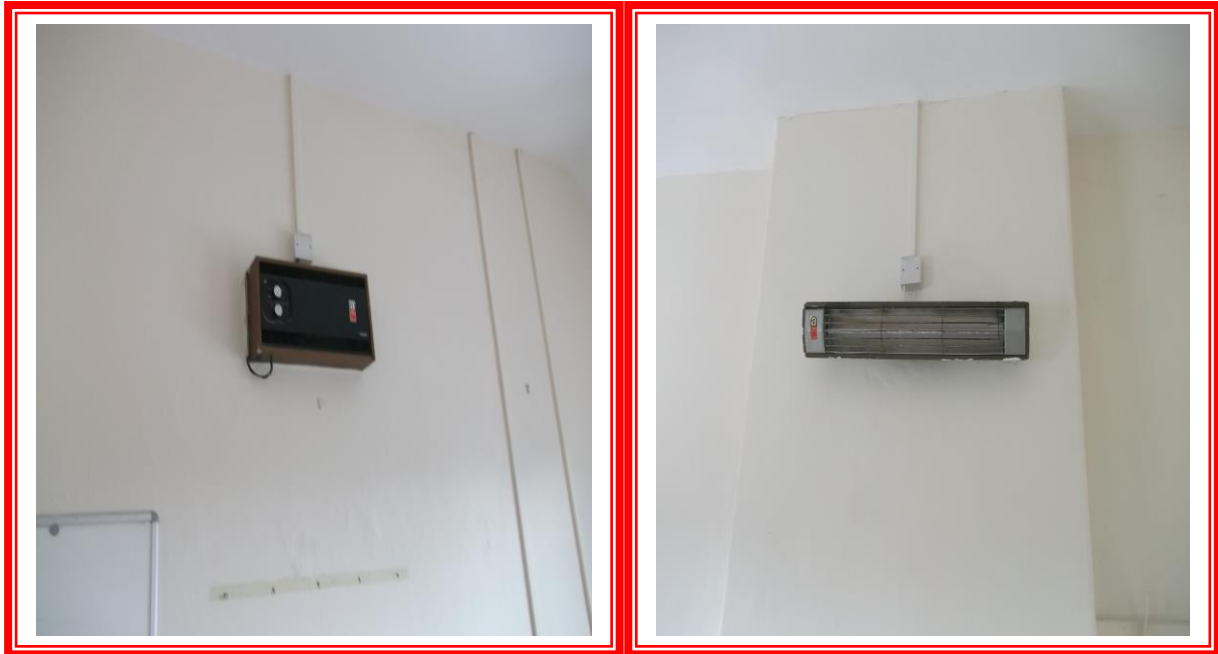
Item No: 3

Location: First Floor – Classroom 1

Material Description:	Asbestos Products to Heaters on Wall	
Identification:	Strongly Presumed to Contain Asbestos	
Approx. quantity:	X2	
Accessibility	Medium	<i>Assessment Score</i>
Product type:	Textile	1
Extent of Damage:	No Access	3
Surface Treatment:	Unsealed	1
Asbestos type:	Chrysotile	1
Material Assessment Score:		6
Priority Assessment Score:		Low
Action:	Manage	
Comments:	Known to Contain Asbestos - On Walls at Height. Unable to sample due to live electrics

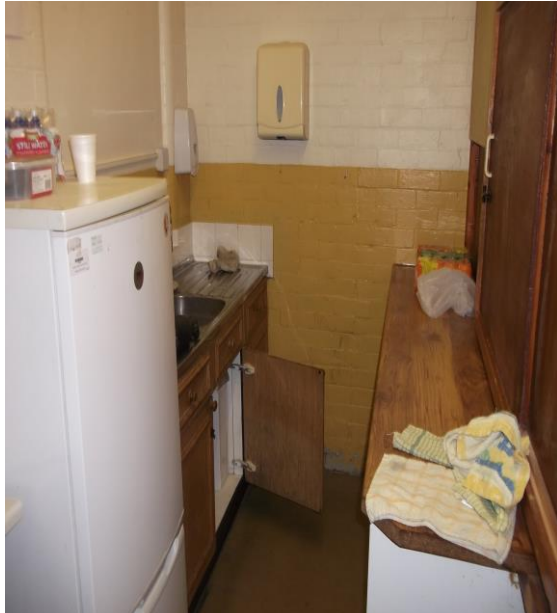
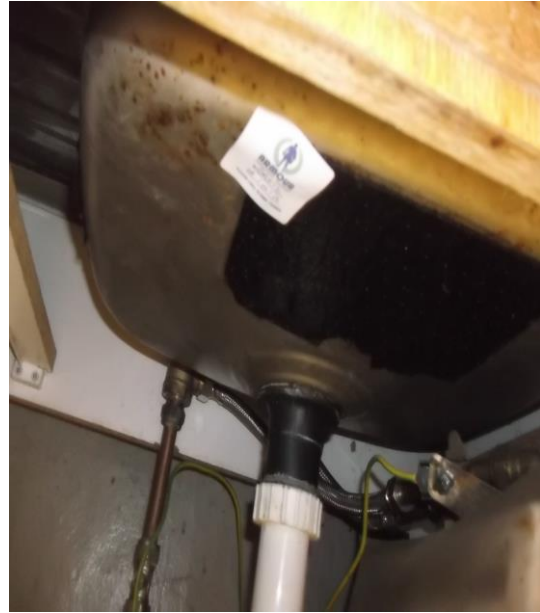
Item No: 8

Location: Ground Floor – Kitchen/ Canteen

Material Description:	Sink Pad to Sink	
Identification:	Sampled – Asbestos Detected	
Approx. quantity:	X1	
Accessibility	High	Assessment Score
Product type:	Bitumen	1
Extent of Damage:	Major	3
Surface Treatment:	Non-Friable	0
Asbestos type:	Chrysotile	1
Material Assessment Score:		5
Priority Assessment Score:		Low
Action:	Manage	
Comments:	N/A

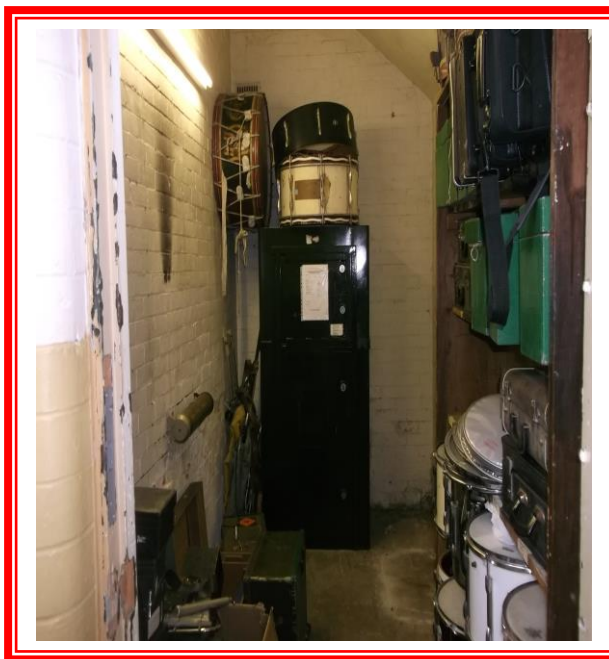
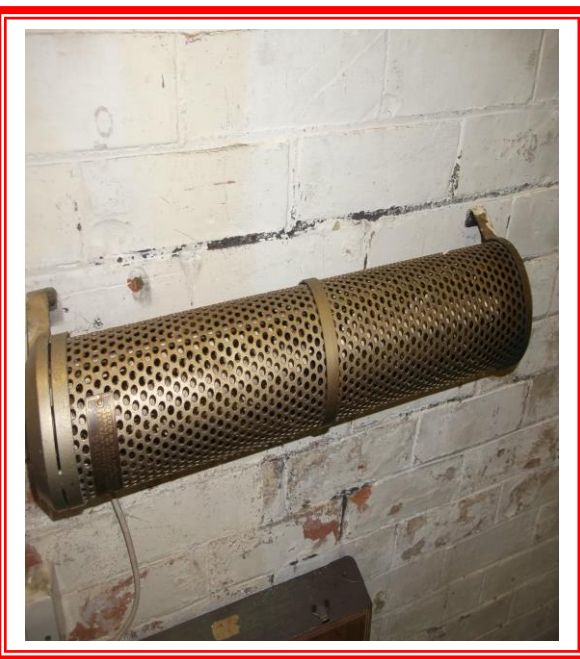
Item No: 9

Location: Ground Floor – Small Band Store Near to Canteen

Material Description:	Textiles to Heater on Wall	
Identification:	Sampled – Asbestos Detected	
Approx. quantity:	X1	
Accessibility	Low	Assessment Score
Product type:	Textile	1
Extent of Damage:	Major	3
Surface Treatment:	Unsealed	1
Asbestos type:	Chrysotile	1
Material Assessment Score:		6
Priority Assessment Score:		Low
Action:	Manage	
Comments:	N/A

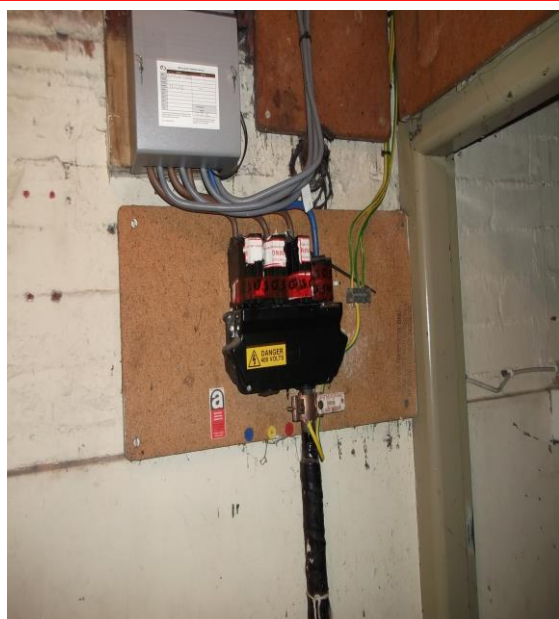
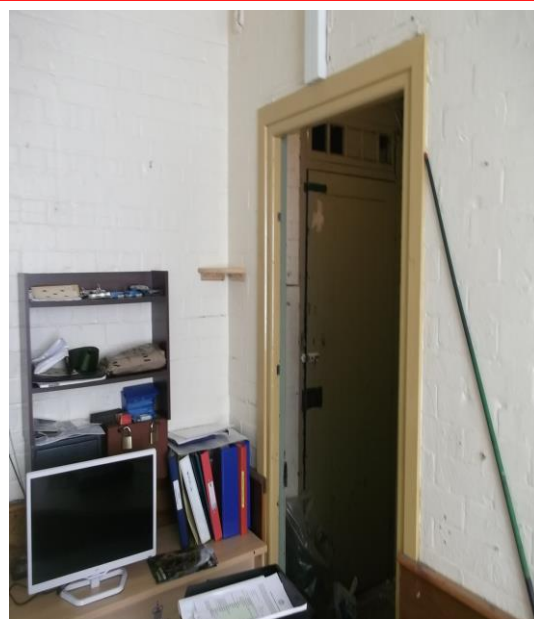
Item No: 14

Location: Ground Floor - ACF Office – Electrical/COSHH Cupboard

Material Description:	Flash Guards to Fuses	
Identification:	Strongly Presumed to Contain Asbestos	
Approx. quantity:	X4	
Accessibility	High	Assessment Score
Product type:	Textile	1
Extent of Damage:	No Access	3
Surface Treatment:	Unsealed	1
Asbestos type:	Chrysotile	1
Material Assessment Score:		6
Priority Assessment Score:		Low
Action:	Manage	
Comments:	Unable to Sample Live Electrics - Asbestos Stickers Present

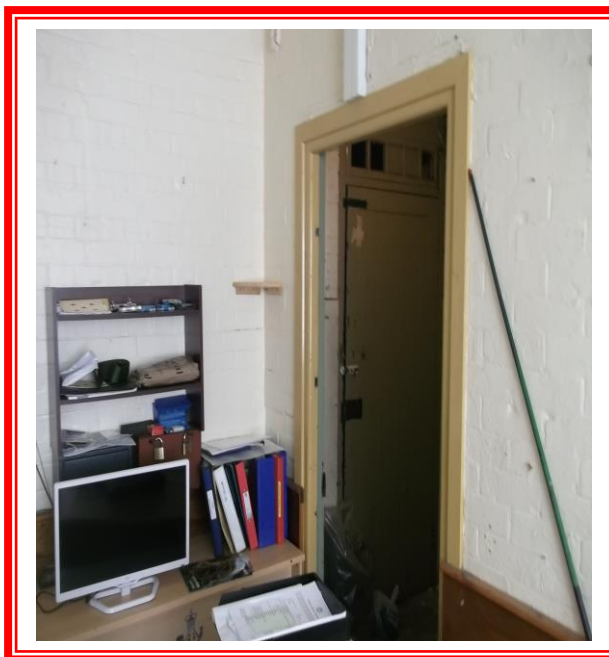
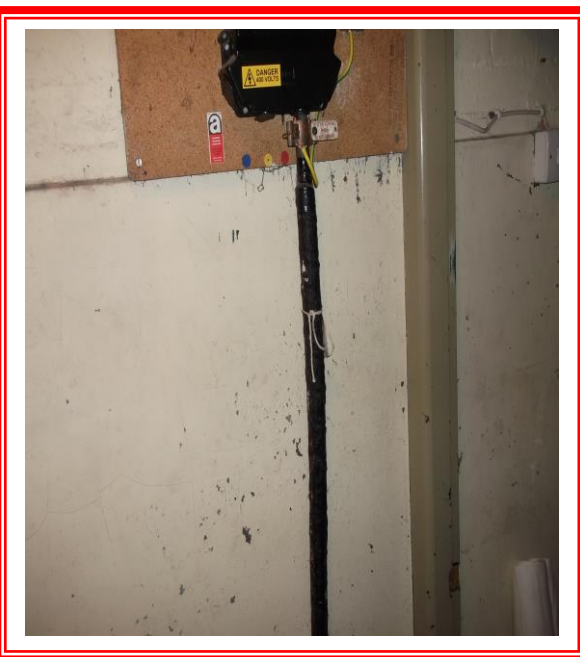
Item No: 15

Location: Ground Floor – ACF Office – Electrical/COSHH Cupboard

Material Description:	Bitumen Wrap to High Voltage Cable	
Identification:	Strongly Presumed to Contain Asbestos	
Approx. quantity:	2LM	
Accessibility	High	<i>Assessment Score</i>
Product type:	Bitumen	1
Extent of Damage:	Major	3
Surface Treatment:	Non-Friable	0
Asbestos type:	Chrysotile	1
Material Assessment Score:		5
Priority Assessment Score:		Low
Action:	Manage	
Comments:	Unable to Sample Live Electrics

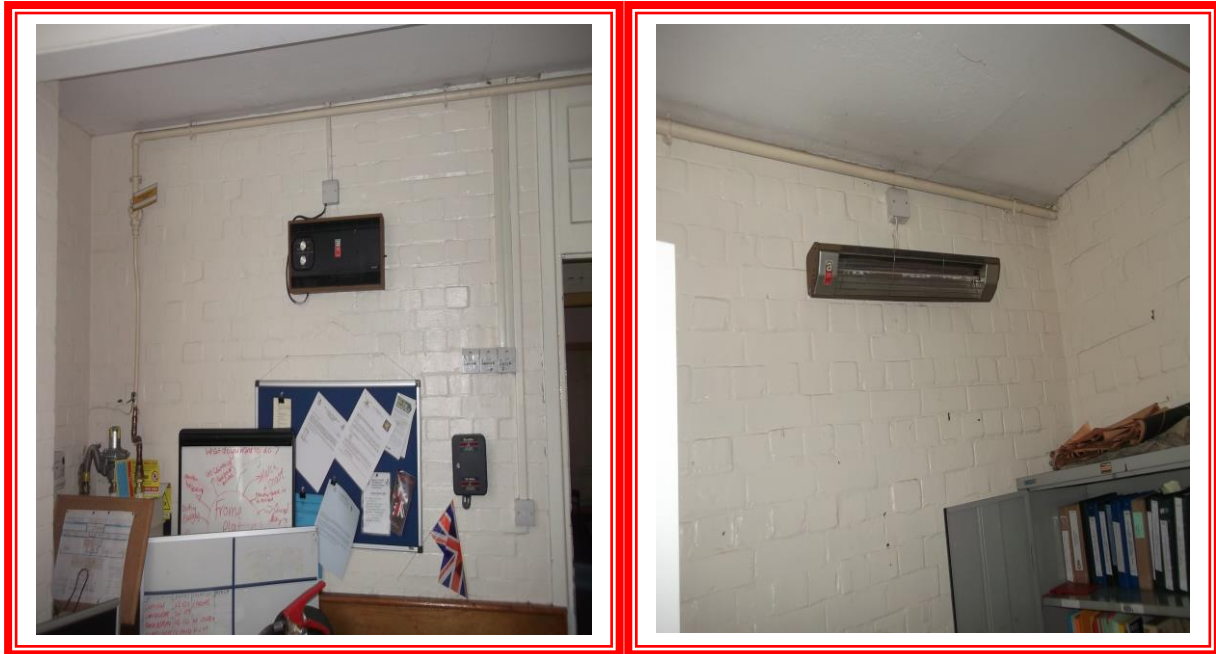
Item No: 16

Location: Ground Floor – ACF Office

Material Description:	Asbestos Products to Wall Heaters	
Identification:	Strongly Presumed to Contain Asbestos	
Approx. quantity:	X2	
Accessibility	Medium	Assessment Score
Product type:	Textile	1
Extent of Damage:	No Access	3
Surface Treatment:	Unsealed	1
Asbestos type:	Chrysotile	1
Material Assessment Score:		6
Priority Assessment Score:		Low
Action:	Manage	
Comments:	Asbestos Warning Labels Already Present. Known to contain asbestos. Unable to sample due to live electrics.

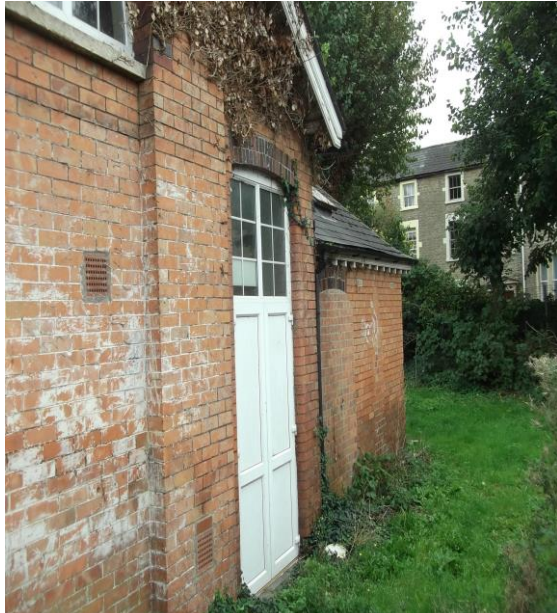
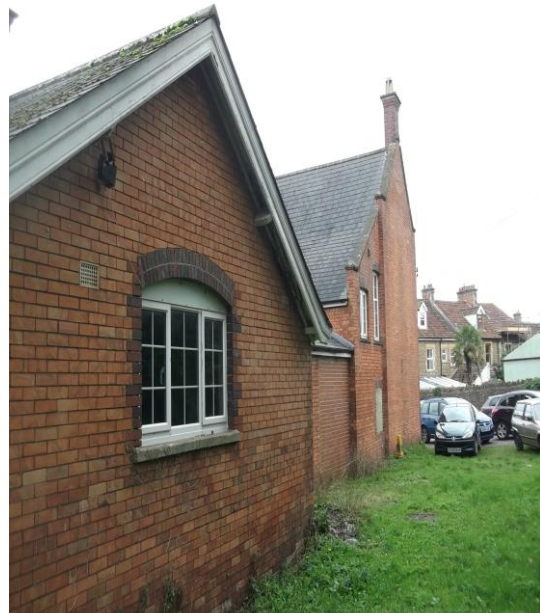
**Item No: 19****Sample No: N/A****Location: Externals**

Material Description:	Roof Tiles	
Identification:	Strongly Presumed to Contain Asbestos	
Approx. quantity:	500M2	
Accessibility	Low	Assessment Score
Product type:	Tile/Composite	1
Extent of Damage:	Moderate	2
Surface Treatment:	Non-Friable	0
Asbestos type:	Chrysotile	1
Material Assessment Score:		4
Priority Assessment Score:		Negligible
Action:	Manage	
Comments:	Unable to Sample as No Safe Roof Access - Sample Before Replacing or Working on Roof

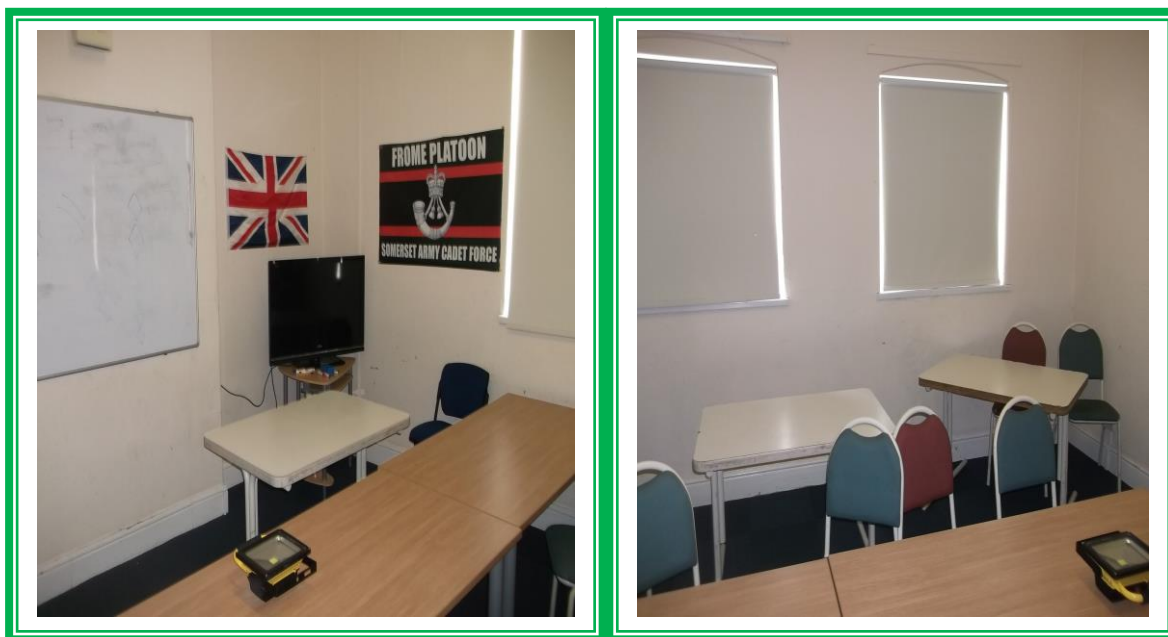
Item No: 1

Location: First Floor – Classroom 3

Material Description:	Visual Inspection – No Suspect Materials Found	
Identification:	N/A	
Approx. quantity:	N/A	
Accessibility	High	<i>Assessment Score</i>
Product type:	N/A	N/A
Extent of Damage:	N/A	N/A
Surface Treatment:	N/A	N/A
Asbestos type:	N/A	N/A
Material Assessment Score:		N/A
Priority Assessment Score:		N/A
Action:	N/A	
Comments:	N/A

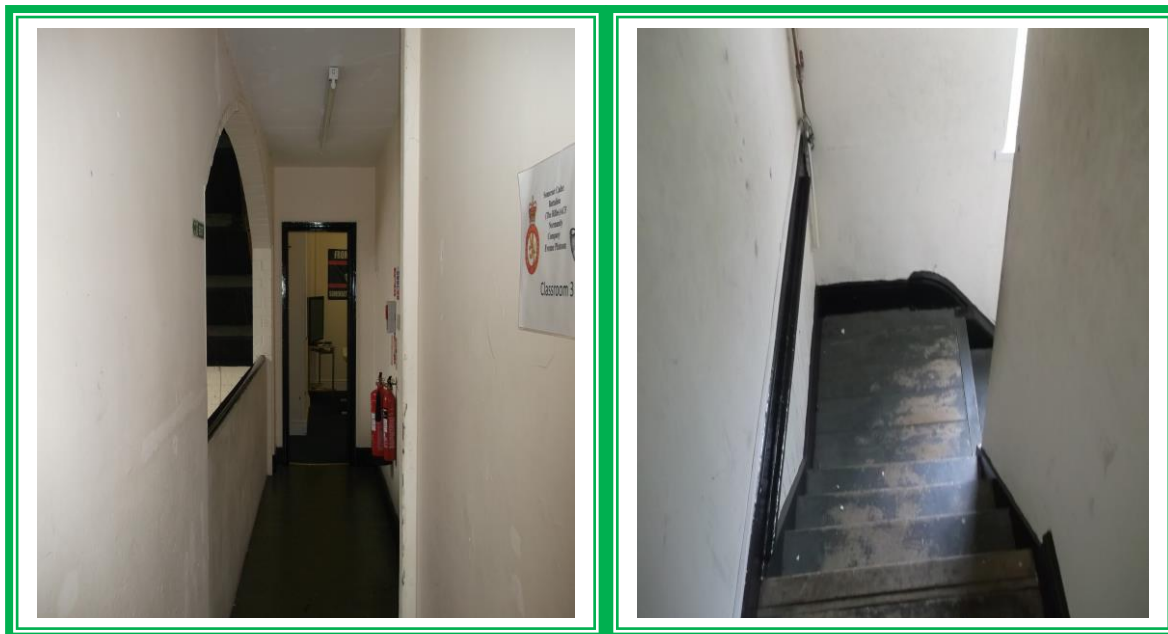
Item No: 4

Location: First Floor – Stairwell and Corridor

Material Description:	Visual Inspection – No Suspect Materials Found	
Identification:	N/A	
Approx. quantity:	N/A	
Accessibility	N/A	<i>Assessment Score</i>
Product type:	N/A	N/A
Extent of Damage:	N/A	N/A
Surface Treatment:	N/A	N/A
Asbestos type:	N/A	N/A
Material Assessment Score:		N/A
Priority Assessment Score:		N/A
Action:	N/A	
Comments:	N/A

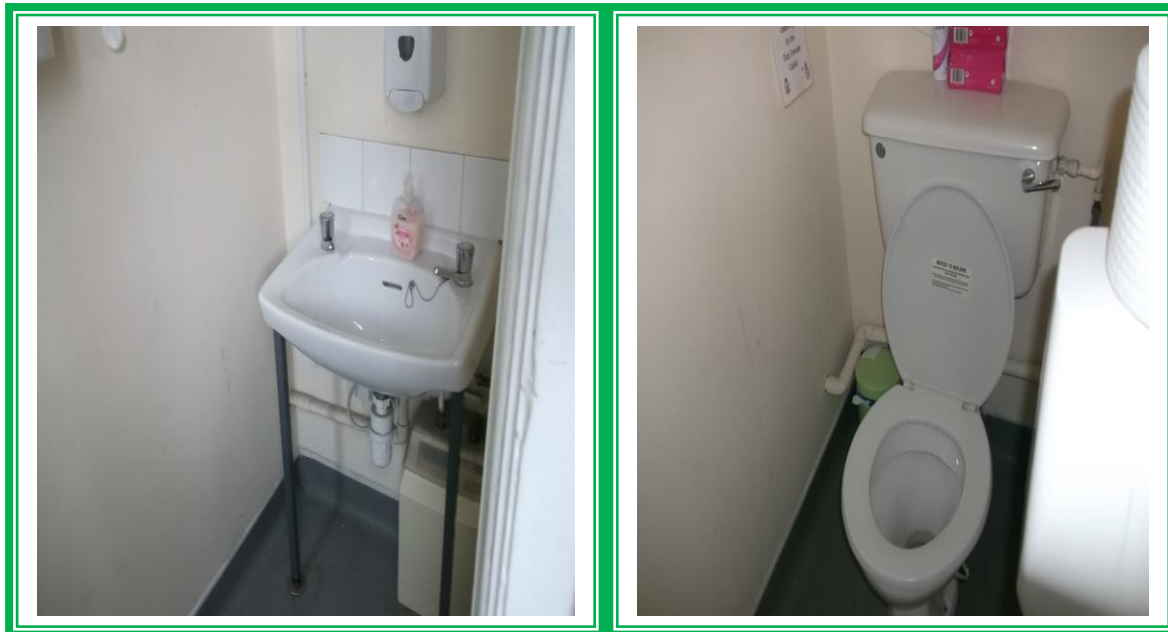
Item No: 5

Location: First Floor – Female Toilets

Material Description:	Visual Inspection – No Suspect Materials Found	
Identification:	N/A	
Approx. quantity:	N/A	
Accessibility	N/A	<i>Assessment Score</i>
Product type:	N/A	N/A
Extent of Damage:	N/A	N/A
Surface Treatment:	N/A	N/A
Asbestos type:	N/A	N/A
Material Assessment Score:		N/A
Priority Assessment Score:		N/A
Action:	N/A	
Comments:	N/A

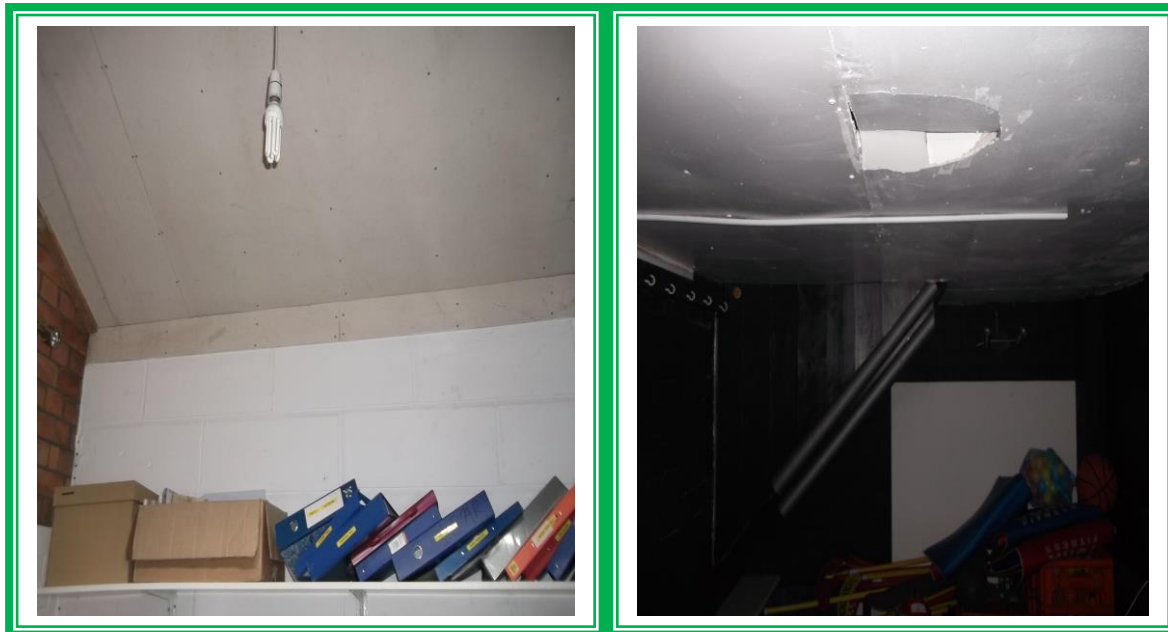
Item No: 6

Location: Ground Floor - Projects/Store

Material Description:	Visual Inspection – No Suspect Materials Found	
Identification:	N/A	
Approx. quantity:	N/A	
Accessibility	N/A	<i>Assessment Score</i>
Product type:	N/A	N/A
Extent of Damage:	N/A	N/A
Surface Treatment:	N/A	N/A
Asbestos type:	N/A	N/A
Material Assessment Score:		N/A
Priority Assessment Score:		N/A
Action:	N/A	
Comments:	Superlux Panel to Ceiling, Damaged Superflux Panel to "Black Room"

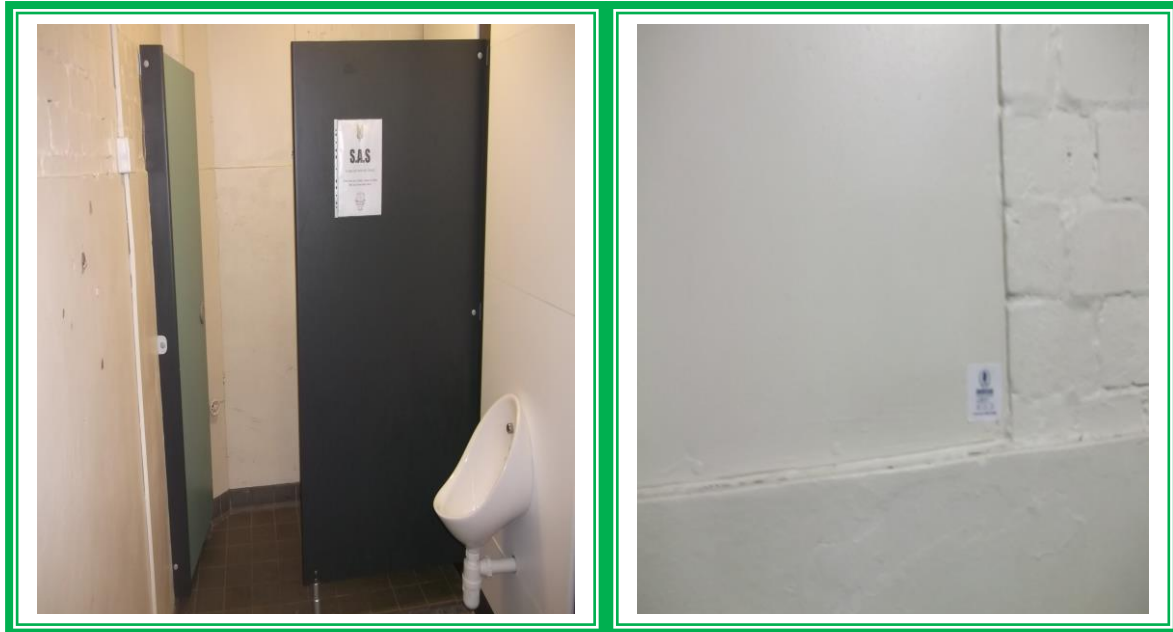
Item No: 7

Location: Ground Floor – Male Toilets

Material Description:	Insulating Board Panel to Wall	
Identification:	Sampled – No Asbestos Detected	
Approx. quantity:	1M2	
Accessibility	N/A	<i>Assessment Score</i>
Product type:	N/A	N/A
Extent of Damage:	N/A	N/A
Surface Treatment:	N/A	N/A
Asbestos type:	N/A	N/A
Material Assessment Score:		N/A
Priority Assessment Score:		N/A
Action:	N/A	
Comments:	N/A

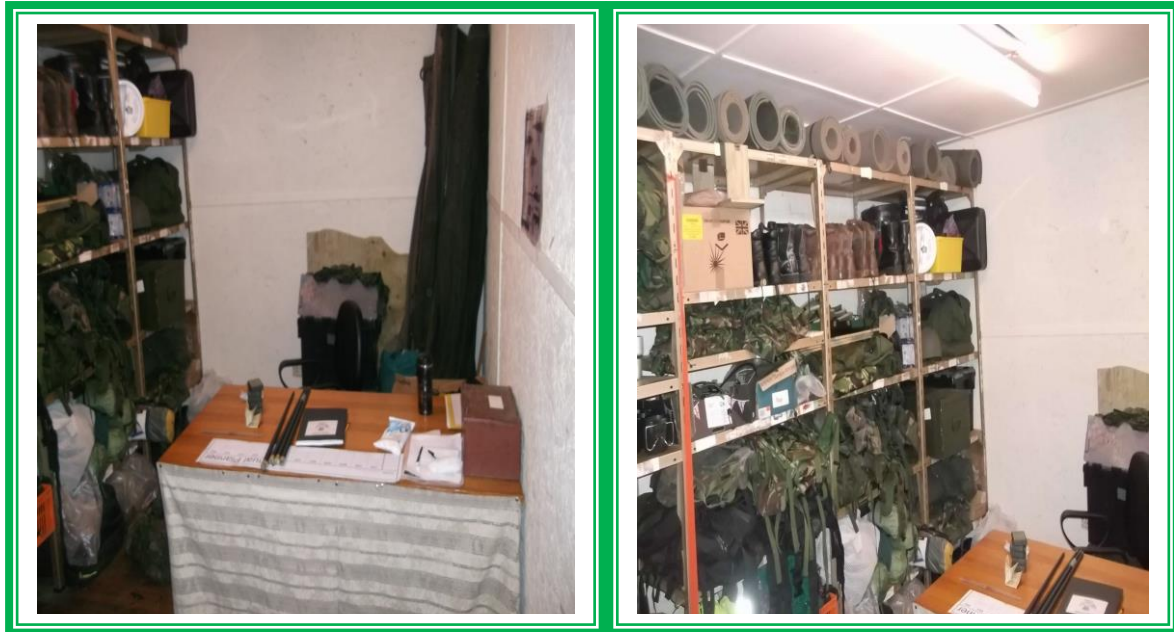
Item No: 10

Location: Ground Floor – Bergan Store

Material Description:	Visual Inspection – No Suspect Materials Found	
Identification:	N/A	
Approx. quantity:	N/A	
Accessibility	N/A	<i>Assessment Score</i>
Product type:	N/A	N/A
Extent of Damage:	N/A	N/A
Surface Treatment:	N/A	N/A
Asbestos type:	N/A	N/A
Material Assessment Score:		N/A
Priority Assessment Score:		N/A
Action:	N/A	
Comments:	Plasterboard Ceilings, Ply Walls and Brick

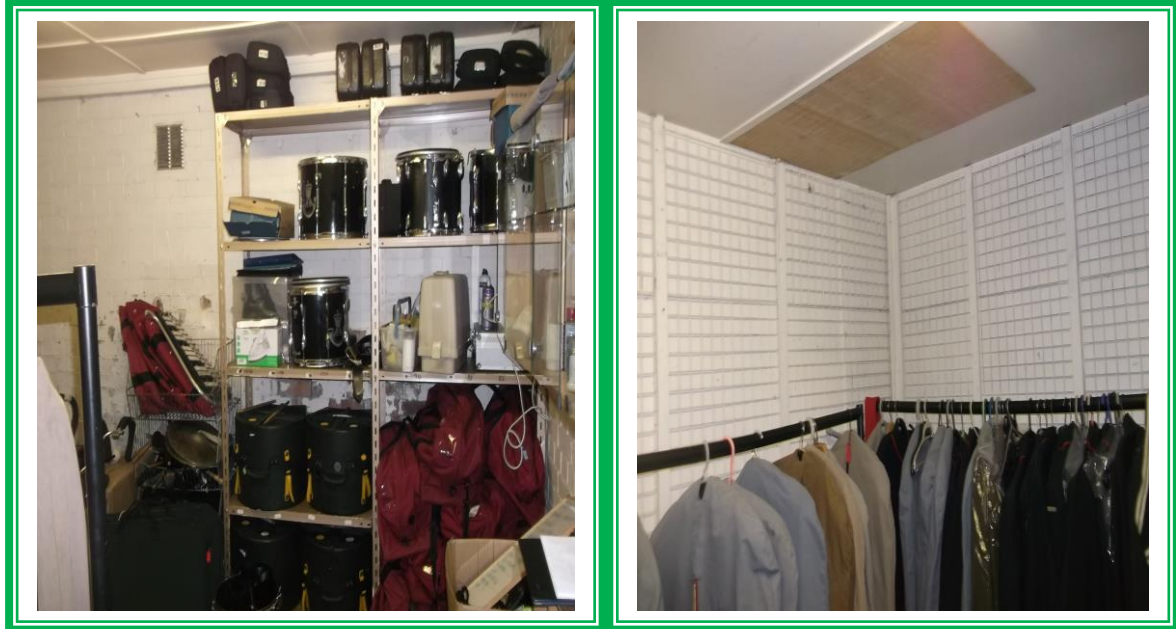
Item No: 11

Location: Ground Floor – Band Store

Material Description:	Visual Inspection – No Suspect Materials Found	
Identification:	N/A	
Approx. quantity:	N/A	
Accessibility	N/A	<i>Assessment Score</i>
Product type:	N/A	N/A
Extent of Damage:	N/A	N/A
Surface Treatment:	N/A	N/A
Asbestos type:	N/A	N/A
Material Assessment Score:		N/A
Priority Assessment Score:		N/A
Action:	N/A	
Comments:	Plasterboard Ceiling

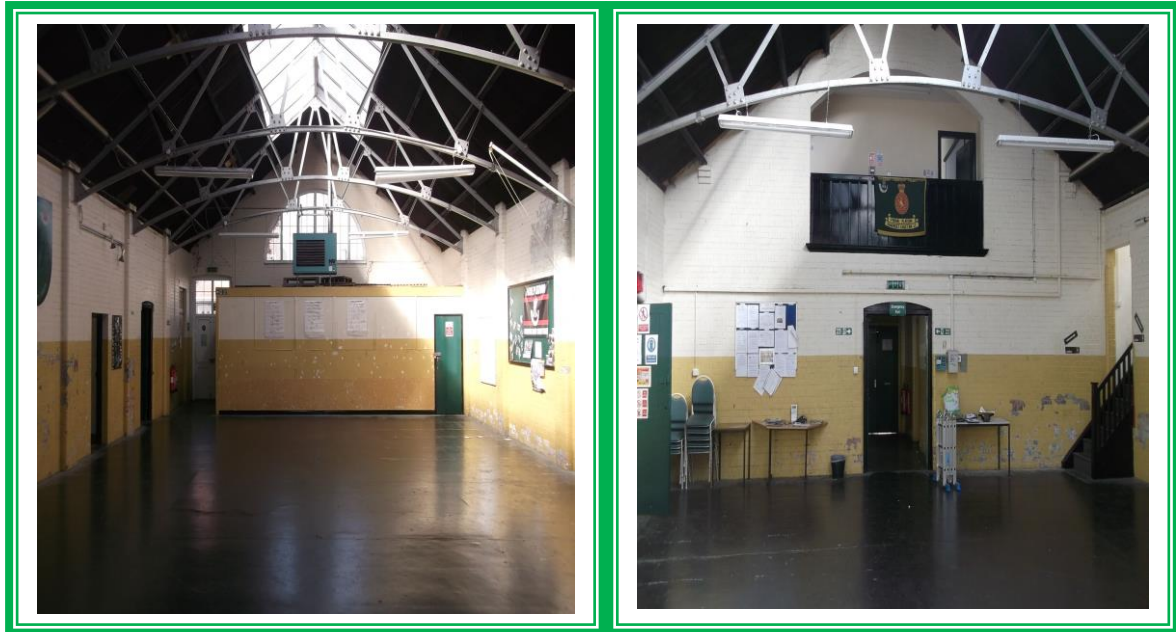
Item No: 12

Location: Ground Floor – Main Drill Hall

Material Description:	Visual Inspection – No Suspect Materials Found	
Identification:	N/A	
Approx. quantity:	N/A	
Accessibility	N/A	<i>Assessment Score</i>
Product type:	N/A	N/A
Extent of Damage:	N/A	N/A
Surface Treatment:	N/A	N/A
Asbestos type:	N/A	N/A
Material Assessment Score:		N/A
Priority Assessment Score:		N/A
Action:	N/A	
Comments:	Heater Checked - No Asbestos Identified on Visual Inspection

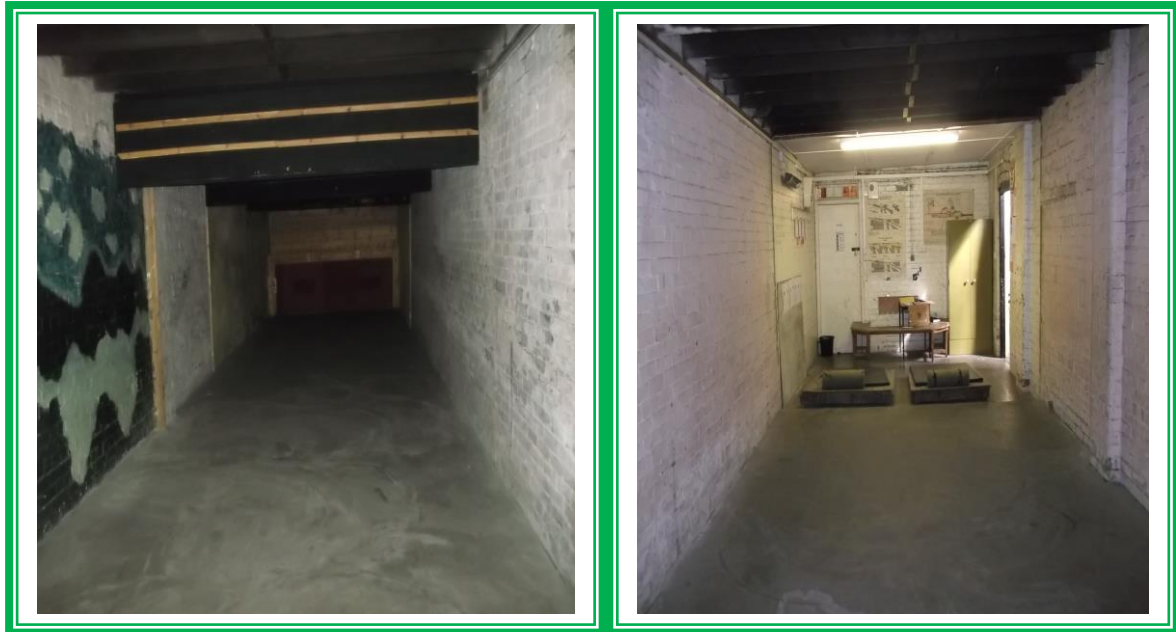
Item No: 13

Location: Ground Floor – Indoor Range

Material Description:	Visual Inspection – No Suspect Materials Found	
Identification:	N/A	
Approx. quantity:	N/A	
Accessibility	N/A	<i>Assessment Score</i>
Product type:	N/A	N/A
Extent of Damage:	N/A	N/A
Surface Treatment:	N/A	N/A
Asbestos type:	N/A	N/A
Material Assessment Score:		N/A
Priority Assessment Score:		N/A
Action:	N/A	
Comments:	N/A

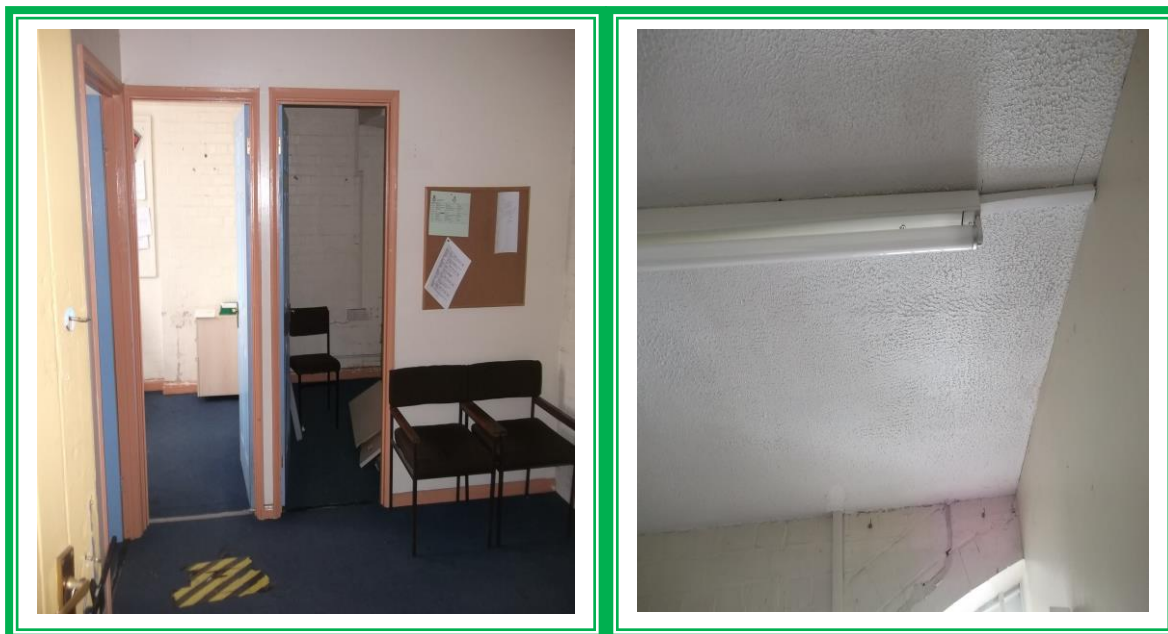
Item No: 17

Location: Ground Floor – ATC Office, Training Room, 2ic's Office and CO Office

Material Description:	Textured Coating to Ceiling	
Identification:	Sampled – No Asbestos Detected	
Approx. quantity:	50M2	
Accessibility	N/A	<i>Assessment Score</i>
Product type:	N/A	N/A
Extent of Damage:	N/A	N/A
Surface Treatment:	N/A	N/A
Asbestos type:	N/A	N/A
Material Assessment Score:		N/A
Priority Assessment Score:		N/A
Action:	N/A	
Comments:	Repair and Then Manage

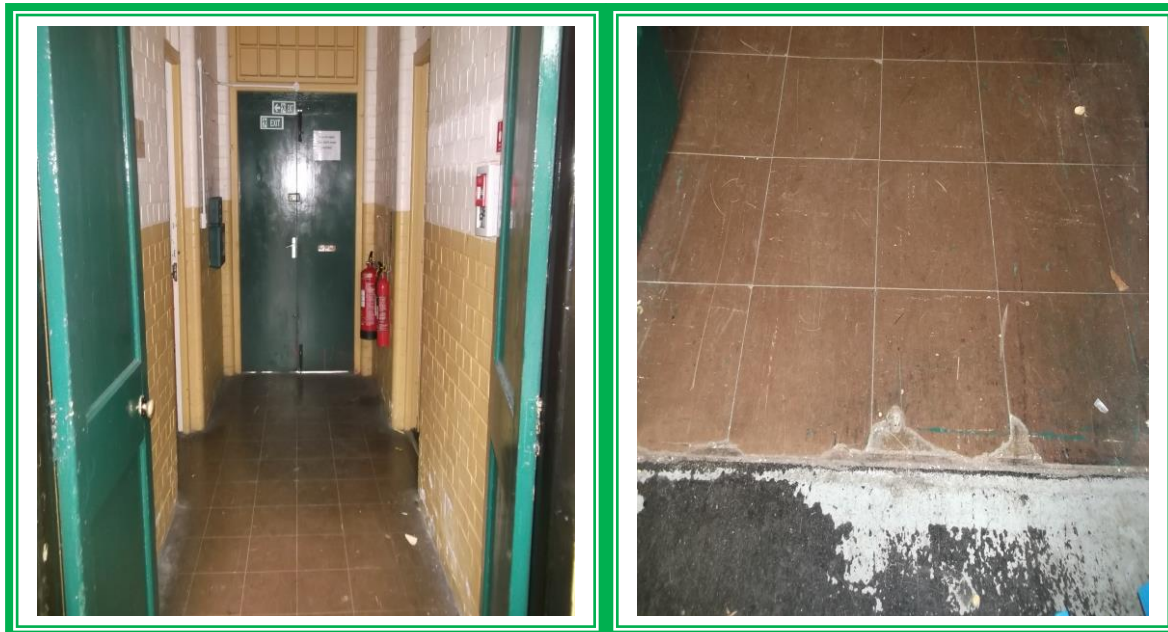
Item No: 18

Location: Ground Floor – Lobby

Material Description:	Floor Tiles and Adhesive	
Identification:	Sampled – No Asbestos Detected	
Approx. quantity:	8M2	
Accessibility	N/A	<i>Assessment Score</i>
Product type:	N/A	N/A
Extent of Damage:	N/A	N/A
Surface Treatment:	N/A	N/A
Asbestos type:	N/A	N/A
Material Assessment Score:		N/A
Priority Assessment Score:		N/A
Action:	N/A	
Comments:	Major Damage to Tile Edges Near Drill Hall
