**Project Number 2481**

**Management  
Asbestos Survey Report**

**Lytchett Matravers ACF Centre, High Street,  
Lytchett Matravers, Dorset, BH16 6BJ**

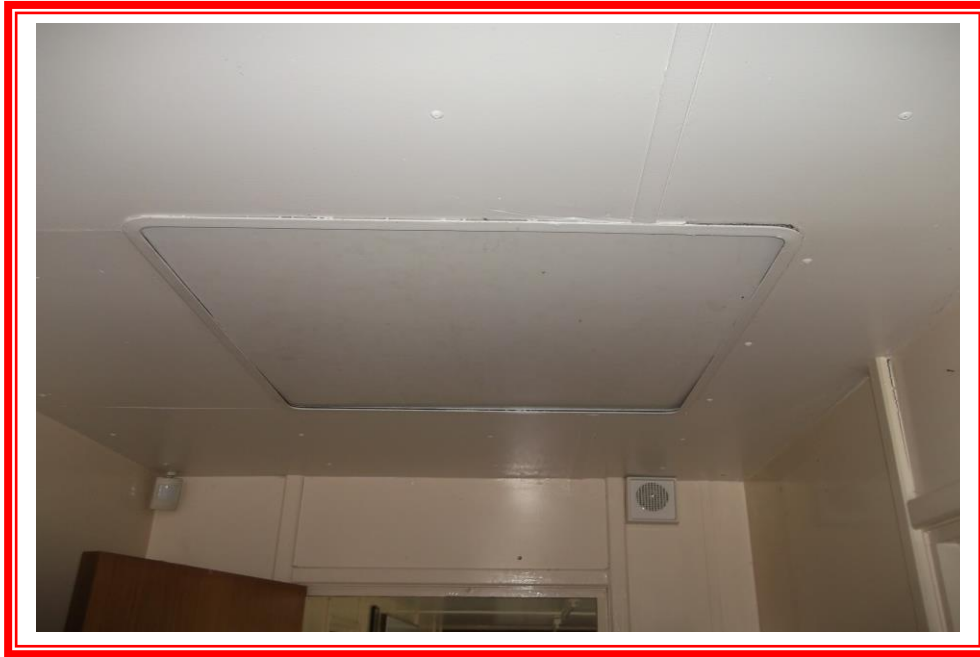
**Item No: 14**

### **Item 14 – Attic Space – No Access**

The presence of asbestos in these areas cannot be ascertained at this time. If any works are to be carried out in these areas in the future, then these works should be approached cautiously.

**Location: Attic Space**

<b>Material Description:</b>	No Access	
<b>Identification:</b>	Presumed to Contain Asbestos	
<b>Approx. quantity:</b>	Unknown	
<b>Accessibility</b>	Low	<i>Assessment Score</i>
<b>Product type:</b>	No Access	2
<b>Extent of Damage:</b>	No Access	3
<b>Surface Treatment:</b>	No Access	2
<b>Asbestos type:</b>	No Access	2
<b>Material Assessment Score:</b>		9
<b>Priority Assessment Score:</b>		Medium
<b>Action:</b>	Manage	
<b>Comments:</b>	Further Investigation Required

In accordance with current legislation, any suspect materials encountered in these areas are to be assumed to contain asbestos until proven otherwise. This will normally involve cessation of works in the affected area.

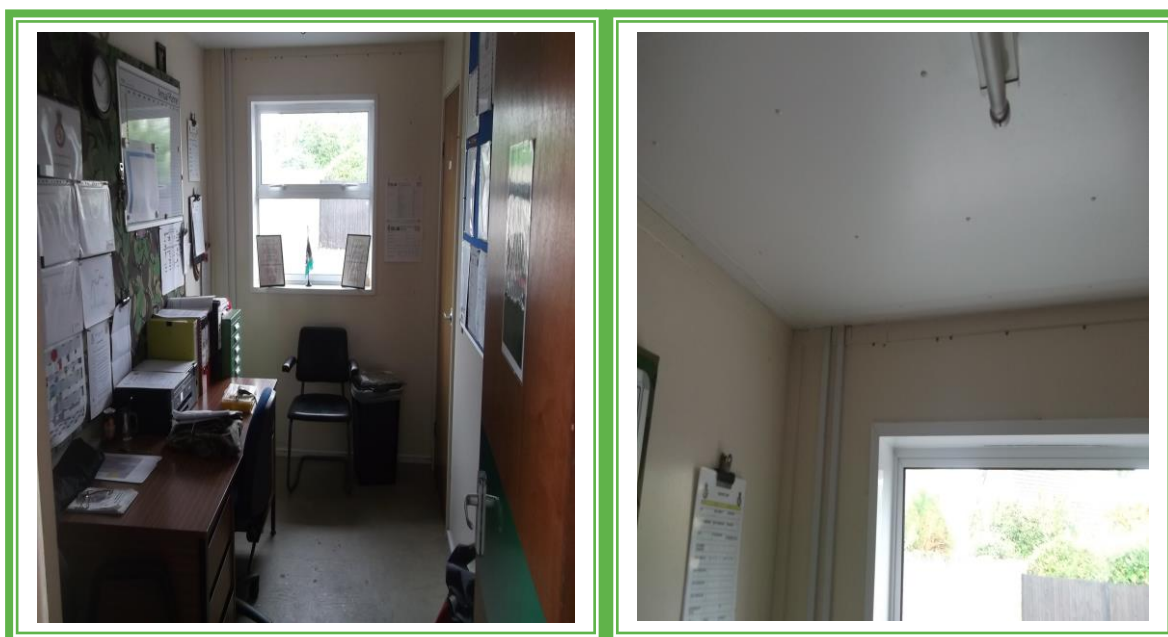
**Item No: 1**

<b>Material Description:</b>	Visual Inspection – No Suspect Materials Found	
<b>Identification:</b>	N/A	
<b>Approx. quantity:</b>	N/A	
<b>Accessibility</b>	N/A	<i>Assessment Score</i>
<b>Product type:</b>		N/A
<b>Extent of Damage:</b>		N/A
<b>Surface Treatment:</b>		N/A
<b>Asbestos type:</b>		N/A
<b>Material Assessment Score:</b>		N/A
<b>Priority Assessment Score:</b>		N/A
<b>Action:</b>	N/A	
<b>Comments:</b>	N/A

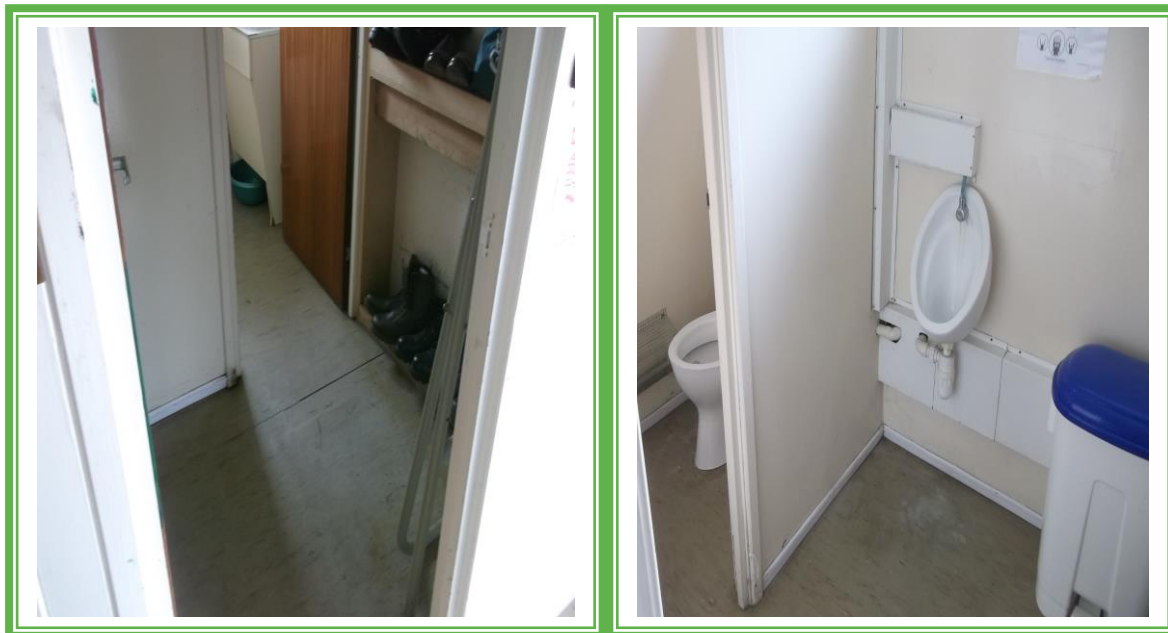
**Item No: 2****Sample No: N/A****Location: Male Toilets**

<b>Material Description:</b>	Visual Inspection – No Suspect Materials Found	
<b>Identification:</b>	N/A	
<b>Approx. quantity:</b>	N/A	
<b>Accessibility</b>	N/A	<i>Assessment Score</i>
<b>Product type:</b>		N/A
<b>Extent of Damage:</b>		N/A
<b>Surface Treatment:</b>		N/A
<b>Asbestos type:</b>		N/A
<b>Material Assessment Score:</b>		N/A
<b>Priority Assessment Score:</b>		N/A
<b>Action:</b>	N/A	
<b>Comments:</b>	N/A

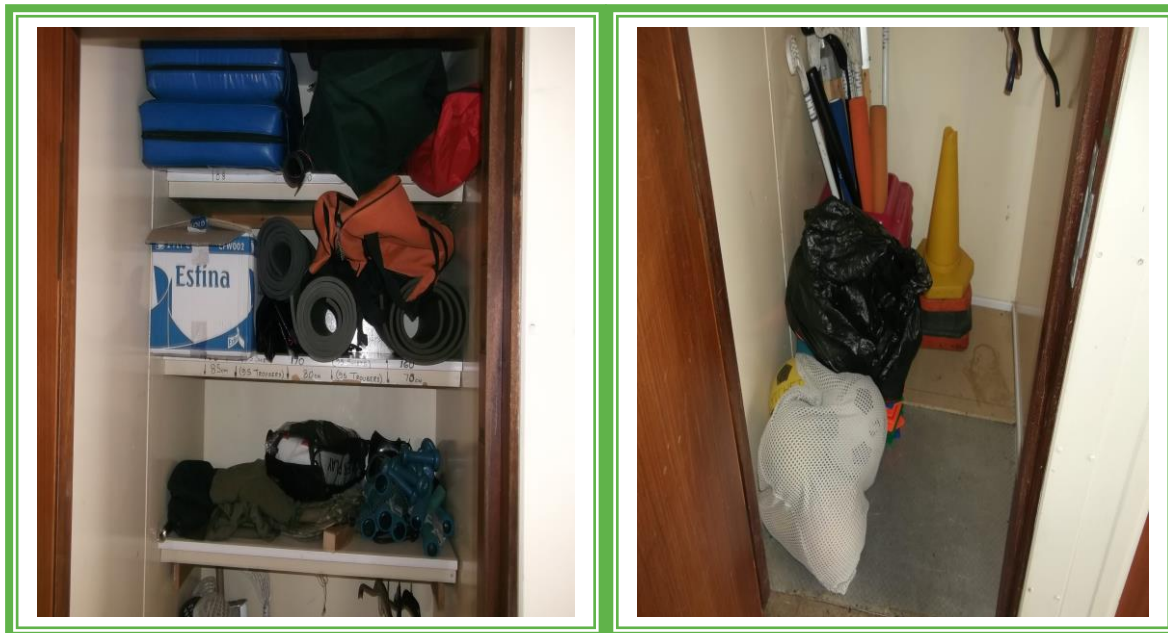
**Item No: 3****Sample No: N/A****Location: Store Room**

<b>Material Description:</b>	Visual Inspection – No Suspect Materials Found	
<b>Identification:</b>	N/A	
<b>Approx. quantity:</b>	N/A	
<b>Accessibility</b>	N/A	<i>Assessment Score</i>
<b>Product type:</b>		N/A
<b>Extent of Damage:</b>		N/A
<b>Surface Treatment:</b>		N/A
<b>Asbestos type:</b>		N/A
<b>Material Assessment Score:</b>		N/A
<b>Priority Assessment Score:</b>		N/A
<b>Action:</b>	N/A	
<b>Comments:</b>	N/A

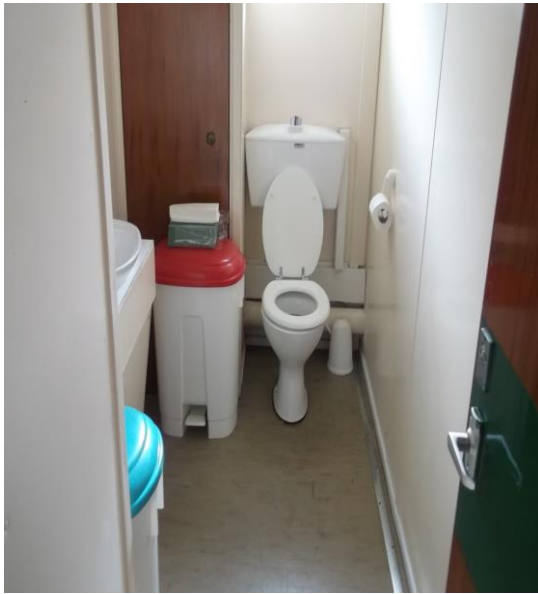
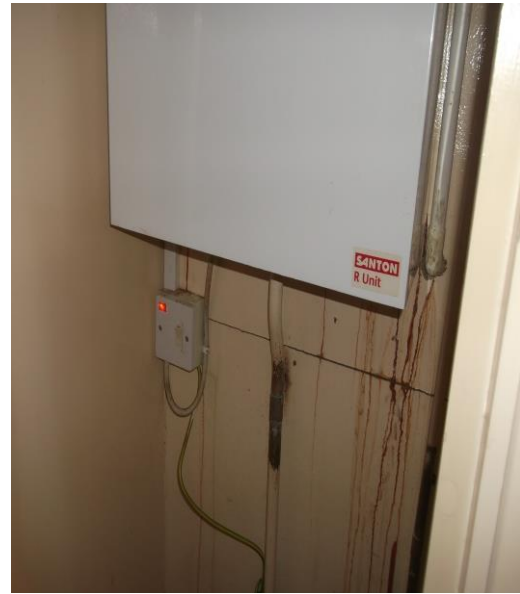
**Item No: 4**

<b>Material Description:</b>	Visual Inspection – No Suspect Materials Found	
<b>Identification:</b>	N/A	
<b>Approx. quantity:</b>	N/A	
<b>Accessibility</b>	N/A	<i>Assessment Score</i>
<b>Product type:</b>		N/A
<b>Extent of Damage:</b>		N/A
<b>Surface Treatment:</b>		N/A
<b>Asbestos type:</b>		N/A
<b>Material Assessment Score:</b>		N/A
<b>Priority Assessment Score:</b>		N/A
<b>Action:</b>	N/A	
<b>Comments:</b>	N/A

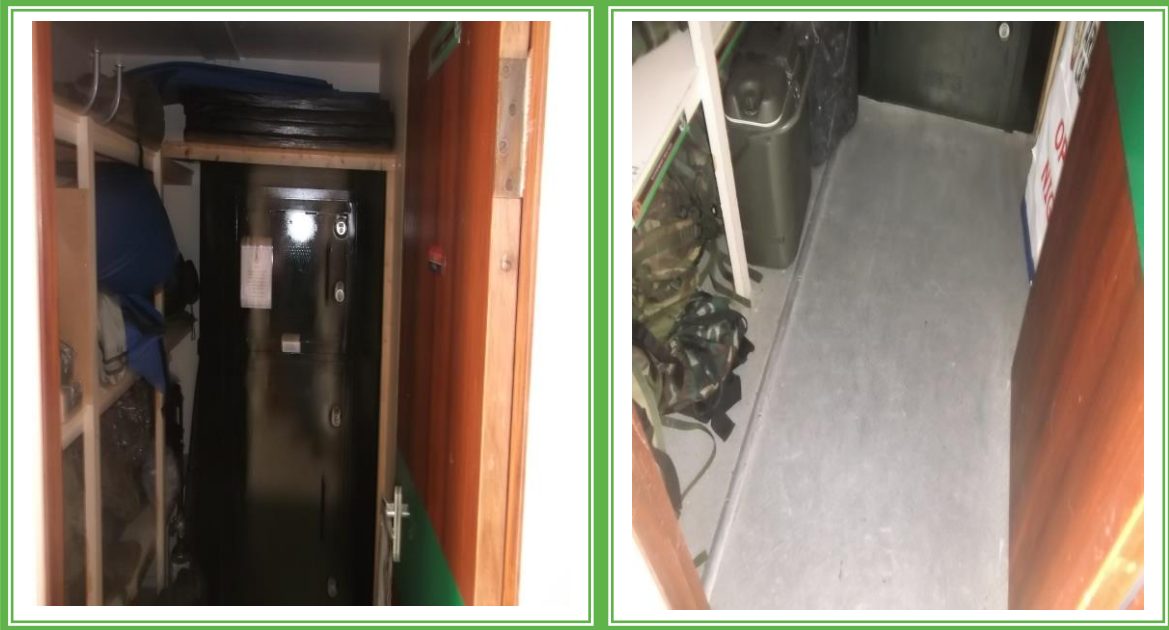
**Item No: 5****Sample No: N/A****Location: Stores**

<b>Material Description:</b>	Visual Inspection – No Suspect Materials Found	
<b>Identification:</b>	N/A	
<b>Approx. quantity:</b>	N/A	
<b>Accessibility</b>	N/A	<i>Assessment Score</i>
<b>Product type:</b>		N/A
<b>Extent of Damage:</b>		N/A
<b>Surface Treatment:</b>		N/A
<b>Asbestos type:</b>		N/A
<b>Material Assessment Score:</b>		N/A
<b>Priority Assessment Score:</b>		N/A
<b>Action:</b>	N/A	
<b>Comments:</b>	N/A

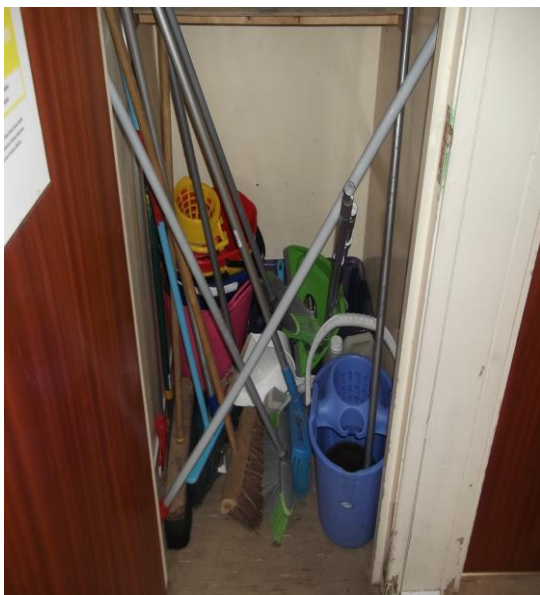
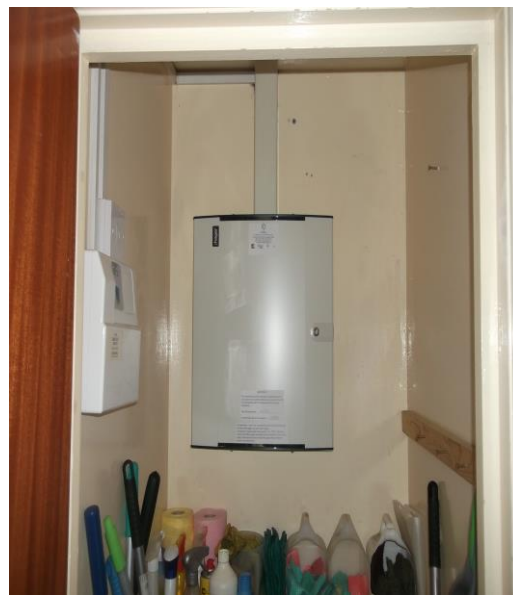
**Item No: 6**

<b>Material Description:</b>	Visual Inspection – No Suspect Materials Found	
<b>Identification:</b>	N/A	
<b>Approx. quantity:</b>	N/A	
<b>Accessibility</b>	N/A	<i>Assessment Score</i>
<b>Product type:</b>		N/A
<b>Extent of Damage:</b>		N/A
<b>Surface Treatment:</b>		N/A
<b>Asbestos type:</b>		N/A
<b>Material Assessment Score:</b>		N/A
<b>Priority Assessment Score:</b>		N/A
<b>Action:</b>	N/A	
<b>Comments:</b>	N/A

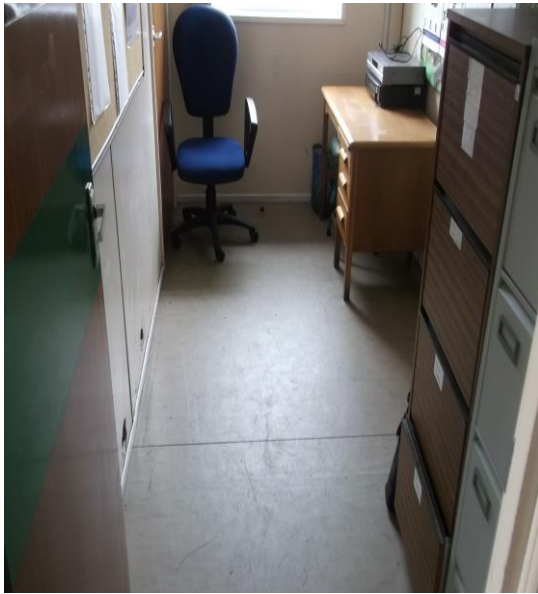
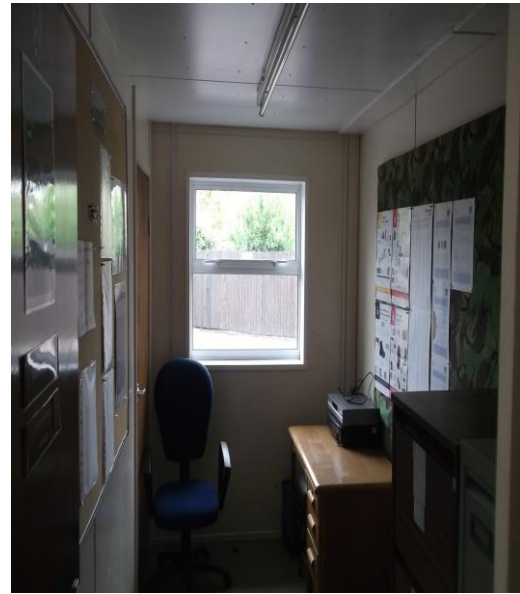
**Item No: 7**

<b>Material Description:</b>	Visual Inspection – No Suspect Materials Found	
<b>Identification:</b>	N/A	
<b>Approx. quantity:</b>	N/A	
<b>Accessibility</b>	N/A	<i>Assessment Score</i>
<b>Product type:</b>		N/A
<b>Extent of Damage:</b>		N/A
<b>Surface Treatment:</b>		N/A
<b>Asbestos type:</b>		N/A
<b>Material Assessment Score:</b>		N/A
<b>Priority Assessment Score:</b>		N/A
<b>Action:</b>	N/A	
<b>Comments:</b>	N/A

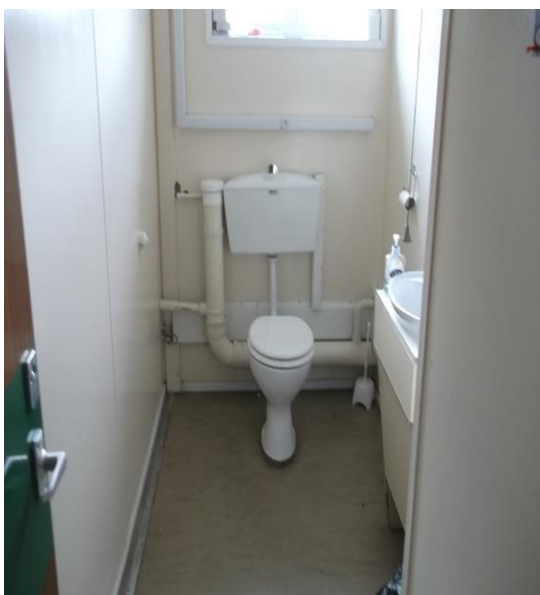
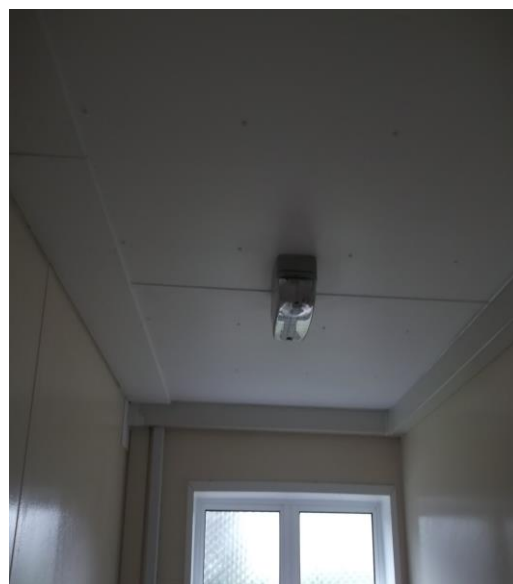
**Item No: 8****Sample No: N/A****Location: Adult Toilets**

<b>Material Description:</b>	Visual Inspection – No Suspect Materials Found	
<b>Identification:</b>	N/A	
<b>Approx. quantity:</b>	N/A	
<b>Accessibility</b>	N/A	<i>Assessment Score</i>
<b>Product type:</b>		N/A
<b>Extent of Damage:</b>		N/A
<b>Surface Treatment:</b>		N/A
<b>Asbestos type:</b>		N/A
<b>Material Assessment Score:</b>		N/A
<b>Priority Assessment Score:</b>		N/A
<b>Action:</b>	N/A	
<b>Comments:</b>	N/A

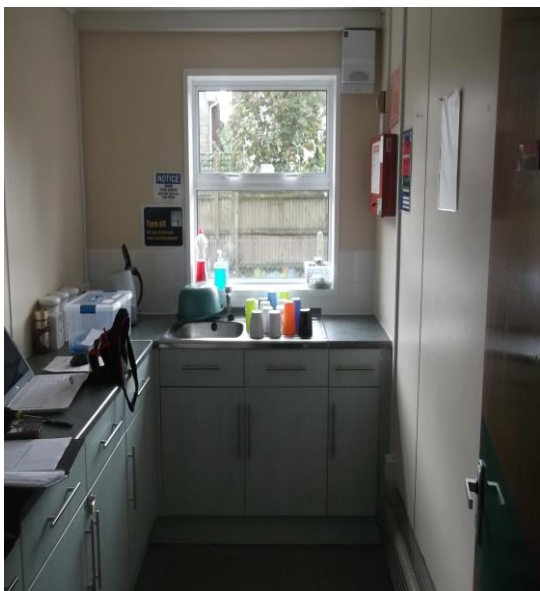
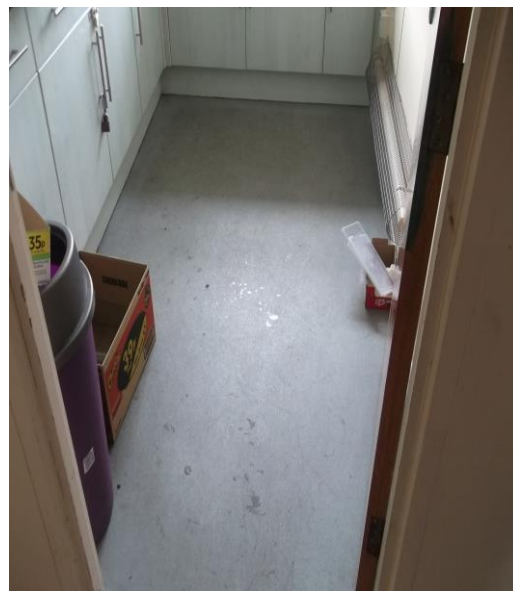
**Item No: 9****Sample No: N/A****Location: Canteen/Kitchen**

<b>Material Description:</b>	Visual Inspection – No Suspect Materials Found	
<b>Identification:</b>	N/A	
<b>Approx. quantity:</b>	N/A	
<b>Accessibility</b>	N/A	<i>Assessment Score</i>
<b>Product type:</b>		N/A
<b>Extent of Damage:</b>		N/A
<b>Surface Treatment:</b>		N/A
<b>Asbestos type:</b>		N/A
<b>Material Assessment Score:</b>		N/A
<b>Priority Assessment Score:</b>		N/A
<b>Action:</b>	N/A	
<b>Comments:</b>	N/A

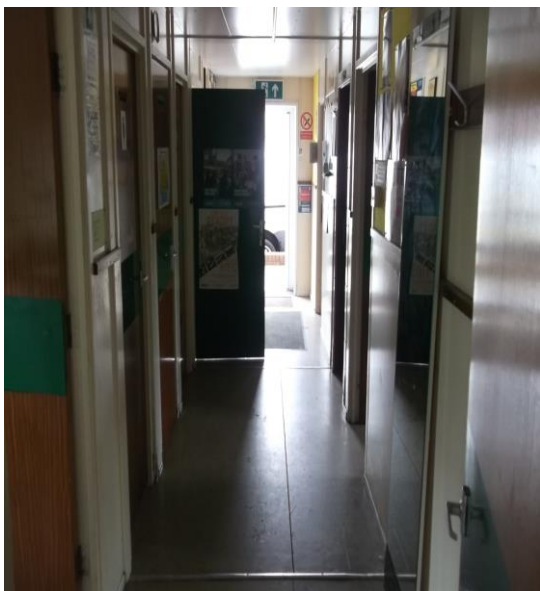
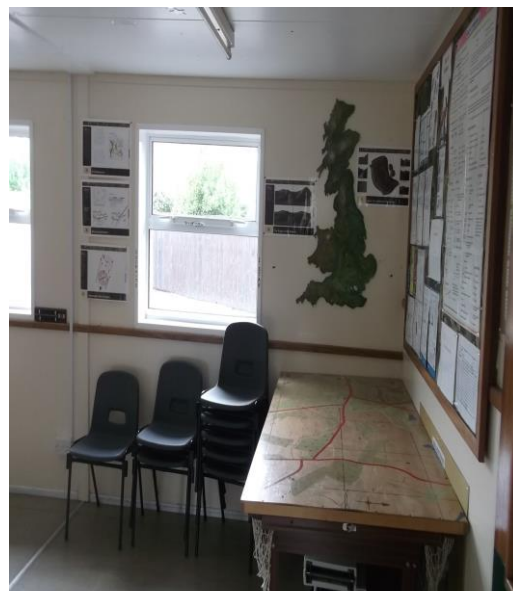
**Item No: 10**

<b>Material Description:</b>	Visual Inspection – No Suspect Materials Found	
<b>Identification:</b>	N/A	
<b>Approx. quantity:</b>	N/A	
<b>Accessibility</b>	N/A	<i>Assessment Score</i>
<b>Product type:</b>		N/A
<b>Extent of Damage:</b>		N/A
<b>Surface Treatment:</b>		N/A
<b>Asbestos type:</b>		N/A
<b>Material Assessment Score:</b>		N/A
<b>Priority Assessment Score:</b>		N/A
<b>Action:</b>	N/A	
<b>Comments:</b>	N/A

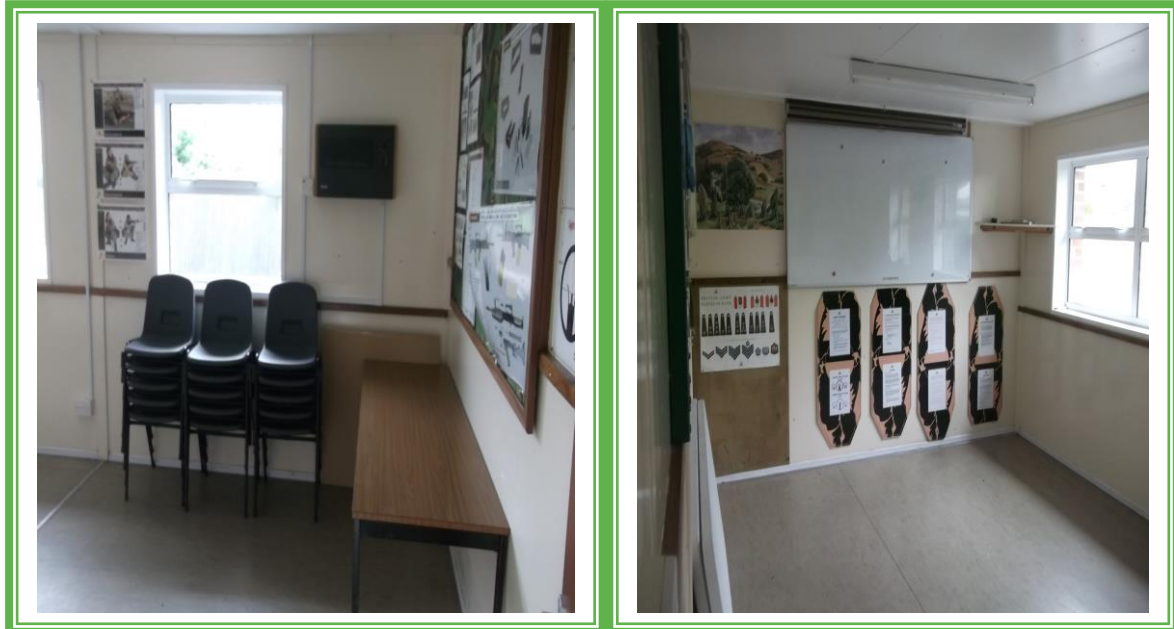
**Item No: 11****Sample No: N/A****Location: Lecture Room 2**

<b>Material Description:</b>	Visual Inspection – No Suspect Materials Found	
<b>Identification:</b>	N/A	
<b>Approx. quantity:</b>	N/A	
<b>Accessibility</b>	N/A	<i>Assessment Score</i>
<b>Product type:</b>		N/A
<b>Extent of Damage:</b>		N/A
<b>Surface Treatment:</b>		N/A
<b>Asbestos type:</b>		N/A
<b>Material Assessment Score:</b>		N/A
<b>Priority Assessment Score:</b>		N/A
<b>Action:</b>	N/A	
<b>Comments:</b>	N/A

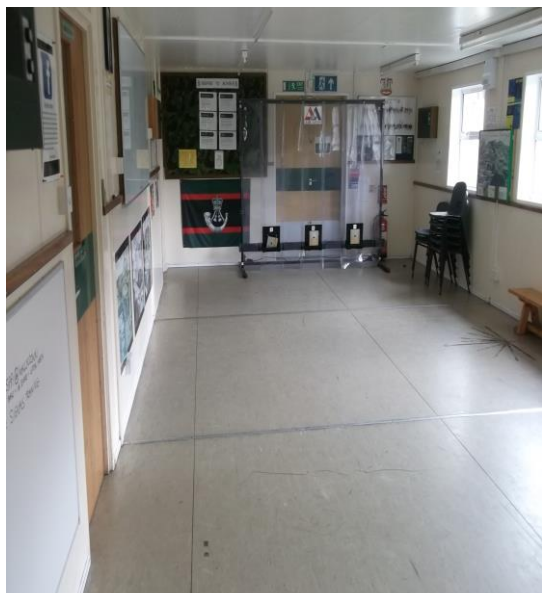
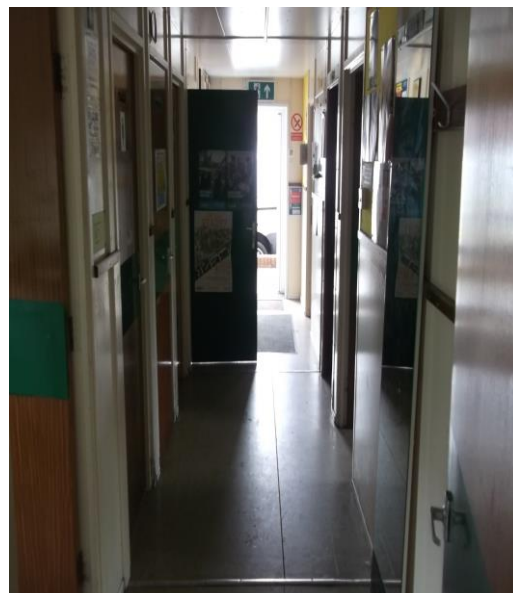
**Item No: 12****Sample No: N/A****Location: Main Hall and Corridor**

<b>Material Description:</b>	Visual Inspection – No Suspect Materials Found	
<b>Identification:</b>	N/A	
<b>Approx. quantity:</b>	N/A	
<b>Accessibility</b>	N/A	<i>Assessment Score</i>
<b>Product type:</b>		N/A
<b>Extent of Damage:</b>		N/A
<b>Surface Treatment:</b>		N/A
<b>Asbestos type:</b>		N/A
<b>Material Assessment Score:</b>		N/A
<b>Priority Assessment Score:</b>		N/A
<b>Action:</b>	N/A	
<b>Comments:</b>	N/A

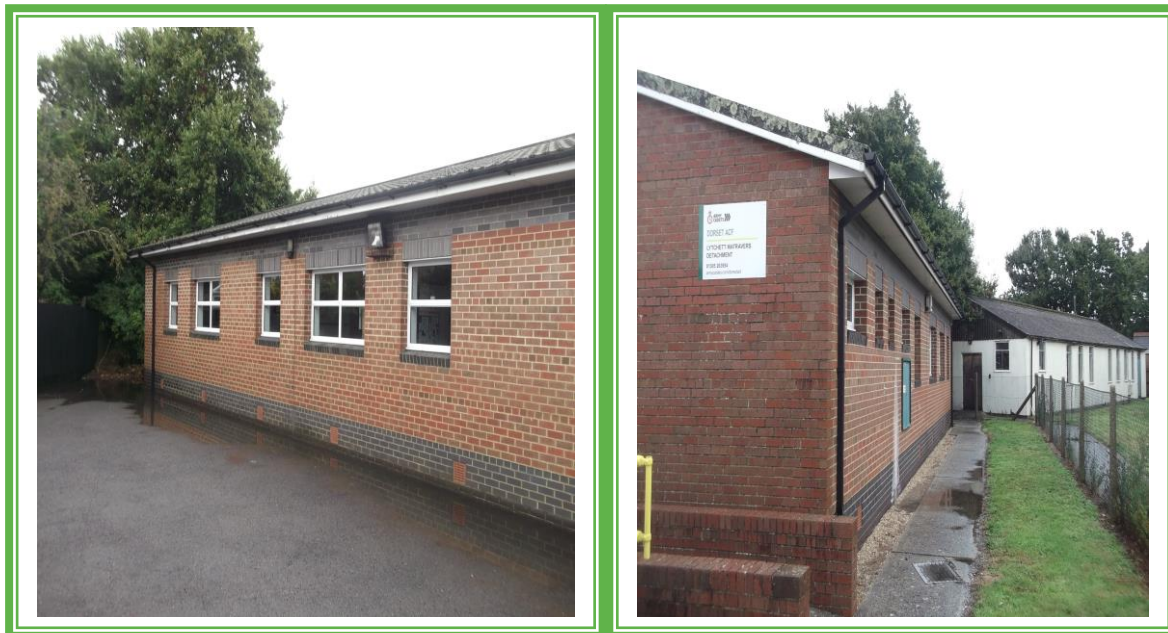
## Item No: 13

<b>Material Description:</b>	Visual Inspection – No Suspect Materials Found	
<b>Identification:</b>	N/A	
<b>Approx. quantity:</b>	N/A	
<b>Accessibility</b>	N/A	<i>Assessment Score</i>
<b>Product type:</b>		N/A
<b>Extent of Damage:</b>		N/A
<b>Surface Treatment:</b>		N/A
<b>Asbestos type:</b>		N/A
<b>Material Assessment Score:</b>		N/A
<b>Priority Assessment Score:</b>		N/A
<b>Action:</b>	N/A	
<b>Comments:</b>	N/A
