Project Number A-00571 (3700)

**Re-Inspection
Asbestos Survey Report**

**Midsomer Norton Platoon
115 High Street
BA3 2DA**

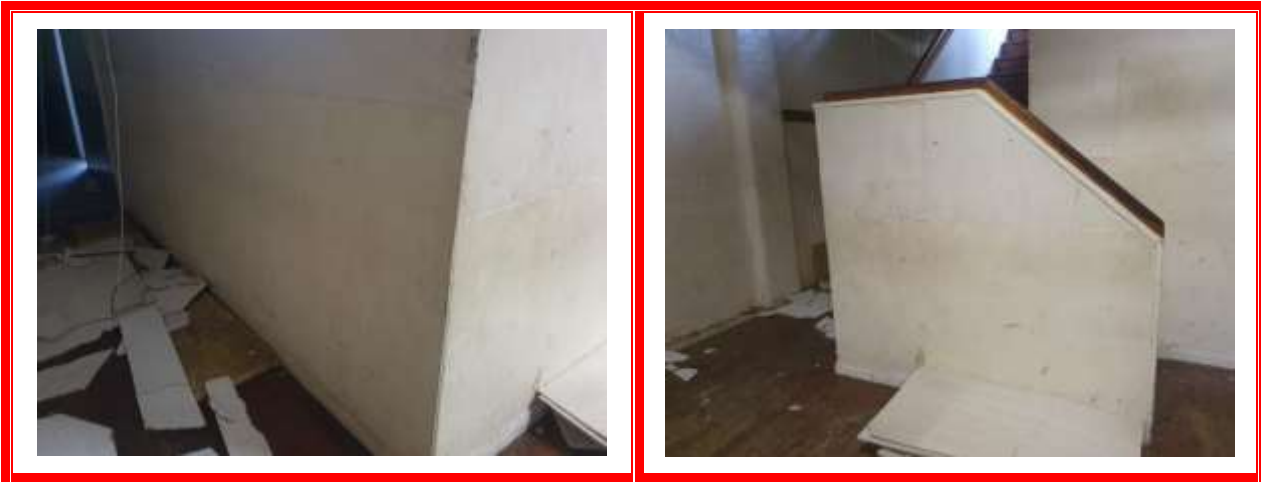
Item No:	3	Sample No:	N/A
Location:	Ground Floor - Void under Stairs 003

Material Description:	All - No Access Gained	
Identification:	Presumed to Contain Asbestos	
Approx. quantity:	1 no	
Accessibility	Difficult	Assessment Score
Product type:	Pipe Insulation	3
Extent of Damage:	Major damage	3
Surface Treatment:	Unsealed Insulation	3
Asbestos type:	Amosite, Chrysotile, Crocidolite	3
Material Assessment Score:		12
Priority Assessment Score:		High
Action:	Further Investigation Needed	
Comments:	No door or access hatch to void

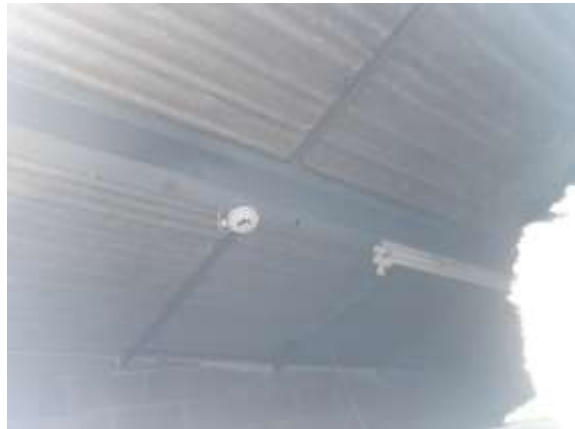
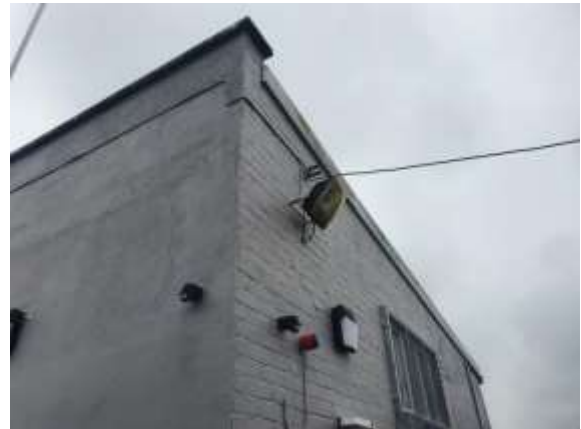
Location: Ground Floor - Garages 004

Material Description:	Profiled Roof - Cement Product	
Identification:	Strongly Presumed to Contain Asbestos	
Approx. quantity:	75 m ²	
Accessibility	Difficult	<i>Assessment Score</i>
Product type:	Cement	1
Extent of Damage:	Slight / minor damage	1
Surface Treatment:	Unsealed Cement	1
Asbestos type:	Chrysotile	1
Material Assessment Score:		4
Priority Assessment Score:		Negligible
Action:	Manage	
Comments:	Too high to sample. Visible above suspended ceiling

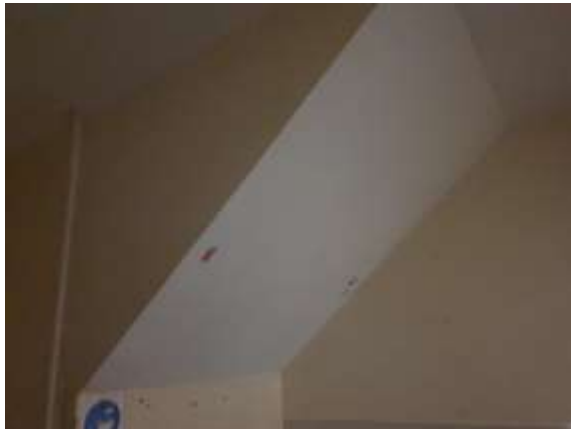
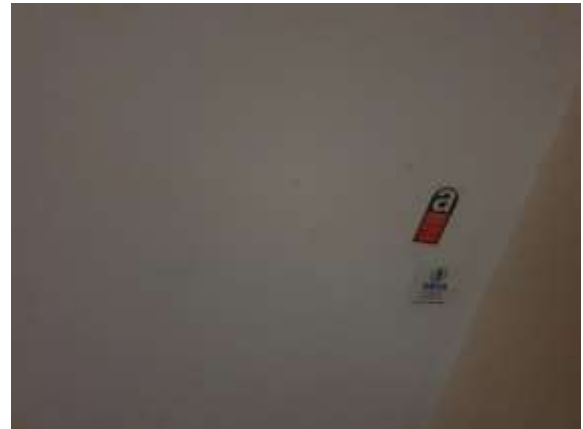
Location: Ground Floor - Kitchen 005

Material Description:	Panel to Underside of Stairs - Insulating Board	
Identification:	Strongly Presumed to Contain Asbestos	
Approx. quantity:	<2 m ²	
Accessibility	Difficult	<i>Assessment Score</i>
Product type:	Cement	1
Extent of Damage:	Slight / minor damage	1
Surface Treatment:	Encapsulated AIB	1
Asbestos type:	Amosite, Chrysotile	2
Material Assessment Score:		5
Priority Assessment Score:		Low
Action:	Manage	
Comments:	Exposed boarding was sampled (ref GBG/1) but does not contain asbestos. As a positive sample has previously been taken, it must be presumed that the Asbestos is concealed behind this

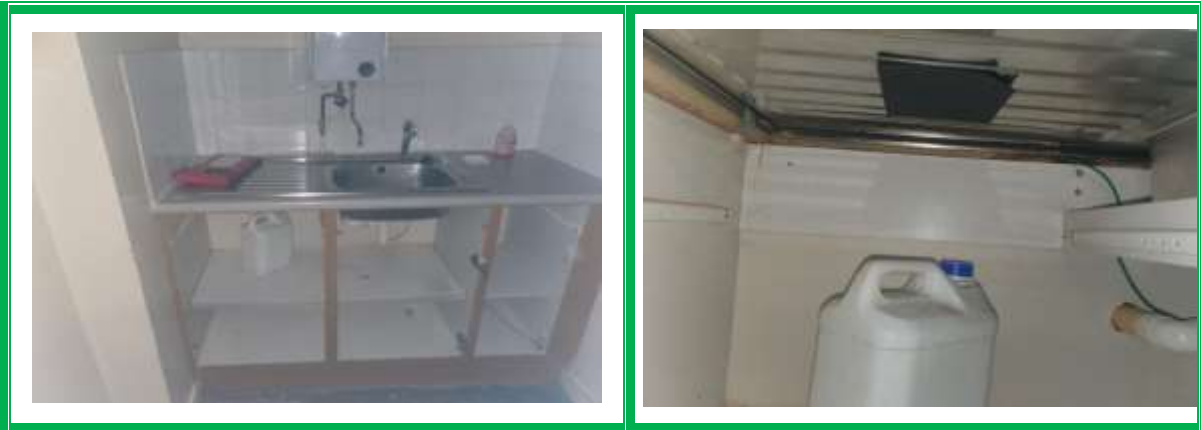
Item No:	1	Sample No:	N/A
Location:	Ground Floor - Kitchen 001

Material Description:	No Suspect Materials Found	
Identification:	N/A	
Approx. quantity:	N/A	
Accessibility	N/A	<i>Assessment Score</i>
Product type:	N/A	N/A
Extent of Damage:	N/A	N/A
Surface Treatment:	N/A	N/A
Asbestos type:	N/A	N/A
Material Assessment Score:		N/A
Priority Assessment Score:		N/A
Action:	N/A	
Comments:	Under sink was previously not accessed. Now accessed and only a non-asbestos sink pad found

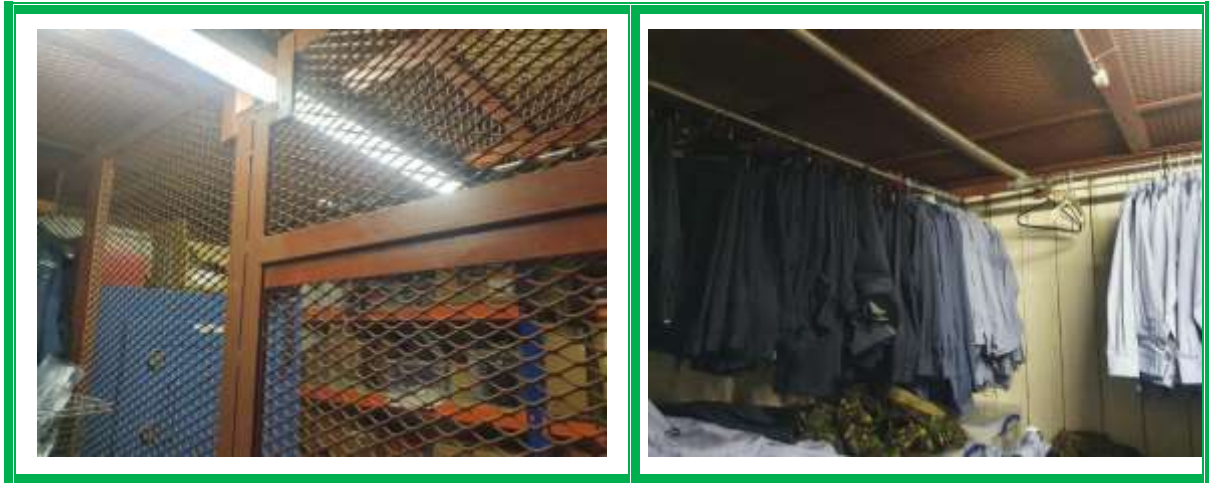
Item No:	2	Sample No:	N/A
Location:	Basement - Armoury 002

Material Description:	No Suspect Materials Found	
Identification:	N/A	
Approx. quantity:	N/A	
Accessibility	N/A	<i>Assessment Score</i>
Product type:	N/A	N/A
Extent of Damage:	N/A	N/A
Surface Treatment:	N/A	N/A
Asbestos type:	N/A	N/A
Material Assessment Score:		N/A
Priority Assessment Score:		N/A
Action:	N/A	
Comments:	Previously a no access area. Now accessed and no asbestos found. Plasterboard ceiling, timber walls and concrete floor
