LEGIONELLA RISK ASSESSMENT

| Client: | Wessex RF & CA | |
|---|---|--|
| Site: | Wyvern Barracks – Building 19 | |
| Address: | Officers & Sgts Mess, Barrack Road, Exeter, Devon EX2 | |
| Report Ref: | AQST/LRA/331 | |

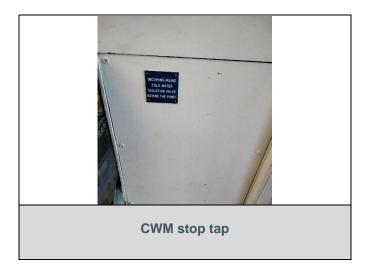
Photos

| Source of supply | Mains water |
|---|--|
| Mains Water Supply Risk Score | Low |

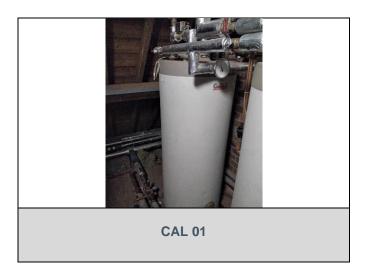
Photos

6. 4 HOT WATER STORAGE REPORT (continued)
