Project Number 2481

**Management
Asbestos Survey Report**

**Wyvern Barracks, Barrack Road, Exeter, Devon,
EX2 6AE (Building 5)**

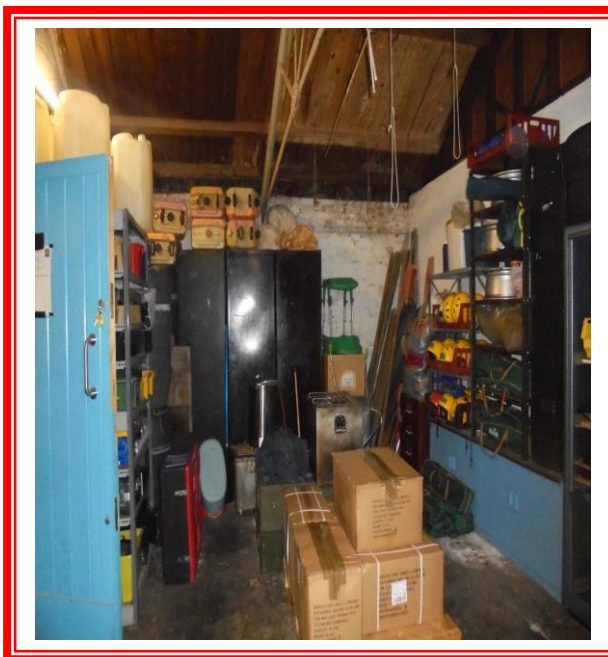
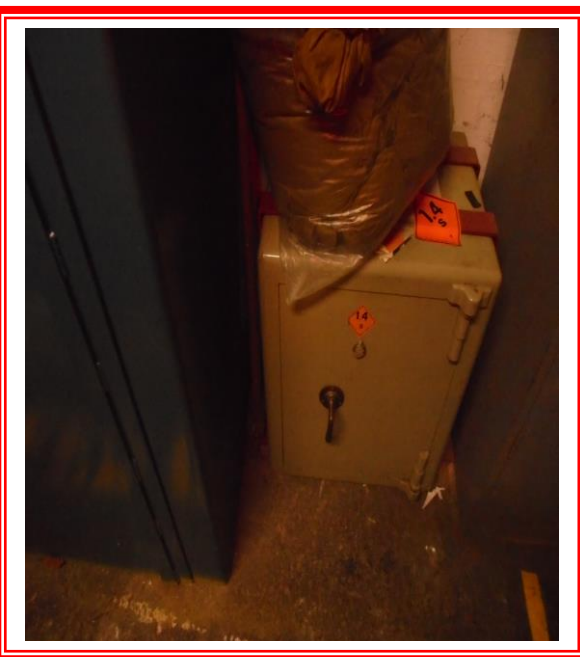
Item No: 3

Item 3 – Large Store – No access with the safe casings without irreparable damage

Material Description:	No access within safe casing	
Identification:	Presumed to Contain Asbestos	
Approx. quantity:	X 1	
Accessibility	Low	<i>Assessment Score</i>
Product type:	No Access	2
Extent of Damage:	No Access	2
Surface Treatment:	No Access	2
Asbestos type:	No Access	2
Material Assessment Score:		8
Priority Assessment Score:		Medium
Action:	Manage	
Comments:	No access with the safe casings without irreparable damage

The presence of asbestos in these areas cannot be ascertained at this time. If any works are to be carried out in these areas in the future, then these works should be approached cautiously.

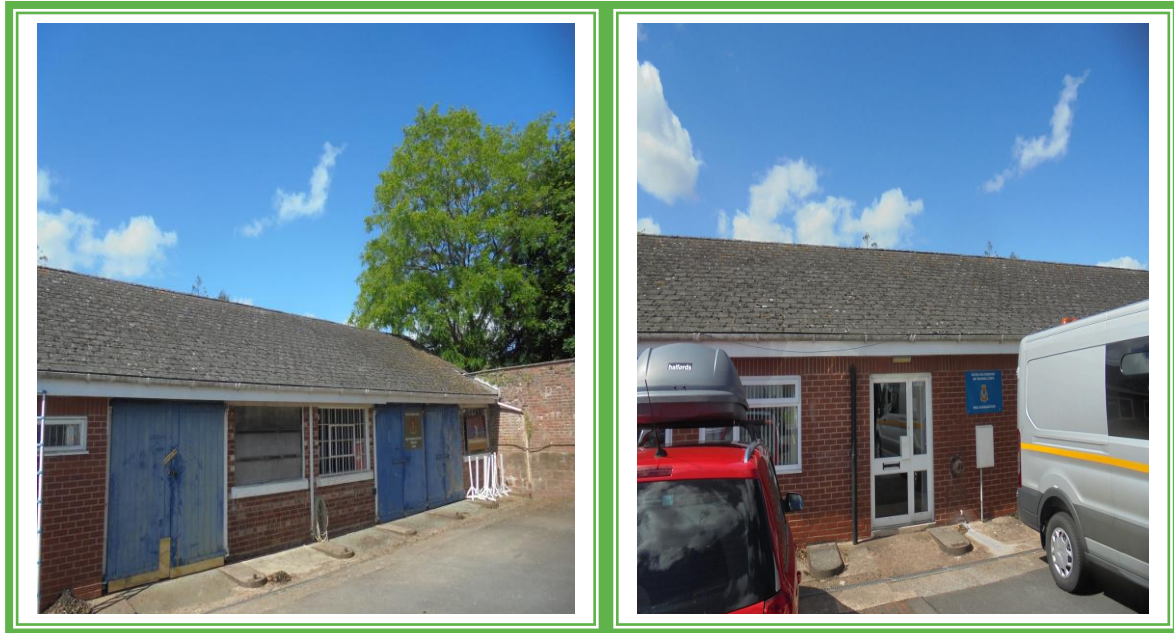
Item No: 1

Material Description:	Cement roof tiles	
Identification:	Sampled – No Asbestos Detected	
Approx. quantity:	250M2	
Accessibility	N/A	<i>Assessment Score</i>
Product type:		N/A
Extent of Damage:		N/A
Surface Treatment:		N/A
Asbestos type:		N/A
Material Assessment Score:		N/A
Priority Assessment Score:		N/A
Action:	N/A	
Comments:	N/A

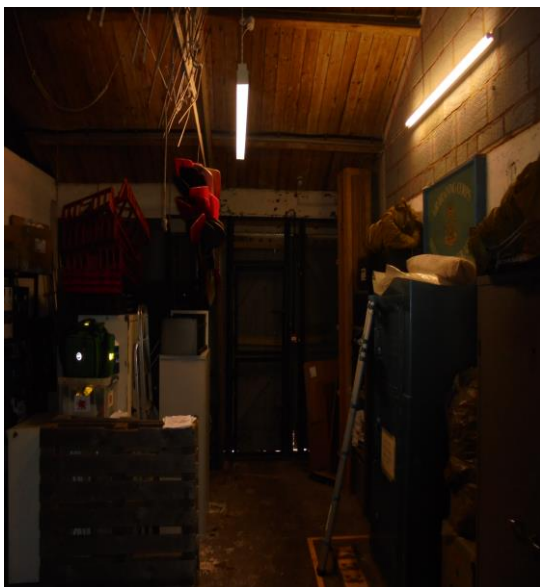
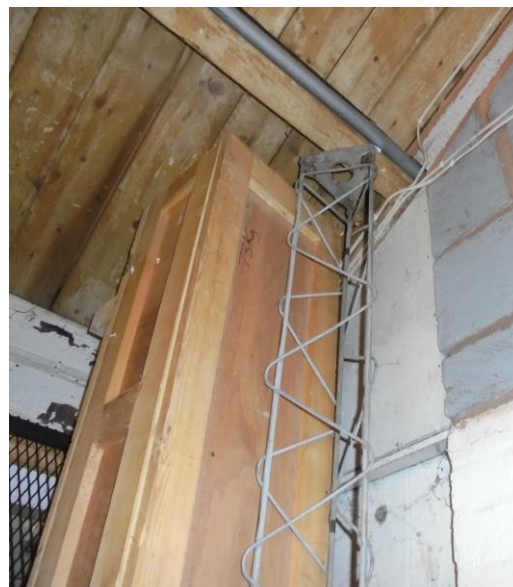
Item No: 2

Material Description:	Insulation board boxing	
Identification:	Sampled – No Asbestos Detected	
Approx. quantity:	1M2	
Accessibility	N/A	<i>Assessment Score</i>
Product type:		N/A
Extent of Damage:		N/A
Surface Treatment:		N/A
Asbestos type:		N/A
Material Assessment Score:		N/A
Priority Assessment Score:		N/A
Action:	N/A	
Comments:	N/A

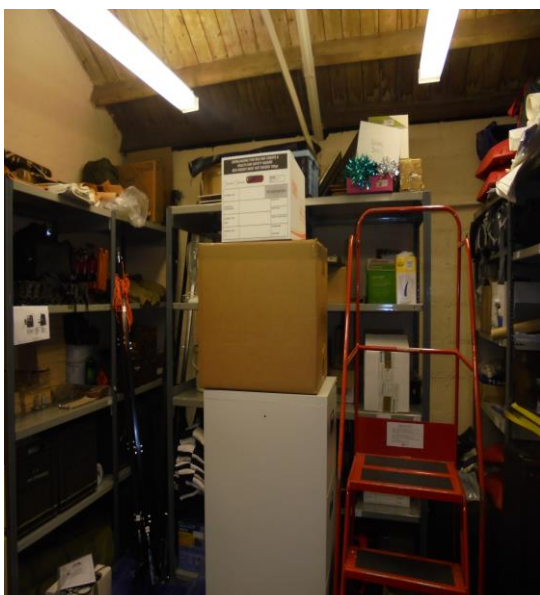
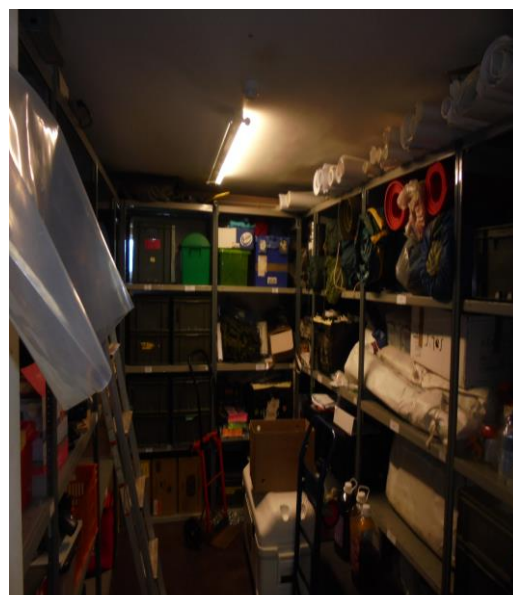
Item No: 4

Material Description:	Visual Inspection – No Suspect Materials Found	
Identification:	N/A	
Approx. quantity:	N/A	
Accessibility	N/A	<i>Assessment Score</i>
Product type:		N/A
Extent of Damage:		N/A
Surface Treatment:		N/A
Asbestos type:		N/A
Material Assessment Score:		N/A
Priority Assessment Score:		N/A
Action:	N/A	
Comments:	N/A

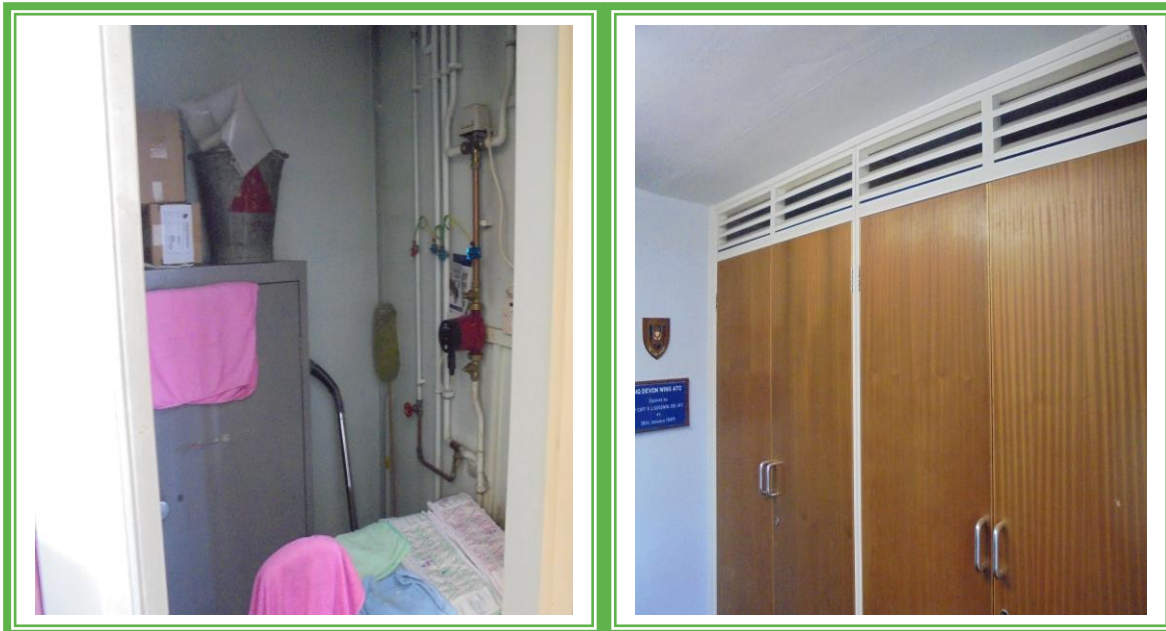
Item No: 5

Material Description:	Visual Inspection – No Suspect Materials Found	
Identification:	N/A	
Approx. quantity:	N/A	
Accessibility	N/A	<i>Assessment Score</i>
Product type:		N/A
Extent of Damage:		N/A
Surface Treatment:		N/A
Asbestos type:		N/A
Material Assessment Score:		N/A
Priority Assessment Score:		N/A
Action:	N/A	
Comments:	Modern Water heater

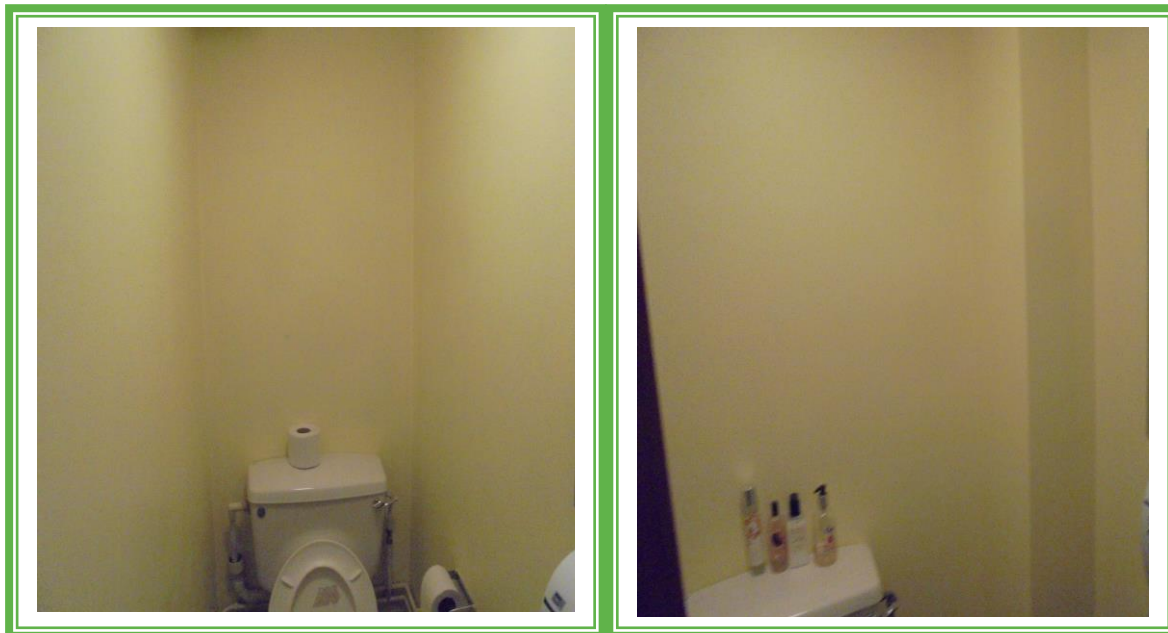
**Item No: 6****Sample No: N/A****Location: WC's x 2**

Material Description:	Visual Inspection – No Suspect Materials Found	
Identification:	N/A	
Approx. quantity:	N/A	
Accessibility	N/A	<i>Assessment Score</i>
Product type:		N/A
Extent of Damage:		N/A
Surface Treatment:		N/A
Asbestos type:		N/A
Material Assessment Score:		N/A
Priority Assessment Score:		N/A
Action:	N/A	
Comments:	No access within timber boxing

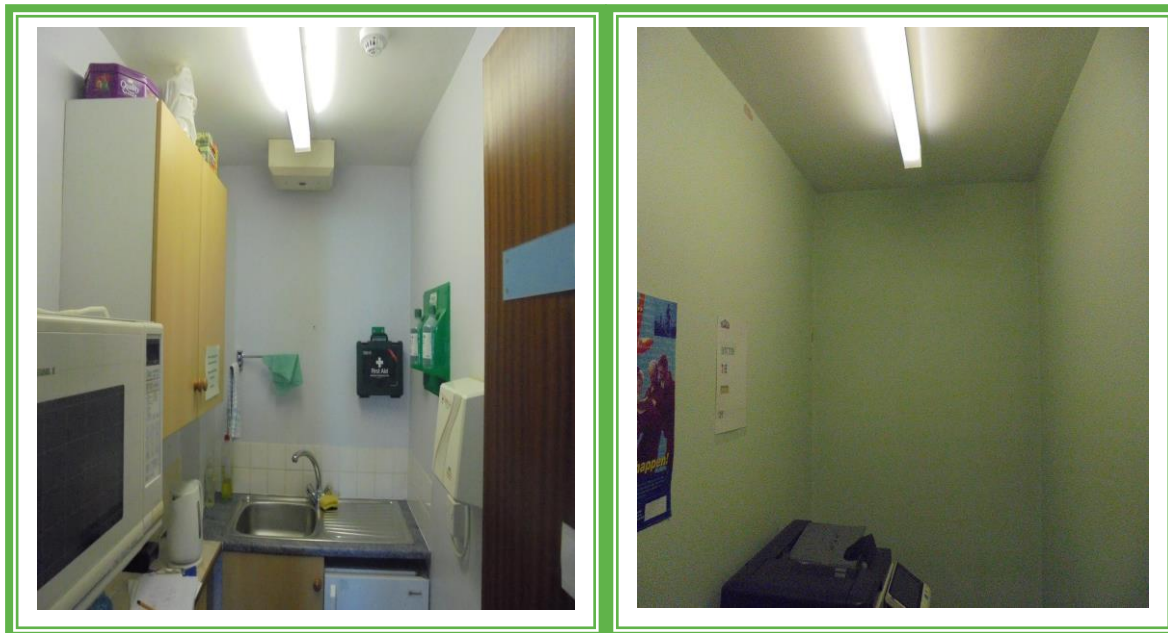
Item No: 7

Material Description:	Visual Inspection – No Suspect Materials Found	
Identification:	N/A	
Approx. quantity:	N/A	
Accessibility	N/A	<i>Assessment Score</i>
Product type:		N/A
Extent of Damage:		N/A
Surface Treatment:		N/A
Asbestos type:		N/A
Material Assessment Score:		N/A
Priority Assessment Score:		N/A
Action:	N/A	
Comments:	Modern sink pad. No access within timber boxing

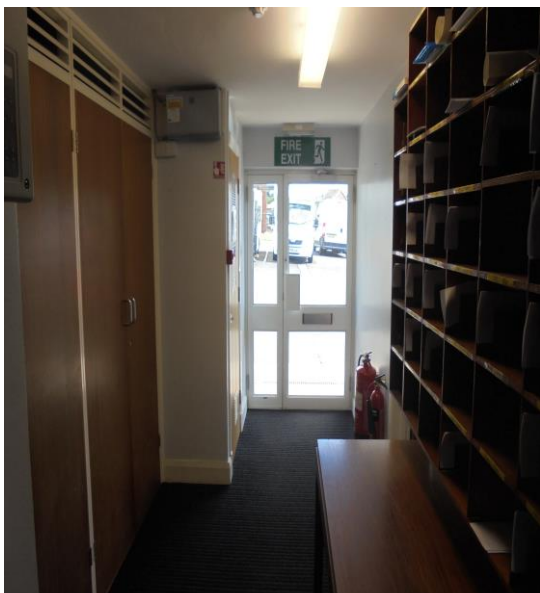
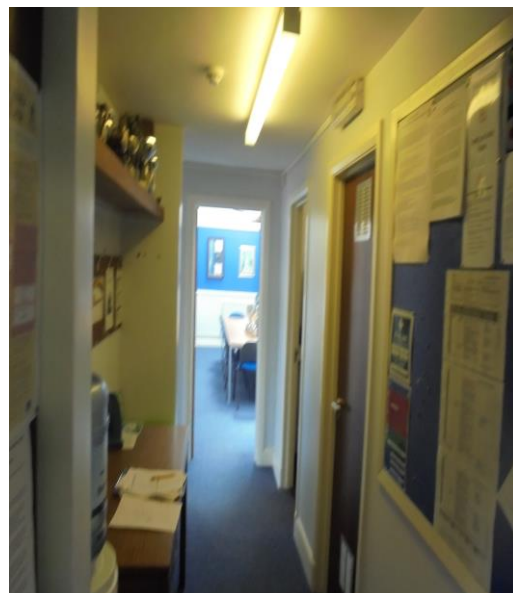
**Item No: 8****Sample No: N/A****Location: Corridor**

Material Description:	Visual Inspection – No Suspect Materials Found	
Identification:	N/A	
Approx. quantity:	N/A	
Accessibility	N/A	<i>Assessment Score</i>
Product type:		N/A
Extent of Damage:		N/A
Surface Treatment:		N/A
Asbestos type:		N/A
Material Assessment Score:		N/A
Priority Assessment Score:		N/A
Action:	N/A	
Comments:	N/A

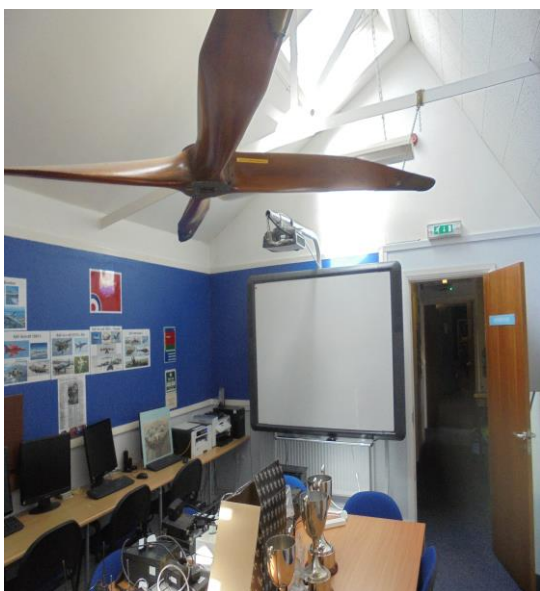
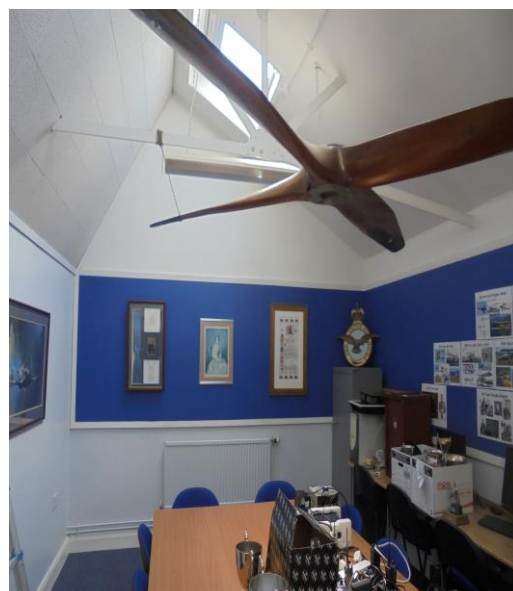
Item No: 9

Material Description:	Visual Inspection – No Suspect Materials Found	
Identification:	N/A	
Approx. quantity:	N/A	
Accessibility	N/A	<i>Assessment Score</i>
Product type:		N/A
Extent of Damage:		N/A
Surface Treatment:		N/A
Asbestos type:		N/A
Material Assessment Score:		N/A
Priority Assessment Score:		N/A
Action:	N/A	
Comments:	N/A

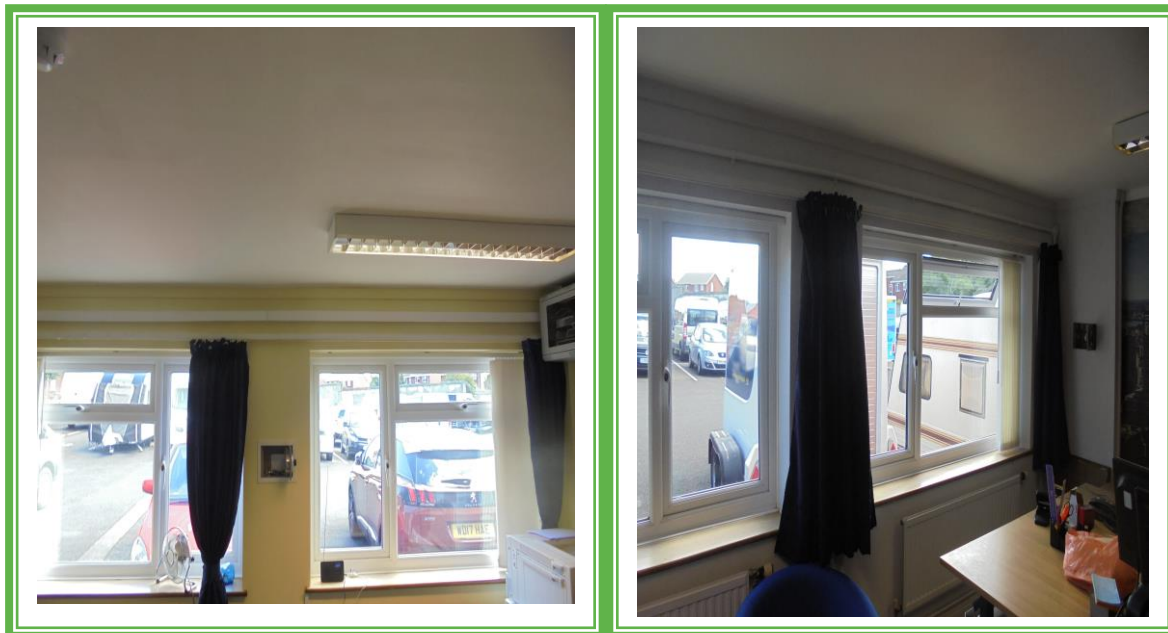
**Item No: 10****Sample No: N/A****Location: Offices x 2**

Material Description:	Visual Inspection – No Suspect Materials Found	
Identification:	N/A	
Approx. quantity:	N/A	
Accessibility	N/A	<i>Assessment Score</i>
Product type:		N/A
Extent of Damage:		N/A
Surface Treatment:		N/A
Asbestos type:		N/A
Material Assessment Score:		N/A
Priority Assessment Score:		N/A
Action:	N/A	
Comments:	N/A

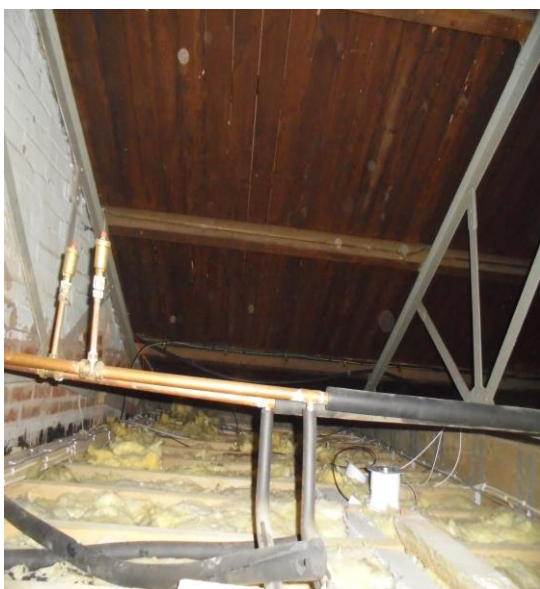
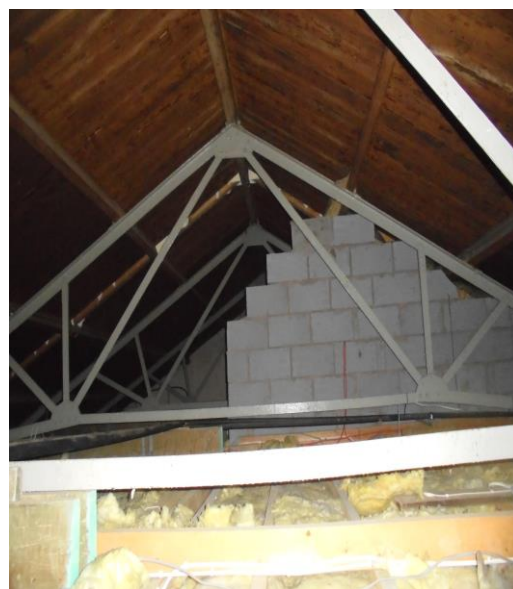
Item No: 11

Material Description:	Visual Inspection – No Suspect Materials Found	
Identification:	N/A	
Approx. quantity:	N/A	
Accessibility	N/A	<i>Assessment Score</i>
Product type:		N/A
Extent of Damage:		N/A
Surface Treatment:		N/A
Asbestos type:		N/A
Material Assessment Score:		N/A
Priority Assessment Score:		N/A
Action:	N/A	
Comments:	Limited access into loft as there were no crawl boards available

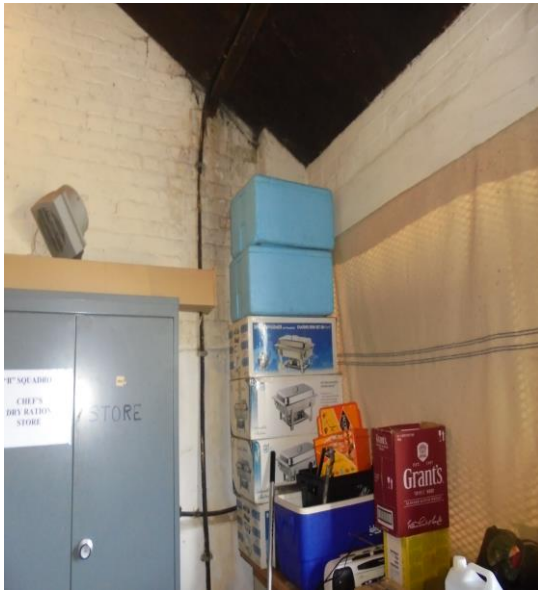
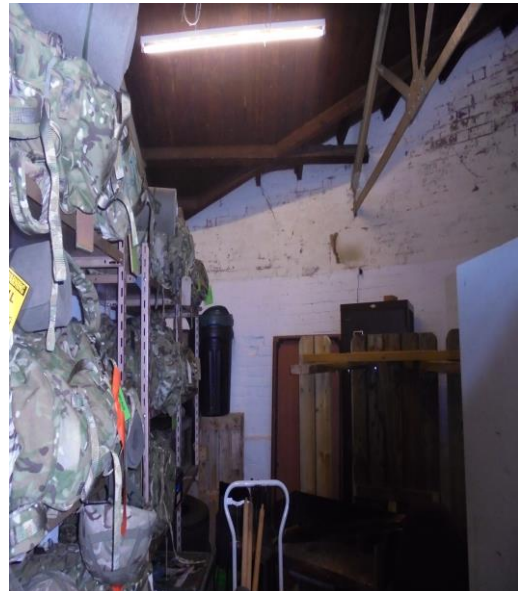
Item No: 12

Material Description:	Visual Inspection – No Suspect Materials Found	
Identification:	N/A	
Approx. quantity:	N/A	
Accessibility	N/A	<i>Assessment Score</i>
Product type:		N/A
Extent of Damage:		N/A
Surface Treatment:		N/A
Asbestos type:		N/A
Material Assessment Score:		N/A
Priority Assessment Score:		N/A
Action:	N/A	
Comments:	Limited access into store due to stored items
