## **Project Number 2481**

### **Management Asbestos Survey Report**

**Wyvern Barracks, Barrack Road, Exeter, Devon,  
EX2 6AE (Building 22)**

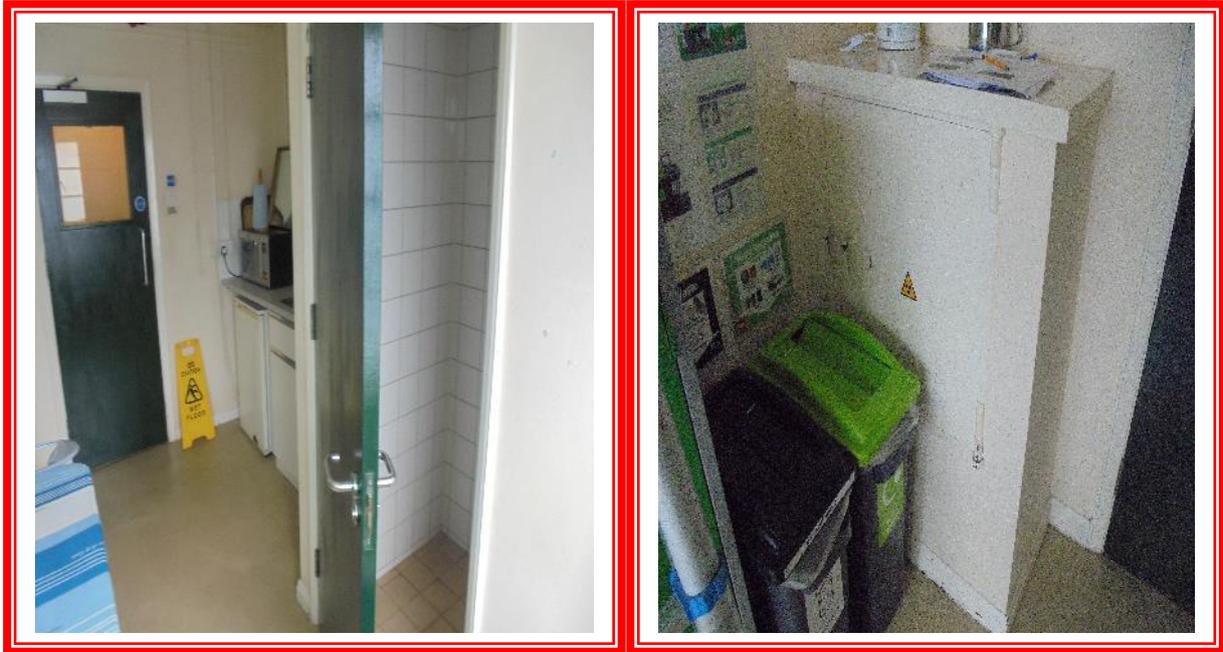
**Item No: 3**

Item 3 – Kitchen and Shower Room – No access with Safe Casings

**Location: Kitchen and Shower Room**

<b>Material Description:</b>	No access within safe casings	
<b>Identification:</b>	Presumed to Contain Asbestos	
<b>Approx. quantity:</b>	X 1 Safe	
<b>Accessibility</b>	Low	<i>Assessment Score</i>
<b>Product type:</b>	No Access	2
<b>Extent of Damage:</b>	No Access	2
<b>Surface Treatment:</b>	No Access	2
<b>Asbestos type:</b>	No Access	2
<b>Material Assessment Score:</b>		8
<b>Priority Assessment Score:</b>		Medium
<b>Action:</b>	Manage	
<b>Comments:</b>	N/A

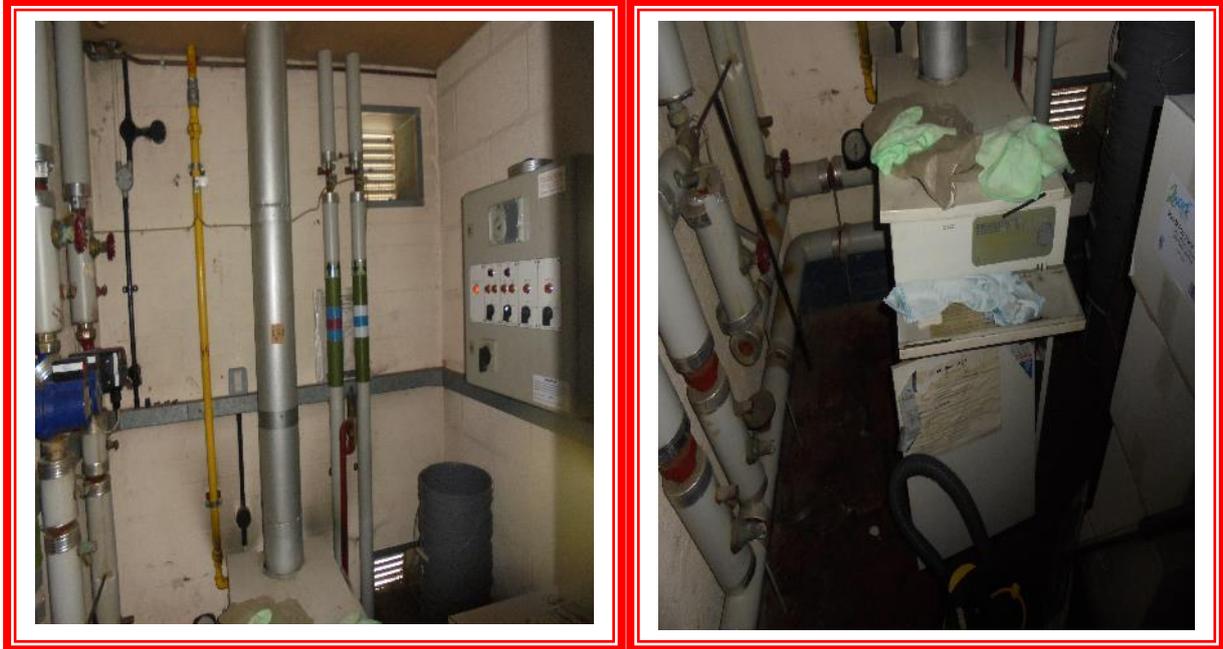
**Item No: 17**

Item 17 – Boiler Room – Boiler – No access within boiler as live

**Location: Boiler Room**

<b>Material Description:</b>	No access within boiler	
<b>Identification:</b>	Presumed to Contain Asbestos	
<b>Approx. quantity:</b>	X 1 Boiler	
<b>Accessibility</b>	Low	<i>Assessment Score</i>
<b>Product type:</b>	No Access	3
<b>Extent of Damage:</b>	No Access	3
<b>Surface Treatment:</b>	No Access	3
<b>Asbestos type:</b>	No Access	3
<b>Material Assessment Score:</b>		12
<b>Priority Assessment Score:</b>		High
<b>Action:</b>	Manage	
<b>Comments:</b>	Modern electrics. No access within boiler as live

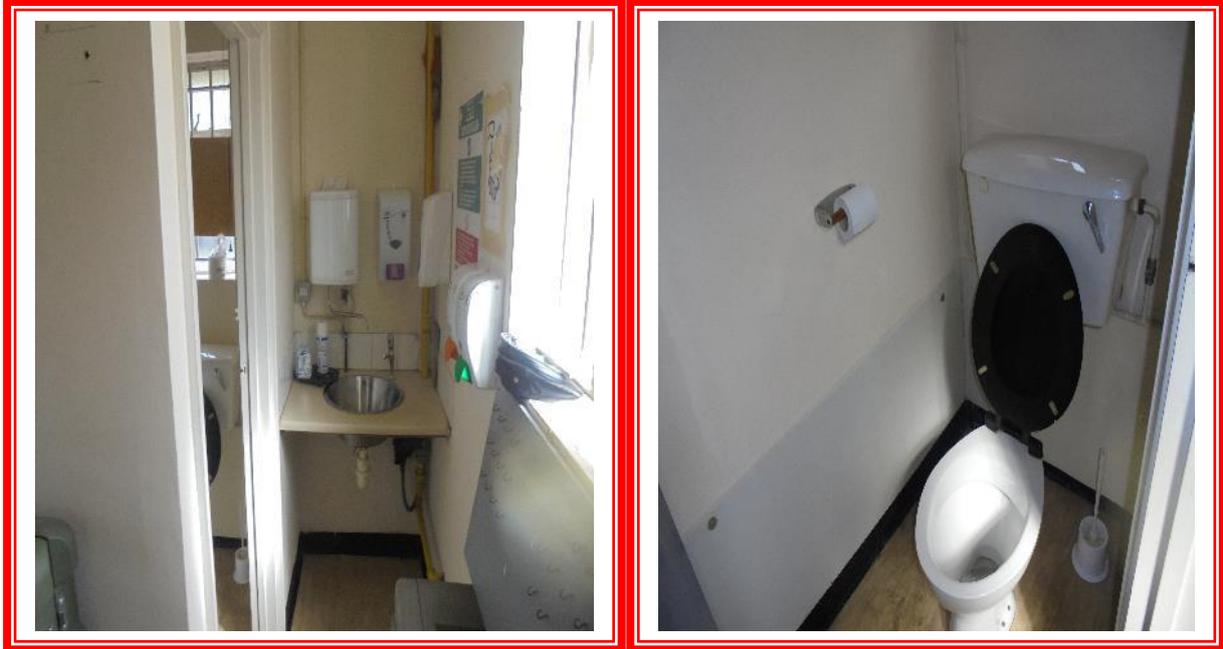
**Item No: 21**

Item 21 – Wash Room and WC – Toilet Seat – Unable to sample as would damage integrity of seat

**Location: Wash Room and WC**

<b>Material Description:</b>	Toiler seat	
<b>Identification:</b>	Presumed to Contain Asbestos	
<b>Approx. quantity:</b>	X 1 Seat	
<b>Accessibility</b>	Low	<i>Assessment Score</i>
<b>Product type:</b>	No Access	1
<b>Extent of Damage:</b>	No Access	0
<b>Surface Treatment:</b>	No Access	0
<b>Asbestos type:</b>	No Access	1
<b>Material Assessment Score:</b>		2
<b>Priority Assessment Score:</b>		Negligible
<b>Action:</b>	Manage	
<b>Comments:</b>	Unable to sample as would damage integrity of the seat

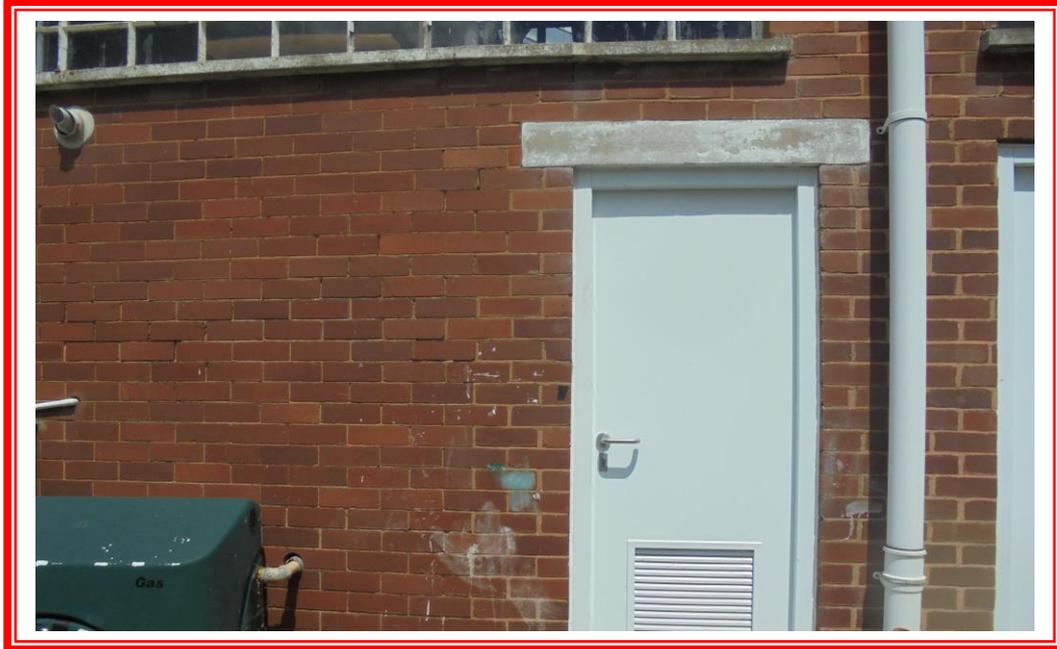
**Item No: 27**

Item 27 – Plant Room – No access as locked and no key was available

**Location: Plant Room**

<b>Material Description:</b>	No access as locked	
<b>Identification:</b>	Presumed to Contain Asbestos	
<b>Approx. quantity:</b>	X 1 Room	
<b>Accessibility</b>	Low	<i>Assessment Score</i>
<b>Product type:</b>	No Access	3
<b>Extent of Damage:</b>	No Access	3
<b>Surface Treatment:</b>	No Access	3
<b>Asbestos type:</b>	No Access	3
<b>Material Assessment Score:</b>		12
<b>Priority Assessment Score:</b>		High
<b>Action:</b>	Further Investigation Required	
<b>Comments:</b>	Site contact did not know where the key was kept

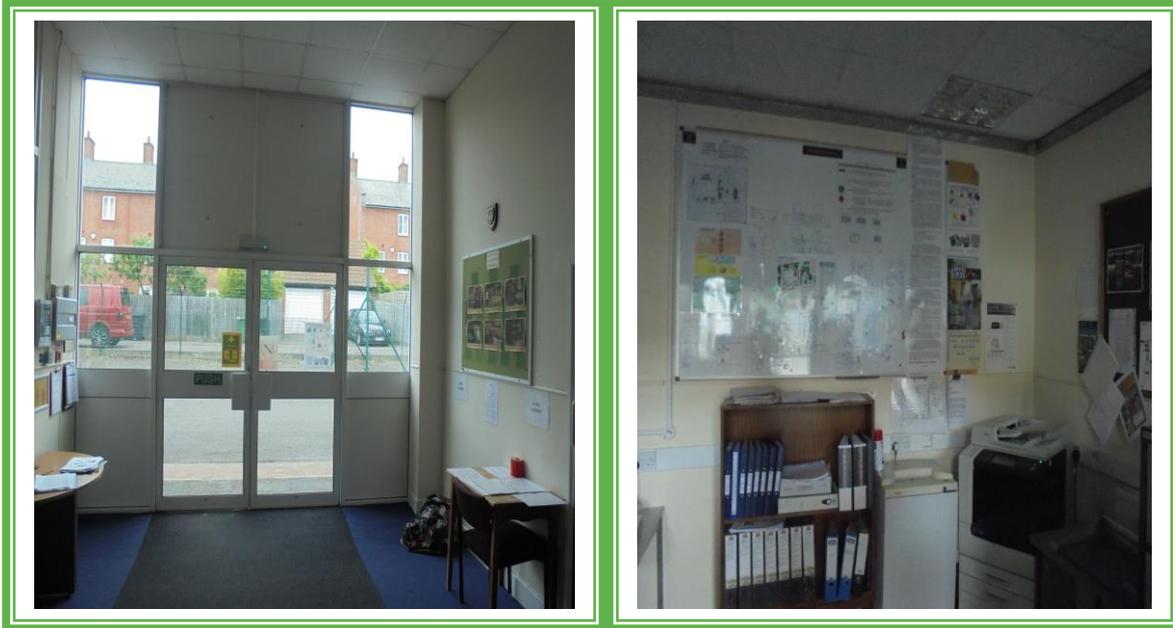
**Item No: 1**

**Location: Entrance Lobby and Print Room**

<b>Material Description:</b>	Visual Inspection – No Suspect Materials Found	
<b>Identification:</b>	N/A	
<b>Approx. quantity:</b>	N/A	
<b>Accessibility</b>	N/A	<i>Assessment Score</i>
<b>Product type:</b>	N/A	
<b>Extent of Damage:</b>	N/A	
<b>Surface Treatment:</b>	N/A	
<b>Asbestos type:</b>	N/A	
<b>Material Assessment Score:</b>		N/A
<b>Priority Assessment Score:</b>		N/A
<b>Action:</b>	N/A	
<b>Comments:</b>	Limited access above high-level suspended ceiling due to height – Roof space visible above

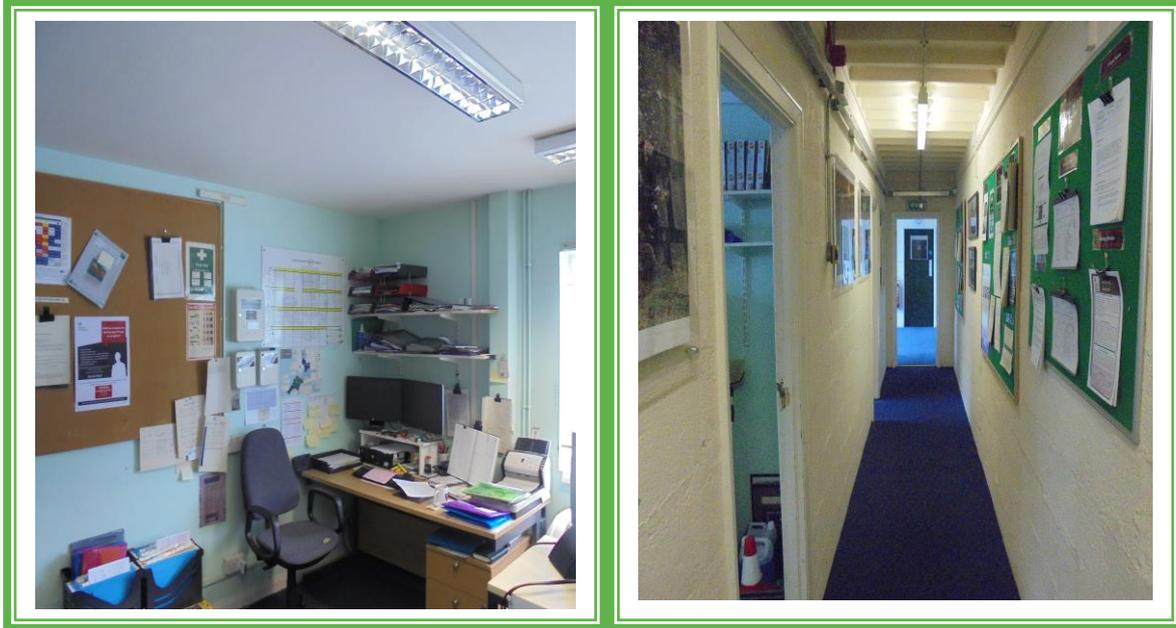
**Item No: 2**

**Location: Offices x 2 and Corridor**

<b>Material Description:</b>	Visual Inspection – No Suspect Materials Found	
<b>Identification:</b>	N/A	
<b>Approx. quantity:</b>	N/A	
<b>Accessibility</b>	N/A	<i>Assessment Score</i>
<b>Product type:</b>	N/A	
<b>Extent of Damage:</b>	N/A	
<b>Surface Treatment:</b>	N/A	
<b>Asbestos type:</b>	N/A	
<b>Material Assessment Score:</b>		N/A
<b>Priority Assessment Score:</b>		N/A
<b>Action:</b>	N/A	
<b>Comments:</b>	N/A

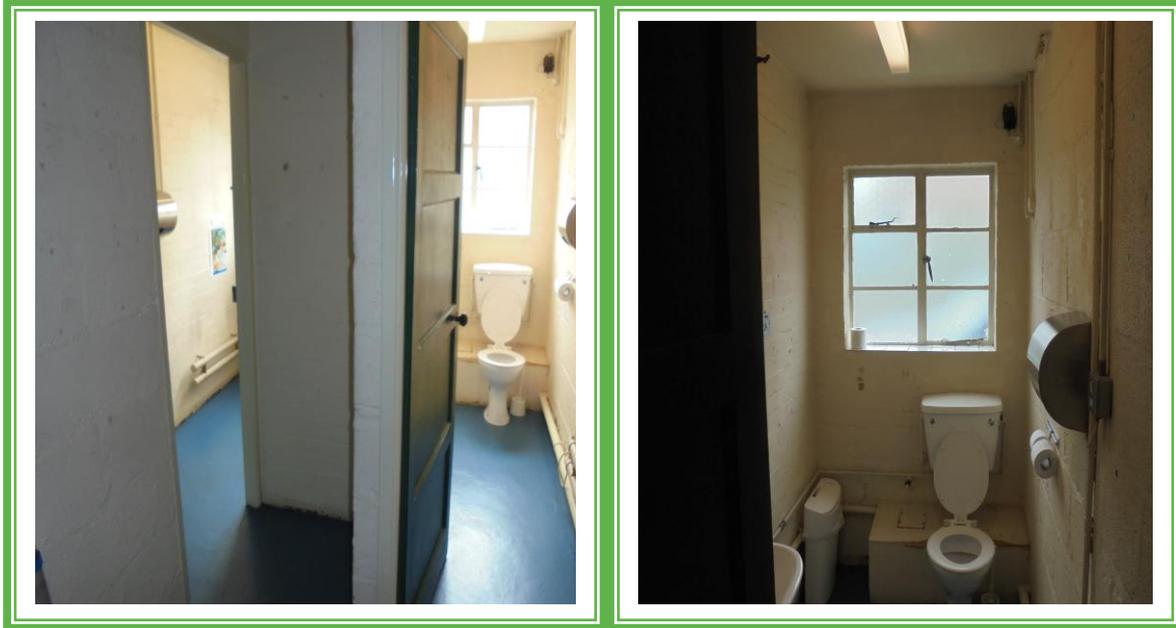
**Item No: 4**

**Location: WC's x 2**

<b>Material Description:</b>	Visual Inspection – No Suspect Materials Found	
<b>Identification:</b>	N/A	
<b>Approx. quantity:</b>	N/A	
<b>Accessibility</b>	N/A	<i>Assessment Score</i>
<b>Product type:</b>	N/A	
<b>Extent of Damage:</b>	N/A	
<b>Surface Treatment:</b>	N/A	
<b>Asbestos type:</b>	N/A	
<b>Material Assessment Score:</b>		N/A
<b>Priority Assessment Score:</b>		N/A
<b>Action:</b>	N/A	
<b>Comments:</b>	N/A

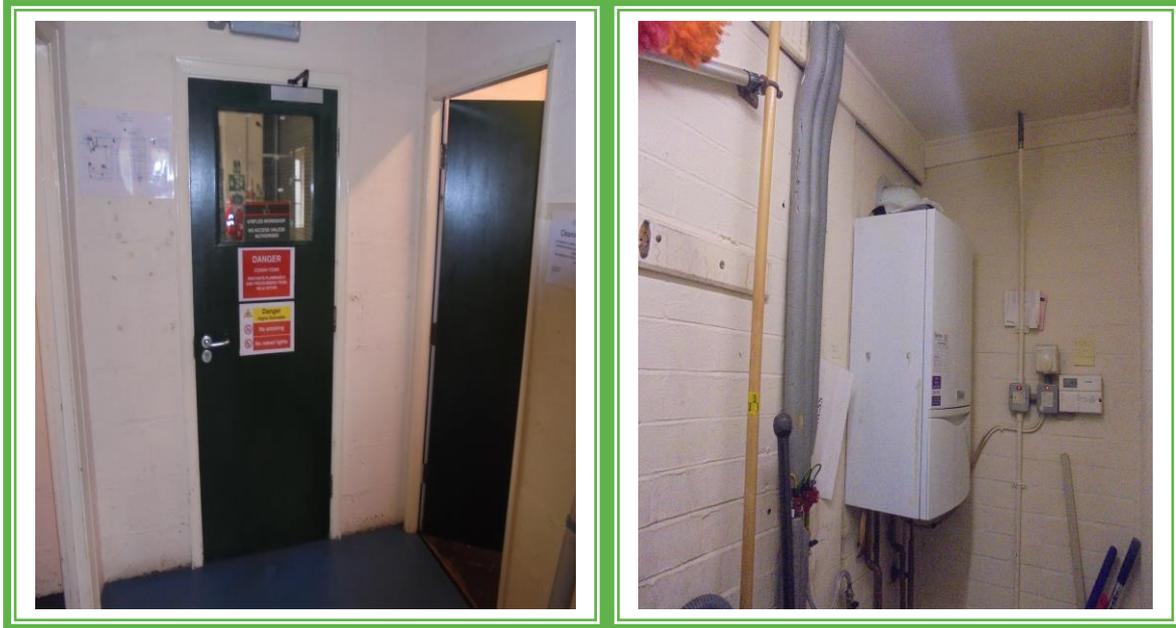
**Item No: 5**

**Location: Circulation and Cupboard**

<b>Material Description:</b>	Visual Inspection – No Suspect Materials Found	
<b>Identification:</b>	N/A	
<b>Approx. quantity:</b>	N/A	
<b>Accessibility</b>	N/A	<i>Assessment Score</i>
<b>Product type:</b>	N/A	
<b>Extent of Damage:</b>	N/A	
<b>Surface Treatment:</b>	N/A	
<b>Asbestos type:</b>	N/A	
<b>Material Assessment Score:</b>		N/A
<b>Priority Assessment Score:</b>		N/A
<b>Action:</b>	N/A	
<b>Comments:</b>	Modern boiler in cupboard

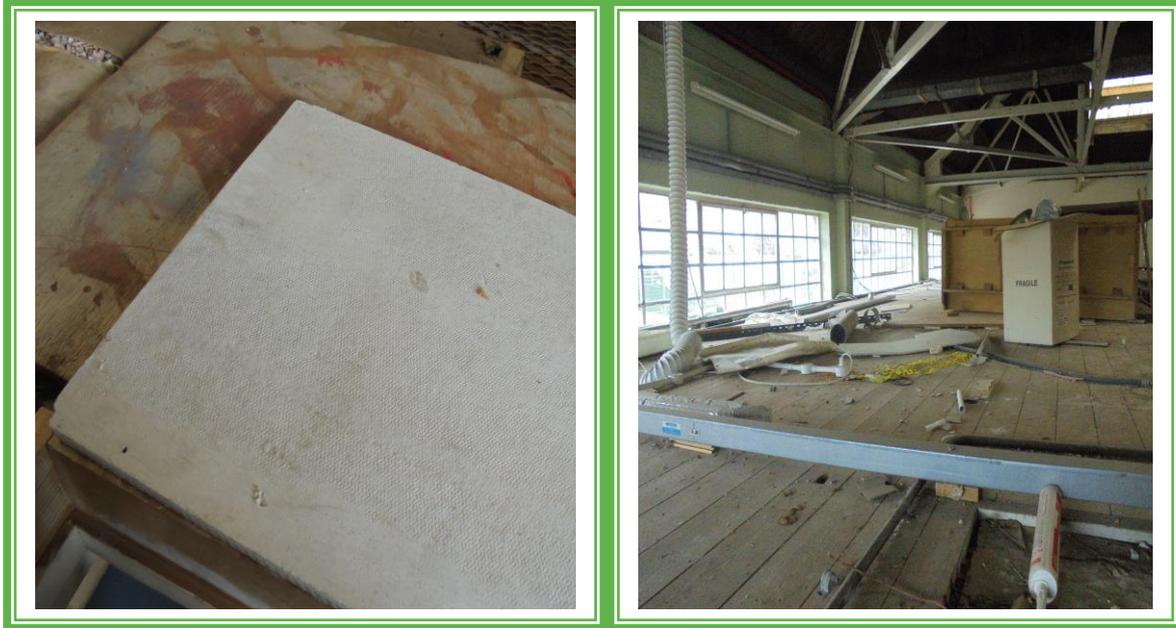
**Item No: 6**

**Location: Loft Space**

<b>Material Description:</b>	Insulation board loft hatch panel	
<b>Identification:</b>	Sampled – No Asbestos Detected	
<b>Approx. quantity:</b>	<1M2	
<b>Accessibility</b>	N/A	<i>Assessment Score</i>
<b>Product type:</b>		N/A
<b>Extent of Damage:</b>		N/A
<b>Surface Treatment:</b>		N/A
<b>Asbestos type:</b>		N/A
<b>Material Assessment Score:</b>		N/A
<b>Priority Assessment Score:</b>		N/A
<b>Action:</b>	N/A	
<b>Comments:</b>	N/A

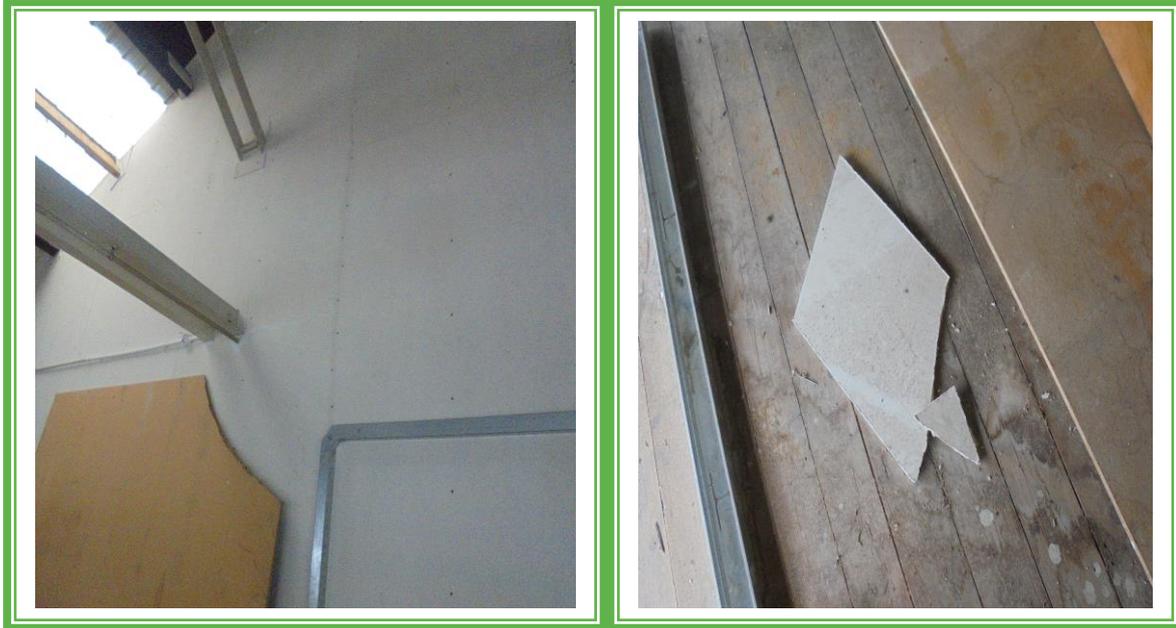
**Item No: 7**

**Location: Loft Space**

<b>Material Description:</b>	Insulation board wall panels and debris	
<b>Identification:</b>	Sampled – No Asbestos Detected	
<b>Approx. quantity:</b>	>100M2	
<b>Accessibility</b>	N/A	<i>Assessment Score</i>
<b>Product type:</b>		N/A
<b>Extent of Damage:</b>		N/A
<b>Surface Treatment:</b>		N/A
<b>Asbestos type:</b>		N/A
<b>Material Assessment Score:</b>		N/A
<b>Priority Assessment Score:</b>		N/A
<b>Action:</b>	N/A	
<b>Comments:</b>	N/A

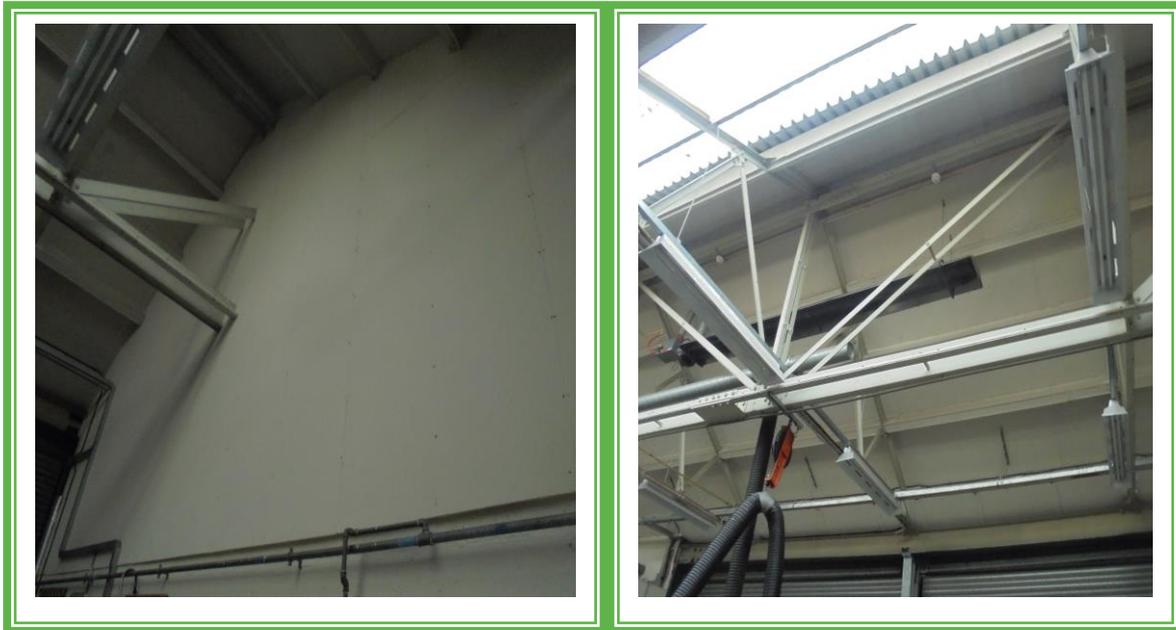
**Item No: 8**

**Location: Workshop, Tool Store and Electrical Cupboard**

<b>Material Description:</b>	Insulation board Wall and Ceiling panels	
<b>Identification:</b>	As Per Sample 2 – No Asbestos Detected	
<b>Approx. quantity:</b>	300M2	
<b>Accessibility</b>	N/A	<i>Assessment Score</i>
<b>Product type:</b>		N/A
<b>Extent of Damage:</b>		N/A
<b>Surface Treatment:</b>		N/A
<b>Asbestos type:</b>		N/A
<b>Material Assessment Score:</b>		N/A
<b>Priority Assessment Score:</b>		N/A
<b>Action:</b>	N/A	
<b>Comments:</b>	To all walls and ceilings, including boxing and also including walls and ceiling to electrical cupboard

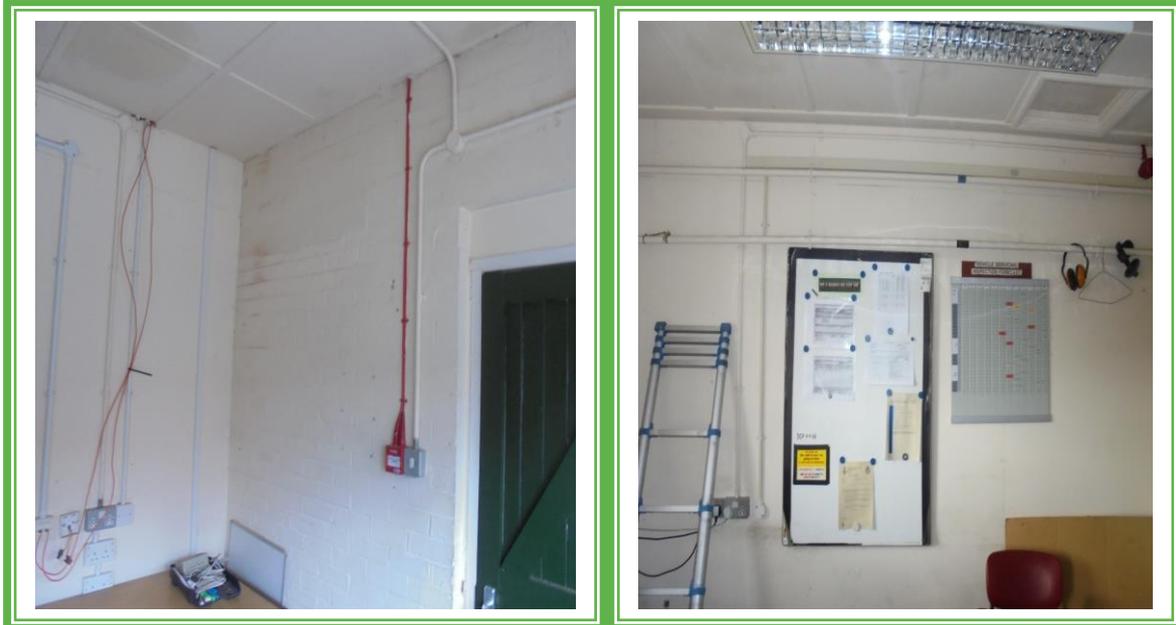
**Item No: 9**

**Location: Offices x 2 and Loft Space**

<b>Material Description:</b>	Insulation board wall panels	
<b>Identification:</b>	As Per Sample 2 – No Asbestos Detected	
<b>Approx. quantity:</b>	100M2	
<b>Accessibility</b>	N/A	<i>Assessment Score</i>
<b>Product type:</b>		N/A
<b>Extent of Damage:</b>		N/A
<b>Surface Treatment:</b>		N/A
<b>Asbestos type:</b>		N/A
<b>Material Assessment Score:</b>		N/A
<b>Priority Assessment Score:</b>		N/A
<b>Action:</b>	N/A	
<b>Comments:</b>	Including panel above external door, loft hatch panel and wall panels in loft hatch

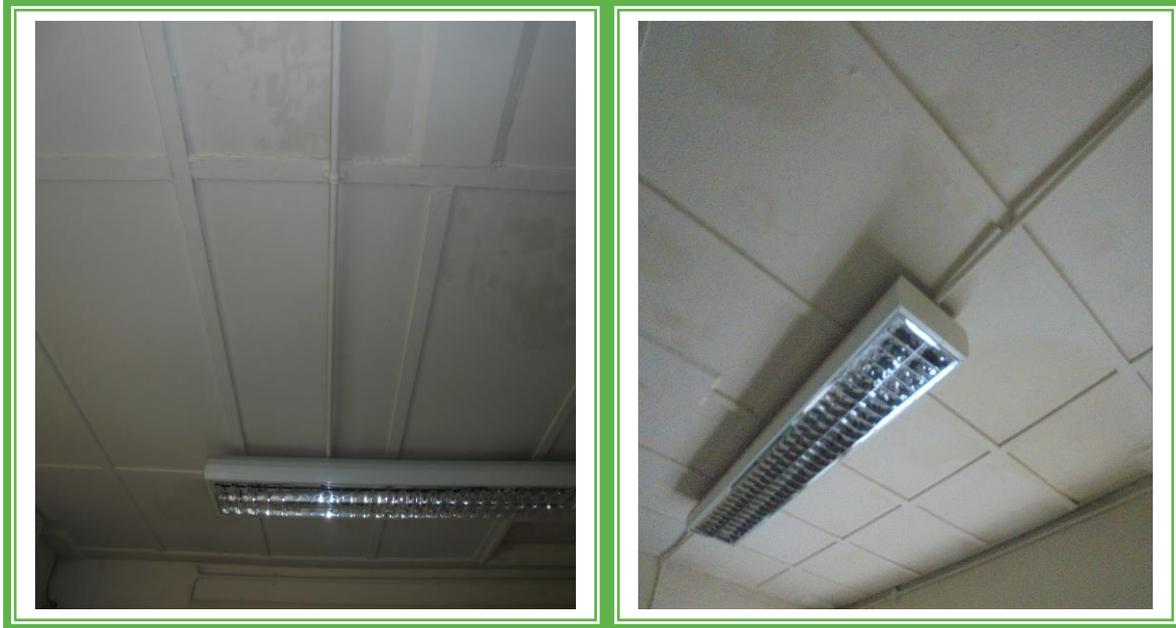
**Item No: 10**

**Location: Offices x 2 and Corridor**

<b>Material Description:</b>	Fibreboard ceiling panels	
<b>Identification:</b>	Sampled – No Asbestos Detected	
<b>Approx. quantity:</b>	40M2	
<b>Accessibility</b>	N/A	<i>Assessment Score</i>
<b>Product type:</b>		N/A
<b>Extent of Damage:</b>		N/A
<b>Surface Treatment:</b>		N/A
<b>Asbestos type:</b>		N/A
<b>Material Assessment Score:</b>		N/A
<b>Priority Assessment Score:</b>		N/A
<b>Action:</b>	N/A	
<b>Comments:</b>	N/A

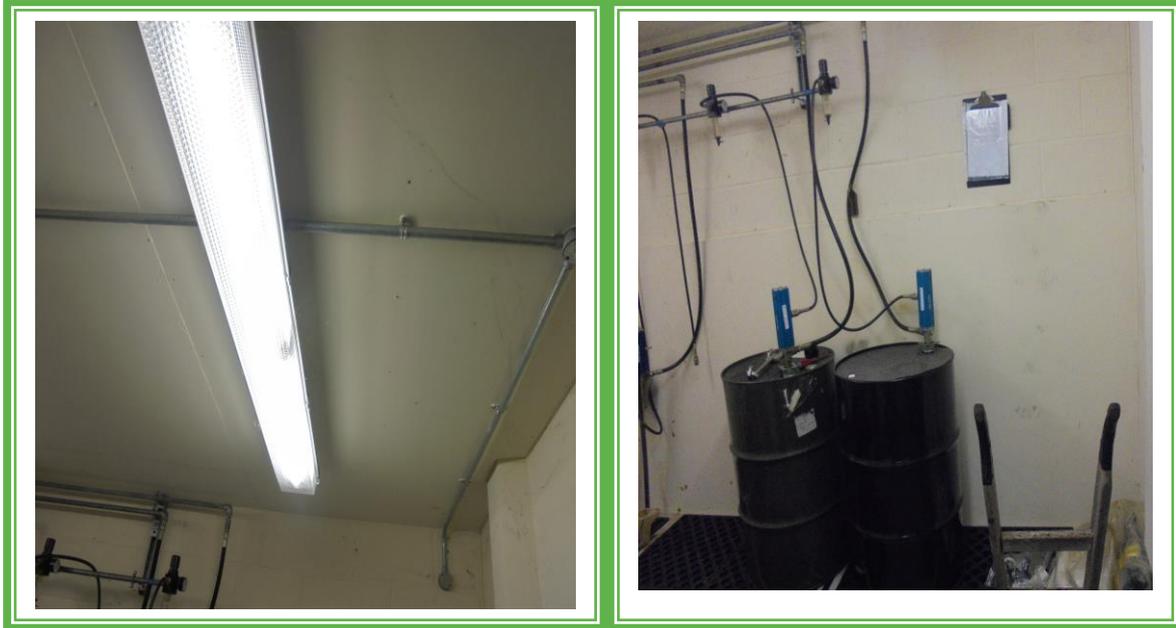
**Item No: 11**

**Location: Stores x 2**

<b>Material Description:</b>	Insulation board Ceiling panels	
<b>Identification:</b>	As Per Sample 2 – No Asbestos Detected	
<b>Approx. quantity:</b>	20M2	
<b>Accessibility</b>	N/A	<i>Assessment Score</i>
<b>Product type:</b>		N/A
<b>Extent of Damage:</b>		N/A
<b>Surface Treatment:</b>		N/A
<b>Asbestos type:</b>		N/A
<b>Material Assessment Score:</b>		N/A
<b>Priority Assessment Score:</b>		N/A
<b>Action:</b>	N/A	
<b>Comments:</b>	N/A

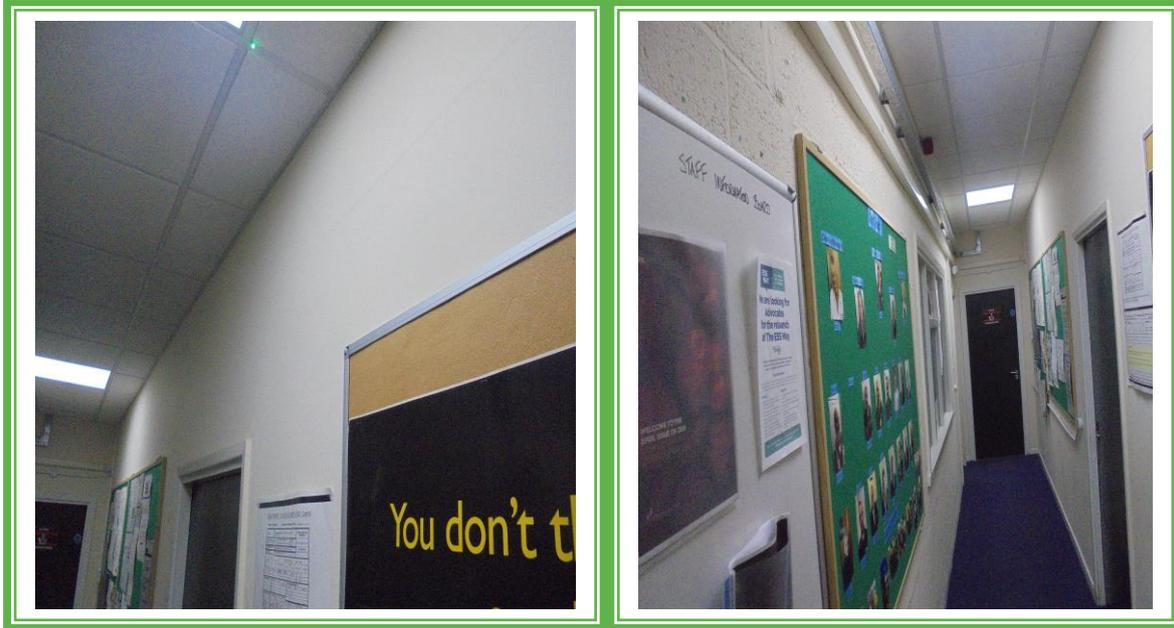
**Item No: 12**

**Location: Corridors x 2**

<b>Material Description:</b>	Insulation board Wall panels	
<b>Identification:</b>	Sampled – No Asbestos Detected	
<b>Approx. quantity:</b>	40M2	
<b>Accessibility</b>	N/A	<i>Assessment Score</i>
<b>Product type:</b>		N/A
<b>Extent of Damage:</b>		N/A
<b>Surface Treatment:</b>		N/A
<b>Asbestos type:</b>		N/A
<b>Material Assessment Score:</b>		N/A
<b>Priority Assessment Score:</b>		N/A
<b>Action:</b>	N/A	
<b>Comments:</b>	N/A

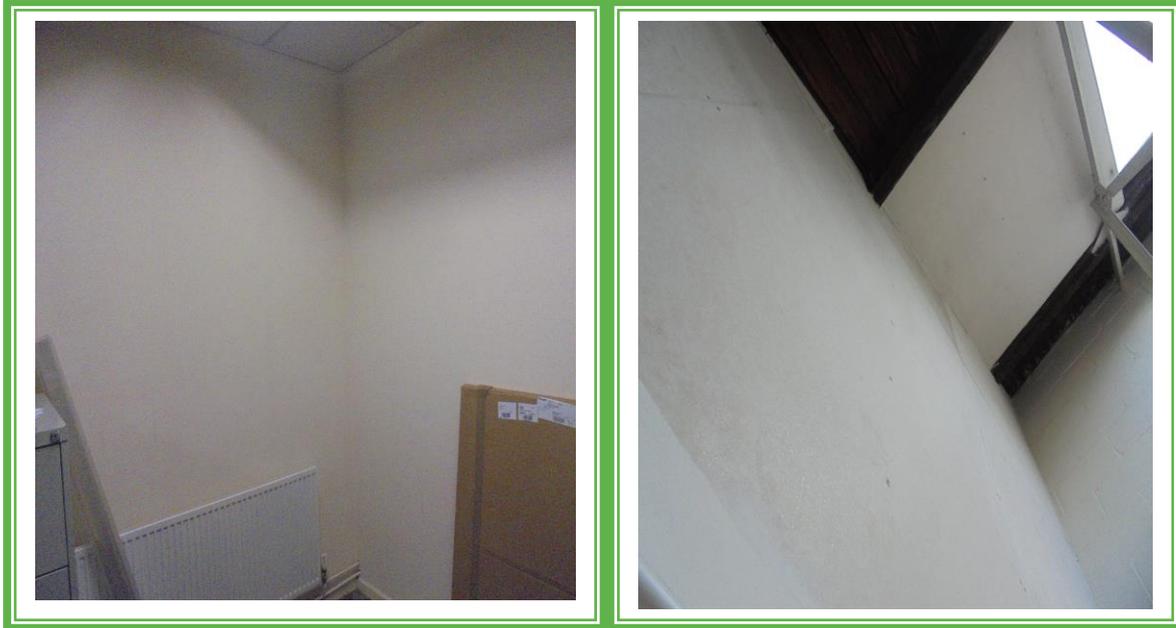
**Item No: 13**

**Location: Offices x 3 and Store**

<b>Material Description:</b>	Insulation board Wall and Ceiling panels above suspended ceiling	
<b>Identification:</b>	As Per Sample 4 – No Asbestos Detected	
<b>Approx. quantity:</b>	100M2+	
<b>Accessibility</b>	N/A	<i>Assessment Score</i>
<b>Product type:</b>		N/A
<b>Extent of Damage:</b>		N/A
<b>Surface Treatment:</b>		N/A
<b>Asbestos type:</b>		N/A
<b>Material Assessment Score:</b>		N/A
<b>Priority Assessment Score:</b>		N/A
<b>Action:</b>	N/A	
<b>Comments:</b>	N/A

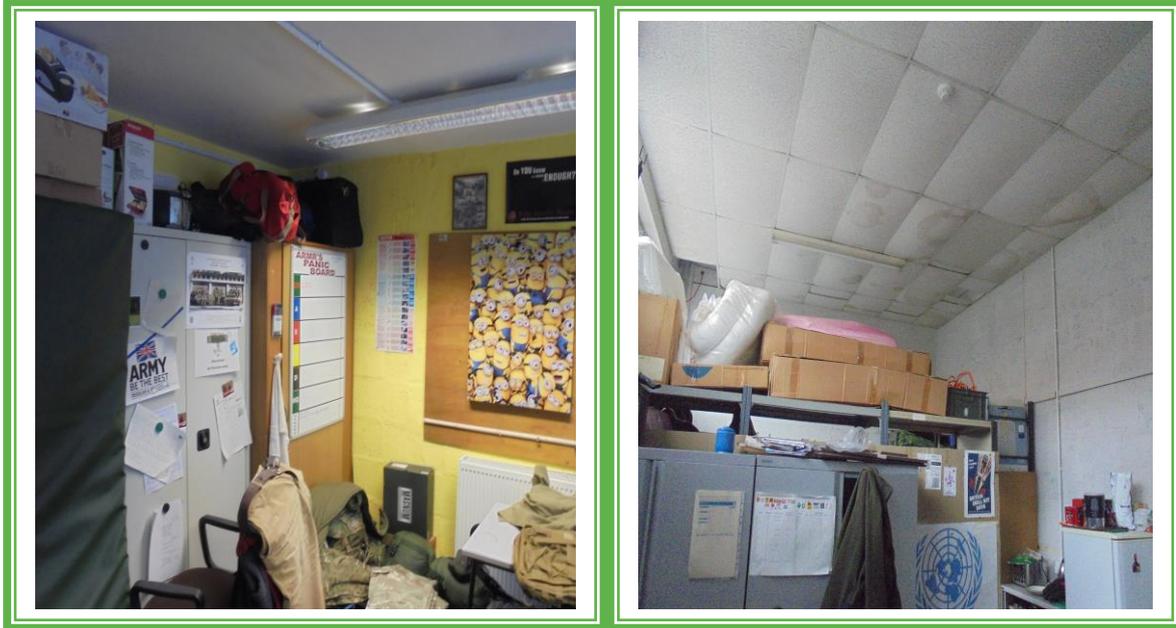
**Item No: 14**

**Location: Office and Store**

<b>Material Description:</b>	Visual Inspection – No Suspect Materials Found	
<b>Identification:</b>	N/A	
<b>Approx. quantity:</b>	N/A	
<b>Accessibility</b>	N/A	<i>Assessment Score</i>
<b>Product type:</b>	N/A	
<b>Extent of Damage:</b>	N/A	
<b>Surface Treatment:</b>	N/A	
<b>Asbestos type:</b>	N/A	
<b>Material Assessment Score:</b>		N/A
<b>Priority Assessment Score:</b>		N/A
<b>Action:</b>	N/A	
<b>Comments:</b>	Limited access above suspended ceiling due to height

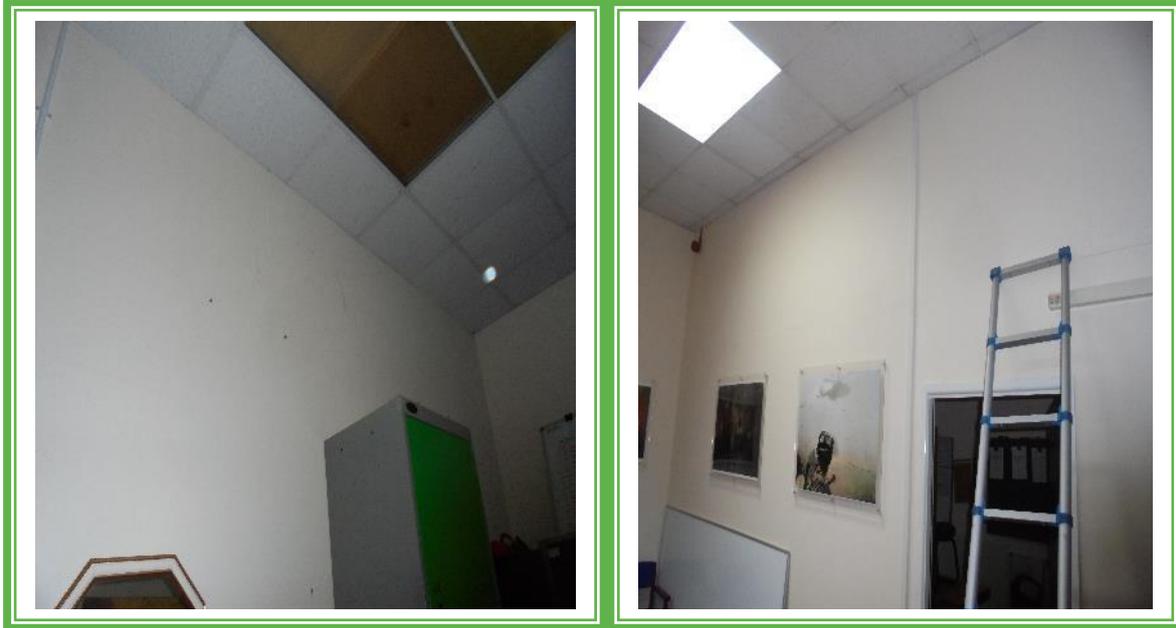
**Item No: 15**

**Location: Meeting Room, Office and Bedroom**

<b>Material Description:</b>	Insulation board Wall panels	
<b>Identification:</b>	As Per Sample 4 – No Asbestos Detected	
<b>Approx. quantity:</b>	60M2	
<b>Accessibility</b>	N/A	<i>Assessment Score</i>
<b>Product type:</b>		N/A
<b>Extent of Damage:</b>		N/A
<b>Surface Treatment:</b>		N/A
<b>Asbestos type:</b>		N/A
<b>Material Assessment Score:</b>		N/A
<b>Priority Assessment Score:</b>		N/A
<b>Action:</b>	N/A	
<b>Comments:</b>	N/A

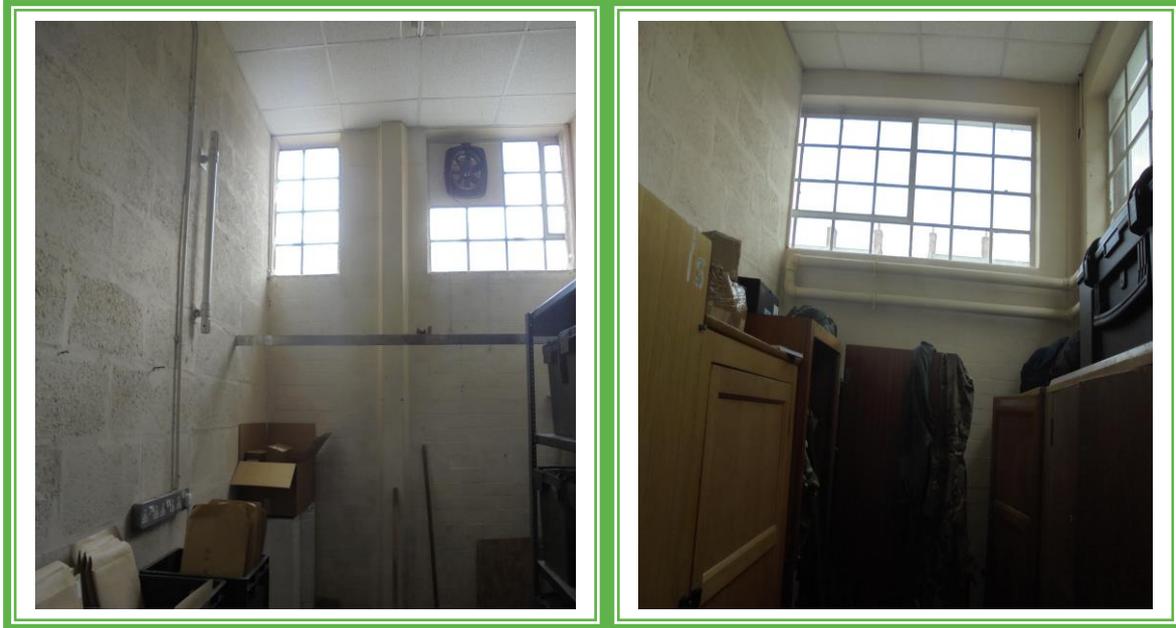
**Item No: 16**

**Location: Store x 2**

<b>Material Description:</b>	Visual Inspection – No Suspect Materials Found	
<b>Identification:</b>	N/A	
<b>Approx. quantity:</b>	N/A	
<b>Accessibility</b>	N/A	<i>Assessment Score</i>
<b>Product type:</b>	N/A	
<b>Extent of Damage:</b>	N/A	
<b>Surface Treatment:</b>	N/A	
<b>Asbestos type:</b>	N/A	
<b>Material Assessment Score:</b>		N/A
<b>Priority Assessment Score:</b>		N/A
<b>Action:</b>	N/A	
<b>Comments:</b>	N/A

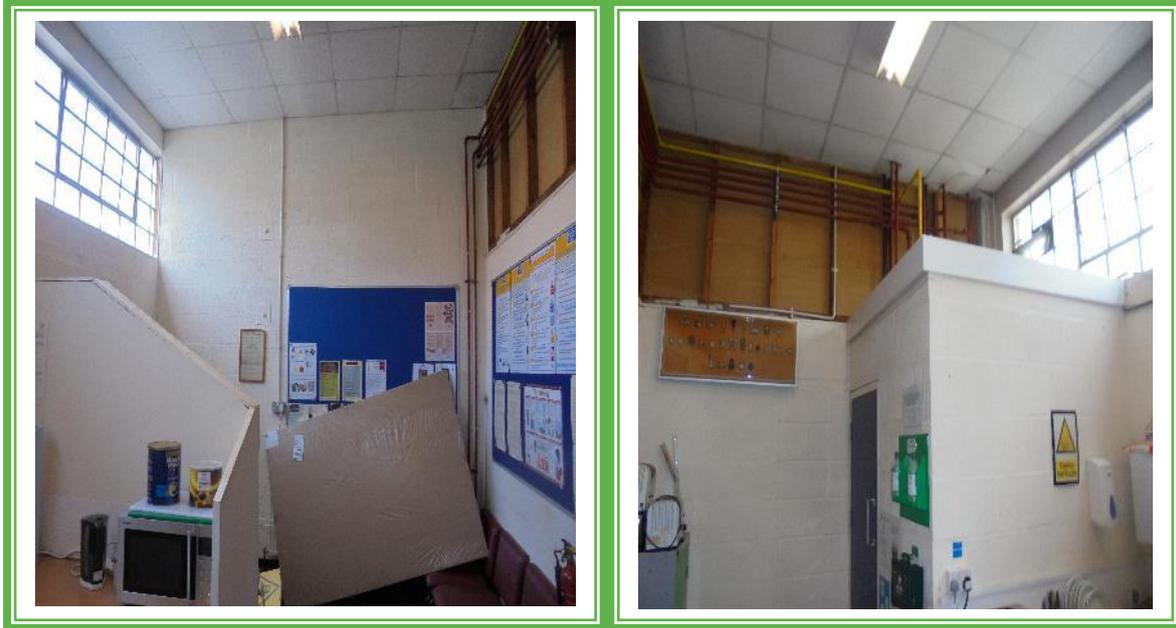
**Item No: 18**

**Location: Lobby and Kitchen**

<b>Material Description:</b>	Visual Inspection – No Suspect Materials Found	
<b>Identification:</b>	N/A	
<b>Approx. quantity:</b>	N/A	
<b>Accessibility</b>	N/A	<i>Assessment Score</i>
<b>Product type:</b>	N/A	
<b>Extent of Damage:</b>	N/A	
<b>Surface Treatment:</b>	N/A	
<b>Asbestos type:</b>	N/A	
<b>Material Assessment Score:</b>		N/A
<b>Priority Assessment Score:</b>		N/A
<b>Action:</b>	N/A	
<b>Comments:</b>	N/A

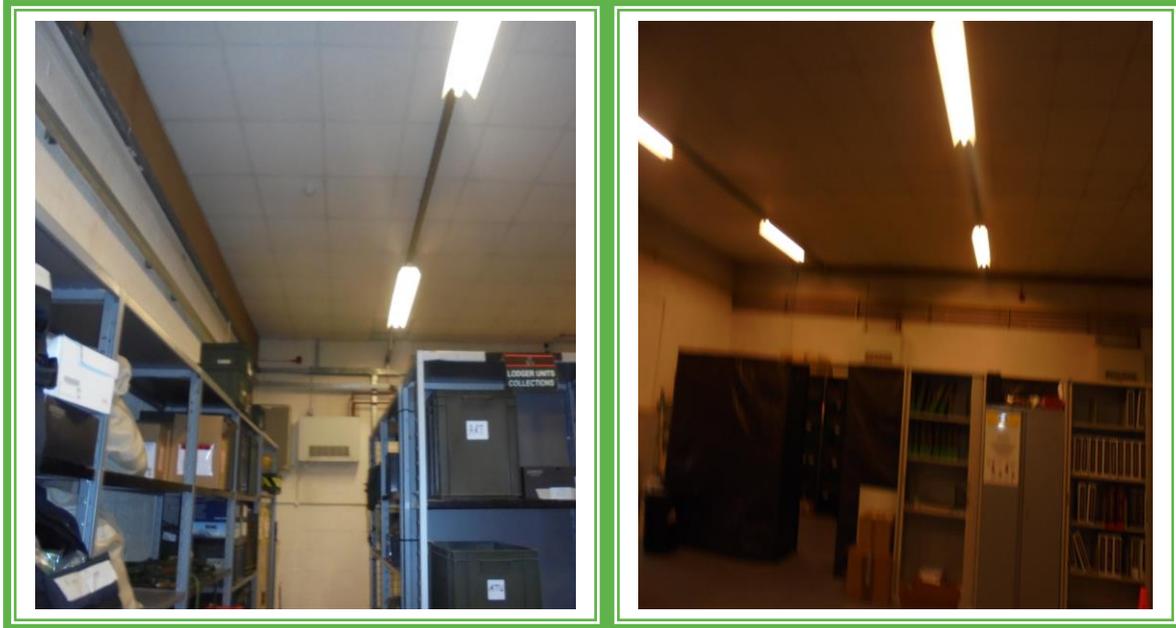
**Item No: 19**

**Location: Large Store**

<b>Material Description:</b>	Visual Inspection – No Suspect Materials Found	
<b>Identification:</b>	N/A	
<b>Approx. quantity:</b>	N/A	
<b>Accessibility</b>	N/A	<i>Assessment Score</i>
<b>Product type:</b>	N/A	
<b>Extent of Damage:</b>	N/A	
<b>Surface Treatment:</b>	N/A	
<b>Asbestos type:</b>	N/A	
<b>Material Assessment Score:</b>		N/A
<b>Priority Assessment Score:</b>		N/A
<b>Action:</b>	N/A	
<b>Comments:</b>	Non-asbestos Sabiana heaters on wall

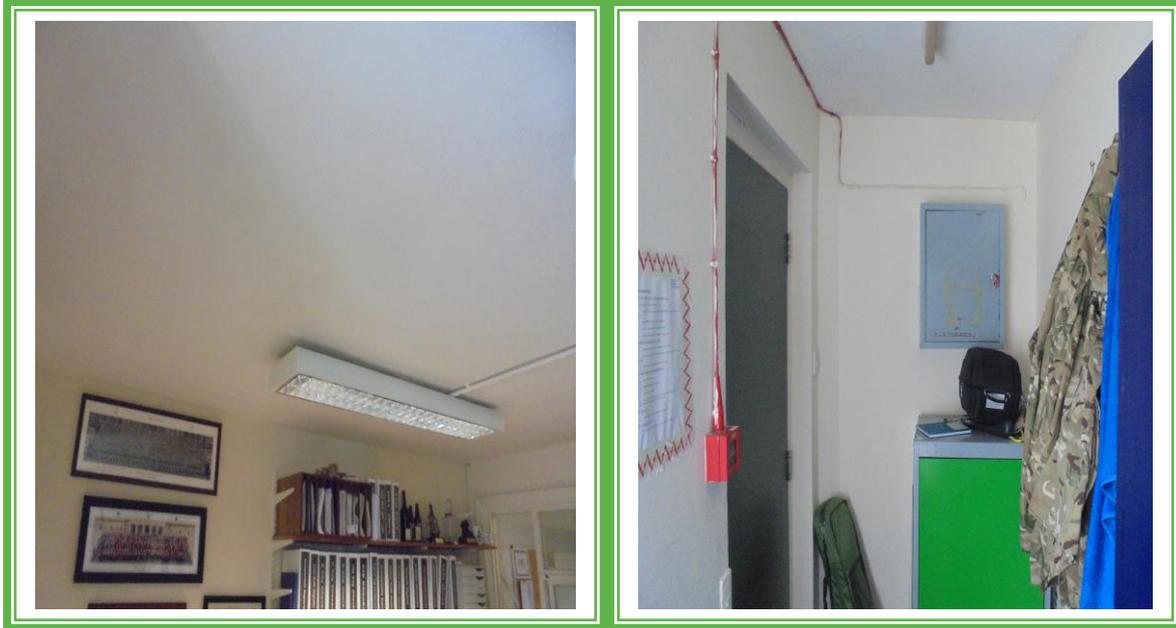
**Item No: 20**

**Location: Office and Stores x 2**

<b>Material Description:</b>	Visual Inspection – No Suspect Materials Found	
<b>Identification:</b>	N/A	
<b>Approx. quantity:</b>	N/A	
<b>Accessibility</b>	N/A	<i>Assessment Score</i>
<b>Product type:</b>	N/A	
<b>Extent of Damage:</b>	N/A	
<b>Surface Treatment:</b>	N/A	
<b>Asbestos type:</b>	N/A	
<b>Material Assessment Score:</b>		N/A
<b>Priority Assessment Score:</b>		N/A
<b>Action:</b>	N/A	
<b>Comments:</b>	N/A

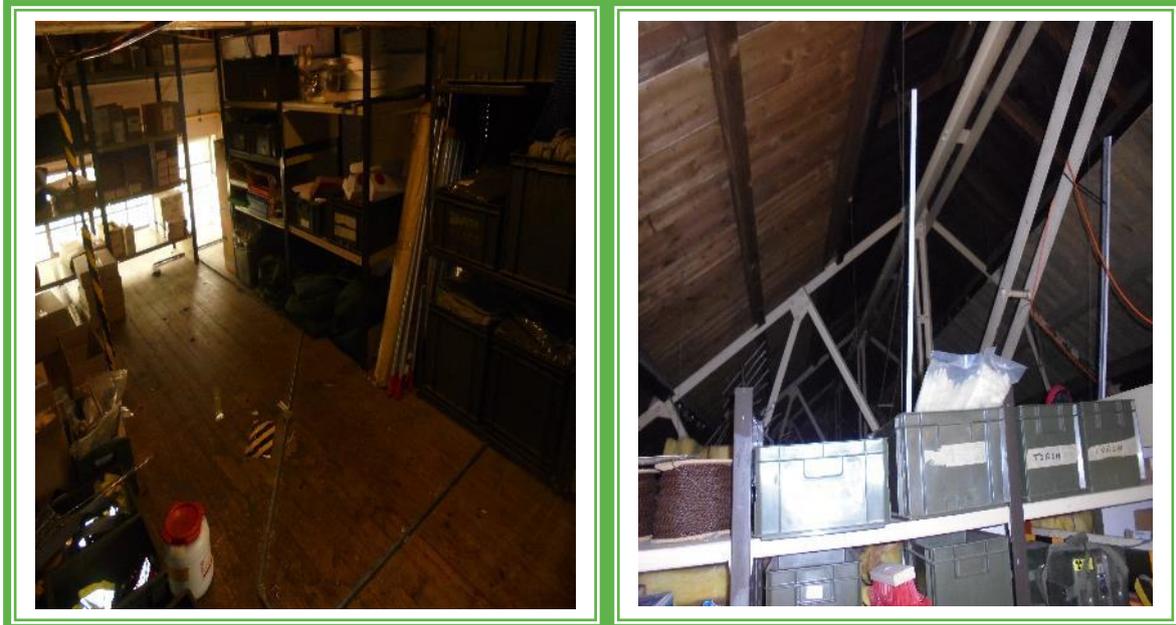
**Item No: 22**

**Location: Mezzanine and Loft Space**

<b>Material Description:</b>	Visual Inspection – No Suspect Materials Found	
<b>Identification:</b>	N/A	
<b>Approx. quantity:</b>	N/A	
<b>Accessibility</b>	N/A	<i>Assessment Score</i>
<b>Product type:</b>	N/A	
<b>Extent of Damage:</b>	N/A	
<b>Surface Treatment:</b>	N/A	
<b>Asbestos type:</b>	N/A	
<b>Material Assessment Score:</b>		N/A
<b>Priority Assessment Score:</b>		N/A
<b>Action:</b>	N/A	
<b>Comments:</b>	N/A

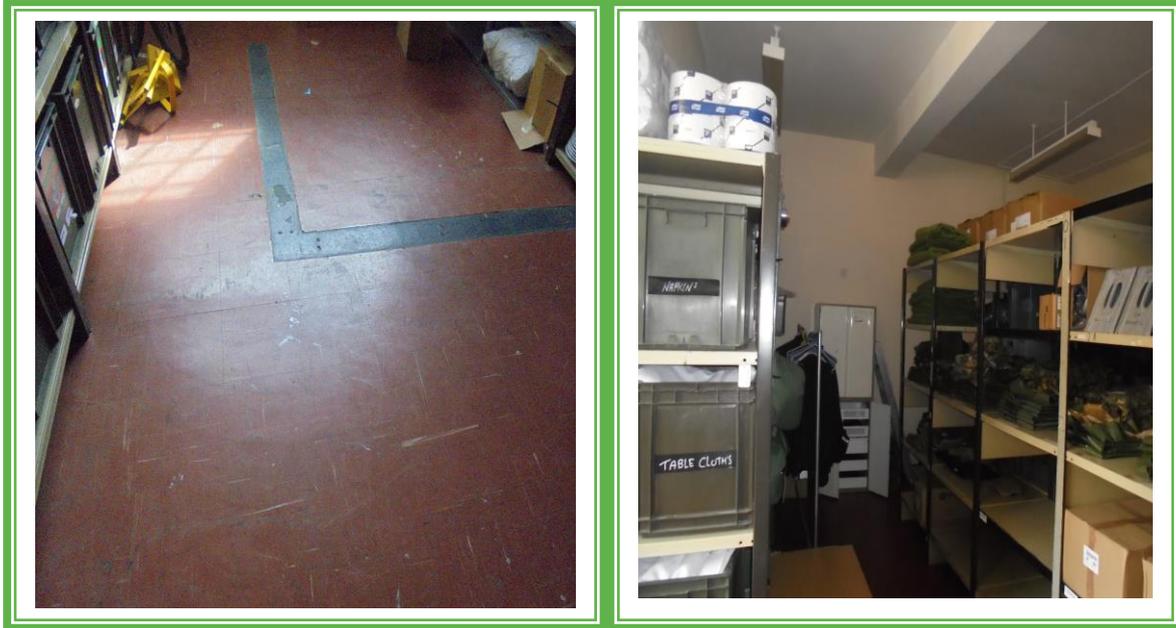
**Item No: 23**

**Location: Store**

<b>Material Description:</b>	Floor tiles and adhesive	
<b>Identification:</b>	Sampled – No Asbestos Detected	
<b>Approx. quantity:</b>	60M2	
<b>Accessibility</b>	N/A	<i>Assessment Score</i>
<b>Product type:</b>		N/A
<b>Extent of Damage:</b>		N/A
<b>Surface Treatment:</b>		N/A
<b>Asbestos type:</b>		N/A
<b>Material Assessment Score:</b>		N/A
<b>Priority Assessment Score:</b>		N/A
<b>Action:</b>	N/A	
<b>Comments:</b>	N/A

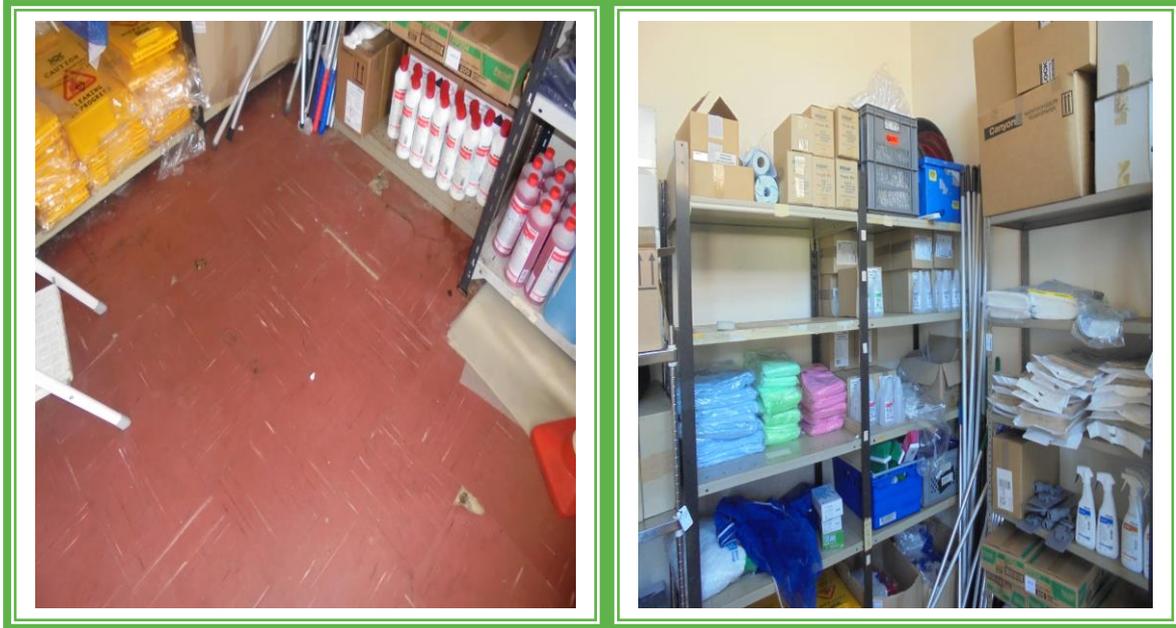
**Item No: 24**

**Location: Store**

<b>Material Description:</b>	Floor tiles and adhesive	
<b>Identification:</b>	As Per Sample 5 – No Asbestos Detected	
<b>Approx. quantity:</b>	16M2	
<b>Accessibility</b>	N/A	<i>Assessment Score</i>
<b>Product type:</b>		N/A
<b>Extent of Damage:</b>		N/A
<b>Surface Treatment:</b>		N/A
<b>Asbestos type:</b>		N/A
<b>Material Assessment Score:</b>		N/A
<b>Priority Assessment Score:</b>		N/A
<b>Action:</b>	N/A	
<b>Comments:</b>	N/A
