## **Project Number 2481**

### **Management Asbestos Survey Report**

**Wyvern Barracks, Barrack Road, Exeter, Devon,  
EX2 6AE (Building 22)**

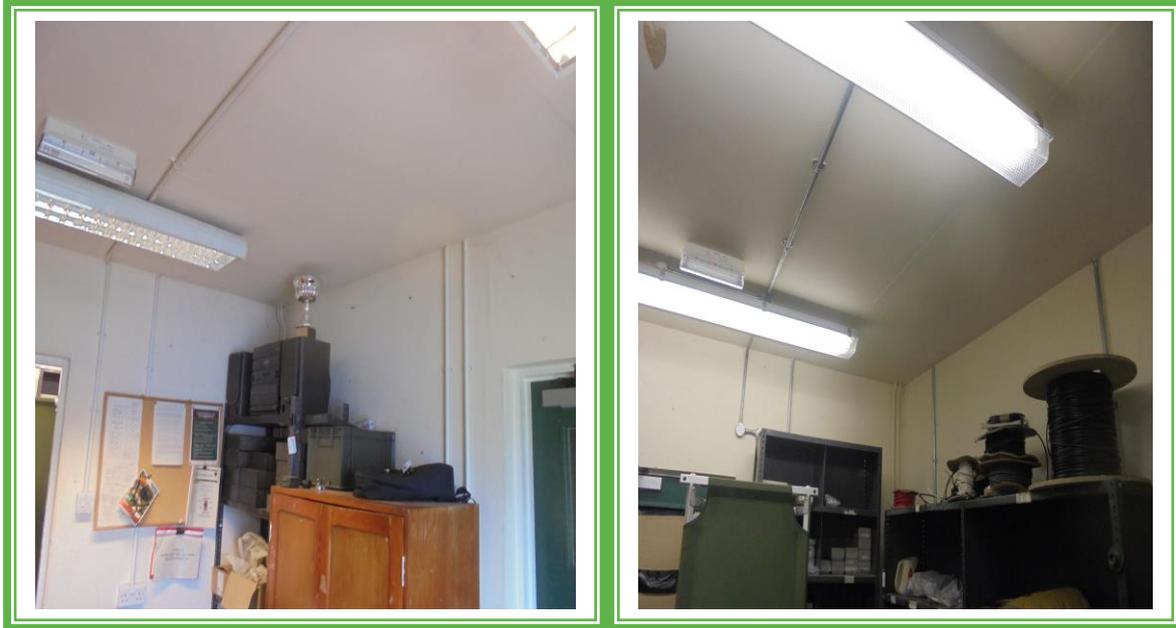
**Item No: 25**

**Location: Offices, Kitchen and Store**

<b>Material Description:</b>	Insulation board walls and ceiling	
<b>Identification:</b>	As Per Sample 4 – No Asbestos Detected	
<b>Approx. quantity:</b>	150M2 +	
<b>Accessibility</b>	N/A	<i>Assessment Score</i>
<b>Product type:</b>		N/A
<b>Extent of Damage:</b>		N/A
<b>Surface Treatment:</b>		N/A
<b>Asbestos type:</b>		N/A
<b>Material Assessment Score:</b>		N/A
<b>Priority Assessment Score:</b>		N/A
<b>Action:</b>	N/A	
<b>Comments:</b>	Modern Sink Pad in kitchen

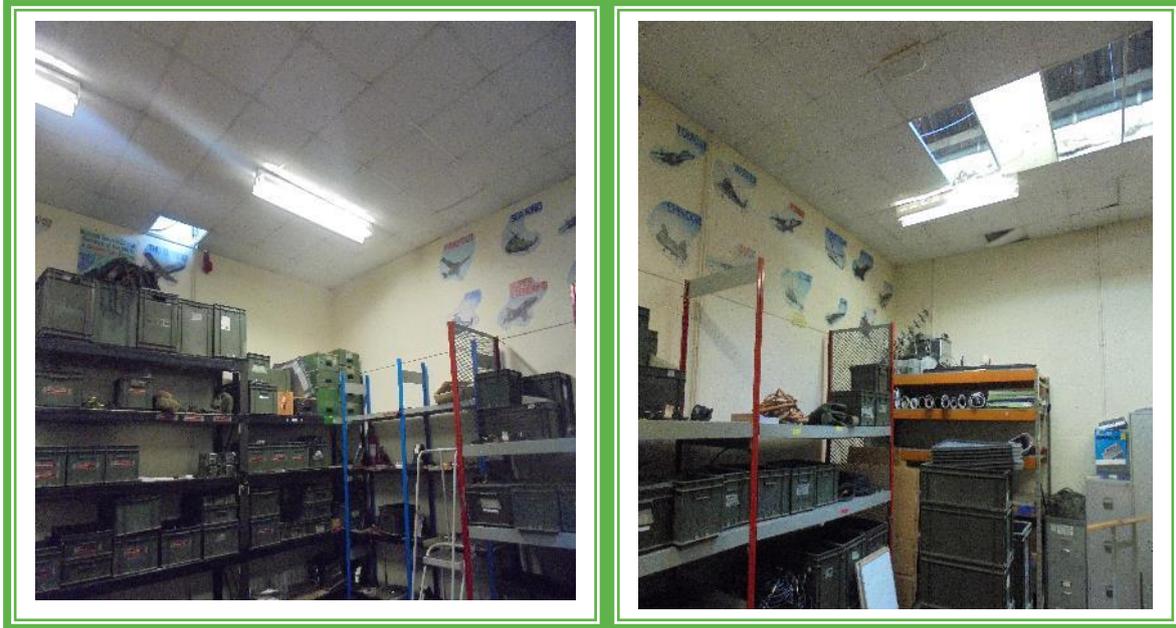
**Item No: 26**

**Location: Large Store**

<b>Material Description:</b>	Visual Inspection – No Suspect Materials Found	
<b>Identification:</b>	N/A	
<b>Approx. quantity:</b>	N/A	
<b>Accessibility</b>	N/A	<i>Assessment Score</i>
<b>Product type:</b>	N/A	
<b>Extent of Damage:</b>	N/A	
<b>Surface Treatment:</b>	N/A	
<b>Asbestos type:</b>	N/A	
<b>Material Assessment Score:</b>		N/A
<b>Priority Assessment Score:</b>		N/A
<b>Action:</b>	N/A	
<b>Comments:</b>	N/A

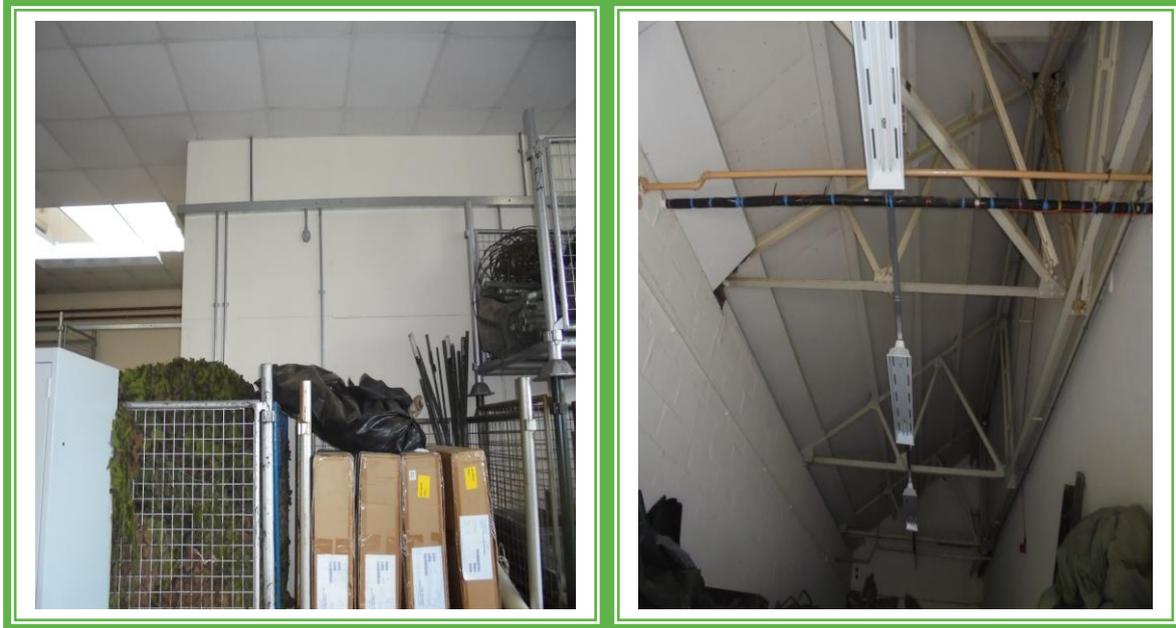
**Item No: 28**

**Location: Large Store rooms x 2**

<b>Material Description:</b>	Insulation board wall and ceiling panels	
<b>Identification:</b>	As Per Sample 4 – No Asbestos Detected	
<b>Approx. quantity:</b>	To several walls – 200M2+	
<b>Accessibility</b>	N/A	<i>Assessment Score</i>
<b>Product type:</b>		N/A
<b>Extent of Damage:</b>		N/A
<b>Surface Treatment:</b>		N/A
<b>Asbestos type:</b>		N/A
<b>Material Assessment Score:</b>		N/A
<b>Priority Assessment Score:</b>		N/A
<b>Action:</b>	N/A	
<b>Comments:</b>	N/A

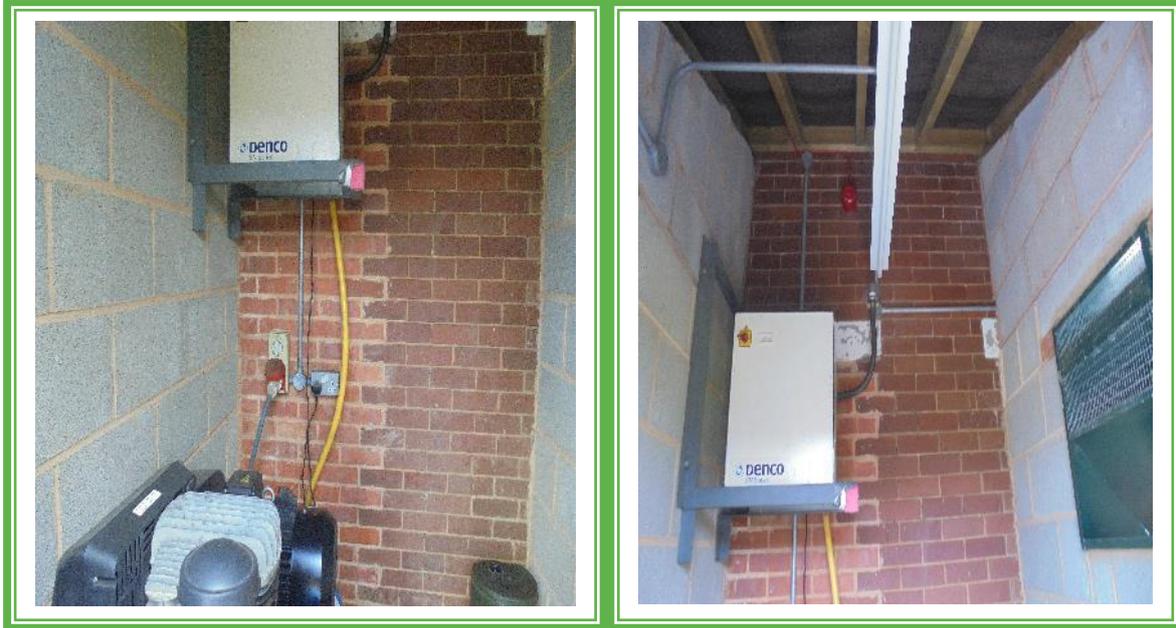
**Item No: 29**

**Location: Compressor Store**

<b>Material Description:</b>	Visual Inspection – No Suspect Materials Found	
<b>Identification:</b>	N/A	
<b>Approx. quantity:</b>	N/A	
<b>Accessibility</b>	N/A	<i>Assessment Score</i>
<b>Product type:</b>	N/A	
<b>Extent of Damage:</b>	N/A	
<b>Surface Treatment:</b>	N/A	
<b>Asbestos type:</b>	N/A	
<b>Material Assessment Score:</b>		N/A
<b>Priority Assessment Score:</b>		N/A
<b>Action:</b>	N/A	
<b>Comments:</b>	Non-asbestos roof felt and electrics
