Project Number A-00523 (3700)

**Re-Inspection
Asbestos Survey Report**

**6th Battalion the rifles D Company
Cornwall
TR1 1DF**

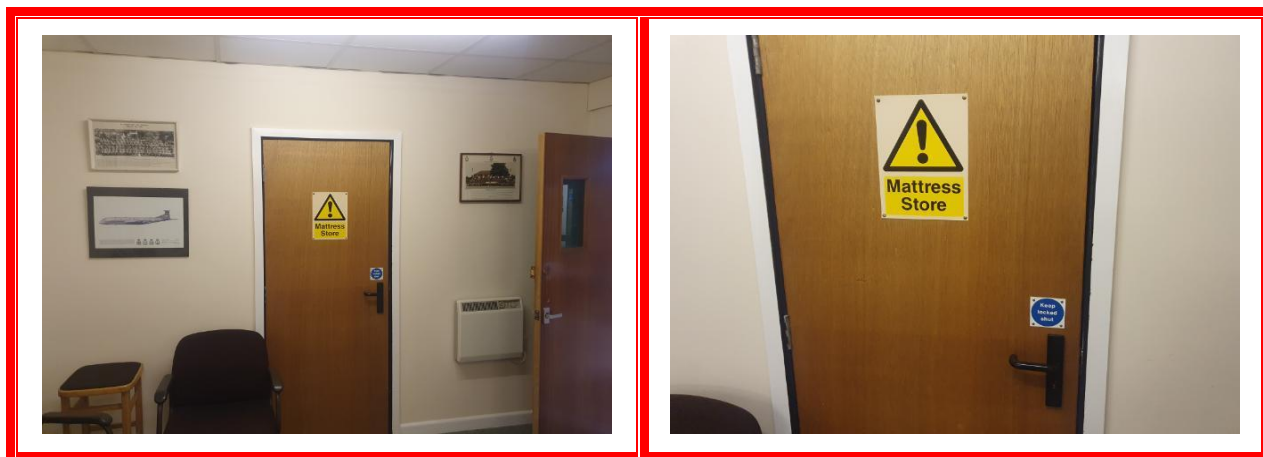
Item No:	1	Sample No:	N/A
Location:	Ground Floor - Mattress Store 001

Material Description:	All - No Access Gained	
Identification:	Presumed to Contain Asbestos	
Approx. quantity:	1 no	
Accessibility	Difficult	Assessment Score
Product type:	Pipe Insulation	3
Extent of Damage:	Major damage	3
Surface Treatment:	Unsealed Insulation	3
Asbestos type:	Amosite, Chrysotile, Crocidolite	3
Material Assessment Score:		12
Priority Assessment Score:		High
Action:	Further Investigation Needed	
Comments:	Locked. No one on site has access to room

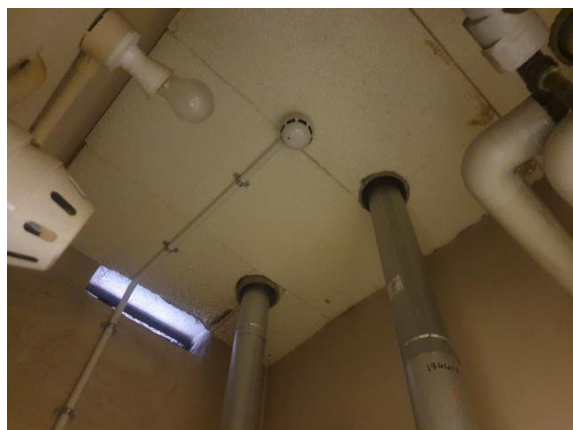
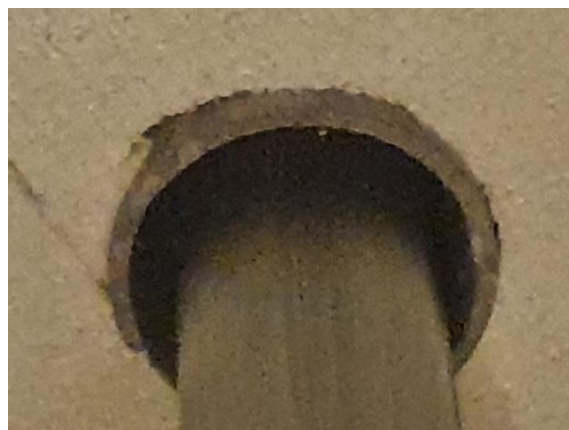
Location: Ground Floor - Boiler Room 002

Material Description:	Flue Pipes - Cement Product	
Identification:	Strongly Presumed to Contain Asbestos	
Approx. quantity:	3 no	
Accessibility	Difficult	<i>Assessment Score</i>
Product type:	Cement	1
Extent of Damage:	Slight / minor damage	1
Surface Treatment:	Unsealed Cement	1
Asbestos type:	Chrysotile	1
Material Assessment Score:		4
Priority Assessment Score:		Negligible
Action:	Manage	
Comments:	Located to the ceiling

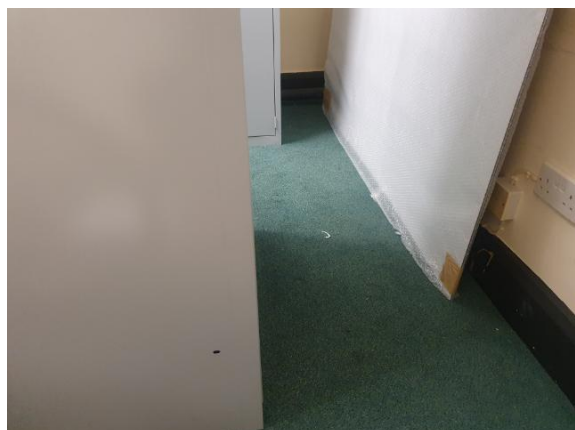
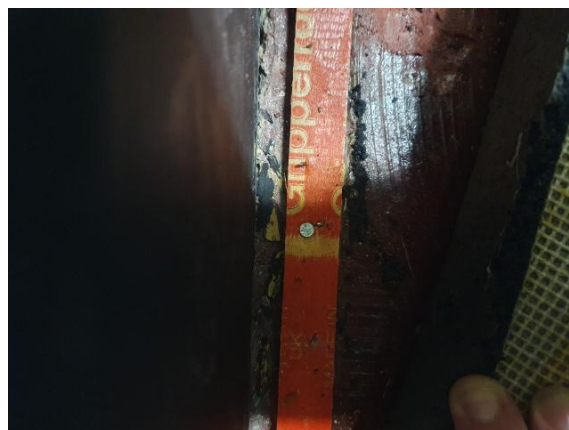
Location: Ground Floor - ACTO Store 006

Material Description:	Red Flooring under Carpet - Vinyl Products	
Identification:	Sampled - Asbestos Detected	
Approx. quantity:	12 m ²	
Accessibility	Difficult	Assessment Score
Product type:	Vinyl	1
Extent of Damage:	Slight / minor damage	1
Surface Treatment:	Non-friable	0
Asbestos type:	Chrysotile	1
Material Assessment Score:		3
Priority Assessment Score:		Negligible
Action:	Manage	
Comments:	N/A

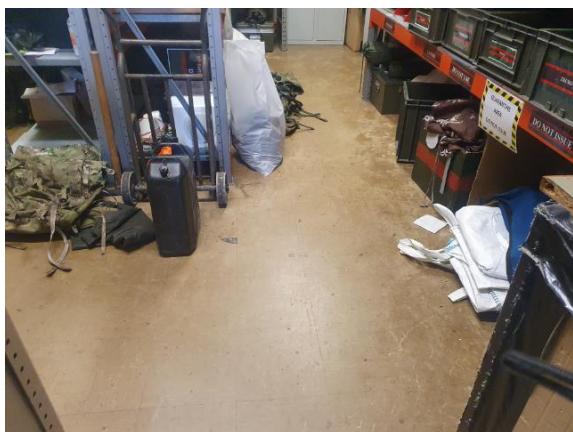
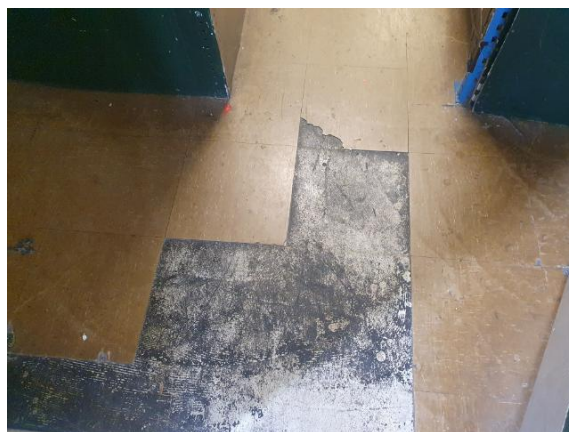
Location: Ground Floor - Equipment Store 007

Material Description:	Floor Tiles and Adhesive - Vinyl Products	
Identification:	Sampled - Asbestos Detected	
Approx. quantity:	40 m ²	
Accessibility	Easy	<i>Assessment Score</i>
Product type:	Vinyl	1
Extent of Damage:	Moderate damage	2
Surface Treatment:	Non-friable	0
Asbestos type:	Chrysotile	1
Material Assessment Score:		4
Priority Assessment Score:		Negligible
Action:	Manage	
Comments:	N/A

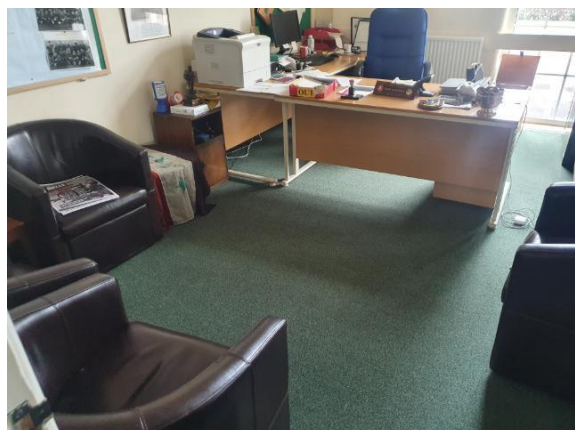
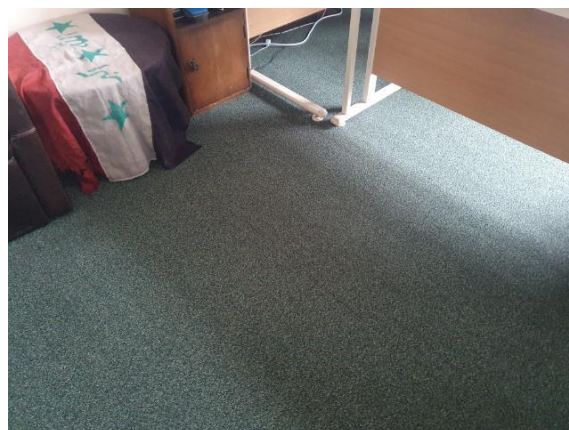
Location: First Floor - PSAO Office 008

Material Description:	Floor Tiles and Adhesive - Vinyl Products	
Identification:	Previously Sampled - Asbestos Detected	
Approx. quantity:	16 m ²	
Accessibility	Difficult	<i>Assessment Score</i>
Product type:	Vinyl	1
Extent of Damage:	Major damage	3
Surface Treatment:	Non-friable	0
Asbestos type:	Chrysotile	1
Material Assessment Score:		5
Priority Assessment Score:		Low
Action:	Manage	
Comments:	Previously sampled ref: Armour 28/1/20 Sample GR003. Now under carpet

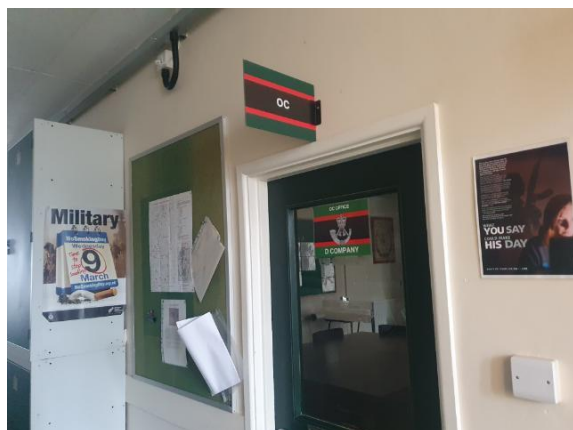
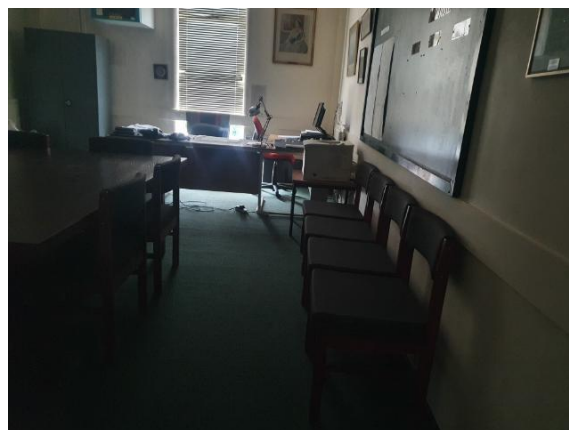
Location: First Floor - OC Office 009

Material Description:	Floor Tiles and Adhesive - Vinyl Products	
Identification:	Previously Sampled - Asbestos Detected	
Approx. quantity:	20 m ²	
Accessibility	Difficult	Assessment Score
Product type:	Vinyl	1
Extent of Damage:	Moderate damage	2
Surface Treatment:	Non-friable	0
Asbestos type:	Chrysotile	1
Material Assessment Score:		4
Priority Assessment Score:		Negligible
Action:	Manage	
Comments:	Previously sampled ref: Armour 28/1/20 Sample GR003. Now under carpet

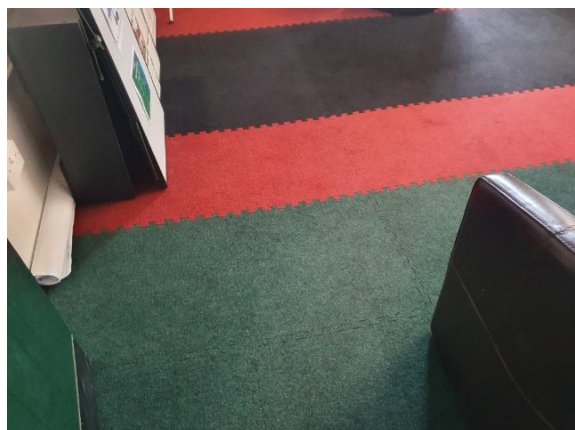
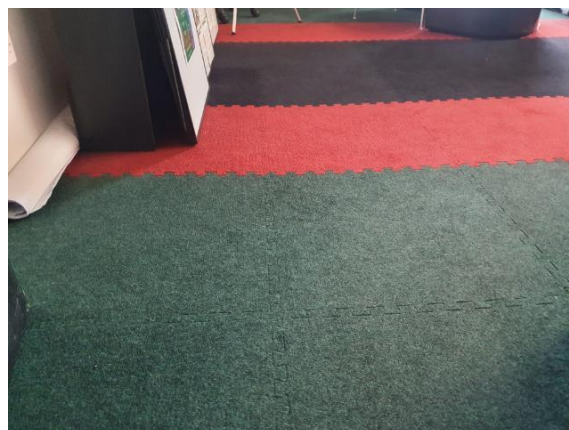
Location: First Floor - RRT Office 010

Material Description:	Floor Tiles and Adhesive - Vinyl Products	
Identification:	Previously Sampled - Asbestos Detected	
Approx. quantity:	12 m ²	
Accessibility	Difficult	<i>Assessment Score</i>
Product type:	Vinyl	1
Extent of Damage:	Moderate damage	2
Surface Treatment:	Non-friable	0
Asbestos type:	Chrysotile	1
Material Assessment Score:		4
Priority Assessment Score:		Negligible
Action:	Manage	
Comments:	Previously sampled ref: Armour 28/1/20 Sample GR003. Now under carpet

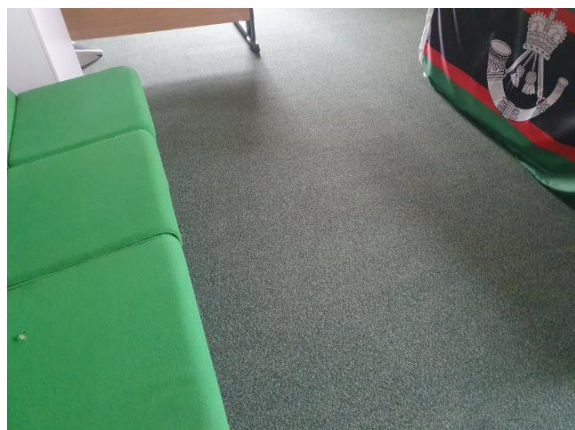
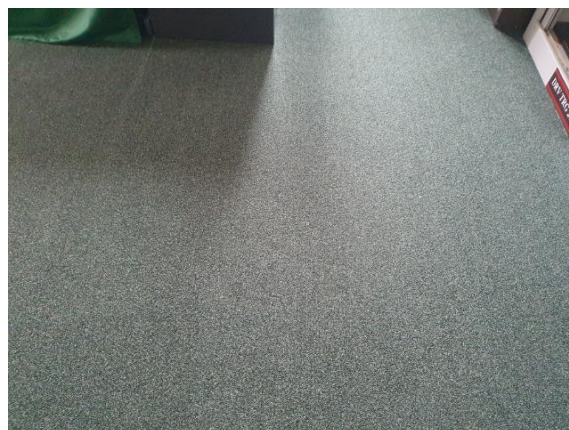
Location: First Floor - SPSI Office 011

Material Description:	Floor Tiles and Adhesive - Vinyl Products	
Identification:	Previously Sampled - Asbestos Detected	
Approx. quantity:	12 m ²	
Accessibility	Difficult	<i>Assessment Score</i>
Product type:	Vinyl	1
Extent of Damage:	Moderate damage	2
Surface Treatment:	Non-friable	0
Asbestos type:	Chrysotile	1
Material Assessment Score:		4
Priority Assessment Score:		Negligible
Action:	Manage	
Comments:	Previously sampled ref: Armour 28/1/20 Sample GR003. Now under carpet

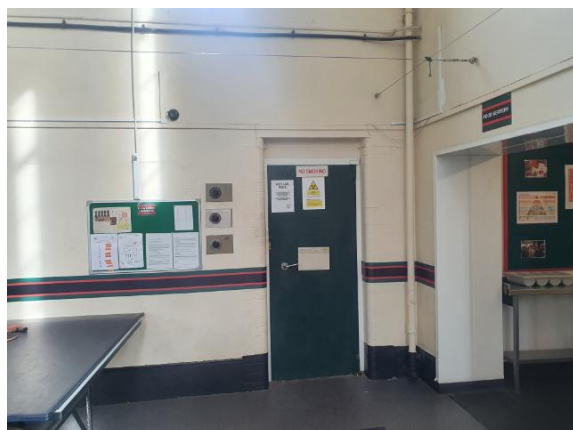
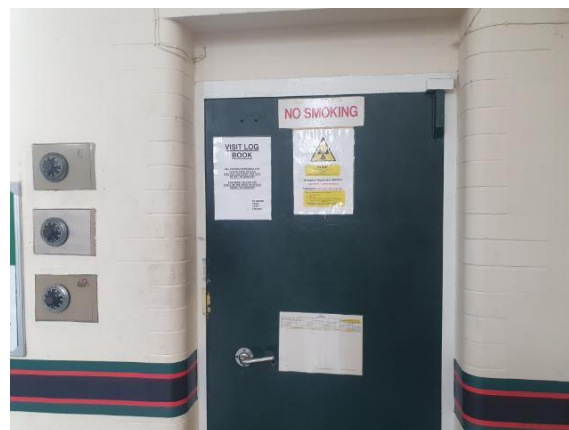
Location: Ground Floor - Armoury 012

Material Description:	All - No Access Gained	
Identification:	Presumed to Contain Asbestos	
Approx. quantity:	1 no	
Accessibility	Difficult	<i>Assessment Score</i>
Product type:	Pipe Insulation	3
Extent of Damage:	Major damage	3
Surface Treatment:	Unsealed Insulation	3
Asbestos type:	Amosite, Chrysotile, Crocidolite	3
Material Assessment Score:		12
Priority Assessment Score:		High
Action:	Further Investigation Needed	
Comments:	Locked. No one on site has access or authorisation to access room.

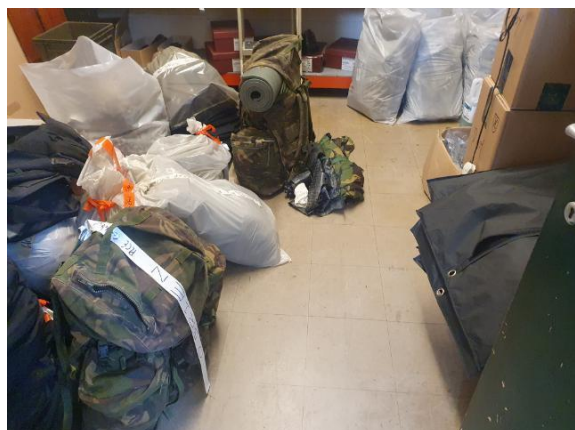
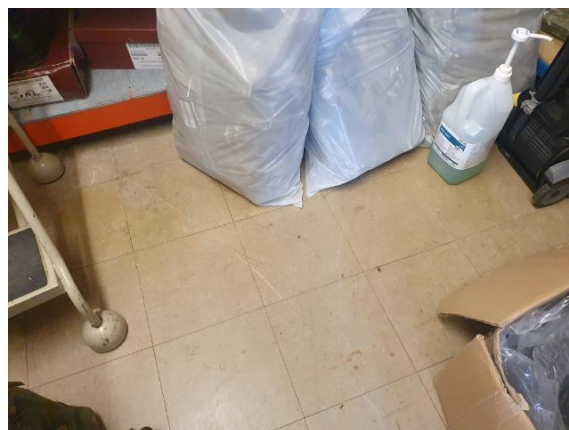
Location: Ground Floor - MSA Store 013

Material Description:	Floor Tiles and Adhesive - Vinyl Products	
Identification:	As Per Sample S003 - Asbestos Detected	
Approx. quantity:	20 m ²	
Accessibility	Easy	<i>Assessment Score</i>
Product type:	Vinyl	1
Extent of Damage:	Slight / minor damage	1
Surface Treatment:	Non-friable	0
Asbestos type:	Chrysotile	1
Material Assessment Score:		3
Priority Assessment Score:		Negligible
Action:	Manage	
Comments:	N/A

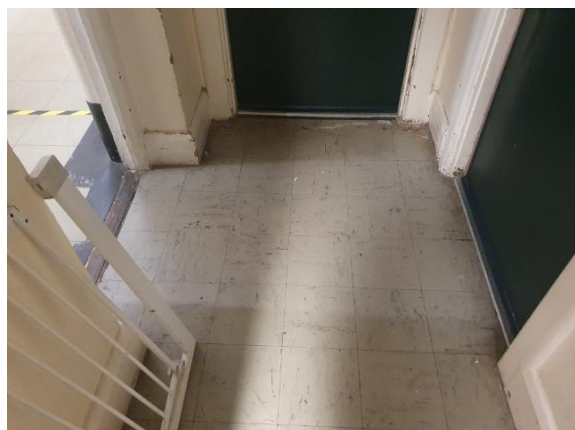
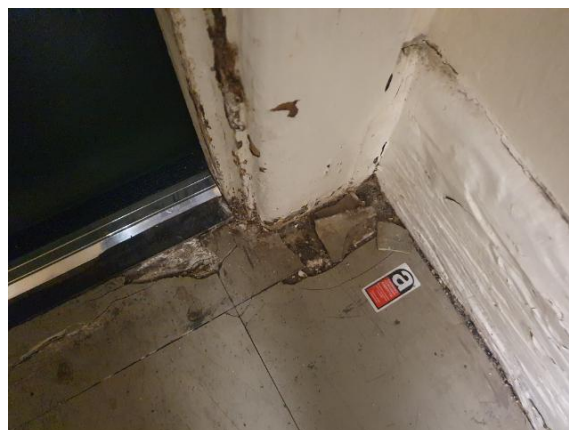
Location: Ground Floor - Admin Office Lobby 014

Material Description:	Floor Tiles and Adhesive - Vinyl Products	
Identification:	Previously Sampled - Asbestos Detected	
Approx. quantity:	2 m ²	
Accessibility	Easy	<i>Assessment Score</i>
Product type:	Vinyl	1
Extent of Damage:	Major damage	3
Surface Treatment:	Non-friable	0
Asbestos type:	Chrysotile	1
Material Assessment Score:		5
Priority Assessment Score:		Low
Action:	Remove	
Comments:	Previously sampled ref: Armour 28/1/20 Sample GR004. Several loose pieces of floor tile. Remove loose pieces and manage the rest of tiles

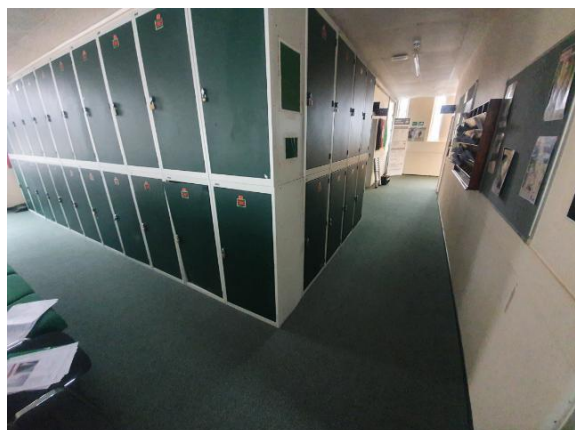
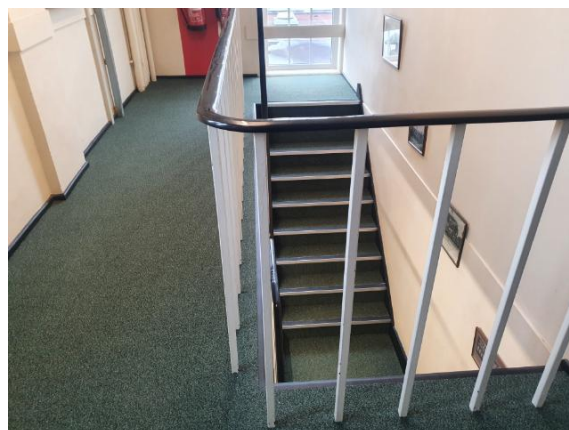
Location: First Floor - Corridor and Stairs 015

Material Description:	Floor Tiles and Adhesive - Vinyl Products	
Identification:	Previously Sampled - Asbestos Detected	
Approx. quantity:	30 m ²	
Accessibility	Difficult	<i>Assessment Score</i>
Product type:	Vinyl	1
Extent of Damage:	Major damage	3
Surface Treatment:	Non-friable	0
Asbestos type:	Chrysotile	1
Material Assessment Score:		5
Priority Assessment Score:		Low
Action:	Manage	
Comments:	Previously sampled ref: Armour 28/1/20 Sample GR003. Now under carpet

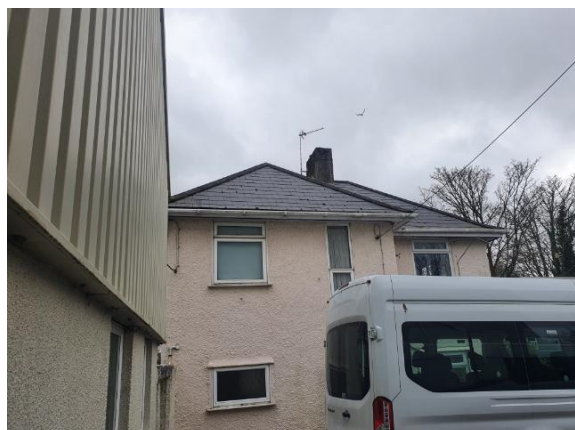
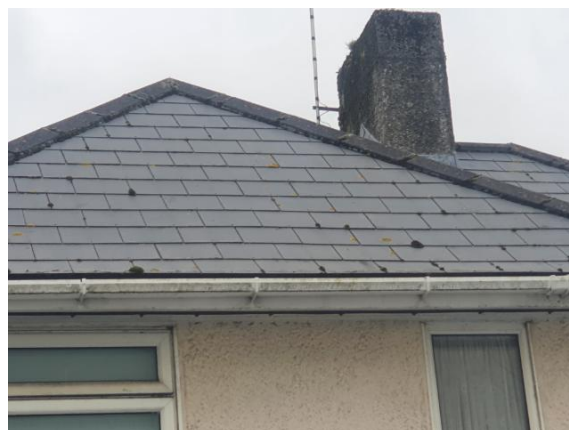
Location: External - Caretakers House 016

Material Description:	Roof Tiles - Cement Product	
Identification:	Presumed to Contain Asbestos	
Approx. quantity:	60 m ²	
Accessibility	Difficult	<i>Assessment Score</i>
Product type:	Cement	1
Extent of Damage:	Major damage	3
Surface Treatment:	Unsealed Insulation	3
Asbestos type:	Chrysotile	1
Material Assessment Score:		8
Priority Assessment Score:		Medium
Action:	Manage	
Comments:	N/A

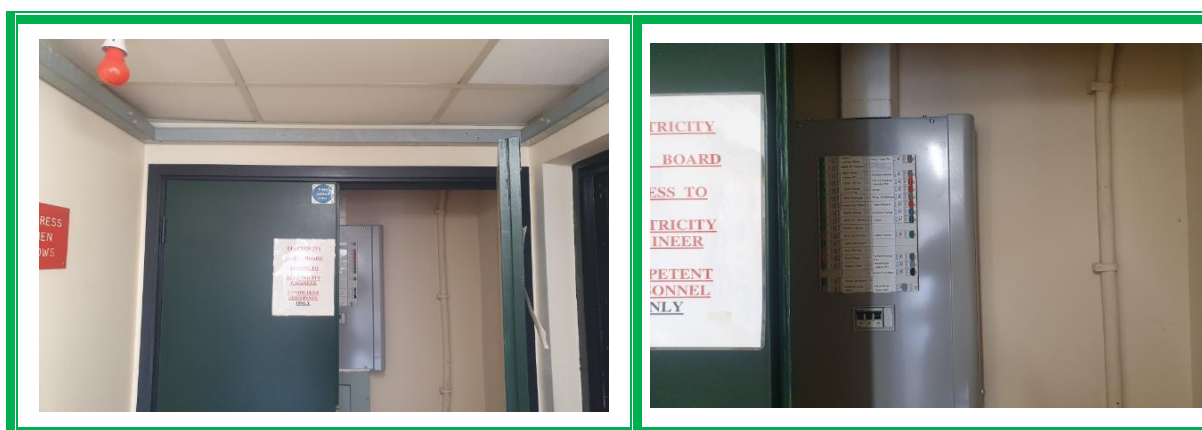
Item No:	3	Sample No:	N/A
Location:	Ground Floor - Electrical Cupboard 003

Material Description:	No Suspect Materials Found	
Identification:	N/A	
Approx. quantity:	N/A	
Accessibility	N/A	<i>Assessment Score</i>
Product type:	N/A	N/A
Extent of Damage:	N/A	N/A
Surface Treatment:	N/A	N/A
Asbestos type:	N/A	N/A
Material Assessment Score:		N/A
Priority Assessment Score:		N/A
Action:	N/A	
Comments:	Previously a no access area. Now accessed and no asbestos found. Non asbestos floor tiles and modern electrics

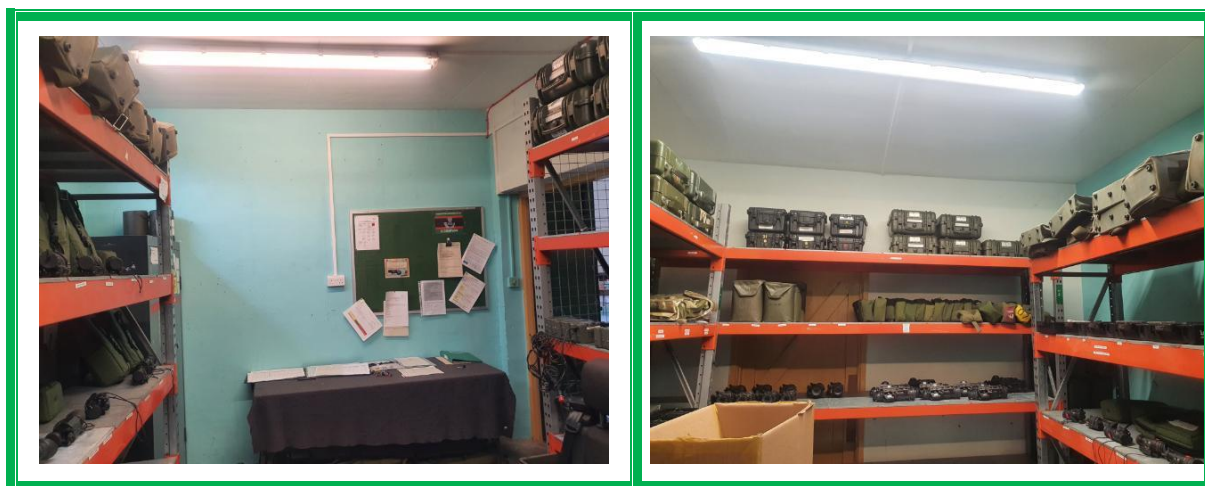
Location: Ground Floor - Signal Store 004

Material Description:	No Suspect Materials Found	
Identification:	N/A	
Approx. quantity:	N/A	
Accessibility	N/A	<i>Assessment Score</i>
Product type:	N/A	N/A
Extent of Damage:	N/A	N/A
Surface Treatment:	N/A	N/A
Asbestos type:	N/A	N/A
Material Assessment Score:		N/A
Priority Assessment Score:		N/A
Action:	N/A	
Comments:	Previously a no access area. Now accessed and no asbestos found

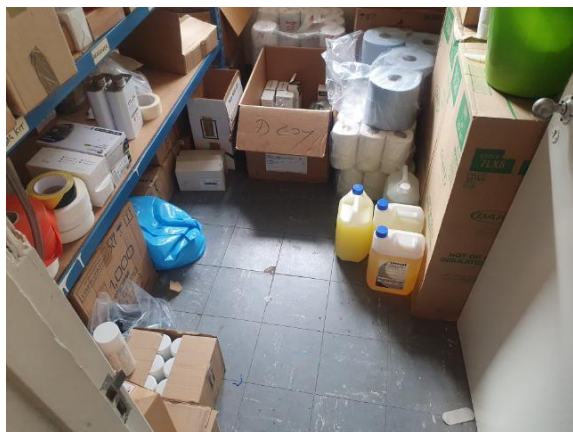
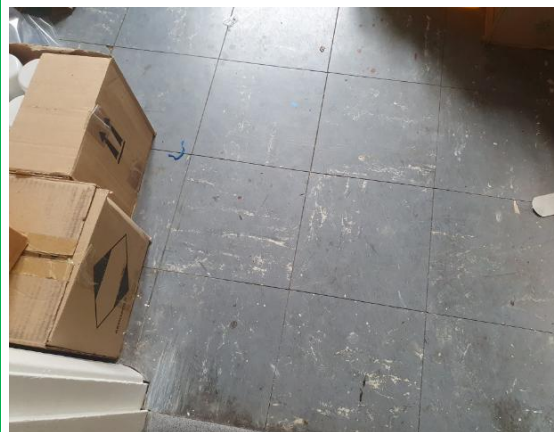
Location: Ground Floor - Flammable Store 005

Material Description:	Floor Tiles and Adhesive - Vinyl Products	
Identification:	Sampled - No Asbestos Found	
Approx. quantity:	N/A	
Accessibility	N/A	Assessment Score
Product type:	N/A	N/A
Extent of Damage:	N/A	N/A
Surface Treatment:	N/A	N/A
Asbestos type:	N/A	N/A
Material Assessment Score:		N/A
Priority Assessment Score:		N/A
Action:	N/A	
Comments:	N/A

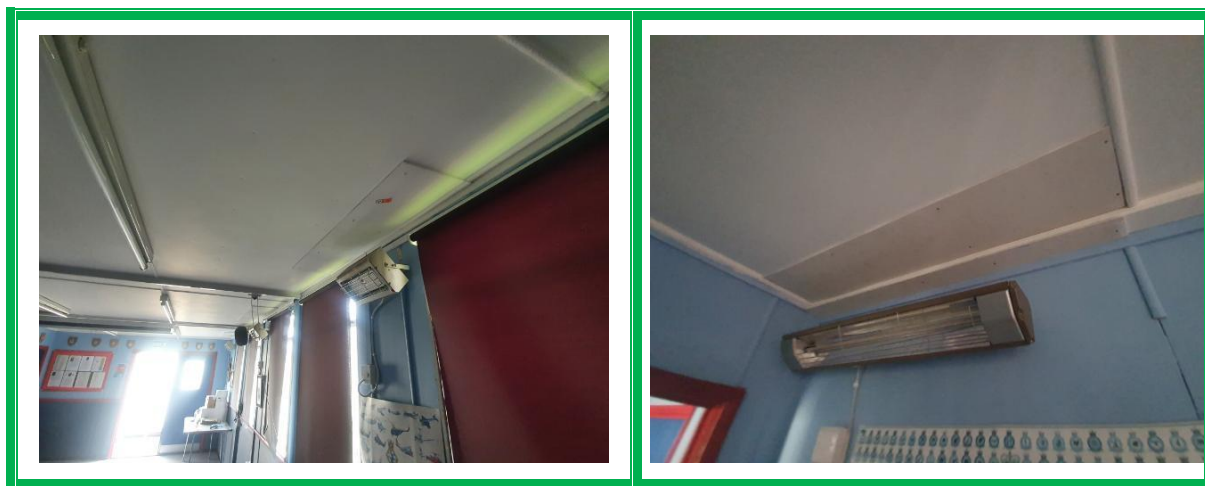
Location: Ground Floor - 730 Squadron Hut - Drill Hall and Classrooms 017

Material Description:	Panels on Ceilings - Insulating Board	
Identification:	Sampled - No Asbestos Found	
Approx. quantity:	N/A	
Accessibility	N/A	Assessment Score
Product type:	N/A	N/A
Extent of Damage:	N/A	N/A
Surface Treatment:	N/A	N/A
Asbestos type:	N/A	N/A
Material Assessment Score:		N/A
Priority Assessment Score:		N/A
Action:	N/A	
Comments:	Panels are non-asbestos Supalux but have been sampled as there are asbestos stickers on the panels. 8no panels

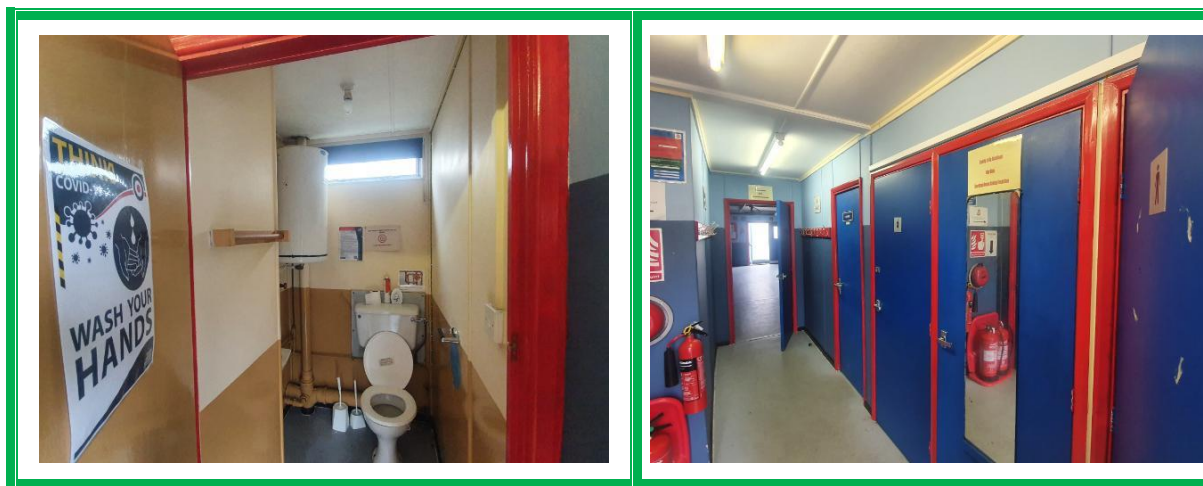
Location: Ground Floor - 730 Squadron Hut - WC's, Cupboard and Kitchen 018

Material Description:	No Suspect Materials Found	
Identification:	N/A	
Approx. quantity:	N/A	
Accessibility	N/A	<i>Assessment Score</i>
Product type:	N/A	N/A
Extent of Damage:	N/A	N/A
Surface Treatment:	N/A	N/A
Asbestos type:	N/A	N/A
Material Assessment Score:		N/A
Priority Assessment Score:		N/A
Action:	N/A	
Comments:	Previously a no access area. Now accessed and no asbestos found. Modern sink pad in kitchen

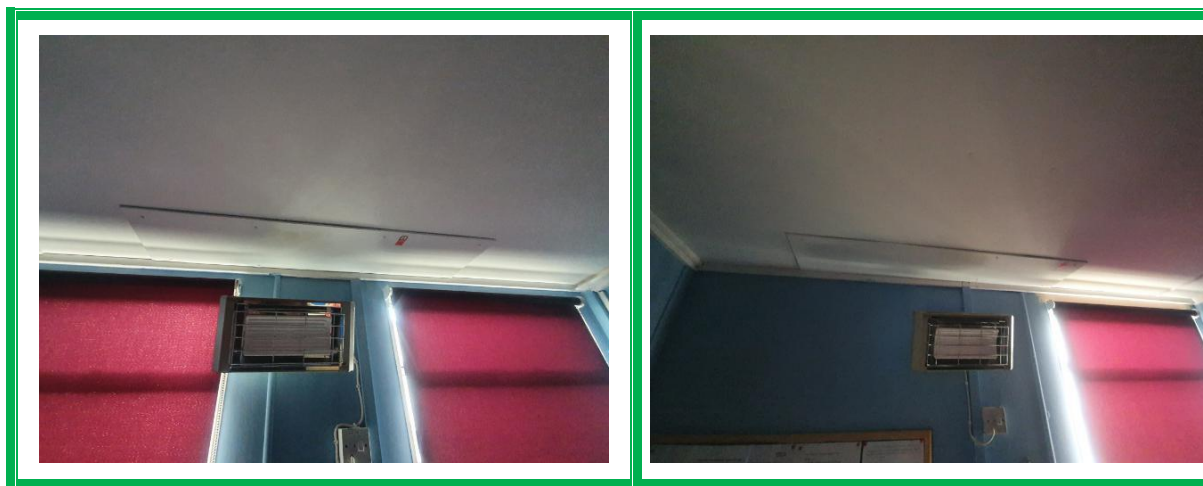
Item No:	19	Sample No:	N/A
Location:	Ground Floor - 730 Squadron Hut - Offices and Store 019

Material Description:	Panels on Ceilings - Insulating Board	
Identification:	As per sample S004 - No Asbestos Found	
Approx. quantity:	N/A	
Accessibility	N/A	<i>Assessment Score</i>
Product type:	N/A	N/A
Extent of Damage:	N/A	N/A
Surface Treatment:	N/A	N/A
Asbestos type:	N/A	N/A
Material Assessment Score:		N/A
Priority Assessment Score:		N/A
Action:	N/A	
Comments:	Panels are non-asbestos Supalux but have been sampled as there are asbestos stickers on the panels. 2no panels

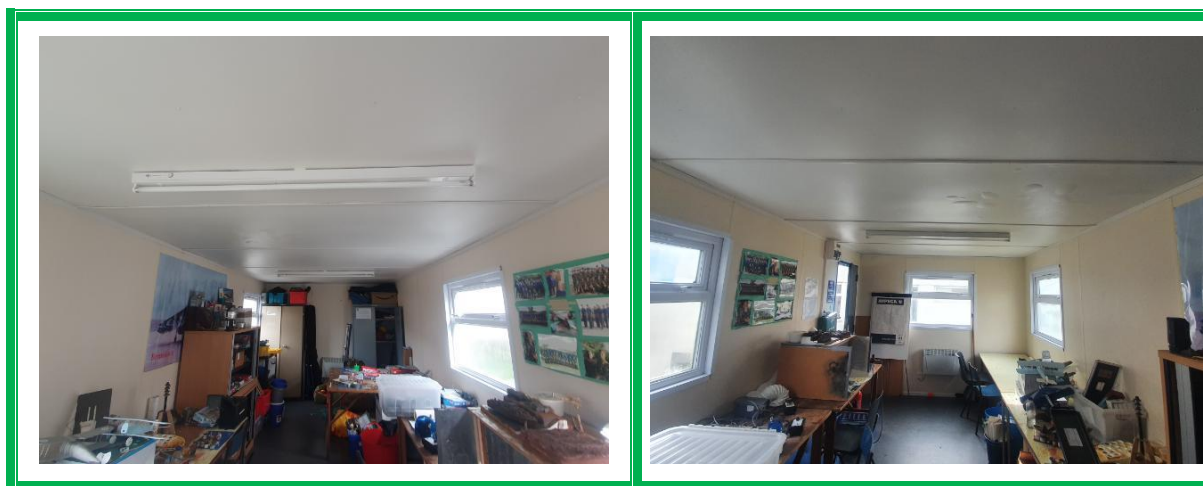
Item No:	20	Sample No:	N/A
Location:	Ground Floor - Modelling Hut - Classroom 3 020

Material Description:	No Suspect Materials Found	
Identification:	N/A	
Approx. quantity:	N/A	
Accessibility	N/A	<i>Assessment Score</i>
Product type:	N/A	N/A
Extent of Damage:	N/A	N/A
Surface Treatment:	N/A	N/A
Asbestos type:	N/A	N/A
Material Assessment Score:		N/A
Priority Assessment Score:		N/A
Action:	N/A	
Comments:	Previously a no access area. Now accessed and no asbestos found
