**Project Number 3700**

**Re-Inspection  
Asbestos Survey Report**

**675 Army Air Corps  
Somerset  
TA1 5LJ**

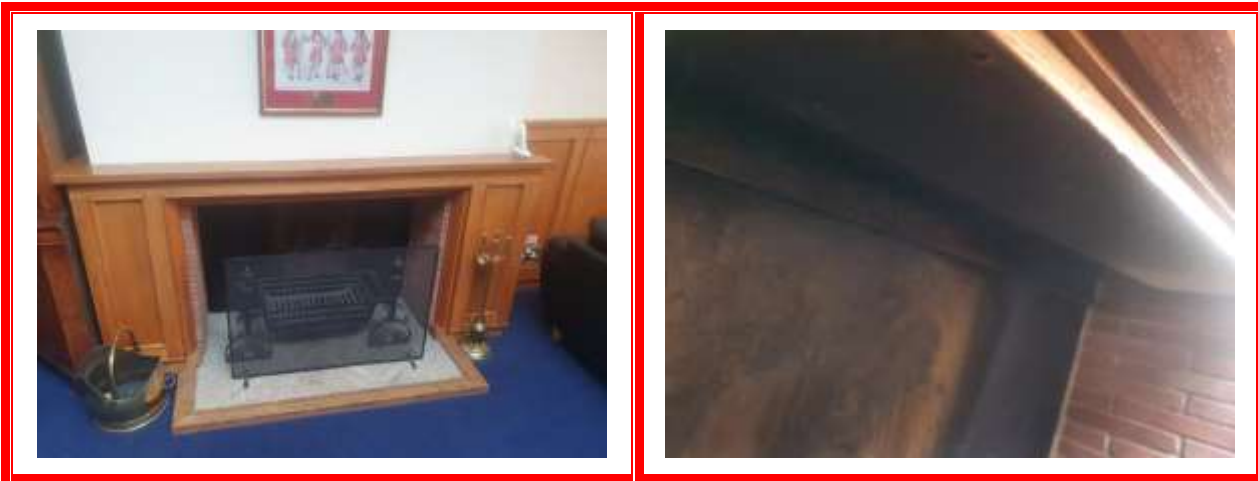
<b>Item No:</b>	<b>1</b>	<b>Sample No:</b>	<b>N/A</b>
<b>Location:</b>	First Floor - Officers Lounge 001

<b>Material Description:</b>	Panel to Top of Fireplace - Cement Product	
<b>Identification:</b>	Previously Sampled - Asbestos Detected	
<b>Approx. quantity:</b>	1 m <sup>2</sup>	
<b>Accessibility</b>	Difficult	Assessment Score
<b>Product type:</b>	Cement	1
<b>Extent of Damage:</b>	Slight / minor damage	1
<b>Surface Treatment:</b>	Unsealed Cement	1
<b>Asbestos type:</b>	Chrysotile	1
<b>Material Assessment Score:</b>		4
<b>Priority Assessment Score:</b>		Negligible
<b>Action:</b>	Encapsulate	
<b>Comments:</b>	Previously sampled ref: Armour 18/6/19 Sample DK/1

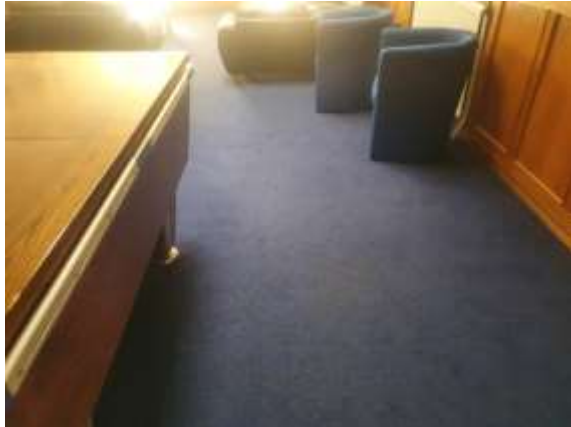
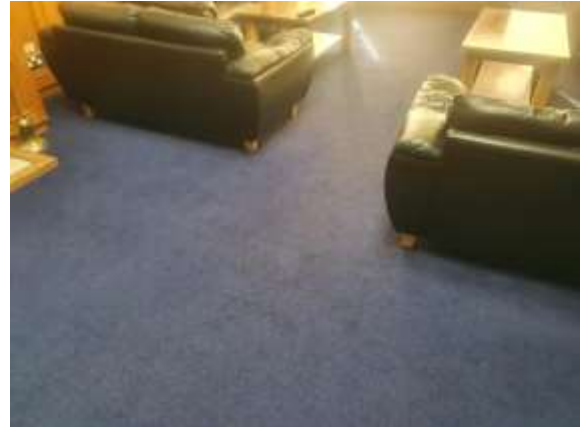
**Location:** First Floor - Officers Lounge 002

<b>Material Description:</b>	Floor Tiles - Vinyl Products	
<b>Identification:</b>	Previously Sampled - Asbestos Detected	
<b>Approx. quantity:</b>	50 m <sup>2</sup>	
<b>Accessibility</b>	Difficult	<i>Assessment Score</i>
<b>Product type:</b>	Vinyl	1
<b>Extent of Damage:</b>	Slight / minor damage	1
<b>Surface Treatment:</b>	Non-friable	0
<b>Asbestos type:</b>	Chrysotile	1
<b>Material Assessment Score:</b>		3
<b>Priority Assessment Score:</b>		Negligible
<b>Action:</b>	Manage	
<b>Comments:</b>	Previously sampled ref: Armour 18/6/19 Sample DK/2. Under carpet

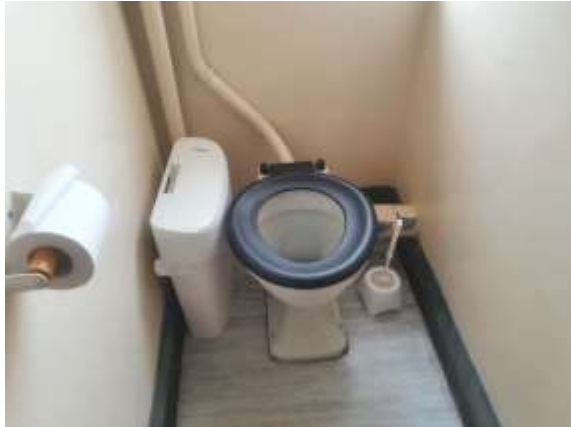
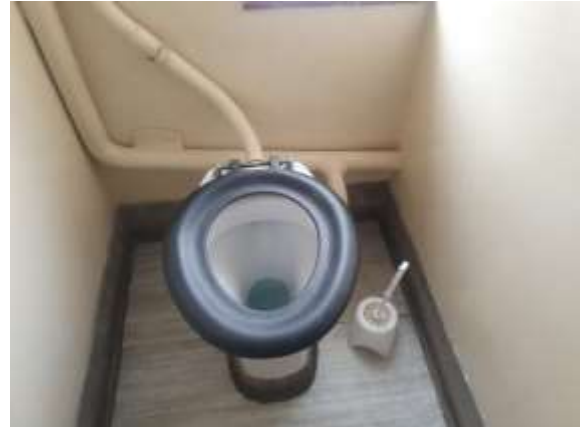
**Location:** First Floor - WC's x 2 003

<b>Material Description:</b>	Toilet Seats - PVC / Reinforced Plastics	
<b>Identification:</b>	Presumed to Contain Asbestos	
<b>Approx. quantity:</b>	2 no	
<b>Accessibility</b>	Easy	<i>Assessment Score</i>
<b>Product type:</b>	Bakelite	1
<b>Extent of Damage:</b>	Major damage	3
<b>Surface Treatment:</b>	Unsealed Insulation	3
<b>Asbestos type:</b>	Chrysotile	1
<b>Material Assessment Score:</b>		8
<b>Priority Assessment Score:</b>		Medium
<b>Action:</b>	Manage	
<b>Comments:</b>	Not possible to sample as may damage integrity of the seats

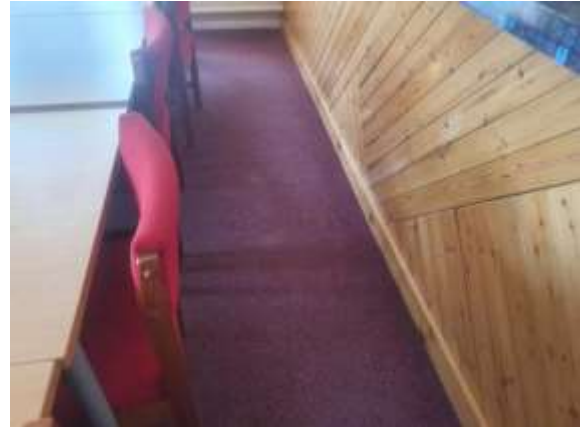
**Location:** First Floor - Conference Room 004

<b>Material Description:</b>	Floor Tiles - Vinyl Products	
<b>Identification:</b>	Previously Sampled - Asbestos Detected	
<b>Approx. quantity:</b>	35 m <sup>2</sup>	
<b>Accessibility</b>	Difficult	<i>Assessment Score</i>
<b>Product type:</b>	Vinyl	1
<b>Extent of Damage:</b>	Slight / minor damage	1
<b>Surface Treatment:</b>	Non-friable	0
<b>Asbestos type:</b>	Chrysotile	1
<b>Material Assessment Score:</b>		3
<b>Priority Assessment Score:</b>		Negligible
<b>Action:</b>	Manage	
<b>Comments:</b>	Previously sampled ref: Armour 18/6/19 Sample DK/4. Under carpet

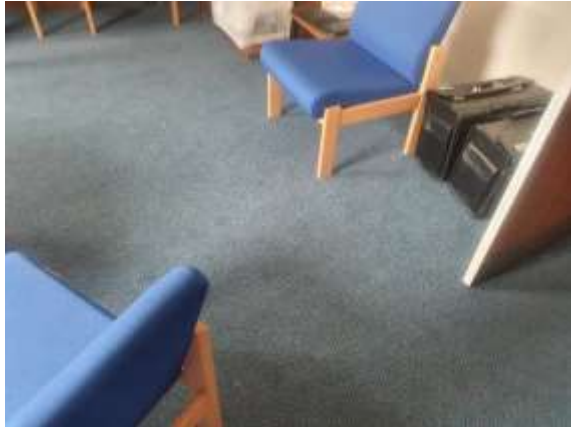
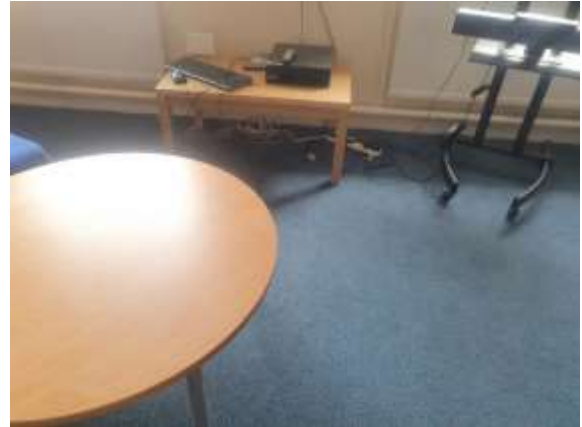
**Location:** First Floor - Harding Room 005

<b>Material Description:</b>	Floor Tiles - Vinyl Products	
<b>Identification:</b>	Previously Sampled - Asbestos Detected	
<b>Approx. quantity:</b>	36 m <sup>2</sup>	
<b>Accessibility</b>	Difficult	<i>Assessment Score</i>
<b>Product type:</b>	Vinyl	1
<b>Extent of Damage:</b>	Slight / minor damage	1
<b>Surface Treatment:</b>	Non-friable	0
<b>Asbestos type:</b>	Chrysotile	1
<b>Material Assessment Score:</b>		3
<b>Priority Assessment Score:</b>		Negligible
<b>Action:</b>	Manage	
<b>Comments:</b>	Previously sampled ref: Armour 18/6/19 Sample DK/6. Under carpet

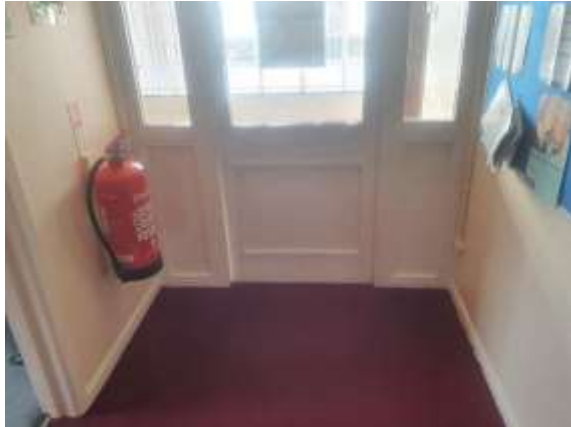
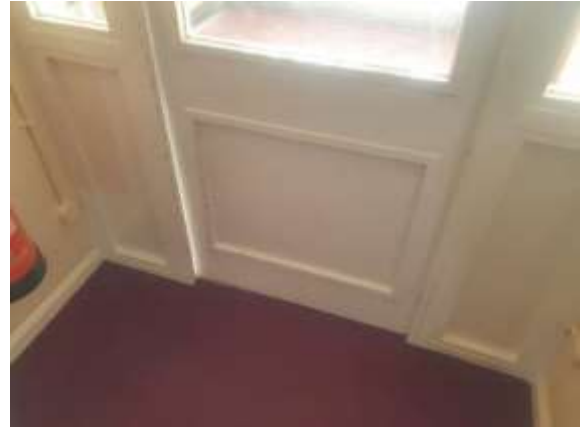
**Location:** First Floor - Corridor 006

<b>Material Description:</b>	Infill Panels to Door - Insulating Board	
<b>Identification:</b>	Previously Sampled - Asbestos Detected	
<b>Approx. quantity:</b>	2 m <sup>2</sup>	
<b>Accessibility</b>	Easy	Assessment Score
<b>Product type:</b>	Asbestos Insulating Board	2
<b>Extent of Damage:</b>	Good	0
<b>Surface Treatment:</b>	Encapsulated AIB	1
<b>Asbestos type:</b>	Amosite	2
<b>Material Assessment Score:</b>		5
<b>Priority Assessment Score:</b>		Low
<b>Action:</b>	Manage	
<b>Comments:</b>	Previously sampled ref: Armour 18/6/19 Sample DK/7. 3no panels

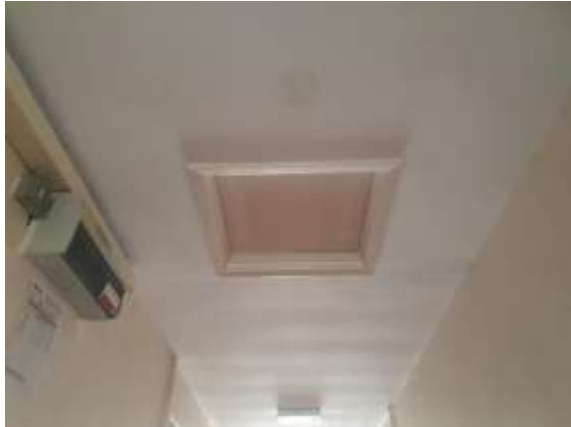
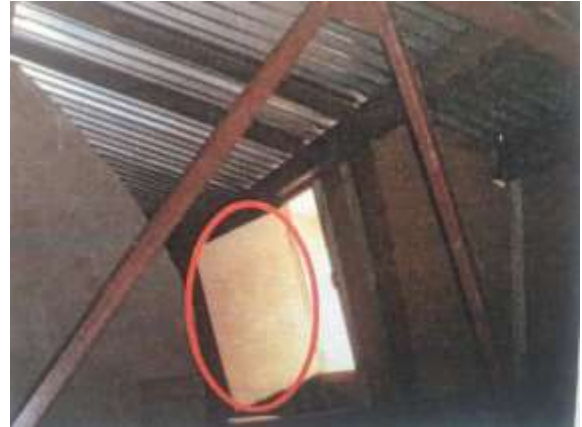
**Location:** First Floor - Loft Space above Corridor 007

<b>Material Description:</b>	Panel to Door - Insulating Board	
<b>Identification:</b>	Previously Sampled - Asbestos Detected	
<b>Approx. quantity:</b>	1 m <sup>2</sup>	
<b>Accessibility</b>	Difficult	<i>Assessment Score</i>
<b>Product type:</b>	Asbestos Insulating Board	2
<b>Extent of Damage:</b>	Slight / minor damage	1
<b>Surface Treatment:</b>	Unsealed AIB	2
<b>Asbestos type:</b>	Amosite	2
<b>Material Assessment Score:</b>		7
<b>Priority Assessment Score:</b>		Medium
<b>Action:</b>	Further Investigation Needed	
<b>Comments:</b>	No safe access to inspect. Panel is visible from the hatch

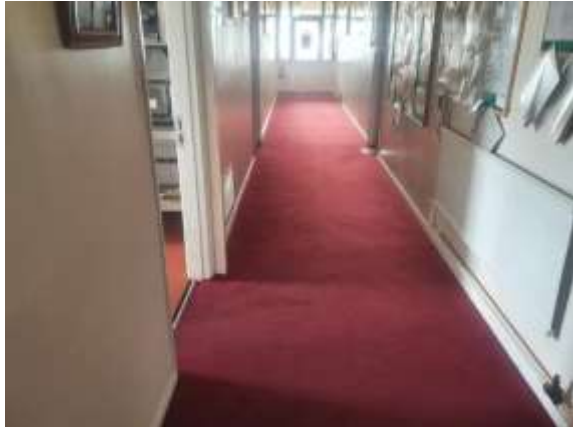
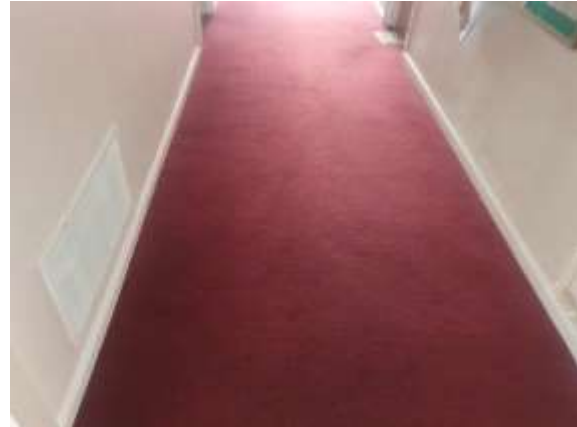
**Location:** First Floor - Corridor 008

<b>Material Description:</b>	Floor Tiles - Vinyl Products	
<b>Identification:</b>	Previously Sampled - Asbestos Detected	
<b>Approx. quantity:</b>	22 m <sup>2</sup>	
<b>Accessibility</b>	Difficult	<i>Assessment Score</i>
<b>Product type:</b>	Vinyl	1
<b>Extent of Damage:</b>	Slight / minor damage	1
<b>Surface Treatment:</b>	Non-friable	0
<b>Asbestos type:</b>	Chrysotile	1
<b>Material Assessment Score:</b>		3
<b>Priority Assessment Score:</b>		Negligible
<b>Action:</b>	Manage	
<b>Comments:</b>	Previously sampled ref: Armour 18/6/19 Sample DK/6. Under carpet

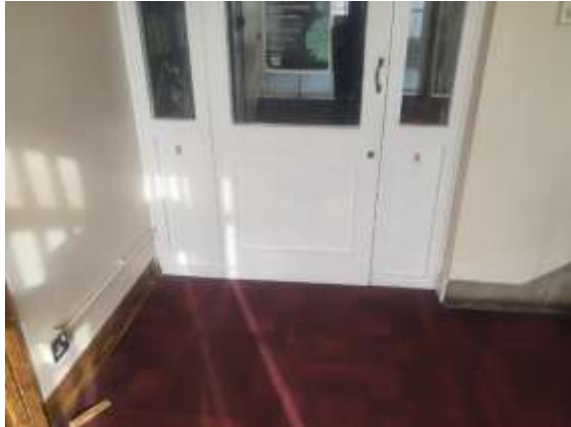
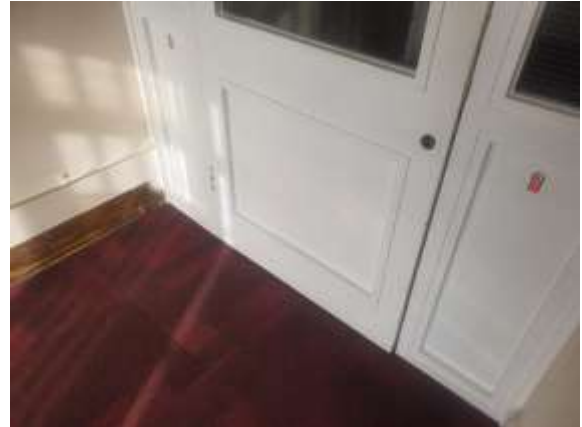
**Location:** First Floor - Landing 009

<b>Material Description:</b>	Infill Panels to Door - Insulating Board	
<b>Identification:</b>	Previously Sampled - Asbestos Detected	
<b>Approx. quantity:</b>	2 m <sup>2</sup>	
<b>Accessibility</b>	Easy	<i>Assessment Score</i>
<b>Product type:</b>	Asbestos Insulating Board	2
<b>Extent of Damage:</b>	Good	0
<b>Surface Treatment:</b>	Encapsulated AIB	1
<b>Asbestos type:</b>	Amosite	2
<b>Material Assessment Score:</b>		5
<b>Priority Assessment Score:</b>		Low
<b>Action:</b>	Manage	
<b>Comments:</b>	Previously sampled ref: Armour 18/6/19 Sample DK/7. 3no panels

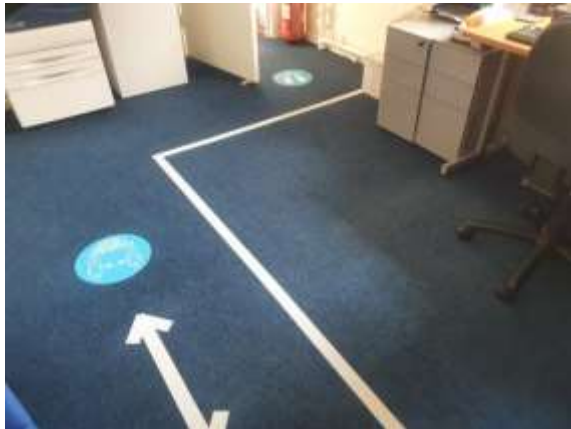
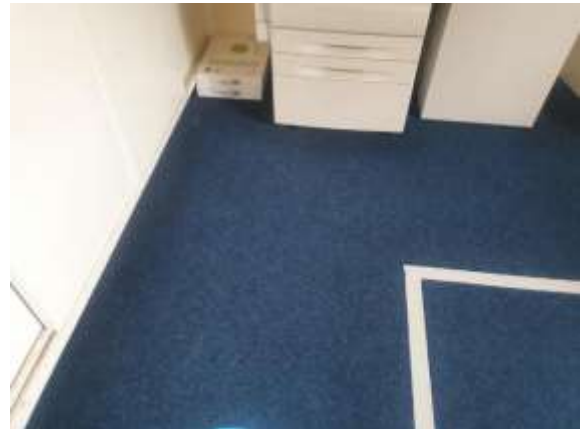
**Location:** First Floor - Office 010

<b>Material Description:</b>	Floor Tiles - Vinyl Products	
<b>Identification:</b>	Previously Sampled - Asbestos Detected	
<b>Approx. quantity:</b>	16 m <sup>2</sup>	
<b>Accessibility</b>	Difficult	<i>Assessment Score</i>
<b>Product type:</b>	Vinyl	1
<b>Extent of Damage:</b>	Slight / minor damage	1
<b>Surface Treatment:</b>	Non-friable	0
<b>Asbestos type:</b>	Chrysotile	1
<b>Material Assessment Score:</b>		3
<b>Priority Assessment Score:</b>		Negligible
<b>Action:</b>	Manage	
<b>Comments:</b>	Previously sampled ref: Armour 18/6/19 Sample DK/6. Under carpet

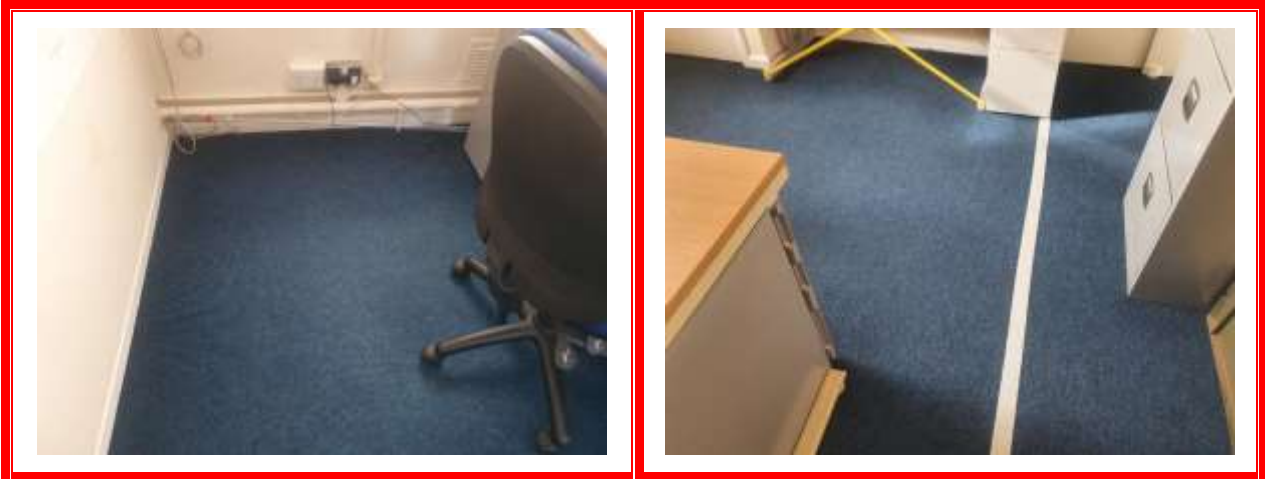
**Location:** First Floor - CEO Office 011

<b>Material Description:</b>	Floor Tiles - Vinyl Products	
<b>Identification:</b>	Previously Sampled - Asbestos Detected	
<b>Approx. quantity:</b>	16 m <sup>2</sup>	
<b>Accessibility</b>	Difficult	<i>Assessment Score</i>
<b>Product type:</b>	Vinyl	1
<b>Extent of Damage:</b>	Slight / minor damage	1
<b>Surface Treatment:</b>	Non-friable	0
<b>Asbestos type:</b>	Chrysotile	1
<b>Material Assessment Score:</b>		3
<b>Priority Assessment Score:</b>		Negligible
<b>Action:</b>	Manage	
<b>Comments:</b>	Previously sampled ref: Armour 18/6/19 Sample DK/6. Under carpet. No access within boxing within room

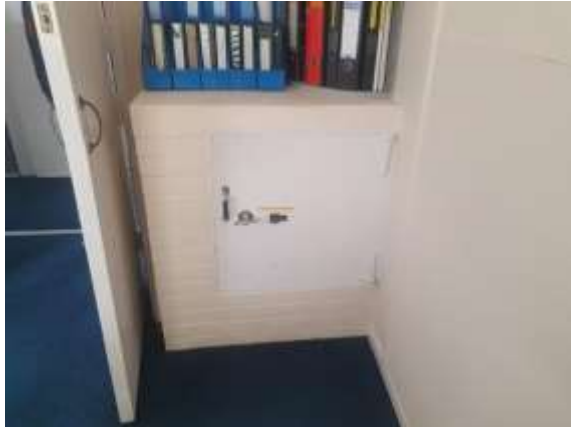
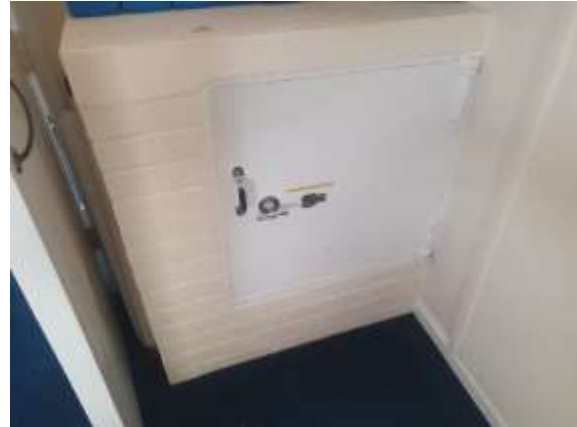
**Location:** First Floor - CEO Office 012

<b>Material Description:</b>	Safe - Insulating Board	
<b>Identification:</b>	Presumed to Contain Asbestos	
<b>Approx. quantity:</b>	1 no	
<b>Accessibility</b>	Difficult	<i>Assessment Score</i>
<b>Product type:</b>	Asbestos Insulating Board	2
<b>Extent of Damage:</b>	Major damage	3
<b>Surface Treatment:</b>	Unsealed Insulation	3
<b>Asbestos type:</b>	Amosite, Chrysotile	2
<b>Material Assessment Score:</b>		10
<b>Priority Assessment Score:</b>		High
<b>Action:</b>	Manage	
<b>Comments:</b>	No access within safe casings without damaging safe

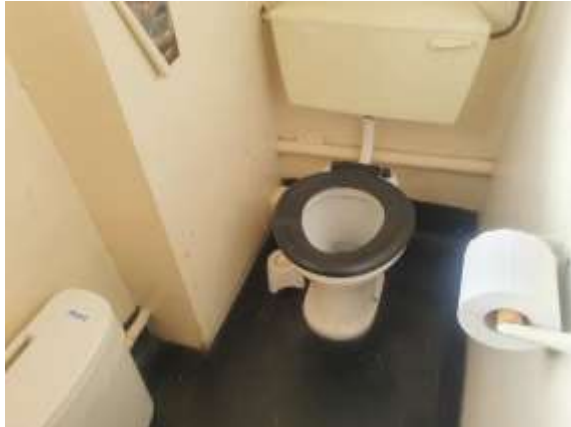
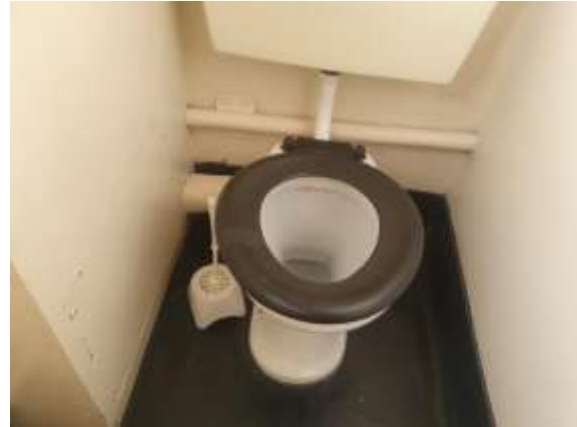
**Location:** First Floor - WC 013

<b>Material Description:</b>	Toilet Seat - PVC / Reinforced Plastics	
<b>Identification:</b>	Presumed to Contain Asbestos	
<b>Approx. quantity:</b>	1 no	
<b>Accessibility</b>	Easy	<i>Assessment Score</i>
<b>Product type:</b>	Bakelite	1
<b>Extent of Damage:</b>	Major damage	3
<b>Surface Treatment:</b>	Unsealed Insulation	3
<b>Asbestos type:</b>	Chrysotile	1
<b>Material Assessment Score:</b>		8
<b>Priority Assessment Score:</b>		Medium
<b>Action:</b>	Manage	
<b>Comments:</b>	Not possible to sample as may damage integrity of the seat

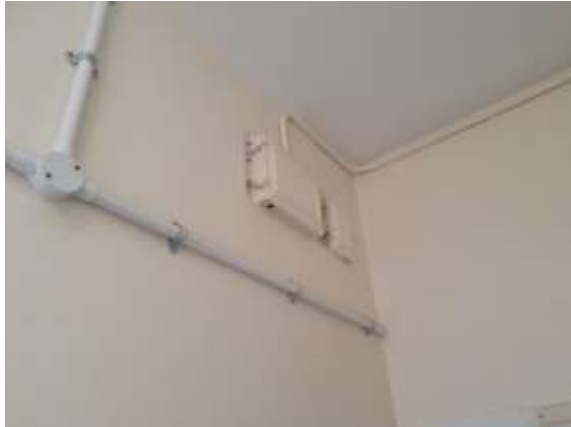
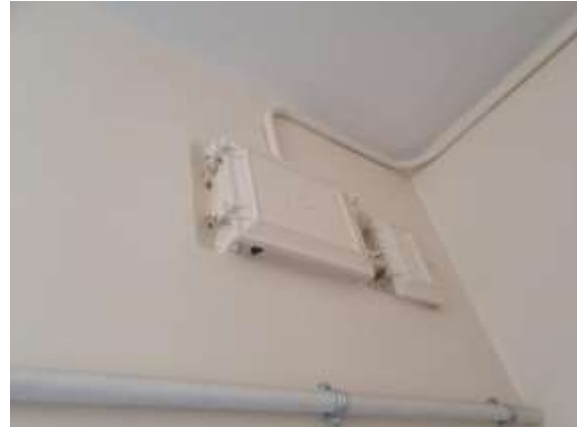
**Location:** First Floor - Landing/Corridor 014

<b>Material Description:</b>	Components within Electrical Boxes - Woven Product	
<b>Identification:</b>	Presumed to Contain Asbestos	
<b>Approx. quantity:</b>	2 no	
<b>Accessibility</b>	Difficult	<i>Assessment Score</i>
<b>Product type:</b>	Rope	2
<b>Extent of Damage:</b>	Major damage	3
<b>Surface Treatment:</b>	Unsealed Insulation	3
<b>Asbestos type:</b>	Chrysotile	1
<b>Material Assessment Score:</b>		9
<b>Priority Assessment Score:</b>		N/A
<b>Action:</b>	Manage	
<b>Comments:</b>	No access within live boxes

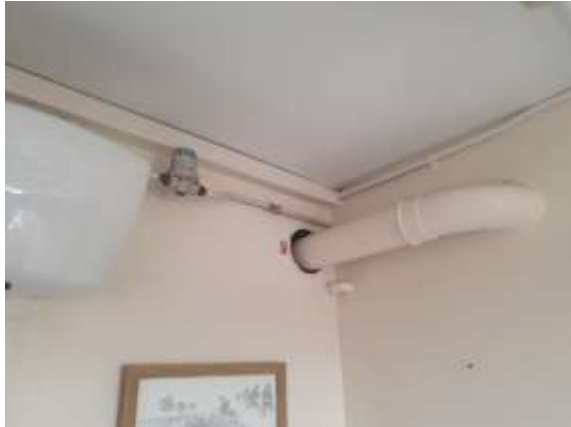
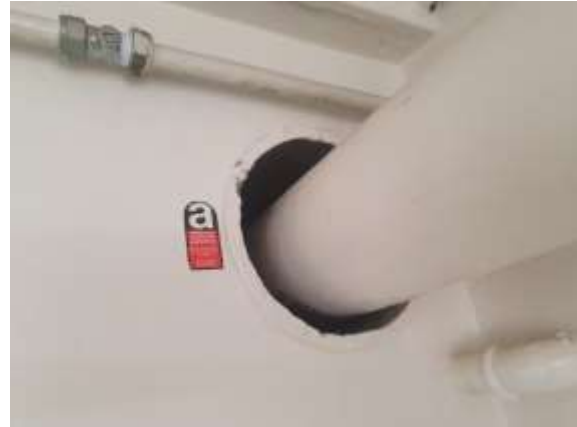
**Location:** Ground Floor - WC 016

<b>Material Description:</b>	Pipework Sleeve within Wall - Cement Product	
<b>Identification:</b>	Previously Sampled - Asbestos Detected	
<b>Approx. quantity:</b>	<1 LM	
<b>Accessibility</b>	Difficult	<i>Assessment Score</i>
<b>Product type:</b>	Cement	1
<b>Extent of Damage:</b>	Slight / minor damage	1
<b>Surface Treatment:</b>	Unsealed Cement	1
<b>Asbestos type:</b>	Chrysotile	1
<b>Material Assessment Score:</b>		4
<b>Priority Assessment Score:</b>		Negligible
<b>Action:</b>	Encapsulate	
<b>Comments:</b>	Previously sampled ref: Armour 18/6/19 Sample DK/9

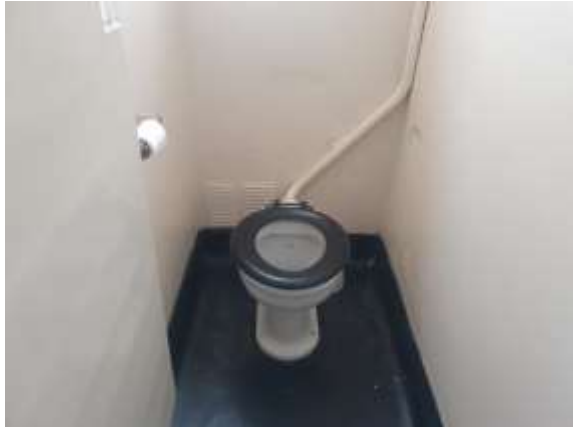
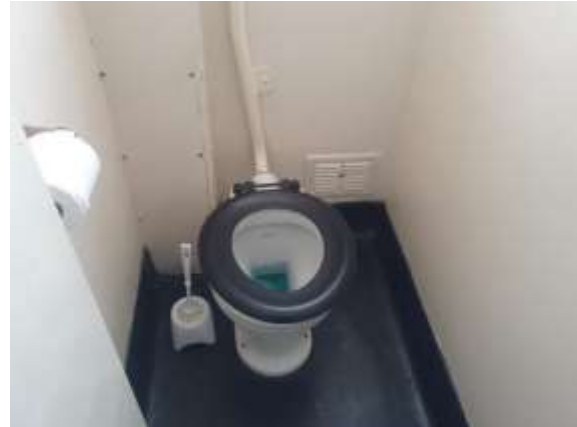
**Location:** Ground Floor - Changing Room 017

<b>Material Description:</b>	Toilet Seat - PVC / Reinforced Plastics	
<b>Identification:</b>	Presumed to Contain Asbestos	
<b>Approx. quantity:</b>	2 no	
<b>Accessibility</b>	Easy	<i>Assessment Score</i>
<b>Product type:</b>	Bakelite	1
<b>Extent of Damage:</b>	Major damage	3
<b>Surface Treatment:</b>	Unsealed Insulation	3
<b>Asbestos type:</b>	Chrysotile	1
<b>Material Assessment Score:</b>		8
<b>Priority Assessment Score:</b>		Medium
<b>Action:</b>	Manage	
<b>Comments:</b>	Not possible to sample as may damage integrity of the seats

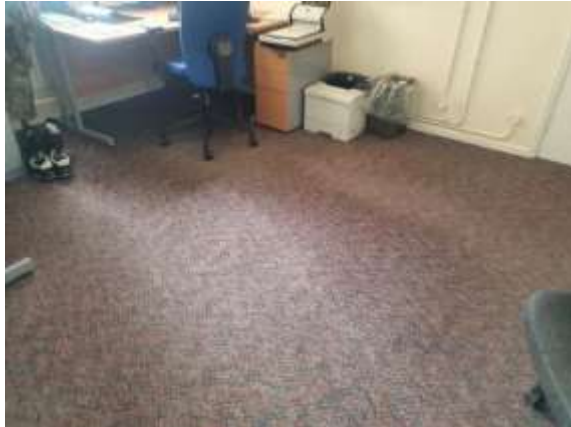
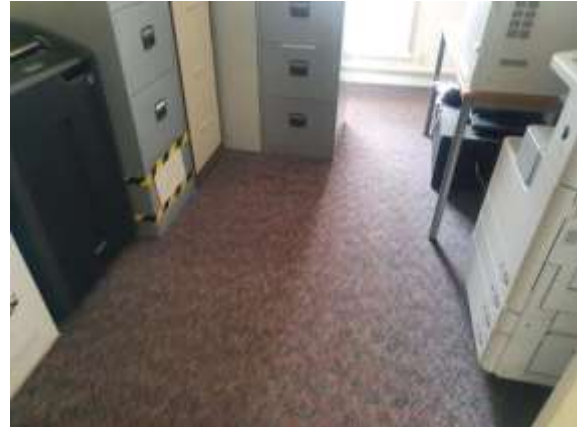
**Location:** Ground Floor - Offices x 2 018

<b>Material Description:</b>	Floor Tiles - Vinyl Products	
<b>Identification:</b>	Previously Sampled - Asbestos Detected	
<b>Approx. quantity:</b>	28 m <sup>2</sup>	
<b>Accessibility</b>	Difficult	<i>Assessment Score</i>
<b>Product type:</b>	Vinyl	1
<b>Extent of Damage:</b>	Moderate damage	2
<b>Surface Treatment:</b>	Non-friable	0
<b>Asbestos type:</b>	Chrysotile	1
<b>Material Assessment Score:</b>		4
<b>Priority Assessment Score:</b>		Negligible
<b>Action:</b>	Manage	
<b>Comments:</b>	Previously sampled ref: Armour 18/6/19 Sample DK/10. Under carpet

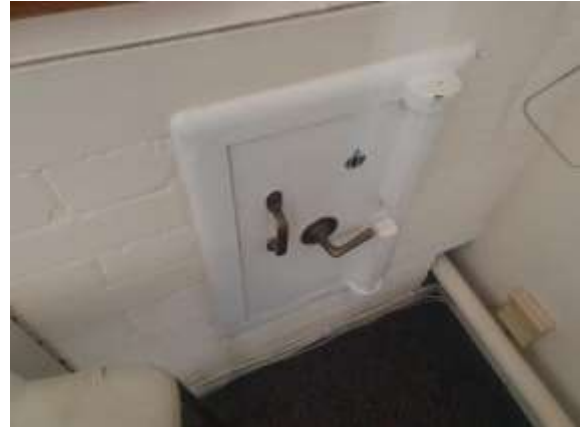
**Location:** Ground Floor - Office 019

<b>Material Description:</b>	Safe - Insulating Board	
<b>Identification:</b>	Presumed to Contain Asbestos	
<b>Approx. quantity:</b>	1 no	
<b>Accessibility</b>	Difficult	<i>Assessment Score</i>
<b>Product type:</b>	Asbestos Insulating Board	2
<b>Extent of Damage:</b>	Major damage	3
<b>Surface Treatment:</b>	Unsealed Insulation	3
<b>Asbestos type:</b>	Amosite, Chrysotile	2
<b>Material Assessment Score:</b>		10
<b>Priority Assessment Score:</b>		High
<b>Action:</b>	Manage	
<b>Comments:</b>	No access within safe casings without damaging safe

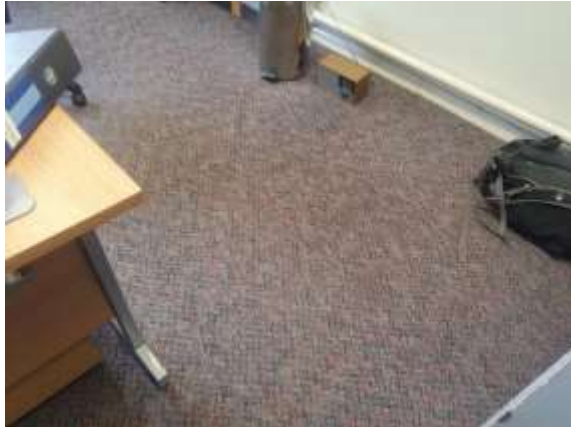
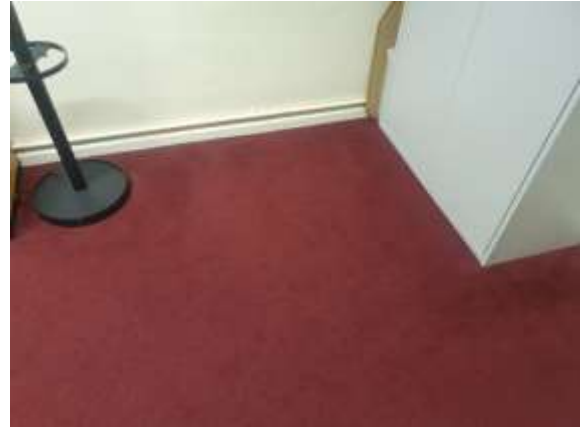
**Location:** Ground Floor - Offices x 2 020

<b>Material Description:</b>	Floor Tiles - Vinyl Products	
<b>Identification:</b>	Previously Sampled - Asbestos Detected	
<b>Approx. quantity:</b>	22 m <sup>2</sup>	
<b>Accessibility</b>	Difficult	<i>Assessment Score</i>
<b>Product type:</b>	Vinyl	1
<b>Extent of Damage:</b>	Slight / minor damage	1
<b>Surface Treatment:</b>	Non-friable	0
<b>Asbestos type:</b>	Chrysotile	1
<b>Material Assessment Score:</b>		3
<b>Priority Assessment Score:</b>		Negligible
<b>Action:</b>	Manage	
<b>Comments:</b>	Previously sampled ref: Armour 18/6/19 Sample DK/10. Under carpet

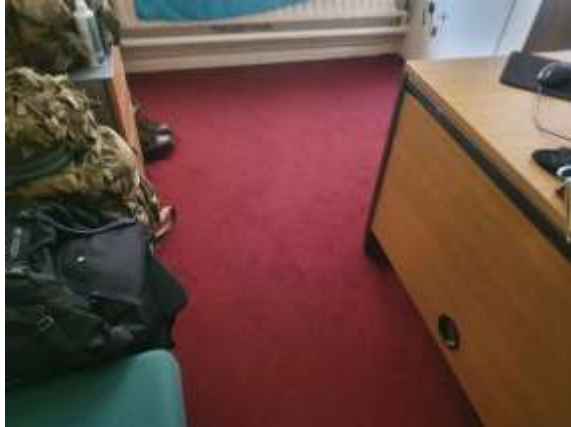
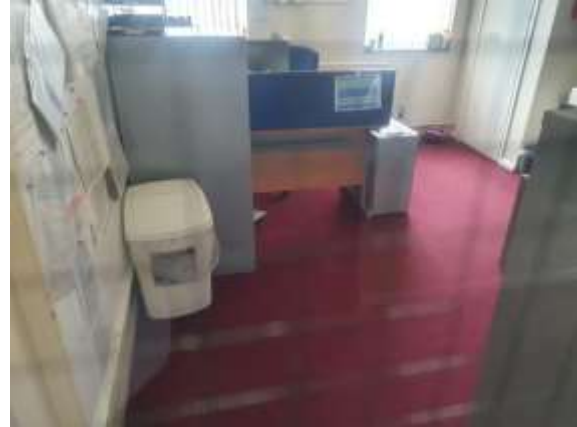
**Location:** Ground Floor - Admin Office and Staff Instructors Office  
021

<b>Material Description:</b>	Floor Tiles - Vinyl Products	
<b>Identification:</b>	Previously Sampled - Asbestos Detected	
<b>Approx. quantity:</b>	30 m <sup>2</sup>	
<b>Accessibility</b>	Difficult	<i>Assessment Score</i>
<b>Product type:</b>	Vinyl	1
<b>Extent of Damage:</b>	Slight / minor damage	1
<b>Surface Treatment:</b>	Non-friable	0
<b>Asbestos type:</b>	Chrysotile	1
<b>Material Assessment Score:</b>		3
<b>Priority Assessment Score:</b>		Negligible
<b>Action:</b>	Manage	
<b>Comments:</b>	Previously sampled ref: Armour 18/6/19 Sample DK/10. Under carpet

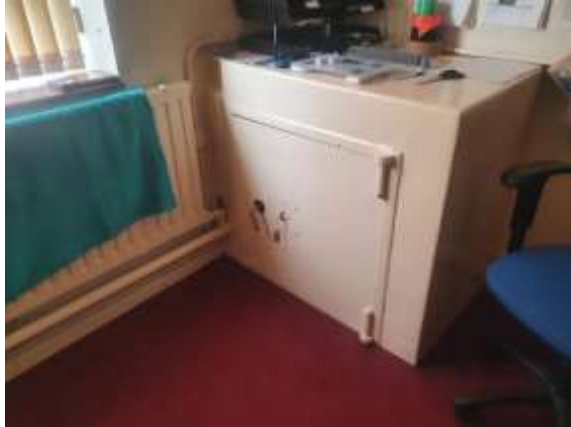
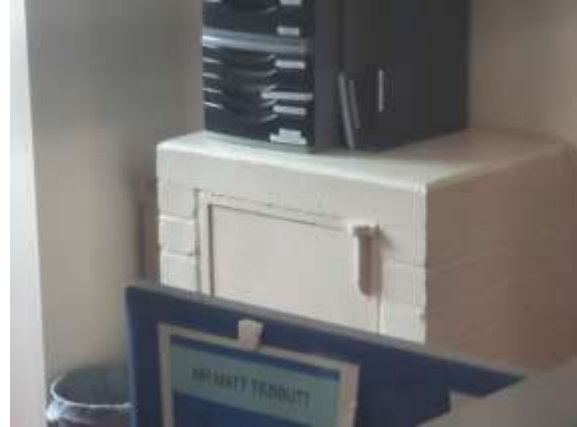
**Location:** Ground Floor - Admin Office and Staff Instructors Office  
022

<b>Material Description:</b>	Safes - Insulating Board	
<b>Identification:</b>	Presumed to Contain Asbestos	
<b>Approx. quantity:</b>	2 no	
<b>Accessibility</b>	Difficult	<i>Assessment Score</i>
<b>Product type:</b>	Asbestos Insulating Board	2
<b>Extent of Damage:</b>	Major damage	3
<b>Surface Treatment:</b>	Unsealed Insulation	3
<b>Asbestos type:</b>	Amosite, Chrysotile	2
<b>Material Assessment Score:</b>		10
<b>Priority Assessment Score:</b>		High
<b>Action:</b>	Manage	
<b>Comments:</b>	No access within safe casings without damaging safes

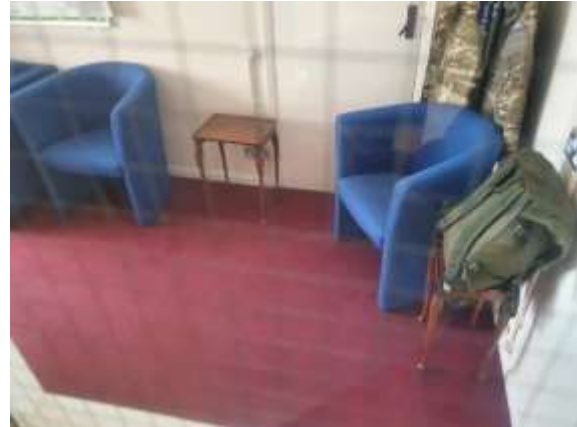
**Location:** Ground Floor - Offices x 3 023

<b>Material Description:</b>	Floor Tiles - Vinyl Products	
<b>Identification:</b>	Previously Sampled - Asbestos Detected	
<b>Approx. quantity:</b>	40 m <sup>2</sup>	
<b>Accessibility</b>	Difficult	<i>Assessment Score</i>
<b>Product type:</b>	Vinyl	1
<b>Extent of Damage:</b>	Slight / minor damage	1
<b>Surface Treatment:</b>	Non-friable	0
<b>Asbestos type:</b>	Chrysotile	1
<b>Material Assessment Score:</b>		3
<b>Priority Assessment Score:</b>		Negligible
<b>Action:</b>	Manage	
<b>Comments:</b>	Previously sampled ref: Armour 18/6/19 Sample DK/10. Under carpet

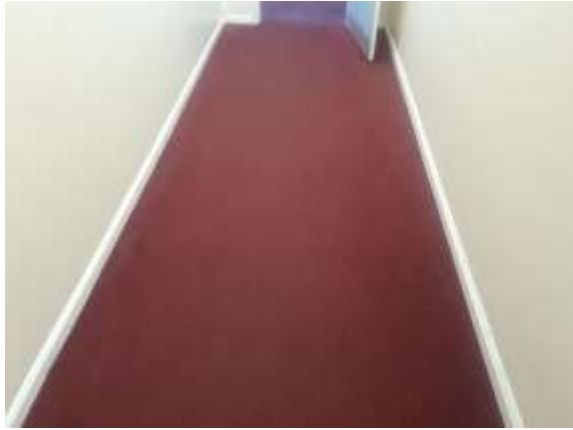
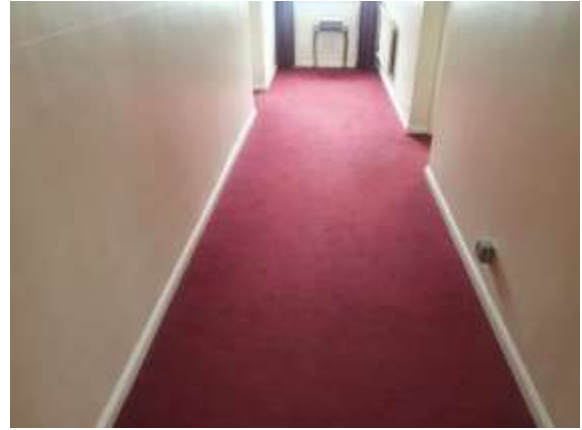
**Location:** Ground Floor - Corridor 024

<b>Material Description:</b>	Floor Tiles - Vinyl Products	
<b>Identification:</b>	Previously Sampled - Asbestos Detected	
<b>Approx. quantity:</b>	30 m <sup>2</sup>	
<b>Accessibility</b>	Difficult	<i>Assessment Score</i>
<b>Product type:</b>	Vinyl	1
<b>Extent of Damage:</b>	Slight / minor damage	1
<b>Surface Treatment:</b>	Non-friable	0
<b>Asbestos type:</b>	Chrysotile	1
<b>Material Assessment Score:</b>		3
<b>Priority Assessment Score:</b>		Negligible
<b>Action:</b>	Manage	
<b>Comments:</b>	Previously sampled ref: Armour 18/6/19 Sample DK/10. Under carpet

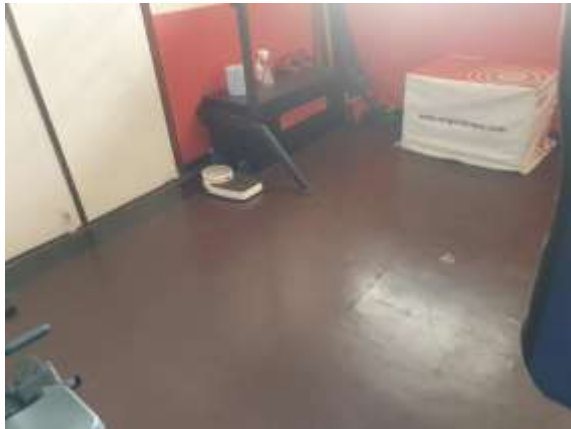
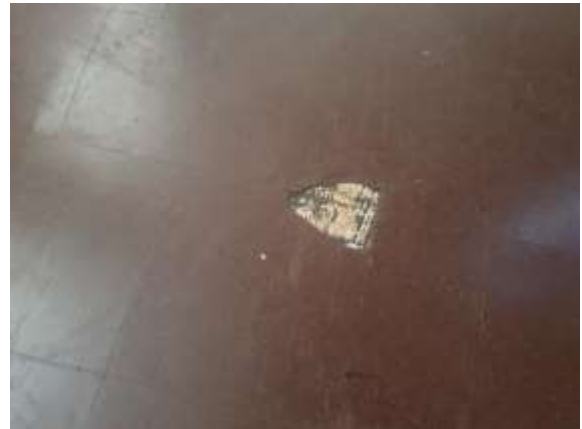
**Location:** Ground Floor - Main Hall and Gym 025

<b>Material Description:</b>	Floor Tiles and Adhesive - Vinyl Products	
<b>Identification:</b>	Previously Sampled - Asbestos Detected	
<b>Approx. quantity:</b>	50 m <sup>2</sup>	
<b>Accessibility</b>	Easy	<i>Assessment Score</i>
<b>Product type:</b>	Vinyl	1
<b>Extent of Damage:</b>	Moderate damage	2
<b>Surface Treatment:</b>	Non-friable	0
<b>Asbestos type:</b>	Chrysotile	1
<b>Material Assessment Score:</b>		4
<b>Priority Assessment Score:</b>		Negligible
<b>Action:</b>	Manage	
<b>Comments:</b>	Previously sampled ref: Armour 18/6/19 Sample DK/11

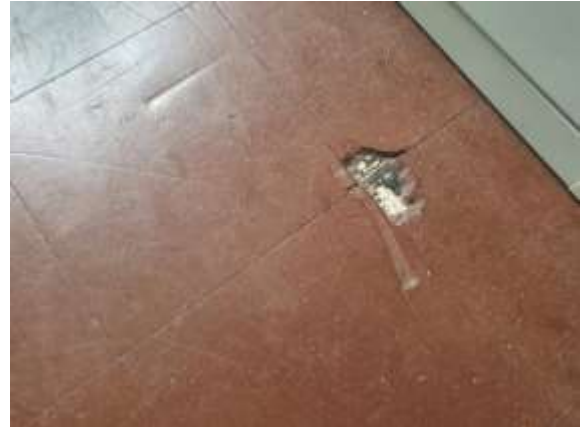
**Location:** Ground Floor - Cadet Locker Room 026

<b>Material Description:</b>	Floor Tiles and Adhesive - Vinyl Products	
<b>Identification:</b>	Previously Sampled - Asbestos Detected	
<b>Approx. quantity:</b>	18 m <sup>2</sup>	
<b>Accessibility</b>	Easy	<i>Assessment Score</i>
<b>Product type:</b>	Vinyl	1
<b>Extent of Damage:</b>	Moderate damage	2
<b>Surface Treatment:</b>	Non-friable	0
<b>Asbestos type:</b>	Chrysotile	1
<b>Material Assessment Score:</b>		4
<b>Priority Assessment Score:</b>		Negligible
<b>Action:</b>	Manage	
<b>Comments:</b>	Previously sampled ref: Armour 18/6/19 Sample DK/11

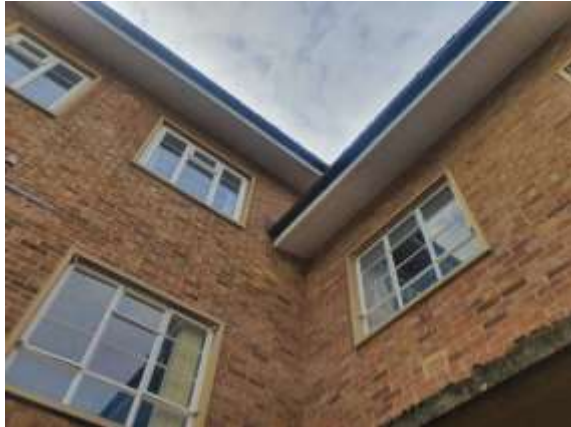
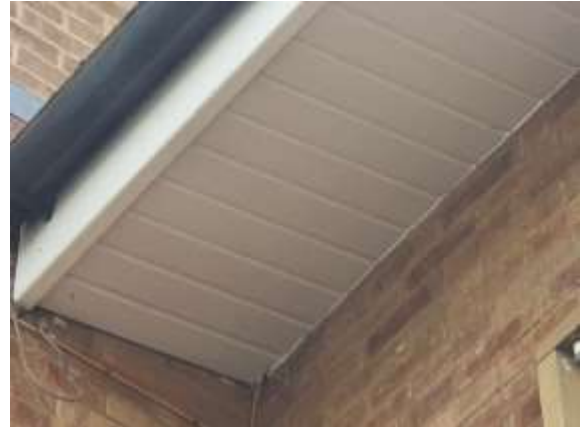
**Location:** External - Main Building 027

<b>Material Description:</b>	Soffits above Plastic - Insulating Board	
<b>Identification:</b>	Presumed to Contain Asbestos	
<b>Approx. quantity:</b>	110 LM	
<b>Accessibility</b>	Difficult	<i>Assessment Score</i>
<b>Product type:</b>	Asbestos Insulating Board	2
<b>Extent of Damage:</b>	Major damage	3
<b>Surface Treatment:</b>	Unsealed Insulation	3
<b>Asbestos type:</b>	Amosite	2
<b>Material Assessment Score:</b>		10
<b>Priority Assessment Score:</b>		High
<b>Action:</b>	Manage	
<b>Comments:</b>	No access above plastic soffits

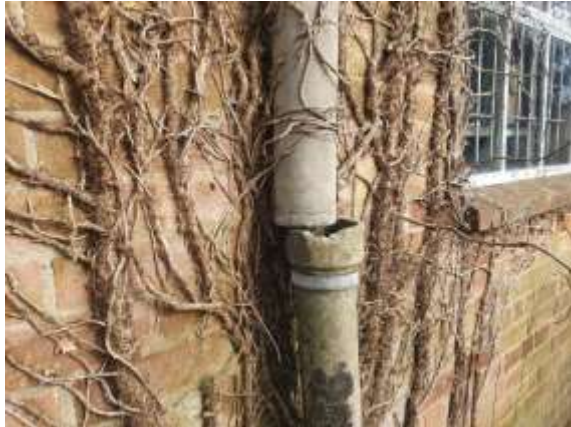
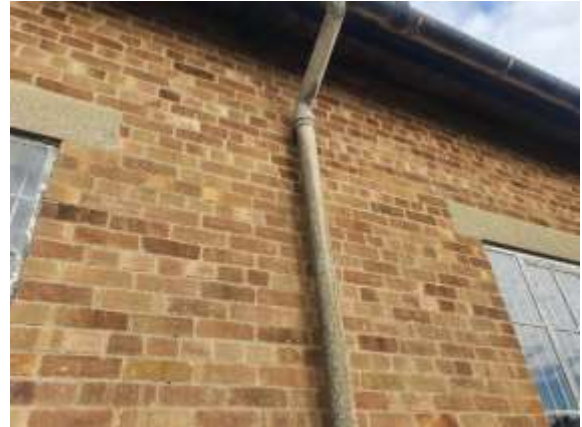
**Location:** External - Garages 028

<b>Material Description:</b>	Downpipes - Cement Product	
<b>Identification:</b>	Previously Sampled - Asbestos Detected	
<b>Approx. quantity:</b>	18 LM	
<b>Accessibility</b>	Medium	<i>Assessment Score</i>
<b>Product type:</b>	Cement	1
<b>Extent of Damage:</b>	Moderate damage	2
<b>Surface Treatment:</b>	Unsealed Cement	1
<b>Asbestos type:</b>	Chrysotile	1
<b>Material Assessment Score:</b>		5
<b>Priority Assessment Score:</b>		Low
<b>Action:</b>	Manage	
<b>Comments:</b>	Previously sampled ref: Armour 18/6/19 Sample DK/12. 3no pipes

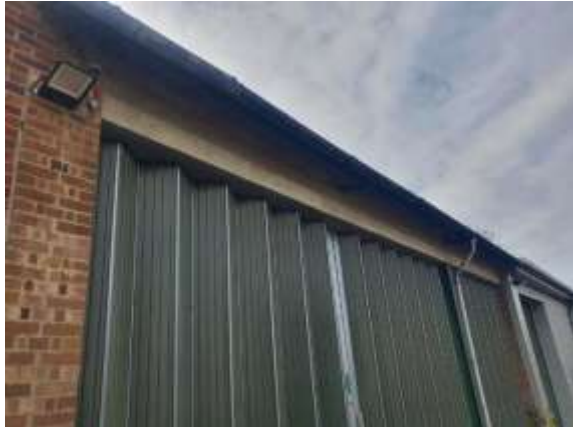
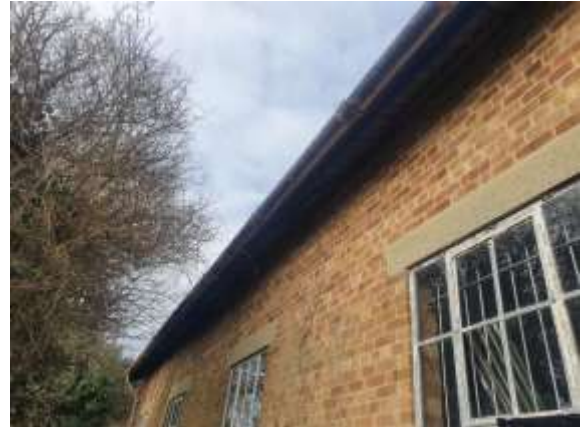
**Location:** External - Garages 029

<b>Material Description:</b>	Guttering - Cement Product	
<b>Identification:</b>	Previously Sampled - Asbestos Detected	
<b>Approx. quantity:</b>	60 LM	
<b>Accessibility</b>	Difficult	<i>Assessment Score</i>
<b>Product type:</b>	Cement	1
<b>Extent of Damage:</b>	Slight / minor damage	1
<b>Surface Treatment:</b>	Unsealed Cement	1
<b>Asbestos type:</b>	Chrysotile	1
<b>Material Assessment Score:</b>		4
<b>Priority Assessment Score:</b>		Negligible
<b>Action:</b>	Manage	
<b>Comments:</b>	Previously sampled ref: Armour 18/6/19 Sample DK/12

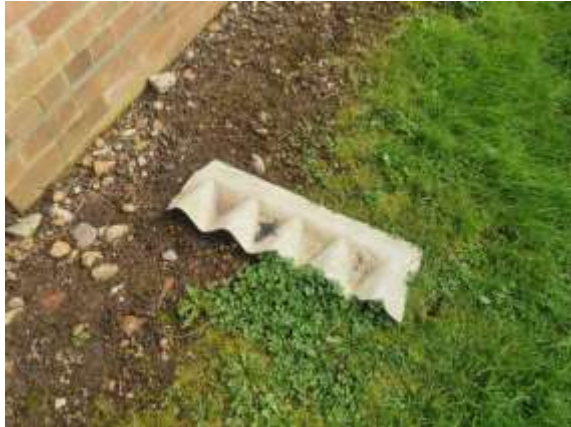
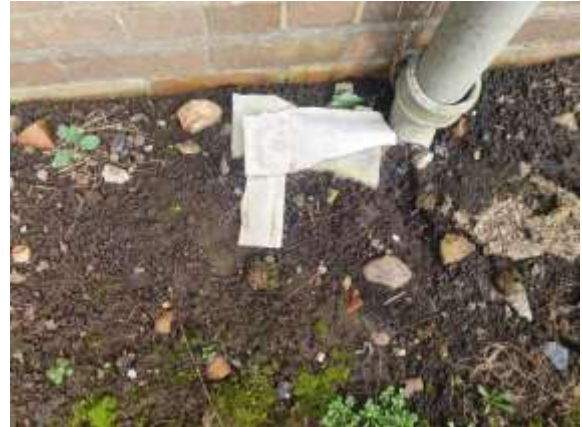
**Location:** External - Garages 030

<b>Material Description:</b>	Profiled Sheet Debris - Cement Product	
<b>Identification:</b>	Previously Sampled - Asbestos Detected	
<b>Approx. quantity:</b>	1 m <sup>2</sup>	
<b>Accessibility</b>	Easy	<i>Assessment Score</i>
<b>Product type:</b>	Cement	1
<b>Extent of Damage:</b>	Major damage	3
<b>Surface Treatment:</b>	Unsealed Cement	1
<b>Asbestos type:</b>	Chrysotile	1
<b>Material Assessment Score:</b>		6
<b>Priority Assessment Score:</b>		Low
<b>Action:</b>	Remove	
<b>Comments:</b>	Previously sampled ref: Armour 18/6/19 Sample DK/19

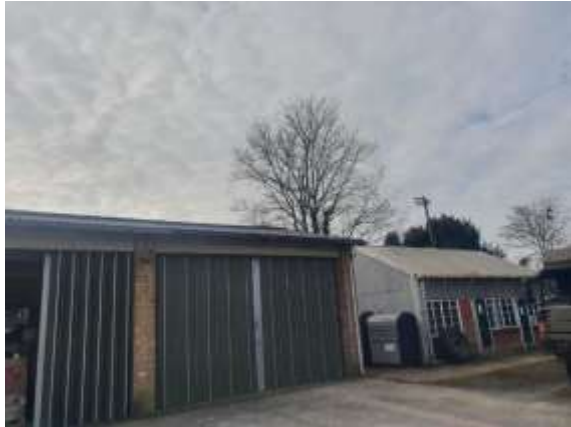
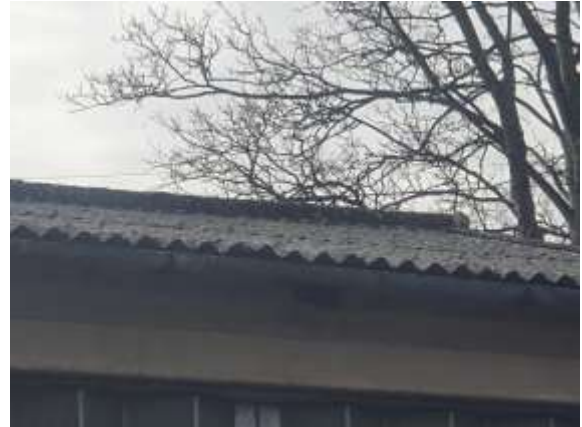
**Location:** External - Garages 031

<b>Material Description:</b>	Profiled Roof - Cement Product	
<b>Identification:</b>	Previously Sampled - Asbestos Detected	
<b>Approx. quantity:</b>	200 m <sup>2</sup>	
<b>Accessibility</b>	Difficult	<i>Assessment Score</i>
<b>Product type:</b>	Cement	1
<b>Extent of Damage:</b>	Slight / minor damage	1
<b>Surface Treatment:</b>	Unsealed Cement	1
<b>Asbestos type:</b>	Chrysotile	1
<b>Material Assessment Score:</b>		4
<b>Priority Assessment Score:</b>		Negligible
<b>Action:</b>	Manage	
<b>Comments:</b>	Previously sampled ref: Armour 18/6/19 Sample DK/19

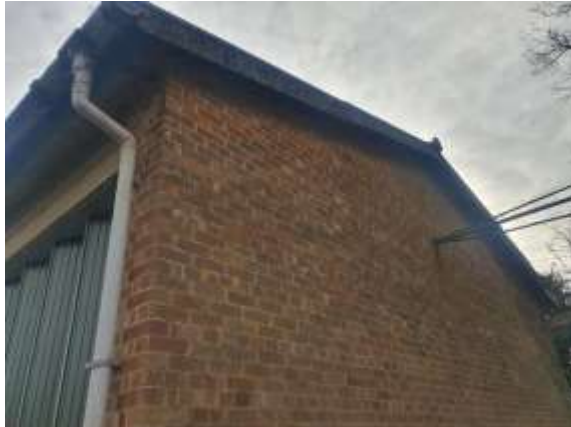
**Location:** External - Garages 032

<b>Material Description:</b>	Roof Edging - Cement Product	
<b>Identification:</b>	Previously Sampled - Asbestos Detected	
<b>Approx. quantity:</b>	8 LM	
<b>Accessibility</b>	Difficult	<i>Assessment Score</i>
<b>Product type:</b>	Cement	1
<b>Extent of Damage:</b>	Slight / minor damage	1
<b>Surface Treatment:</b>	Unsealed Cement	1
<b>Asbestos type:</b>	Chrysotile	1
<b>Material Assessment Score:</b>		4
<b>Priority Assessment Score:</b>		Negligible
<b>Action:</b>	Manage	
<b>Comments:</b>	No access to sample due to height restrictions

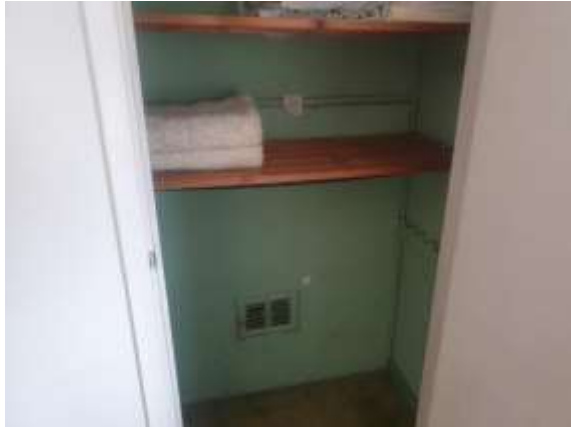
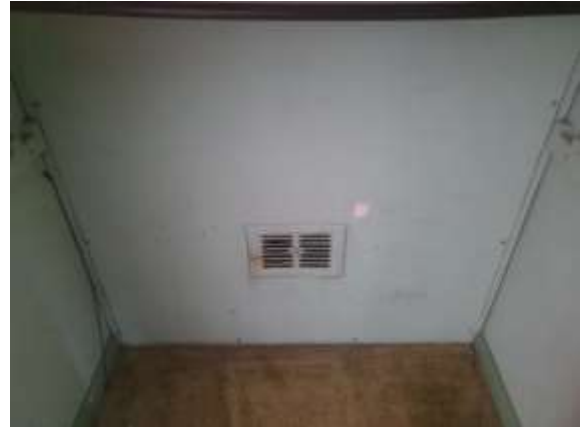
**Location:** Second Floor - Bedroom 2 Cupboard 033

<b>Material Description:</b>	Wall Panel - Cement Product	
<b>Identification:</b>	Previously Sampled - Asbestos Detected	
<b>Approx. quantity:</b>	3 m <sup>2</sup>	
<b>Accessibility</b>	Easy	<i>Assessment Score</i>
<b>Product type:</b>	Cement	1
<b>Extent of Damage:</b>	Slight / minor damage	1
<b>Surface Treatment:</b>	Unsealed Cement	1
<b>Asbestos type:</b>	Chrysotile	1
<b>Material Assessment Score:</b>		4
<b>Priority Assessment Score:</b>		Negligible
<b>Action:</b>	Manage	
<b>Comments:</b>	Previously sampled ref: Armour 18/6/19 Sample DK/13. Entire back wall of cupboard

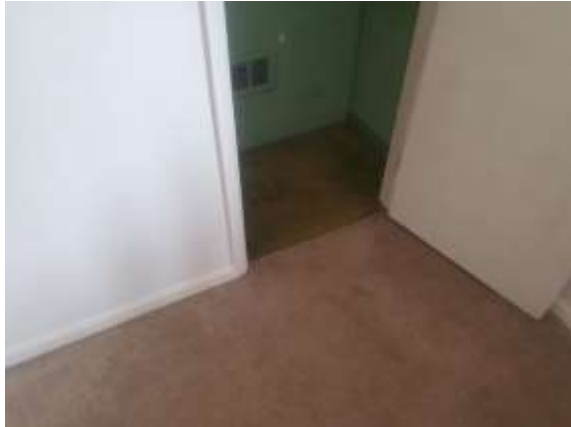
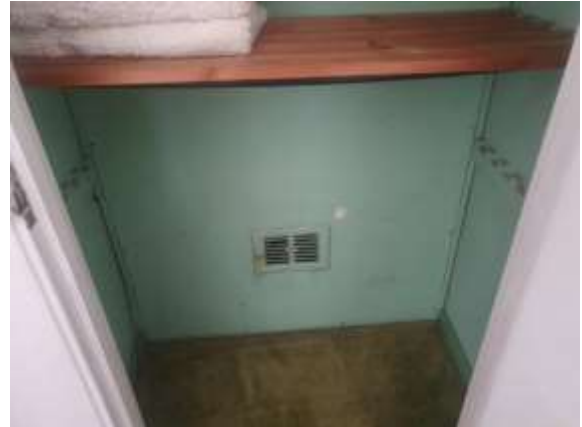
**Location:** Second Floor - Bedroom 2 and Cupboard 034

<b>Material Description:</b>	Floor Tiles and Adhesive - Vinyl Products	
<b>Identification:</b>	Previously Sampled - Asbestos Detected	
<b>Approx. quantity:</b>	8 m <sup>2</sup>	
<b>Accessibility</b>	Difficult	<i>Assessment Score</i>
<b>Product type:</b>	Vinyl	1
<b>Extent of Damage:</b>	Slight / minor damage	1
<b>Surface Treatment:</b>	Non-friable	0
<b>Asbestos type:</b>	Chrysotile	1
<b>Material Assessment Score:</b>		3
<b>Priority Assessment Score:</b>		Negligible
<b>Action:</b>	Manage	
<b>Comments:</b>	Previously sampled ref: Armour 18/6/19 Sample DK/14. Under carpet

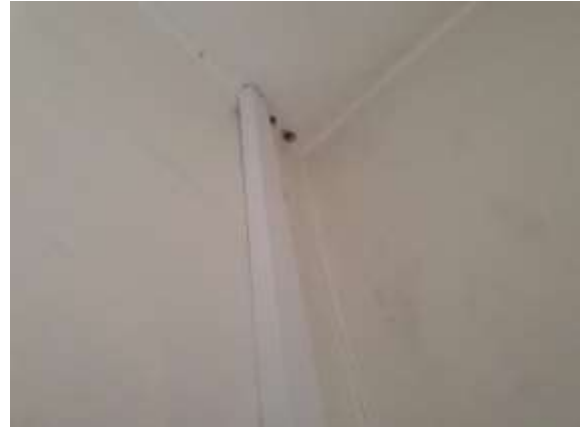
**Location:** Second Floor - Bedroom 1 Cupboard 035

<b>Material Description:</b>	Ceiling to Cupboard - Insulating Board	
<b>Identification:</b>	Previously Sampled - Asbestos Detected	
<b>Approx. quantity:</b>	2 m <sup>2</sup>	
<b>Accessibility</b>	Medium	<i>Assessment Score</i>
<b>Product type:</b>	Asbestos Insulating Board	2
<b>Extent of Damage:</b>	Moderate damage	2
<b>Surface Treatment:</b>	Unsealed AIB	2
<b>Asbestos type:</b>	Amosite	2
<b>Material Assessment Score:</b>		8
<b>Priority Assessment Score:</b>		Medium
<b>Action:</b>	Encapsulate	
<b>Comments:</b>	Previously sampled ref: GU/TA/001/17. 4no holes in panel require encapsulation. Do not remove wires

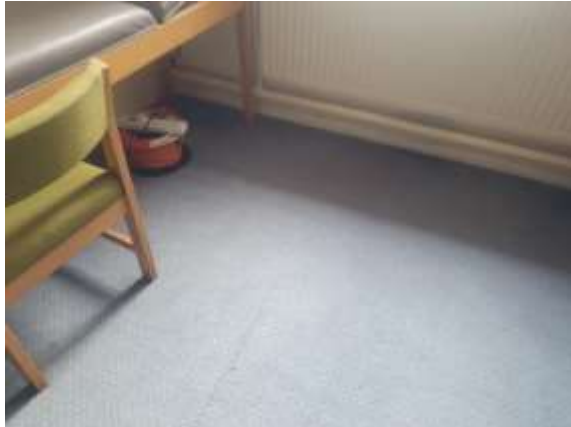
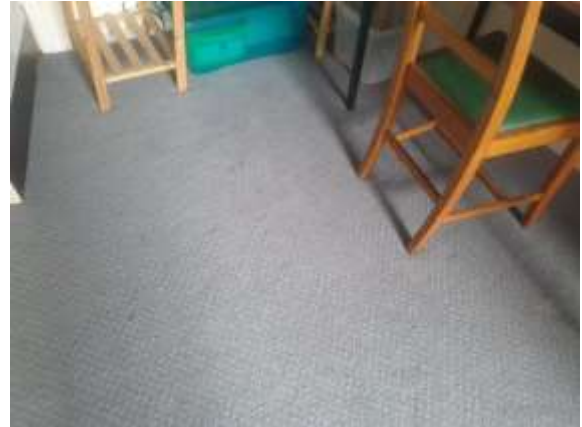
**Location:** First Floor - Medical Room 036

<b>Material Description:</b>	Floor Tiles and Adhesive - Vinyl Products	
<b>Identification:</b>	Previously Sampled - Asbestos Detected	
<b>Approx. quantity:</b>	15 m <sup>2</sup>	
<b>Accessibility</b>	Difficult	<i>Assessment Score</i>
<b>Product type:</b>	Vinyl	1
<b>Extent of Damage:</b>	Slight / minor damage	1
<b>Surface Treatment:</b>	Non-friable	0
<b>Asbestos type:</b>	Chrysotile	1
<b>Material Assessment Score:</b>		3
<b>Priority Assessment Score:</b>		Negligible
<b>Action:</b>	Manage	
<b>Comments:</b>	Previously sampled ref: Armour 18/6/19 Sample DK/6. Under carpet

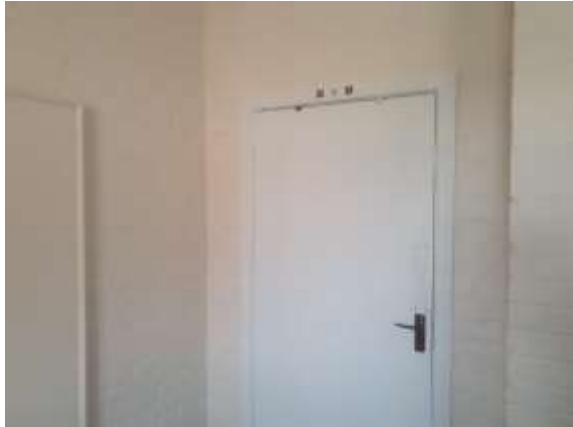
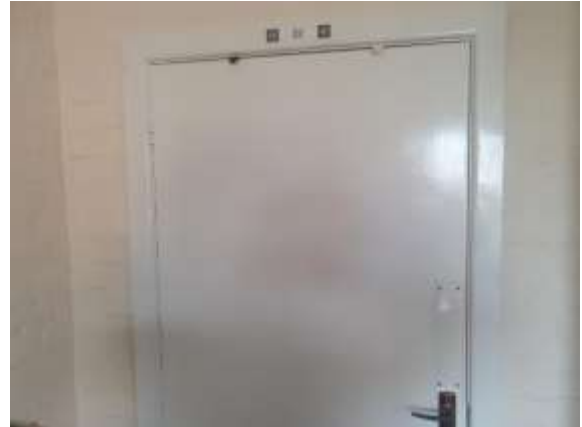
**Location:** First Floor - Office 22 037

<b>Material Description:</b>	All - No Access Gained	
<b>Identification:</b>	Presumed to Contain Asbestos	
<b>Approx. quantity:</b>	1 no	
<b>Accessibility</b>	Difficult	<i>Assessment Score</i>
<b>Product type:</b>	Pipe Insulation	3
<b>Extent of Damage:</b>	Major damage	3
<b>Surface Treatment:</b>	Unsealed Insulation	3
<b>Asbestos type:</b>	Amosite, Chrysotile, Crocidolite	3
<b>Material Assessment Score:</b>		12
<b>Priority Assessment Score:</b>		High
<b>Action:</b>	Further Investigation Needed	
<b>Comments:</b>	Key holder was not on site during the survey
