**Project Number 3700**

**Re-Inspection  
Asbestos Survey Report**

**675 Army Air Corps  
Somerset  
TA1 5LJ**

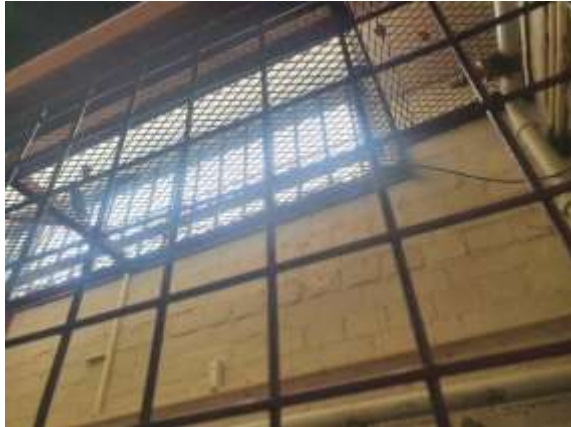
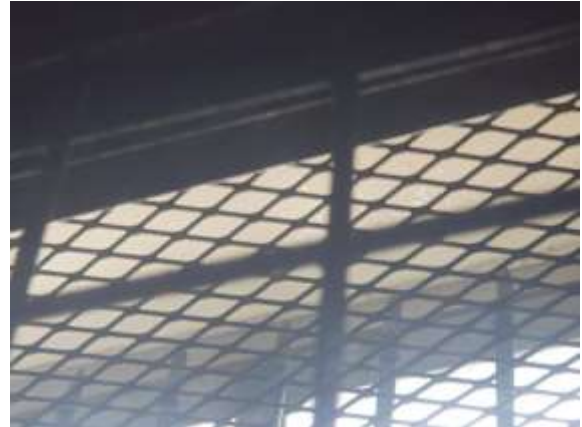
<b>Material Description:</b>	Panels above Cage - Insulating Board	
<b>Identification:</b>	Presumed to Contain Asbestos	
<b>Approx. quantity:</b>	6 LM	
<b>Accessibility</b>	Difficult	<i>Assessment Score</i>
<b>Product type:</b>	Asbestos Insulating Board	2
<b>Extent of Damage:</b>	Major damage	3
<b>Surface Treatment:</b>	Unsealed Insulation	3
<b>Asbestos type:</b>	Amosite	2
<b>Material Assessment Score:</b>		10
<b>Priority Assessment Score:</b>		High
<b>Action:</b>	Manage	
<b>Comments:</b>	No access above cage to sample. Panels located above cage next to windows

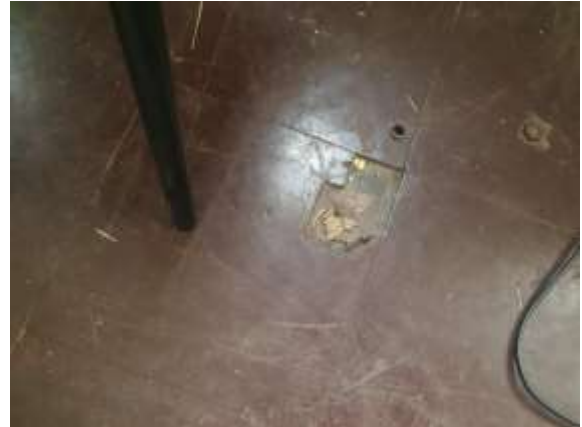
<b>Material Description:</b>	Floor Tiles and Adhesive - Vinyl Products	
<b>Identification:</b>	Previously Sampled - Asbestos Detected	
<b>Approx. quantity:</b>	20 m <sup>2</sup>	
<b>Accessibility</b>	Easy	<i>Assessment Score</i>
<b>Product type:</b>	Vinyl	1
<b>Extent of Damage:</b>	Moderate damage	2
<b>Surface Treatment:</b>	Non-friable	0
<b>Asbestos type:</b>	Chrysotile	1
<b>Material Assessment Score:</b>		4
<b>Priority Assessment Score:</b>		Negligible
<b>Action:</b>	Manage	
<b>Comments:</b>	Previously sampled ref: Armour 18/6/19 Sample DK/11

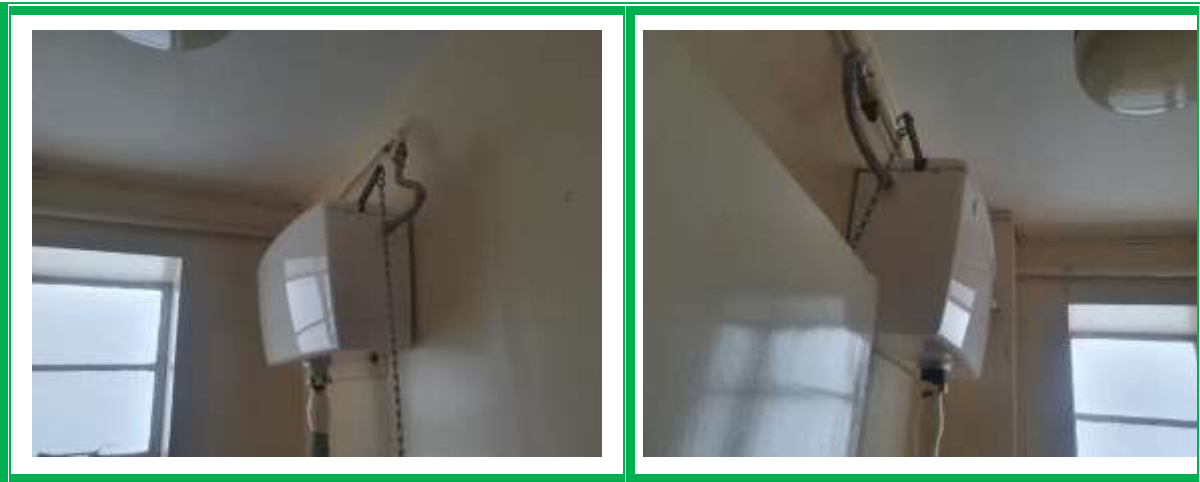
<b>Material Description:</b>	No Suspect Materials Found	
<b>Identification:</b>	N/A	
<b>Approx. quantity:</b>	N/A	
<b>Accessibility</b>	N/A	<i>Assessment Score</i>
<b>Product type:</b>	N/A	N/A
<b>Extent of Damage:</b>	N/A	N/A
<b>Surface Treatment:</b>	N/A	N/A
<b>Asbestos type:</b>	N/A	N/A
<b>Material Assessment Score:</b>		N/A
<b>Priority Assessment Score:</b>		N/A
<b>Action:</b>	N/A	
<b>Comments:</b>	all cisterns replaced

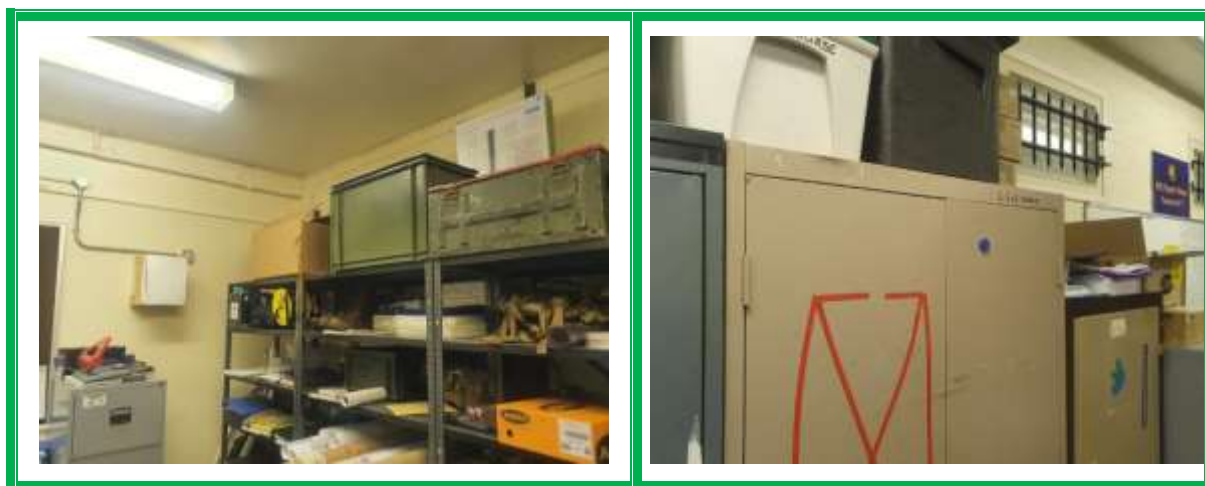
<b>Material Description:</b>	No Suspect Materials Found	
<b>Identification:</b>	N/A	
<b>Approx. quantity:</b>	N/A	
<b>Accessibility</b>	N/A	<i>Assessment Score</i>
<b>Product type:</b>	N/A	N/A
<b>Extent of Damage:</b>	N/A	N/A
<b>Surface Treatment:</b>	N/A	N/A
<b>Asbestos type:</b>	N/A	N/A
<b>Material Assessment Score:</b>		N/A
<b>Priority Assessment Score:</b>		N/A
<b>Action:</b>	N/A	
<b>Comments:</b>	Non asbestos lino under carpet
