Project Number A-00414 (3700)

**Re-Inspection
Asbestos Survey Report**

**ACF County
Cheltenham
Gloucestershire
GL51 8JU**

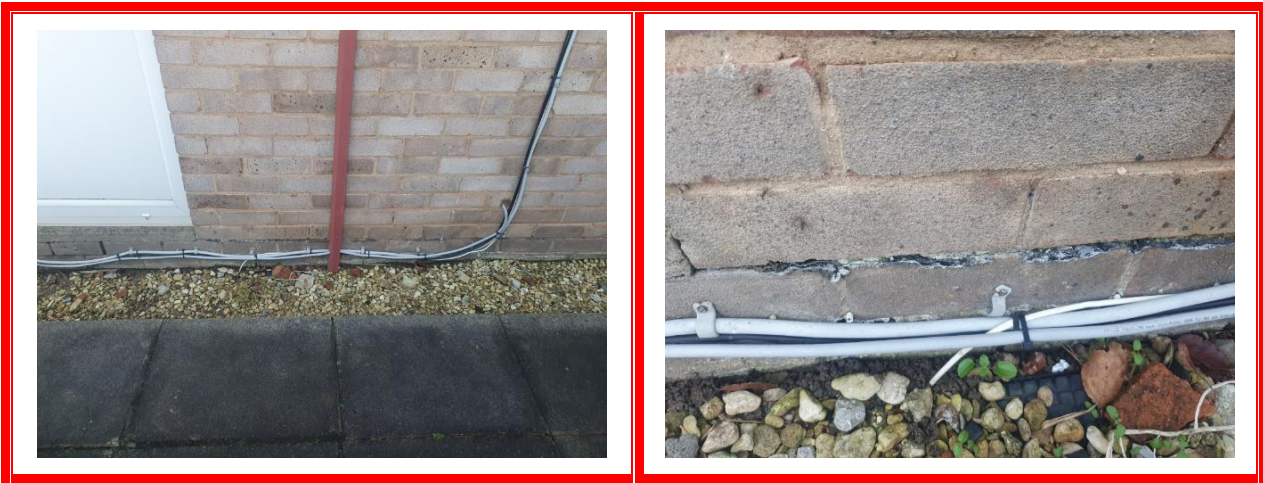
Item No:	1	Sample No:	N/A
Location:	External - Walls 001

Material Description:	Damp Proof Course - Bitumen	
Identification:	Previously Sampled - Asbestos Detected	
Approx. quantity:	Entire Perimeter	
Accessibility	Difficult	Assessment Score
Product type:	Bitumen	1
Extent of Damage:	Slight / minor damage	1
Surface Treatment:	Non-friable	0
Asbestos type:	Chrysotile	1
Material Assessment Score:		3
Priority Assessment Score:		Negligible
Action:	Manage	
Comments:	Previously sampled ref: Armour 9/9/19 Sample DK/1

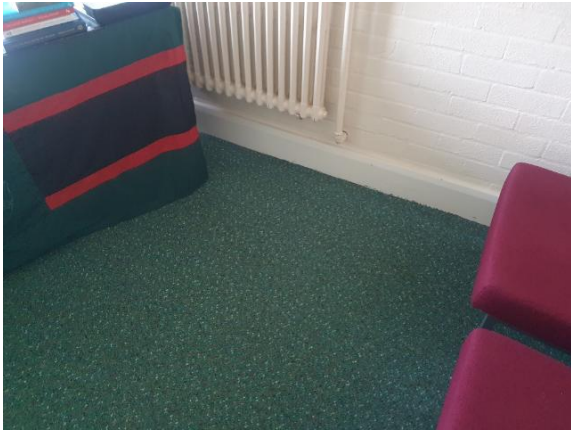
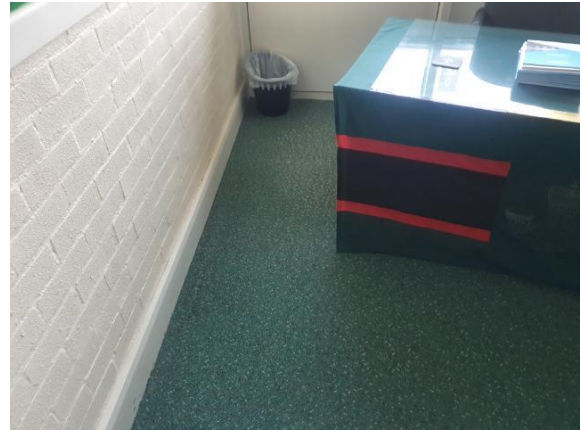
Location: Ground Floor - Commandant Office 002

Material Description:	Adhesive under Parquet Flooring - Bitumen	
Identification:	Presumed to Contain Asbestos	
Approx. quantity:	8 m ²	
Accessibility	Difficult	<i>Assessment Score</i>
Product type:	Bitumen	1
Extent of Damage:	Slight / minor damage	1
Surface Treatment:	Non-friable	0
Asbestos type:	Chrysotile	1
Material Assessment Score:		3
Priority Assessment Score:		Negligible
Action:	Manage	
Comments:	Under carpet. No access to sample without damaging flooring

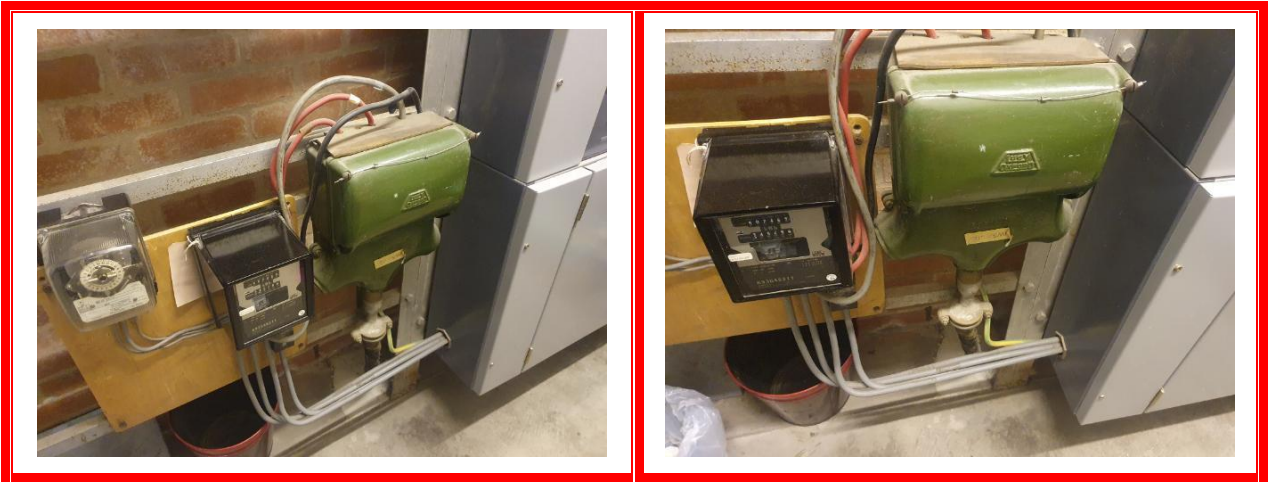
Item No:	3	Sample No:	N/A
Location:	Ground Floor - Electrical Cupboard 003

Material Description:	Old Electrical Box and Mains Cable - Gaskets (rope/woven)	
Identification:	Presumed to Contain Asbestos	
Approx. quantity:	1 no	
Accessibility	Difficult	<i>Assessment Score</i>
Product type:	Flashguards	2
Extent of Damage:	Minor damage	1
Surface Treatment:	Woven	1
Asbestos type:	Chrysotile	1
Material Assessment Score:		5
Priority Assessment Score:		Low
Action:	Manage	
Comments:	Not possible to sample as live

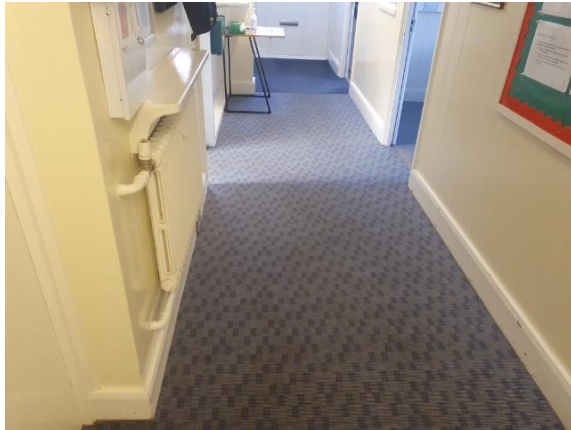
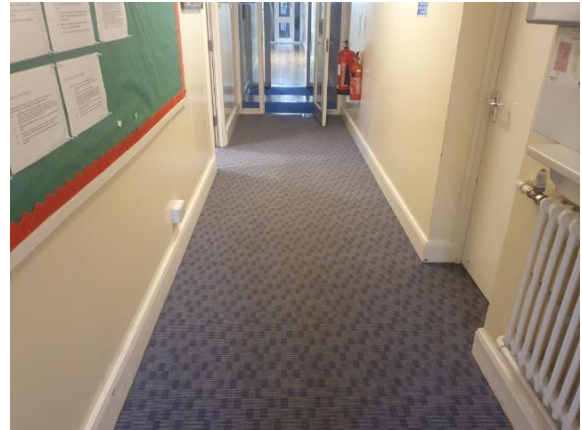
Location: Ground Floor - Corridors x 2 and Lobby 004

Material Description:	Adhesive under Parquet Flooring - Bitumen	
Identification:	Presumed to Contain Asbestos	
Approx. quantity:	60 m ²	
Accessibility	Difficult	<i>Assessment Score</i>
Product type:	Bitumen	1
Extent of Damage:	Slight / minor damage	1
Surface Treatment:	Non-friable	0
Asbestos type:	Chrysotile	1
Material Assessment Score:		3
Priority Assessment Score:		Negligible
Action:	Manage	
Comments:	Under carpet. No access to sample without damaging flooring

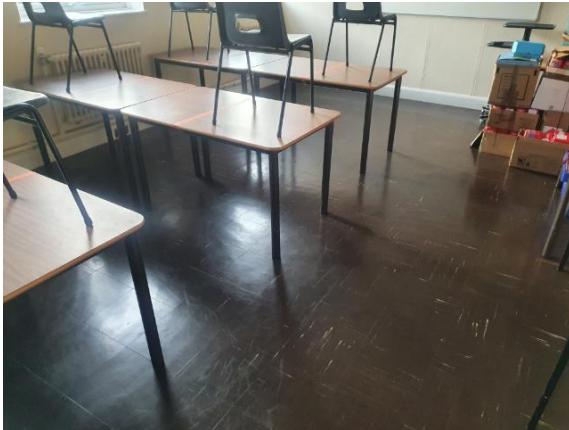
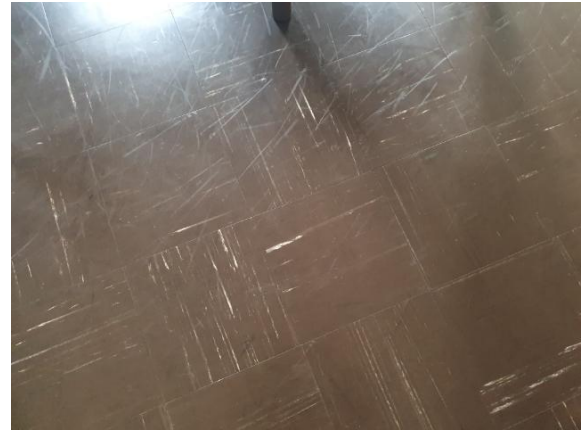
Location: Ground Floor - Classroom 2 005

Material Description:	Floor Tiles & Adhesive - Vinyl	
Identification:	Previously Sampled - Asbestos Detected	
Approx. quantity:	24 m ²	
Accessibility	Easy	<i>Assessment Score</i>
Product type:	Vinyl	1
Extent of Damage:	Slight / minor damage	1
Surface Treatment:	Non-friable	0
Asbestos type:	Chrysotile	1
Material Assessment Score:		3
Priority Assessment Score:		Negligible
Action:	Manage	
Comments:	Previously sampled ref: Armour 9/9/19 Sample DK/4

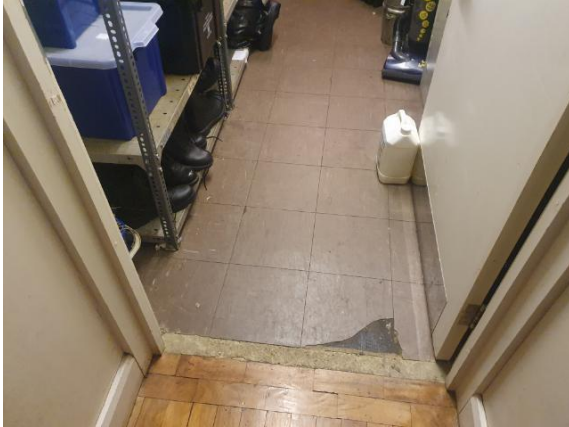
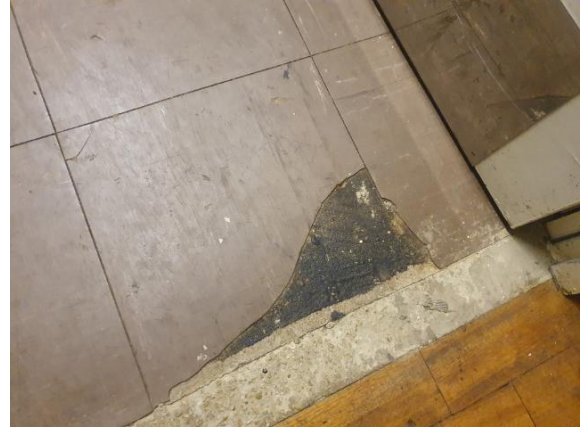
Item No:	6	Sample No:	N/A
Location:	Ground Floor - Store 006

Material Description:	Floor Tiles & Adhesive - Vinyl	
Identification:	Previously Sampled - Asbestos Detected	
Approx. quantity:	10 m ²	
Accessibility	Easy	<i>Assessment Score</i>
Product type:	Vinyl	1
Extent of Damage:	Moderate damage	2
Surface Treatment:	Non-friable	0
Asbestos type:	Chrysotile	1
Material Assessment Score:		4
Priority Assessment Score:		Negligible
Action:	Manage	
Comments:	Previously sampled ref: Armour 9/9/19 Sample DK/5

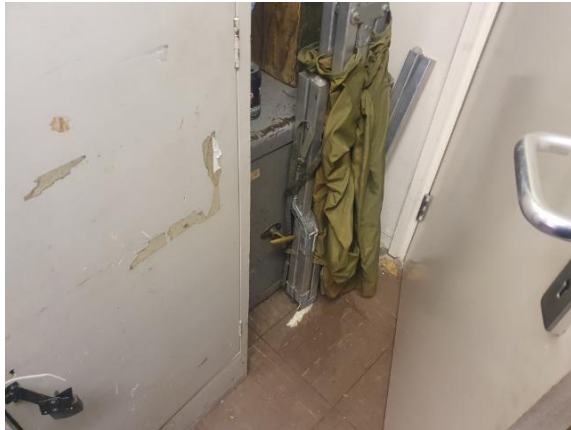
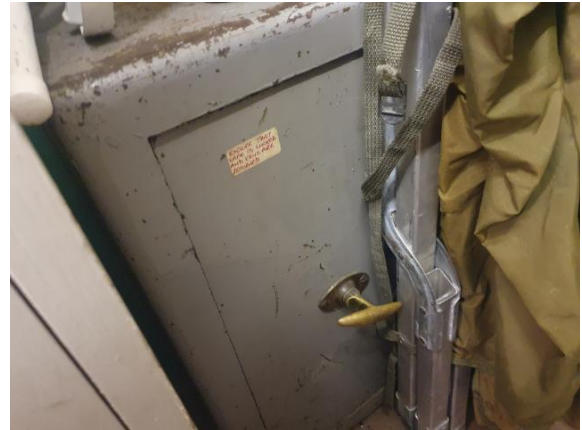
Location: Ground Floor - Store 007

Material Description:	Safe - Asbestos Insulation Board	
Identification:	Presumed to Contain Asbestos	
Approx. quantity:	1 no	
Accessibility	Difficult	<i>Assessment Score</i>
Product type:	Asbestos insulating board	2
Extent of Damage:	Minor damage	1
Surface Treatment:	Unsealed AIB	1
Asbestos type:	Amosite, Chrysotile	2
Material Assessment Score:		6
Priority Assessment Score:		Low
Action:	Manage	
Comments:	No access with safe casings without damaging safe

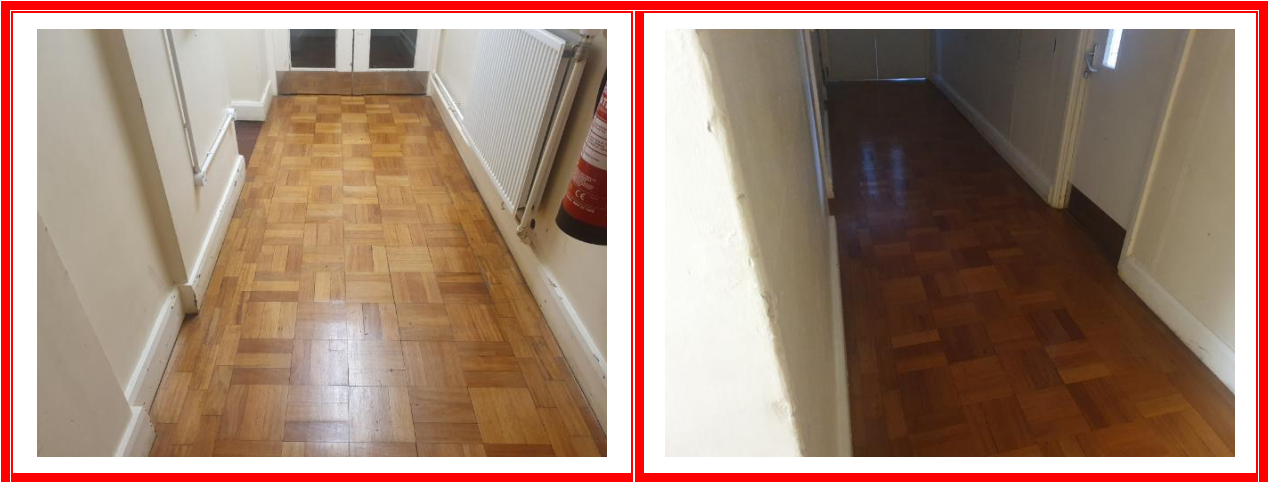
Item No:	8	Sample No:	N/A
Location:	Ground Floor - Corridors x 2 008

Material Description:	Adhesive under Parquet Flooring - Bitumen	
Identification:	Presumed to Contain Asbestos	
Approx. quantity:	26 m ²	
Accessibility	Difficult	<i>Assessment Score</i>
Product type:	Bitumen	1
Extent of Damage:	Slight / minor damage	1
Surface Treatment:	Non-friable	0
Asbestos type:	Chrysotile	1
Material Assessment Score:		3
Priority Assessment Score:		Negligible
Action:	Manage	
Comments:	No access to sample without damaging flooring

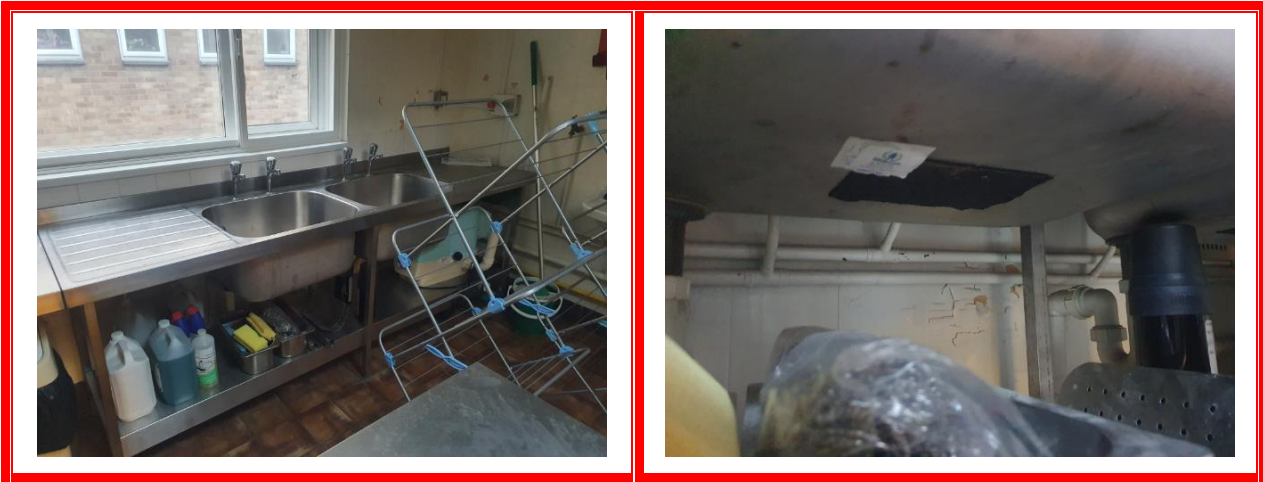
Item No:	9	Sample No:	N/A
Location:	Ground Floor - Kitchen 009

Material Description:	Floor Tiles & Adhesive - Vinyl	
Identification:	Previously Sampled - Asbestos Detected	
Approx. quantity:	2 no	
Accessibility	Medium	<i>Assessment Score</i>
Product type:	Vinyl	1
Extent of Damage:	Slight / minor damage	1
Surface Treatment:	Non-friable	0
Asbestos type:	Chrysotile	1
Material Assessment Score:		3
Priority Assessment Score:		Negligible
Action:	Manage	
Comments:	Previously sampled ref: Armour 9/9/19 Sample DK/6

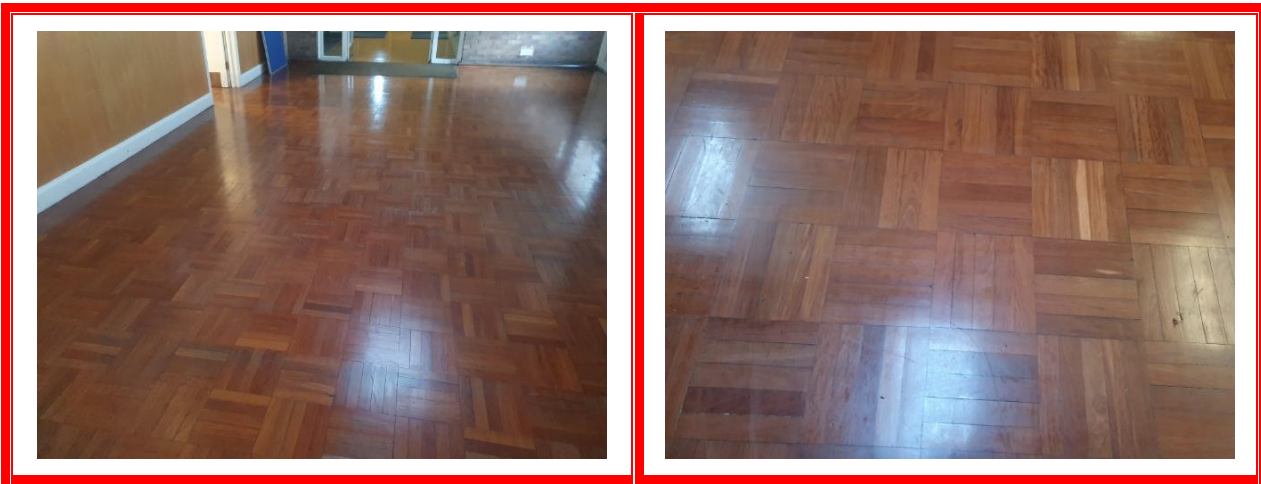
Item No:	10	Sample No:	N/A
Location:	Ground Floor - Drill Hall 010

Material Description:	Adhesive under Parquet Flooring - Bitumen	
Identification:	Presumed to Contain Asbestos	
Approx. quantity:	66 m ²	
Accessibility	Difficult	<i>Assessment Score</i>
Product type:	Bitumen	1
Extent of Damage:	Slight / minor damage	1
Surface Treatment:	Non-friable	0
Asbestos type:	Chrysotile	1
Material Assessment Score:		3
Priority Assessment Score:		Negligible
Action:	Manage	
Comments:	No access to sample without damaging flooring

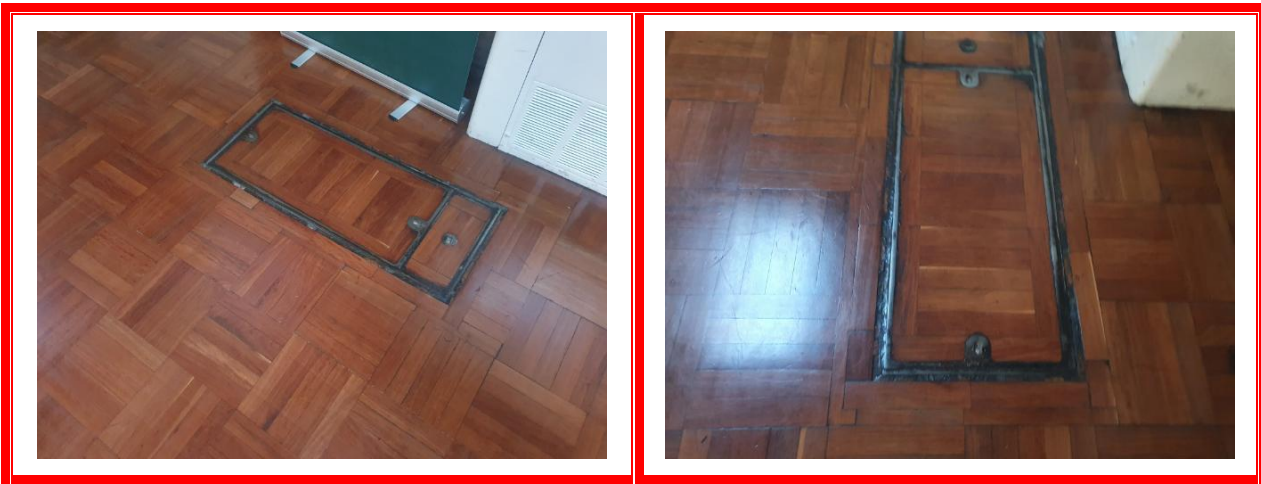
Item No:	11	Sample No:	N/A
Location:	Ground Floor - Floor Ducts 011

Material Description:	Insulation to Pipework - Insulation	
Identification:	Presumed to Contain Asbestos	
Approx. quantity:	Unknown	
Accessibility	Difficult	<i>Assessment Score</i>
Product type:	Pipe insulation	3
Extent of Damage:	Major damage	3
Surface Treatment:	Unsealed Insulation	3
Asbestos type:	Chrysotile	3
Material Assessment Score:		12
Priority Assessment Score:		High
Action:	Manage	
Comments:	No access within floor ducts

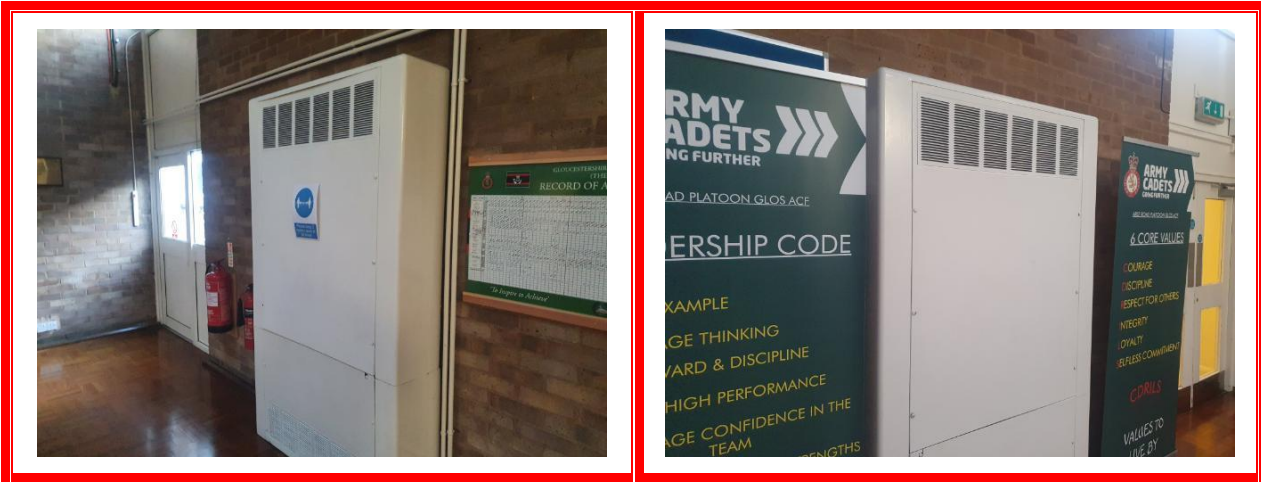
Item No:	12	Sample No:	N/A
Location:	Ground Floor - Drill Hall 012

Material Description:	Heaters - No Access Gained	
Identification:	Presumed to Contain Asbestos	
Approx. quantity:	2 no	
Accessibility	Difficult	Assessment Score
Product type:	Asbestos insulating board	2
Extent of Damage:	Minor damage	1
Surface Treatment:	Unsealed AIB	2
Asbestos type:	Amosite, Chrysotile	2
Material Assessment Score:		7
Priority Assessment Score:		Medium
Action:	Manage	
Comments:	No access within live heaters

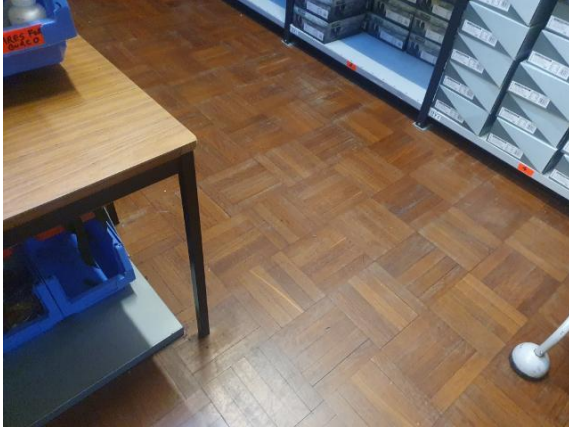
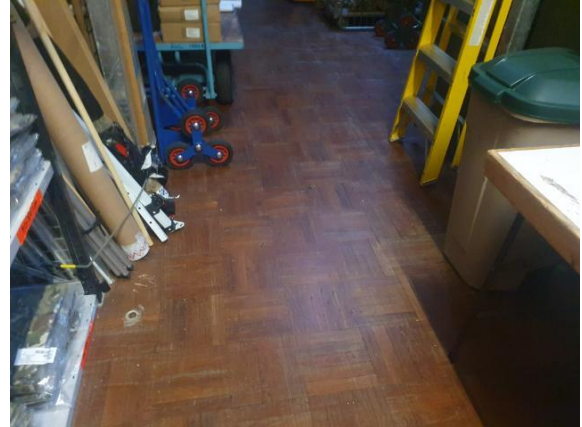
Location: Ground Floor - Store 013

Material Description:	Adhesive under Parquet Flooring - Bitumen	
Identification:	Presumed to Contain Asbestos	
Approx. quantity:	90 m ²	
Accessibility	Difficult	<i>Assessment Score</i>
Product type:	Bitumen	1
Extent of Damage:	Slight / minor damage	1
Surface Treatment:	Non-friable	0
Asbestos type:	Chrysotile	1
Material Assessment Score:		3
Priority Assessment Score:		Negligible
Action:	Manage	
Comments:	No access to sample without damaging flooring

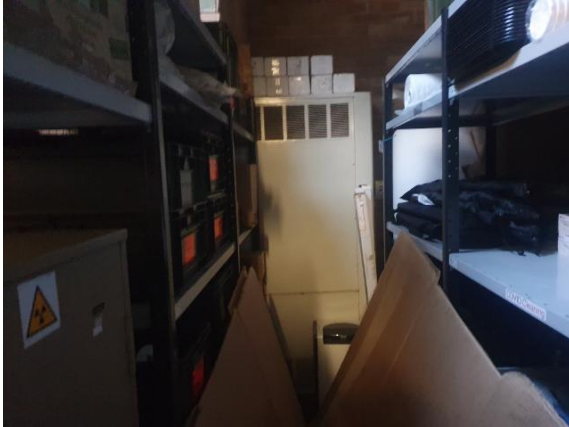
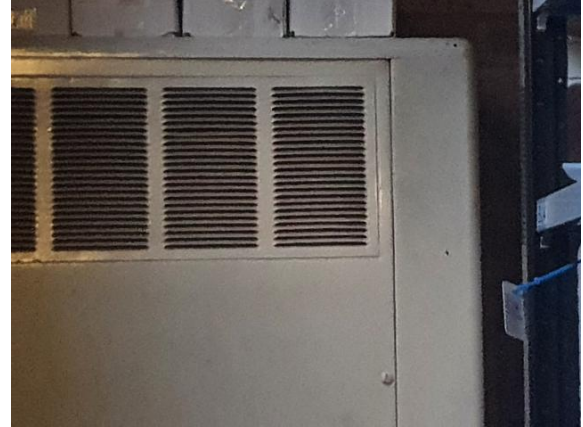
Item No:	14	Sample No:	N/A
Location:	Ground Floor - Store 014

Material Description:	Heater - No Access Gained	
Identification:	Presumed to Contain Asbestos	
Approx. quantity:	1 no	
Accessibility	Difficult	<i>Assessment Score</i>
Product type:	Asbestos insulating board	2
Extent of Damage:	Minor damage	1
Surface Treatment:	Unsealed AIB	2
Asbestos type:	Amosite, Chrysotile	2
Material Assessment Score:		7
Priority Assessment Score:		Medium
Action:	Manage	
Comments:	No access within live heater

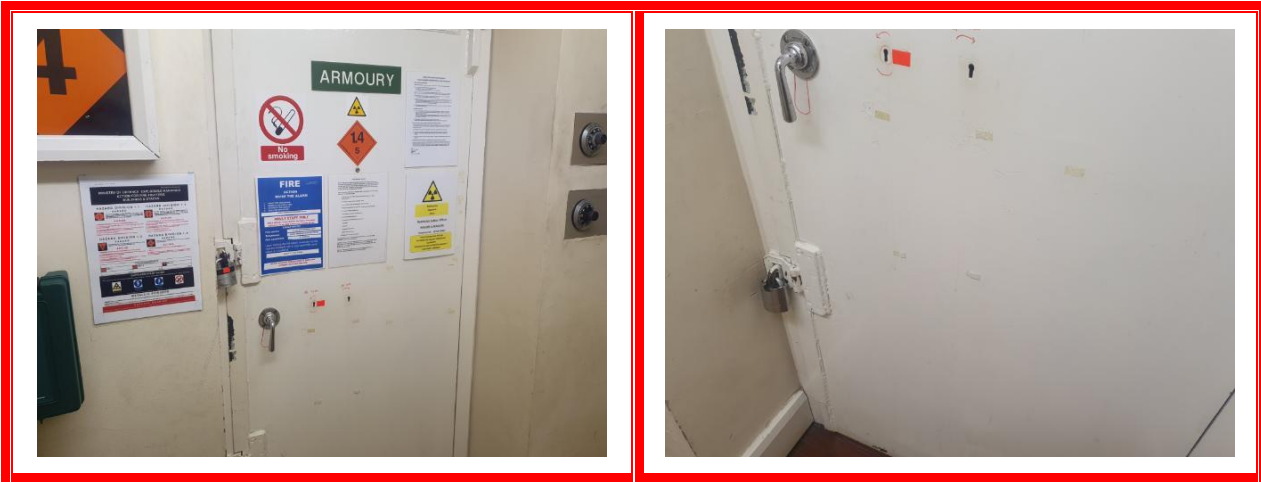
Item No:	15	Sample No:	N/A
Location:	Ground Floor - Armoury 015

Material Description:	Door Casings - No Access Gained	
Identification:	Presumed to Contain Asbestos	
Approx. quantity:	2 no	
Accessibility	Difficult	<i>Assessment Score</i>
Product type:	Asbestos insulating board	2
Extent of Damage:	Minor damage	1
Surface Treatment:	Unsealed AIB	2
Asbestos type:	Amosite, Chrysotile	2
Material Assessment Score:		7
Priority Assessment Score:		Medium
Action:	Manage	
Comments:	No access within door casings without damaging doors

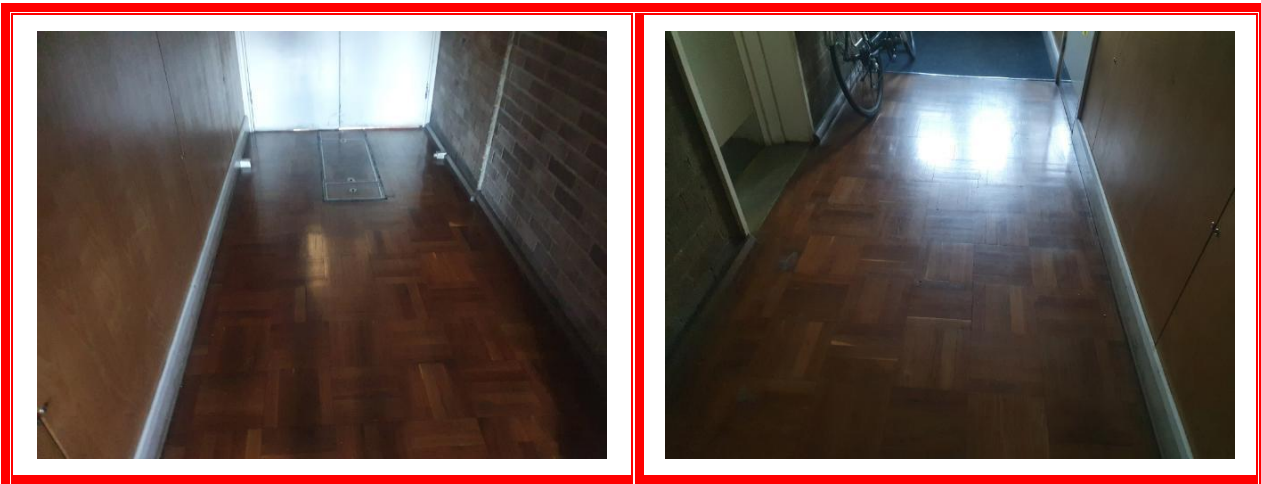
Item No:	16	Sample No:	N/A
Location:	Ground Floor - Corridor 016

Material Description:	Adhesive under Parquet Flooring - Bitumen	
Identification:	Presumed to Contain Asbestos	
Approx. quantity:	10 m ²	
Accessibility	Difficult	<i>Assessment Score</i>
Product type:	Bitumen	1
Extent of Damage:	Slight / minor damage	1
Surface Treatment:	Non-friable	0
Asbestos type:	Chrysotile	1
Material Assessment Score:		3
Priority Assessment Score:		Negligible
Action:	Manage	
Comments:	No access to sample without damaging flooring

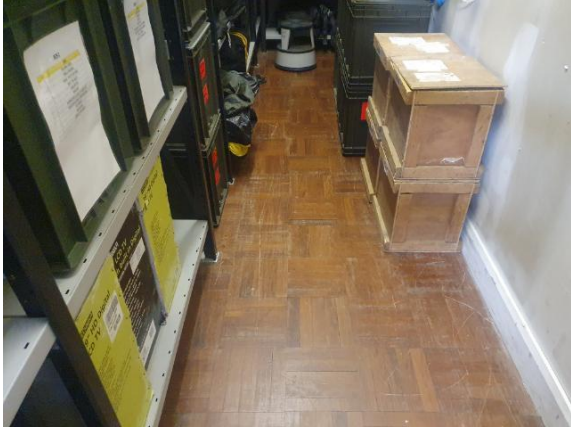
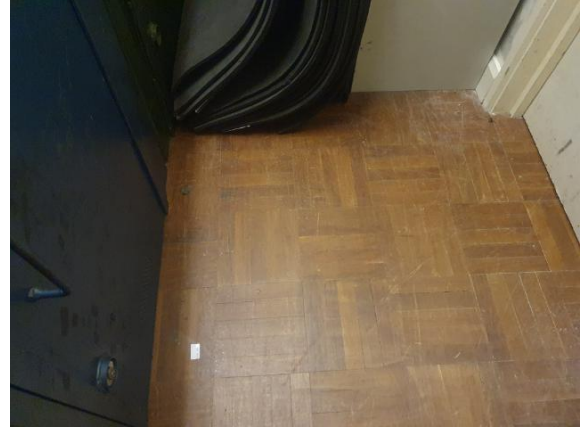
Location: Ground Floor - Side Store and Banwell Store 017

Material Description:	Adhesive under Parquet Flooring - Bitumen	
Identification:	Presumed to Contain Asbestos	
Approx. quantity:	22 m ²	
Accessibility	Difficult	<i>Assessment Score</i>
Product type:	Bitumen	1
Extent of Damage:	Slight / minor damage	1
Surface Treatment:	Non-friable	0
Asbestos type:	Chrysotile	1
Material Assessment Score:		3
Priority Assessment Score:		Negligible
Action:	Manage	
Comments:	No access to sample without damaging flooring

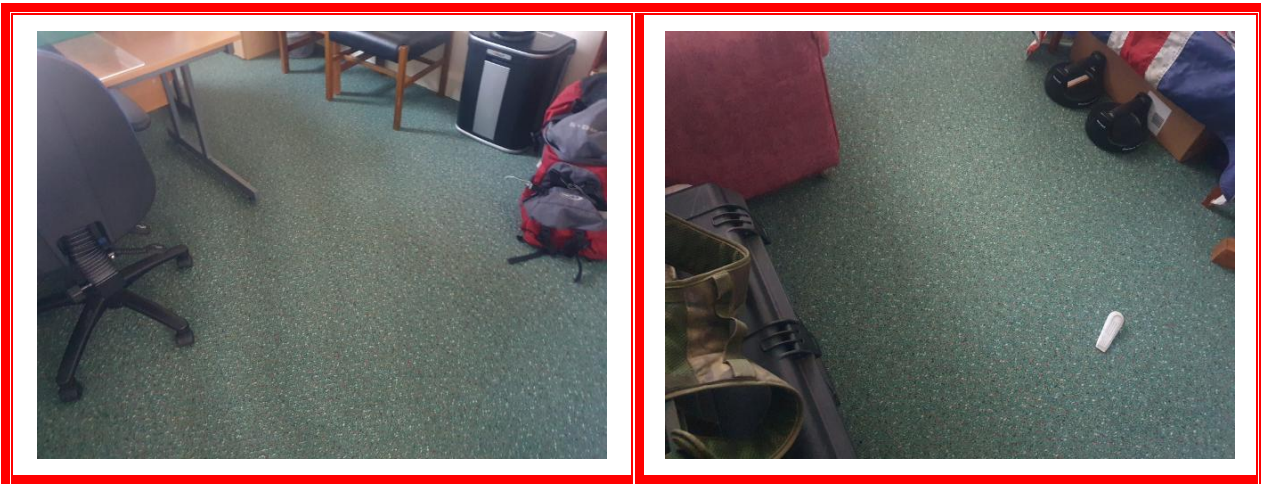
Item No:	18	Sample No:	N/A
Location:	First Floor - Offices x 3 018

Material Description:	Adhesive under Parquet Flooring - Bitumen	
Identification:	Presumed to Contain Asbestos	
Approx. quantity:	32 m ²	
Accessibility	Difficult	<i>Assessment Score</i>
Product type:	Bitumen	1
Extent of Damage:	Slight / minor damage	1
Surface Treatment:	Non-friable	0
Asbestos type:	Chrysotile	1
Material Assessment Score:		3
Priority Assessment Score:		Negligible
Action:	Manage	
Comments:	Under carpet. No access to sample without damaging flooring

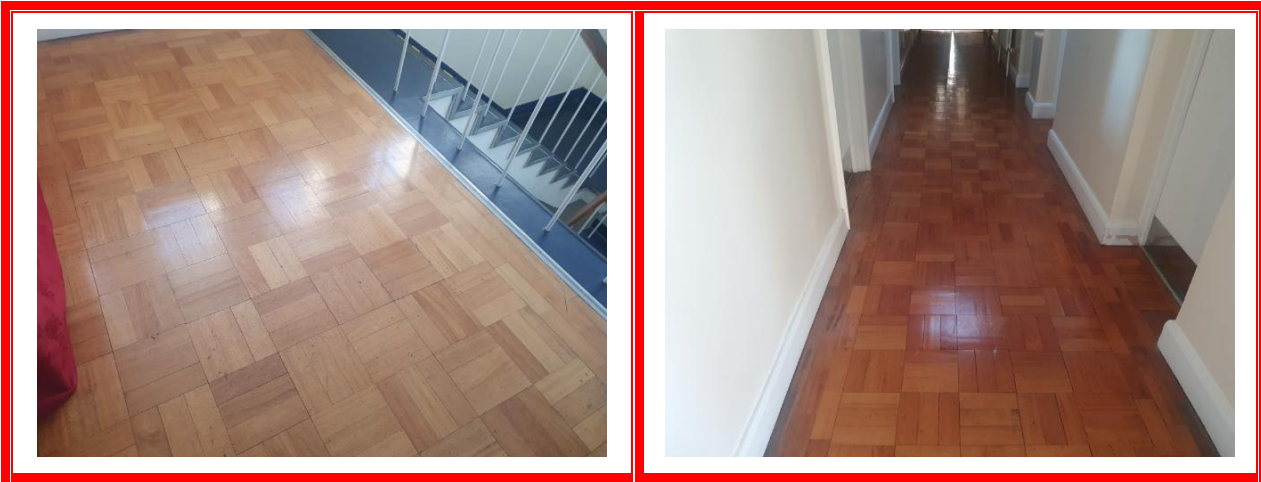
Item No:	19	Sample No:	N/A
Location:	First Floor - Landing and Corridor 019

Material Description:	Adhesive under Parquet Flooring - Bitumen	
Identification:	Presumed to Contain Asbestos	
Approx. quantity:	48 m ²	
Accessibility	Difficult	<i>Assessment Score</i>
Product type:	Bitumen	1
Extent of Damage:	Slight / minor damage	1
Surface Treatment:	Non-friable	0
Asbestos type:	Chrysotile	1
Material Assessment Score:		3
Priority Assessment Score:		Negligible
Action:	Manage	
Comments:	No access to sample without damaging flooring

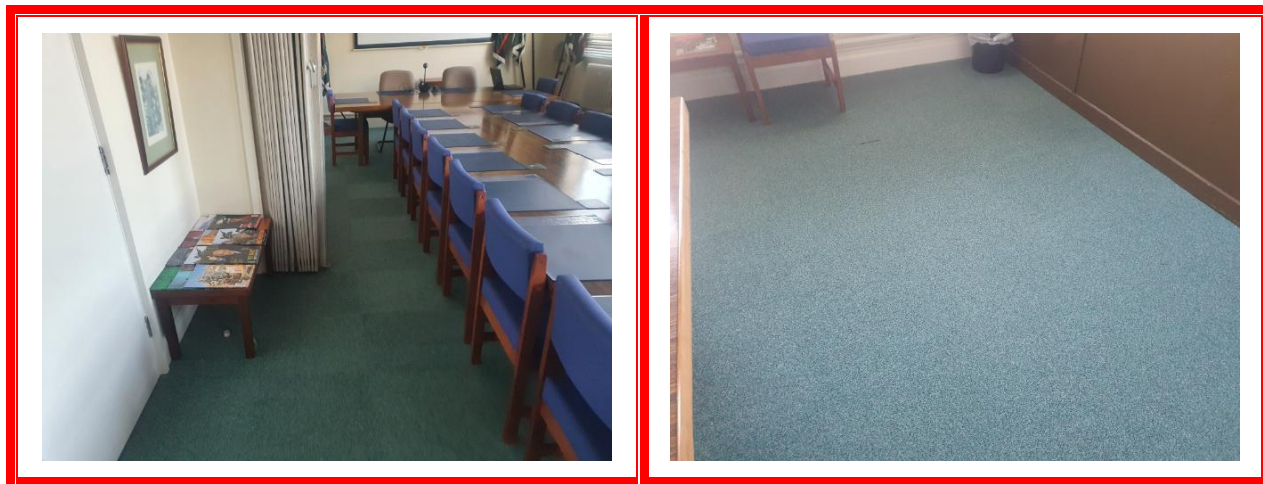
Item No:	20	Sample No:	N/A
Location:	First Floor - Conference Room 020

Material Description:	Adhesive under Parquet Flooring - Bitumen	
Identification:	Presumed to Contain Asbestos	
Approx. quantity:	50 m ²	
Accessibility	Difficult	<i>Assessment Score</i>
Product type:	Bitumen	1
Extent of Damage:	Slight / minor damage	1
Surface Treatment:	Non-friable	0
Asbestos type:	Chrysotile	1
Material Assessment Score:		3
Priority Assessment Score:		Negligible
Action:	Manage	
Comments:	Under carpet. No access to sample without damaging flooring

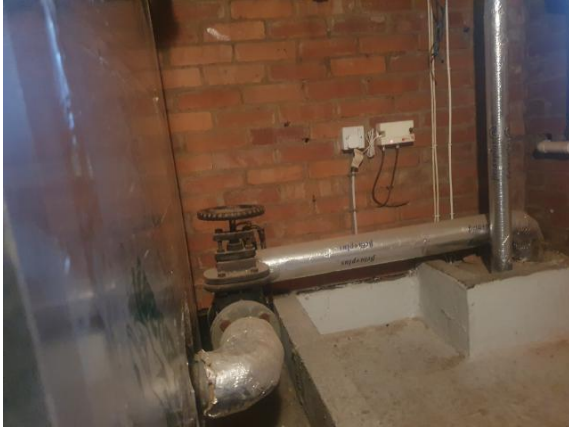
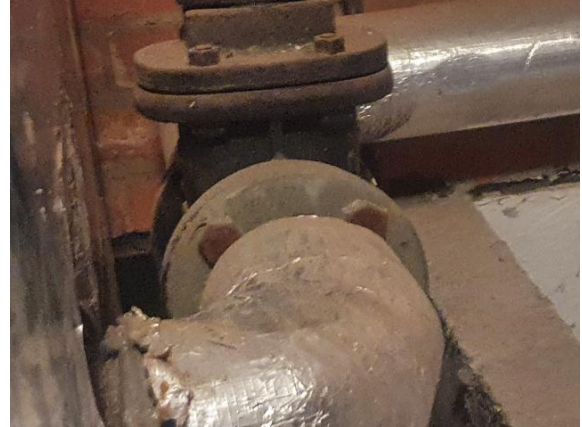
Location: First Floor - Tank Room 021

Material Description:	Gaskets - Gaskets (compressed)	
Identification:	Presumed to Contain Asbestos	
Approx. quantity:	2 no	
Accessibility	Difficult	<i>Assessment Score</i>
Product type:	Gaskets	2
Extent of Damage:	Minor damage	1
Surface Treatment:	Gaskets	1
Asbestos type:	Chrysotile	1
Material Assessment Score:		5
Priority Assessment Score:		Low
Action:	Manage	
Comments:	Not possible to sample as gaskets were to inset within flanges

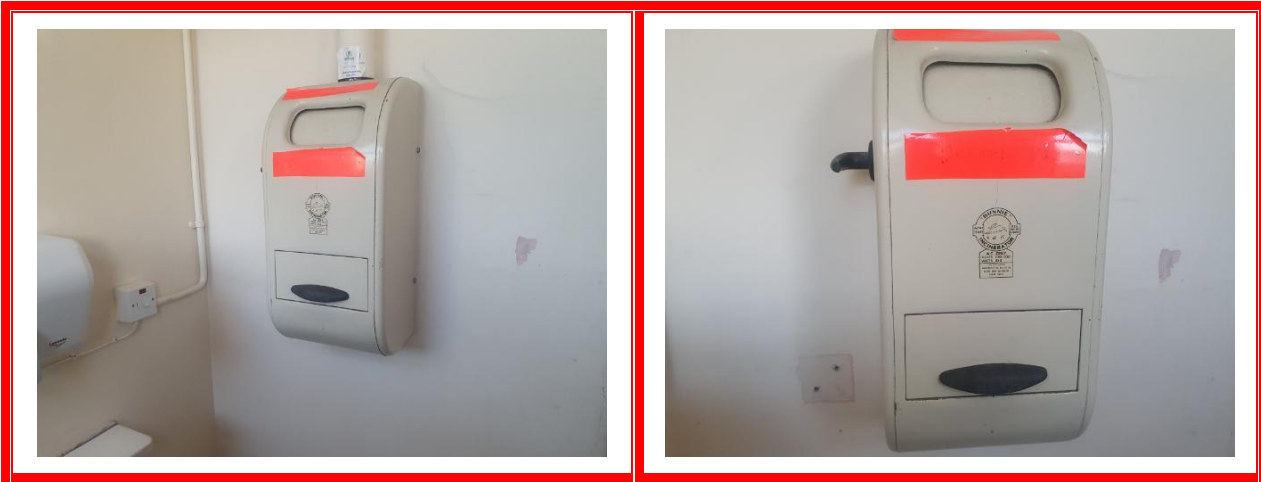
Item No:	22	Sample No:	N/A
Location:	First Floor - Female WC 022

Material Description:	Bunnie Incinerator - No Access Gained	
Identification:	Presumed to Contain Asbestos	
Approx. quantity:	1 no	
Accessibility	Difficult	<i>Assessment Score</i>
Product type:	Asbestos insulating board	2
Extent of Damage:	Minor damage	1
Surface Treatment:	Unsealed AIB	2
Asbestos type:	Amosite	2
Material Assessment Score:		7
Priority Assessment Score:		Medium
Action:	Manage	
Comments:	Presumed asbestos insulation board within bunnie incinerator. No access possible as live

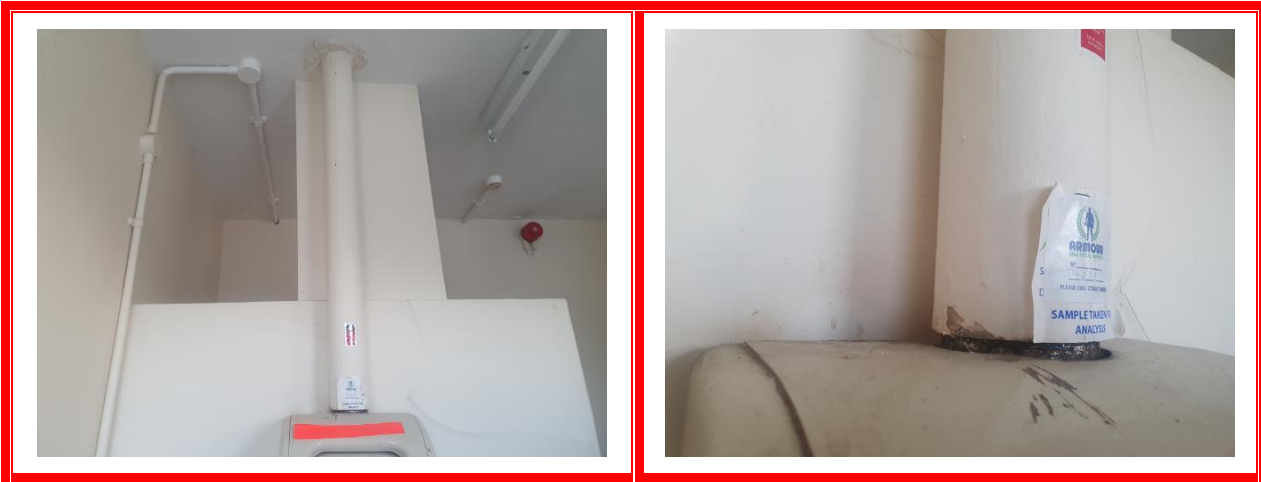
Item No:	23	Sample No:	N/A
Location:	First Floor - Ladies WC 023

Material Description:	Flue Pipe - Cement	
Identification:	Previously Sampled - Asbestos Detected	
Approx. quantity:	2 LM	
Accessibility	Medium	Assessment Score
Product type:	Cement	1
Extent of Damage:	Slight / minor damage	1
Surface Treatment:	Unsealed Cement	1
Asbestos type:	Chrysotile	1
Material Assessment Score:		4
Priority Assessment Score:		Negligible
Action:	Manage	
Comments:	Previously sampled ref: Armour 9/9/19 Sample DK/7

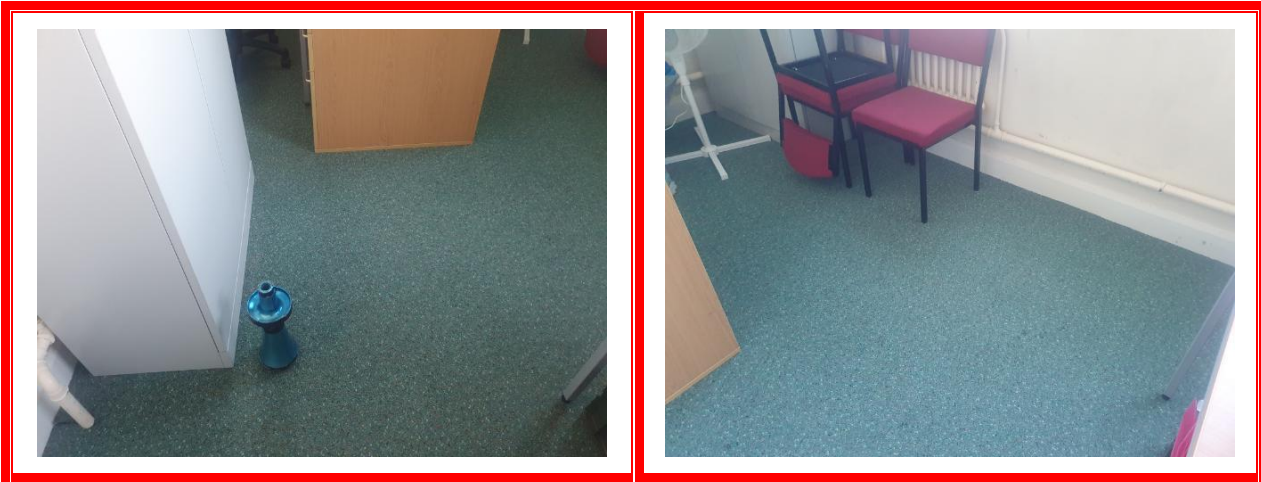
Item No:	24	Sample No:	N/A
Location:	First Floor - Office 024

Material Description:	Adhesive under Parquet Flooring - Bitumen	
Identification:	Presumed to Contain Asbestos	
Approx. quantity:	20 m ²	
Accessibility	Difficult	<i>Assessment Score</i>
Product type:	Bitumen	1
Extent of Damage:	Slight / minor damage	1
Surface Treatment:	Non-friable	0
Asbestos type:	Chrysotile	1
Material Assessment Score:		3
Priority Assessment Score:		Negligible
Action:	Manage	
Comments:	Under carpet. No access to sample without damaging flooring

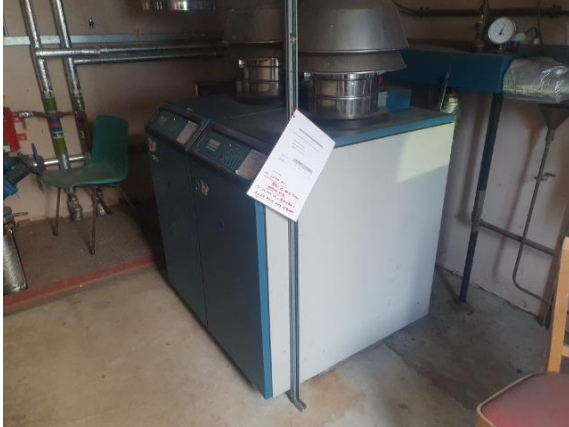
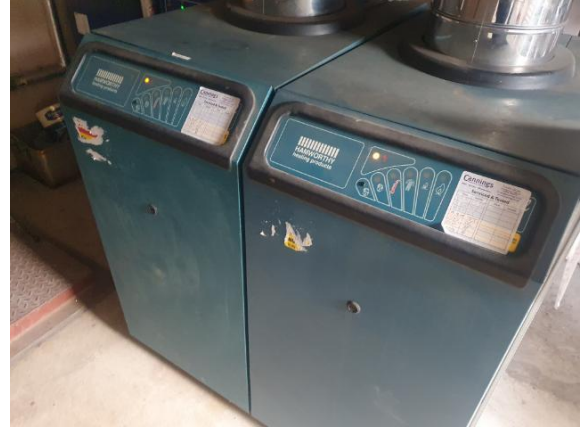
Item No:	25	Sample No:	N/A
Location:	Ground Floor - Boiler Room 025

Material Description:	Boilers - No Access Gained	
Identification:	Presumed to Contain Asbestos	
Approx. quantity:	2 no	
Accessibility	Difficult	<i>Assessment Score</i>
Product type:	Asbestos insulating board	2
Extent of Damage:	Minor damage	1
Surface Treatment:	Unsealed AIB	2
Asbestos type:	Chrysotile, Amosite	2
Material Assessment Score:		7
Priority Assessment Score:		Medium
Action:	Manage	
Comments:	No access within live Hamworthy boilers

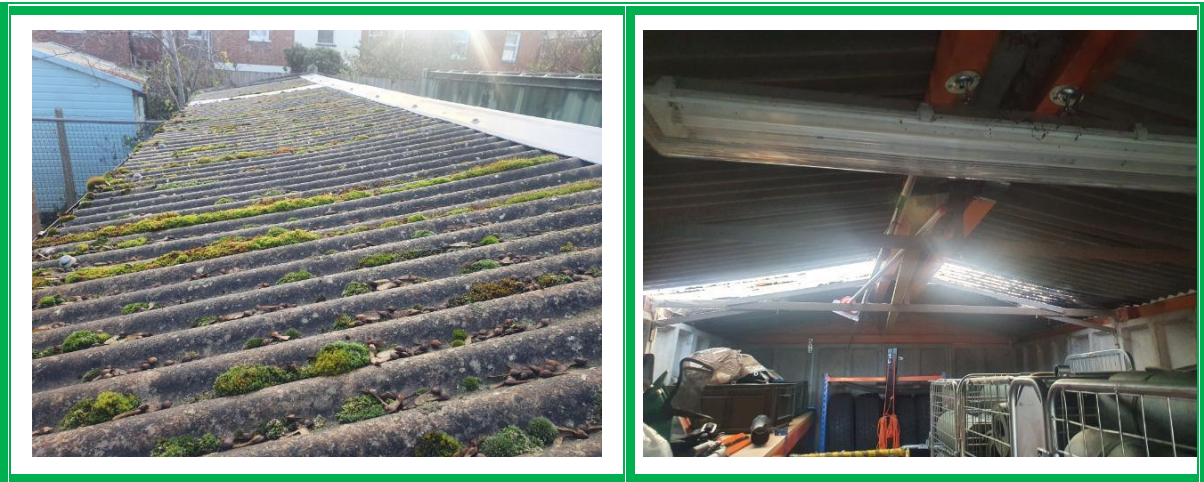
Item No:	26	Sample No:	DK/01
Location:	Ground Floor - Garage 026

Material Description:	Profiled Roof - Cement	
Identification:	Sampled - No Asbestos Found	
Approx. quantity:	N/A	
Accessibility	N/A	Assessment Score
Product type:	N/A	N/A
Extent of Damage:	N/A	N/A
Surface Treatment:	N/A	N/A
Asbestos type:	N/A	N/A
Material Assessment Score:		
Priority Assessment Score:		
Action:	N/A	
Comments:	Previously un-accessed garage
