**Project Number A-00520 (3700)**

**Re-Inspection  
Asbestos Survey Report - Revised**

**6th Battalion The Rifles C  
Poundbury Road  
Dorset  
DT1 1TA**

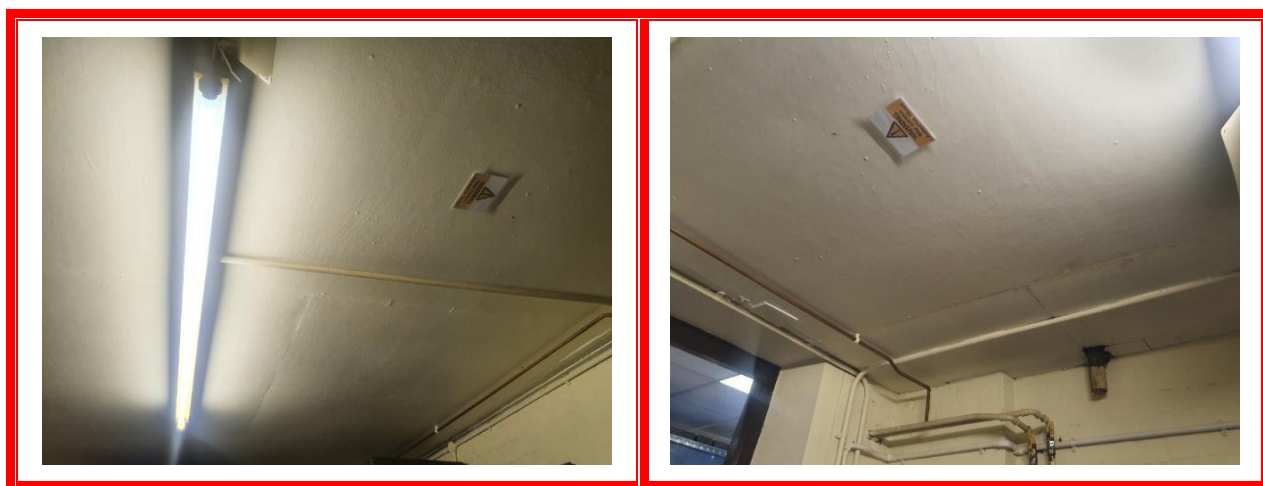
<b>Item No:</b>	<b>1</b>	<b>Sample No:</b>	<b>N/A</b>
<b>Location:</b>	Ground Floor - Building 1 - Store 001

<b>Material Description:</b>	Flat Sheet Cement Ceiling - Cement Product	
<b>Identification:</b>	Previously Sampled - Asbestos Detected	
<b>Approx. quantity:</b>	16 m <sup>2</sup>	
<b>Accessibility</b>	Medium	Assessment Score
<b>Product type:</b>	Cement	1
<b>Extent of Damage:</b>	Slight / minor damage	1
<b>Surface Treatment:</b>	Unsealed Cement	1
<b>Asbestos type:</b>	Chrysotile	1
<b>Material Assessment Score:</b>		4
<b>Priority Assessment Score:</b>		Negligible
<b>Action:</b>	Encapsulate	
<b>Comments:</b>	Previously sampled ref: Armour 21/10/19 Sample DK/3

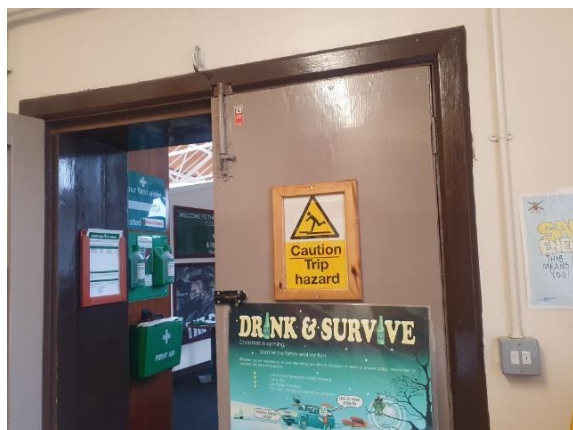
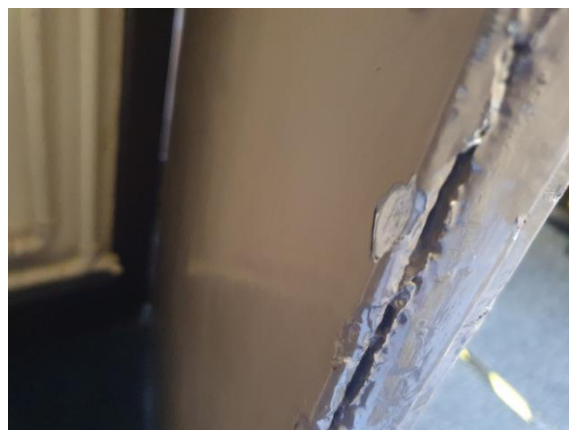
**Location:** Ground Floor - Building 1 - Coms Store Lobby 002

<b>Material Description:</b>	Panels to Doors - Insulating Board	
<b>Identification:</b>	Previously Sampled - Asbestos Detected	
<b>Approx. quantity:</b>	4 m <sup>2</sup>	
<b>Accessibility</b>	Easy	Assessment Score
<b>Product type:</b>	Asbestos Insulating Board	2
<b>Extent of Damage:</b>	Moderate damage	2
<b>Surface Treatment:</b>	Unsealed AIB	2
<b>Asbestos type:</b>	Amosite	2
<b>Material Assessment Score:</b>		8
<b>Priority Assessment Score:</b>		Medium
<b>Action:</b>	Encapsulate	
<b>Comments:</b>	Previously sampled ref: Armour 21/10/19 Sample DK/4. Several areas of slight damage

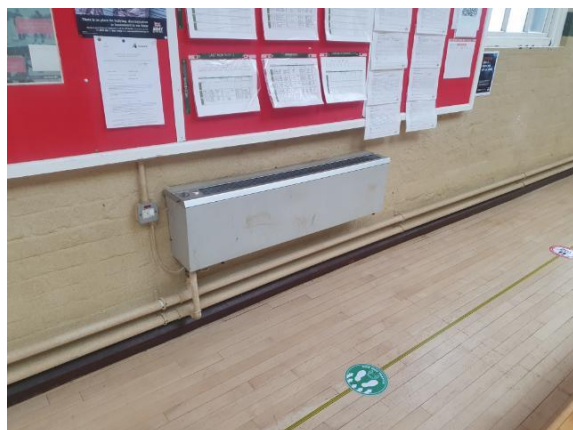
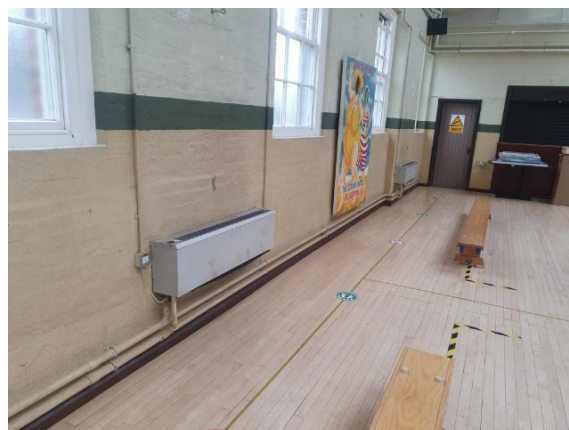
**Location:** Ground Floor - Building 1 - Drill Hall 003

<b>Material Description:</b>	Components with Gas Heaters - Insulating Board	
<b>Identification:</b>	Presumed to Contain Asbestos	
<b>Approx. quantity:</b>	6 no	
<b>Accessibility</b>	Difficult	<i>Assessment Score</i>
<b>Product type:</b>	Asbestos Insulating Board	2
<b>Extent of Damage:</b>	Major damage	3
<b>Surface Treatment:</b>	Unsealed Insulation	3
<b>Asbestos type:</b>	Amosite, Chrysotile	2
<b>Material Assessment Score:</b>		10
<b>Priority Assessment Score:</b>		High
<b>Action:</b>	Manage	
<b>Comments:</b>	No access within live heaters

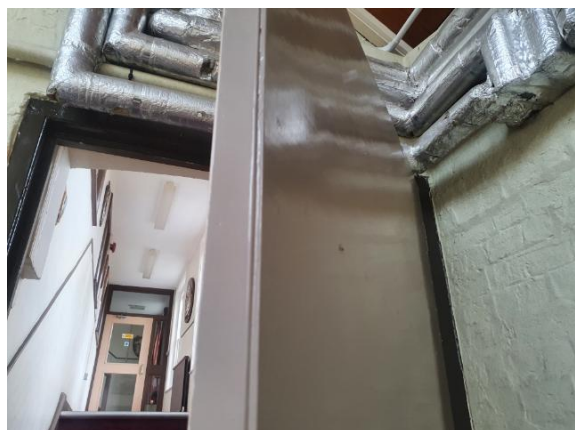
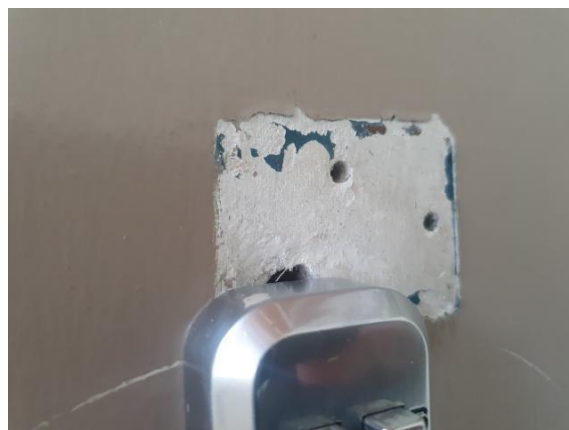
**Location:** Ground Floor - Building 1 - Drill Hall 004

<b>Material Description:</b>	Panels to Door - Insulating Board	
<b>Identification:</b>	Previously Sampled - Asbestos Detected	
<b>Approx. quantity:</b>	4 m <sup>2</sup>	
<b>Accessibility</b>	Easy	<i>Assessment Score</i>
<b>Product type:</b>	Asbestos Insulating Board	2
<b>Extent of Damage:</b>	Moderate damage	2
<b>Surface Treatment:</b>	Unsealed AIB	2
<b>Asbestos type:</b>	Amosite	2
<b>Material Assessment Score:</b>		8
<b>Priority Assessment Score:</b>		Medium
<b>Action:</b>	Encapsulate	
<b>Comments:</b>	Previously sampled ref: Armour 21/10/19 Sample DK/4. Several areas of slight damage

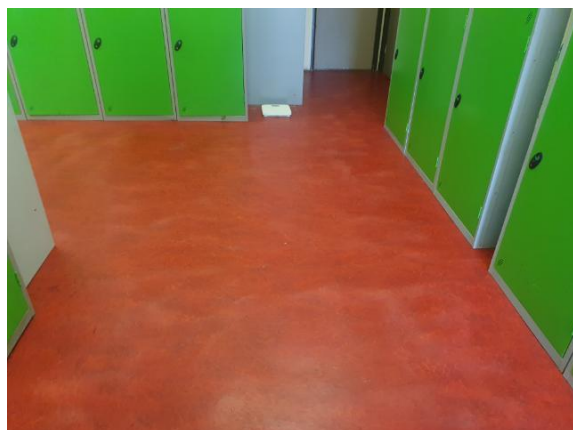
**Location:** Ground Floor - Building 1 - Locker Room 005

<b>Material Description:</b>	Adhesive under Lino Flooring - Bituminous Product	
<b>Identification:</b>	Previously Sampled - Asbestos Detected	
<b>Approx. quantity:</b>	40 m <sup>2</sup>	
<b>Accessibility</b>	Difficult	<i>Assessment Score</i>
<b>Product type:</b>	Asbestos Insulating Board	2
<b>Extent of Damage:</b>	Slight / minor damage	1
<b>Surface Treatment:</b>	Non-friable	0
<b>Asbestos type:</b>	Chrysotile	1
<b>Material Assessment Score:</b>		4
<b>Priority Assessment Score:</b>		Negligible
<b>Action:</b>	Manage	
<b>Comments:</b>	Previously sampled ref: Armour 21/10/19 Sample DK/6

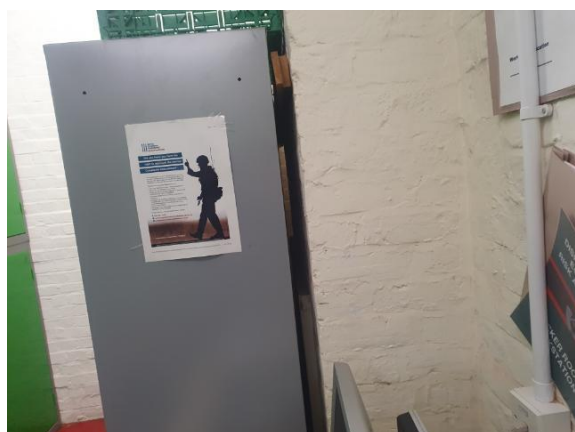
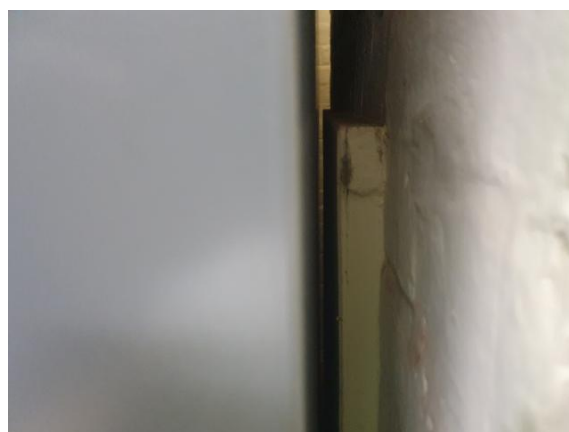
**Location:** Ground Floor - Building 1 - Locker Room 006

<b>Material Description:</b>	Fireplace Cover - Insulating Board	
<b>Identification:</b>	Previously Sampled - Asbestos Detected	
<b>Approx. quantity:</b>	2 m <sup>2</sup>	
<b>Accessibility</b>	Easy	Assessment Score
<b>Product type:</b>	Asbestos Insulating Board	2
<b>Extent of Damage:</b>	Slight / minor damage	1
<b>Surface Treatment:</b>	Encapsulated AIB	1
<b>Asbestos type:</b>	Amosite	2
<b>Material Assessment Score:</b>		6
<b>Priority Assessment Score:</b>		Low
<b>Action:</b>	Manage	
<b>Comments:</b>	Previously sampled ref: SWA02665/3/3. Located behind a fixed locker

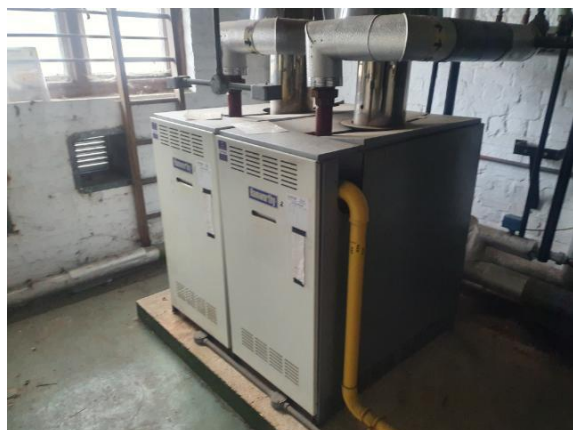
**Location:** Ground Floor - Building 1 - Boiler Room 007

<b>Material Description:</b>	Components with Boilers - Insulating Board	
<b>Identification:</b>	Presumed to Contain Asbestos	
<b>Approx. quantity:</b>	2 no	
<b>Accessibility</b>	Difficult	<i>Assessment Score</i>
<b>Product type:</b>	Asbestos Insulating Board	2
<b>Extent of Damage:</b>	Major damage	3
<b>Surface Treatment:</b>	Unsealed Insulation	3
<b>Asbestos type:</b>	Amosite, Chrysotile	2
<b>Material Assessment Score:</b>		10
<b>Priority Assessment Score:</b>		High
<b>Action:</b>	Manage	
<b>Comments:</b>	No access within live boilers

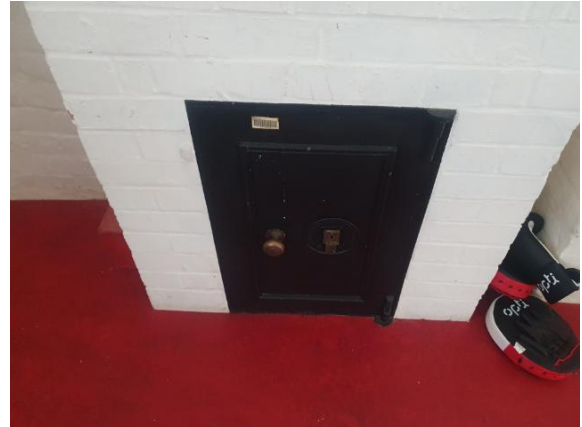
**Location:** Ground Floor - Building 1 - Boiler Room 008

<b>Material Description:</b>	Safe Casings - Insulating Board	
<b>Identification:</b>	Presumed to Contain Asbestos	
<b>Approx. quantity:</b>	1 no	
<b>Accessibility</b>	Difficult	<i>Assessment Score</i>
<b>Product type:</b>	Asbestos Insulating Board	2
<b>Extent of Damage:</b>	Major damage	3
<b>Surface Treatment:</b>	Unsealed Insulation	3
<b>Asbestos type:</b>	Amosite, Chrysotile	2
<b>Material Assessment Score:</b>		10
<b>Priority Assessment Score:</b>		High
<b>Action:</b>	Manage	
<b>Comments:</b>	No access within safe casings

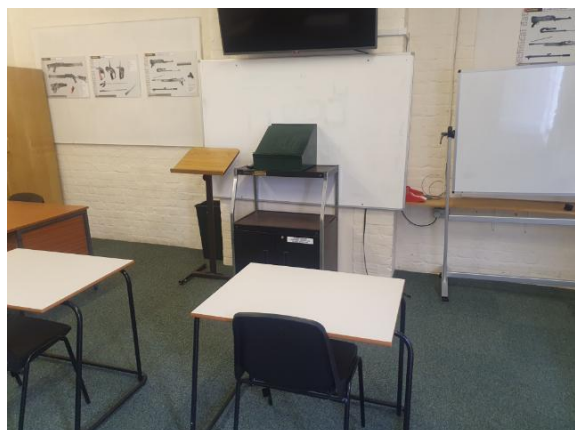
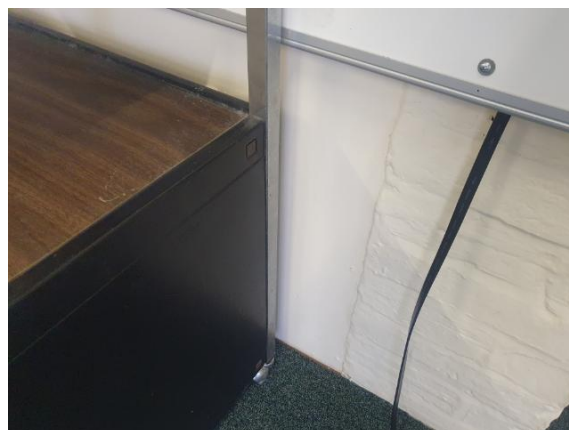
**Location:** Ground Floor - Building 1 - Classroom 009

<b>Material Description:</b>	Fireplace Cover - Cement Product	
<b>Identification:</b>	Previously Sampled - Asbestos Detected	
<b>Approx. quantity:</b>	2 m <sup>2</sup>	
<b>Accessibility</b>	Easy	Assessment Score
<b>Product type:</b>	Cement	1
<b>Extent of Damage:</b>	Slight / minor damage	1
<b>Surface Treatment:</b>	Unsealed Cement	1
<b>Asbestos type:</b>	Chrysotile	1
<b>Material Assessment Score:</b>		4
<b>Priority Assessment Score:</b>		Negligible
<b>Action:</b>	Manage	
<b>Comments:</b>	Previously sampled ref: Armour 21/10/19 Sample DK/8. Partially covered by whiteboard

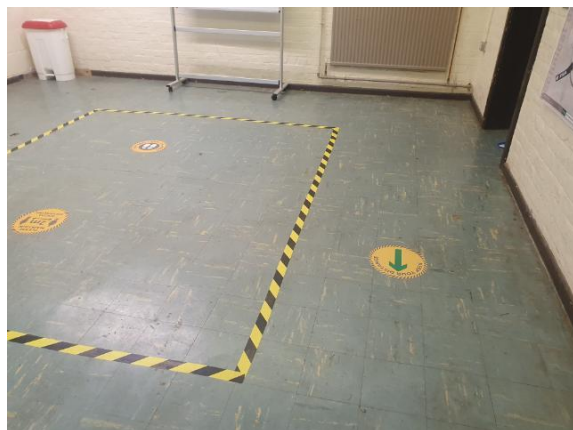
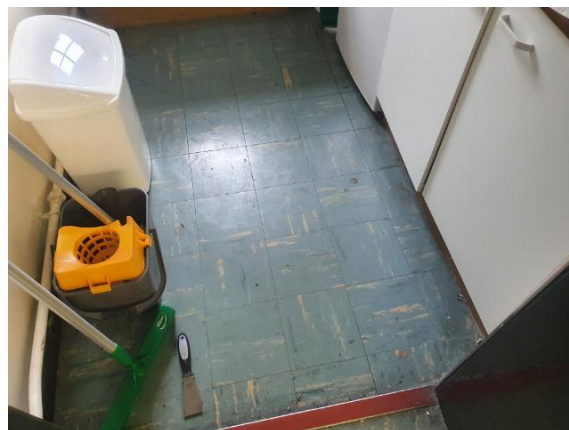
**Location:** Ground Floor - Building 1 - ACF Classroom, WC, Office and Canteen 010

<b>Material Description:</b>	Floor Tiles and Adhesive - Vinyl Products	
<b>Identification:</b>	Previously Sampled - Asbestos Detected	
<b>Approx. quantity:</b>	40 m <sup>2</sup>	
<b>Accessibility</b>	Easy	Assessment Score
<b>Product type:</b>	Cement	1
<b>Extent of Damage:</b>	Slight / minor damage	1
<b>Surface Treatment:</b>	Non-friable	0
<b>Asbestos type:</b>	Chrysotile	1
<b>Material Assessment Score:</b>		3
<b>Priority Assessment Score:</b>		Negligible
<b>Action:</b>	Manage	
<b>Comments:</b>	Previously sampled ref: Armour 21/10/19 Sample DK/9

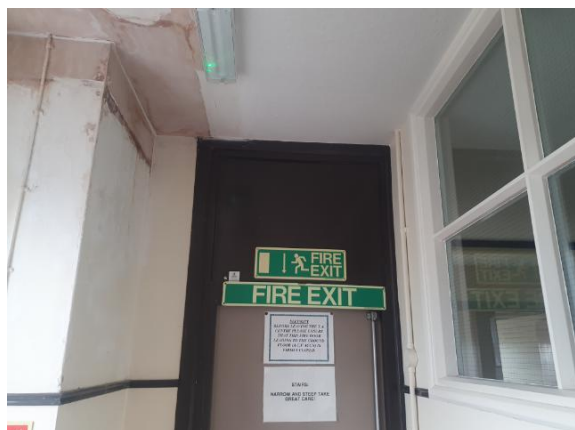
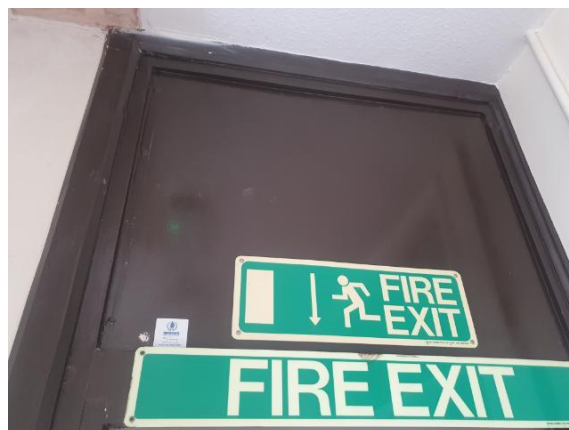
**Location:** First Floor - Building 1 - Corridor 011

<b>Material Description:</b>	Door Header Panel - Insulating Board	
<b>Identification:</b>	Previously Sampled - Asbestos Detected	
<b>Approx. quantity:</b>	1 m <sup>2</sup>	
<b>Accessibility</b>	Difficult	Assessment Score
<b>Product type:</b>	Asbestos Insulating Board	2
<b>Extent of Damage:</b>	Slight / minor damage	1
<b>Surface Treatment:</b>	Encapsulated AIB	1
<b>Asbestos type:</b>	Amosite	2
<b>Material Assessment Score:</b>		6
<b>Priority Assessment Score:</b>		Low
<b>Action:</b>	Manage	
<b>Comments:</b>	Previously sampled ref: Armour 21/10/19 Sample DK/12. Fire exit sign is screwed into panel. Do not remove sign

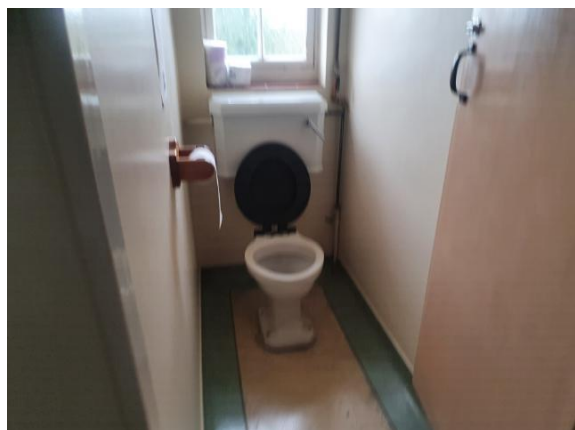
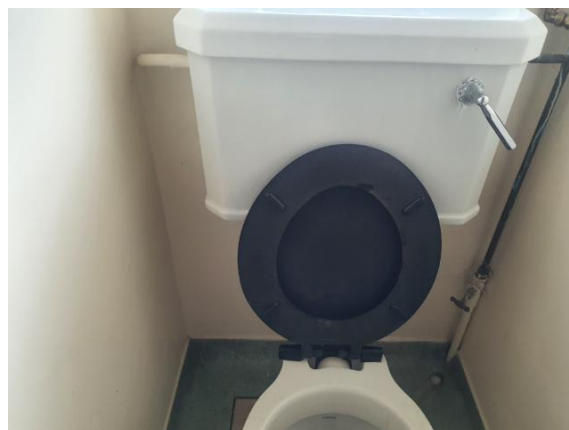
**Location:** First Floor - Building 1 – Men's WC 012

<b>Material Description:</b>	Toilet Seat - PVC / Reinforced Plastics	
<b>Identification:</b>	Presumed to Contain Asbestos	
<b>Approx. quantity:</b>	1 no	
<b>Accessibility</b>	Easy	<i>Assessment Score</i>
<b>Product type:</b>	Bakelite	1
<b>Extent of Damage:</b>	Major damage	3
<b>Surface Treatment:</b>	Unsealed Insulation	3
<b>Asbestos type:</b>	Chrysotile	1
<b>Material Assessment Score:</b>		8
<b>Priority Assessment Score:</b>		Medium
<b>Action:</b>	Manage	
<b>Comments:</b>	Not possible to sample as may damage integrity of the seat

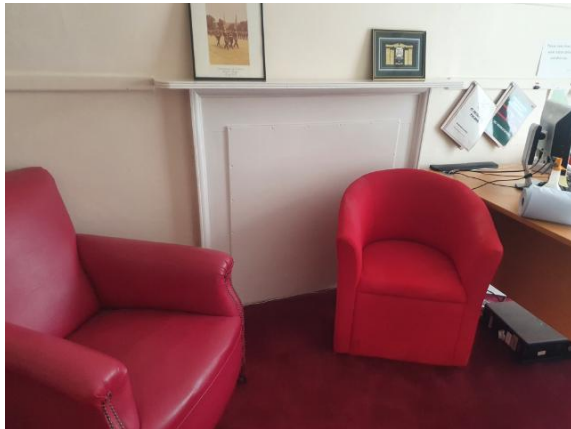
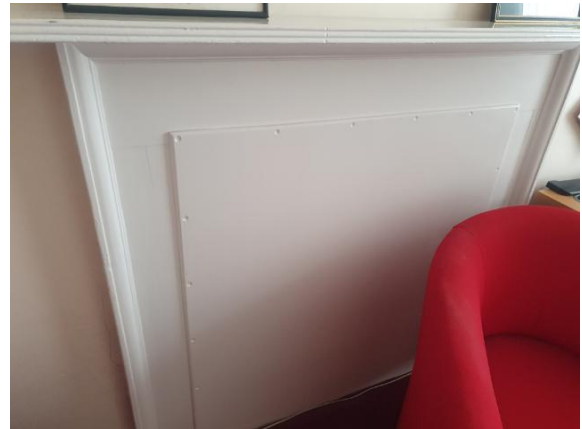
**Location:** First Floor - Building 1 - Office 013

<b>Material Description:</b>	Fireplace Cover - Insulating Board	
<b>Identification:</b>	Previously Sampled - Asbestos Detected	
<b>Approx. quantity:</b>	1 m <sup>2</sup>	
<b>Accessibility</b>	Easy	<i>Assessment Score</i>
<b>Product type:</b>	Asbestos Insulating Board	2
<b>Extent of Damage:</b>	Good	0
<b>Surface Treatment:</b>	Encapsulated AIB	1
<b>Asbestos type:</b>	Amosite	2
<b>Material Assessment Score:</b>		5
<b>Priority Assessment Score:</b>		Low
<b>Action:</b>	Manage	
<b>Comments:</b>	Previously sampled ref: Armour Sample DK/15

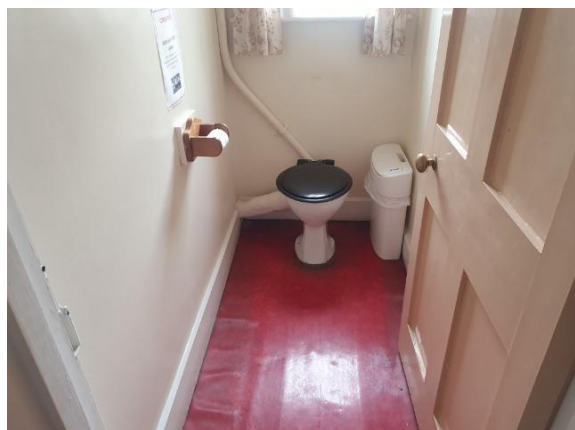
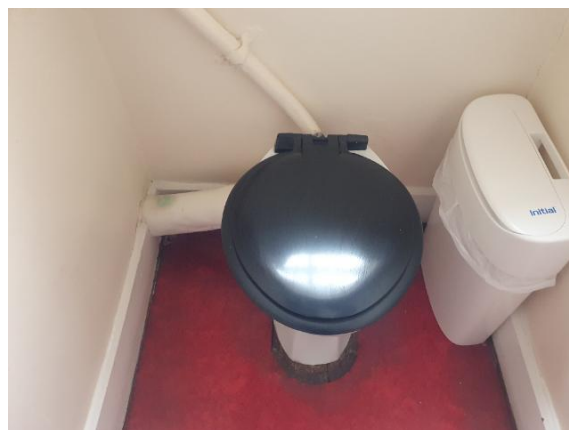
**Location:** First Floor - Building 1 - Ladies WC 014

<b>Material Description:</b>	Toilet Seat - PVC / Reinforced Plastics	
<b>Identification:</b>	Presumed to Contain Asbestos	
<b>Approx. quantity:</b>	1 no	
<b>Accessibility</b>	Easy	<i>Assessment Score</i>
<b>Product type:</b>	Bakelite	1
<b>Extent of Damage:</b>	Major damage	3
<b>Surface Treatment:</b>	Unsealed Insulation	3
<b>Asbestos type:</b>	Chrysotile	1
<b>Material Assessment Score:</b>		8
<b>Priority Assessment Score:</b>		Medium
<b>Action:</b>	Manage	
<b>Comments:</b>	Not possible to sample as may damage integrity of the seat. Cistern returned a negative sample

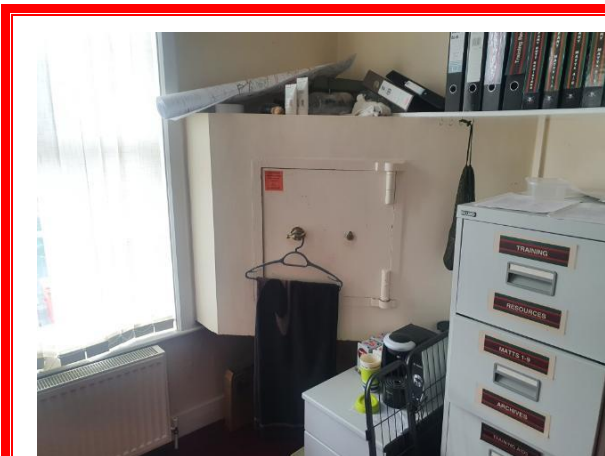
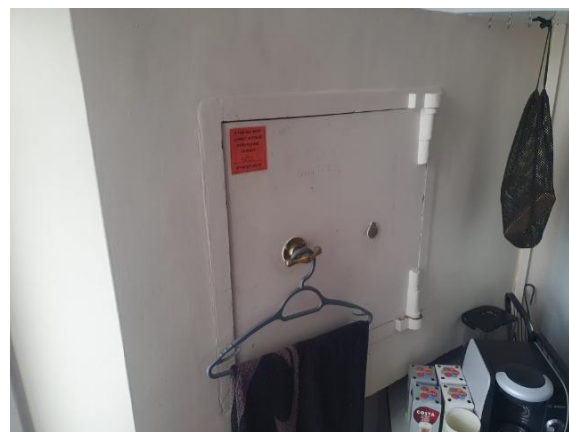
**Location:** First Floor - Building 1 - PSI Office 015

<b>Material Description:</b>	Safe Casings - Insulating Board	
<b>Identification:</b>	Presumed to Contain Asbestos	
<b>Approx. quantity:</b>	1 no	
<b>Accessibility</b>	Difficult	Assessment Score
<b>Product type:</b>	Asbestos Insulating Board	2
<b>Extent of Damage:</b>	Major damage	3
<b>Surface Treatment:</b>	Unsealed Insulation	3
<b>Asbestos type:</b>	Amosite, Chrysotile	2
<b>Material Assessment Score:</b>		10
<b>Priority Assessment Score:</b>		High
<b>Action:</b>	Manage	
<b>Comments:</b>	No access within safe casings. Fireplace panel is timber

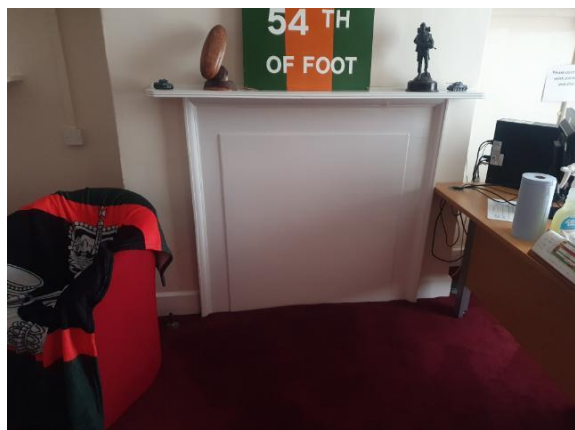
**Location:** First Floor - Building 1 - Company Command Office 016

<b>Material Description:</b>	Fireplace Cover - Insulating Board	
<b>Identification:</b>	Previously Sampled - Asbestos Detected	
<b>Approx. quantity:</b>	1 m <sup>2</sup>	
<b>Accessibility</b>	Easy	Assessment Score
<b>Product type:</b>	Asbestos Insulating Board	2
<b>Extent of Damage:</b>	Good	0
<b>Surface Treatment:</b>	Encapsulated AIB	1
<b>Asbestos type:</b>	Amosite	2
<b>Material Assessment Score:</b>		5
<b>Priority Assessment Score:</b>		Low
<b>Action:</b>	Manage	
<b>Comments:</b>	Previously sampled ref: Armour Sample DK/15

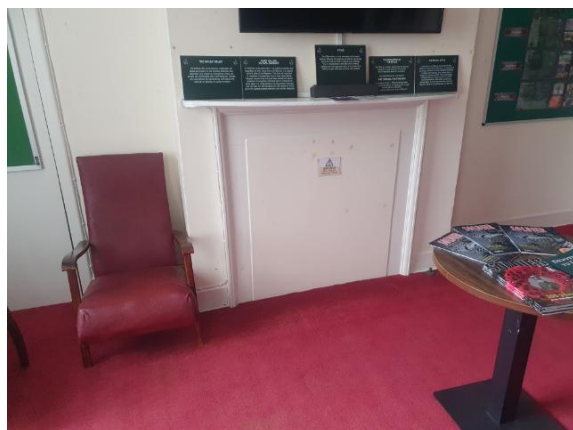
**Location:** First Floor - Building 1 - Recruit Office 017

<b>Material Description:</b>	Fireplace Cover - Insulating Board	
<b>Identification:</b>	Previously Sampled - Asbestos Detected	
<b>Approx. quantity:</b>	1 m <sup>2</sup>	
<b>Accessibility</b>	Easy	Assessment Score
<b>Product type:</b>	Asbestos Insulating Board	2
<b>Extent of Damage:</b>	Good	0
<b>Surface Treatment:</b>	Encapsulated AIB	1
<b>Asbestos type:</b>	Amosite	2
<b>Material Assessment Score:</b>		5
<b>Priority Assessment Score:</b>		Low
<b>Action:</b>	Manage	
<b>Comments:</b>	Previously sampled ref: Armour Sample DK/15

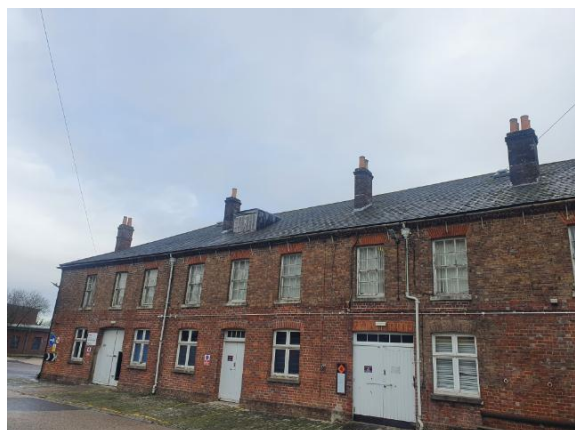
**Location:** External - Building 1 018

<b>Material Description:</b>	Roof Tiles - Cement Product	
<b>Identification:</b>	Previously Sampled - Asbestos Detected	
<b>Approx. quantity:</b>	600 m <sup>2</sup>	
<b>Accessibility</b>	Difficult	<i>Assessment Score</i>
<b>Product type:</b>	Cement	1
<b>Extent of Damage:</b>	Slight / minor damage	1
<b>Surface Treatment:</b>	Unsealed Cement	1
<b>Asbestos type:</b>	Chrysotile	1
<b>Material Assessment Score:</b>		4
<b>Priority Assessment Score:</b>		Negligible
<b>Action:</b>	Manage	
<b>Comments:</b>	Previously sampled ref: Armour Sample DK/19

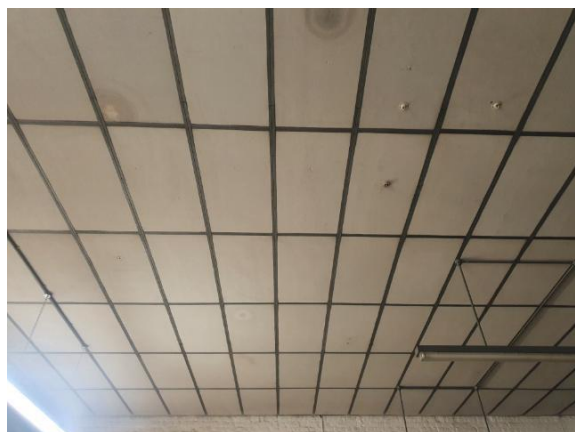
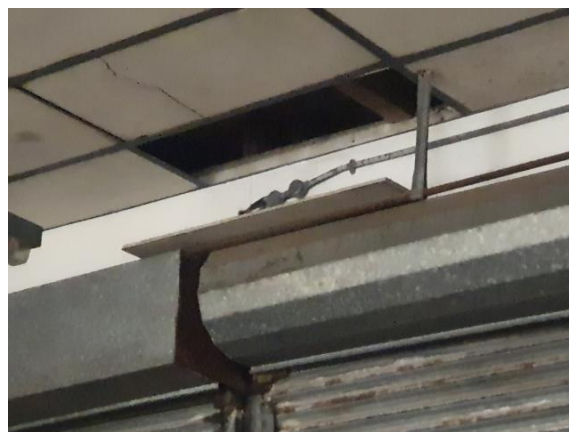
**Location:** Ground Floor - Main Garage 019

<b>Material Description:</b>	Ceiling Tiles - Insulating Board	
<b>Identification:</b>	Previously Sampled - Asbestos Detected	
<b>Approx. quantity:</b>	96 m <sup>2</sup>	
<b>Accessibility</b>	Difficult	<i>Assessment Score</i>
<b>Product type:</b>	Asbestos Insulating Board	2
<b>Extent of Damage:</b>	Moderate damage	2
<b>Surface Treatment:</b>	Unsealed AIB	2
<b>Asbestos type:</b>	Chrysotile	1
<b>Material Assessment Score:</b>		7
<b>Priority Assessment Score:</b>		Medium
<b>Action:</b>	Remove	
<b>Comments:</b>	Previously sampled ref: Armour Sample DK/20. Several areas of damage to tiles. Ceiling tile resting on top of shutter doors. Remove tile and encapsulate all other tiles

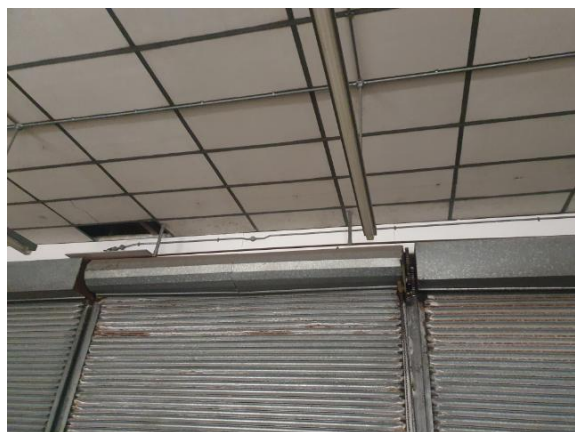
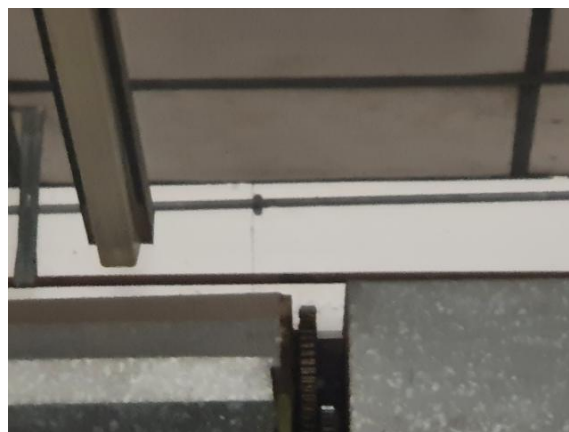
**Location:** Ground Floor - Main Garage 020

<b>Material Description:</b>	Bulk Head Panels - Insulating Board	
<b>Identification:</b>	Strongly Presumed to Contain Asbestos	
<b>Approx. quantity:</b>	10 m <sup>2</sup>	
<b>Accessibility</b>	Difficult	<i>Assessment Score</i>
<b>Product type:</b>	Asbestos Insulating Board	2
<b>Extent of Damage:</b>	Slight / minor damage	1
<b>Surface Treatment:</b>	Unsealed AIB	2
<b>Asbestos type:</b>	Amosite, Chrysotile	2
<b>Material Assessment Score:</b>		7
<b>Priority Assessment Score:</b>		Medium
<b>Action:</b>	Encapsulate	
<b>Comments:</b>	N/A

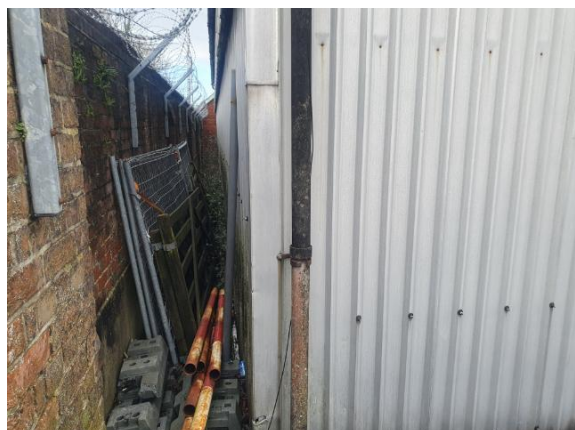
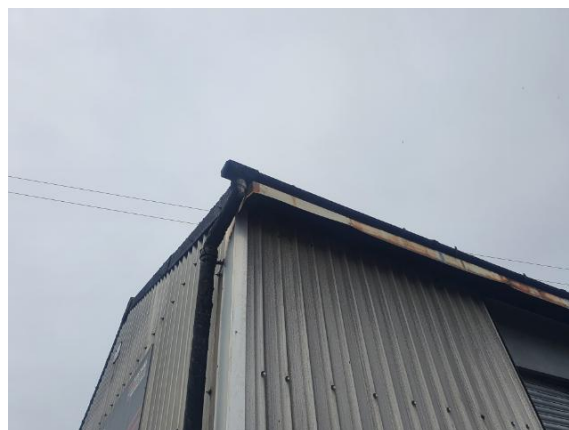
**Location:** External - MT Garage 021

<b>Material Description:</b>	Guttering and Downpipes - Cement Product	
<b>Identification:</b>	Previously Sampled - Asbestos Detected	
<b>Approx. quantity:</b>	45 LM	
<b>Accessibility</b>	Medium	<i>Assessment Score</i>
<b>Product type:</b>	Cement	1
<b>Extent of Damage:</b>	Slight / minor damage	1
<b>Surface Treatment:</b>	Unsealed Cement	1
<b>Asbestos type:</b>	Chrysotile	1
<b>Material Assessment Score:</b>		4
<b>Priority Assessment Score:</b>		Negligible
<b>Action:</b>	Manage	
<b>Comments:</b>	Previously sampled ref: Armour Sample DK/21. 4 x pipes, 2 x gutters

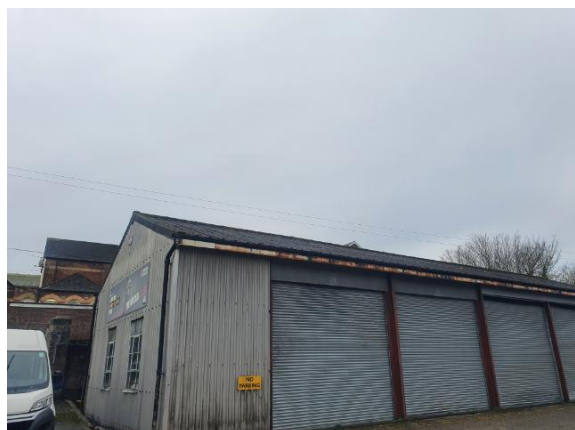
<b>Material Description:</b>	Roof Sheets and Edging - Cement Product	
<b>Identification:</b>	Previously Sampled - Asbestos Detected	
<b>Approx. quantity:</b>	280 m <sup>2</sup>	
<b>Accessibility</b>	Difficult	<i>Assessment Score</i>
<b>Product type:</b>	Cement	1
<b>Extent of Damage:</b>	Slight / minor damage	1
<b>Surface Treatment:</b>	Unsealed Cement	1
<b>Asbestos type:</b>	Chrysotile	1
<b>Material Assessment Score:</b>		4
<b>Priority Assessment Score:</b>		Negligible
<b>Action:</b>	Manage	
<b>Comments:</b>	Previously sampled ref: Armour Sample DK/21

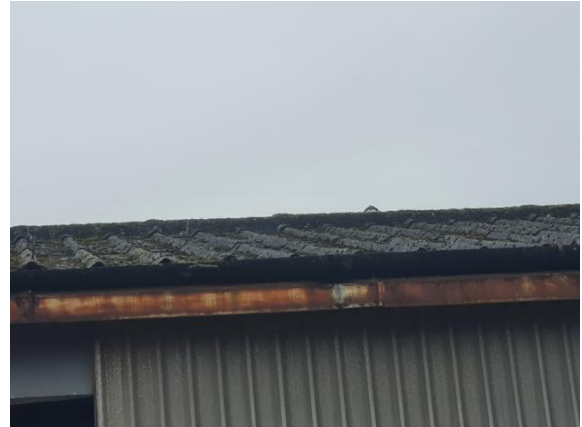
<b>Material Description:</b>	Roof Sheets - Cement Product	
<b>Identification:</b>	Previously Sampled - Asbestos Detected	
<b>Approx. quantity:</b>	280 m <sup>2</sup>	
<b>Accessibility</b>	Difficult	<i>Assessment Score</i>
<b>Product type:</b>	Cement	1
<b>Extent of Damage:</b>	Slight / minor damage	1
<b>Surface Treatment:</b>	Unsealed Cement	1
<b>Asbestos type:</b>	Chrysotile	1
<b>Material Assessment Score:</b>		4
<b>Priority Assessment Score:</b>		Negligible
<b>Action:</b>	Manage	
<b>Comments:</b>	Previously sampled ref: Armour Sample DK/21

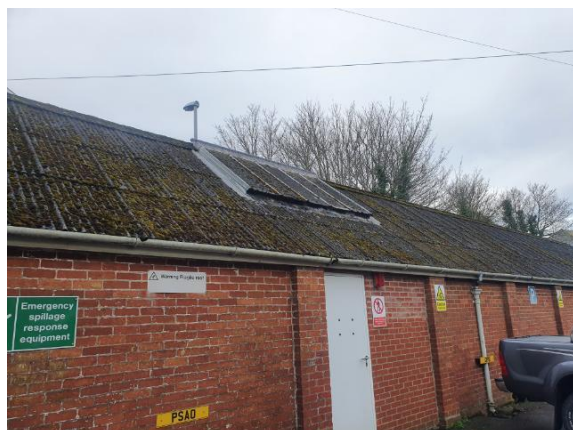
<b>Material Description:</b>	Roof Sheets and Skylight Panels - Cement Product	
<b>Identification:</b>	Previously Sampled - Asbestos Detected	
<b>Approx. quantity:</b>	140 m <sup>2</sup>	
<b>Accessibility</b>	Difficult	<i>Assessment Score</i>
<b>Product type:</b>	Cement	1
<b>Extent of Damage:</b>	Slight / minor damage	1
<b>Surface Treatment:</b>	Unsealed Cement	1
<b>Asbestos type:</b>	Chrysotile	1
<b>Material Assessment Score:</b>		4
<b>Priority Assessment Score:</b>		Negligible
<b>Action:</b>	Manage	
<b>Comments:</b>	Previously sampled ref: Armour Sample DK/22

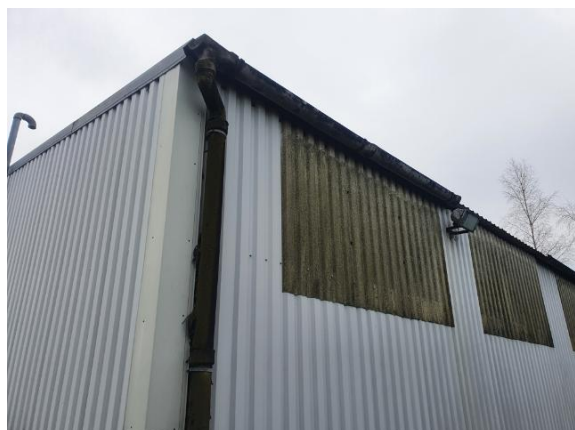
<b>Material Description:</b>	Downpipes, Guttering and Debris - Cement Product	
<b>Identification:</b>	Previously Sampled - Asbestos Detected	
<b>Approx. quantity:</b>	16 LM	
<b>Accessibility</b>	Difficult	<i>Assessment Score</i>
<b>Product type:</b>	Cement	1
<b>Extent of Damage:</b>	Slight / minor damage	1
<b>Surface Treatment:</b>	Unsealed Cement	1
<b>Asbestos type:</b>	Chrysotile	1
<b>Material Assessment Score:</b>		4
<b>Priority Assessment Score:</b>		Negligible
<b>Action:</b>	Remove	
<b>Comments:</b>	Previously sampled ref: Armour Sample DK/23. 1 x downpipes, 1 x gutter

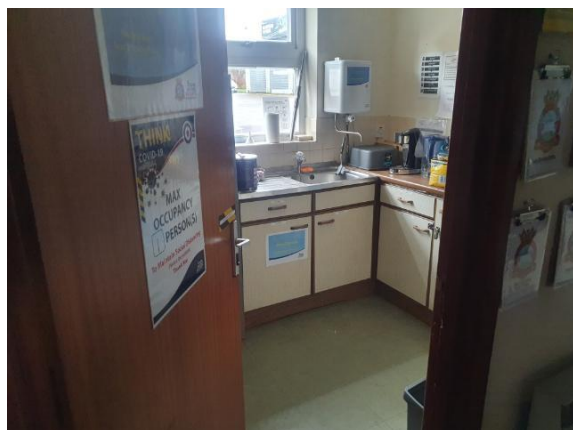
<b>Material Description:</b>	Sink Pad - Bituminous Product	
<b>Identification:</b>	Previously Sampled - Asbestos Detected	
<b>Approx. quantity:</b>	1 no	
<b>Accessibility</b>	Medium	Assessment Score
<b>Product type:</b>	Bitumen	1
<b>Extent of Damage:</b>	Slight / minor damage	1
<b>Surface Treatment:</b>	Non-friable	0
<b>Asbestos type:</b>	Chrysotile	1
<b>Material Assessment Score:</b>		3
<b>Priority Assessment Score:</b>		Negligible
<b>Action:</b>	Manage	
<b>Comments:</b>	Previously sampled ref: Armour Sample DK/27

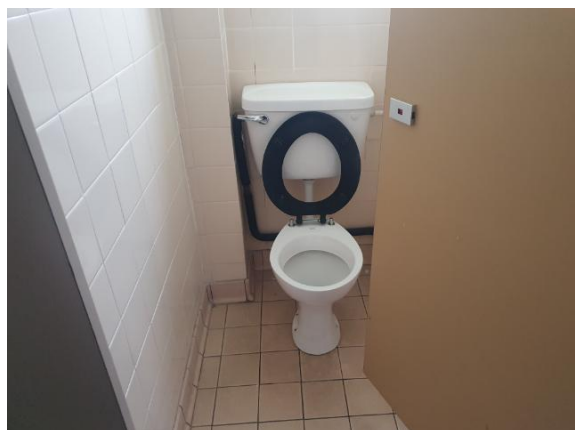
<b>Material Description:</b>	Toilet Seat - PVC / Reinforced Plastics	
<b>Identification:</b>	Presumed to Contain Asbestos	
<b>Approx. quantity:</b>	2 no	
<b>Accessibility</b>	Easy	<i>Assessment Score</i>
<b>Product type:</b>	Bakelite	1
<b>Extent of Damage:</b>	Major damage	3
<b>Surface Treatment:</b>	Unsealed Insulation	3
<b>Asbestos type:</b>	Chrysotile	1
<b>Material Assessment Score:</b>		8
<b>Priority Assessment Score:</b>		Medium
<b>Action:</b>	Manage	
<b>Comments:</b>	Not possible to sample as may damage integrity of the seat

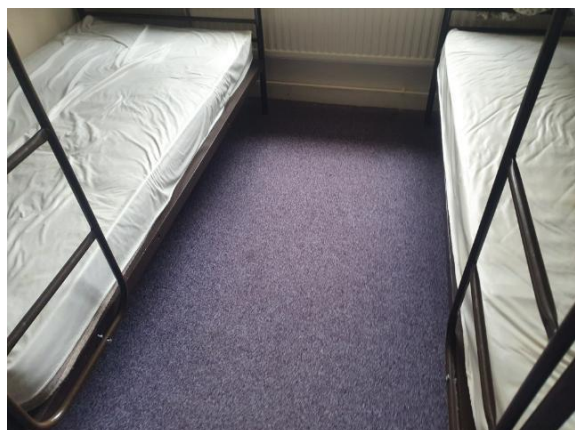
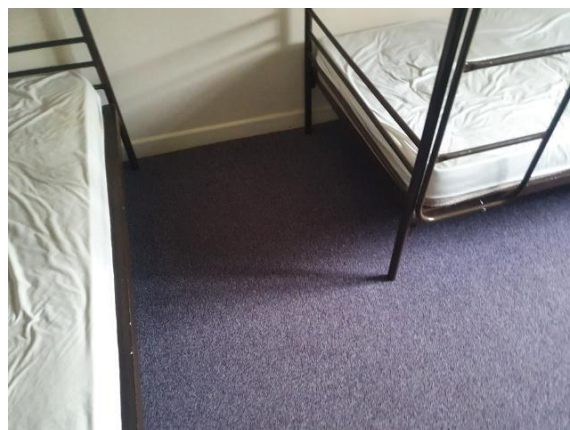
<b>Material Description:</b>	Adhesive under Carpet - Bituminous Product	
<b>Identification:</b>	Previously Sampled - Asbestos Detected	
<b>Approx. quantity:</b>	10 m <sup>2</sup>	
<b>Accessibility</b>	Difficult	Assessment Score
<b>Product type:</b>	Bitumen	1
<b>Extent of Damage:</b>	Slight / minor damage	1
<b>Surface Treatment:</b>	Non-friable	0
<b>Asbestos type:</b>	Chrysotile	1
<b>Material Assessment Score:</b>		3
<b>Priority Assessment Score:</b>		Negligible
<b>Action:</b>	Manage	
<b>Comments:</b>	Previously sampled ref: Armour Sample DK/33. Under carpet

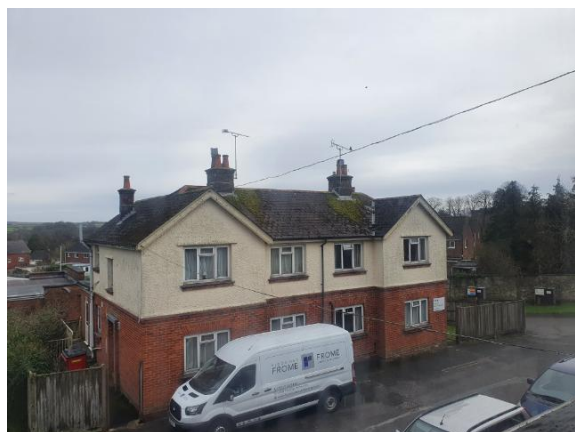
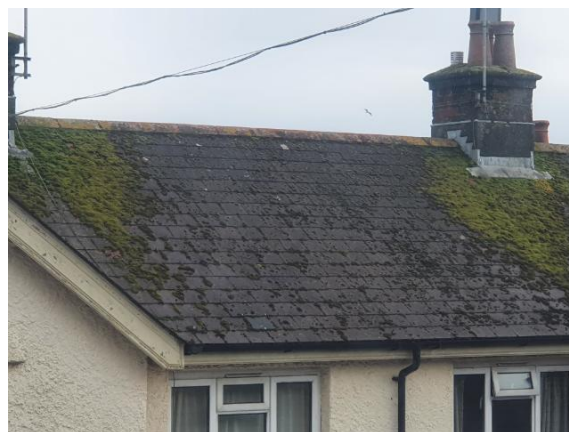
<b>Material Description:</b>	Roof Tiles - Cement Product	
<b>Identification:</b>	Strongly Presumed to Contain Asbestos	
<b>Approx. quantity:</b>	112 m <sup>2</sup>	
<b>Accessibility</b>	Difficult	<i>Assessment Score</i>
<b>Product type:</b>	Bitumen	1
<b>Extent of Damage:</b>	Slight / minor damage	1
<b>Surface Treatment:</b>	Unsealed Cement	1
<b>Asbestos type:</b>	Chrysotile	1
<b>Material Assessment Score:</b>		4
<b>Priority Assessment Score:</b>		Negligible
<b>Action:</b>	Manage	
<b>Comments:</b>	N/A

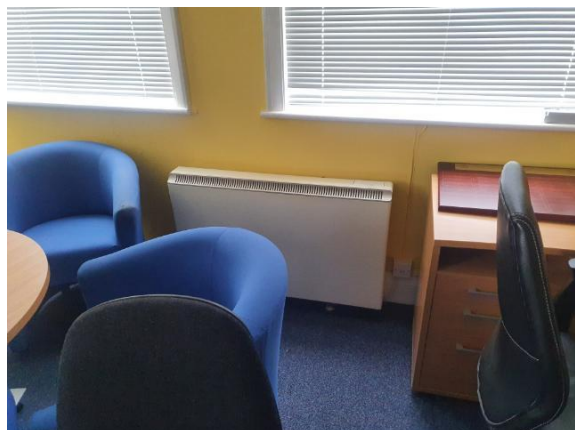
<b>Material Description:</b>	Night Storage Heaters - No Access Gained	
<b>Identification:</b>	Presumed to Contain Asbestos	
<b>Approx. quantity:</b>	1 no	
<b>Accessibility</b>	Difficult	Assessment Score
<b>Product type:</b>	Asbestos Insulating Board	2
<b>Extent of Damage:</b>	Major damage	3
<b>Surface Treatment:</b>	Unsealed Insulation	3
<b>Asbestos type:</b>	Amosite, Chrysotile	2
<b>Material Assessment Score:</b>		10
<b>Priority Assessment Score:</b>		High
<b>Action:</b>	Manage	
<b>Comments:</b>	No access as live

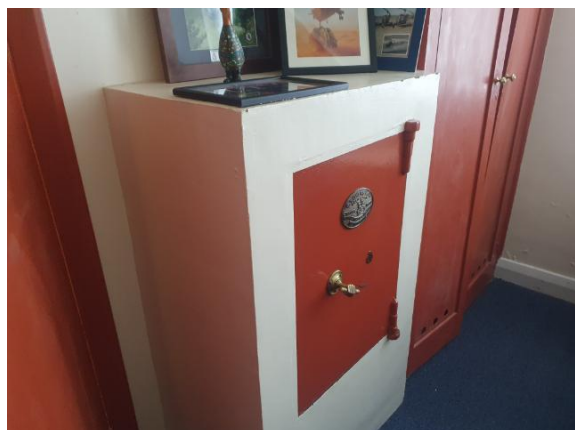
<b>Material Description:</b>	Safe Casings - Insulating Board	
<b>Identification:</b>	Presumed to Contain Asbestos	
<b>Approx. quantity:</b>	1 no	
<b>Accessibility</b>	Difficult	<i>Assessment Score</i>
<b>Product type:</b>	Asbestos Insulating Board	2
<b>Extent of Damage:</b>	Major damage	3
<b>Surface Treatment:</b>	Unsealed Insulation	3
<b>Asbestos type:</b>	Amosite, Chrysotile	2
<b>Material Assessment Score:</b>		10
<b>Priority Assessment Score:</b>		High
<b>Action:</b>	Manage	
<b>Comments:</b>	No access within safe casings

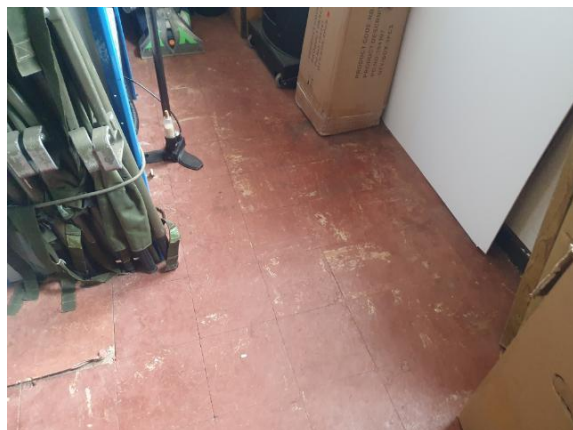
<b>Material Description:</b>	Floor Tiles and Adhesive - Vinyl Products	
<b>Identification:</b>	Previously Sampled - Asbestos Detected	
<b>Approx. quantity:</b>	40 m <sup>2</sup>	
<b>Accessibility</b>	Easy	Assessment Score
<b>Product type:</b>	Vinyl	1
<b>Extent of Damage:</b>	Slight / minor damage	1
<b>Surface Treatment:</b>	Non-friable	0
<b>Asbestos type:</b>	Chrysotile	1
<b>Material Assessment Score:</b>		3
<b>Priority Assessment Score:</b>		Negligible
<b>Action:</b>	Manage	
<b>Comments:</b>	Previously sampled ref: Armour Sample DK/35

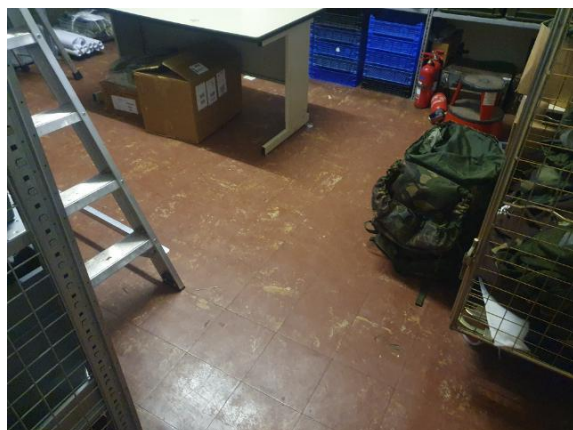
<b>Material Description:</b>	Floor Tiles and Adhesive - Vinyl Products	
<b>Identification:</b>	Previously Sampled - Asbestos Detected	
<b>Approx. quantity:</b>	60 m <sup>2</sup>	
<b>Accessibility</b>	Easy	<i>Assessment Score</i>
<b>Product type:</b>	Vinyl	1
<b>Extent of Damage:</b>	Moderate damage	2
<b>Surface Treatment:</b>	Non-friable	0
<b>Asbestos type:</b>	Chrysotile	1
<b>Material Assessment Score:</b>		4
<b>Priority Assessment Score:</b>		Negligible
<b>Action:</b>	Manage	
<b>Comments:</b>	Previously sampled ref: Armour Sample DK/35

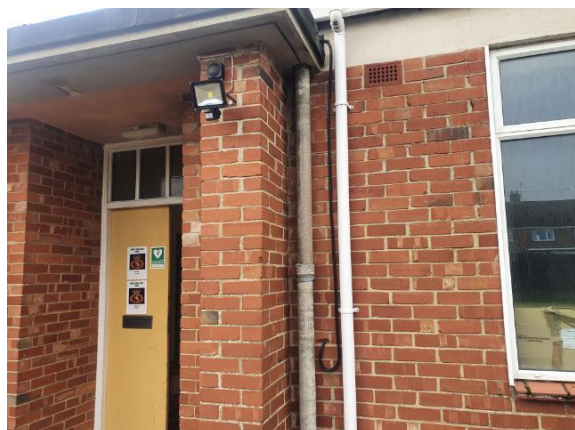
<b>Material Description:</b>	Downpipe - Cement Product	
<b>Identification:</b>	Previously Sampled - Asbestos Detected	
<b>Approx. quantity:</b>	3 LM	
<b>Accessibility</b>	Medium	Assessment Score
<b>Product type:</b>	Cement	1
<b>Extent of Damage:</b>	Slight / minor damage	1
<b>Surface Treatment:</b>	Unsealed Cement	1
<b>Asbestos type:</b>	Chrysotile	1
<b>Material Assessment Score:</b>		4
<b>Priority Assessment Score:</b>		Negligible
<b>Action:</b>	Manage	
<b>Comments:</b>	Previously sampled ref: Armour Sample DK/37

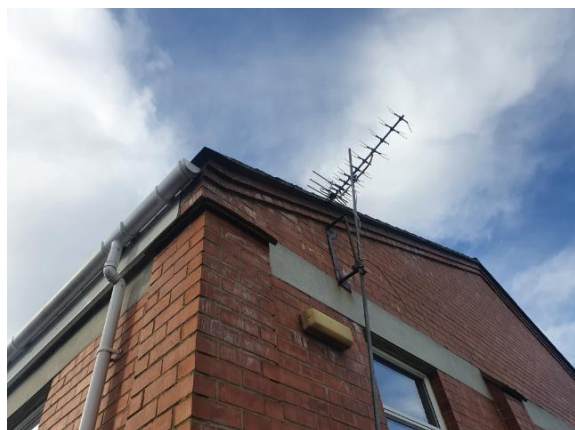
<b>Material Description:</b>	Undercloaking - Cement Product	
<b>Identification:</b>	Presumed to Contain Asbestos	
<b>Approx. quantity:</b>	20 LM	
<b>Accessibility</b>	Difficult	<i>Assessment Score</i>
<b>Product type:</b>	Cement	1
<b>Extent of Damage:</b>	Slight / minor damage	1
<b>Surface Treatment:</b>	Unsealed Cement	1
<b>Asbestos type:</b>	Chrysotile	1
<b>Material Assessment Score:</b>		4
<b>Priority Assessment Score:</b>		Negligible
<b>Action:</b>	Manage	
<b>Comments:</b>	N/A

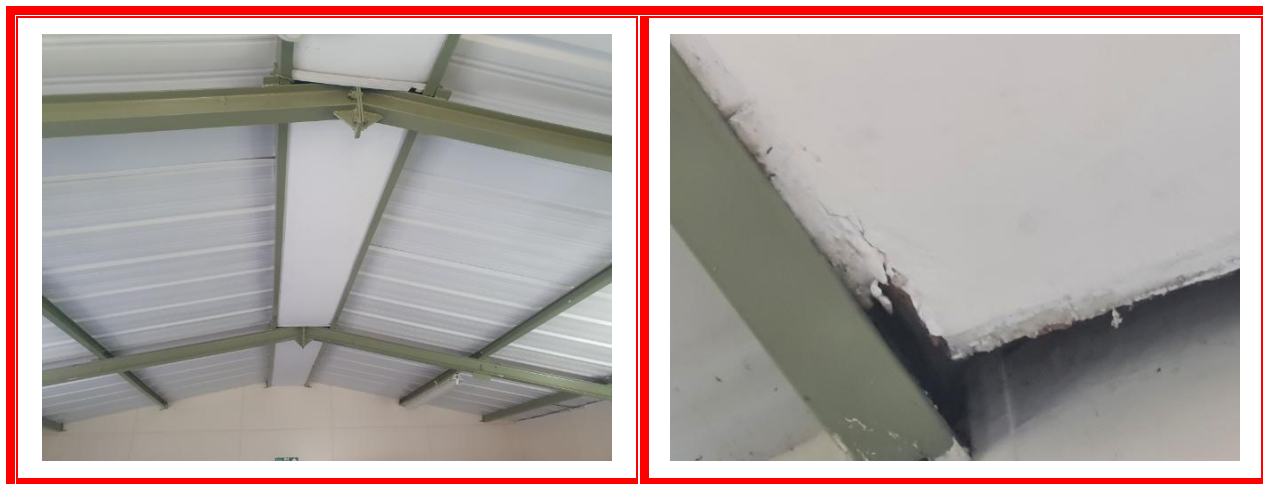
<b>Material Description:</b>	Fiberboard Ceiling - Paper Product	
<b>Identification:</b>	Previously Sampled - Asbestos Detected	
<b>Approx. quantity:</b>	10 m <sup>2</sup>	
<b>Accessibility</b>	Medium	Assessment Score
<b>Product type:</b>	Paper	2
<b>Extent of Damage:</b>	Moderate damage	2
<b>Surface Treatment:</b>	Paper	1
<b>Asbestos type:</b>	Chrysotile	1
<b>Material Assessment Score:</b>		6
<b>Priority Assessment Score:</b>		Low
<b>Action:</b>	Encapsulate	
<b>Comments:</b>	Previously sampled ref: Armour 21/10/19 Sample DK/39

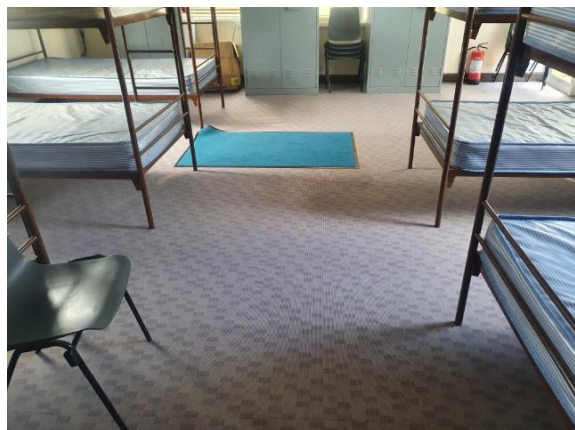
<b>Material Description:</b>	Floor Tiles and Adhesive - Vinyl Products	
<b>Identification:</b>	Previously Sampled - Asbestos Detected	
<b>Approx. quantity:</b>	100 m <sup>2</sup>	
<b>Accessibility</b>	Difficult	Assessment Score
<b>Product type:</b>	Vinyl	1
<b>Extent of Damage:</b>	Slight / minor damage	1
<b>Surface Treatment:</b>	Non-friable	0
<b>Asbestos type:</b>	Chrysotile	1
<b>Material Assessment Score:</b>		3
<b>Priority Assessment Score:</b>		Negligible
<b>Action:</b>	Manage	
<b>Comments:</b>	Previously sampled ref: Armour 21/10/19 Sample DK/40. Under carpet

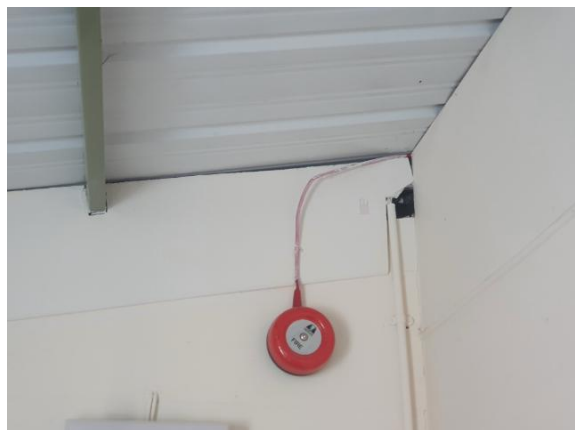
<b>Material Description:</b>	Wall Panels - Insulating Board	
<b>Identification:</b>	Previously Sampled - Asbestos Detected	
<b>Approx. quantity:</b>	16 LM	
<b>Accessibility</b>	Difficult	Assessment Score
<b>Product type:</b>	Asbestos Insulating Board	2
<b>Extent of Damage:</b>	Moderate damage	2
<b>Surface Treatment:</b>	Encapsulated AIB	1
<b>Asbestos type:</b>	Amosite	2
<b>Material Assessment Score:</b>		7
<b>Priority Assessment Score:</b>		Medium
<b>Action:</b>	Manage	
<b>Comments:</b>	Previously sampled ref: Armour 21/10/19 Sample DK/41. Panels have been encapsulated since the original survey

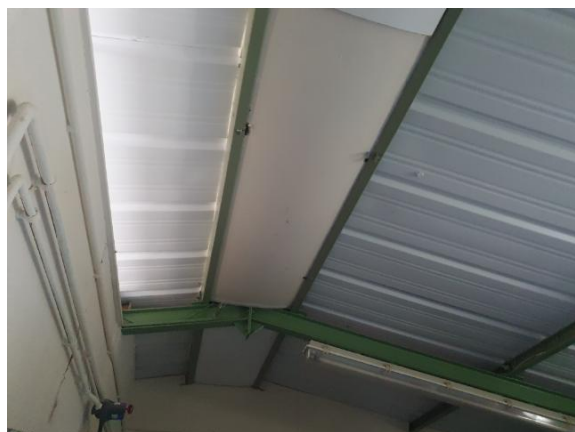
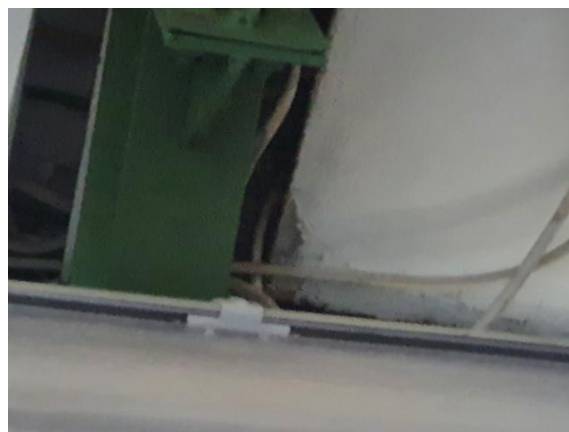
<b>Material Description:</b>	Fiberboard Ceiling - Paper Product	
<b>Identification:</b>	Previously Sampled - Asbestos Detected	
<b>Approx. quantity:</b>	6 m <sup>2</sup>	
<b>Accessibility</b>	Difficult	Assessment Score
<b>Product type:</b>	Paper	2
<b>Extent of Damage:</b>	Moderate damage	2
<b>Surface Treatment:</b>	Paper	1
<b>Asbestos type:</b>	Chrysotile	1
<b>Material Assessment Score:</b>		6
<b>Priority Assessment Score:</b>		Low
<b>Action:</b>	Encapsulate	
<b>Comments:</b>	Previously sampled ref: Armour 21/10/19 Sample DK/39

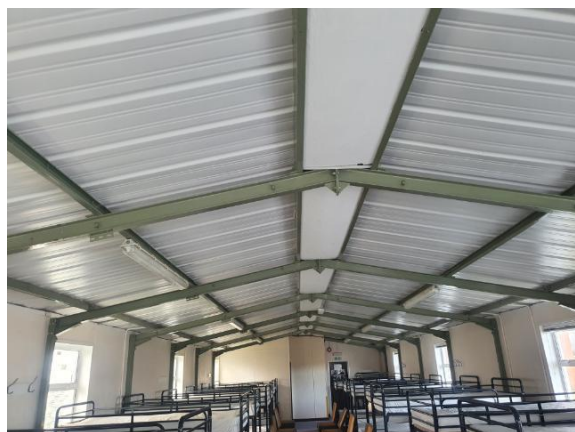
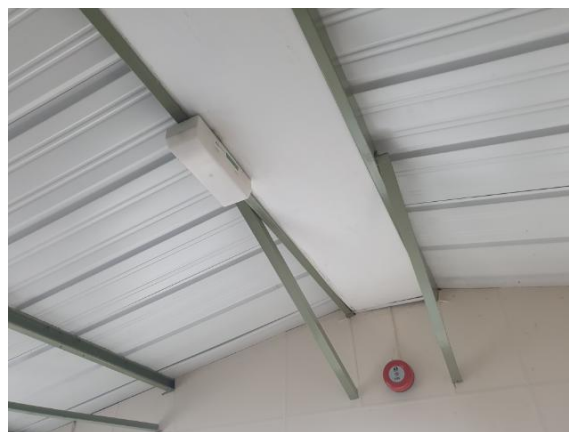
<b>Material Description:</b>	Fiberboard Ceiling - Paper Product	
<b>Identification:</b>	Previously Sampled - Asbestos Detected	
<b>Approx. quantity:</b>	10 m <sup>2</sup>	
<b>Accessibility</b>	Medium	Assessment Score
<b>Product type:</b>	Paper	2
<b>Extent of Damage:</b>	Slight / minor damage	1
<b>Surface Treatment:</b>	Paper	1
<b>Asbestos type:</b>	Chrysotile	1
<b>Material Assessment Score:</b>		5
<b>Priority Assessment Score:</b>		Low
<b>Action:</b>	Encapsulate	
<b>Comments:</b>	Previously sampled ref: Armour 21/10/19 Sample DK/39

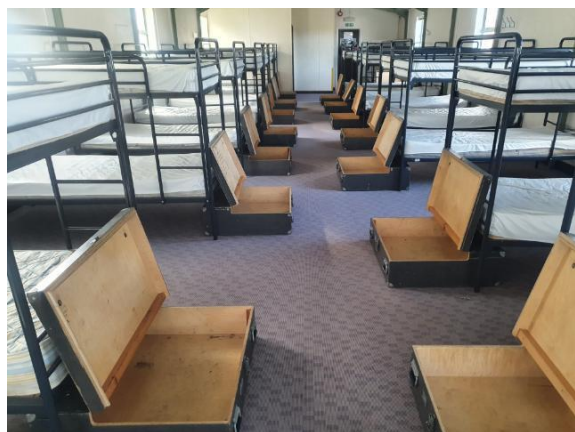
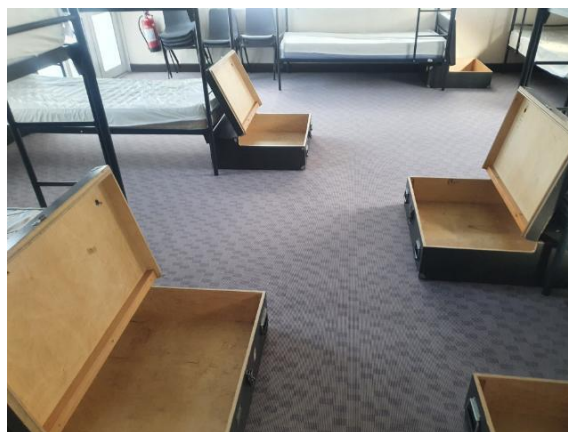
<b>Material Description:</b>	Floor Tiles and Adhesive - Vinyl Products	
<b>Identification:</b>	Previously Sampled - Asbestos Detected	
<b>Approx. quantity:</b>	100 m <sup>2</sup>	
<b>Accessibility</b>	Difficult	<i>Assessment Score</i>
<b>Product type:</b>	Vinyl	1
<b>Extent of Damage:</b>	Slight / minor damage	1
<b>Surface Treatment:</b>	Non-friable	0
<b>Asbestos type:</b>	Chrysotile	1
<b>Material Assessment Score:</b>		3
<b>Priority Assessment Score:</b>		Negligible
<b>Action:</b>	Manage	
<b>Comments:</b>	Previously sampled ref: Armour 21/10/19 Sample DK/40. Under carpet
