**Project Number A-00520 (3700)**

**Re-Inspection  
Asbestos Survey Report - Revised**

**6th Battalion The Rifles C  
Poundbury Road  
Dorset  
DT1 1TA**

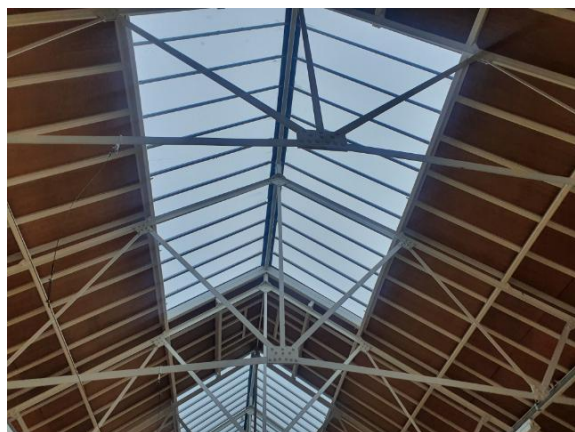
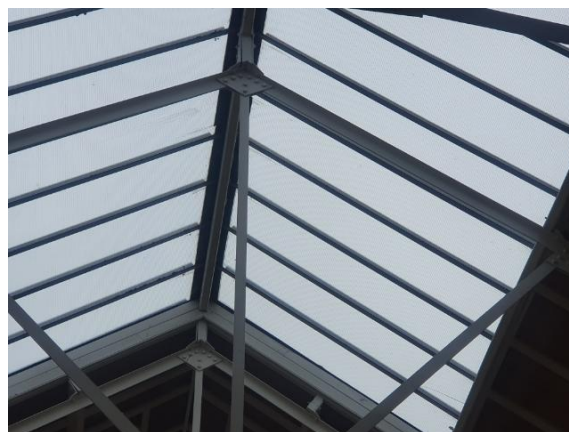
<b>Material Description:</b>	Rope Seals to Skylights - Gaskets (rope/woven)	
<b>Identification:</b>	Presumed to Contain Asbestos	
<b>Approx. quantity:</b>	80 m <sup>2</sup>	
<b>Accessibility</b>	Difficult	<i>Assessment Score</i>
<b>Product type:</b>	Rope	2
<b>Extent of Damage:</b>	Slight / minor damage	1
<b>Surface Treatment:</b>	Non-friable	0
<b>Asbestos type:</b>	Chrysotile	1
<b>Material Assessment Score:</b>		4
<b>Priority Assessment Score:</b>		Negligible
<b>Action:</b>	Manage	
<b>Comments:</b>	No access to sample due to height restrictions

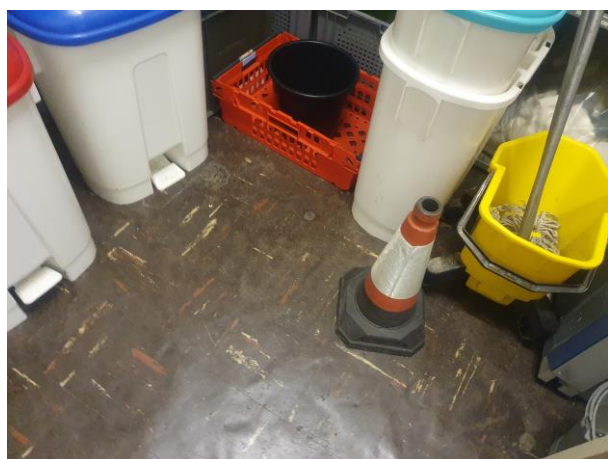
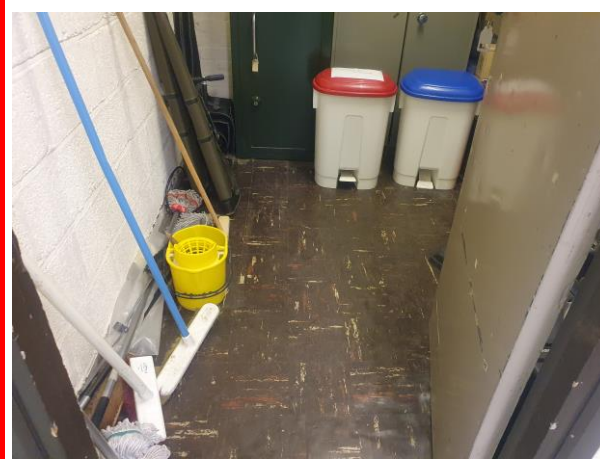
<b>Material Description:</b>	Floor Tiles and Adhesive - Vinyl Products	
<b>Identification:</b>	Previously Sampled - Asbestos Detected	
<b>Approx. quantity:</b>	9m2	
<b>Accessibility</b>	Easy	Assessment Score
<b>Product type:</b>	Vinyl	1
<b>Extent of Damage:</b>	Slight/minor damage	0
<b>Surface Treatment:</b>	Non-Friable	1
<b>Asbestos type:</b>	Chrysotile	1
<b>Material Assessment Score:</b>		3
<b>Priority Assessment Score:</b>		Negligible
<b>Action:</b>	Manage	
<b>Comments:</b>	<p>Previously a no access area, now accessed.</p> <p>Previously Sampled: Ref Armour 21/10/2019 Sample DK/9</p>

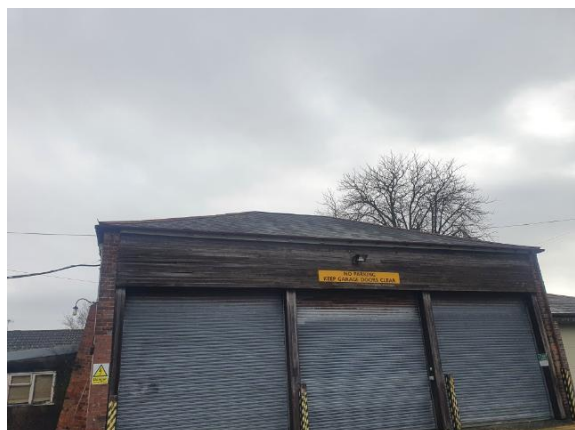
<b>Material Description:</b>	Roof Tiles - Cement Product	
<b>Identification:</b>	Strongly Presumed to Contain Asbestos	
<b>Approx. quantity:</b>	100 m <sup>2</sup>	
<b>Accessibility</b>	Difficult	<i>Assessment Score</i>
<b>Product type:</b>	Cement	1
<b>Extent of Damage:</b>	Slight / minor damage	1
<b>Surface Treatment:</b>	Unsealed Cement	1
<b>Asbestos type:</b>	Chrysotile	1
<b>Material Assessment Score:</b>		4
<b>Priority Assessment Score:</b>		Negligible
<b>Action:</b>	Manage	
<b>Comments:</b>	N/A
