Project Number 3700

Re-Inspection
Asbestos Survey Report - Revised

Liskeard Platoon
Liskeard
Cornwall
PL14 8BE

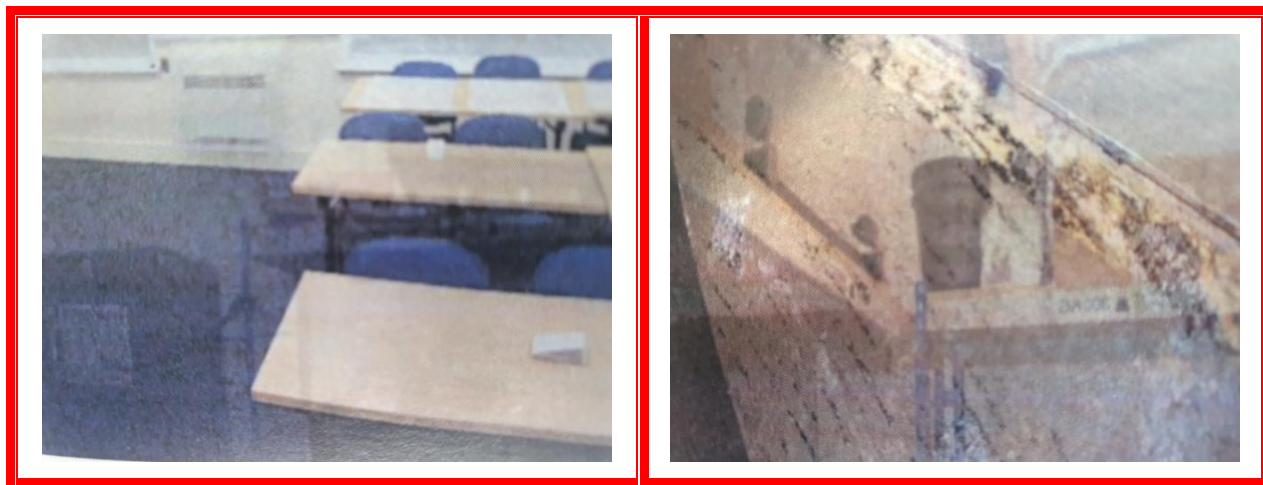
Item No:	2	Sample No:	N/A
Location:	First Floor - Classrooms x 2 002

Material Description:	Adhesive under Carpet - Bituminous Product	
Identification:	Previously Sampled - Asbestos Detected	
Approx. quantity:	72 m ²	
Accessibility	Difficult	Assessment Score
Product type:	Bitumen	1
Extent of Damage:	Slight / minor damage	1
Surface Treatment:	Non-friable	0
Asbestos type:	Chrysotile	1
Material Assessment Score:		3
Priority Assessment Score:		Negligible
Action:	Manage	
Comments:	N/A

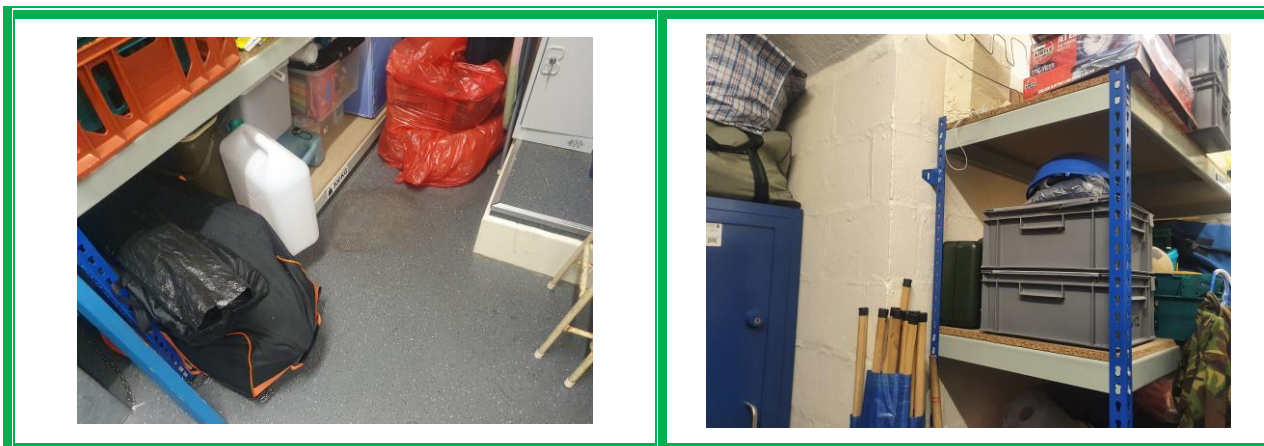
Item No:	1	Sample No:	N/A
Location:	Ground Floor – Ground Floor ATC Store - 001

Material Description:	No Suspect Materials Found	
Identification:	N/A	
Approx. quantity:	N/A	
Accessibility	N/A	<i>Assessment Score</i>
Product type:	N/A	N/A
Extent of Damage:	N/A	N/A
Surface Treatment:	N/A	N/A
Asbestos type:	N/A	N/A
Material Assessment Score:		N/A
Priority Assessment Score:		N/A
Action:	N/A	
Comments:	<p>Previously a no access area. Now accessed and no asbestos found.</p> <p>Plasterboard/blockwork walls, plasterboard, and concrete ceiling.</p> <p>No access under modern lino.</p>
