Project Number 2481

**Management
Asbestos Survey Report**

**Wyvern Barracks, Barrack Road, Exeter, Devon,
EX2 6AE (Building 11)**

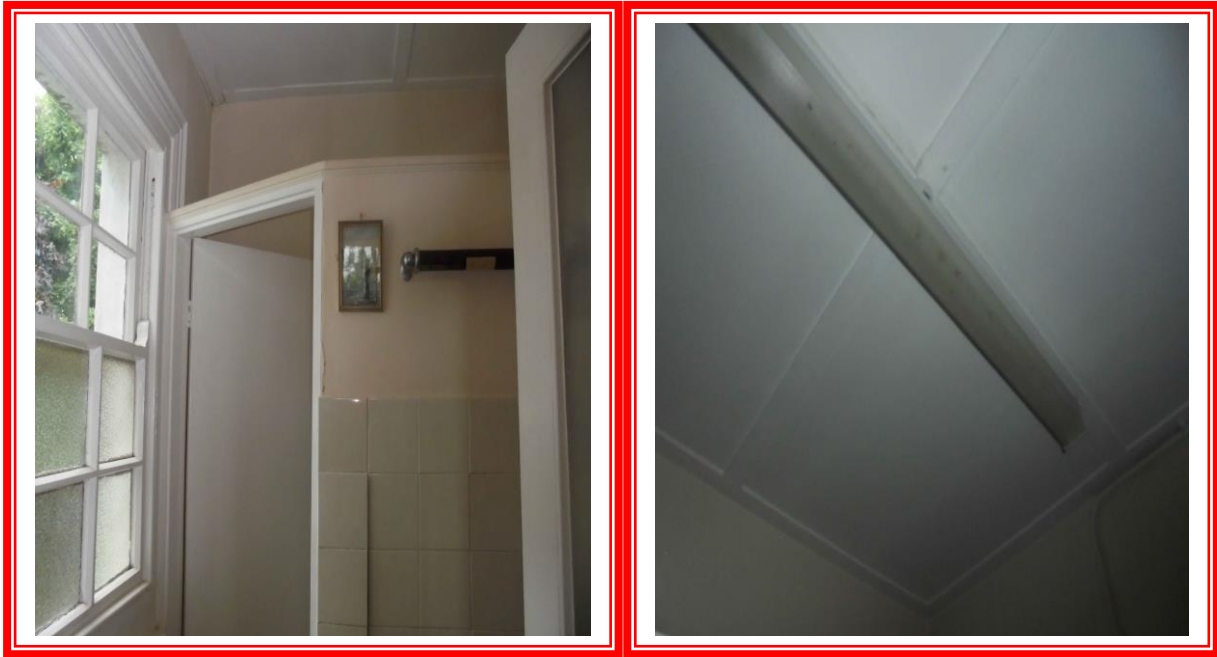
Item No: 7

Material Description:	Cement Ceiling Panels	
Identification:	Sampled – Asbestos Detected	
Approx. quantity:	4M2	
Accessibility	Low	<i>Assessment Score</i>
Product type:	Cement	1
Extent of Damage:	Minor	1
Surface Treatment:	Sealed	0
Asbestos type:	Chrysotile	1
Material Assessment Score:		3
Priority Assessment Score:		Negligible
Action:	Manage	
Comments:	N/A

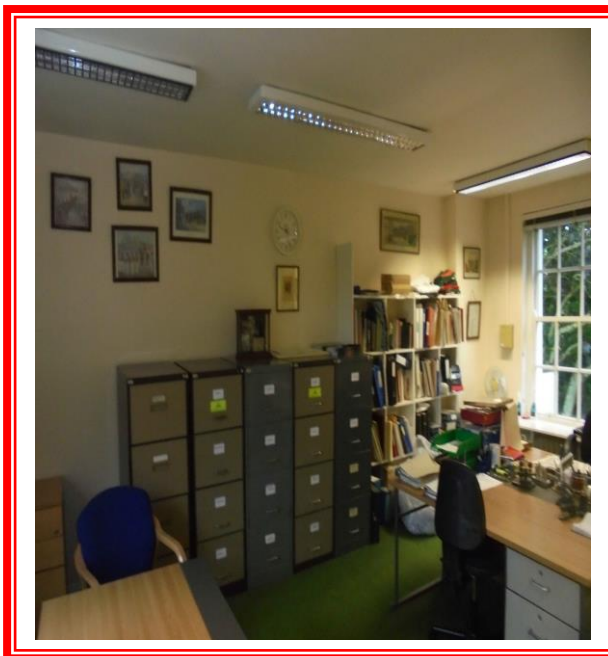
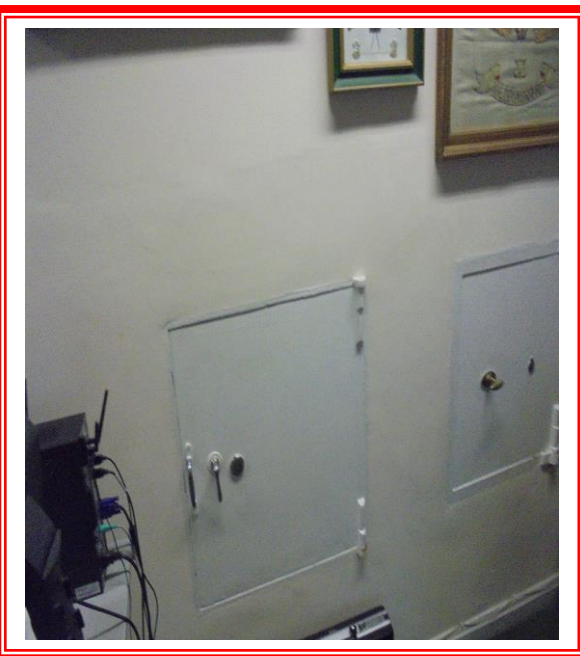
Item No: 12

Item 12 – Main Office – No Access within Safe Casings – No access to sample

Material Description:	No access within safe casing	
Identification:	Presumed to Contain Asbestos	
Approx. quantity:	X 2 Safes	
Accessibility	Low	Assessment Score
Product type:	No Access	2
Extent of Damage:	No Access	2
Surface Treatment:	No Access	2
Asbestos type:	No Access	2
Material Assessment Score:		8
Priority Assessment Score:		Medium
Action:	Manage	
Comments:	N/A

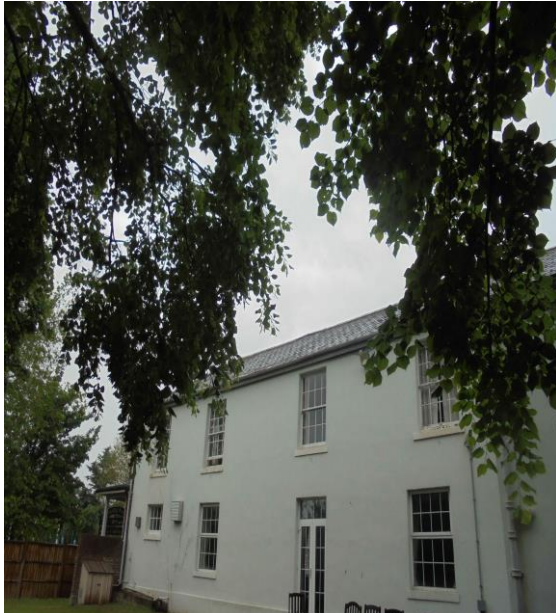
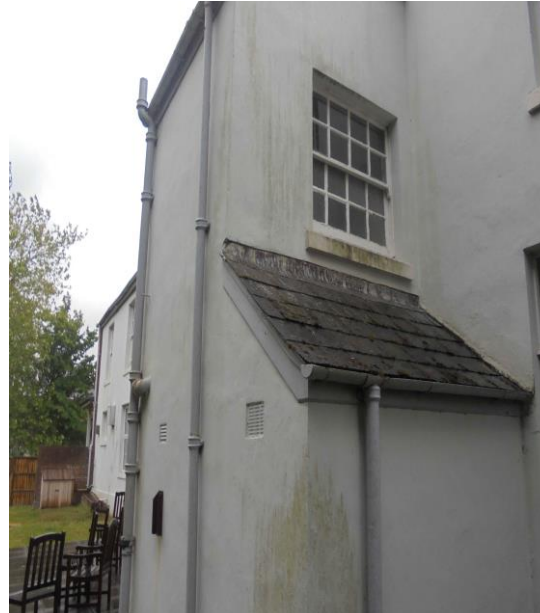
**Item No: 13****Sample No: 4****Location: External**

Material Description:	Cement roof tiles	
Identification:	Sampled – Asbestos Detected	
Approx. quantity:	230M2	
Accessibility	Low	<i>Assessment Score</i>
Product type:	Cement	1
Extent of Damage:	Minor	1
Surface Treatment:	Unsealed	1
Asbestos type:	Chrysotile	1
Material Assessment Score:		4
Priority Assessment Score:		Negligible
Action:	Manage	
Comments:	Located to all roofs

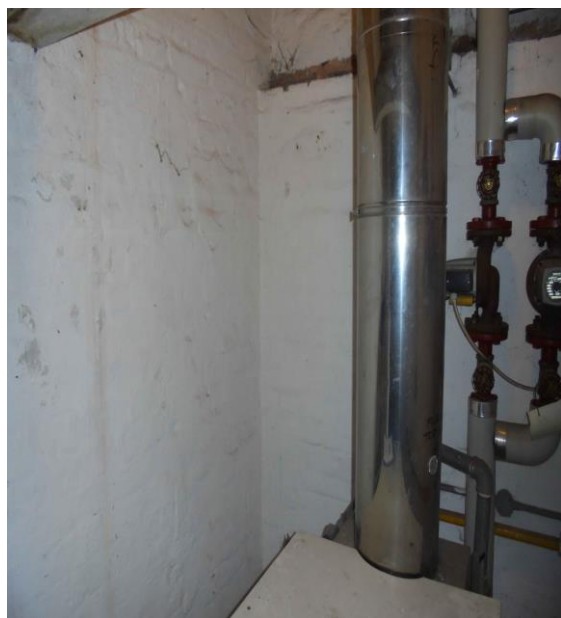
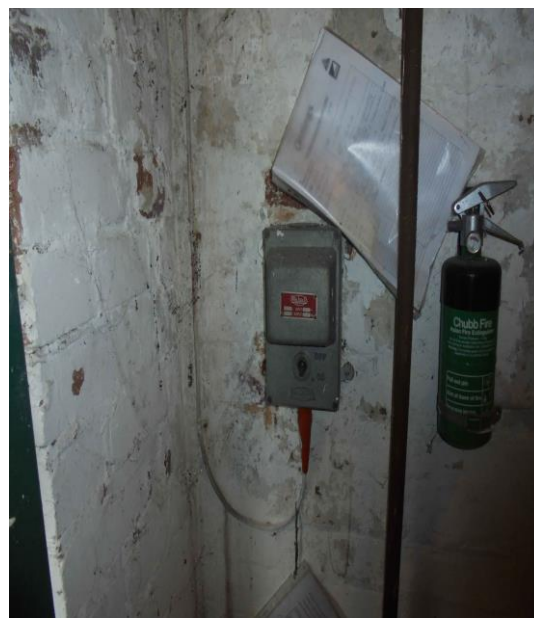
Item No: 14

Item 14 – Boiler Room – Electrical Box – No access to sample as live

Material Description:	No access within Electrical Box	
Identification:	Presumed to Contain Asbestos	
Approx. quantity:	X 1 Box	
Accessibility	Low	<i>Assessment Score</i>
Product type:	No Access	2
Extent of Damage:	No Access	1
Surface Treatment:	No Access	1
Asbestos type:	No Access	1
Material Assessment Score:		5
Priority Assessment Score:		Low
Action:	Manage	
Comments:	Non-Asbestos roof felt. Non-asbestos ideal Concorde cx boiler

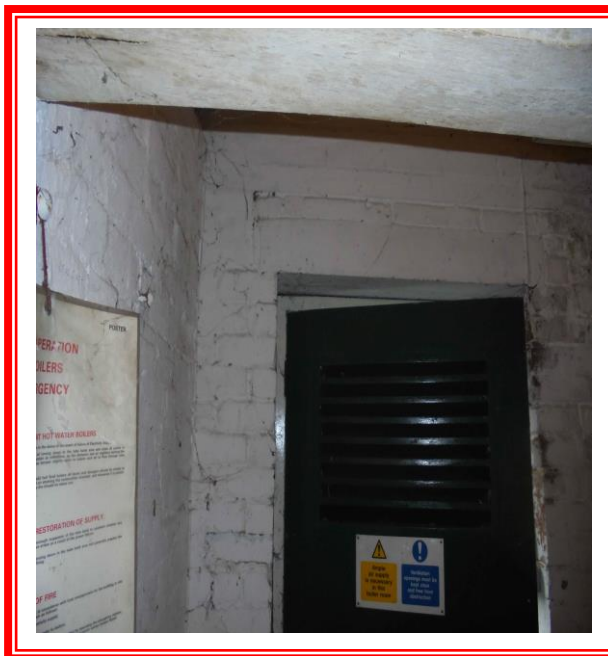
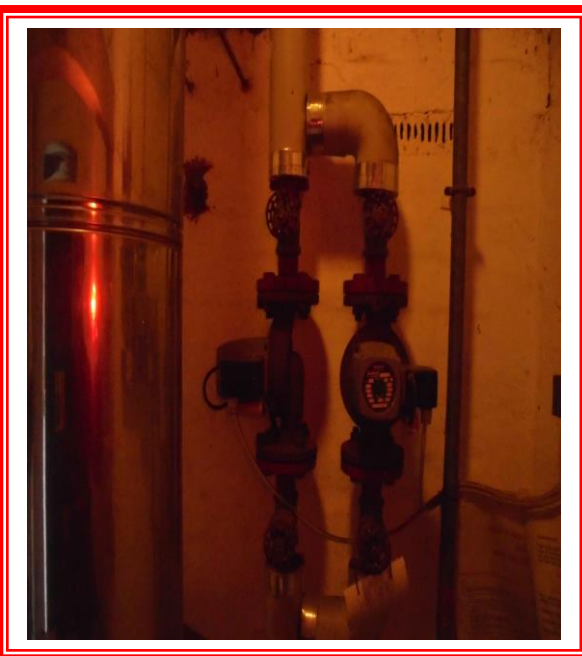
Item No: 15

Item 15 – Boiler Room – Gaskets – No access to sample as gaskets too inset within flanges

Material Description:	Gaskets	
Identification:	Presumed to Contain Asbestos	
Approx. quantity:	X 4	
Accessibility	Low	<i>Assessment Score</i>
Product type:	No Access	2
Extent of Damage:	No Access	1
Surface Treatment:	No Access	1
Asbestos type:	No Access	1
Material Assessment Score:		5
Priority Assessment Score:		Low
Action:	Manage	
Comments:	No access to sample as gaskets too inset within flanges

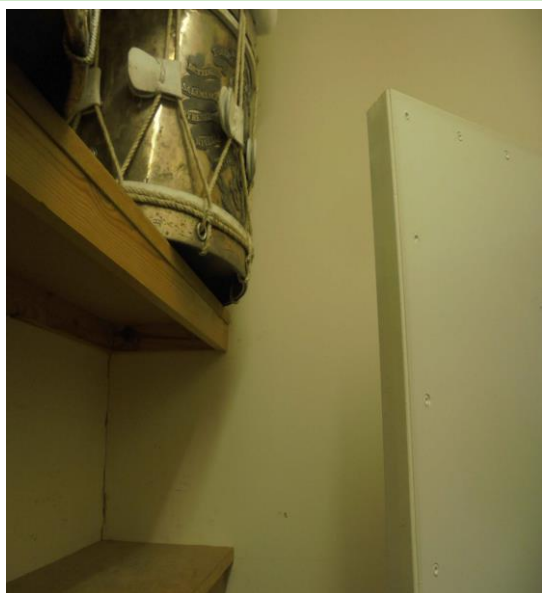
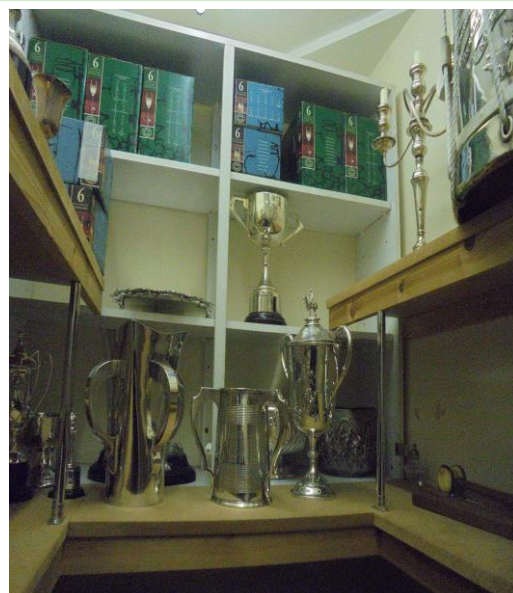
Item No: 1

Material Description:	Visual Inspection – No Suspect Materials Found	
Identification:	N/A	
Approx. quantity:	N/A	
Accessibility	N/A	<i>Assessment Score</i>
Product type:		N/A
Extent of Damage:		N/A
Surface Treatment:		N/A
Asbestos type:		N/A
Material Assessment Score:		N/A
Priority Assessment Score:		N/A
Action:	N/A	
Comments:	N/A

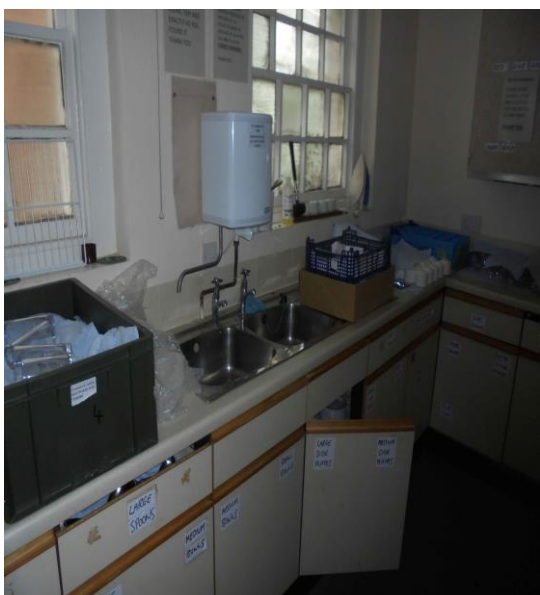
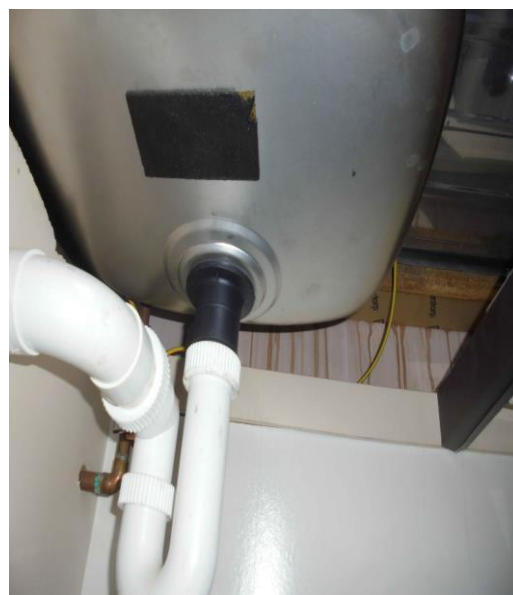
**Item No: 2****Sample No: 1****Location: Kitchen – Ground Floor**

Material Description:	Sink Pad	
Identification:	Sampled – No Asbestos Detected	
Approx. quantity:	X2	
Accessibility	N/A	<i>Assessment Score</i>
Product type:		N/A
Extent of Damage:		N/A
Surface Treatment:		N/A
Asbestos type:		N/A
Material Assessment Score:		N/A
Priority Assessment Score:		N/A
Action:	N/A	
Comments:	Modern electrics in kitchen

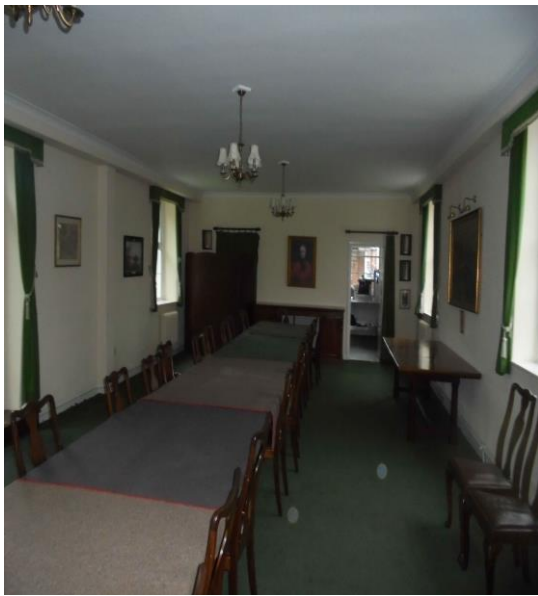
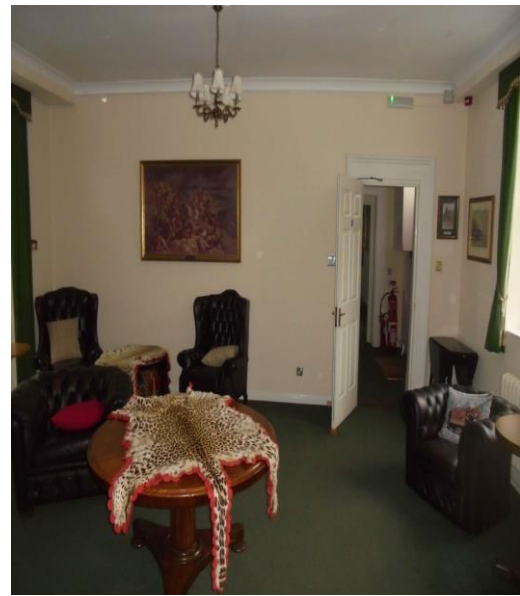
Item No: 3

Material Description:	Visual Inspection – No Suspect Materials Found	
Identification:	N/A	
Approx. quantity:	N/A	
Accessibility	N/A	<i>Assessment Score</i>
Product type:		N/A
Extent of Damage:		N/A
Surface Treatment:		N/A
Asbestos type:		N/A
Material Assessment Score:		N/A
Priority Assessment Score:		N/A
Action:	N/A	
Comments:	No access within timber boxings or below fixed carpets

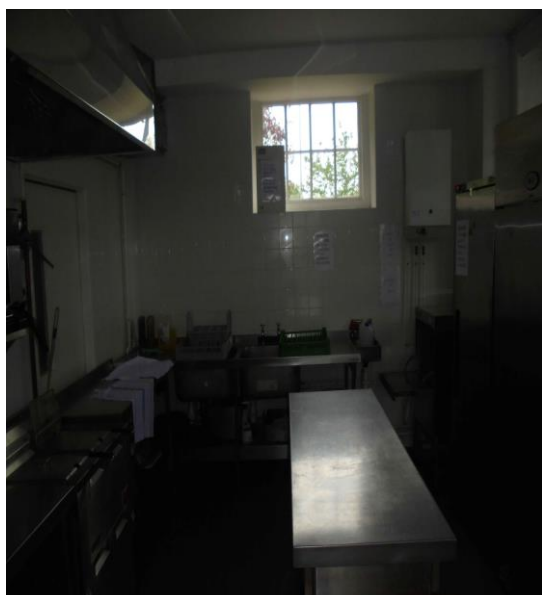
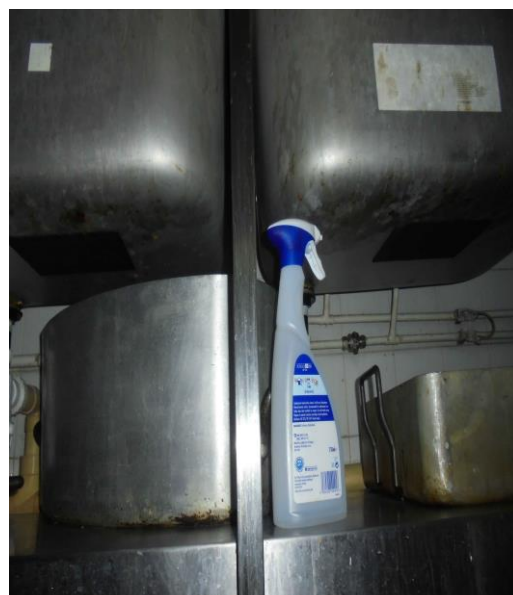
**Item No: 4****Sample No: 2****Location: Kitchen – Ground Floor**

Material Description:	Sink Pads	
Identification:	Sampled – No Asbestos Detected	
Approx. quantity:	X 2 Pads	
Accessibility	N/A	<i>Assessment Score</i>
Product type:		N/A
Extent of Damage:		N/A
Surface Treatment:		N/A
Asbestos type:		N/A
Material Assessment Score:		N/A
Priority Assessment Score:		N/A
Action:	N/A	
Comments:	No access within timber boxings. Modern boiler and electrics

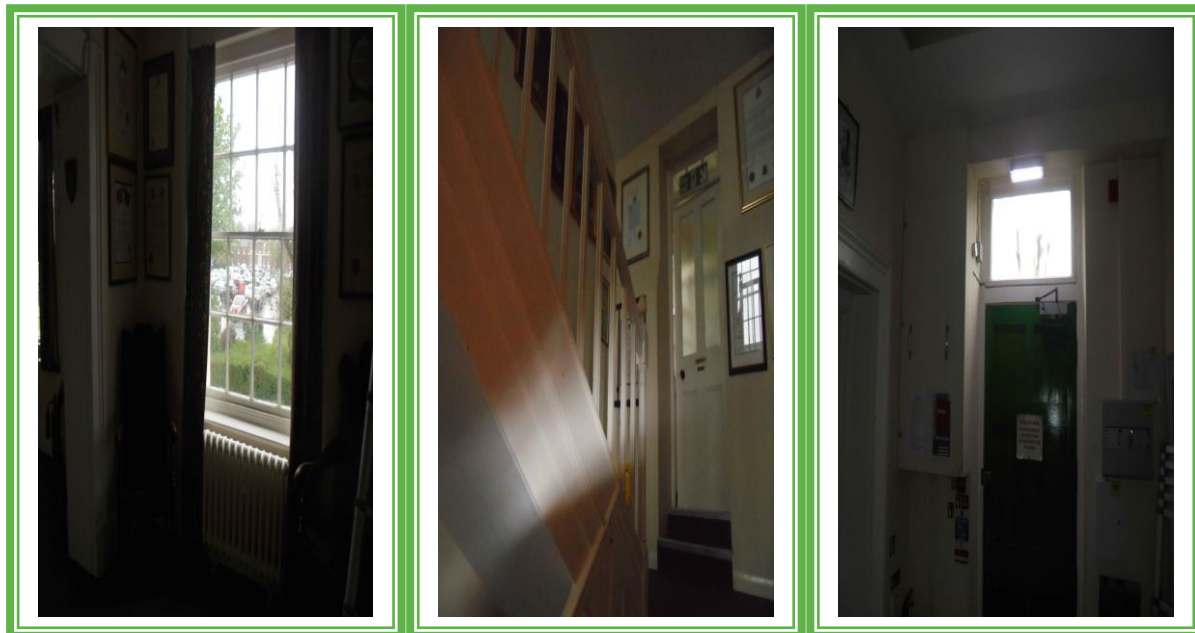
Item No: 5

Material Description:	Visual Inspection – No Suspect Materials Found	
Identification:	N/A	
Approx. quantity:	N/A	
Accessibility	N/A	<i>Assessment Score</i>
Product type:		N/A
Extent of Damage:		N/A
Surface Treatment:		N/A
Asbestos type:		N/A
Material Assessment Score:		N/A
Priority Assessment Score:		N/A
Action:	N/A	
Comments:	No access within locked cupboard as no key available during surveys - apply caution. Modern electrics in lobby

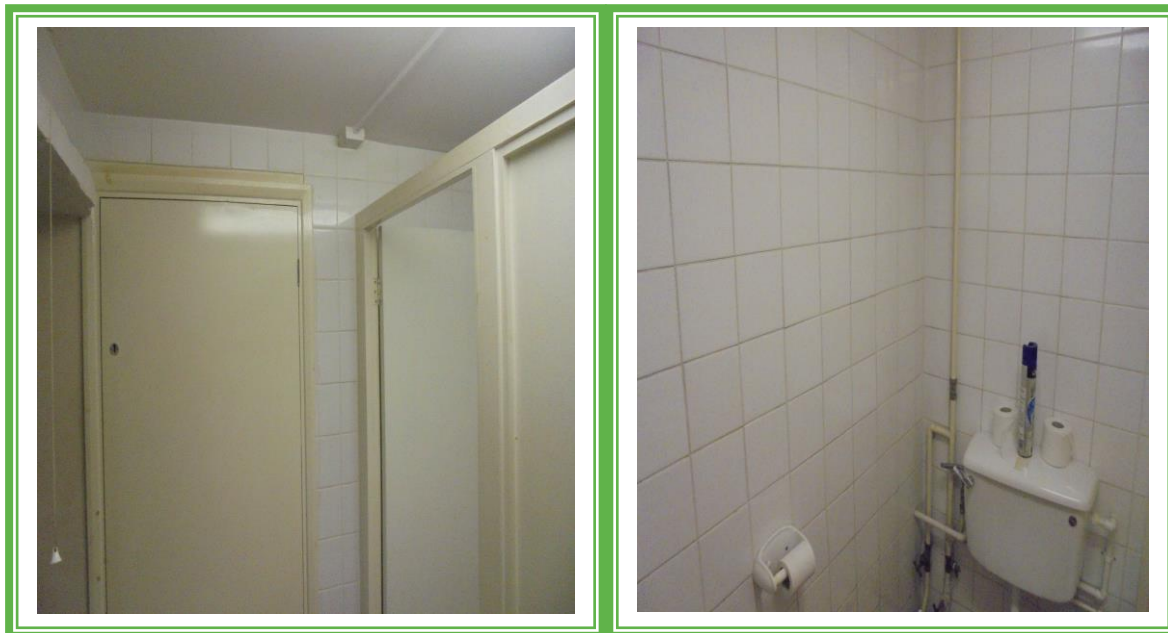
Item No: 6

Material Description:	Visual Inspection – No Suspect Materials Found	
Identification:	N/A	
Approx. quantity:	N/A	
Accessibility	N/A	<i>Assessment Score</i>
Product type:		N/A
Extent of Damage:		N/A
Surface Treatment:		N/A
Asbestos type:		N/A
Material Assessment Score:		N/A
Priority Assessment Score:		N/A
Action:	N/A	
Comments:	N/A

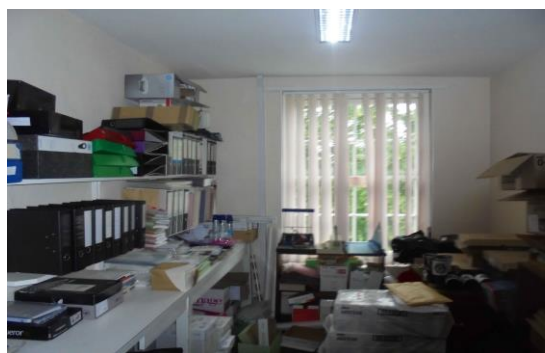
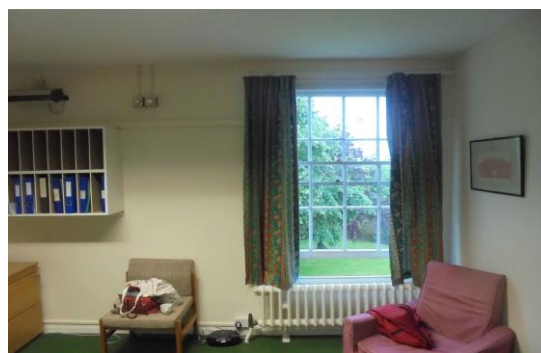
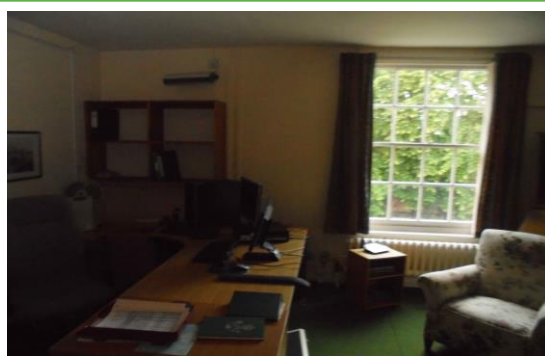
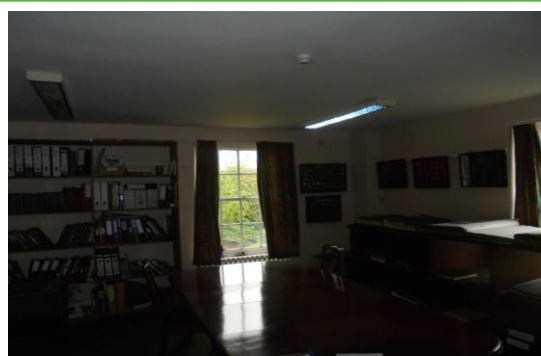
Item No: 8

Material Description:	Visual Inspection – No Suspect Materials Found	
Identification:	N/A	
Approx. quantity:	N/A	
Accessibility	N/A	<i>Assessment Score</i>
Product type:		N/A
Extent of Damage:		N/A
Surface Treatment:		N/A
Asbestos type:		N/A
Material Assessment Score:		N/A
Priority Assessment Score:		N/A
Action:	N/A	
Comments:	No access within timber boxing in meeting room

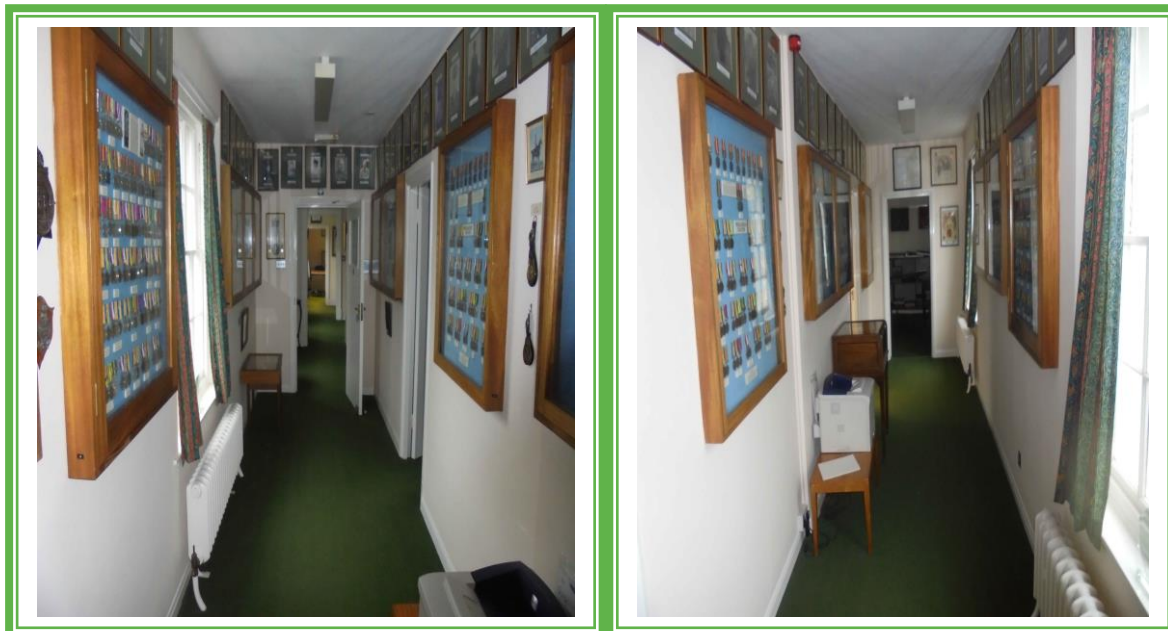
Item No: 9

Material Description:	Visual Inspection – No Suspect Materials Found	
Identification:	N/A	
Approx. quantity:	N/A	
Accessibility	N/A	<i>Assessment Score</i>
Product type:		N/A
Extent of Damage:		N/A
Surface Treatment:		N/A
Asbestos type:		N/A
Material Assessment Score:		N/A
Priority Assessment Score:		N/A
Action:	N/A	
Comments:	No access under fixed carpets

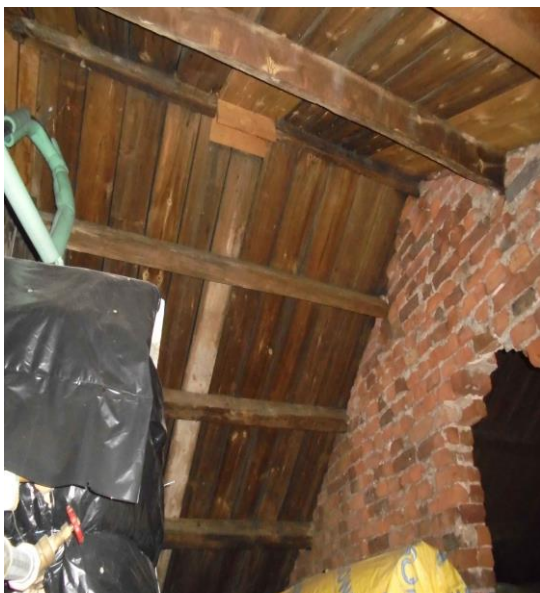
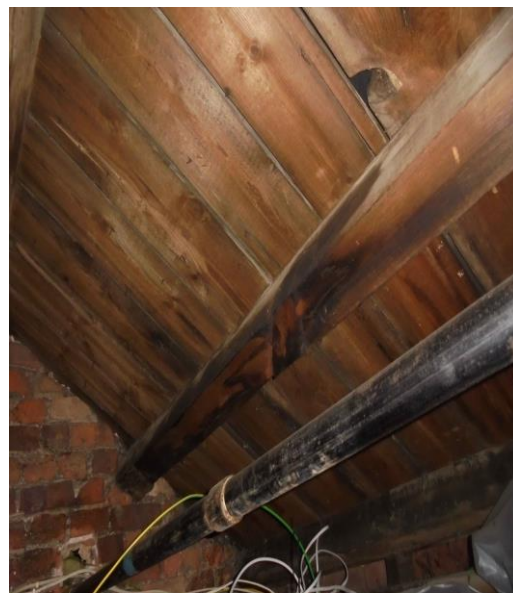
**Item No: 10****Sample No: N/A****Location: Loft Space**

Material Description:	Visual Inspection – No Suspect Materials Found	
Identification:	N/A	
Approx. quantity:	N/A	
Accessibility	N/A	<i>Assessment Score</i>
Product type:		N/A
Extent of Damage:		N/A
Surface Treatment:		N/A
Asbestos type:		N/A
Material Assessment Score:		N/A
Priority Assessment Score:		N/A
Action:	N/A	
Comments:	Limited access into loft due to height and no crawl boards available

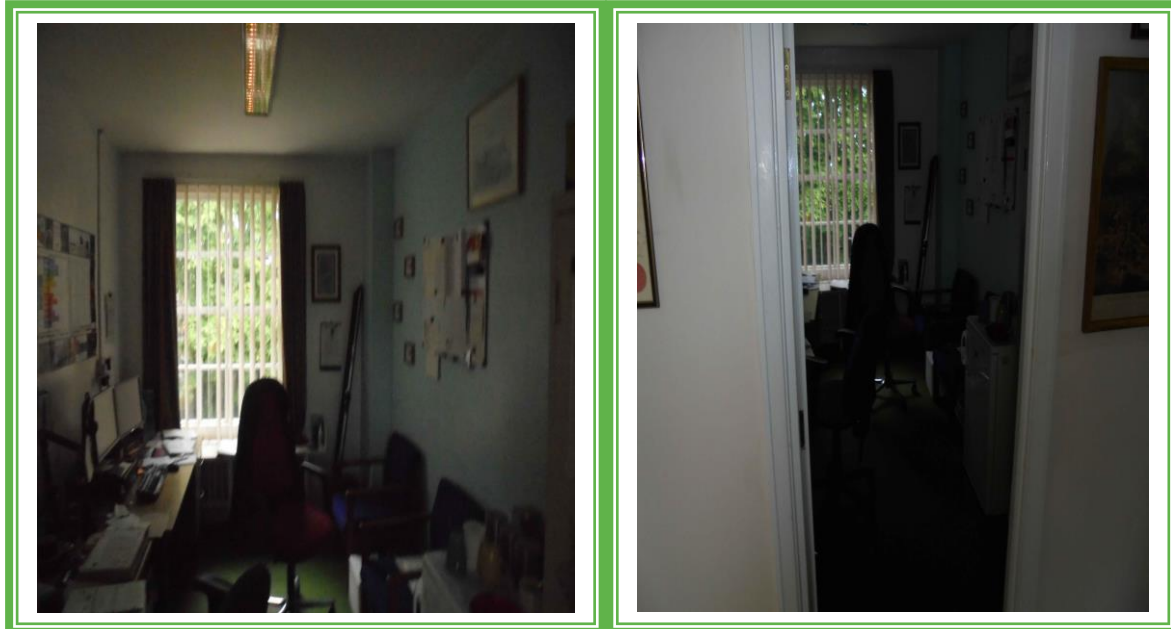
Item No: 11

Material Description:	Visual Inspection – No Suspect Materials Found	
Identification:	N/A	
Approx. quantity:	N/A	
Accessibility	N/A	<i>Assessment Score</i>
Product type:		N/A
Extent of Damage:		N/A
Surface Treatment:		N/A
Asbestos type:		N/A
Material Assessment Score:		N/A
Priority Assessment Score:		N/A
Action:	N/A	
Comments:	No access within timber boxing
