Project Number 3700

**Re-Inspection
Asbestos Survey Report**

**Bude Platoon
Cornwall
EX23 8QN**

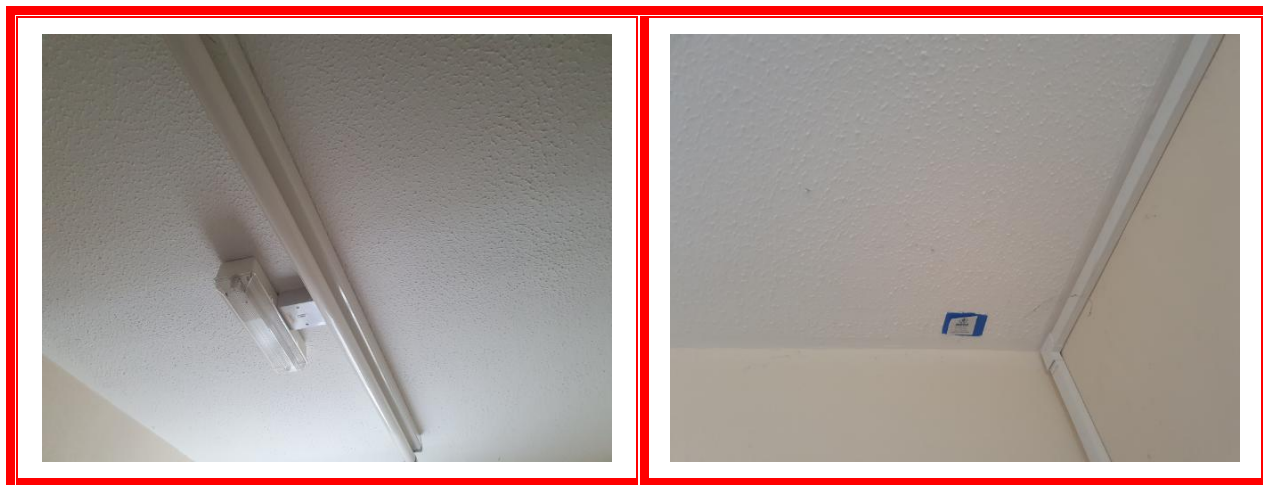
Item No:	1	Sample No:	N/A
Location:	Ground Floor - Female WC 001

Material Description:	Ceiling - Textured Coating	
Identification:	Previously Sampled - Asbestos Detected	
Approx. quantity:	4 m ²	
Accessibility	Difficult	Assessment Score
Product type:	Textured Coating	1
Extent of Damage:	Slight / minor damage	1
Surface Treatment:	Non-friable	0
Asbestos type:	Chrysotile	1
Material Assessment Score:		3
Priority Assessment Score:		Negligible
Action:	Manage	
Comments:	Previously sampled ref: Armour 21/10/19 Sample DK/1

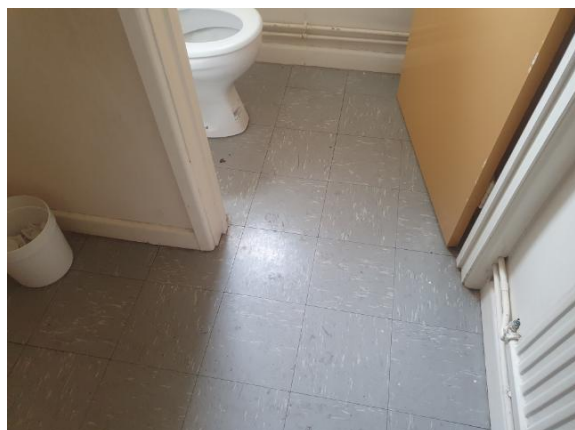
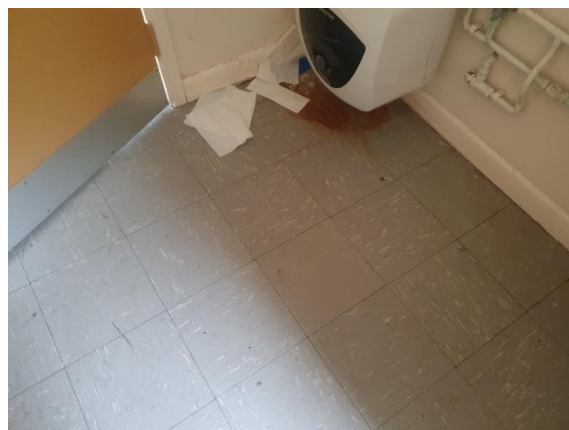
Location: Ground Floor - Female WC 002

Material Description:	Floor Tiles and Adhesive - Vinyl Products	
Identification:	Previously Sampled - Asbestos Detected	
Approx. quantity:	4 m ²	
Accessibility	Easy	<i>Assessment Score</i>
Product type:	Vinyl	1
Extent of Damage:	Slight / minor damage	1
Surface Treatment:	Non-friable	0
Asbestos type:	Chrysotile	1
Material Assessment Score:		3
Priority Assessment Score:		Negligible
Action:	Manage	
Comments:	Previously sampled ref: Armour 21/10/19 Sample DK/2

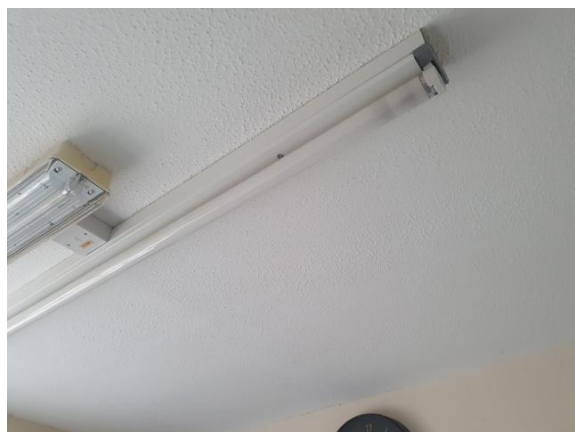
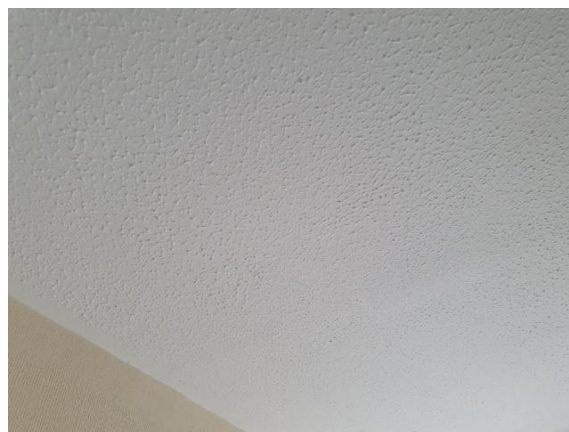
Location: Ground Floor - Office 003

Material Description:	Ceiling - Textured Coating	
Identification:	Previously Sampled - Asbestos Detected	
Approx. quantity:	4 m ²	
Accessibility	Difficult	<i>Assessment Score</i>
Product type:	Textured Coating	1
Extent of Damage:	Slight / minor damage	1
Surface Treatment:	Non-friable	0
Asbestos type:	Chrysotile	1
Material Assessment Score:		3
Priority Assessment Score:		Negligible
Action:	Manage	
Comments:	Previously sampled ref: Armour 21/10/19 Sample DK/1

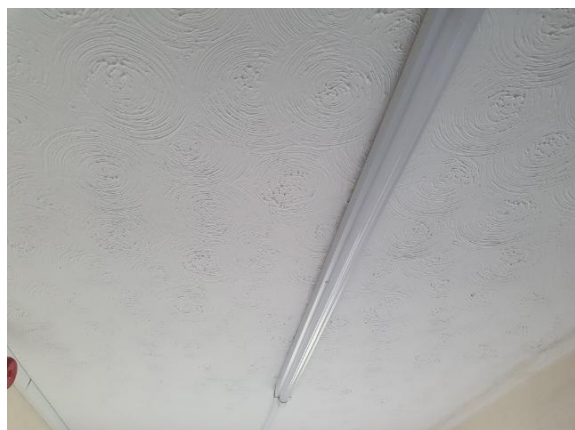
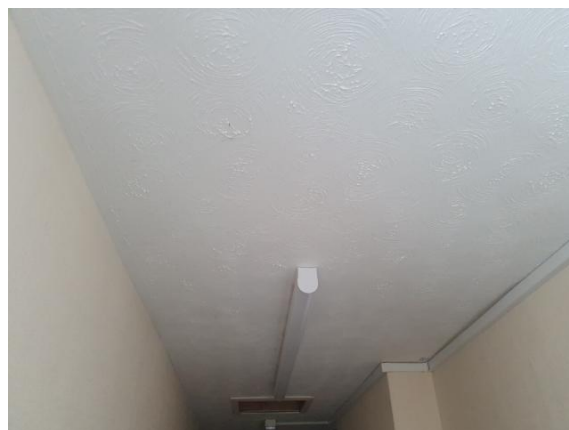
Location: Ground Floor - Entrance Lobby and Corridor 004

Material Description:	Ceilings - Textured Coating	
Identification:	Previously Sampled - Asbestos Detected	
Approx. quantity:	14 m ²	
Accessibility	Difficult	<i>Assessment Score</i>
Product type:	Textured Coating	1
Extent of Damage:	Moderate damage	2
Surface Treatment:	Non-friable	0
Asbestos type:	Chrysotile	1
Material Assessment Score:		4
Priority Assessment Score:		Negligible
Action:	Manage	
Comments:	Previously sampled ref: Armour 21/10/19 Sample DK/3

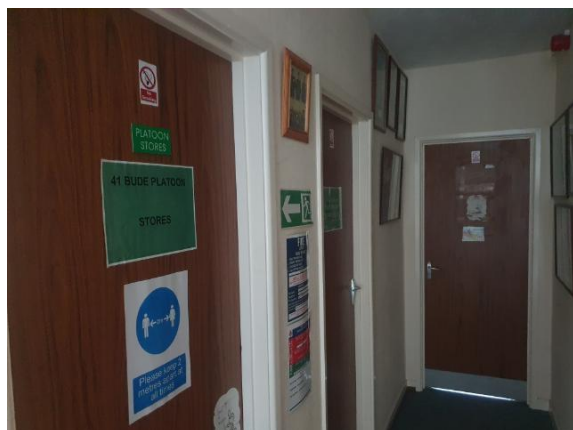
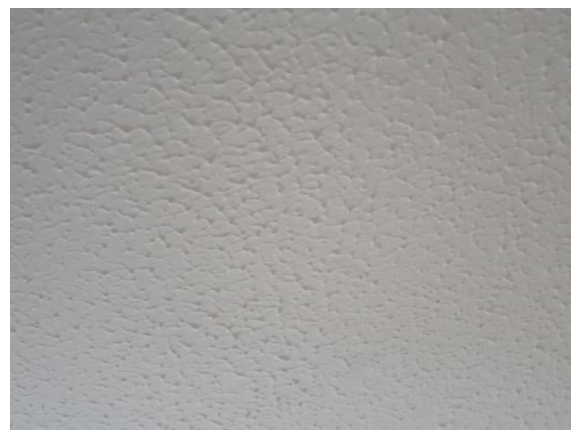
Location: Ground Floor - Office and Stores x 2 005

Material Description:	Ceilings - Textured Coating	
Identification:	Previously Sampled - Asbestos Detected	
Approx. quantity:	30 m ²	
Accessibility	Difficult	<i>Assessment Score</i>
Product type:	Textured Coating	1
Extent of Damage:	Slight / minor damage	1
Surface Treatment:	Non-friable	0
Asbestos type:	Chrysotile	1
Material Assessment Score:		3
Priority Assessment Score:		Negligible
Action:	Manage	
Comments:	Previously sampled ref: Armour 21/10/19 Sample DK/4

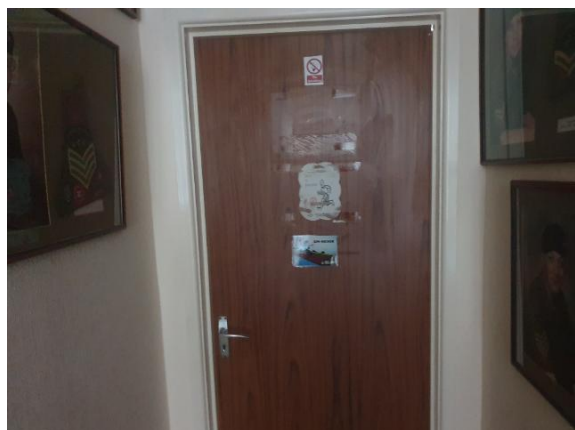
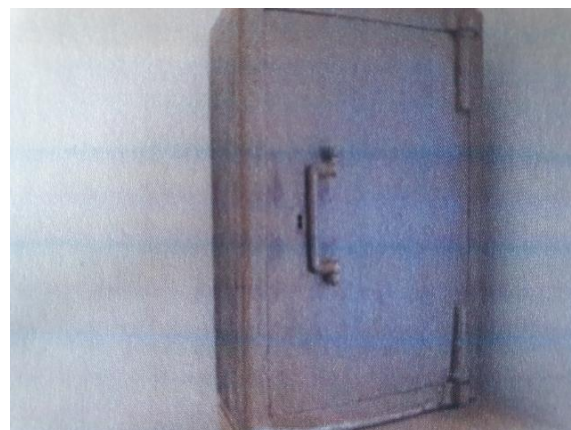
Location: Ground Floor - Office 006

Material Description:	Safe - Insulating Board	
Identification:	Presumed to Contain Asbestos	
Approx. quantity:	1 no	
Accessibility	Difficult	<i>Assessment Score</i>
Product type:	Asbestos Insulating Board	2
Extent of Damage:	Major damage	3
Surface Treatment:	Unsealed Insulation	3
Asbestos type:	Amosite, Chrysotile	2
Material Assessment Score:		10
Priority Assessment Score:		High
Action:	Manage	
Comments:	No access within safe casings without damaging safe

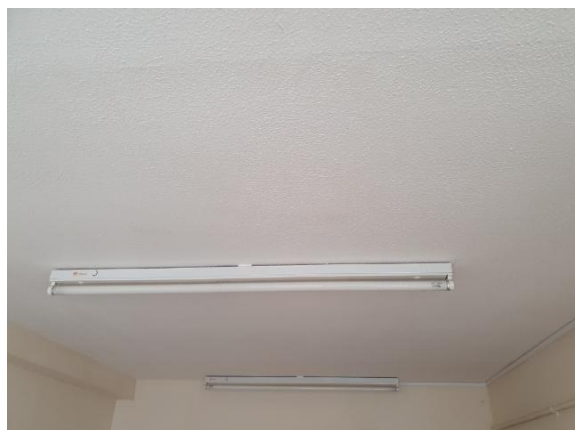
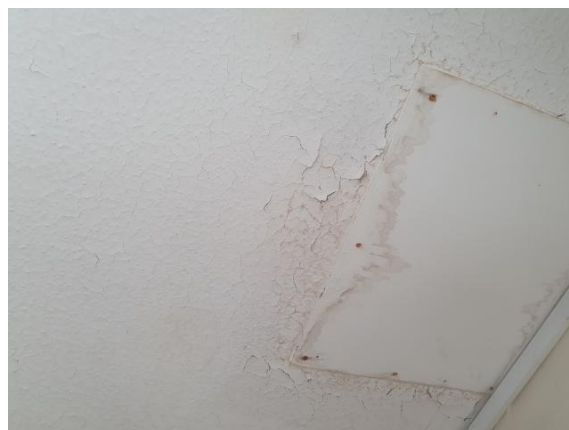
Location: Ground Floor - Lecture Room 2, Circulation & Store 007

Material Description:	Ceilings - Textured Coating	
Identification:	Previously Sampled - Asbestos Detected	
Approx. quantity:	24 m ²	
Accessibility	Difficult	<i>Assessment Score</i>
Product type:	Textured Coating	1
Extent of Damage:	Moderate damage	2
Surface Treatment:	Non-friable	0
Asbestos type:	Chrysotile	1
Material Assessment Score:		4
Priority Assessment Score:		Negligible
Action:	Encapsulate	
Comments:	Previously sampled ref: Armour 21/10/19 Samples DK/1 & DK/4

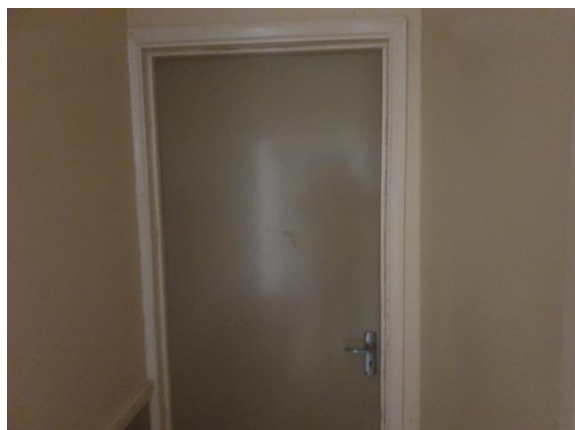
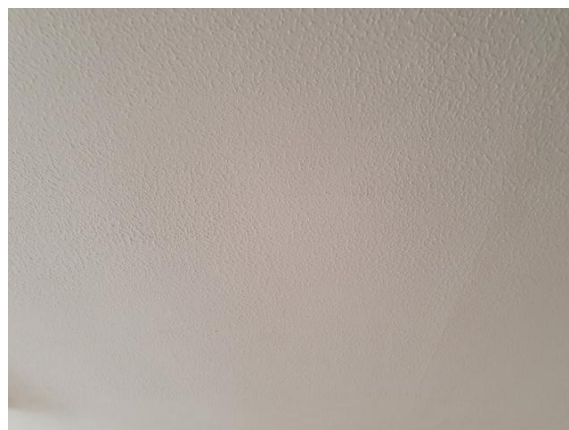
Location: Ground Floor - Store 008

Material Description:	Ceiling - Textured Coating	
Identification:	Previously Sampled - Asbestos Detected	
Approx. quantity:	1 m ²	
Accessibility	Difficult	<i>Assessment Score</i>
Product type:	Textured Coating	1
Extent of Damage:	Slight / minor damage	1
Surface Treatment:	Non-friable	0
Asbestos type:	Chrysotile	1
Material Assessment Score:		3
Priority Assessment Score:		Negligible
Action:	Manage	
Comments:	Previously sampled ref: Armour 21/10/19 Sample DK/3

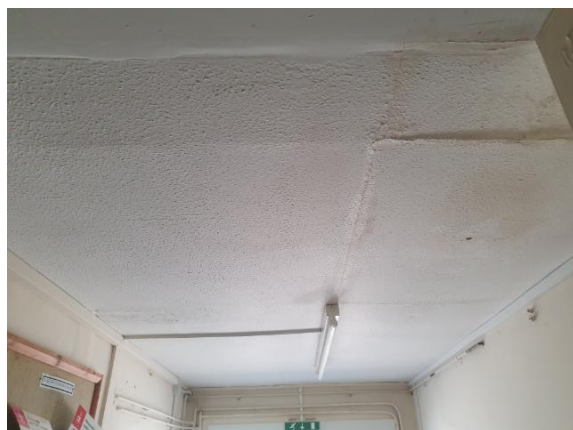
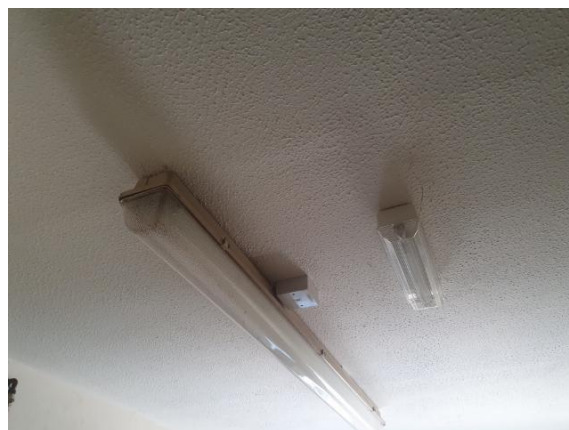
Location: Ground Floor - Lobby and WC 009

Material Description:	Ceiling - Textured Coating	
Identification:	Previously Sampled - Asbestos Detected	
Approx. quantity:	16 m ²	
Accessibility	Difficult	<i>Assessment Score</i>
Product type:	Textured Coating	1
Extent of Damage:	Moderate damage	2
Surface Treatment:	Non-friable	0
Asbestos type:	Chrysotile	1
Material Assessment Score:		4
Priority Assessment Score:		Negligible
Action:	Manage	
Comments:	Previously sampled ref: Armour 21/10/19 Sample DK/5

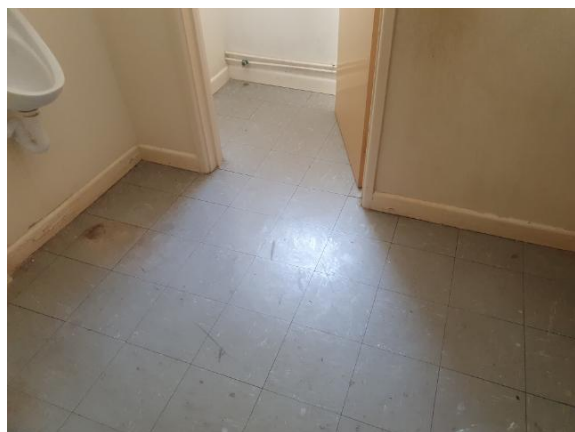
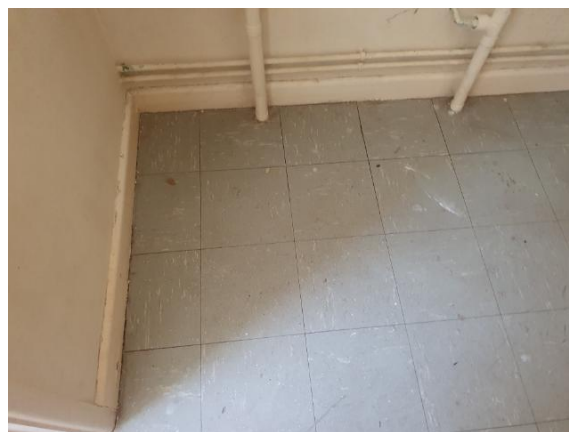
Location: Ground Floor - Men's WC 010

Material Description:	Floor Tiles and Adhesive - Vinyl Products	
Identification:	Previously Sampled - Asbestos Detected	
Approx. quantity:	7 m ²	
Accessibility	Easy	<i>Assessment Score</i>
Product type:	Vinyl	1
Extent of Damage:	Slight / minor damage	1
Surface Treatment:	Non-friable	0
Asbestos type:	Chrysotile	1
Material Assessment Score:		3
Priority Assessment Score:		Negligible
Action:	Manage	
Comments:	Previously sampled ref: Armour 21/10/19 Sample DK/2

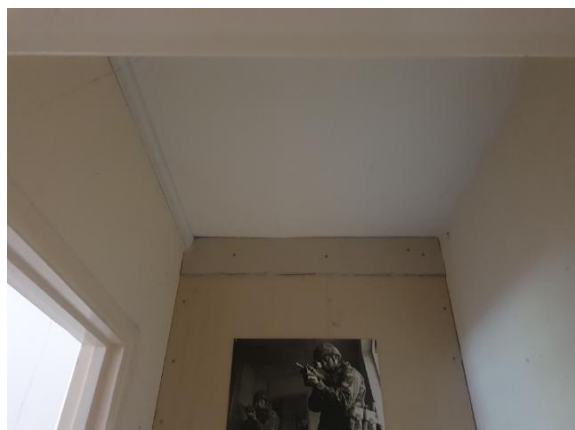
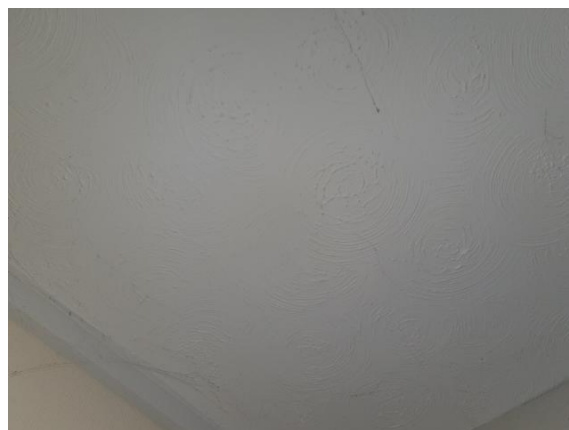
Location: Ground Floor - Men's WC Lobby 011

Material Description:	Ceiling - Textured Coating	
Identification:	Previously Sampled - Asbestos Detected	
Approx. quantity:	2 m ²	
Accessibility	Difficult	<i>Assessment Score</i>
Product type:	Textured Coating	1
Extent of Damage:	Moderate damage	2
Surface Treatment:	Non-friable	0
Asbestos type:	Chrysotile	1
Material Assessment Score:		4
Priority Assessment Score:		Negligible
Action:	Manage	
Comments:	Previously sampled ref: Armour 21/10/19 Sample DK/3

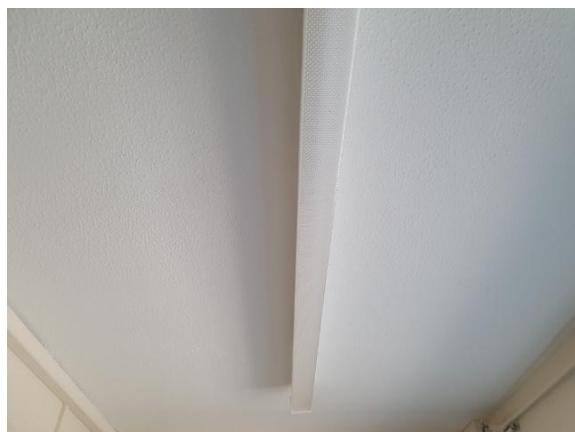
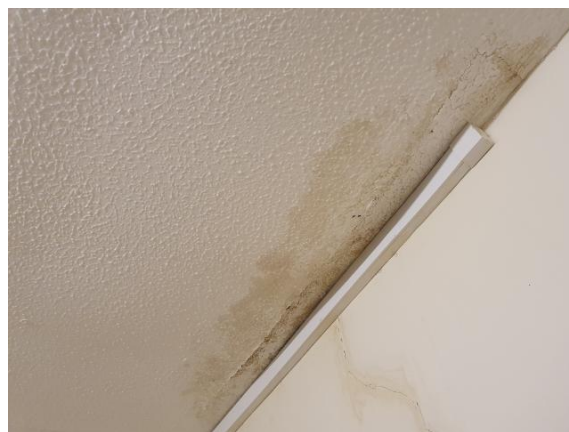
Location: Ground Floor - Lecture Room 1, Office and Kitchen 012

Material Description:	Ceilings - Textured Coating	
Identification:	Previously Sampled - Asbestos Detected	
Approx. quantity:	47 m ²	
Accessibility	Difficult	<i>Assessment Score</i>
Product type:	Textured Coating	1
Extent of Damage:	Moderate damage	2
Surface Treatment:	Non-friable	0
Asbestos type:	Chrysotile	1
Material Assessment Score:		4
Priority Assessment Score:		Negligible
Action:	Encapsulate	
Comments:	Previously sampled ref: Armour 21/10/19 Samples DK/1, DK/4 and DK/5

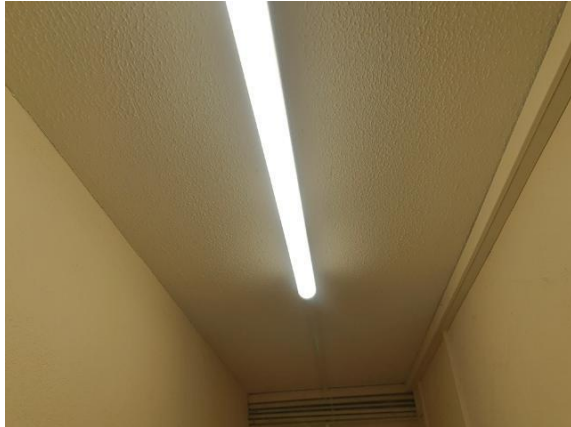
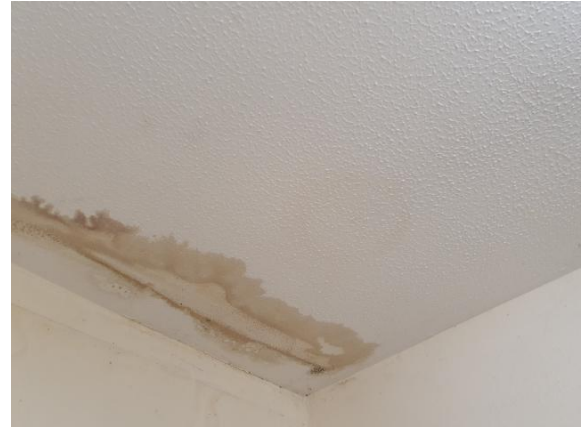
Location: Ground Floor - Lobby 013

Material Description:	Ceiling - Textured Coating	
Identification:	Previously Sampled - Asbestos Detected	
Approx. quantity:	5 m ²	
Accessibility	Difficult	<i>Assessment Score</i>
Product type:	Textured Coating	1
Extent of Damage:	Slight / minor damage	1
Surface Treatment:	Non-friable	0
Asbestos type:	Chrysotile	1
Material Assessment Score:		3
Priority Assessment Score:		Negligible
Action:	Manage	
Comments:	Previously sampled ref: Armour 21/10/19 Samples DK/1, DK/4 and DK/5

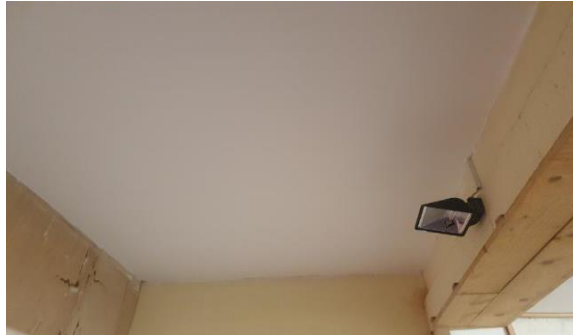
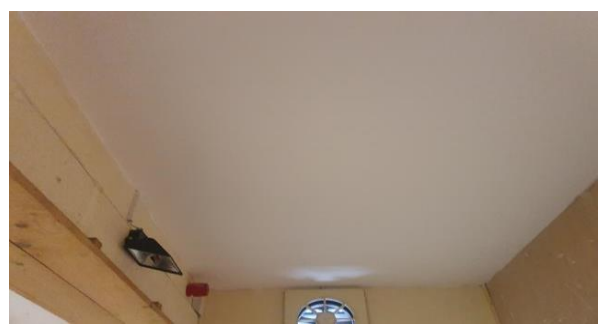
Location: Ground Floor - Range 014

Material Description:	Ceiling - Insulating Board	
Identification:	Previously Sampled - Asbestos Detected	
Approx. quantity:	8 m ²	
Accessibility	Difficult	<i>Assessment Score</i>
Product type:	Textured Coating	1
Extent of Damage:	Good	0
Surface Treatment:	Encapsulated AIB	1
Asbestos type:	Amosite	2
Material Assessment Score:		4
Priority Assessment Score:		Negligible
Action:	Manage	
Comments:	Previously sampled ref: Armour 21/10/19 Samples DK/6. Ceiling has been repaired and the asbestos boarding is no longer exposed. Presumed to still be above plasterboard ceiling. May be found above other plasterboard ceilings throughout building

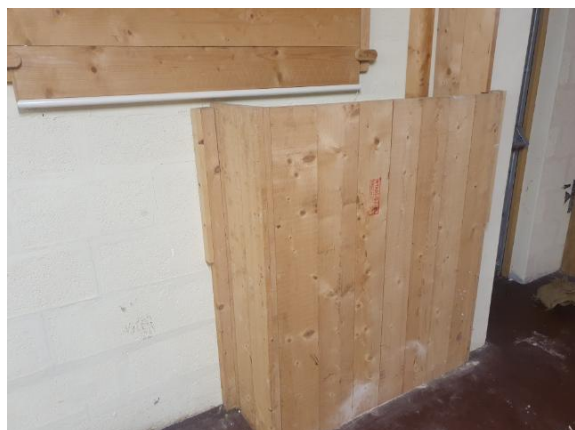
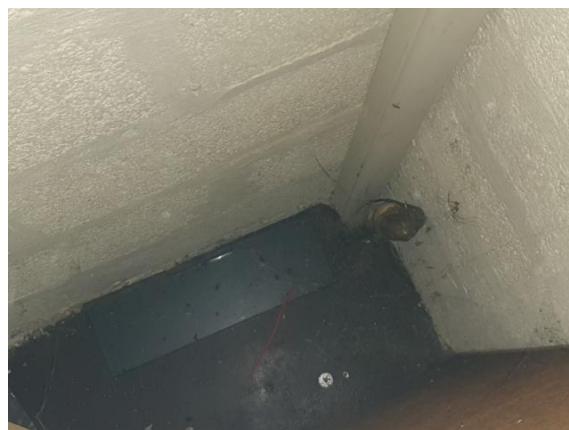
Location: Ground Floor - Range 015

Material Description:	Wrap to Mains Cable - Bituminous Product	
Identification:	Presumed to Contain Asbestos	
Approx. quantity:	1 LM	
Accessibility	Difficult	<i>Assessment Score</i>
Product type:	Bitumen	1
Extent of Damage:	Major damage	3
Surface Treatment:	Unsealed Insulation	3
Asbestos type:	Chrysotile	1
Material Assessment Score:		8
Priority Assessment Score:		Medium
Action:	Manage	
Comments:	Located in boxing

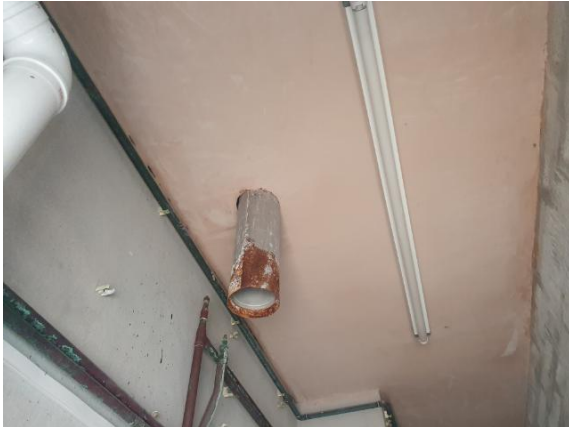
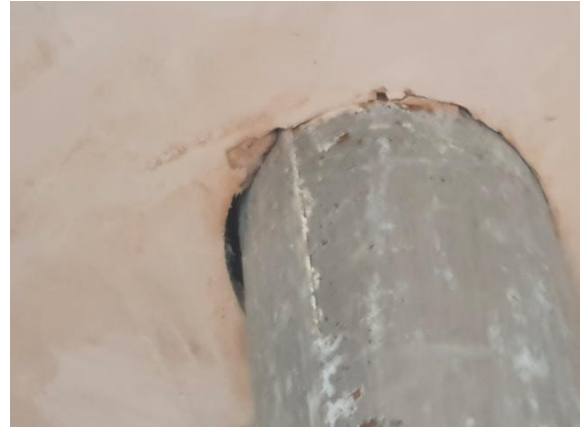
Location: Ground Floor - Boiler Room 016

Material Description:	Ceiling - Insulating Board	
Identification:	Previously Sampled - Asbestos Detected	
Approx. quantity:	4 m ²	
Accessibility	Difficult	<i>Assessment Score</i>
Product type:	Textured Coating	1
Extent of Damage:	Moderate damage	2
Surface Treatment:	Unsealed AIB	2
Asbestos type:	Amosite	2
Material Assessment Score:		7
Priority Assessment Score:		Medium
Action:	Encapsulate	
Comments:	Previously sampled ref: Armour 21/10/19 Samples DK/6. Located above plasterboard ceiling. May be found above other plasterboard ceilings throughout building
