Project Number 2481

**Management
Asbestos Survey Report**

**Shepton Mallet Platoon, Charlton Road,
Somerset, BA4 5AR**

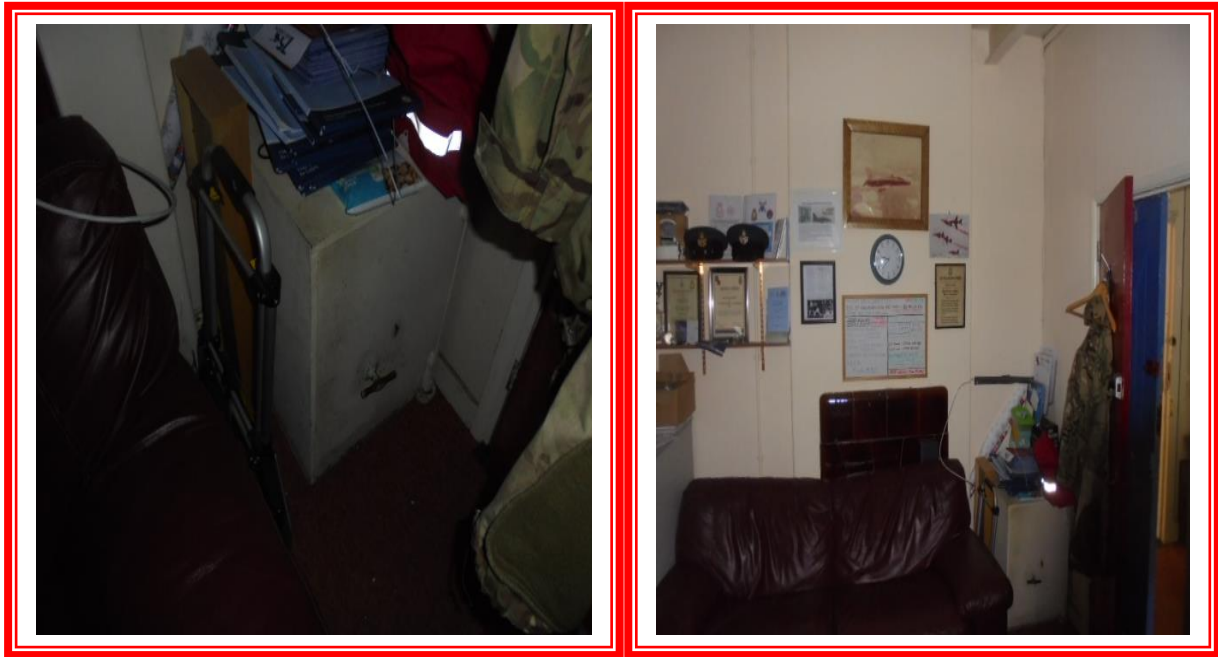
Item No: 2

Material Description:	No Access within Safe Casings	
Identification:	Presumed to Contain Asbestos	
Approx. quantity:	1 X Safe	
Accessibility	Low	<i>Assessment Score</i>
Product type:	No Access	3
Extent of Damage:	No Access	3
Surface Treatment:	No Access	3
Asbestos type:	No Access	3
Material Assessment Score:		12
Priority Assessment Score:		High
Action:	Manage	
Comments:	No Access without Damaging Safe

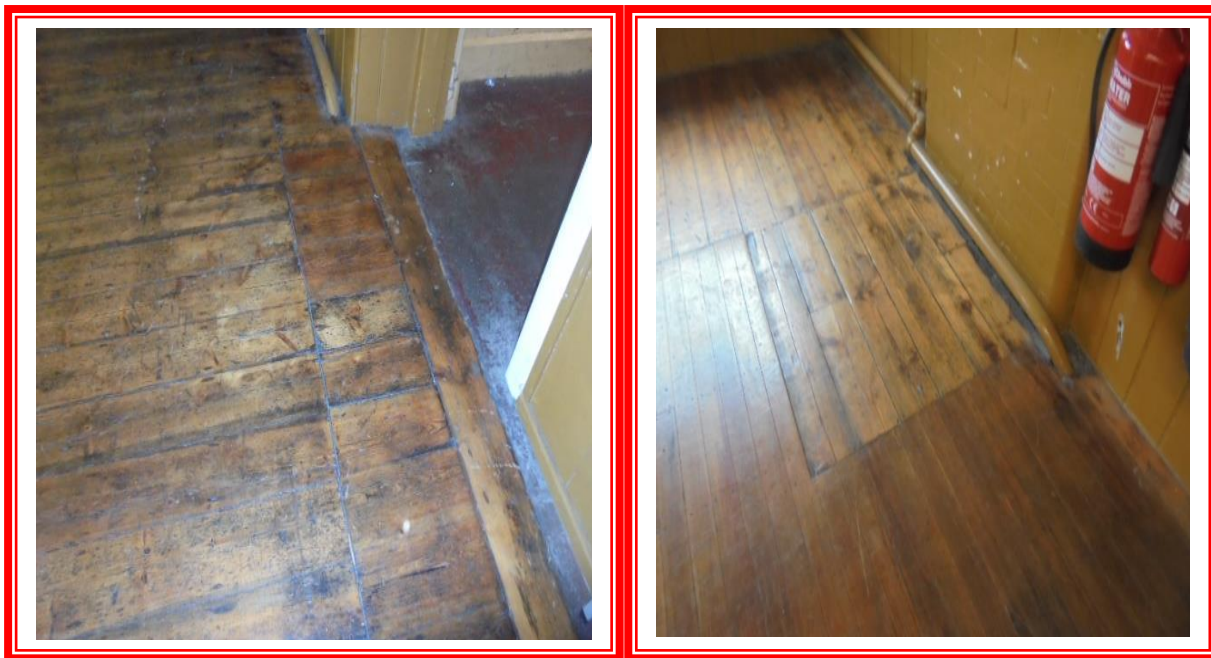
Item No: 7

Material Description:	No Access within Floor Ducts	
Identification:	Presumed to Contain Asbestos	
Approx. quantity:	Unknown	
Accessibility	Low	Assessment Score
Product type:	No Access	3
Extent of Damage:	No Access	3
Surface Treatment:	No Access	3
Asbestos type:	No Access	3
Material Assessment Score:		12
Priority Assessment Score:		High
Action:	Further Investigation Required	
Comments:	No Access as May Damage Flooring

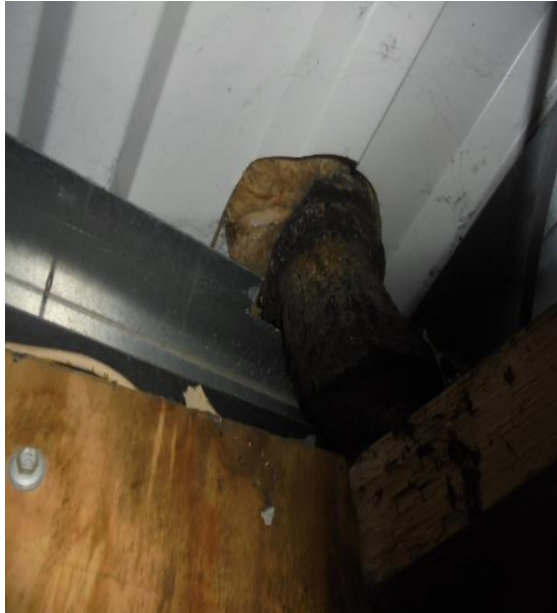
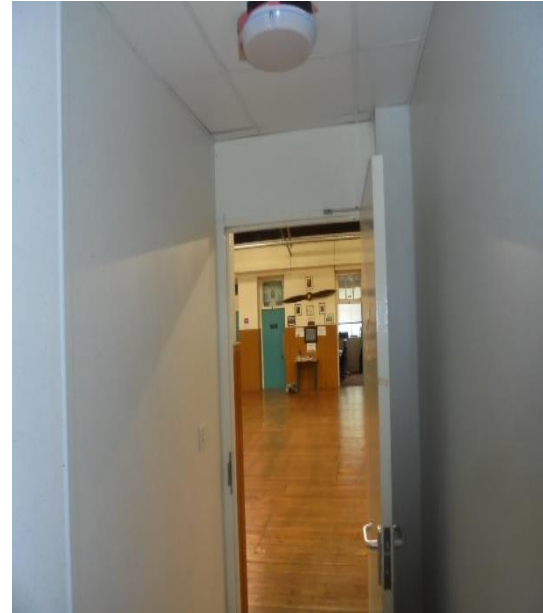
Item No: 8

Material Description:	Bitumen Coating to Metal Pipe	
Identification:	Sampled – Asbestos Detected	
Approx. quantity:	<1LM	
Accessibility	Low	Assessment Score
Product type:	Bitumen	1
Extent of Damage:	Moderate	2
Surface Treatment:	Non-Friable	0
Asbestos type:	Chrysotile	1
Material Assessment Score:		3
Priority Assessment Score:		Negligible
Action:	Manage	
Comments:	Located in ceiling void

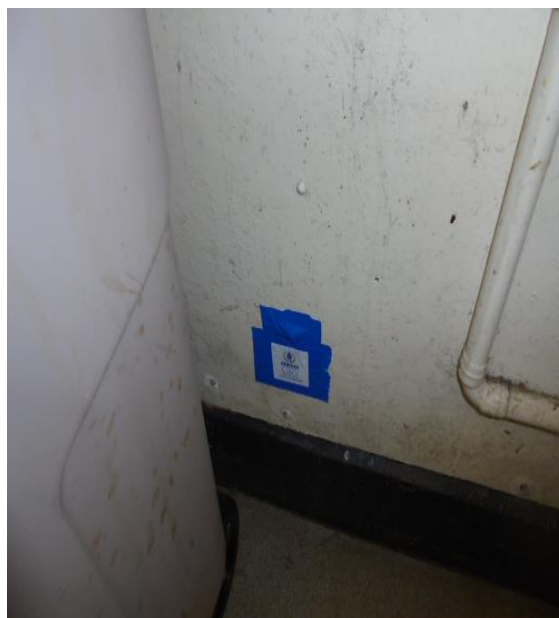
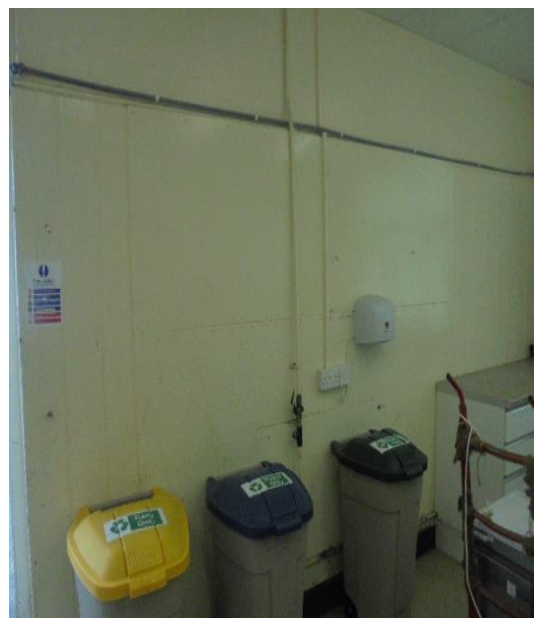
**Item No: 14****Sample No: DK/4****Location: Ground Floor - Kitchen**

Material Description:	Cement Wall Panels	
Identification:	Sampled – Asbestos Detected	
Approx. quantity:	4M2	
Accessibility	High	Assessment Score
Product type:	Cement	1
Extent of Damage:	Minor	1
Surface Treatment:	Unsealed Cement	1
Asbestos type:	Chrysotile	1
Material Assessment Score:		4
Priority Assessment Score:		Negligible
Action:	Encapsulate/Label	
Comments:	Located to External Door Wall, Behind the Bins. Several Areas of Low Damage – Encapsulate Panels

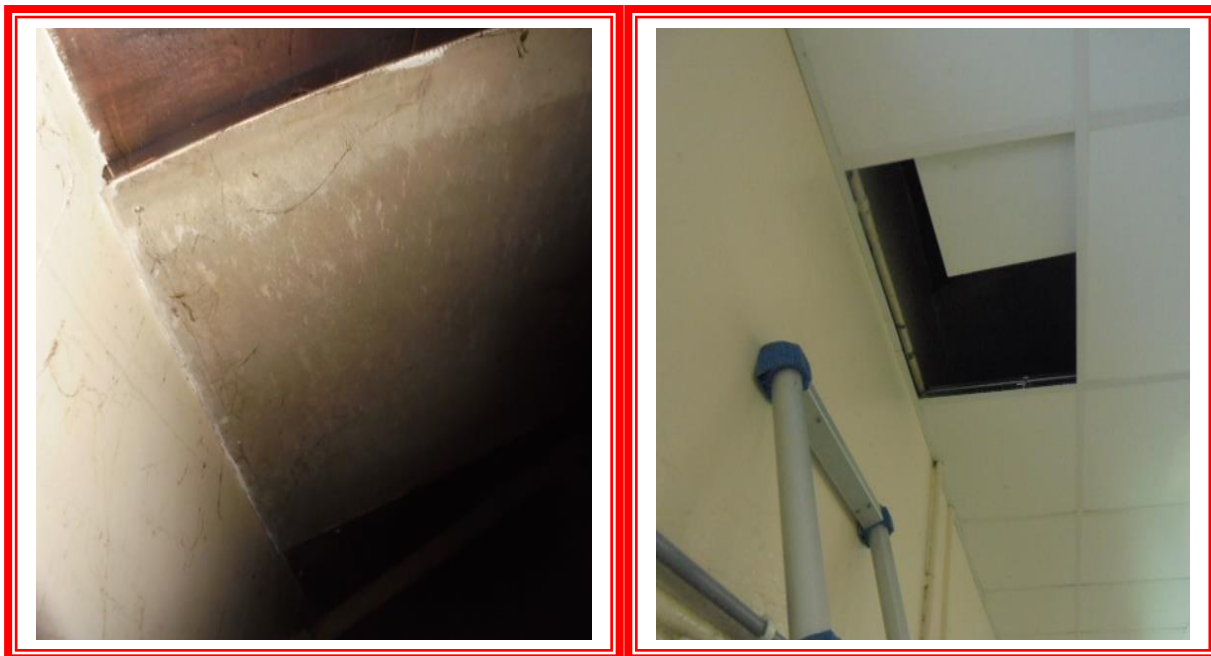
Item No: 15

Material Description:	Cement Panels Fixed to Roof Batons	
Identification:	As Per Sample DK/4 – Asbestos Detected	
Approx. quantity:	1M2	
Accessibility	Low	Assessment Score
Product type:	Cement	1
Extent of Damage:	Minor	1
Surface Treatment:	Unsealed Cement	1
Asbestos type:	Chrysotile	1
Material Assessment Score:		4
Priority Assessment Score:		Negligible
Action:	Manage	
Comments:	Located in ceiling void

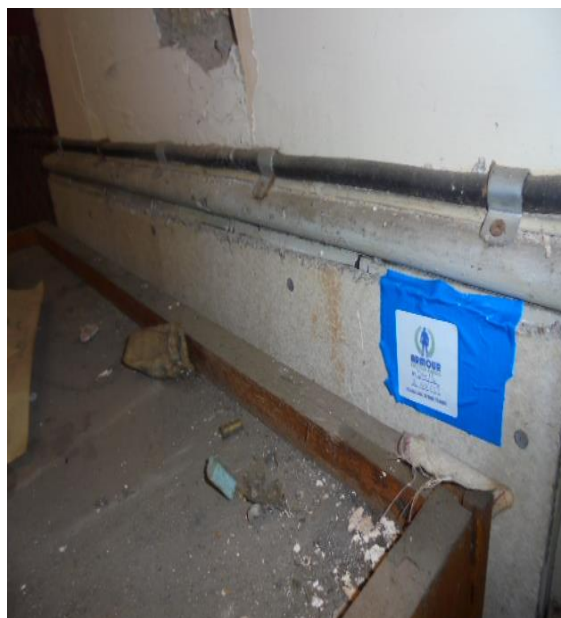
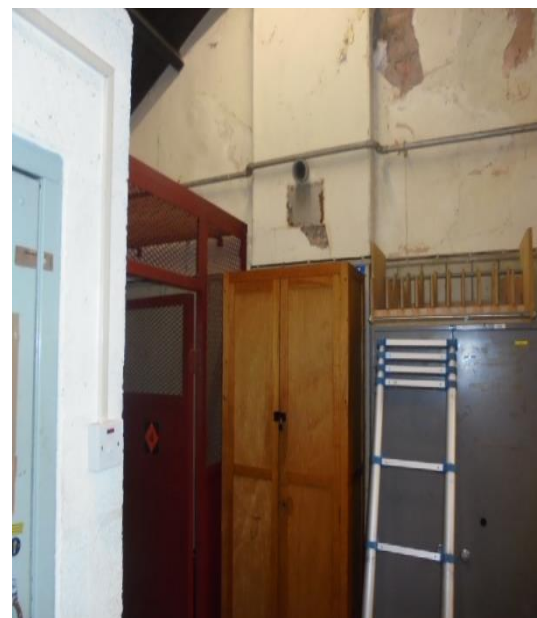
**Item No: 25****Sample No: DK/6****Location: Ground Floor - Armoury**

Material Description:	Insulation Board Wall Panel	
Identification:	Sampled – Asbestos Detected	
Approx. quantity:	2M2	
Accessibility	Low	Assessment Score
Product type:	Asbestos Insulation Board	2
Extent of Damage:	Moderate	2
Surface Treatment:	Unsealed	2
Asbestos type:	Chrysotile	1
Material Assessment Score:		7
Priority Assessment Score:		Medium
Action:	Encapsulate/Label	
Comments:	Fraying to Edges of Panel – Encapsulate

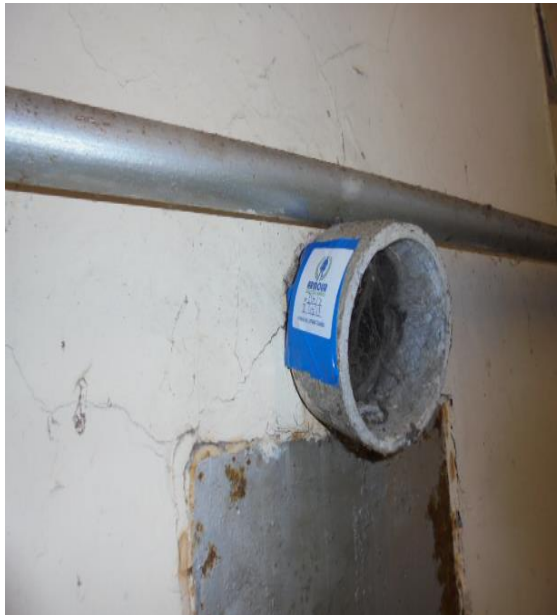
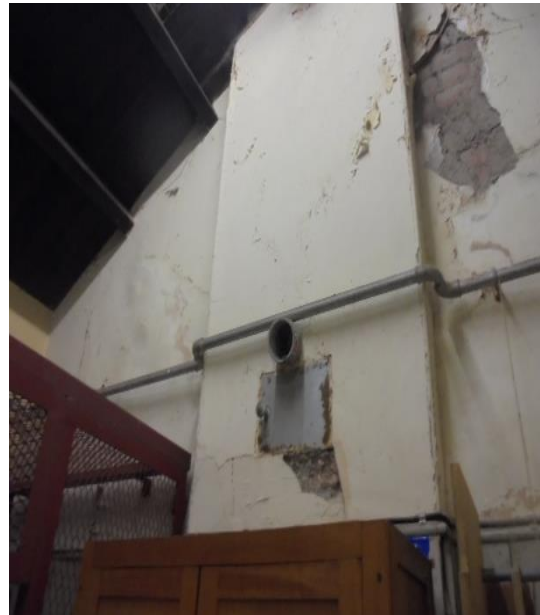
Item No: 26

Material Description:	Cement Pipe	
Identification:	Sampled – Asbestos Detected	
Approx. quantity:	<1LM	
Accessibility	Low	Assessment Score
Product type:	Cement	1
Extent of Damage:	Minor	1
Surface Treatment:	Unsealed Cement	1
Asbestos type:	Chrysotile	1
Material Assessment Score:		4
Priority Assessment Score:		Negligible
Action:	Manage	
Comments:	N/A

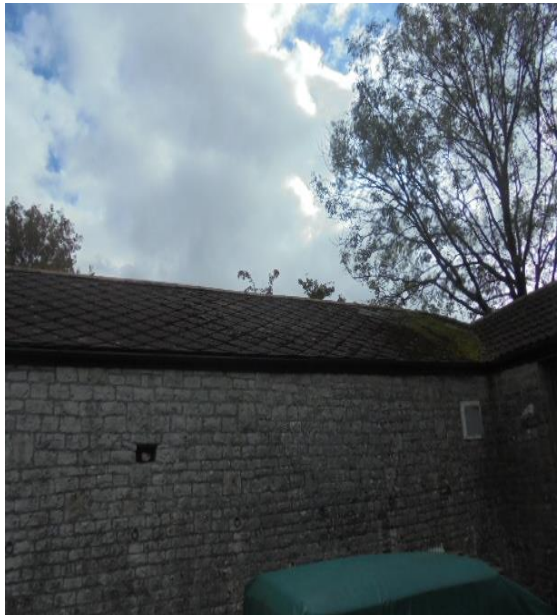
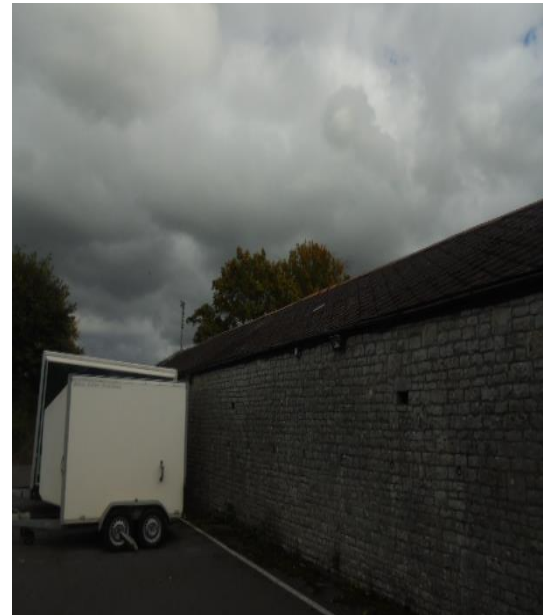
Item No: 27

Material Description:	Cement Roof Tiles	
Identification:	Sampled – Asbestos Detected	
Approx. quantity:	180M2	
Accessibility	Low	Assessment Score
Product type:	Cement	1
Extent of Damage:	Minor	1
Surface Treatment:	Unsealed Cement	1
Asbestos type:	Chrysotile	1
Material Assessment Score:		4
Priority Assessment Score:		Negligible
Action:	Manage	
Comments:	N/A

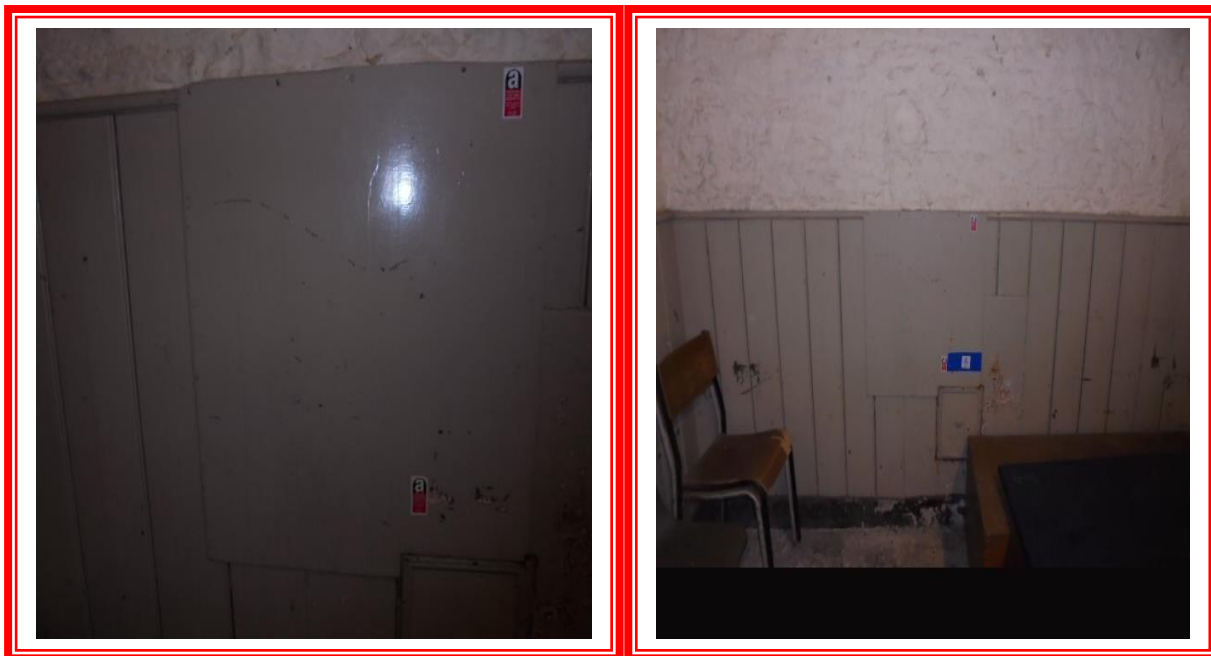
**Item No: 34****Sample No: DK/10****Location: Range**

Material Description:	Insulation Board Panel on Wall	
Identification:	Sampled – Asbestos Detected	
Approx. quantity:	<1M2	
Accessibility	High	Assessment Score
Product type:	Asbestos Insulation Board	2
Extent of Damage:	Moderate	2
Surface Treatment:	Unsealed Cement	2
Asbestos type:	Chrysotile	1
Material Assessment Score:		7
Priority Assessment Score:		Medium
Action:	Encapsulate	
Comments:	Temporarily Sealed with Tape but Requires Encapsulation

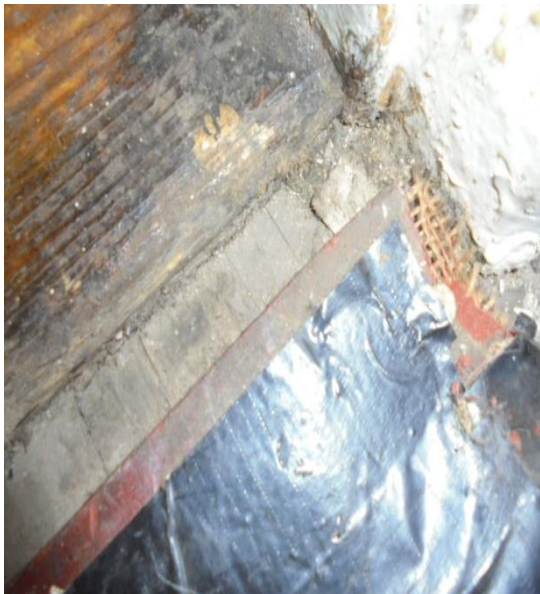
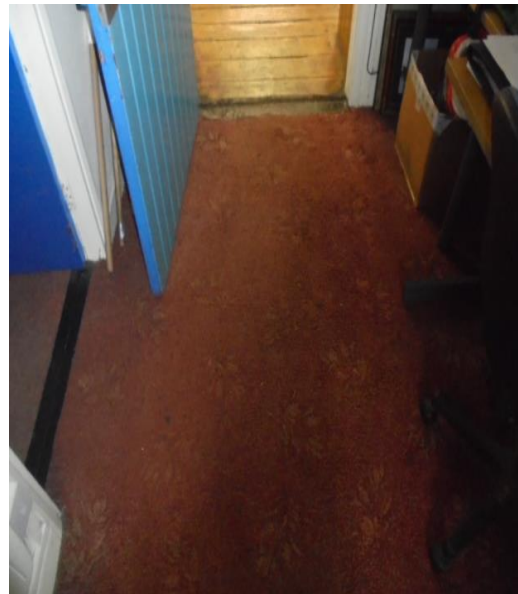
Item No: 1

Material Description:	Lino Flooring Under Carpet	
Identification:	Sampled – No Asbestos Detected	
Approx. quantity:	20M2	
Accessibility	N/A	<i>Assessment Score</i>
Product type:	N/A	N/A
Extent of Damage:	N/A	N/A
Surface Treatment:	N/A	N/A
Asbestos type:	N/A	N/A
Material Assessment Score:		N/A
Priority Assessment Score:		N/A
Action:	N/A	
Comments:	N/A

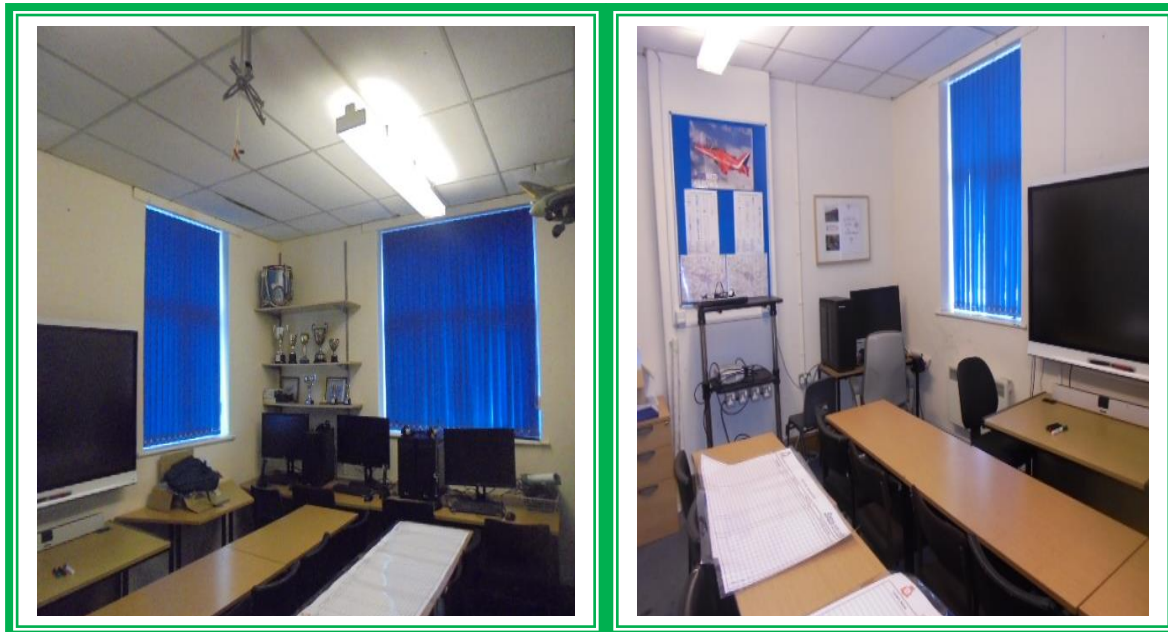
Item No: 3

Material Description:	Visual Inspection – No Suspect Materials Found	
Identification:	N/A	
Approx. quantity:	N/A	
Accessibility	N/A	Assessment Score
Product type:	N/A	N/A
Extent of Damage:	N/A	N/A
Surface Treatment:	N/A	N/A
Asbestos type:	N/A	N/A
Material Assessment Score:		N/A
Priority Assessment Score:		N/A
Action:	N/A	
Comments:	No Access behind Timber Fireplace Panel – Apply Caution

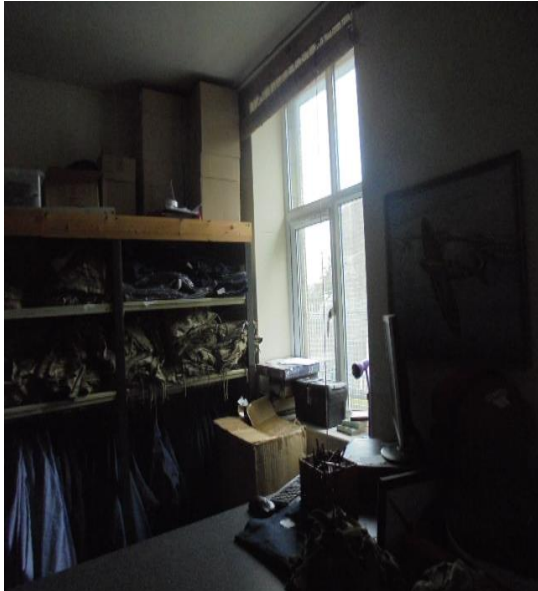
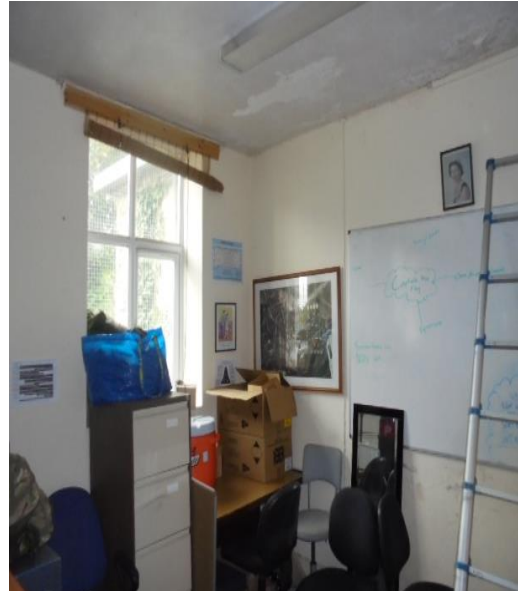
Item No: 5

Material Description:	Visual Inspection – No Suspect Materials Found	
Identification:	N/A	
Approx. quantity:	N/A	
Accessibility	N/A	Assessment Score
Product type:	N/A	N/A
Extent of Damage:	N/A	N/A
Surface Treatment:	N/A	N/A
Asbestos type:	N/A	N/A
Material Assessment Score:		N/A
Priority Assessment Score:		N/A
Action:	N/A	
Comments:	No Access Behind Timber Fireplace Panel – Apply Caution

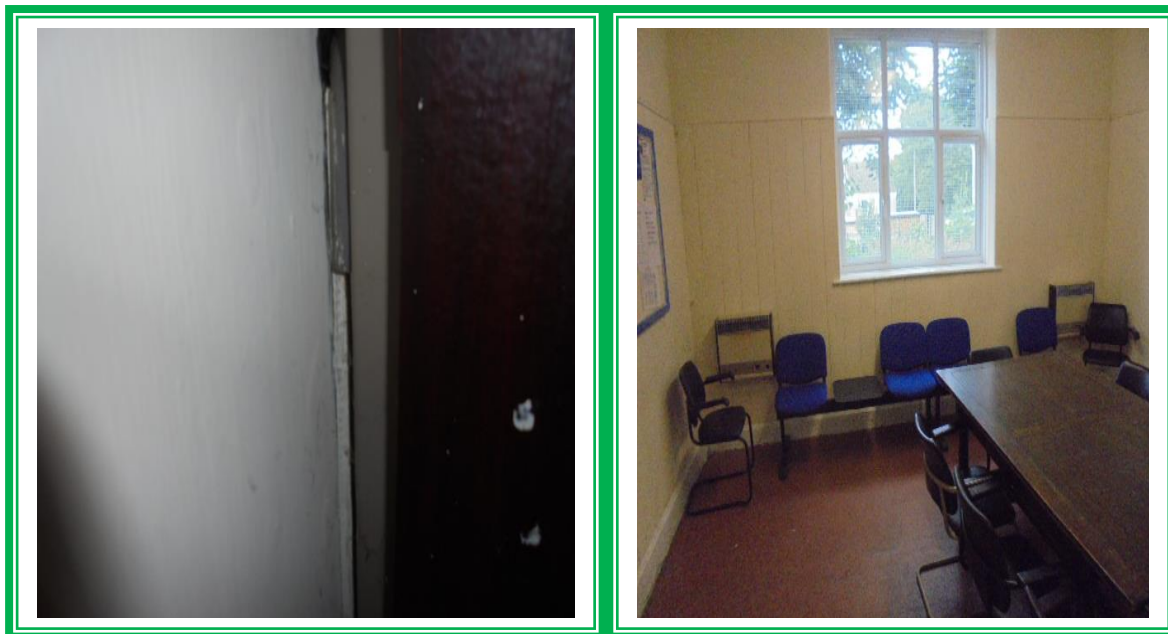
Item No: 6

Material Description:	Panels behind Heater	
Identification:	Sampled – No Asbestos Detected	
Approx. quantity:	2 X Heaters	
Accessibility	N/A	<i>Assessment Score</i>
Product type:	N/A	N/A
Extent of Damage:	N/A	N/A
Surface Treatment:	N/A	N/A
Asbestos type:	N/A	N/A
Material Assessment Score:		N/A
Priority Assessment Score:		N/A
Action:	N/A	
Comments:	N/A

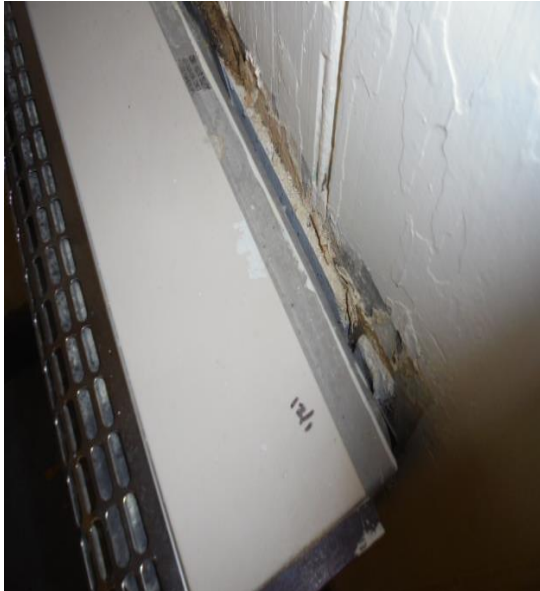
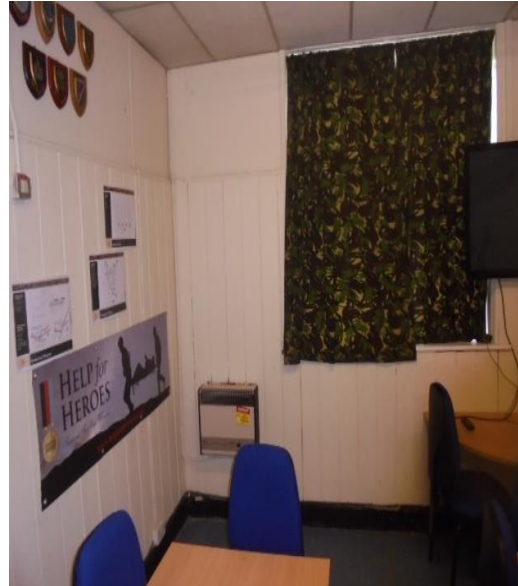
Item No: 12

Material Description:	Panels Behind Heater	
Identification:	As Sample DK/2	
Approx. quantity:	<1M2	
Accessibility	N/A	<i>Assessment Score</i>
Product type:	N/A	N/A
Extent of Damage:	N/A	N/A
Surface Treatment:	N/A	N/A
Asbestos type:	N/A	N/A
Material Assessment Score:		N/A
Priority Assessment Score:		N/A
Action:	N/A	
Comments:	N/A

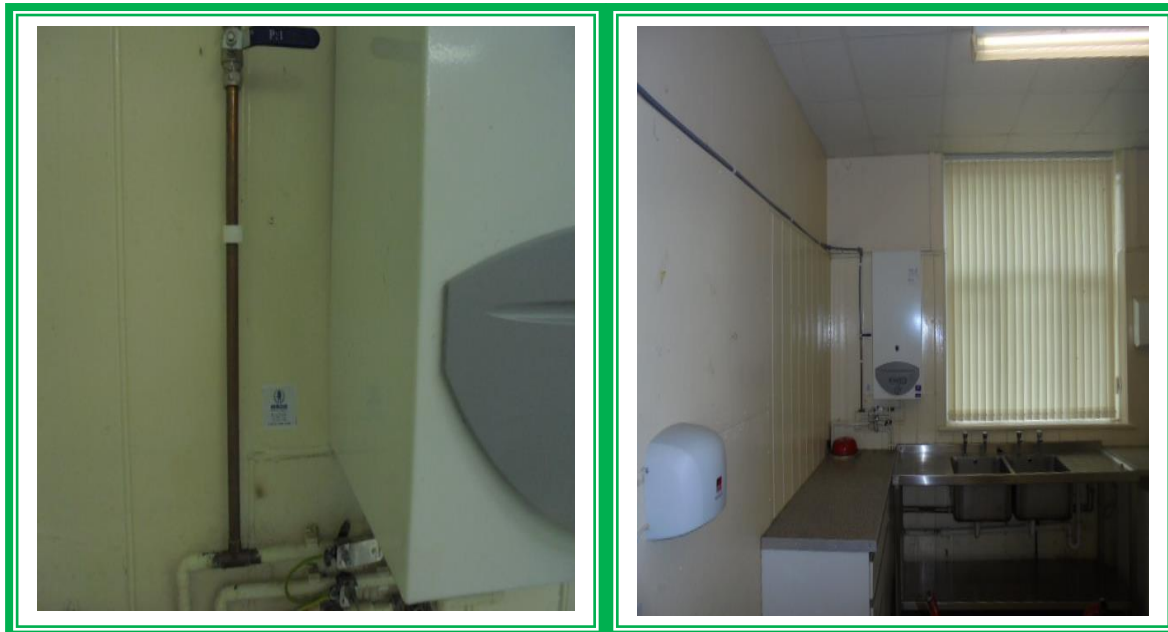
Item No: 16

Material Description:	Panel Behind Boiler	
Identification:	Sampled – No Asbestos Detected	
Approx. quantity:	<1M2	
Accessibility	N/A	<i>Assessment Score</i>
Product type:	N/A	N/A
Extent of Damage:	N/A	N/A
Surface Treatment:	N/A	N/A
Asbestos type:	N/A	N/A
Material Assessment Score:		N/A
Priority Assessment Score:		N/A
Action:	N/A	
Comments:	Modern Boiler

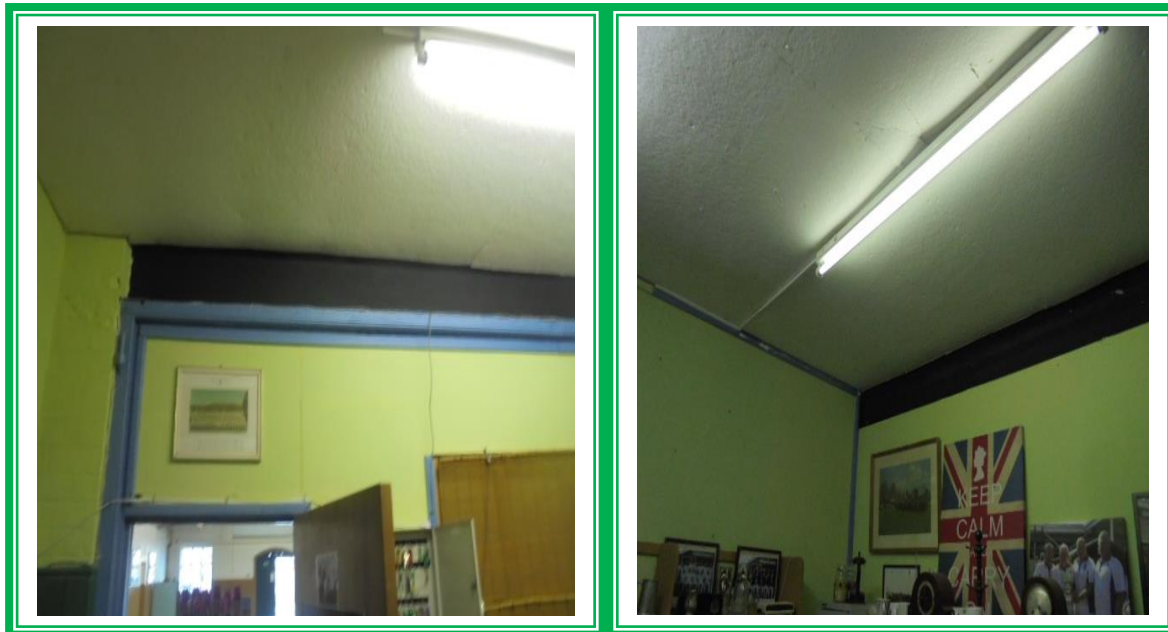
Item No: 18

Material Description:	Visual Inspection – No Suspect Materials Found	
Identification:	N/A	
Approx. quantity:	N/A	
Accessibility	N/A	<i>Assessment Score</i>
Product type:	N/A	N/A
Extent of Damage:	N/A	N/A
Surface Treatment:	N/A	N/A
Asbestos type:	N/A	N/A
Material Assessment Score:		N/A
Priority Assessment Score:		N/A
Action:	N/A	
Comments:	Non-Asbestos Fiberboard Ceiling

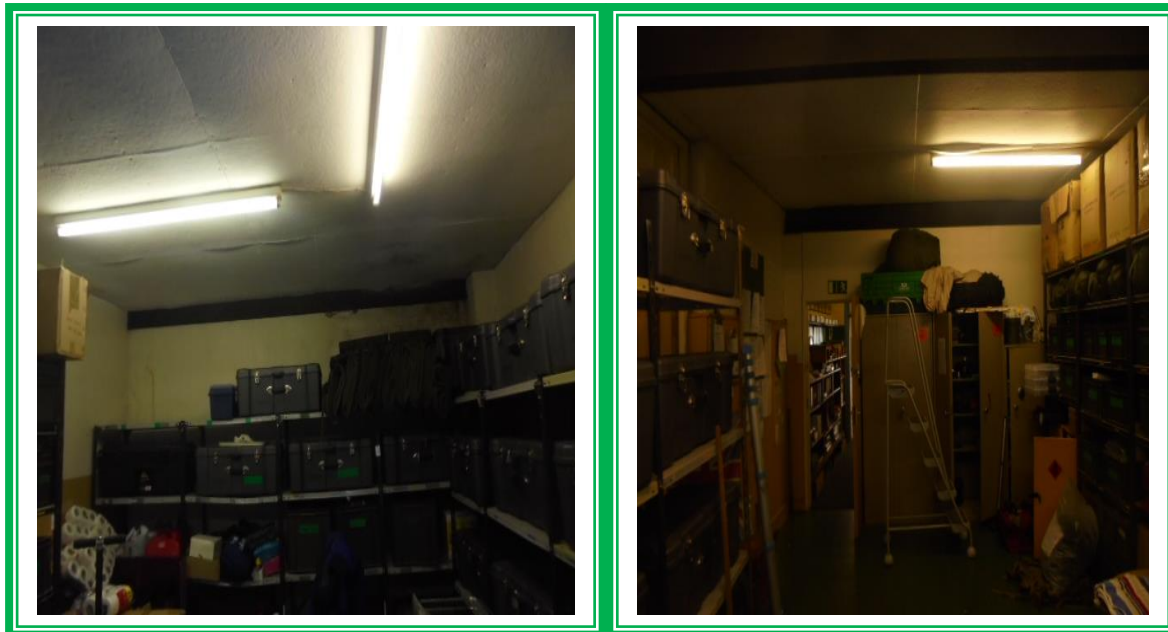
Item No: 19

Material Description:	Visual Inspection – No Suspect Materials Found	
Identification:	N/A	
Approx. quantity:	N/A	
Accessibility	N/A	<i>Assessment Score</i>
Product type:	N/A	N/A
Extent of Damage:	N/A	N/A
Surface Treatment:	N/A	N/A
Asbestos type:	N/A	N/A
Material Assessment Score:		N/A
Priority Assessment Score:		N/A
Action:	N/A	
Comments:	Non-Asbestos Fiberboard Ceiling

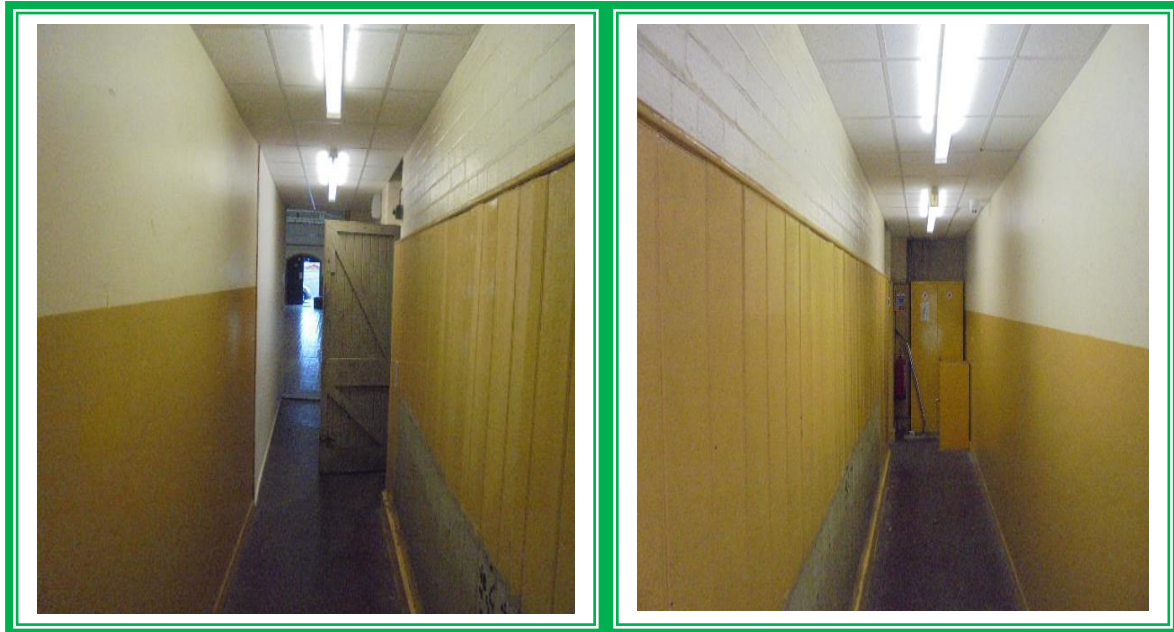
Item No: 24

Material Description:	Visual Inspection – No Suspect Materials Found	
Identification:	N/A	
Approx. quantity:	N/A	
Accessibility	N/A	<i>Assessment Score</i>
Product type:	N/A	N/A
Extent of Damage:	N/A	N/A
Surface Treatment:	N/A	N/A
Asbestos type:	N/A	N/A
Material Assessment Score:		N/A
Priority Assessment Score:		N/A
Action:	N/A	
Comments:	Non-Asbestos Fiberboard Ceiling

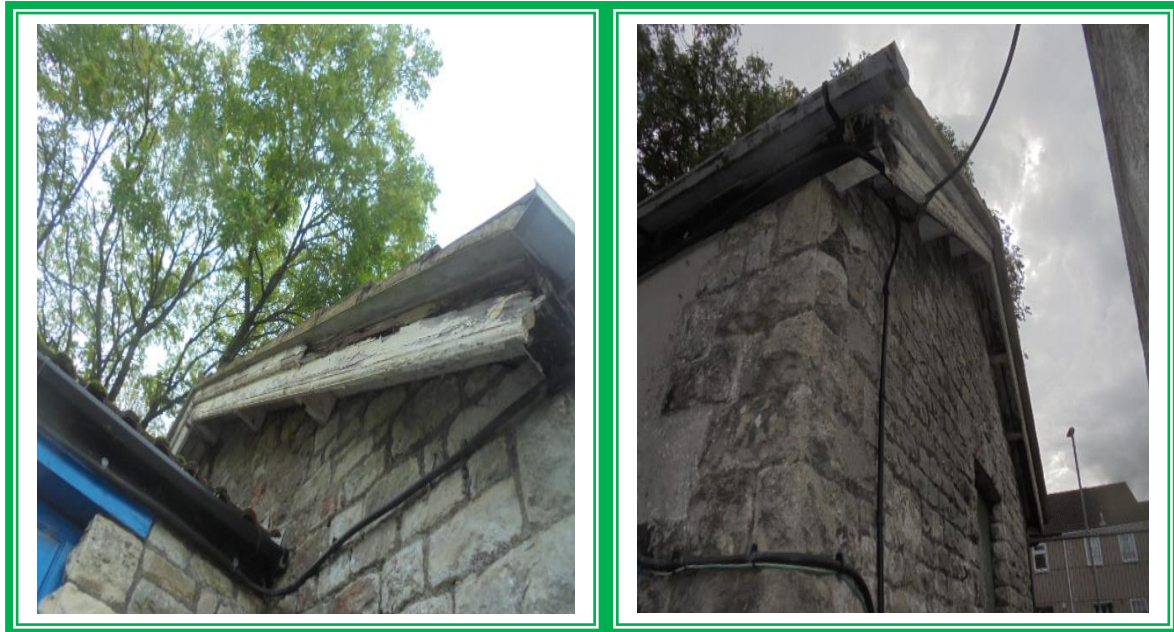
Item No: 28

Material Description:	Cement Undercloaking	
Identification:	Sampled – No Asbestos Detected	
Approx. quantity:	10LM	
Accessibility	N/A	<i>Assessment Score</i>
Product type:	N/A	N/A
Extent of Damage:	N/A	N/A
Surface Treatment:	N/A	N/A
Asbestos type:	N/A	N/A
Material Assessment Score:		N/A
Priority Assessment Score:		N/A
Action:	N/A	
Comments:	N/A

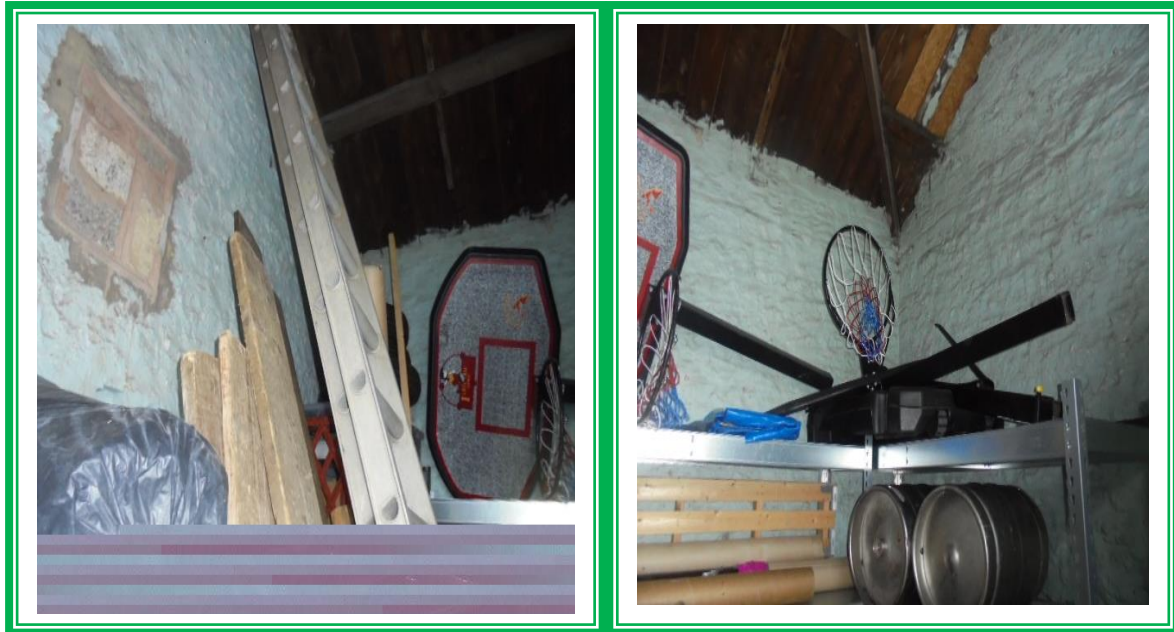
Item No: 29

Material Description:	Visual Inspection – No Suspect Materials Found	
Identification:	N/A	
Approx. quantity:	N/A	
Accessibility	N/A	<i>Assessment Score</i>
Product type:	N/A	N/A
Extent of Damage:	N/A	N/A
Surface Treatment:	N/A	N/A
Asbestos type:	N/A	N/A
Material Assessment Score:		N/A
Priority Assessment Score:		N/A
Action:	N/A	
Comments:	Limited Access to inspect Due to Stored Items

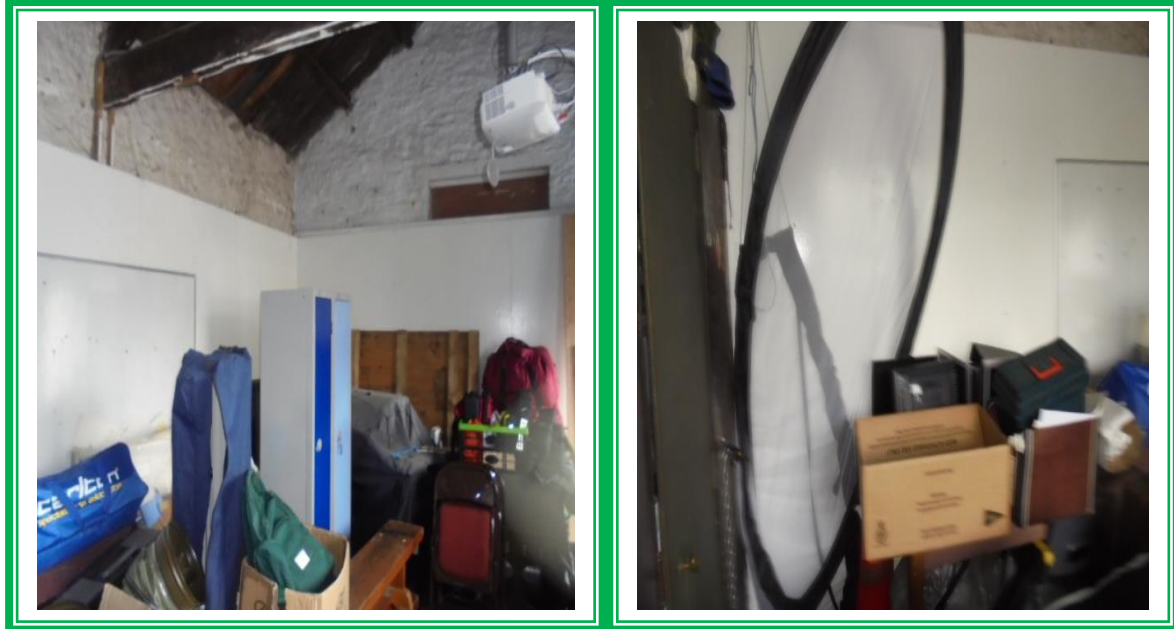
Item No: 30

Material Description:	Visual Inspection – No Suspect Materials Found	
Identification:	N/A	
Approx. quantity:	N/A	
Accessibility	N/A	<i>Assessment Score</i>
Product type:	N/A	N/A
Extent of Damage:	N/A	N/A
Surface Treatment:	N/A	N/A
Asbestos type:	N/A	N/A
Material Assessment Score:		N/A
Priority Assessment Score:		N/A
Action:	N/A	
Comments:	Limited Access to inspect Due to Stored Items
