Project Number A-00377 (3700)

**Re-Inspection
Asbestos Survey Report**

**Portland Platoon
Easton Road
Dorset
DT5 1BW**

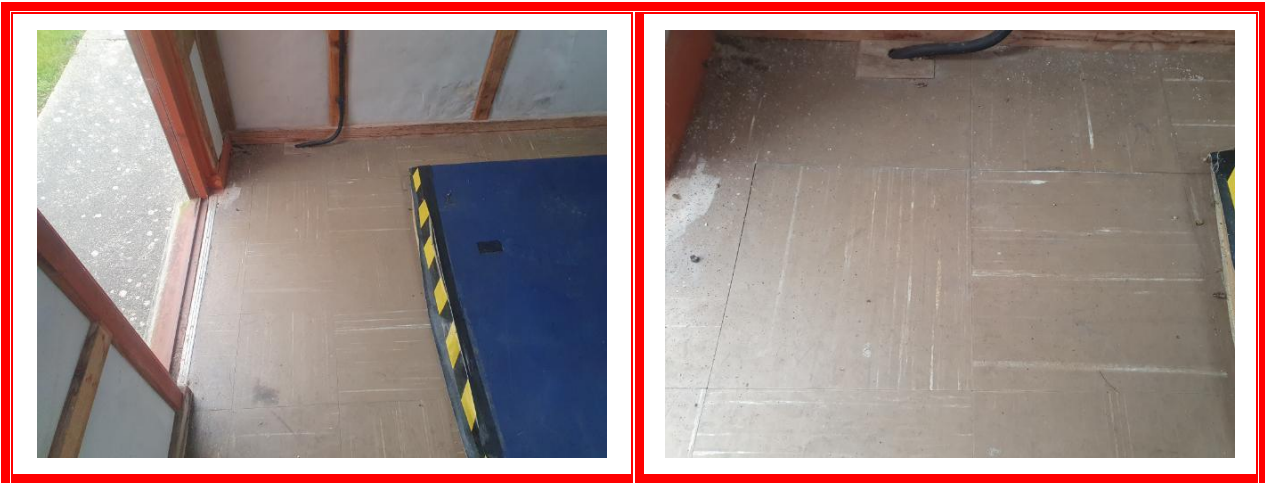
Item No:	1	Sample No:	N/A
Location:	Ground Floor - Range 1 001

Material Description:	Floor Tiles & Adhesive - Vinyl Products	
Identification:	Previously Sampled - Asbestos Detected	
Approx. quantity:	9 m ²	
Accessibility	Easy	<i>Assessment Score</i>
Product type:	Vinyl	1
Extent of Damage:	Slight / minor damage	1
Surface Treatment:	Non-friable	0
Asbestos type:	Chrysotile	1
Material Assessment Score:		3
Priority Assessment Score:		Negligible
Action:	Manage	
Comments:	Previously sampled ref: Armour 17/10/19 - Sample 3

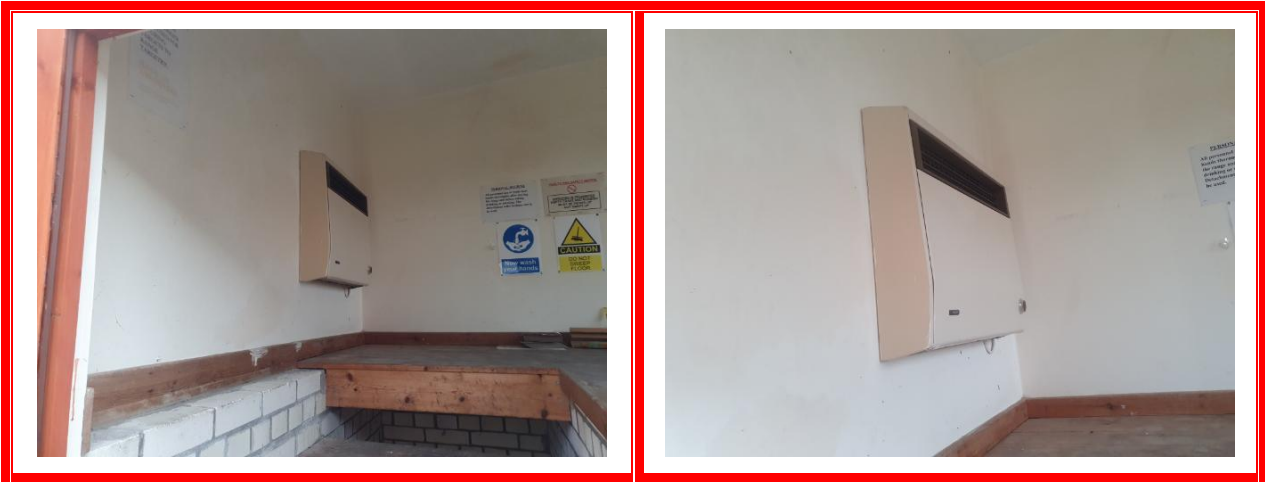
Item No:	2	Sample No:	N/A
Location:	Ground Floor - Range 2 002

Material Description:	Heater - No Access Gained	
Identification:	Presumed to Contain Asbestos	
Approx. quantity:	1 no	
Accessibility	Difficult	<i>Assessment Score</i>
Product type:	Asbestos insulating board	2
Extent of Damage:	Major damage	3
Surface Treatment:	Unsealed AIB	2
Asbestos type:	Amosite, Chrysotile	2
Material Assessment Score:		9
Priority Assessment Score:		Medium
Action:	Manage	
Comments:	No access within heater as presumed live

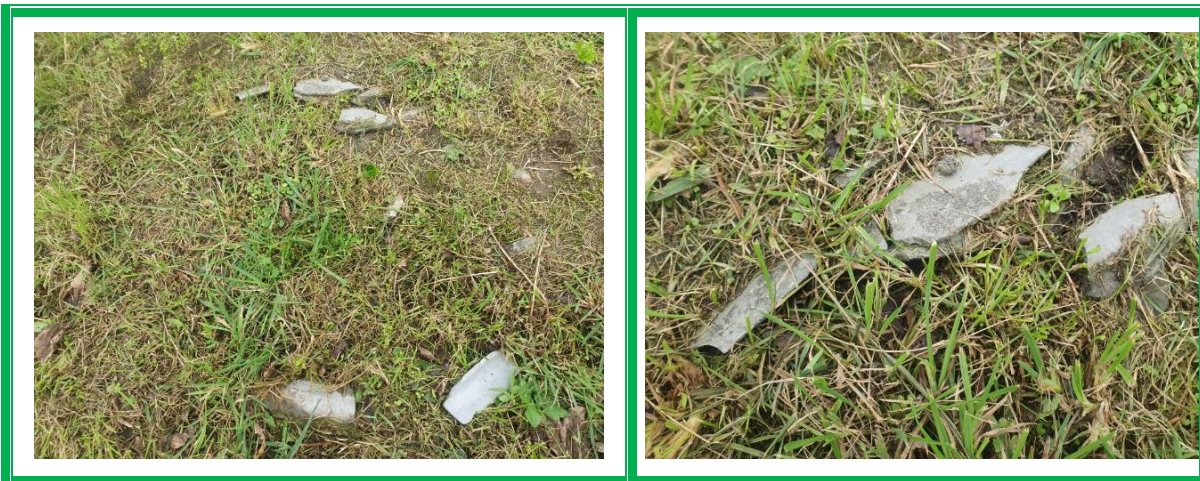
Item No:	3	Sample No:	DK/01
Location:	External 003

Material Description:	Debris in Ground - Cement Product	
Identification:	Sampled - No Asbestos Found	
Approx. quantity:	N/A	
Accessibility	N/A	<i>Assessment Score</i>
Product type:	N/A	N/A
Extent of Damage:	N/A	N/A
Surface Treatment:	N/A	N/A
Asbestos type:	N/A	N/A
Material Assessment Score:		
Priority Assessment Score:		
Action:	N/A	
Comments:	Cement debris on floor and partially buried
