Project Number 2481

**Management
Asbestos Survey Report**

**Weston-Super-Mare Platoon, Langford Road,
Weston-Super-Mare, Somerset, BS23 3PG**

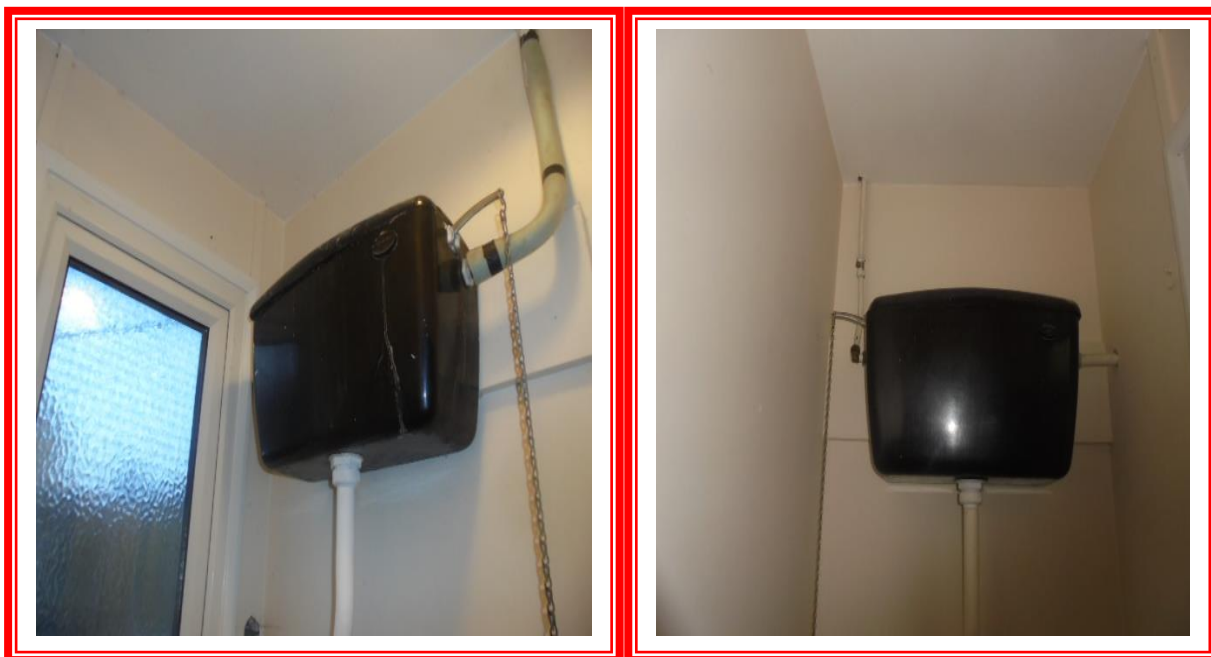
Item No: 2

Sample Number	Sample Type	Location	Analysis
DK/1	Toilet Cisterns	Army Cadet Hut WC'S X2	Amosite
DK/2	Insulation Board Panels on Ceiling	Army Cadet Hut Drill Hall and Mess Room	N.A.D.I.S
DK/3	Textured Coating to Ceiling	Air Cadet Hut Office	N.A.D.I.S
DK/4	Soffit Boards	Air Cadets Hut External	N.A.D.I.S

Location: Ground Floor - Army Cadet Hut – WC's X 2

Material Description:	Toilet Cisterns	
Identification:	Sampled – Asbestos Detected	
Approx. quantity:	2 X Cisterns	
Accessibility	Low	<i>Assessment Score</i>
Product type:	Composite	1
Extent of Damage:	Minor	1
Surface Treatment:	Non-Friable	0
Asbestos type:	Amosite	2
Material Assessment Score:		4
Priority Assessment Score:		Negligible
Action:	Manage	
Comments:	N/A

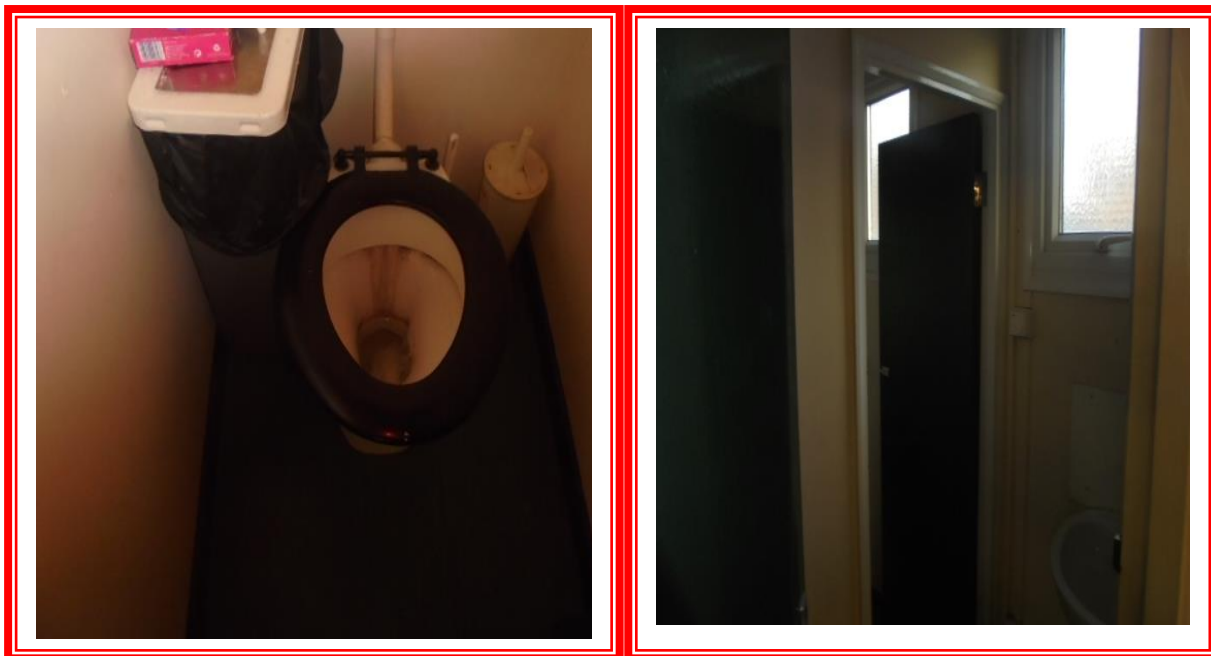
Item No: 3

Item 3 – Ground Floor - Army Cadet Hut – WC – Toilet Seat - Not Possible to Sample as may Damage Seat

Location: Ground Floor - Army Cadet Hut - WC

Material Description:	Toilet Seat	
Identification:	Presumed to Contain Asbestos	
Approx. quantity:	1 X Seat	
Accessibility	High	Assessment Score
Product type:	Composite	1
Extent of Damage:	Good	0
Surface Treatment:	Non-Friable	0
Asbestos type:	Chrysotile	1
Material Assessment Score:		2
Priority Assessment Score:		Negligible
Action:	Manage	
Comments:	Not Possible to Sample as May Damage the Integrity of The Seat

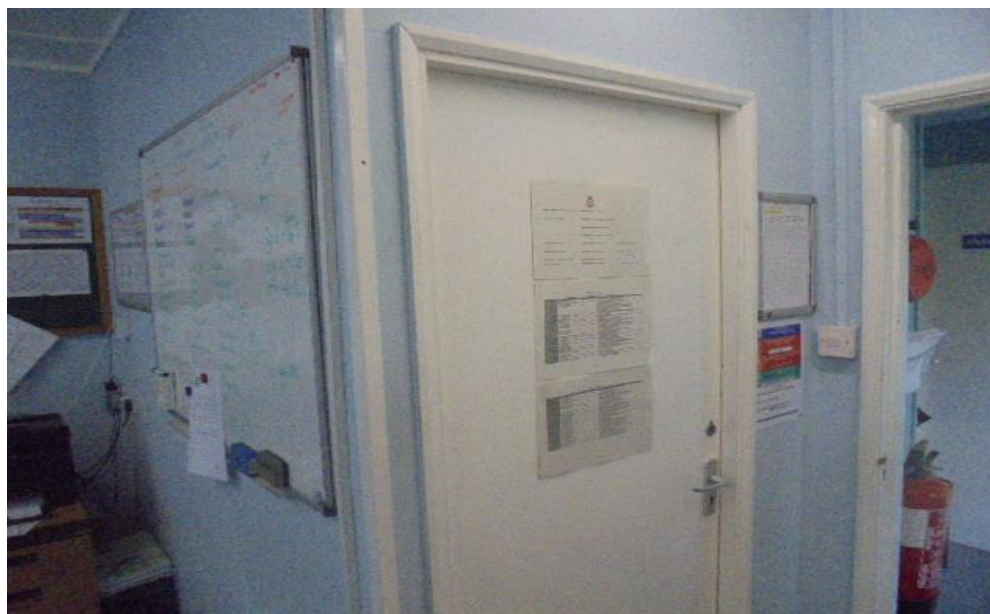
**Item No: 9****Sample No: N/A****Location: Ground Floor - Air Cadet Hut – Stores**

Item 9 – Ground Floor – Air Cadet Hut - Stores – No access as locked

Material Description:	No Access Within Locked Room	
Identification:	Presumed to Contain Asbestos	
Approx. quantity:	1 X Room	
Accessibility	Low	Assessment Score
Product type:	No Access	3
Extent of Damage:	No Access	3
Surface Treatment:	No Access	3
Asbestos type:	No Access	3
Material Assessment Score:		12
Priority Assessment Score:		High
Action:	Further Investigation Required	
Comments:	No Key was Available During Survey

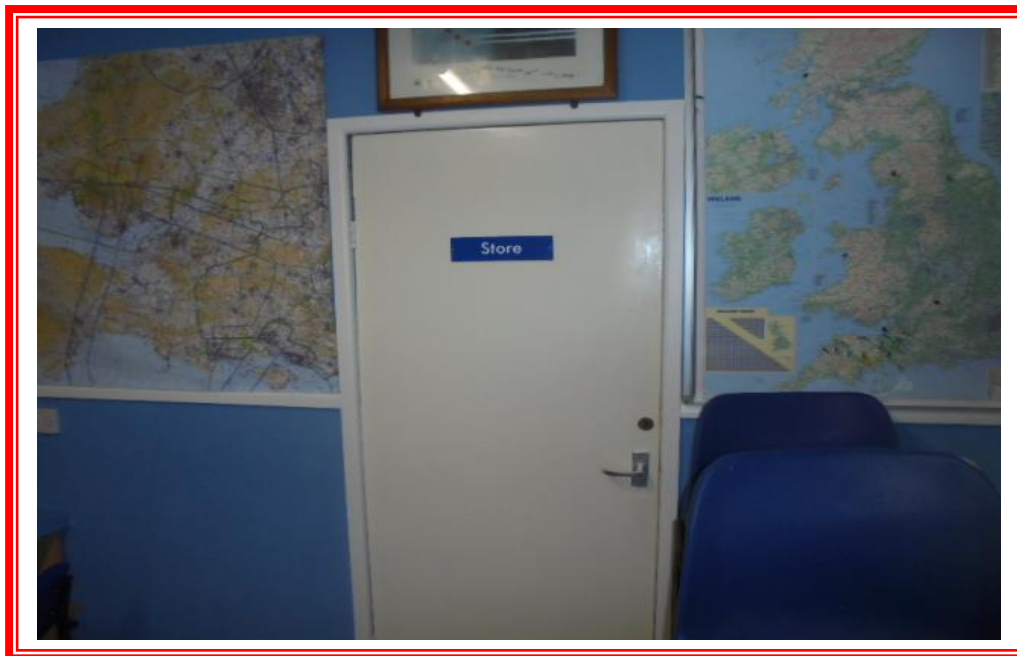
Item No: 15

Item 15 - Ground Floor – Air Cadet Hut - Stores – No access as locked

Location: Ground Floor - Air Cadet Hut – Stores

Material Description:	No Access Within Locked Room	
Identification:	Presumed to Contain Asbestos	
Approx. quantity:	1 X Room	
Accessibility	Low	Assessment Score
Product type:	No Access	3
Extent of Damage:	No Access	3
Surface Treatment:	No Access	3
Asbestos type:	No Access	3
Material Assessment Score:		12
Priority Assessment Score:		High
Action:	Further Investigation Required	
Comments:	No Key was Available During Survey

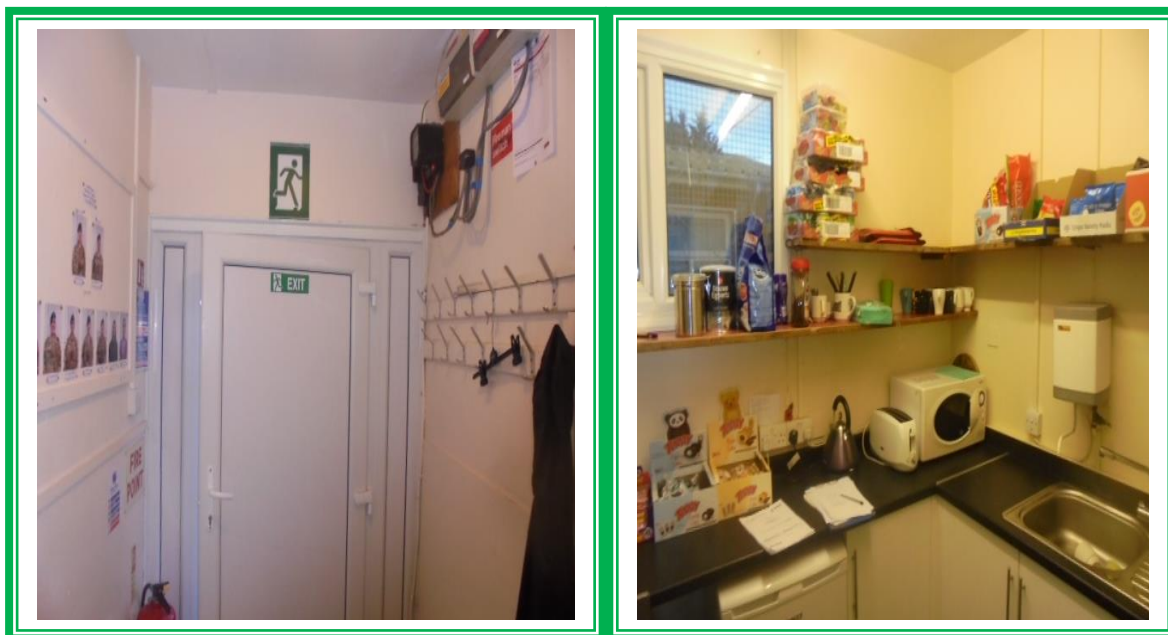
Item No: 1

Location: Ground Floor - Army Cadet Hut – Lobby and Kitchen

Material Description:	Visual Inspection – No Suspect Materials Found	
Identification:	N/A	
Approx. quantity:	N/A	
Accessibility	N/A	<i>Assessment Score</i>
Product type:	N/A	N/A
Extent of Damage:	N/A	N/A
Surface Treatment:	N/A	N/A
Asbestos type:	N/A	N/A
Material Assessment Score:		N/A
Priority Assessment Score:		N/A
Action:	N/A	
Comments:	Modern Electrics

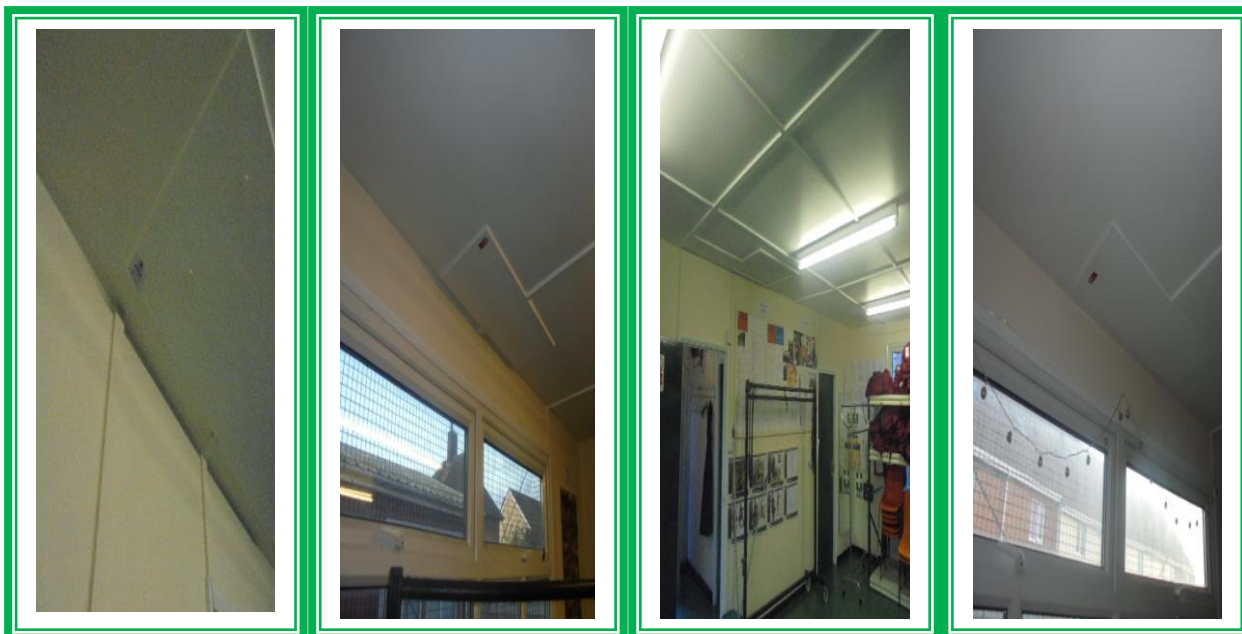
Item No: 4

Location: Ground Floor - Army Cadet Hut – Drill Hall and Mess Room

Material Description:	Insulation Board Panels on Ceilings	
Identification:	Sampled – No Asbestos Detected	
Approx. quantity:	6 X Panels (3M2 Total)	
Accessibility	N/A	<i>Assessment Score</i>
Product type:	N/A	N/A
Extent of Damage:	N/A	N/A
Surface Treatment:	N/A	N/A
Asbestos type:	N/A	N/A
Material Assessment Score:		N/A
Priority Assessment Score:		N/A
Action:	N/A	
Comments:	N/A

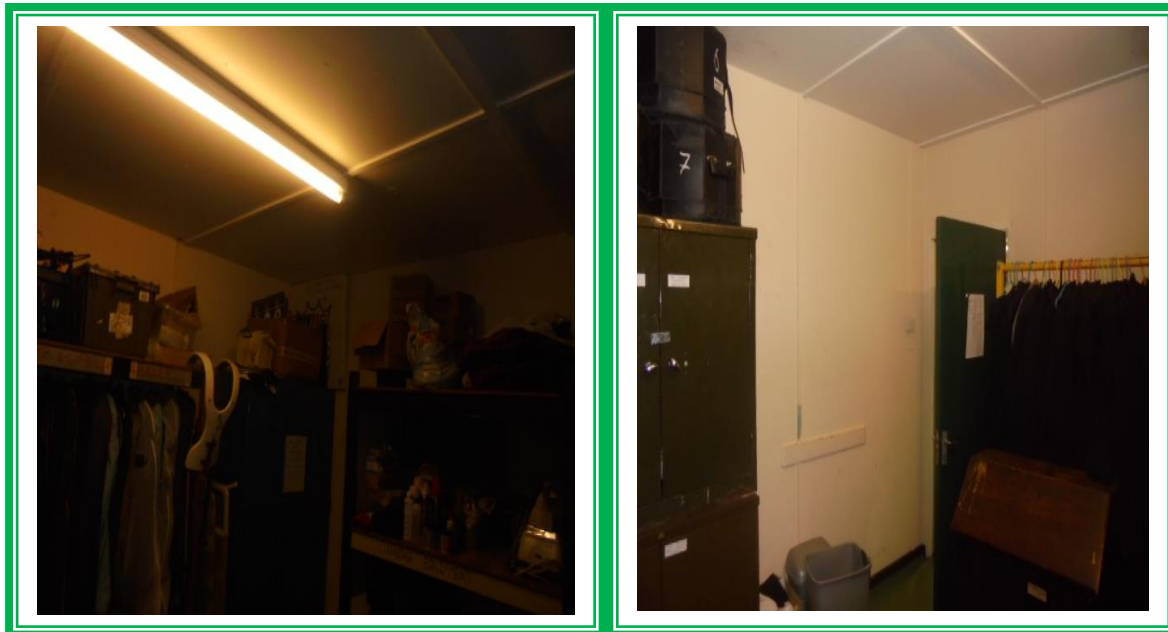
Item No: 5

Location: Ground Floor - Army Cadet Hut – Stores

Material Description:	Visual Inspection – No Suspect Materials Found	
Identification:	N/A	
Approx. quantity:	N/A	
Accessibility	N/A	<i>Assessment Score</i>
Product type:	N/A	N/A
Extent of Damage:	N/A	N/A
Surface Treatment:	N/A	N/A
Asbestos type:	N/A	N/A
Material Assessment Score:		N/A
Priority Assessment Score:		N/A
Action:	N/A	
Comments:	N/A

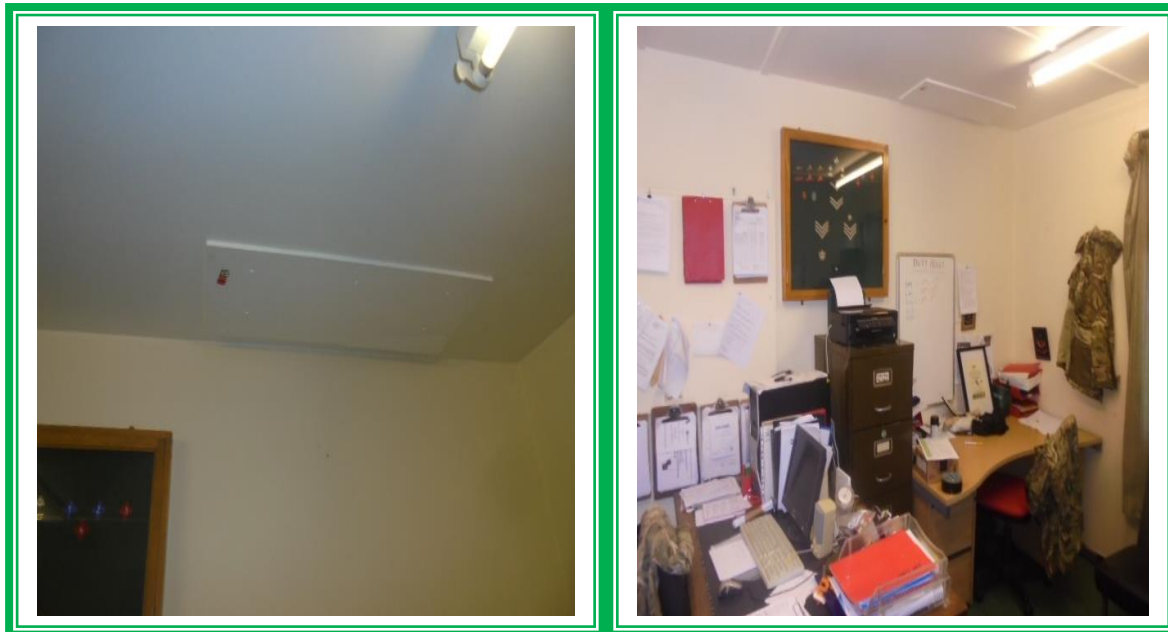
Item No: 6

Location: Ground Floor - Army Cadet Hut – Office

Material Description:	Insulation Board Panel on Ceiling	
Identification:	As Per Sample DK/2 – No Asbestos Detected	
Approx. quantity:	1 X Panel (<1M2)	
Accessibility	N/A	<i>Assessment Score</i>
Product type:	N/A	N/A
Extent of Damage:	N/A	N/A
Surface Treatment:	N/A	N/A
Asbestos type:	N/A	N/A
Material Assessment Score:		N/A
Priority Assessment Score:		N/A
Action:	N/A	
Comments:	N/A

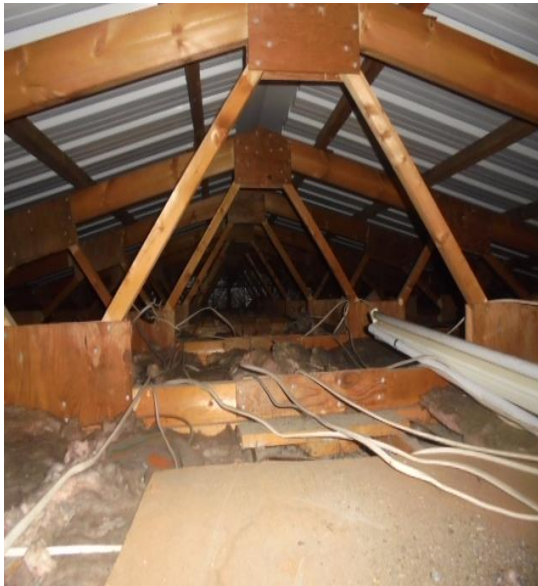
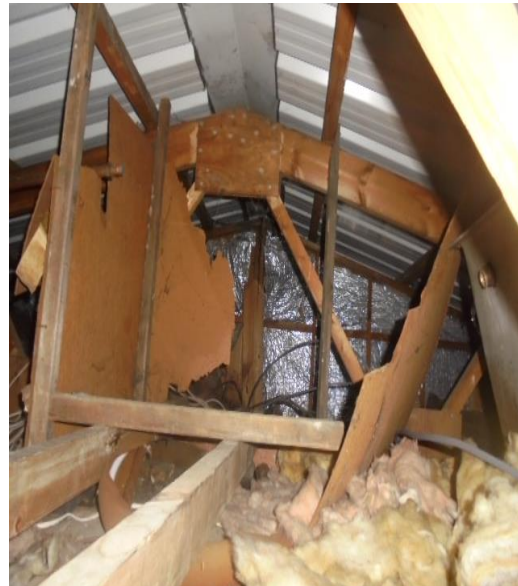
Item No: 7

Location: Army Cadet Hut – Loft Space

Material Description:	Visual Inspection – No Suspect Materials Found	
Identification:	N/A	
Approx. quantity:	N/A	
Accessibility	N/A	<i>Assessment Score</i>
Product type:	N/A	N/A
Extent of Damage:	N/A	N/A
Surface Treatment:	N/A	N/A
Asbestos type:	N/A	N/A
Material Assessment Score:		N/A
Priority Assessment Score:		N/A
Action:	N/A	
Comments:	N/A

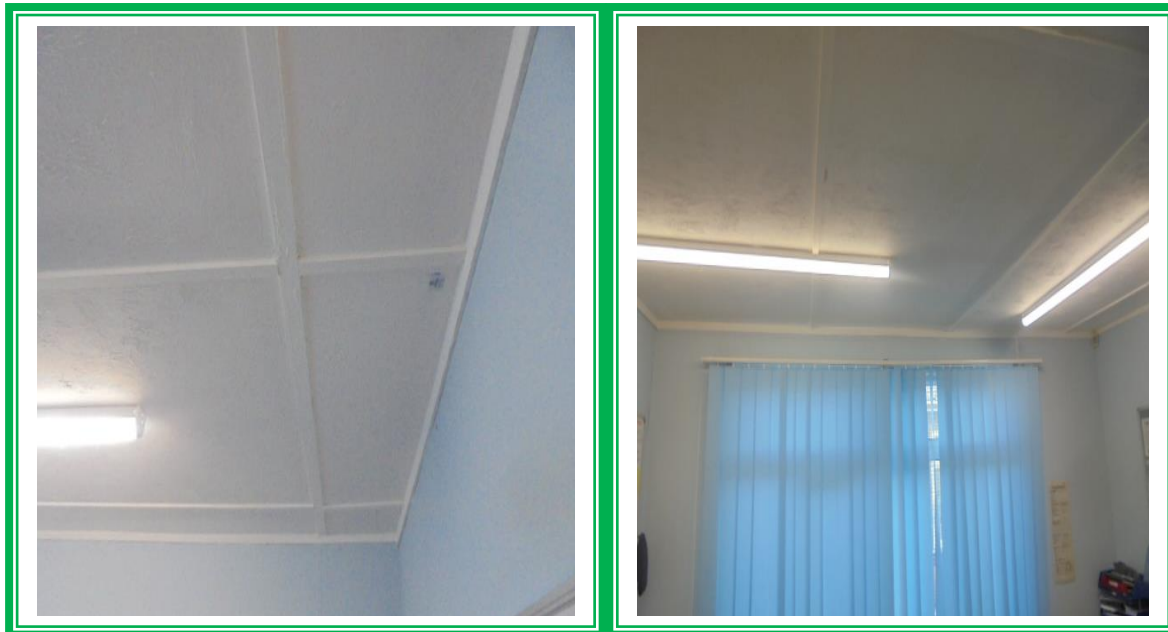
Item No: 8

Location: Ground Floor - Army Cadet Hut - Office

Material Description:	Textured Coating to Ceiling	
Identification:	Sampled – No Asbestos Detected	
Approx. quantity:	12M2	
Accessibility	Low	<i>Assessment Score</i>
Product type:	N/A	N/A
Extent of Damage:	N/A	N/A
Surface Treatment:	N/A	N/A
Asbestos type:	N/A	N/A
Material Assessment Score:		N/A
Priority Assessment Score:		N/A
Action:	N/A	
Comments:	N/A

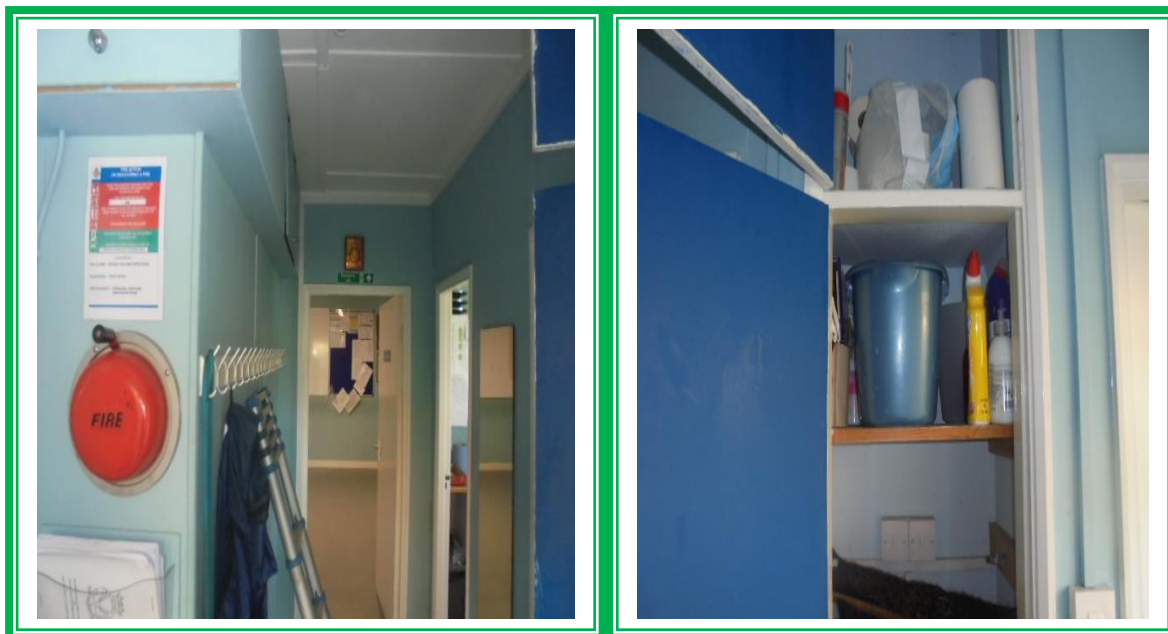
Item No: 10

Location: Ground Floor - Air Cadet Hut – Lobby and Cupboard

Material Description:	Visual Inspection – No Suspect Materials Found	
Identification:	N/A	
Approx. quantity:	N/A	
Accessibility	N/A	Assessment Score
Product type:	N/A	N/A
Extent of Damage:	N/A	N/A
Surface Treatment:	N/A	N/A
Asbestos type:	N/A	N/A
Material Assessment Score:		N/A
Priority Assessment Score:		N/A
Action:	N/A	
Comments:	Modern Electrics

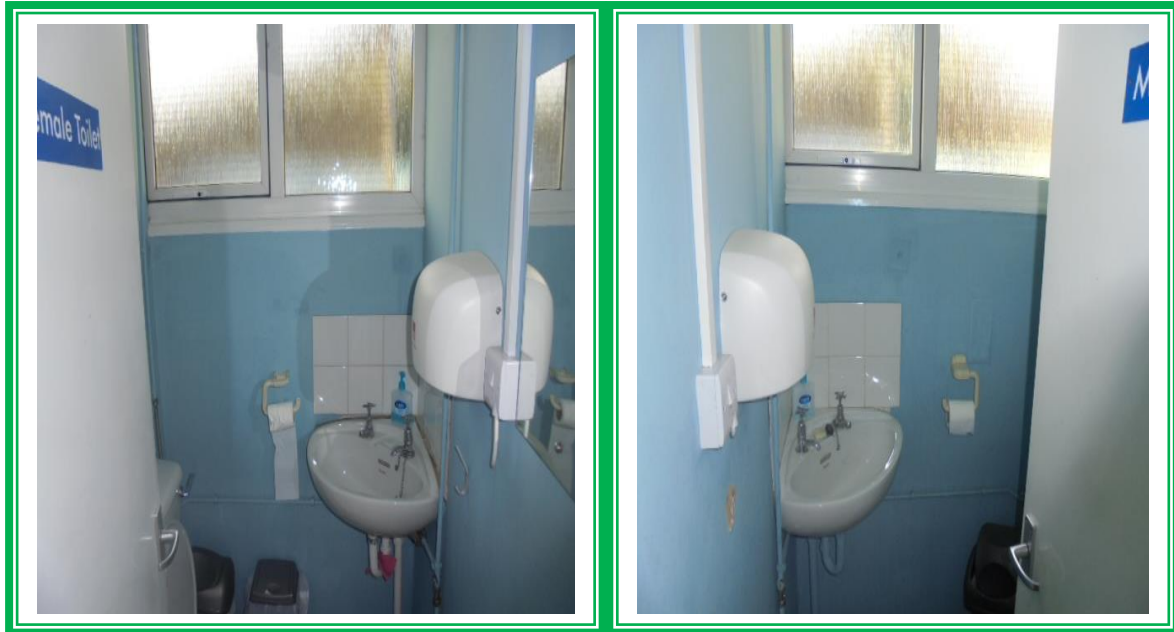
Item No: 11

Location: Ground Floor - Air Cadet Hut – WC's X 2

Material Description:	Visual Inspection – No Suspect Materials Found	
Identification:	N/A	
Approx. quantity:	N/A	
Accessibility	N/A	<i>Assessment Score</i>
Product type:	N/A	N/A
Extent of Damage:	N/A	N/A
Surface Treatment:	N/A	N/A
Asbestos type:	N/A	N/A
Material Assessment Score:		N/A
Priority Assessment Score:		N/A
Action:	N/A	
Comments:	N/A

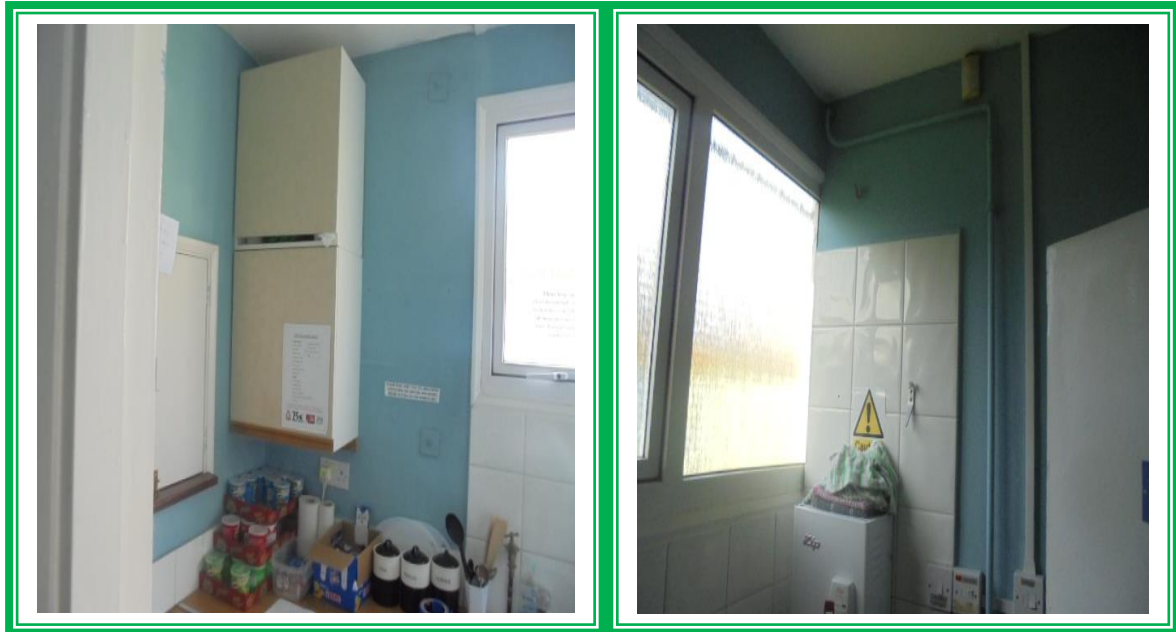
Item No: 12

Location: Ground Floor - Air Cadet Hut - Kitchen

Material Description:	Visual Inspection – No Suspect Materials Found	
Identification:	N/A	
Approx. quantity:	N/A	
Accessibility	N/A	<i>Assessment Score</i>
Product type:	N/A	N/A
Extent of Damage:	N/A	N/A
Surface Treatment:	N/A	N/A
Asbestos type:	N/A	N/A
Material Assessment Score:		N/A
Priority Assessment Score:		N/A
Action:	N/A	
Comments:	N/A

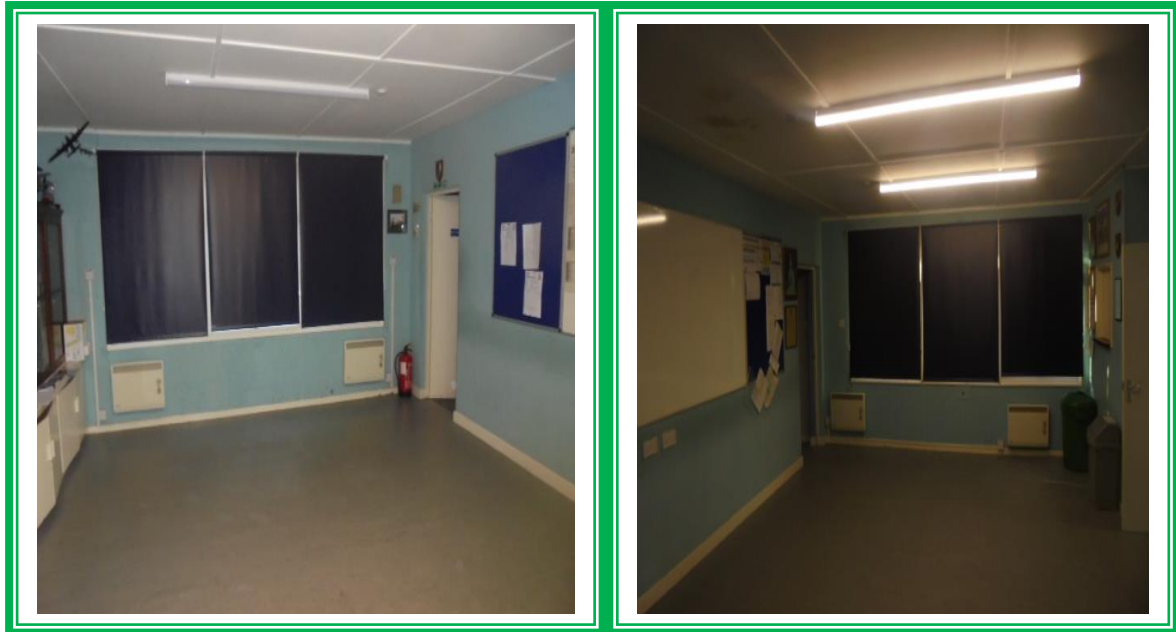
Item No: 13

Location: Ground Floor - Air Cadet Hut – Drill Hall

Material Description:	Visual Inspection – No Suspect Materials Found	
Identification:	N/A	
Approx. quantity:	N/A	
Accessibility	N/A	<i>Assessment Score</i>
Product type:	N/A	N/A
Extent of Damage:	N/A	N/A
Surface Treatment:	N/A	N/A
Asbestos type:	N/A	N/A
Material Assessment Score:		N/A
Priority Assessment Score:		N/A
Action:	N/A	
Comments:	N/A

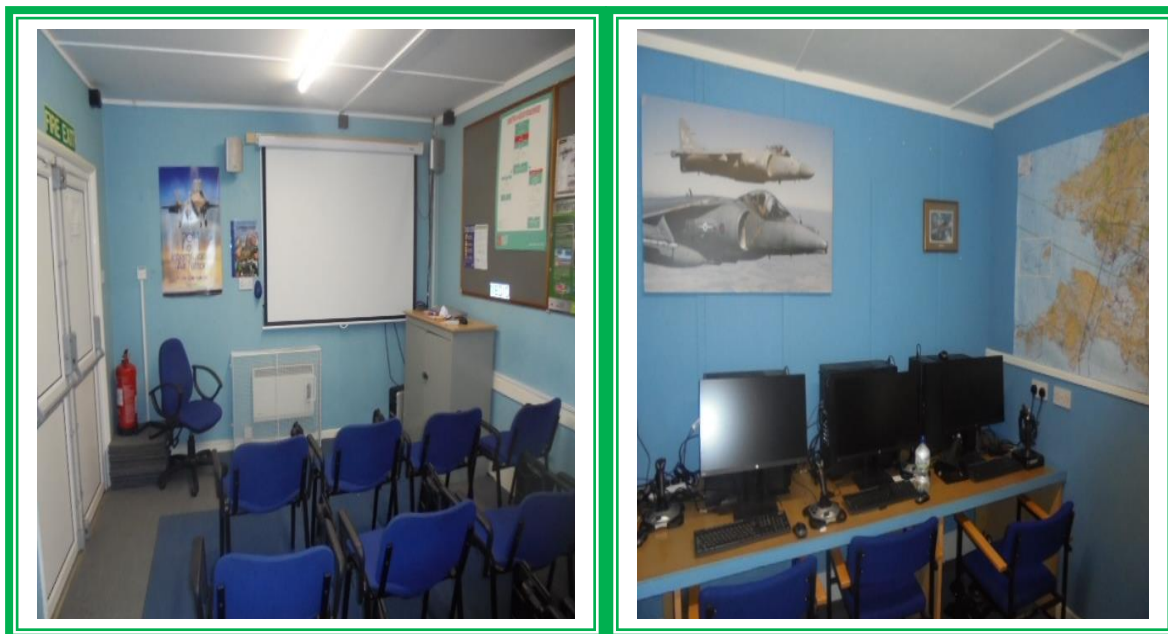
Item No: 14

Location: Ground Floor - Air Cadet Hut – Lecture Rooms 1 and 2

Material Description:	Visual Inspection – No Suspect Materials Found	
Identification:	N/A	
Approx. quantity:	N/A	
Accessibility	N/A	Assessment Score
Product type:	N/A	N/A
Extent of Damage:	N/A	N/A
Surface Treatment:	N/A	N/A
Asbestos type:	N/A	N/A
Material Assessment Score:		N/A
Priority Assessment Score:		N/A
Action:	N/A	
Comments:	N/A

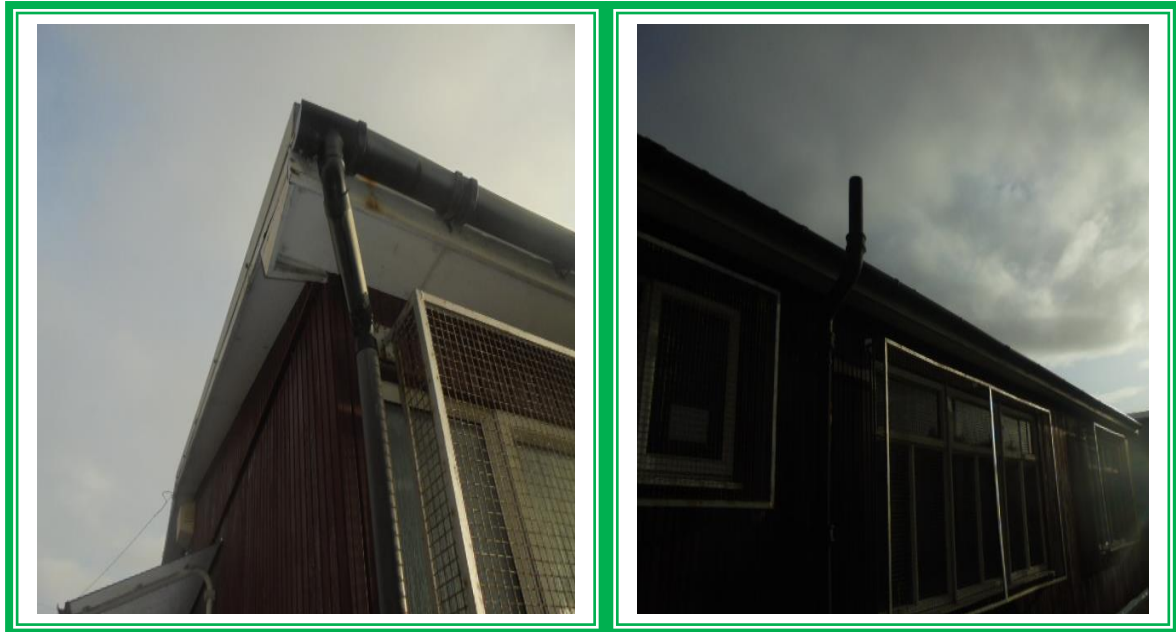
Item No: 16

Location: Ground Floor - Air Cadet Hut – External

Material Description:	Soffit Boards	
Identification:	Sampled - No Asbestos Detected	
Approx. quantity:	42LM	
Accessibility	Low	<i>Assessment Score</i>
Product type:	N/A	N/A
Extent of Damage:	N/A	N/A
Surface Treatment:	N/A	N/A
Asbestos type:	N/A	N/A
Material Assessment Score:		N/A
Priority Assessment Score:		N/A
Action:	N/A	
Comments:	N/A

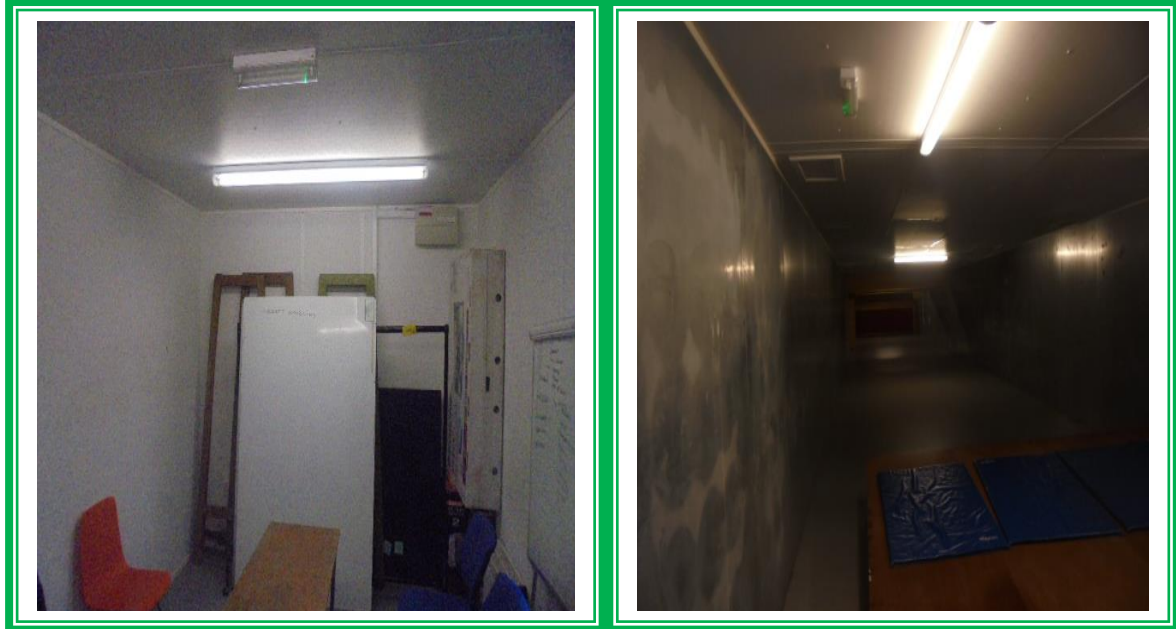
Item No: 17

Location: Range and Range Lobby

Material Description:	Visual Inspection – No Suspect Materials Found	
Identification:	N/A	
Approx. quantity:	N/A	
Accessibility	N/A	<i>Assessment Score</i>
Product type:	N/A	N/A
Extent of Damage:	N/A	N/A
Surface Treatment:	N/A	N/A
Asbestos type:	N/A	N/A
Material Assessment Score:		N/A
Priority Assessment Score:		N/A
Action:	N/A	
Comments:	Built Circa 2013
