Project Number 2481

Management Asbestos Survey Report

Lawrence Weston Platoon, **Bristol, BS11 ONT**

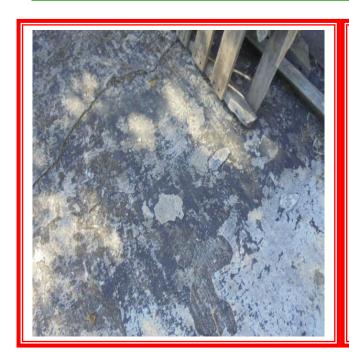
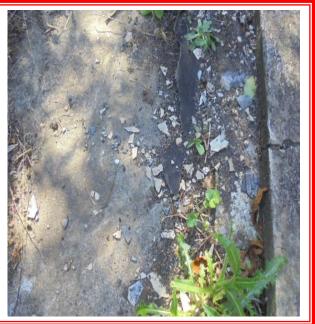
Item No: 1 Sample No: DK/1

Sample Number	Sample Type	Location	Analysis
DK/1	Floor Tiles, Adhesive and Debris	External - Concrete Base	Chrysotile
DK/2	Damp Proof Course to concrete base	External - Concrete Base	N.A.D.I.S

Location: External – Concrete Base

Material Description:	Floor Tile and Adhesive debris on floor		
-			
Identification:	Sampled – Asbestos Dete	ected	
Approx. quantity:	12M2 of Adhesive 1-2M2 o	f Tiles	
Accessibility	Medium	Assessment Score	
Product type:	Composite	1	
Extent of Damage:	Major 3		
Surface Treatment:	Non-Friable 0		
Asbestos type:	Chrysotile 1		
	Material Assessment Score:	4	
Priority Assessment Score: Negligible			
Action:	Manage/Remove Debris		
Comments:	N/A

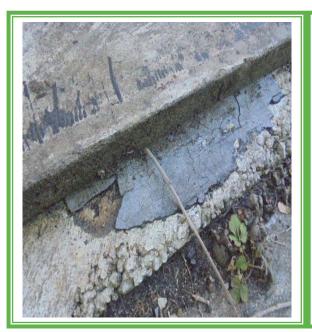
Item No: 2 Sample No: DK/2

Location: External – Concrete Base

Material Description:	Damp Proof Course to C	Damp Proof Course to Concrete Base		
Identification:	Sampled – No Asbesto	os Detected		
Approx. quantity:	6LM	6LM		
Accessibility	N/A	Assessment Score		
Product type:		N/A		
Extent of Damage:		N/A		
Surface Treatment:		N/A		
Asbestos type:		N/A		
	Material Assessment Score:	N/A		
	Priority Assessment Score:	N/A		
Action:	N/A			
Comments:	N/A

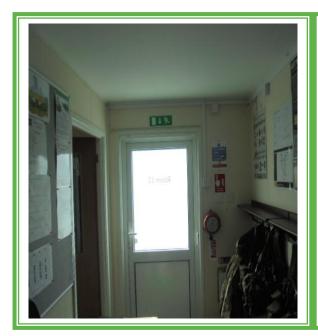
Item No: 3 Sample No: N/A

Location: Lobby

Material Description:	Visual Inspection – No Suspe	Visual Inspection – No Suspect Materials Found			
Identification:	N/A				
Approx. quantity:	N/A				
Accessibility	N/A	Assessment Score			
Product type:		N/A			
Extent of Damage:	N/A				
Surface Treatment:		N/A			
Asbestos type:		N/A			
	Material Assessment Score:	N/A			
Priority Assessment Score: N/A					
Action:	Action: N/A				
Comments:	N/A

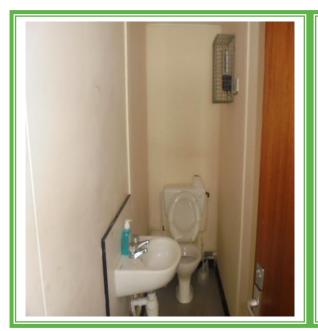
Item No: 4 Sample No: N/A

Location: WC's x 2

Material Description:	Visual Inspection – No Suspe	ct Materials Found		
Identification:	N/A	N/A		
Approx. quantity:	N/A			
Accessibility	N/A Assessment Sco			
Product type:		N/A		
Extent of Damage:		N/A		
Surface Treatment:		N/A		
Asbestos type:		N/A		
	Material Assessment Score:	N/A		
	Priority Assessment Score: N/A			
Action:	Action: N/A			
Comments:	N/A

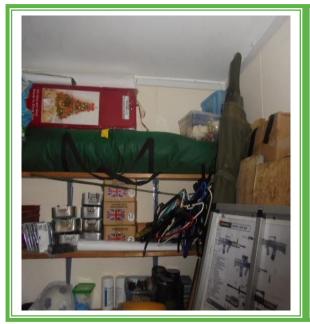
Item No: 5 Sample No: N/A

Location: Store

Material Description:	Visual Inspection - No Suspe	ct Materials Found	
Identification:	N/A		
Approx. quantity:	N/A		
Accessibility	N/A Assessment Scor		
Product type:	N/A		
Extent of Damage:	e: N/.		
Surface Treatment:		N/A	
Asbestos type:		N/A	
	Material Assessment Score:	N/A	
	N/A		
Action:	N/A		
Comments:	Modern electrics and w	ater heater

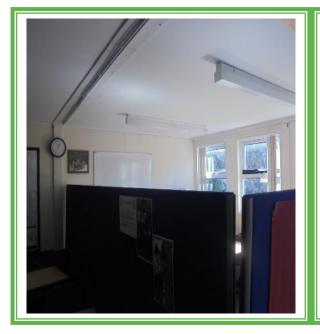
Item No: 6 Sample No: N/A

Location: Classroom

Material Description:	Visual Inspection – No Suspe	ct Materials Found	
Identification:	N/A		
Approx. quantity:	N/A		
Accessibility	N/A Assessment Scor		
Product type:	N/A		
Extent of Damage:		N/A	
Surface Treatment:		N/A	
Asbestos type:		N/A	
	Material Assessment Score:	N/A	
	Priority Assessment Score:		
Action:	N/A		
Comments:	Comments: N/A
