**Project Number 2481**

**Management  
Asbestos Survey Report**

**Wyvern Barracks, Barrack Road, Exeter, Devon,  
EX2 6AE (Building 1)**

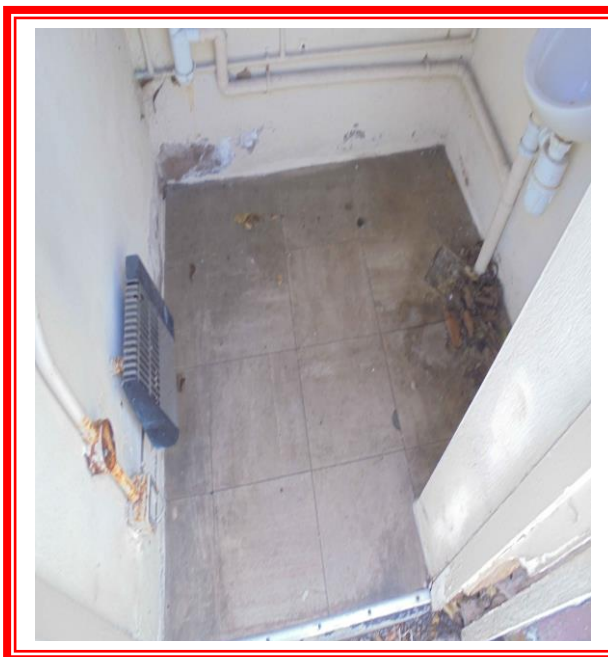
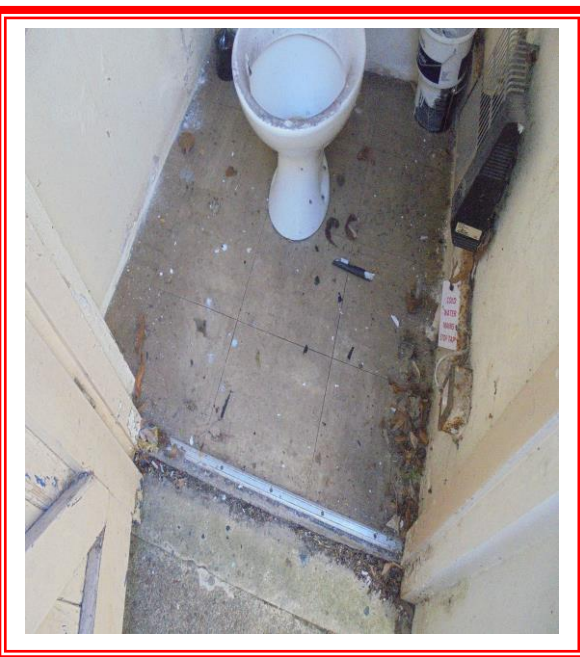
**Item No: 6**

**Location: External – WC's x 2**

<b>Material Description:</b>	Floor tiles and adhesive	
<b>Identification:</b>	Sampled – Asbestos Detected	
<b>Approx. quantity:</b>	4M2	
<b>Accessibility</b>	High	<i>Assessment Score</i>
<b>Product type:</b>	Composite	1
<b>Extent of Damage:</b>	Minor	1
<b>Surface Treatment:</b>	Non-Friable	0
<b>Asbestos type:</b>	Chrysotile	1
<b>Material Assessment Score:</b>		3
<b>Priority Assessment Score:</b>		Negligible
<b>Action:</b>	Manage	
<b>Comments:</b>	Non-Asbestos fibreboard ceiling panels

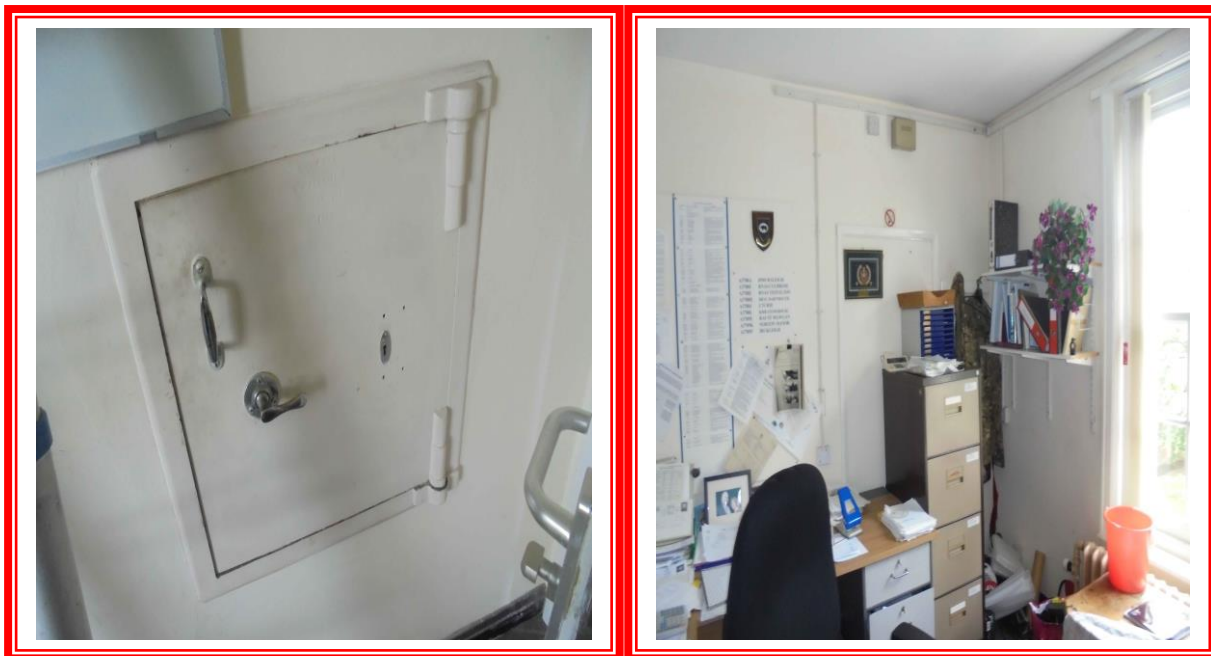
**Item No: 13**

Item 13 – Office – First Floor – No access within the safe casings

**Location: Office – First Floor**

<b>Material Description:</b>	No access within safe casings	
<b>Identification:</b>	Presumed to Contain Asbestos	
<b>Approx. quantity:</b>	X 1 Safe	
<b>Accessibility</b>	Low	<i>Assessment Score</i>
<b>Product type:</b>	No Access	2
<b>Extent of Damage:</b>	No Access	2
<b>Surface Treatment:</b>	No Access	2
<b>Asbestos type:</b>	No Access	2
<b>Material Assessment Score:</b>		8
<b>Priority Assessment Score:</b>		Medium
<b>Action:</b>	Manage	
<b>Comments:</b>	N/A

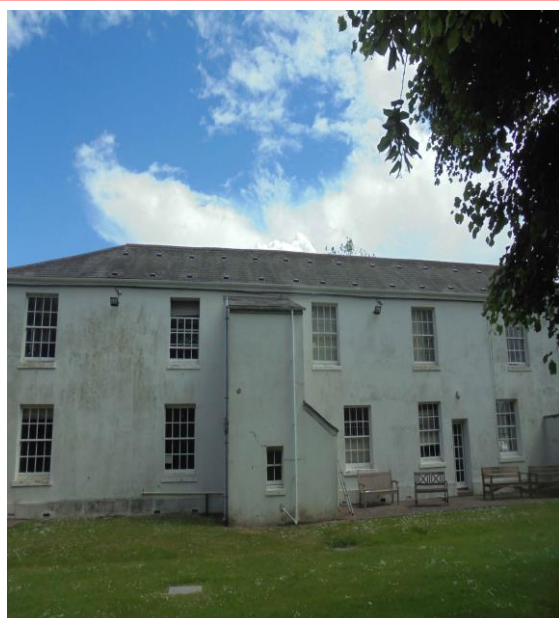
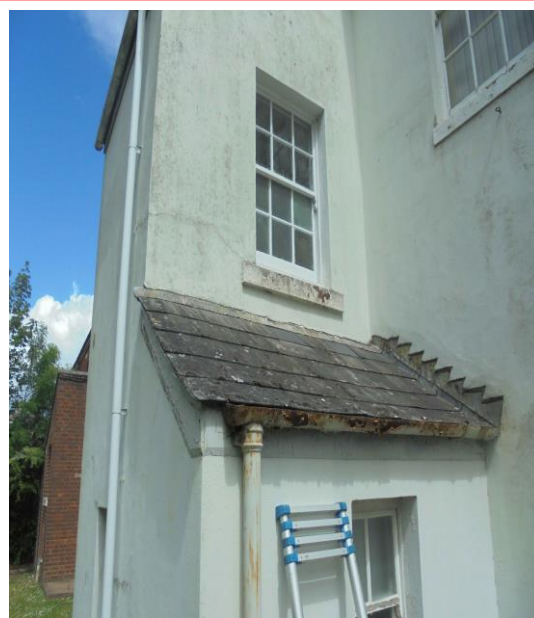
**Item No: 18**

**Location: External**

<b>Material Description:</b>	Cement roof tiles	
<b>Identification:</b>	Sampled – Asbestos Detected	
<b>Approx. quantity:</b>	168M2	
<b>Accessibility</b>	Low	Assessment Score
<b>Product type:</b>	Cement	1
<b>Extent of Damage:</b>	Minor	1
<b>Surface Treatment:</b>	Unsealed	1
<b>Asbestos type:</b>	Chrysotile	1
<b>Material Assessment Score:</b>		4
<b>Priority Assessment Score:</b>		Negligible
<b>Action:</b>	Manage	
<b>Comments:</b>	N/A

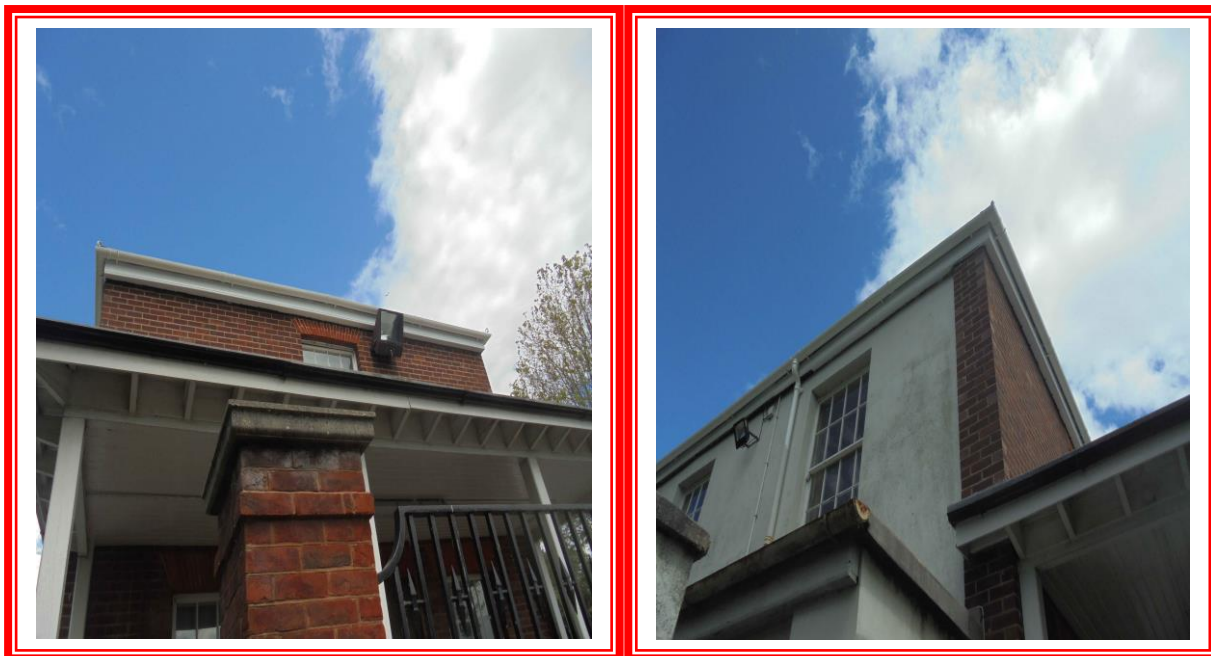
**Item No: 19****Sample No: N/A****Location: External**

Item 19 – External – Soffit Boards – No access to sample due to height

<b>Material Description:</b>	Soffit Boards	
<b>Identification:</b>	Presumed to Contain Asbestos	
<b>Approx. quantity:</b>	100M2	
<b>Accessibility</b>	Low	Assessment Score
<b>Product type:</b>	Insulation Board	2
<b>Extent of Damage:</b>	Moderate	2
<b>Surface Treatment:</b>	Unsealed	2
<b>Asbestos type:</b>	Amosite	2
<b>Material Assessment Score:</b>		8
<b>Priority Assessment Score:</b>		Medium
<b>Action:</b>	Manage	
<b>Comments:</b>	Small area of soffit remaining to high level roof. No access to sample due to height

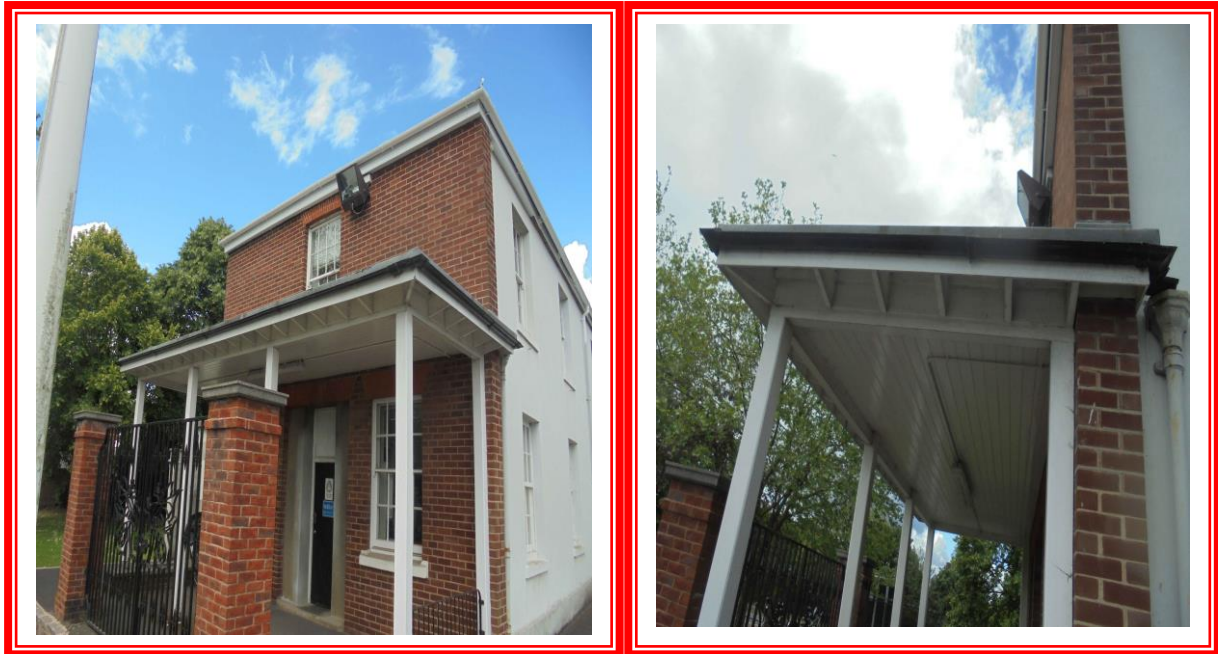
**Item No: 20****Sample No: N/A****Location: External – Canopy**

<b>Material Description:</b>	Roof felt under modern roof covering	
<b>Identification:</b>	As Per Previous Sample – 8-68880	
<b>Approx. quantity:</b>	15M2	
<b>Accessibility</b>	Low	<i>Assessment Score</i>
<b>Product type:</b>	Bitumen	1
<b>Extent of Damage:</b>	Minor	1
<b>Surface Treatment:</b>	Non-Friable	0
<b>Asbestos type:</b>	Chrysotile	1
<b>Material Assessment Score:</b>		3
<b>Priority Assessment Score:</b>		Negligible
<b>Action:</b>	Manage	
<b>Comments:</b>	Roof felt under modern roof covering was previously sampled and was found to contain asbestos. No access was possible under modern roof covering without irreparable damage, so it has been presumed that the old asbestos felt is still present.

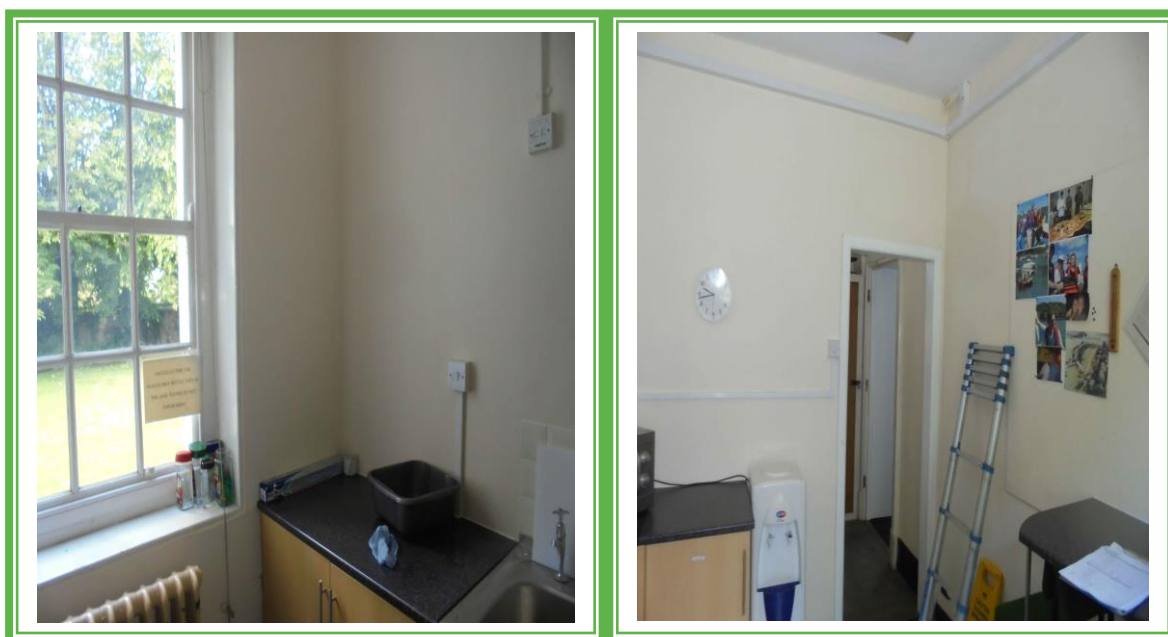
**Item No: 1**

**Location: Kitchen and Lobby – Ground Floor**

<b>Material Description:</b>	Visual Inspection – No Suspect Materials Found	
<b>Identification:</b>	N/A	
<b>Approx. quantity:</b>	N/A	
<b>Accessibility</b>	N/A	<i>Assessment Score</i>
<b>Product type:</b>		N/A
<b>Extent of Damage:</b>		N/A
<b>Surface Treatment:</b>		N/A
<b>Asbestos type:</b>		N/A
<b>Material Assessment Score:</b>		N/A
<b>Priority Assessment Score:</b>		N/A
<b>Action:</b>	N/A	
<b>Comments:</b>	Modern Sink Pad

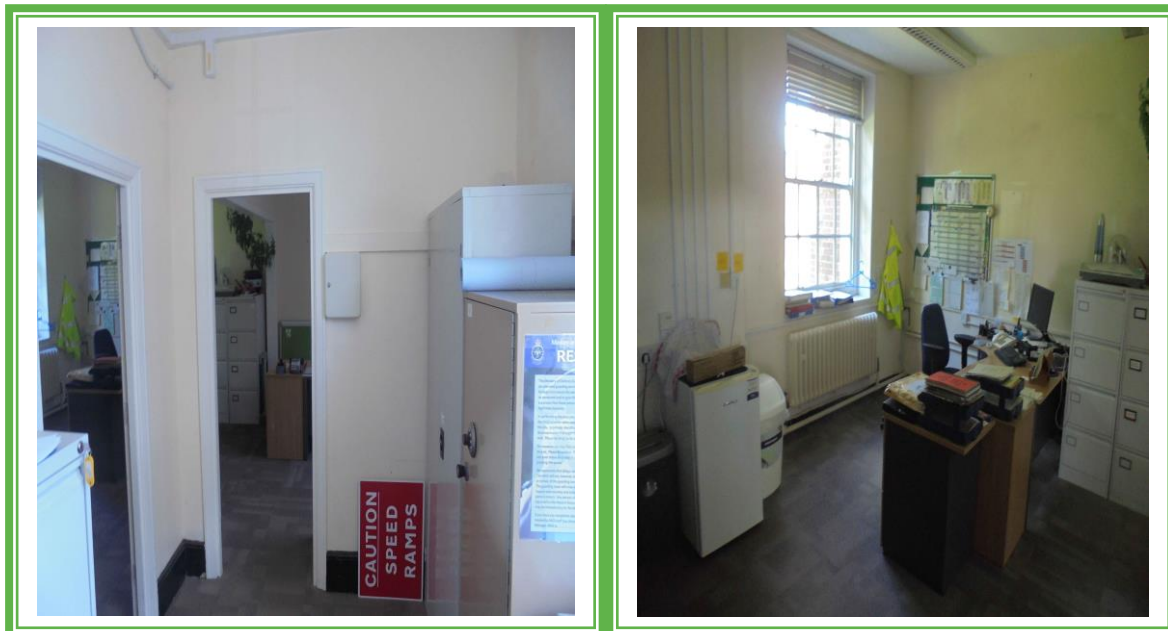
**Item No: 2**

**Location: Office and Store – Ground Floor**

<b>Material Description:</b>	Visual Inspection – No Suspect Materials Found	
<b>Identification:</b>	N/A	
<b>Approx. quantity:</b>	N/A	
<b>Accessibility</b>	N/A	<i>Assessment Score</i>
<b>Product type:</b>		N/A
<b>Extent of Damage:</b>		N/A
<b>Surface Treatment:</b>		N/A
<b>Asbestos type:</b>		N/A
<b>Material Assessment Score:</b>		N/A
<b>Priority Assessment Score:</b>		N/A
<b>Action:</b>	N/A	
<b>Comments:</b>	N/A

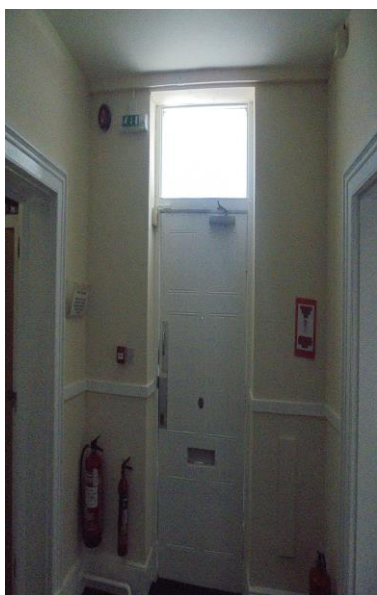
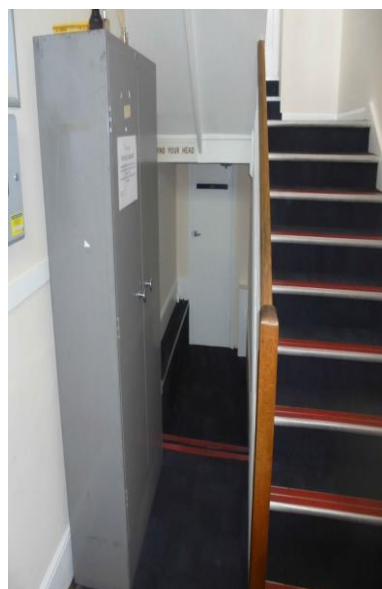
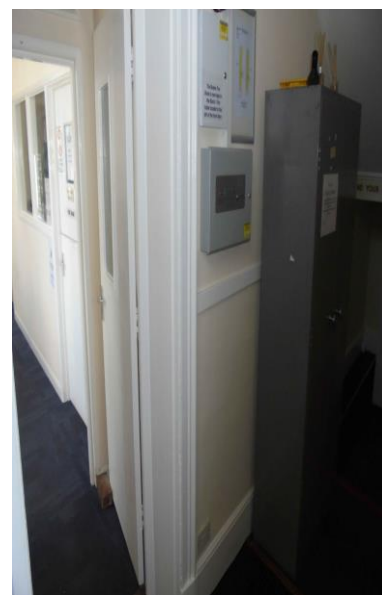
**Item No: 3**

**Location: Main Lobby and Lobby – Ground Floor**

<b>Material Description:</b>	Visual Inspection – No Suspect Materials Found	
<b>Identification:</b>	N/A	
<b>Approx. quantity:</b>	N/A	
<b>Accessibility</b>	N/A	<i>Assessment Score</i>
<b>Product type:</b>		N/A
<b>Extent of Damage:</b>		N/A
<b>Surface Treatment:</b>		N/A
<b>Asbestos type:</b>		N/A
<b>Material Assessment Score:</b>		N/A
<b>Priority Assessment Score:</b>		N/A
<b>Action:</b>	N/A	
<b>Comments:</b>	No access within timber boxings throughout

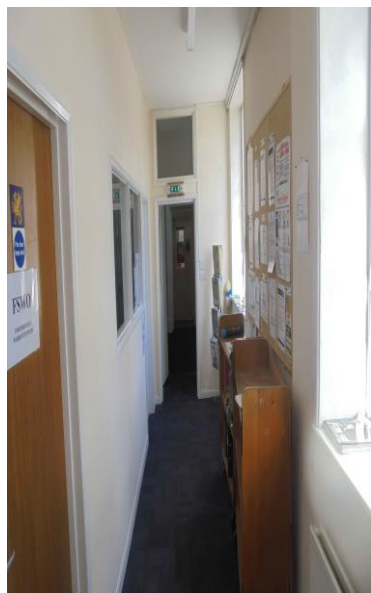
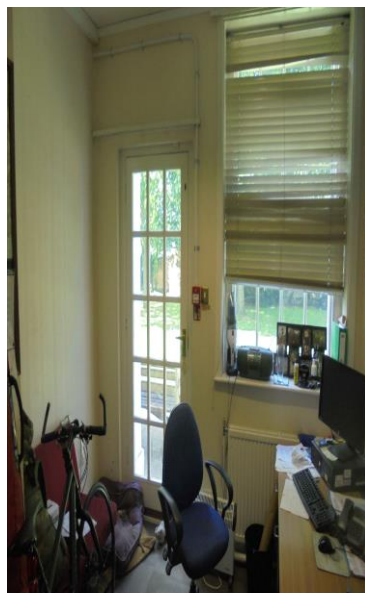
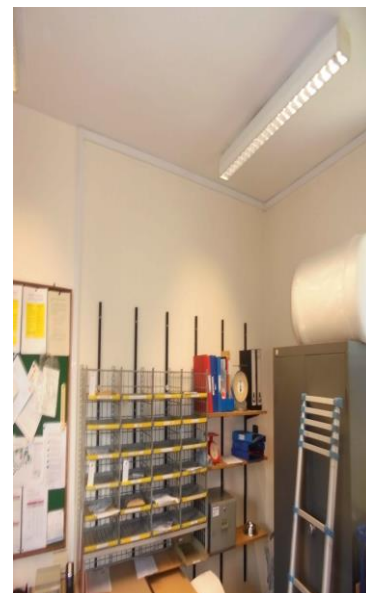
**Item No: 4**

**Location: Offices x 2 and Corridor – Second Floor**

<b>Material Description:</b>	Visual Inspection – No Suspect Materials Found	
<b>Identification:</b>	N/A	
<b>Approx. quantity:</b>	N/A	
<b>Accessibility</b>	N/A	<i>Assessment Score</i>
<b>Product type:</b>		N/A
<b>Extent of Damage:</b>		N/A
<b>Surface Treatment:</b>		N/A
<b>Asbestos type:</b>		N/A
<b>Material Assessment Score:</b>		N/A
<b>Priority Assessment Score:</b>		N/A
<b>Action:</b>	N/A	
<b>Comments:</b>	N/A

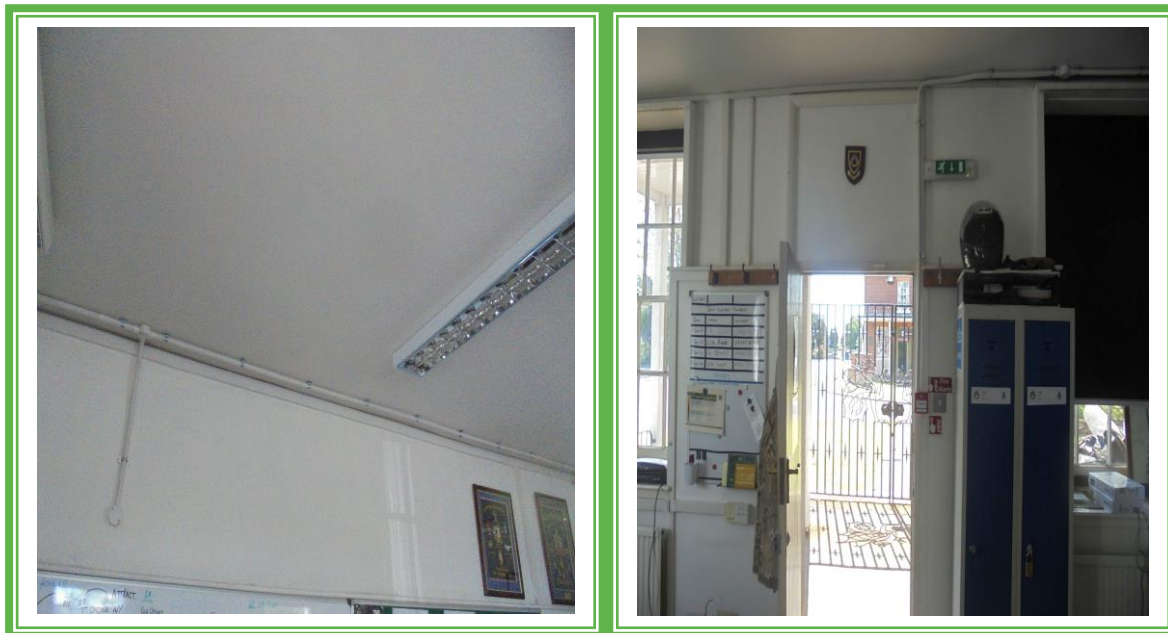
**Item No: 5****Sample No: N/A****Location: Office – Ground Floor**

<b>Material Description:</b>	Visual Inspection – No Suspect Materials Found	
<b>Identification:</b>	N/A	
<b>Approx. quantity:</b>	N/A	
<b>Accessibility</b>	N/A	<i>Assessment Score</i>
<b>Product type:</b>		N/A
<b>Extent of Damage:</b>		N/A
<b>Surface Treatment:</b>		N/A
<b>Asbestos type:</b>		N/A
<b>Material Assessment Score:</b>		N/A
<b>Priority Assessment Score:</b>		N/A
<b>Action:</b>	N/A	
<b>Comments:</b>	N/A

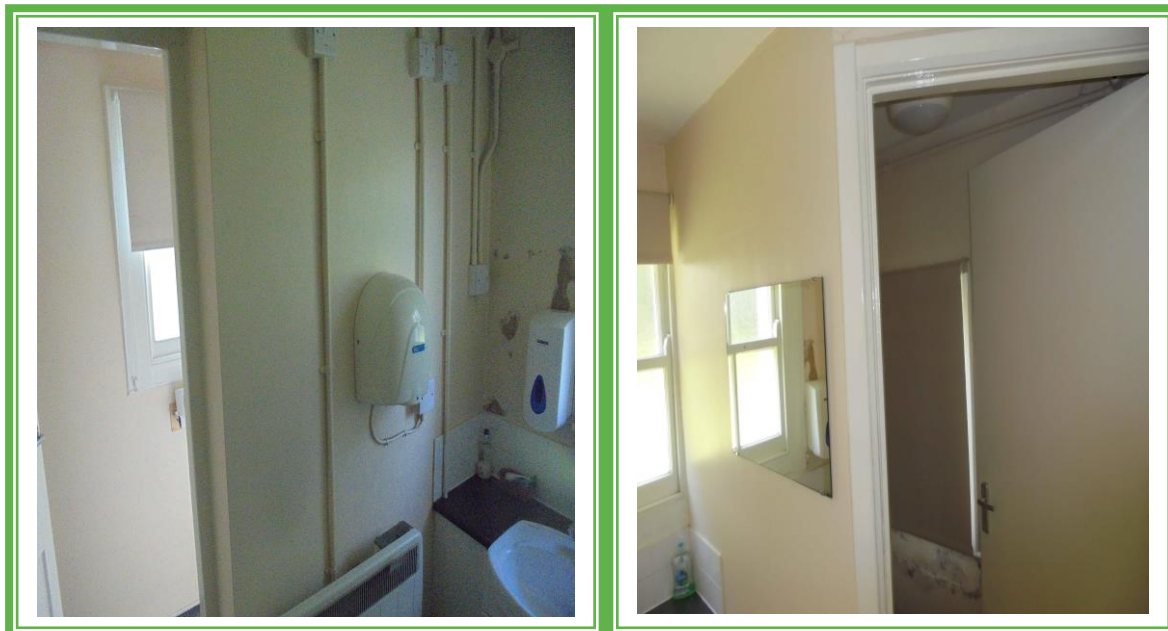
**Item No: 7**

**Location: Ladies WC – Ground Floor**

<b>Material Description:</b>	Visual Inspection – No Suspect Materials Found	
<b>Identification:</b>	N/A	
<b>Approx. quantity:</b>	N/A	
<b>Accessibility</b>	N/A	<i>Assessment Score</i>
<b>Product type:</b>		N/A
<b>Extent of Damage:</b>		N/A
<b>Surface Treatment:</b>		N/A
<b>Asbestos type:</b>		N/A
<b>Material Assessment Score:</b>		N/A
<b>Priority Assessment Score:</b>		N/A
<b>Action:</b>	N/A	
<b>Comments:</b>	N/A

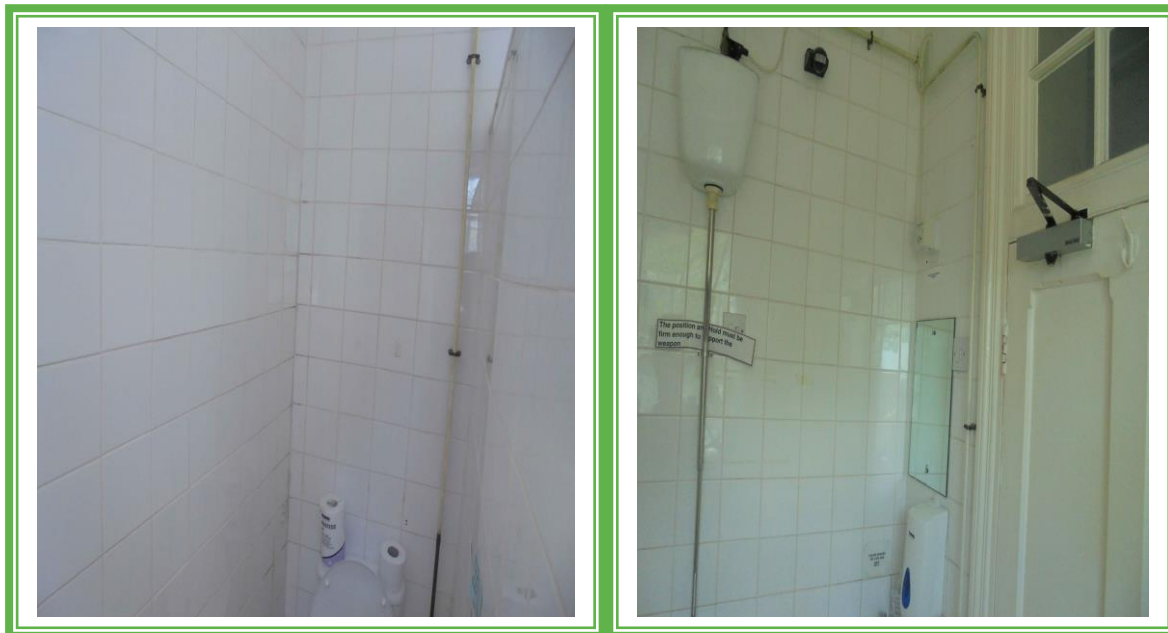
**Item No: 8**

**Location: Men's WC – First Floor**

<b>Material Description:</b>	Visual Inspection – No Suspect Materials Found	
<b>Identification:</b>	N/A	
<b>Approx. quantity:</b>	N/A	
<b>Accessibility</b>	N/A	<i>Assessment Score</i>
<b>Product type:</b>		N/A
<b>Extent of Damage:</b>		N/A
<b>Surface Treatment:</b>		N/A
<b>Asbestos type:</b>		N/A
<b>Material Assessment Score:</b>		N/A
<b>Priority Assessment Score:</b>		N/A
<b>Action:</b>	N/A	
<b>Comments:</b>	No access behind ceramic tiles

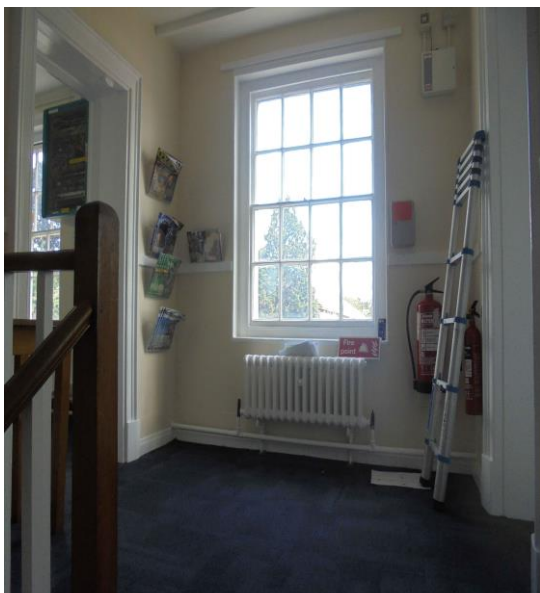
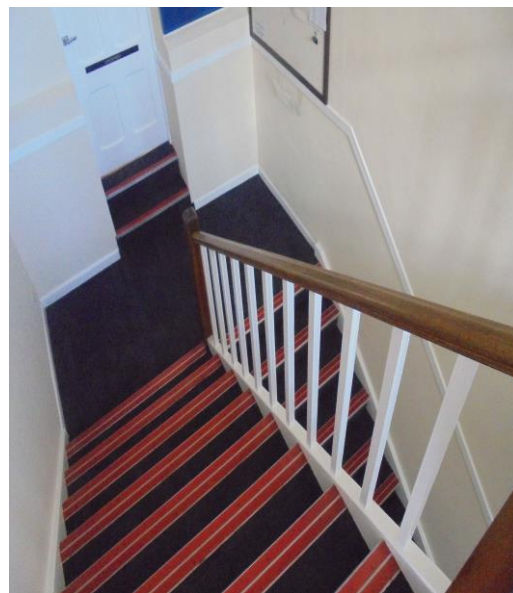
**Item No: 9**

**Location: Stairwell and Landing**

<b>Material Description:</b>	Visual Inspection – No Suspect Materials Found	
<b>Identification:</b>	N/A	
<b>Approx. quantity:</b>	N/A	
<b>Accessibility</b>	N/A	<i>Assessment Score</i>
<b>Product type:</b>		N/A
<b>Extent of Damage:</b>		N/A
<b>Surface Treatment:</b>		N/A
<b>Asbestos type:</b>		N/A
<b>Material Assessment Score:</b>		N/A
<b>Priority Assessment Score:</b>		N/A
<b>Action:</b>	N/A	
<b>Comments:</b>	N/A

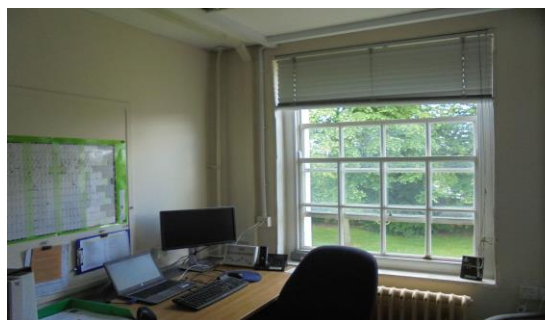
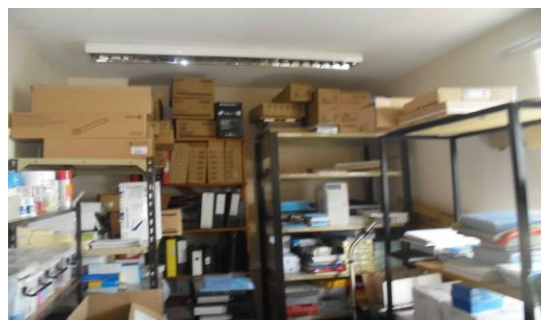
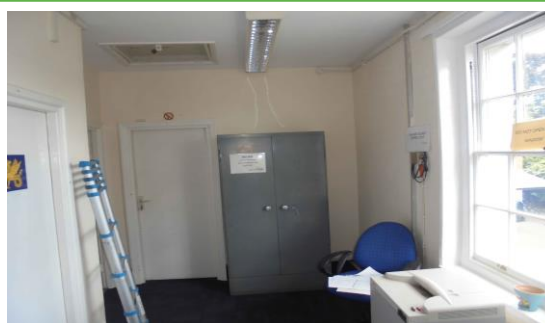
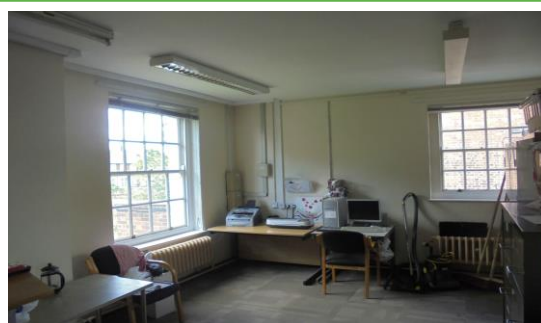
**Item No: 10**

**Location: Offices x 2, Circulation and Store – First Floor**

<b>Material Description:</b>	Visual Inspection – No Suspect Materials Found	
<b>Identification:</b>	N/A	
<b>Approx. quantity:</b>	N/A	
<b>Accessibility</b>	N/A	<i>Assessment Score</i>
<b>Product type:</b>		N/A
<b>Extent of Damage:</b>		N/A
<b>Surface Treatment:</b>		N/A
<b>Asbestos type:</b>		N/A
<b>Material Assessment Score:</b>		N/A
<b>Priority Assessment Score:</b>		N/A
<b>Action:</b>	N/A	
<b>Comments:</b>	No access within timber boxing in store

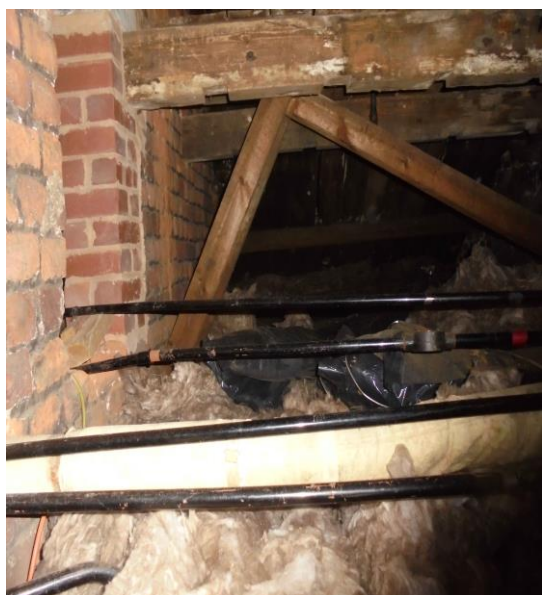
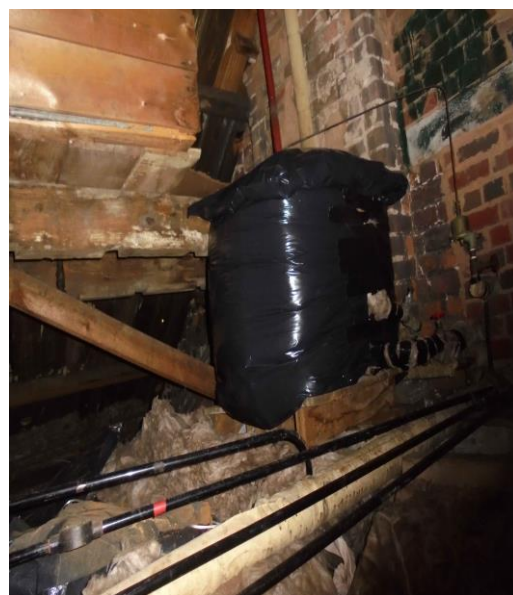
**Item No: 11**

**Location: Loft Space**

<b>Material Description:</b>	Visual Inspection – No Suspect Materials Found	
<b>Identification:</b>	N/A	
<b>Approx. quantity:</b>	N/A	
<b>Accessibility</b>	N/A	<i>Assessment Score</i>
<b>Product type:</b>		N/A
<b>Extent of Damage:</b>		N/A
<b>Surface Treatment:</b>		N/A
<b>Asbestos type:</b>		N/A
<b>Material Assessment Score:</b>		N/A
<b>Priority Assessment Score:</b>		N/A
<b>Action:</b>	N/A	
<b>Comments:</b>	Limited access to inspect loft due to height and no crawl boards were available

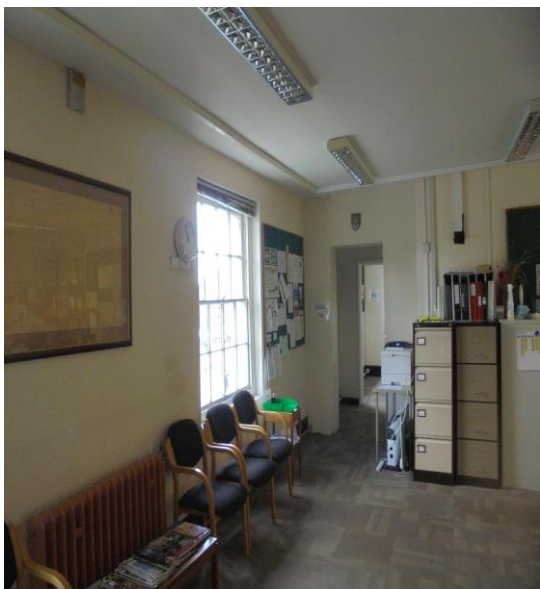
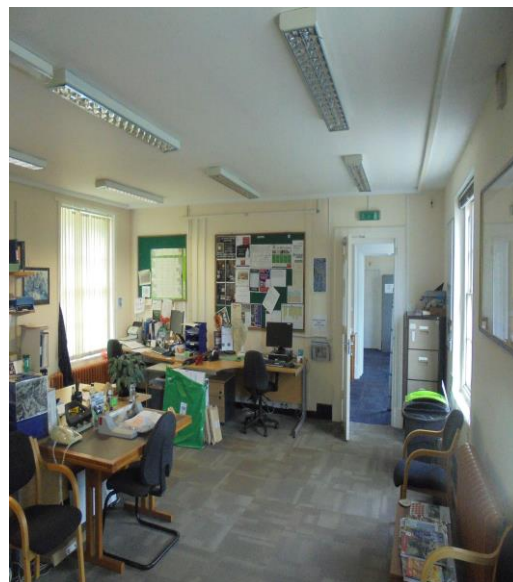
**Item No: 12**

**Location: Admin Office – First Floor**

<b>Material Description:</b>	Visual Inspection – No Suspect Materials Found	
<b>Identification:</b>	N/A	
<b>Approx. quantity:</b>	N/A	
<b>Accessibility</b>	N/A	<i>Assessment Score</i>
<b>Product type:</b>		N/A
<b>Extent of Damage:</b>		N/A
<b>Surface Treatment:</b>		N/A
<b>Asbestos type:</b>		N/A
<b>Material Assessment Score:</b>		N/A
<b>Priority Assessment Score:</b>		N/A
<b>Action:</b>	N/A	
<b>Comments:</b>	N/A

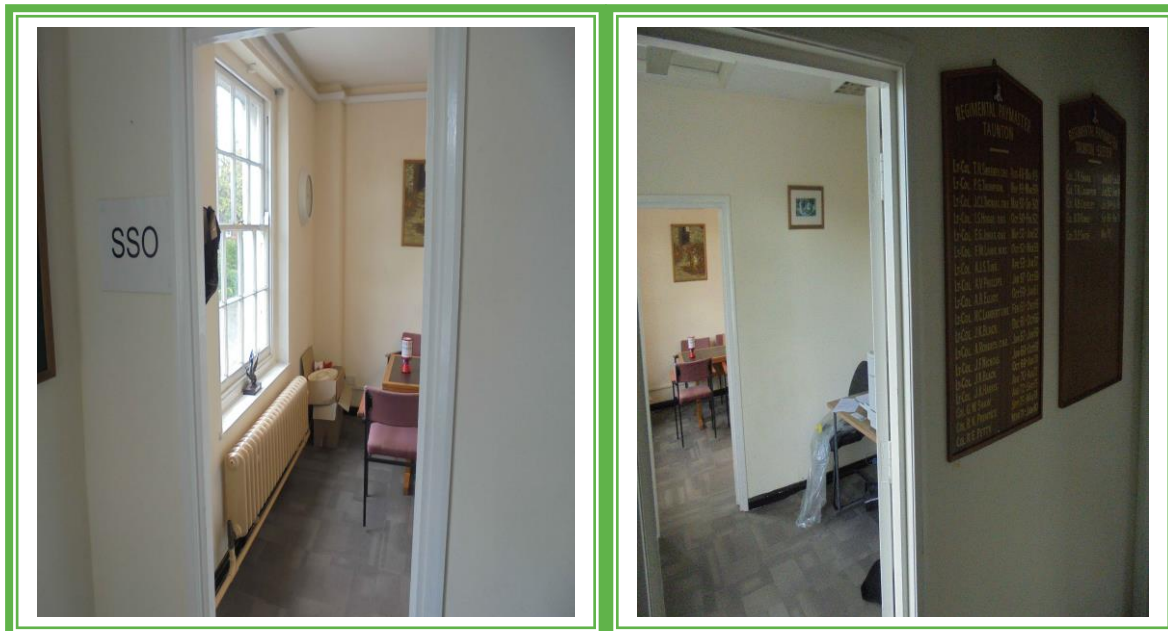
**Item No: 14**

**Location: Office, Copy Room and Lobby – First Floor**

<b>Material Description:</b>	Visual Inspection – No Suspect Materials Found	
<b>Identification:</b>	N/A	
<b>Approx. quantity:</b>	N/A	
<b>Accessibility</b>	N/A	<i>Assessment Score</i>
<b>Product type:</b>		N/A
<b>Extent of Damage:</b>		N/A
<b>Surface Treatment:</b>		N/A
<b>Asbestos type:</b>		N/A
<b>Material Assessment Score:</b>		N/A
<b>Priority Assessment Score:</b>		N/A
<b>Action:</b>	N/A	
<b>Comments:</b>	N/A

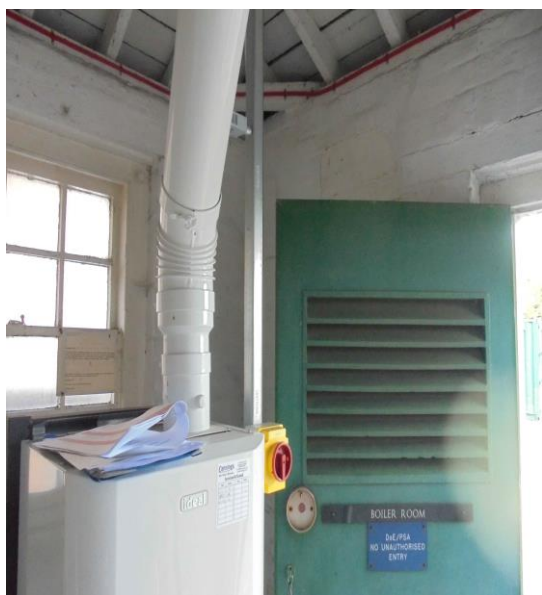
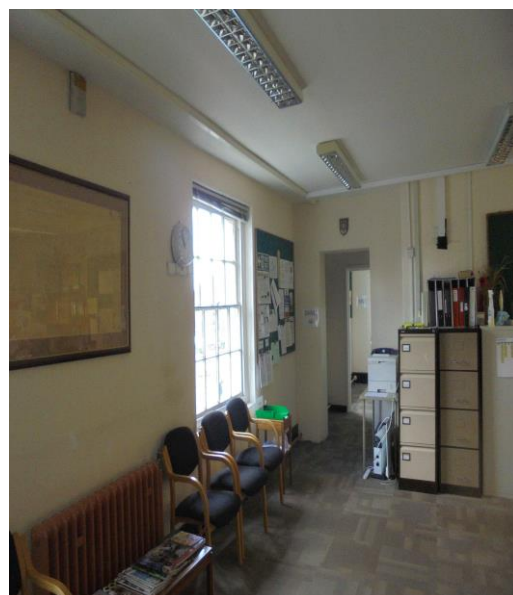
**Item No: 15**

**Location: Boiler Room**

<b>Material Description:</b>	Visual Inspection – No Suspect Materials Found	
<b>Identification:</b>	N/A	
<b>Approx. quantity:</b>	N/A	
<b>Accessibility</b>	N/A	<i>Assessment Score</i>
<b>Product type:</b>		N/A
<b>Extent of Damage:</b>		N/A
<b>Surface Treatment:</b>		N/A
<b>Asbestos type:</b>		N/A
<b>Material Assessment Score:</b>		N/A
<b>Priority Assessment Score:</b>		N/A
<b>Action:</b>	N/A	
<b>Comments:</b>	Modern boiler, electrics, pipework and gasket

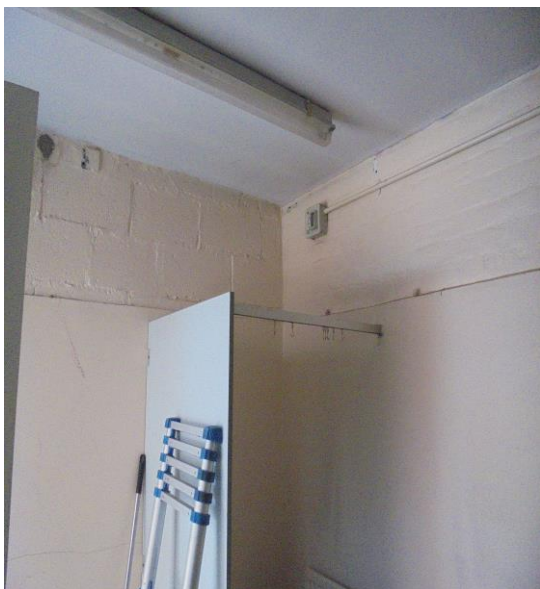
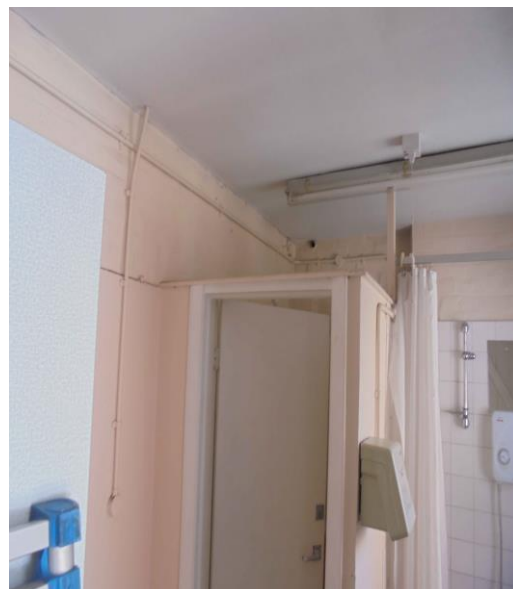
**Item No: 16**

**Location: Shower Room**

<b>Material Description:</b>	Visual Inspection – No Suspect Materials Found	
<b>Identification:</b>	N/A	
<b>Approx. quantity:</b>	N/A	
<b>Accessibility</b>	N/A	<i>Assessment Score</i>
<b>Product type:</b>		N/A
<b>Extent of Damage:</b>		N/A
<b>Surface Treatment:</b>		N/A
<b>Asbestos type:</b>		N/A
<b>Material Assessment Score:</b>		N/A
<b>Priority Assessment Score:</b>		N/A
<b>Action:</b>	N/A	
<b>Comments:</b>	N/A

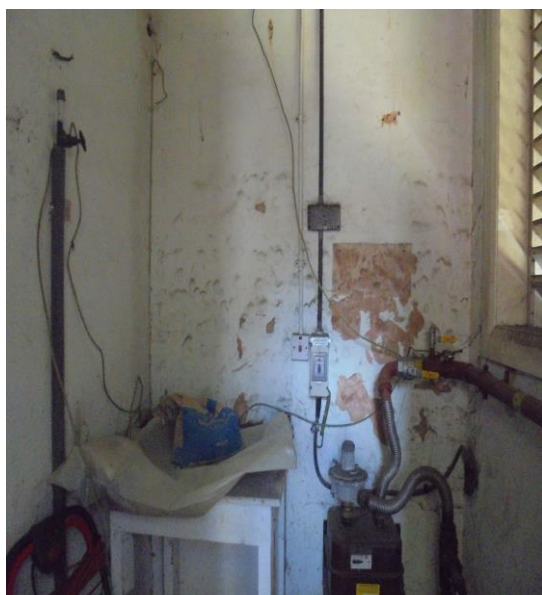
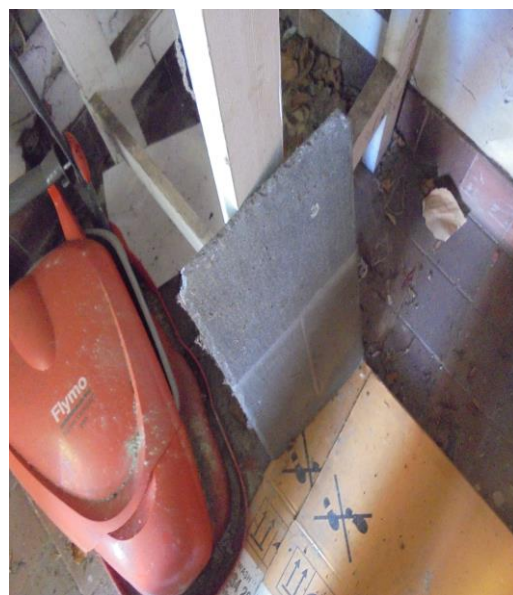
**Item No: 17**

**Location: Gas Meter Room**

<b>Material Description:</b>	Stored Roof Slate	
<b>Identification:</b>	Sampled – No Asbestos Detected	
<b>Approx. quantity:</b>	<1M2	
<b>Accessibility</b>	N/A	<i>Assessment Score</i>
<b>Product type:</b>		N/A
<b>Extent of Damage:</b>		N/A
<b>Surface Treatment:</b>		N/A
<b>Asbestos type:</b>		N/A
<b>Material Assessment Score:</b>		N/A
<b>Priority Assessment Score:</b>		N/A
<b>Action:</b>	N/A	
<b>Comments:</b>	N/A
