Project Number 2481

**Management
Asbestos Survey Report**

**Wyvern Barracks, Barrack Road, Exeter, Devon,
EX2 6AE (Building 14)**

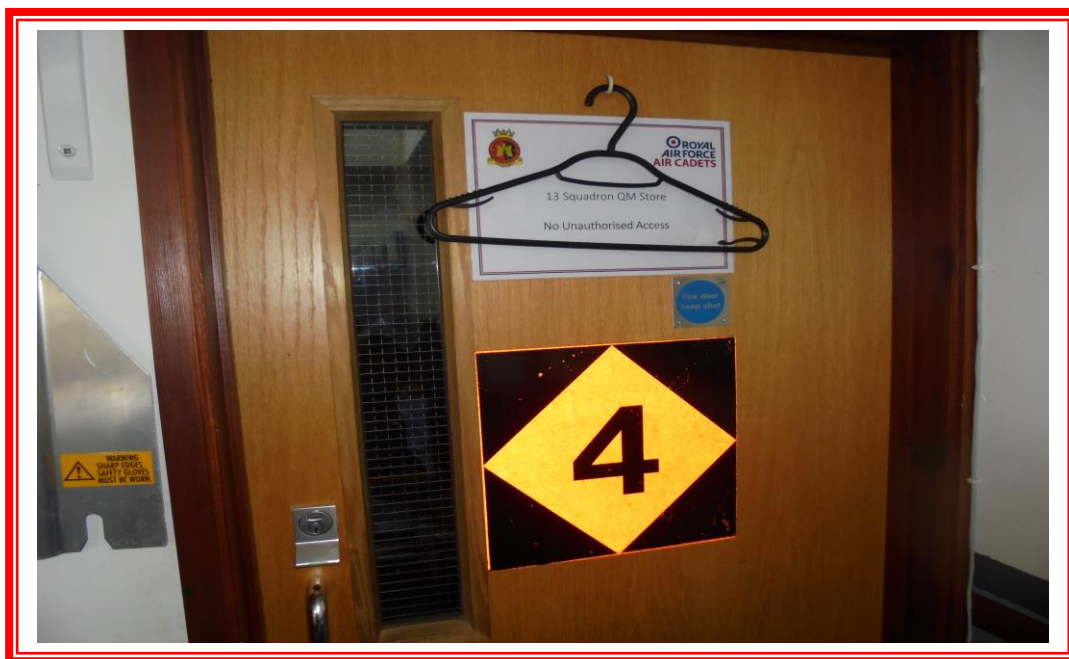
Item No: 5

Location: Store

| Material Description: | No access within store as locked | |
| Identification: | Presumed to Contain Asbestos | |
| Priority Assessment Score: | | High |
| Comments: | No key available. No one onsite had a key during the survey | |

| Action: | Further Investigation Required | |

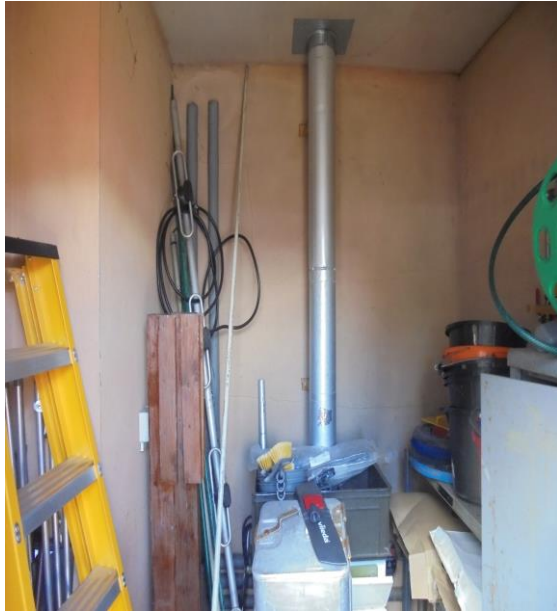
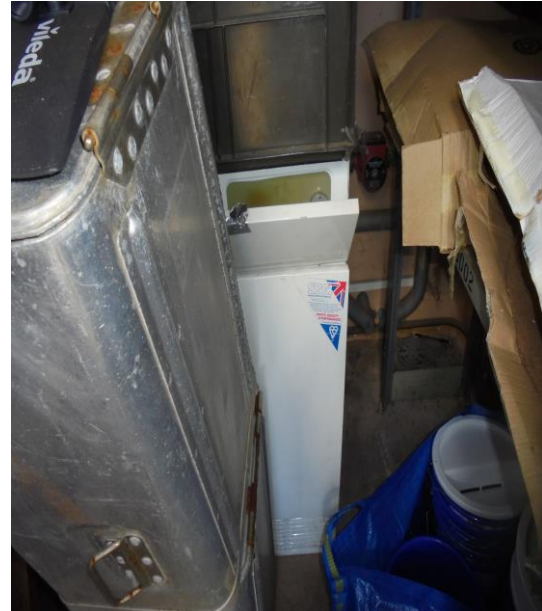
**Item No: 10****Sample No: N/A****Location: Boiler Room**

| Material Description: | No access within Live Boiler | |
| Identification: | Presumed to Contain Asbestos | |
| Priority Assessment Score: | | High |
| Comments: | Unable to inspect within boiler as live | |

| Action: | Manage | |

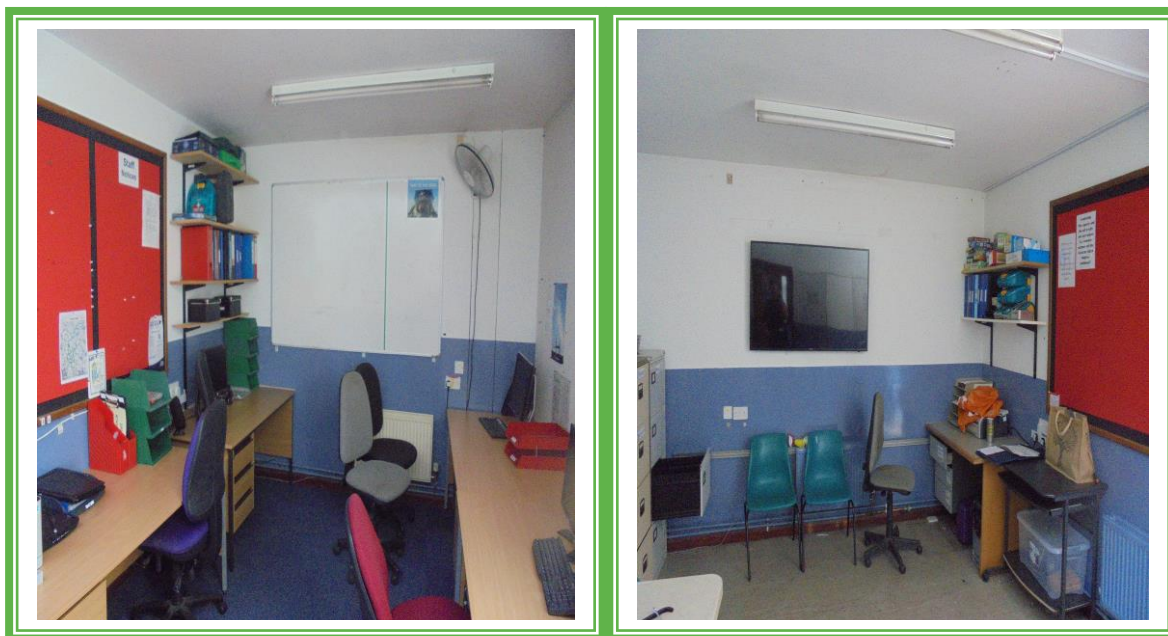
Item No: 1

Location: Offices x 2

| Material Description: | Visual Inspection – No Suspect Materials Found | |

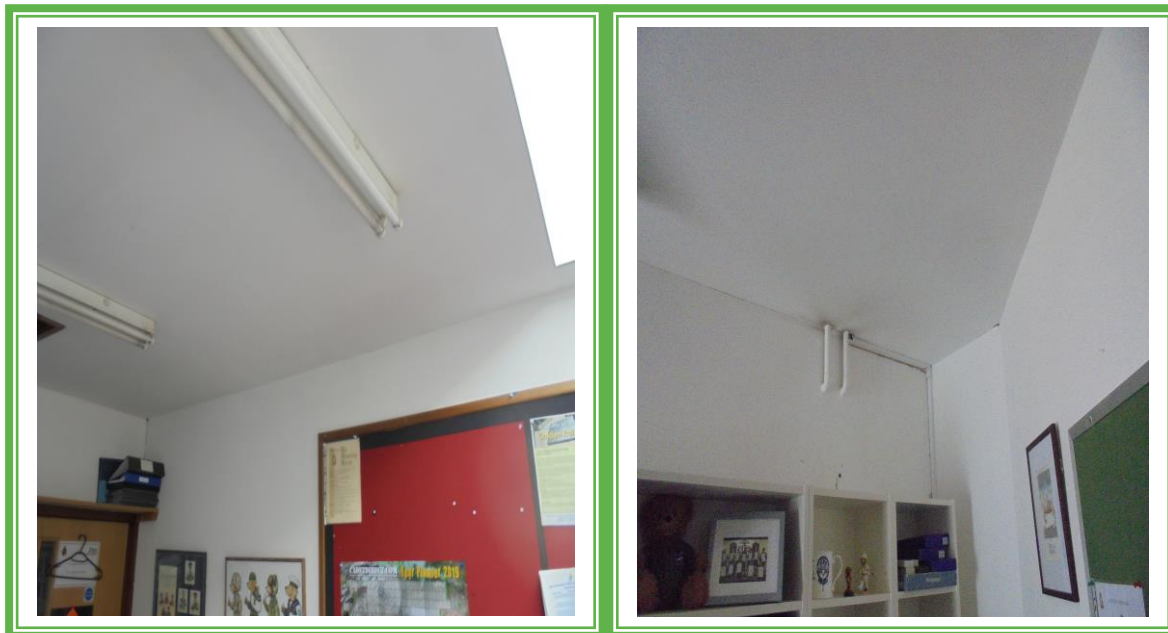
Item No: 2

Location: Offices x 2 and Electric Cupboard

| Material Description: | Visual Inspection – No Suspect Materials Found | |
| Comments: | No access within timber boxing. Modern electrics in cupboard | |

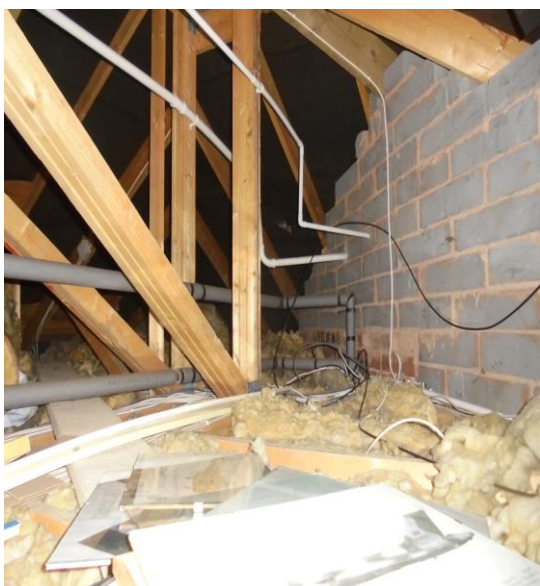
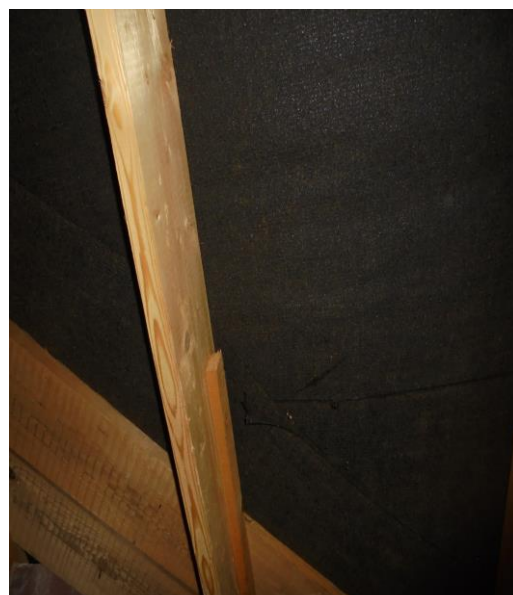
Item No: 3

Location: Loft Space

| Material Description: | Roof felt | |
| Identification: | Sampled – No Asbestos Detected | |
| Comments: | Limited access into loft as no crawl boards were available | |

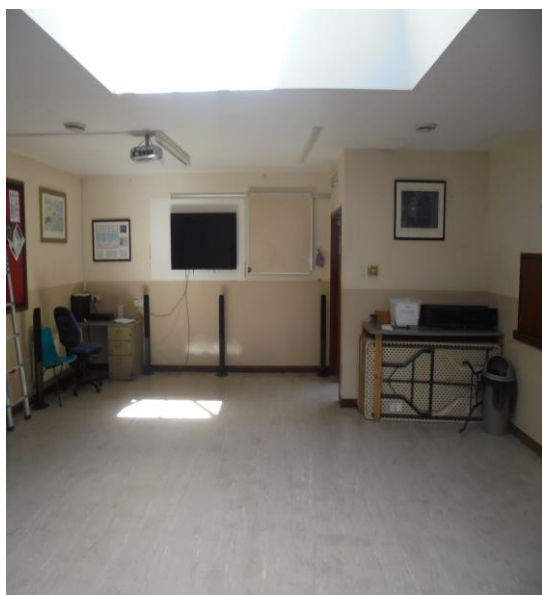
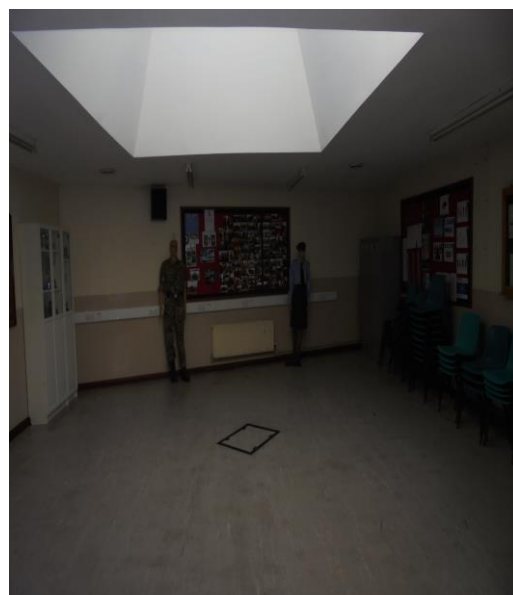
Item No: 4

Location: Hall

| Material Description: | Visual Inspection – No Suspect Materials Found | |
| Comments: | No access within the timber boxing | |

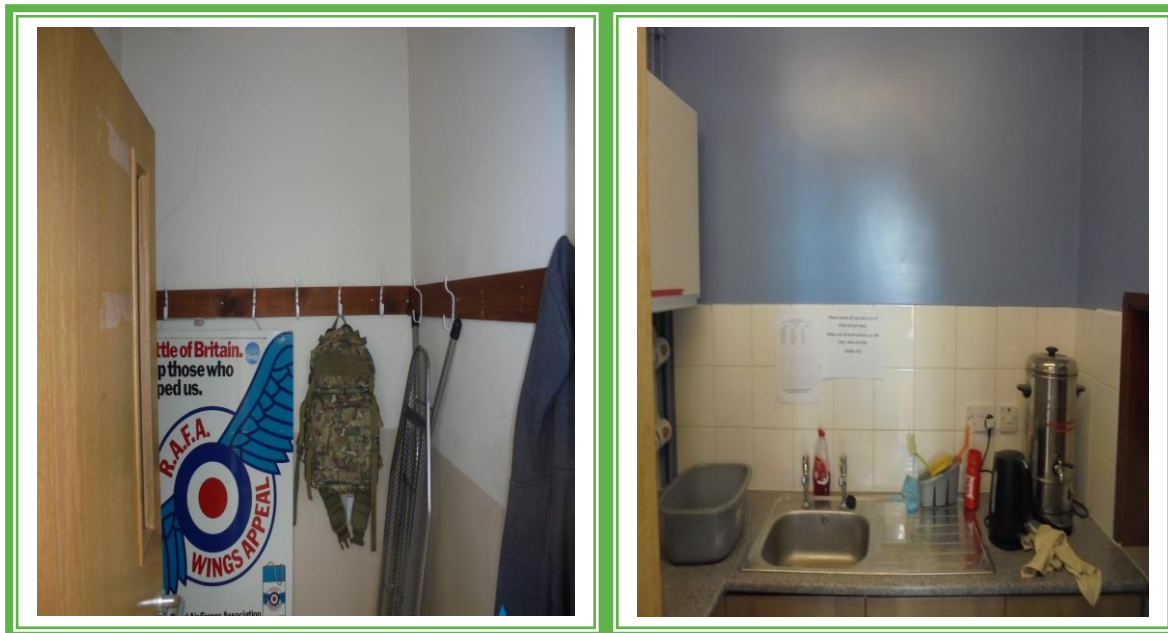
Item No: 6

Location: Kitchen and Cupboard

| Material Description: | Visual Inspection – No Suspect Materials Found | |
| Comments: | Modern Sink Pad | |

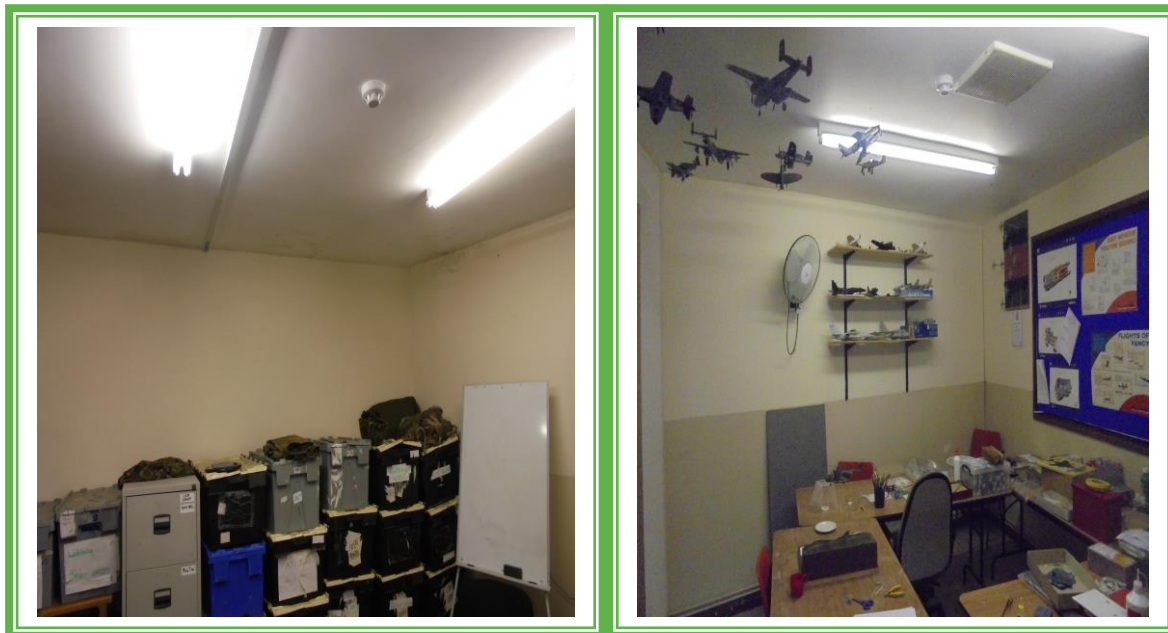
Item No: 7

Location: Modelling and Comms Rooms

| Material Description: | Visual Inspection – No Suspect Materials Found | |

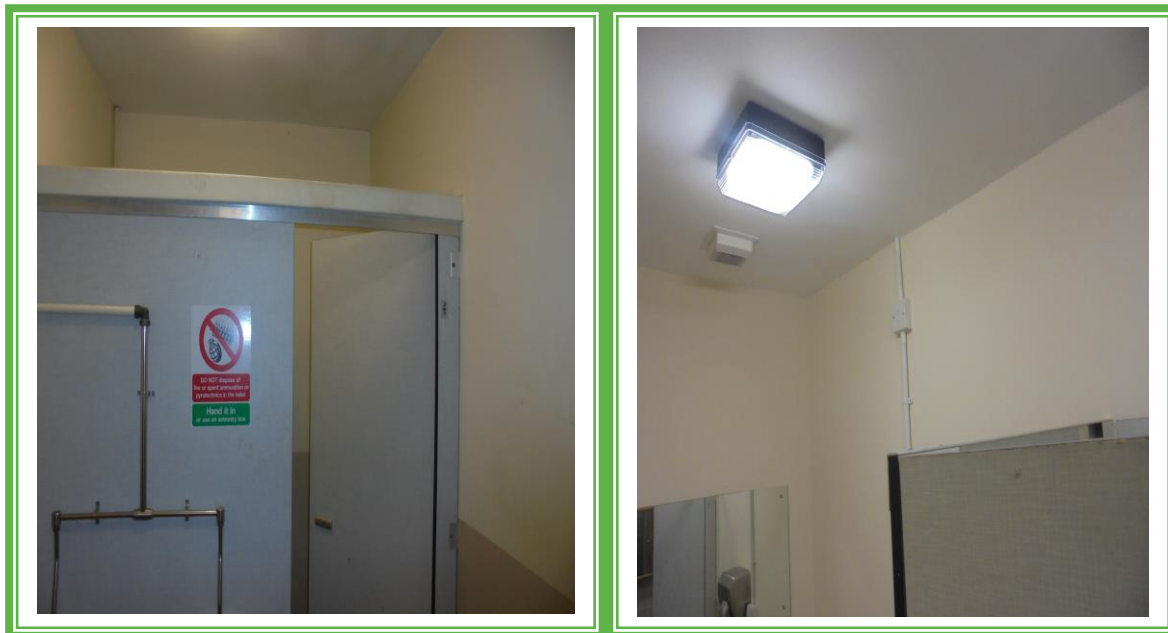
Item No: 8

Location: WC's x 2

| Material Description: | Visual Inspection – No Suspect Materials Found | |

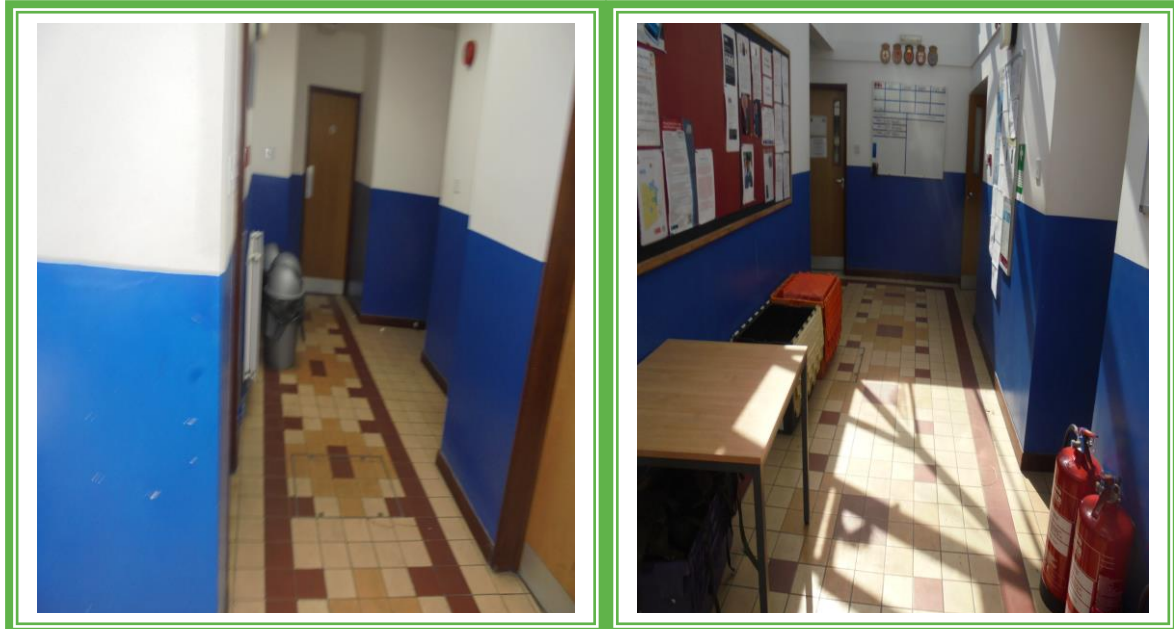
**Item No: 9****Sample No: N/A****Location: Corridor**

| Material Description: | Visual Inspection – No Suspect Materials Found | |

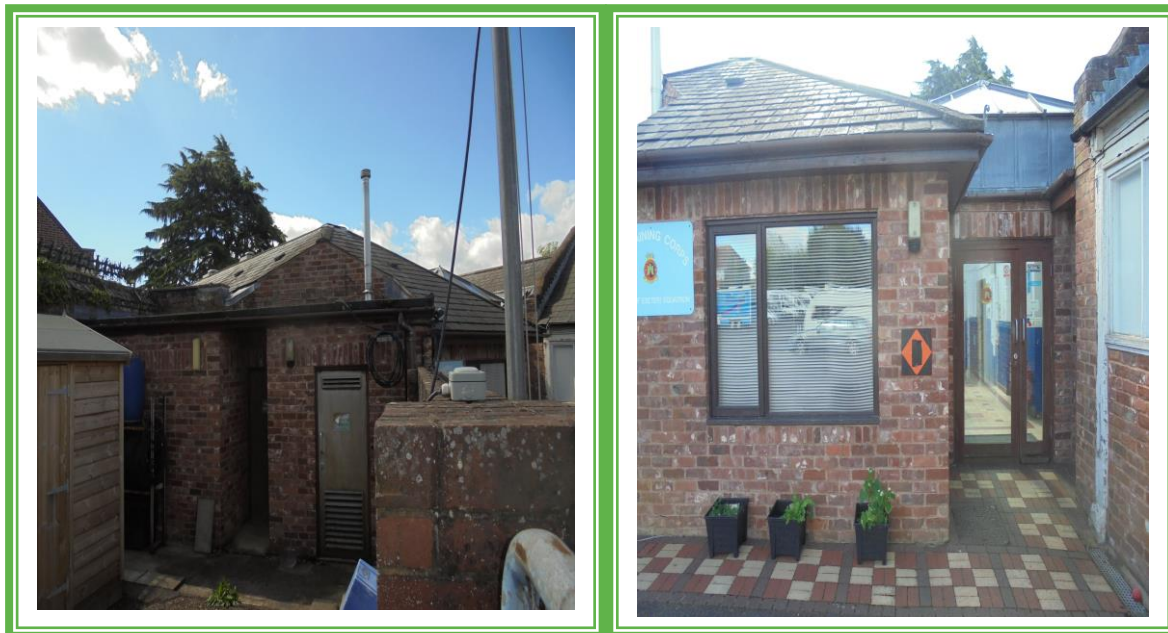
Item No: 11

Location: External

| Material Description: | Visual Inspection – No Suspect Materials Found | |
| Comments: | Slate roof tiles. Modern damp proof course | |
