## LEGIONELLA RISK ASSESSMENT

| <b>Site:</b> | Truro ARC |
| <b>Report Ref:</b> | AQST/LRA/124 |
| <b>Survey Date:</b> | 9 <sup>th</sup> August 2023 |

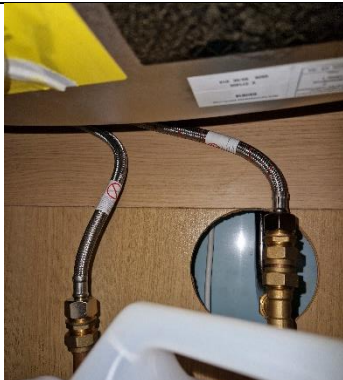
| Example of Bossmix TMV | Example of Flexi's |

| SYSTEM TYPES | | RISK RATING |
|---|---|---|
| 02 | Flexi hoses should be WRAS approved and not coiled/twisted | High |

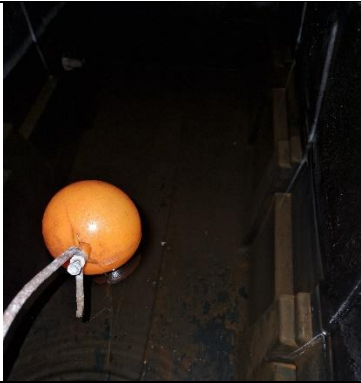
| <p>CWST 01 &amp; 02</p> | <p>Inside CWST 01</p> |

| SYSTEM TYPES | | RISK RATING |
|---|---|---|
| 02 | Recommend cleaning and disinfecting of CWST 01 & 02 (requires 2 people for H & S) | High |

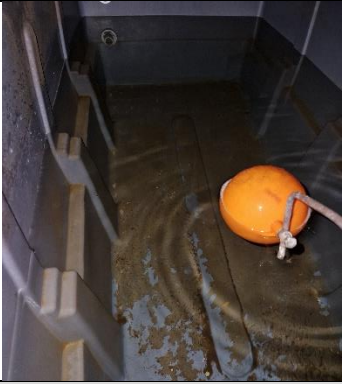
| <p>Inside CWST 02</p> | <p>Hole in lid of CWST 02</p> |

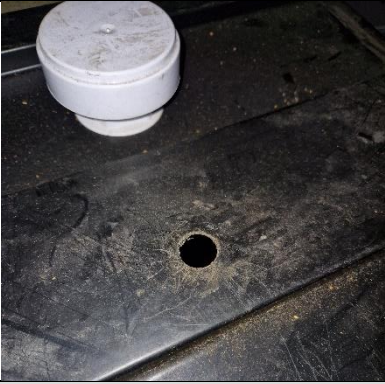
| SYSTEM TYPES | | RISK RATING |
|---|---|---|
| 01 | CWST 02 has a hole in the lid – requires sealing | High |

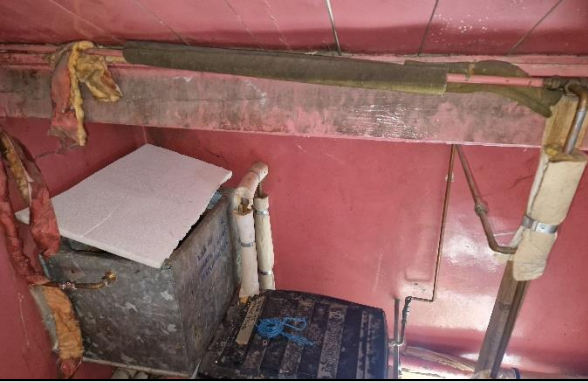
| <p>Feed to F &amp; E for NRV's</p> | |

| SYSTEM TYPES | | RISK RATING |
|---|---|---|
| 03 | Recommend fitting 2 x 15mm NRV's at CWST's/branch to F & E (2 x F & E tanks) | High |

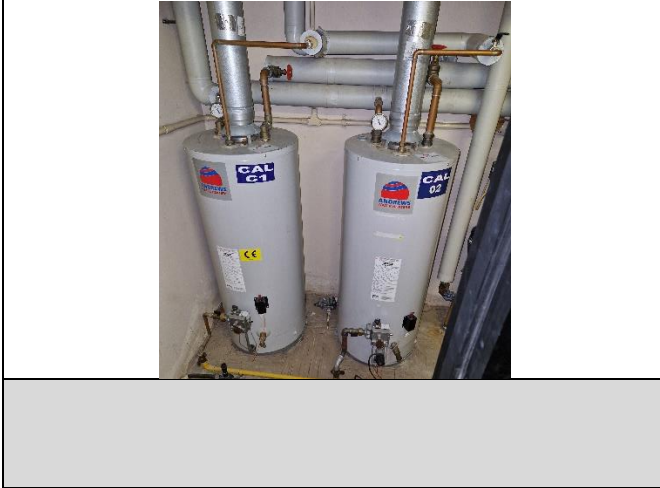
1. Cals 01 & 02 are producing low temperatures. They are set to the highest setting (3). This could possibly be due to internal scale. We would recommend descaling (internal inspection carried out at time of Risk Assessment).
