Project Number 2481

**Management
Asbestos Survey Report**

**Parkstone Platoon (ACF), Weymouth Road,
Poole, Dorset, BH14 0DS**

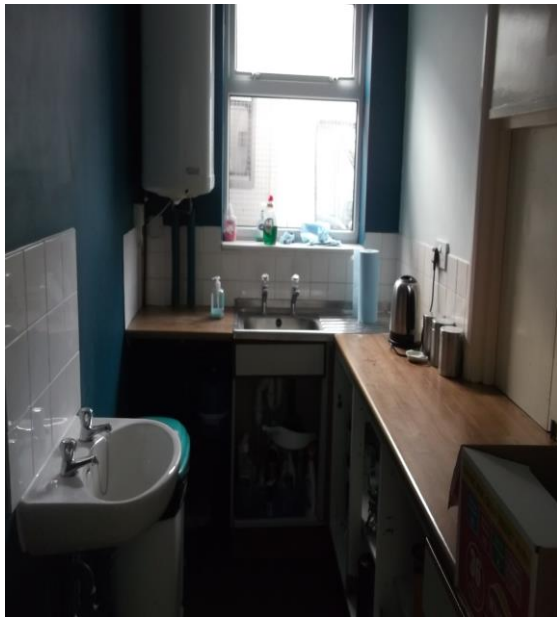
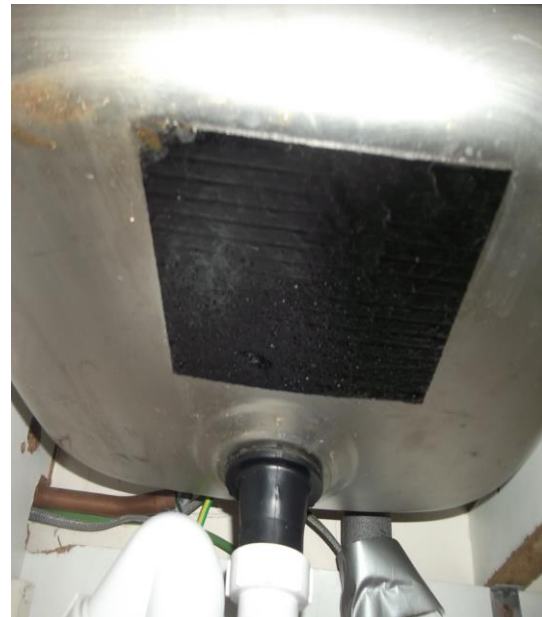
Item No: 5

Sample Number	Sample Type	Location	Analysis
GR001	Floor Tiles (Brown)	Lobby	N.A.D.I.S
GR002	Floor Tiles (Grey)	Adult Toilet	N.A.D.I.S
GR003	Sink Pad	Kitchen	Chrysotile

Material Description:	Sink Pad	
Identification:	Sampled - Asbestos Detected	
Approx. quantity:	X 1	
Accessibility	High	Assessment Score
Product type:	Bitumen	1
Extent of Damage:	Major	3
Surface Treatment:	Non-Friable	0
Asbestos type:	Chrysotile	1
Material Assessment Score:		4
Priority Assessment Score:		Negligible
Action:	Remove	
Comments:	N/A

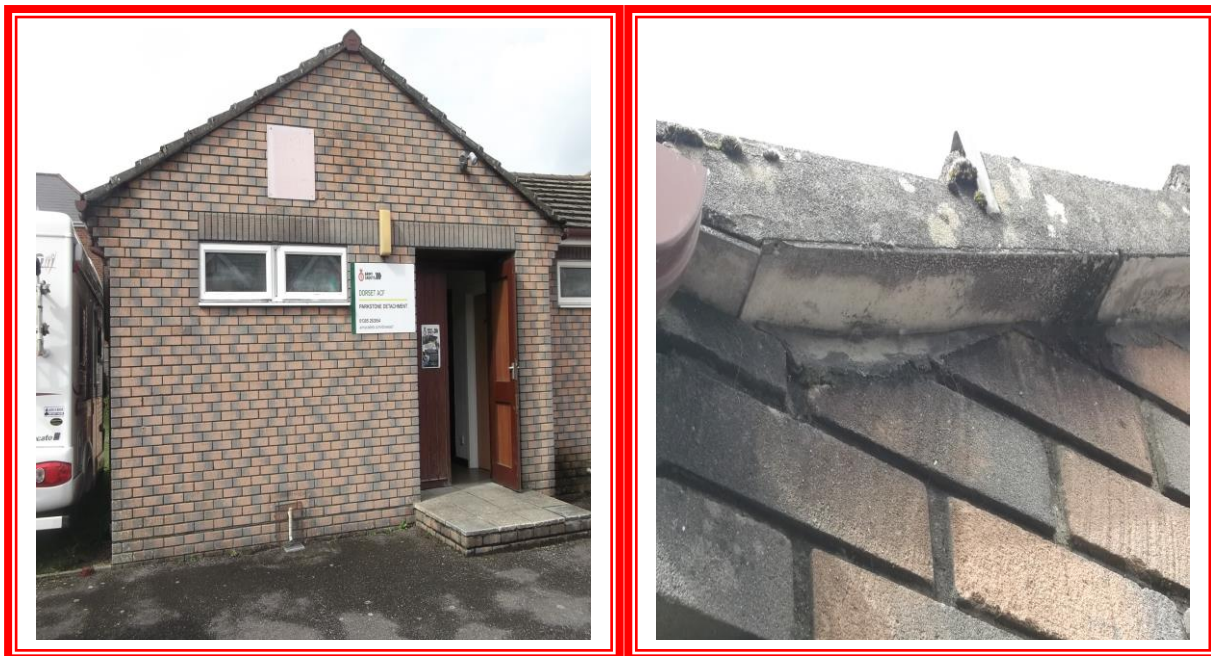
Item No: 12

Item 12 – External – Cement Under cloaking – Identical to Parkstone ATC which has Positive in Sample

Material Description:	Cement Under cloaking	
Identification:	Strongly Presumed to Contain Asbestos	
Approx. quantity:	25LM	
Accessibility	Low	Assessment Score
Product type:	Cement	1
Extent of Damage:	Major	3
Surface Treatment:	Unsealed	1
Asbestos type:	Chrysotile	1
Material Assessment Score:		6
Priority Assessment Score:		Low
Action:	Manage	
Comments:	Identical to Parkstone ATC – Which was Positive in Sample. See Parkstone ATC Sample Results

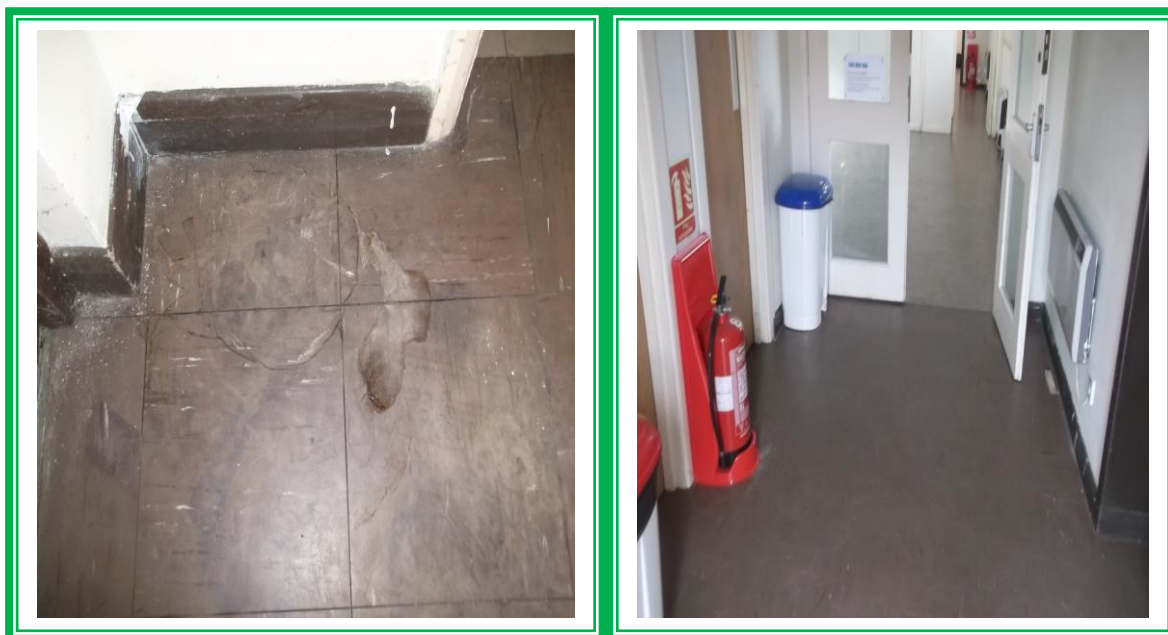
Item No: 1
Sample No: GR001
Location: Ground Floor - Lobby

Material Description:	Floor Tiles (Brown)	
Identification:	Sampled – No Asbestos Detected	
Approx. quantity:	6M2	
Accessibility	N/A	<i>Assessment Score</i>
Product type:	N/A	N/A
Extent of Damage:	N/A	N/A
Surface Treatment:	N/A	N/A
Asbestos type:	N/A	N/A
Material Assessment Score:		N/A
Priority Assessment Score:		N/A
Action:	N/A	
Comments:	Modern Walls and Ceiling

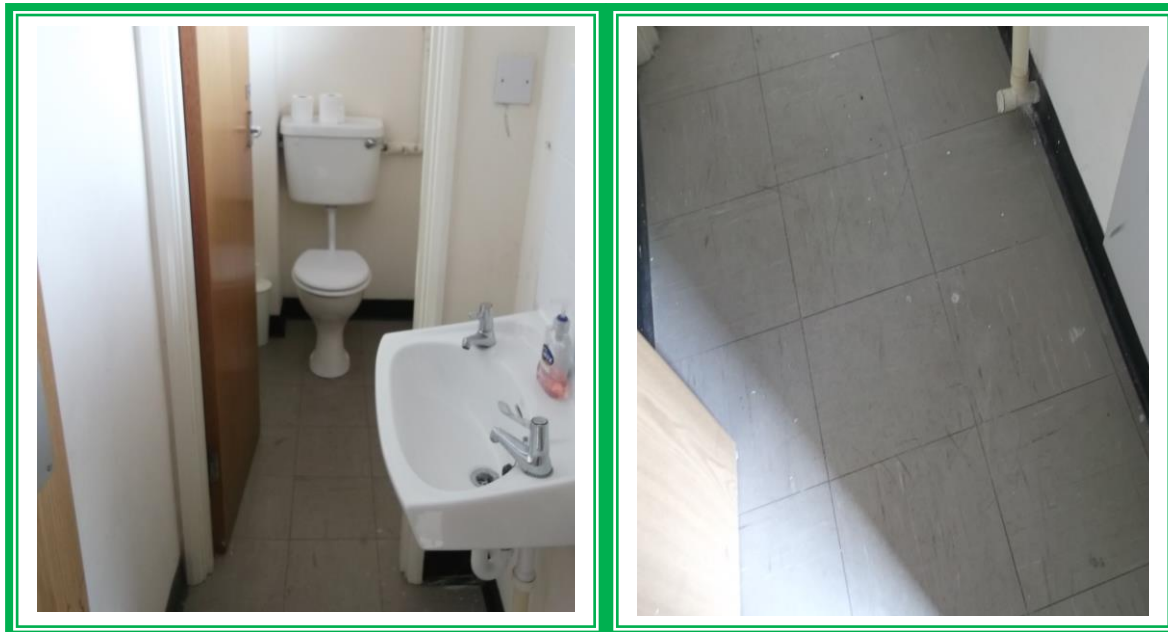
Item No: 3

Material Description:	Floor Tiles (Grey)	
Identification:	As Per Sample GR002 – No Asbestos Detected	
Approx. quantity:	3M2	
Accessibility	N/A	<i>Assessment Score</i>
Product type:	N/A	N/A
Extent of Damage:	N/A	N/A
Surface Treatment:	N/A	N/A
Asbestos type:	N/A	N/A
Material Assessment Score:		N/A
Priority Assessment Score:		N/A
Action:	N/A	
Comments:	N/A

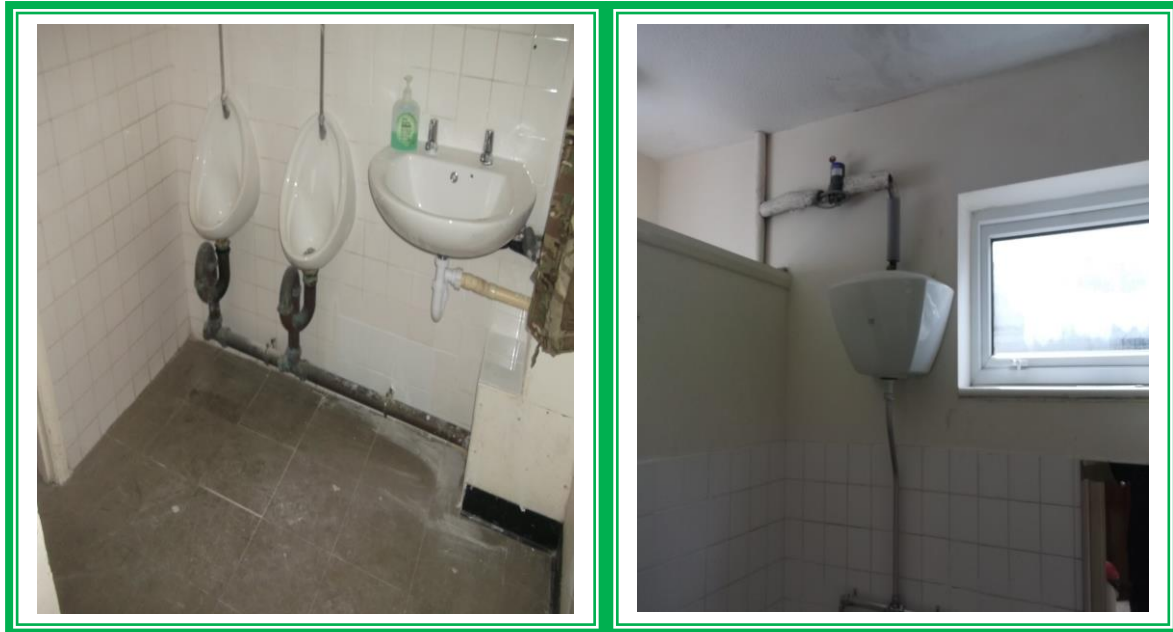
Item No: 4

Material Description:	Floor Tiles (Brown)	
Identification:	As Per Sample GR001 – No Asbestos Detected	
Approx. quantity:	6M2	
Accessibility	N/A	<i>Assessment Score</i>
Product type:	N/A	N/A
Extent of Damage:	N/A	N/A
Surface Treatment:	N/A	N/A
Asbestos type:	N/A	N/A
Material Assessment Score:		N/A
Priority Assessment Score:		N/A
Action:	N/A	
Comments:	N/A

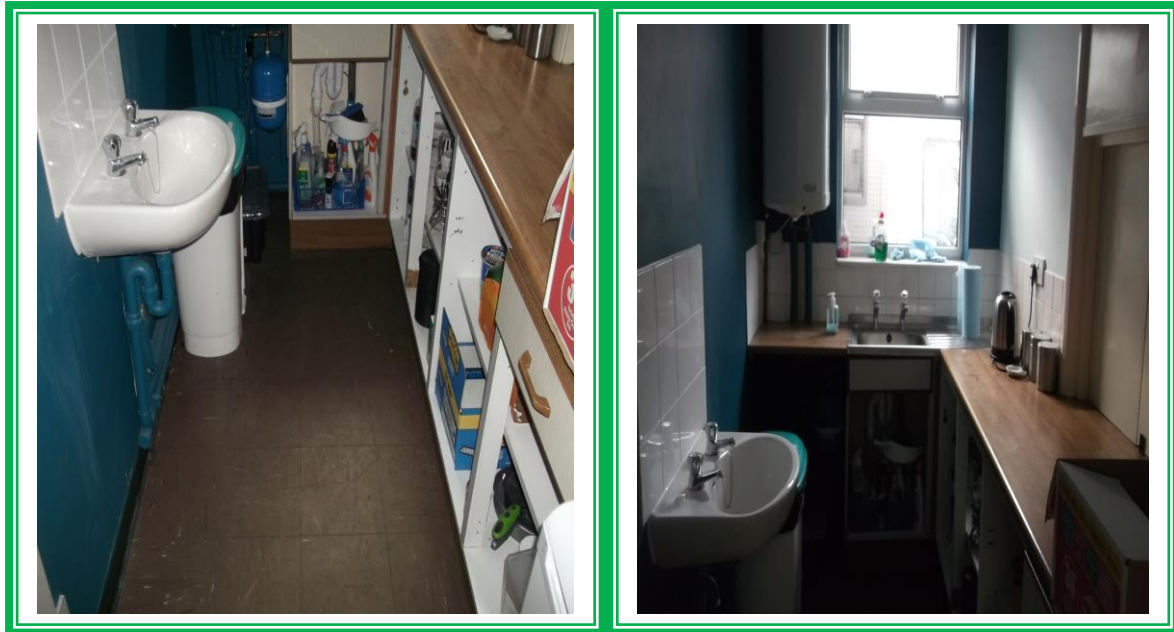
Item No: 6

Material Description:	Floor Tiles (Brown)	
Identification:	As Per Sample GR001 – No Asbestos Detected	
Approx. quantity:	6M2	
Accessibility	N/A	<i>Assessment Score</i>
Product type:	N/A	N/A
Extent of Damage:	N/A	N/A
Surface Treatment:	N/A	N/A
Asbestos type:	N/A	N/A
Material Assessment Score:		N/A
Priority Assessment Score:		N/A
Action:	N/A	
Comments:	N/A

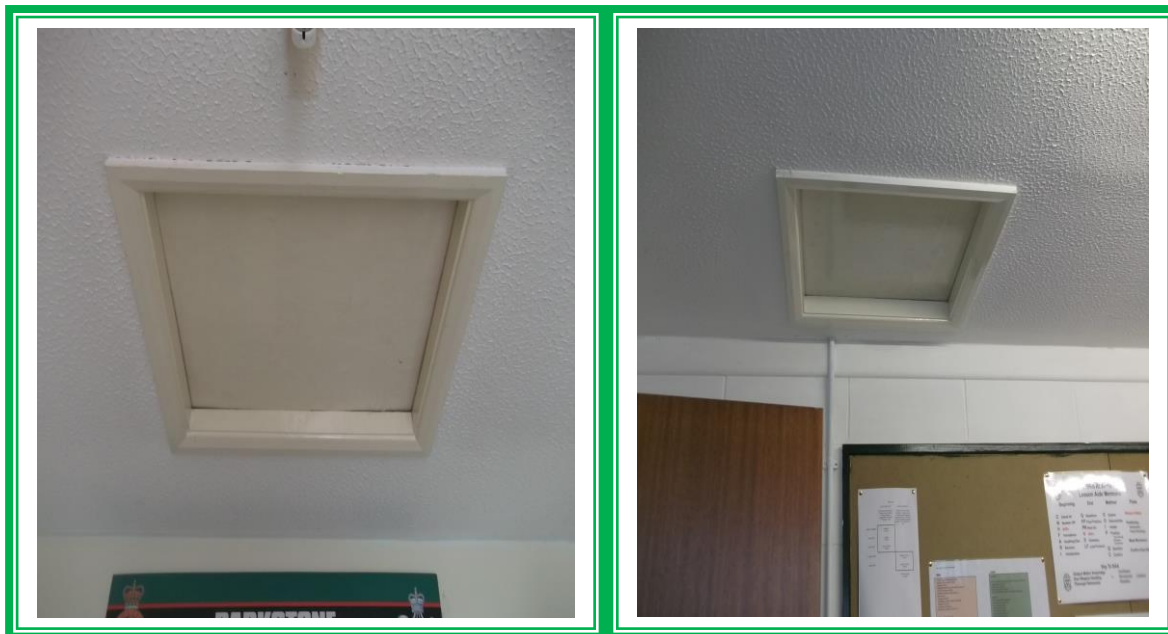
Item No: 7

Material Description:	Visual Inspection – No Suspect Materials Found	
Identification:	N/A	
Approx. quantity:	N/A	
Accessibility	N/A	<i>Assessment Score</i>
Product type:	N/A	N/A
Extent of Damage:	N/A	N/A
Surface Treatment:	N/A	N/A
Asbestos type:	N/A	N/A
Material Assessment Score:		N/A
Priority Assessment Score:		N/A
Action:	N/A	
Comments:	N/A

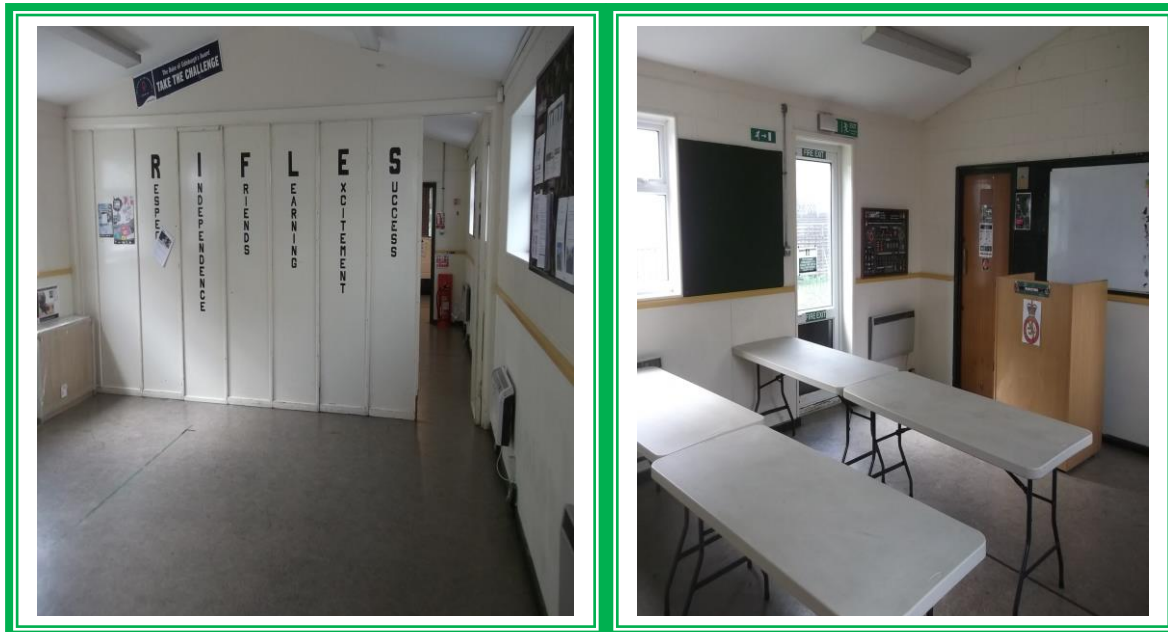
Item No: 8

Material Description:	Visual Inspection – No Suspect Materials Found	
Identification:	N/A	
Approx. quantity:	N/A	
Accessibility	N/A	Assessment Score
Product type:	N/A	N/A
Extent of Damage:	N/A	N/A
Surface Treatment:	N/A	N/A
Asbestos type:	N/A	N/A
Material Assessment Score:		N/A
Priority Assessment Score:		N/A
Action:	N/A	
Comments:	N/A

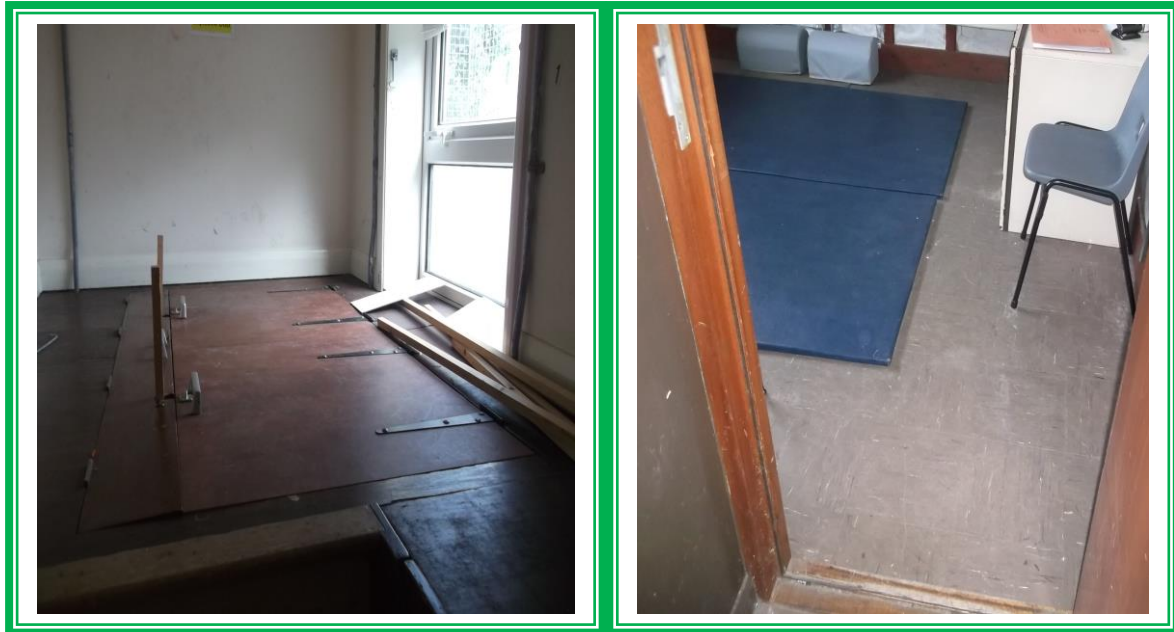
Item No: 9

Material Description:	Floor Tiles (GREY)	
Identification:	As Per Sample GR002 – No Asbestos Detected	
Approx. quantity:	2M2	
Accessibility	N/A	<i>Assessment Score</i>
Product type:	N/A	N/A
Extent of Damage:	N/A	N/A
Surface Treatment:	N/A	N/A
Asbestos type:	N/A	N/A
Material Assessment Score:		N/A
Priority Assessment Score:		N/A
Action:	N/A	
Comments:	N/A

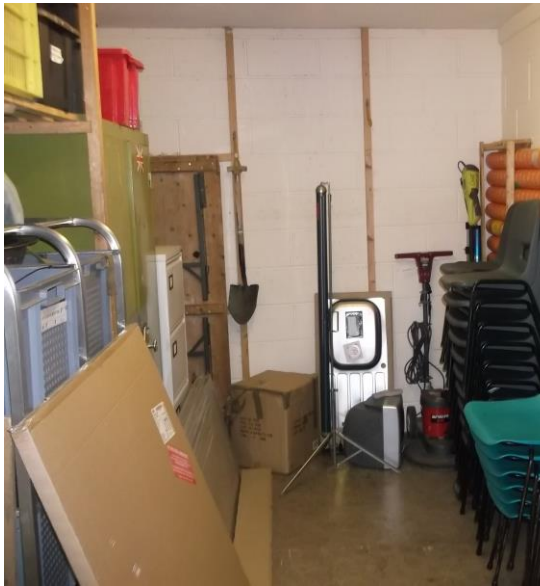
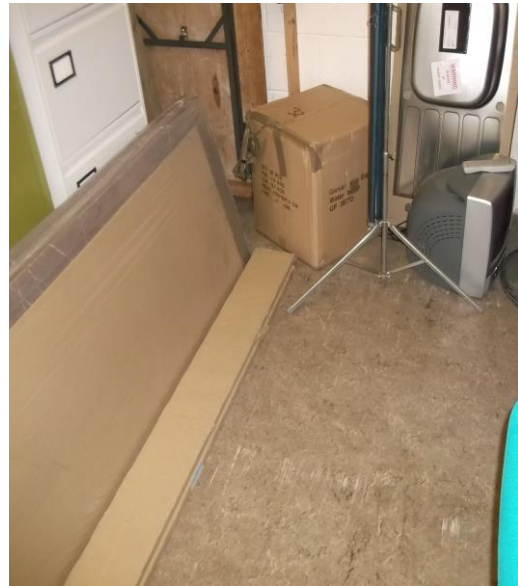
Item No: 10

Material Description:	Visual Inspection – No Suspect Materials Found	
Identification:	N/A	
Approx. quantity:	N/A	
Accessibility	N/A	<i>Assessment Score</i>
Product type:	N/A	N/A
Extent of Damage:	N/A	N/A
Surface Treatment:	N/A	N/A
Asbestos type:	N/A	N/A
Material Assessment Score:		N/A
Priority Assessment Score:		N/A
Action:	N/A	
Comments:	N/A

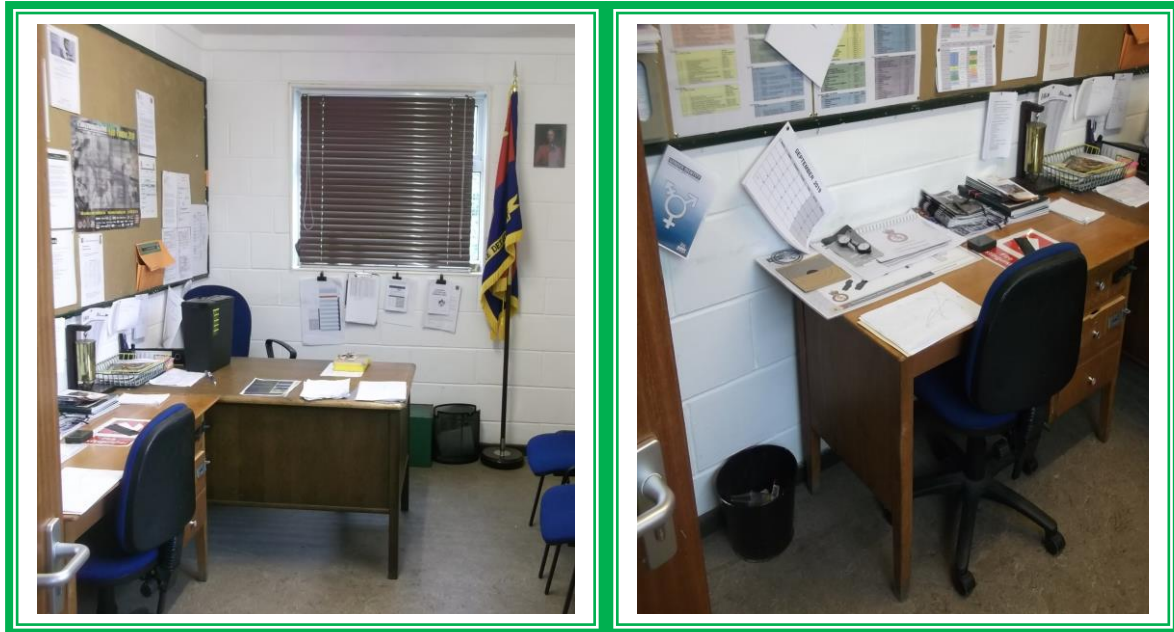
Item No: 11

Material Description:	Visual Inspection – No Suspect Materials Found	
Identification:	N/A	
Approx. quantity:	N/A	
Accessibility	N/A	<i>Assessment Score</i>
Product type:	N/A	N/A
Extent of Damage:	N/A	N/A
Surface Treatment:	N/A	N/A
Asbestos type:	N/A	N/A
Material Assessment Score:		N/A
Priority Assessment Score:		N/A
Action:	N/A	
Comments:	N/A
