Project Number A-00642 (3700)

**Re-Inspection
Asbestos Survey Report**

**Wellington Platoon
Somerset
TA21 8AX**

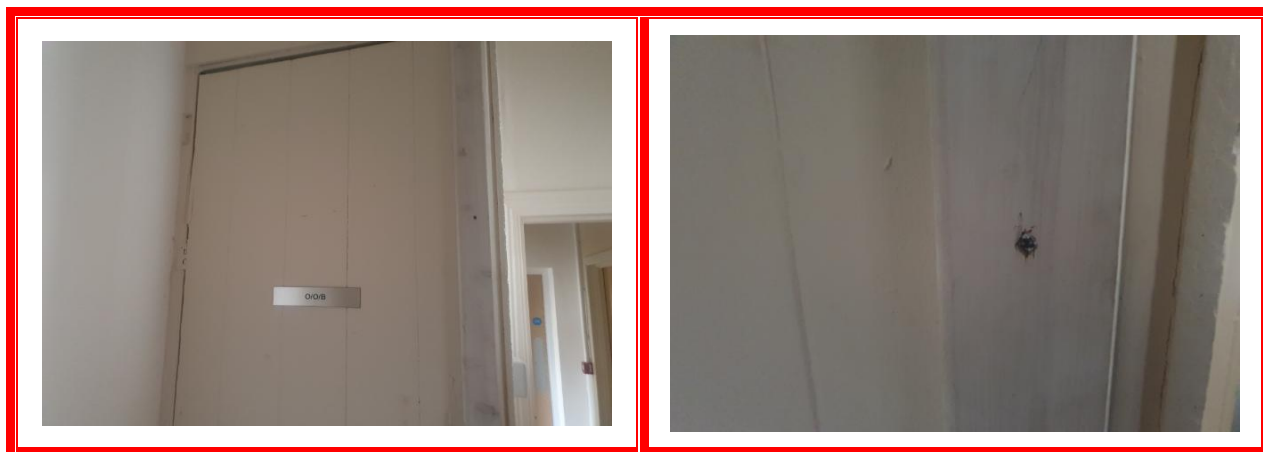
Item No:	2	Sample No:	N/A
Location:	Second Floor - Attic Area 002

Material Description:	All - No Access Gained	
Identification:	Presumed to Contain Asbestos	
Approx. quantity:	1 no	
Accessibility	Difficult	Assessment Score
Product type:	Pipe Insulation	3
Extent of Damage:	Major damage	3
Surface Treatment:	Unsealed Insulation	3
Asbestos type:	Amosite, Chrysotile, Crocidolite	3
Material Assessment Score:		12
Priority Assessment Score:		High
Action:	Further Investigation Needed	
Comments:	No access as the area is deemed unsafe and has been screwed shut

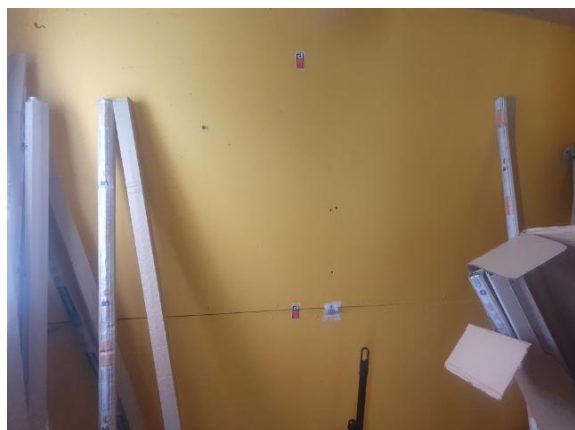
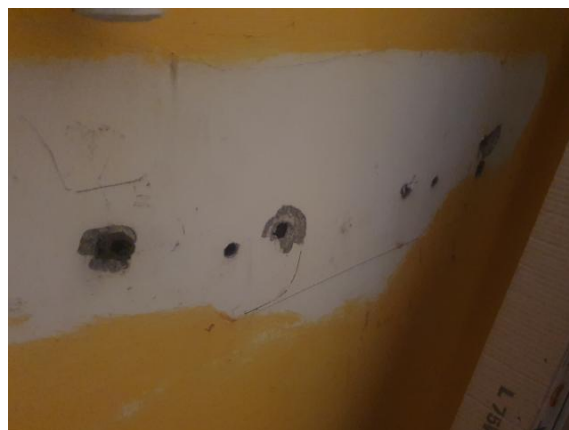
Location: Ground Floor - Store 003

Material Description:	Wall Panels - Insulating Board	
Identification:	Previously Sampled - Asbestos Detected	
Approx. quantity:	7 m ²	
Accessibility	Easy	Assessment Score
Product type:	Asbestos Insulating Board	2
Extent of Damage:	Moderate damage	2
Surface Treatment:	Unsealed AIB	2
Asbestos type:	Chrysotile	1
Material Assessment Score:		7
Priority Assessment Score:		Medium
Action:	Encapsulate	
Comments:	Previously sampled ref: Armour 6/11/19 Sample GR001. Several small areas of damage

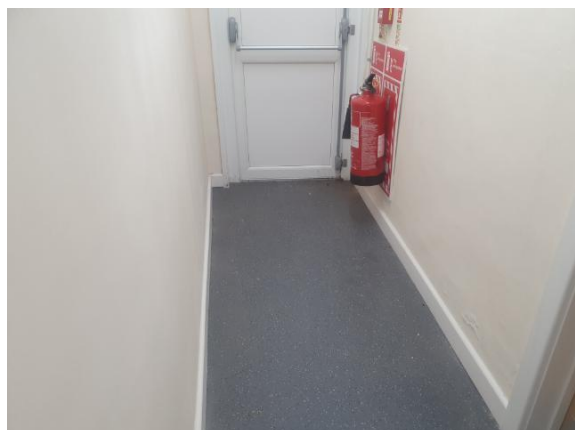
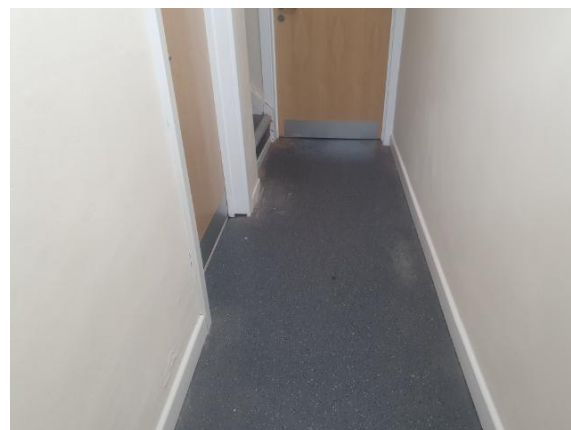
Location: Ground Floor - Hallway 004

Material Description:	Floor Tiles under Carpet - Vinyl Products	
Identification:	Strongly Presumed to Contain Asbestos	
Approx. quantity:	4 m ²	
Accessibility	Difficult	<i>Assessment Score</i>
Product type:	Vinyl	1
Extent of Damage:	Slight / minor damage	1
Surface Treatment:	Non-friable	0
Asbestos type:	Chrysotile	1
Material Assessment Score:		3
Priority Assessment Score:		Negligible
Action:	Manage	
Comments:	Site contact informed of floor tiles under the lino. Unable to lift lino to inspect or sample

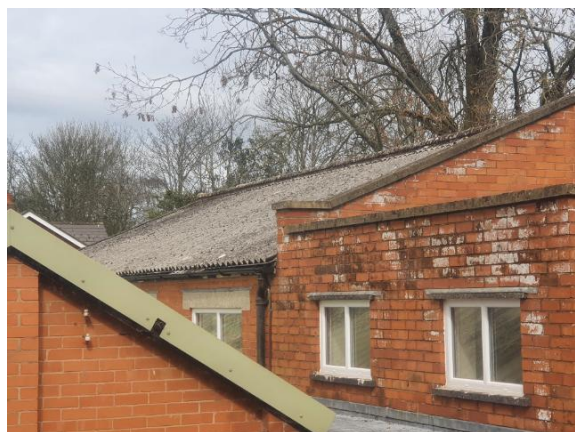
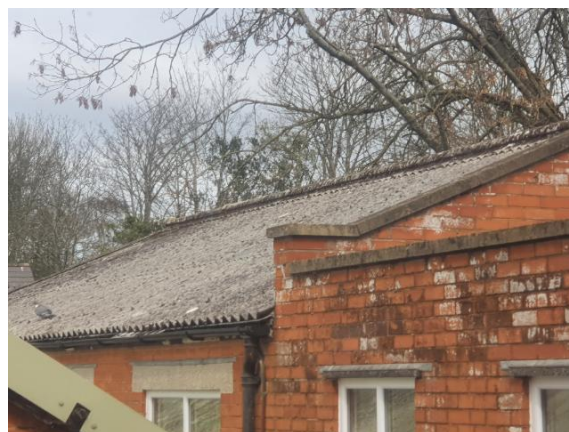
Location: External - Drill Hall 005

Material Description:	Profiled Roof - Cement Product	
Identification:	Strongly Presumed to Contain Asbestos	
Approx. quantity:	225 m ²	
Accessibility	Difficult	<i>Assessment Score</i>
Product type:	Vinyl	1
Extent of Damage:	Slight / minor damage	1
Surface Treatment:	Unsealed Cement	1
Asbestos type:	Chrysotile	1
Material Assessment Score:		4
Priority Assessment Score:		Negligible
Action:	Manage	
Comments:	To drill hall roof only

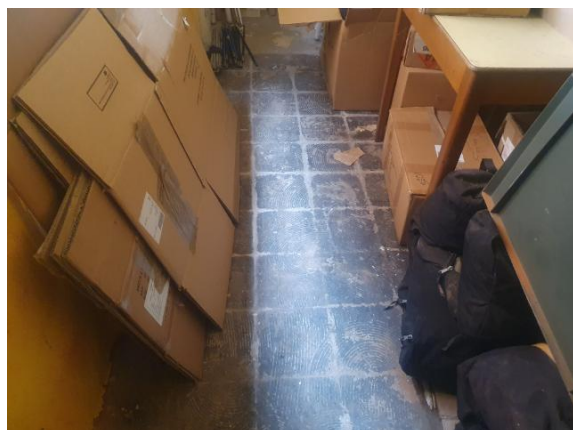
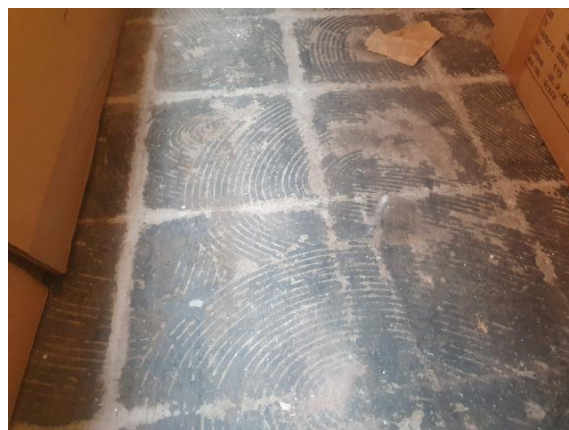
Location: Ground Floor - Store 006

Material Description:	Bitumen to Floor - Bituminous Product	
Identification:	Strongly Presumed to Contain Asbestos	
Approx. quantity:	8 m ²	
Accessibility	Easy	<i>Assessment Score</i>
Product type:	Bitumen	1
Extent of Damage:	Moderate damage	2
Surface Treatment:	Non-friable	0
Asbestos type:	Chrysotile	1
Material Assessment Score:		4
Priority Assessment Score:		Negligible
Action:	Manage	
Comments:	N/A

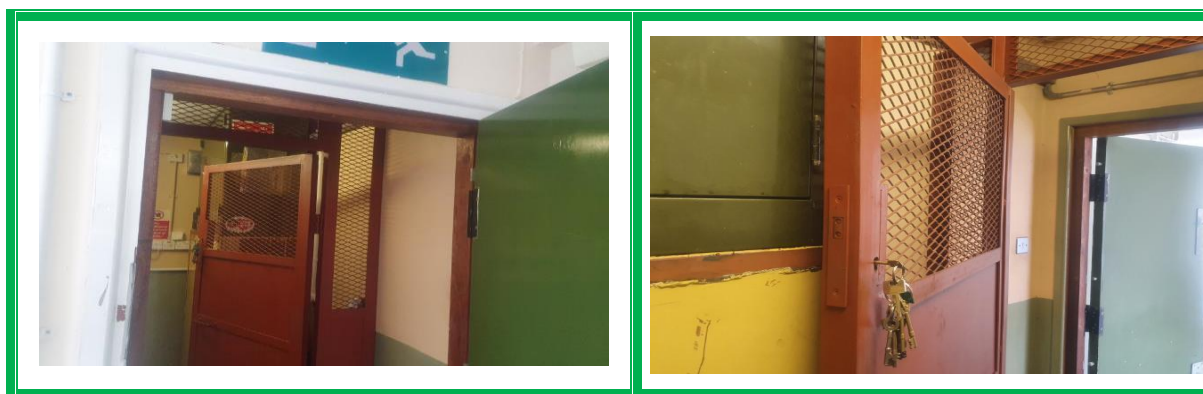
Item No:	1	Sample No:	N/A
Location:	First Floor - Armoury 001

Material Description:	No Suspect Materials Found	
Identification:	N/A	
Approx. quantity:	N/A	
Accessibility	N/A	<i>Assessment Score</i>
Product type:	N/A	N/A
Extent of Damage:	N/A	N/A
Surface Treatment:	N/A	N/A
Asbestos type:	N/A	N/A
Material Assessment Score:		N/A
Priority Assessment Score:		N/A
Action:	N/A	
Comments:	Previously a no access area. Now accessed and no asbestos found
