**Project Number 2481**

**Management  
Asbestos Survey Report**

**Chard Platoon, Somerset, TA20 1AE**

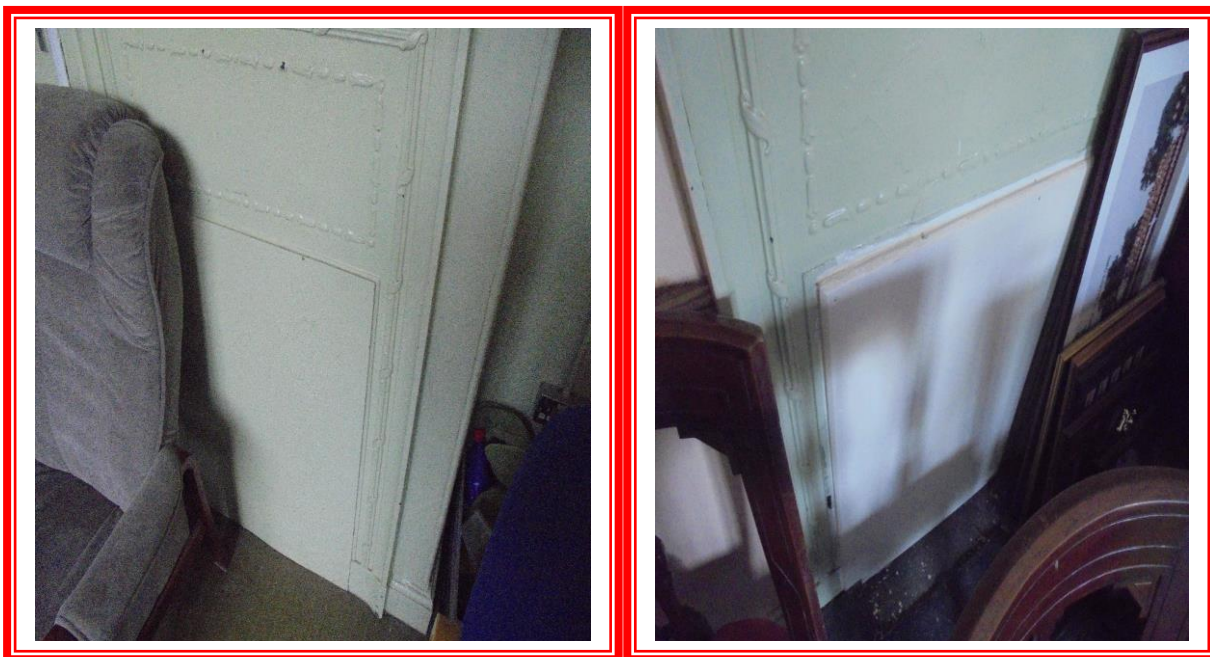
**Item No: 4**

Item 4 – Offices – First Floor – Fireplace Panels – No access without damage to the panel  
 Item 11 – WC and Washroom – First Floor – Toilet Seat – No sample possible without damage  
 Item 15 – Mess Room - Fireplace Panels – No access without damage to the panel

<b>Material Description:</b>	No access behind Timber Fireplace Panels	
<b>Identification:</b>	Presumed to Contain Asbestos	
<b>Approx. quantity:</b>	X 2 Fireplaces	
<b>Accessibility</b>	Low	<i>Assessment Score</i>
<b>Product type:</b>	No Access	2
<b>Extent of Damage:</b>	No Access	2
<b>Surface Treatment:</b>	No Access	2
<b>Asbestos type:</b>	No Access	2
<b>Material Assessment Score:</b>		8
<b>Priority Assessment Score:</b>		Medium
<b>Action:</b>	Manage	
<b>Comments:</b>	No access without causing damage to the panel

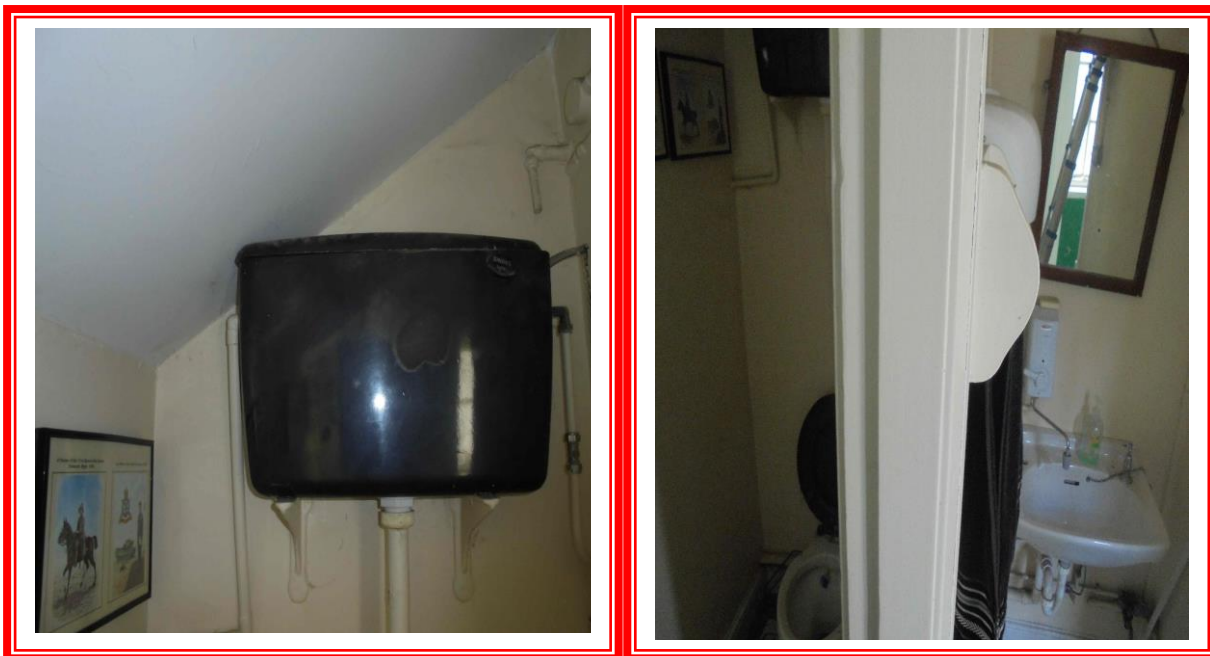
**Item No: 10****Sample No: 3****Location: WC and Washroom – First Floor**

<b>Material Description:</b>	Reinforced Plastic Toilet Cistern	
<b>Identification:</b>	Sampled – Asbestos Detected	
<b>Approx. quantity:</b>	X 1 Cistern	
<b>Accessibility</b>	Medium	<i>Assessment Score</i>
<b>Product type:</b>	Composite	1
<b>Extent of Damage:</b>	Minor	1
<b>Surface Treatment:</b>	Non-Friable	0
<b>Asbestos type:</b>	Amosite	2
<b>Material Assessment Score:</b>		4
<b>Priority Assessment Score:</b>		Negligible
<b>Action:</b>	Manage	
<b>Comments:</b>	N/A

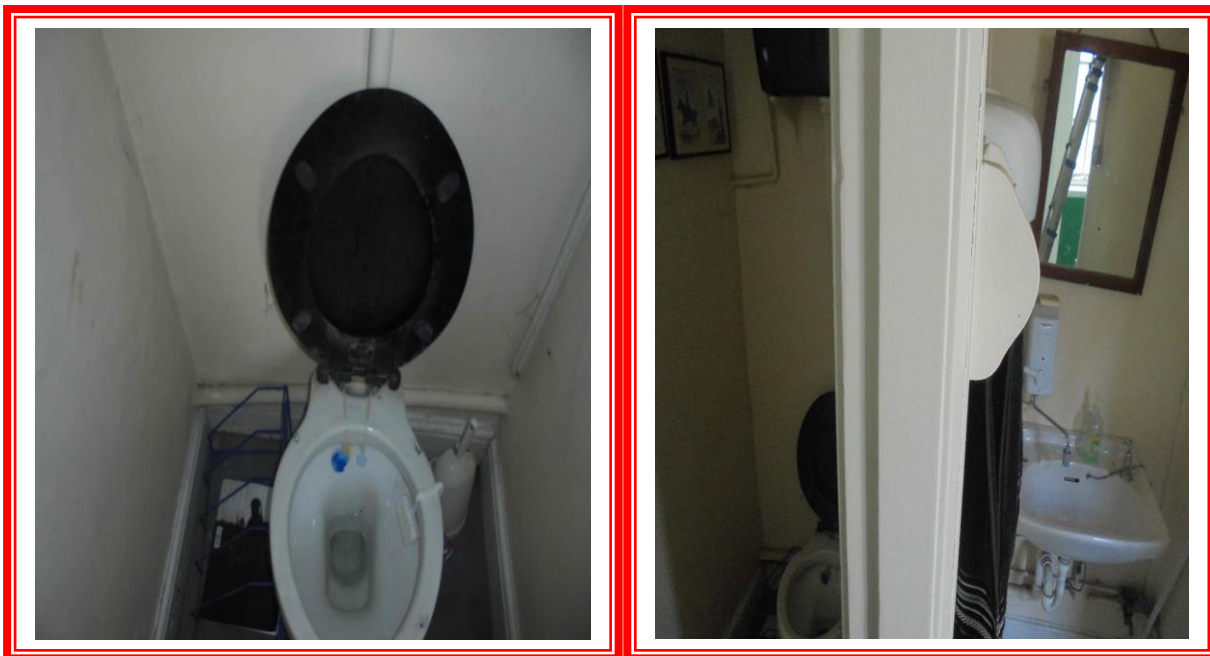
**Item No: 11**

<b>Material Description:</b>	Reinforced Plastic Toilet Seat	
<b>Identification:</b>	Presumed to Contain Asbestos	
<b>Approx. quantity:</b>	X 1 Seat	
<b>Accessibility</b>	High	<i>Assessment Score</i>
<b>Product type:</b>	Composite	1
<b>Extent of Damage:</b>	Minor	1
<b>Surface Treatment:</b>	Non-Friable	0
<b>Asbestos type:</b>	Amosite	2
<b>Material Assessment Score:</b>		4
<b>Priority Assessment Score:</b>		Negligible
<b>Action:</b>	Manage	
<b>Comments:</b>	Not samples as it would damage the integrity of the seat

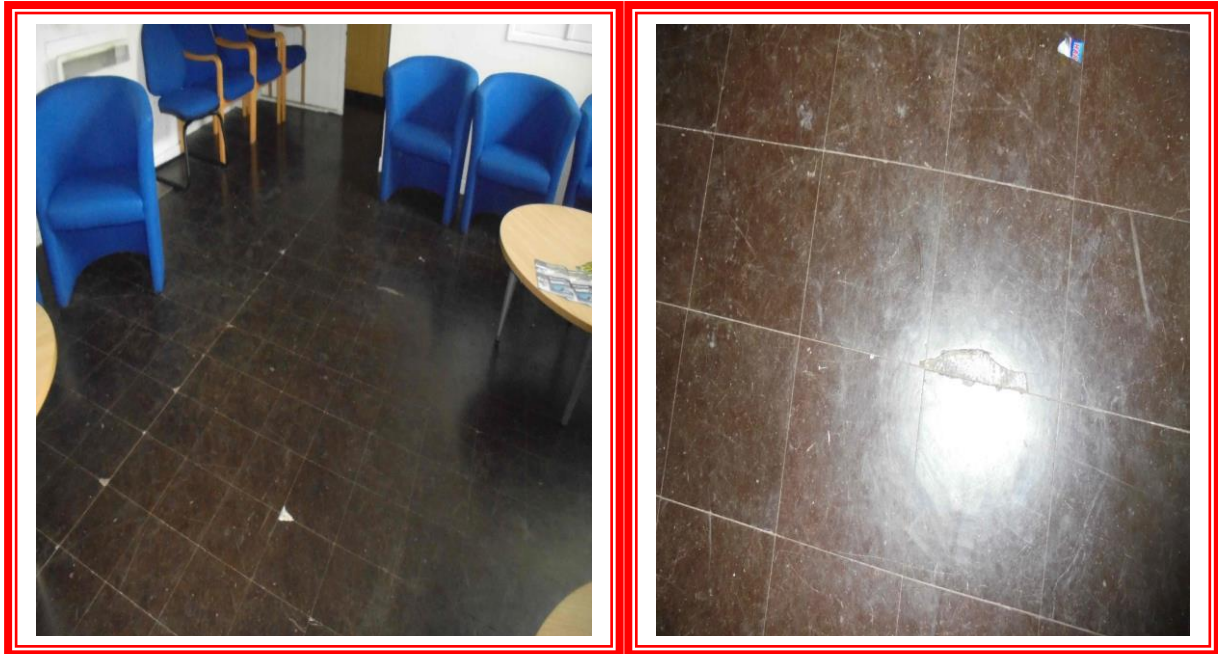
**Item No: 14**

<b>Material Description:</b>	Floor Tiles and Adhesive	
<b>Identification:</b>	Sampled – Asbestos Detected	
<b>Approx. quantity:</b>	40M2	
<b>Accessibility</b>	High	Assessment Score
<b>Product type:</b>	Composite	1
<b>Extent of Damage:</b>	Moderate	2
<b>Surface Treatment:</b>	Non-Friable	0
<b>Asbestos type:</b>	Chrysotile	1
<b>Material Assessment Score:</b>		4
<b>Priority Assessment Score:</b>		Negligible
<b>Action:</b>	Manage	
<b>Comments:</b>	N/A

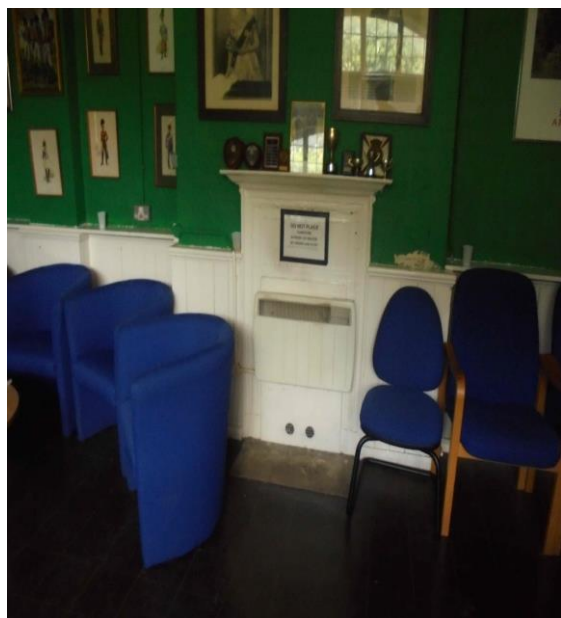
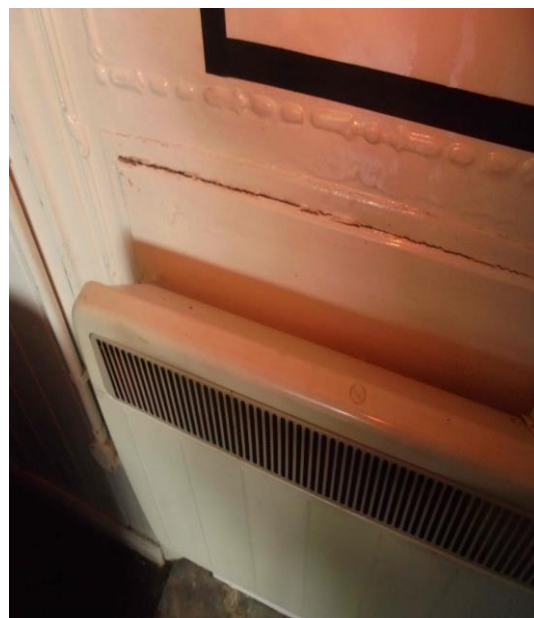
**Item No: 15**

<b>Material Description:</b>	No Access Behind Panel to Fireplace	
<b>Identification:</b>	Presumed to Contain Asbestos	
<b>Approx. quantity:</b>	X 1 Fireplace	
<b>Accessibility</b>	Low	Assessment Score
<b>Product type:</b>	No Access	2
<b>Extent of Damage:</b>	No Access	2
<b>Surface Treatment:</b>	No Access	2
<b>Asbestos type:</b>	No Access	2
<b>Material Assessment Score:</b>		8
<b>Priority Assessment Score:</b>		Medium
<b>Action:</b>	Manage	
<b>Comments:</b>	No Access without irreparable damage to panel

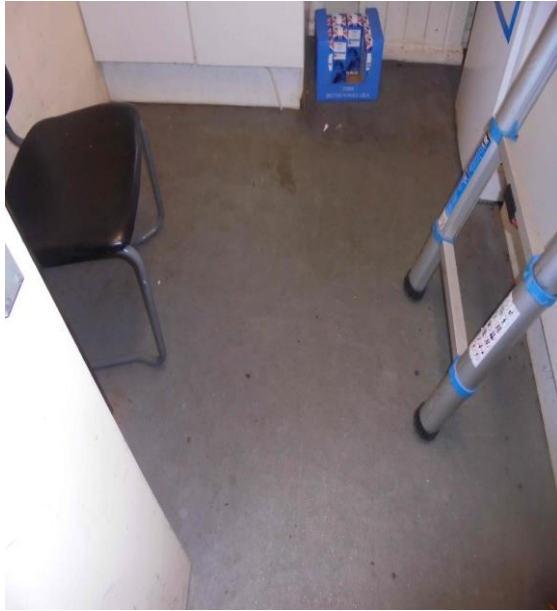
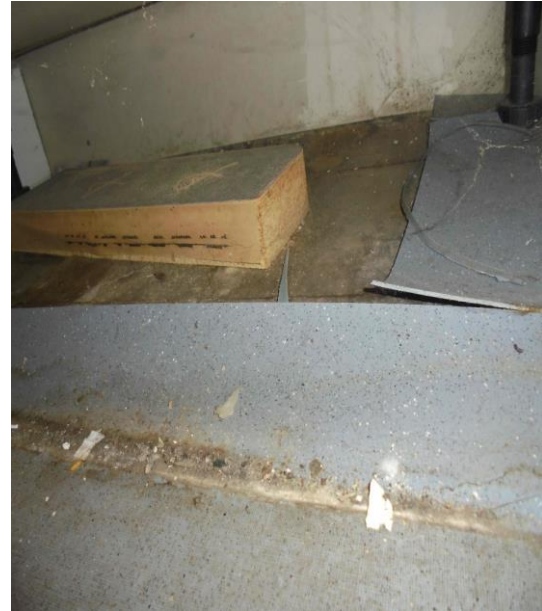
**Item No: 16****Sample No: N/A****Location: Kitchen – Ground Floor**

<b>Material Description:</b>	Floor Tiles and Adhesive	
<b>Identification:</b>	As Per Sample DK/4 – Asbestos Detected	
<b>Approx. quantity:</b>	9M2	
<b>Accessibility</b>	Low	<i>Assessment Score</i>
<b>Product type:</b>	Composite	1
<b>Extent of Damage:</b>	Minor	1
<b>Surface Treatment:</b>	Non-Friable	0
<b>Asbestos type:</b>	Chrysotile	1
<b>Material Assessment Score:</b>		3
<b>Priority Assessment Score:</b>		Negligible
<b>Action:</b>	Manage	
<b>Comments:</b>	Located under lino, visible under kitchen units

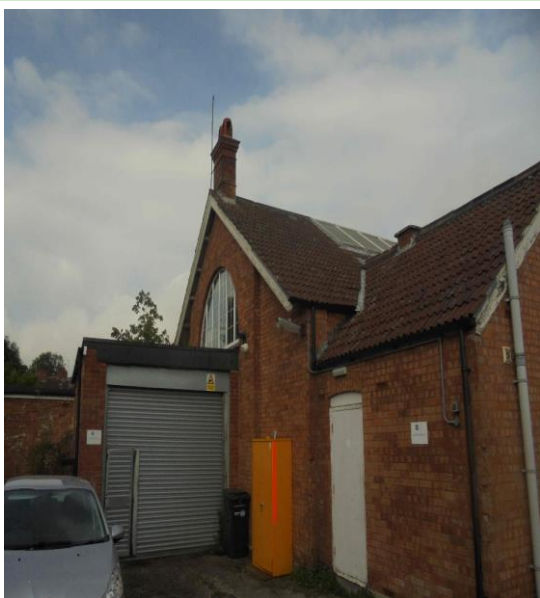
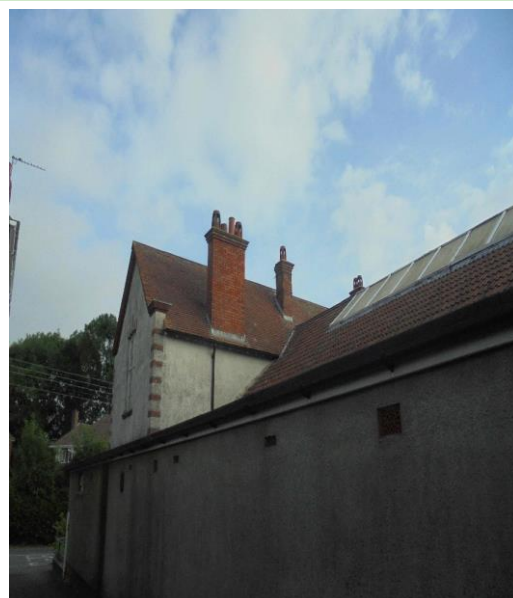
**Item No: 1**

<b>Material Description:</b>	Visual Inspection – No Suspect Materials Found	
<b>Identification:</b>	N/A	
<b>Approx. quantity:</b>	N/A	
<b>Accessibility</b>	N/A	<i>Assessment Score</i>
<b>Product type:</b>		N/A
<b>Extent of Damage:</b>		N/A
<b>Surface Treatment:</b>		N/A
<b>Asbestos type:</b>		N/A
<b>Material Assessment Score:</b>		N/A
<b>Priority Assessment Score:</b>		N/A
<b>Action:</b>	N/A	
<b>Comments:</b>	N/A

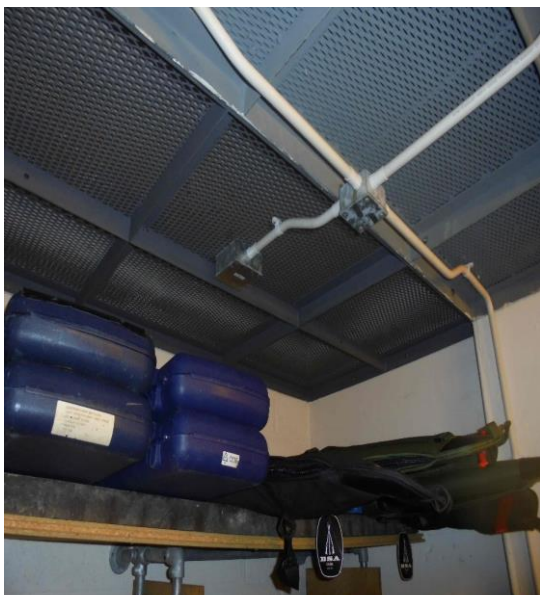
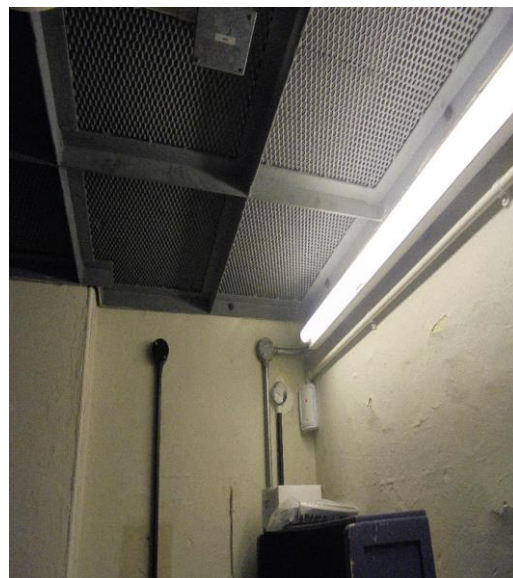
**Item No: 2**

<b>Material Description:</b>	Visual Inspection – No Suspect Materials Found	
<b>Identification:</b>	N/A	
<b>Approx. quantity:</b>	N/A	
<b>Accessibility</b>	N/A	<i>Assessment Score</i>
<b>Product type:</b>		N/A
<b>Extent of Damage:</b>		N/A
<b>Surface Treatment:</b>		N/A
<b>Asbestos type:</b>		N/A
<b>Material Assessment Score:</b>		N/A
<b>Priority Assessment Score:</b>		N/A
<b>Action:</b>	N/A	
<b>Comments:</b>	No access above metal ceiling

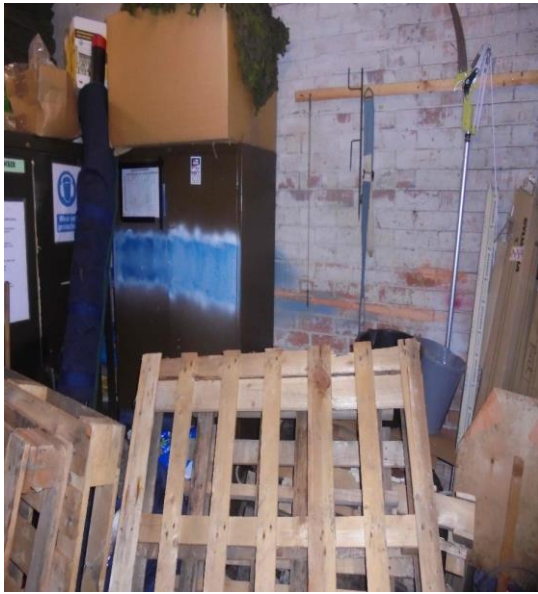
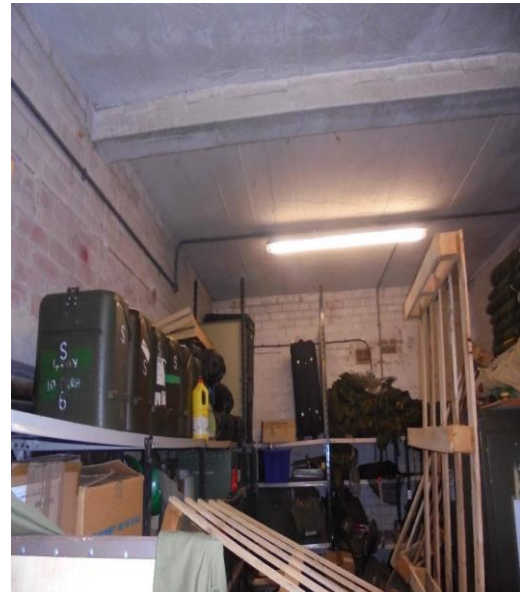
**Item No: 3**

<b>Material Description:</b>	Visual Inspection – No Suspect Materials Found	
<b>Identification:</b>	N/A	
<b>Approx. quantity:</b>	N/A	
<b>Accessibility</b>	N/A	<i>Assessment Score</i>
<b>Product type:</b>		N/A
<b>Extent of Damage:</b>		N/A
<b>Surface Treatment:</b>		N/A
<b>Asbestos type:</b>		N/A
<b>Material Assessment Score:</b>		N/A
<b>Priority Assessment Score:</b>		N/A
<b>Action:</b>	N/A	
<b>Comments:</b>	Limited access to inspect due to stored items

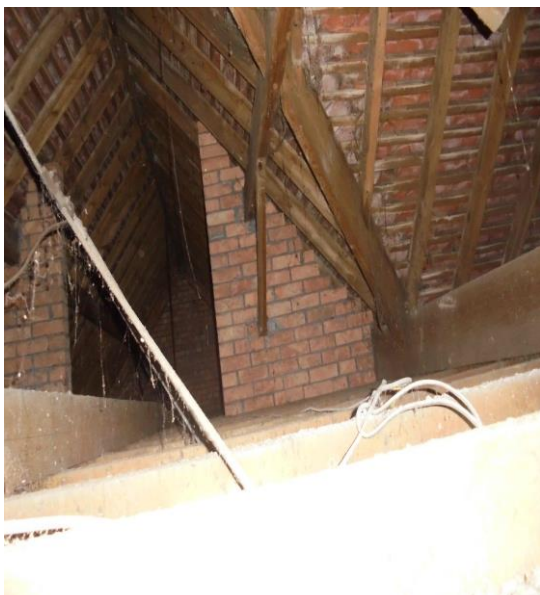
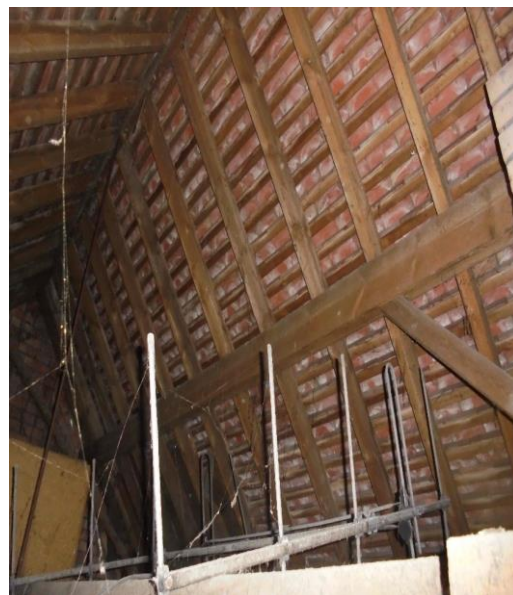
**Item No: 5**

<b>Material Description:</b>	Visual Inspection – No Suspect Materials Found	
<b>Identification:</b>	N/A	
<b>Approx. quantity:</b>	N/A	
<b>Accessibility</b>	N/A	<i>Assessment Score</i>
<b>Product type:</b>		N/A
<b>Extent of Damage:</b>		N/A
<b>Surface Treatment:</b>		N/A
<b>Asbestos type:</b>		N/A
<b>Material Assessment Score:</b>		N/A
<b>Priority Assessment Score:</b>		N/A
<b>Action:</b>	N/A	
<b>Comments:</b>	Limited access into loft space due to height of hatch

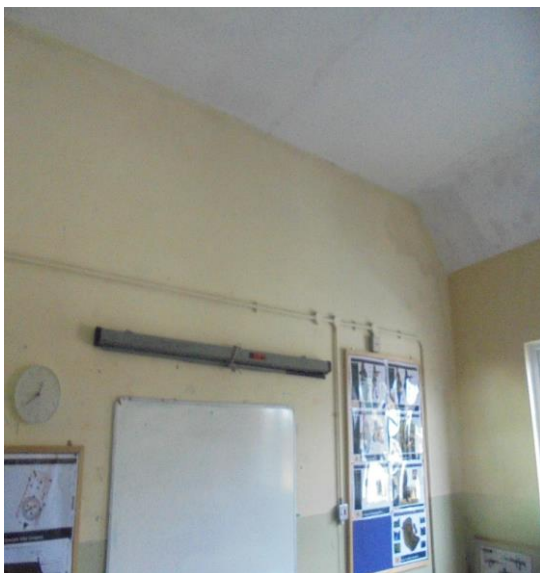
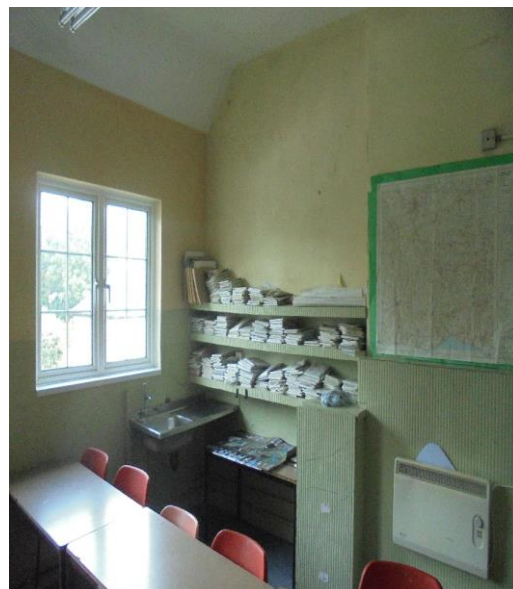
**Item No: 6****Sample No: N/A****Location: Classroom – First Floor**

<b>Material Description:</b>	Visual Inspection – No Suspect Materials Found	
<b>Identification:</b>	N/A	
<b>Approx. quantity:</b>	N/A	
<b>Accessibility</b>	N/A	<i>Assessment Score</i>
<b>Product type:</b>		N/A
<b>Extent of Damage:</b>		N/A
<b>Surface Treatment:</b>		N/A
<b>Asbestos type:</b>		N/A
<b>Material Assessment Score:</b>		N/A
<b>Priority Assessment Score:</b>		N/A
<b>Action:</b>	N/A	
<b>Comments:</b>	No access within timber boxing

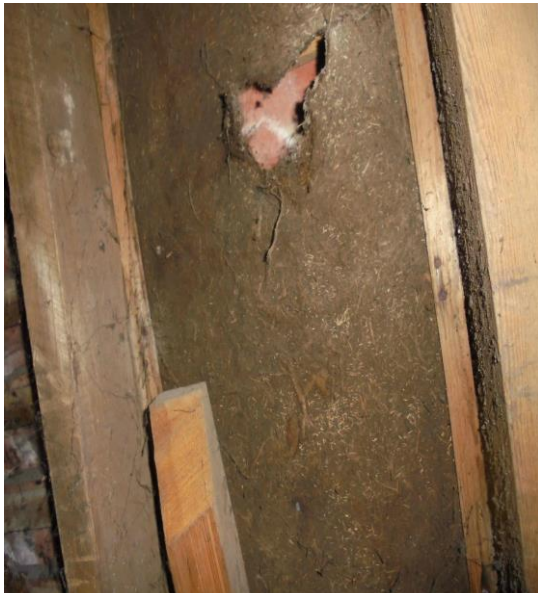
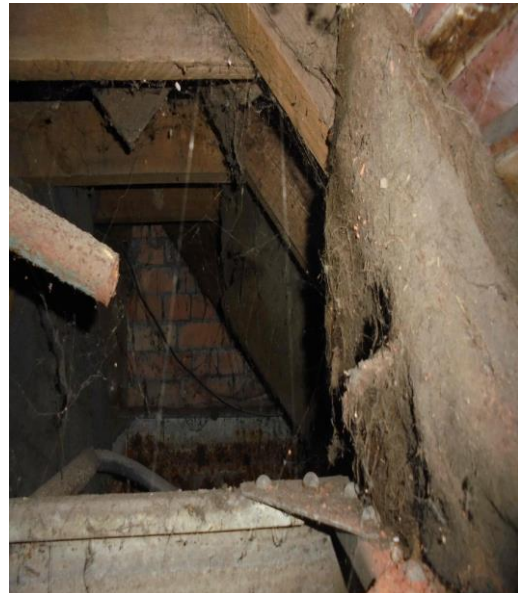
**Item No: 7**

<b>Material Description:</b>	Felt to Underside of Roof	
<b>Identification:</b>	Sampled – No Asbestos Detected	
<b>Approx. quantity:</b>	10M2	
<b>Accessibility</b>	N/A	<i>Assessment Score</i>
<b>Product type:</b>		N/A
<b>Extent of Damage:</b>		N/A
<b>Surface Treatment:</b>		N/A
<b>Asbestos type:</b>		N/A
<b>Material Assessment Score:</b>		N/A
<b>Priority Assessment Score:</b>		N/A
<b>Action:</b>	N/A	
<b>Comments:</b>	Limited access into loft space due to minimal space

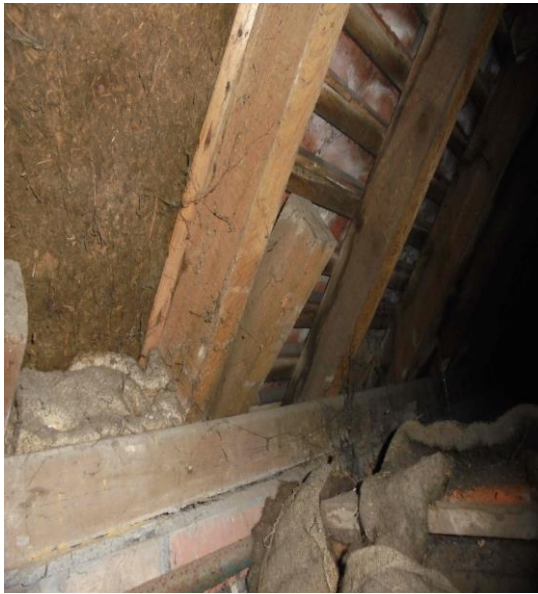
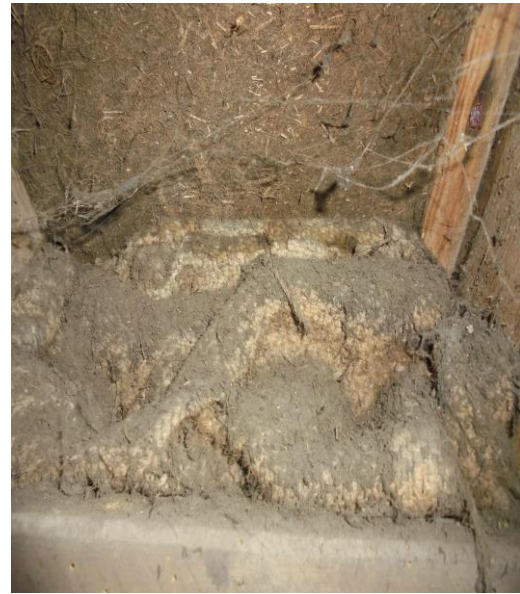
**Item No: 8****Sample No: 2****Location: Corridor Loft Space**

<b>Material Description:</b>	Textile Packers under Roof Brackets	
<b>Identification:</b>	Sampled – No Asbestos Detected	
<b>Approx. quantity:</b>	1M2	
<b>Accessibility</b>	N/A	<i>Assessment Score</i>
<b>Product type:</b>		N/A
<b>Extent of Damage:</b>		N/A
<b>Surface Treatment:</b>		N/A
<b>Asbestos type:</b>		N/A
<b>Material Assessment Score:</b>		N/A
<b>Priority Assessment Score:</b>		N/A
<b>Action:</b>	N/A	
<b>Comments:</b>	N/A

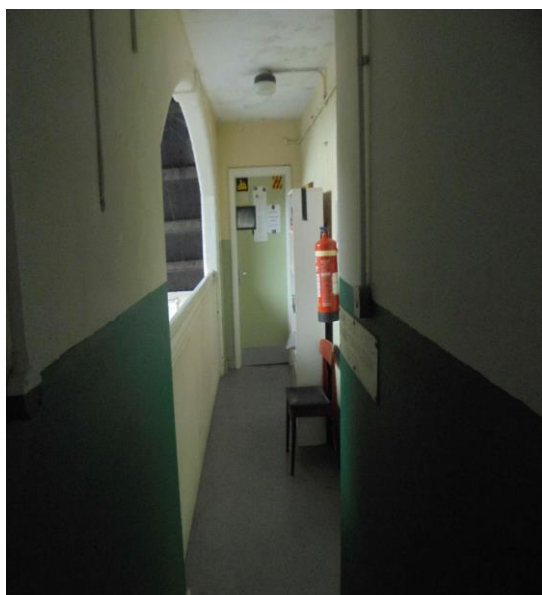
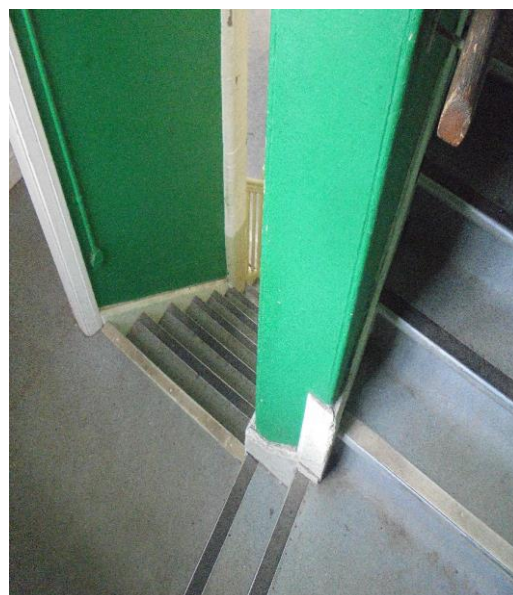
**Item No: 9**

<b>Material Description:</b>	Visual Inspection – No Suspect Materials Found	
<b>Identification:</b>	N/A	
<b>Approx. quantity:</b>	N/A	
<b>Accessibility</b>	N/A	<i>Assessment Score</i>
<b>Product type:</b>		N/A
<b>Extent of Damage:</b>		N/A
<b>Surface Treatment:</b>		N/A
<b>Asbestos type:</b>		N/A
<b>Material Assessment Score:</b>		N/A
<b>Priority Assessment Score:</b>		N/A
<b>Action:</b>	N/A	
<b>Comments:</b>	Modern Stair Nosing

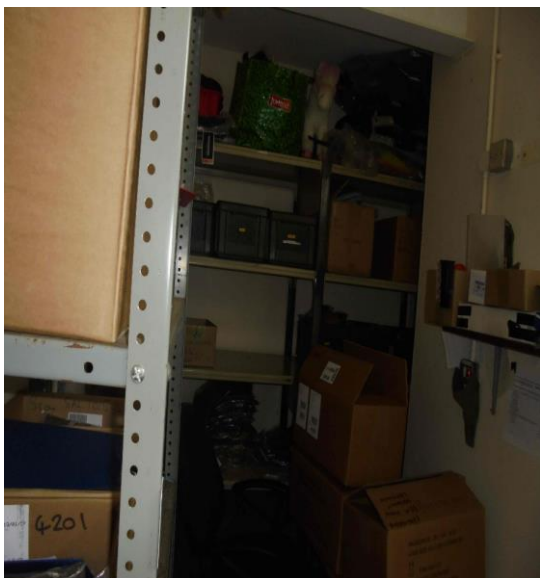
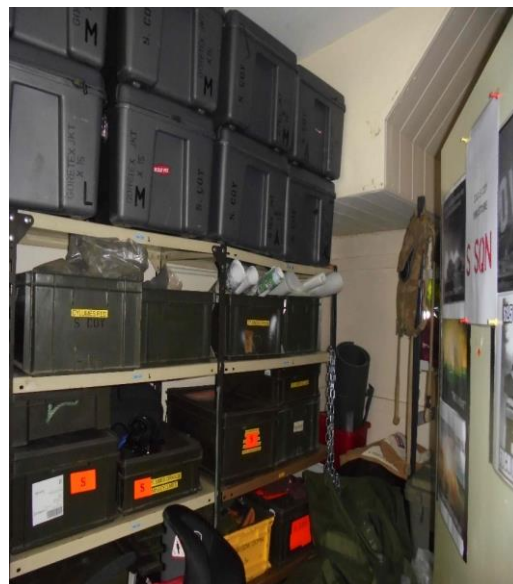
**Item No: 12**

<b>Material Description:</b>	Visual Inspection – No Suspect Materials Found	
<b>Identification:</b>	N/A	
<b>Approx. quantity:</b>	N/A	
<b>Accessibility</b>	N/A	<i>Assessment Score</i>
<b>Product type:</b>		N/A
<b>Extent of Damage:</b>		N/A
<b>Surface Treatment:</b>		N/A
<b>Asbestos type:</b>		N/A
<b>Material Assessment Score:</b>		N/A
<b>Priority Assessment Score:</b>		N/A
<b>Action:</b>	N/A	
<b>Comments:</b>	Limited access into room due to stored items

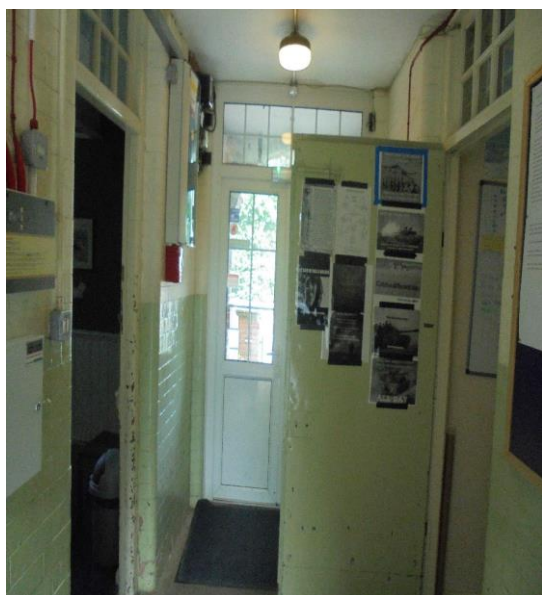
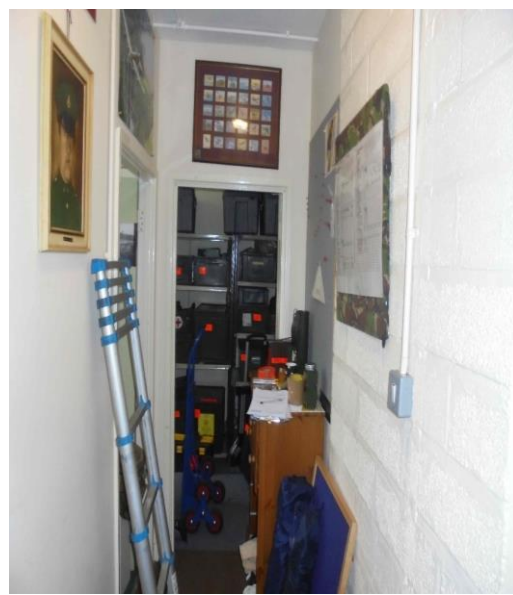
**Item No: 13**

<b>Material Description:</b>	Visual Inspection – No Suspect Materials Found	
<b>Identification:</b>	N/A	
<b>Approx. quantity:</b>	N/A	
<b>Accessibility</b>	N/A	<i>Assessment Score</i>
<b>Product type:</b>		N/A
<b>Extent of Damage:</b>		N/A
<b>Surface Treatment:</b>		N/A
<b>Asbestos type:</b>		N/A
<b>Material Assessment Score:</b>		N/A
<b>Priority Assessment Score:</b>		N/A
<b>Action:</b>	N/A	
<b>Comments:</b>	Modern Electrics

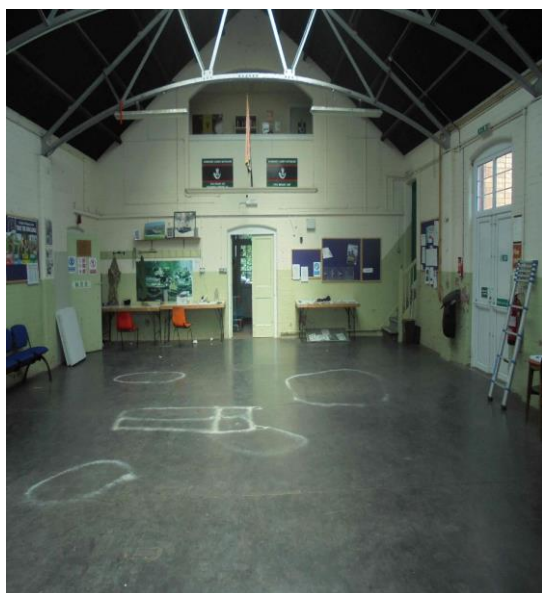
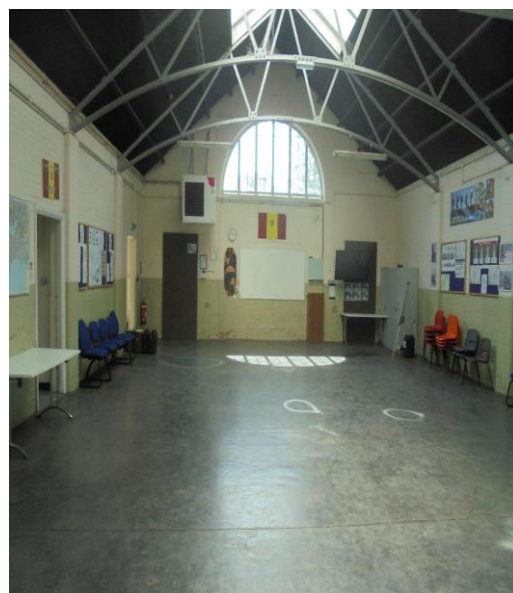
**Item No: 17****Sample No: N/A****Location: Drill Hall – Ground Floor**

<b>Material Description:</b>	Visual Inspection – No Suspect Materials Found	
<b>Identification:</b>	N/A	
<b>Approx. quantity:</b>	N/A	
<b>Accessibility</b>	N/A	<i>Assessment Score</i>
<b>Product type:</b>		N/A
<b>Extent of Damage:</b>		N/A
<b>Surface Treatment:</b>		N/A
<b>Asbestos type:</b>		N/A
<b>Material Assessment Score:</b>		N/A
<b>Priority Assessment Score:</b>		N/A
<b>Action:</b>	N/A	
<b>Comments:</b>	N/A

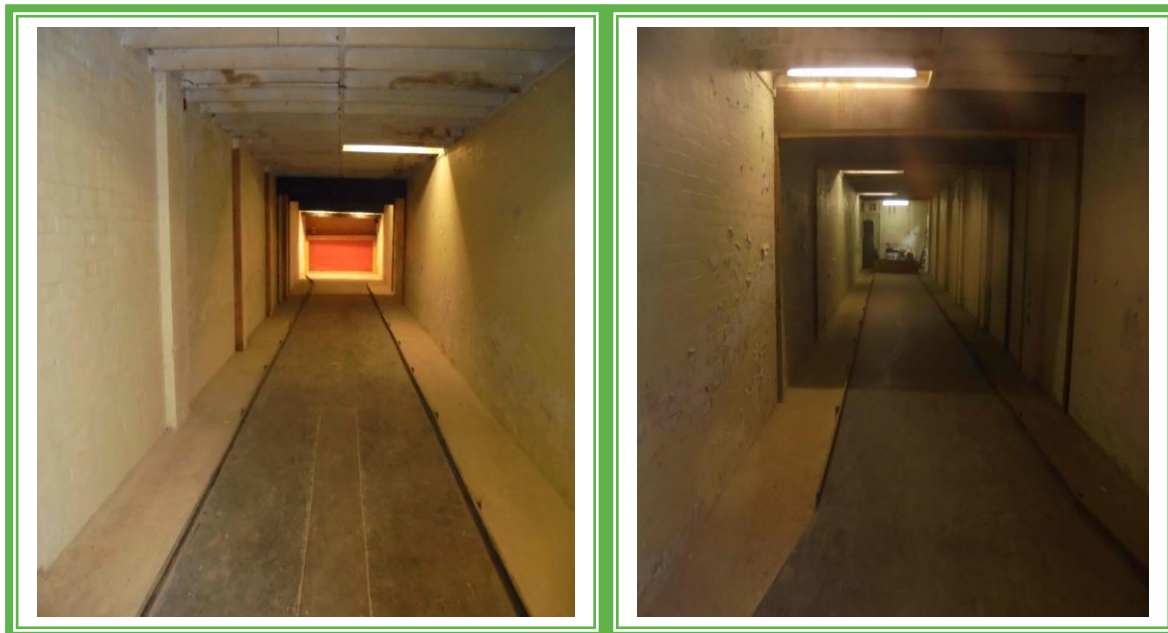
**Item No: 18**

<b>Material Description:</b>	Visual Inspection – No Suspect Materials Found	
<b>Identification:</b>	N/A	
<b>Approx. quantity:</b>	N/A	
<b>Accessibility</b>	N/A	<i>Assessment Score</i>
<b>Product type:</b>		N/A
<b>Extent of Damage:</b>		N/A
<b>Surface Treatment:</b>		N/A
<b>Asbestos type:</b>		N/A
<b>Material Assessment Score:</b>		N/A
<b>Priority Assessment Score:</b>		N/A
<b>Action:</b>	N/A	
<b>Comments:</b>	N/A

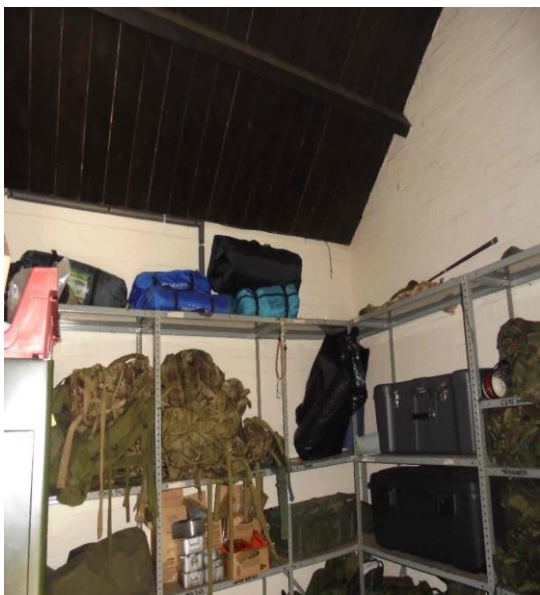
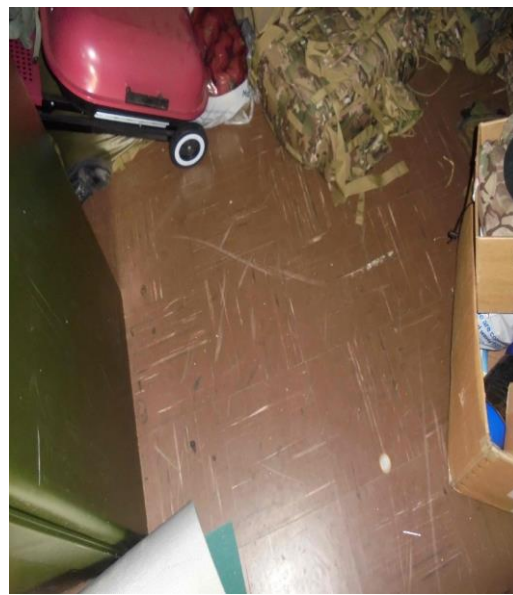
**Item No: 19****Sample No: 5****Location: Store – Ground Floor**

<b>Material Description:</b>	Floor Tiles	
<b>Identification:</b>	Sampled – No Asbestos Detected	
<b>Approx. quantity:</b>	14M2	
<b>Accessibility</b>	N/A	<i>Assessment Score</i>
<b>Product type:</b>		N/A
<b>Extent of Damage:</b>		N/A
<b>Surface Treatment:</b>		N/A
<b>Asbestos type:</b>		N/A
<b>Material Assessment Score:</b>		N/A
<b>Priority Assessment Score:</b>		N/A
<b>Action:</b>	N/A	
<b>Comments:</b>	N/A

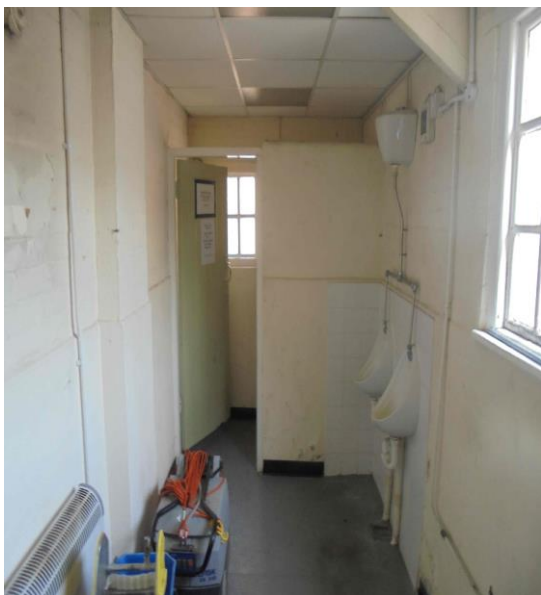
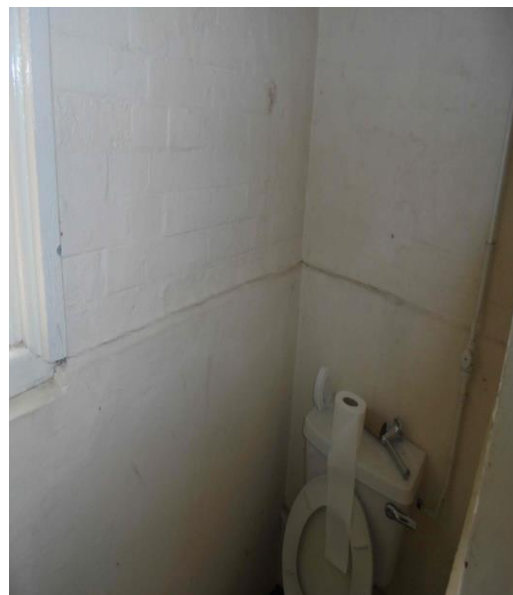
**Item No: 20**

<b>Material Description:</b>	Visual Inspection – No Suspect Materials Found	
<b>Identification:</b>	N/A	
<b>Approx. quantity:</b>	N/A	
<b>Accessibility</b>	N/A	<i>Assessment Score</i>
<b>Product type:</b>		N/A
<b>Extent of Damage:</b>		N/A
<b>Surface Treatment:</b>		N/A
<b>Asbestos type:</b>		N/A
<b>Material Assessment Score:</b>		N/A
<b>Priority Assessment Score:</b>		N/A
<b>Action:</b>	N/A	
<b>Comments:</b>	N/A

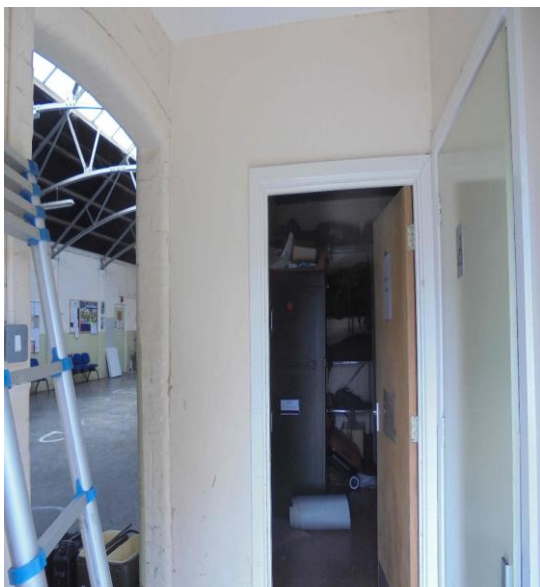
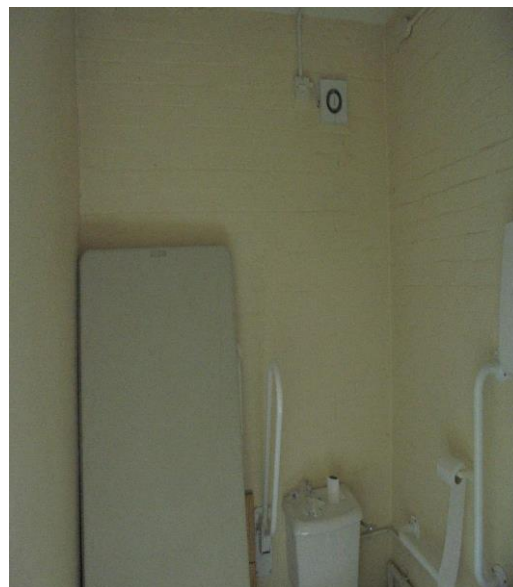
**Item No: 21**

<b>Material Description:</b>	Visual Inspection – No Suspect Materials Found	
<b>Identification:</b>	N/A	
<b>Approx. quantity:</b>	N/A	
<b>Accessibility</b>	N/A	<i>Assessment Score</i>
<b>Product type:</b>		N/A
<b>Extent of Damage:</b>		N/A
<b>Surface Treatment:</b>		N/A
<b>Asbestos type:</b>		N/A
<b>Material Assessment Score:</b>		N/A
<b>Priority Assessment Score:</b>		N/A
<b>Action:</b>	N/A	
<b>Comments:</b>	N/A

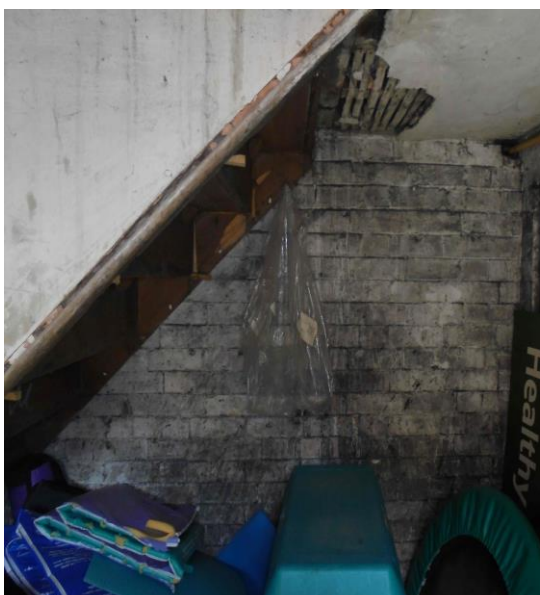
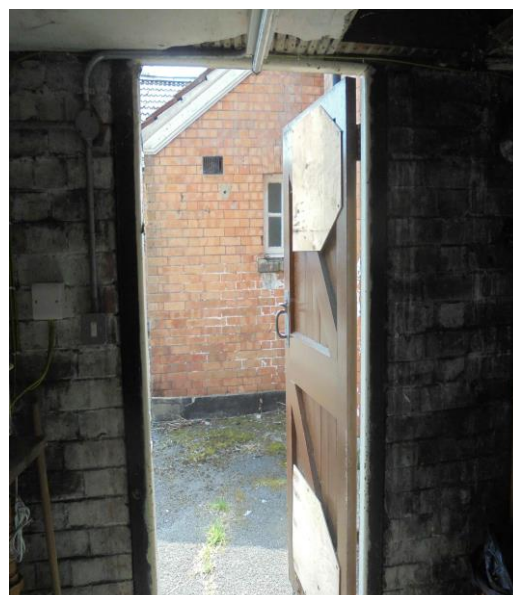
**Item No: 22**

<b>Material Description:</b>	Visual Inspection – No Suspect Materials Found	
<b>Identification:</b>	N/A	
<b>Approx. quantity:</b>	N/A	
<b>Accessibility</b>	N/A	<i>Assessment Score</i>
<b>Product type:</b>		N/A
<b>Extent of Damage:</b>		N/A
<b>Surface Treatment:</b>		N/A
<b>Asbestos type:</b>		N/A
<b>Material Assessment Score:</b>		N/A
<b>Priority Assessment Score:</b>		N/A
<b>Action:</b>	N/A	
<b>Comments:</b>	N/A
