ARMOUR
ANALYTICAL SERVICES

Project Number 2481

**Management
Asbestos Survey Report**

**Camborne Platoon, Camborne, Cornwall,
TR14 8PU**

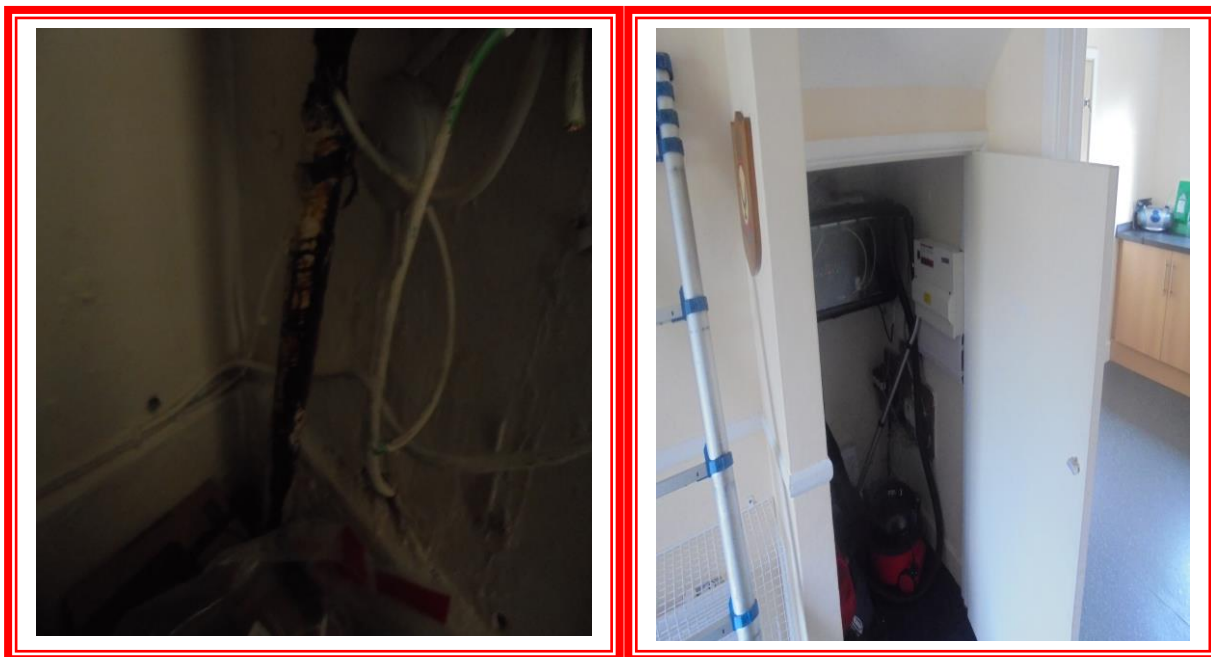
Item No: 6

Item 6 – House 1 – Lobby and Cupboard – Ground Floor – Bitumen Wrap to Mains Cable – Unable to sample as presumed live

Location: House 1 - lobby and cupboard – Ground Floor

Material Description:	Bitumen Wrap to Mains Cable	
Identification:	Presumed to Contain Asbestos	
Approx. quantity:	<1LM	
Accessibility	Low	<i>Assessment Score</i>
Product type:	Bitumen	1
Extent of Damage:	Minor	1
Surface Treatment:	Non-friable	0
Asbestos type:	Chrysotile	1
Material Assessment Score:		3
Priority Assessment Score:		Negligible
Action:	Manage	
Comments:	No access to sample as live

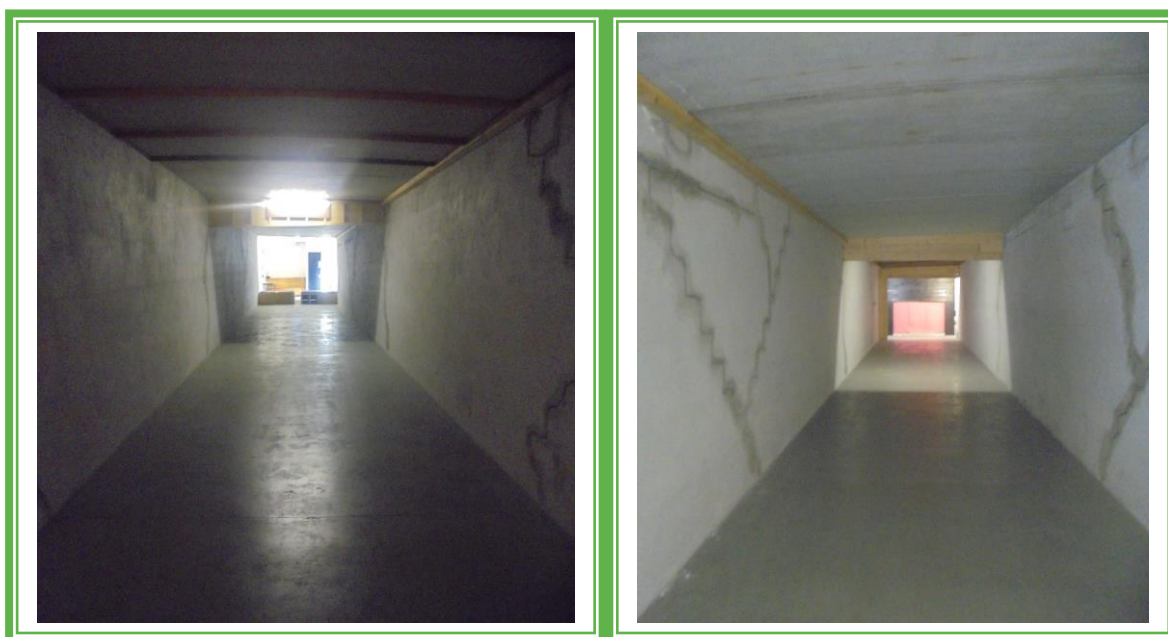
Item No: 1

Location: Range and Cupboard

Material Description:	Visual Inspection – No Suspect Materials Found	
Identification:	N/A	
Approx. quantity:	N/A	
Accessibility	N/A	<i>Assessment Score</i>
Product type:		N/A
Extent of Damage:		N/A
Surface Treatment:		N/A
Asbestos type:		N/A
Material Assessment Score:		N/A
Priority Assessment Score:		N/A
Action:	N/A	
Comments:	N/A

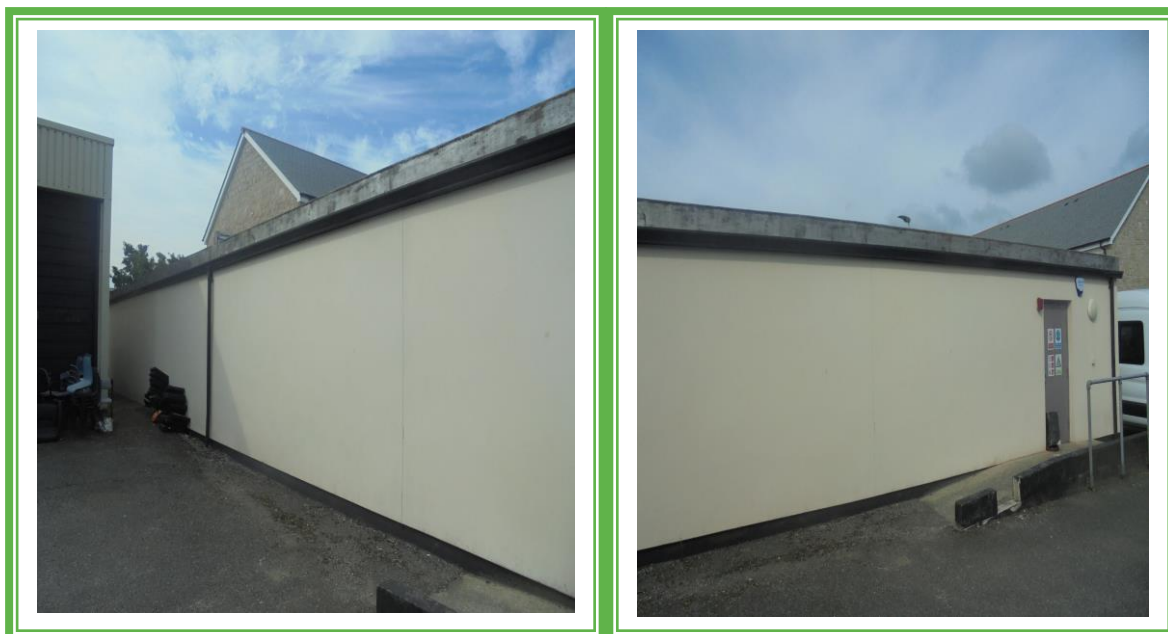
Item No: 2

Location: Range - External

Material Description:	Visual Inspection – No Suspect Materials Found	
Identification:	N/A	
Approx. quantity:	N/A	
Accessibility	N/A	<i>Assessment Score</i>
Product type:		N/A
Extent of Damage:		N/A
Surface Treatment:		N/A
Asbestos type:		N/A
Material Assessment Score:		N/A
Priority Assessment Score:		N/A
Action:	N/A	
Comments:	N/A

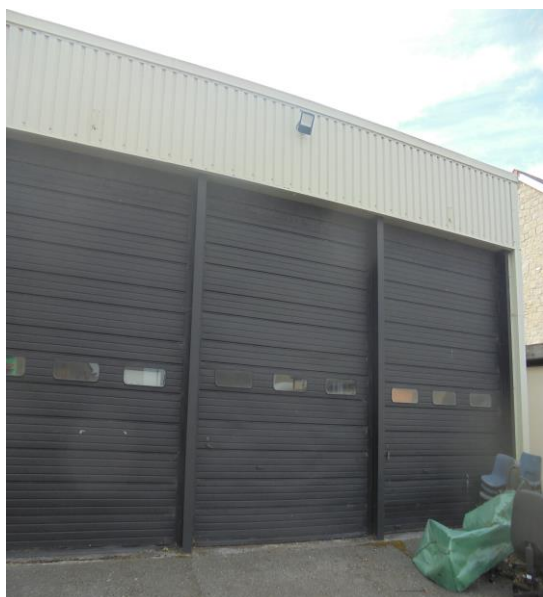
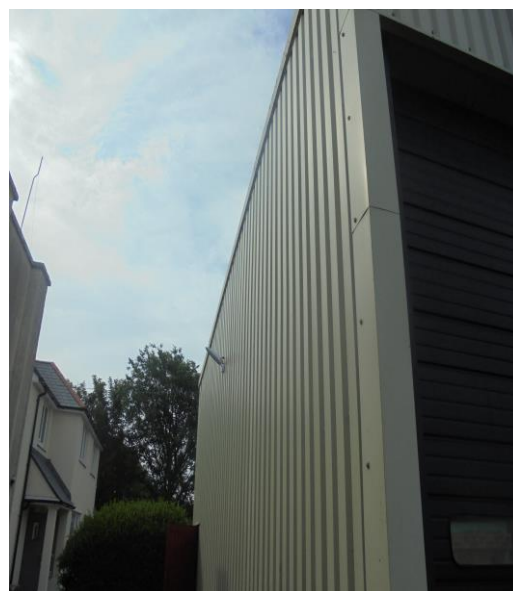
**Item No: 3****Sample No: N/A****Location: Garage - External**

Material Description:	Visual Inspection – No Suspect Materials Found	
Identification:	N/A	
Approx. quantity:	N/A	
Accessibility	N/A	<i>Assessment Score</i>
Product type:		N/A
Extent of Damage:		N/A
Surface Treatment:		N/A
Asbestos type:		N/A
Material Assessment Score:		N/A
Priority Assessment Score:		N/A
Action:	N/A	
Comments:	N/A

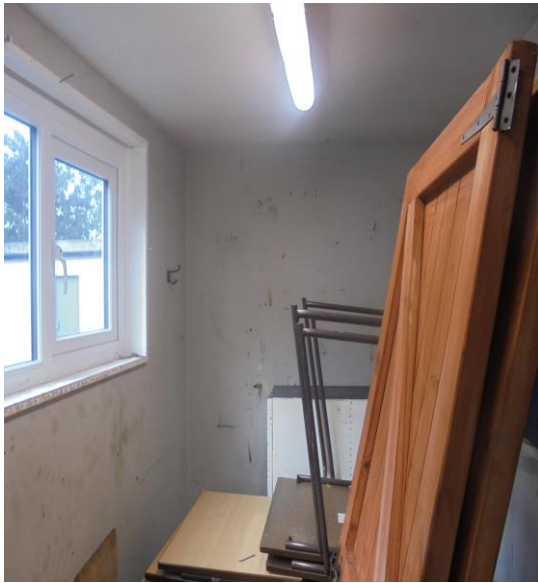
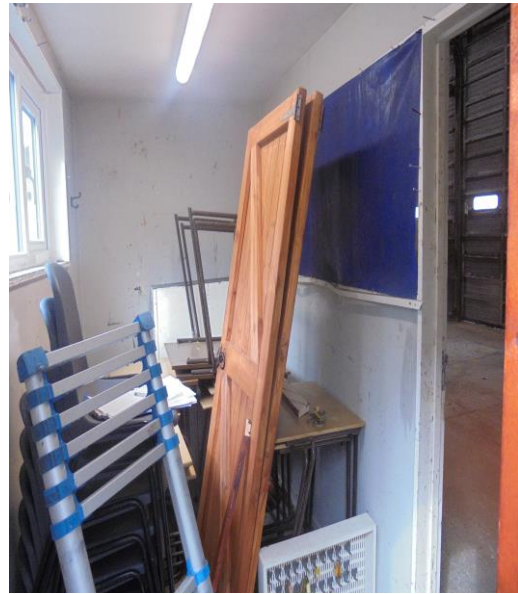
Item No: 4

Location: Garage - Lobby

Material Description:	Visual Inspection – No Suspect Materials Found	
Identification:	N/A	
Approx. quantity:	N/A	
Accessibility	N/A	<i>Assessment Score</i>
Product type:		N/A
Extent of Damage:		N/A
Surface Treatment:		N/A
Asbestos type:		N/A
Material Assessment Score:		N/A
Priority Assessment Score:		N/A
Action:	N/A	
Comments:	No access within plasterboard boxings

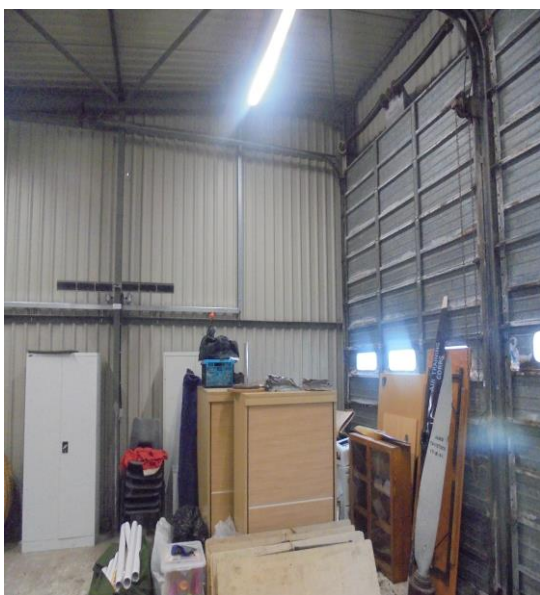
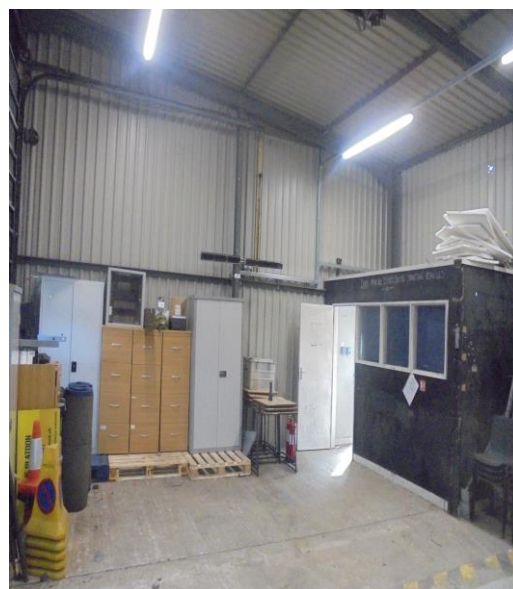
Item No: 5

Location: Garage

Material Description:	Visual Inspection – No Suspect Materials Found	
Identification:	N/A	
Approx. quantity:	N/A	
Accessibility	N/A	<i>Assessment Score</i>
Product type:		N/A
Extent of Damage:		N/A
Surface Treatment:		N/A
Asbestos type:		N/A
Material Assessment Score:		N/A
Priority Assessment Score:		N/A
Action:	N/A	
Comments:	N/A

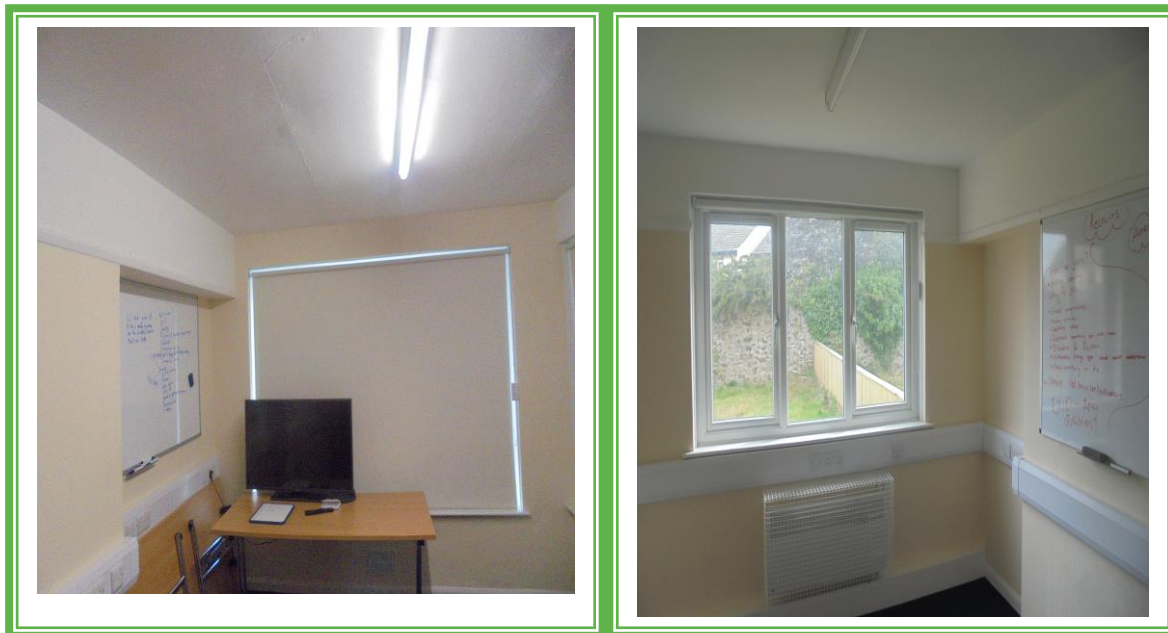
Item No: 7

Location: House 1 - Classroom 1 and 2 - Ground Floor

Material Description:	Visual Inspection – No Suspect Materials Found	
Identification:	N/A	
Approx. quantity:	N/A	
Accessibility	N/A	<i>Assessment Score</i>
Product type:		N/A
Extent of Damage:		N/A
Surface Treatment:		N/A
Asbestos type:		N/A
Material Assessment Score:		N/A
Priority Assessment Score:		N/A
Action:	N/A	
Comments:	No access within plasterboard or timber boxings

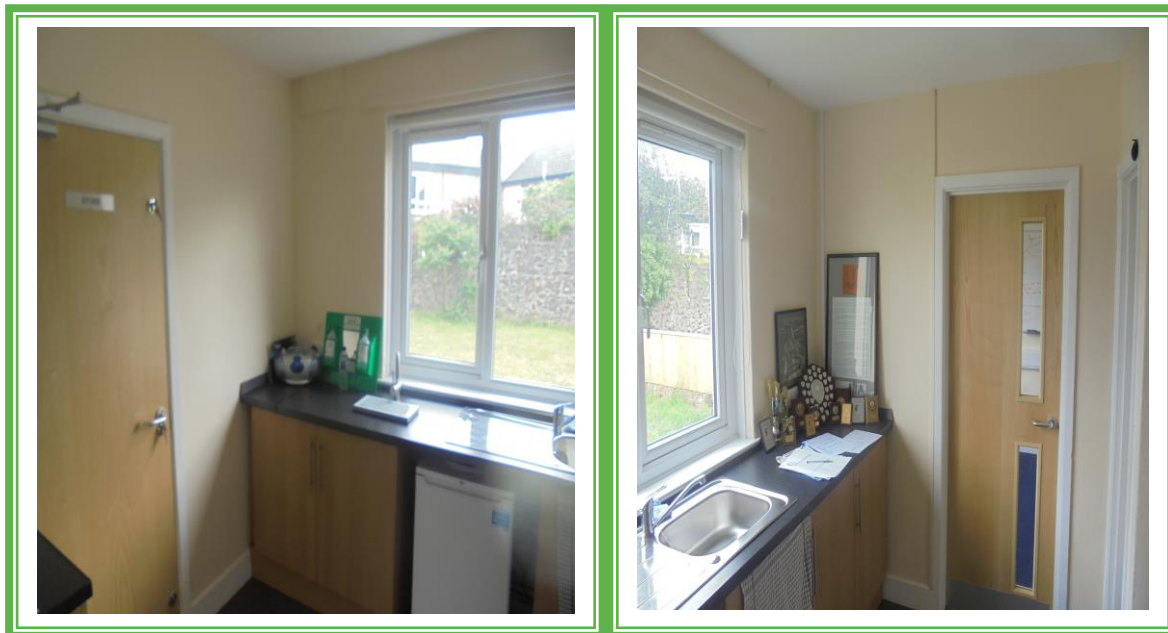
Item No: 8

Location: House 1 – kitchen – Ground Floor

Material Description:	Visual Inspection – No Suspect Materials Found	
Identification:	N/A	
Approx. quantity:	N/A	
Accessibility	N/A	<i>Assessment Score</i>
Product type:		N/A
Extent of Damage:		N/A
Surface Treatment:		N/A
Asbestos type:		N/A
Material Assessment Score:		N/A
Priority Assessment Score:		N/A
Action:	N/A	
Comments:	Modern Sink Pad

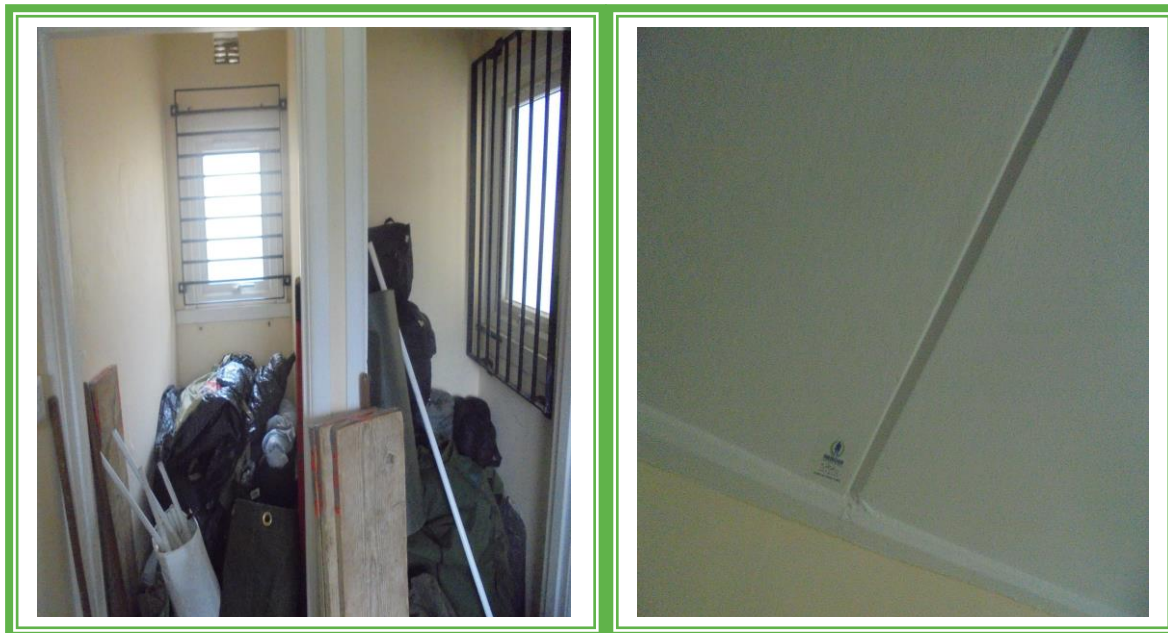
Item No: 9

Location: House 1 – Store – Ground Floor

Material Description:	Fibreboard Ceiling Panels	
Identification:	Sampled – No Asbestos Detected	
Approx. quantity:	4M2	
Accessibility	N/A	<i>Assessment Score</i>
Product type:		N/A
Extent of Damage:		N/A
Surface Treatment:		N/A
Asbestos type:		N/A
Material Assessment Score:		N/A
Priority Assessment Score:		N/A
Action:	N/A	
Comments:	Limited access to inspect room due to stored items

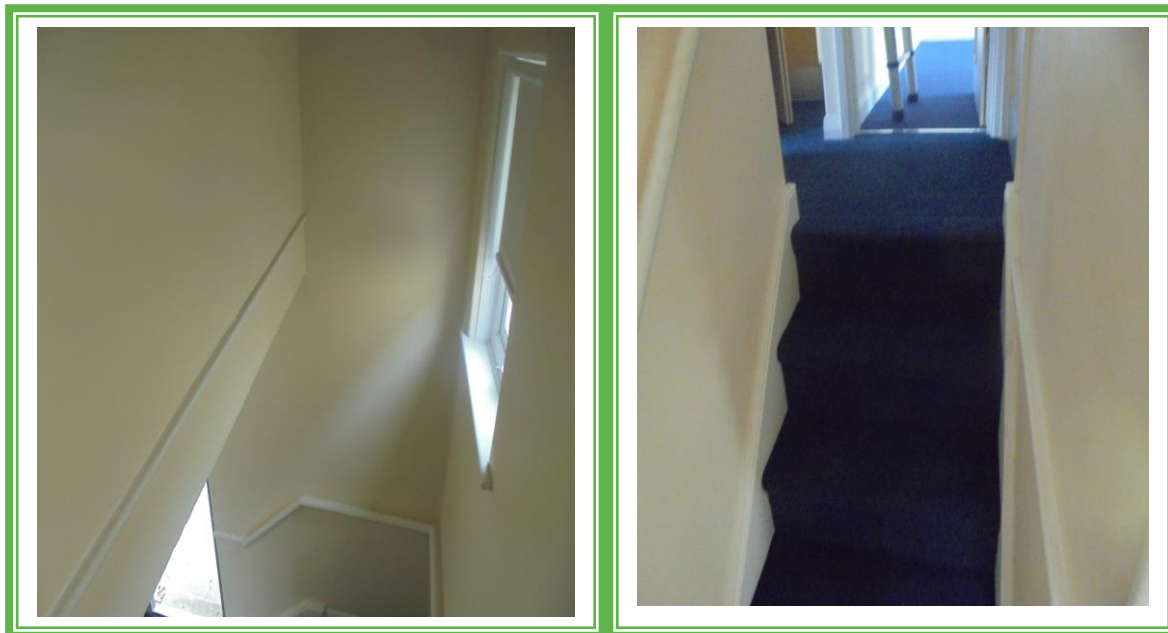
Item No: 10

Location: House 1 - Stairs

Material Description:	Visual Inspection – No Suspect Materials Found	
Identification:	N/A	
Approx. quantity:	N/A	
Accessibility	N/A	<i>Assessment Score</i>
Product type:		N/A
Extent of Damage:		N/A
Surface Treatment:		N/A
Asbestos type:		N/A
Material Assessment Score:		N/A
Priority Assessment Score:		N/A
Action:	N/A	
Comments:	N/A

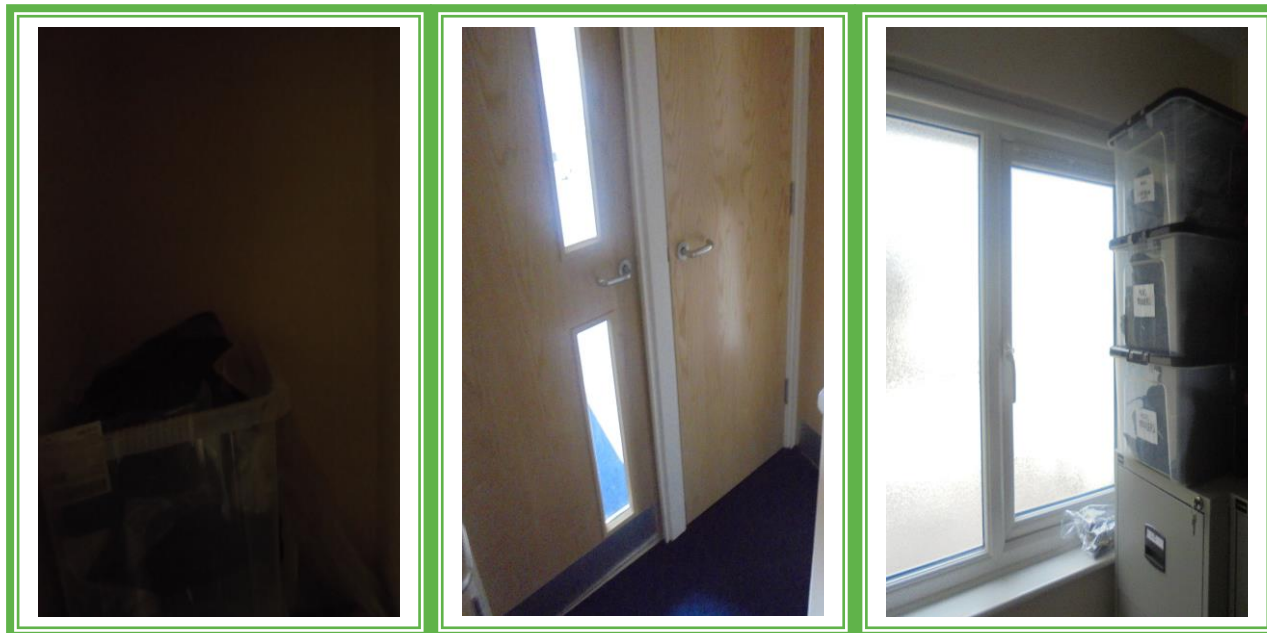
**Item No: 11****Sample No: N/A****Location: House 1 - Circulation, Cupboard and Store-First Floor**

Material Description:	Visual Inspection – No Suspect Materials Found	
Identification:	N/A	
Approx. quantity:	N/A	
Accessibility	N/A	<i>Assessment Score</i>
Product type:		N/A
Extent of Damage:		N/A
Surface Treatment:		N/A
Asbestos type:		N/A
Material Assessment Score:		N/A
Priority Assessment Score:		N/A
Action:	N/A	
Comments:	N/A

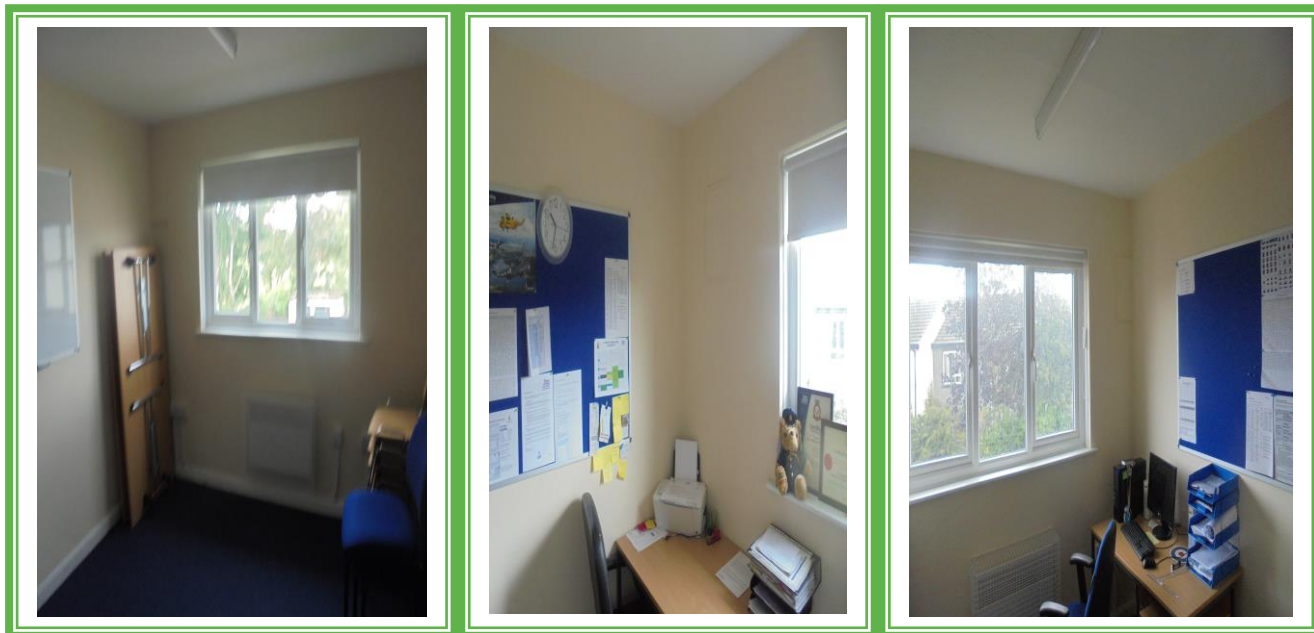
**Item No: 12****Sample No: N/A****Location: House 1 - Offices X3 - First Floor**

Material Description:	Visual Inspection – No Suspect Materials Found	
Identification:	N/A	
Approx. quantity:	N/A	
Accessibility	N/A	<i>Assessment Score</i>
Product type:		N/A
Extent of Damage:		N/A
Surface Treatment:		N/A
Asbestos type:		N/A
Material Assessment Score:		N/A
Priority Assessment Score:		N/A
Action:	N/A	
Comments:	N/A

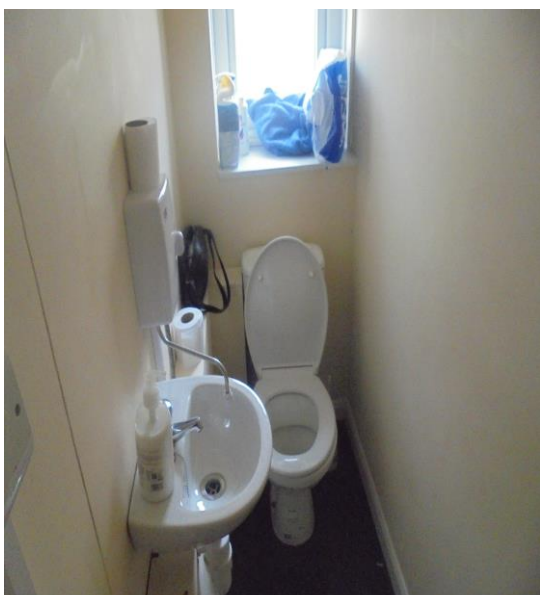
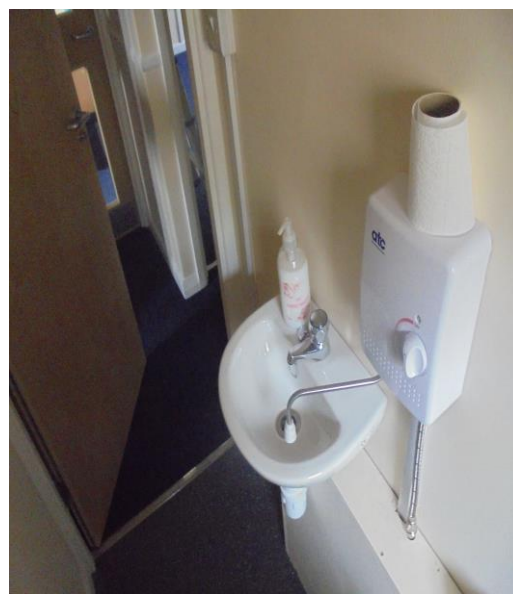
**Item No: 13****Sample No: N/A****Location: House 1 – WC - First Floor**

Material Description:	Visual Inspection – No Suspect Materials Found	
Identification:	N/A	
Approx. quantity:	N/A	
Accessibility	N/A	<i>Assessment Score</i>
Product type:		N/A
Extent of Damage:		N/A
Surface Treatment:		N/A
Asbestos type:		N/A
Material Assessment Score:		N/A
Priority Assessment Score:		N/A
Action:	N/A	
Comments:	No access within timber boxing

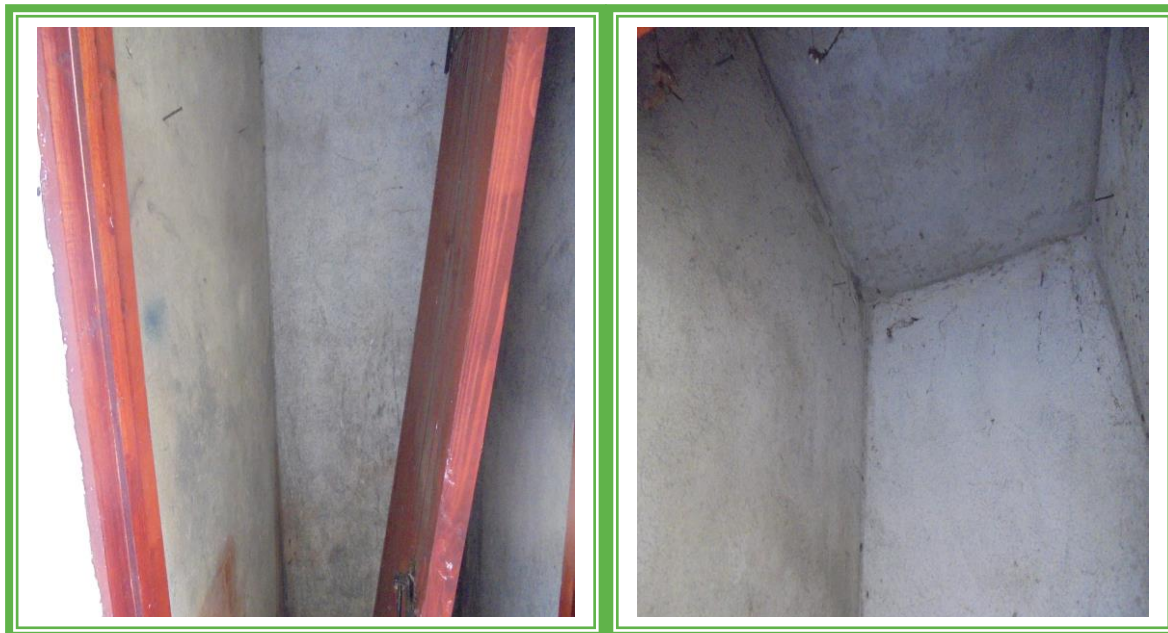
Item No: 14

Location: House 1 - External Cupboard

Material Description:	Visual Inspection – No Suspect Materials Found	
Identification:	N/A	
Approx. quantity:	N/A	
Accessibility	N/A	<i>Assessment Score</i>
Product type:		N/A
Extent of Damage:		N/A
Surface Treatment:		N/A
Asbestos type:		N/A
Material Assessment Score:		N/A
Priority Assessment Score:		N/A
Action:	N/A	
Comments:	N/A

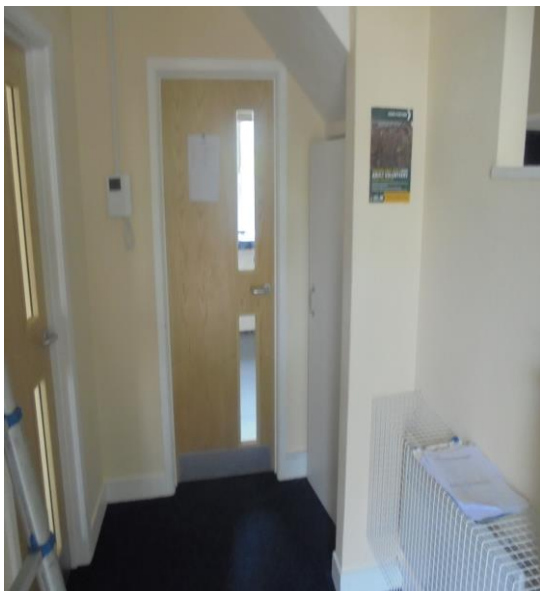
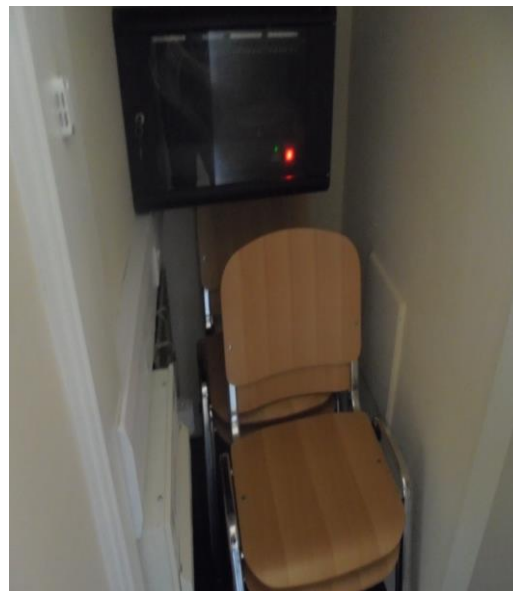
Item No: 15

Location: House 2 - Lobby and Cupboard - Ground Floor

Material Description:	Visual Inspection – No Suspect Materials Found	
Identification:	N/A	
Approx. quantity:	N/A	
Accessibility	N/A	<i>Assessment Score</i>
Product type:		N/A
Extent of Damage:		N/A
Surface Treatment:		N/A
Asbestos type:		N/A
Material Assessment Score:		N/A
Priority Assessment Score:		N/A
Action:	N/A	
Comments:	N/A

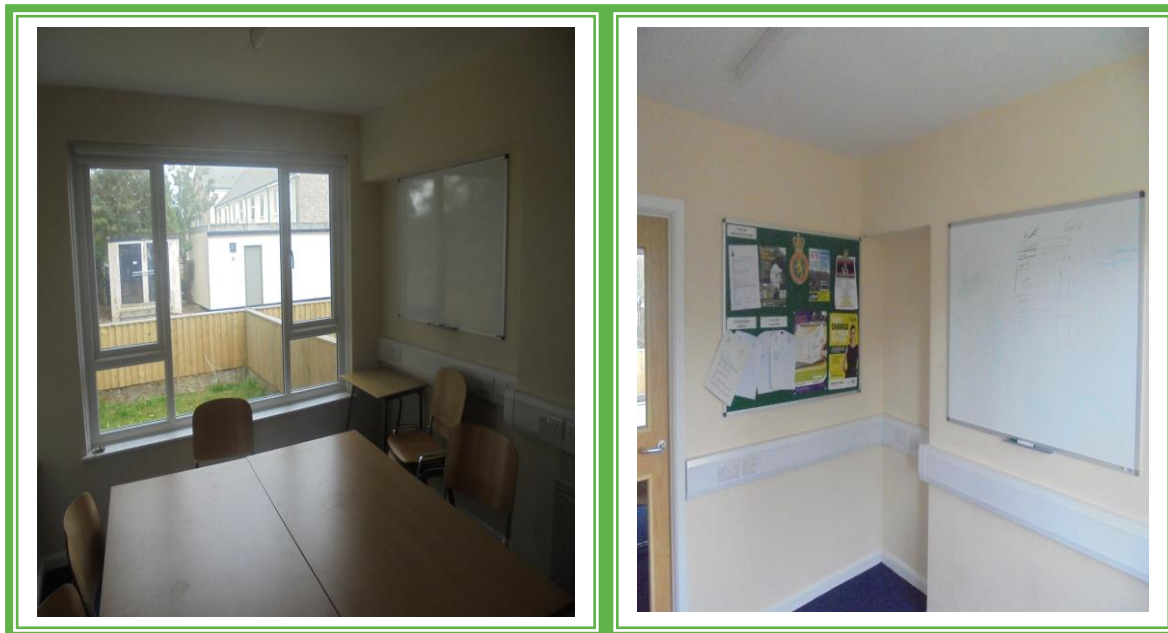
Item No: 16

Location: House 2 - Classrooms 1 and 2

Material Description:	Visual Inspection – No Suspect Materials Found	
Identification:	N/A	
Approx. quantity:	N/A	
Accessibility	N/A	<i>Assessment Score</i>
Product type:		N/A
Extent of Damage:		N/A
Surface Treatment:		N/A
Asbestos type:		N/A
Material Assessment Score:		N/A
Priority Assessment Score:		N/A
Action:	N/A	
Comments:	N/A

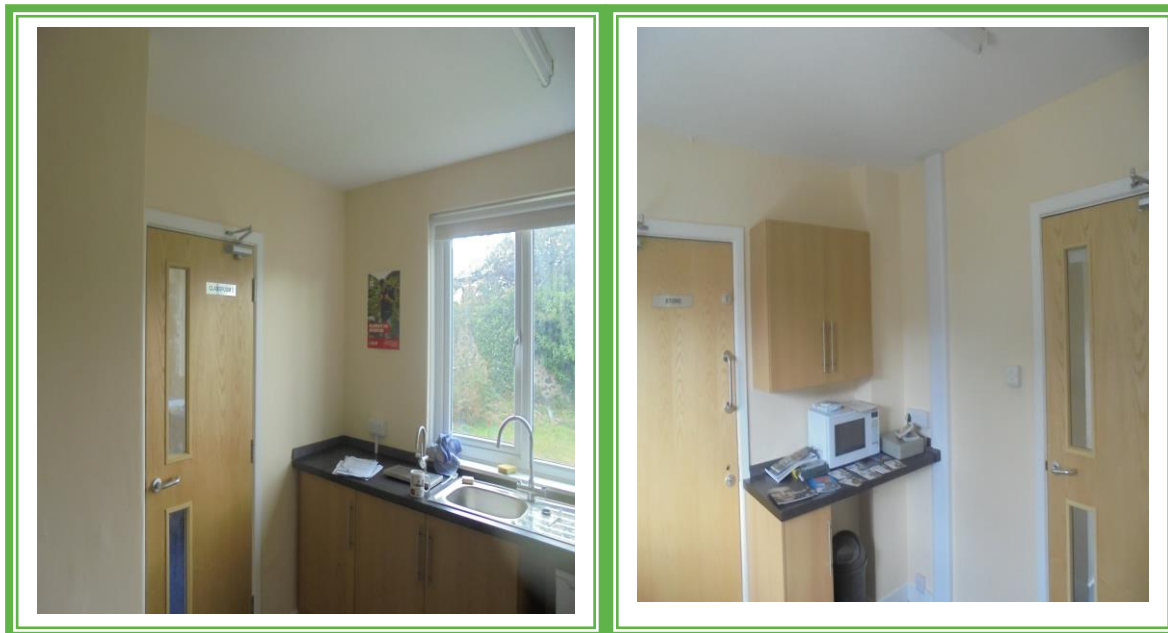
**Item No: 17****Sample No: N/A****Location: House 2 – Store - Ground Floor**

Material Description:	Visual Inspection – No Suspect Materials Found	
Identification:	N/A	
Approx. quantity:	N/A	
Accessibility	N/A	<i>Assessment Score</i>
Product type:		N/A
Extent of Damage:		N/A
Surface Treatment:		N/A
Asbestos type:		N/A
Material Assessment Score:		N/A
Priority Assessment Score:		N/A
Action:	N/A	
Comments:	Modern Sink Pad

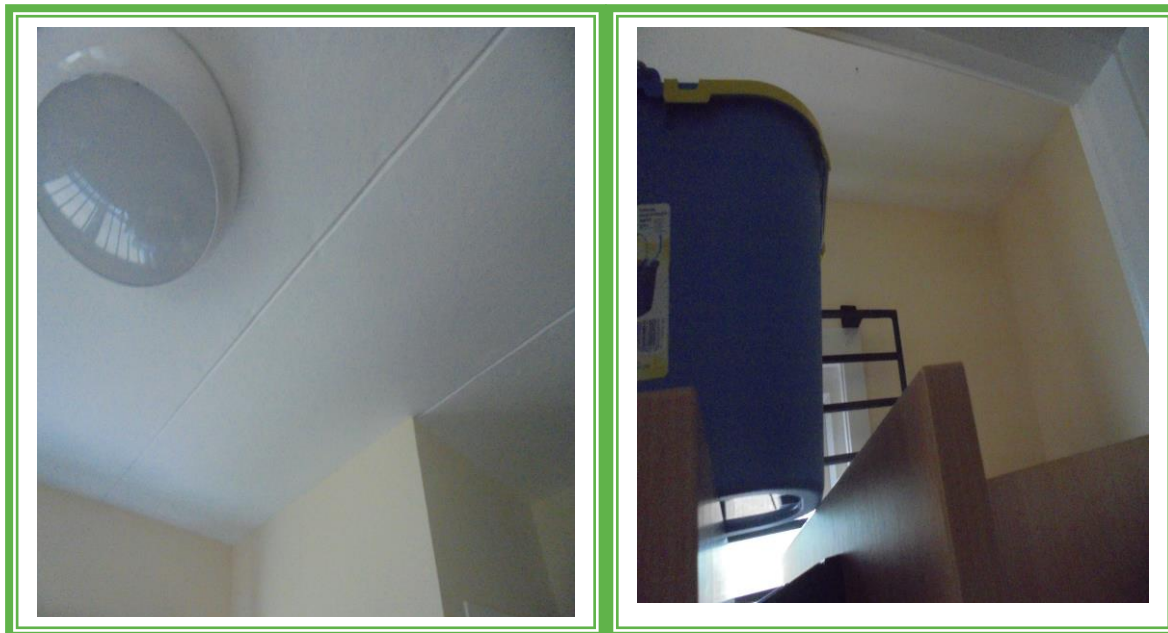
Item No: 18

Location: House 2 – Store - Ground Floor

Material Description:	Fibreboard Ceiling Panels	
Identification:	As Per Sample 1 – No Asbestos Detected	
Approx. quantity:	6M2	
Accessibility	N/A	<i>Assessment Score</i>
Product type:		N/A
Extent of Damage:		N/A
Surface Treatment:		N/A
Asbestos type:		N/A
Material Assessment Score:		N/A
Priority Assessment Score:		N/A
Action:	N/A	
Comments:	Modern Sink Pad

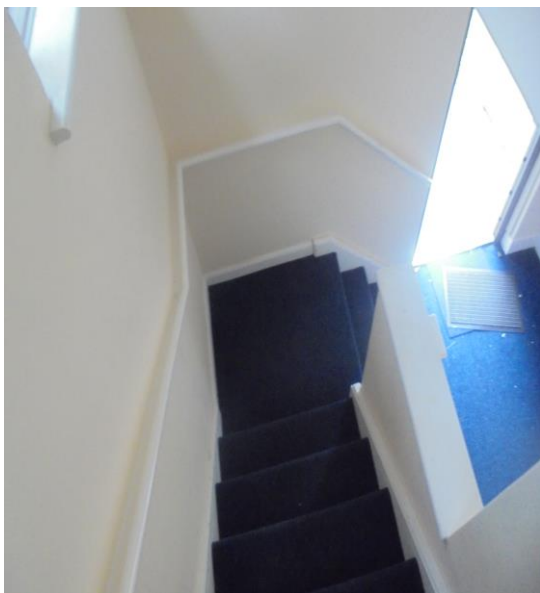
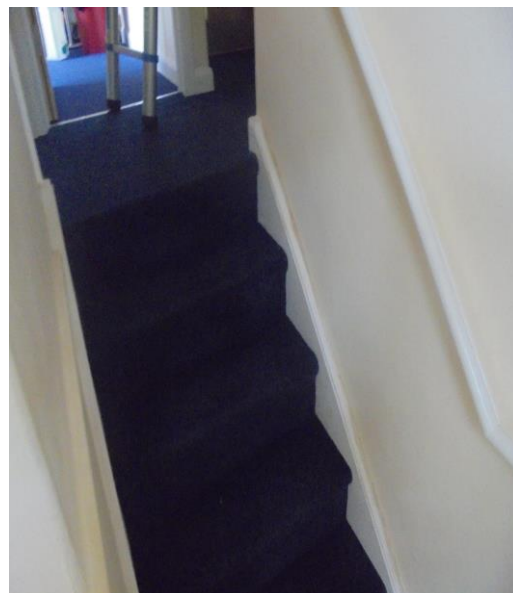
**Item No: 19****Sample No: N/A****Location: House 2 - Stairwell**

Material Description:	Visual Inspection – No Suspect Materials Found	
Identification:	N/A	
Approx. quantity:	N/A	
Accessibility	N/A	<i>Assessment Score</i>
Product type:		N/A
Extent of Damage:		N/A
Surface Treatment:		N/A
Asbestos type:		N/A
Material Assessment Score:		N/A
Priority Assessment Score:		N/A
Action:	N/A	
Comments:	N/A

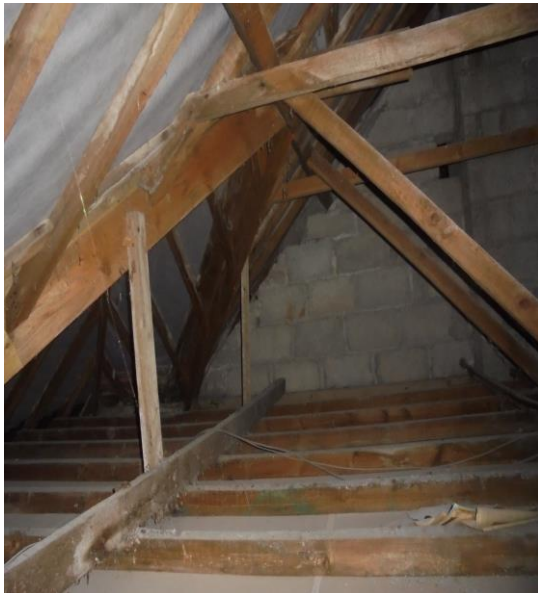
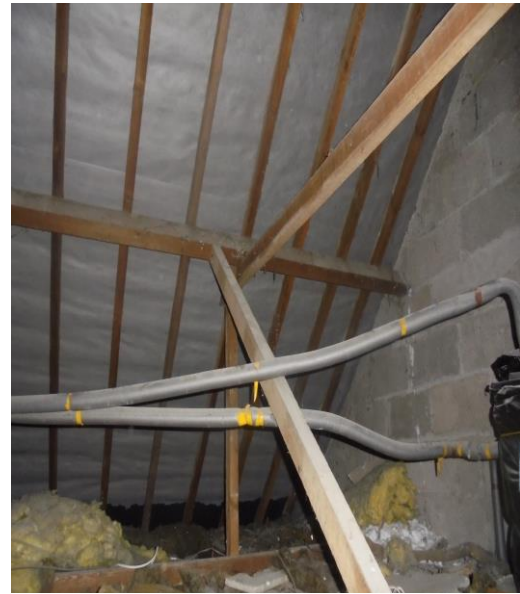
Item No: 20

Location: House 1 and House 2 - Loft Spaces

Material Description:	Visual Inspection – No Suspect Materials Found	
Identification:	N/A	
Approx. quantity:	N/A	
Accessibility	N/A	<i>Assessment Score</i>
Product type:		N/A
Extent of Damage:		N/A
Surface Treatment:		N/A
Asbestos type:		N/A
Material Assessment Score:		N/A
Priority Assessment Score:		N/A
Action:	N/A	
Comments:	Limited access into loft spaces as no crawlboards available

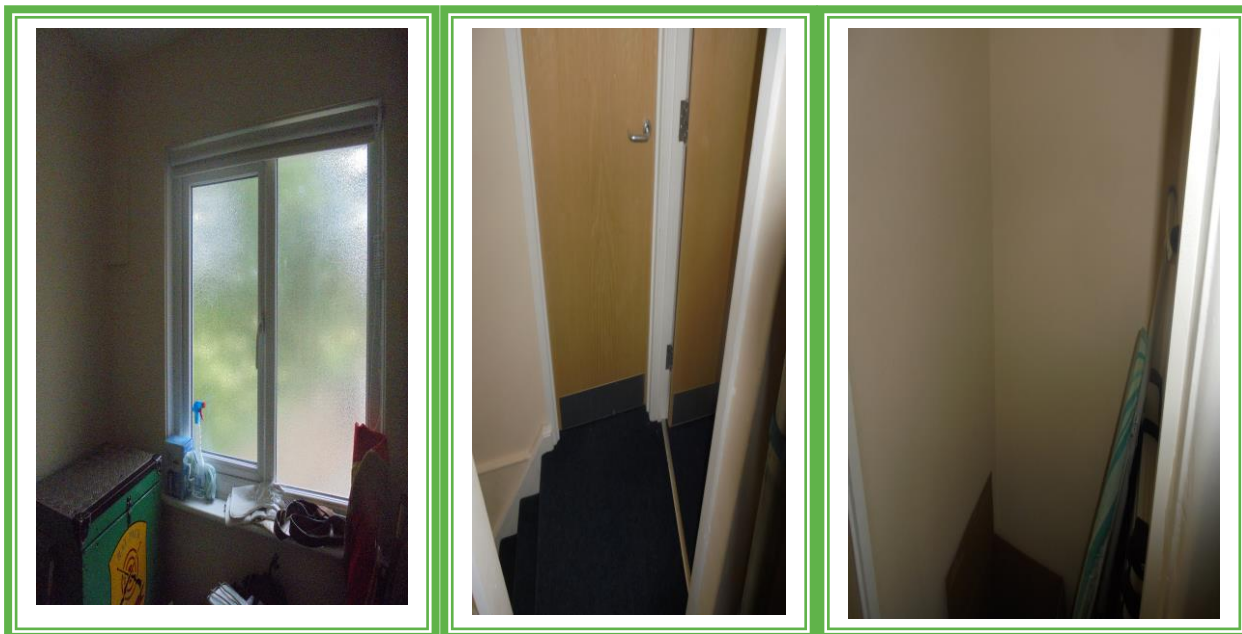
Item No: 21

Location: House 2 - Circulation Store and Cupboard - First Floor

Material Description:	Visual Inspection – No Suspect Materials Found	
Identification:	N/A	
Approx. quantity:	N/A	
Accessibility	N/A	<i>Assessment Score</i>
Product type:		N/A
Extent of Damage:		N/A
Surface Treatment:		N/A
Asbestos type:		N/A
Material Assessment Score:		N/A
Priority Assessment Score:		N/A
Action:	N/A	
Comments:	N/A

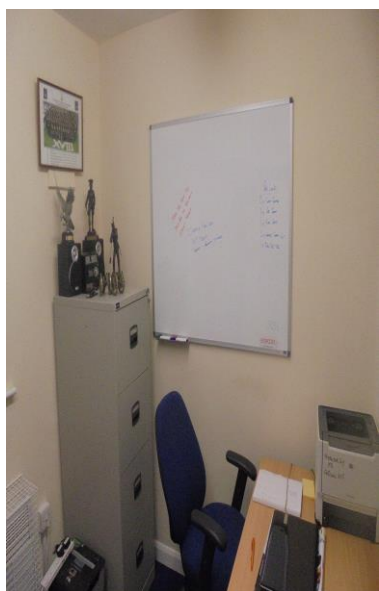
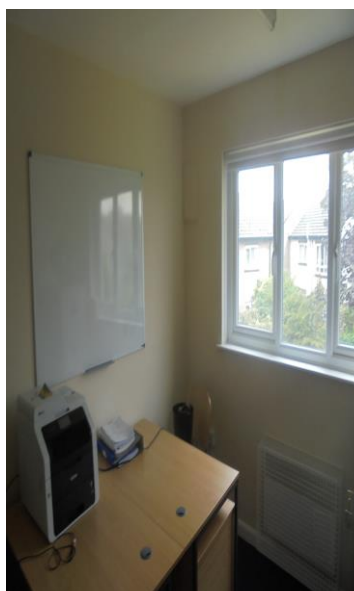
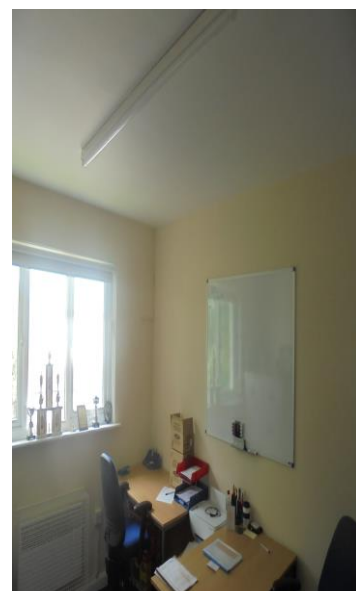
**Item No: 22****Sample No: N/A****Location: House 2 - Offices X3 - First Floor**

Material Description:	Visual Inspection – No Suspect Materials Found	
Identification:	N/A	
Approx. quantity:	N/A	
Accessibility	N/A	<i>Assessment Score</i>
Product type:		N/A
Extent of Damage:		N/A
Surface Treatment:		N/A
Asbestos type:		N/A
Material Assessment Score:		N/A
Priority Assessment Score:		N/A
Action:	N/A	
Comments:	N/A

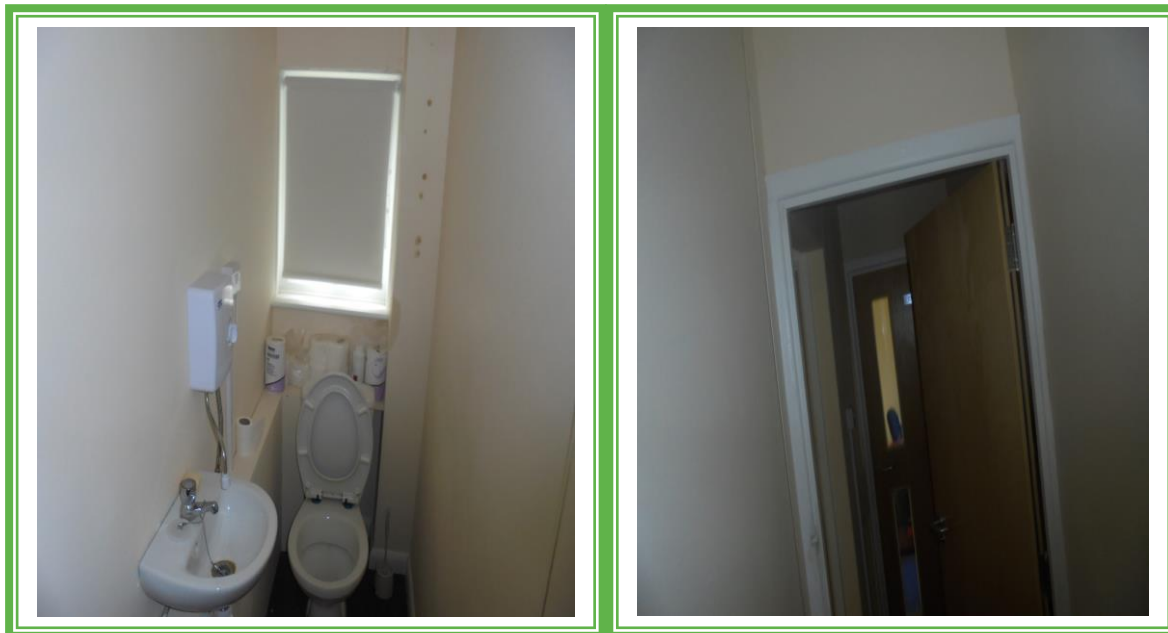
Item No: 23

Location: House 2 – WC - First Floor

Material Description:	Visual Inspection – No Suspect Materials Found	
Identification:	N/A	
Approx. quantity:	N/A	
Accessibility	N/A	<i>Assessment Score</i>
Product type:		N/A
Extent of Damage:		N/A
Surface Treatment:		N/A
Asbestos type:		N/A
Material Assessment Score:		N/A
Priority Assessment Score:		N/A
Action:	N/A	
Comments:	No access into timber boxing

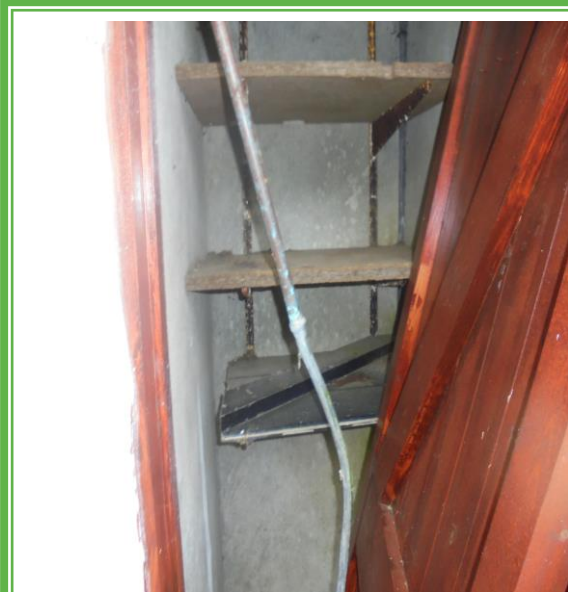
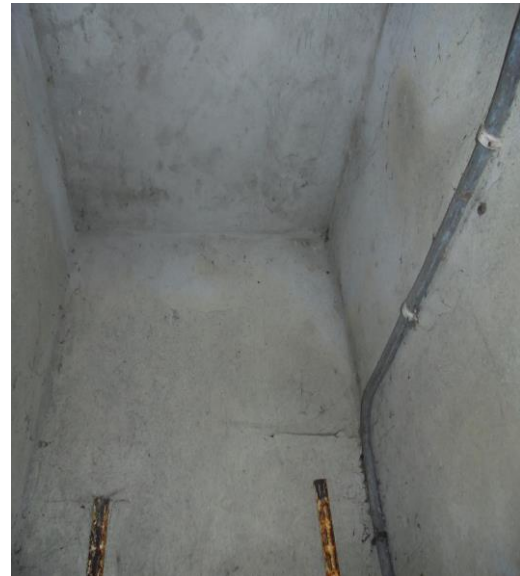
Item No: 24

Location: House 2 - External Store - Ground Floor

Material Description:	Visual Inspection – No Suspect Materials Found	
Identification:	N/A	
Approx. quantity:	N/A	
Accessibility	N/A	<i>Assessment Score</i>
Product type:		N/A
Extent of Damage:		N/A
Surface Treatment:		N/A
Asbestos type:		N/A
Material Assessment Score:		N/A
Priority Assessment Score:		N/A
Action:	N/A	
Comments:	N/A

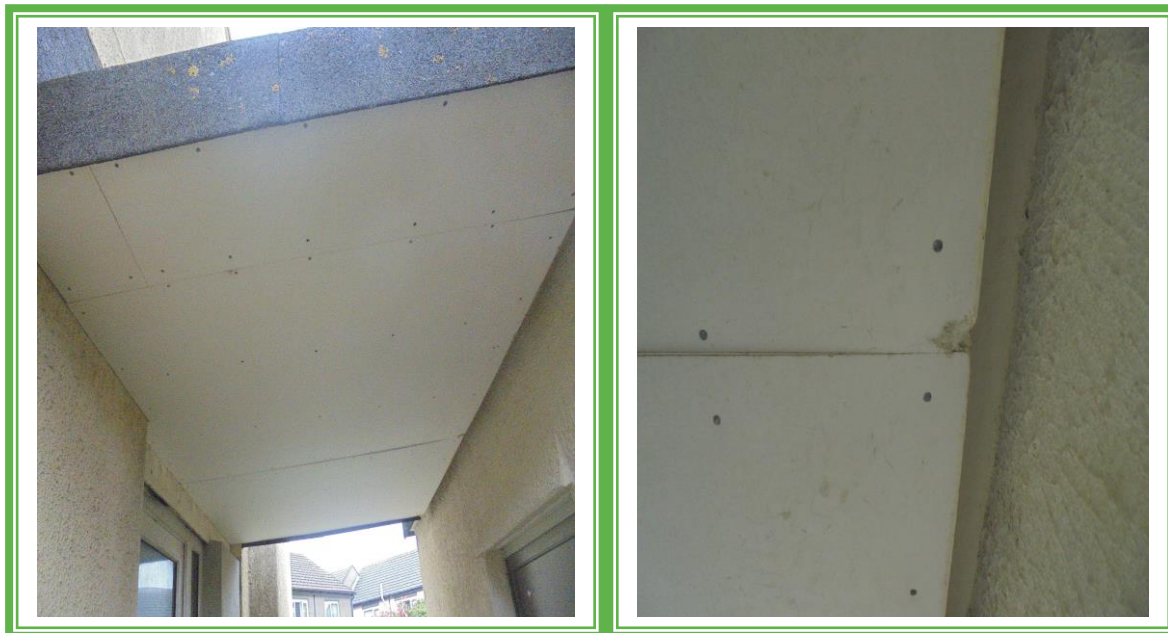
**Item No: 25****Sample No: 2****Location: External – Covered Area**

Material Description:	Insulation Board Ceiling Panels	
Identification:	Sampled – No Asbestos Detected	
Approx. quantity:	4M2	
Accessibility	N/A	<i>Assessment Score</i>
Product type:		N/A
Extent of Damage:		N/A
Surface Treatment:		N/A
Asbestos type:		N/A
Material Assessment Score:		N/A
Priority Assessment Score:		N/A
Action:	N/A	
Comments:	N/A

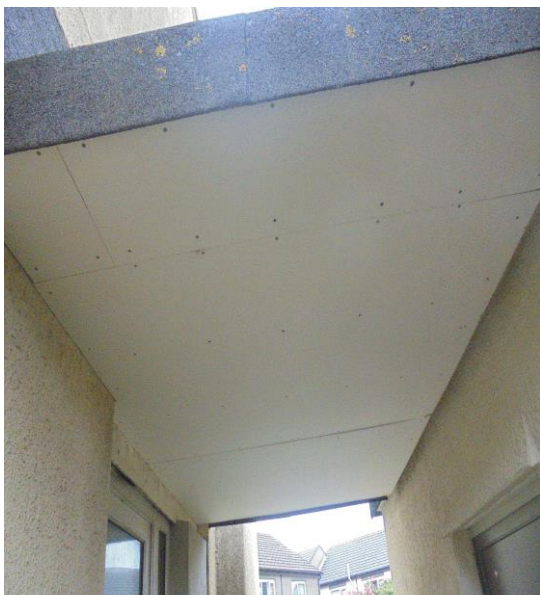
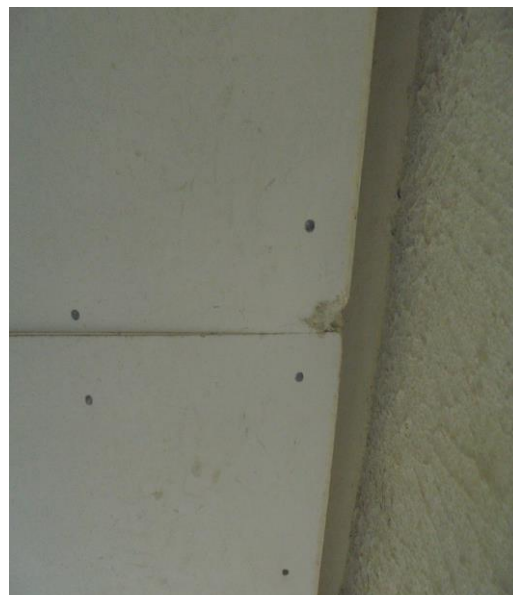
**Item No: 26****Sample No: 3****Location: External Porches x 2**

Material Description:	Ceiling Panels	
Identification:	Sampled – No Asbestos Detected	
Approx. quantity:	8M2	
Accessibility	N/A	<i>Assessment Score</i>
Product type:		N/A
Extent of Damage:		N/A
Surface Treatment:		N/A
Asbestos type:		N/A
Material Assessment Score:		N/A
Priority Assessment Score:		N/A
Action:	N/A	
Comments:	N/A

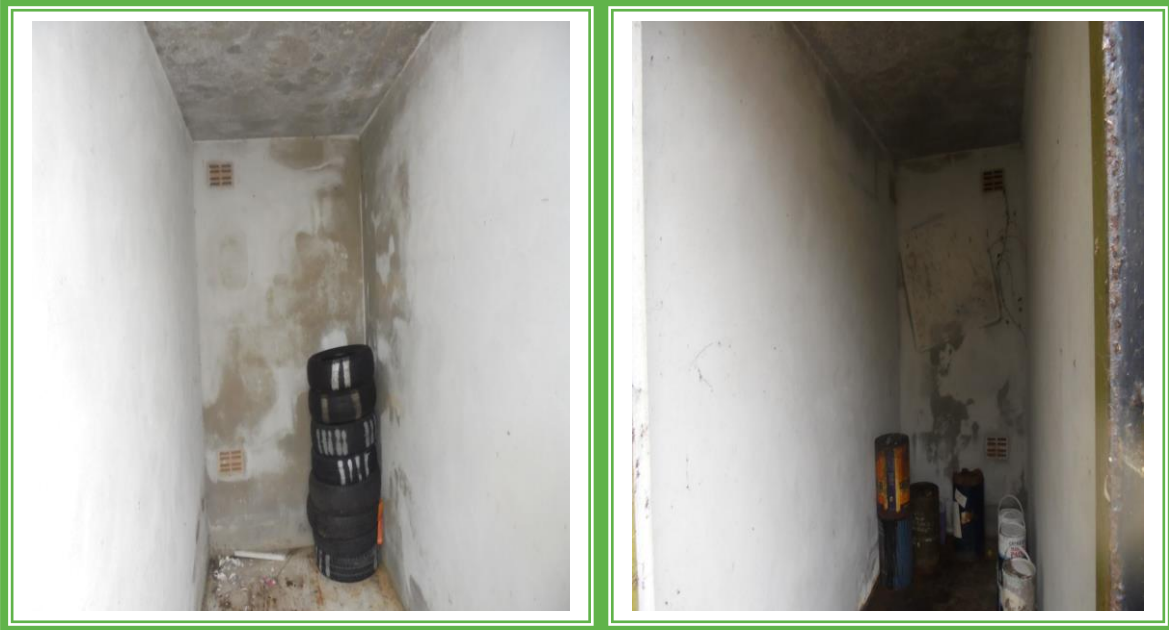
**Item No: 27****Sample No: N/A****Location: External Stores x 2**

Material Description:	Visual Inspection – No Suspect Materials Found	
Identification:	N/A	
Approx. quantity:	N/A	
Accessibility	N/A	<i>Assessment Score</i>
Product type:		N/A
Extent of Damage:		N/A
Surface Treatment:		N/A
Asbestos type:		N/A
Material Assessment Score:		N/A
Priority Assessment Score:		N/A
Action:	N/A	
Comments:	N/A
