Project Number 2481

**Management
Asbestos Survey Report**

**Wyvern Barracks, Barrack Road, Exeter, Devon,
EX2 6AE (Building 19)**

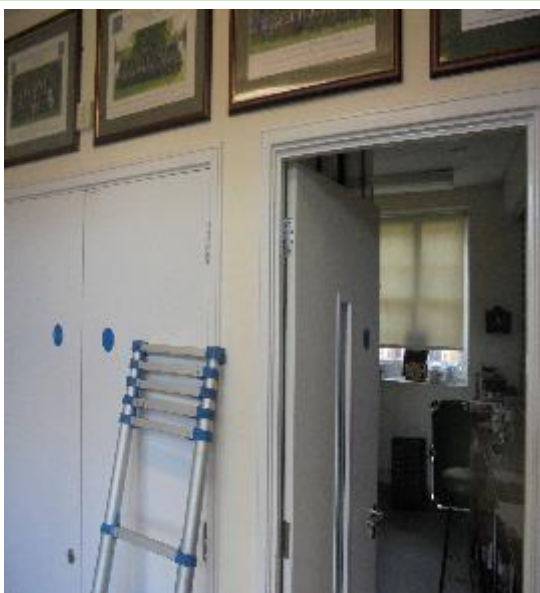
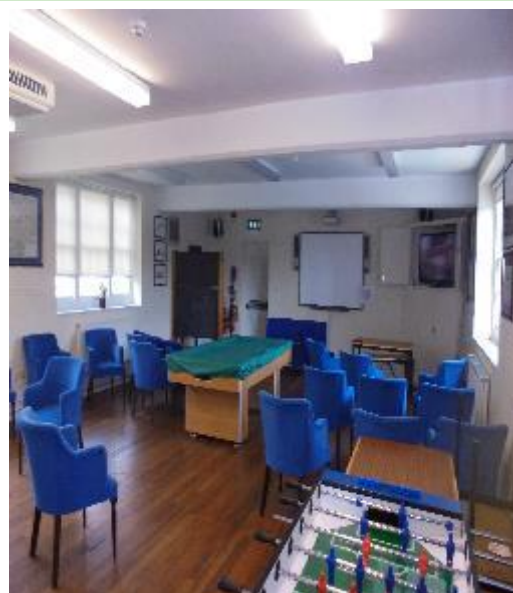
Item No: 1

Location: Mess Rooms, Bar and Cupboards

Material Description:	Visual Inspection – No Suspect Materials Found	
Identification:	N/A	
Approx. quantity:	N/A	
Accessibility	N/A	<i>Assessment Score</i>
Product type:		N/A
Extent of Damage:		N/A
Surface Treatment:		N/A
Asbestos type:		N/A
Material Assessment Score:		N/A
Priority Assessment Score:		N/A
Action:	N/A	
Comments:	Modern sink pad in bar

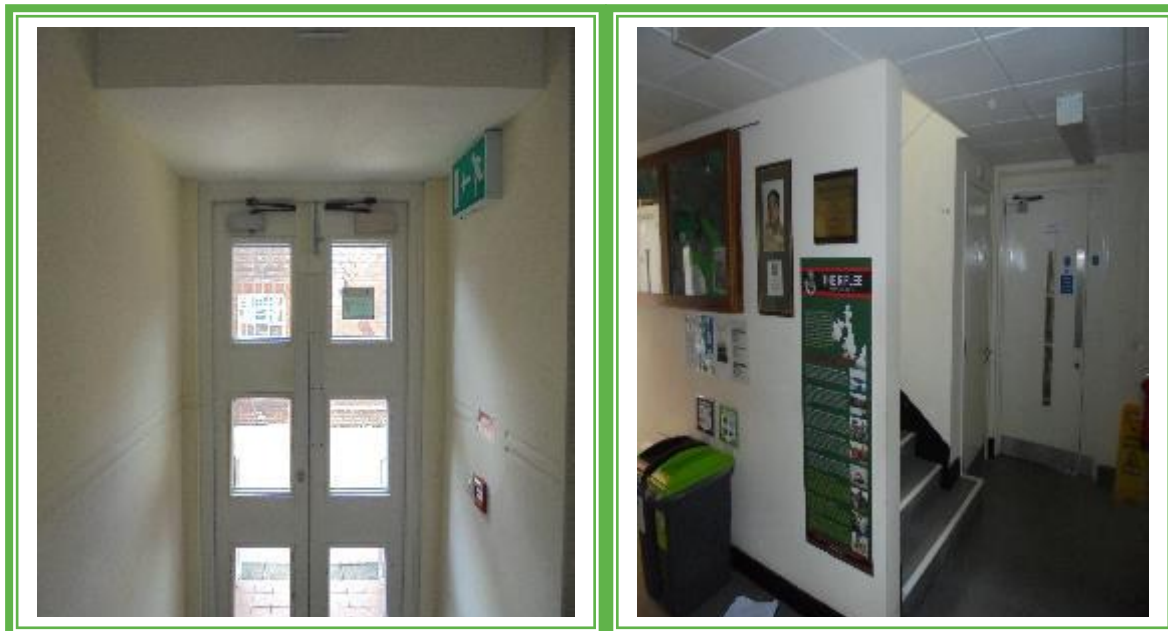
Item No: 2

Location: Circulation and Lobby – Ground Floor

Material Description:	Visual Inspection – No Suspect Materials Found	
Identification:	N/A	
Approx. quantity:	N/A	
Accessibility	N/A	<i>Assessment Score</i>
Product type:		N/A
Extent of Damage:		N/A
Surface Treatment:		N/A
Asbestos type:		N/A
Material Assessment Score:		N/A
Priority Assessment Score:		N/A
Action:	N/A	
Comments:	N/A

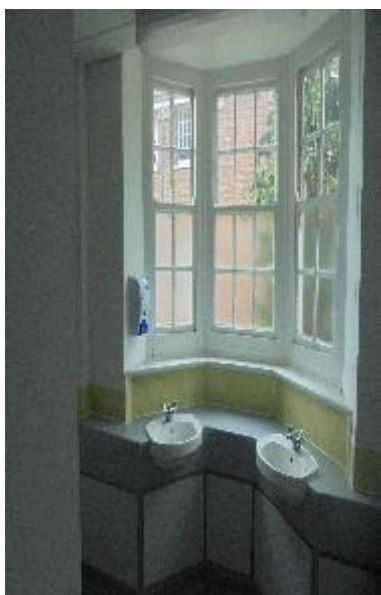
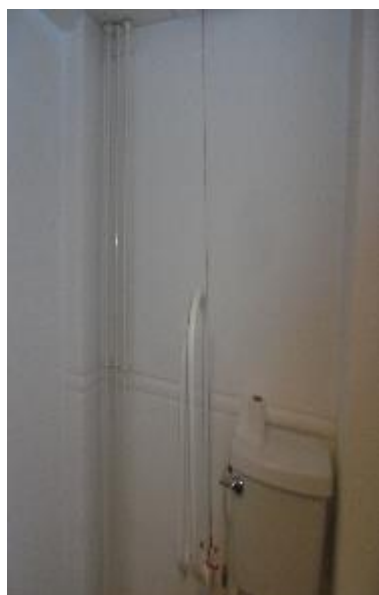
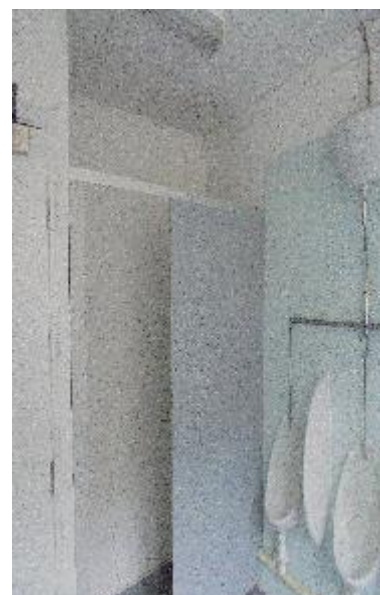
**Item No: 3****Sample No: N/A****Location: WC's x 3 – Ground Floor**

Material Description:	Visual Inspection – No Suspect Materials Found	
Identification:	N/A	
Approx. quantity:	N/A	
Accessibility	N/A	<i>Assessment Score</i>
Product type:		N/A
Extent of Damage:		N/A
Surface Treatment:		N/A
Asbestos type:		N/A
Material Assessment Score:		N/A
Priority Assessment Score:		N/A
Action:	N/A	
Comments:	N/A

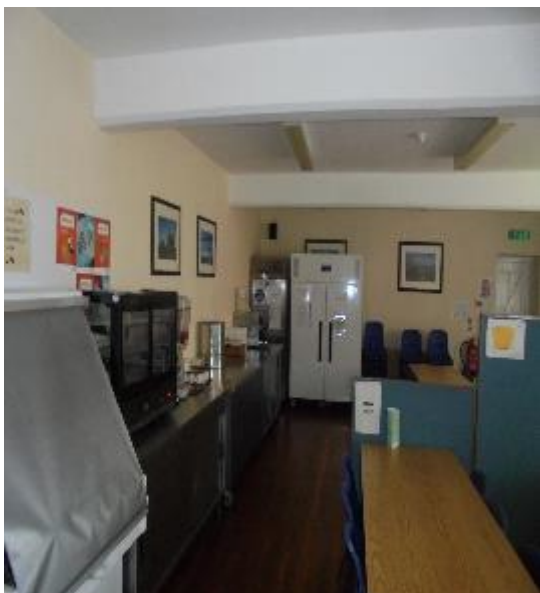
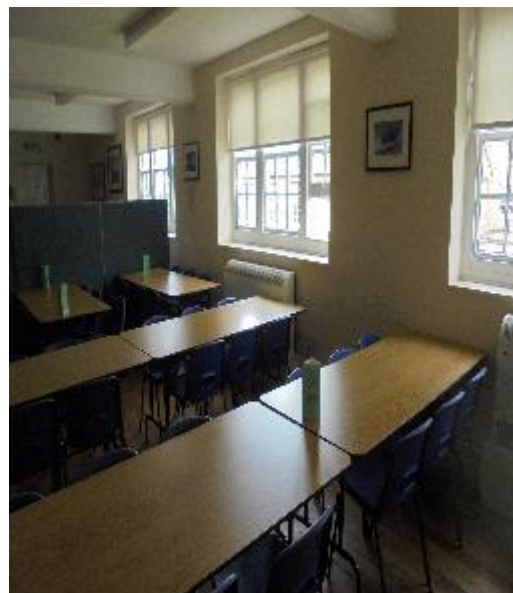
**Item No: 4****Sample No: N/A****Location: Dining room – Ground Floor**

Material Description:	Visual Inspection – No Suspect Materials Found	
Identification:	N/A	
Approx. quantity:	N/A	
Accessibility	N/A	<i>Assessment Score</i>
Product type:		N/A
Extent of Damage:		N/A
Surface Treatment:		N/A
Asbestos type:		N/A
Material Assessment Score:		N/A
Priority Assessment Score:		N/A
Action:	N/A	
Comments:	Non-asbestos modern heaters in room, no access within timber boxings under heaters

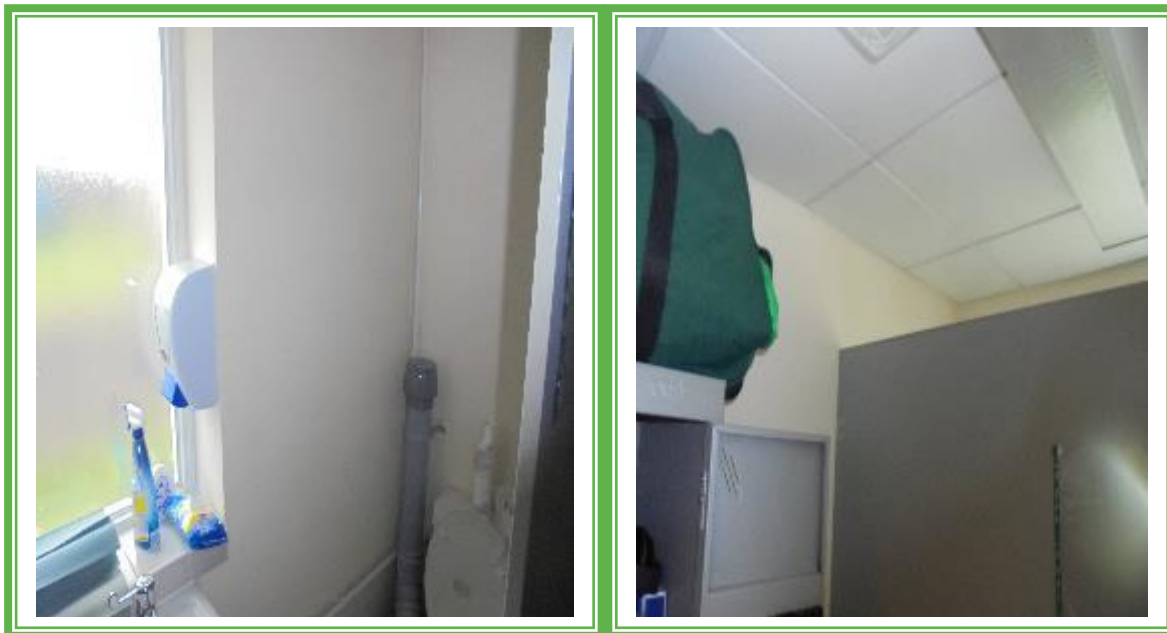
Item No: 5

Location: Kitchen and WC's x 2

Material Description:	Visual Inspection – No Suspect Materials Found	
Identification:	N/A	
Approx. quantity:	N/A	
Accessibility	N/A	<i>Assessment Score</i>
Product type:		N/A
Extent of Damage:		N/A
Surface Treatment:		N/A
Asbestos type:		N/A
Material Assessment Score:		N/A
Priority Assessment Score:		N/A
Action:	N/A	
Comments:	N/A

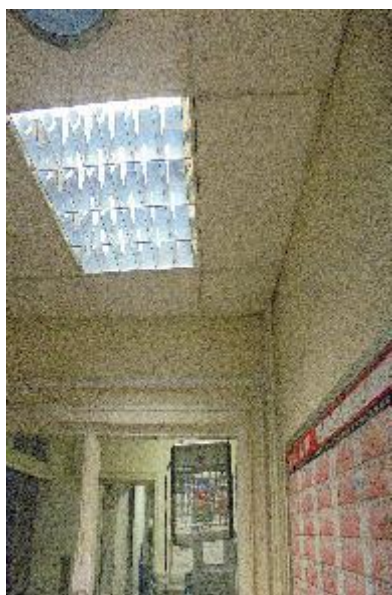
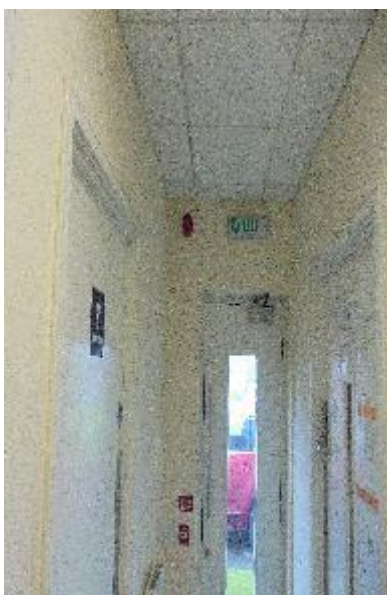
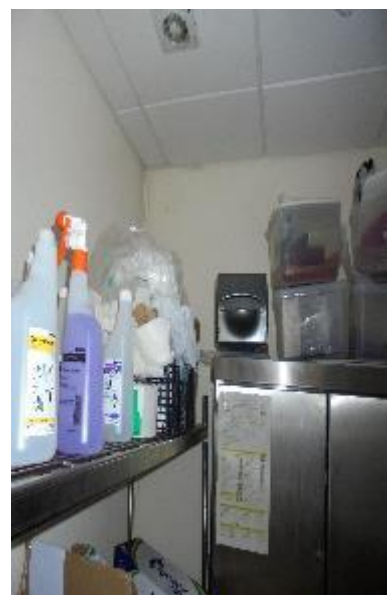
**Item No: 6****Sample No: N/A****Location: Kitchen Store, Office and Lobby**

Material Description:	Visual Inspection – No Suspect Materials Found	
Identification:	N/A	
Approx. quantity:	N/A	
Accessibility	N/A	<i>Assessment Score</i>
Product type:		N/A
Extent of Damage:		N/A
Surface Treatment:		N/A
Asbestos type:		N/A
Material Assessment Score:		N/A
Priority Assessment Score:		N/A
Action:	N/A	
Comments:	N/A

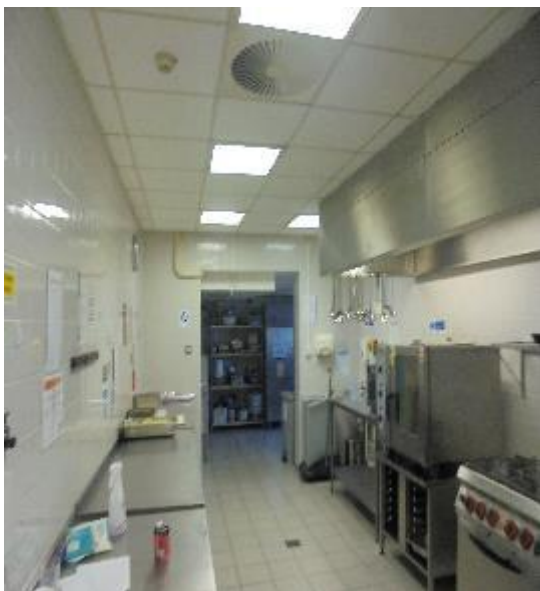
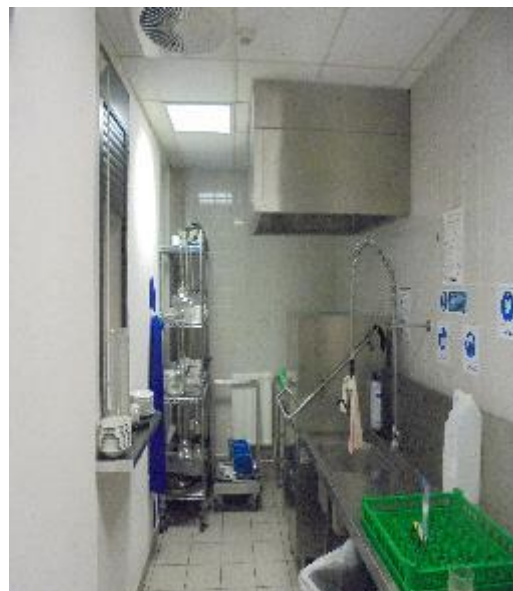
**Item No: 7****Sample No: N/A****Location: Kitchen Area x 2**

Material Description:	Visual Inspection – No Suspect Materials Found	
Identification:	N/A	
Approx. quantity:	N/A	
Accessibility	N/A	<i>Assessment Score</i>
Product type:		N/A
Extent of Damage:		N/A
Surface Treatment:		N/A
Asbestos type:		N/A
Material Assessment Score:		N/A
Priority Assessment Score:		N/A
Action:	N/A	
Comments:	N/A

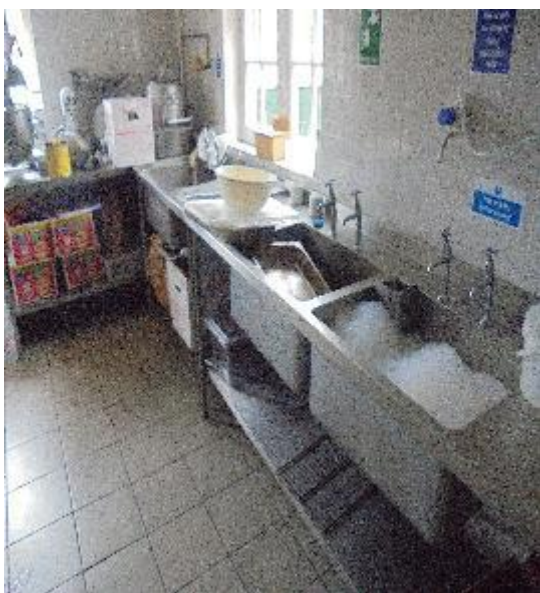
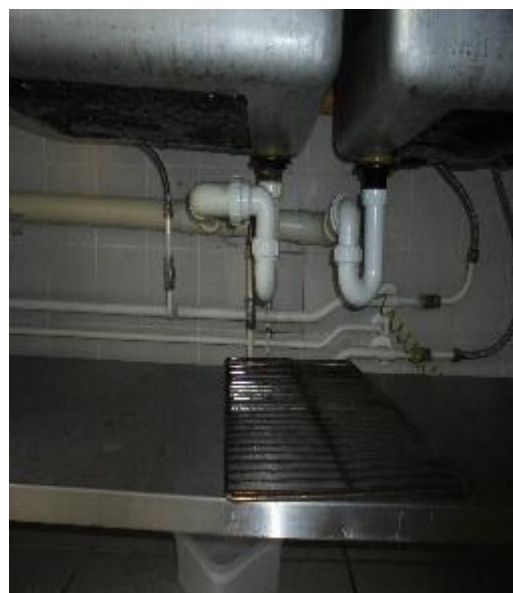
**Item No: 8****Sample No: 1****Location: Kitchen Area**

Material Description:	Sink Pads	
Identification:	Sampled – No Asbestos Detected	
Approx. quantity:	X 3 Sinks	
Accessibility	N/A	<i>Assessment Score</i>
Product type:		N/A
Extent of Damage:		N/A
Surface Treatment:		N/A
Asbestos type:		N/A
Material Assessment Score:		N/A
Priority Assessment Score:		N/A
Action:	N/A	
Comments:	N/A

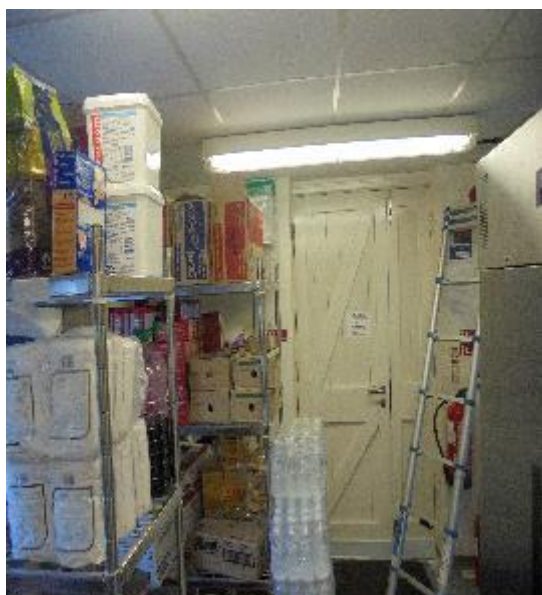
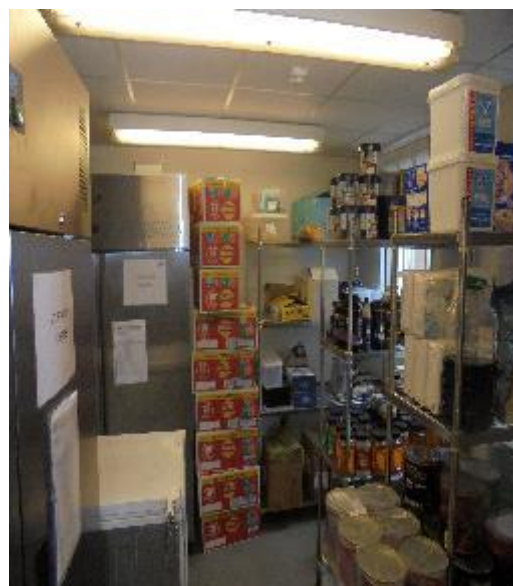
Item No: 9

Location: Kitchen Store

Material Description:	Visual Inspection – No Suspect Materials Found	
Identification:	N/A	
Approx. quantity:	N/A	
Accessibility	N/A	<i>Assessment Score</i>
Product type:		N/A
Extent of Damage:		N/A
Surface Treatment:		N/A
Asbestos type:		N/A
Material Assessment Score:		N/A
Priority Assessment Score:		N/A
Action:	N/A	
Comments:	N/A

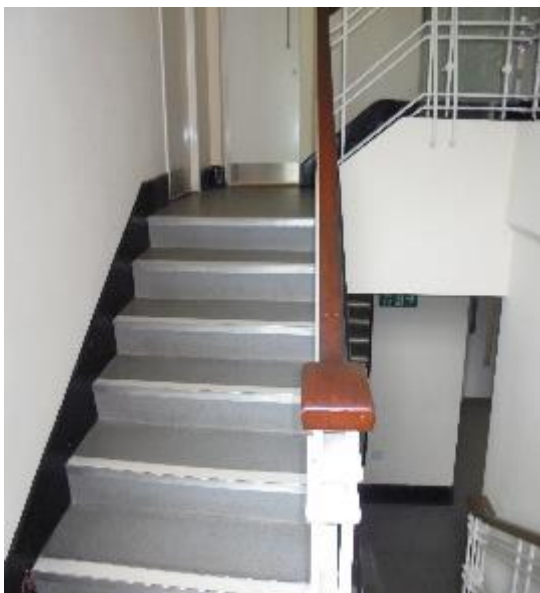
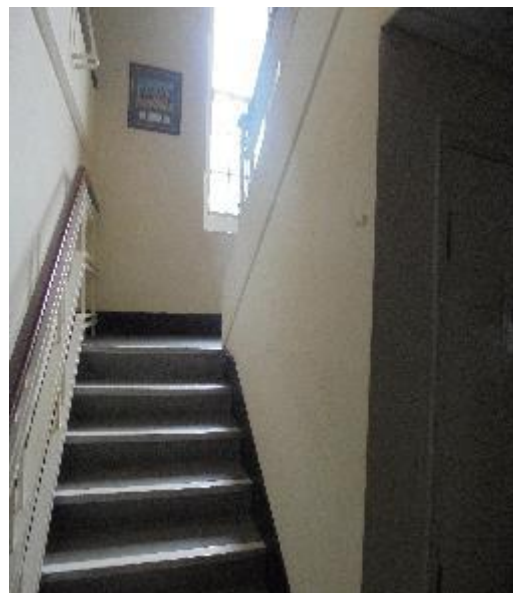
Item No: 10

Location: Stairwell and Cleaners Cupboards

Material Description:	Visual Inspection – No Suspect Materials Found	
Identification:	N/A	
Approx. quantity:	N/A	
Accessibility	N/A	<i>Assessment Score</i>
Product type:		N/A
Extent of Damage:		N/A
Surface Treatment:		N/A
Asbestos type:		N/A
Material Assessment Score:		N/A
Priority Assessment Score:		N/A
Action:	N/A	
Comments:	Modern Stair Nosing

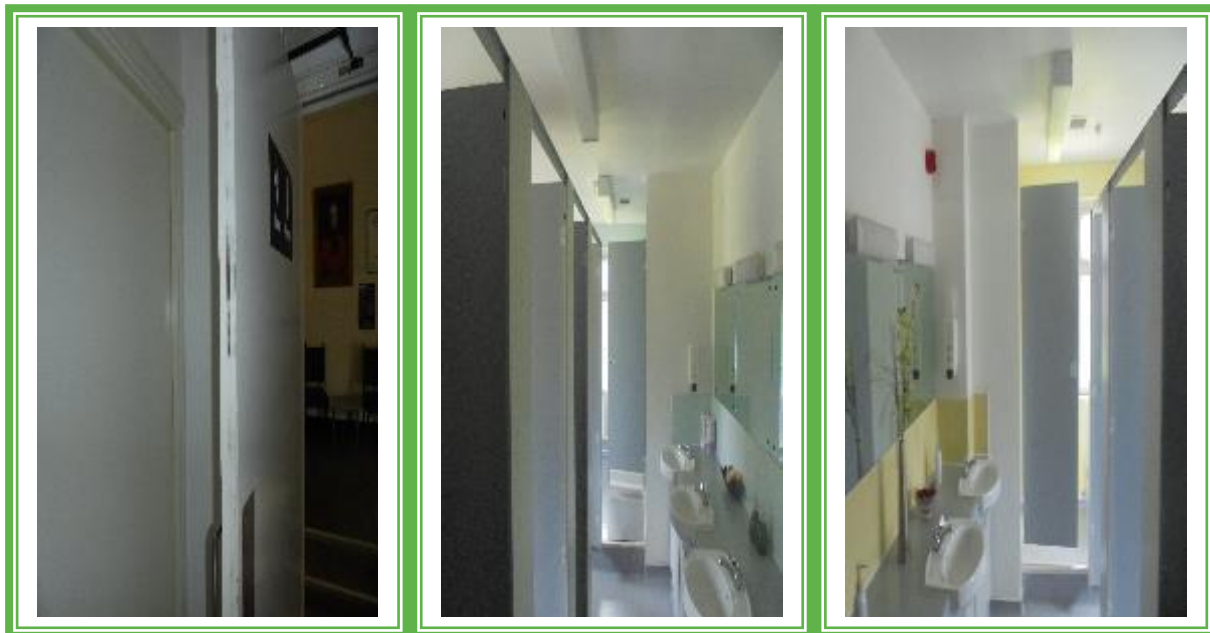
Item No: 11

Location: WC's x 2, Store and Lobby

Material Description:	Visual Inspection – No Suspect Materials Found	
Identification:	N/A	
Approx. quantity:	N/A	
Accessibility	N/A	<i>Assessment Score</i>
Product type:		N/A
Extent of Damage:		N/A
Surface Treatment:		N/A
Asbestos type:		N/A
Material Assessment Score:		N/A
Priority Assessment Score:		N/A
Action:	N/A	
Comments:	N/A

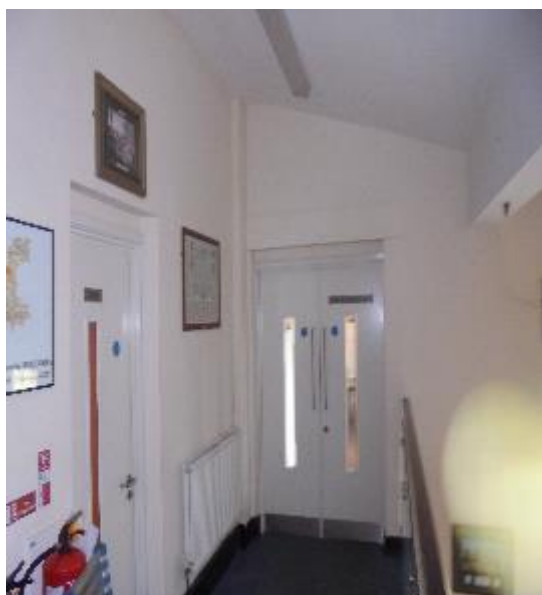
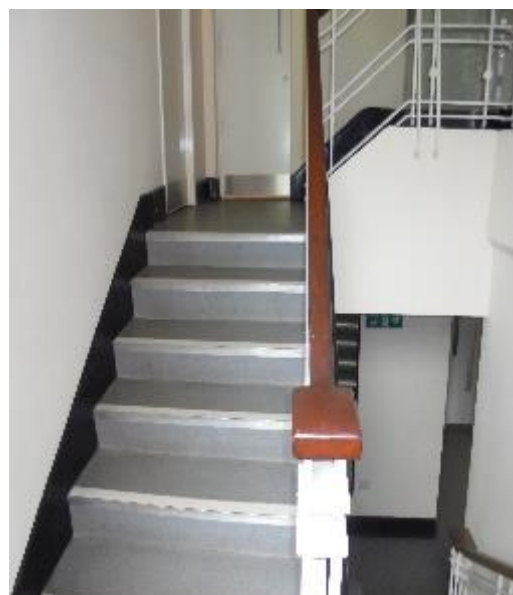
**Item No: 12****Sample No: N/A****Location: Corridor and Lobby – First Floor**

Material Description:	Visual Inspection – No Suspect Materials Found	
Identification:	N/A	
Approx. quantity:	N/A	
Accessibility	N/A	<i>Assessment Score</i>
Product type:		N/A
Extent of Damage:		N/A
Surface Treatment:		N/A
Asbestos type:		N/A
Material Assessment Score:		N/A
Priority Assessment Score:		N/A
Action:	N/A	
Comments:	No access within loft space due to height

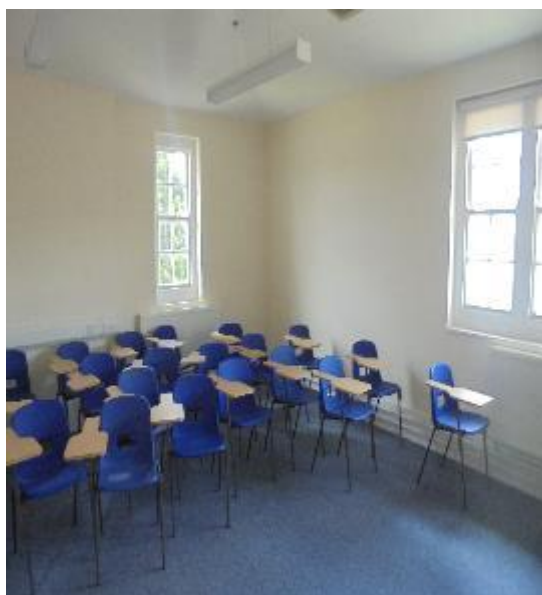
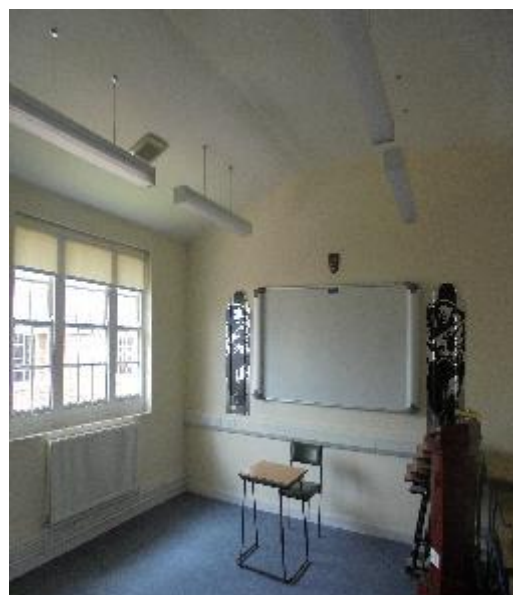
Item No: 13

Location: Lecture Rooms 1, 2 and 3 – First Floor

Material Description:	Visual Inspection – No Suspect Materials Found	
Identification:	N/A	
Approx. quantity:	N/A	
Accessibility	N/A	<i>Assessment Score</i>
Product type:		N/A
Extent of Damage:		N/A
Surface Treatment:		N/A
Asbestos type:		N/A
Material Assessment Score:		N/A
Priority Assessment Score:		N/A
Action:	N/A	
Comments:	N/A

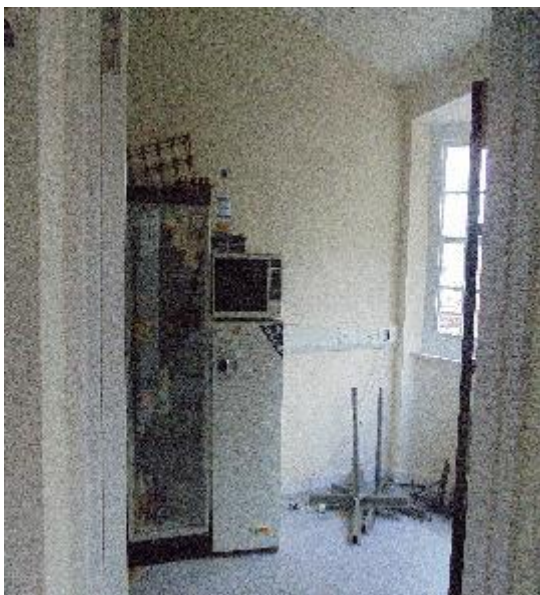
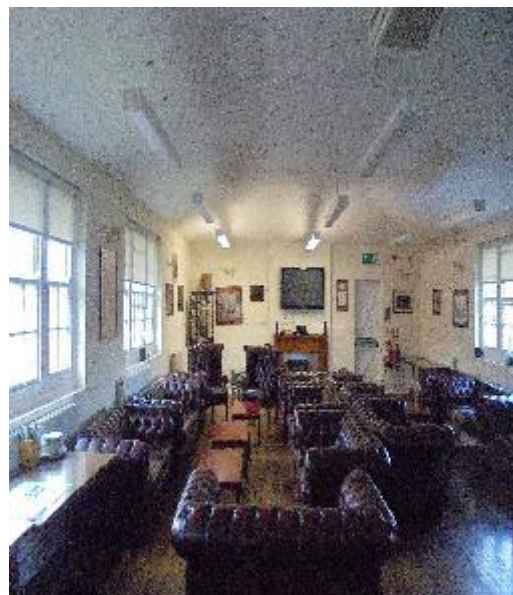
**Item No: 14****Sample No: N/A****Location: Mess Room and Store**

Material Description:	Visual Inspection – No Suspect Materials Found	
Identification:	N/A	
Approx. quantity:	N/A	
Accessibility	N/A	<i>Assessment Score</i>
Product type:		N/A
Extent of Damage:		N/A
Surface Treatment:		N/A
Asbestos type:		N/A
Material Assessment Score:		N/A
Priority Assessment Score:		N/A
Action:	N/A	
Comments:	Modern sink pad behind bar, no access within timber boxing

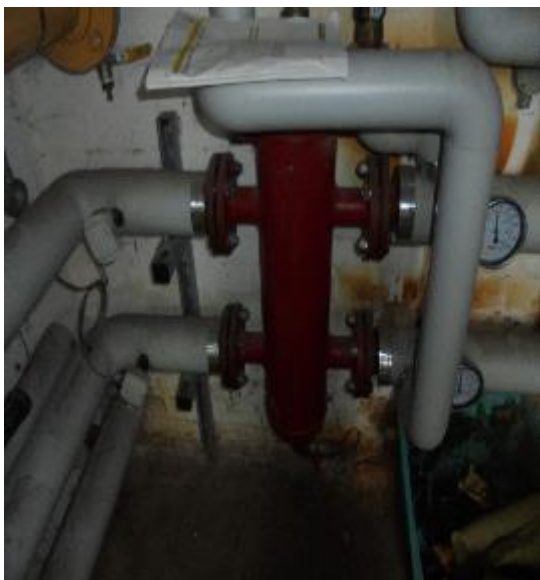
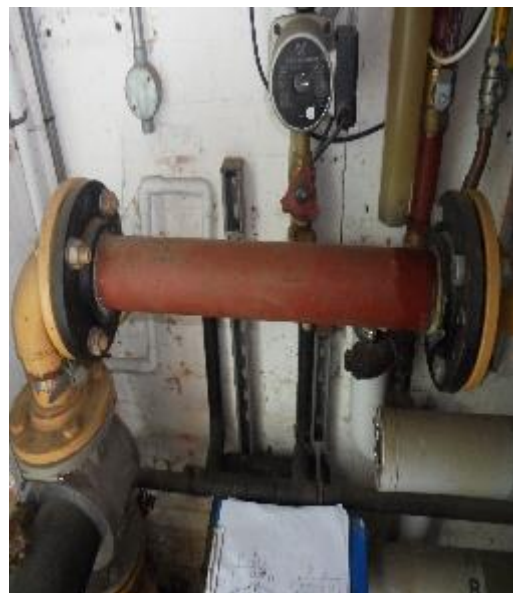
Item No: 15

Location: Boiler Room

Material Description:	Gaskets	
Identification:	Sampled – No Asbestos Detected	
Approx. quantity:	X 8 Gaskets	
Accessibility	N/A	<i>Assessment Score</i>
Product type:		N/A
Extent of Damage:		N/A
Surface Treatment:		N/A
Asbestos type:		N/A
Material Assessment Score:		N/A
Priority Assessment Score:		N/A
Action:	N/A	
Comments:	Modern boiler and electrics
