Project Number 2481

**Management
Asbestos Survey Report**

Bude Platoon, Cornwall, EX23 8QN

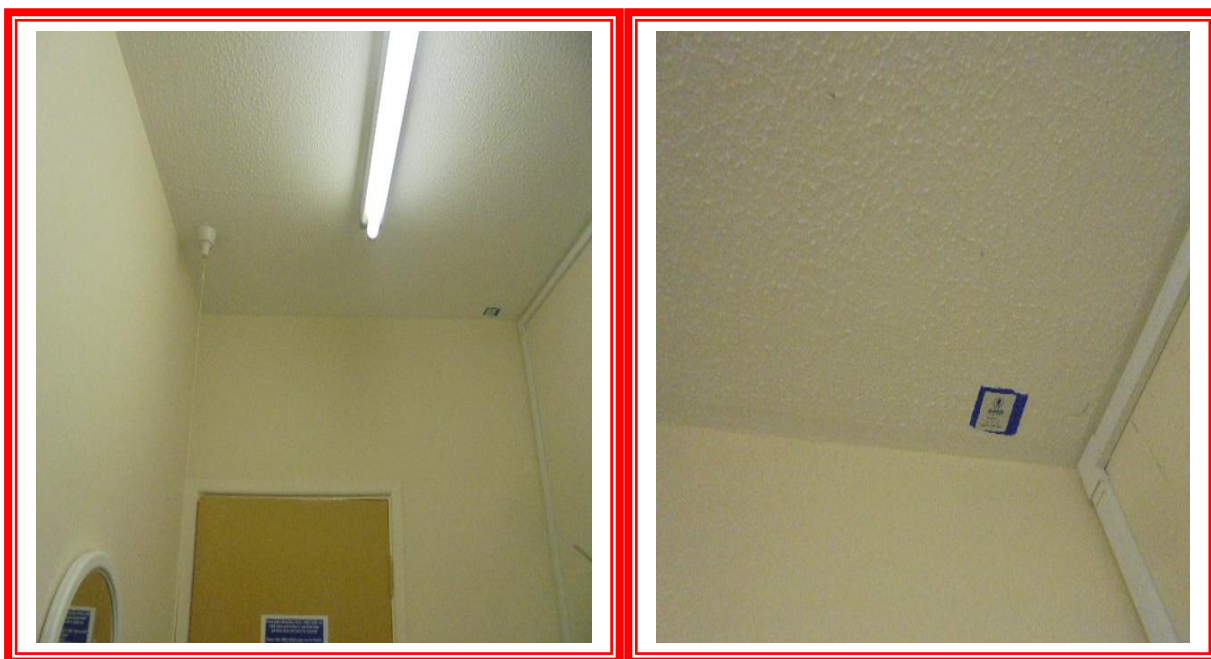
Item No: 1

Material Description:	Textured Coating to Ceiling	
Identification:	Sampled – Asbestos Detected	
Approx. quantity:	4M2	
Accessibility	Low	Assessment Score
Product type:	Composite	1
Extent of Damage:	Minor	1
Surface Treatment:	Non-Friable	0
Asbestos type:	Chrysotile	1
Material Assessment Score:		3
Priority Assessment Score:		Negligible
Action:	Manage	
Comments:	N/A

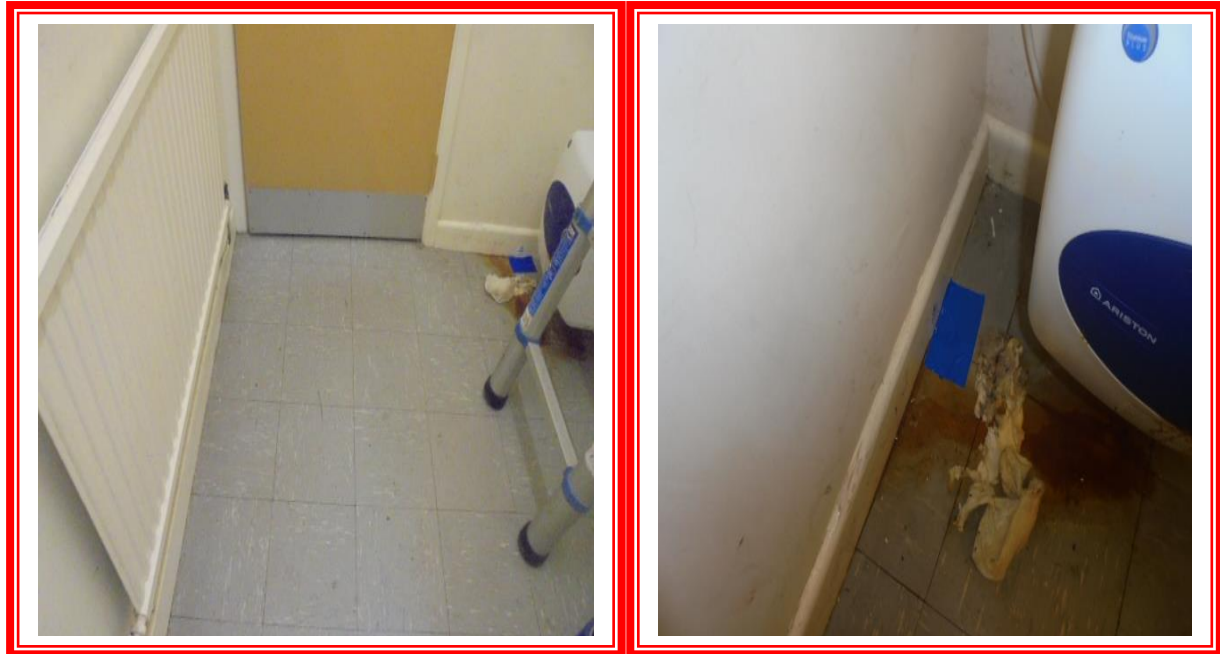
Item No: 2

Material Description:	Floor Tiles and Adhesive	
Identification:	Sampled – Asbestos Detected	
Approx. quantity:	4M2	
Accessibility	High	Assessment Score
Product type:	Composite	1
Extent of Damage:	Minor	1
Surface Treatment:	Non-Friable	0
Asbestos type:	Chrysotile	1
Material Assessment Score:		3
Priority Assessment Score:		Negligible
Action:	Manage	
Comments:	N/A

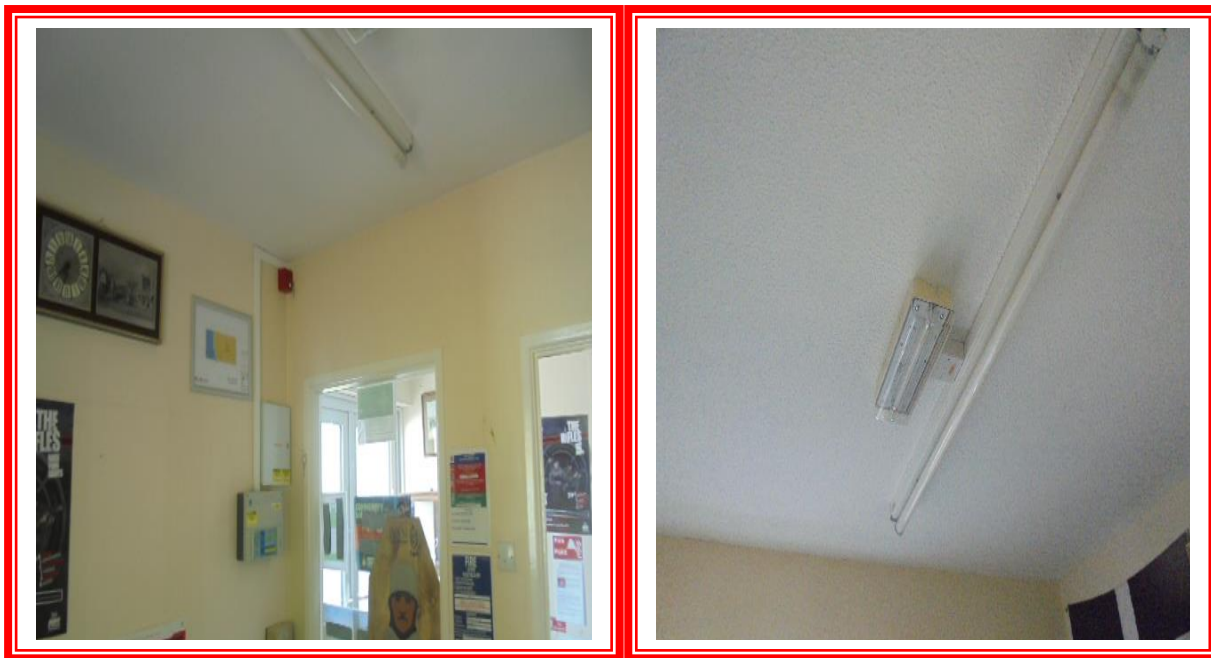
Item No: 3

Material Description:	Textured Coating to Ceiling	
Identification:	As Per Sample DK/1 – Asbestos Detected	
Approx. quantity:	4M2	
Accessibility	Low	Assessment Score
Product type:	Composite	1
Extent of Damage:	Minor	1
Surface Treatment:	Non-Friable	0
Asbestos type:	Chrysotile	1
Material Assessment Score:		3
Priority Assessment Score:		Negligible
Action:	Manage	
Comments:	N/A

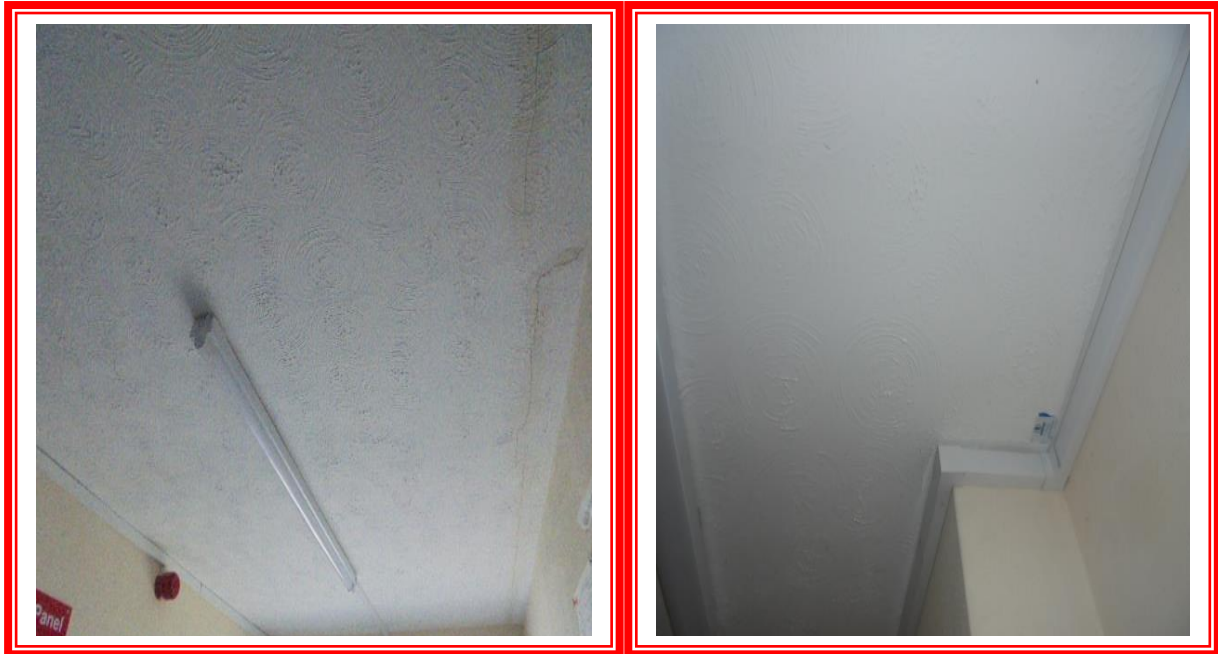
Item No: 4

Material Description:	Swirl Effect Textured Coating to Ceiling	
Identification:	Sampled – Asbestos Detected	
Approx. quantity:	14M2	
Accessibility	Low	Assessment Score
Product type:	Composite	1
Extent of Damage:	Moderate	2
Surface Treatment:	Non-Friable	0
Asbestos type:	Chrysotile	1
Material Assessment Score:		4
Priority Assessment Score:		Negligible
Action:	Manage	
Comments:	N/A

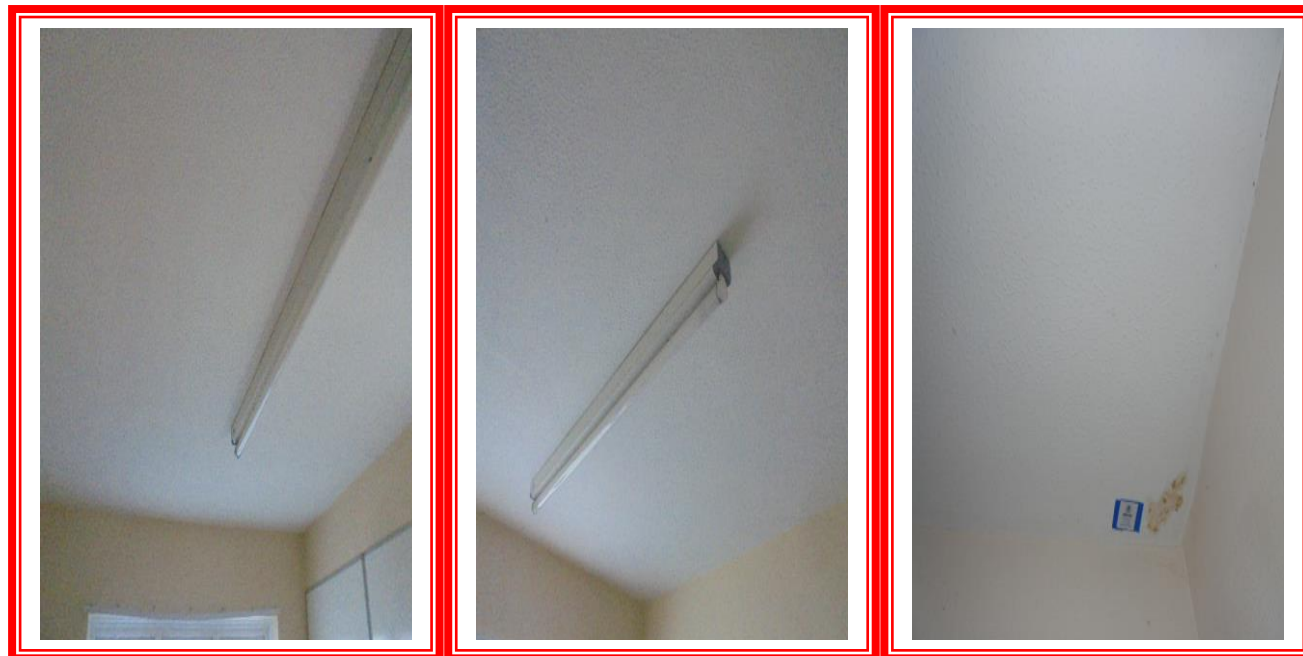
**Item No: 5****Sample No: DK/4****Location: Ground Floor – Office and Stores x 2**

Material Description:	Textured Coating to Ceiling	
Identification:	Sampled – Asbestos Detected	
Approx. quantity:	30M2	
Accessibility	Low	Assessment Score
Product type:	Composite	1
Extent of Damage:	Minor	1
Surface Treatment:	Non-Friable	0
Asbestos type:	Chrysotile	1
Material Assessment Score:		3
Priority Assessment Score:		Negligible
Action:	Manage	
Comments:	Located in each room

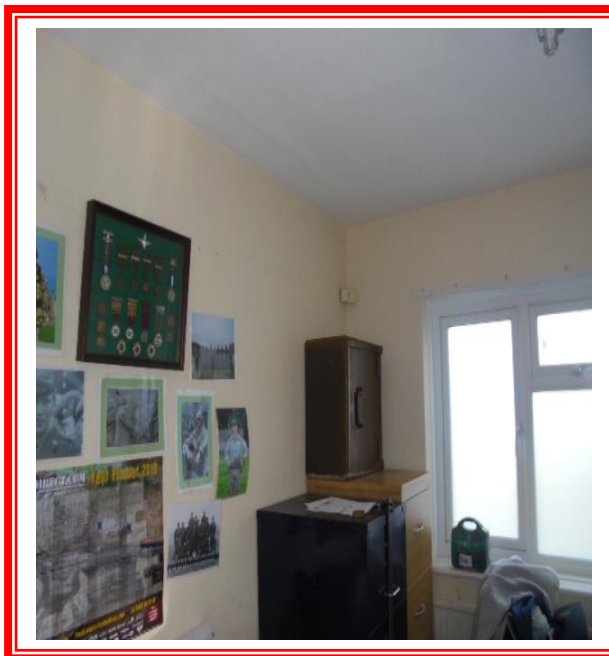
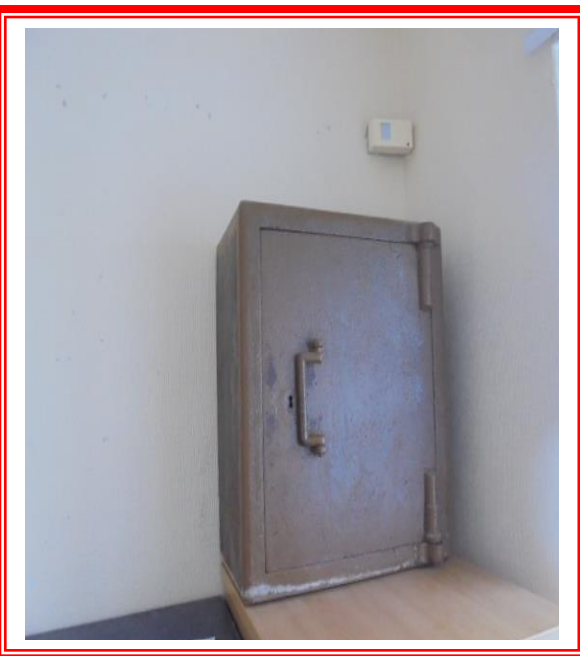
Item No: 6

Item 6 – Ground Floor – Office – No access within Safe Casings

Material Description:	No Access within Safe Casings	
Identification:	Presumed to Contain Asbestos	
Approx. quantity:	X 1 Safe	
Accessibility	Low	Assessment Score
Product type:	No Access	2
Extent of Damage:	No Access	2
Surface Treatment:	No Access	2
Asbestos type:	No Access	2
Material Assessment Score:		8
Priority Assessment Score:		Medium
Action:	Manage	
Comments:	No access without damaging safe

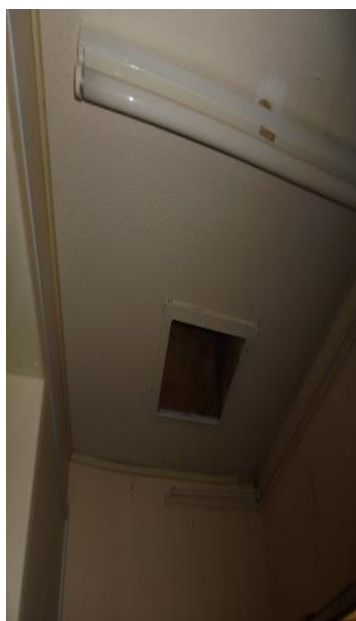
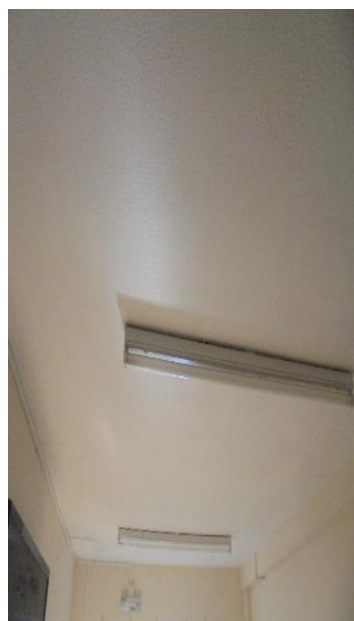
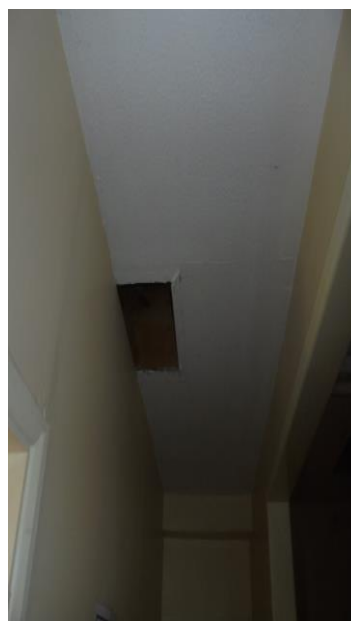
Item No: 7

Material Description:	Textured Coating to Ceiling	
Identification:	As Per Sampled DK/1 and DK/4 – Asbestos Detected	
Approx. quantity:	24M2	
Accessibility	Low	<i>Assessment Score</i>
Product type:	Composite	1
Extent of Damage:	Minor	1
Surface Treatment:	Non-Friable	0
Asbestos type:	Chrysotile	1
Material Assessment Score:		3
Priority Assessment Score:		Negligible
Action:	Manage	
Comments:	N/A

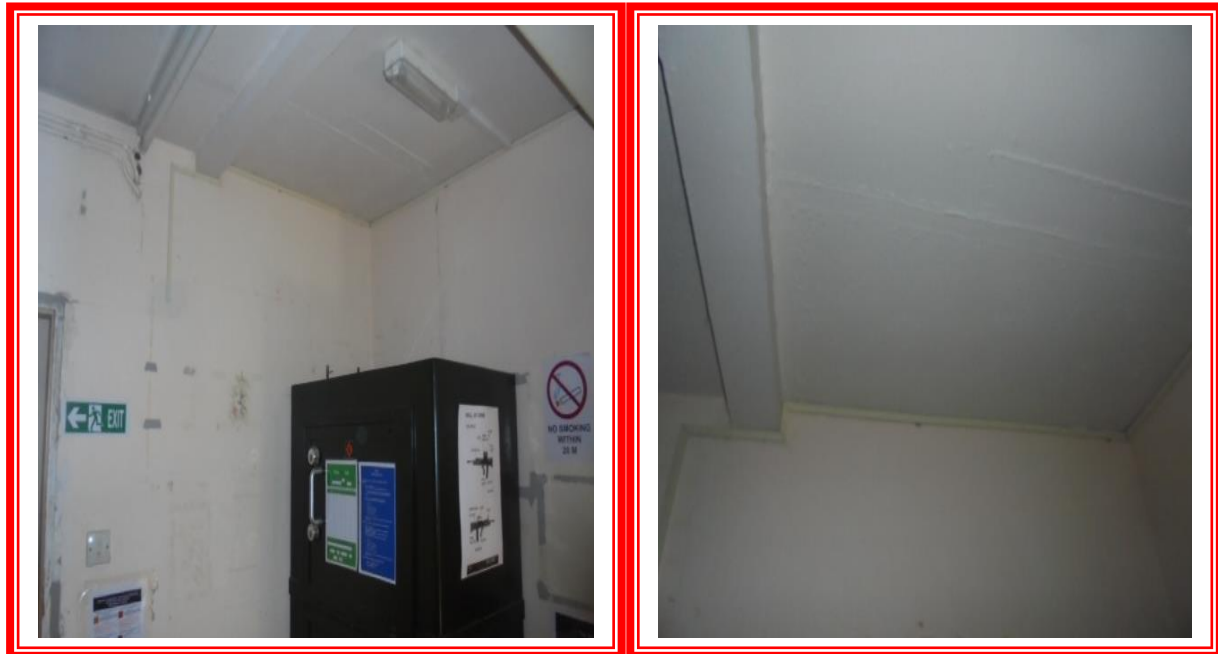
Item No: 8

Material Description:	Textured Coating to Ceiling	
Identification:	As Per Sampled DK/3 – Asbestos Detected	
Approx. quantity:	1M2	
Accessibility	Low	<i>Assessment Score</i>
Product type:	Composite	1
Extent of Damage:	Minor	1
Surface Treatment:	Non-Friable	0
Asbestos type:	Chrysotile	1
Material Assessment Score:		3
Priority Assessment Score:		Negligible
Action:	Manage	
Comments:	N/A

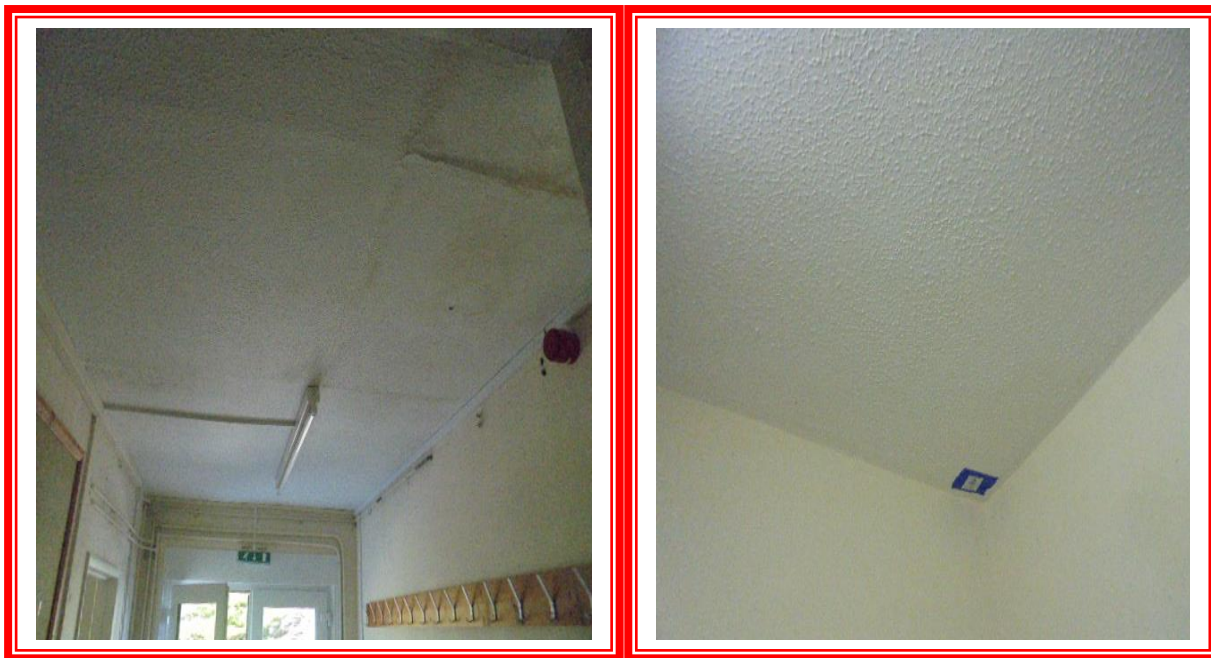
**Item No: 9****Sample No: DK/5****Location: Ground Floor – Lobby and WC**

Material Description:	Textured Coating to Ceiling	
Identification:	Sampled – Asbestos Detected	
Approx. quantity:	16M2	
Accessibility	Low	Assessment Score
Product type:	Composite	1
Extent of Damage:	Minor	1
Surface Treatment:	Non-Friable	0
Asbestos type:	Chrysotile	1
Material Assessment Score:		3
Priority Assessment Score:		Negligible
Action:	Manage	
Comments:	N/A

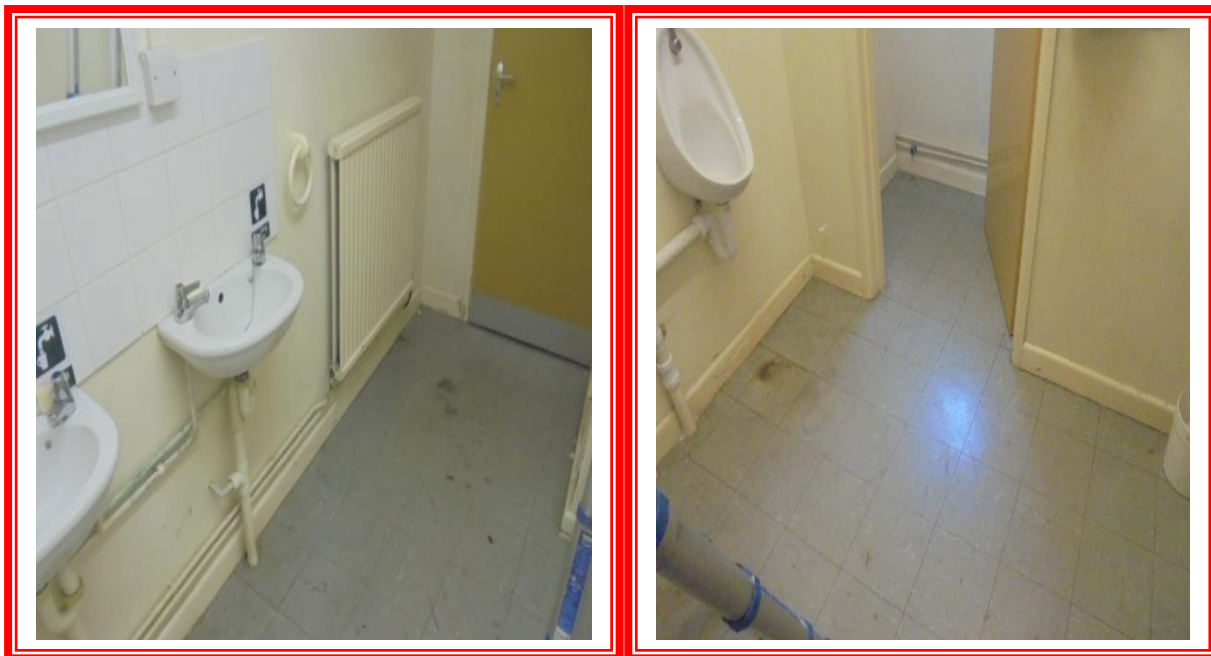
Item No: 10

Material Description:	Floor Tiles and Adhesive	
Identification:	As Per Sample DK/2 – Asbestos Detected	
Approx. quantity:	7M2	
Accessibility	High	Assessment Score
Product type:	Composite	1
Extent of Damage:	Minor	1
Surface Treatment:	Non-Friable	0
Asbestos type:	Chrysotile	1
Material Assessment Score:		3
Priority Assessment Score:		Negligible
Action:	Manage	
Comments:	N/A

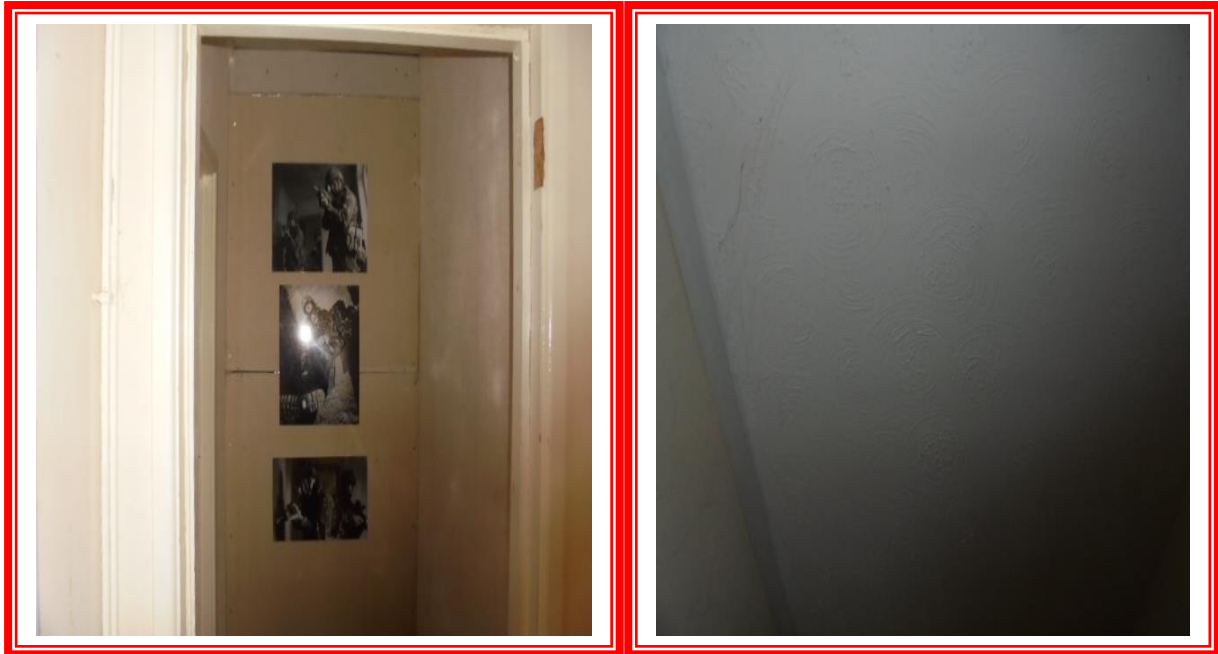
Item No: 11

Material Description:	Swirl Effect Textured Coating to Ceiling	
Identification:	As Per Sample DK/3 – Asbestos Detected	
Approx. quantity:	2M2	
Accessibility	Low	Assessment Score
Product type:	Composite	1
Extent of Damage:	Moderate	2
Surface Treatment:	Non-Friable	0
Asbestos type:	Chrysotile	1
Material Assessment Score:		4
Priority Assessment Score:		Negligible
Action:	Manage	
Comments:	N/A

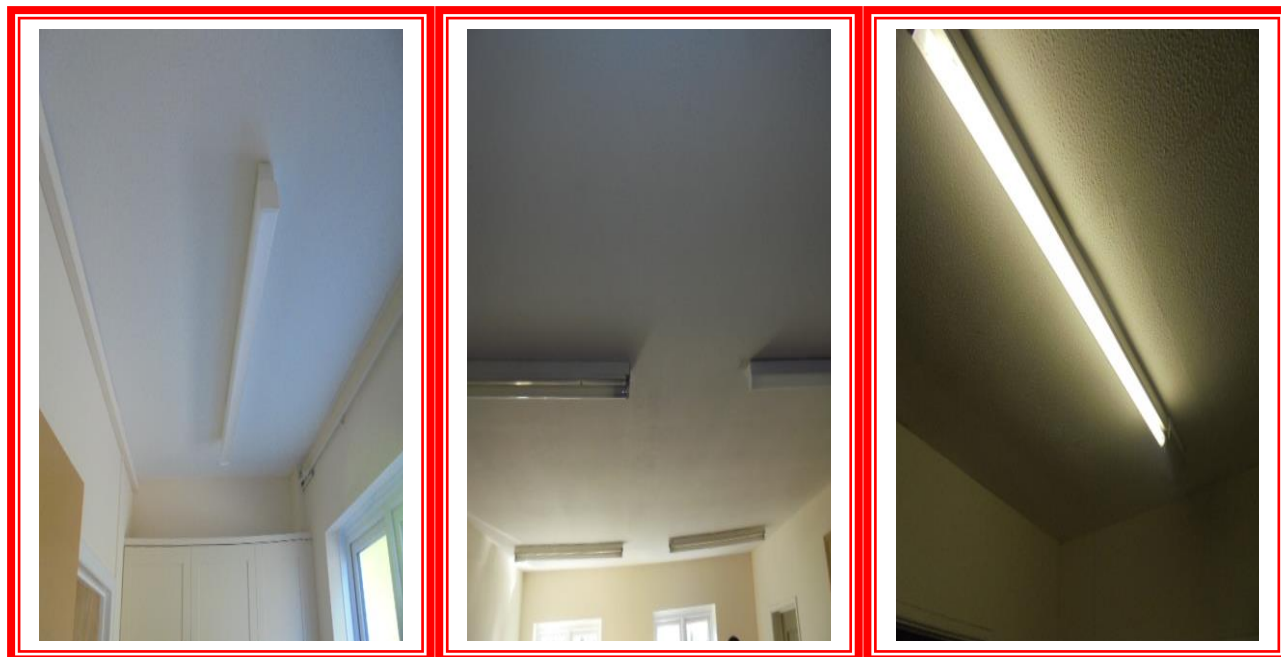
Item No: 12

Material Description:	Textured Coating to Ceiling	
Identification:	As Per Samples DK/1, DK/4 and DK/5 – Asbestos Detected	
Approx. quantity:	47M2	
Accessibility	Low	<i>Assessment Score</i>
Product type:	Composite	1
Extent of Damage:	Moderate	2
Surface Treatment:	Non-Friable	0
Asbestos type:	Chrysotile	1
Material Assessment Score:		4
Priority Assessment Score:		Negligible
Action:	Manage	
Comments:	Modern sink pad in kitchen

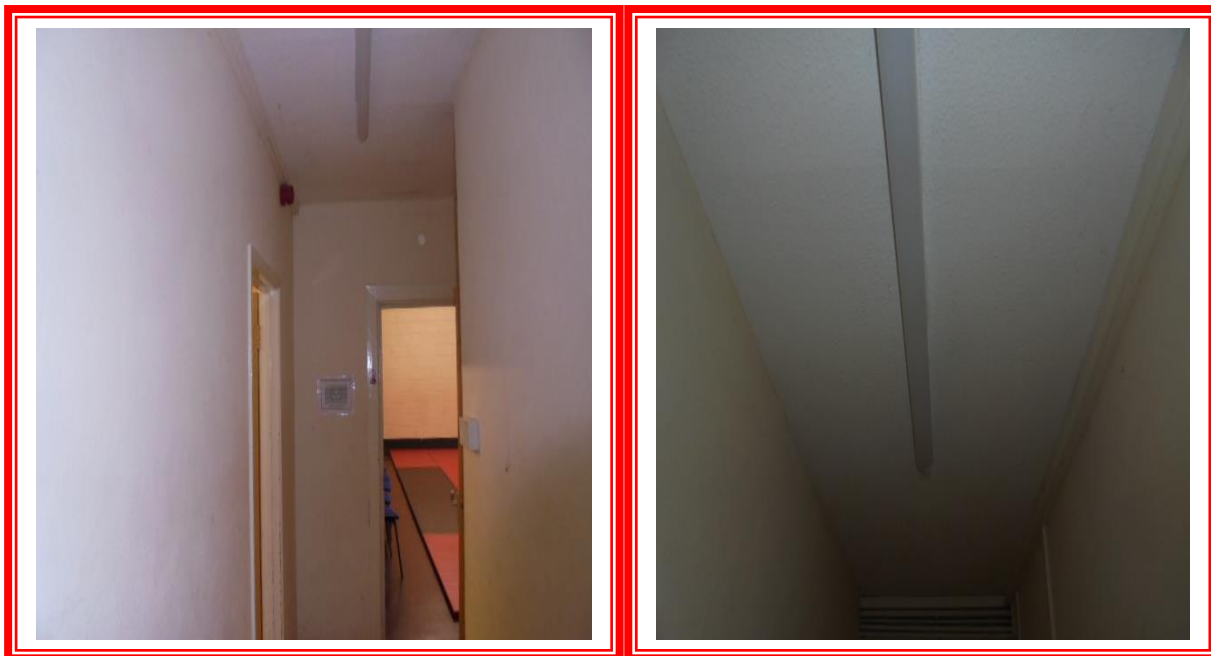
Item No: 13

Material Description:	Textured Coating to Ceiling	
Identification:	As Per Samples DK/1, DK/4 and DK/5 – Asbestos Detected	
Approx. quantity:	5M2	
Accessibility	Low	Assessment Score
Product type:	Composite	1
Extent of Damage:	Minor	1
Surface Treatment:	Non-Friable	0
Asbestos type:	Chrysotile	1
Material Assessment Score:		3
Priority Assessment Score:		Negligible
Action:	Manage	
Comments:	No access above plasterboard ceiling – apply caution

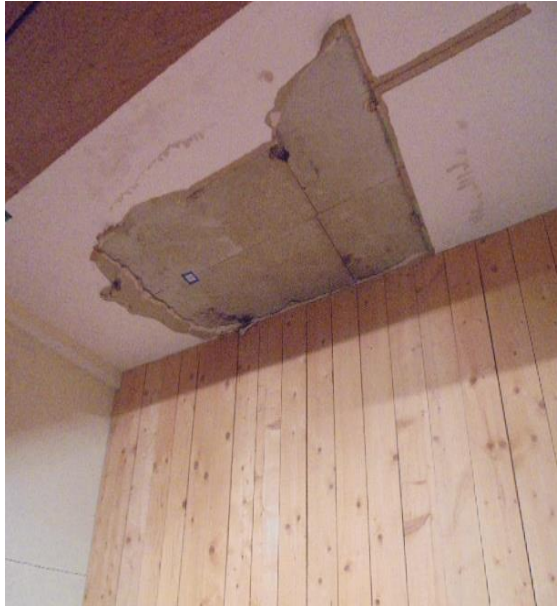
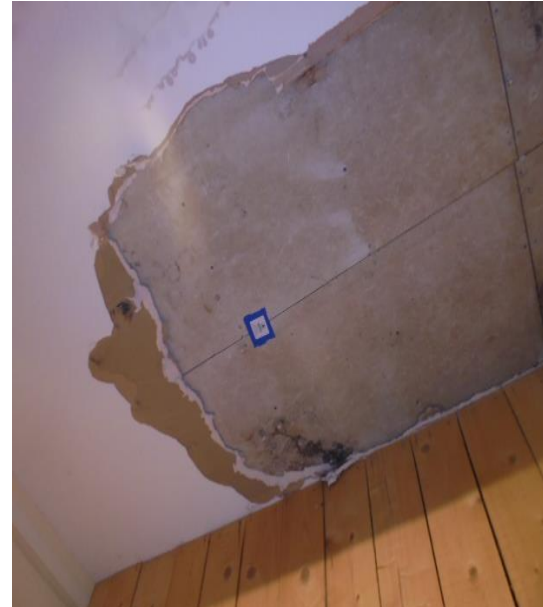
**Item No: 15****Sample No: DK/6****Location: Ground Floor – Range**

Material Description:	Insulation Board Ceiling	
Identification:	Sampled – Asbestos Detected	
Approx. quantity:	8M2	
Accessibility	Low	Assessment Score
Product type:	Asbestos Insulation Board	2
Extent of Damage:	Moderate	2
Surface Treatment:	Unsealed	2
Asbestos type:	Amosite	2
Material Assessment Score:		8
Priority Assessment Score:		Medium
Action:	Encapsulate/Restrict Access/Environmental Clean	
Comments:	Located above plasterboard. May also be found above plasterboard throughout range – Apply Caution. Possible debris on floor due to bullet impact

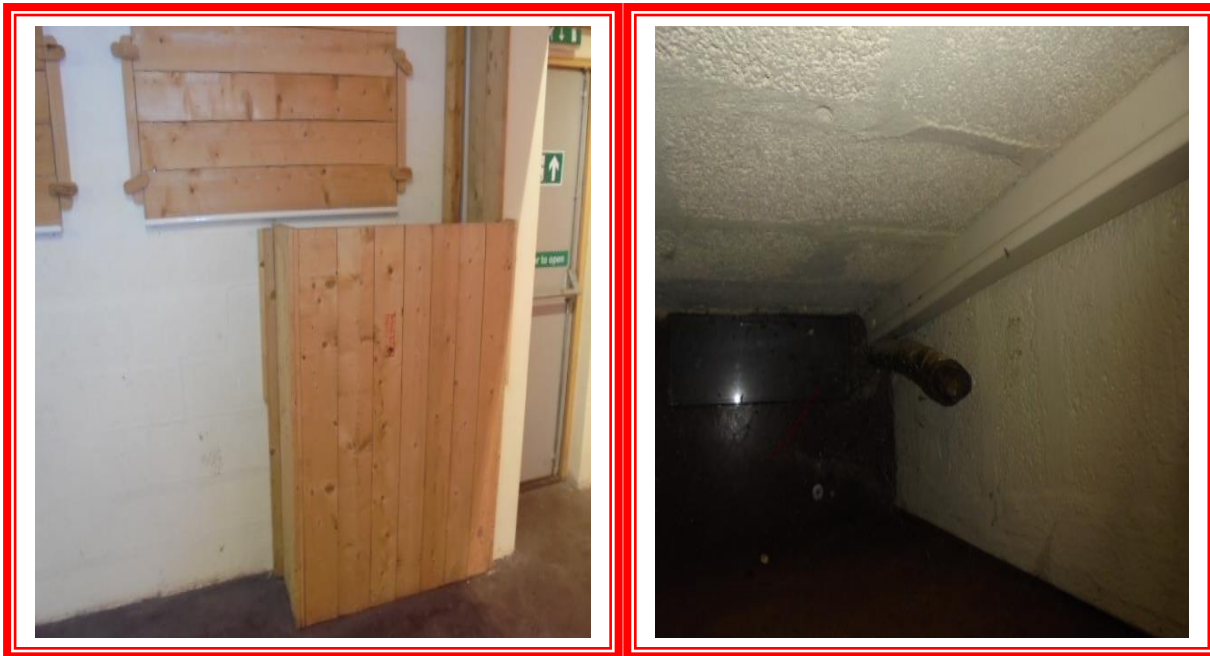
Item No: 16

Item 16 – Ground Floor – Range – Bitumen Wrap to disconnected main cable – Unable to sample as live

Material Description:	Bitumen wrap to disconnected mains cable	
Identification:	Presumed to Contain asbestos	
Approx. quantity:	1LM	
Accessibility	Low	<i>Assessment Score</i>
Product type:	Bitumen	1
Extent of Damage:	Minor	1
Surface Treatment:	Non-Friable	0
Asbestos type:	Chrysotile	1
Material Assessment Score:		3
Priority Assessment Score:		Negligible
Action:	Manage	
Comments:	N/A

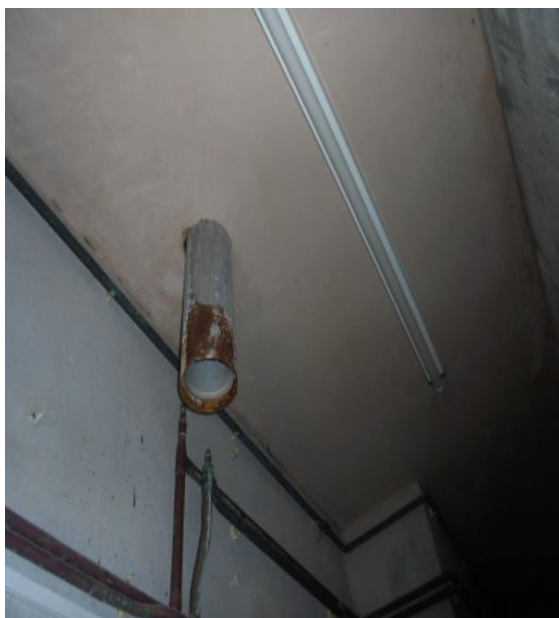
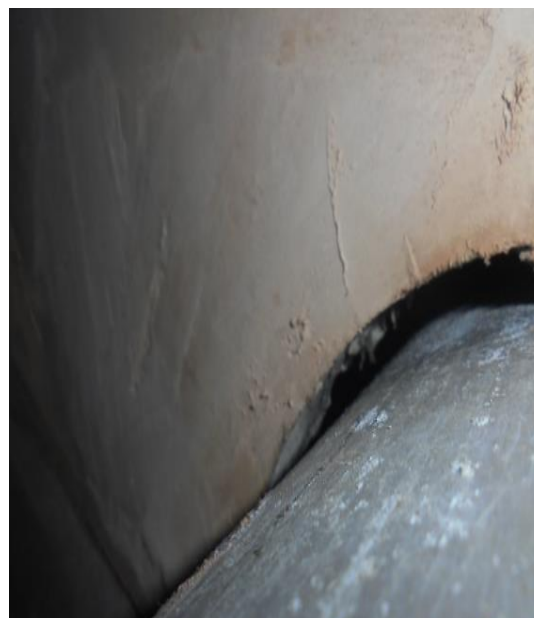
**Item No: 17****Sample No: N/A****Location: Ground Floor – Boiler Room**

Material Description:	Insulation Board Ceiling	
Identification:	As Per DK/6 – Asbestos Detected	
Approx. quantity:	4M2	
Accessibility	Low	Assessment Score
Product type:	Asbestos Insulation Board	2
Extent of Damage:	Moderate	2
Surface Treatment:	Sealed	1
Asbestos type:	Amosite	2
Material Assessment Score:		7
Priority Assessment Score:		Medium
Action:	Manage	
Comments:	Visible above plasterboard ceiling. No access to sample but is visually similar to sample DK/6

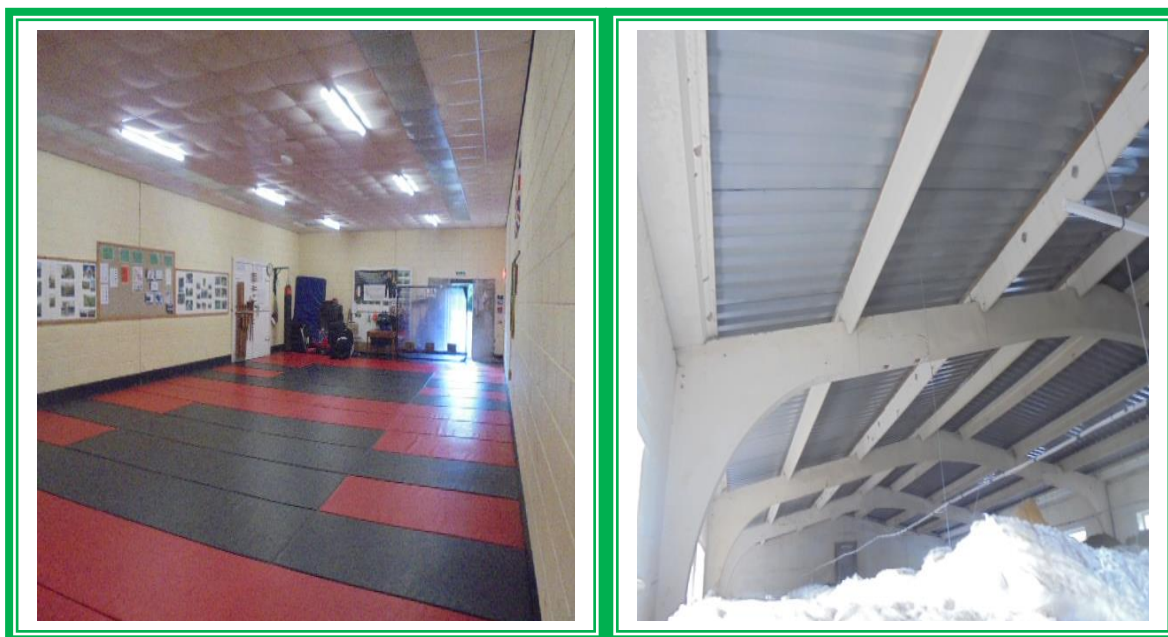
Item No: 14
Sample No: N/A
Location: Ground Floor – Parade Hall

Material Description:	Visual Inspection – No Suspect Materials Found	
Identification:	N/A	
Approx. quantity:	N/A	
Accessibility	N/A	<i>Assessment Score</i>
Product type:	N/A	N/A
Extent of Damage:	N/A	N/A
Surface Treatment:	N/A	N/A
Asbestos type:	N/A	N/A
Material Assessment Score:		N/A
Priority Assessment Score:		N/A
Action:	N/A	
Comments:	N/A

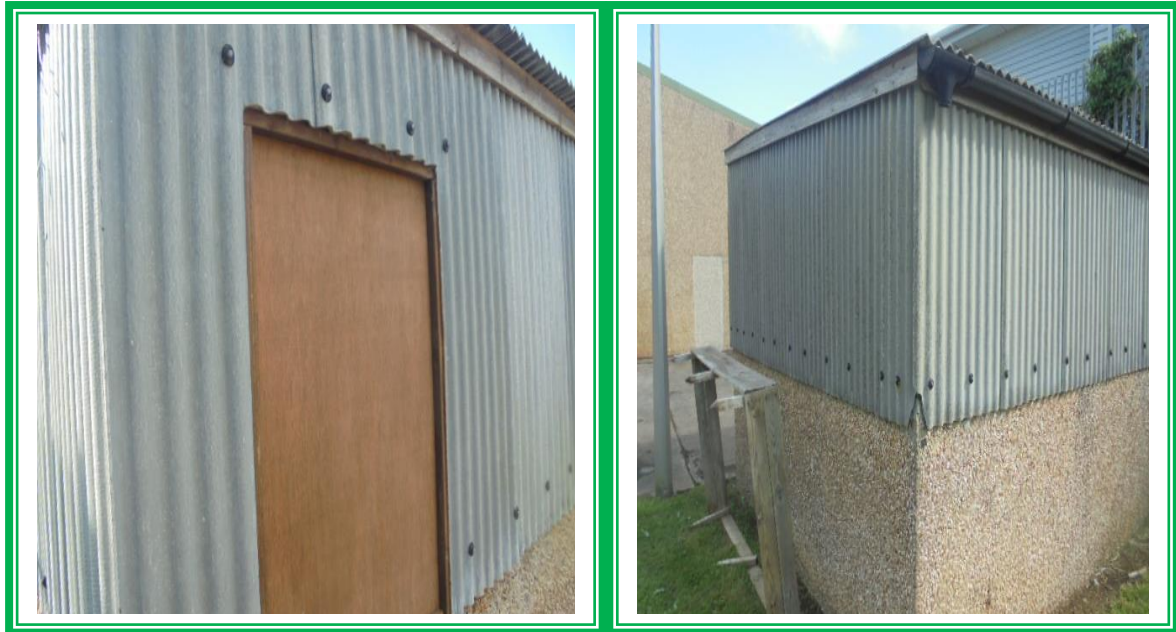
Item No: 18

Material Description:	Cement Wall Cladding	
Identification:	Sampled – No Asbestos Detected	
Approx. quantity:	9M2	
Accessibility	N/A	<i>Assessment Score</i>
Product type:	N/A	N/A
Extent of Damage:	N/A	N/A
Surface Treatment:	N/A	N/A
Asbestos type:	N/A	N/A
Material Assessment Score:		N/A
Priority Assessment Score:		N/A
Action:	N/A	
Comments:	N/A

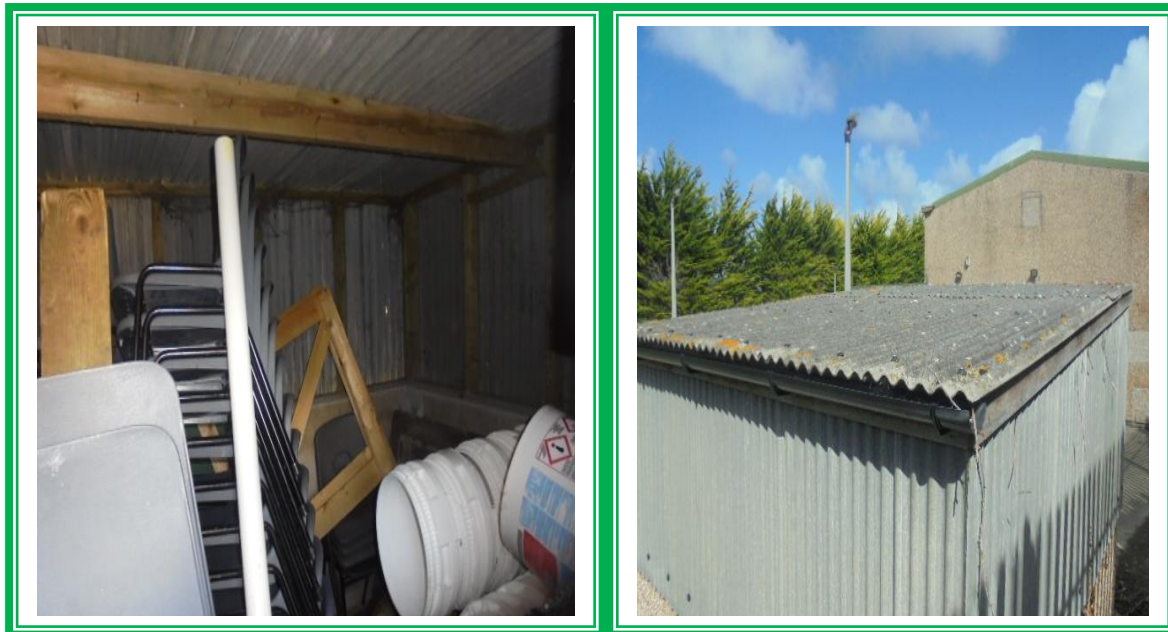
Item No: 19

Material Description:	Profiled Cement Roof	
Identification:	Sampled – No Asbestos Detected	
Approx. quantity:	9M2	
Accessibility	N/A	<i>Assessment Score</i>
Product type:	N/A	N/A
Extent of Damage:	N/A	N/A
Surface Treatment:	N/A	N/A
Asbestos type:	N/A	N/A
Material Assessment Score:		N/A
Priority Assessment Score:		N/A
Action:	N/A	
Comments:	N/A
