**Project Number 2481**

**Management  
Asbestos Survey Report**

**Brockworth Platoon,  
Gloucestershire, GL3 4JP**

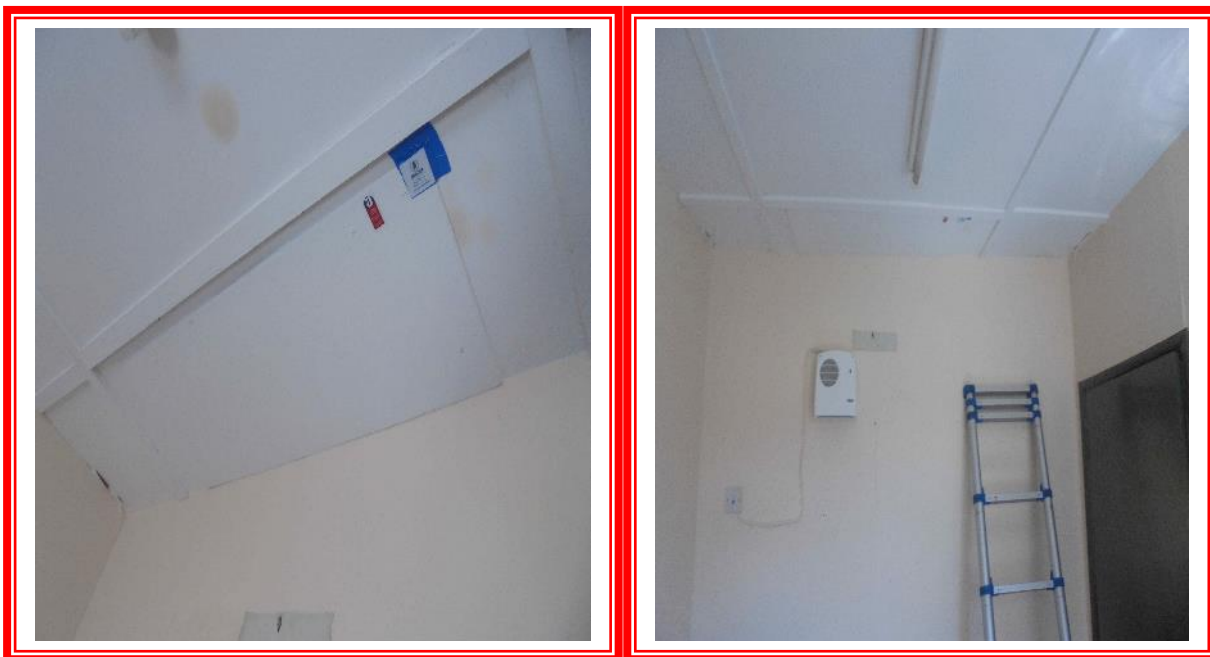
**Item No: 1**

Sample Number	Sample Type	Location	Analysis
DK/1	Insulation Board Ceiling Panels	Office	Amosite

<b>Material Description:</b>	Insulation Board Panels on Ceiling	
<b>Identification:</b>	Sampled – Asbestos Detected	
<b>Approx. quantity:</b>	2 x Panels (1M2 Total)	
<b>Accessibility</b>	Low	<i>Assessment Score</i>
<b>Product type:</b>	Insulating Board	2
<b>Extent of Damage:</b>	Minor	1
<b>Surface Treatment:</b>	Sealed	1
<b>Asbestos type:</b>	Amosite	2
<b>Material Assessment Score:</b>		6
<b>Priority Assessment Score:</b>		Low
<b>Action:</b>	Manage	
<b>Comments:</b>	NA

Sample No.	Sample Ref.	Location	Asbestos Detected	Asbestos Type
DK/1	BS565948	Office. Insulation board ceiling tiles	Yes	Amosite

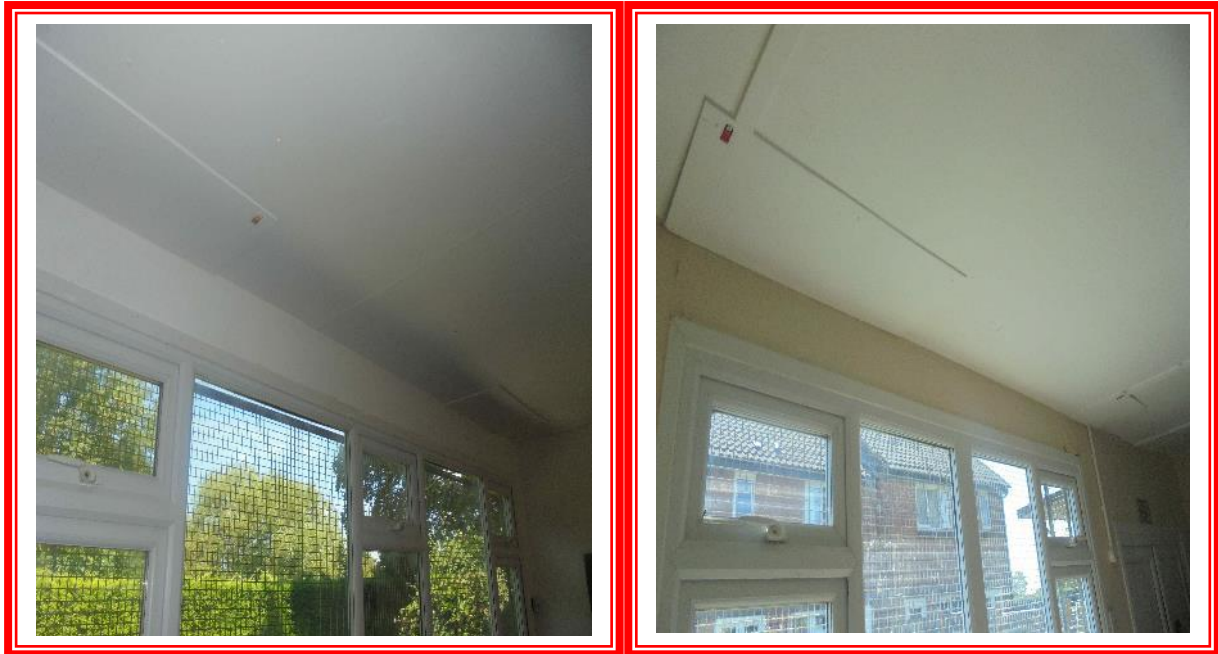
**Item No: 6****Sample No: N/A****Location: Ground Floor - Drill Hall & Classroom**

<b>Material Description:</b>	Insulation board Panels on Ceiling	
<b>Identification:</b>	As Per Sample DK/1 – Asbestos Detected	
<b>Approx. quantity:</b>	X 6 panels (3M2 total)	
<b>Accessibility</b>	Low	<i>Assessment Score</i>
<b>Product type:</b>	Insulation Board	2
<b>Extent of Damage:</b>	Minor	1
<b>Surface Treatment:</b>	Sealed	1
<b>Asbestos type:</b>	Amosite	2
<b>Material Assessment Score:</b>		6
<b>Priority Assessment Score:</b>		Low
<b>Action:</b>	Manage/Encapsulate	
<b>Comments:</b>	Minor damage to panels

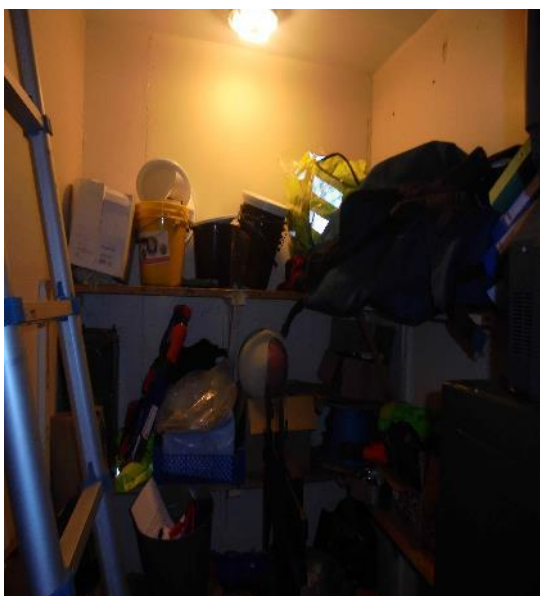
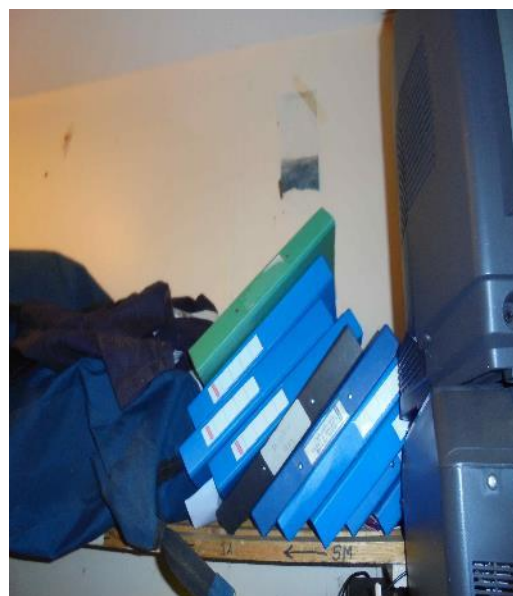
**Item No: 2**

<b>Material Description:</b>	Visual Inspection – No Suspect Materials Found	
<b>Identification:</b>	N/A	
<b>Approx. quantity:</b>	N/A	
<b>Accessibility</b>	N/A	<i>Assessment Score</i>
<b>Product type:</b>		N/A
<b>Extent of Damage:</b>		N/A
<b>Surface Treatment:</b>		N/A
<b>Asbestos type:</b>		N/A
<b>Material Assessment Score:</b>		N/A
<b>Priority Assessment Score:</b>		N/A
<b>Action:</b>	N/A	
<b>Comments:</b>	N/A

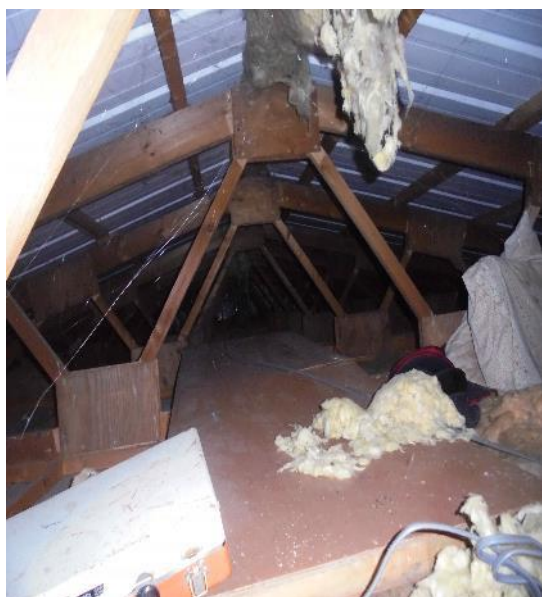
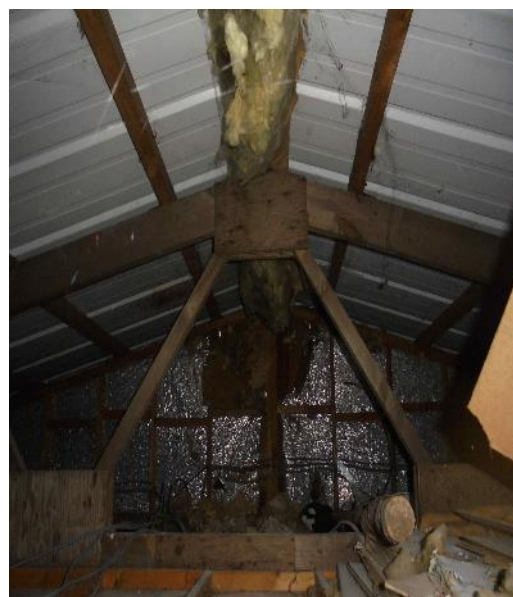
**Item No: 3**

<b>Material Description:</b>	Visual Inspection – No Suspect Materials Found	
<b>Identification:</b>	N/A	
<b>Approx. quantity:</b>	N/A	
<b>Accessibility</b>	N/A	<i>Assessment Score</i>
<b>Product type:</b>		N/A
<b>Extent of Damage:</b>		N/A
<b>Surface Treatment:</b>		N/A
<b>Asbestos type:</b>		N/A
<b>Material Assessment Score:</b>		N/A
<b>Priority Assessment Score:</b>		N/A
<b>Action:</b>	N/A	
<b>Comments:</b>	Limited access into loft as no crawlboards were available

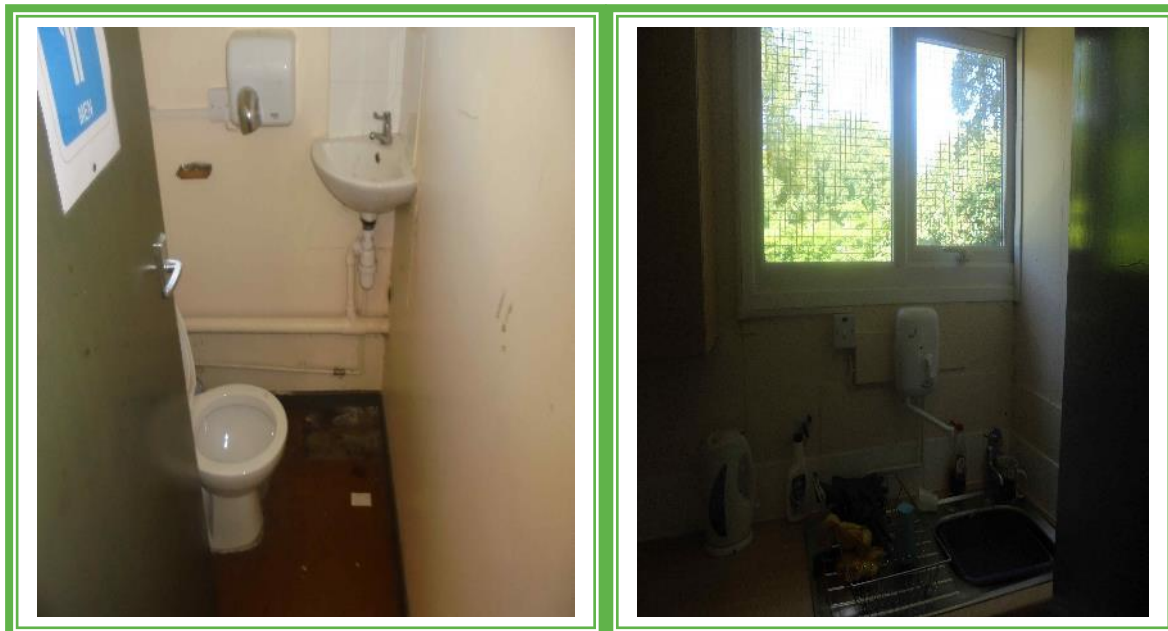
**Item No: 4**

<b>Material Description:</b>	Visual Inspection – No Suspect Materials Found	
<b>Identification:</b>	N/A	
<b>Approx. quantity:</b>	N/A	
<b>Accessibility</b>	N/A	<i>Assessment Score</i>
<b>Product type:</b>		N/A
<b>Extent of Damage:</b>		N/A
<b>Surface Treatment:</b>		N/A
<b>Asbestos type:</b>		N/A
<b>Material Assessment Score:</b>		N/A
<b>Priority Assessment Score:</b>		N/A
<b>Action:</b>	N/A	
<b>Comments:</b>	Modern electrics

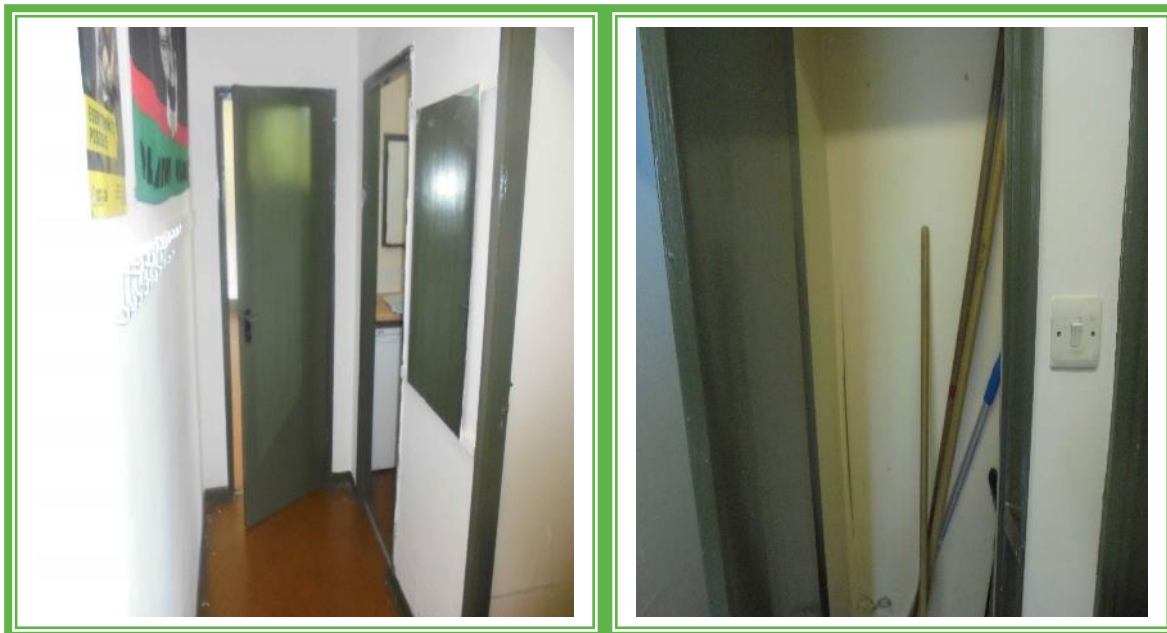
**Item No: 5**

<b>Material Description:</b>	Visual Inspection – No Suspect Materials Found	
<b>Identification:</b>	N/A	
<b>Approx. quantity:</b>	N/A	
<b>Accessibility</b>	N/A	<i>Assessment Score</i>
<b>Product type:</b>		N/A
<b>Extent of Damage:</b>		N/A
<b>Surface Treatment:</b>		N/A
<b>Asbestos type:</b>		N/A
<b>Material Assessment Score:</b>		N/A
<b>Priority Assessment Score:</b>		N/A
<b>Action:</b>	N/A	
<b>Comments:</b>	Modern electrics

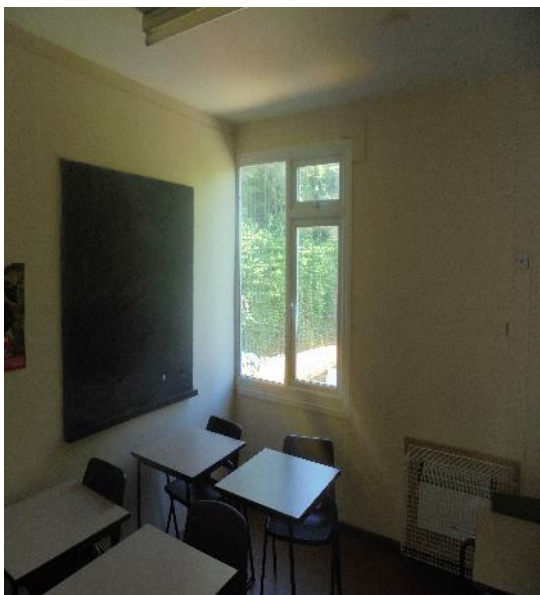
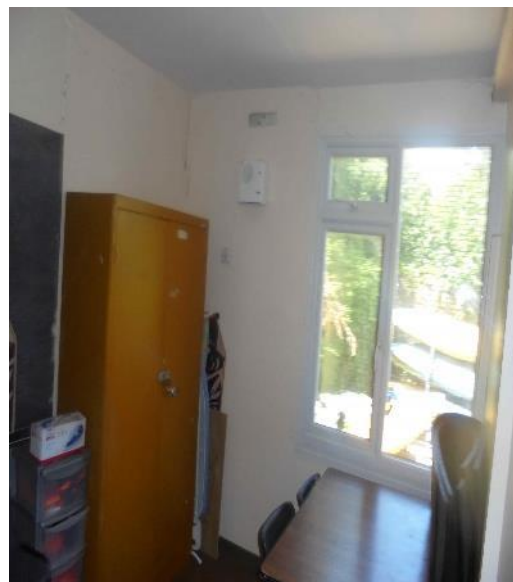
**Item No: 7**

<b>Material Description:</b>	Visual Inspection – No Suspect Materials Found	
<b>Identification:</b>	N/A	
<b>Approx. quantity:</b>	N/A	
<b>Accessibility</b>	N/A	<i>Assessment Score</i>
<b>Product type:</b>		N/A
<b>Extent of Damage:</b>		N/A
<b>Surface Treatment:</b>		N/A
<b>Asbestos type:</b>		N/A
<b>Material Assessment Score:</b>		N/A
<b>Priority Assessment Score:</b>		N/A
<b>Action:</b>	N/A	
<b>Comments:</b>	N/A

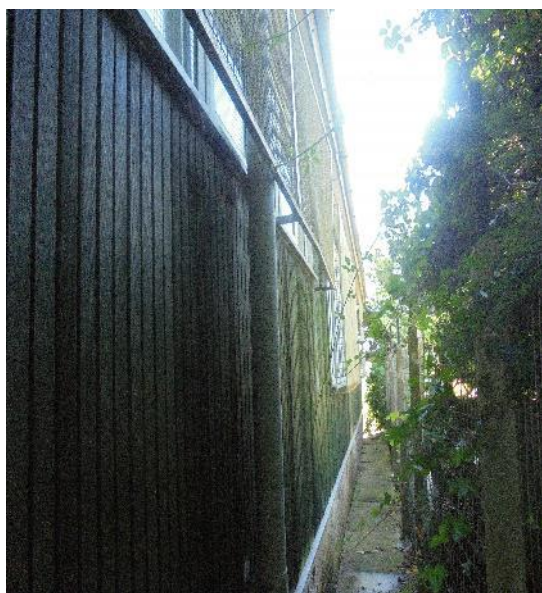
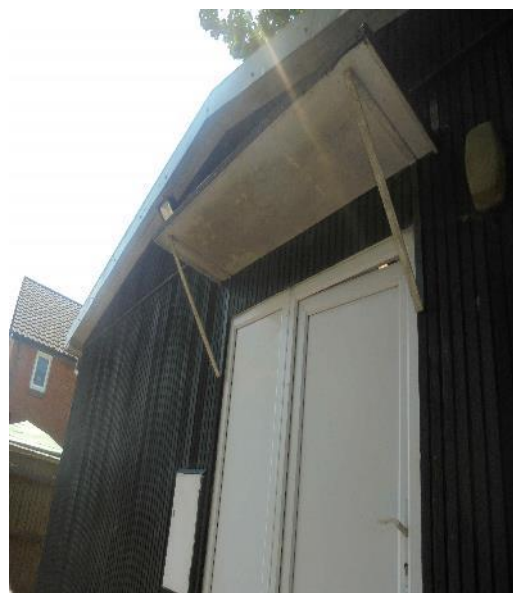
**Item No: 8**

<b>Material Description:</b>	Visual Inspection – No Suspect Materials Found	
<b>Identification:</b>	N/A	
<b>Approx. quantity:</b>	N/A	
<b>Accessibility</b>	N/A	<i>Assessment Score</i>
<b>Product type:</b>		N/A
<b>Extent of Damage:</b>		N/A
<b>Surface Treatment:</b>		N/A
<b>Asbestos type:</b>		N/A
<b>Material Assessment Score:</b>		N/A
<b>Priority Assessment Score:</b>		N/A
<b>Action:</b>	N/A	
<b>Comments:</b>	No damp proof course visible
