**Project Number A-00571 (3700)**

**Re-Inspection  
Asbestos Survey Report - Revised**

**Midsomer Norton Platoon  
115 High Street  
BA3 2DA**

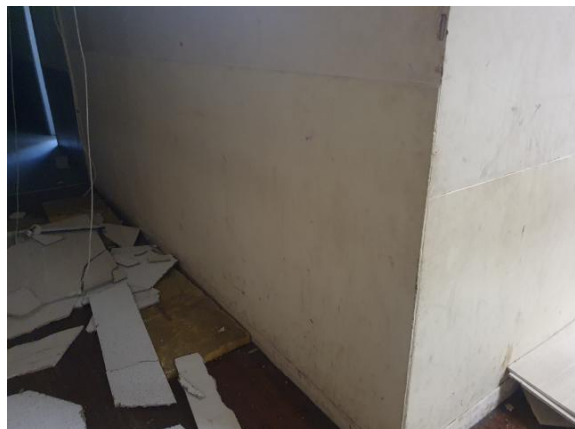
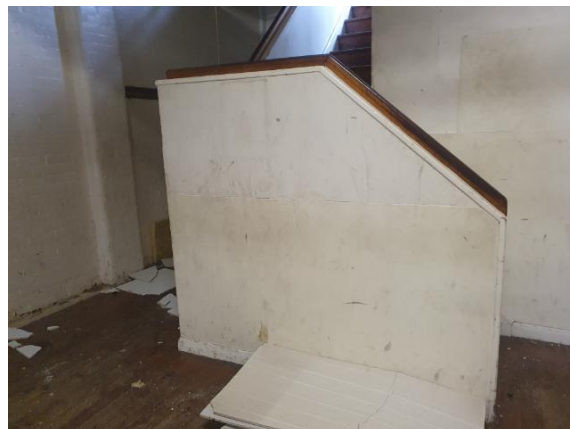
| <b>Location:</b> | Ground Floor - Void under Stairs 003 | | |

| <b>Material Description:</b> | All - No Access Gained | |
| <b>Identification:</b> | Presumed to Contain Asbestos | |
| <b>Product type:</b> | Pipe Insulation | 3 |
| <b>Extent of Damage:</b> | Major damage | 3 |
| <b>Surface Treatment:</b> | Unsealed Insulation | 3 |
| <b>Asbestos type:</b> | Amosite, Chrysotile, Crocidolite | 3 |
| <b>Material Assessment Score:</b> | | 12 |
| <b>Priority Assessment Score:</b> | | High |
| <b>Comments:</b> | No door or access hatch to void | |

| <b>Action:</b> | Further Investigation Needed | |

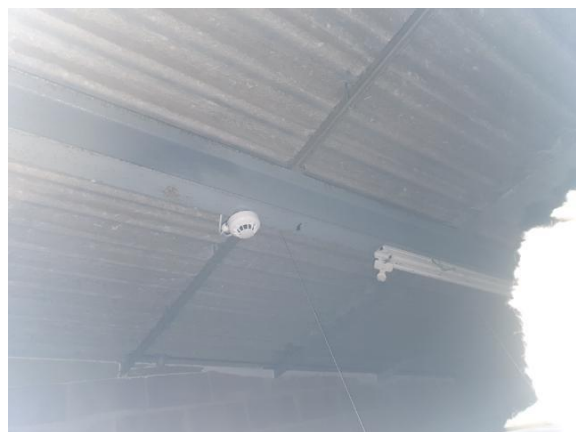
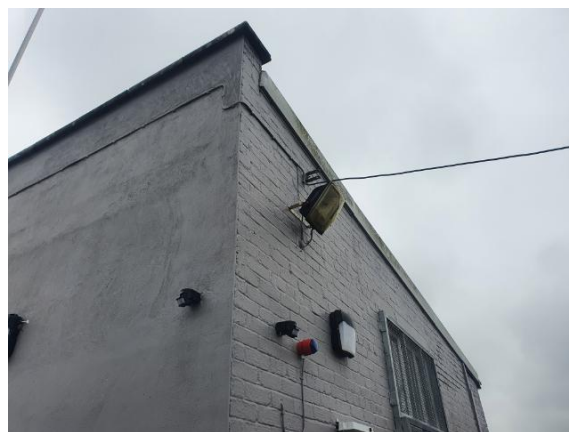
**Location:** Ground Floor - Garages 004

| <b>Material Description:</b> | Profiled Roof - Cement Product | |
| <b>Identification:</b> | Strongly Presumed to Contain Asbestos | |
| <b>Approx. quantity:</b> | 75 m <sup>2</sup> | |
| <b>Extent of Damage:</b> | Slight / minor damage | 1 |
| <b>Material Assessment Score:</b> | | 4 |
| <b>Priority Assessment Score:</b> | | Negligible |
| <b>Comments:</b> | Too high to sample. Visible above suspended ceiling | |

| <b>Action:</b> | Manage | |

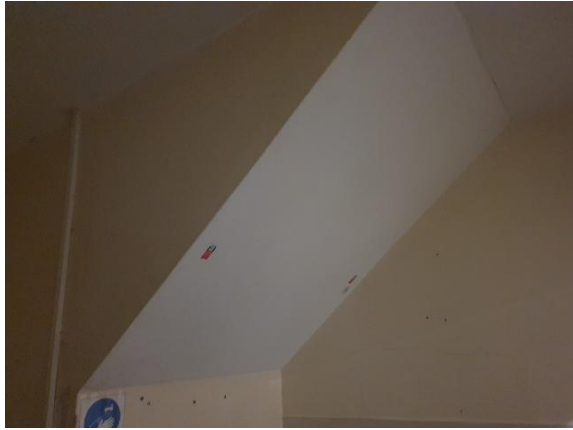
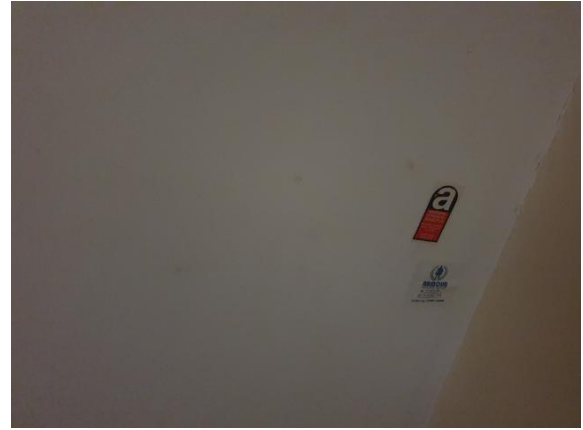
**Location:** Ground Floor - Kitchen 005

| <b>Material Description:</b> | Panel to Underside of Stairs - Insulating Board | |
| <b>Identification:</b> | Strongly Presumed to Contain Asbestos | |
| <b>Approx. quantity:</b> | <2 m <sup>2</sup> | |
| <b>Extent of Damage:</b> | Slight / minor damage | 1 |
| <b>Surface Treatment:</b> | Encapsulated AIB | 1 |
| <b>Asbestos type:</b> | Amosite, Chrysotile | 2 |
| <b>Material Assessment Score:</b> | | 5 |
| <b>Priority Assessment Score:</b> | | Low |
| <b>Comments:</b> | Exposed boarding was sampled (ref GBG/1) but does not contain asbestos. As a positive sample has previously been taken, it must be presumed that the Asbestos is concealed behind this | |

| <b>Action:</b> | Manage | |

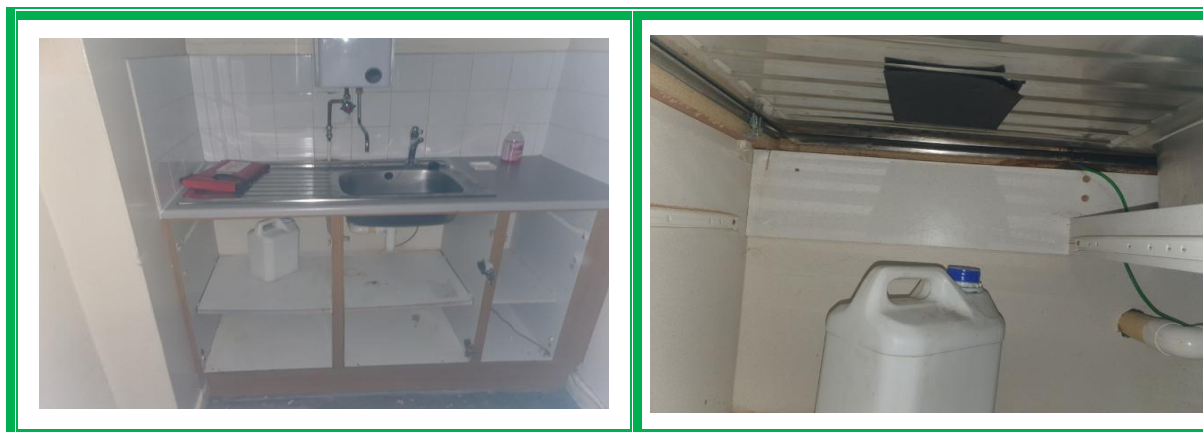
| <b>Location:</b> | Ground Floor - Kitchen 001 | | |

| <b>Material Description:</b> | No Suspect Materials Found | |
| <b>Comments:</b> | Under sink was previously not accessed. Now accessed and only a non-asbestos sink pad found | |

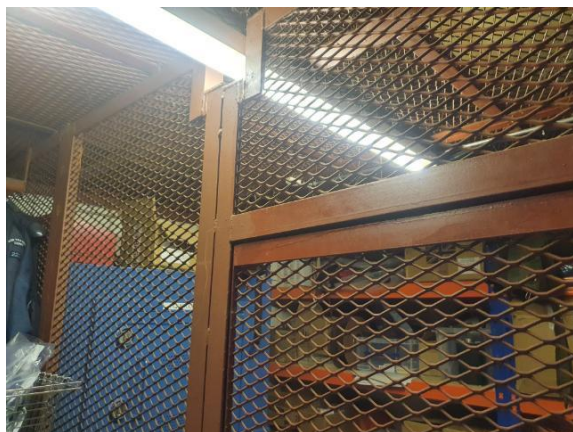
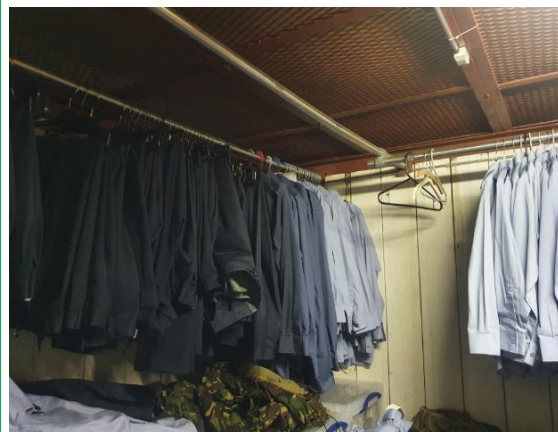
**Location:** Basement - Armoury 002

| <b>Material Description:</b> | No Suspect Materials Found | |
| <b>Comments:</b> | Previously a no access area. Now accessed and no asbestos found. Plasterboard ceiling, timber walls and concrete floor | |

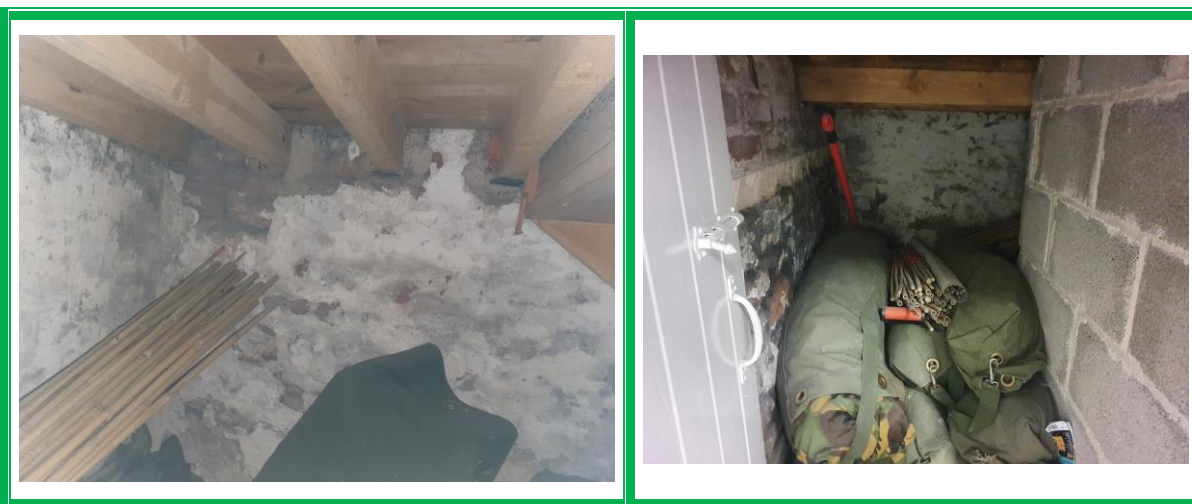
| <b>Location:</b> | Ground Floor - Void under Stairs 003 | | |

| <b>Material Description:</b> | No Suspect Materials Found | |
| <b>Comments:</b> | Previously a no access area, now accessed. No asbestos found. | |
