**Project Number A-00556 (3700)**

**Re-Inspection  
Asbestos Survey Report - Revised**

**Crownhill Platoon  
Crownhill  
Devon  
PL6 5EA**

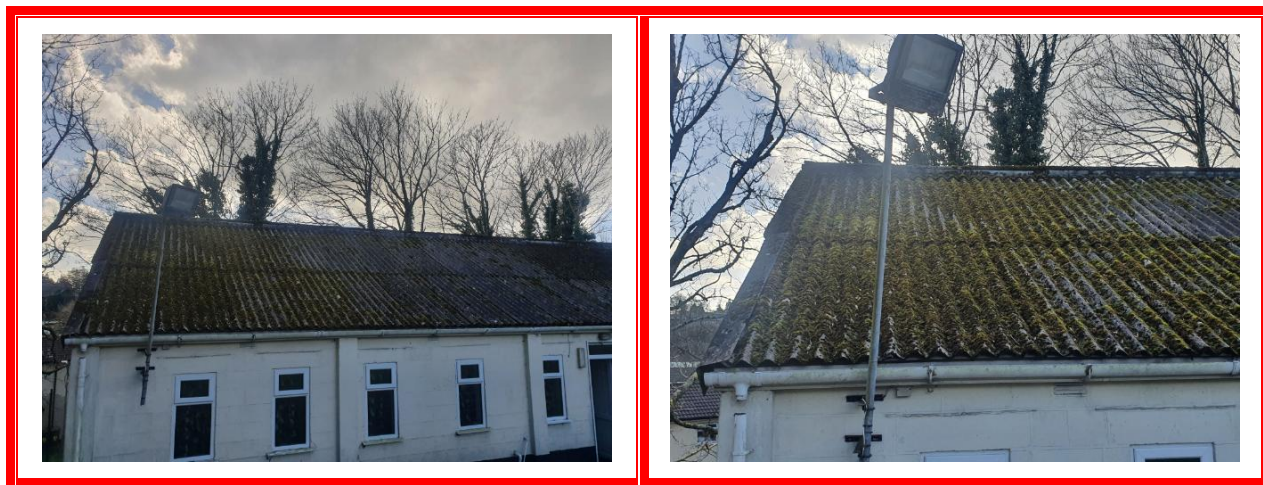
<b>Item No:</b>	<b>1</b>	<b>Sample No:</b>	<b>N/A</b>
<b>Location:</b>	External - Roof 001

<b>Material Description:</b>	Profiled Roof - Cement Product	
<b>Identification:</b>	Previously Sampled - Asbestos Detected	
<b>Approx. quantity:</b>	160 m <sup>2</sup>	
<b>Accessibility</b>	Difficult	Assessment Score
<b>Product type:</b>	Cement	1
<b>Extent of Damage:</b>	Slight / minor damage	1
<b>Surface Treatment:</b>	Unsealed Cement	1
<b>Asbestos type:</b>	Chrysotile	1
<b>Material Assessment Score:</b>		4
<b>Priority Assessment Score:</b>		Negligible
<b>Action:</b>	Manage	
<b>Comments:</b>	Previously sampled ref: Armour 10/10/19 Sample DK/1

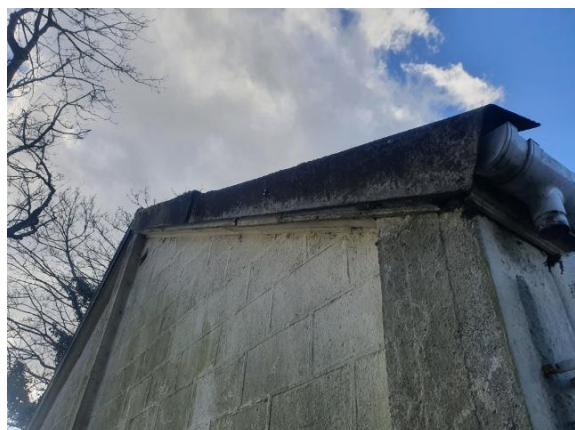
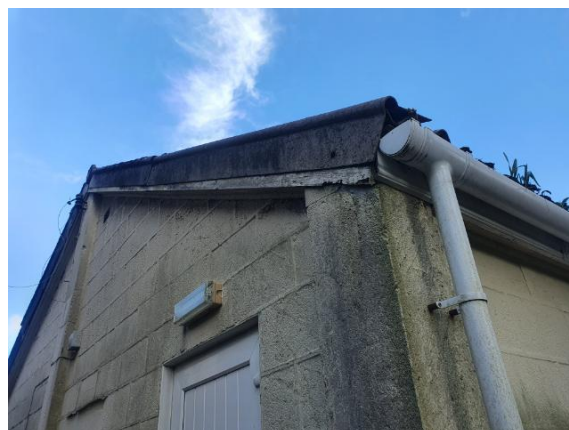
**Location:** External - Roof 002

<b>Material Description:</b>	Roof Edging - Cement Product	
<b>Identification:</b>	Previously Sampled - Asbestos Detected	
<b>Approx. quantity:</b>	16 LM	
<b>Accessibility</b>	Difficult	<i>Assessment Score</i>
<b>Product type:</b>	Cement	1
<b>Extent of Damage:</b>	Slight / minor damage	1
<b>Surface Treatment:</b>	Unsealed Cement	1
<b>Asbestos type:</b>	Chrysotile	1
<b>Material Assessment Score:</b>		4
<b>Priority Assessment Score:</b>		Negligible
<b>Action:</b>	Manage	
<b>Comments:</b>	Previously sampled ref: Armour 10/10/19 Sample DK/2

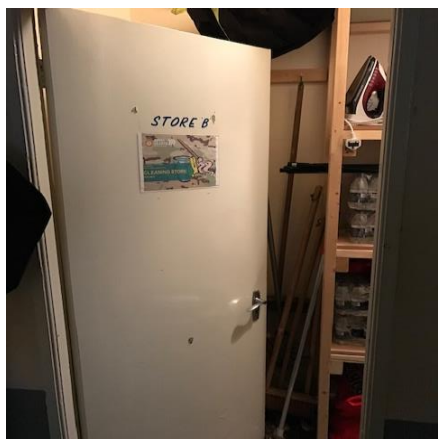
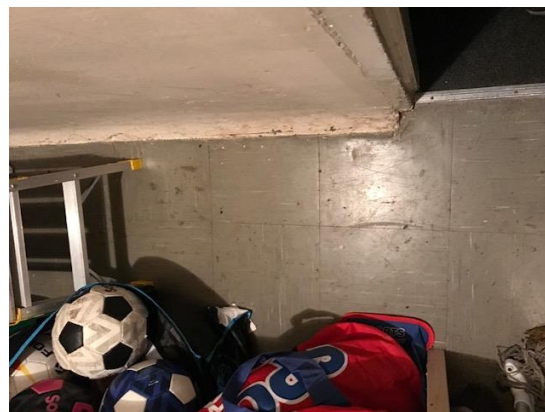
**Location:** Ground Floor - Store B 003

<b>Material Description:</b>	Floor Tiles and Adhesive	
<b>Identification:</b>	Previously Sampled – Asbestos Detected	
<b>Approx. quantity:</b>	6m2	
<b>Accessibility</b>	Easy	Assessment Score
<b>Product type:</b>	Vinyl	1
<b>Extent of Damage:</b>	Slight/minor damage	1
<b>Surface Treatment:</b>	Non-Friable	0
<b>Asbestos type:</b>	Chrysotile	1
<b>Material Assessment Score:</b>		3
<b>Priority Assessment Score:</b>		Negligible
<b>Action:</b>	Manage	
<b>Comments:</b>	Previously a no accessed area, now accessed. Previously sampled ref: Armour 10/10/2019 Sample DK/3

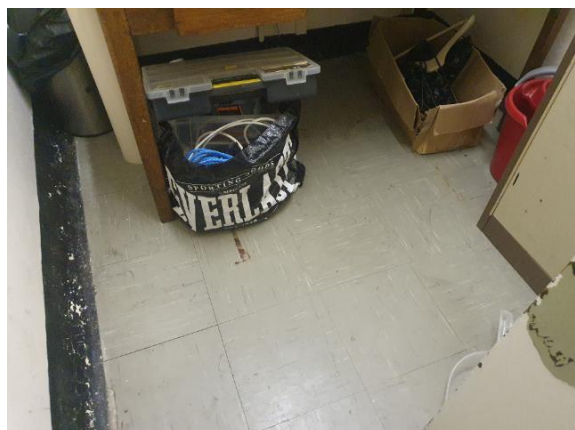
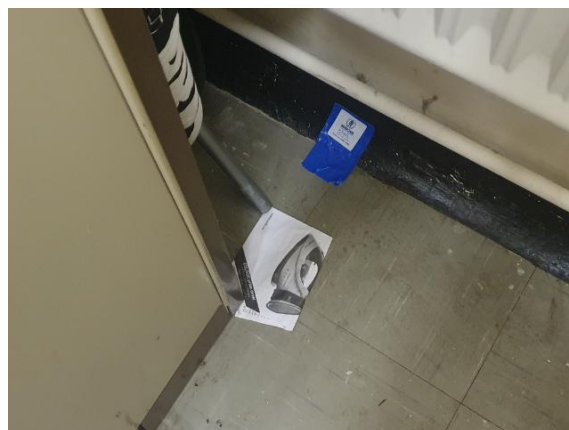
**Location:** Ground Floor - Office 004

<b>Material Description:</b>	Floor Tiles and Adhesive - Vinyl Products	
<b>Identification:</b>	Previously Sampled - Asbestos Detected	
<b>Approx. quantity:</b>	6 m <sup>2</sup>	
<b>Accessibility</b>	Easy	Assessment Score
<b>Product type:</b>	Vinyl	1
<b>Extent of Damage:</b>	Slight / minor damage	1
<b>Surface Treatment:</b>	Non-friable	0
<b>Asbestos type:</b>	Chrysotile	1
<b>Material Assessment Score:</b>		3
<b>Priority Assessment Score:</b>		Negligible
<b>Action:</b>	Manage	
<b>Comments:</b>	Previously sampled ref: Armour 10/10/19 Sample DK/3

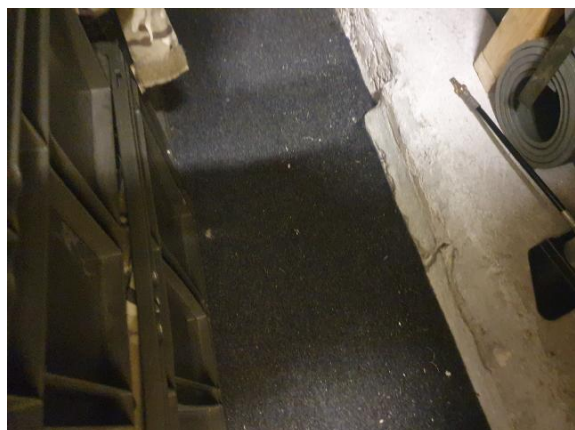
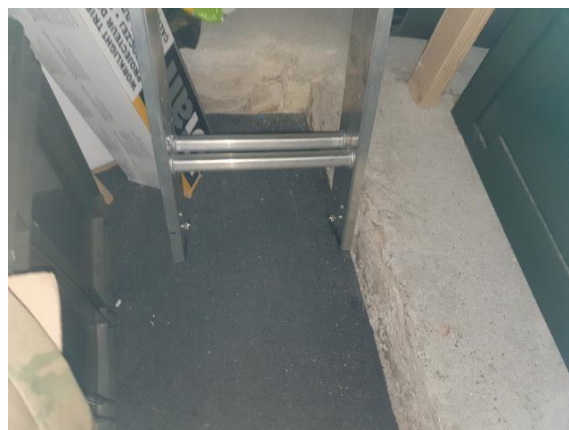
**Location:** Ground Floor - Armoury 005

<b>Material Description:</b>	Floor Tiles and Adhesive - Vinyl Products	
<b>Identification:</b>	Previously Sampled - Asbestos Detected	
<b>Approx. quantity:</b>	2 m <sup>2</sup>	
<b>Accessibility</b>	Difficult	<i>Assessment Score</i>
<b>Product type:</b>	Vinyl	1
<b>Extent of Damage:</b>	Slight / minor damage	1
<b>Surface Treatment:</b>	Non-friable	0
<b>Asbestos type:</b>	Chrysotile	1
<b>Material Assessment Score:</b>		3
<b>Priority Assessment Score:</b>		Negligible
<b>Action:</b>	Manage	
<b>Comments:</b>	Previously sampled ref: Armour 10/10/19 Sample DK/4. Under carpet

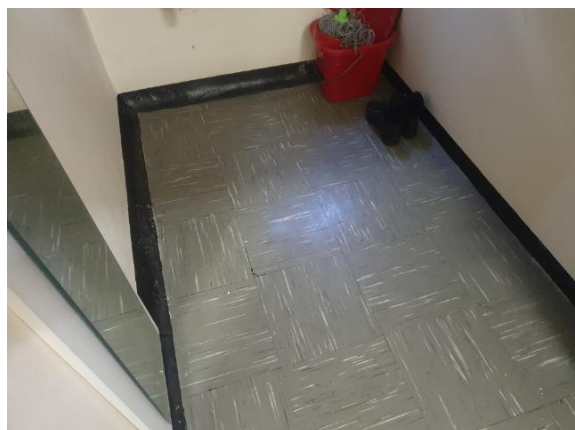
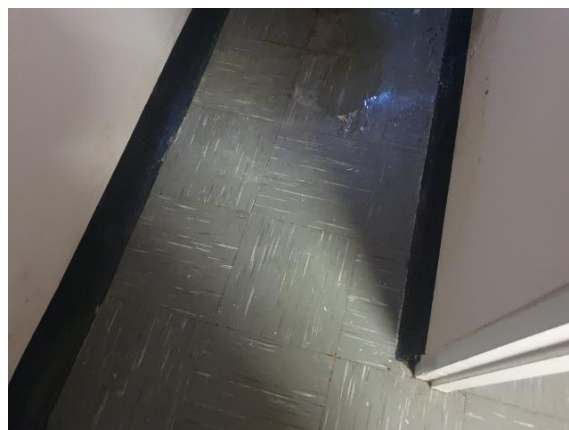
**Location:** Ground Floor - Ladies WC 006

<b>Material Description:</b>	Floor Tiles and Adhesive - Vinyl Products	
<b>Identification:</b>	Previously Sampled - Asbestos Detected	
<b>Approx. quantity:</b>	6 m <sup>2</sup>	
<b>Accessibility</b>	Difficult	<i>Assessment Score</i>
<b>Product type:</b>	Vinyl	1
<b>Extent of Damage:</b>	Slight / minor damage	1
<b>Surface Treatment:</b>	Non-friable	0
<b>Asbestos type:</b>	Chrysotile	1
<b>Material Assessment Score:</b>		3
<b>Priority Assessment Score:</b>		Negligible
<b>Action:</b>	Manage	
<b>Comments:</b>	Previously sampled ref: Armour 10/10/19 Sample DK/3

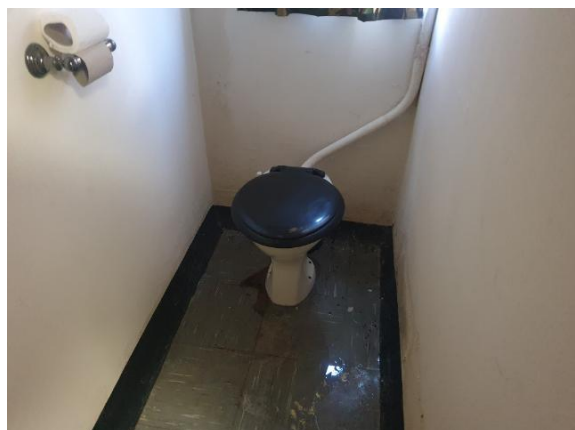
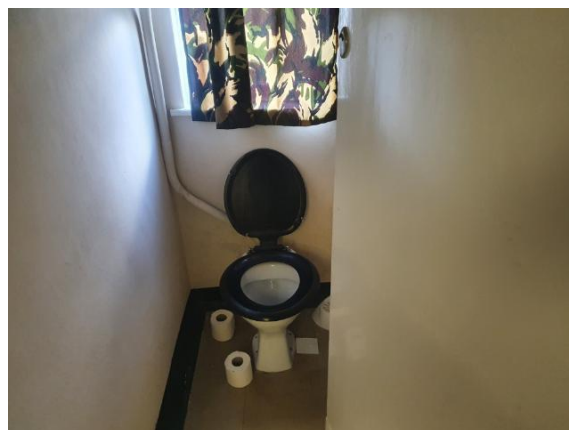
**Location:** Ground Floor - Ladies and Men's WC 007

<b>Material Description:</b>	Toilet Seats - PVC / Reinforced Plastics	
<b>Identification:</b>	Presumed to Contain Asbestos	
<b>Approx. quantity:</b>	3 no	
<b>Accessibility</b>	Easy	<i>Assessment Score</i>
<b>Product type:</b>	Bakelite	1
<b>Extent of Damage:</b>	Major damage	3
<b>Surface Treatment:</b>	Unsealed Insulation	3
<b>Asbestos type:</b>	Chrysotile	1
<b>Material Assessment Score:</b>		8
<b>Priority Assessment Score:</b>		Medium
<b>Action:</b>	Manage	
<b>Comments:</b>	Not possible to sample as may damage integrity of seats

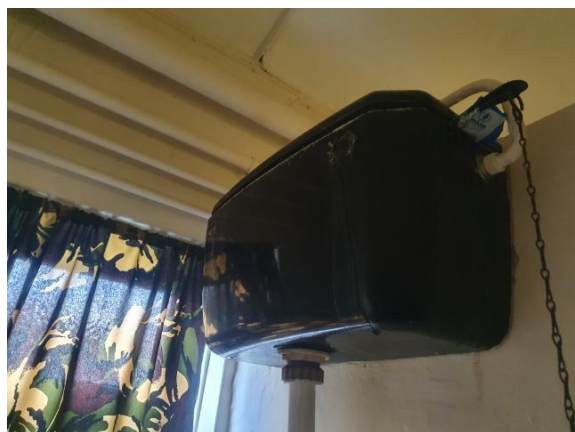
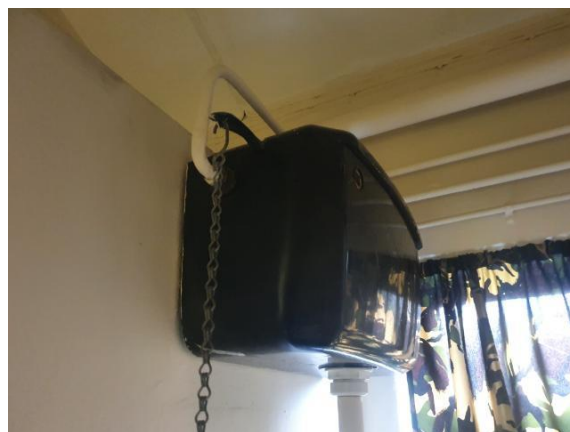
**Location:** Ground Floor - Ladies and Men's WC 008

<b>Material Description:</b>	Toilet Cisterns - PVC / Reinforced Plastics	
<b>Identification:</b>	Previously Sampled - Asbestos Detected	
<b>Approx. quantity:</b>	2 no	
<b>Accessibility</b>	Medium	<i>Assessment Score</i>
<b>Product type:</b>	Bakelite	1
<b>Extent of Damage:</b>	Slight / minor damage	1
<b>Surface Treatment:</b>	Non-friable	0
<b>Asbestos type:</b>	Chrysotile	1
<b>Material Assessment Score:</b>		3
<b>Priority Assessment Score:</b>		Negligible
<b>Action:</b>	Manage	
<b>Comments:</b>	Previously sampled ref: Armour 10/10/19 Sample DK/5

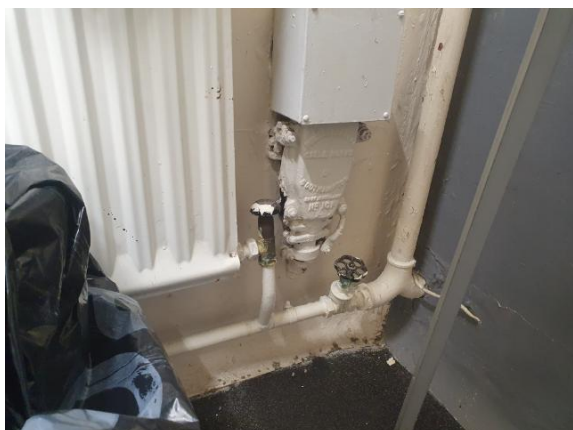
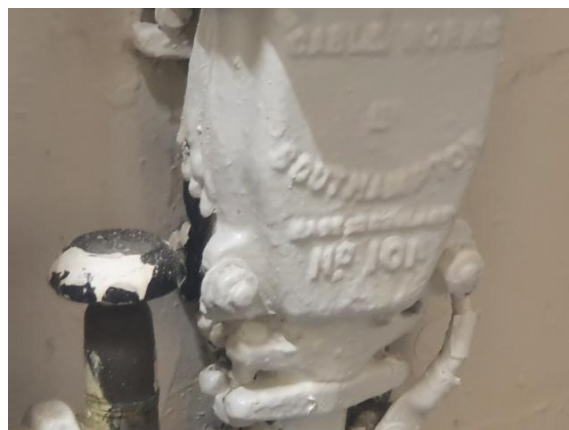
**Location:** Ground Floor - Classroom 1 009

<b>Material Description:</b>	Electrical Box - Gaskets (rope/woven)	
<b>Identification:</b>	Presumed to Contain Asbestos	
<b>Approx. quantity:</b>	1 no	
<b>Accessibility</b>	Difficult	<i>Assessment Score</i>
<b>Product type:</b>	Rope	2
<b>Extent of Damage:</b>	Major damage	3
<b>Surface Treatment:</b>	Unsealed Insulation	3
<b>Asbestos type:</b>	Chrysotile	1
<b>Material Assessment Score:</b>		9
<b>Priority Assessment Score:</b>		N/A
<b>Action:</b>	Manage	
<b>Comments:</b>	No access within live electrical box
