Project Number 2481

**Management
Asbestos Survey Report**

**232 Port Squadron, Bodmin, Cornwall,
PL31 1DX**

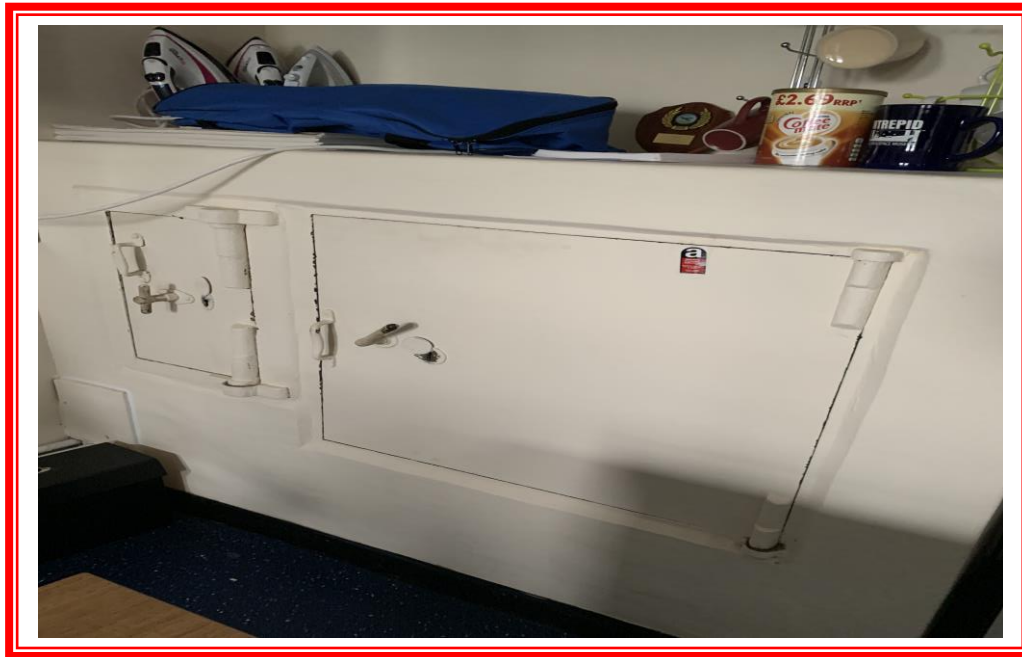
Item No: 1

Material Description:	Safe Built into the Wall	
Identification:	Presumed to Contain Asbestos	
Approx. quantity:	X 1	
Accessibility	High	Assessment Score
Product type:	No Access	2
Extent of Damage:	No Access	3
Surface Treatment:	No Access	3
Asbestos type:	No Access	2
Material Assessment Score:		10
Priority Assessment Score:		High
Action:	Further Investigation Needed	
Comments:	No access to sample as it was locked

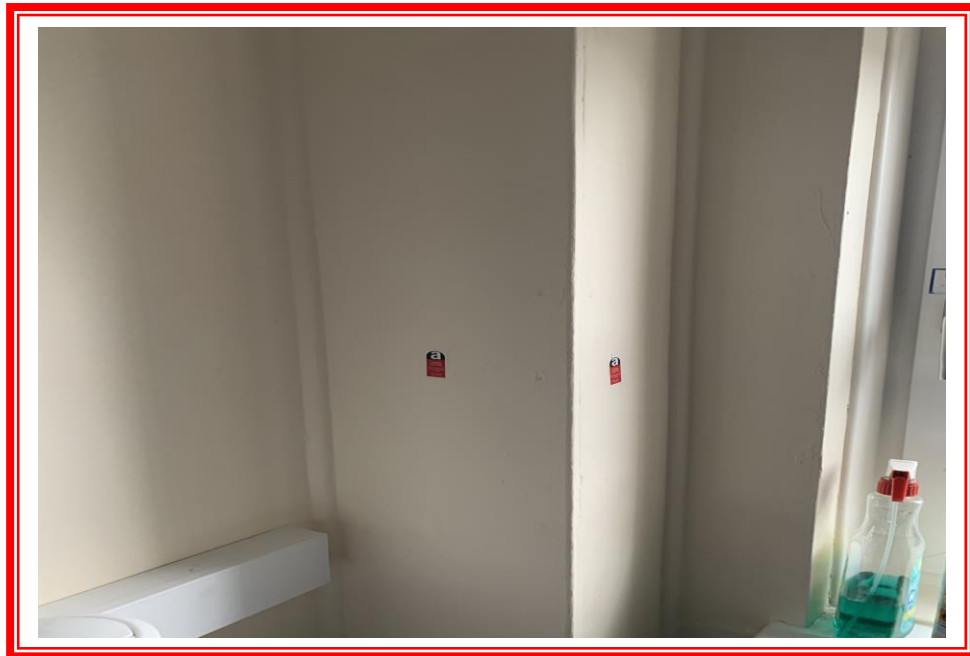
Item No: 2

Material Description:	Riser Panel	
Identification:	As Per Previous Sample REF93 – Asbestos Detected	
Approx. quantity:	1.5M2	
Accessibility	Low	Assessment Score
Product type:	AIB	2
Extent of Damage:	Minor	1
Surface Treatment:	Encapsulated	1
Asbestos type:	Amosite	2
Material Assessment Score:		6
Priority Assessment Score:		Low
Action:	Manage	
Comments:	N/A

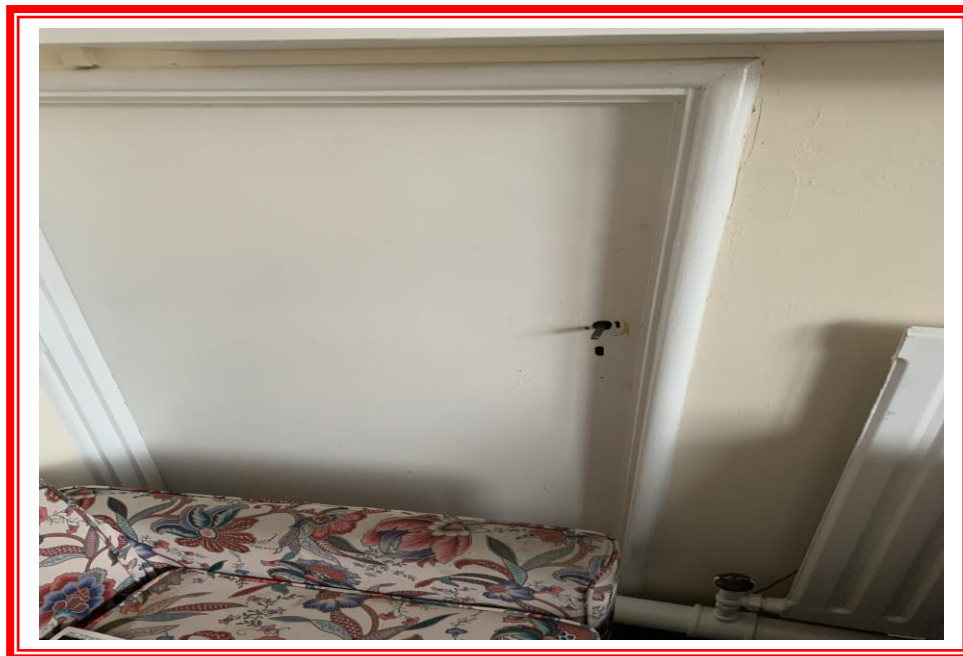
Item No: 3

Material Description:	Door Inside Room	
Identification:	Presumed to Contain Asbestos	
Approx. quantity:	Unknown	
Accessibility	High	Assessment Score
Product type:	No Access	3
Extent of Damage:	No Access	3
Surface Treatment:	No Access	3
Asbestos type:	No Access	3
Material Assessment Score:		12
Priority Assessment Score:		High
Action:	Further Investigation Needed	
Comments:	No access to sample as the door handle was broken

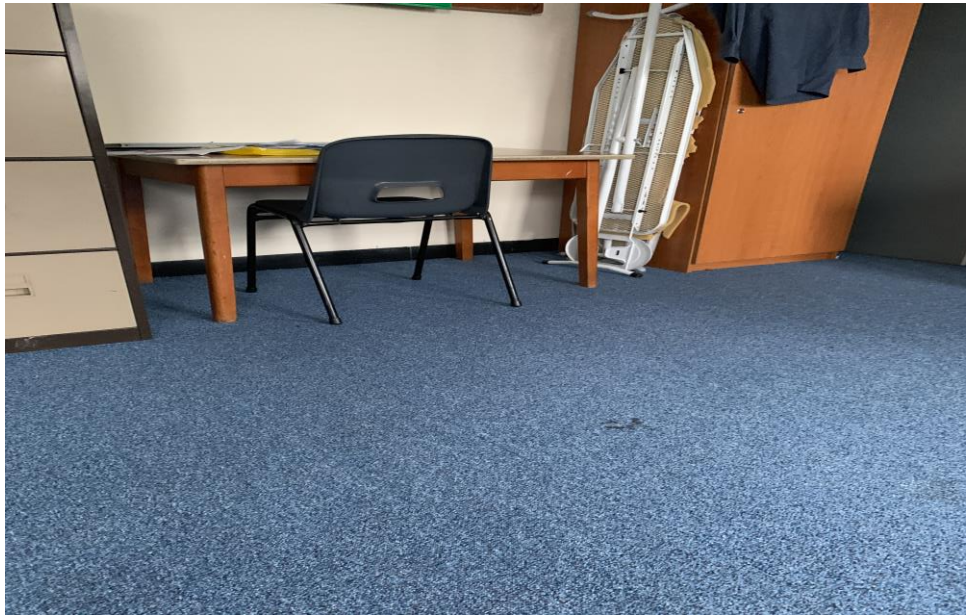
Item No: 4

Material Description:	Floor Tiles	
Identification:	As Per Previous Sample REF96 – Asbestos Detected	
Approx. quantity:	20M2	
Accessibility	Medium	Assessment Score
Product type:	Vinyl	1
Extent of Damage:	Minor	1
Surface Treatment:	Non-Friable	0
Asbestos type:	Chrysotile	1
Material Assessment Score:		3
Priority Assessment Score:		Negligible
Action:	Manage	
Comments:	N/A

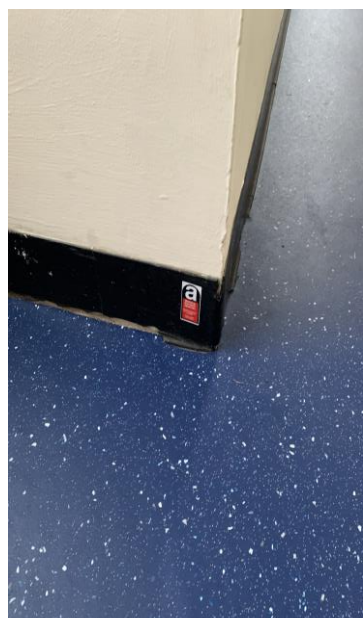
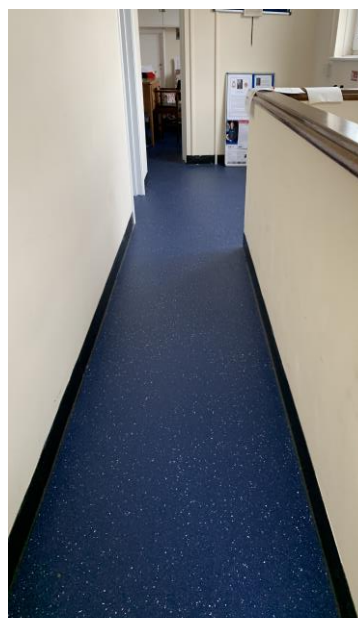
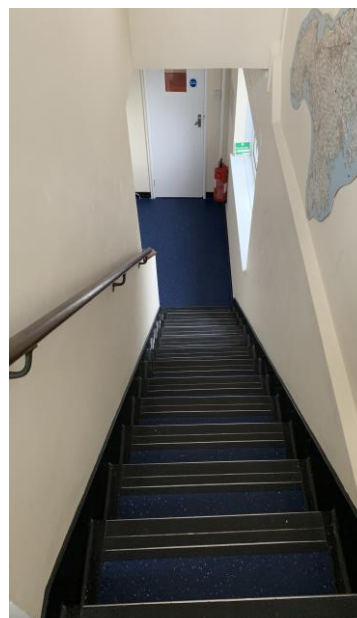
Item No: 5

Material Description:	Floor Tiles and Stair Nosing	
Identification:	Strongly Presumed to Contain Asbestos	
Approx. quantity:	18M2	
Accessibility	Medium	Assessment Score
Product type:	Vinyl	1
Extent of Damage:	Minor	1
Surface Treatment:	Non-Friable	0
Asbestos type:	Chrysotile	1
Material Assessment Score:		3
Priority Assessment Score:		Negligible
Action:	Manage	
Comments:	N/A

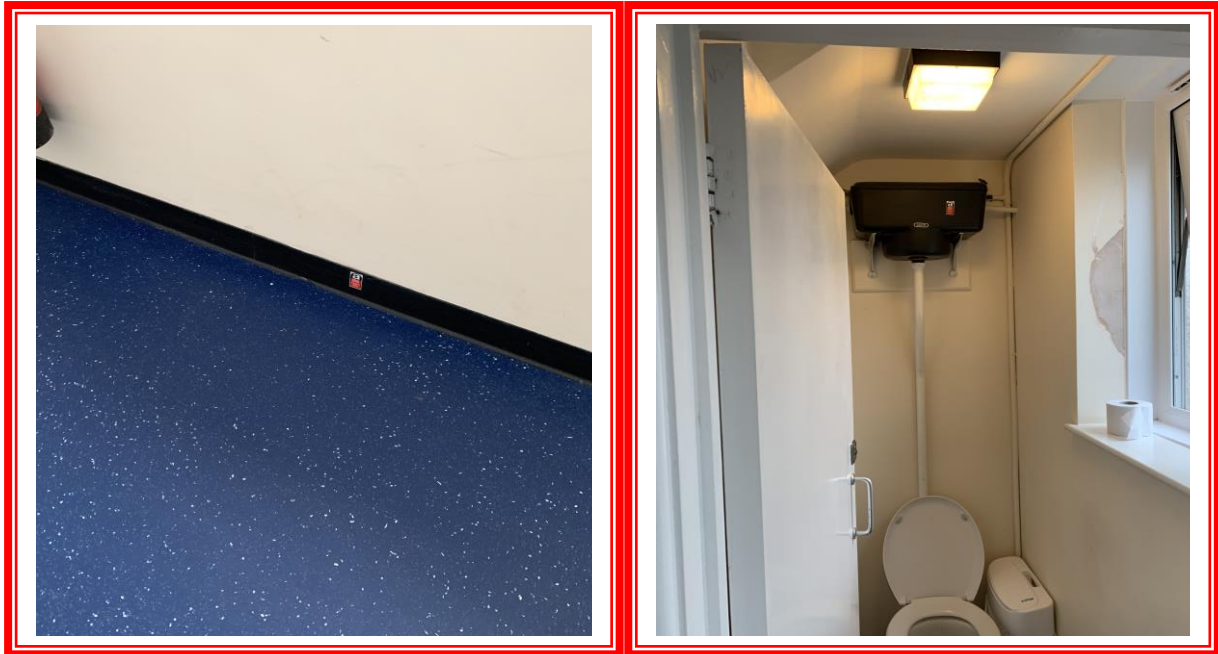
Item No: 6

Material Description:	Toilet Cistern	
Identification:	Presumed to Contain Asbestos	
Approx. quantity:	X 1	
Accessibility	Medium	Assessment Score
Product type:	Composite	1
Extent of Damage:	Good	0
Surface Treatment:	Non-Friable	1
Asbestos type:	Chrysotile	1
Material Assessment Score:		3
Priority Assessment Score:		Negligible
Action:	Manage	
Comments:	Unable to sample as it would cause irreparable damage

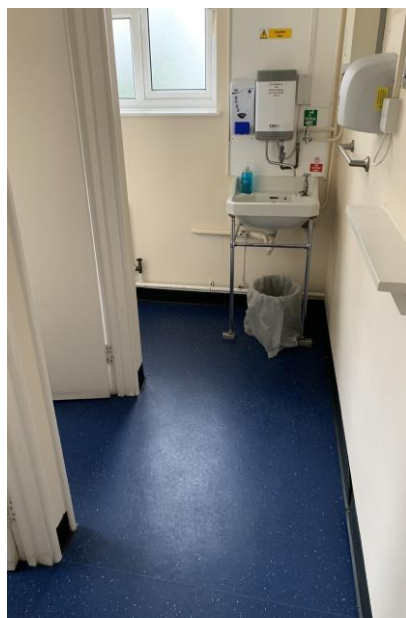
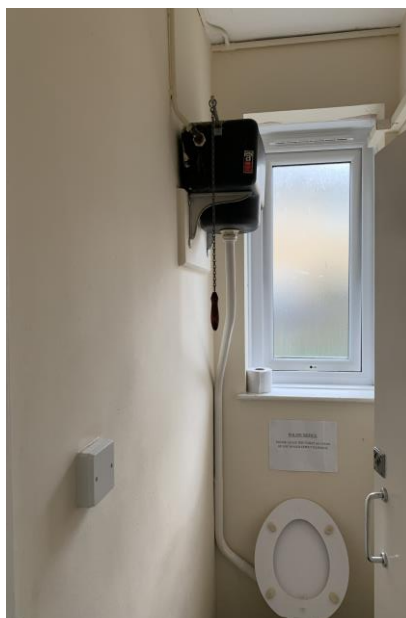
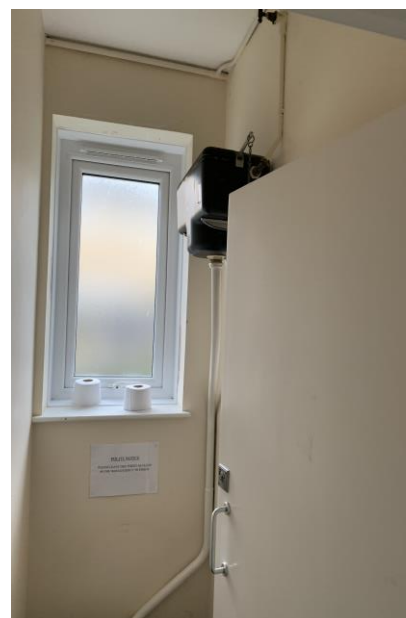
Item No: 7

Material Description:	Toilet Cistern	
Identification:	Presumed to Contain Asbestos	
Approx. quantity:	X 2	
Accessibility	Medium	Assessment Score
Product type:	Composite	1
Extent of Damage:	Good	0
Surface Treatment:	Non-Friable	1
Asbestos type:	Chrysotile	1
Material Assessment Score:		3
Priority Assessment Score:		Negligible
Action:	Manage	
Comments:	Unable to sample as it would cause irreparable damage

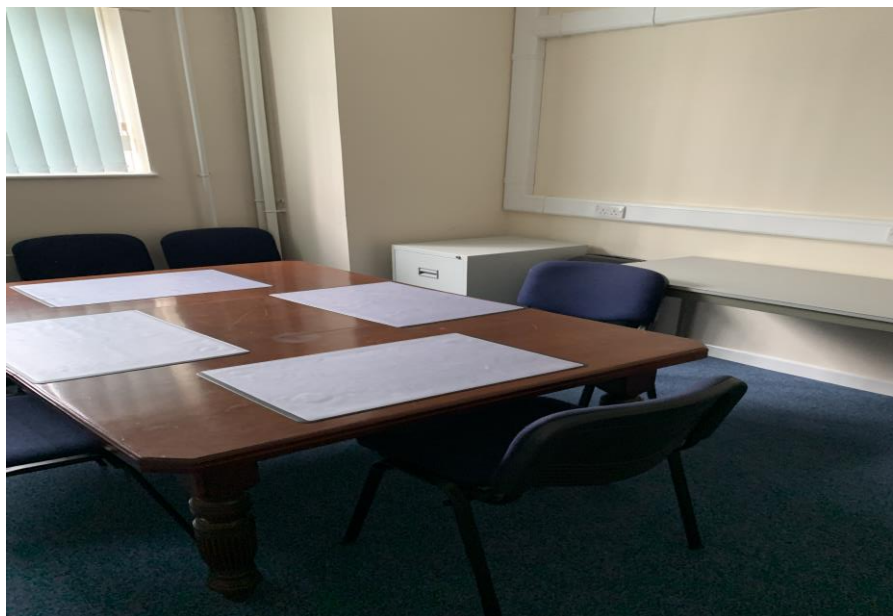
Item No: 8

Material Description:	Floor Tiles	
Identification:	As Per Previous Sample REF78 – Asbestos Detected	
Approx. quantity:	16M2	
Accessibility	Medium	Assessment Score
Product type:	Vinyl	1
Extent of Damage:	Good	0
Surface Treatment:	Non-Friable	0
Asbestos type:	Chrysotile	1
Material Assessment Score:		2
Priority Assessment Score:		Negligible
Action:	Manage	
Comments:	The floor tiles are covered with carpet

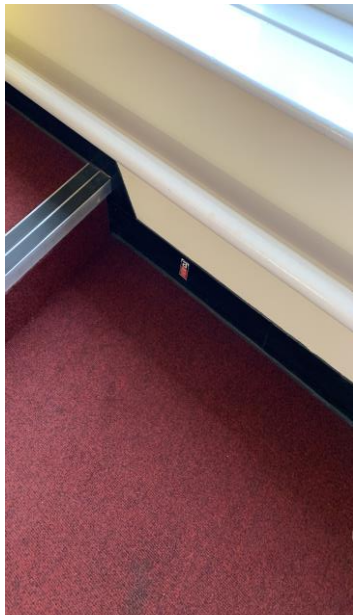
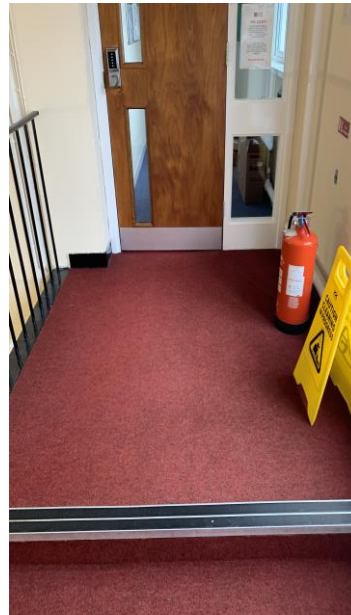
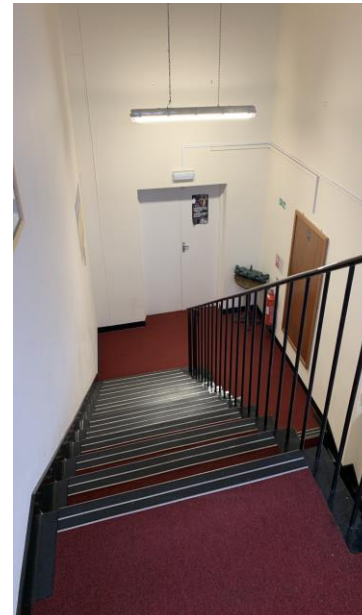
**Item No: 9****Sample No: N/A****Location: First Floor – Stairwell**

Material Description:	Floor Tiles	
Identification:	Strongly Presumed to Contain Asbestos	
Approx. quantity:	6.5M2	
Accessibility	Medium	Assessment Score
Product type:	Vinyl	1
Extent of Damage:	Good	0
Surface Treatment:	Non-Friable	0
Asbestos type:	Chrysotile	1
Material Assessment Score:		2
Priority Assessment Score:		Negligible
Action:	Manage	
Comments:	The floor tiles are covered with carpet

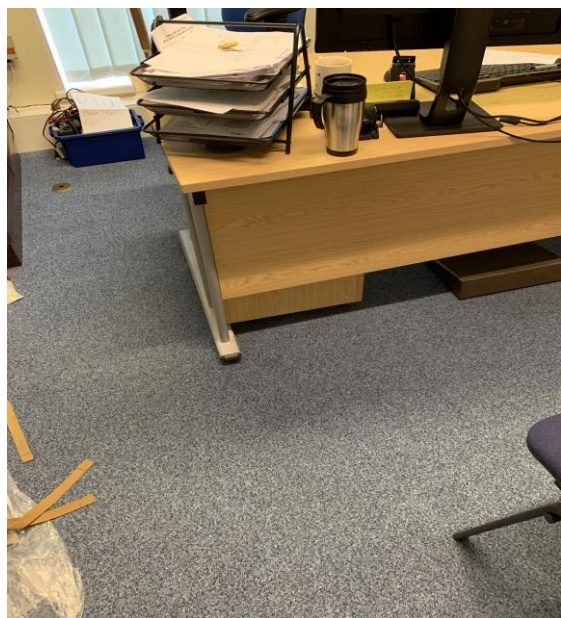
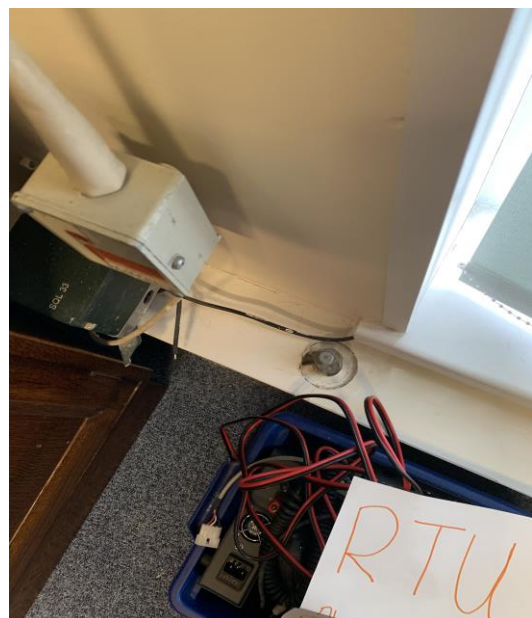
Item No: 10

Material Description:	Boxing in along the back wall	
Identification:	Presumed to Contain Asbestos	
Approx. quantity:	6LM	
Accessibility	High	Assessment Score
Product type:	No Access	3
Extent of Damage:	No Access	3
Surface Treatment:	No Access	3
Asbestos type:	No Access	3
Material Assessment Score:		12
Priority Assessment Score:		High
Action:	Further Investigation Needed	
Comments:	No access to sample

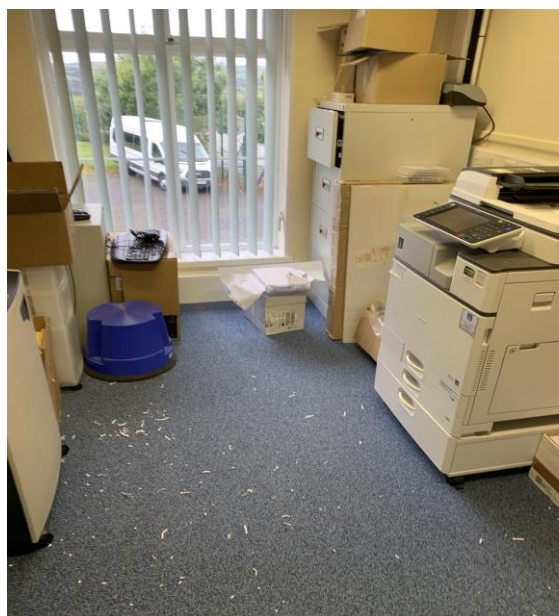
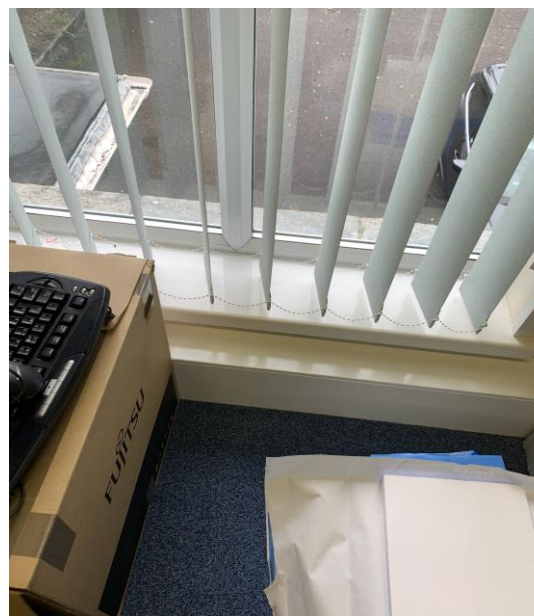
Item No: 11

Material Description:	Floor Tiles	
Identification:	As Per Previous Sample REF16 – Asbestos Detected	
Approx. quantity:	22M2	
Accessibility	Medium	Assessment Score
Product type:	Vinyl	1
Extent of Damage:	Good	0
Surface Treatment:	Non-Friable	0
Asbestos type:	Chrysotile	1
Material Assessment Score:		2
Priority Assessment Score:		Negligible
Action:	Manage	
Comments:	Beige floor tiles were previously presumed in the older survey, black floor tiles are strongly presumed

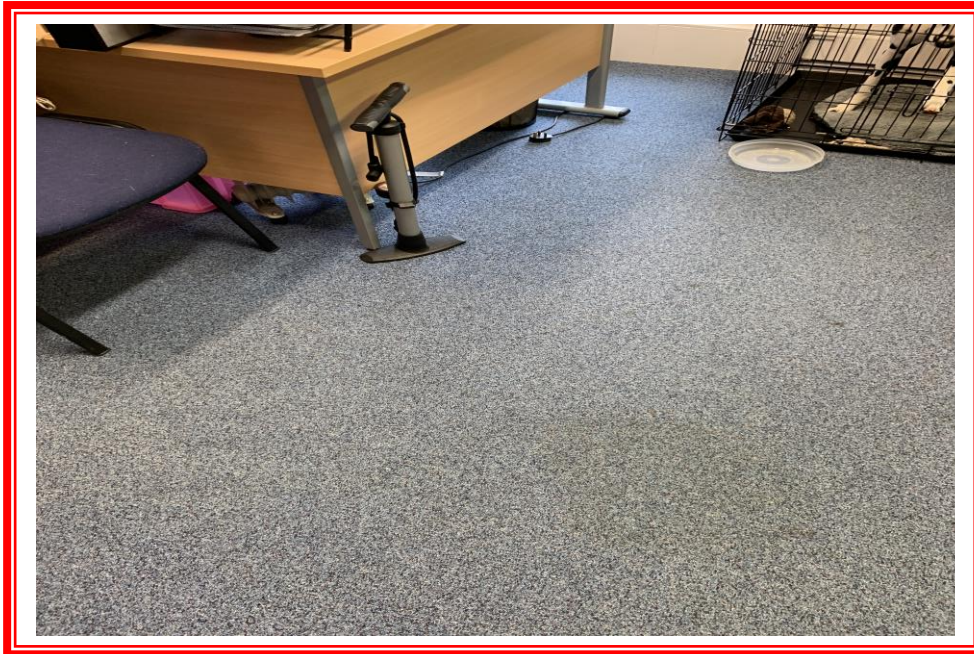
Item No: 12

Material Description:	Floor Tiles	
Identification:	Strongly Presumed to Contain Asbestos	
Approx. quantity:	29M2	
Accessibility	Medium	Assessment Score
Product type:	Vinyl	1
Extent of Damage:	Good	0
Surface Treatment:	Non-Friable	0
Asbestos type:	Chrysotile	1
Material Assessment Score:		2
Priority Assessment Score:		Negligible
Action:	Manage	
Comments:	The floor tiles are covered with carpet

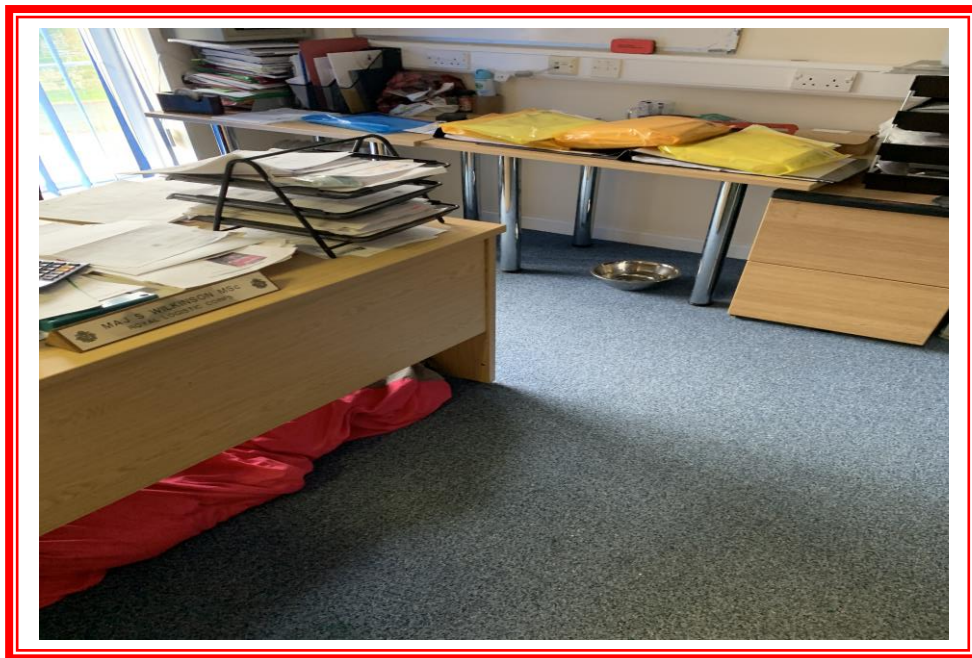
**Item No: 13****Sample No: N/A****Location: First Floor – ACF AO Office**

Material Description:	Boxing in	
Identification:	Presumed to Contain Asbestos	
Approx. quantity:	6LM	
Accessibility	High	<i>Assessment Score</i>
Product type:	No Access	3
Extent of Damage:	No Access	3
Surface Treatment:	No Access	3
Asbestos type:	No Access	3
Material Assessment Score:		12
Priority Assessment Score:		High
Action:	Further Investigation Needed	
Comments:	No access to sample

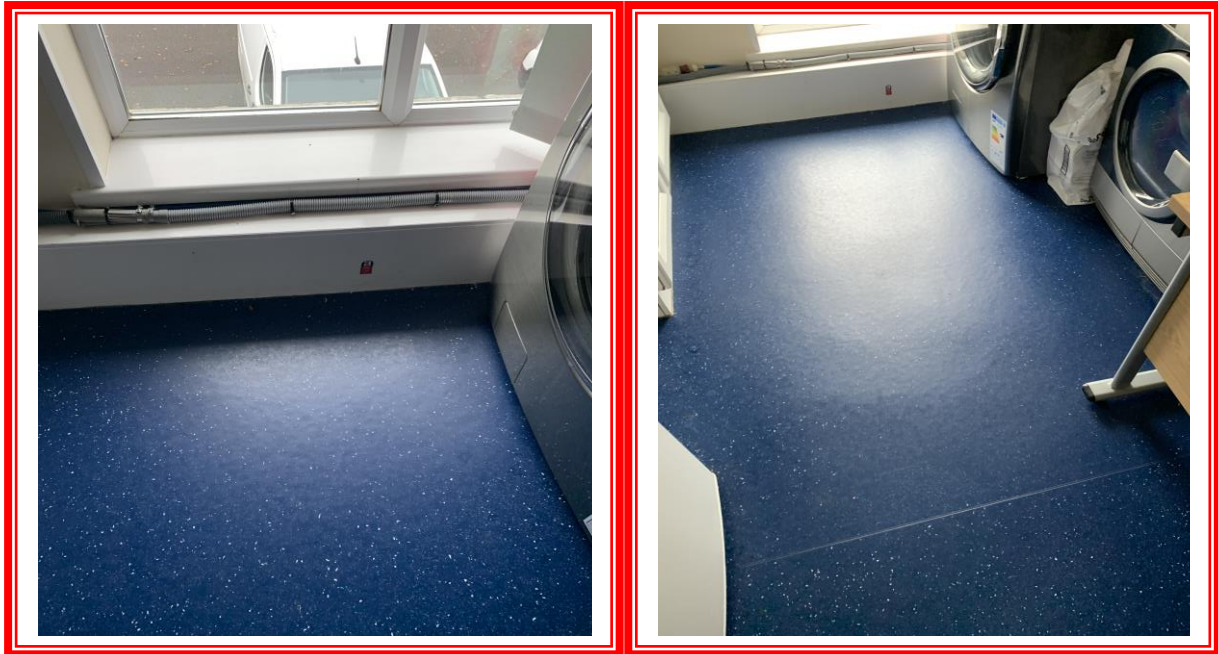
Item No: 14

Material Description:	Floor Tiles	
Identification:	Strongly Presumed to Contain Asbestos	
Approx. quantity:	10M2	
Accessibility	Medium	Assessment Score
Product type:	Vinyl	1
Extent of Damage:	Good	0
Surface Treatment:	Non-Friable	0
Asbestos type:	Chrysotile	1
Material Assessment Score:		2
Priority Assessment Score:		Negligible
Action:	Manage	
Comments:	The floor tiles are covered with carpet

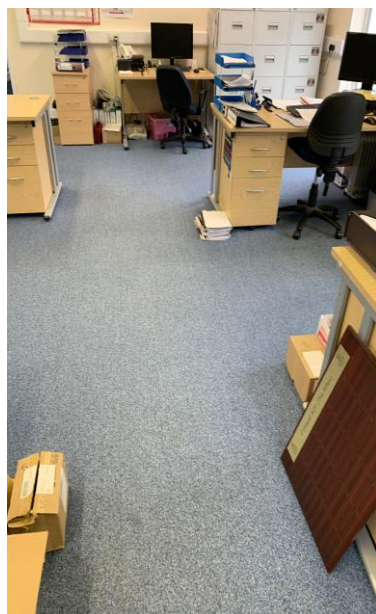
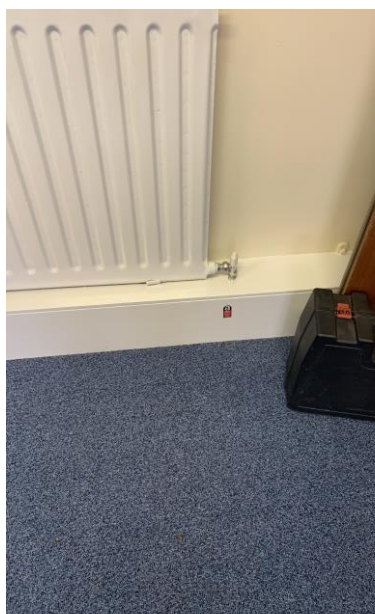
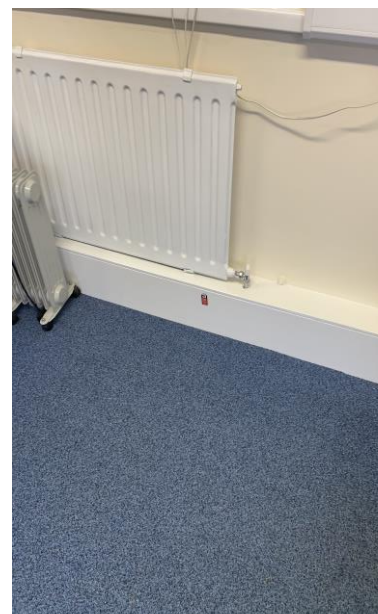
Item No: 15

Material Description:	Floor Tiles	
Identification:	As Per Previous Sample REF16 – Asbestos Detected	
Approx. quantity:	43M2	
Accessibility	Medium	Assessment Score
Product type:	Vinyl	1
Extent of Damage:	Good	0
Surface Treatment:	Non-Friable	0
Asbestos type:	Chrysotile	1
Material Assessment Score:		2
Priority Assessment Score:		Negligible
Action:	Manage	
Comments:	The floor tiles are covered with carpet

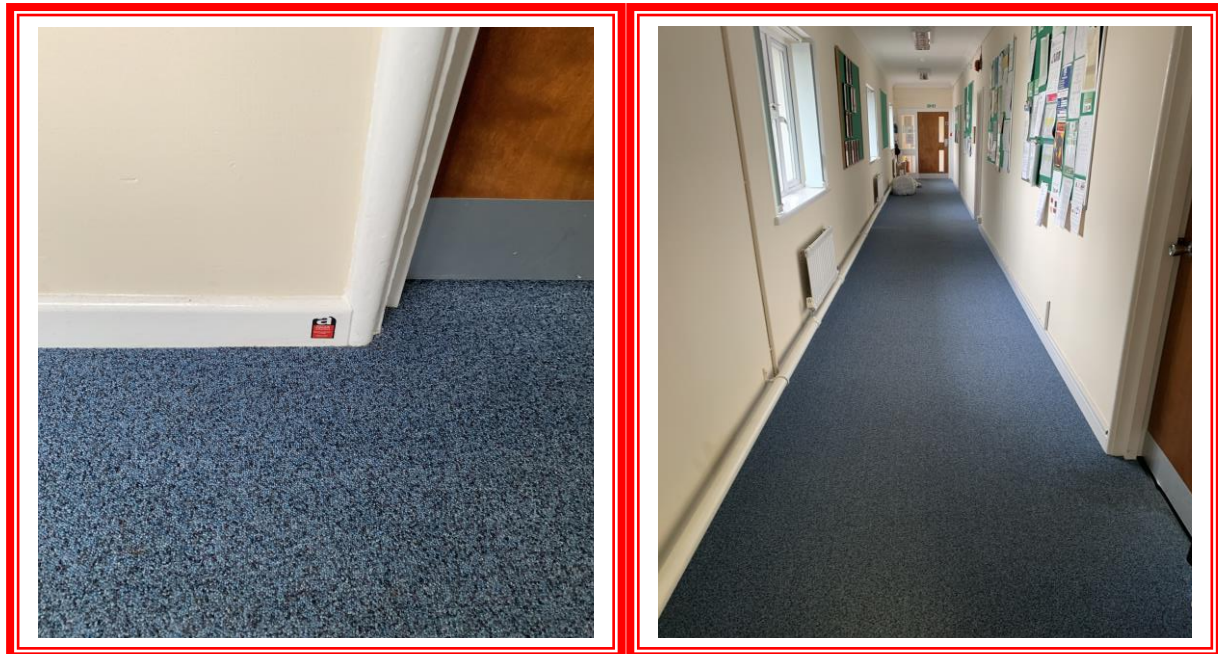
Item No: 16

Material Description:	Floor Tiles	
Identification:	Strongly Presumed to Contain Asbestos	
Approx. quantity:	24M2	
Accessibility	Medium	Assessment Score
Product type:	Vinyl	1
Extent of Damage:	Good	0
Surface Treatment:	Non-Friable	0
Asbestos type:	Chrysotile	1
Material Assessment Score:		2
Priority Assessment Score:		Negligible
Action:	Manage	
Comments:	The floor tiles are covered with carpet

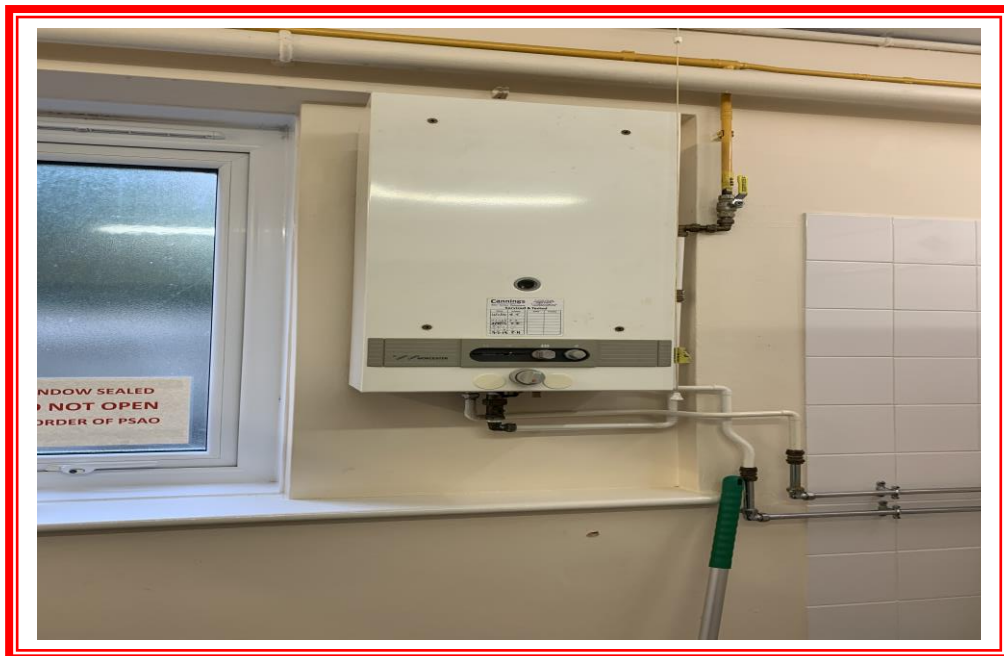
Item No: 18

Material Description:	Old Boiler	
Identification:	Presumed to Contain Asbestos	
Approx. quantity:	X 1	
Accessibility	High	Assessment Score
Product type:	No Access	3
Extent of Damage:	No Access	3
Surface Treatment:	No Access	3
Asbestos type:	No Access	3
Material Assessment Score:		12
Priority Assessment Score:		High
Action:	Further Investigation Needed	
Comments:	No access to sample as it was live

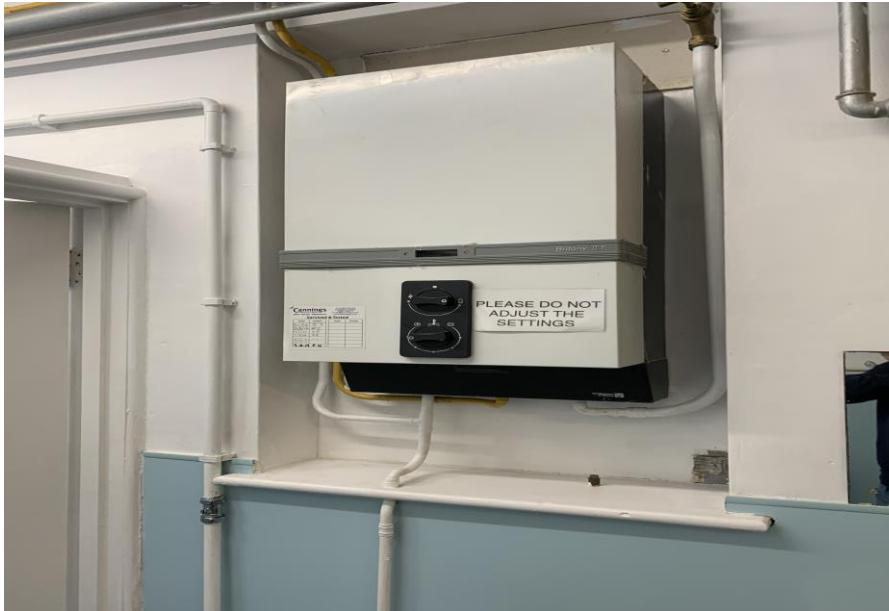
Item No: 19

Material Description:	Old Boiler	
Identification:	Presumed to Contain Asbestos	
Approx. quantity:	X 1	
Accessibility	High	Assessment Score
Product type:	No Access	3
Extent of Damage:	No Access	3
Surface Treatment:	No Access	3
Asbestos type:	No Access	3
Material Assessment Score:		12
Priority Assessment Score:		High
Action:	Further Investigation Needed	
Comments:	No access to sample as it was live

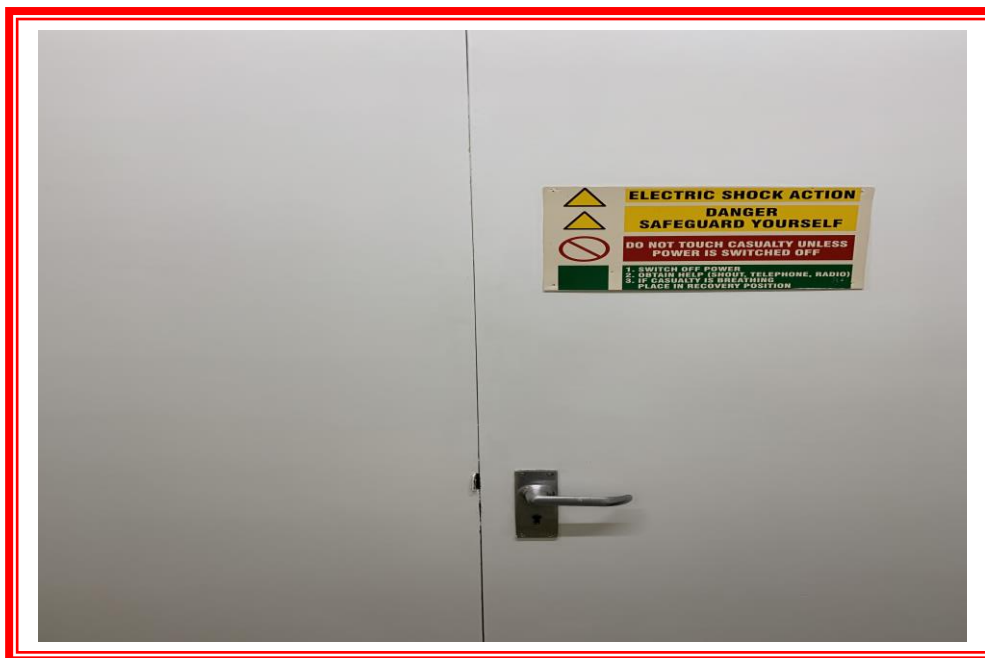
Item No: 22

Material Description:	No Access	
Identification:	Presumed to Contain Asbestos	
Approx. quantity:	Unknown	
Accessibility	High	<i>Assessment Score</i>
Product type:	No Access	3
Extent of Damage:	No Access	3
Surface Treatment:	No Access	3
Asbestos type:	No Access	3
Material Assessment Score:		12
Priority Assessment Score:		High
Action:	Further Investigation Needed	
Comments:	No access to sample as locked

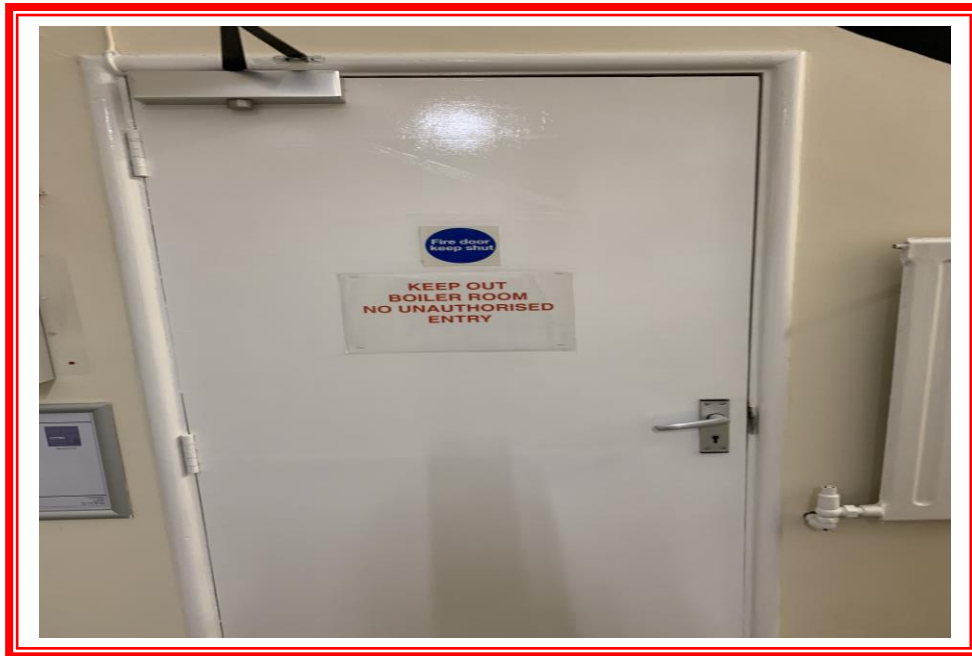
Item No: 23

Material Description:	No Access	
Identification:	Presumed to Contain Asbestos	
Approx. quantity:	Unknown	
Accessibility	High	Assessment Score
Product type:	No Access	3
Extent of Damage:	No Access	3
Surface Treatment:	No Access	3
Asbestos type:	No Access	3
Material Assessment Score:		12
Priority Assessment Score:		High
Action:	Further Investigation Needed	
Comments:	No access to sample as locked

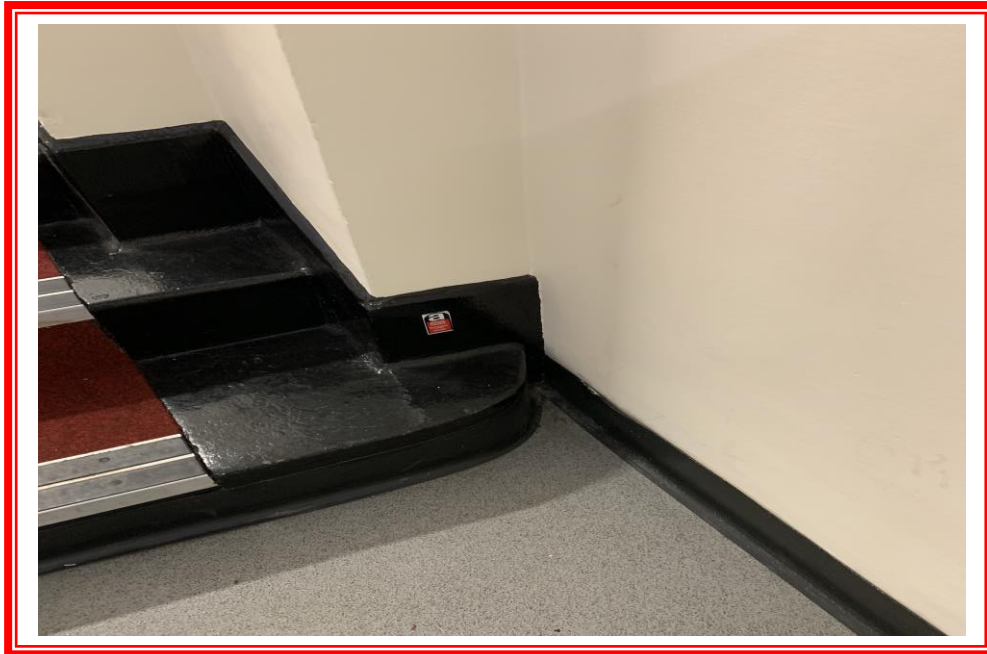
Item No: 24

Material Description:	Floor Tiles	
Identification:	Strongly Presumed to Contain Asbestos	
Approx. quantity:	7M2	
Accessibility	Low	Assessment Score
Product type:	Vinyl	1
Extent of Damage:	Good	0
Surface Treatment:	Non-Friable	0
Asbestos type:	Chrysotile	1
Material Assessment Score:		2
Priority Assessment Score:		Negligible
Action:	Manage	
Comments:	The floor tiles are covered with vinyl

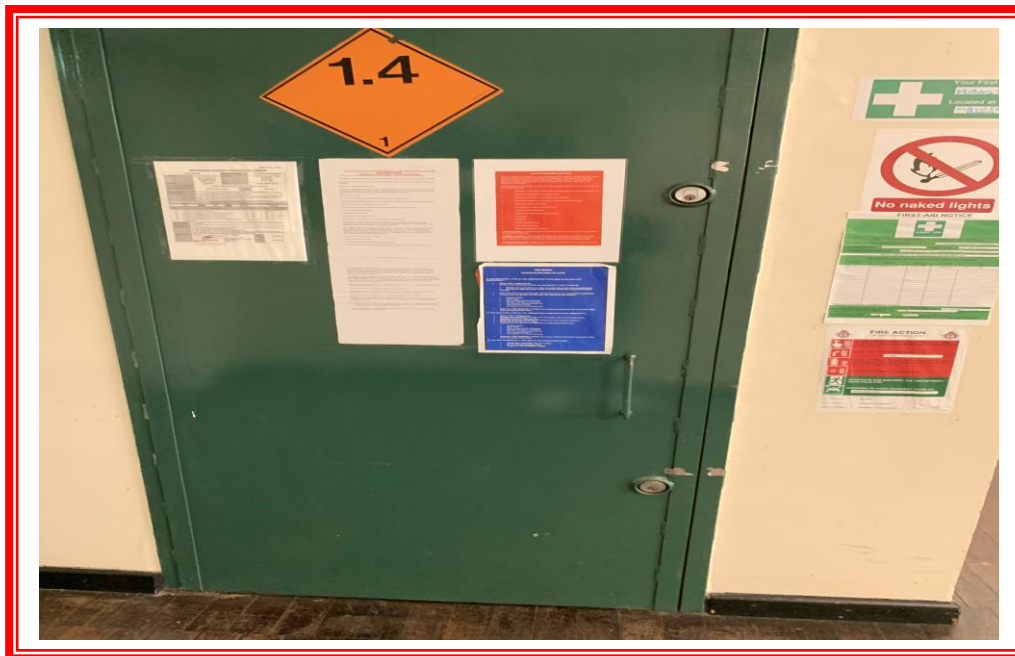
Item No: 25

Material Description:	No Access	
Identification:	Presumed to Contain Asbestos	
Approx. quantity:	Unknown	
Accessibility	High	Assessment Score
Product type:	No Access	3
Extent of Damage:	No Access	3
Surface Treatment:	No Access	3
Asbestos type:	No Access	3
Material Assessment Score:		12
Priority Assessment Score:		High
Action:	Further Investigation Needed	
Comments:	No access to sample as locked

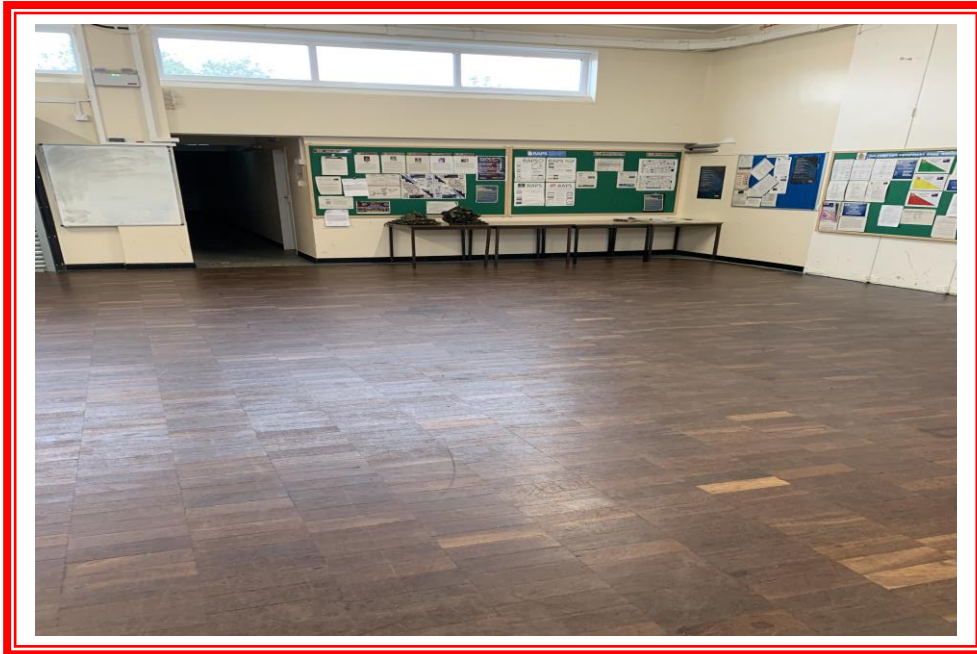
Item No: 26

Material Description:	Parquet Flooring and Bitumen	
Identification:	Presumed to Contain Asbestos	
Approx. quantity:	70M2	
Accessibility	High	<i>Assessment Score</i>
Product type:	Bitumen	1
Extent of Damage:	Minor	1
Surface Treatment:	Encapsulated	2
Asbestos type:	Chrysotile	1
Material Assessment Score:		5
Priority Assessment Score:		Low
Action:	Manage	
Comments:	N/A

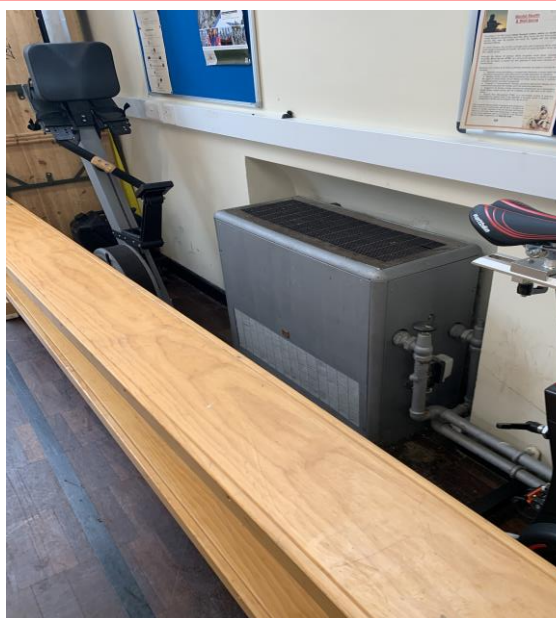
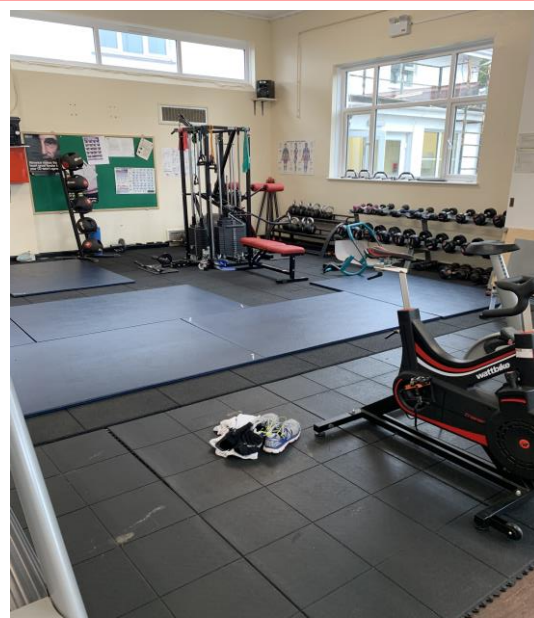
Item No: 27

Material Description:	Storage Heater	
Identification:	Presumed to Contain Asbestos	
Approx. quantity:	X 1	
Accessibility	High	Assessment Score
Product type:	No Access	2
Extent of Damage:	No Access	0
Surface Treatment:	No Access	1
Asbestos type:	No Access	2
Material Assessment Score:		5
Priority Assessment Score:		Low
Action:	Manage	
Comments:	No access to sample as live

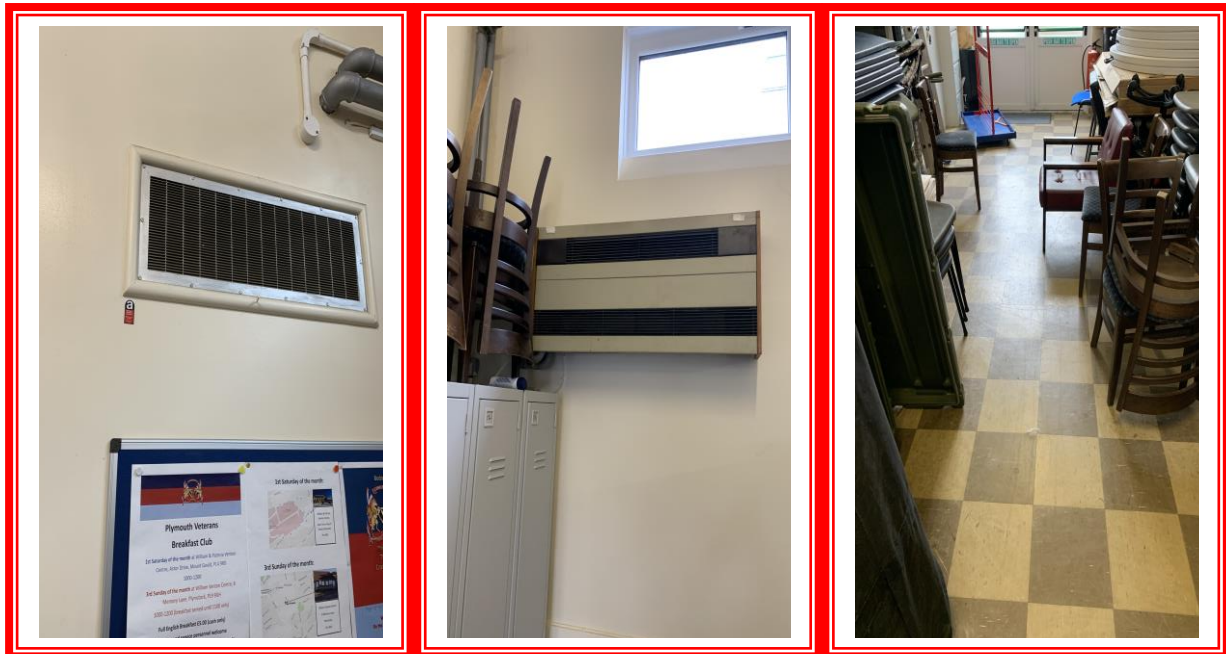
Item No: 28

Material Description:	Floor Tiles and Storage Heater	
Identification:	Strongly Presumed to Contain Asbestos	
Approx. quantity:	20M2 (Floor Tiles) x 1 (Storage Heater)	
Accessibility	Medium	Assessment Score
Product type:	Composite	1
Extent of Damage:	Good	0
Surface Treatment:	Non-Friable	0
Asbestos type:	Chrysotile	1
Material Assessment Score:		2
Priority Assessment Score:		Negligible
Action:	Manage	
Comments:	The floor tiles are covered with carpet. Floor tiles are presumed to be as per item 11

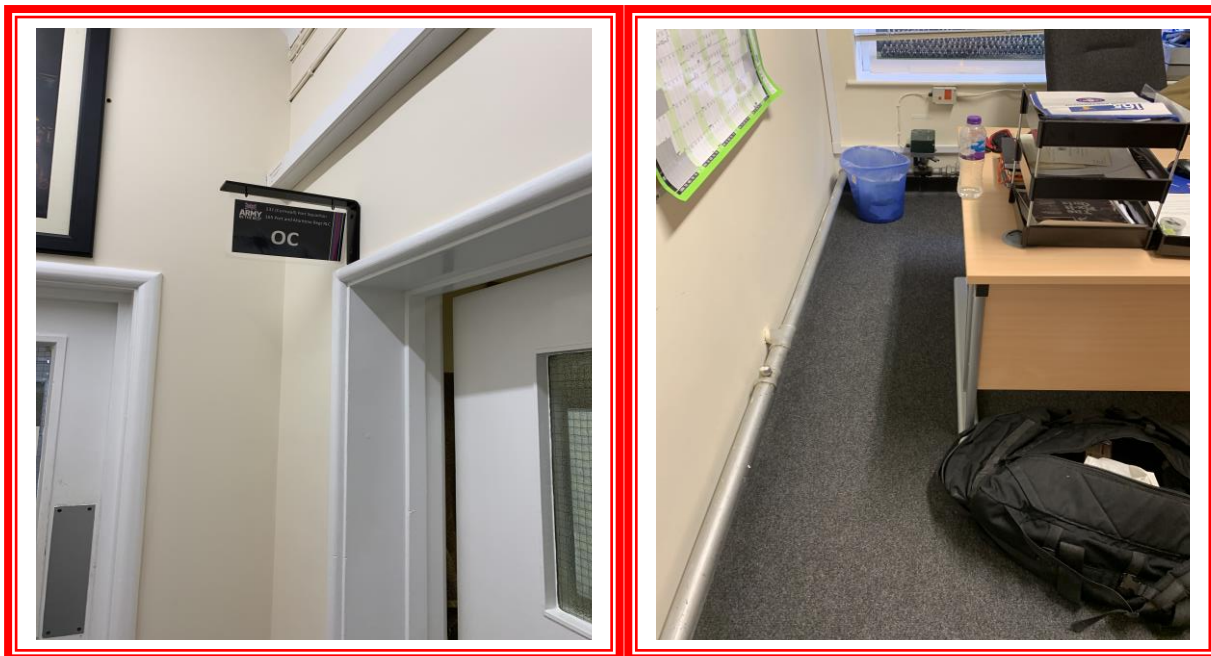
Item No: 29

Material Description:	Floor Tiles	
Identification:	Strongly Presumed to Contain Asbestos	
Approx. quantity:	24M2	
Accessibility	Low	Assessment Score
Product type:	Composite	1
Extent of Damage:	Good	0
Surface Treatment:	Non-Friable	0
Asbestos type:	Chrysotile	1
Material Assessment Score:		2
Priority Assessment Score:		Negligible
Action:	Manage	
Comments:	The floor tiles are covered with carpet

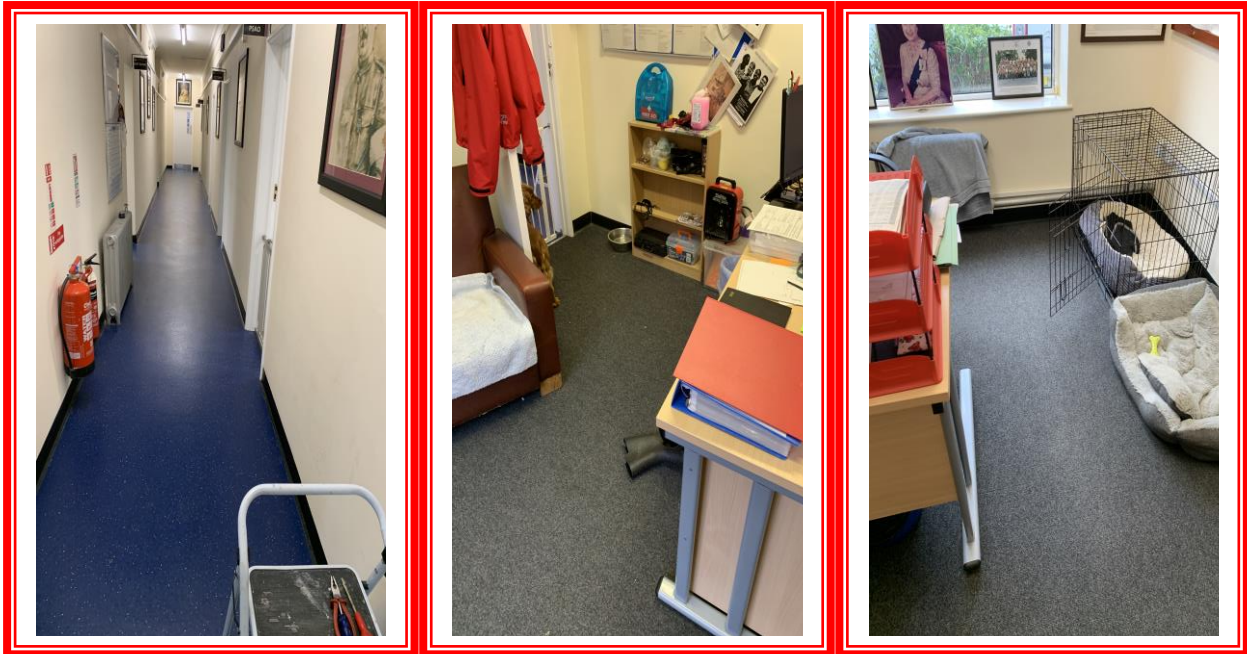
Location: Ground Floor – PASO and OPS Offices

Material Description:	Floor Tiles	
Identification:	Strongly Presumed to Contain Asbestos	
Approx. quantity:	45M2	
Accessibility	Low	Assessment Score
Product type:	Composite	1
Extent of Damage:	Good	0
Surface Treatment:	Non-Friable	0
Asbestos type:	Chrysotile	1
Material Assessment Score:		2
Priority Assessment Score:		Negligible
Action:	Manage	
Comments:	The floor tiles are covered with carpet

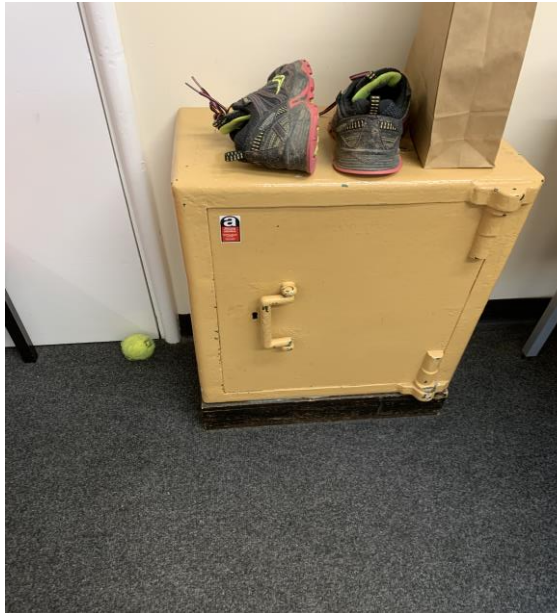
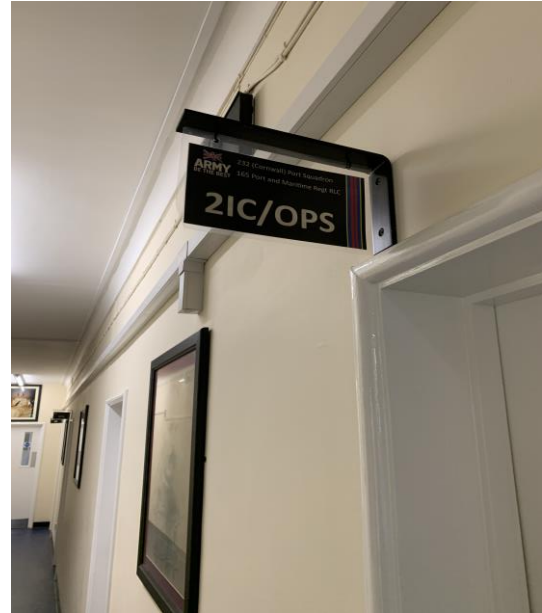
Location: Ground Floor – SPSI Office

Material Description:	Safe	
Identification:	Presumed to Contain Asbestos	
Approx. quantity:	X 1	
Accessibility	High	Assessment Score
Product type:	No Access	3
Extent of Damage:	No Access	3
Surface Treatment:	No Access	3
Asbestos type:	No Access	3
Material Assessment Score:		12
Priority Assessment Score:		High
Action:	Manage	
Comments:	No access to sample
