Project Number 2481

**Management
Asbestos Survey Report**

**232 Port Squadron, Bodmin, Cornwall,
PL31 1DX**

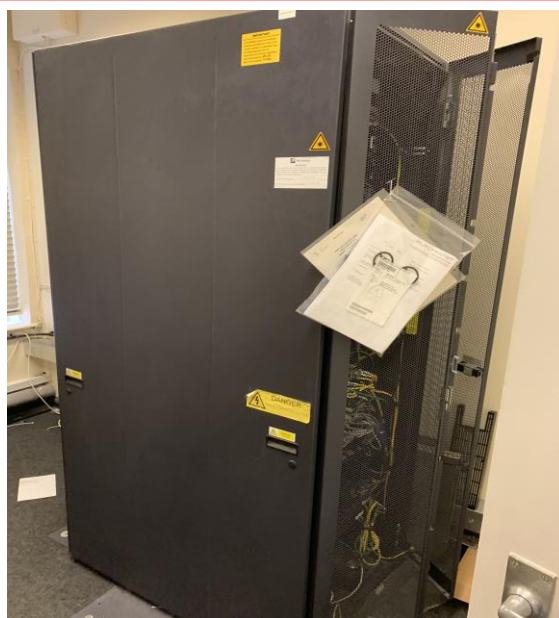
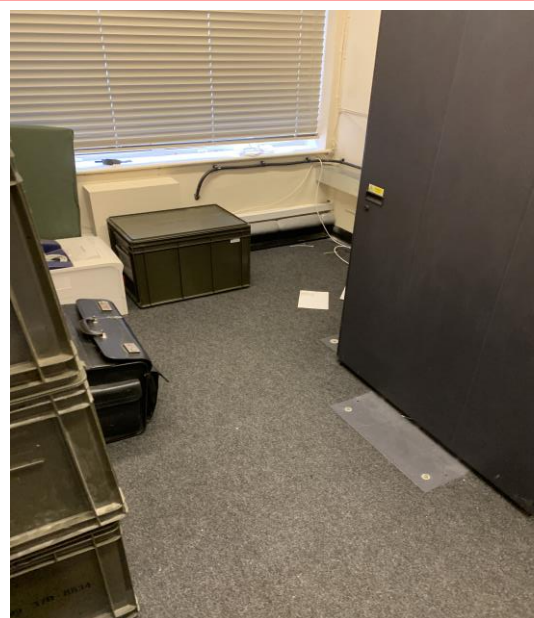
Location: Ground Floor – Server Room

Material Description:	Floor Tiles	
Identification:	Presumed to Contain Asbestos	
Approx. quantity:	18M2	
Accessibility	Low	Assessment Score
Product type:	Composite	1
Extent of Damage:	Good	0
Surface Treatment:	Non-Friable	0
Asbestos type:	Chrysotile	1
Material Assessment Score:		2
Priority Assessment Score:		Negligible
Action:	Manage	
Comments:	The floor tiles are covered with carpet

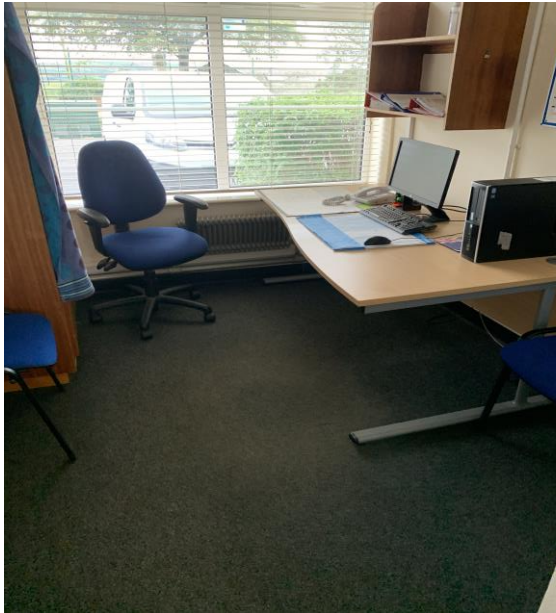
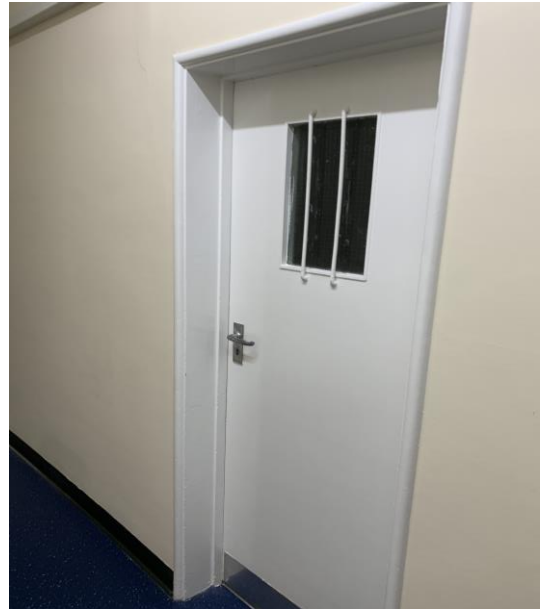
Location: Ground Floor – Troop Office

Material Description:	Floor Tiles	
Identification:	Presumed to Contain Asbestos	
Approx. quantity:	18M2	
Accessibility	Low	Assessment Score
Product type:	Composite	1
Extent of Damage:	Good	0
Surface Treatment:	Non-Friable	0
Asbestos type:	Chrysotile	1
Material Assessment Score:		2
Priority Assessment Score:		Negligible
Action:	Manage	
Comments:	The floor tiles are covered with carpet

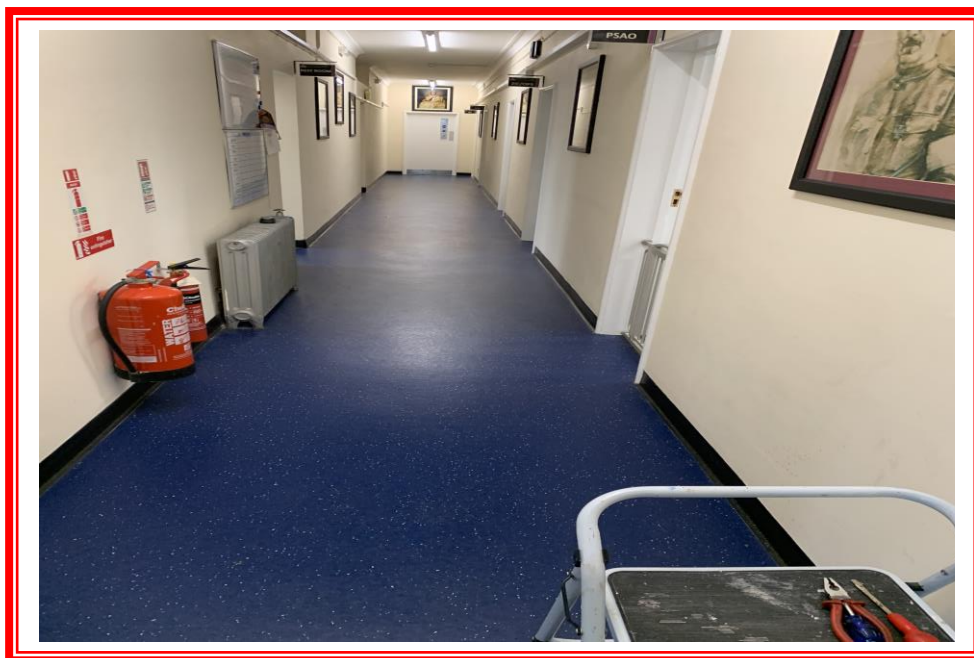
Location: Ground Floor – Hallway

Material Description:	Floor Tiles	
Identification:	Presumed to Contain Asbestos	
Approx. quantity:	20M2	
Accessibility	Low	Assessment Score
Product type:	Composite	1
Extent of Damage:	Good	0
Surface Treatment:	Non-Friable	0
Asbestos type:	Chrysotile	1
Material Assessment Score:		2
Priority Assessment Score:		Negligible
Action:	Manage	
Comments:	The floor tiles are covered with carpet

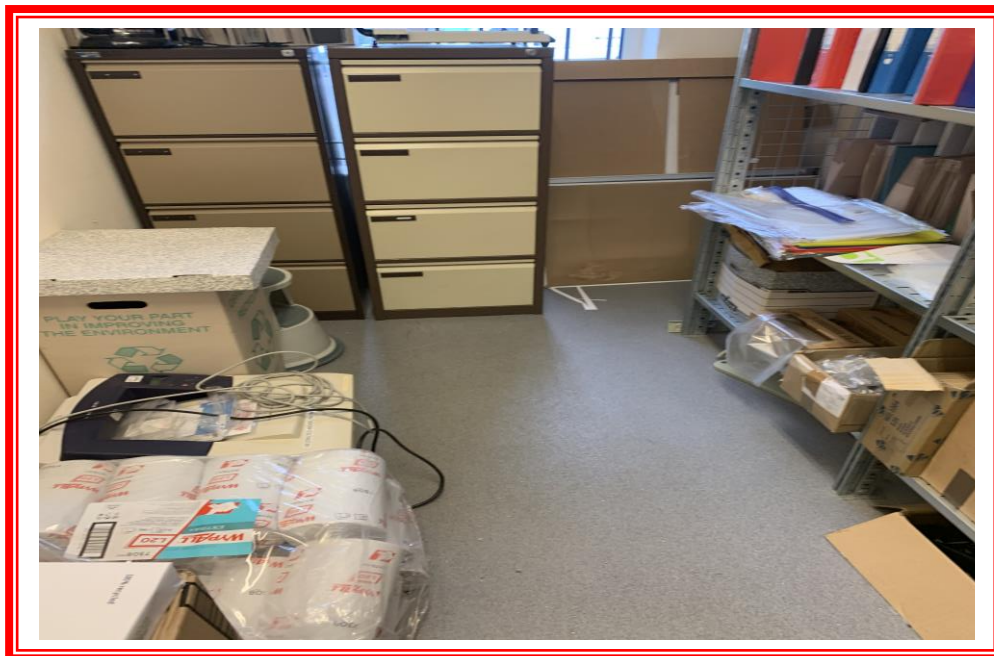
Location: Ground Floor – Stationary Office

Material Description:	Floor Tiles	
Identification:	Presumed to Contain Asbestos	
Approx. quantity:	15M2	
Accessibility	Low	Assessment Score
Product type:	Composite	1
Extent of Damage:	Good	0
Surface Treatment:	Non-Friable	0
Asbestos type:	Chrysotile	1
Material Assessment Score:		2
Priority Assessment Score:		Negligible
Action:	Manage	
Comments:	The floor tiles are covered with carpet

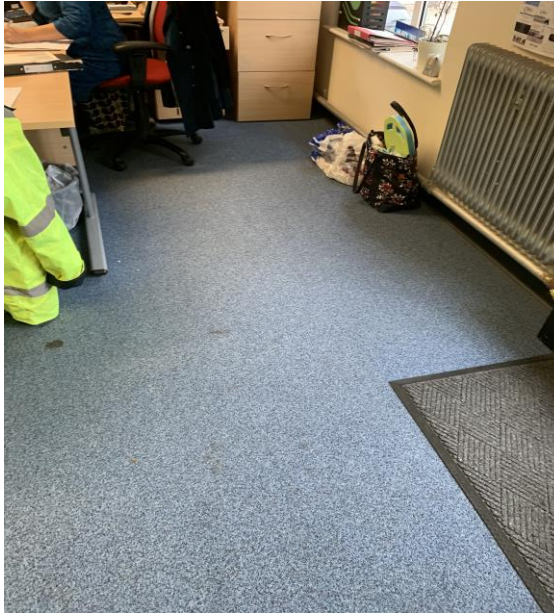
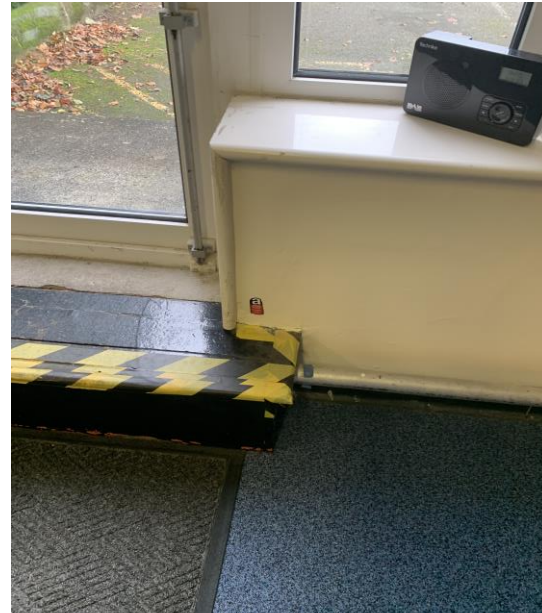
**Item No: 36****Sample No: N/A****Location: Ground Floor – AO Office**

Material Description:	Floor Tiles	
Identification:	As Per Previous Sample REF30 and 31 – Asbestos Detected	
Approx. quantity:	43M2	
Accessibility	High	Assessment Score
Product type:	Composite	1
Extent of Damage:	Good	0
Surface Treatment:	Non-Friable	0
Asbestos type:	Chrysotile	1
Material Assessment Score:		2
Priority Assessment Score:		Negligible
Action:	Manage	
Comments:	The floor tiles are covered with carpet

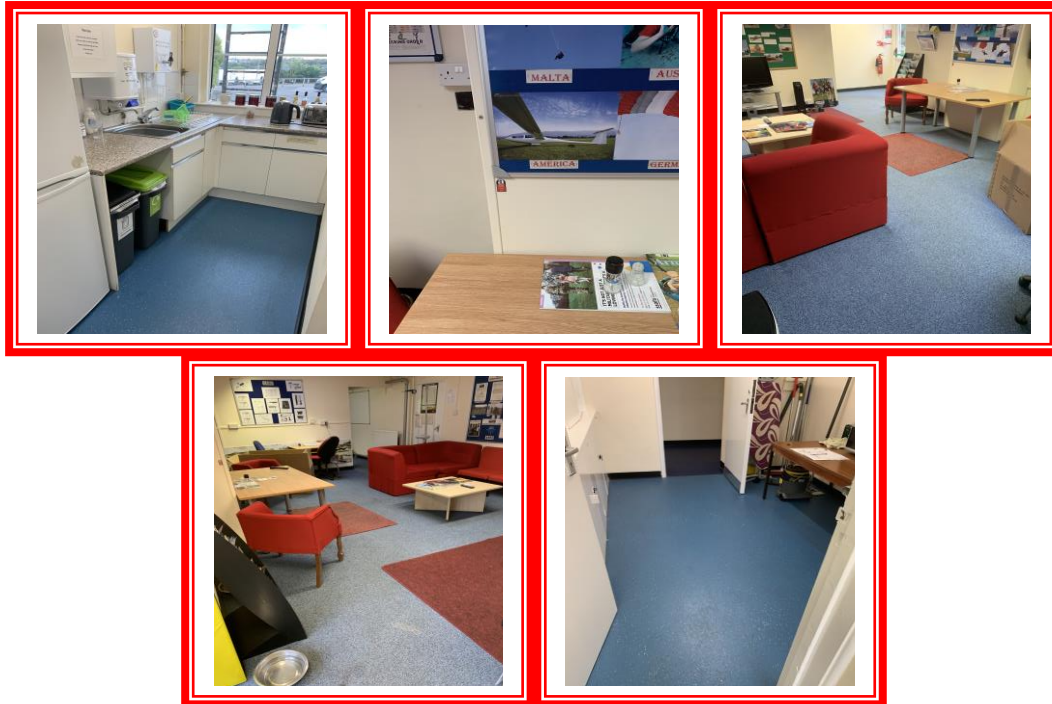
Location: Ground Floor – Rest Room and RRTT

Material Description:	Floor Tiles	
Identification:	Presumed to Contain Asbestos	
Approx. quantity:	70M2	
Accessibility	Low	Assessment Score
Product type:	Composite	1
Extent of Damage:	Good	0
Surface Treatment:	Non-Friable	0
Asbestos type:	Chrysotile	1
Material Assessment Score:		2
Priority Assessment Score:		Negligible
Action:	Manage	
Comments:	The floor tiles are covered with carpet

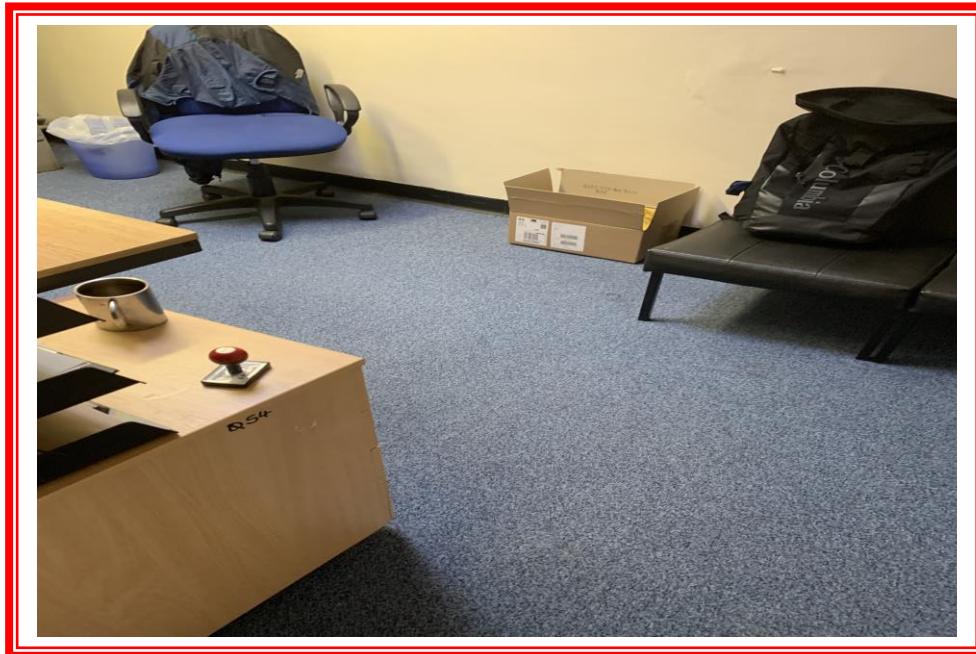
Location: Ground Floor – RRTT Office

Material Description:	Floor Tiles	
Identification:	Presumed to Contain Asbestos	
Approx. quantity:	15M2	
Accessibility	Low	<i>Assessment Score</i>
Product type:	Composite	1
Extent of Damage:	Good	0
Surface Treatment:	Non-Friable	0
Asbestos type:	Chrysotile	1
Material Assessment Score:		2
Priority Assessment Score:		Negligible
Action:	Manage	
Comments:	The floor tiles are covered with carpet

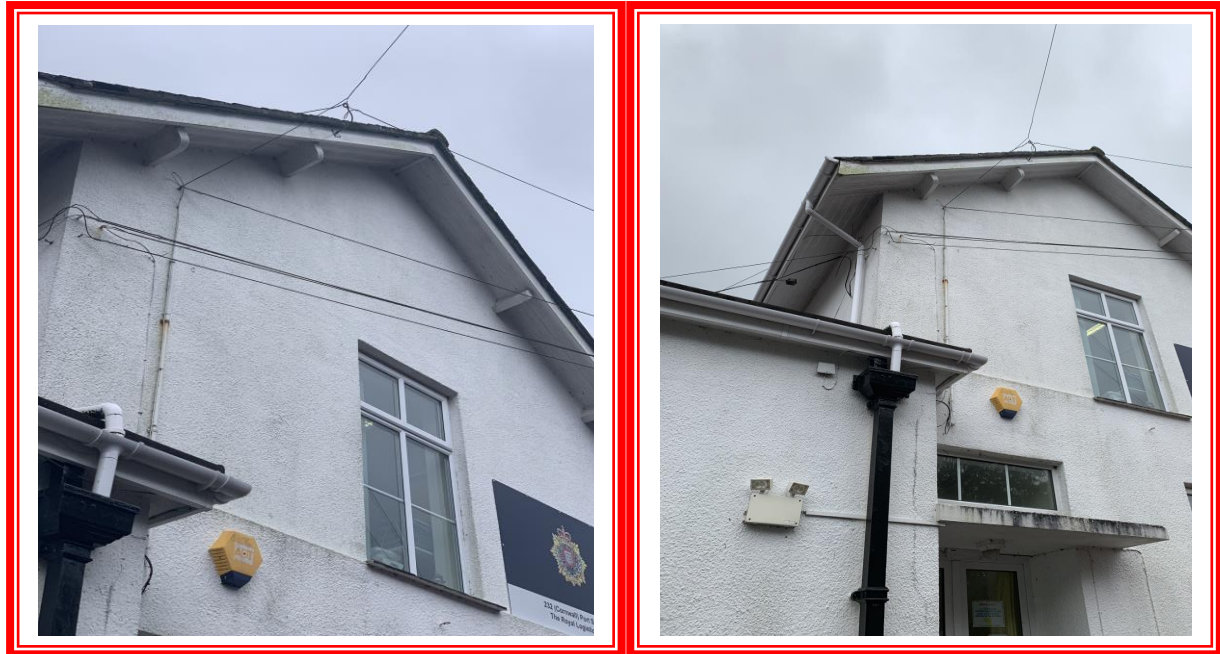
**Item No: 39****Sample No: N/A****Location: Roof – Front Elevation**

Material Description:	Under Cloaking	
Identification:	Presumed to Contain Asbestos	
Approx. quantity:	16LM	
Accessibility	High	Assessment Score
Product type:	Cement	1
Extent of Damage:	Minor	1
Surface Treatment:	Unsealed	1
Asbestos type:	Chrysotile	1
Material Assessment Score:		4
Priority Assessment Score:		Negligible
Action:	Manage	
Comments:	Unable to sample due to height

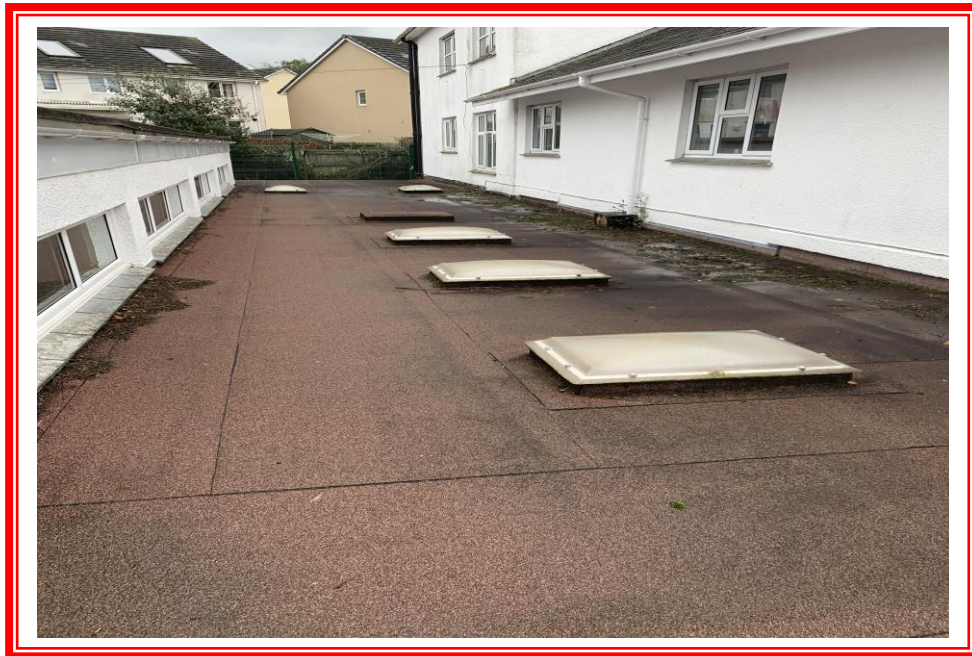
Material Description:	Roof Lights	
Identification:	As Per Previous Sample REF111 – Asbestos Detected	
Approx. quantity:	X 6	
Accessibility	High	Assessment Score
Product type:	Rope	2
Extent of Damage:	Moderate	2
Surface Treatment:	Unsealed	3
Asbestos type:	Chrysotile	1
Material Assessment Score:		8
Priority Assessment Score:		Medium
Action:	Manage	
Comments:	Monitor Annually

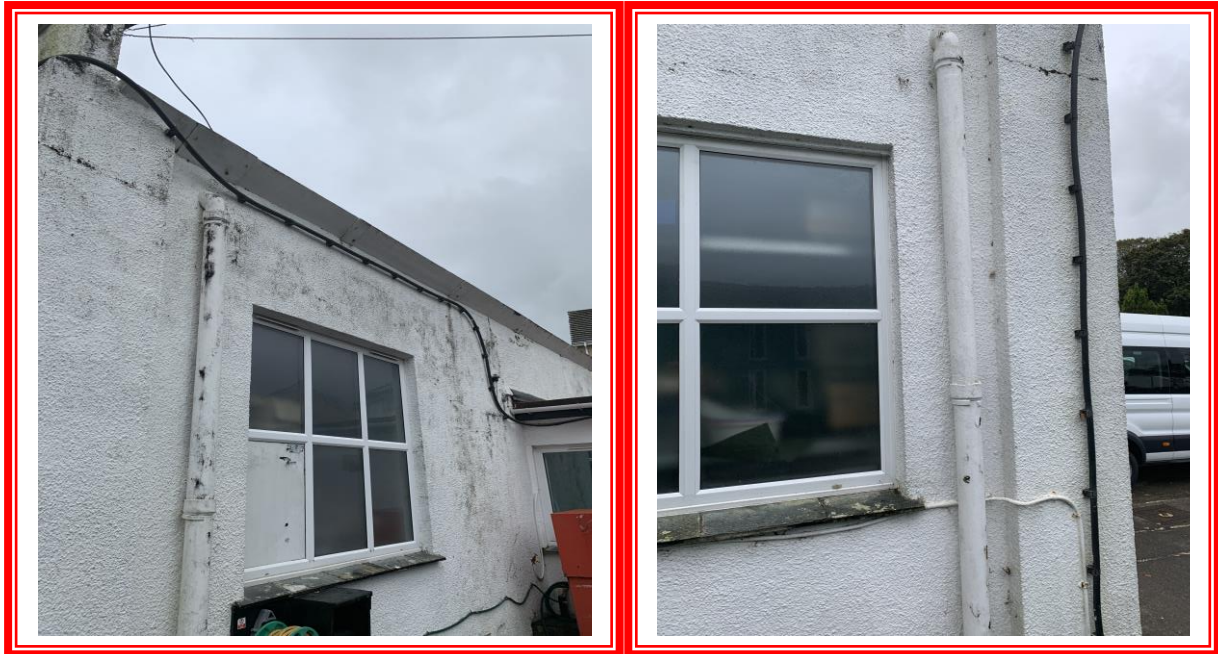
Material Description:	Downpipes	
Identification:	Strongly Presumed to Contain Asbestos	
Approx. quantity:	12LM	
Accessibility	High	Assessment Score
Product type:	Cement	1
Extent of Damage:	Minor	1
Surface Treatment:	Unsealed	1
Asbestos type:	Chrysotile	1
Material Assessment Score:		4
Priority Assessment Score:		Negligible
Action:	Manage	
Comments:	N/A

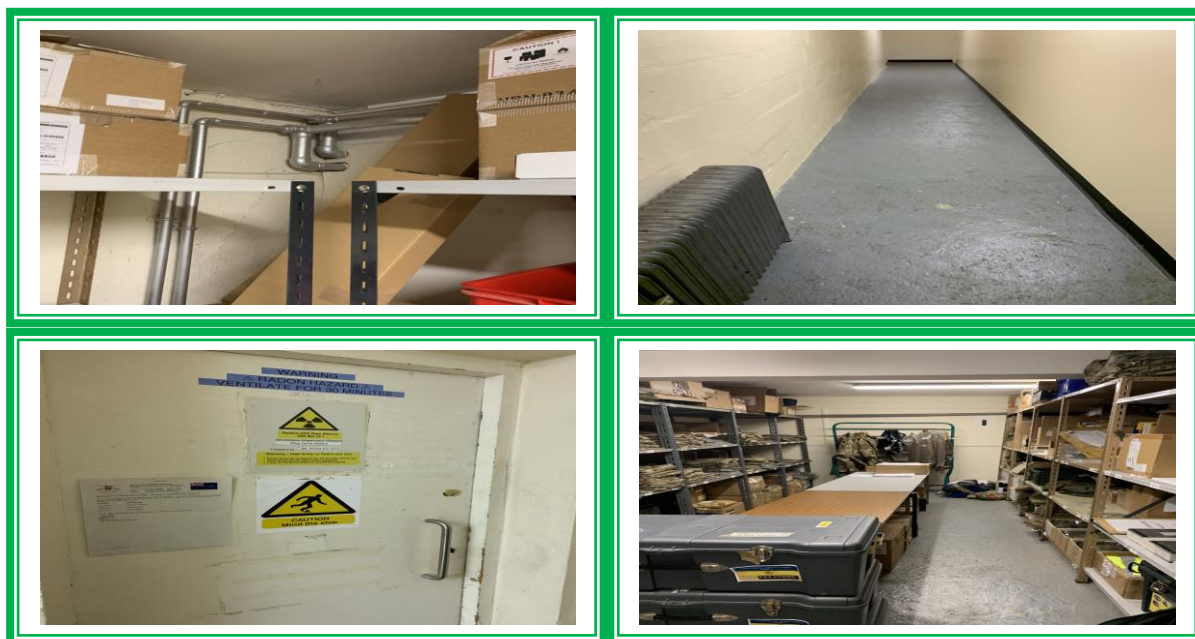
Material Description:	Visual Inspection – No Suspect Materials Found	
Identification:	N/A	
Approx. quantity:	N/A	
Accessibility	N/A	<i>Assessment Score</i>
Product type:	N/A	N/A
Extent of Damage:	N/A	N/A
Surface Treatment:	N/A	N/A
Asbestos type:	N/A	N/A
Material Assessment Score:		N/A
Priority Assessment Score:		N/A
Action:	N/A	
Comments:	N/A
