**Project Number 2481**

**Management  
Asbestos Survey Report**

**992 Malmesbury, Wiltshire, SN16 9JR**

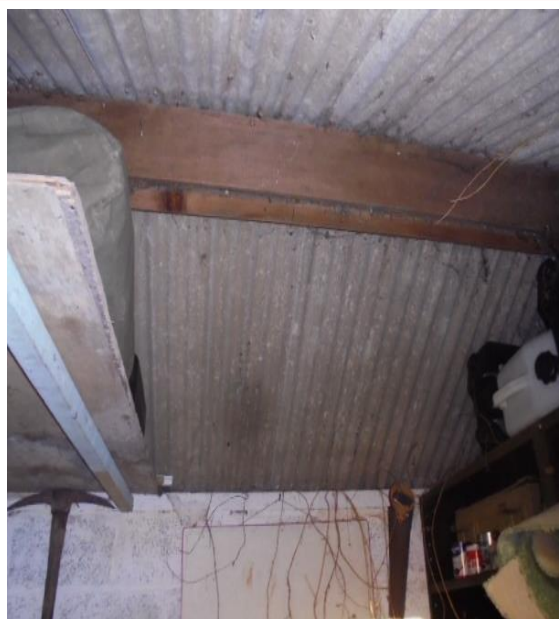
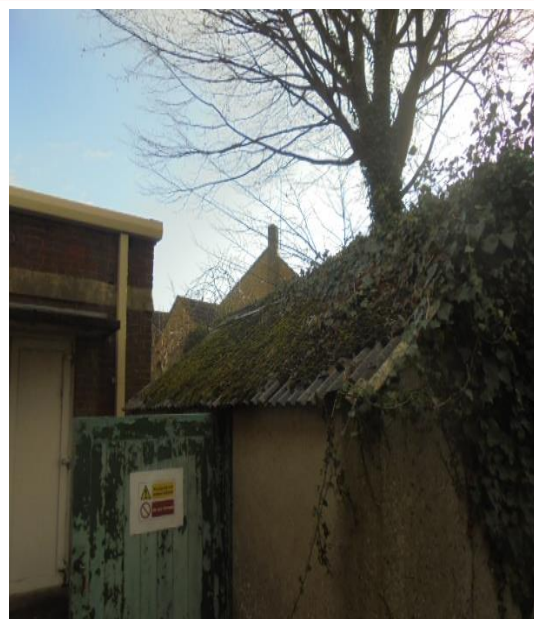
**Item No: 1**

Sample Number	Sample Type	Location	Analysis
DK/1	Profiled Cement Roof	Shed	Chrysotile
DK/2	Sink Pad	Kitchen	N.A.D.I.S

<b>Material Description:</b>	Profiled Cement Roof	
<b>Identification:</b>	Sampled – Asbestos Detected	
<b>Approx. quantity:</b>	4M2	
<b>Accessibility</b>	Low	Assessment Score
<b>Product type:</b>	Cement	1
<b>Extent of Damage:</b>	Minor	1
<b>Surface Treatment:</b>	Unsealed	1
<b>Asbestos type:</b>	Chrysotile	1
<b>Material Assessment Score:</b>		4
<b>Priority Assessment Score:</b>		Negligible
<b>Action:</b>	Manage	
<b>Comments:</b>	N/A

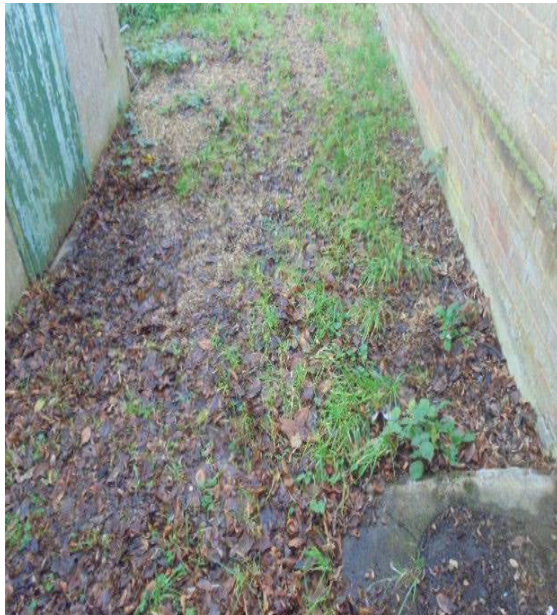
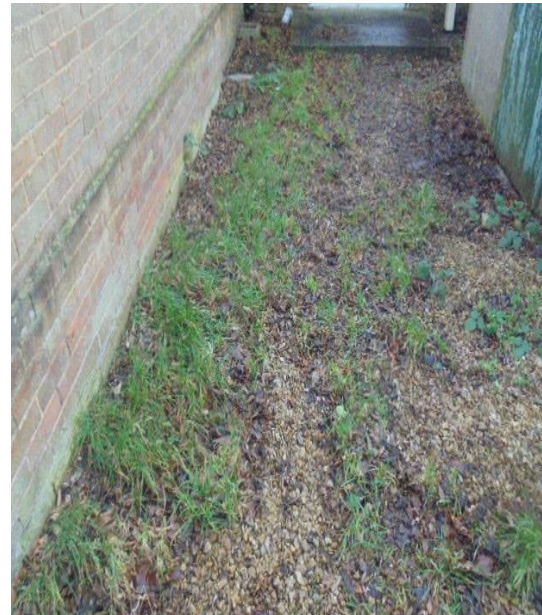
**Item No: 2****Sample No: N/A****Location: External – Old Boiler Room**

Item 2 – External – Old Boiler Room – Lagging to Boiler and Pipework – Unable to sample as boiler room filled in with concrete

<b>Material Description:</b>	Lagging to Boiler and Pipework	
<b>Identification:</b>	Presumed to Contain Asbestos	
<b>Approx. quantity:</b>	Unknown	
<b>Accessibility</b>	Low	<i>Assessment Score</i>
<b>Product type:</b>	Lagging	3
<b>Extent of Damage:</b>	Major	3
<b>Surface Treatment:</b>	Unsealed	3
<b>Asbestos type:</b>	Crocidolite	3
<b>Material Assessment Score:</b>		12
<b>Priority Assessment Score:</b>		High
<b>Action:</b>	Manage	
<b>Comments:</b>	Old boiler room contained asbestos boiler and pipework lagging but have been filled in with concrete as informed by the site contact. Site contact was aware that asbestos lagging was present in old boiler room.

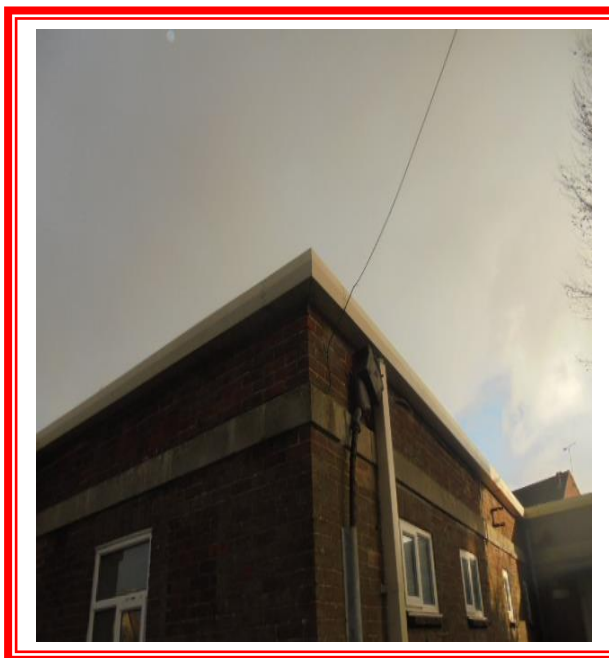
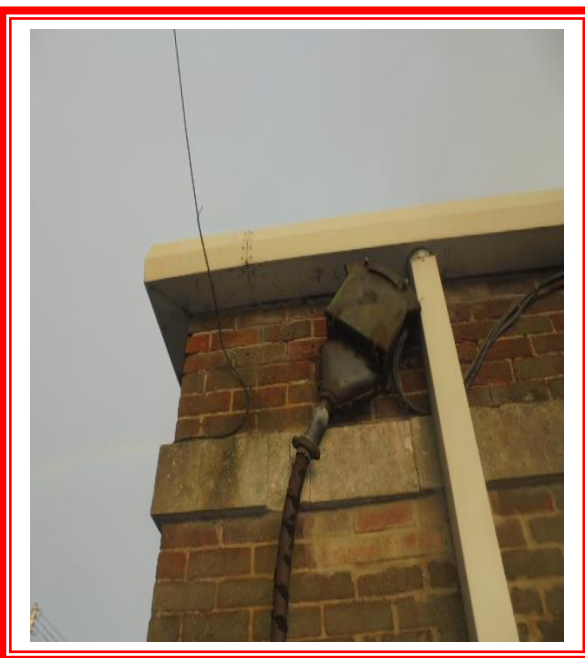
**Item No: 3****Sample No: N/A****Location: External**

Item 3 – External – No access within Electrical Box – No access as live

<b>Material Description:</b>	Electrical Box	
<b>Identification:</b>	Presumed to Contain Asbestos	
<b>Approx. quantity:</b>	X 1	
<b>Accessibility</b>	Low	<i>Assessment Score</i>
<b>Product type:</b>	No Access	2
<b>Extent of Damage:</b>	No Access	1
<b>Surface Treatment:</b>	No Access	1
<b>Asbestos type:</b>	No Access	1
<b>Material Assessment Score:</b>		5
<b>Priority Assessment Score:</b>		Low
<b>Action:</b>	Manage	
<b>Comments:</b>	No access as live

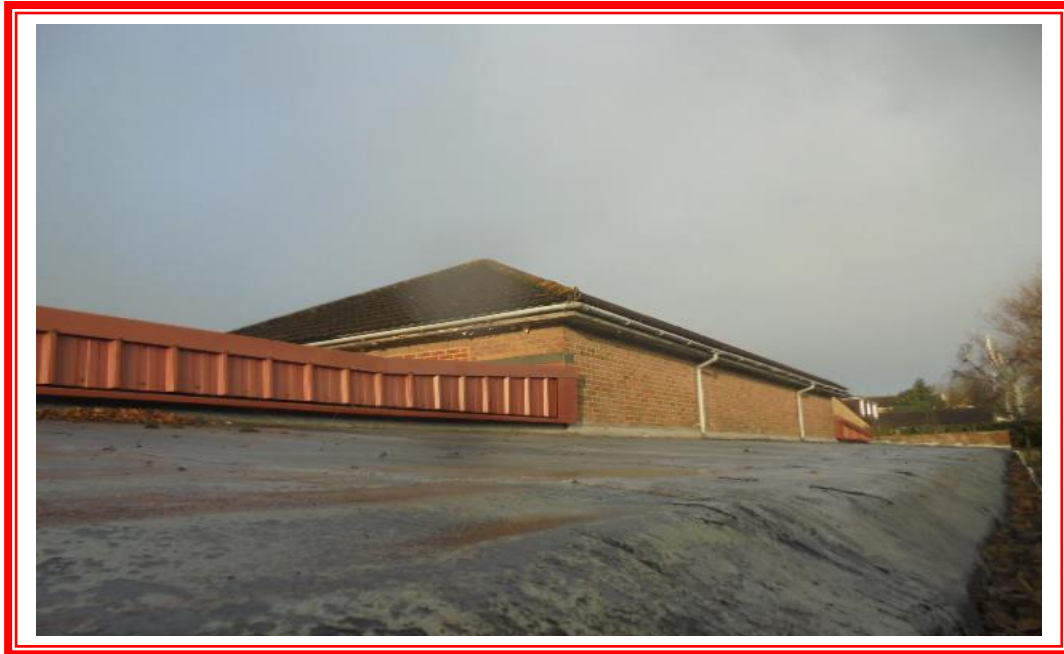
**Item No: 4**

Item 4 – External to Drill Hall – Soffit Boards – No access to sample due to the height

<b>Material Description:</b>	Soffit Boards	
<b>Identification:</b>	Presumed to Contain Asbestos	
<b>Approx. quantity:</b>	42LM	
<b>Accessibility</b>	Low	Assessment Score
<b>Product type:</b>	No Access	2
<b>Extent of Damage:</b>	No Access	2
<b>Surface Treatment:</b>	No Access	2
<b>Asbestos type:</b>	No Access	2
<b>Material Assessment Score:</b>		8
<b>Priority Assessment Score:</b>		Medium
<b>Action:</b>	Manage	
<b>Comments:</b>	No access to inspect due to height

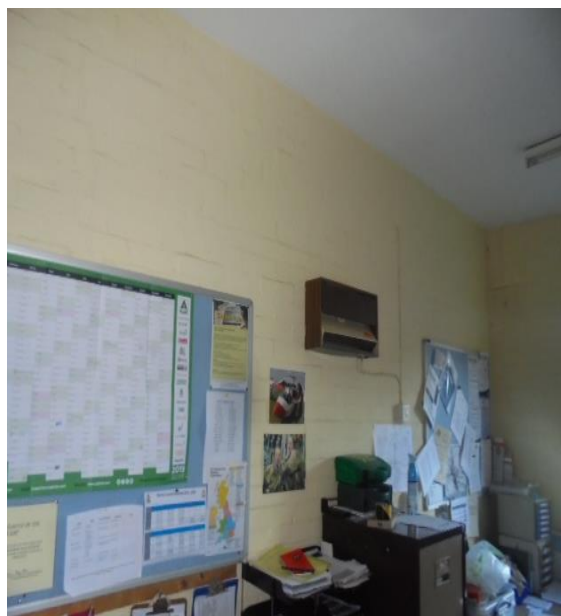
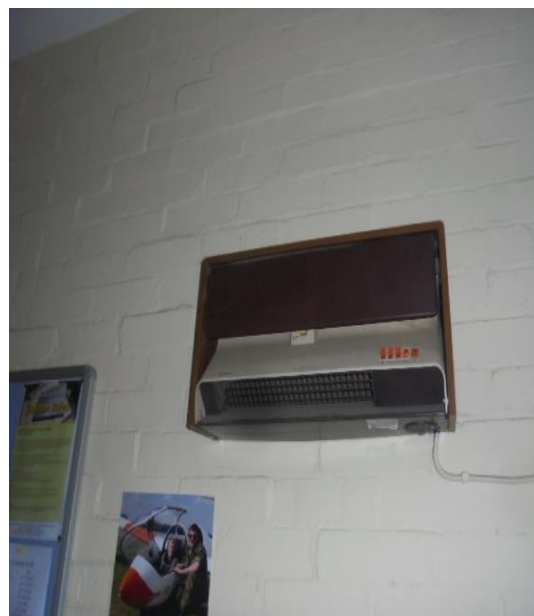
**Item No: 10****Sample No: N/A****Location: Office**

Item 10 – Office – Live Heater – No access to sample as live

<b>Material Description:</b>	Live Heater	
<b>Identification:</b>	Presumed to Contain Asbestos	
<b>Approx. quantity:</b>	X 1	
<b>Accessibility</b>	Low	Assessment Score
<b>Product type:</b>	No Access	2
<b>Extent of Damage:</b>	No Access	2
<b>Surface Treatment:</b>	No Access	2
<b>Asbestos type:</b>	No Access	2
<b>Material Assessment Score:</b>		8
<b>Priority Assessment Score:</b>		Medium
<b>Action:</b>	Manage	
<b>Comments:</b>	No access as live

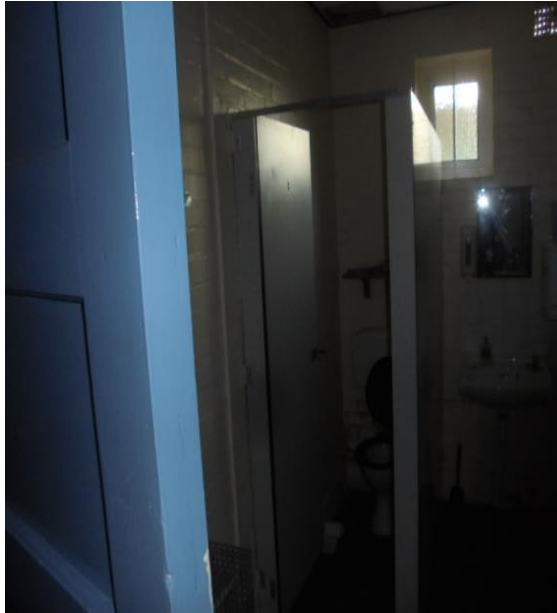
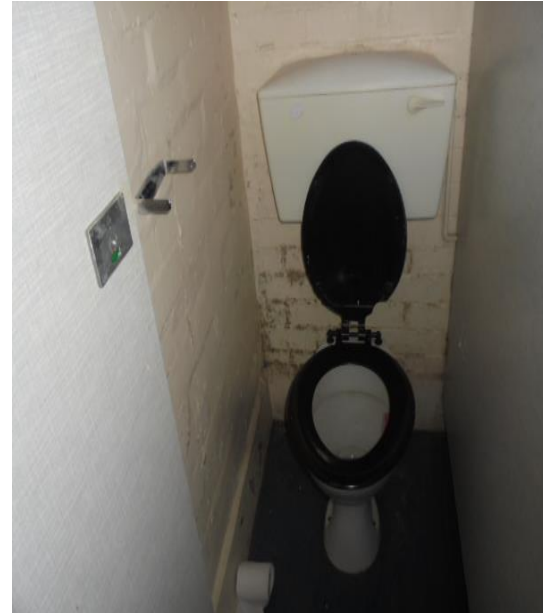
**Item No: 15**

Item 15 – Female WC – Toilet Seat – Unable to sample as it would damage the integrity

<b>Material Description:</b>	Toilet Seat	
<b>Identification:</b>	Presumed to Contain Asbestos	
<b>Approx. quantity:</b>	X 1 Seat	
<b>Accessibility</b>	High	Assessment Score
<b>Product type:</b>	Composite	1
<b>Extent of Damage:</b>	Minor	1
<b>Surface Treatment:</b>	Non-Friable	0
<b>Asbestos type:</b>	Chrysotile	1
<b>Material Assessment Score:</b>		3
<b>Priority Assessment Score:</b>		Negligible
<b>Action:</b>	Manage	
<b>Comments:</b>	Unable to sample as it may damage the integrity of the seat

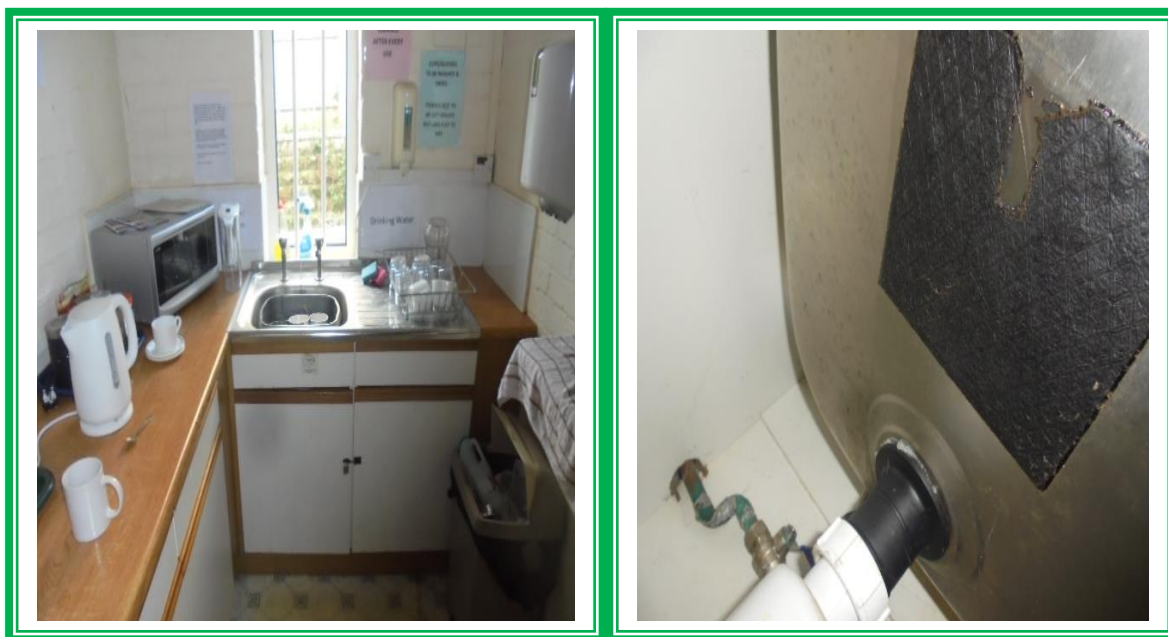
**Item No: 5**

<b>Material Description:</b>	Sink Pad	
<b>Identification:</b>	Sampled - No Asbestos Detected	
<b>Approx. quantity:</b>	X 1 Sink	
<b>Accessibility</b>	High	Assessment Score
<b>Product type:</b>	N/A	N/A
<b>Extent of Damage:</b>	N/A	N/A
<b>Surface Treatment:</b>	N/A	N/A
<b>Asbestos type:</b>	N/A	N/A
<b>Material Assessment Score:</b>		N/A
<b>Priority Assessment Score:</b>		N/A
<b>Action:</b>	N/A	
<b>Comments:</b>	N/A

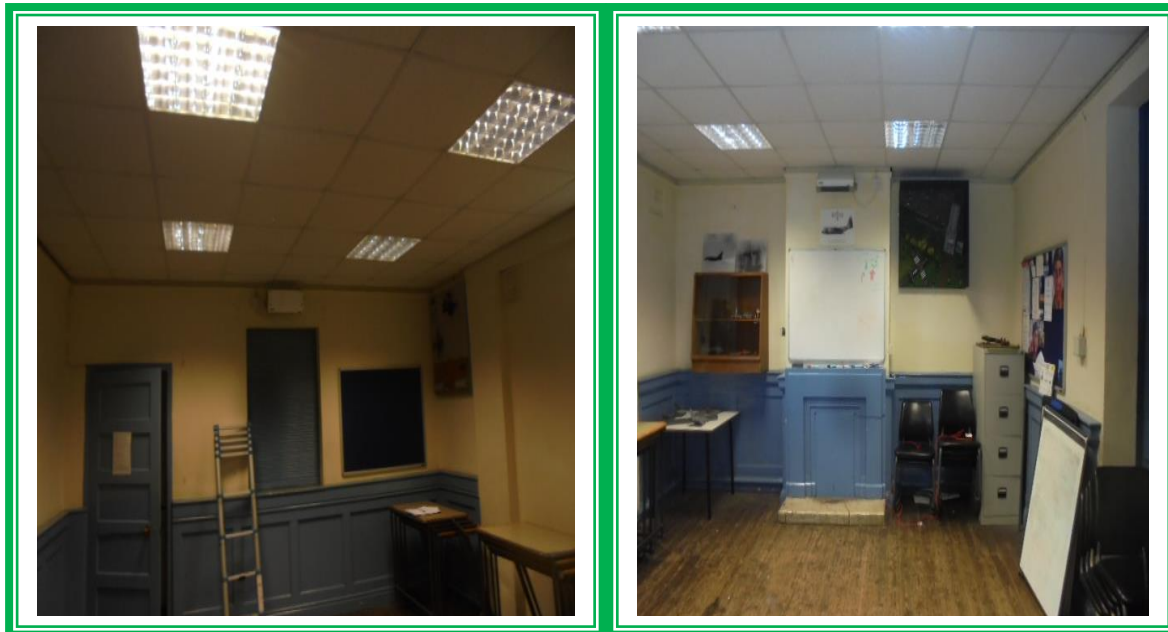
**Item No: 6**

<b>Material Description:</b>	Visual Inspection – No Suspect Materials Found	
<b>Identification:</b>	N/A	
<b>Approx. quantity:</b>	N/A	
<b>Accessibility</b>	N/A	Assessment Score
<b>Product type:</b>	N/A	N/A
<b>Extent of Damage:</b>	N/A	N/A
<b>Surface Treatment:</b>	N/A	N/A
<b>Asbestos type:</b>	N/A	N/A
<b>Material Assessment Score:</b>		N/A
<b>Priority Assessment Score:</b>		N/A
<b>Action:</b>	N/A	
<b>Comments:</b>	No Access behind timber fireplace panel

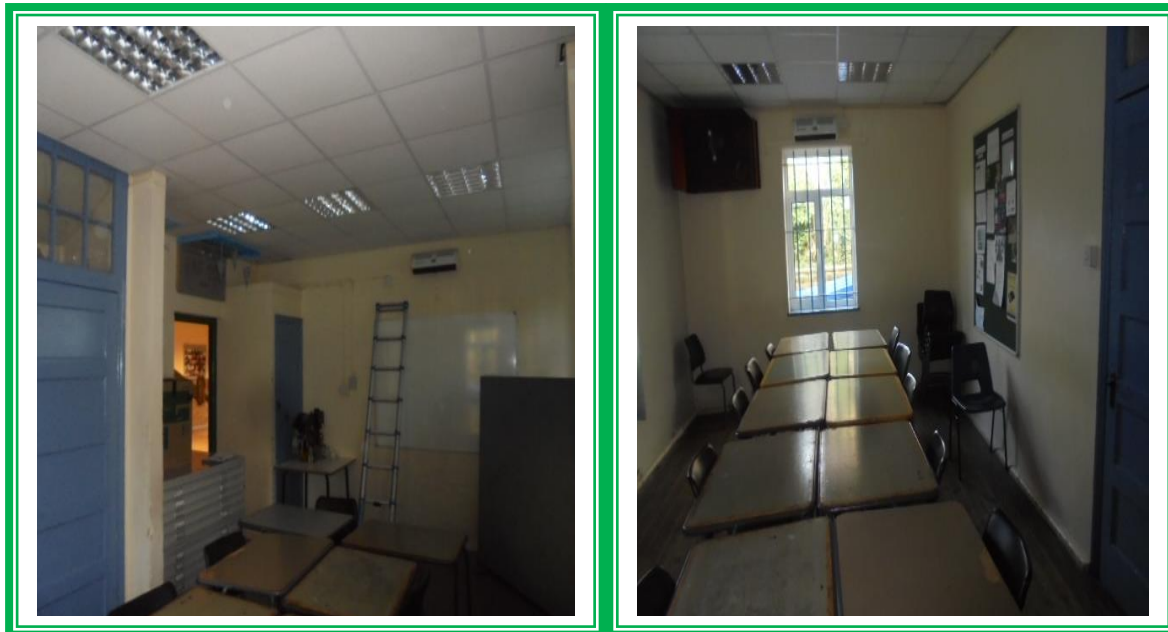
**Item No: 7**

<b>Material Description:</b>	Visual Inspection – No Suspect Materials Found	
<b>Identification:</b>	N/A	
<b>Approx. quantity:</b>	N/A	
<b>Accessibility</b>	N/A	<i>Assessment Score</i>
<b>Product type:</b>	N/A	N/A
<b>Extent of Damage:</b>	N/A	N/A
<b>Surface Treatment:</b>	N/A	N/A
<b>Asbestos type:</b>	N/A	N/A
<b>Material Assessment Score:</b>		N/A
<b>Priority Assessment Score:</b>		N/A
<b>Action:</b>	N/A	
<b>Comments:</b>	N/A

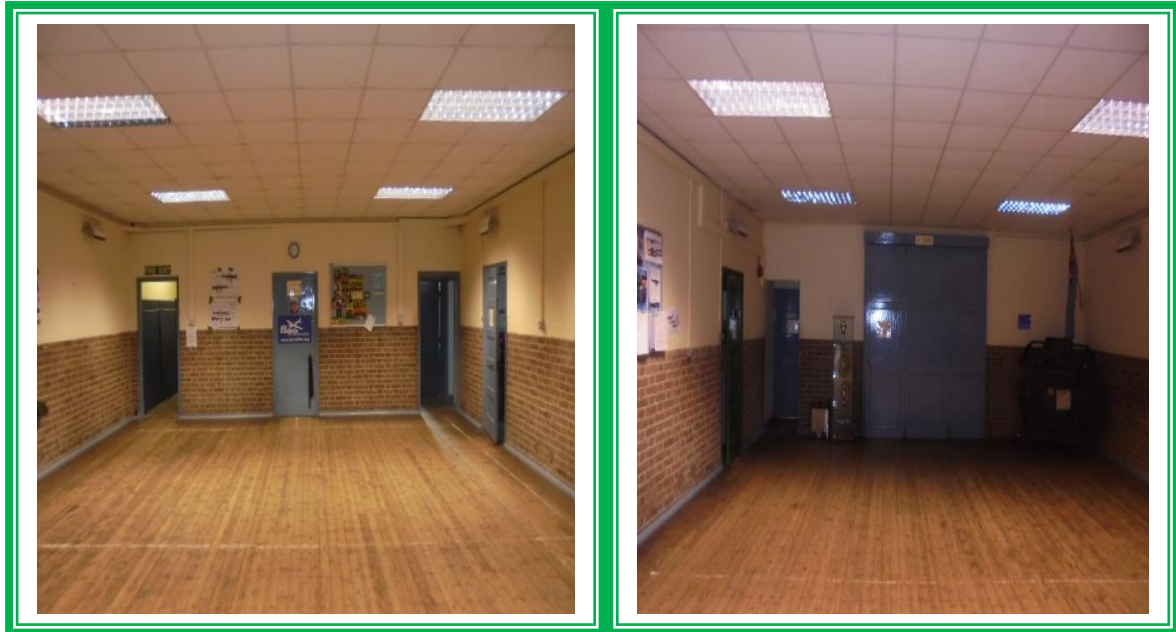
**Item No: 8**

<b>Material Description:</b>	Visual Inspection – No Suspect Materials Found	
<b>Identification:</b>	N/A	
<b>Approx. quantity:</b>	N/A	
<b>Accessibility</b>	N/A	<i>Assessment Score</i>
<b>Product type:</b>	N/A	N/A
<b>Extent of Damage:</b>	N/A	N/A
<b>Surface Treatment:</b>	N/A	N/A
<b>Asbestos type:</b>	N/A	N/A
<b>Material Assessment Score:</b>		N/A
<b>Priority Assessment Score:</b>		N/A
<b>Action:</b>	N/A	
<b>Comments:</b>	N/A

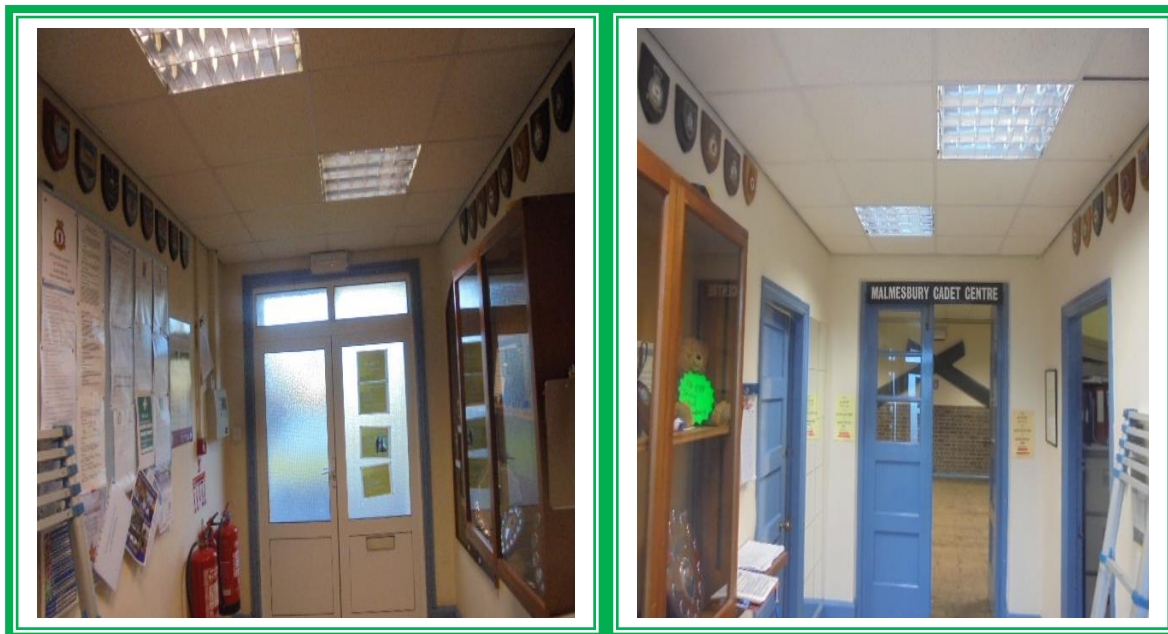
**Item No: 9**

<b>Material Description:</b>	Visual Inspection – No Suspect Materials Found	
<b>Identification:</b>	N/A	
<b>Approx. quantity:</b>	N/A	
<b>Accessibility</b>	N/A	<i>Assessment Score</i>
<b>Product type:</b>	N/A	N/A
<b>Extent of Damage:</b>	N/A	N/A
<b>Surface Treatment:</b>	N/A	N/A
<b>Asbestos type:</b>	N/A	N/A
<b>Material Assessment Score:</b>		N/A
<b>Priority Assessment Score:</b>		N/A
<b>Action:</b>	N/A	
<b>Comments:</b>	N/A

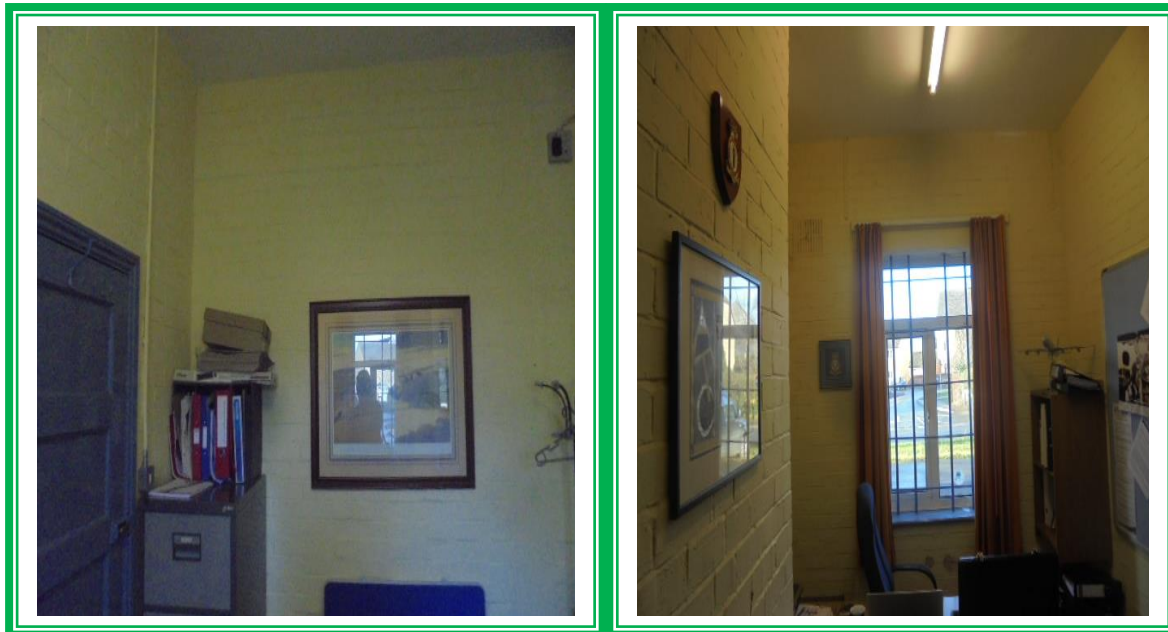
**Item No: 11**

<b>Material Description:</b>	Visual Inspection – No Suspect Materials Found	
<b>Identification:</b>	N/A	
<b>Approx. quantity:</b>	N/A	
<b>Accessibility</b>	N/A	<i>Assessment Score</i>
<b>Product type:</b>	N/A	N/A
<b>Extent of Damage:</b>	N/A	N/A
<b>Surface Treatment:</b>	N/A	N/A
<b>Asbestos type:</b>	N/A	N/A
<b>Material Assessment Score:</b>		N/A
<b>Priority Assessment Score:</b>		N/A
<b>Action:</b>	N/A	
<b>Comments:</b>	No access behind timber fireplace panel

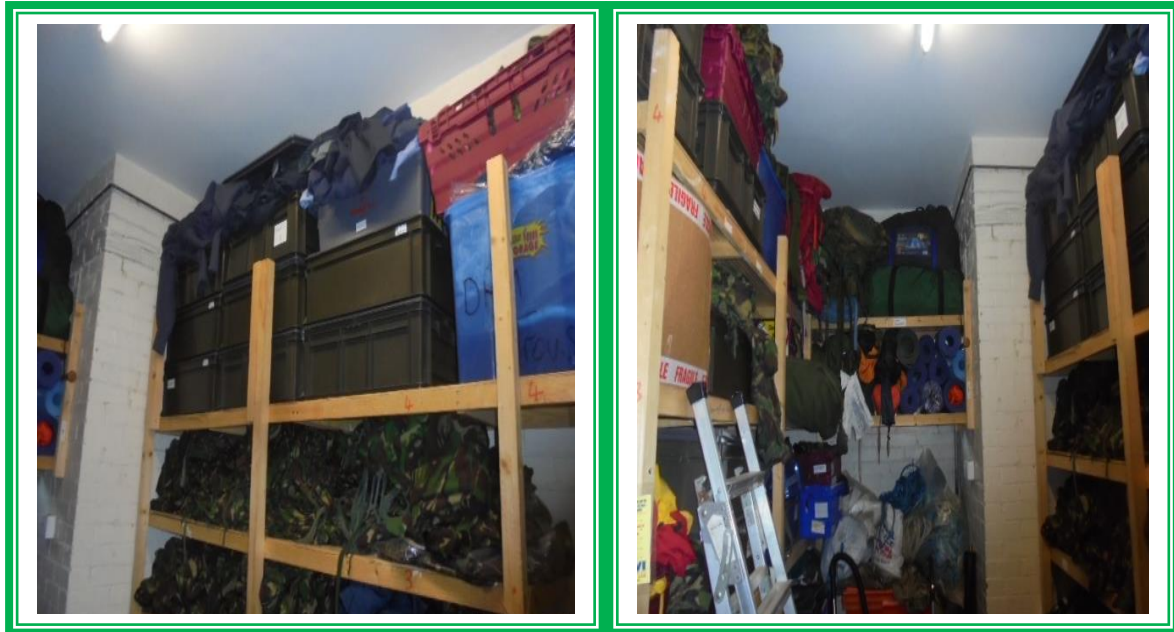
**Item No: 12**

<b>Material Description:</b>	Visual Inspection – No Suspect Materials Found	
<b>Identification:</b>	N/A	
<b>Approx. quantity:</b>	N/A	
<b>Accessibility</b>	N/A	<i>Assessment Score</i>
<b>Product type:</b>	N/A	N/A
<b>Extent of Damage:</b>	N/A	N/A
<b>Surface Treatment:</b>	N/A	N/A
<b>Asbestos type:</b>	N/A	N/A
<b>Material Assessment Score:</b>		N/A
<b>Priority Assessment Score:</b>		N/A
<b>Action:</b>	N/A	
<b>Comments:</b>	N/A

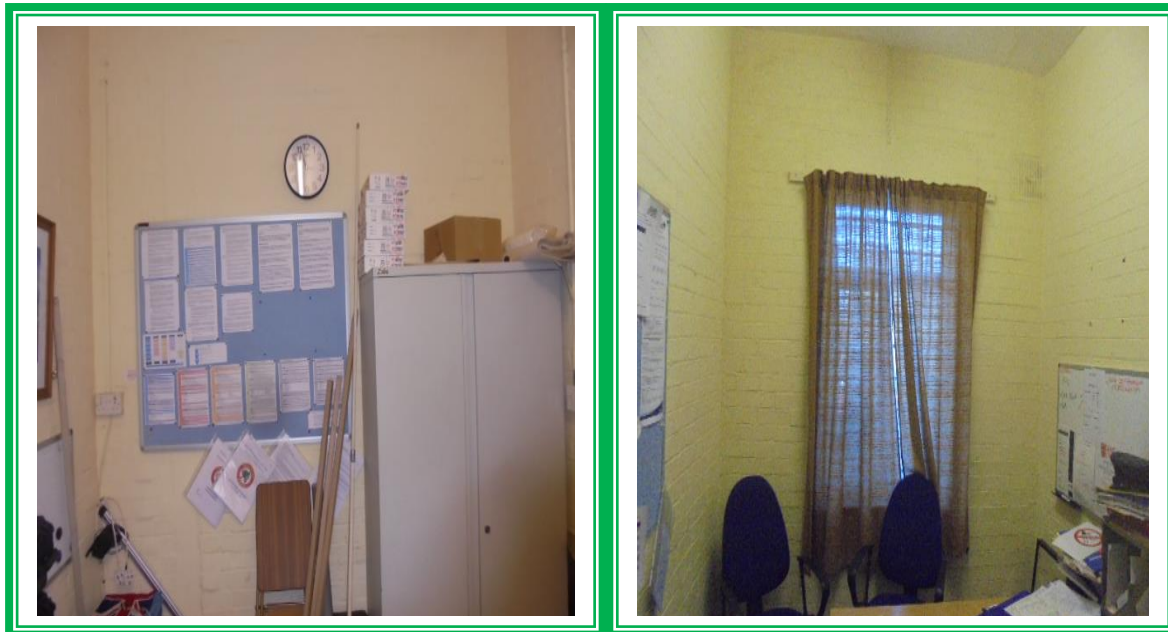
**Item No: 13**

<b>Material Description:</b>	Visual Inspection – No Suspect Materials Found	
<b>Identification:</b>	N/A	
<b>Approx. quantity:</b>	N/A	
<b>Accessibility</b>	N/A	Assessment Score
<b>Product type:</b>	N/A	N/A
<b>Extent of Damage:</b>	N/A	N/A
<b>Surface Treatment:</b>	N/A	N/A
<b>Asbestos type:</b>	N/A	N/A
<b>Material Assessment Score:</b>		N/A
<b>Priority Assessment Score:</b>		N/A
<b>Action:</b>	N/A	
<b>Comments:</b>	No access behind timber fireplace panel

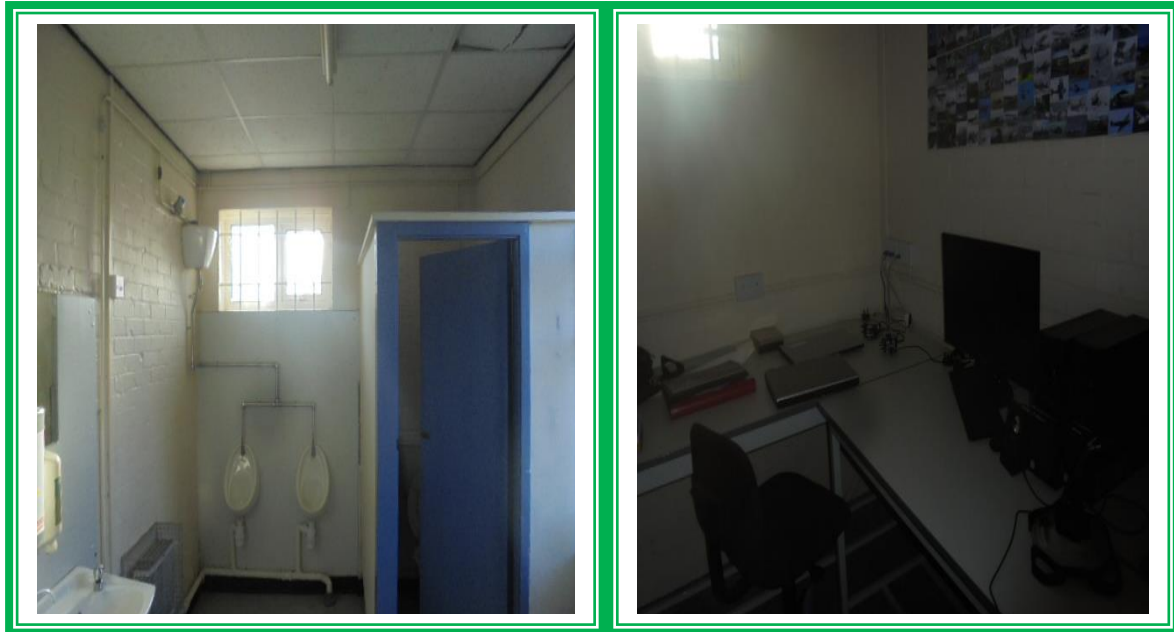
**Item No: 14**

<b>Material Description:</b>	Visual Inspection – No Suspect Materials Found	
<b>Identification:</b>	N/A	
<b>Approx. quantity:</b>	N/A	
<b>Accessibility</b>	N/A	<i>Assessment Score</i>
<b>Product type:</b>	N/A	N/A
<b>Extent of Damage:</b>	N/A	N/A
<b>Surface Treatment:</b>	N/A	N/A
<b>Asbestos type:</b>	N/A	N/A
<b>Material Assessment Score:</b>		N/A
<b>Priority Assessment Score:</b>		N/A
<b>Action:</b>	N/A	
<b>Comments:</b>	N/A

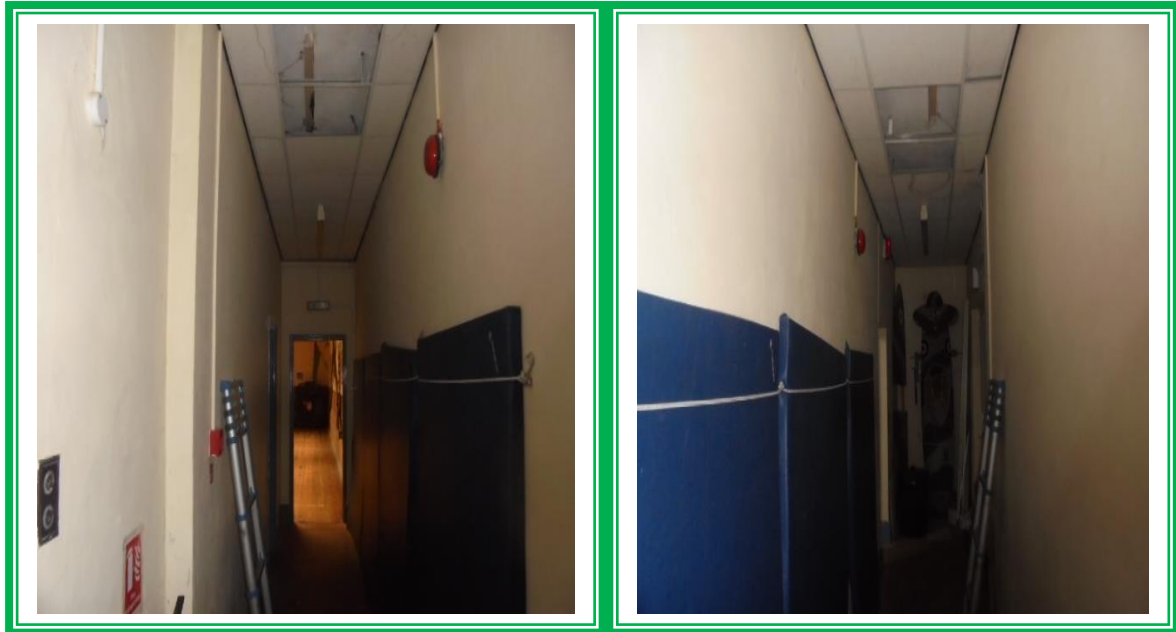
**Item No: 16**

<b>Material Description:</b>	Visual Inspection – No Suspect Materials Found	
<b>Identification:</b>	N/A	
<b>Approx. quantity:</b>	N/A	
<b>Accessibility</b>	N/A	<i>Assessment Score</i>
<b>Product type:</b>	N/A	N/A
<b>Extent of Damage:</b>	N/A	N/A
<b>Surface Treatment:</b>	N/A	N/A
<b>Asbestos type:</b>	N/A	N/A
<b>Material Assessment Score:</b>		N/A
<b>Priority Assessment Score:</b>		N/A
<b>Action:</b>	N/A	
<b>Comments:</b>	N/A

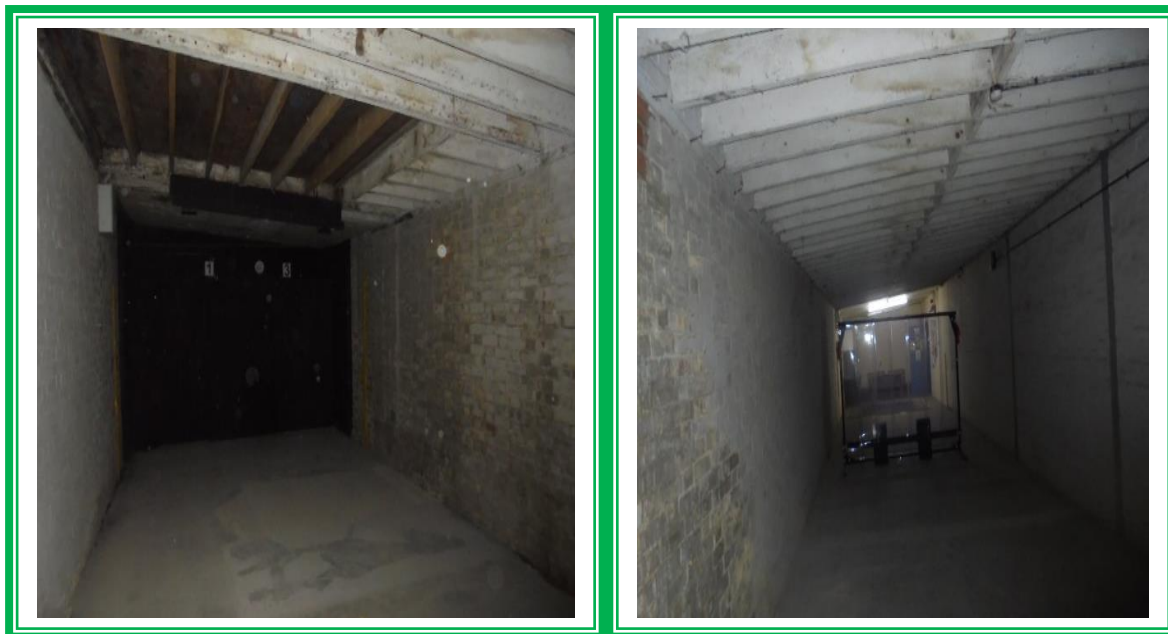
**Item No: 17**

<b>Material Description:</b>	Visual Inspection – No Suspect Materials Found	
<b>Identification:</b>	N/A	
<b>Approx. quantity:</b>	N/A	
<b>Accessibility</b>	N/A	<i>Assessment Score</i>
<b>Product type:</b>	N/A	N/A
<b>Extent of Damage:</b>	N/A	N/A
<b>Surface Treatment:</b>	N/A	N/A
<b>Asbestos type:</b>	N/A	N/A
<b>Material Assessment Score:</b>		N/A
<b>Priority Assessment Score:</b>		N/A
<b>Action:</b>	N/A	
<b>Comments:</b>	N/A
