Project Number 2481

**Management
Asbestos Survey Report**

**Wyvern Barracks, Barrack Road, Exeter, Devon,
EX2 6AE (Building 3)**

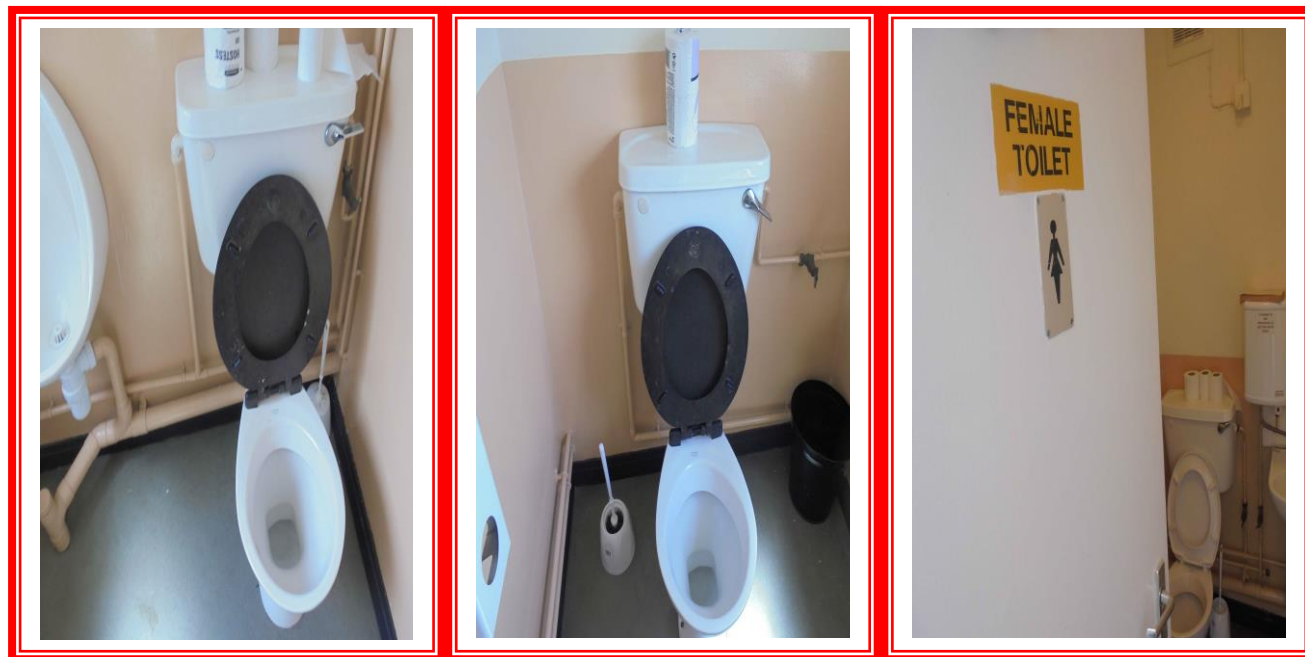
Item No: 7

Location: Male WC's x 2 and Female WC x 1

Material Description:	Reinforced plastic toilet seats	
Identification:	Presumed to Contain Asbestos	
Approx. quantity:	X2	
Accessibility	High	<i>Assessment Score</i>
Product type:	Composite	1
Extent of Damage:	Good	0
Surface Treatment:	Non-Friable	0
Asbestos type:	Chrysotile	1
Material Assessment Score:		2
Priority Assessment Score:		Negligible
Action:	Manage	
Comments:	Located in both male toilets, the seat in the female WC has been replaced. No access to sample as it would damage the integrity of the seats

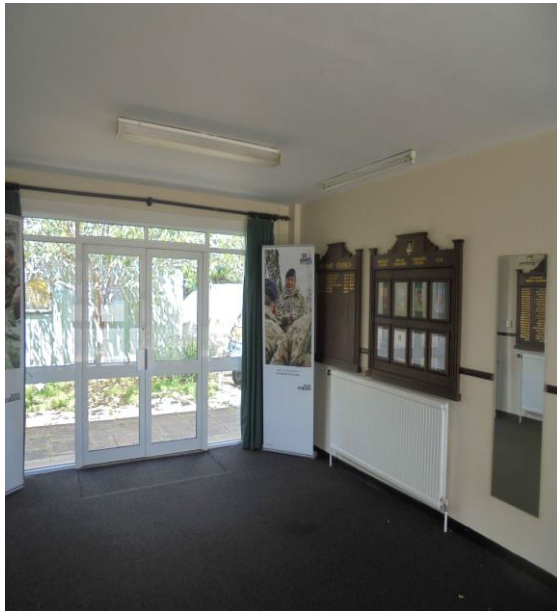
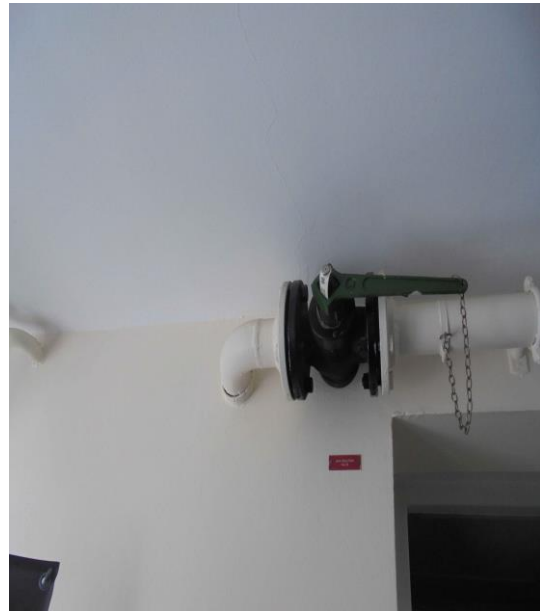
**Item No: 11****Sample No: 1****Location: Lobby – Ground Floor**

Material Description:	Gaskets	
Identification:	Sampled – Asbestos Detected	
Approx. quantity:	X 2	
Accessibility	Low	<i>Assessment Score</i>
Product type:	Textiles	2
Extent of Damage:	Minor	1
Surface Treatment:	Unsealed	1
Asbestos type:	Chrysotile	1
Material Assessment Score:		5
Priority Assessment Score:		Low
Action:	Manage	
Comments:	N/A

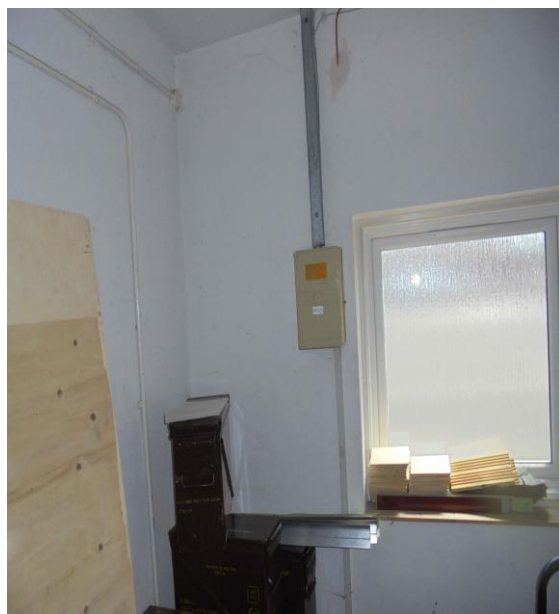
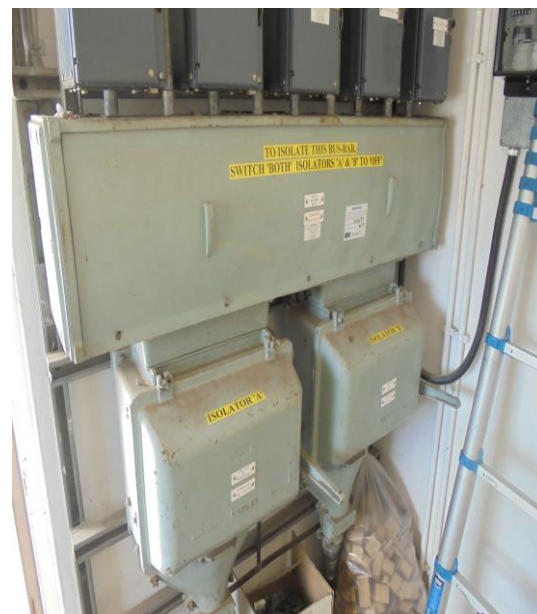
**Item No: 12****Sample No: N/A****Location: Electricity Cupboard**

Material Description:	Flashguards within isolator panels	
Identification:	Presumed to Contain Asbestos	
Approx. quantity:	X 3 Boxes	
Accessibility	Low	<i>Assessment Score</i>
Product type:	No Access	2
Extent of Damage:	No Access	1
Surface Treatment:	No Access	1
Asbestos type:	No Access	1
Material Assessment Score:		5
Priority Assessment Score:		Low
Action:	Manage	
Comments:	No access within panels as live

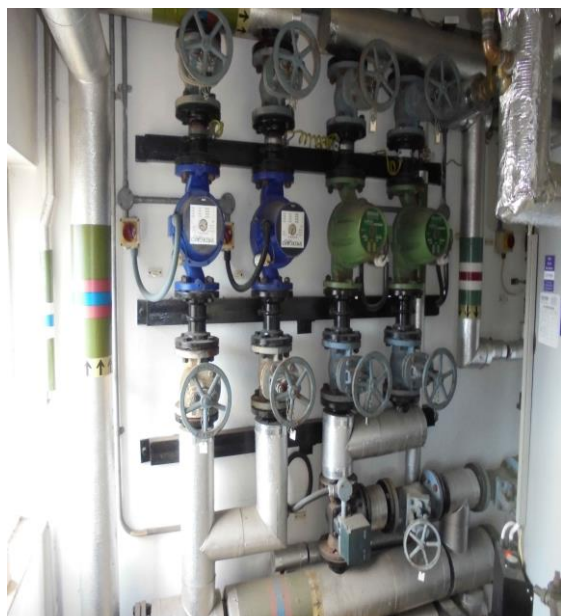
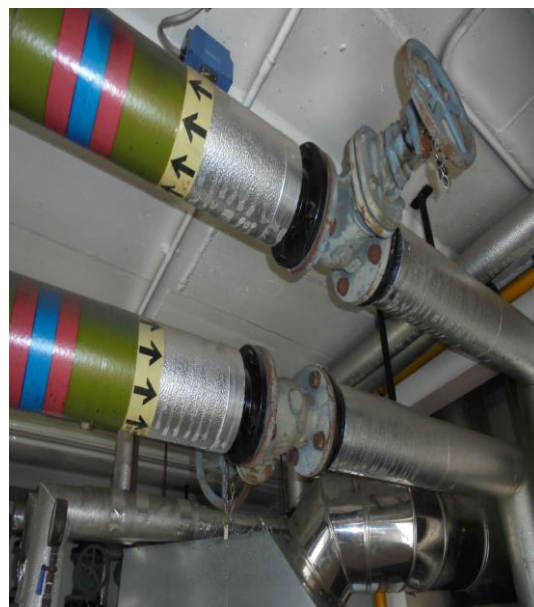
**Item No: 13****Sample No: 2****Location: Boiler Room**

Material Description:	Gaskets	
Identification:	Sampled – Asbestos Detected	
Approx. quantity:	X 50 Gaskets (Approximately)	
Accessibility	Low	Assessment Score
Product type:	Textiles	2
Extent of Damage:	Minor	1
Surface Treatment:	Unsealed	1
Asbestos type:	Chrysotile	1
Material Assessment Score:		5
Priority Assessment Score:		Low
Action:	Manage	
Comments:	Non-asbestos boiler and water heater

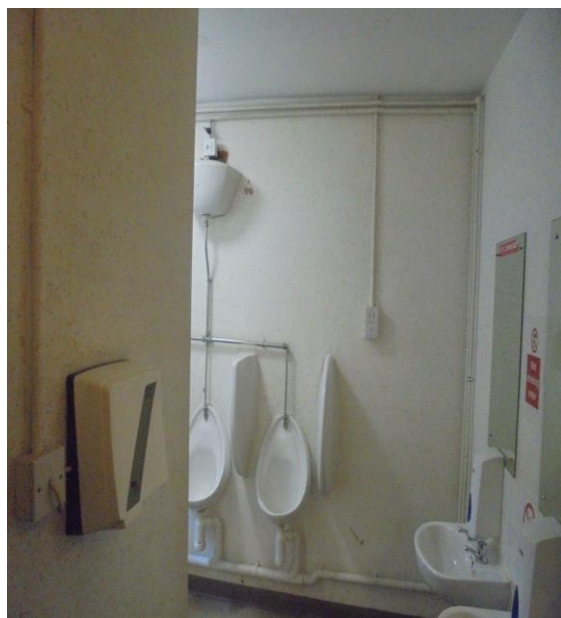
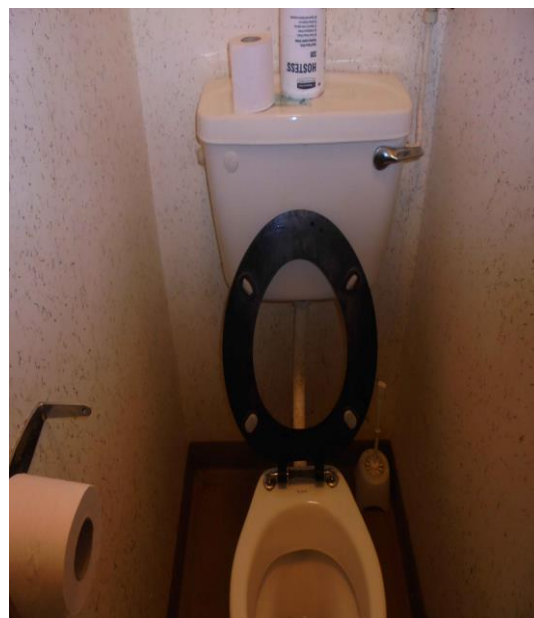
**Item No: 20****Sample No: N/A****Location: Male WC – Ground Floor**

Material Description:	Reinforced plastic toilet seat	
Identification:	Presumed to Contain Asbestos	
Approx. quantity:	X 1 Seat	
Accessibility	High	<i>Assessment Score</i>
Product type:	Composite	1
Extent of Damage:	Good	0
Surface Treatment:	Non-Friable	0
Asbestos type:	Chrysotile	1
Material Assessment Score:		2
Priority Assessment Score:		Negligible
Action:	Manage	
Comments:	Unable to sample as would damage the integrity of the seat

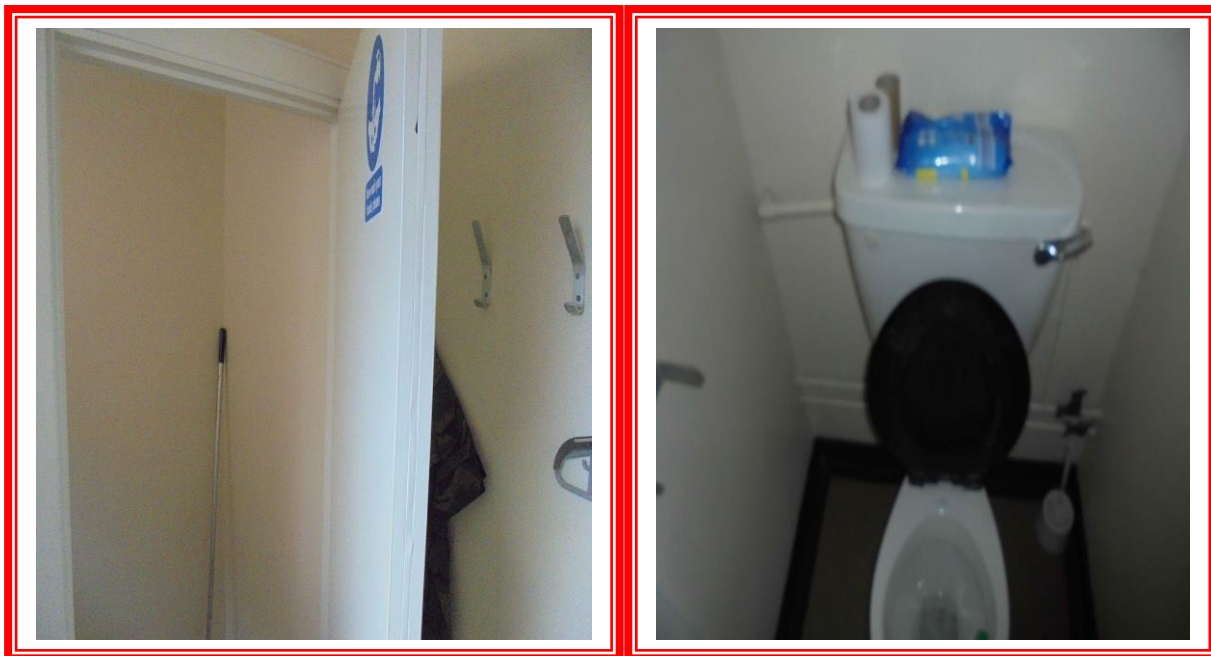
Item No: 24

Location: Kitchen WC – Ground Floor

Material Description:	Reinforced plastic toilet seat	
Identification:	Presumed to Contain Asbestos	
Approx. quantity:	X 1 Seat	
Accessibility	High	<i>Assessment Score</i>
Product type:	Composite	1
Extent of Damage:	Good	0
Surface Treatment:	Non-Friable	0
Asbestos type:	Chrysotile	1
Material Assessment Score:		2
Priority Assessment Score:		Negligible
Action:	Manage	
Comments:	Unable to sample as would damage the integrity of the seat

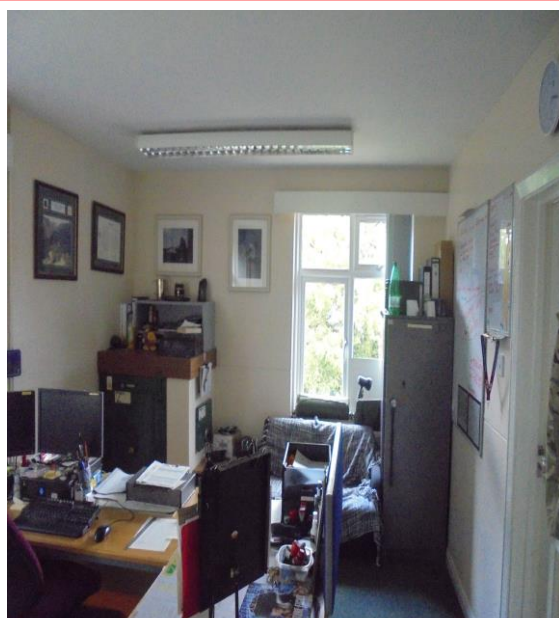
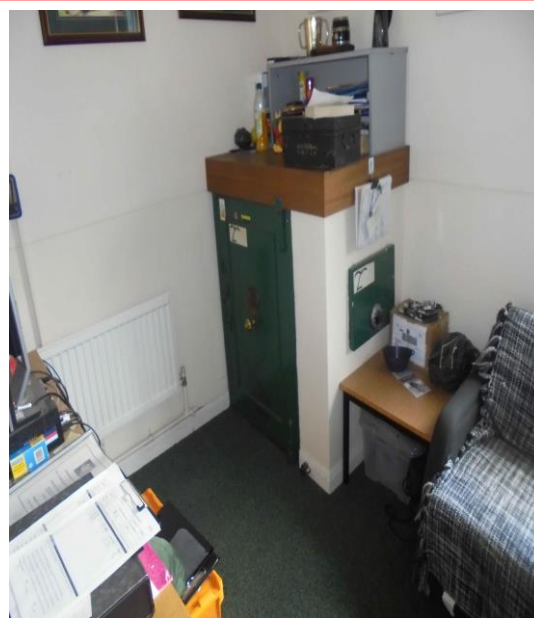
**Item No: 37****Sample No: N/A****Location: Office – First Floor**

Material Description:	No access within safe casings	
Identification:	Presumed to Contain Asbestos	
Approx. quantity:	X 1 Safe	
Accessibility	Low	<i>Assessment Score</i>
Product type:	No Access	2
Extent of Damage:	No Access	2
Surface Treatment:	No Access	2
Asbestos type:	No Access	2
Material Assessment Score:		8
Priority Assessment Score:		Medium
Action:	Manage	
Comments:	No access within safe casings without irreparable damage

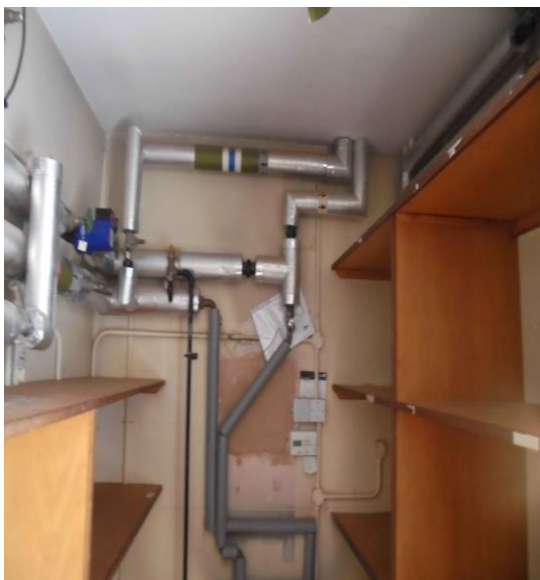
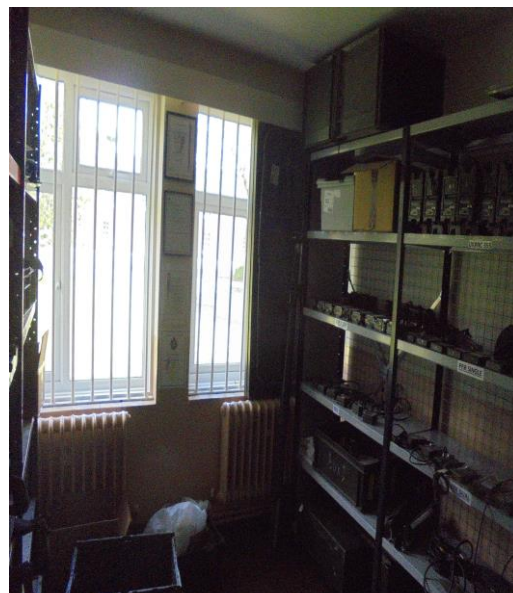
**Item No: 7****Sample No: N/A****Location: Store and Boiler Room**

Material Description:	Visual Inspection – No Suspect Materials Found	
Identification:	N/A	
Approx. quantity:	N/A	
Accessibility	N/A	<i>Assessment Score</i>
Product type:		N/A
Extent of Damage:		N/A
Surface Treatment:		N/A
Asbestos type:		N/A
Material Assessment Score:		N/A
Priority Assessment Score:		N/A
Action:	N/A	
Comments:	Modern Boiler and Pipework

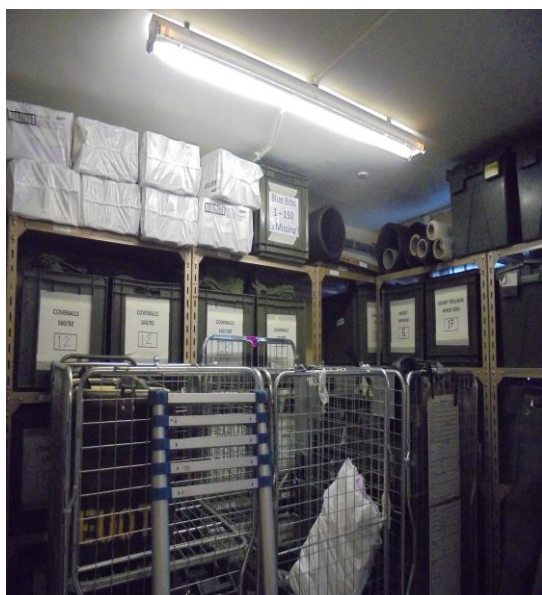
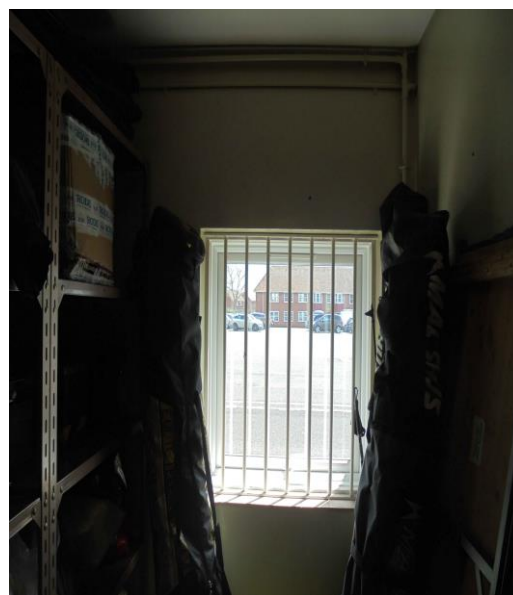
Item No: 8

Location: Stores x 3

Material Description:	Visual Inspection – No Suspect Materials Found	
Identification:	N/A	
Approx. quantity:	N/A	
Accessibility	N/A	<i>Assessment Score</i>
Product type:		N/A
Extent of Damage:		N/A
Surface Treatment:		N/A
Asbestos type:		N/A
Material Assessment Score:		N/A
Priority Assessment Score:		N/A
Action:	N/A	
Comments:	Limited access into stores due to stored items and cabinets

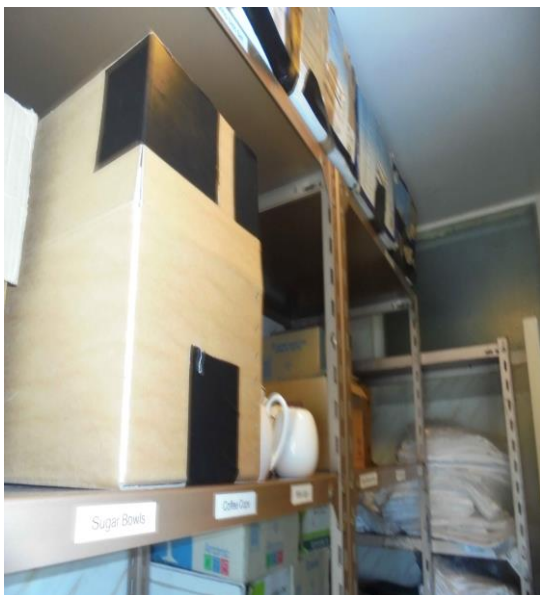
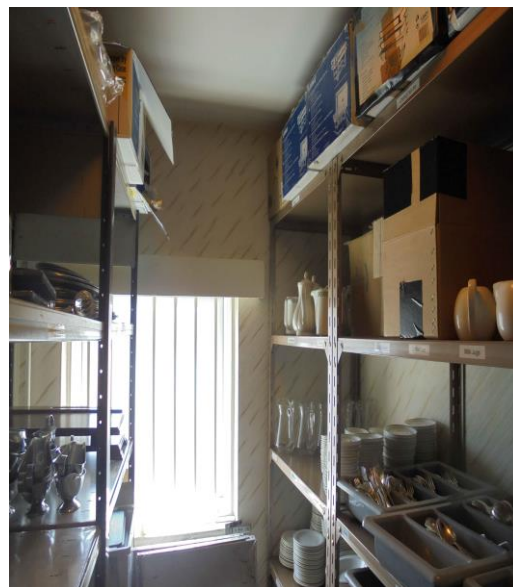
**Item No: 9****Sample No: N/A****Location: Cutlery Store – Ground Floor**

Material Description:	Visual Inspection – No Suspect Materials Found	
Identification:	N/A	
Approx. quantity:	N/A	
Accessibility	N/A	<i>Assessment Score</i>
Product type:		N/A
Extent of Damage:		N/A
Surface Treatment:		N/A
Asbestos type:		N/A
Material Assessment Score:		N/A
Priority Assessment Score:		N/A
Action:	N/A	
Comments:	Non-asbestos lino under carpet

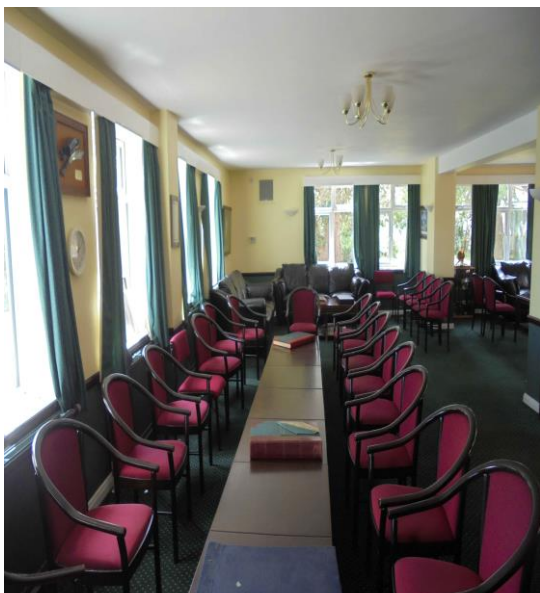
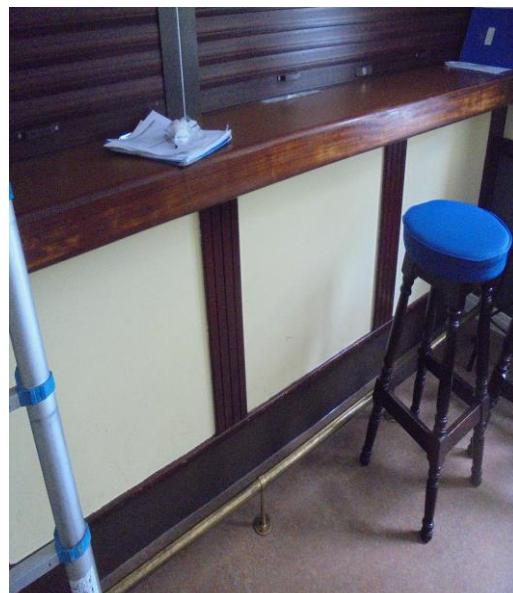
**Item No: 15****Sample No: 3****Location: Messing Room/Bar**

Material Description:	Panels under bar	
Identification:	Sampled – No Asbestos Detected	
Approx. quantity:	3M2	
Accessibility	N/A	<i>Assessment Score</i>
Product type:		N/A
Extent of Damage:		N/A
Surface Treatment:		N/A
Asbestos type:		N/A
Material Assessment Score:		N/A
Priority Assessment Score:		N/A
Action:	N/A	
Comments:	No access under fixed carpet. No access within timber boxings

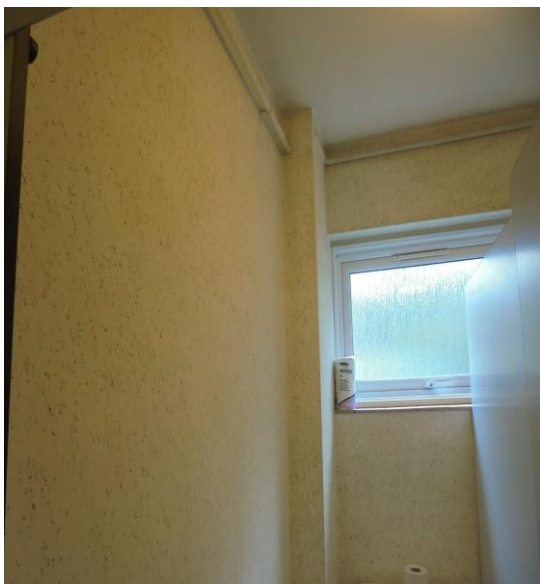
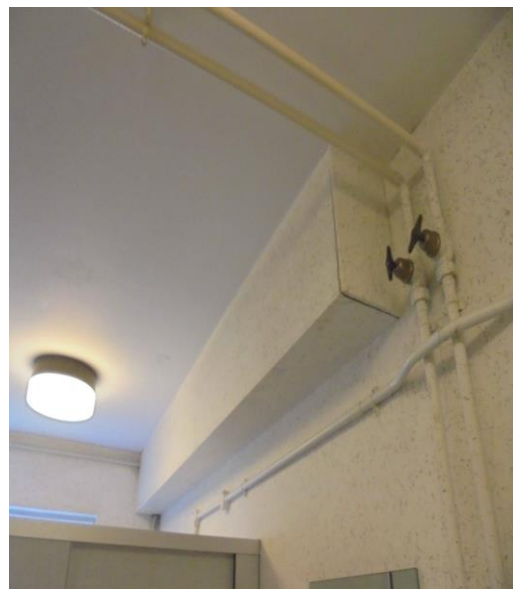
Item No: 19

Location: Female WC – Ground Floor

Material Description:	Insulation board boxing	
Identification:	Sampled – No Asbestos Detected	
Approx. quantity:	6LM	
Accessibility	N/A	<i>Assessment Score</i>
Product type:		N/A
Extent of Damage:		N/A
Surface Treatment:		N/A
Asbestos type:		N/A
Material Assessment Score:		N/A
Priority Assessment Score:		N/A
Action:	N/A	
Comments:	No access within boxing

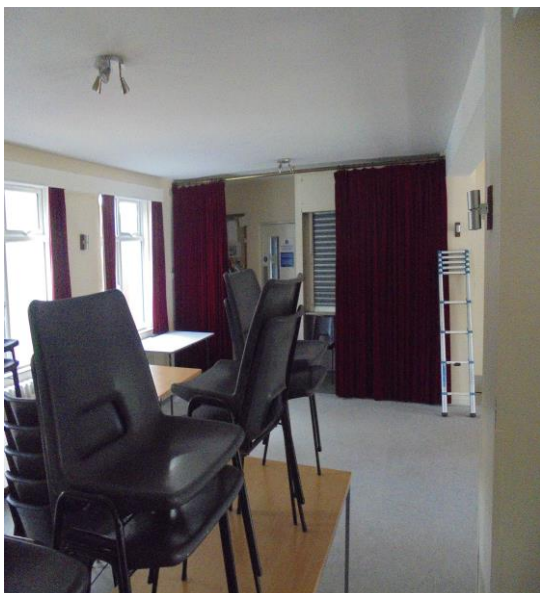
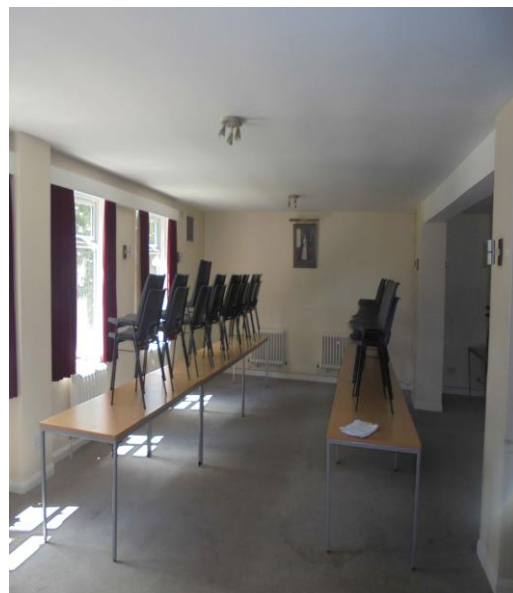
**Item No: 22****Sample No: N/A****Location: Dining Room – Ground Floor**

Material Description:	Visual Inspection – No Suspect Materials Found	
Identification:	N/A	
Approx. quantity:	N/A	
Accessibility	N/A	<i>Assessment Score</i>
Product type:		N/A
Extent of Damage:		N/A
Surface Treatment:		N/A
Asbestos type:		N/A
Material Assessment Score:		N/A
Priority Assessment Score:		N/A
Action:	N/A	
Comments:	No access within plasterboard or timber boxing. No access under the fixed carpet

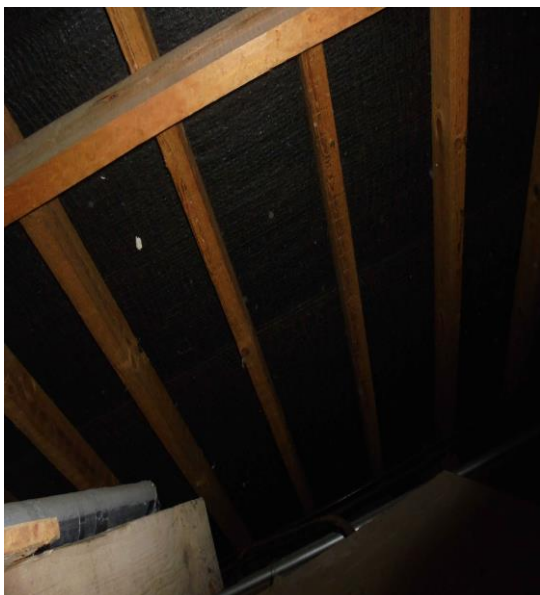
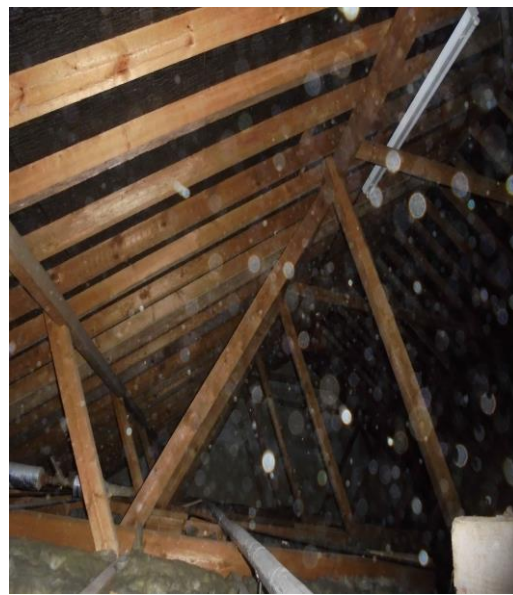
Item No: 27

Location: Loft Space

Material Description:	Visual Inspection – No Suspect Materials Found	
Identification:	N/A	
Approx. quantity:	N/A	
Accessibility	N/A	<i>Assessment Score</i>
Product type:		N/A
Extent of Damage:		N/A
Surface Treatment:		N/A
Asbestos type:		N/A
Material Assessment Score:		N/A
Priority Assessment Score:		N/A
Action:	N/A	
Comments:	Limited access within loft space as no crawl boards were available

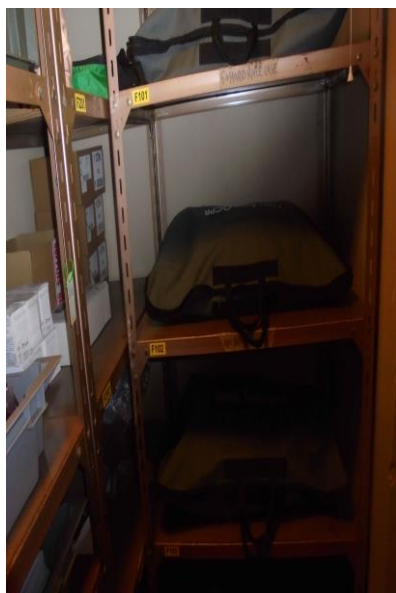
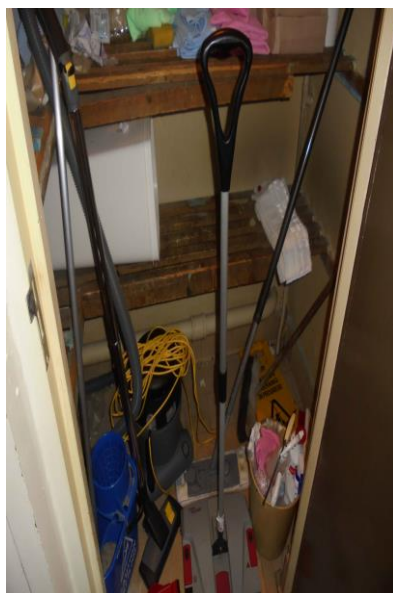
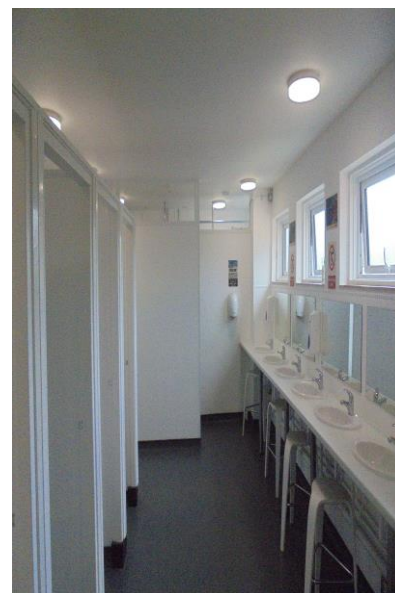
Item No: 29

Location: Cupboard, Drying Room and Female Changing Rooms – First Floor

Material Description:	Visual Inspection – No Suspect Materials Found	
Identification:	N/A	
Approx. quantity:	N/A	
Accessibility	N/A	<i>Assessment Score</i>
Product type:		N/A
Extent of Damage:		N/A
Surface Treatment:		N/A
Asbestos type:		N/A
Material Assessment Score:		N/A
Priority Assessment Score:		N/A
Action:	N/A	
Comments:	No access within boxings in changing room

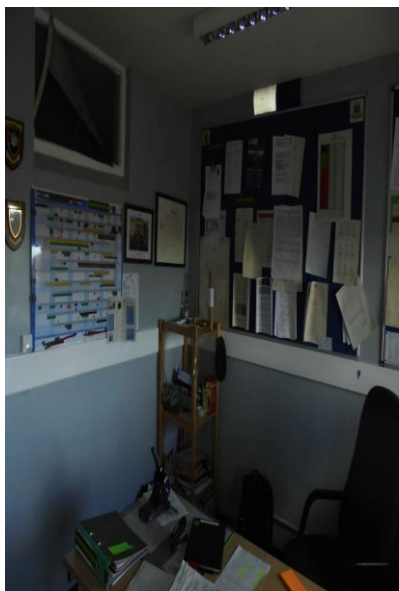
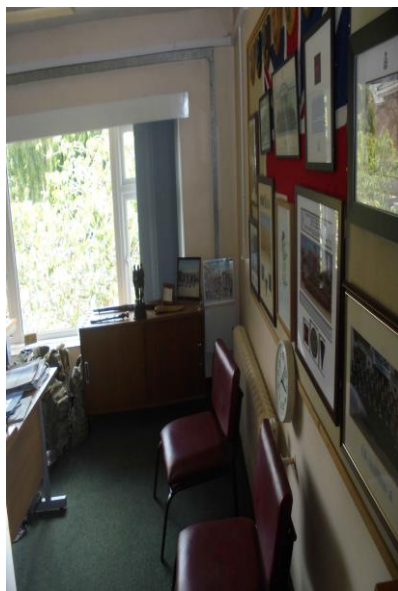
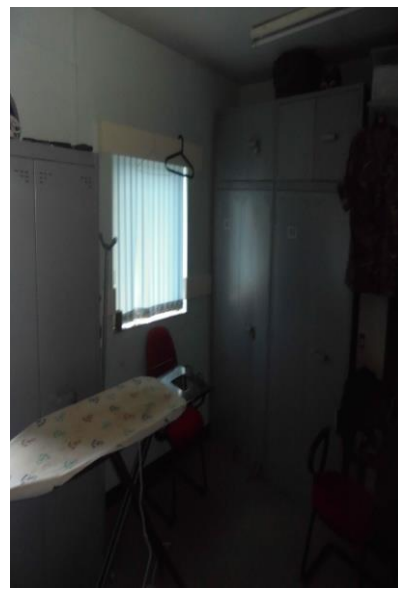
Item No: 32

Location: Offices x 2 and Locker room

Material Description:	Visual Inspection – No Suspect Materials Found	
Identification:	N/A	
Approx. quantity:	N/A	
Accessibility	N/A	<i>Assessment Score</i>
Product type:		N/A
Extent of Damage:		N/A
Surface Treatment:		N/A
Asbestos type:		N/A
Material Assessment Score:		N/A
Priority Assessment Score:		N/A
Action:	N/A	
Comments:	No access within locked cupboards in changing rooms

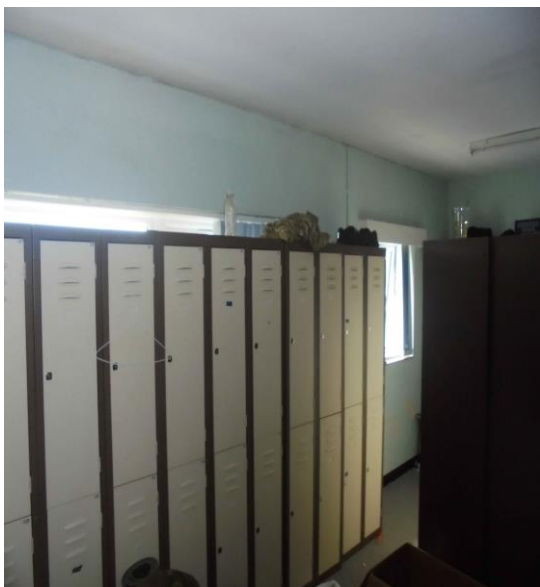
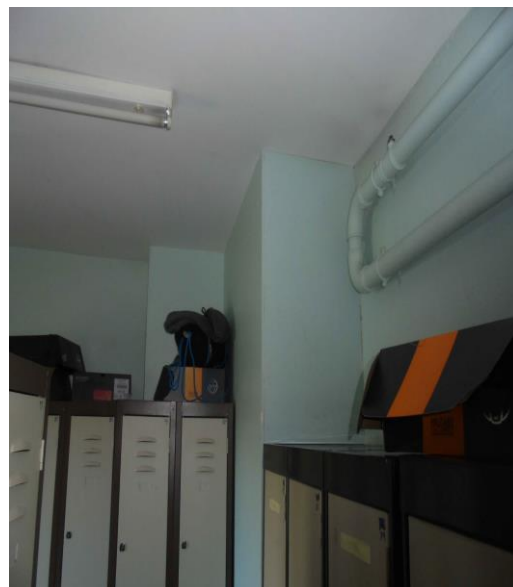
**Item No: 33****Sample No: N/A****Location: Locker Room – First Floor**

Material Description:	Insulation Board Boxing	
Identification:	As Per Sample 4 – No Asbestos Detected	
Approx. quantity:	8M2	
Accessibility	N/A	<i>Assessment Score</i>
Product type:		N/A
Extent of Damage:		N/A
Surface Treatment:		N/A
Asbestos type:		N/A
Material Assessment Score:		N/A
Priority Assessment Score:		N/A
Action:	N/A	
Comments:	N/A

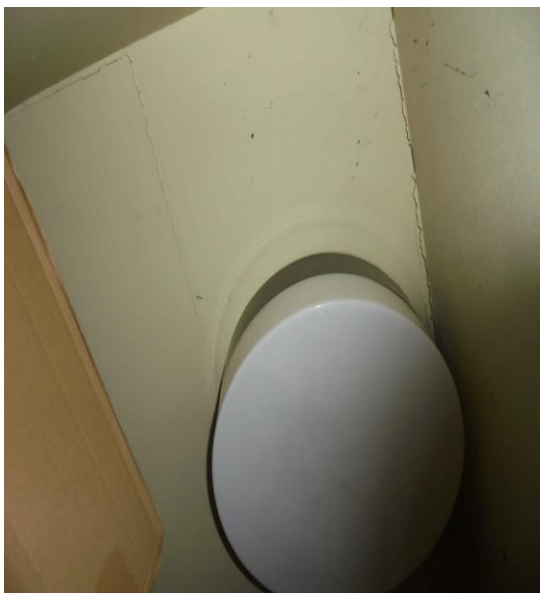
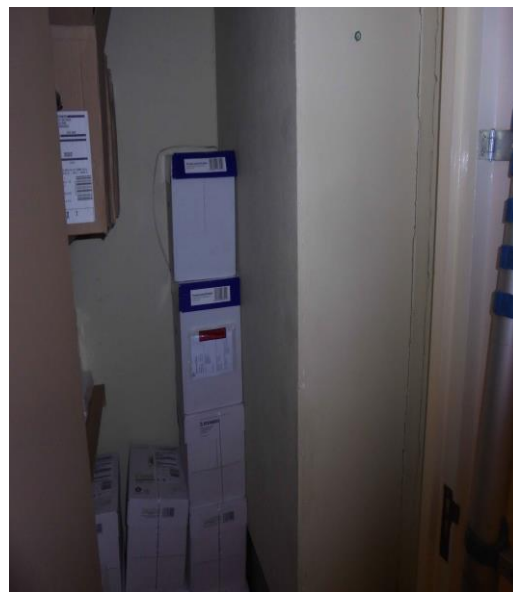
**Item No: 38****Sample No: N/A****Location: Electrical Cupboard**

Material Description:	Insulation board boxing and ceiling	
Identification:	As Per Sample 4 – No Asbestos Detected	
Approx. quantity:	5M2	
Accessibility	N/A	<i>Assessment Score</i>
Product type:		N/A
Extent of Damage:		N/A
Surface Treatment:		N/A
Asbestos type:		N/A
Material Assessment Score:		N/A
Priority Assessment Score:		N/A
Action:	N/A	
Comments:	N/A

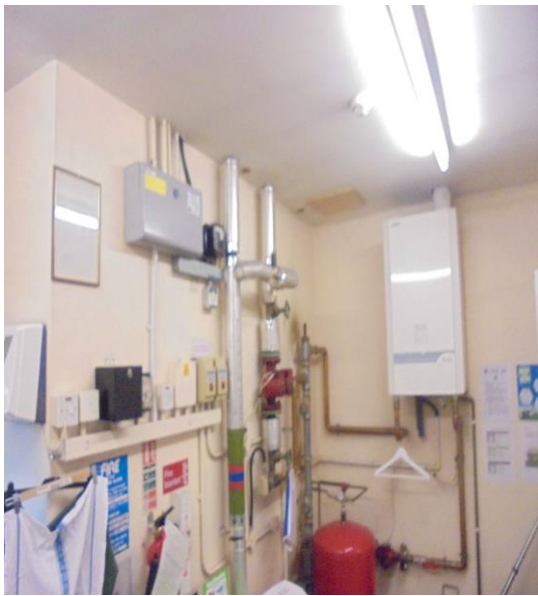
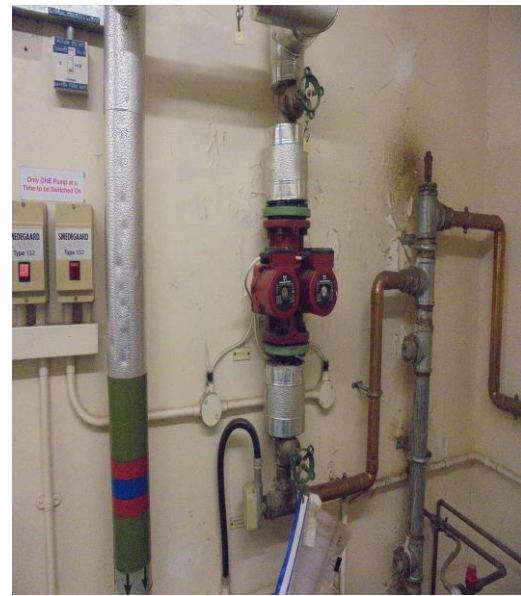
Material Description:	Gaskets	
Identification:	Sampled – No Asbestos Detected	
Approx. quantity:	X 2	
Accessibility	N/A	<i>Assessment Score</i>
Product type:		N/A
Extent of Damage:		N/A
Surface Treatment:		N/A
Asbestos type:		N/A
Material Assessment Score:		N/A
Priority Assessment Score:		N/A
Action:	N/A	
Comments:	Modern Imax boiler and Pipework
