**Project Number 2481**

**Management  
Asbestos Survey Report**

**Royal Wessex Yeomanry, Salisbury, SP4 6BY**

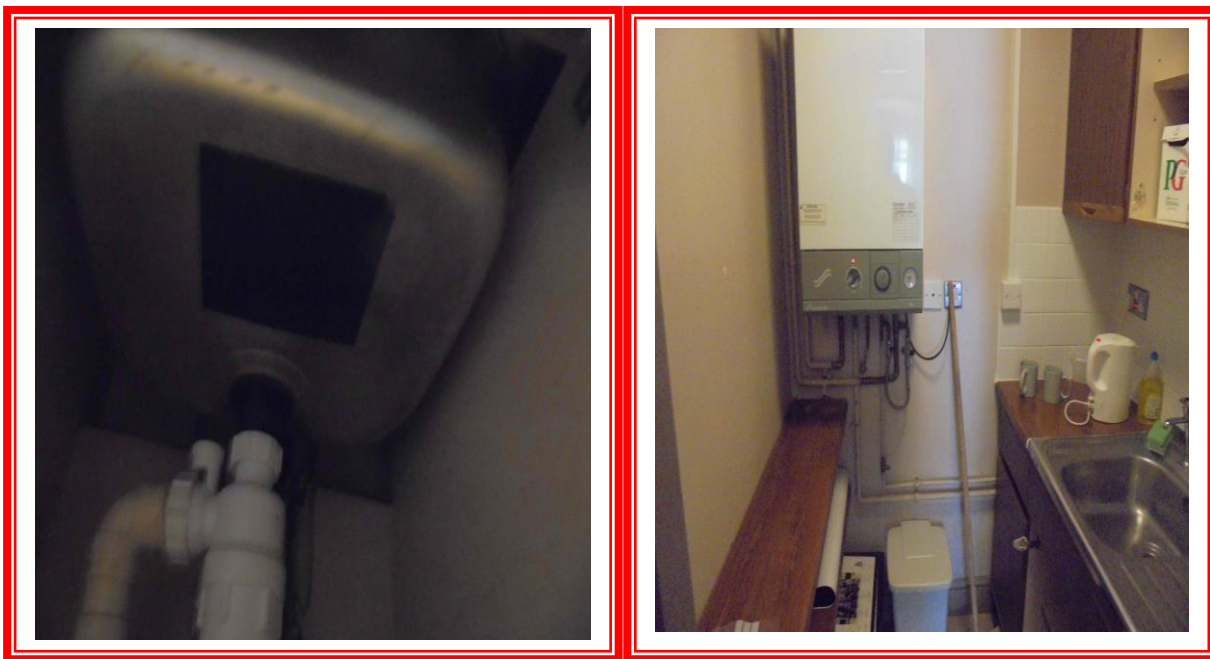
**Location: Kitchen - Recruit reception centre**

<b>Material Description:</b>	Sink Pad	
<b>Identification:</b>	Sampled – Asbestos Detected	
<b>Approx. quantity:</b>	1 x Sink	
<b>Accessibility</b>	Low	<i>Assessment Score</i>
<b>Product type:</b>	Bitumen	1
<b>Extent of Damage:</b>	Minor	1
<b>Surface Treatment:</b>	Non-friable	0
<b>Asbestos type:</b>	Chrysotile	1
<b>Material Assessment Score:</b>		3
<b>Priority Assessment Score:</b>		Negligible
<b>Action:</b>	Manage	
<b>Comments:</b>	Modern Worcester boiler

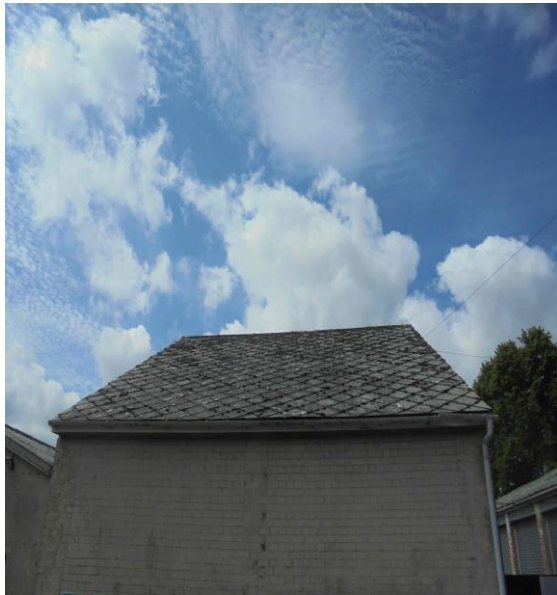
<b>Material Description:</b>	Cement roof tiles	
<b>Identification:</b>	Sampled – Asbestos Detected	
<b>Approx. quantity:</b>	55M2	
<b>Accessibility</b>	Low	Assessment Score
<b>Product type:</b>	Cement	1
<b>Extent of Damage:</b>	Minor	1
<b>Surface Treatment:</b>	Unsealed cement	1
<b>Asbestos type:</b>	Chrysotile	1
<b>Material Assessment Score:</b>		4
<b>Priority Assessment Score:</b>		Negligible
<b>Action:</b>	Manage	
<b>Comments:</b>	N/A

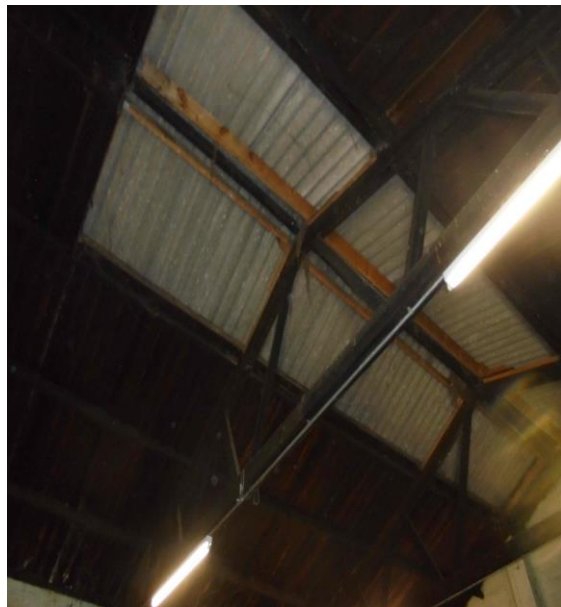
<b>Material Description:</b>	Profiled cement roof	
<b>Identification:</b>	Presumed to Contain Asbestos	
<b>Approx. quantity:</b>	400M2 -entire roof (Garages 1-11)	
<b>Accessibility</b>	Low	<i>Assessment Score</i>
<b>Product type:</b>	Cement	1
<b>Extent of Damage:</b>	Minor	1
<b>Surface Treatment:</b>	Unsealed cement	1
<b>Asbestos type:</b>	Chrysotile	1
<b>Material Assessment Score:</b>		4
<b>Priority Assessment Score:</b>		Negligible
<b>Action:</b>	Manage	
<b>Comments:</b>	No safe access to sample due to height of roof

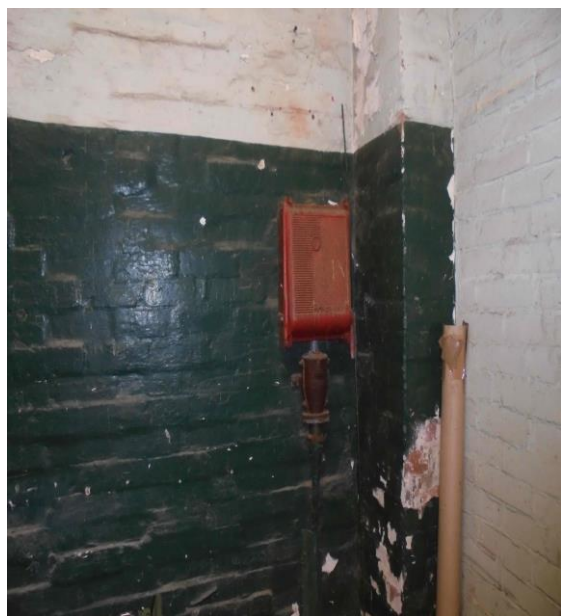
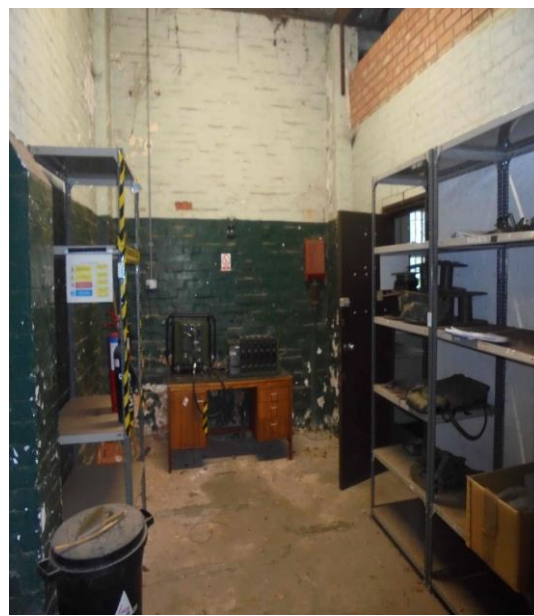
<b>Material Description:</b>	Flashguards within electrical box	
<b>Identification:</b>	Presumed to Contain Asbestos	
<b>Approx. quantity:</b>	1 X box	
<b>Accessibility</b>	Low	<i>Assessment Score</i>
<b>Product type:</b>	No Access	2
<b>Extent of Damage:</b>	No Access	1
<b>Surface Treatment:</b>	No Access	1
<b>Asbestos type:</b>	No Access	1
<b>Material Assessment Score:</b>		5
<b>Priority Assessment Score:</b>		Low
<b>Action:</b>	Manage	
<b>Comments:</b>	N/A

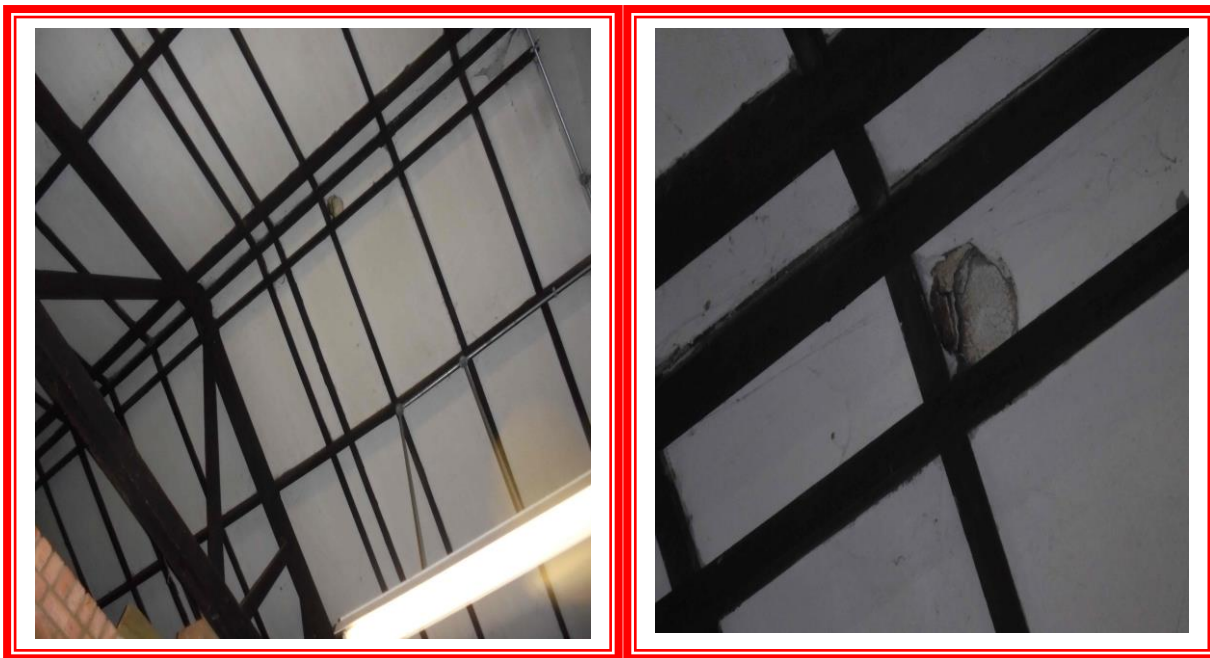
<b>Material Description:</b>	Flat sheet cement ceiling panels	
<b>Identification:</b>	Sampled from previous survey- REF: SWAO2665/1/MO4 item 6	
<b>Approx. quantity:</b>	50M2	
<b>Accessibility</b>	Low	<i>Assessment Score</i>
<b>Product type:</b>	Cement	1
<b>Extent of Damage:</b>	Moderate	2
<b>Surface Treatment:</b>	Unsealed cement	1
<b>Asbestos type:</b>	Chrysotile	1
<b>Material Assessment Score:</b>		5
<b>Priority Assessment Score:</b>		Low
<b>Action:</b>	Manage repair	
<b>Comments:</b>	Various areas of damage. No access to sample due to height.

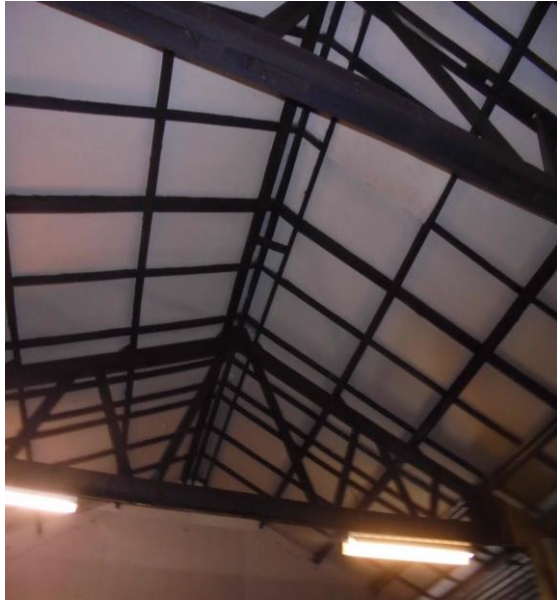
<b>Material Description:</b>	Flat sheet cement ceiling panels	
<b>Identification:</b>	Sampled on previous survey- REF: SWAO2665/1/MO4 item 6	
<b>Approx. quantity:</b>	120M2	
<b>Accessibility</b>	Low	<i>Assessment Score</i>
<b>Product type:</b>	Cement	1
<b>Extent of Damage:</b>	Minor	1
<b>Surface Treatment:</b>	Unsealed cement	1
<b>Asbestos type:</b>	Chrysotile	1
<b>Material Assessment Score:</b>		4
<b>Priority Assessment Score:</b>		Negligible
<b>Action:</b>	Manage	
<b>Comments:</b>	No access to sample due to height

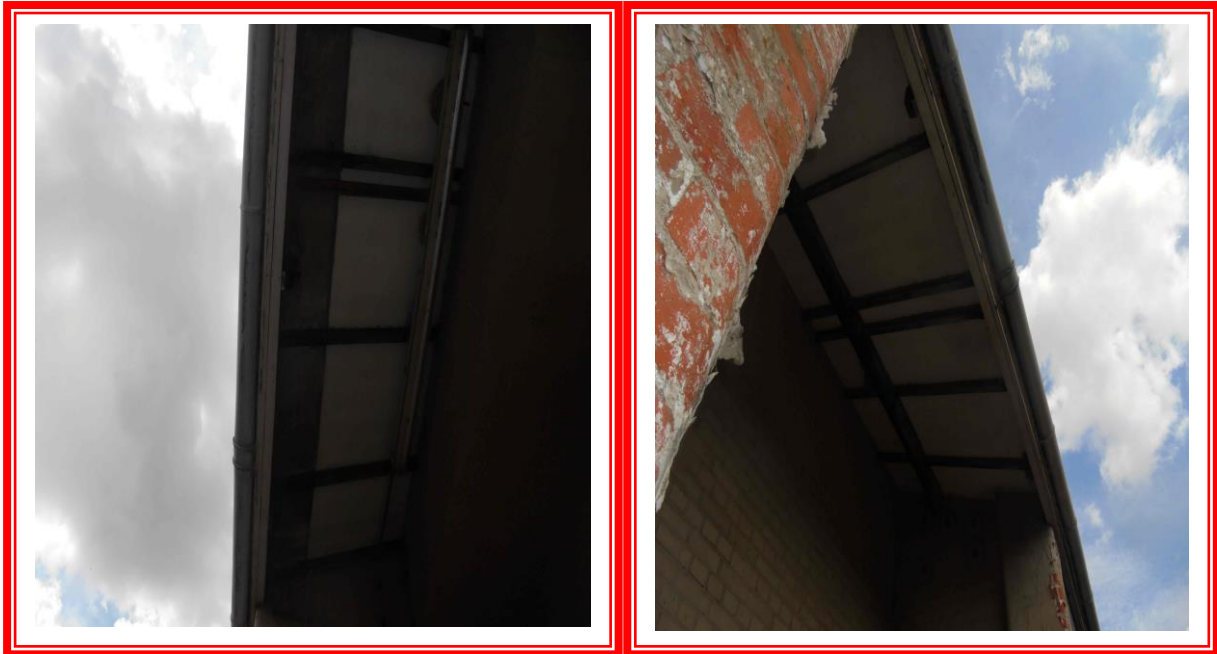
<b>Material Description:</b>	Flat sheet cement ceiling panels	
<b>Identification:</b>	Sampled on previous survey REF: SWA02665/1/MO4 item 6	
<b>Approx. quantity:</b>	10M2	
<b>Accessibility</b>	Low	<i>Assessment Score</i>
<b>Product type:</b>	Cement	1
<b>Extent of Damage:</b>	Minor	1
<b>Surface Treatment:</b>	Unsealed cement	1
<b>Asbestos type:</b>	Chrysotile	1
<b>Material Assessment Score:</b>		4
<b>Priority Assessment Score:</b>		Negligible
<b>Action:</b>	Manage	
<b>Comments:</b>	N/A

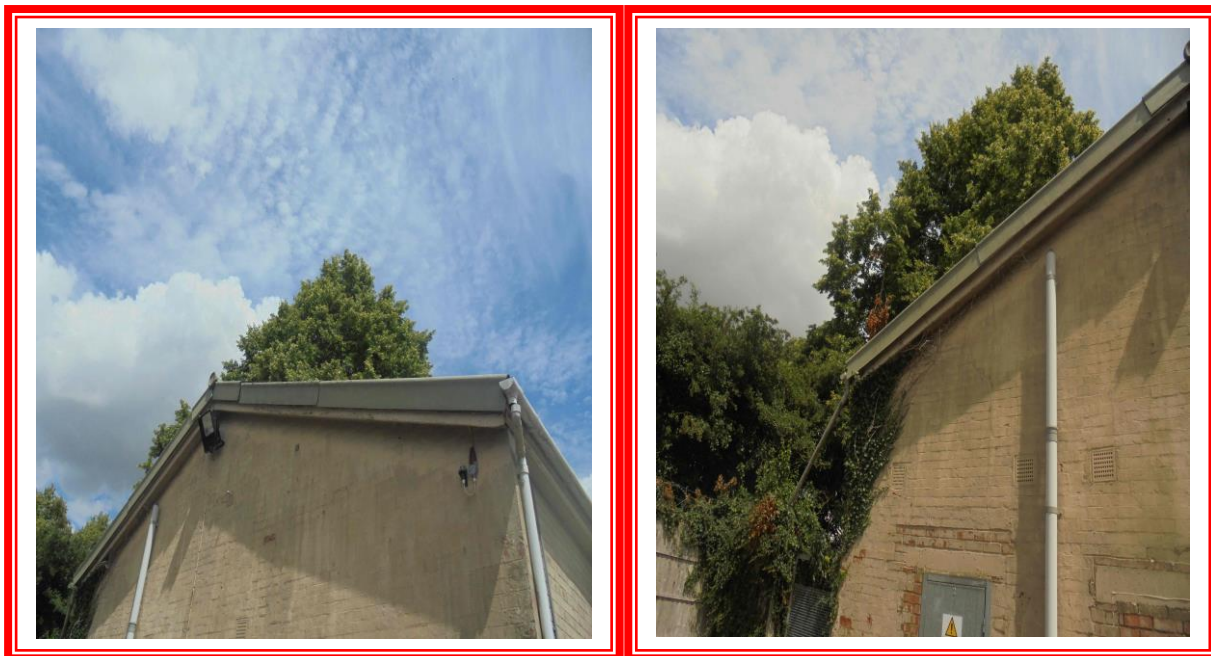
<b>Material Description:</b>	Cement roof edging	
<b>Identification:</b>	Sampled – Asbestos Detected	
<b>Approx. quantity:</b>	20LM	
<b>Accessibility</b>	Low	<i>Assessment Score</i>
<b>Product type:</b>	Cement	1
<b>Extent of Damage:</b>	Minor	1
<b>Surface Treatment:</b>	Unsealed	1
<b>Asbestos type:</b>	chrysotile	1
<b>Material Assessment Score:</b>		4
<b>Priority Assessment Score:</b>		Negligible
<b>Action:</b>	Manage	
<b>Comments:</b>	Located at both ends of building

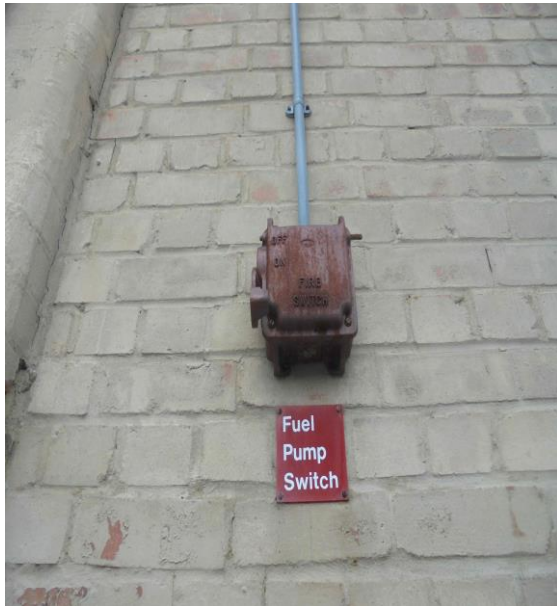
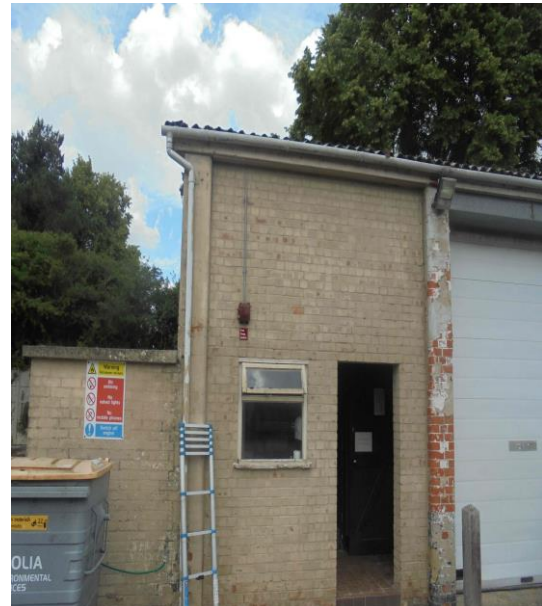
<b>Material Description:</b>	No access within electrical panel	
<b>Identification:</b>	Presumed to Contain Asbestos	
<b>Approx. quantity:</b>	1 X Box	
<b>Accessibility</b>	Low	<i>Assessment Score</i>
<b>Product type:</b>	No Access	2
<b>Extent of Damage:</b>	No Access	1
<b>Surface Treatment:</b>	No Access	1
<b>Asbestos type:</b>	No Access	1
<b>Material Assessment Score:</b>		5
<b>Priority Assessment Score:</b>		Low
<b>Action:</b>	Manage	
<b>Comments:</b>	No access as live

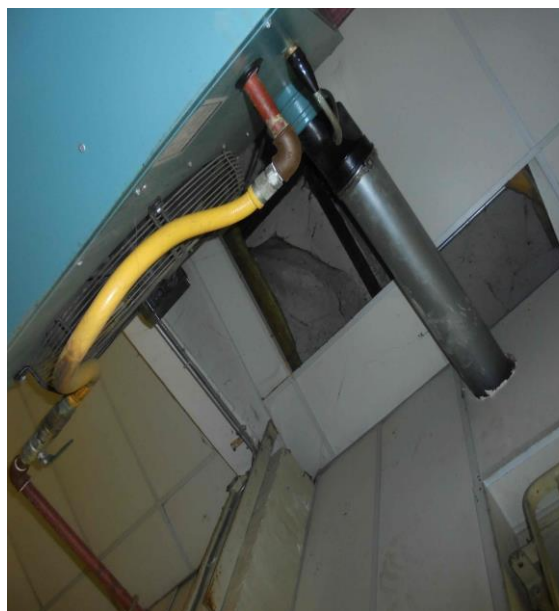
<b>Material Description:</b>	Flat sheet cement ceiling panels	
<b>Identification:</b>	Sampled in previous survey REF- SWAO2665/1/MO4 item 6	
<b>Approx. quantity:</b>	120M2	
<b>Accessibility</b>	Low	<i>Assessment Score</i>
<b>Product type:</b>	Cement	1
<b>Extent of Damage:</b>	Minor	1
<b>Surface Treatment:</b>	Unsealed cement	1
<b>Asbestos type:</b>	Chrysotile	1
<b>Material Assessment Score:</b>		4
<b>Priority Assessment Score:</b>		Negligible
<b>Action:</b>	Manage	
<b>Comments:</b>	Located above plastered ceiling panels and above plasterboard ceilings to stores.

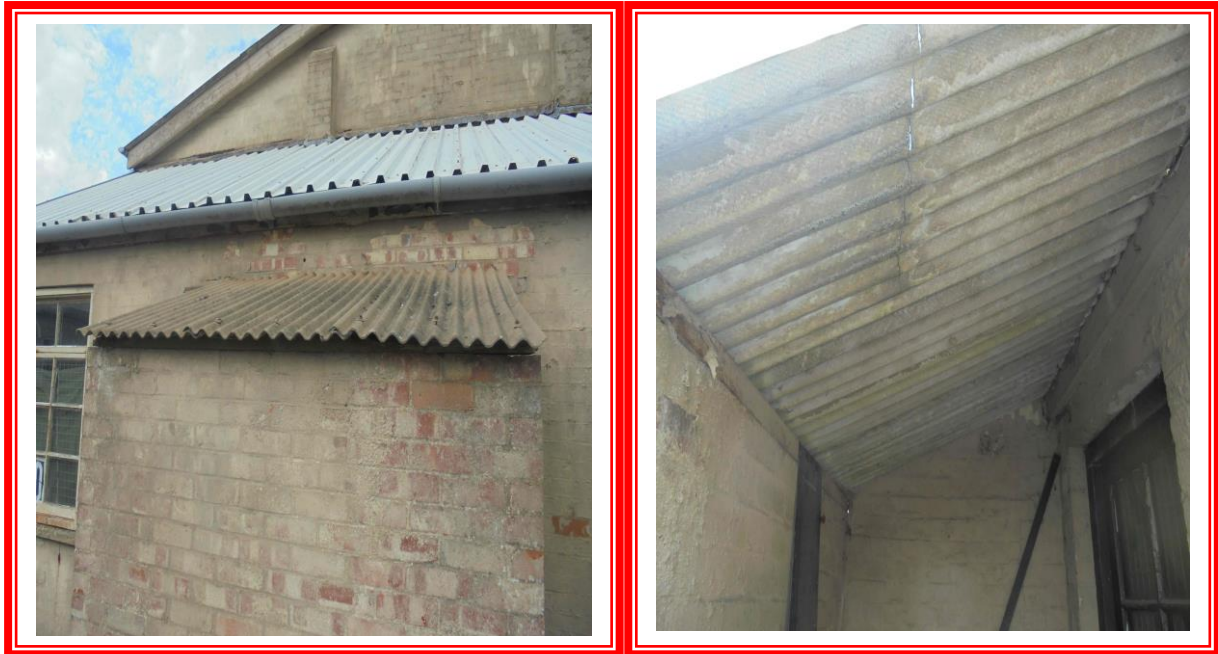
<b>Material Description:</b>	Profiled cement roof	
<b>Identification:</b>	Sampled – Asbestos Detected	
<b>Approx. quantity:</b>	4M2	
<b>Accessibility</b>	Low	<i>Assessment Score</i>
<b>Product type:</b>	Cement	1
<b>Extent of Damage:</b>	Minor	1
<b>Surface Treatment:</b>	Unsealed cement	1
<b>Asbestos type:</b>	Chrysotile	1
<b>Material Assessment Score:</b>		4
<b>Priority Assessment Score:</b>		Negligible
<b>Action:</b>	Manage	
<b>Comments:</b>	N/A

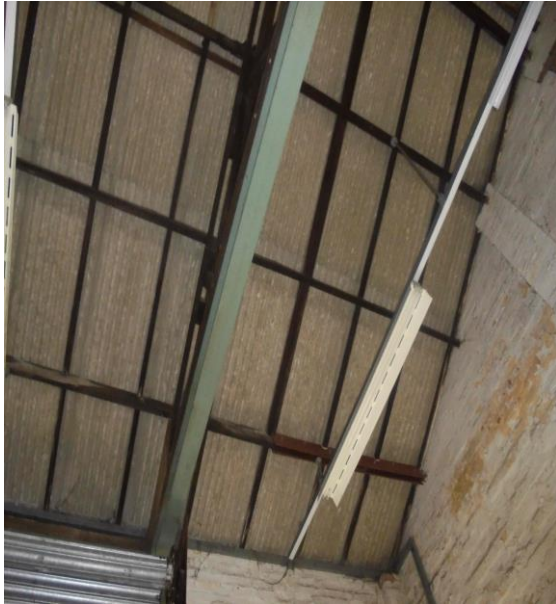
<b>Material Description:</b>	Profiled cement roof	
<b>Identification:</b>	As sample 5 – Asbestos Detected	
<b>Approx. quantity:</b>	150M2	
<b>Accessibility</b>	Low	<i>Assessment Score</i>
<b>Product type:</b>	Cement	1
<b>Extent of Damage:</b>	Minor	1
<b>Surface Treatment:</b>	Unsealed cement	1
<b>Asbestos type:</b>	chrysotile	1
<b>Material Assessment Score:</b>		4
<b>Priority Assessment Score:</b>		Negligible
<b>Action:</b>	Manage	
<b>Comments:</b>	N/A

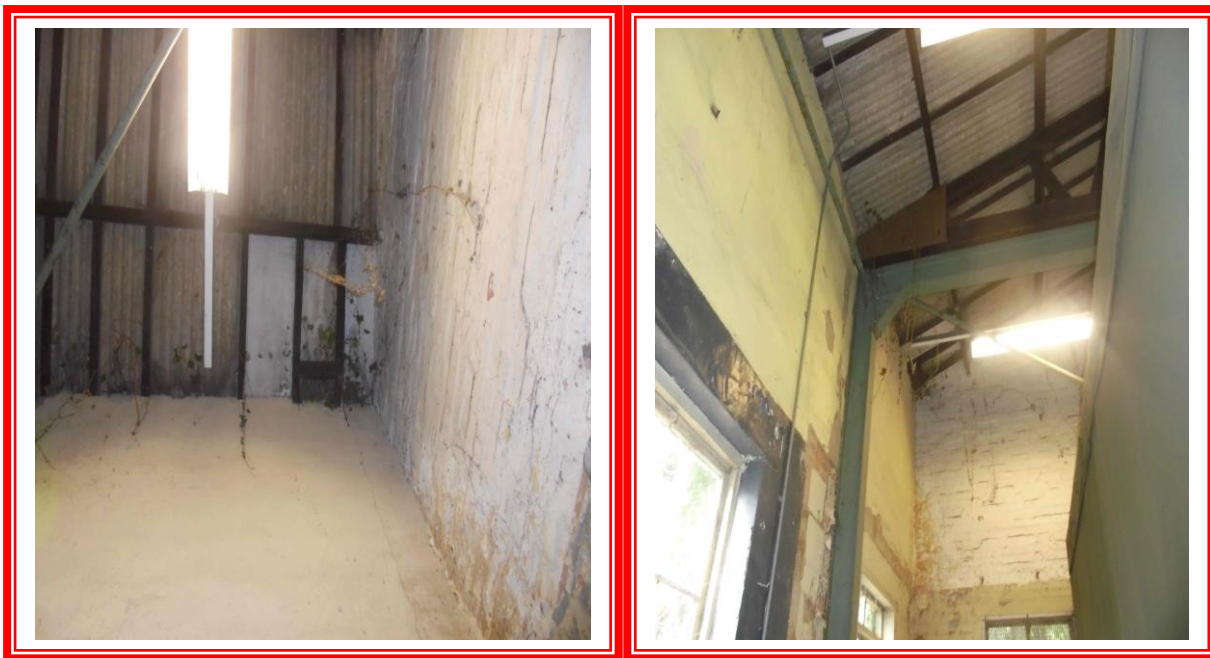
<b>Material Description:</b>	Flat sheet cement panels to ceiling	
<b>Identification:</b>	Presumed to Contain Asbestos	
<b>Approx. quantity:</b>	2M2	
<b>Accessibility</b>	Low	<i>Assessment Score</i>
<b>Product type:</b>	Cement	1
<b>Extent of Damage:</b>	Minor	1
<b>Surface Treatment:</b>	Unsealed cement	1
<b>Asbestos type:</b>	Chrysotile	1
<b>Material Assessment Score:</b>		4
<b>Priority Assessment Score:</b>		Negligible
<b>Action:</b>	Manage	
<b>Comments:</b>	No access to sample due to height

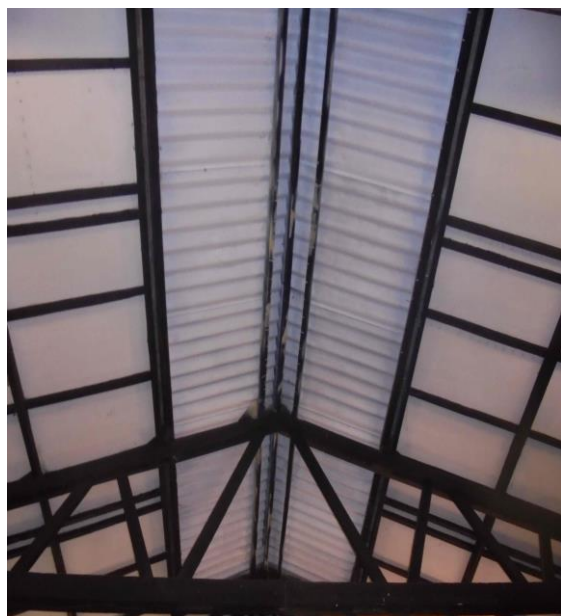
<b>Material Description:</b>	Profiled cement roof	
<b>Identification:</b>	Previously sampled-REF-SWA02665/1/4 item 5	
<b>Approx. quantity:</b>	400M2 - entire roof	
<b>Accessibility</b>	Low	<i>Assessment Score</i>
<b>Product type:</b>	Cement	1
<b>Extent of Damage:</b>	Minor	1
<b>Surface Treatment:</b>	Unsealed cement	1
<b>Asbestos type:</b>	chrysotile	1
<b>Material Assessment Score:</b>		4
<b>Priority Assessment Score:</b>		Negligible
<b>Action:</b>	Manage	
<b>Comments:</b>	N/A

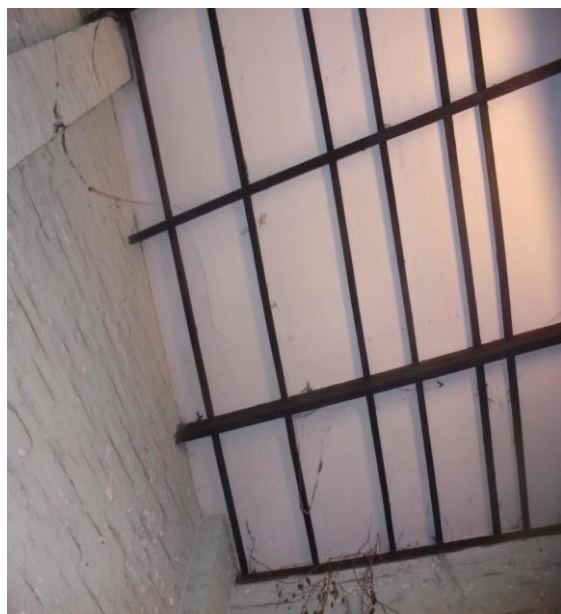
<b>Material Description:</b>	Flat sheet cement ceiling panels	
<b>Identification:</b>	Presumed to Contain Asbestos	
<b>Approx. quantity:</b>	400M2	
<b>Accessibility</b>	Low	<i>Assessment Score</i>
<b>Product type:</b>	Cement	1
<b>Extent of Damage:</b>	Moderate	2
<b>Surface Treatment:</b>	Unsealed cement	1
<b>Asbestos type:</b>	Chrysotile	1
<b>Material Assessment Score:</b>		5
<b>Priority Assessment Score:</b>		Low
<b>Action:</b>	Manage/Encapsulate	
<b>Comments:</b>	No access to sample due to height. Several areas of damage

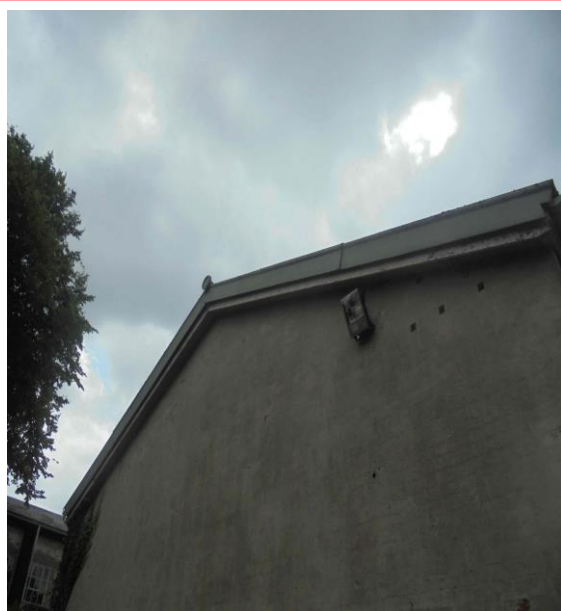
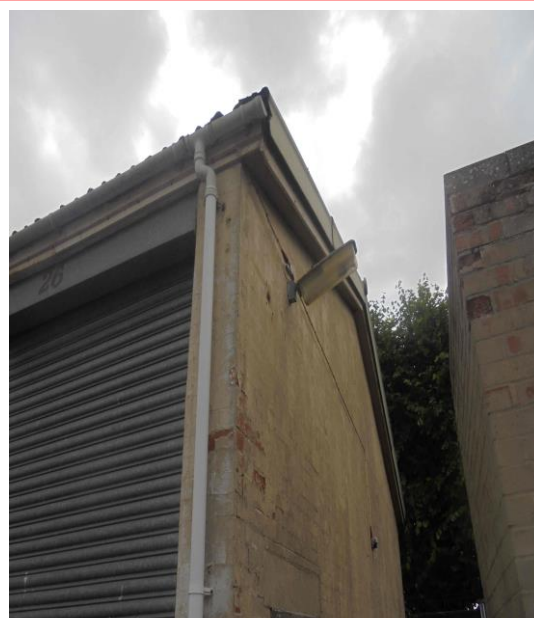
<b>Material Description:</b>	Cement roof edging	
<b>Identification:</b>	Previously sampled -REF: SWAO2665/1/3 item 4	
<b>Approx. quantity:</b>	20LM	
<b>Accessibility</b>	Low	<i>Assessment Score</i>
<b>Product type:</b>	Cement	1
<b>Extent of Damage:</b>	Minor	1
<b>Surface Treatment:</b>	Unsealed cement	1
<b>Asbestos type:</b>	chrysotile	1
<b>Material Assessment Score:</b>		4
<b>Priority Assessment Score:</b>		Negligible
<b>Action:</b>	Manage	
<b>Comments:</b>	Located on both ends of garage

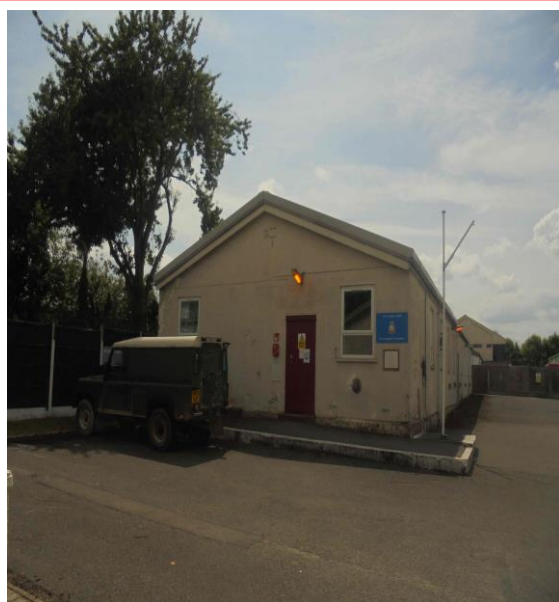
<b>Material Description:</b>	No access within building as locked	
<b>Identification:</b>	Presumed to Contain Asbestos	
<b>Approx. quantity:</b>	Unknown	
<b>Accessibility</b>	Low	<i>Assessment Score</i>
<b>Product type:</b>	No Access	3
<b>Extent of Damage:</b>	No Access	3
<b>Surface Treatment:</b>	No Access	3
<b>Asbestos type:</b>	No Access	3
<b>Material Assessment Score:</b>		12
<b>Priority Assessment Score:</b>		High
<b>Action:</b>	Further Investigation Required	
<b>Comments:</b>	Building is managed by the air cadets ad no one on site had access to the building during the two day survey

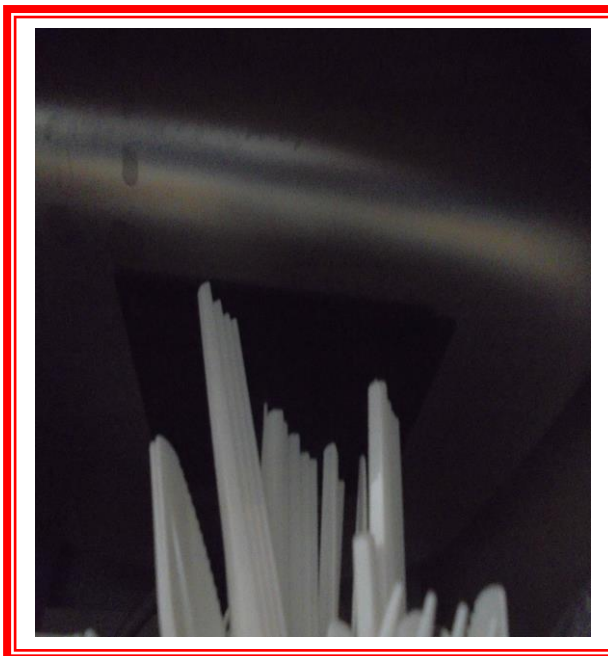
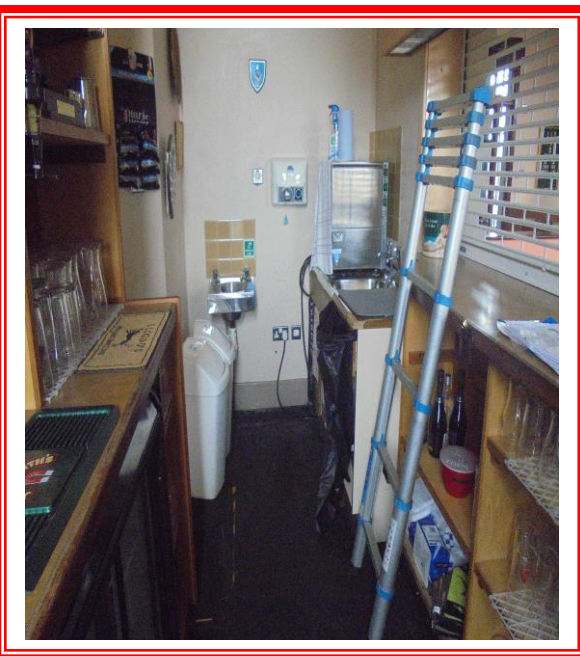
<b>Material Description:</b>	Sink pads	
<b>Identification:</b>	Sampled – Asbestos Detected	
<b>Approx. quantity:</b>	2 x sinks	
<b>Accessibility</b>	Low	<i>Assessment Score</i>
<b>Product type:</b>	Bitumen	1
<b>Extent of Damage:</b>	Minor	1
<b>Surface Treatment:</b>	Non-friable	0
<b>Asbestos type:</b>	Chrysotile	1
<b>Material Assessment Score:</b>		3
<b>Priority Assessment Score:</b>		Negligible
<b>Action:</b>	Manage	
<b>Comments:</b>	N/A

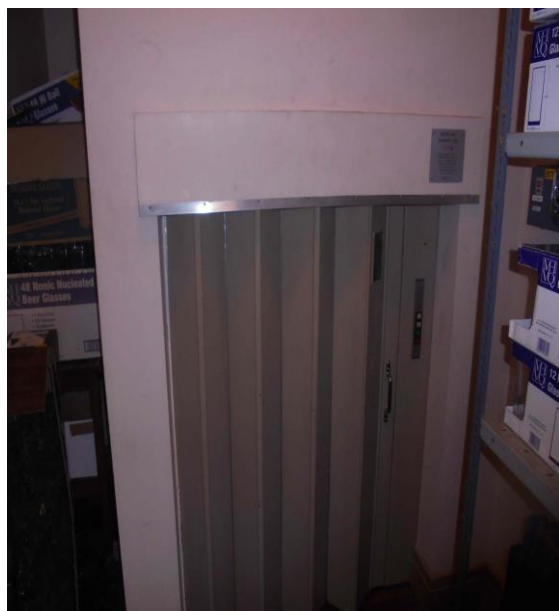
<b>Material Description:</b>	No access within lift shafts	
<b>Identification:</b>	Presumed to Contain Asbestos	
<b>Approx. quantity:</b>	1 X Lift	
<b>Accessibility</b>	Low	<i>Assessment Score</i>
<b>Product type:</b>	No Access	3
<b>Extent of Damage:</b>	No Access	3
<b>Surface Treatment:</b>	No Access	3
<b>Asbestos type:</b>	No Access	3
<b>Material Assessment Score:</b>		12
<b>Priority Assessment Score:</b>		Low
<b>Action:</b>	Further Investigation Required	
<b>Comments:</b>	No access as no lift engineer on site.

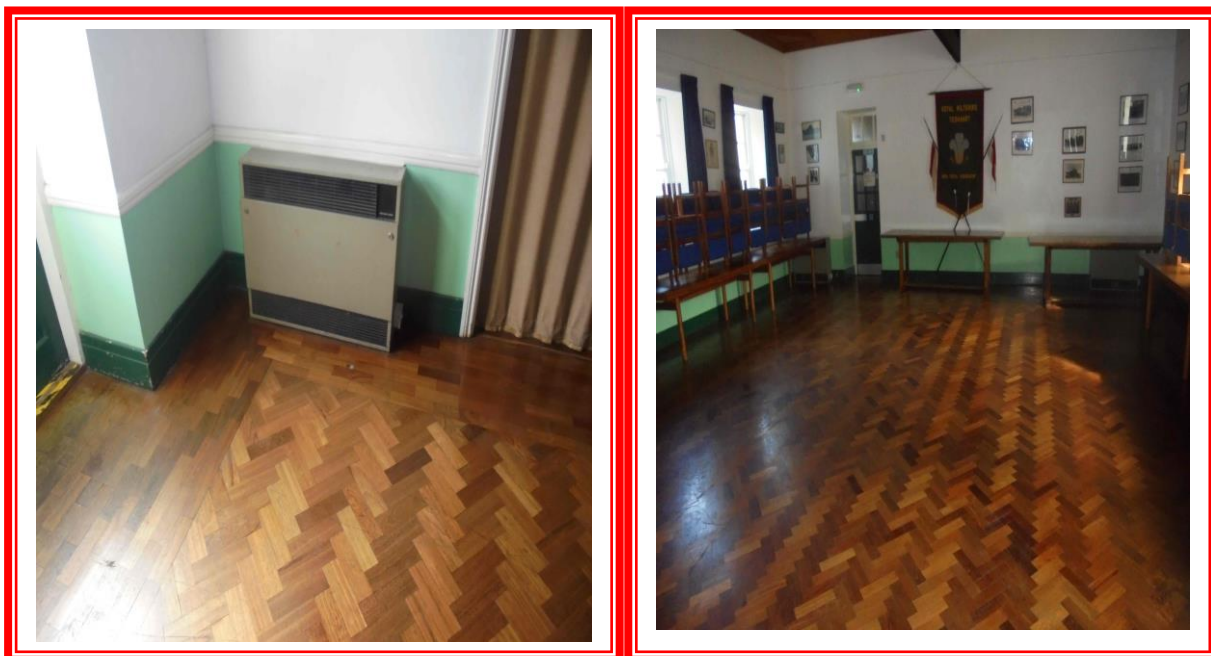
<b>Material Description:</b>	No access within the heater	
<b>Identification:</b>	Presumed to Contain Asbestos	
<b>Approx. quantity:</b>	X 4 heaters	
<b>Accessibility</b>	Low	<i>Assessment Score</i>
<b>Product type:</b>	No Access	2
<b>Extent of Damage:</b>	No Access	2
<b>Surface Treatment:</b>	No Access	2
<b>Asbestos type:</b>	No Access	2
<b>Material Assessment Score:</b>		8
<b>Priority Assessment Score:</b>		Low
<b>Action:</b>	Manage	
<b>Comments:</b>	No access as live

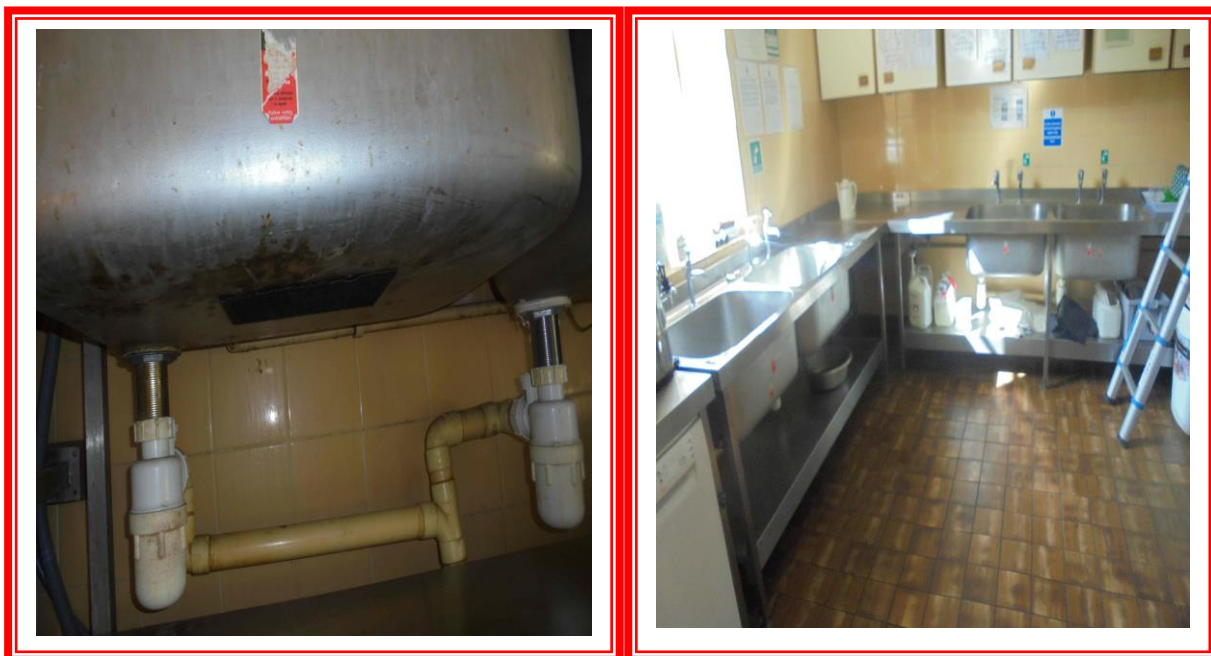
<b>Material Description:</b>	Sink Pads	
<b>Identification:</b>	Sampled – Asbestos Detected	
<b>Approx. quantity:</b>	X 4 sinks	
<b>Accessibility</b>	Low	<i>Assessment Score</i>
<b>Product type:</b>	Bitumen	1
<b>Extent of Damage:</b>	Moderate	2
<b>Surface Treatment:</b>	Non-friable	0
<b>Asbestos type:</b>	Chrysotile	1
<b>Material Assessment Score:</b>		4
<b>Priority Assessment Score:</b>		Negligible
<b>Action:</b>	Manage	
<b>Comments:</b>	N/A

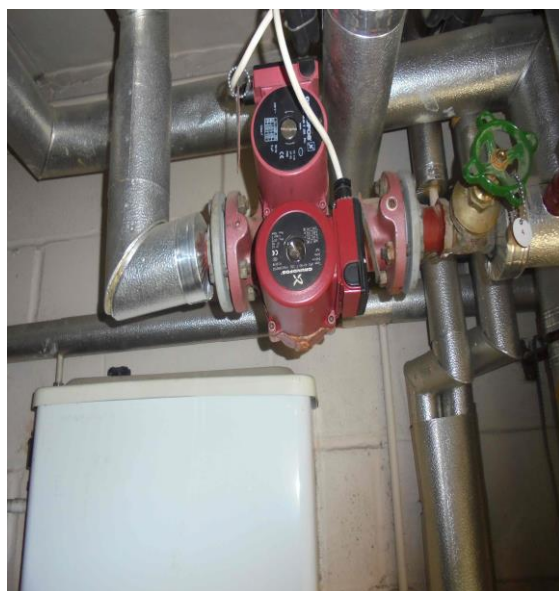
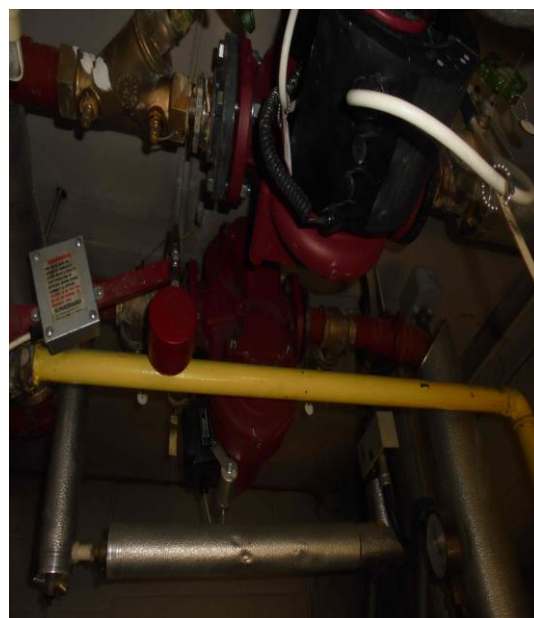
<b>Material Description:</b>	Gaskets	
<b>Identification:</b>	Sampled – Asbestos Detected	
<b>Approx. quantity:</b>	8 x gaskets	
<b>Accessibility</b>	Low	<i>Assessment Score</i>
<b>Product type:</b>	Textiles	2
<b>Extent of Damage:</b>	Minor	1
<b>Surface Treatment:</b>	Unsealed	1
<b>Asbestos type:</b>	Chrysotile	1
<b>Material Assessment Score:</b>		5
<b>Priority Assessment Score:</b>		Low
<b>Action:</b>	Manage	
<b>Comments:</b>	N/A

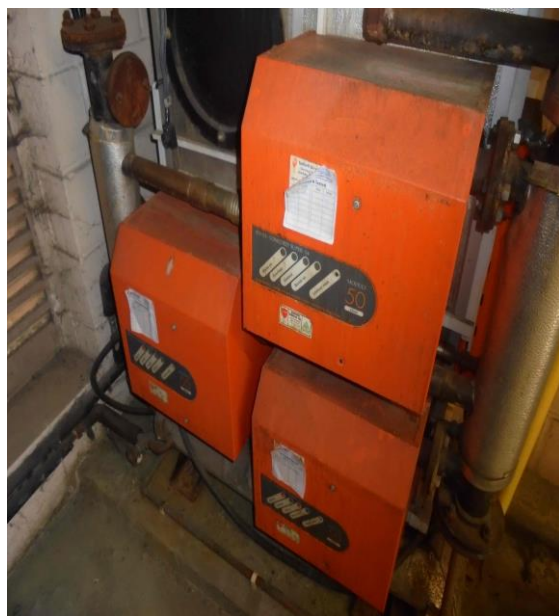
<b>Material Description:</b>	No access within boilers	
<b>Identification:</b>	Presumed to Contain Asbestos	
<b>Approx. quantity:</b>	1 x boiler	
<b>Accessibility</b>	Low	<i>Assessment Score</i>
<b>Product type:</b>	No Access	3
<b>Extent of Damage:</b>	No Access	3
<b>Surface Treatment:</b>	No Access	3
<b>Asbestos type:</b>	No Access	3
<b>Material Assessment Score:</b>		12
<b>Priority Assessment Score:</b>		Low
<b>Action:</b>	Manage	
<b>Comments:</b>	No access and live

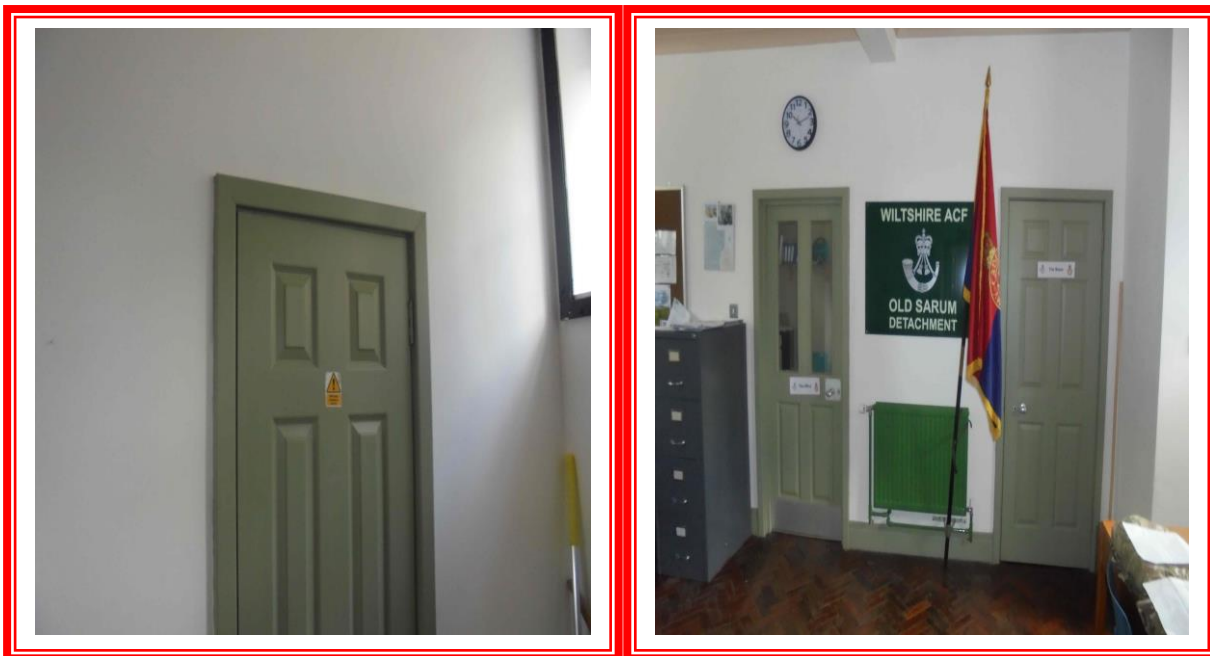
<b>Material Description:</b>	No access within locked rooms	
<b>Identification:</b>	Presumed to Contain Asbestos	
<b>Approx. quantity:</b>	3 x rooms	
<b>Accessibility</b>	Low	<i>Assessment Score</i>
<b>Product type:</b>	No Access	3
<b>Extent of Damage:</b>	No Access	3
<b>Surface Treatment:</b>	No Access	3
<b>Asbestos type:</b>	No Access	3
<b>Material Assessment Score:</b>		12
<b>Priority Assessment Score:</b>		High
<b>Action:</b>	Further Investigation required	
<b>Comments:</b>	No key available during the survey. Store door has sticker reading 'asbestos within' please refer to previous survey for details.

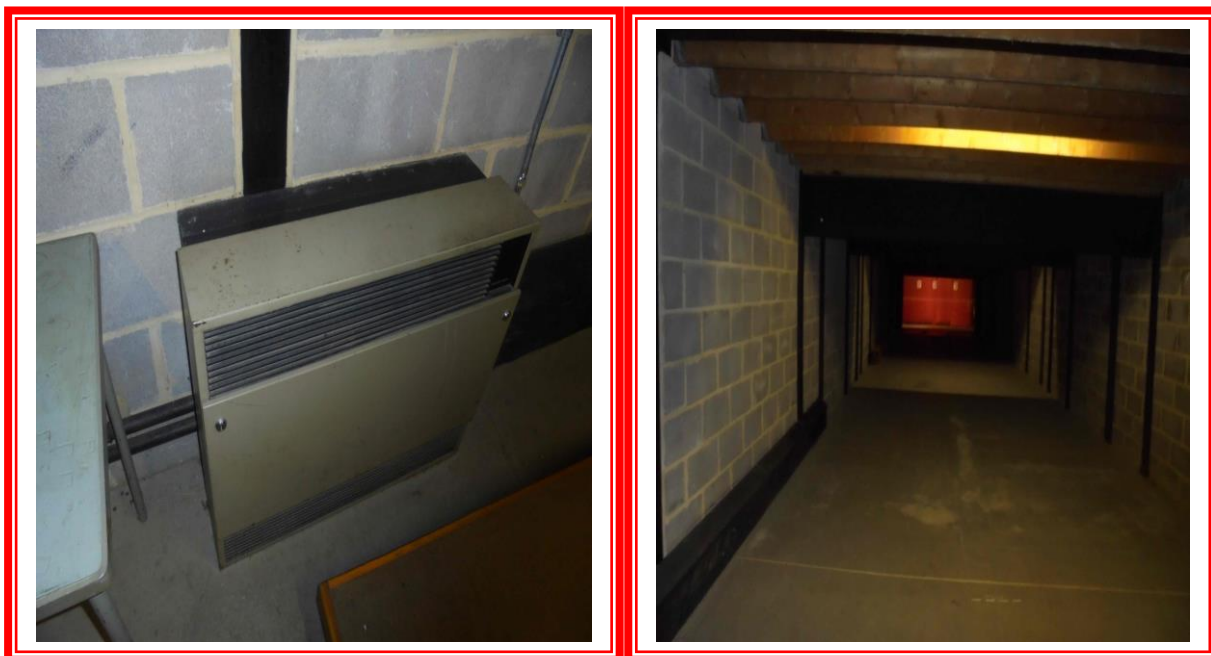
<b>Material Description:</b>	No access within gas heater	
<b>Identification:</b>	Presumed to Contain Asbestos	
<b>Approx. quantity:</b>	1 x heater	
<b>Accessibility</b>	Low	<i>Assessment Score</i>
<b>Product type:</b>	No Access	2
<b>Extent of Damage:</b>	No Access	2
<b>Surface Treatment:</b>	No Access	2
<b>Asbestos type:</b>	No Access	2
<b>Material Assessment Score:</b>		8
<b>Priority Assessment Score:</b>		Medium
<b>Action:</b>	Manage	
<b>Comments:</b>	No access as live

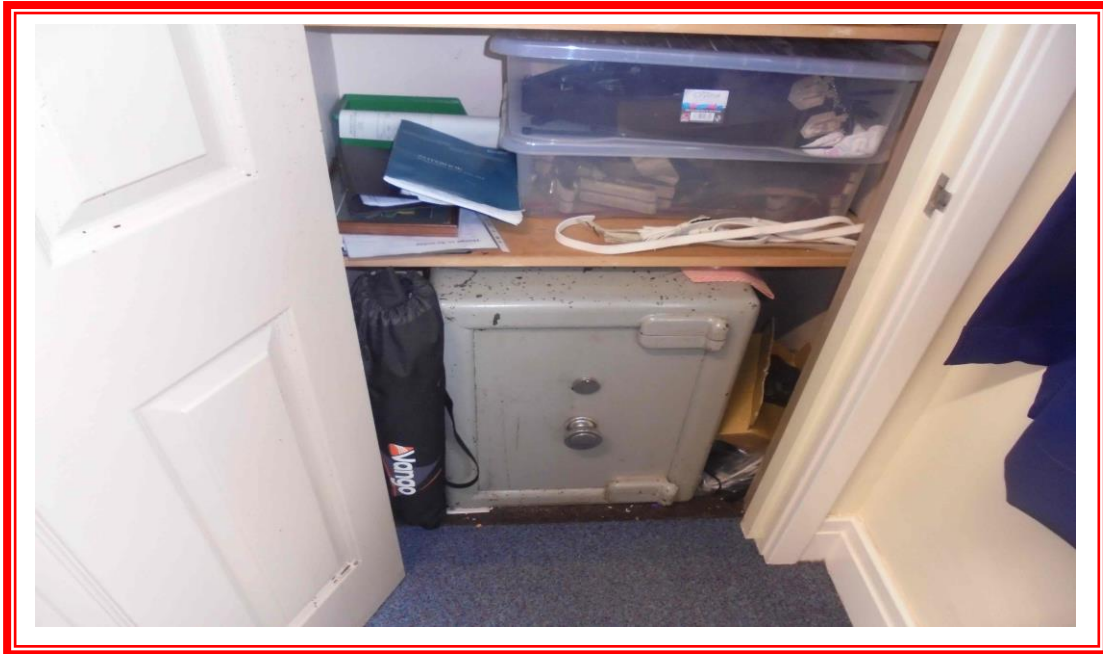
<b>Material Description:</b>	No access within safe casings	
<b>Identification:</b>	Presumed to Contain Asbestos	
<b>Approx. quantity:</b>	1 x Safe	
<b>Accessibility</b>	Low	<i>Assessment Score</i>
<b>Product type:</b>	No Access	2
<b>Extent of Damage:</b>	No Access	2
<b>Surface Treatment:</b>	No Access	2
<b>Asbestos type:</b>	No Access	2
<b>Material Assessment Score:</b>		8
<b>Priority Assessment Score:</b>		Medium
<b>Action:</b>	Manage	
<b>Comments:</b>	N/A

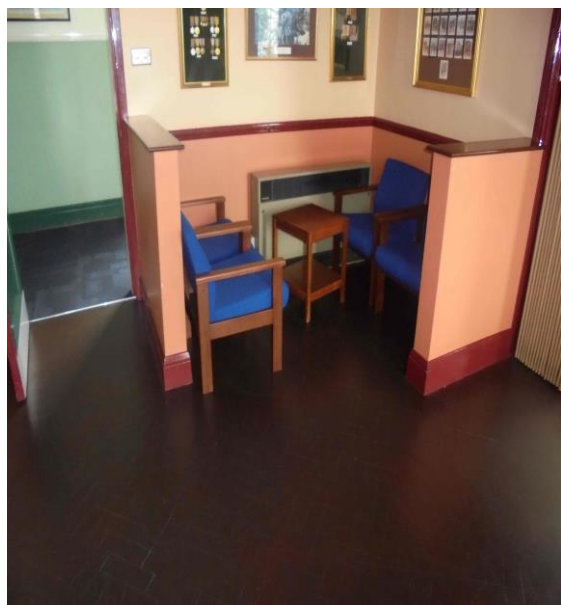
<b>Material Description:</b>	No access within live gas heaters	
<b>Identification:</b>	Presumed to Contain Asbestos	
<b>Approx. quantity:</b>	X 2 heaters	
<b>Accessibility</b>	Low	<i>Assessment Score</i>
<b>Product type:</b>	No Access	2
<b>Extent of Damage:</b>	No Access	2
<b>Surface Treatment:</b>	No Access	2
<b>Asbestos type:</b>	No Access	2
<b>Material Assessment Score:</b>		8
<b>Priority Assessment Score:</b>		Medium
<b>Action:</b>	Manage	
<b>Comments:</b>	N/A

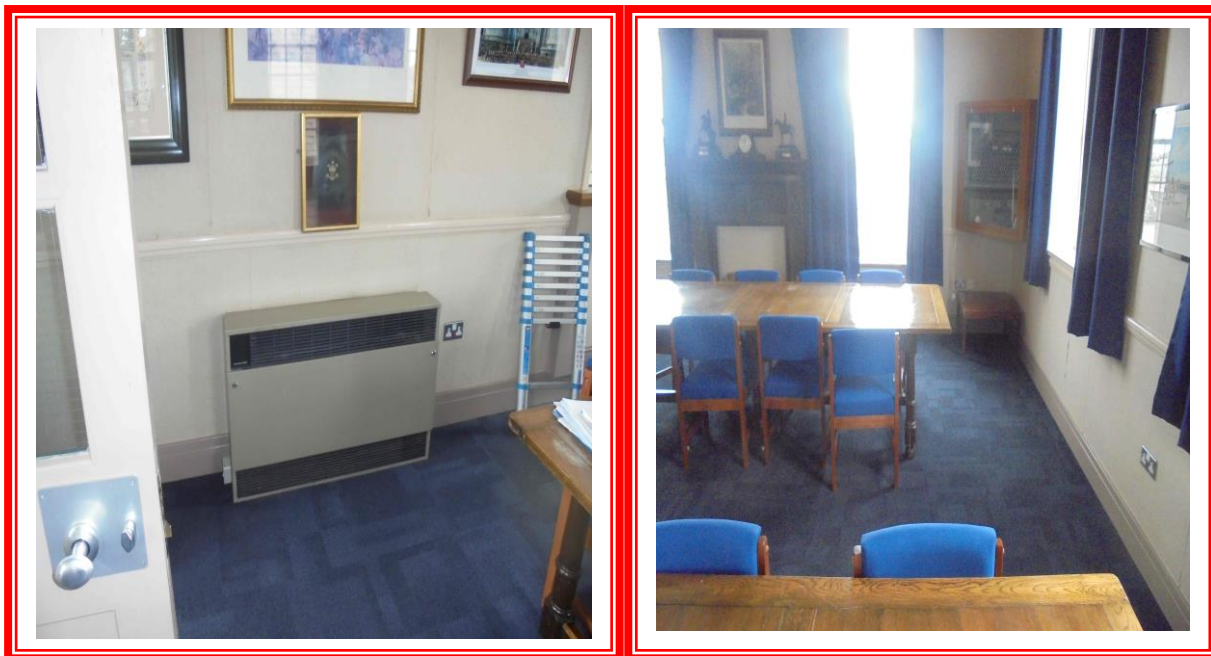
<b>Material Description:</b>	No access within live heater	
<b>Identification:</b>	Presumed to Contain Asbestos	
<b>Approx. quantity:</b>	1 x heater	
<b>Accessibility</b>	Low	<i>Assessment Score</i>
<b>Product type:</b>	No Access	2
<b>Extent of Damage:</b>	No Access	2
<b>Surface Treatment:</b>	No Access	2
<b>Asbestos type:</b>	No Access	2
<b>Material Assessment Score:</b>		8
<b>Priority Assessment Score:</b>		Medium
<b>Action:</b>	Manage	
<b>Comments:</b>	N/A

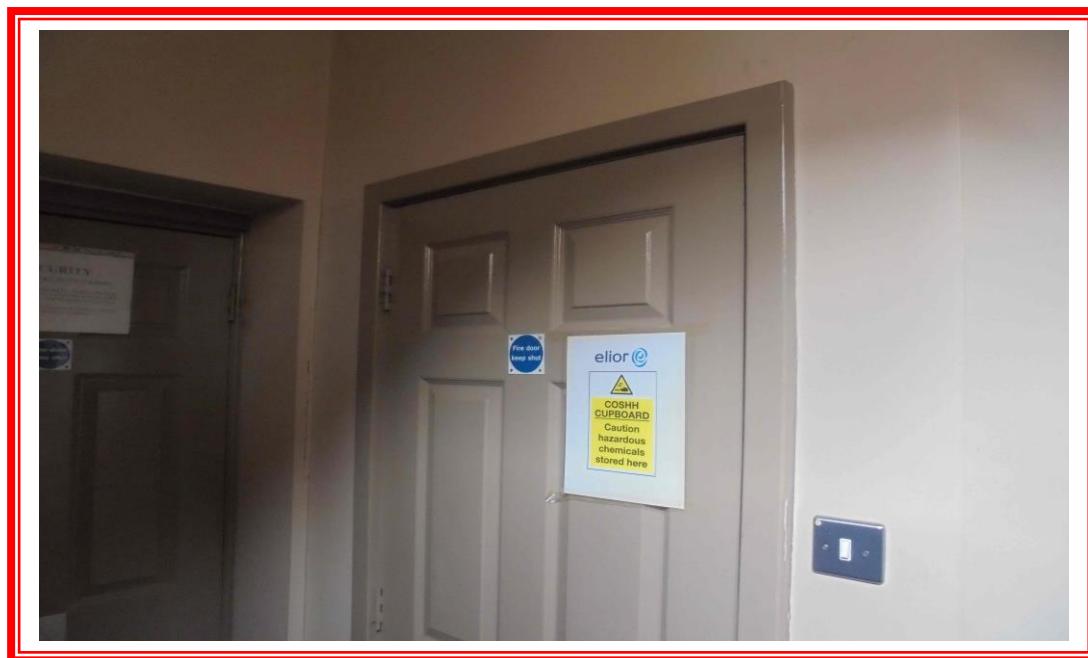
<b>Material Description:</b>	No access to locked cupboard	
<b>Identification:</b>	Presumed to Contain Asbestos	
<b>Approx. quantity:</b>	1 x room	
<b>Accessibility</b>	Low	<i>Assessment Score</i>
<b>Product type:</b>	No Access	3
<b>Extent of Damage:</b>	No Access	3
<b>Surface Treatment:</b>	No Access	3
<b>Asbestos type:</b>	No Access	3
<b>Material Assessment Score:</b>		12
<b>Priority Assessment Score:</b>		High
<b>Action:</b>	Manage	
<b>Comments:</b>	Further investigation required

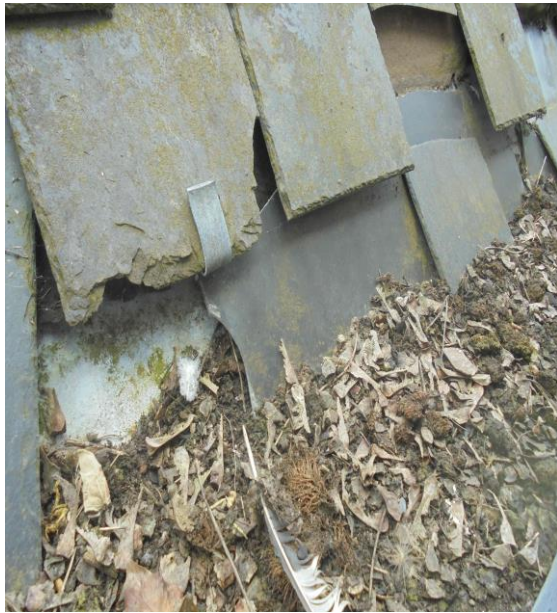
<b>Material Description:</b>	Cement replacement roof tiles	
<b>Identification:</b>	Sampled – No Asbestos Detected	
<b>Approx. quantity:</b>	Unknown-all replacement tiles	
<b>Accessibility</b>	Low	<i>Assessment Score</i>
<b>Product type:</b>		N/A
<b>Extent of Damage:</b>		N/A
<b>Surface Treatment:</b>		N/A
<b>Asbestos type:</b>		N/A
<b>Material Assessment Score:</b>		N/A
<b>Priority Assessment Score:</b>		N/A
<b>Action:</b>	N/A	
<b>Comments:</b>	Tiles are natural slate apart from a number of cement replacement tiles

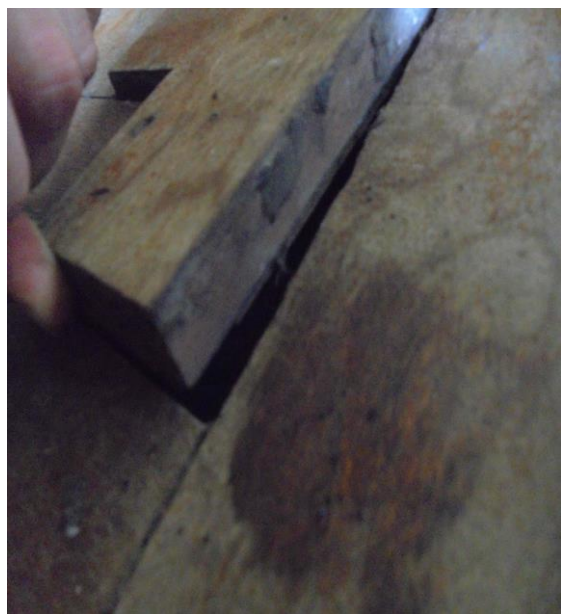
<b>Material Description:</b>	Bitumen under Parquet Flooring	
<b>Identification:</b>	Sampled – Asbestos Detected	
<b>Approx. quantity:</b>	Parquet flooring throughout building	
<b>Accessibility</b>	Low	<i>Assessment Score</i>
<b>Product type:</b>		N/A
<b>Extent of Damage:</b>		N/A
<b>Surface Treatment:</b>		N/A
<b>Asbestos type:</b>		N/A
<b>Material Assessment Score:</b>		N/A
<b>Priority Assessment Score:</b>		N/A
<b>Action:</b>	N/A	
<b>Comments:</b>	Treat as uniform to parquet flooring throughout building
