Project Number 2481

**Management
Asbestos Survey Report**

**675 Army Air Corps, Yeovil, Somerset,
BA21 4JA**

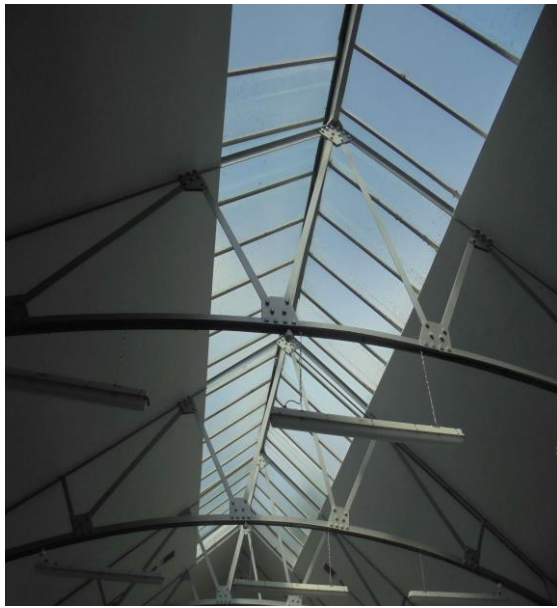
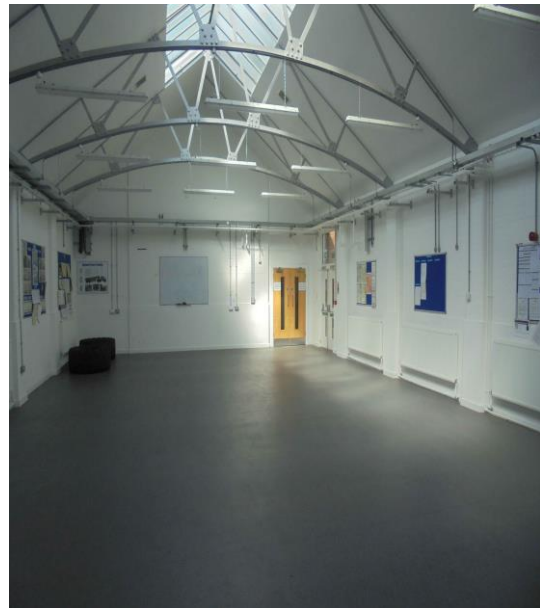
Item No: 8

Item 8 – Drill Hall – Rope Seals to skylights – No access to sample due to the height
 Item 32 – External (House) – Soffit Boards - No access to sample due to the height

Material Description:	Rope seal within metal skylights	
Identification:	Presumed to Contain Asbestos	
Approx. quantity:	55M2 of Glazing	
Accessibility	Low	<i>Assessment Score</i>
Product type:	No Access	2
Extent of Damage:	No Access	1
Surface Treatment:	No Access	1
Asbestos type:	No Access	1
Material Assessment Score:		5
Priority Assessment Score:		Low
Action:	Manage	
Comments:	No access to sample due to height

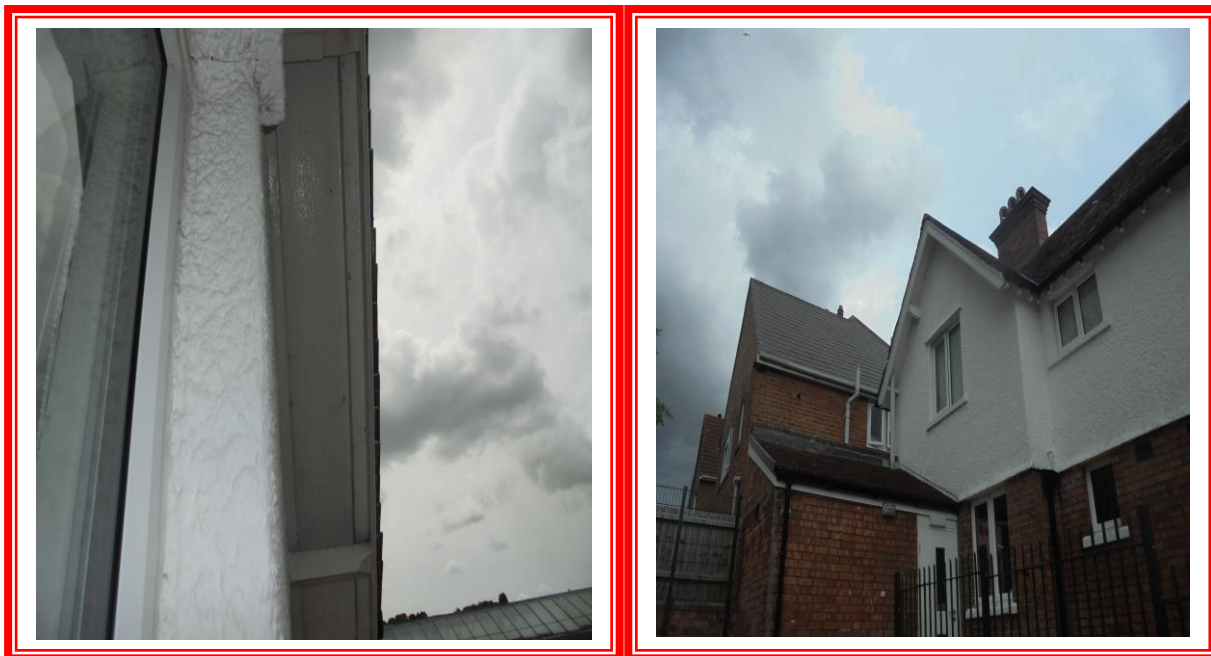
**Item No: 32****Sample No: N/A****Location: External**

Material Description:	Soffit Boards	
Identification:	Presumed to Contain Asbestos	
Approx. quantity:	24LM	
Accessibility	Low	<i>Assessment Score</i>
Product type:	No Access	2
Extent of Damage:	No Access	1
Surface Treatment:	No Access	1
Asbestos type:	No Access	2
Material Assessment Score:		5
Priority Assessment Score:		Low
Action:	Manage	
Comments:	No access to sample due to height

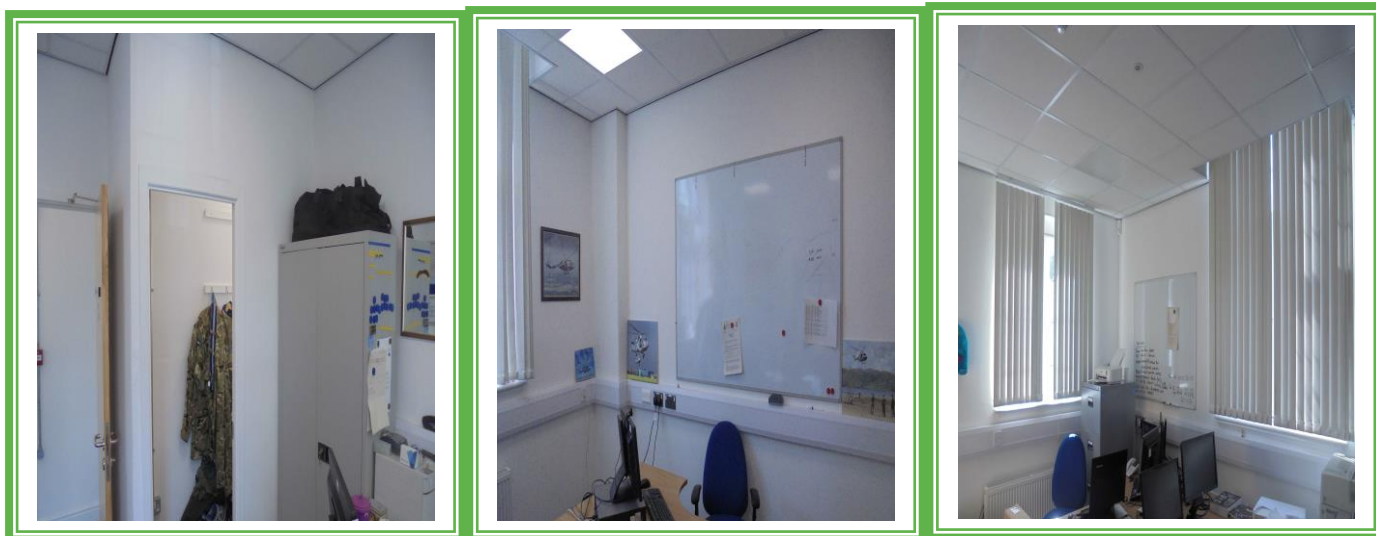
Item No: 1

Material Description:	Visual Inspection – No Suspect Materials Found	
Identification:	N/A	
Approx. quantity:	N/A	
Accessibility	N/A	<i>Assessment Score</i>
Product type:		N/A
Extent of Damage:		N/A
Surface Treatment:		N/A
Asbestos type:		N/A
Material Assessment Score:		N/A
Priority Assessment Score:		N/A
Action:	N/A	
Comments:	No access above the suspended ceiling in the recruitment office cupboards as services fixed into tiles. No access under timber carpet underlay throughout

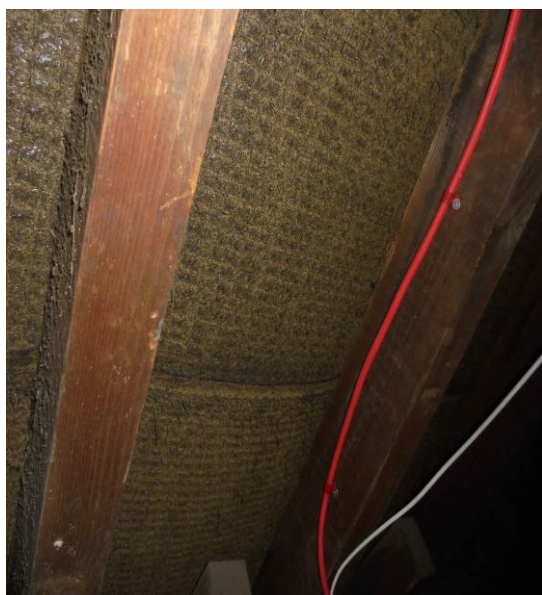
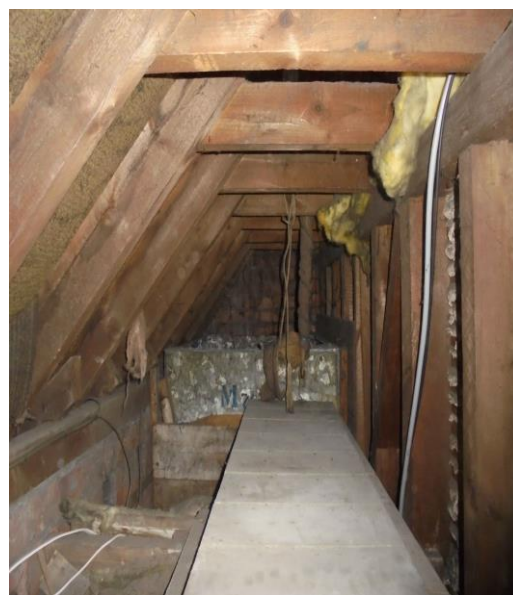
Item No: 2

Material Description:	Felt to underside of the roof	
Identification:	Sampled – No Asbestos Detected	
Approx. quantity:	10M2 Visible	
Accessibility	N/A	<i>Assessment Score</i>
Product type:		N/A
Extent of Damage:		N/A
Surface Treatment:		N/A
Asbestos type:		N/A
Material Assessment Score:		N/A
Priority Assessment Score:		N/A
Action:	N/A	
Comments:	Non-asbestos hessian pipework insulation

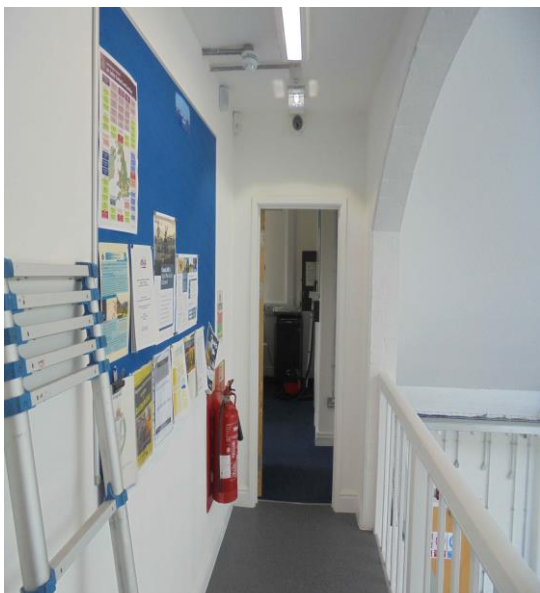
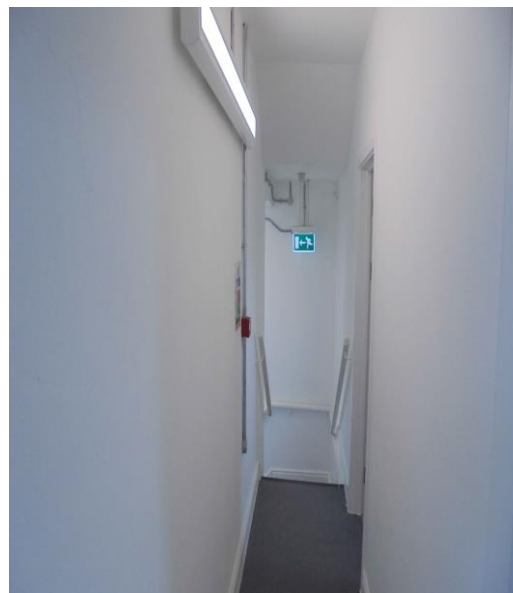
Item No: 3

Material Description:	Visual Inspection – No Suspect Materials Found	
Identification:	N/A	
Approx. quantity:	N/A	
Accessibility	N/A	<i>Assessment Score</i>
Product type:		N/A
Extent of Damage:		N/A
Surface Treatment:		N/A
Asbestos type:		N/A
Material Assessment Score:		N/A
Priority Assessment Score:		N/A
Action:	N/A	
Comments:	Modern Stair Nosing

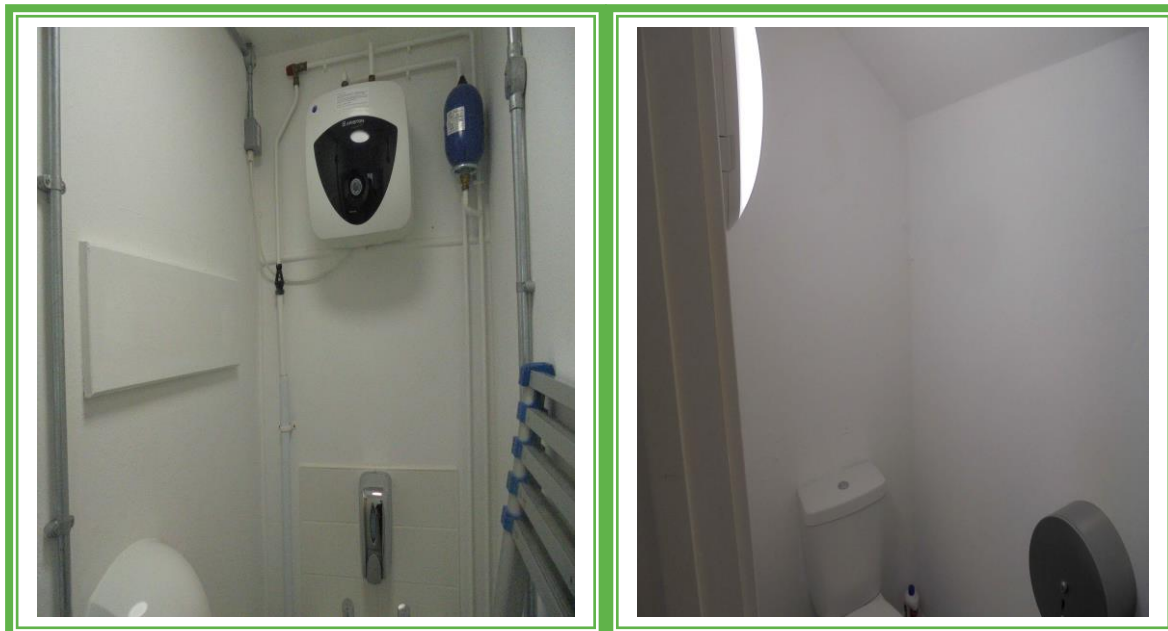
**Item No: 4****Sample No: N/A****Location: First Floor - WC**

Material Description:	Visual Inspection – No Suspect Materials Found	
Identification:	N/A	
Approx. quantity:	N/A	
Accessibility	N/A	<i>Assessment Score</i>
Product type:		N/A
Extent of Damage:		N/A
Surface Treatment:		N/A
Asbestos type:		N/A
Material Assessment Score:		N/A
Priority Assessment Score:		N/A
Action:	N/A	
Comments:	Modern Water Heater

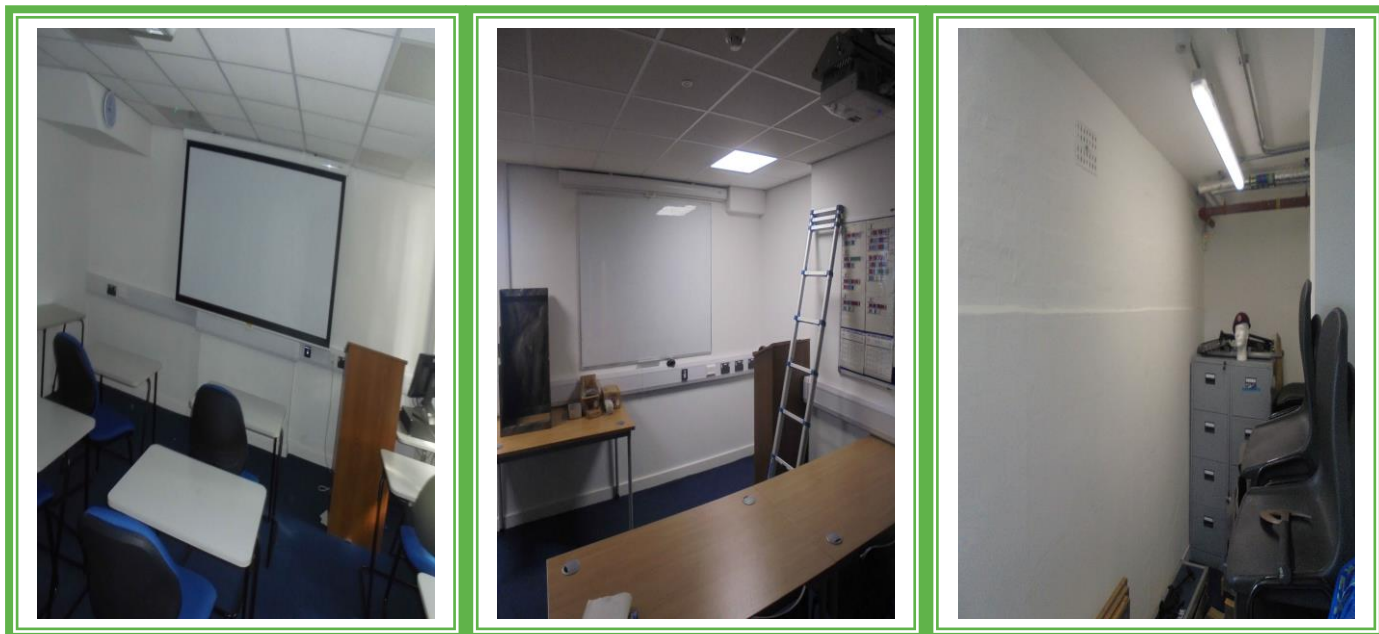
Item No: 5

Material Description:	Visual Inspection – No Suspect Materials Found	
Identification:	N/A	
Approx. quantity:	N/A	
Accessibility	N/A	<i>Assessment Score</i>
Product type:		N/A
Extent of Damage:		N/A
Surface Treatment:		N/A
Asbestos type:		N/A
Material Assessment Score:		N/A
Priority Assessment Score:		N/A
Action:	N/A	
Comments:	MDF Boxing. Modern pipework insulation

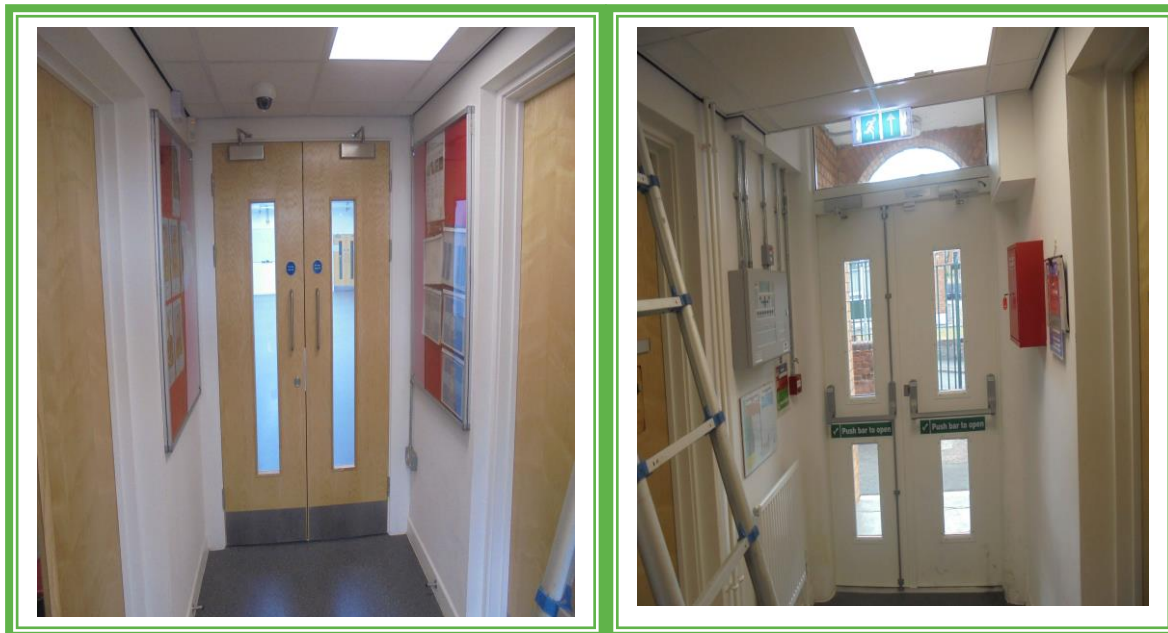
Item No: 6

Material Description:	Visual Inspection – No Suspect Materials Found	
Identification:	N/A	
Approx. quantity:	N/A	
Accessibility	N/A	<i>Assessment Score</i>
Product type:		N/A
Extent of Damage:		N/A
Surface Treatment:		N/A
Asbestos type:		N/A
Material Assessment Score:		N/A
Priority Assessment Score:		N/A
Action:	N/A	
Comments:	Modern Electrics

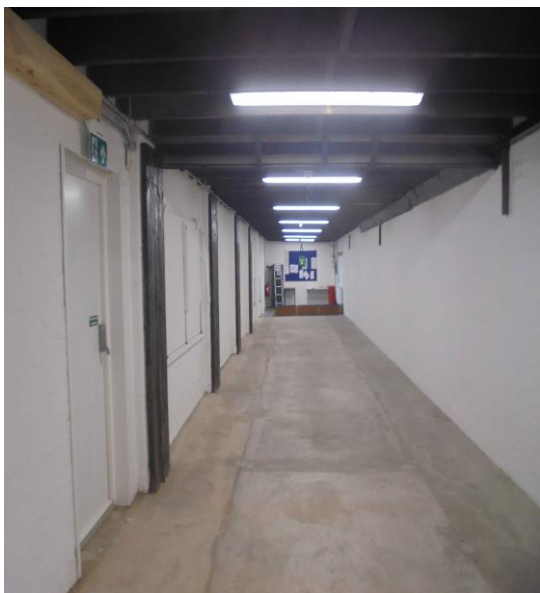
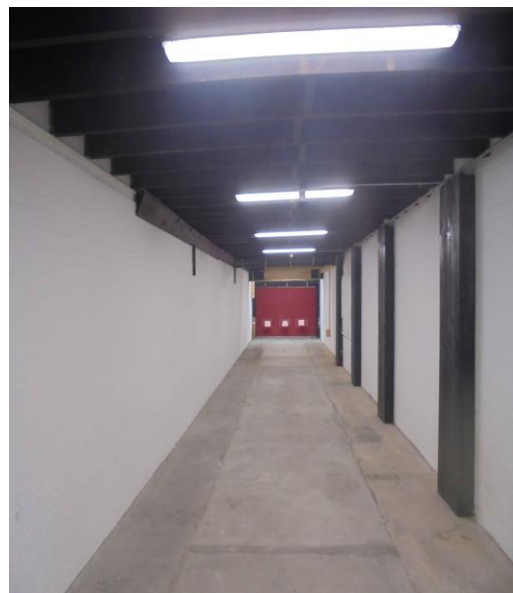
**Item No: 7****Sample No: N/A****Location: Ground Floor – Firing Range**

Material Description:	Visual Inspection – No Suspect Materials Found	
Identification:	N/A	
Approx. quantity:	N/A	
Accessibility	N/A	<i>Assessment Score</i>
Product type:		N/A
Extent of Damage:		N/A
Surface Treatment:		N/A
Asbestos type:		N/A
Material Assessment Score:		N/A
Priority Assessment Score:		N/A
Action:	N/A	
Comments:	N/A

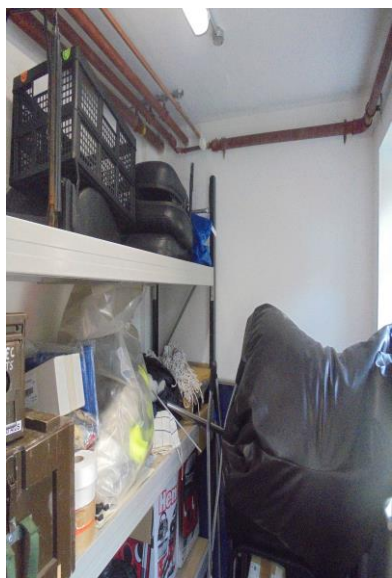
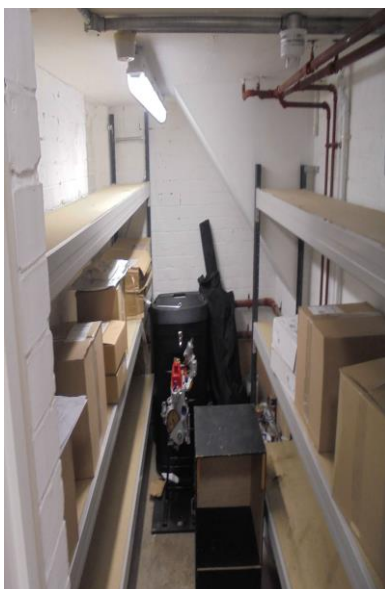
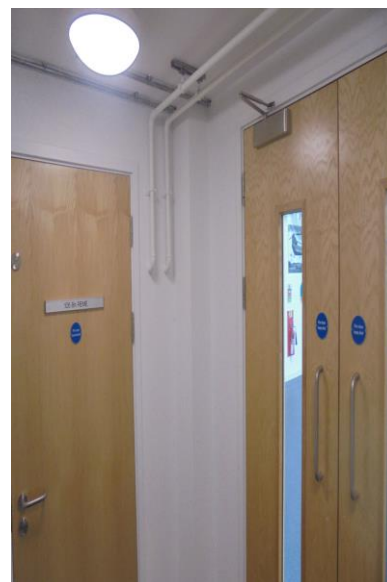
Item No: 9

Material Description:	Visual Inspection – No Suspect Materials Found	
Identification:	N/A	
Approx. quantity:	N/A	
Accessibility	N/A	<i>Assessment Score</i>
Product type:		N/A
Extent of Damage:		N/A
Surface Treatment:		N/A
Asbestos type:		N/A
Material Assessment Score:		N/A
Priority Assessment Score:		N/A
Action:	N/A	
Comments:	No access within timber boxing in lobby

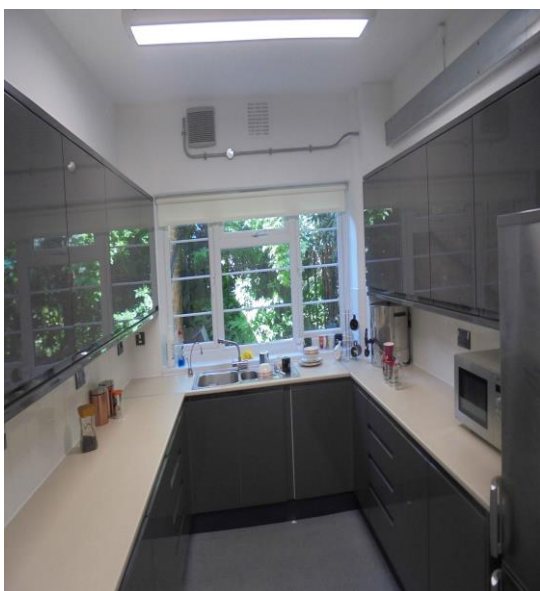
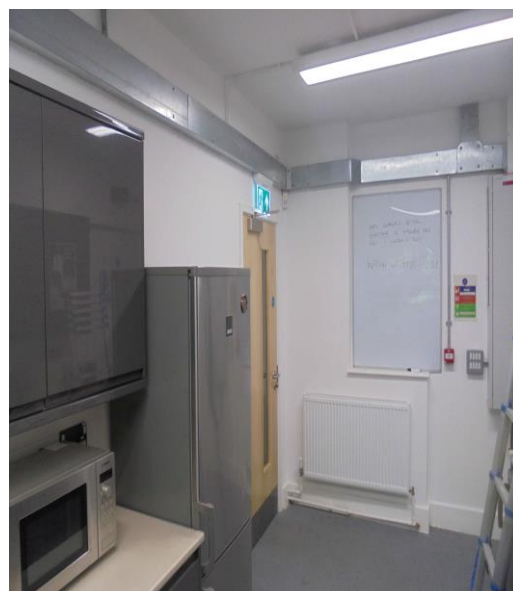
**Item No: 10****Sample No: N/A****Location: Ground Floor - Kitchen**

Material Description:	Visual Inspection – No Suspect Materials Found	
Identification:	N/A	
Approx. quantity:	N/A	
Accessibility	N/A	<i>Assessment Score</i>
Product type:		N/A
Extent of Damage:		N/A
Surface Treatment:		N/A
Asbestos type:		N/A
Material Assessment Score:		N/A
Priority Assessment Score:		N/A
Action:	N/A	
Comments:	No access within timber boxings. Modern sink pad, Modern electrics

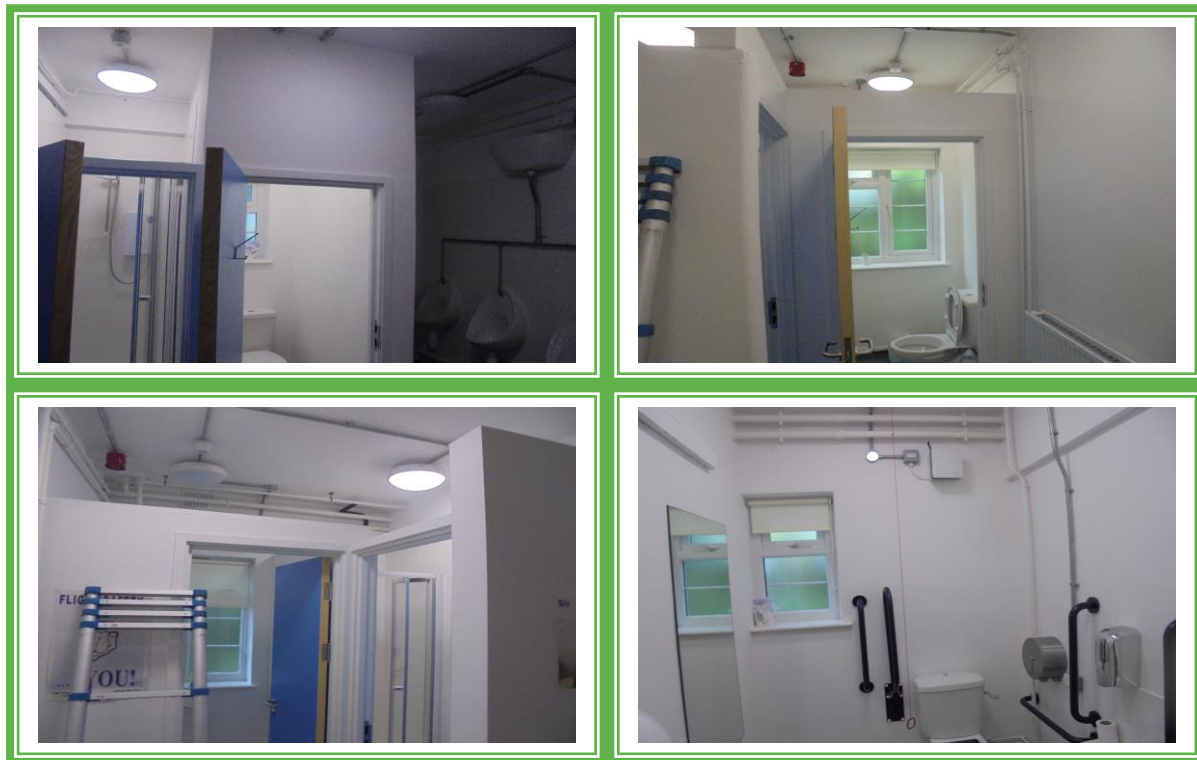
Item No: 11

Material Description:	Visual Inspection – No Suspect Materials Found	
Identification:	N/A	
Approx. quantity:	N/A	
Accessibility	N/A	<i>Assessment Score</i>
Product type:		N/A
Extent of Damage:		N/A
Surface Treatment:		N/A
Asbestos type:		N/A
Material Assessment Score:		N/A
Priority Assessment Score:		N/A
Action:	N/A	
Comments:	Modern water heater

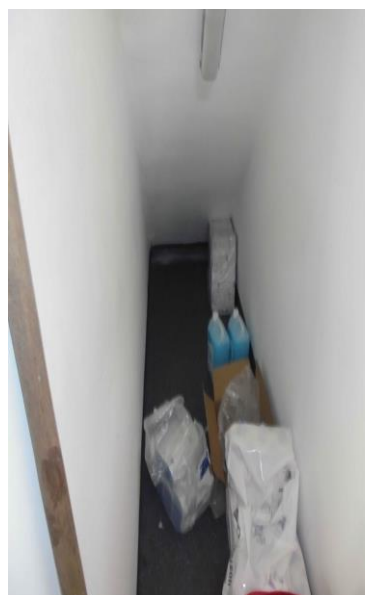
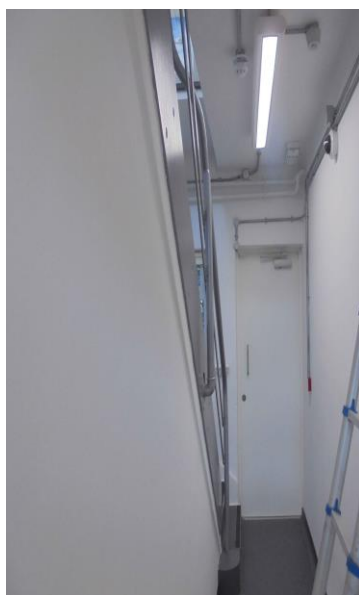
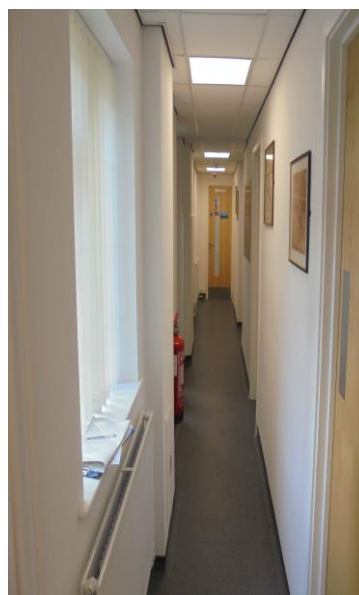
**Item No: 12****Sample No: N/A****Location: Ground Floor – Circulation and Cupboard**

Material Description:	Visual Inspection – No Suspect Materials Found	
Identification:	N/A	
Approx. quantity:	N/A	
Accessibility	N/A	<i>Assessment Score</i>
Product type:		N/A
Extent of Damage:		N/A
Surface Treatment:		N/A
Asbestos type:		N/A
Material Assessment Score:		N/A
Priority Assessment Score:		N/A
Action:	N/A	
Comments:	N/A

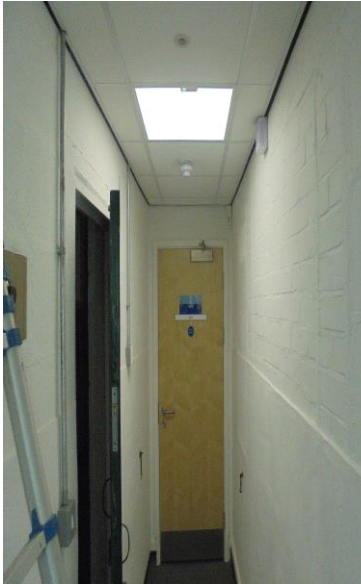
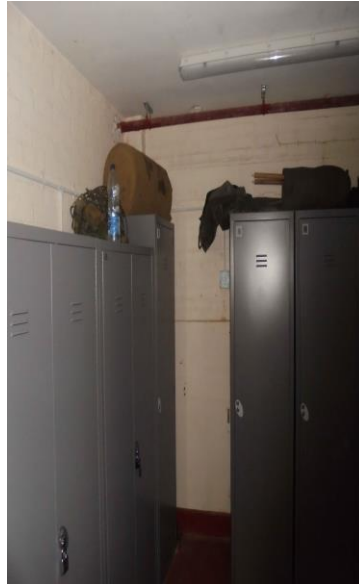
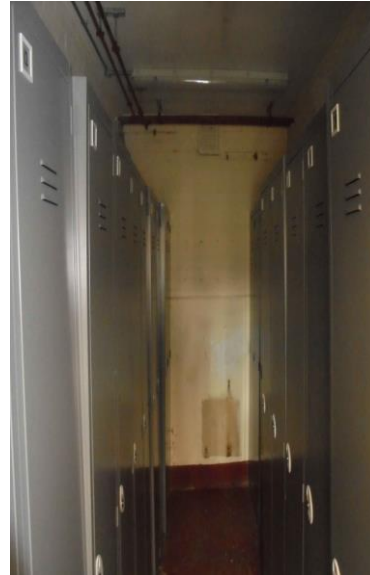
**Item No: 13****Sample No: N/A****Location: Ground Floor – Ammo Bunker, Armoury and Corridor**

Material Description:	Visual Inspection – No Suspect Materials Found	
Identification:	N/A	
Approx. quantity:	N/A	
Accessibility	N/A	<i>Assessment Score</i>
Product type:		N/A
Extent of Damage:		N/A
Surface Treatment:		N/A
Asbestos type:		N/A
Material Assessment Score:		N/A
Priority Assessment Score:		N/A
Action:	N/A	
Comments:	Limited access to inspect rooms due to lockers

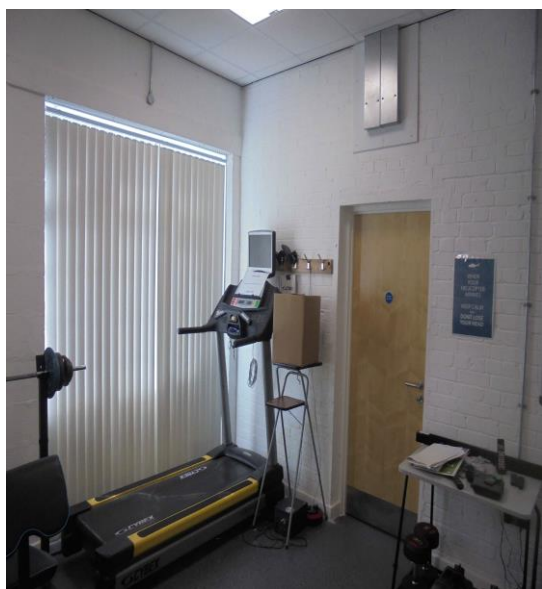
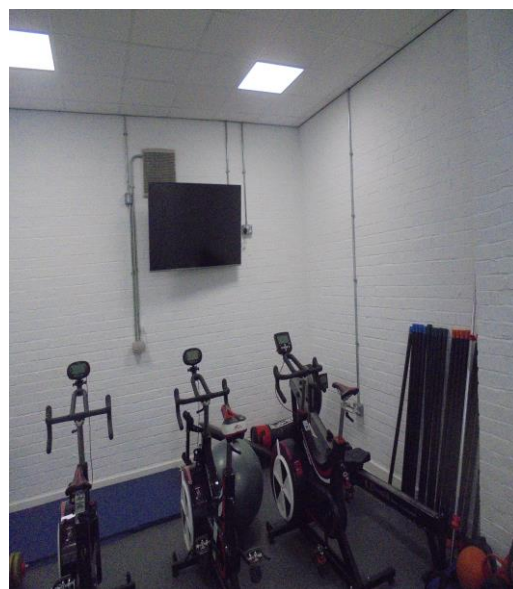
Item No: 14

Material Description:	Visual Inspection – No Suspect Materials Found	
Identification:	N/A	
Approx. quantity:	N/A	
Accessibility	N/A	<i>Assessment Score</i>
Product type:		N/A
Extent of Damage:		N/A
Surface Treatment:		N/A
Asbestos type:		N/A
Material Assessment Score:		N/A
Priority Assessment Score:		N/A
Action:	N/A	
Comments:	N/A

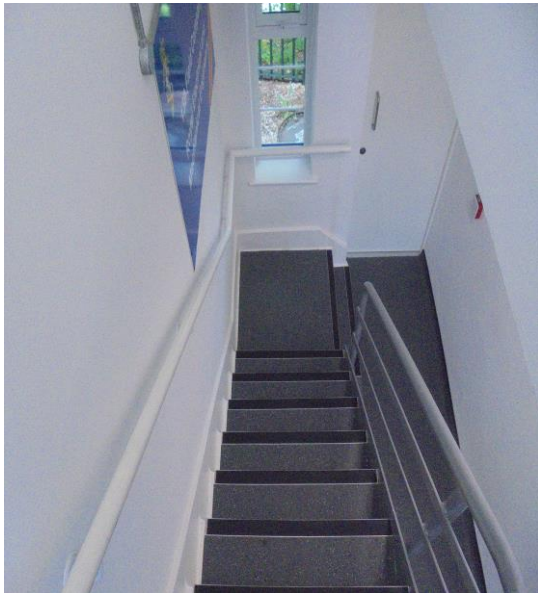
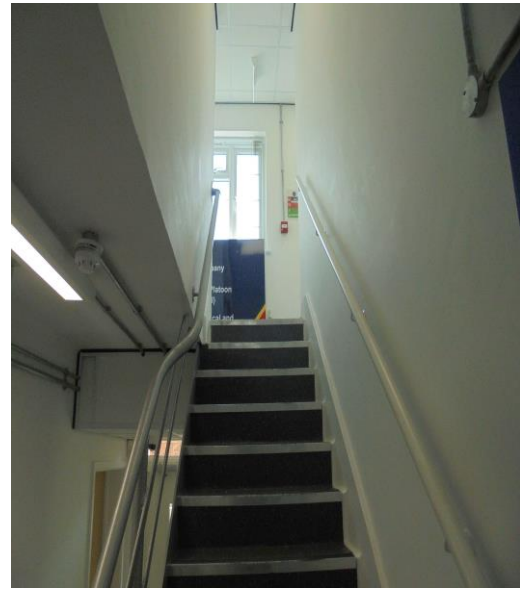
**Item No: 15****Sample No: N/A****Location: Stairwell**

Material Description:	Visual Inspection – No Suspect Materials Found	
Identification:	N/A	
Approx. quantity:	N/A	
Accessibility	N/A	<i>Assessment Score</i>
Product type:		N/A
Extent of Damage:		N/A
Surface Treatment:		N/A
Asbestos type:		N/A
Material Assessment Score:		N/A
Priority Assessment Score:		N/A
Action:	N/A	
Comments:	Modern Stair Nosing

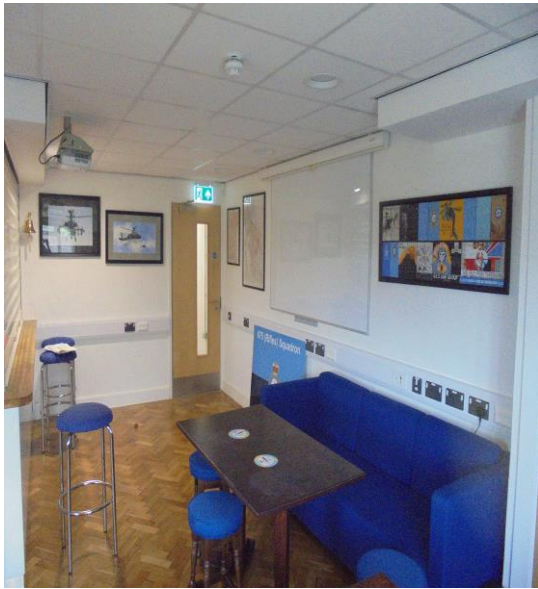
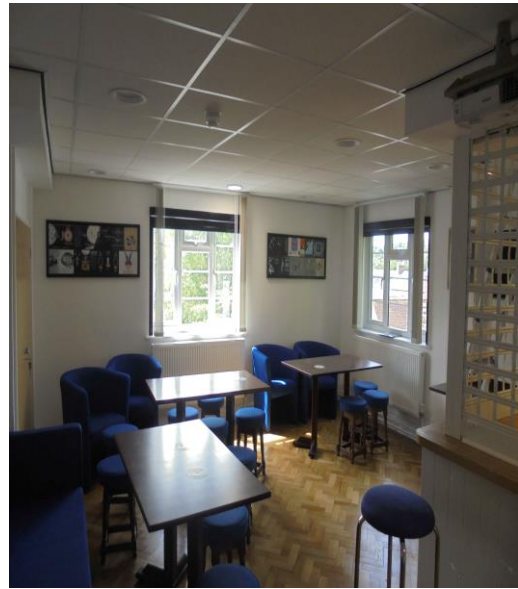
**Item No: 16****Sample No: N/A****Location: Mess Room/Bar**

Material Description:	Visual Inspection – No Suspect Materials Found	
Identification:	N/A	
Approx. quantity:	N/A	
Accessibility	N/A	<i>Assessment Score</i>
Product type:		N/A
Extent of Damage:		N/A
Surface Treatment:		N/A
Asbestos type:		N/A
Material Assessment Score:		N/A
Priority Assessment Score:		N/A
Action:	N/A	
Comments:	Modern sink. No access under the parquet flooring. Limited access into the ceiling void due to height level of insulation. modern electrics

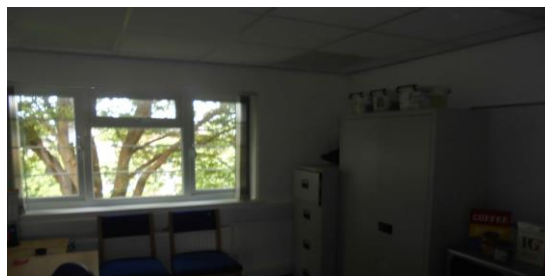
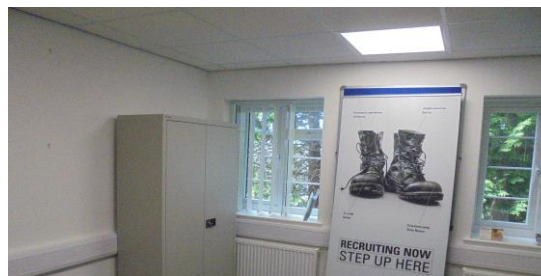
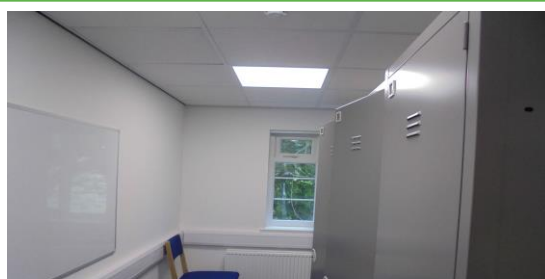
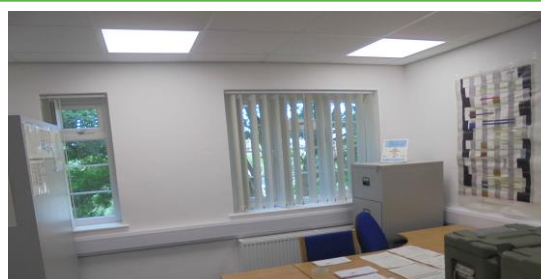
Item No: 17

Material Description:	Visual Inspection – No Suspect Materials Found	
Identification:	N/A	
Approx. quantity:	N/A	
Accessibility	N/A	<i>Assessment Score</i>
Product type:		N/A
Extent of Damage:		N/A
Surface Treatment:		N/A
Asbestos type:		N/A
Material Assessment Score:		N/A
Priority Assessment Score:		N/A
Action:	N/A	
Comments:	Limited access above the suspended ceiling due to high level of insulation

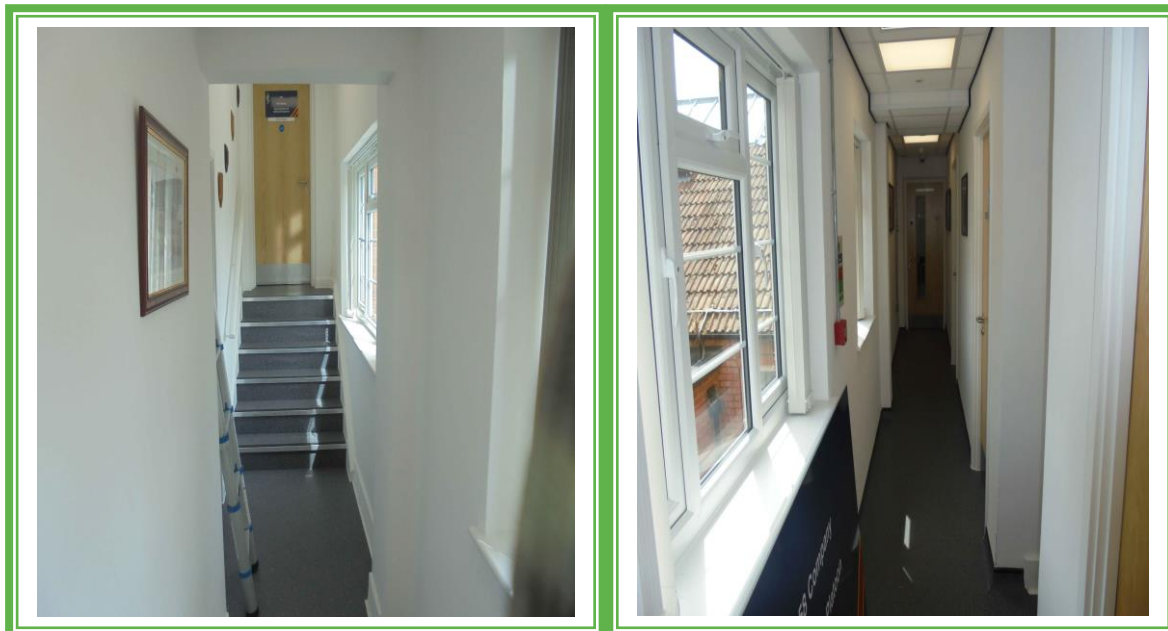
Item No: 18

Material Description:	Visual Inspection – No Suspect Materials Found	
Identification:	N/A	
Approx. quantity:	N/A	
Accessibility	N/A	<i>Assessment Score</i>
Product type:		N/A
Extent of Damage:		N/A
Surface Treatment:		N/A
Asbestos type:		N/A
Material Assessment Score:		N/A
Priority Assessment Score:		N/A
Action:	N/A	
Comments:	Modern stair nosing. Limited access above the suspended ceiling due to high level of insulation

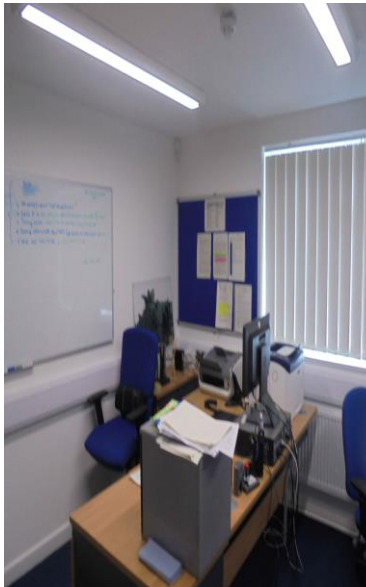
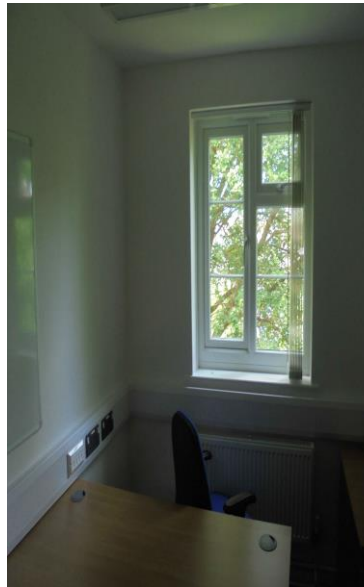
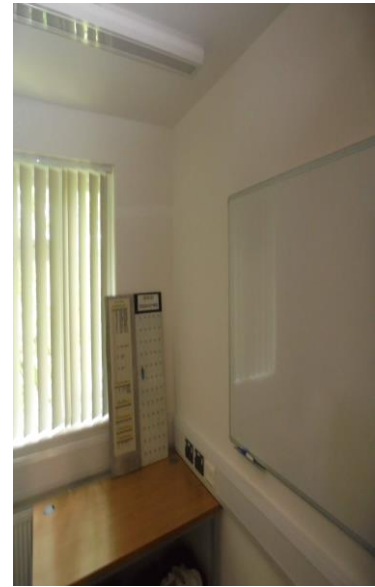
**Item No: 19****Sample No: N/A****Location: First Floor – Offices**

Material Description:	Visual Inspection – No Suspect Materials Found	
Identification:	N/A	
Approx. quantity:	N/A	
Accessibility	N/A	<i>Assessment Score</i>
Product type:		N/A
Extent of Damage:		N/A
Surface Treatment:		N/A
Asbestos type:		N/A
Material Assessment Score:		N/A
Priority Assessment Score:		N/A
Action:	N/A	
Comments:	N/A

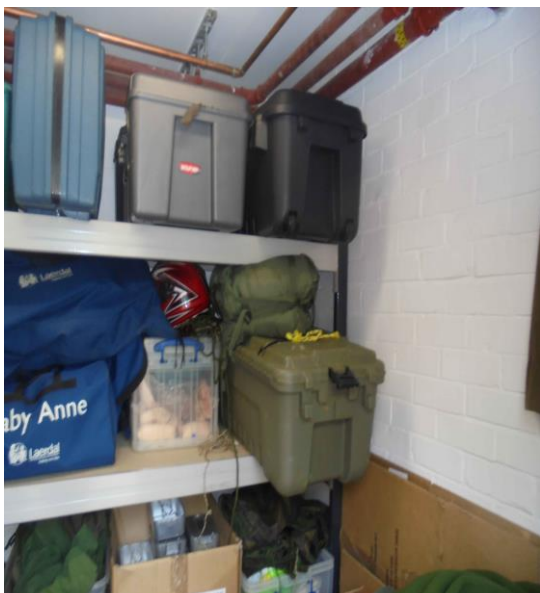
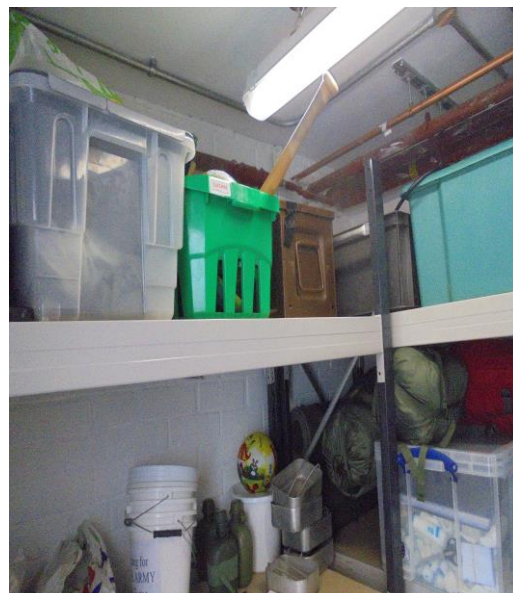
Item No: 20

Material Description:	Visual Inspection – No Suspect Materials Found	
Identification:	N/A	
Approx. quantity:	N/A	
Accessibility	N/A	<i>Assessment Score</i>
Product type:		N/A
Extent of Damage:		N/A
Surface Treatment:		N/A
Asbestos type:		N/A
Material Assessment Score:		N/A
Priority Assessment Score:		N/A
Action:	N/A	
Comments:	N/A

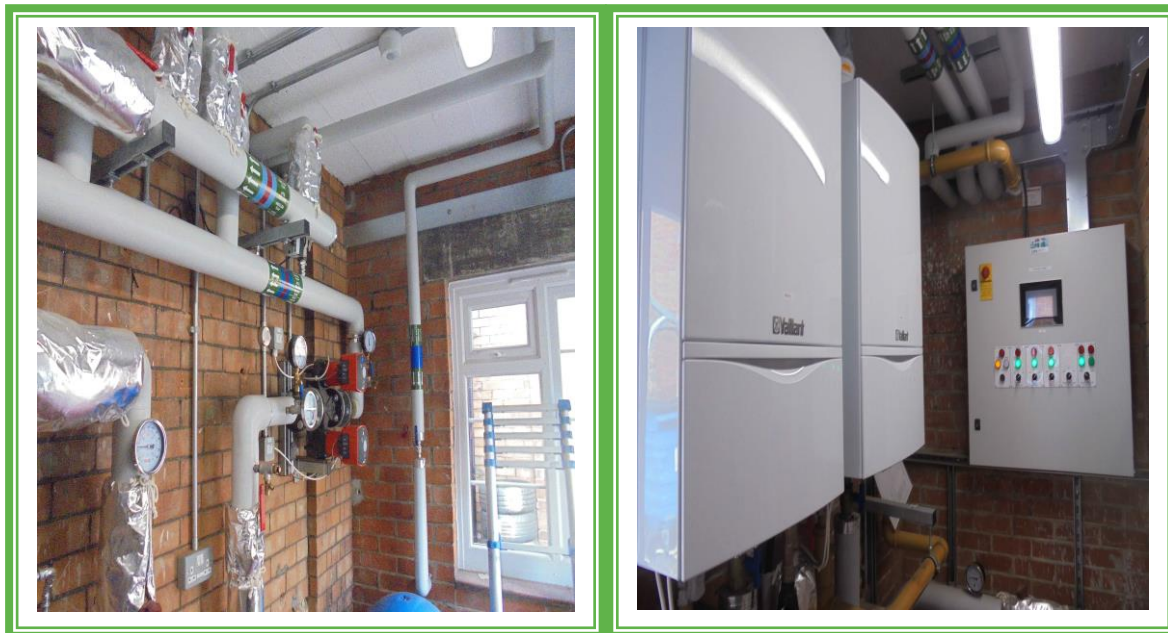
Item No: 21

Material Description:	Visual Inspection – No Suspect Materials Found	
Identification:	N/A	
Approx. quantity:	N/A	
Accessibility	N/A	<i>Assessment Score</i>
Product type:		N/A
Extent of Damage:		N/A
Surface Treatment:		N/A
Asbestos type:		N/A
Material Assessment Score:		N/A
Priority Assessment Score:		N/A
Action:	N/A	
Comments:	Modern Boilers, Pipework and gaskets

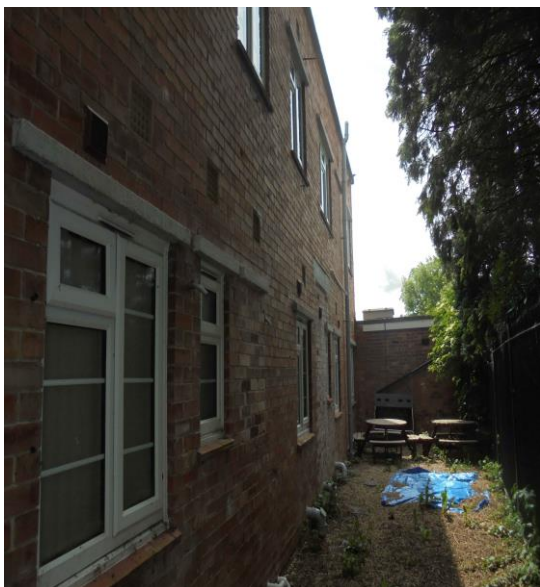
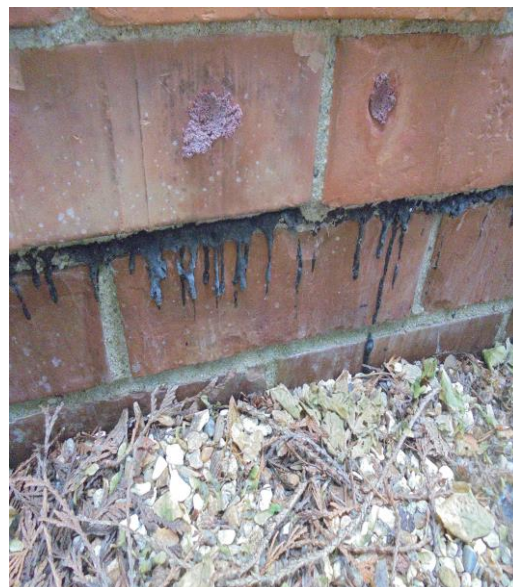
Item No: 22

Material Description:	Damp Proof Course	
Identification:	Sampled – No Asbestos Detected	
Approx. quantity:	To the Entire Perimeter	
Accessibility	N/A	<i>Assessment Score</i>
Product type:		N/A
Extent of Damage:		N/A
Surface Treatment:		N/A
Asbestos type:		N/A
Material Assessment Score:		N/A
Priority Assessment Score:		N/A
Action:	N/A	
Comments:	N/A

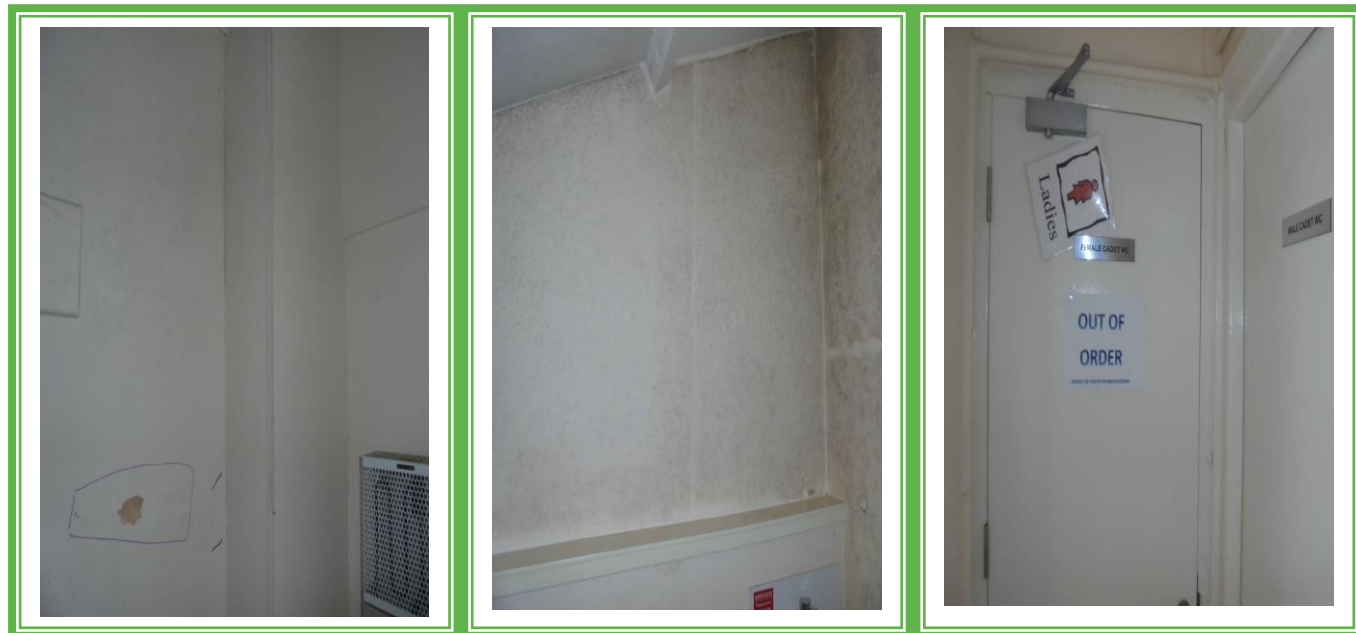
Item No: 23

Material Description:	Visual Inspection – No Suspect Materials Found	
Identification:	N/A	
Approx. quantity:	N/A	
Accessibility	N/A	<i>Assessment Score</i>
Product type:		N/A
Extent of Damage:		N/A
Surface Treatment:		N/A
Asbestos type:		N/A
Material Assessment Score:		N/A
Priority Assessment Score:		N/A
Action:	N/A	
Comments:	No access within timber boxings

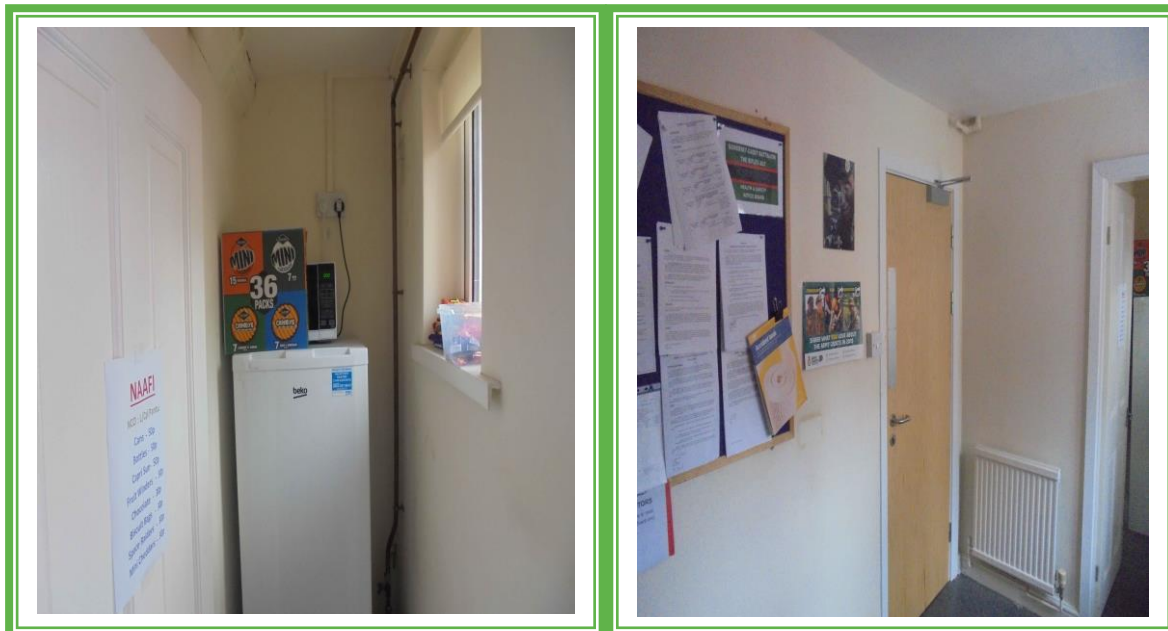
Item No: 24

Material Description:	Visual Inspection – No Suspect Materials Found	
Identification:	N/A	
Approx. quantity:	N/A	
Accessibility	N/A	<i>Assessment Score</i>
Product type:		N/A
Extent of Damage:		N/A
Surface Treatment:		N/A
Asbestos type:		N/A
Material Assessment Score:		N/A
Priority Assessment Score:		N/A
Action:	N/A	
Comments:	N/A

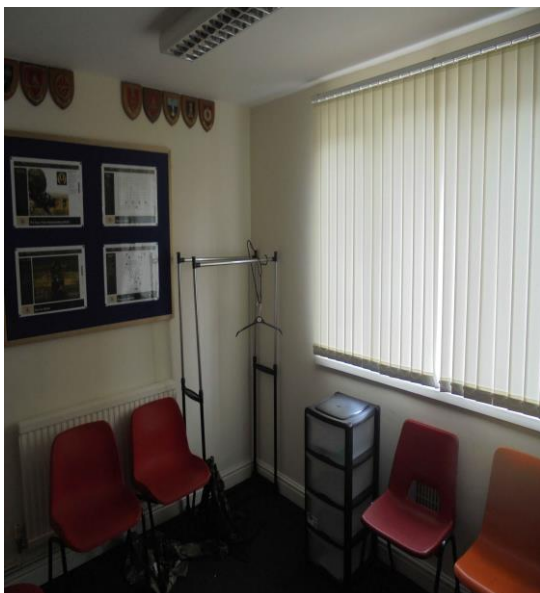
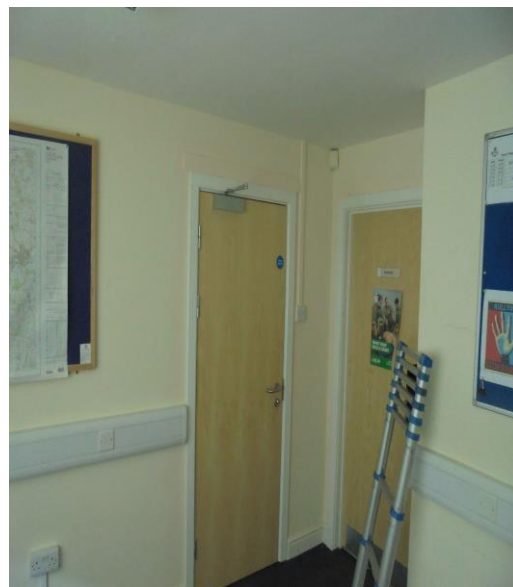
**Item No: 25****Sample No: N/A****Location: House – Ground Floor – Classroom 1**

Material Description:	Visual Inspection – No Suspect Materials Found	
Identification:	N/A	
Approx. quantity:	N/A	
Accessibility	N/A	<i>Assessment Score</i>
Product type:		N/A
Extent of Damage:		N/A
Surface Treatment:		N/A
Asbestos type:		N/A
Material Assessment Score:		N/A
Priority Assessment Score:		N/A
Action:	N/A	
Comments:	N/A

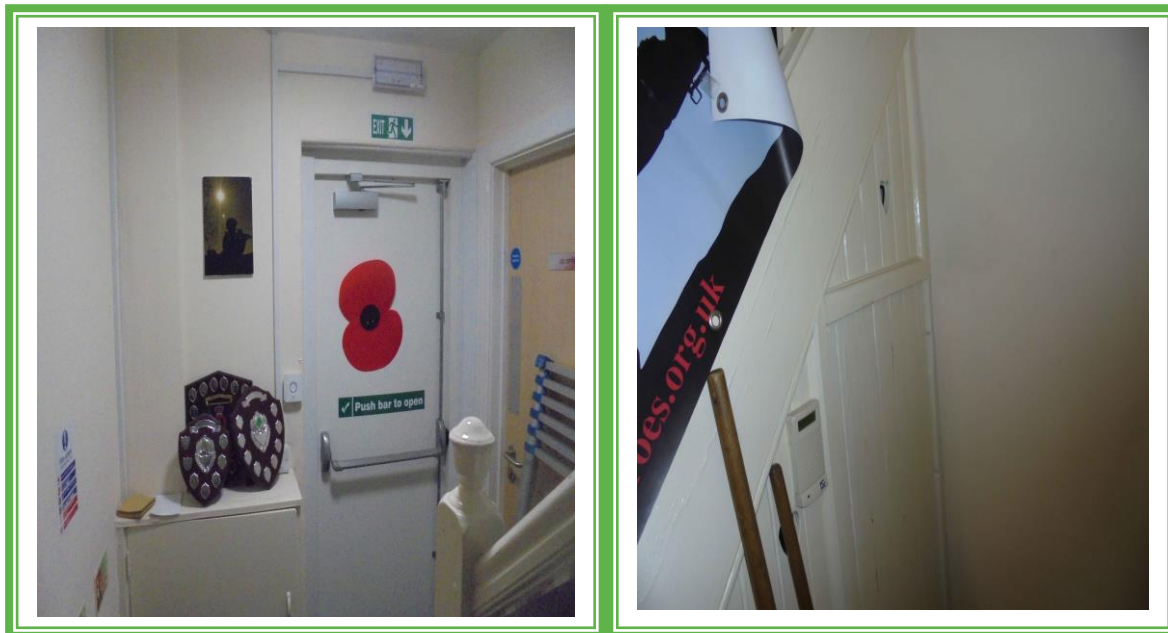
Item No: 26

Material Description:	Visual Inspection – No Suspect Materials Found	
Identification:	N/A	
Approx. quantity:	N/A	
Accessibility	N/A	<i>Assessment Score</i>
Product type:		N/A
Extent of Damage:		N/A
Surface Treatment:		N/A
Asbestos type:		N/A
Material Assessment Score:		N/A
Priority Assessment Score:		N/A
Action:	N/A	
Comments:	Modern electrics. No access within under stairs cupboard as it was sealed shut

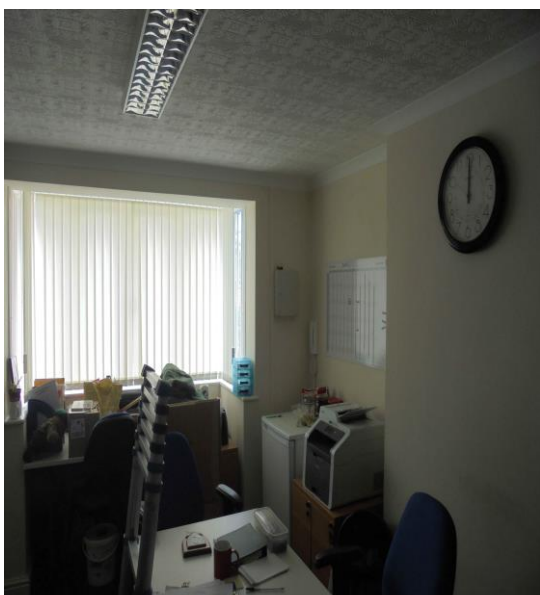
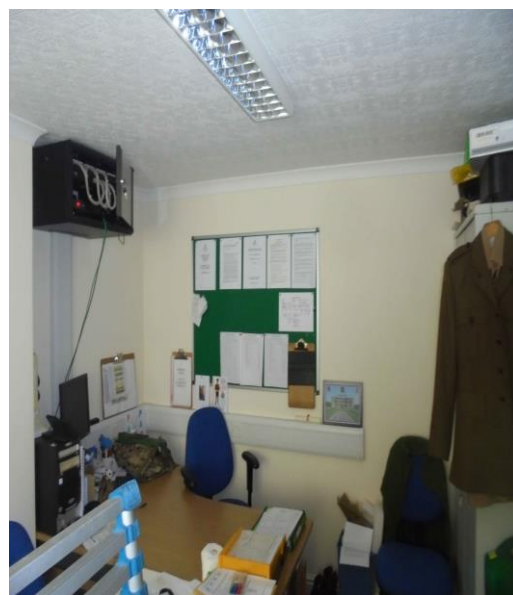
Item No: 27

Material Description:	Visual Inspection – No Suspect Materials Found	
Identification:	N/A	
Approx. quantity:	N/A	
Accessibility	N/A	<i>Assessment Score</i>
Product type:		N/A
Extent of Damage:		N/A
Surface Treatment:		N/A
Asbestos type:		N/A
Material Assessment Score:		N/A
Priority Assessment Score:		N/A
Action:	N/A	
Comments:	N/A
