Project Number 2481

**Management
Asbestos Survey Report**

**675 Army Air Corps, Yeovil, Somerset,
BA21 4JA**

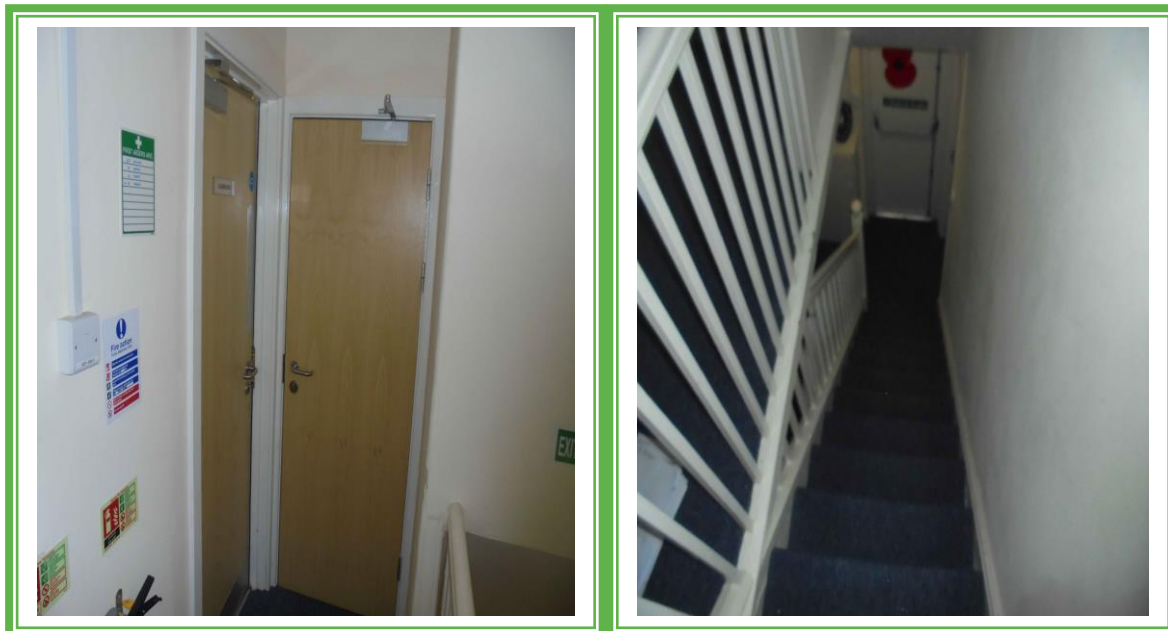
Item No: 28

Material Description:	Visual Inspection – No Suspect Materials Found	
Identification:	N/A	
Approx. quantity:	N/A	
Accessibility	N/A	<i>Assessment Score</i>
Product type:		N/A
Extent of Damage:		N/A
Surface Treatment:		N/A
Asbestos type:		N/A
Material Assessment Score:		N/A
Priority Assessment Score:		N/A
Action:	N/A	
Comments:	N/A

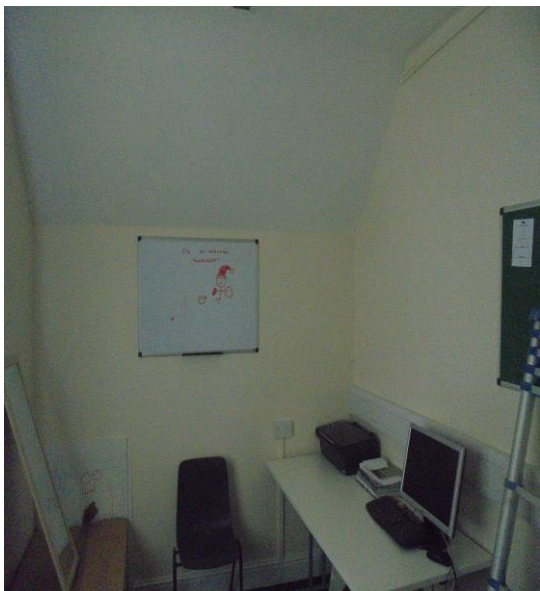
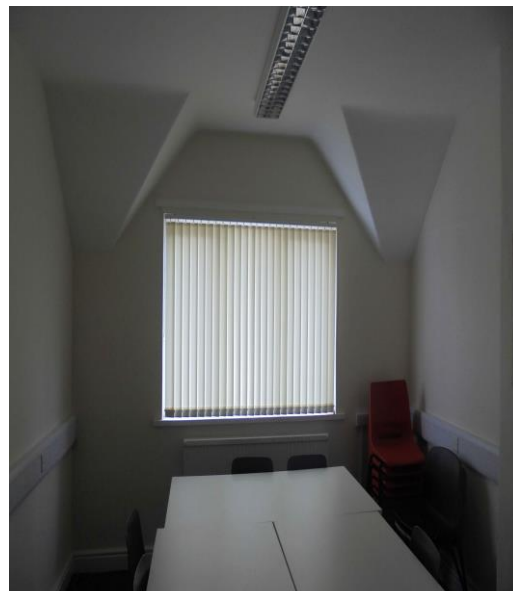
Item No: 29

Material Description:	Visual Inspection – No Suspect Materials Found	
Identification:	N/A	
Approx. quantity:	N/A	
Accessibility	N/A	<i>Assessment Score</i>
Product type:		N/A
Extent of Damage:		N/A
Surface Treatment:		N/A
Asbestos type:		N/A
Material Assessment Score:		N/A
Priority Assessment Score:		N/A
Action:	N/A	
Comments:	N/A

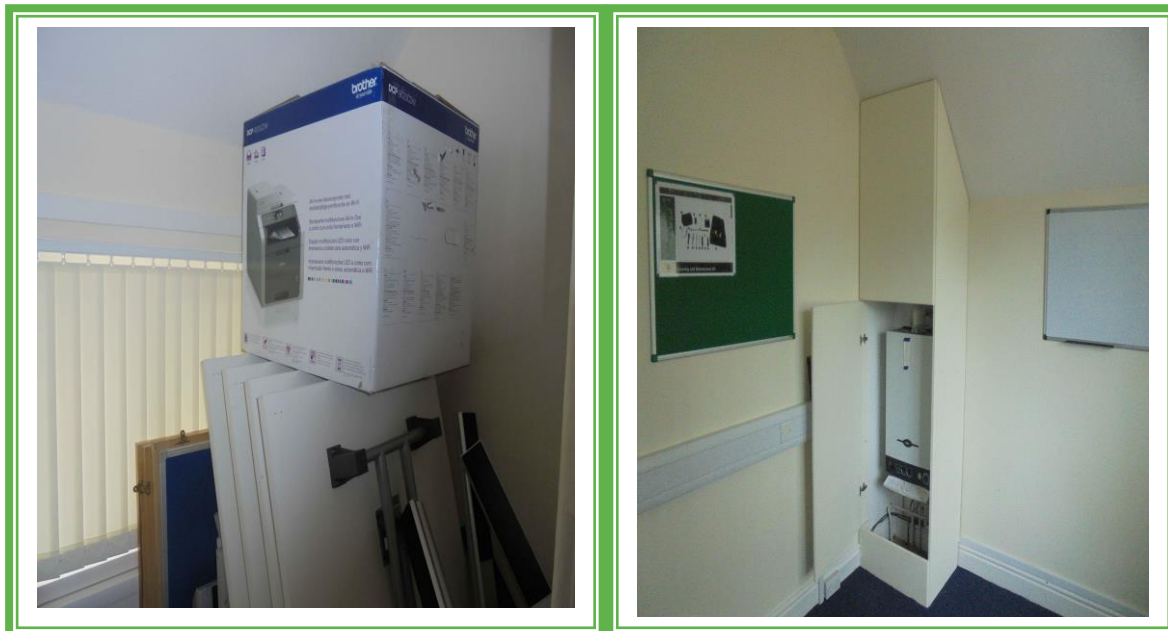
Item No: 30

Material Description:	Visual Inspection – No Suspect Materials Found	
Identification:	N/A	
Approx. quantity:	N/A	
Accessibility	N/A	<i>Assessment Score</i>
Product type:		N/A
Extent of Damage:		N/A
Surface Treatment:		N/A
Asbestos type:		N/A
Material Assessment Score:		N/A
Priority Assessment Score:		N/A
Action:	N/A	
Comments:	Modern Baxi boiler. Limited access into store due to stored items

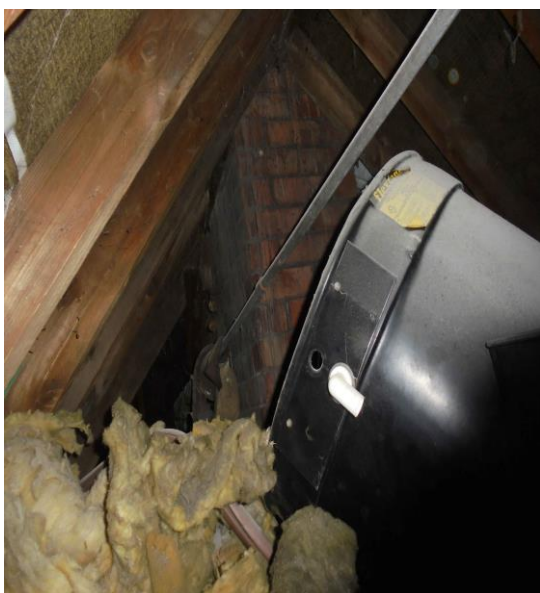
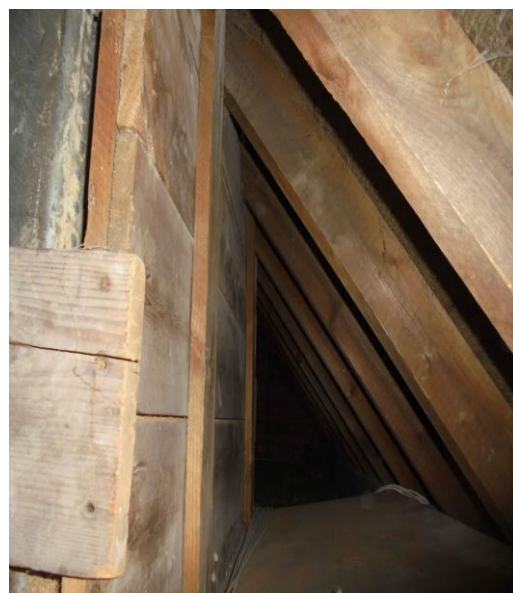
Item No: 31

Material Description:	Visual Inspection – No Suspect Materials Found	
Identification:	N/A	
Approx. quantity:	N/A	
Accessibility	N/A	<i>Assessment Score</i>
Product type:		N/A
Extent of Damage:		N/A
Surface Treatment:		N/A
Asbestos type:		N/A
Material Assessment Score:		N/A
Priority Assessment Score:		N/A
Action:	N/A	
Comments:	Limited access into loft due to lack of space. Non-asbestos roof felt
