**Project Number 2481**

**Management  
Asbestos Survey Report**

**Wotton Platoon, Old Grammar School,  
Gloucestershire, GL12 7JL**

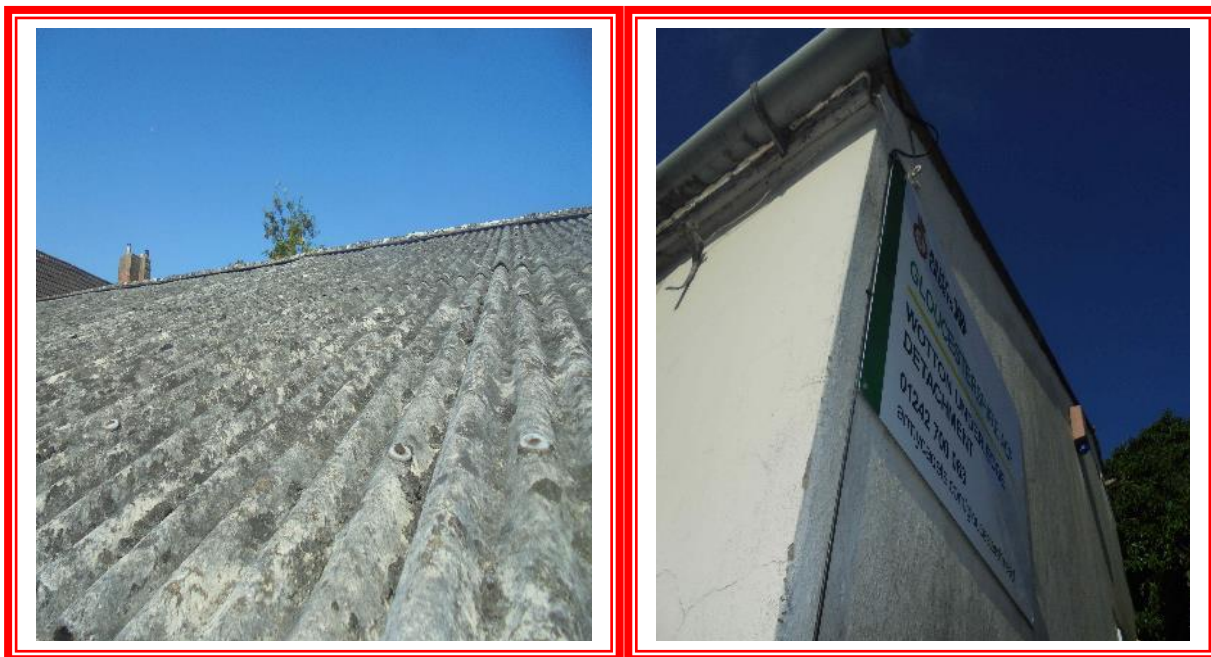
**Item No: 5**

| <b>Material Description:</b> | Profiled Cement Roof | |
| <b>Identification:</b> | Sampled – Asbestos Detected | |
| <b>Approx. quantity:</b> | 84M2 | |
| <b>Extent of Damage:</b> | Minor | 1 |
| <b>Material Assessment Score:</b> | | 4 |
| <b>Priority Assessment Score:</b> | | Negligible |

| Sample No. | Sample Ref. | Location | Asbestos Detected | Asbestos Type |
|---|---|---|---|---|
| DK/1 | BS565949 | External. Profiled cement roof | Yes | Chrysotile |

| <b>Action:</b> | Manage | |

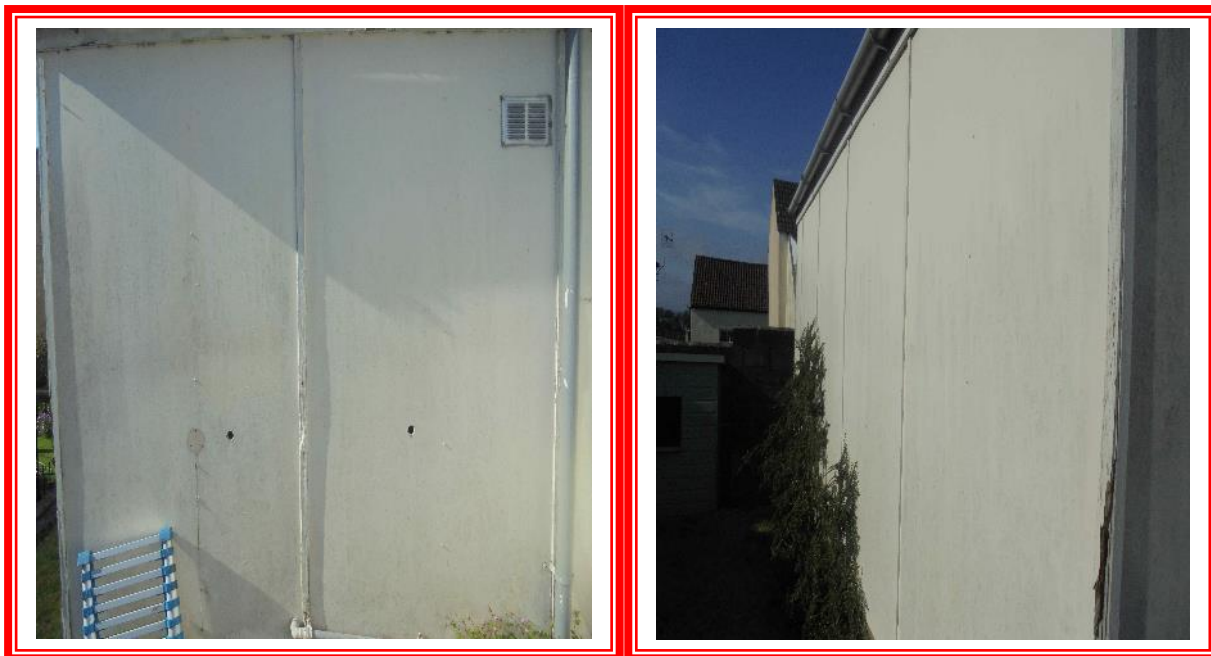
**Item No: 6****Sample No: DK/2****Location: External to Extension**

| <b>Material Description:</b> | Flat Sheet Cement Wall Panels | |
| <b>Identification:</b> | Sampled – Asbestos Detected | |
| <b>Approx. quantity:</b> | 20M2 | |
| <b>Extent of Damage:</b> | Moderate | 2 |
| <b>Material Assessment Score:</b> | | 5 |
| <b>Priority Assessment Score:</b> | | Low |
| <b>Comments:</b> | Holes have been drilled into panels – encapsulate holes and any other visible damage | |

| Sample No. | Sample Ref. | Location | Asbestos Detected | Asbestos Type |
|---|---|---|---|---|
| DK/2 | BS565950 | External. Flat sheet cement wall panels | Yes | Chrysotile |

| <b>Action:</b> | Encapsulate/Manage | |

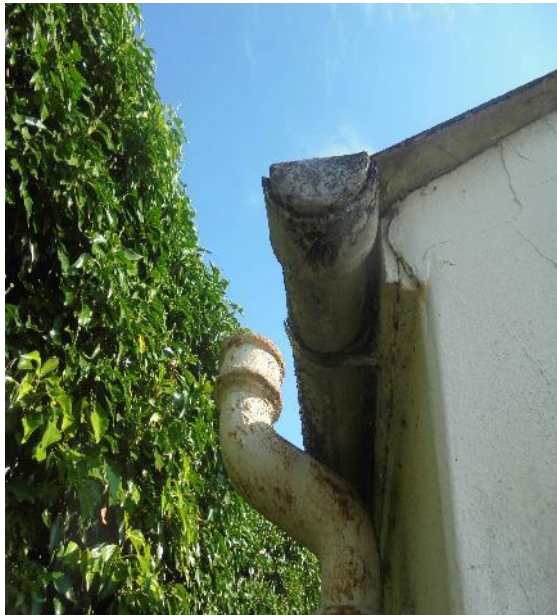
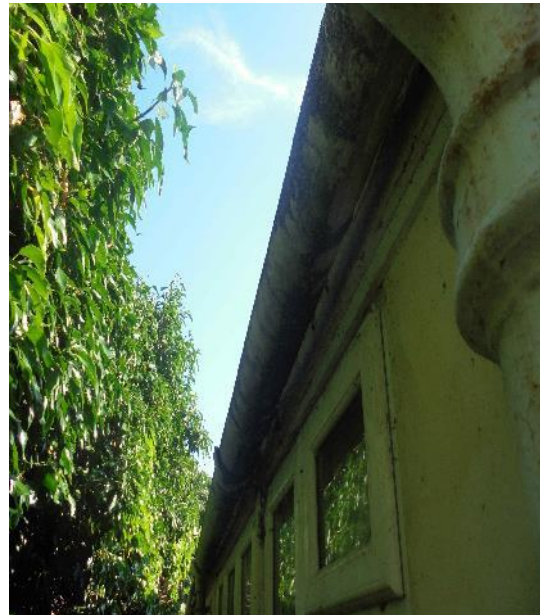
**Item No: 7****Sample No: DK/3****Location: External**

| <b>Material Description:</b> | Cement Guttering | |
| <b>Identification:</b> | Sampled – Asbestos Detected | |
| <b>Approx. quantity:</b> | 12LM | |
| <b>Extent of Damage:</b> | Minor | 1 |
| <b>Material Assessment Score:</b> | | 4 |
| <b>Priority Assessment Score:</b> | | Negligible |

| Sample No. | Sample Ref. | Location | Asbestos Detected | Asbestos Type |
|---|---|---|---|---|
| DK/3 | BS565951 | External. Cement guttering | Yes | Chrysotile |

| <b>Action:</b> | Manage | |

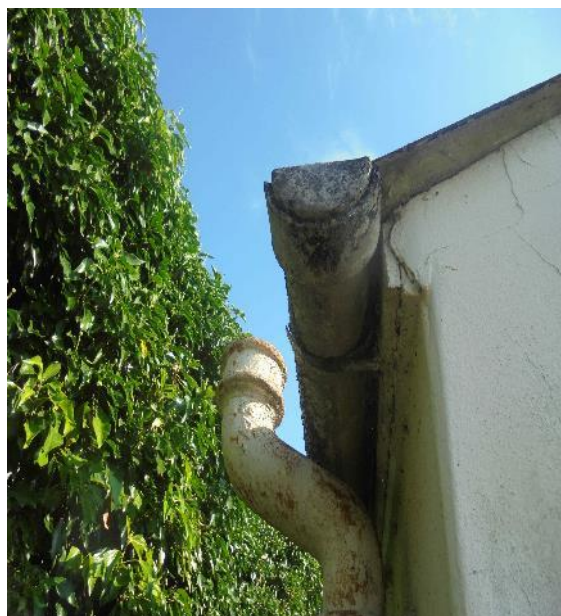
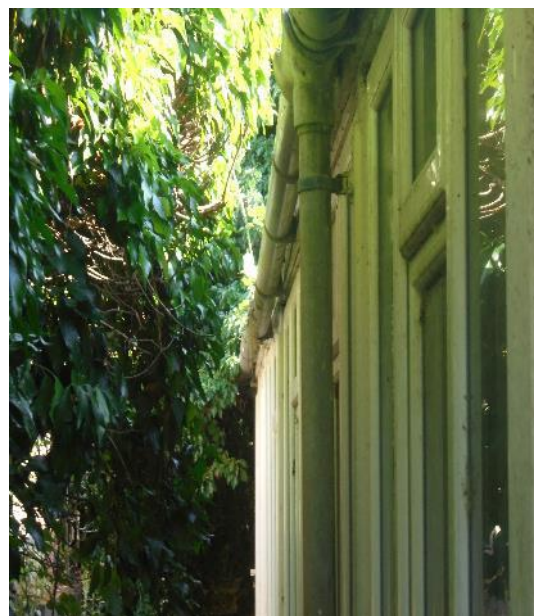
**Item No: 8****Sample No: N/A****Location: External**

| <b>Material Description:</b> | Cement Downpipes | |
| <b>Identification:</b> | As Per Sample DK/3 – Asbestos Detected | |
| <b>Approx. quantity:</b> | 2 x Pipes (6LM Total) | |
| <b>Extent of Damage:</b> | Minor | 1 |
| <b>Material Assessment Score:</b> | | 4 |
| <b>Priority Assessment Score:</b> | | Negligible |
| <b>Comments:</b> | Limited access around building due to overgrown vegetation. | |

| <b>Action:</b> | Manage | |

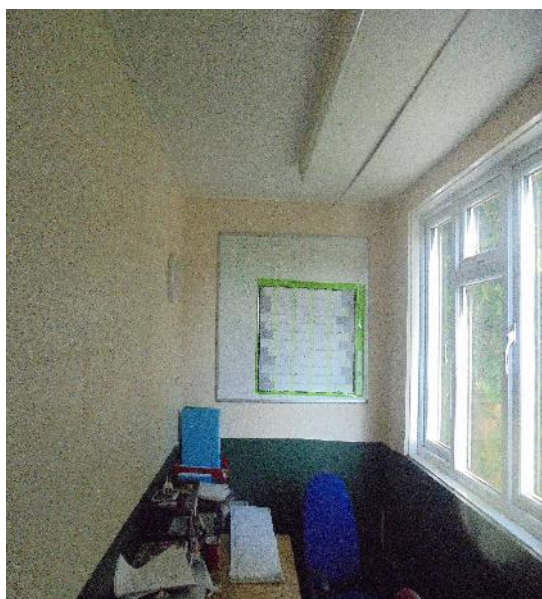
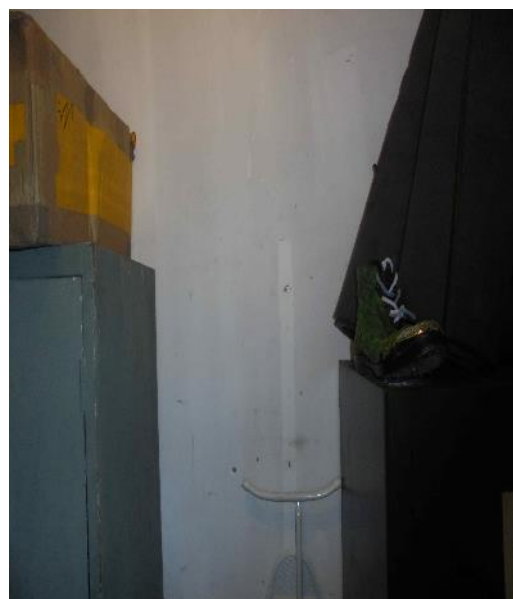
**Item No: 1**

| <b>Material Description:</b> | Visual Inspection – No Suspect Materials Found | |

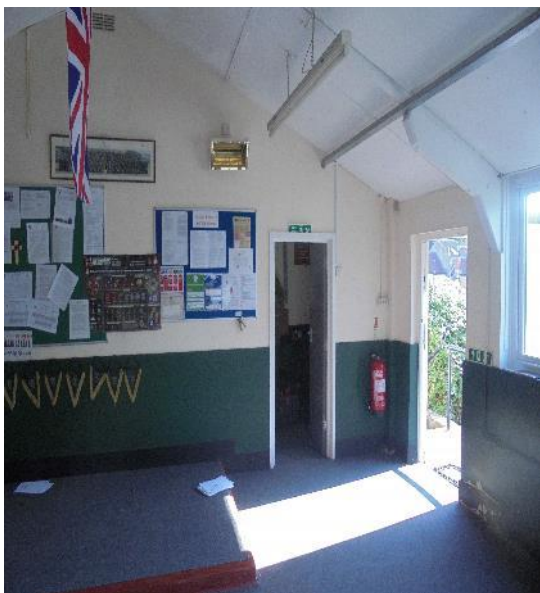
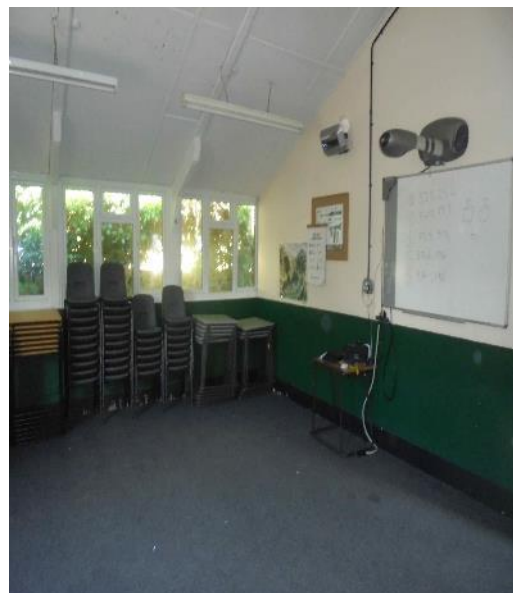
**Item No: 2****Sample No: N/A****Location: Classrooms x 2**

| <b>Material Description:</b> | Visual Inspection – No Suspect Materials Found | |

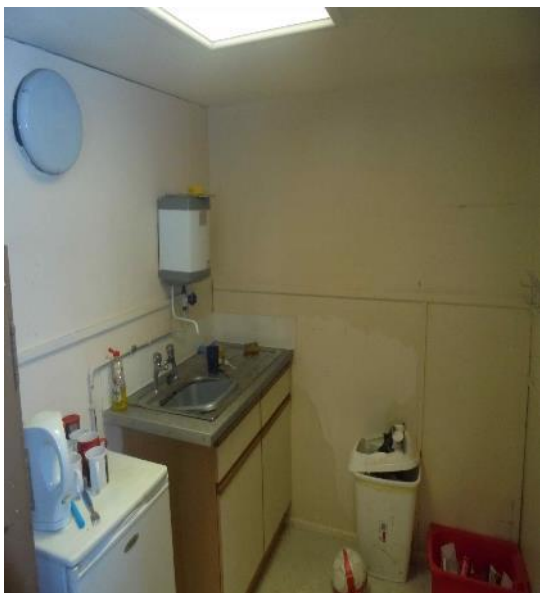
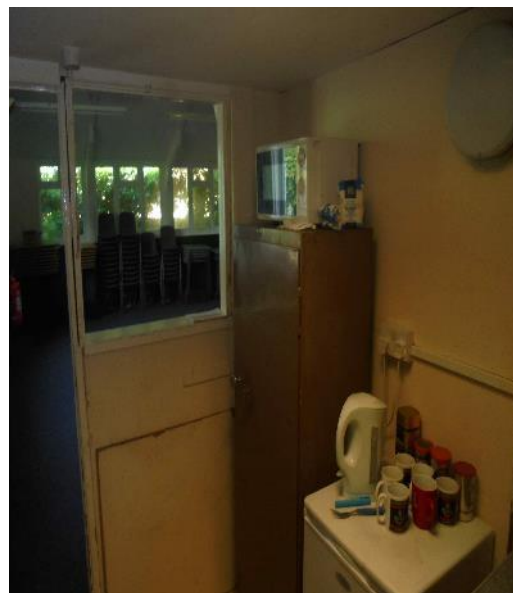
**Item No: 3****Sample No: N/A****Location: Kitchen**

| <b>Material Description:</b> | Visual Inspection – No Suspect Materials Found | |
| <b>Comments:</b> | Modern sink pad | |

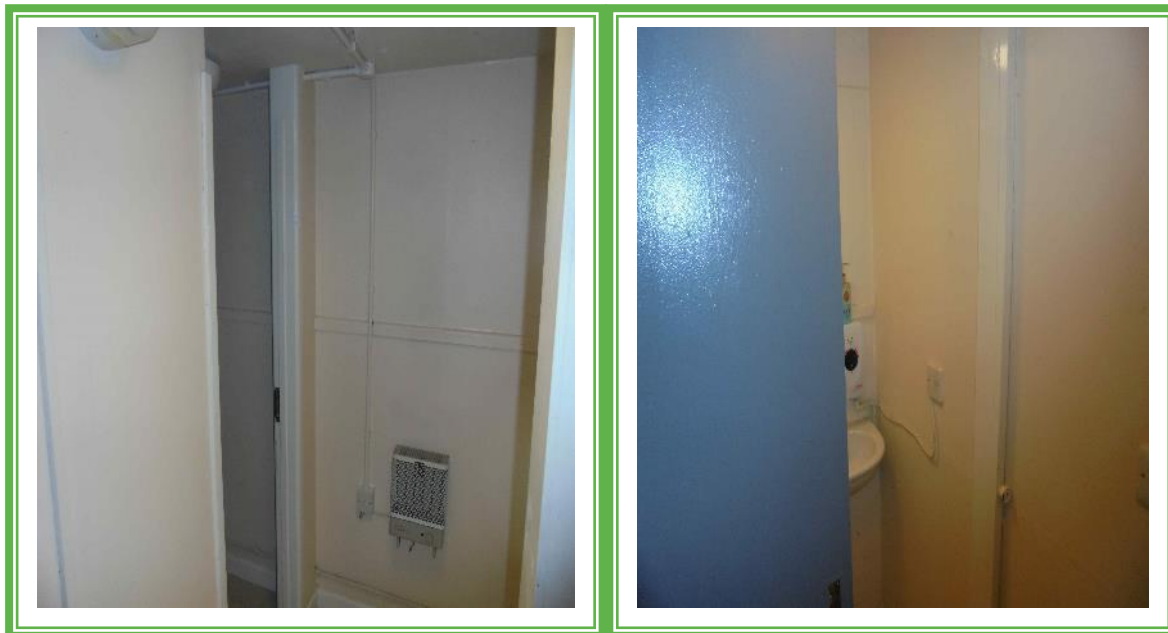
**Item No: 4**

| <b>Material Description:</b> | Visual Inspection – No Suspect Materials Found | |
